GREAT BOWDEN HERITAGE & ARCHAEOLOGY

EXCAVATION AT THE STRIP, GREAT BOWDEN

17TH-18TH JULY 2010

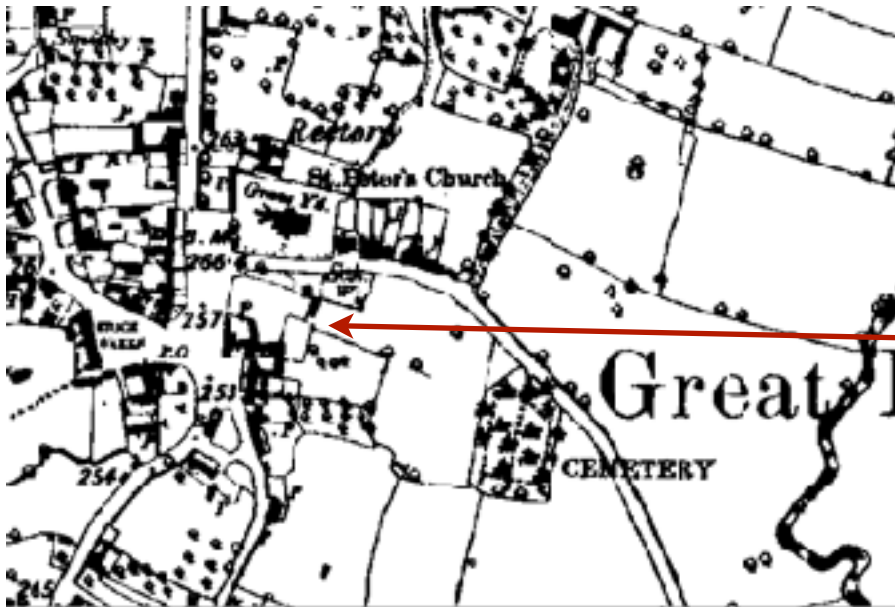
OS Map from 1891
(surveyed during the 1880s)

Nineteenth century maps indicate that the paddock was occupied by a large building occupying most of its width. As no garden area is shown on the maps this was probably a barn with a short piece of wall completing the bisection of the paddock. Nothing remains visible above ground and it was the foundations of this barn that the excavation hoped to discover. It is not clear from the maps whether the barn's main access is from the West, through the brick gateposts or from the East via Christchurch paddock.

Arrows indicates former building and area of excavation.

The stone foundations found in Pits 2 and 6 would appear to relate to the barn shown on the 1891 map. The large quantity of ceramic tile and brick debris suggests that this barn was brick built and probably with a tile roof. The barn or other building shown the earlier 1843 estate map may have been a different building and the earlier date suggests it could have been of mud and thatch construction, the predominant construction material at the time, similar to the mud barn still in existence in Sutton Road, Great Bowden. (*This barn has been demolished since 2010*) However the brick works in Bowden started around 1811 and so local bricks would have been available for construction perhaps for higher status buildings such as houses but not for barns.

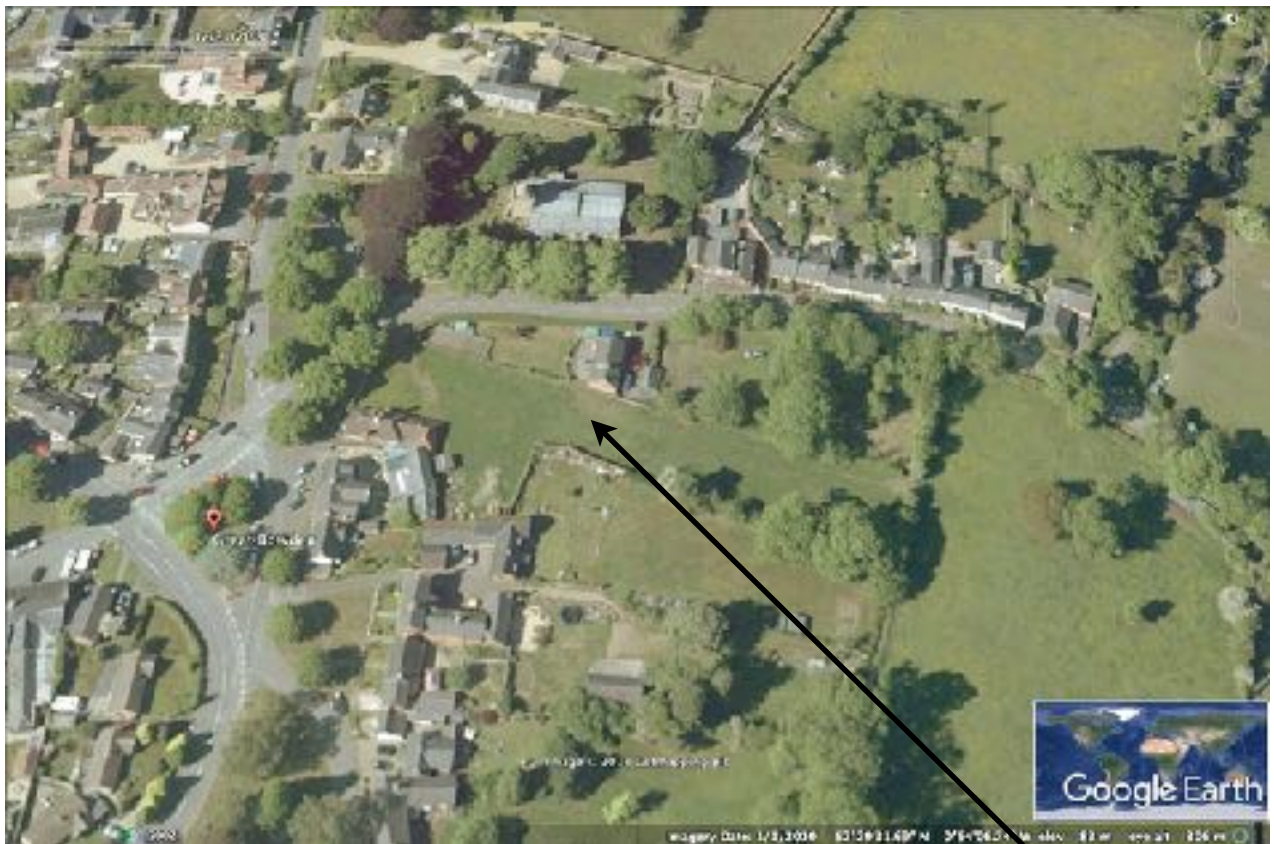
Google Earth photograph taken in 2010. Arrow shows the paddock.

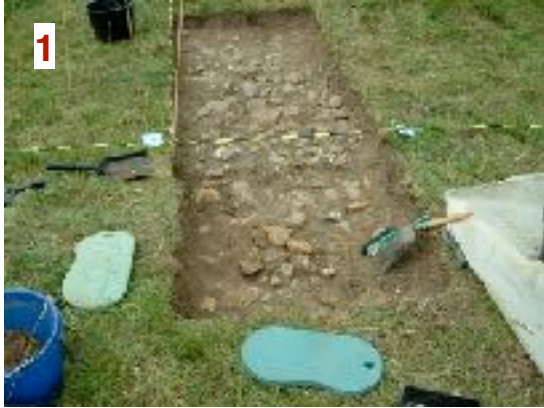
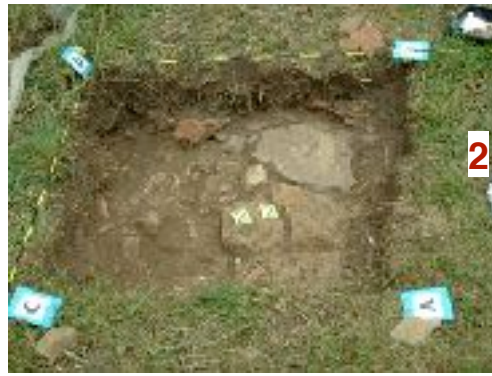
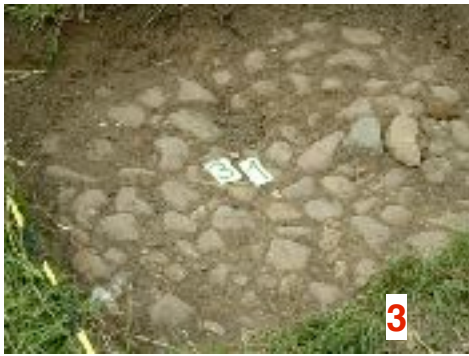
Photographs:

1. Pit 1 rough stone surface
2. Pit 2 stone foundations
3. Pit 3 cobbled surface
4. Excavating Pit 6
5. and 6. Team excavating
7. 8. 9. The Festival visitors working on the site

The floor or yard surface at the eastern end of the gridded site was of a rougher nature to the neater cobbled surfaces unearthed at the western side of the site and could be from a different building. If there were mud walls and thatched roofs they would have decayed into the ground leaving no evidence behind.

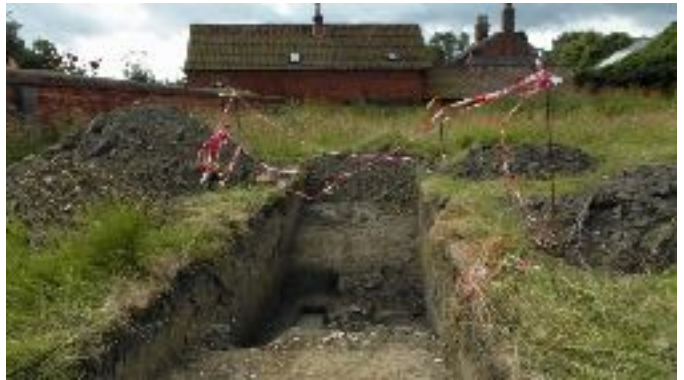
ULAS excavations 2016 in The Strip. Trench revealed deep ditch - no further information

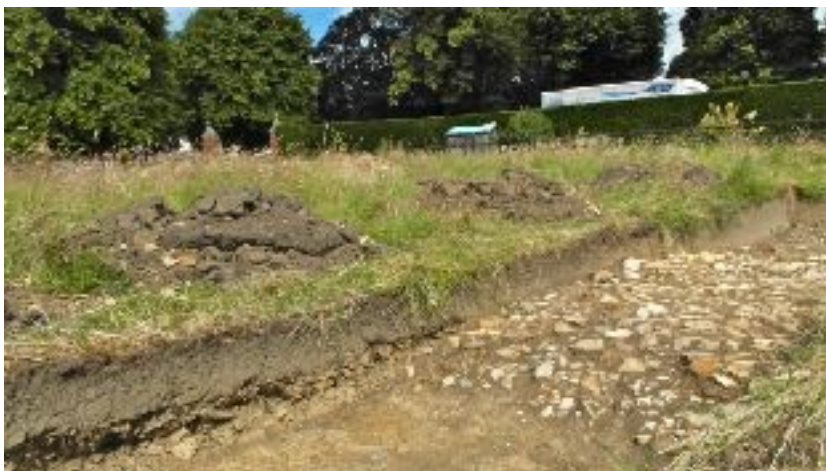
ULAS excavations in 2016. Stone surface in similar position to our excavations in 2010. Note the brick gateposts in the distance on Dingley Road.
