Portelet Hotel, Kalima, and Aisling, Le Chemin du Portelet, St Brelade, JE3 8AU

Project: Report Archaeological Trench Evaluation

Client/Agent Name: Cote Ouest Ltd./Godel Architects
Project Site: Portelet Hotel, Kalima, and Aisling, Le Chemin du Portelet, JE3
8AU
NGR: UTM 60500 47600
Document Type: Trench Evaluation Report
Issue Number: 1.0
Date of Preparation: 07-01-2016
Oasis Reference: heritage10-236873
Museum Accession Number: JHT/AA/00063
Local Planning Authority: States of Jersey
Planning Reference: P/2015/0015
HPS Site Code: HPS-109/15
Fieldwork Dates: 19/10/2015 – 21/10/2015
OS Licence: 100048201

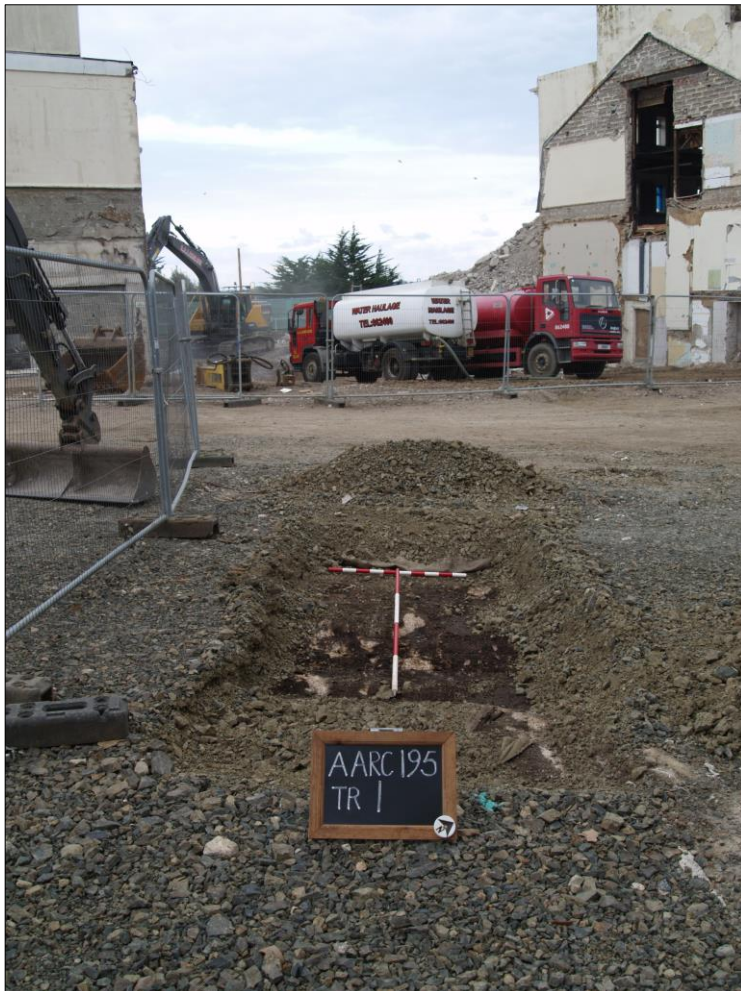
4.2. Trench One (3.5mx1.7m) was orientated ESE-WNW and revealed a layer of modern hardcore material (100) directly overlying the natural geology (101). It is believed that the topsoil/subsoil was removed prior to the laying of the hardcore.

4.3. No archaeological features were identified in Trench One and no finds were recovered from the spoil.

Photo 1 WNW facing view of Trench One (1x2m, 1x1m)

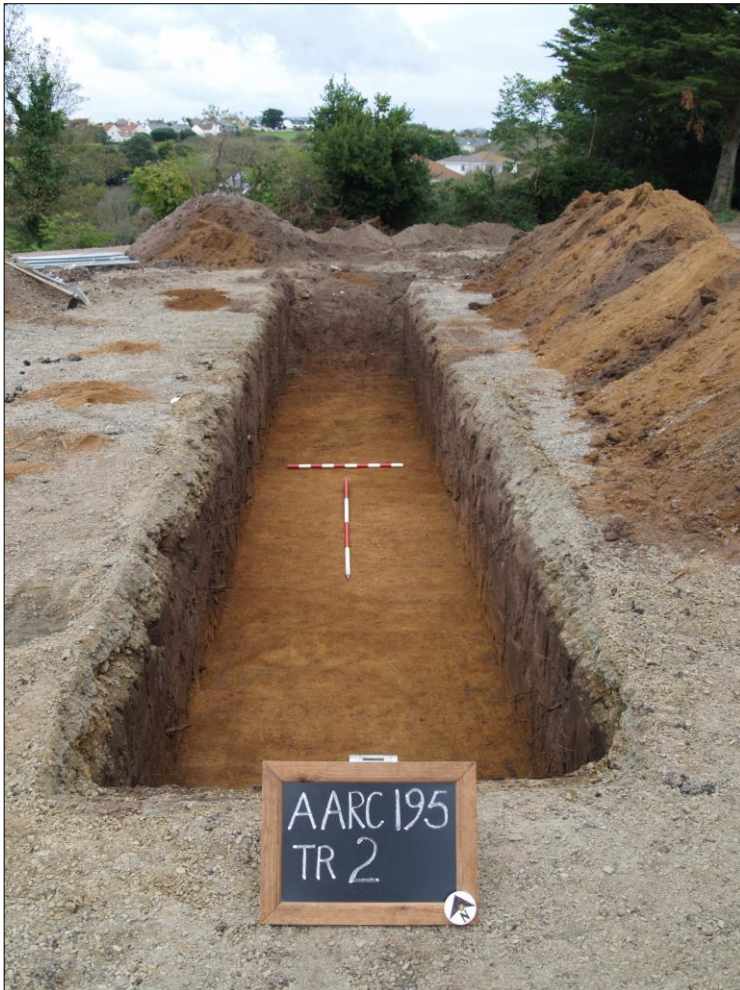
4.4. Trench Two (12mx1.7m) was orientated NNE-SSW and revealed a modern make-up layer (200) which measured approximately 100mm in depth. This layer (200) directly overlaid up to 800mm of topsoil (201) which can be described as a loamy sand and, in turn, overlaid the sandy scree subsoil (202). Directly beneath the subsoil (202) lay the natural geology (203).

4.5. No archaeological features were identified in Trench Two and no finds were recovered from the spoil.

Photo 2 NNE facing view of Trench Two (1x2m, 1x1m)

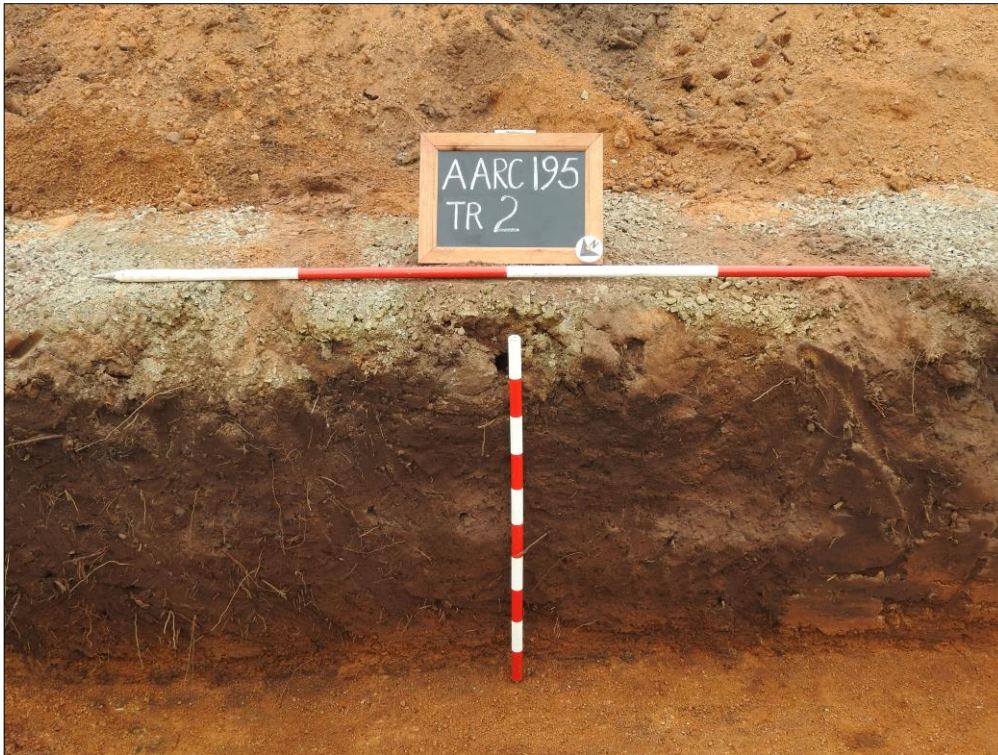
Photo 3 WNW facing section of Trench 2 (1x2m, 1x1m)

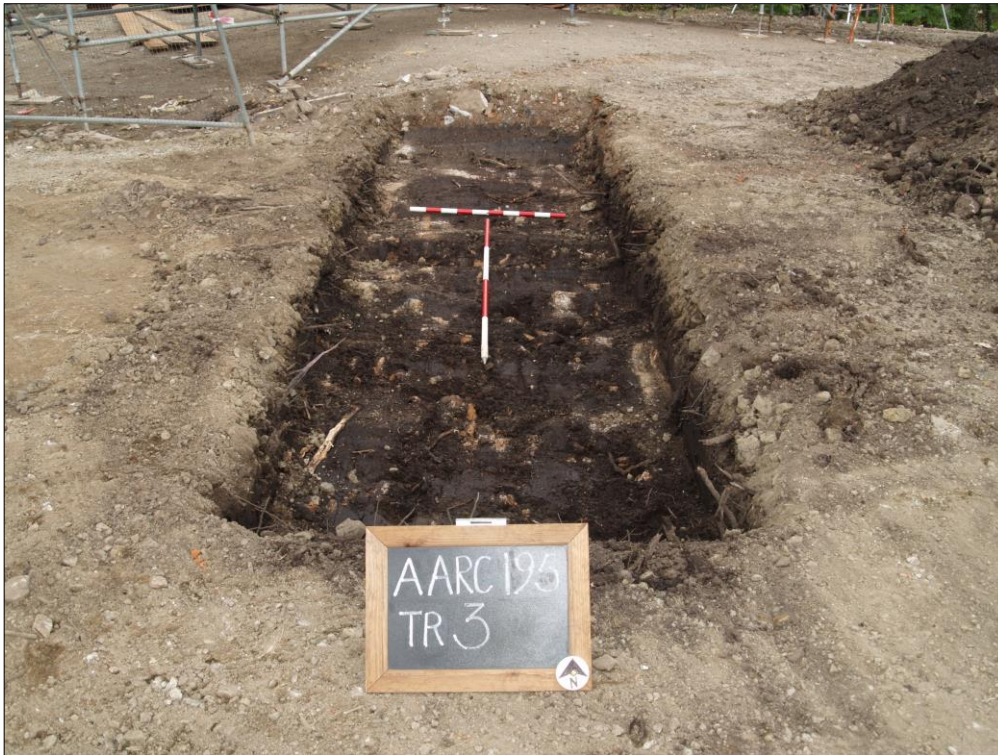
- 4.6. Trench Three (6mx1.7m) was orientated north-south and revealed an overburden (300) of up to 150mm. This covered a very dark layer with a high organic content with a sandy consistency (301) which overlaid the natural geology (302).
- 4.7. No archaeological features were identified in Trench Three and no finds were recovered from the spoil.

Photo 4 South facing view of Trench 3 (1x2m, 1x1m)

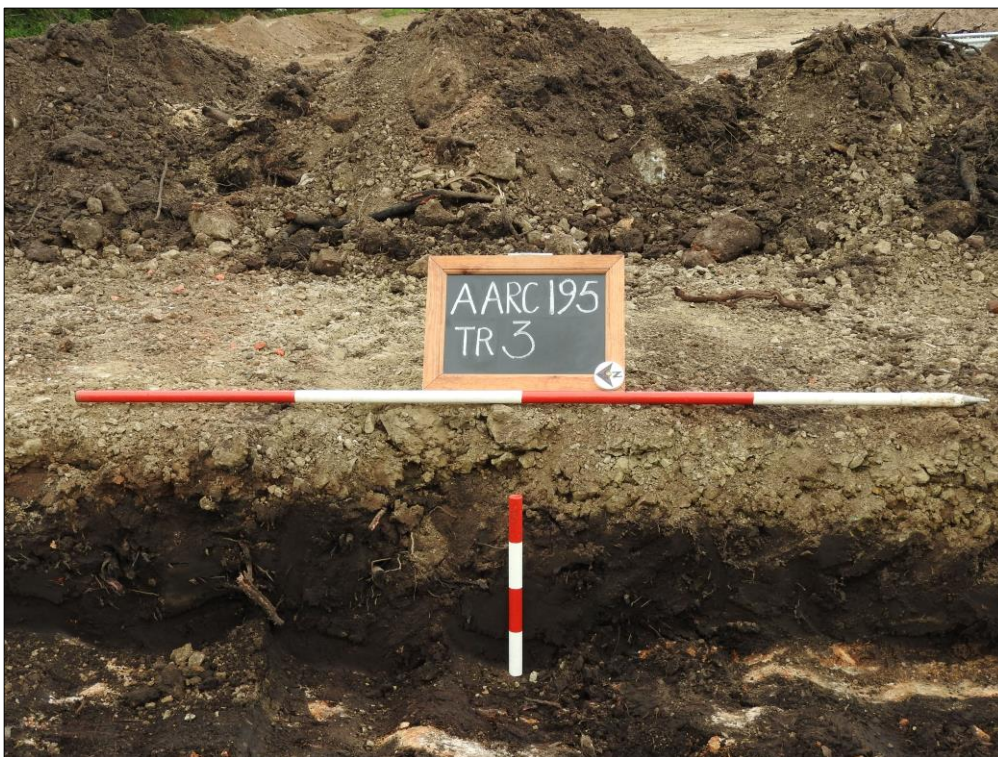
Photo 5 West facing section of Trench 3 (1x400mm, 1x2m)

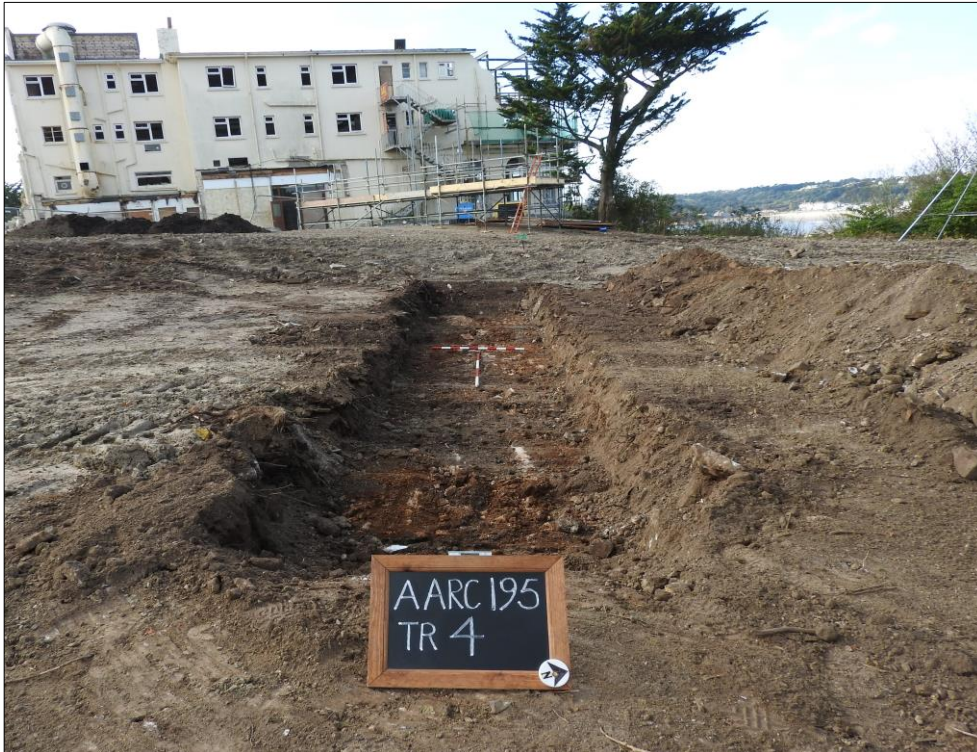
4.8. Trench Four (10mx1.7m) was orientated WNW-ESE and revealed made ground (400) of up to 500mm in places. This was present throughout the trench and directly overlaid the natural geology (401).

4.9. No archaeological features were identified in Trench Four and no finds were recovered from the spoil.

Photo 6 WNW facing view of Trench 4 (1x2m, 1x1m)

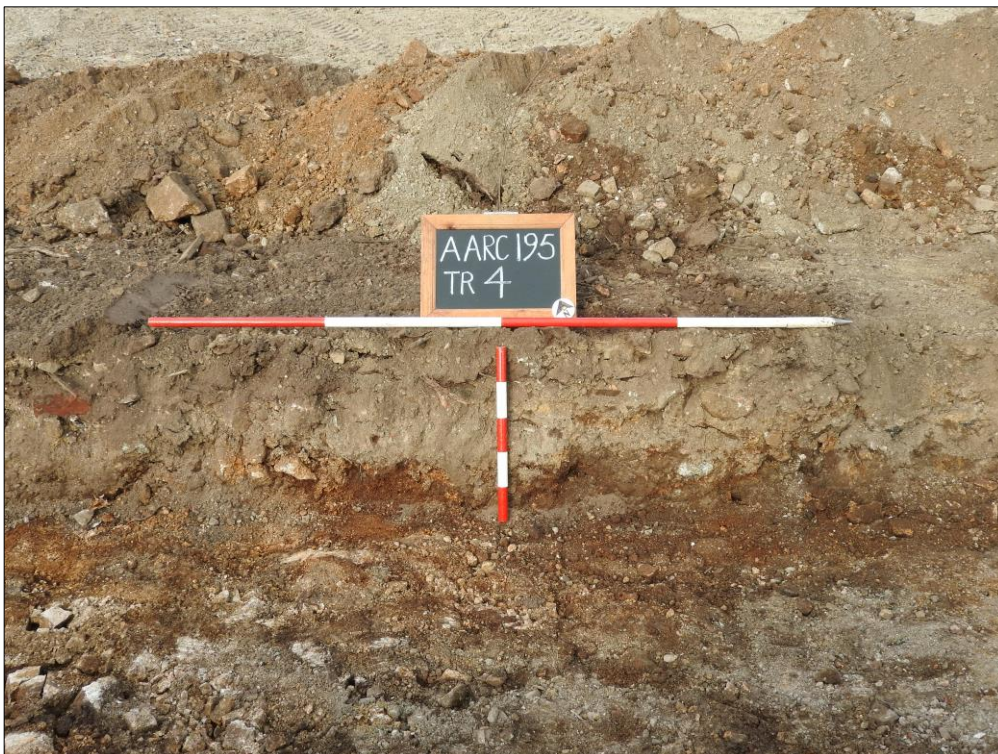
Photo 7 SSW facing section of Trench 4 (1x500mm, 1x2m)

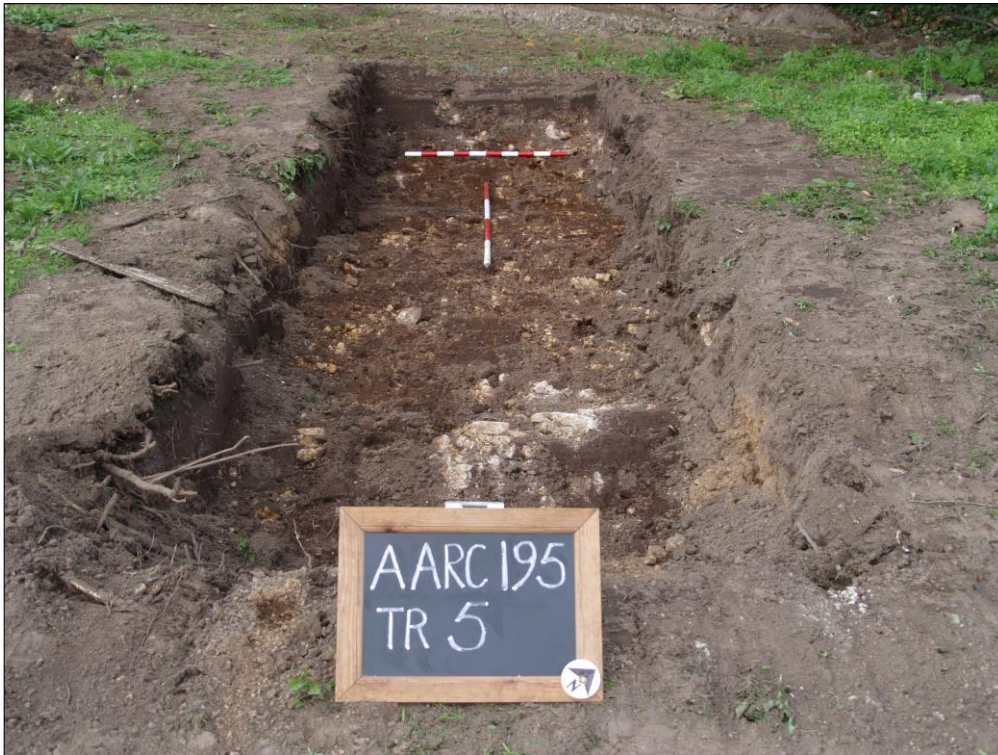
4.10. Trench Five (7mx1.7m) was orientated NW-SE and revealed 400mm of topsoil (500). This can be described as a sandy loam and overlaid the natural geology (501).

4.11. No archaeological features were identified in Trench Five and no finds were recovered from the spoil.

Photo 8 NW facing view of Trench 5 (1x2m, 1x1m)

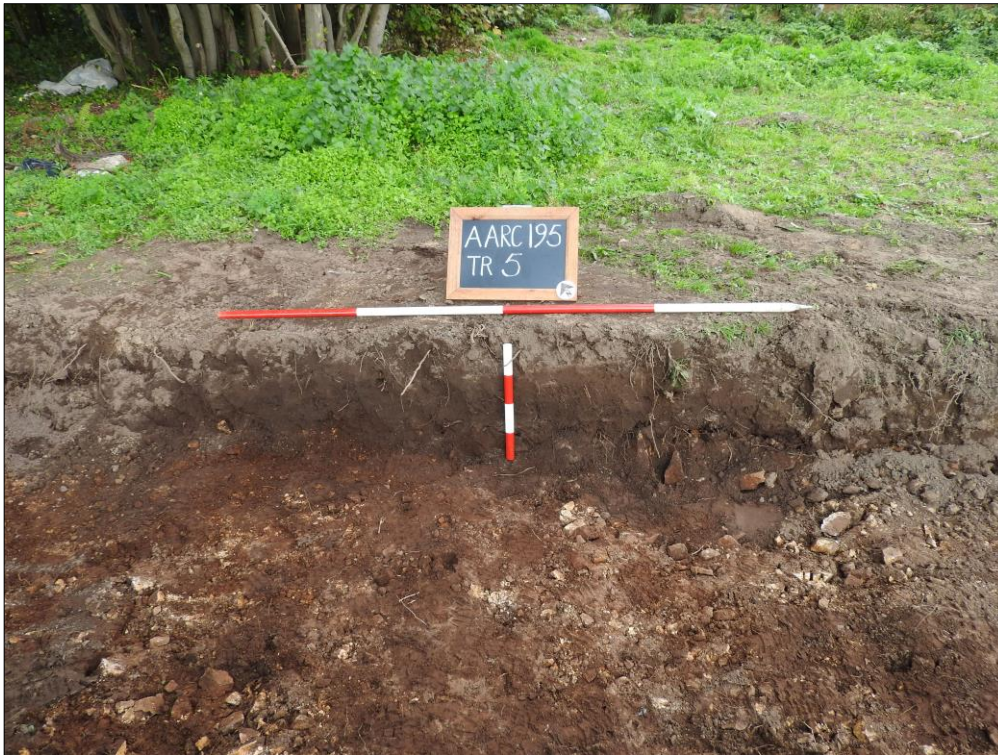
Photo 9 SW facing section of Trench 5 (1x400mm, 1x2m)

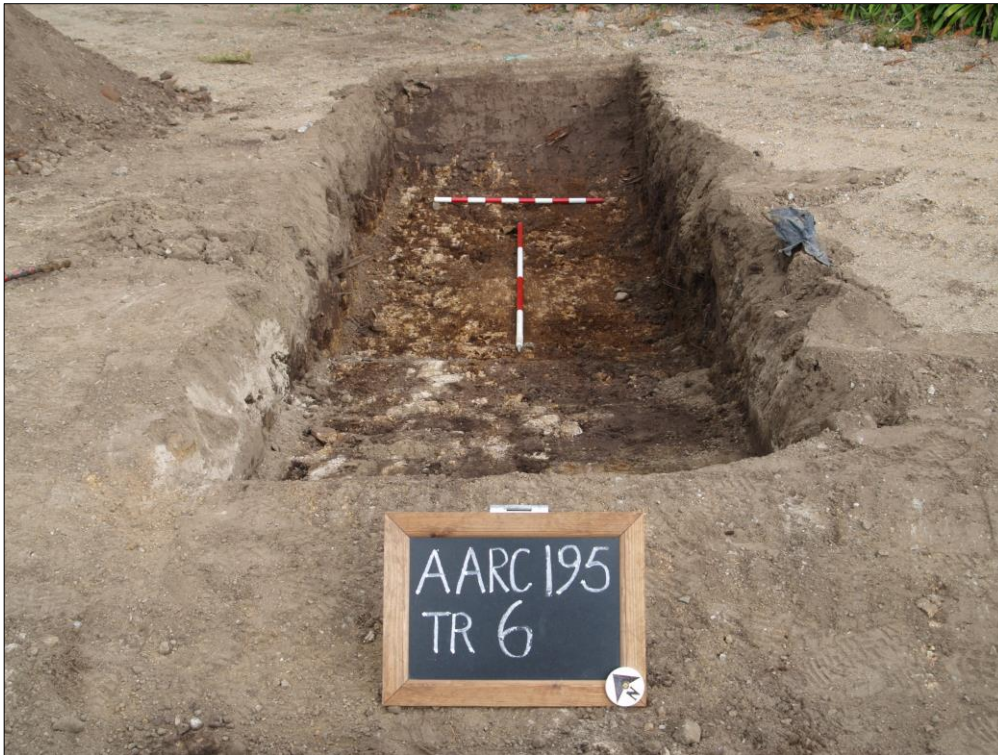
4.12. Trench Six (5mx1.7m) was orientated NE-SW revealed made ground (600) throughout the trench, measuring up to 150mm in depth. The made ground (600) directly overlaid the topsoil (601), a sandy loam of 500mm depth, which in turn overlaid the subsoil/topsoil mix (602). This measured up to 100mm in depth and directly covered the natural geology (603).

4.13. No archaeological features were identified in Trench Six and no finds were recovered from the spoil.

Photo 10 NE facing view of Trench 6 (1x2m, 1x1m)

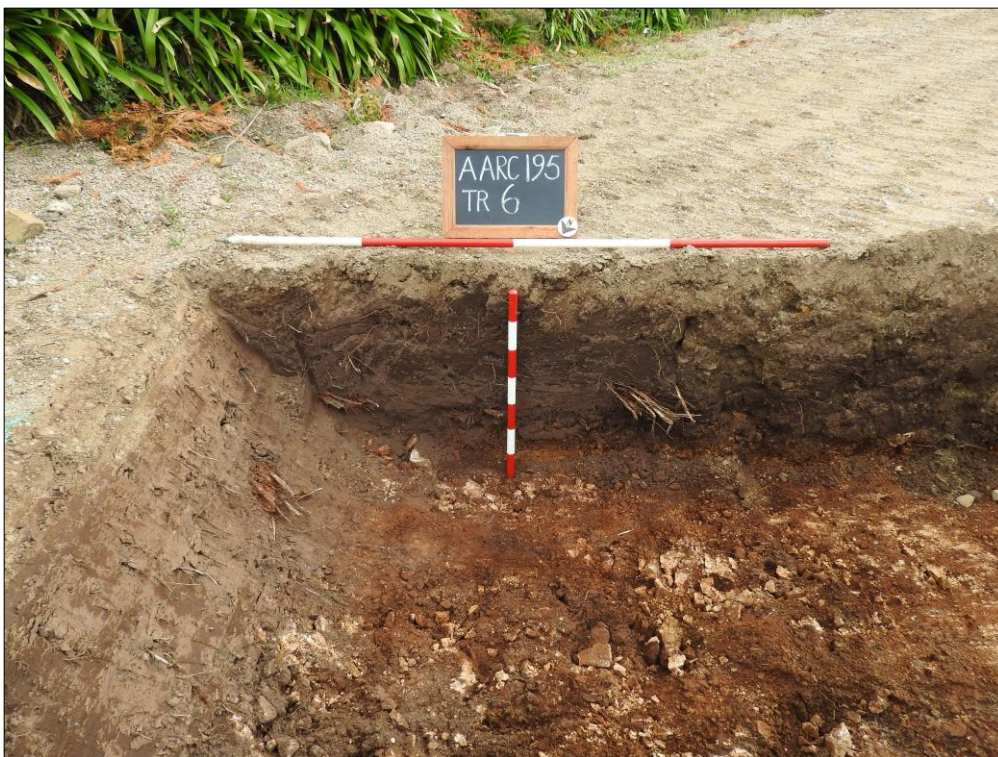
Photo 11 NW facing section of Trench 6 (1x700mm, 1x2m)
