Dyrham Park (Lightening Protection), South Gloucestershire, SN14 8ER

Client: National Trust

Project: Programme of Archaeological Monitoring and Recording

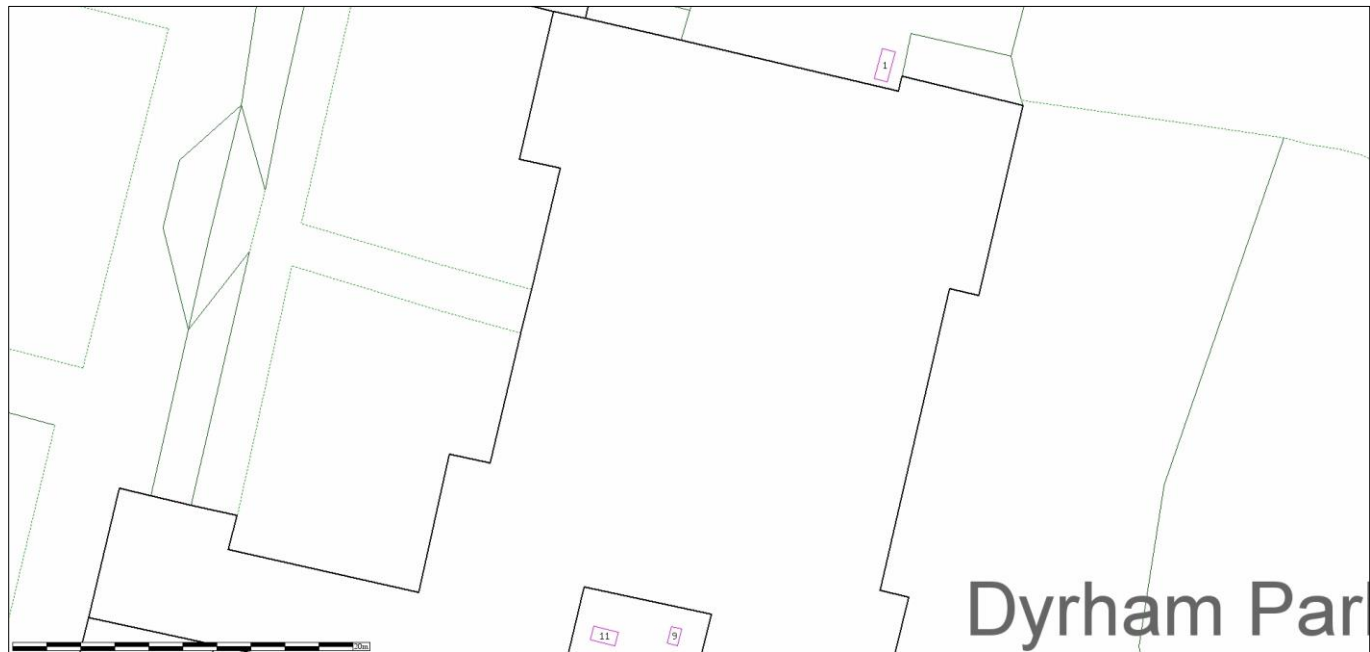
2.2. Following the erection of the scaffold to facilitate repairs to the roof of Dyrham House, the number of lightening protection pads required were reduced. 10 locations (2, 5, 6, 7, 8, 10, 13, 14, 15 and 18) have been omitted entirely and connections to the ground at 5 locations (3, 4, 12, 16, and 17) have been amended to utilise the scaffold screw piles. The 3 remaining locations requiring excavation to install ground mats are 1, 9, and 11 (pers comm A Jeremy, Purcell: 16/03/2016).

Figure 3 Mat Locations 1, 9, & 11

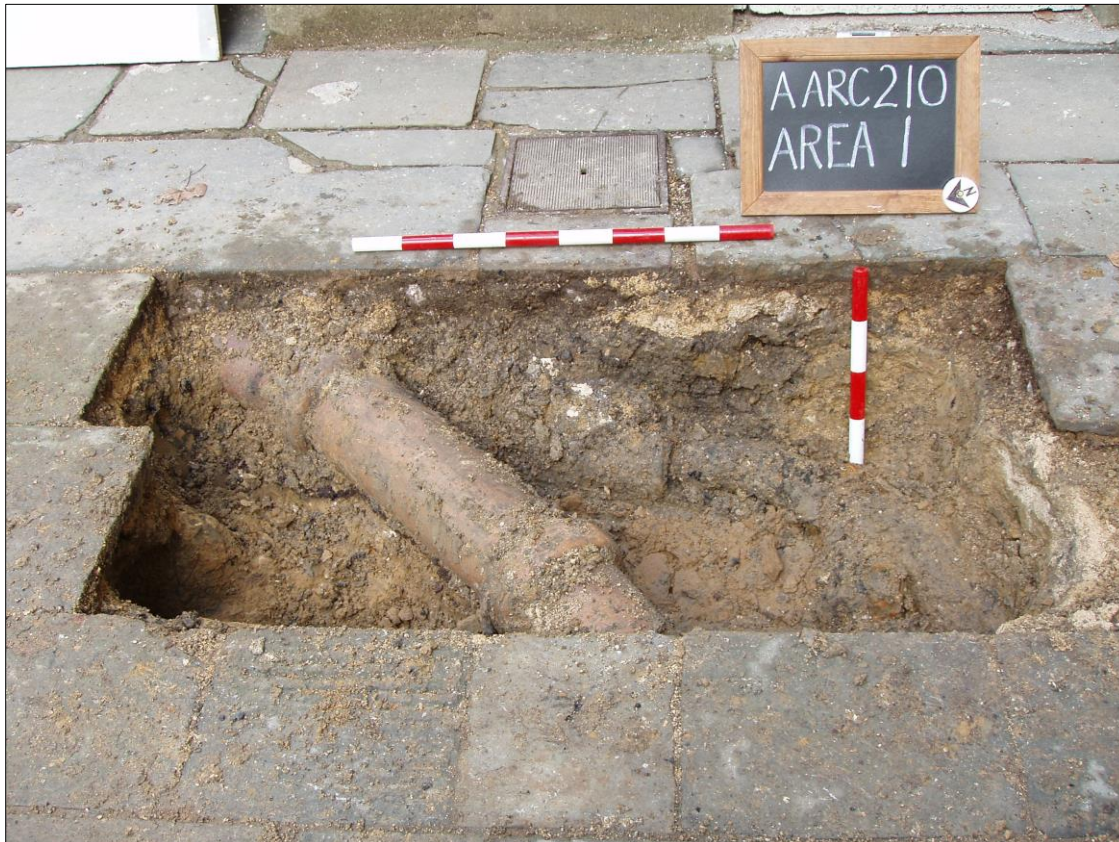
- 5.1. Pit One was located against the NNE outer wall of Dyrham House and measured 900mm (w) x 1.7m (l) to a depth of 400mm (d). The excavation revealed made ground (101) sealing truncated natural limestone (102) and Post-Medieval / Modern services.

Photo 1 SSE Facing View Pit 1 (Scales 1 x 400mm & 1 x 800mm)

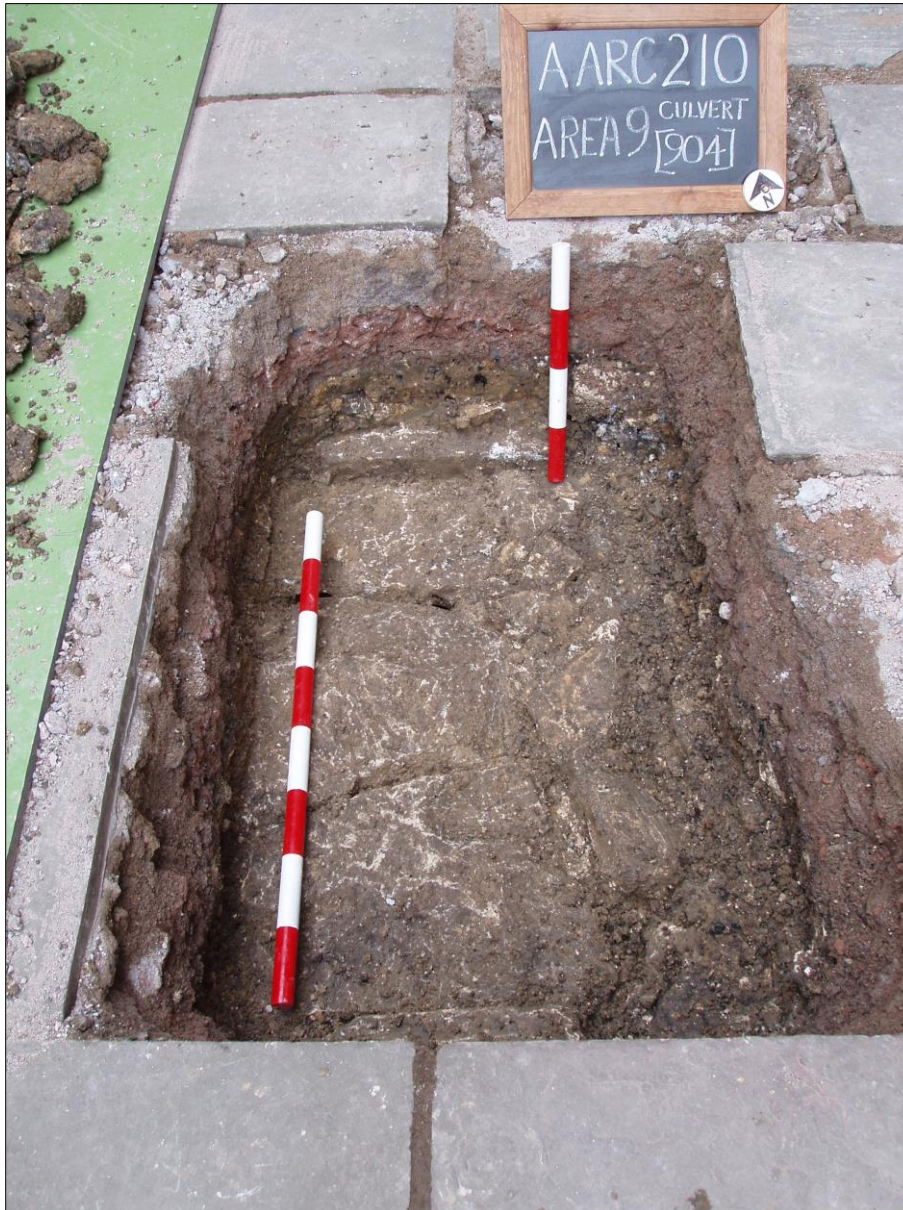
5.3. Pit Nine was located to the SSW of Dyrham House and measured 600mm (w) x 1.2m (l), to a depth of 430mm. The excavation revealed a limestone capped culvert, orientated NNE – SSW. Although no dating material was recovered, the culvert is likely to date to the Post Medieval period.

Photo 2 NNE facing view of Pit Nine (Scales 1 x 800mm & 1 x 400mm)

- 6.1. Pits Nine and Eleven preserve features relating to the historic use of the park. The limestone culvert identified in Pit Nine, is similar in style to the culvert that runs the length of the Stable Block, in the West Garden, identified during a watching brief carried out by Absolute Archaeology in 2011 (Martin & Driscoll: 2011). The features are thought to relate to the development of the current property and most likely date to the late 17th / early 18th century.
- 6.2. Pit Eleven preserved the truncated remains of a mortared limestone wall. The masonry appeared to be orientated in line with the current property, which it is thought is built on the partial plan of the Medieval house. As there is no comparable structure depicted in this location on early plans detailing

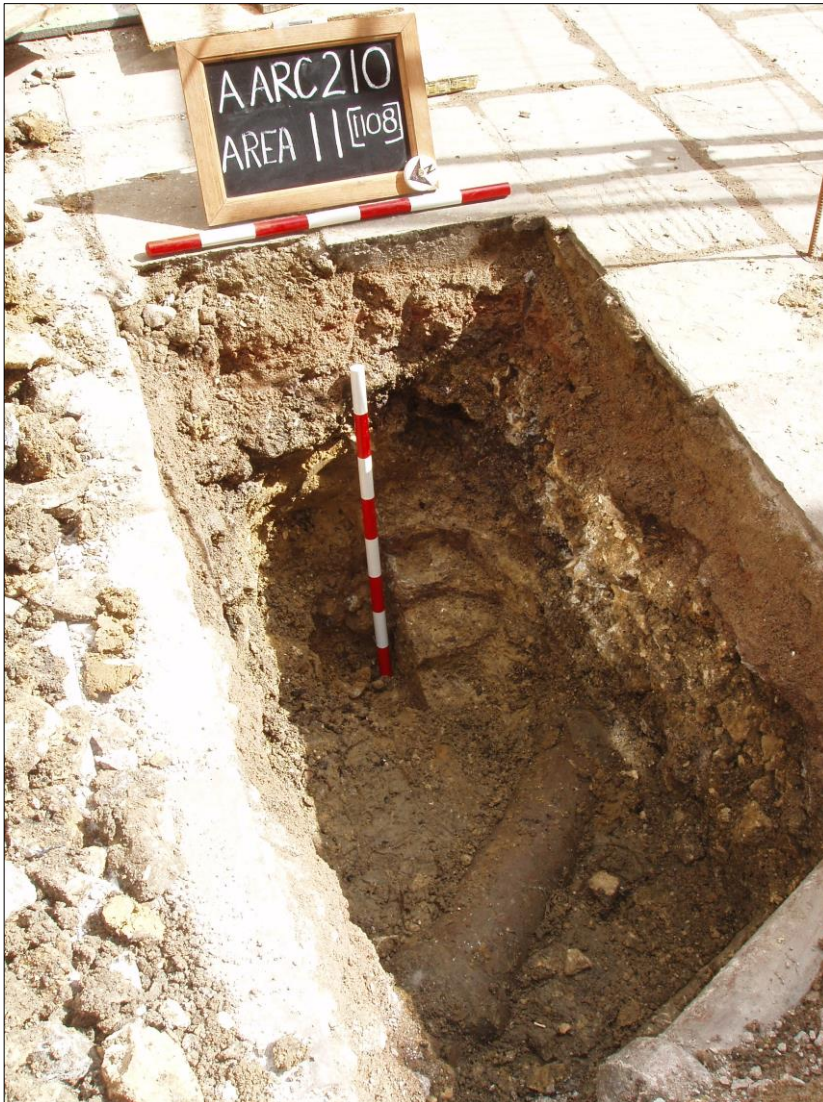
- 5.5. Pit Eleven was also located to the SSW of Dyrham House and measured 800mm (w) x 1.8m (l) x 870mm (d). The excavation revealed a truncated wall, comprising dressed limestone blocks with lime mortar. The wall is orientated ESE – WSW and has been preserved in situ.
- 5.6. A limestone slab was partially visible to the west of the area of excavation. Although the date and nature of the stone is unknown, it appears to preserve further evidence of early building activity in this area of the site.

5.7. Whilst there was no dating evidence identified, the wall appears to predate the current 1720 layout of Dyrham House.

Photo 3 ESE facing view of Pit Eleven showing limestone wall cut by service trench (Scales 1 x 800mm & 1 x 700mm)

the layout of the Baroque Mansion, it is concluded that the masonry must predated Blathwayt's renovation. It is therefore proposed that the wall may preserve a remnant of the Medieval property or perhaps evidence of Romano-British occupation relating to the widespread material evidence for activity in this period recovered from the West Garden. For this reason the wall has been preserved in situ.
