The Grove, Clifton Hill, Bristol, BS8 1BN

Project: Historic Building Recording

Client/Agent Name: Mr & Mrs Birnie / 105 West Architects Ltd
Project Site: The Grove, Clifton Hill, Bristol, BS8 1BN
NGR: ST 57192 72876
Document Type: Interim Report
Issue Number: V1.0
Date of Preparation: 16 October 2016
Oasis Reference: heritage10-253405
HER Reference: Requested – Awaiting Response
Local Planning Authority: Bristol City Council
Planning Reference: 16/01043/LA
HPS Site Code: HPS-135/16
OS Licence: 100048201

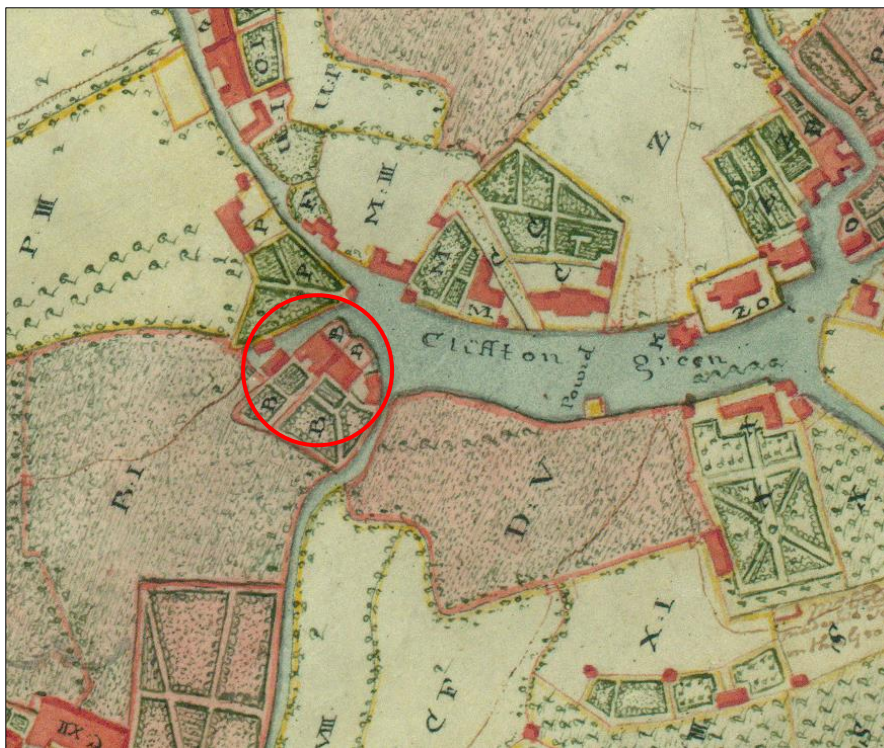
Figure 4 Jacob de Wilstar's map of the Manor of Clifton 1746 (Project Site circled in red) © Know Your Place, Bristol

- 2.4. The earliest lease for the Project Site has been traced to 1696, at which time the land was leased to James Hollidge by the Merchant Venturers. By 1707, records suggest that there are buildings on the plot, as Hollidge is documented as repairing one messuage¹ and building another (Leech 2015; 8).
- 2.5. The land was still leased by Hollidge at the time of the survey of the Manor of Clifton carried out by Jacob de Wilstar's in 1746. The properties are clearly shown on the corresponding map (Figure 4). The Project Site is depicted as a square building, adjoining the larger property to the northwest.

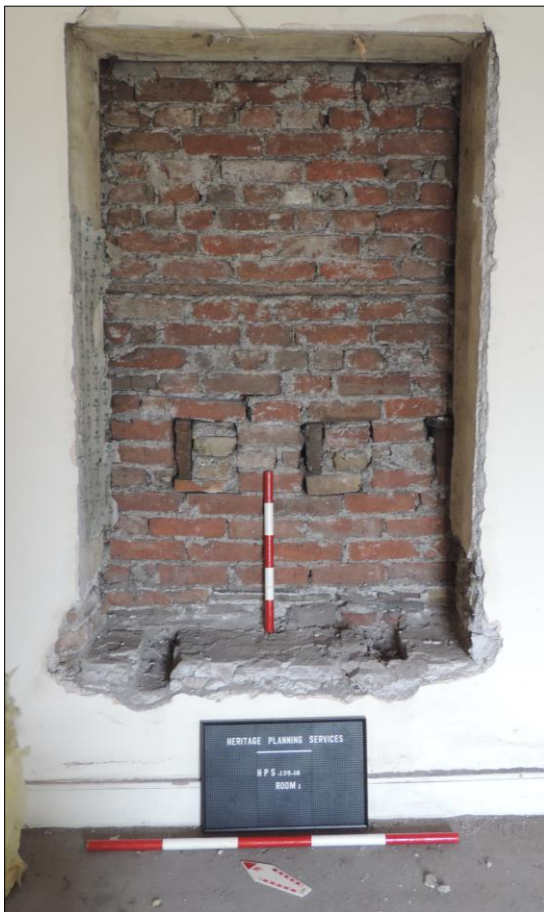
5.4. Room 1 is located in the southwest bay of the c. 1707 building and as such occupies one of the earliest parts of the property. Removal of modern materials revealed evidence of the bricked up window openings from the original northeast façade. The bricks appear to be early in date, which

would fit with the estimated date of renovations from Leech's report, which places the extension to the property in the late 18th century. At this time documentary and cartographic resources show that two southwest bays and a three storey porch were added, concealing the early building and internalising the openings. Random brick coursing is evident, along with a thin piece of timber bisecting the brickwork horizontally. The function of this is not known, but it may have been incorporated to allow a wall covering to be nailed in place, most likely on the other side of the wall which forms the rear of the internal partition belonging to the c. 1790 / 1800 extension. A row of square timbers which have the appearance of sawn off joists in brick joist pockets are evident below. These appear to be represent the terminals of the joists creating the elevated floor level to the extension, on the opposite side of the partition.

Photo 1 c. 1790 / 1800 Northwest bricked up window, northeast facing view (Scale 1 x 1m & 1 x 500mm).

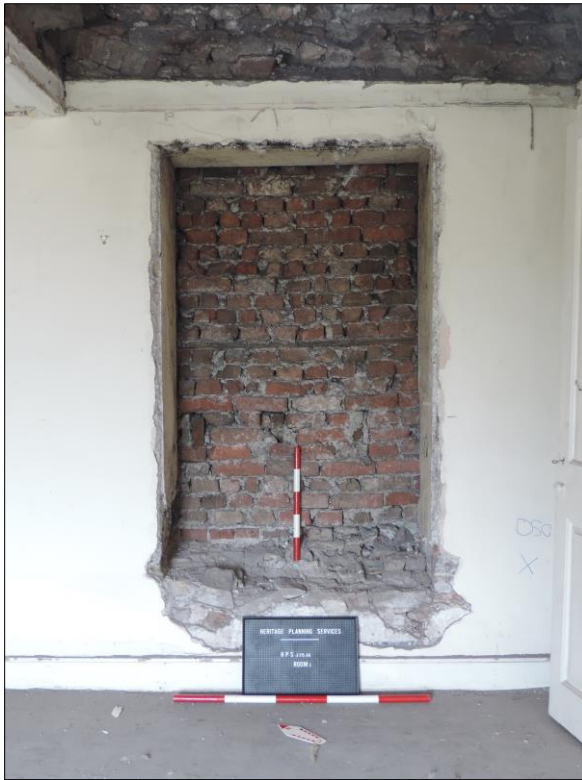
Photo 2 c. 1790 / 1800 Southeast bricked up window, northeast facing view (Scale 1 x 1m & 1 x 500mm).

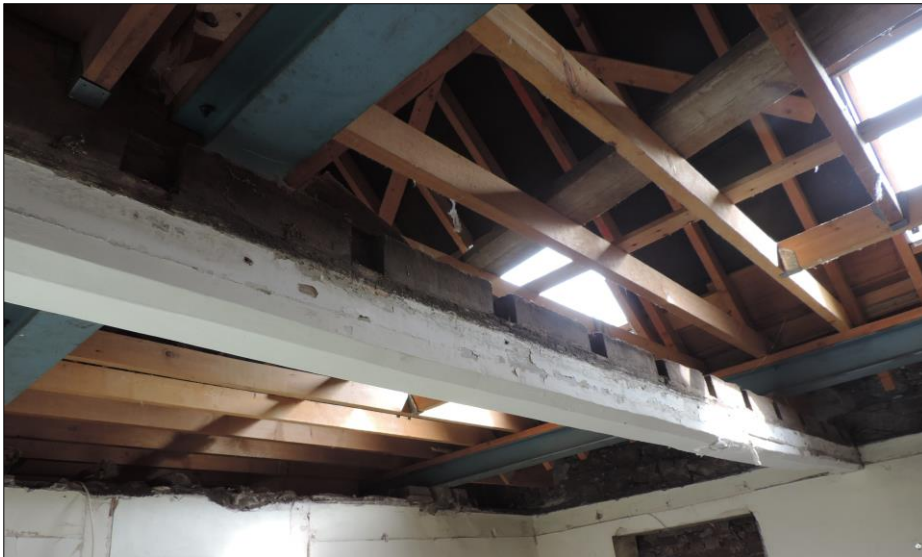
5.1. One of the early chamfered roof beams was revealed as a result of the work. The uneven finish suggests that this is likely to be contemporary with the early building and it would appear to be in situ. Evidence of the beam being bedded neatly into the wall, beneath a stable arch would appear to represent an original feature. Furthermore, the location of the beam which respects the location of the original windows lends further weight to this. The beam is no longer serving a purpose, but can be seen to have been incorporated into the renovation at the time that the modern roof was constructed. The corresponding joist pockets can be seen against the southeast wall, representing the gable end of the c. 1707 property.

Photo 3 Detail of early chamfered beam beneath modern roof.

- 6.4. Evidence to support an early date for the main property was also suggested by the nature of roof beams preserved on the Second Floor. The timbers were clearly hewn by hand, suggesting an early 18th century date for the beams, which are still in their original position, with the corresponding arch

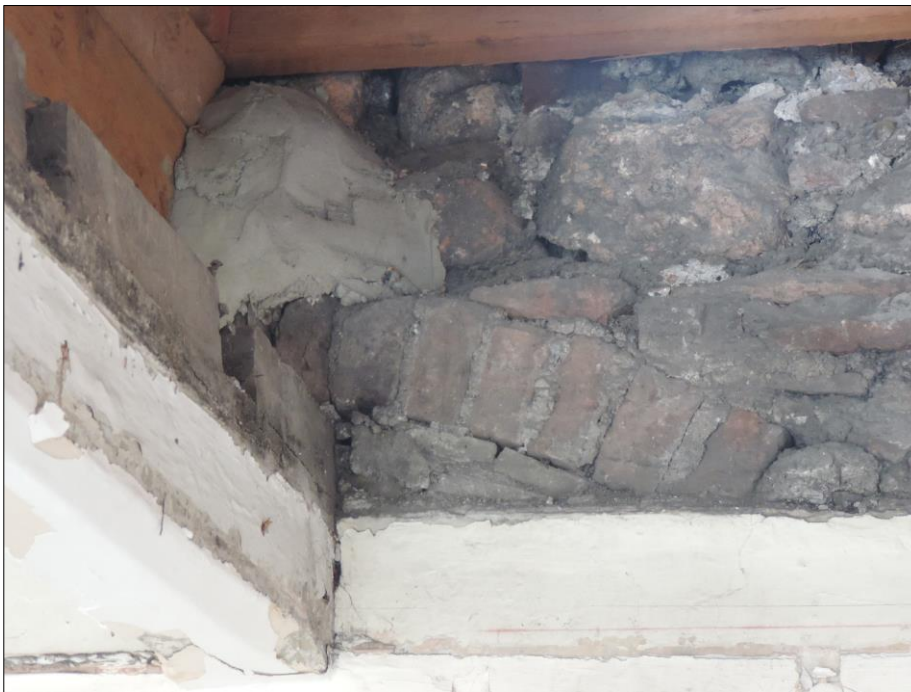
Photo 4 Detail of arch with beam slot and beam.

identified in Room 1. This had been carefully preserved in situ during the modern replacement of the roof.

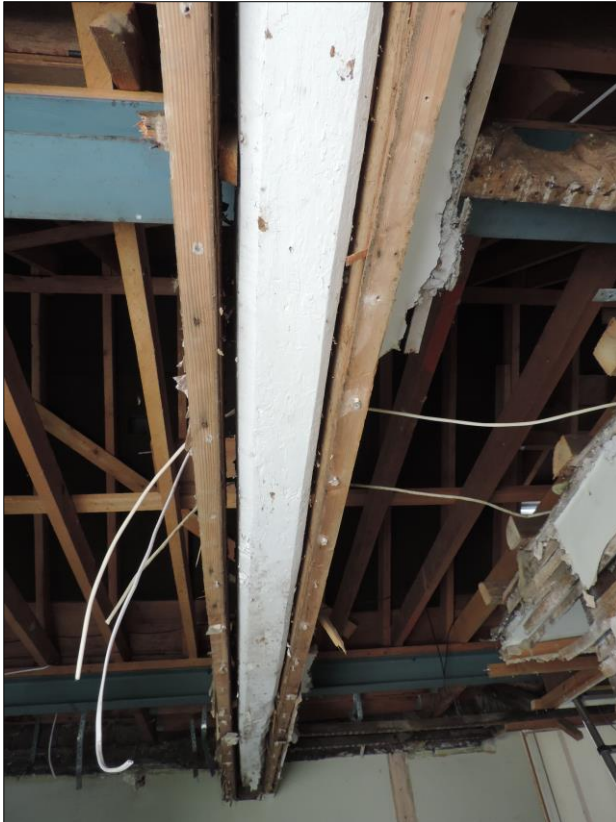
- 5.2. Room two preserves further evidence of the original roof structure with a similar chamfered beam spanning the room. Once again the original joist pockets are preserved against the northwest gable. Remnants of the original joists are preserved, resting where they lay when then were sawn off to make way for the new roof. The material was located on top of the partition wall, separating Room 2 from the stairwell. The timbers appear to be very roughly hewn and have clearly not been machine cut, again suggesting a date in the first half of the 18th century.

Photo 5 Detail of roof beam set into northeast wall

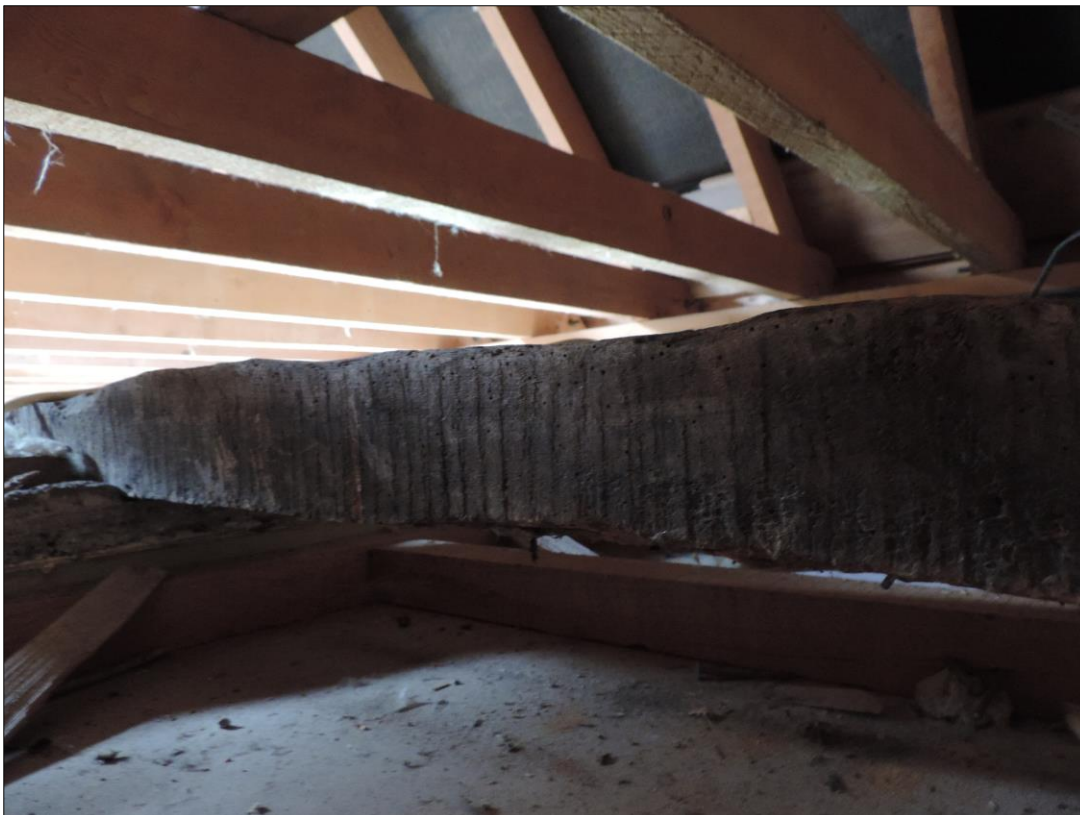
Photo 6 Detail of floor joist resting on the top of the partition wall

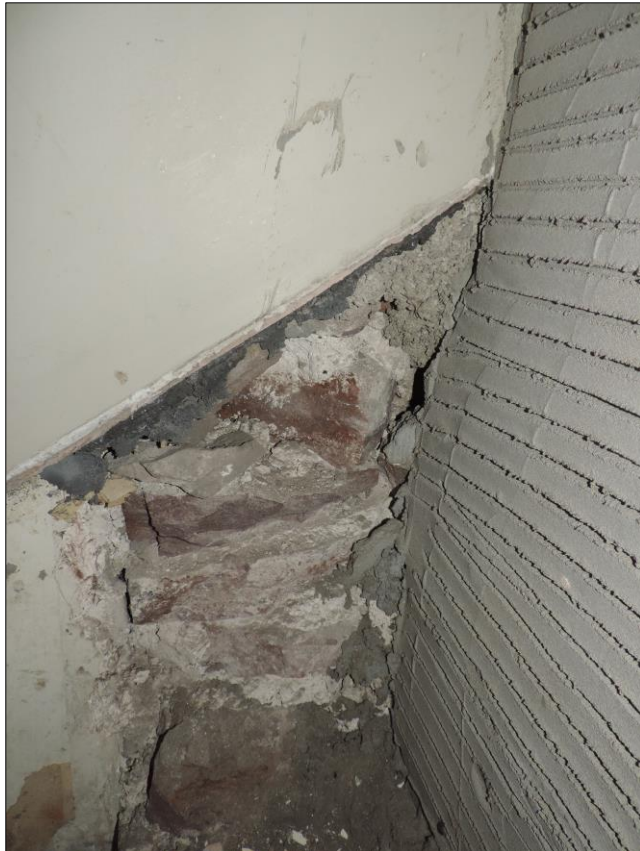
- 5.2. The doorway in Room 11 has been inserted into the original gable end of the c. 1707 property. However, an inspection of the removal of materials in the doorway unfortunately failed to reveal any significant historic fabric. Modern materials were seen to mask the majority of the wall in this area. Only a small area of original locally quarried Limestone Rubblestone was visible, where the stairs have been removed.

Photo 7 Southwest facing view of random Rubblestone fabric of 18th century property.

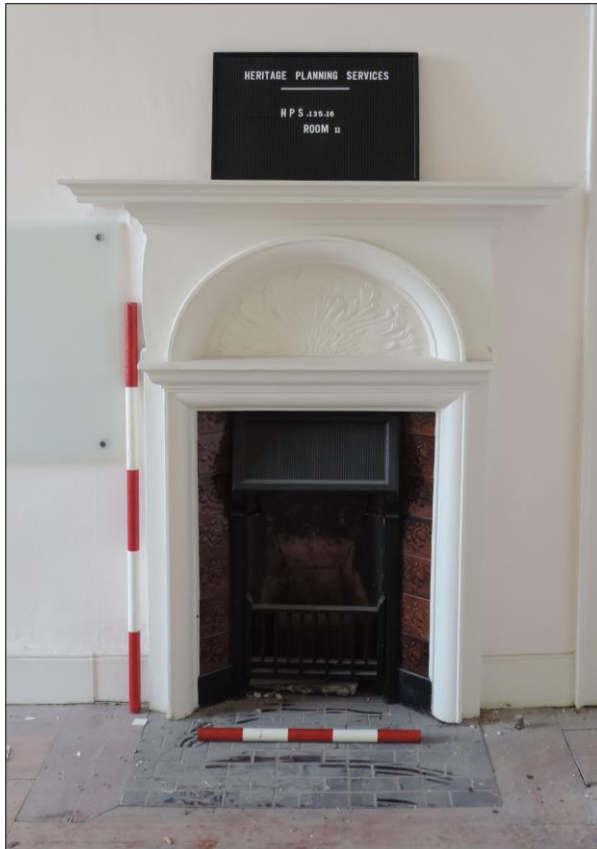
- 5.3. Decorative fireplace surrounds have been installed throughout the property during the Modern Period. An example was viewed in Room 11.

Photo 8 Modern fireplace surround, Room 11.

- 6.7. Original fire surrounds had previously been replaced throughout the property, with reclaimed and reproduction examples, during modern renovations. No original / period examples were noted at the time of the survey.

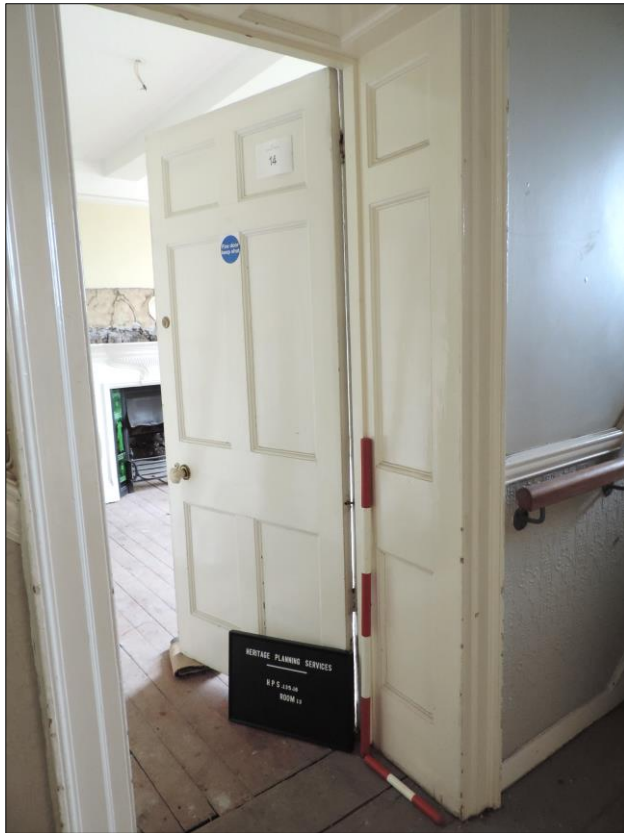
- 5.4. Room 13 is located in the southeast bay of the c. 1707 building, with original window openings blocked up and converted to cupboard space. A deep doorway in the entrance to this room highlights the thickness of the original wall, and 19th century wood panelling creates a decorative surround.

Photo 9 SSW facing view of 19th century wooden panelling.

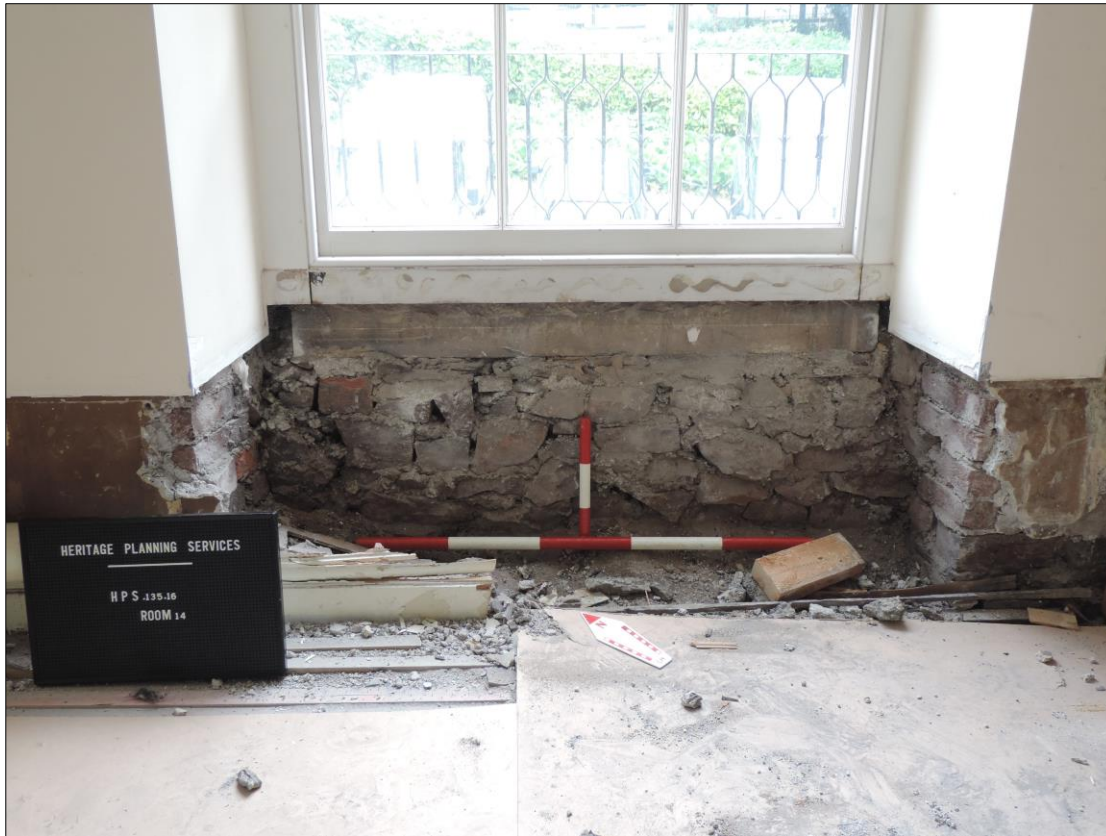
- 5.5. Room 14 is located in the northeast bay of the c. 1790 /1800 extension. Rooms 14 and 15 were divided by a stud wall, which will be removed to open up the space. During the removal of fixtures below the windows, a small portion of the masonry belonging to the earlier structure was revealed. Limestone sills and random mortared Rubblestone coursing was evident.

Photo 10 Northeast facing view of c. 1790 / 1800 materials (Scales 1 x 1 & 1 x 300mm)

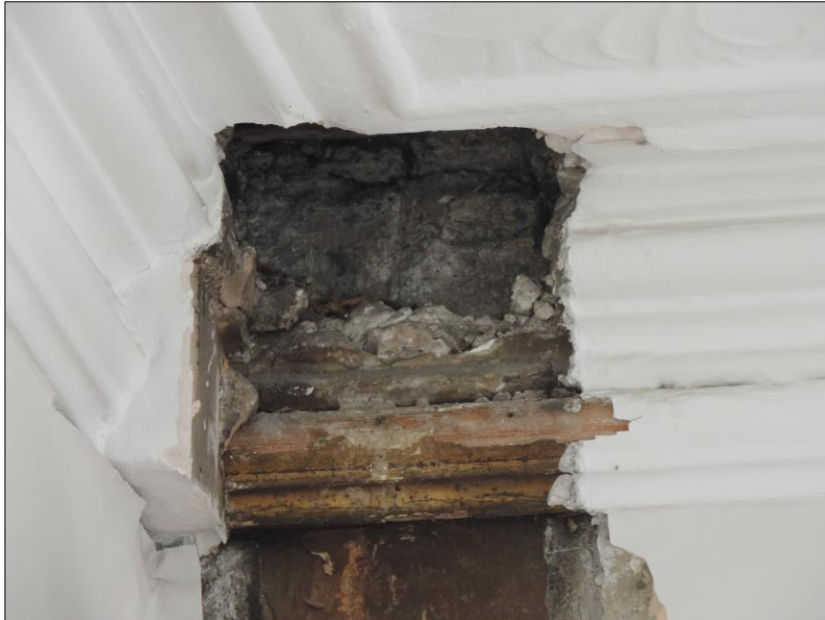
- 5.2. Much of the interior finish exhibits Modern Period renovation and as such very few original 18th – 19th century features remain throughout the house. For example, in Room 17 removal of the fireplace surround revealed newspaper packing dating 1987, indicating the date after which the interiors were revamped.
- 5.3. This room also revealed evidence of alterations to the cornice. An earlier cornice has been given greater depth with the addition of a wooden extension to the base. Whilst it is not known when this

work was carried out, it is notable that an 18th century cornice is often much narrower than a 19th century example. A closer inspection of the woodwork would suggest a late 19th – early 20th century renovation.

Photo 11 Detail of altered cornice with wooden baton addition to the base.

- 6.6. Evidence suggests that the interior coverings may have been altered in the 19th- early 20th century, at which time coving appears to have been enhanced to create a deeper cornice, in keeping with the time. Ceiling Roses have been removed throughout the property, with the exception of one, which appears to be 19th century in style. This will be repaired and reinstated.

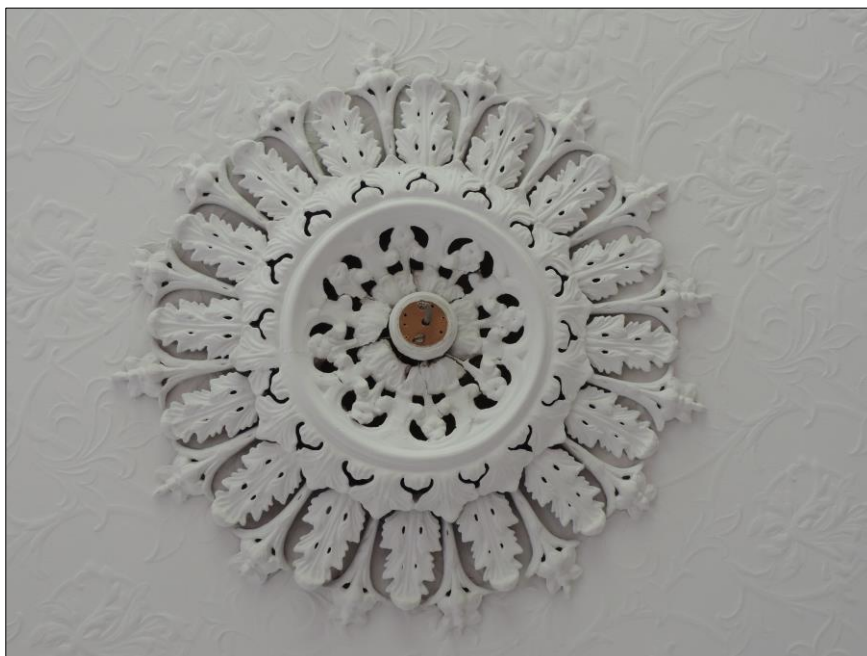
- 5.4. Only one Ceiling Rose is preserved and the feature exhibits a 19th century design. The detail in the centre of the feature is cracked, probably occurring when the light fitting was inserted. With this in mind the casting may date to the 19th – early 20th century.

Photo 12 Ceiling Rose

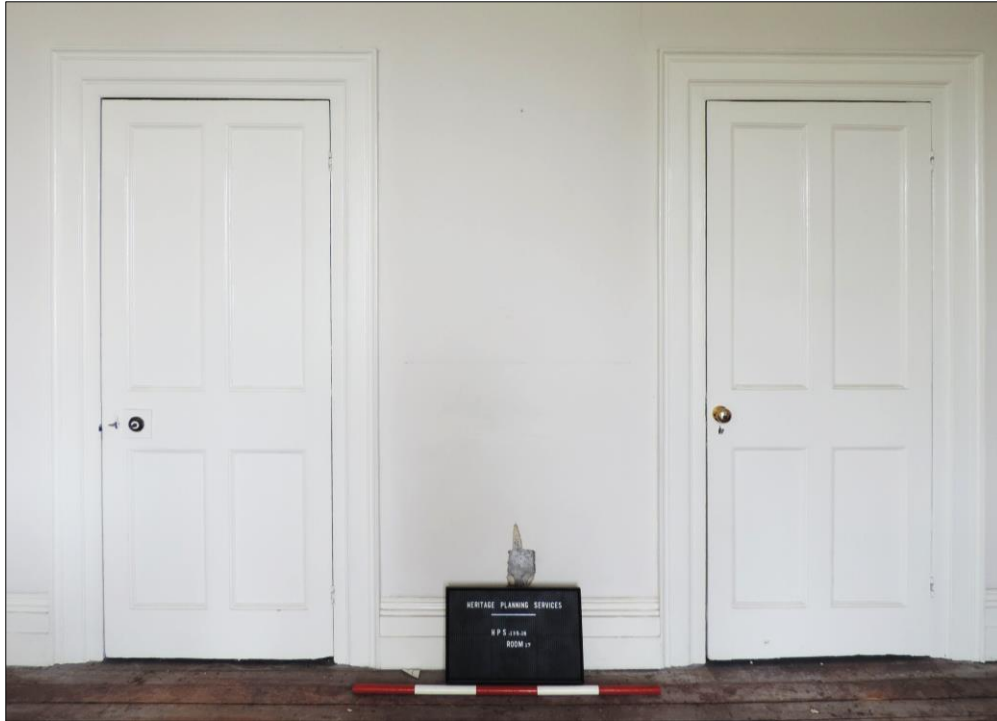
- 5.5. The original layout of the early 18th century building is evident in the northeast wall, with cupboards denoting the location of the original window openings.

Photo 13 Northeast facing view of position of 18th century window openings (Scales 1 x 1m)

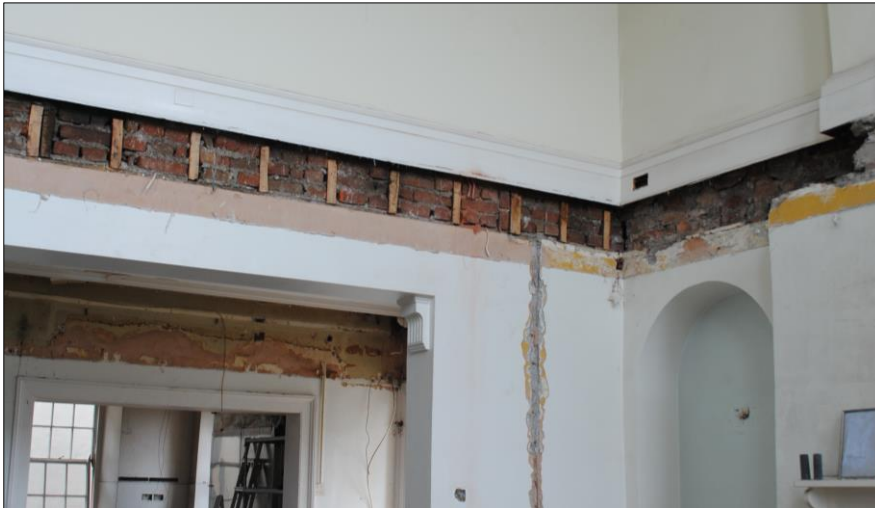
- 5.8. The floor joists above Room 23 had been removed, revealing the joist pockets set within a later partition wall. The timber appears to have been replaced in the 20th century. Although there was a restricted view of the brickwork, the materials would appear to represent a 19th century fabric.

Photo 14 East facing view of brickwork revealed following the removal of the floor joists.

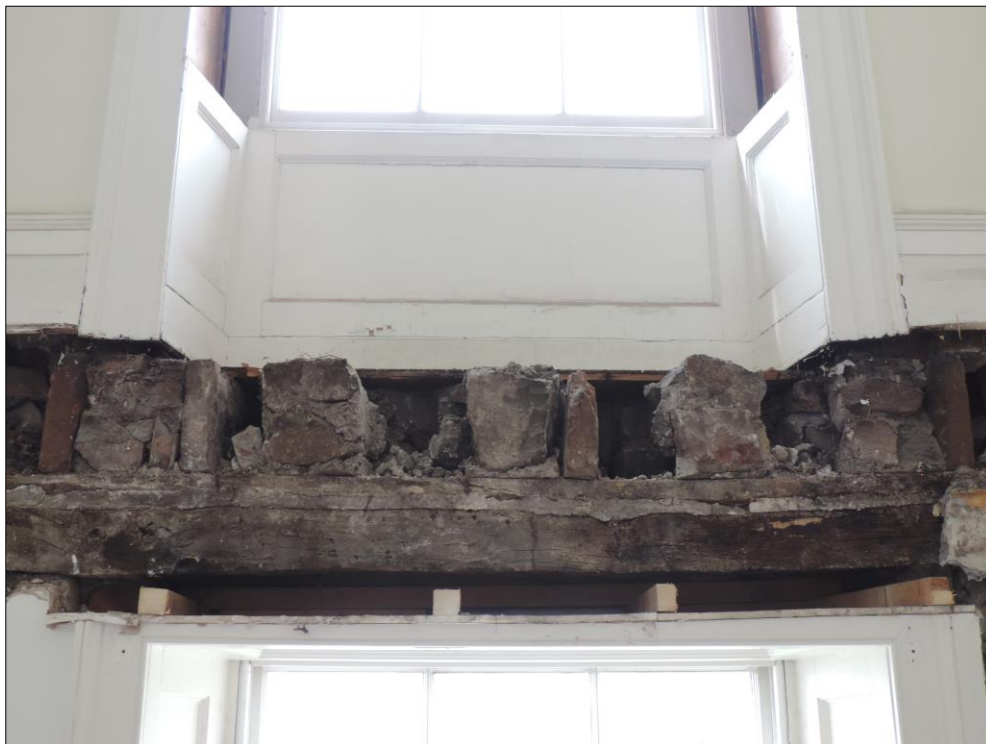
- 5.9. A small portion of the original fabric of the c. 1790 / 1800 southwest elevation was revealed as a result of the removal of the ceiling. Floor joist pockets were identified, comprised of Rubblestone with dressed stone packing. The fabric would appear to comprise locally quarried material.

Photo 15 Southwest facing view of early 18th century Limestone rubble joist pockets.

- 6.5. Evidence of the use of local Rubblestone was identified as a result of the removal of floor joists between Basement and Ground Floor levels. The material has been used on the interior of the walls, where unseen in order to mitigate costs. Quarries operating in the vicinity were active from the mid-18th century, which again supports Leech's date for the extension of the early dwelling.

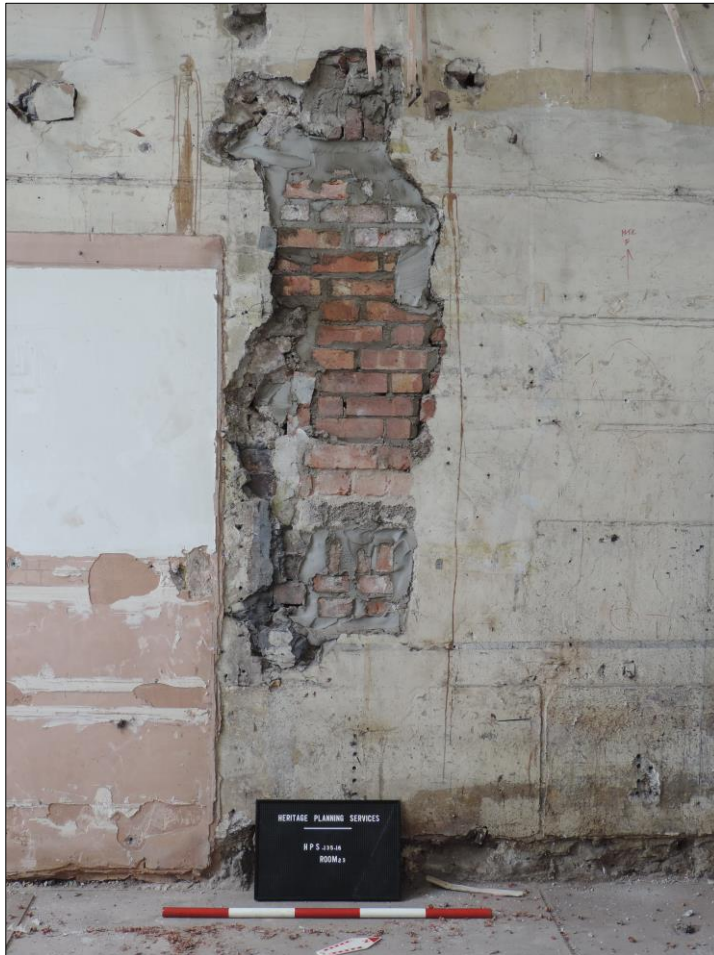
5.10. Plasterwork removed from the northwest partition wall revealed a modern brick infill. This part of the property should be representative of the garble end of the early 18th century structure and there is no recorded evidence of an opening or recess. This area of infill is in the region of the recently demolished Boiler Room and is most likely the result of alterations in the Modern Period. As such no part of the original fabric was revealed.

Photo 16 Northwest partition wall (Scale 1m)

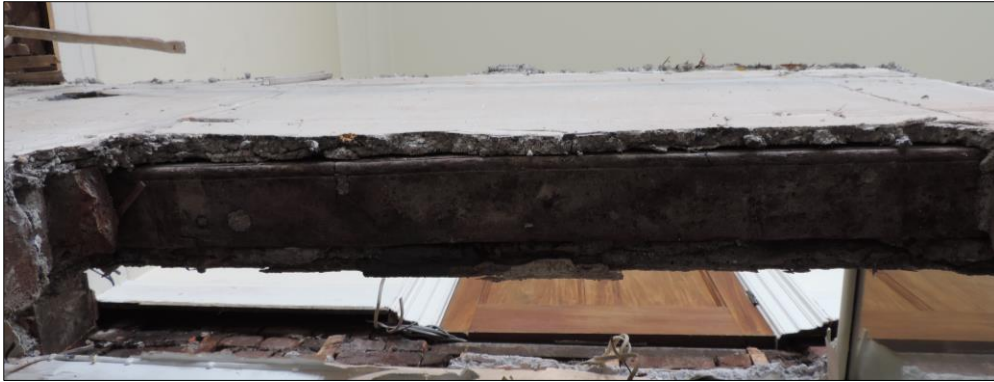
5.11. A repurposed 18th century decorative beam was located during works to redesign the Boiler Room entrance. The image below shows the feature in place as a lintel.

Photo 17 Detail of repurposed 18th century decorative timber.

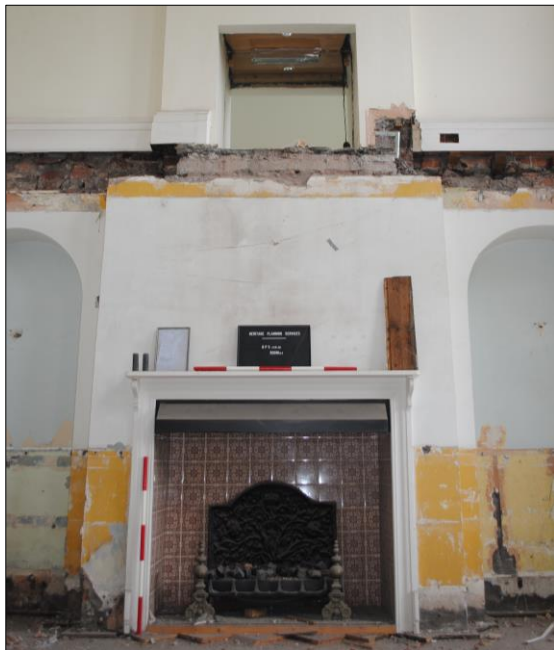
5.12. The only other feature noted in the basement is the 20th century fireplace surround at the southeast end of the Room 23.

Photo 18 Southeast view of fireplace (scales 2 x 1m)

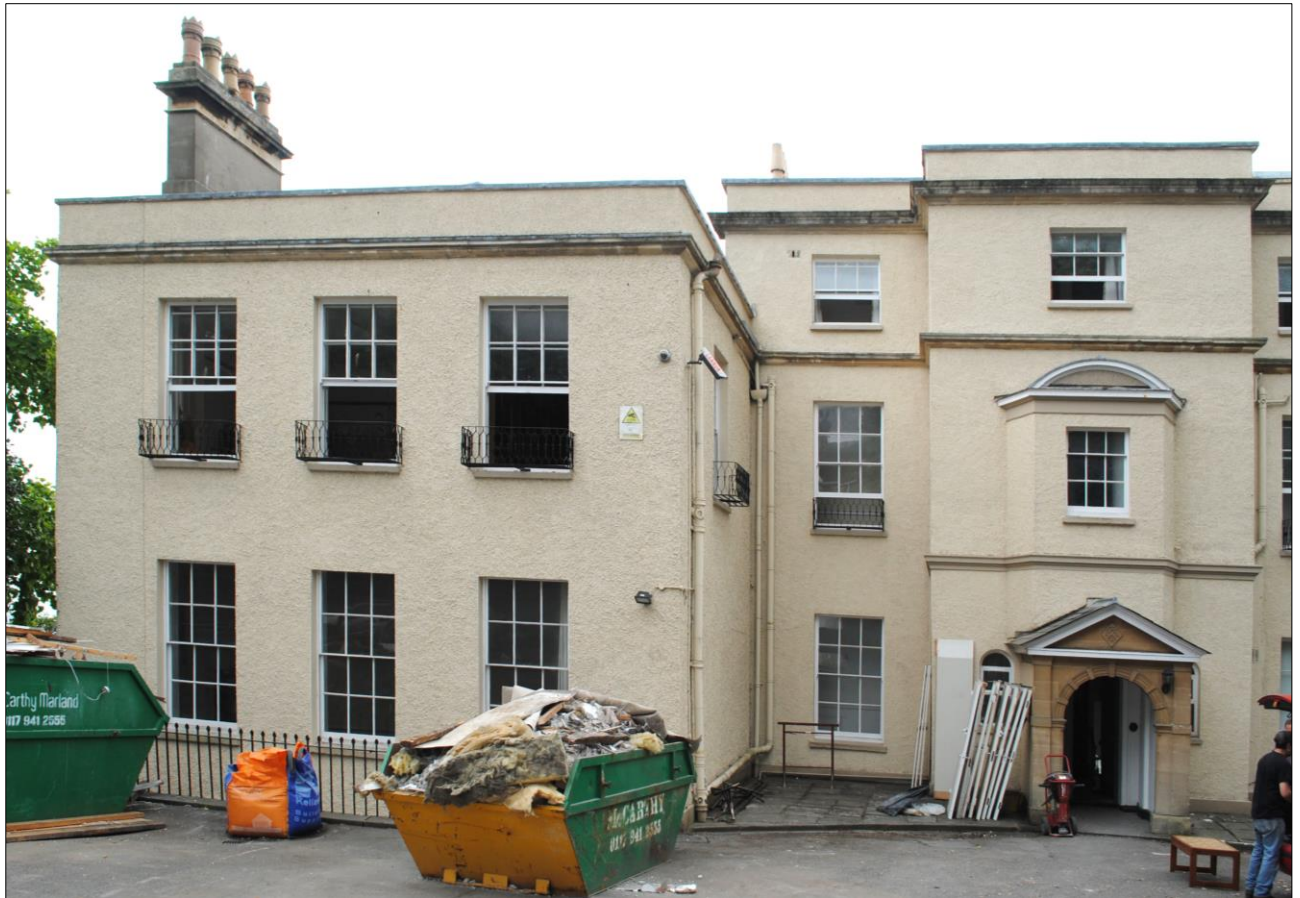
5.13. As mentioned in the introduction, no alterations had been made to the façade at the time of the survey. The current building and adjacent attached property have been finished in a modern sand and cement render, with painted finish, in an attempt to conceal differing building phases and materials and to give the appearance of a uniform build. The render was noted to have failed and cracked in a number of locations, which may result in water ingress and damage to the historic fabric of the building.

Photo 19 Northeast elevation of The Grove, with modern sand and cement render and paint finish.
