Land on the North Side of Belgrave Hill, Clifton, Bristol, BS8 2UA

Project: Historic Building Recording

Client: Mr J King
Project Site: Land to the North Side of Belgrave Hill, Clifton, Bristol, BS8 2UA
NGR: ST 57213 74692
Document Type: Interim Report
Issue Number: 1.0
Date of Preparation: 13 October 2016
Oasis Reference: heritage10-258358 (1)
Local Planning Authority: Bristol City Council
Planning Reference: 14/02366/F
HPS Site Code: HPS-136/16
OS Licence: 100048201

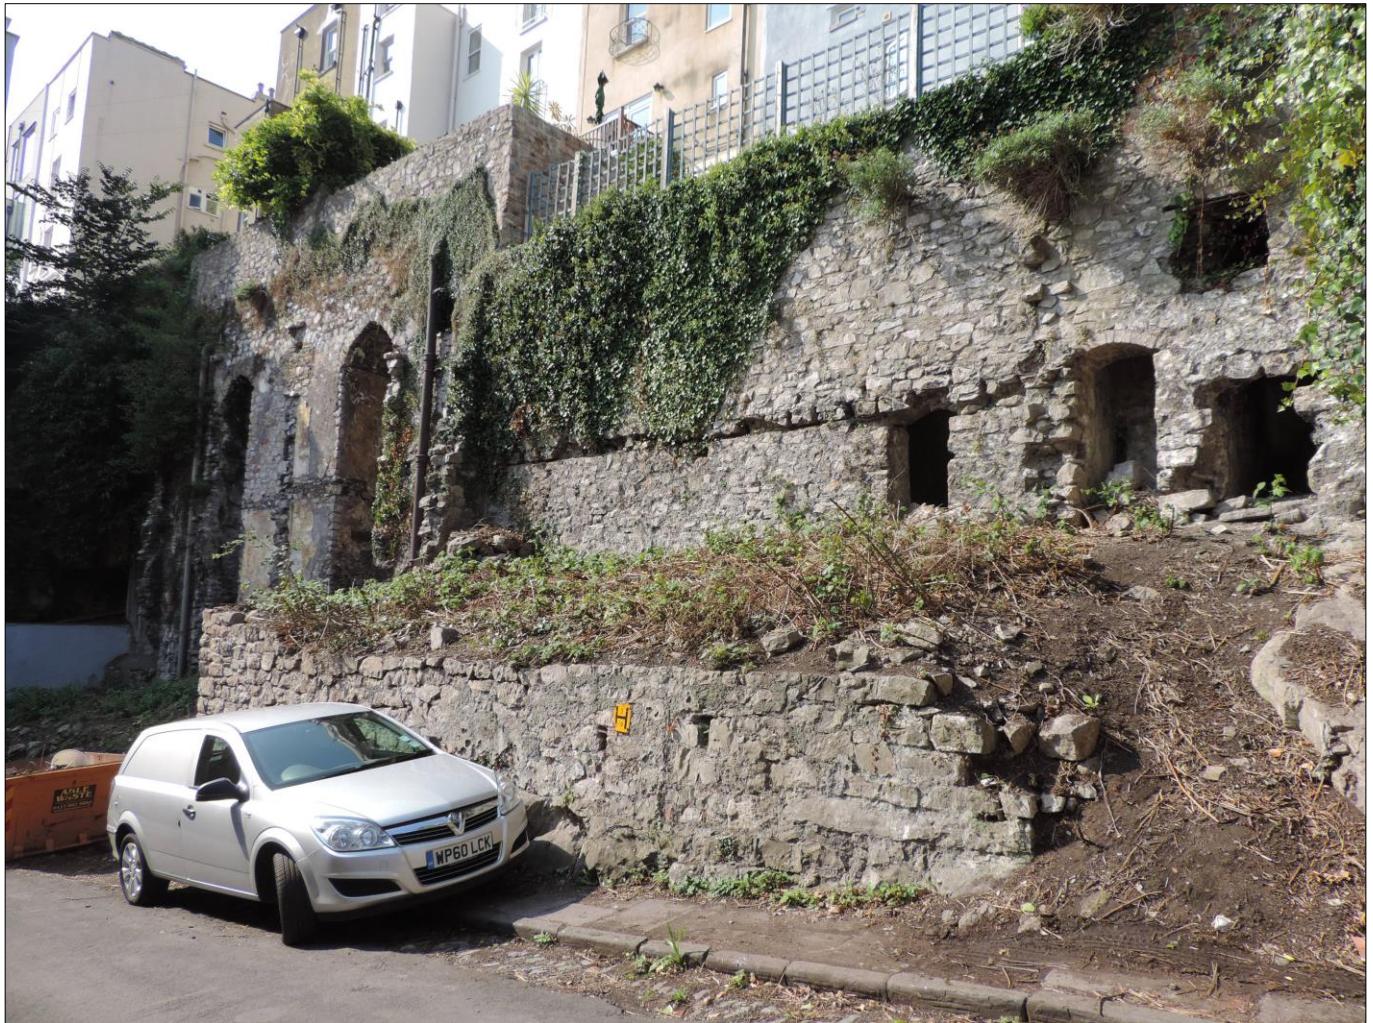
Figure 3 WNW facing view of the Project Site

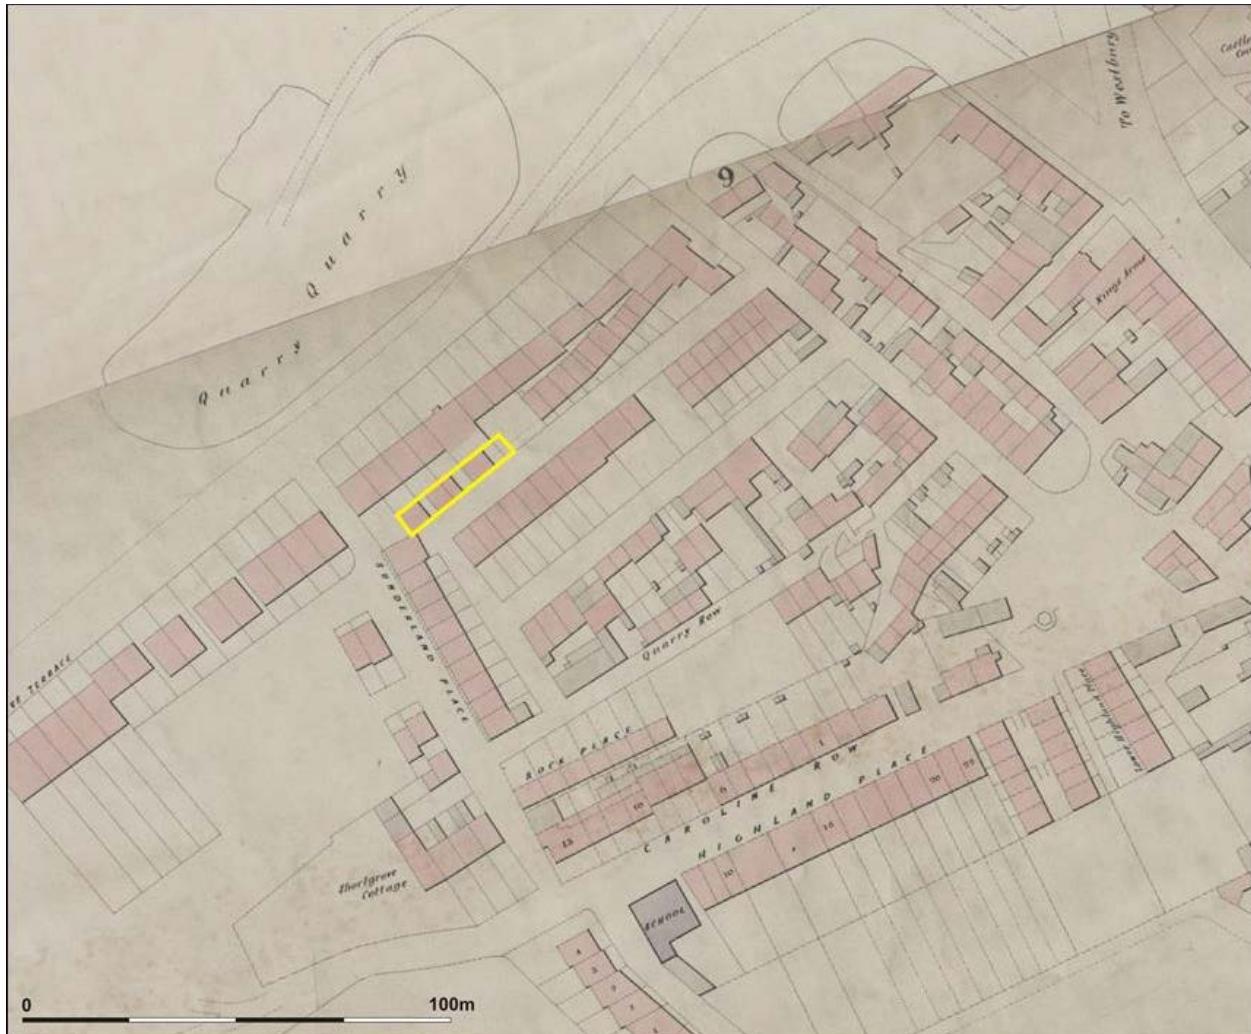
Figure 6 1855 Ashmead Map with Project Site outlined in yellow.

1.10. By 1855 the transformation of the area was complete. Figure 6 shows four structures depicted in the region of the development area. The new street plan is also complete, with Granby Hill (now Belgrave Hill), Richmond Hill (now Richmond Dale) and Quarry Row (now Quarry Steps) fully developed to the south, and High Street and Wesley Place to the east.

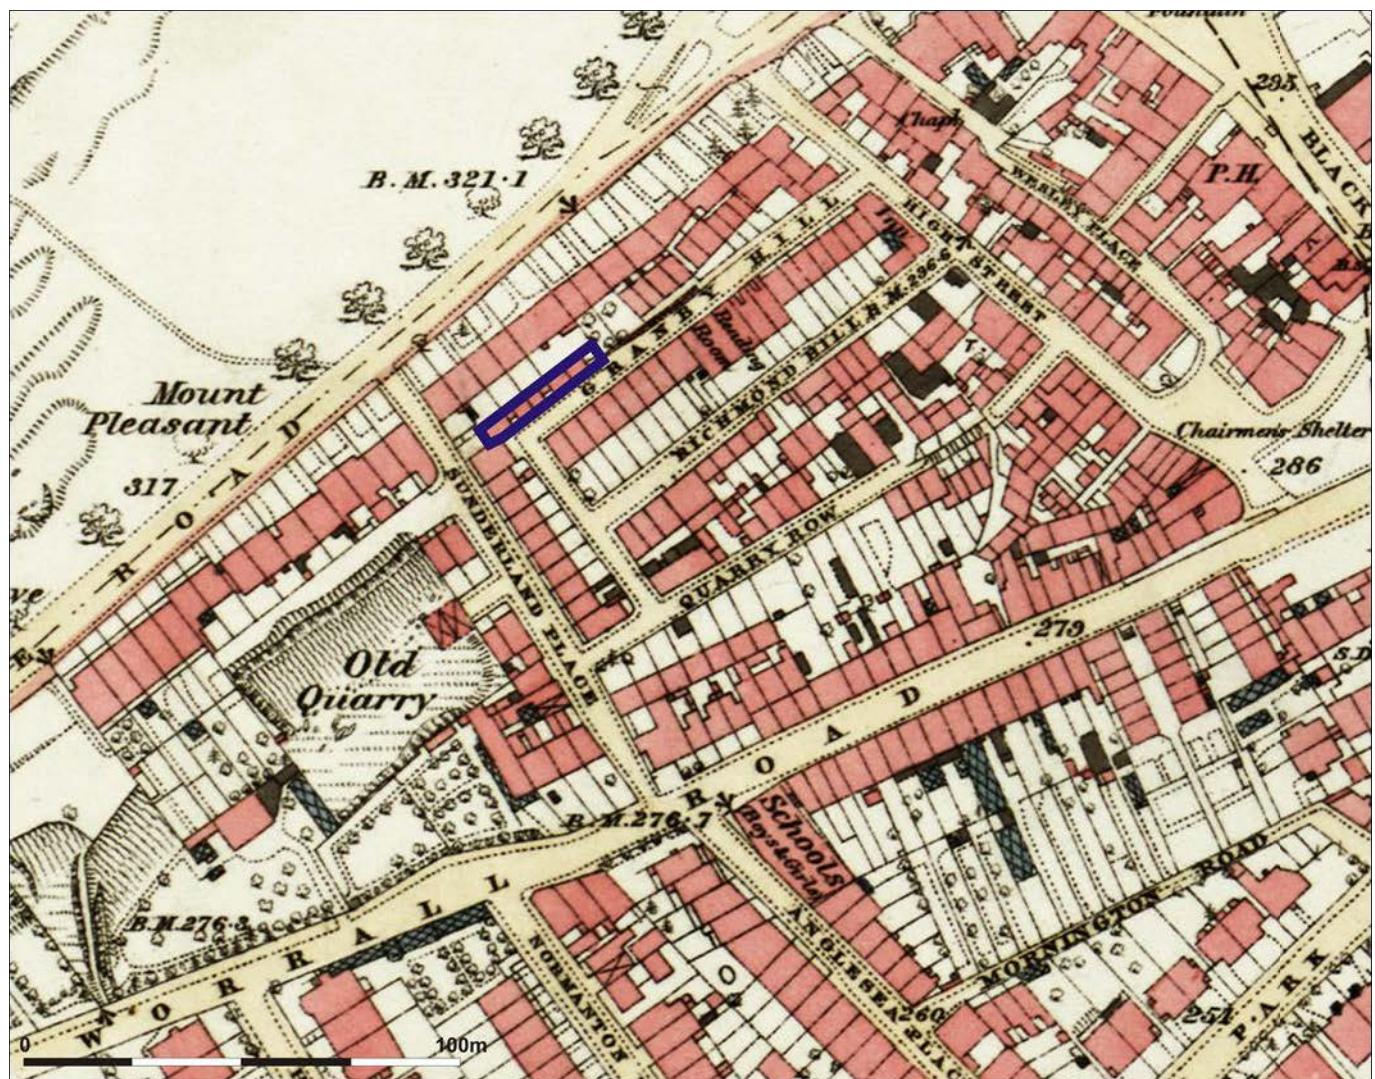
Figure 7 1883 1st Edition Ordnance Survey with Project Site shown in purple

1.11. By the 1st edition Ordnance Survey in 1883 the Project Site has seen further development, with the north-eastern dwelling redeveloped to create two units. Open area quarries to the north of Upper Belgrave Road were decommissioned in 1880 and are not depicted, however the remnant of the south-western extent of the quarry that defined the development can still be seen, clearly marked Old Quarry on Figure 7.

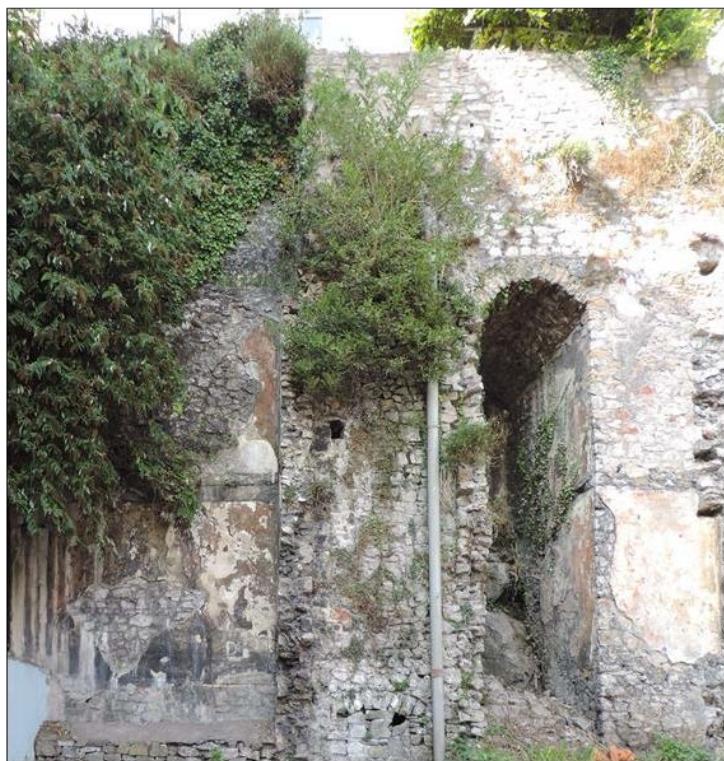
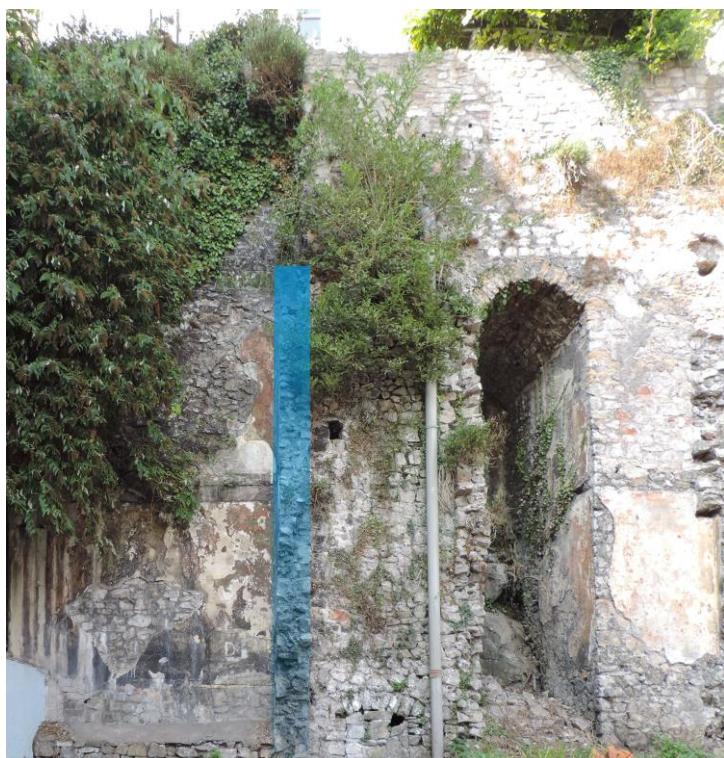
- 4.2. Positions 1 & 2 (Figure 8 / Figure 9) show the south-western structure façade, constructed of local Rubblestone. The wall has been erected to shore up the face of the quarry, following the closure of this section of the works in the mid-19th century. The original quarry face is still evident to the rear of the arches.

- 4.3. Three arches measuring >6m in height x 1.6m in width are present, with one having been infilled (arches highlighted in yellow). A fourth infilled arch is potentially preserved to the north-east. The full height of the arches was not ascertained at the time of the survey, but may be recorded once the ground reduction is carried out to the front of the plot. Double skin walls (now truncated) can be seen to have been built into the original construction, flanking the arches and defining the south-western terminal (Figure 9 highlighted in blue/ detail Figure 10). The central infilled arch can be seen to have a later partition added to the random Rubblestone fill, denoting an alteration to the layout (highlighted in green).

Figure 8 Position 1 ENE facing view of south-western extent of structure.

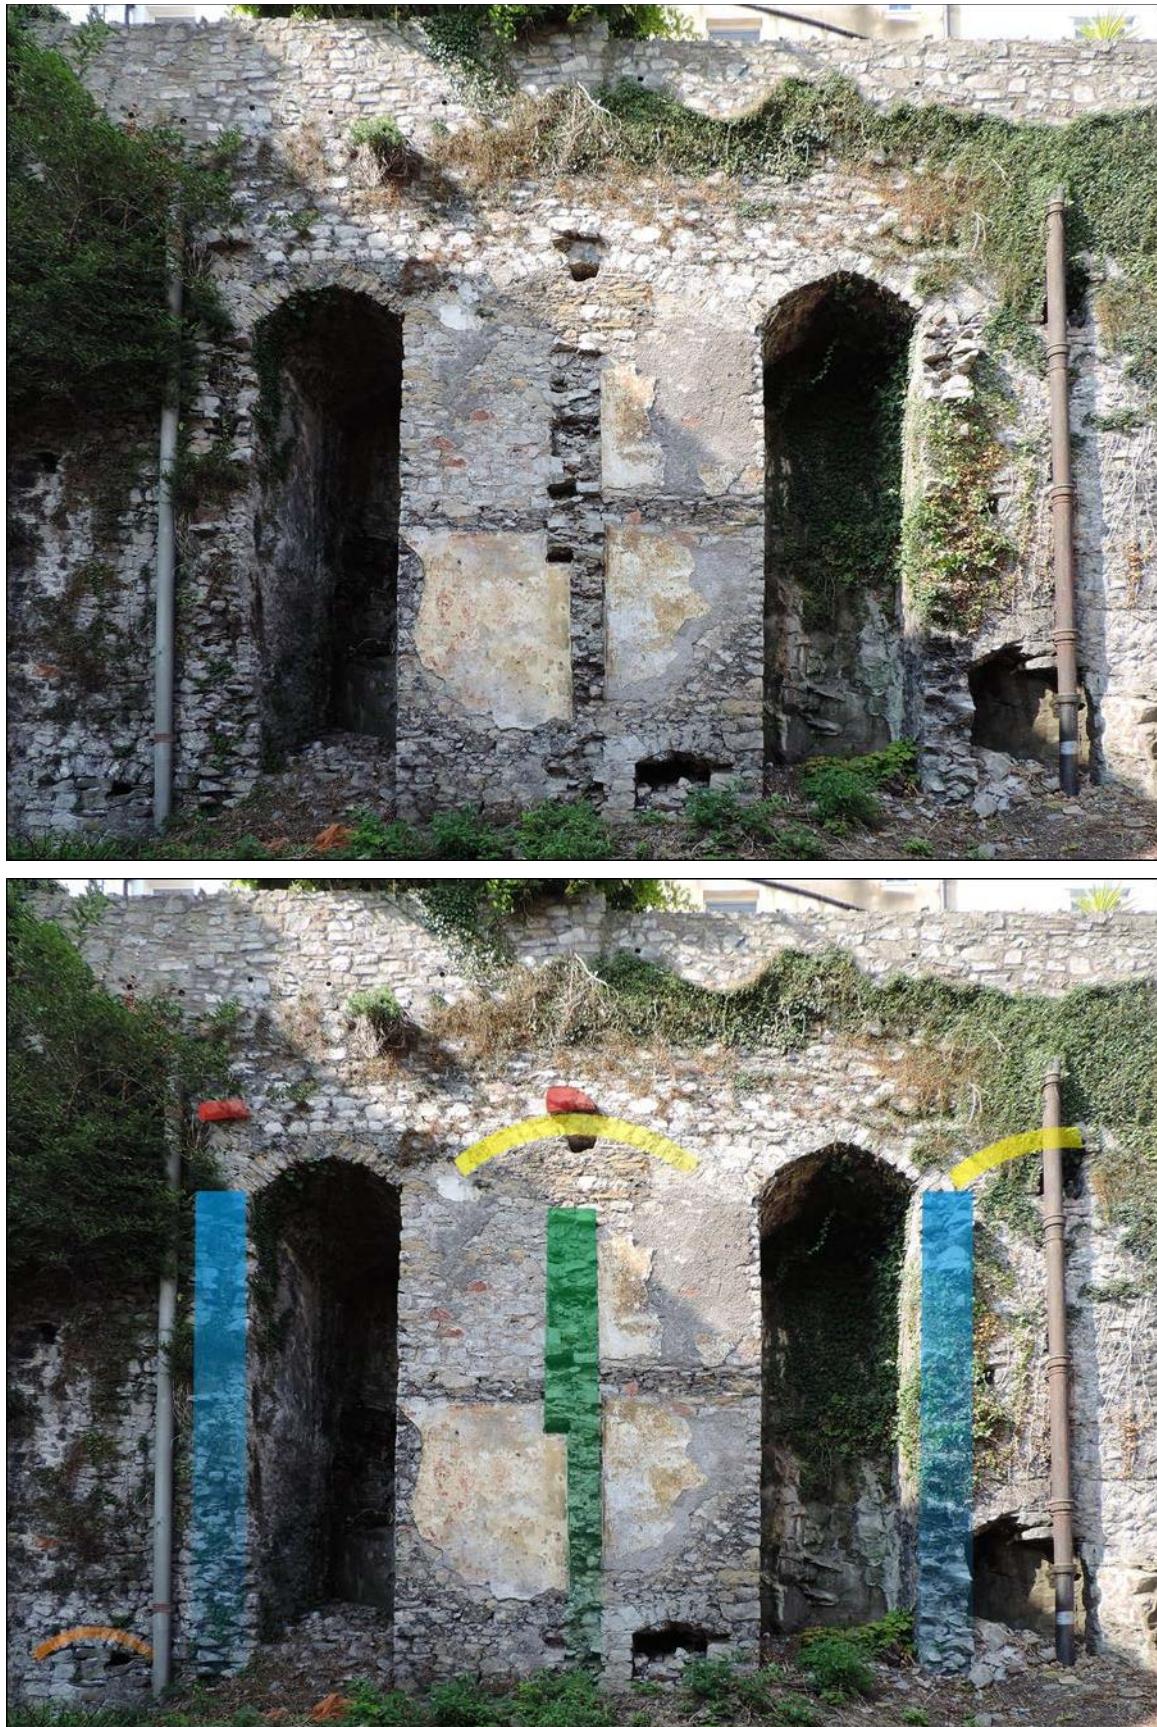
- 4.4. The tops of three lower openings can be seen, with one infilled (arch highlighted in orange on Figure 9 & detail in Figure 11). These recesses appear to be utilitarian.

Figure 9 Position 2 WNW facing view of open arches.

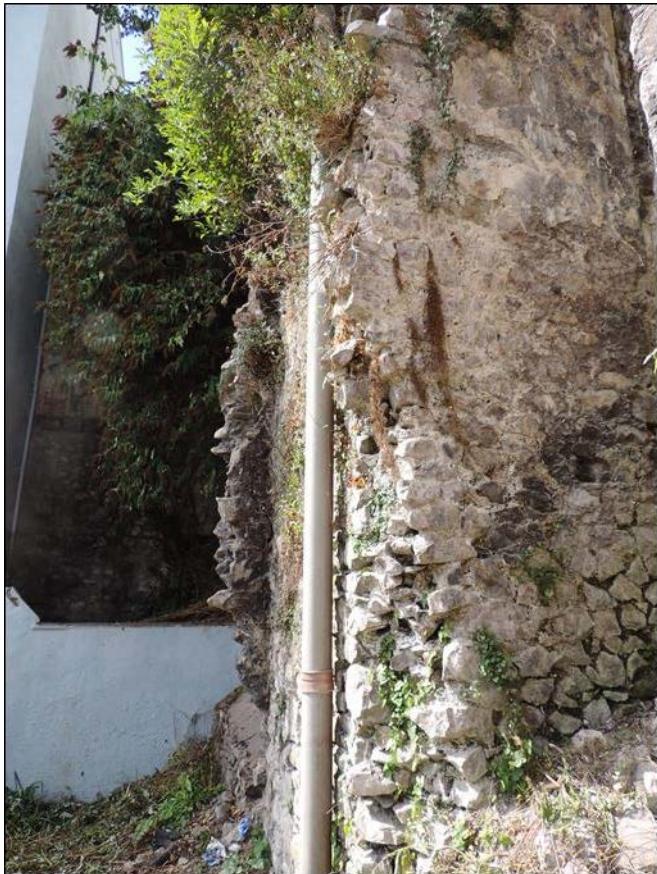
Figure 10 north-east facing elevation of arch showing partition masonry keyed into original build.

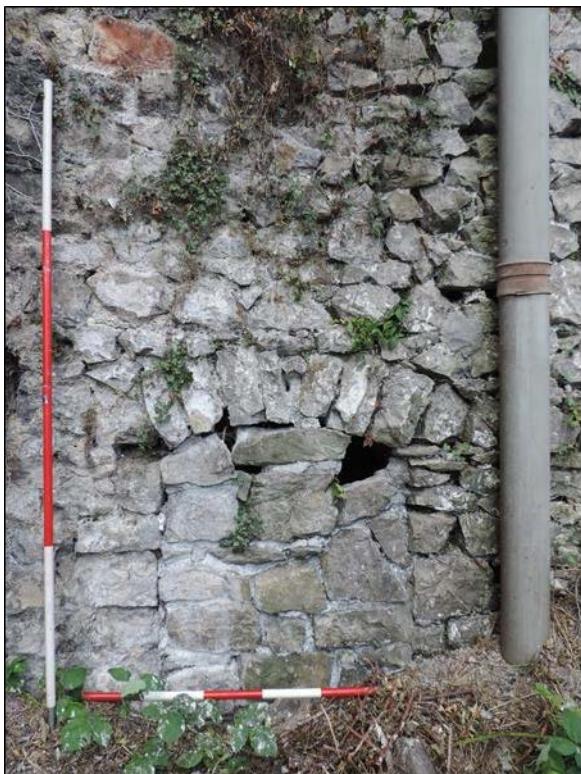
Figure 11 Detail of blocked recess (Scales 1 x 2m & 1 x 1m)

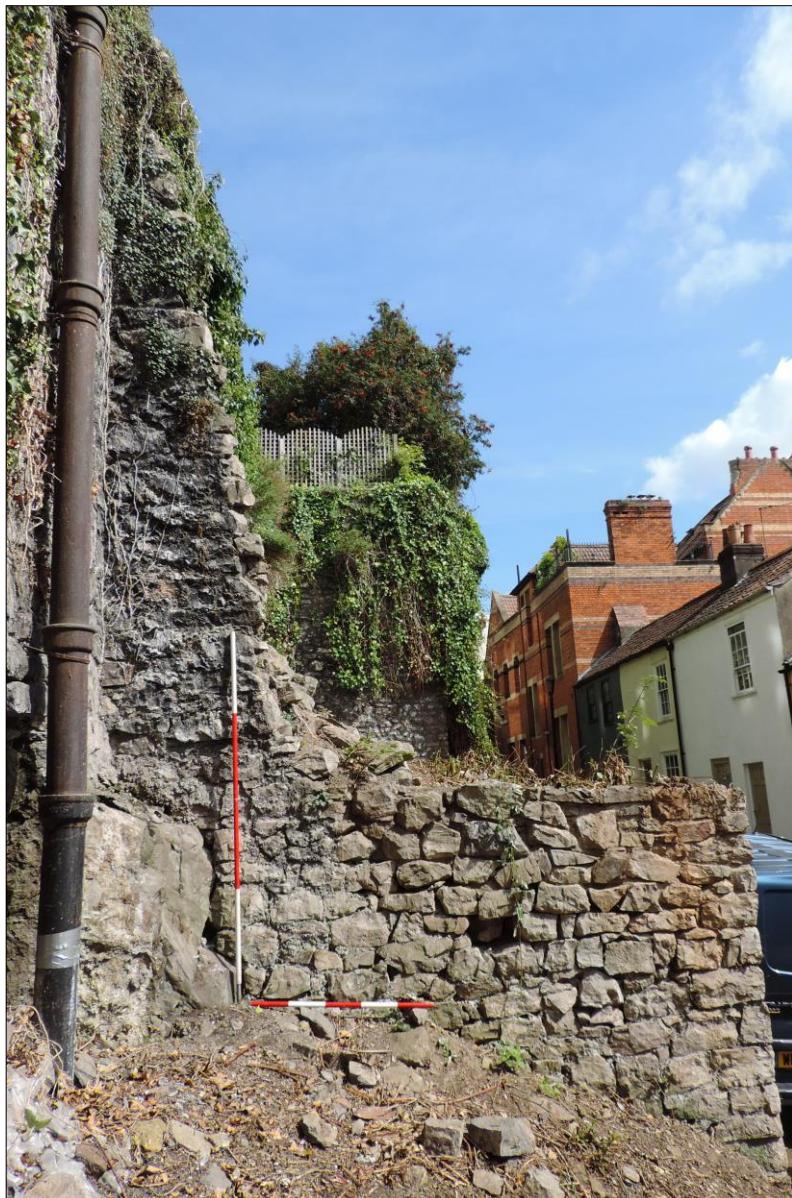
- 4.5. To the north-east, the height of the wall steps down, with a c. 6m high elevation visible (although it is likely that the height has been truncated). Once again constructed from random local Rubblestone, the corner of a dwelling is preserved (Figure 12) and a portion of the façade, fronting Belgrave Hill. The rear wall appears to be masked by approximately 3m (height) of spoil. Remnants of a partition wall (highlighted in blue Figure 13) are preserved, along with evidence of one of the floor levels (highlighted in yellow Figure 13).

Figure 12 South west elevation of property wall (Scales 1 x 2m & 1 x 1m)

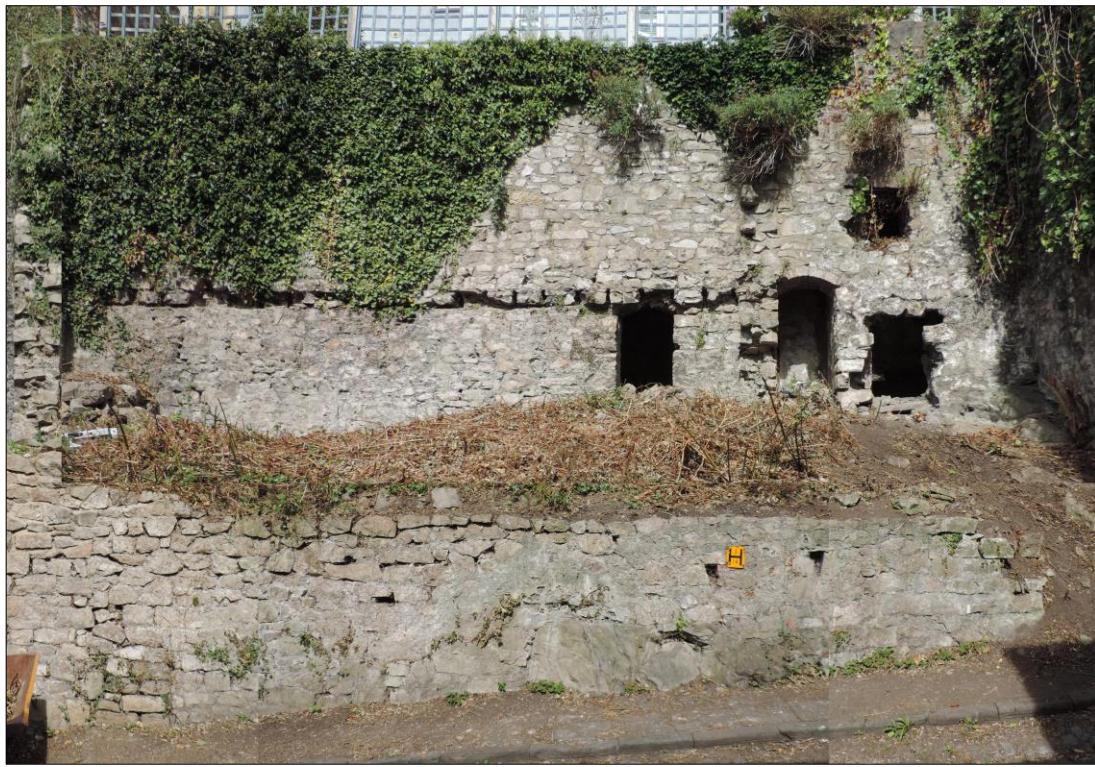
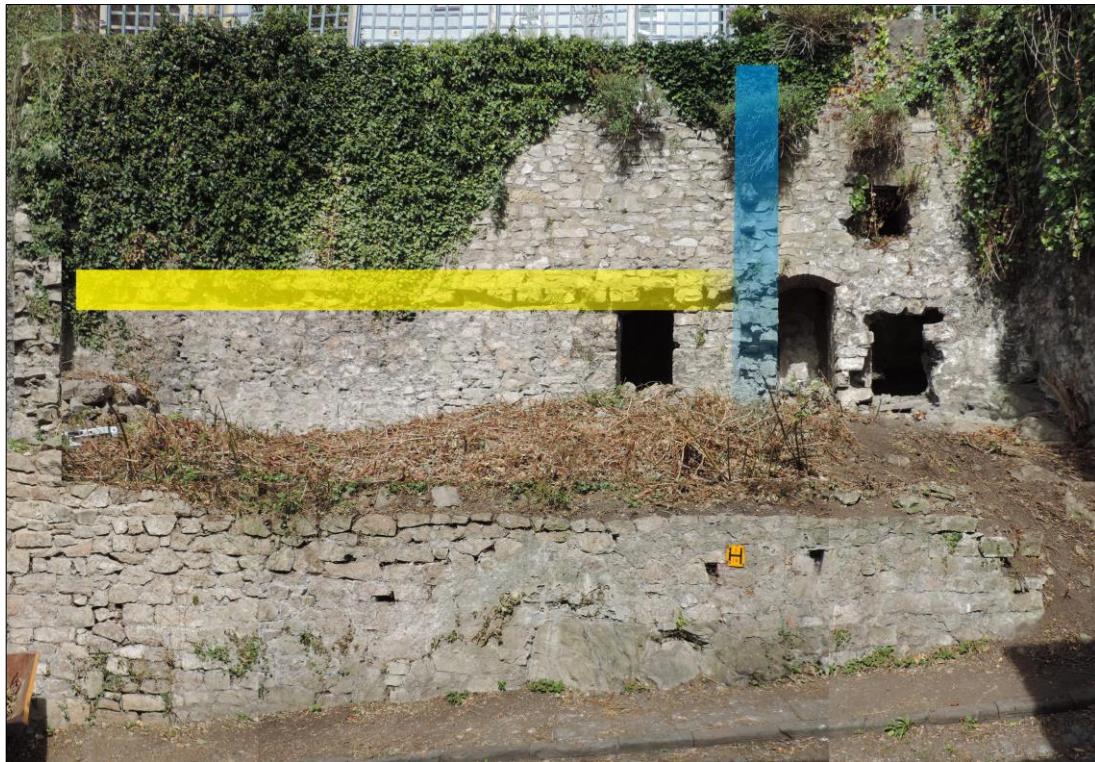
Figure 13 South east facing elevation of north east section of Project Site.

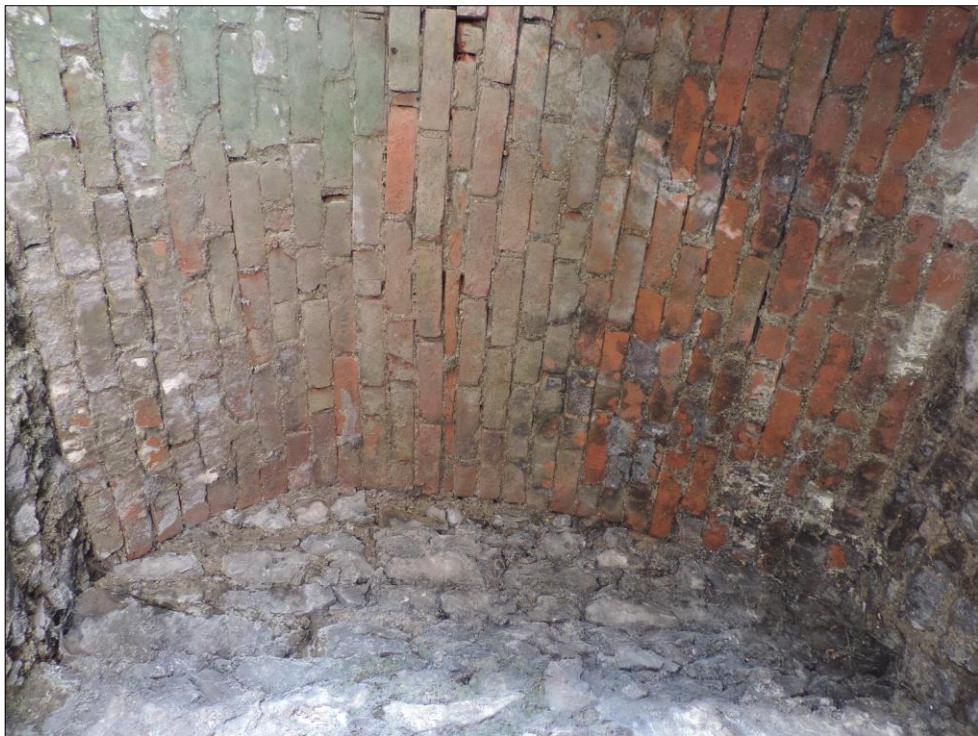
- 4.6. One internal recess is evident and appears to have been carefully constructed, with a roughly dressed stone opening and brick arch with brick vaulted ceiling (Figure 14). The feature appears to have been a full-length doorway, which has subsequently been bricked up to form a smaller opening. Access was not gained to the recess at this time, due to health and safety concerns, however it was clear that the base and rear of the feature comprised the natural face of the quarry. The recess presumably had a utilitarian function, perhaps a larder? Further inspection may shed more light on the nature of the feature, once the current ground level is reduced.

Figure 14 Brick vaulted ceiling.

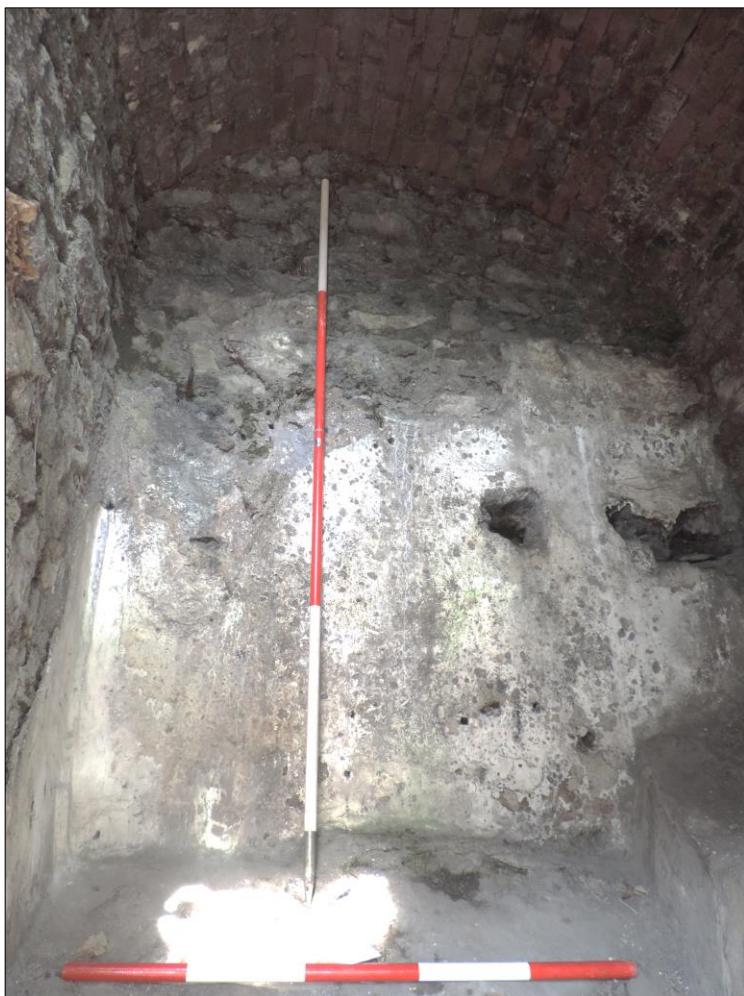
- 4.7. Adjacent and to the north-east of the partition or outer wall (?) two more recesses are evident. Both exhibit brick vaulted roofs and plasterwork. Evidence would suggest that these were located in an external wall, as the end recess appears to comprise an entrance to a small room, with a window

Figure 15 Internal View of north-eastern recess with plastered wall and vaulted ceiling (Scales 1 x 2m & 1 x 1m)

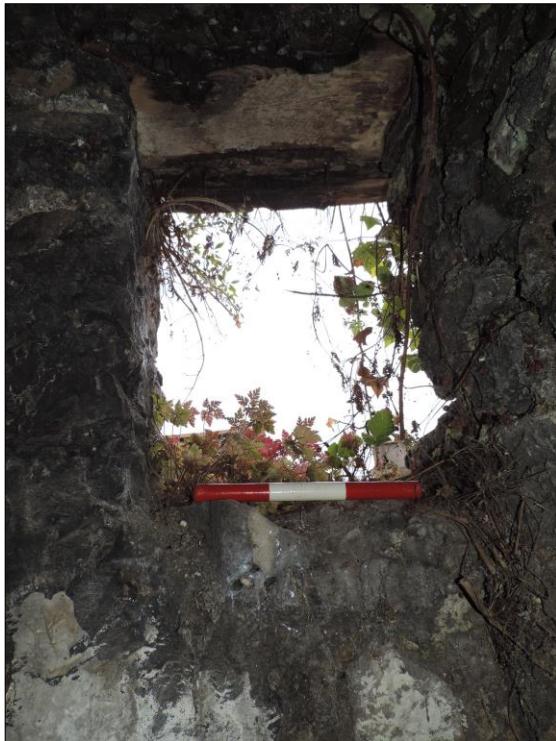
with wooden lintel preserved above (Figure 16). In both recesses the quarry face forms the rear walls.

Figure 16 Internal view of window with wooden lintel (Scale 1 x 300mm)

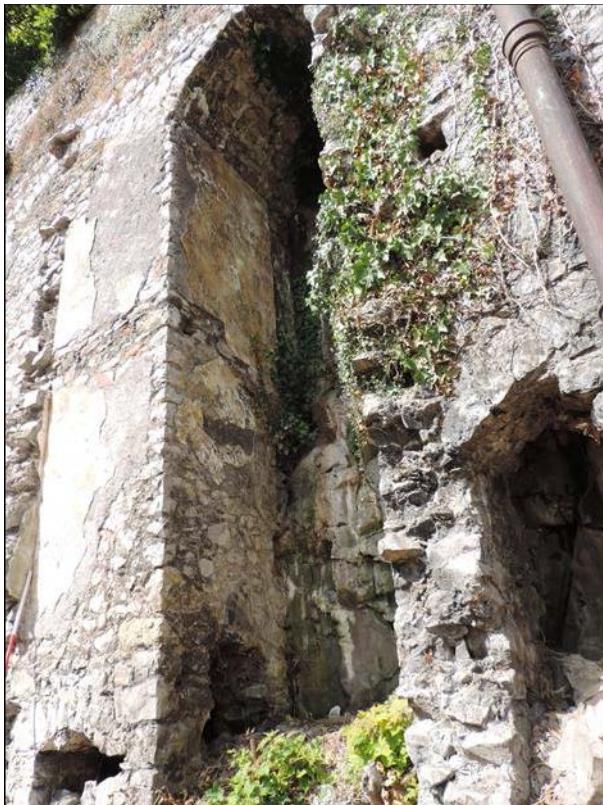
- 4.8. Enough of the original plaster remains to illustrate some of the internal features. For example, the tall arched recesses are plastered internally, confirming that they were incorporated into the layout of the individual dwellings at some point. The depth of the rooms can be ascertained by a line dictating the extent of the plasterwork, which is seen in both arched recesses. An example is shown in Figure 17, where the rear of the dwelling is clearly marked by the line of the plaster.

Figure 17 Internal view of north-east facing elevation of arch, showing internal plasterwork.

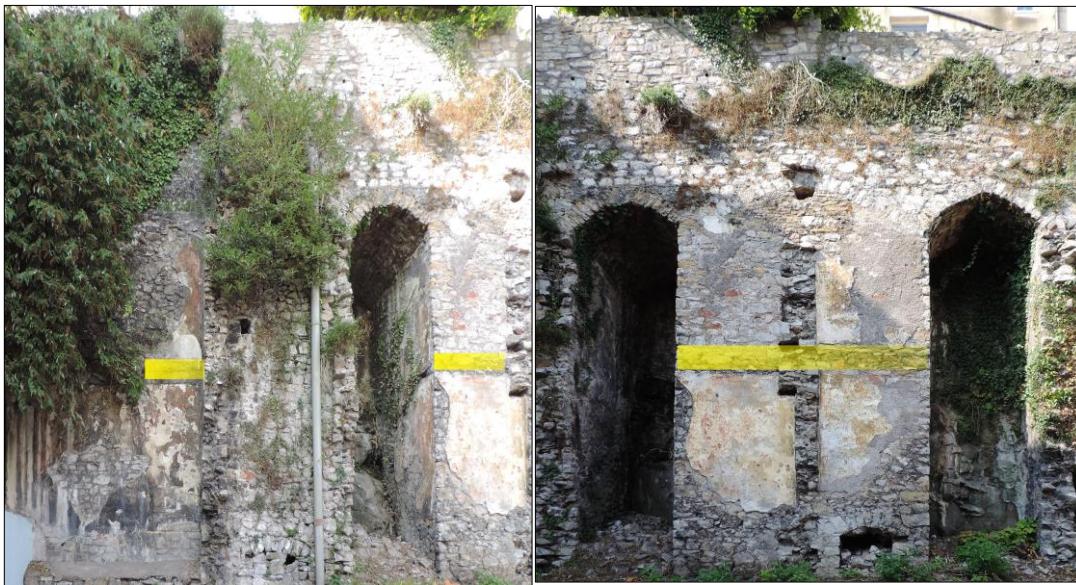
4.9. Evidence of the floor levels is also highlighted in the remaining plaster (Figure 18). The level of the Plasterwork to the south-west of the structure corresponds to the floor location demonstrated in the location of the arches, suggesting a similar internal layout.

Figure 18 South east facing elevation. Plaster demonstrating location of floor timbers (floor level highlighted in yellow).

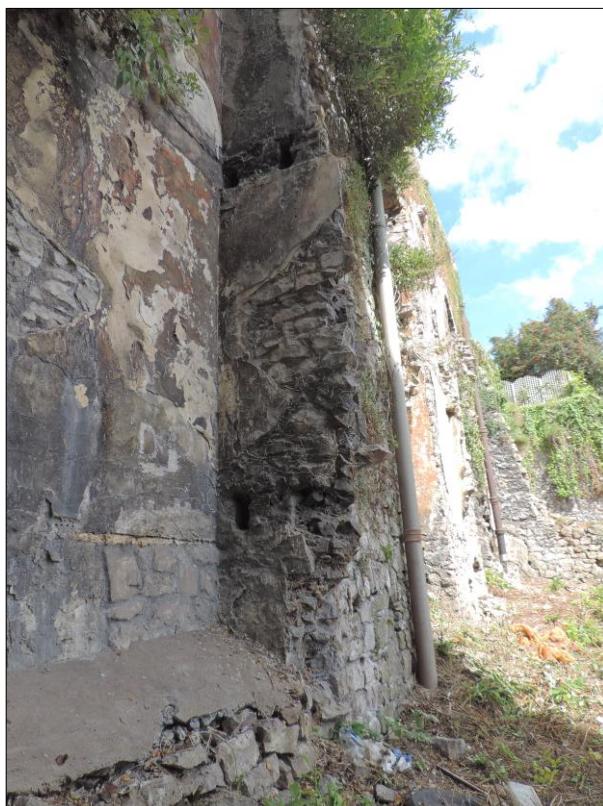
- 4.10. To the south-west of the structure there is clear evidence of the housing for floor joists. The upper level corresponds to the floor level marked out by the plasterwork, discussed above. However, the south-west facing elevation of the south-western partition wall suggests that the structures are likely to have been three storeys (Figure 19). There may be room to accommodate another level if the masonry continues to the modern street level (which would add approximately 2m from ground level to roof height).

Figure 19 South-west elevation of south-western partition wall showing upper row of floor joist housing and potential lower level.
