# HPS

**Project:** Desk Based Assessment

Applicant Name / Agent: Ms A Mckinley  
Project Site: Bank Cottage, High Street, Clearwell, Coleford, Gloucestershire, GL16  
8JS  
NGR: 357339, 208011  
Document Type: Desk-Based Assessment  
Issue ID: V1.0  
Date of Preparation: 7<sup>th</sup> September 2016  
Local Planning Authority: Forest of Dean District Council  
Application Reference: P0276/16/FUL  
HPS Site Code: HPS-132/16  
Oasis ID: heritage10-260403  
OS Licence: 100048201

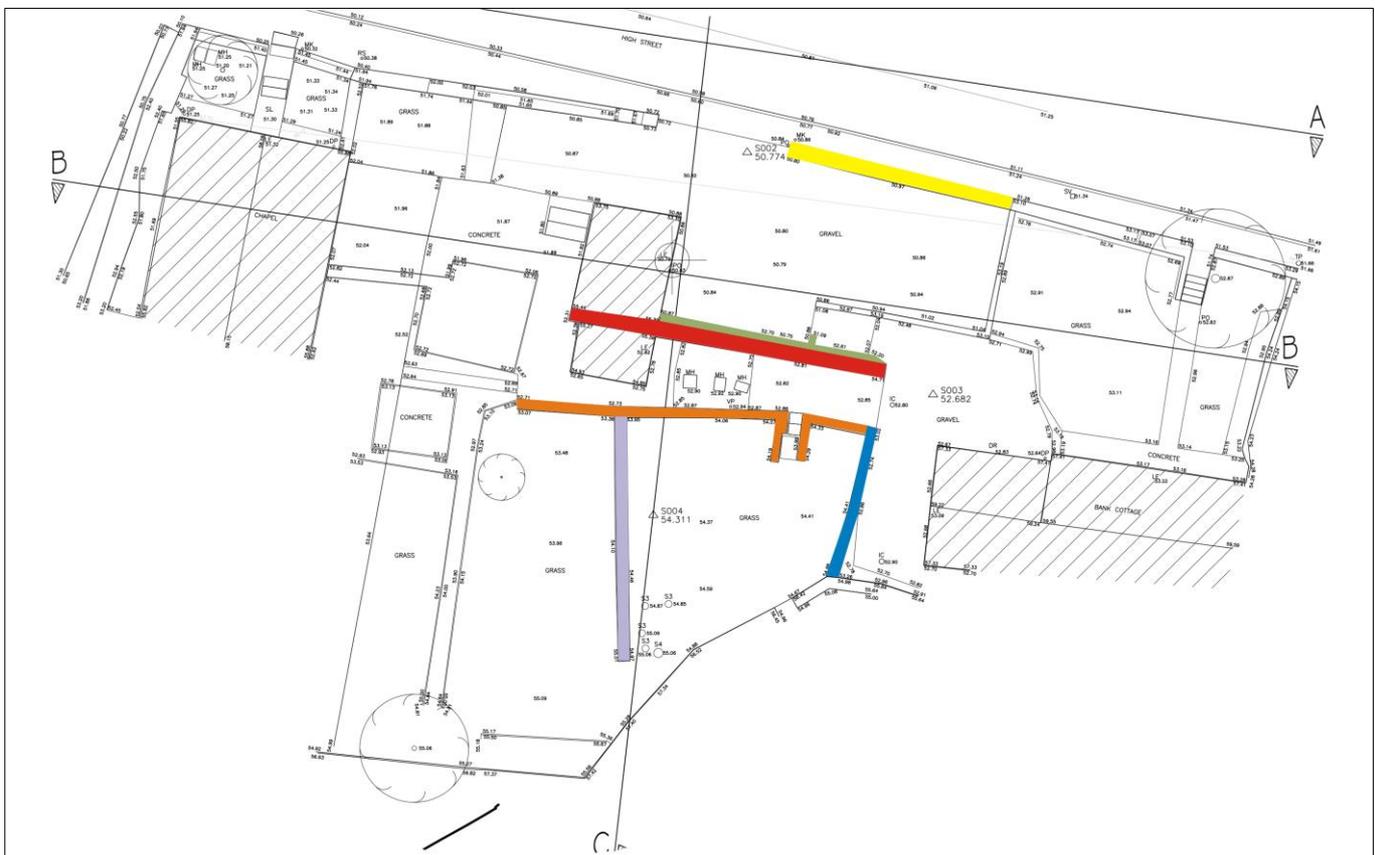
Figure 3 Project Site survey © Total Design Limited Yellow = northern plot boundary / Green = late buttressing / Red = retaining wall/ Orange = upper terrace garden wall / Purple = upper terrace garden wall / Blue = eastern retaining wall.

1.11. The development area is fronted by a partially truncated double skin wall (Figure 3 yellow), constructed in local sandstone (Photo 1). The remaining five courses suggests that the structure has been reconstructed at some point in its history, as only the lower two courses exhibit the design which is demonstrated by the continuation of the intact wall fronting the neighbouring Bank Cottage. The upper three courses of the truncated wall fronting the Project Site demonstrate a regular coursed design.

1.12. A 3.2m high wall is located 9.5m to the rear of the plot (Figure 3 red). Breeze block walls mark the location of degraded garden steps, leading east up to the level of Bank Cottage. The lower portion

of the wall (approximately 2m in height) appears to have been constructed in front of the original retaining wall and is probably acting as a buttress (Figure 3 green).

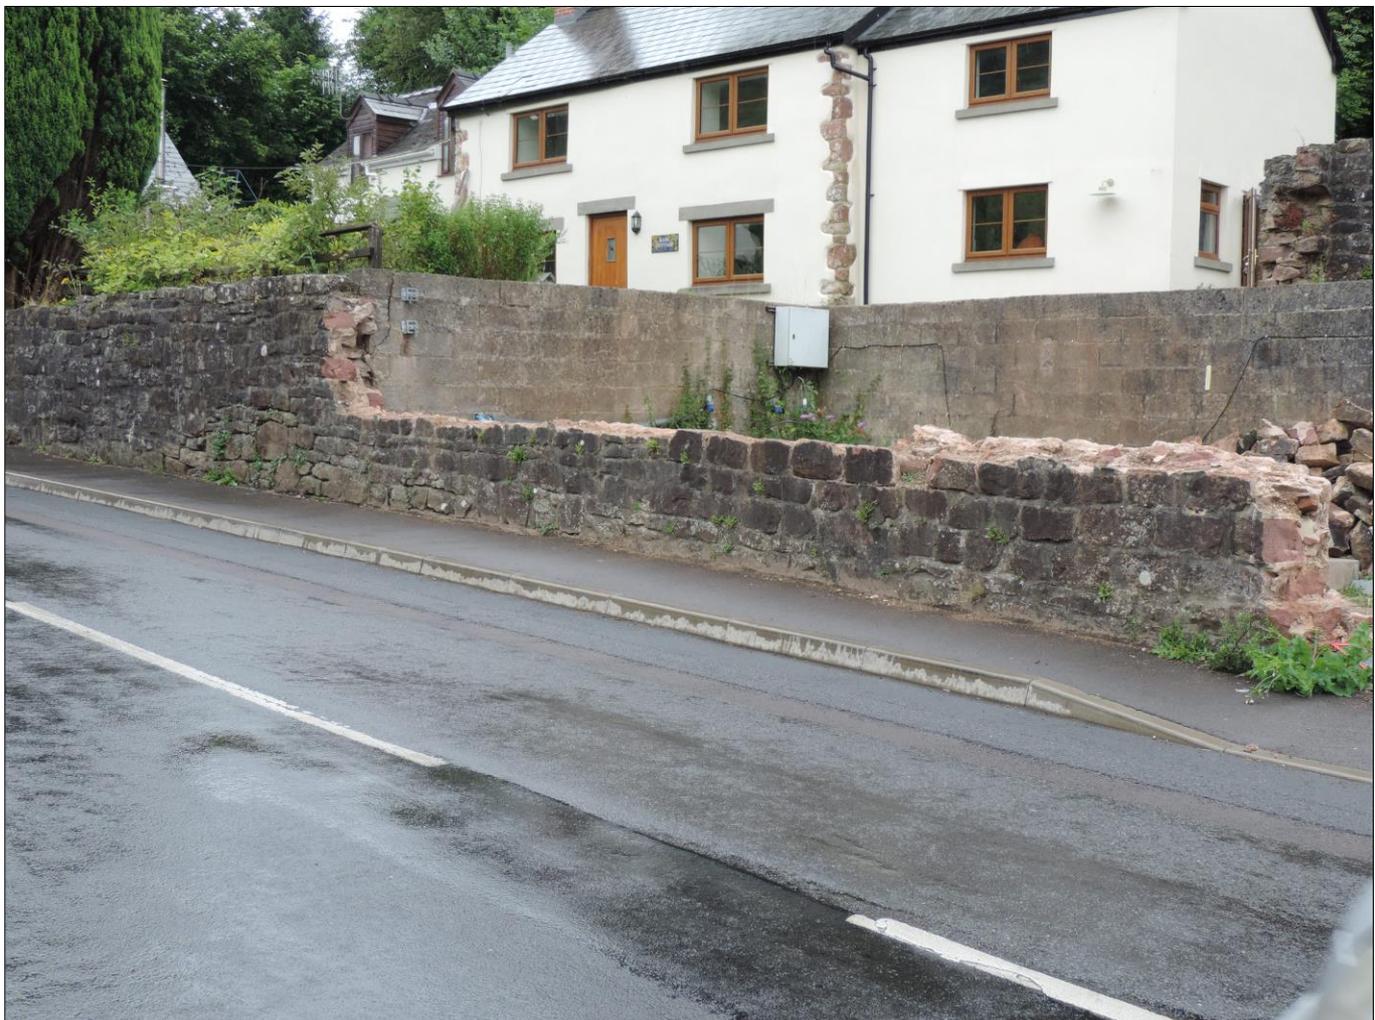
*Photo 1 South-east facing view of boundary wall*

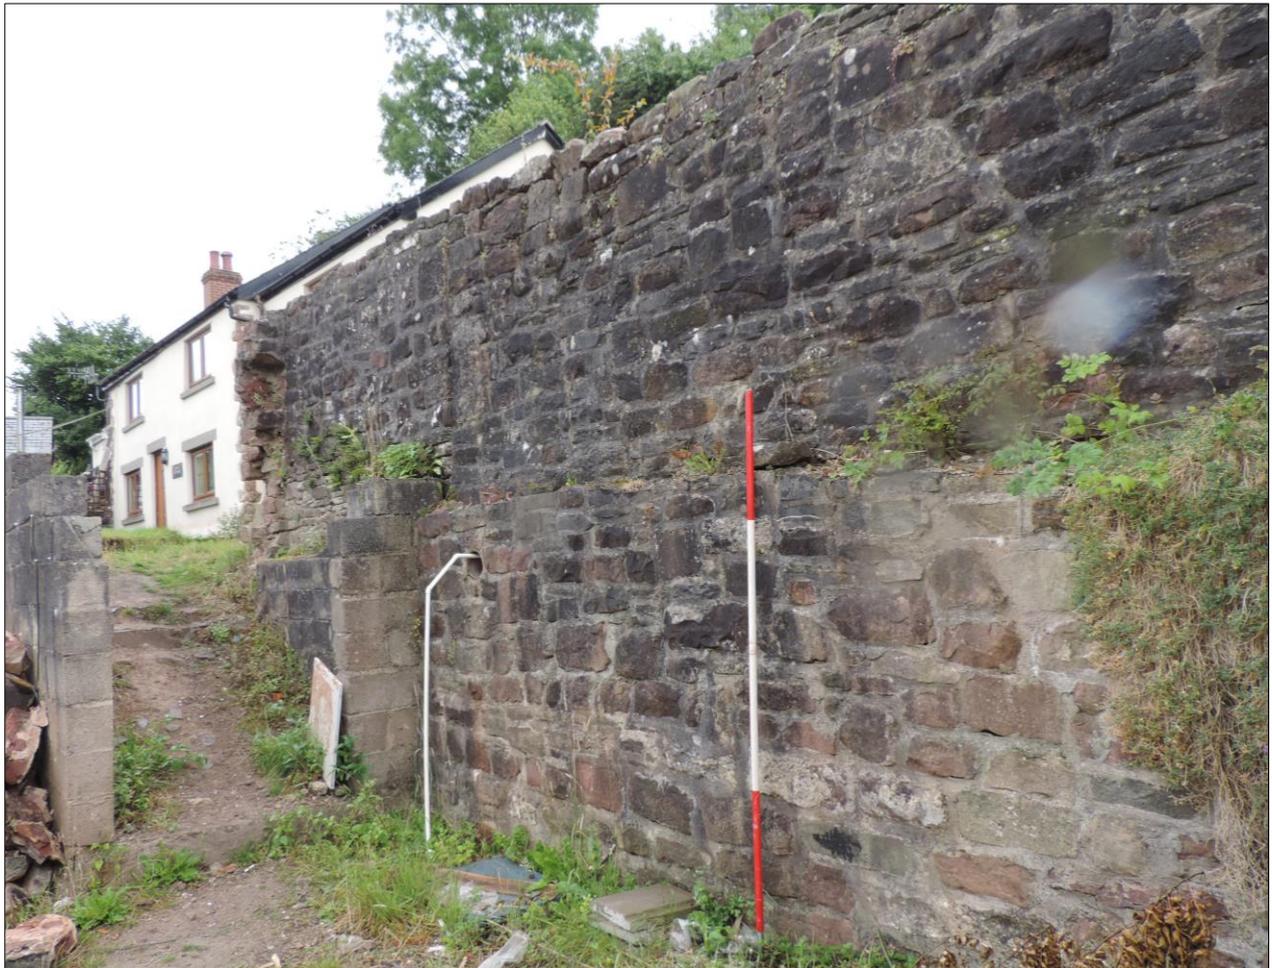
*Photo 2 ESE facing view of retaining wall (Scale 2m)*

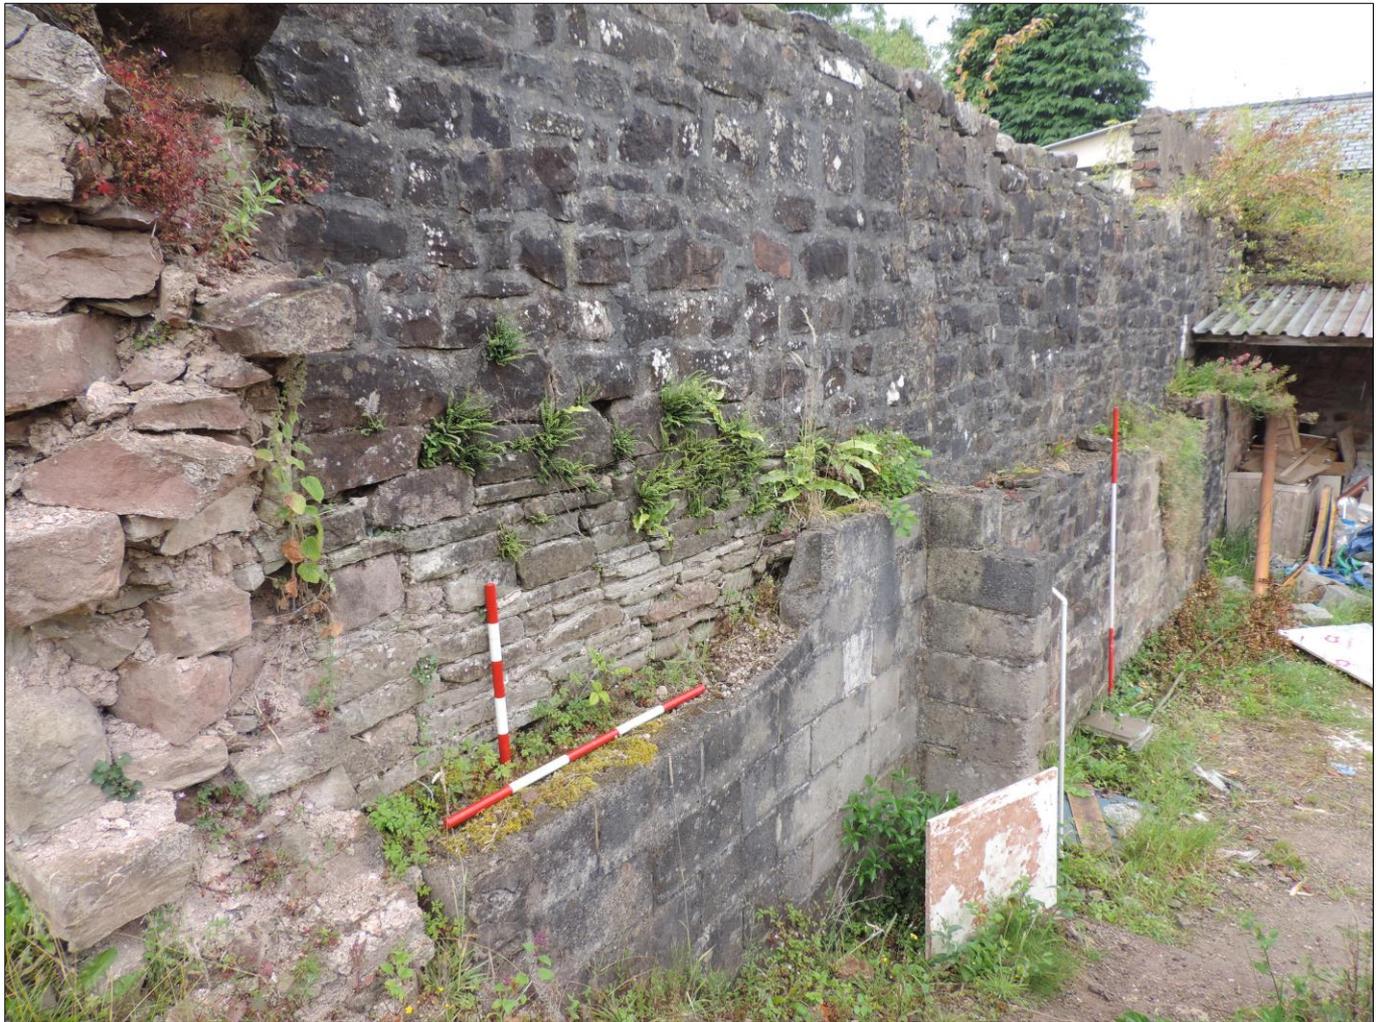
1.13. The wall may preserve at least four phases of construction. The earliest portion appears to be the uneven coursed section visible to the east terminal, which is now protected by a single skin of breeze blocks (representing the latest phase), built just above the height of the terrace (Photo 3). The second phase appears to be the visible upper coursing, followed by the lower coursing which is seen to be stepped out by the depth of a single stone and is probably supporting the original structure.

*Photo 3 West facing view of retaining wall from east terminal. Potential first phase of wall is marked by scales, 1 x 500mm & 1 x 1m*

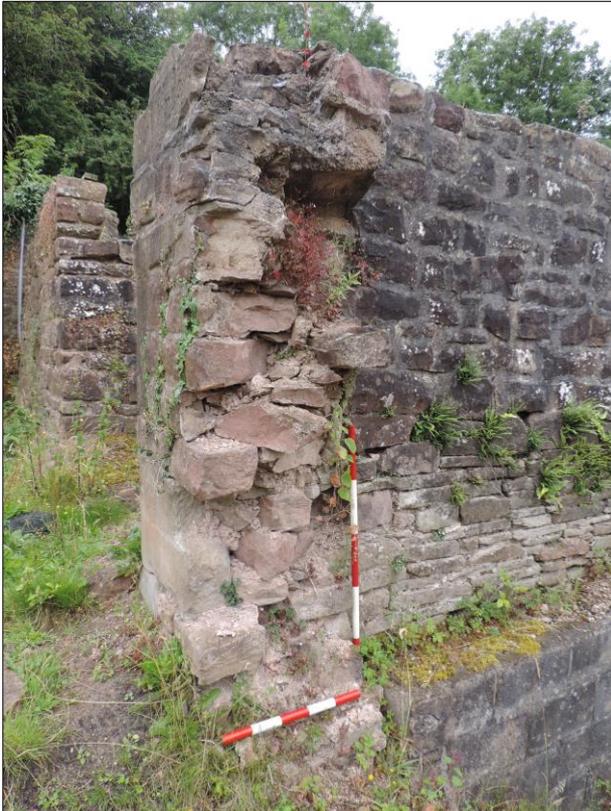
1.14. A return could clearly be seen at the eastern end of the retaining wall (Photo 4). The southern façade exhibits quoining comprising reclaimed masonry (Photo 5). This suggests that the wall was adapted to form the rear wall of a structure.

*Photo 4 SSW facing view of NNE return of retaining wall (Scales 1 x 500mm & 1 x 1m)*

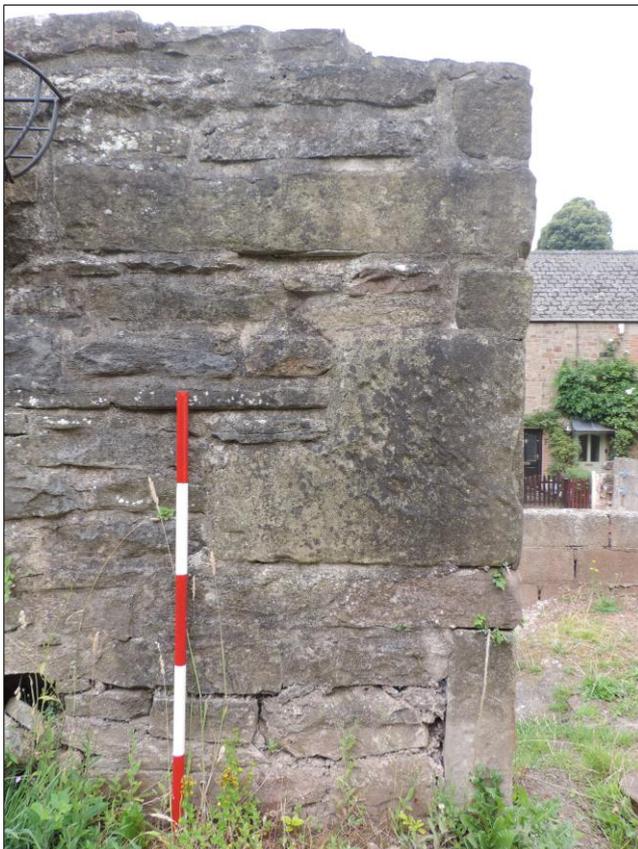
*Photo 5 North facing view of return (Scale 1 x 1m)*

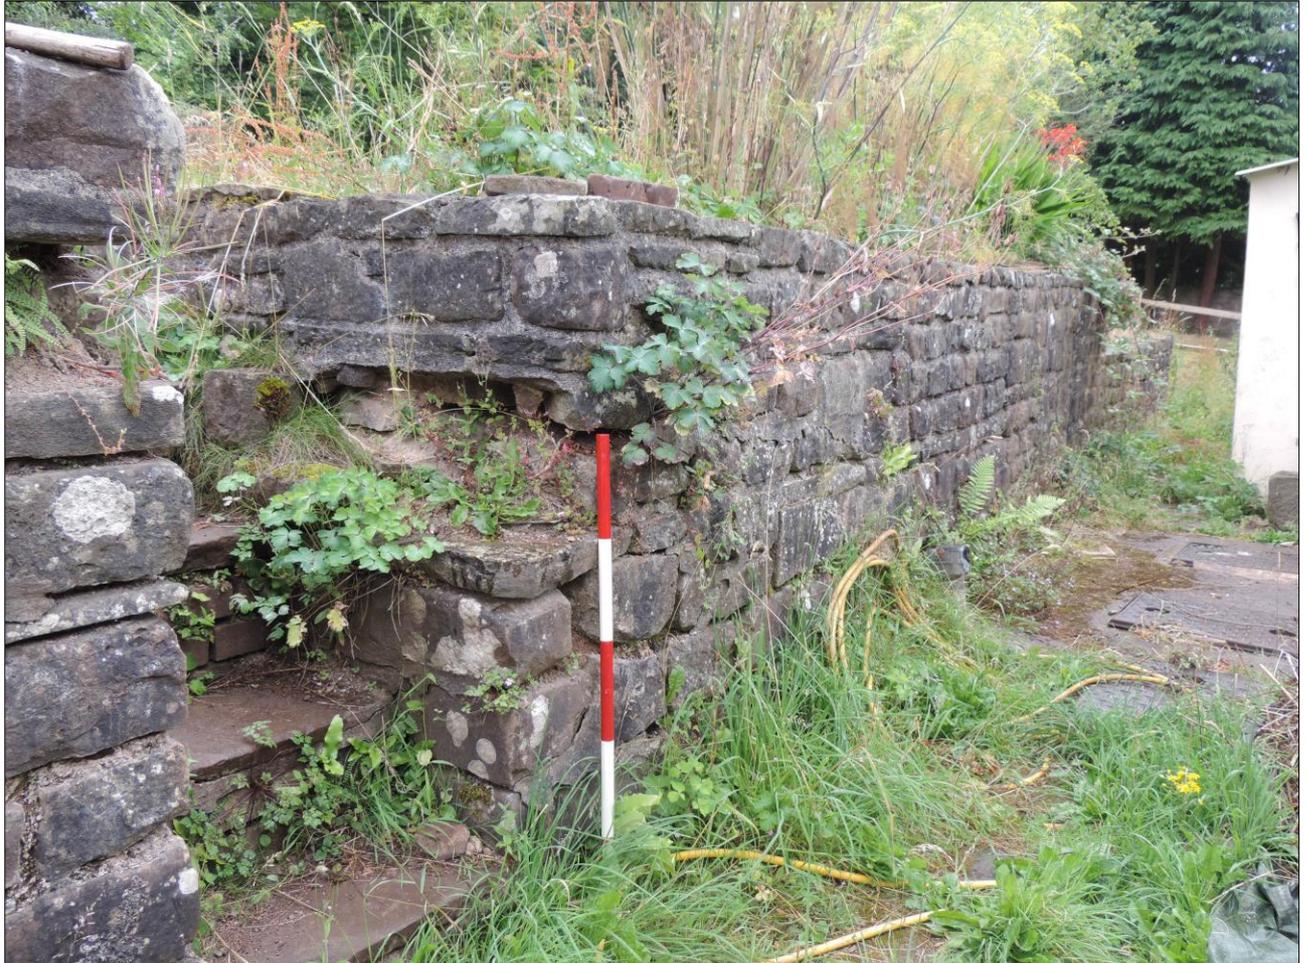
1.15. A third wall is orientated parallel to the retaining wall, on the upper terrace (Photo 6). This forms a narrow pathway, with five steps leading up to another terraced area, seemingly used as a garden (Photo 7). This wall is neatly capped with local sandstone, however the upper coursing exhibits at least three obvious changes in height, suggesting that this wall has been truncated and made good at some time in the past (Figure 3 orange).

*Photo 6 South-west facing view of upper terrace garden wall (Scale 1m)*

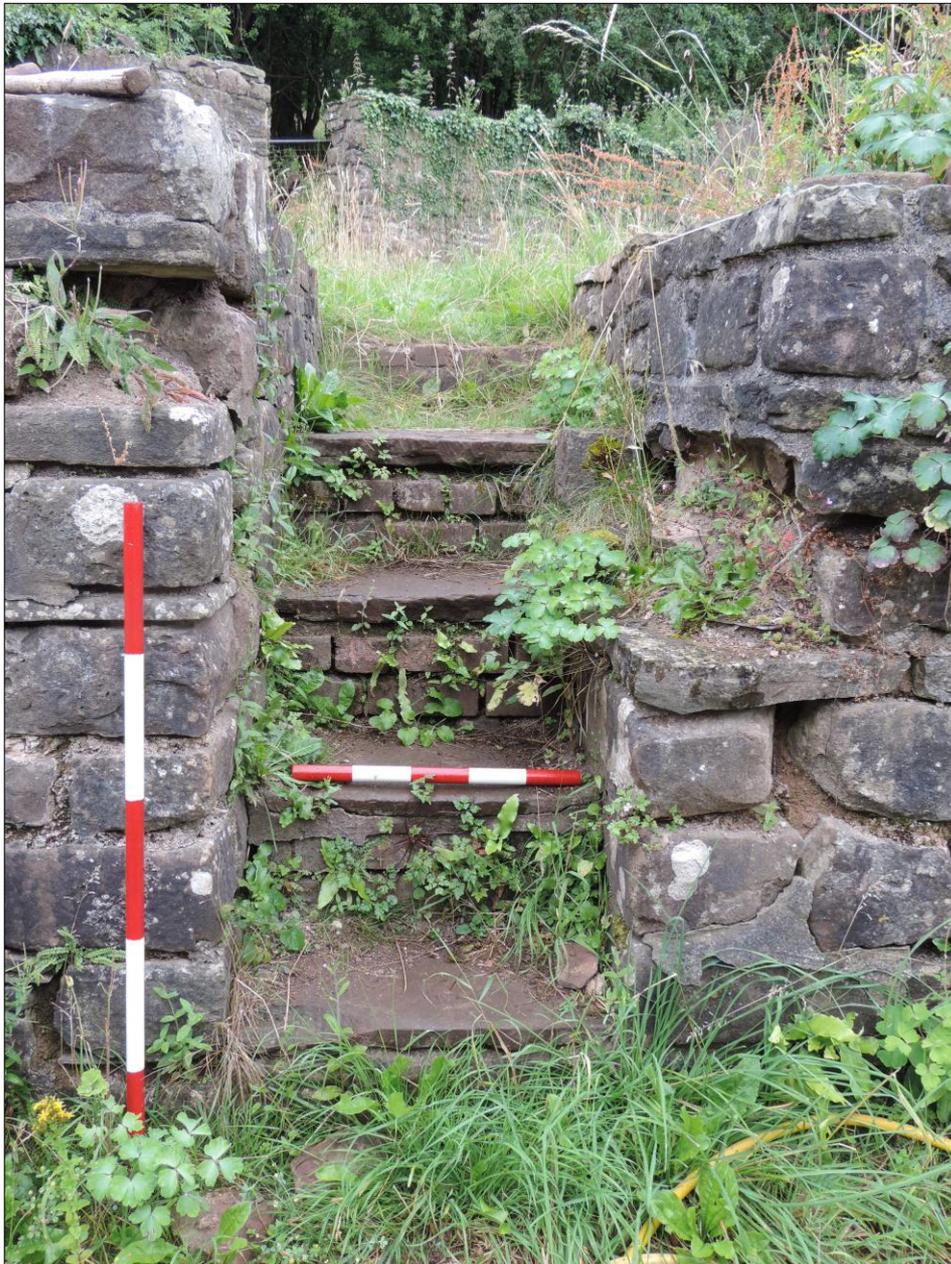
*Photo 7 South facing view of terrace steps (Scales 1 x 500mm & 1m)*

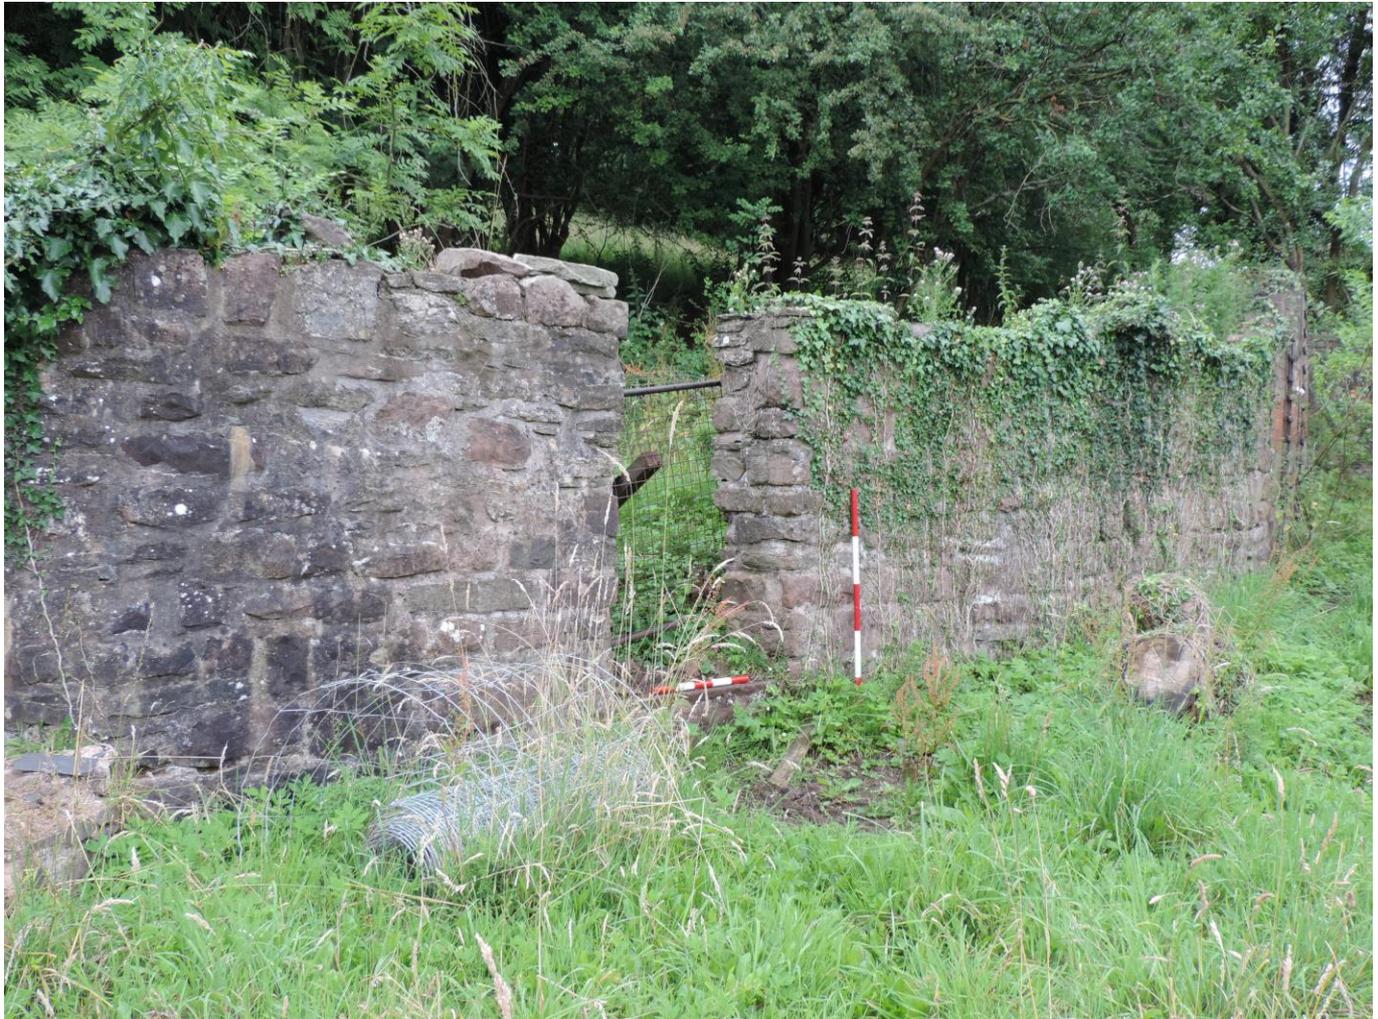
1.16. To the rear of the plot, a forth wall denotes the back of the terrace, behind which the land continues to rise (Photo 8). This randomly coursed wall, in local sandstone may represent one of the oldest of the structures and is the only one to be easily matched to the early maps.

*Photo 8 SW facing view of rear wall (Scales 1 x 500mm & 1 x 1m)*

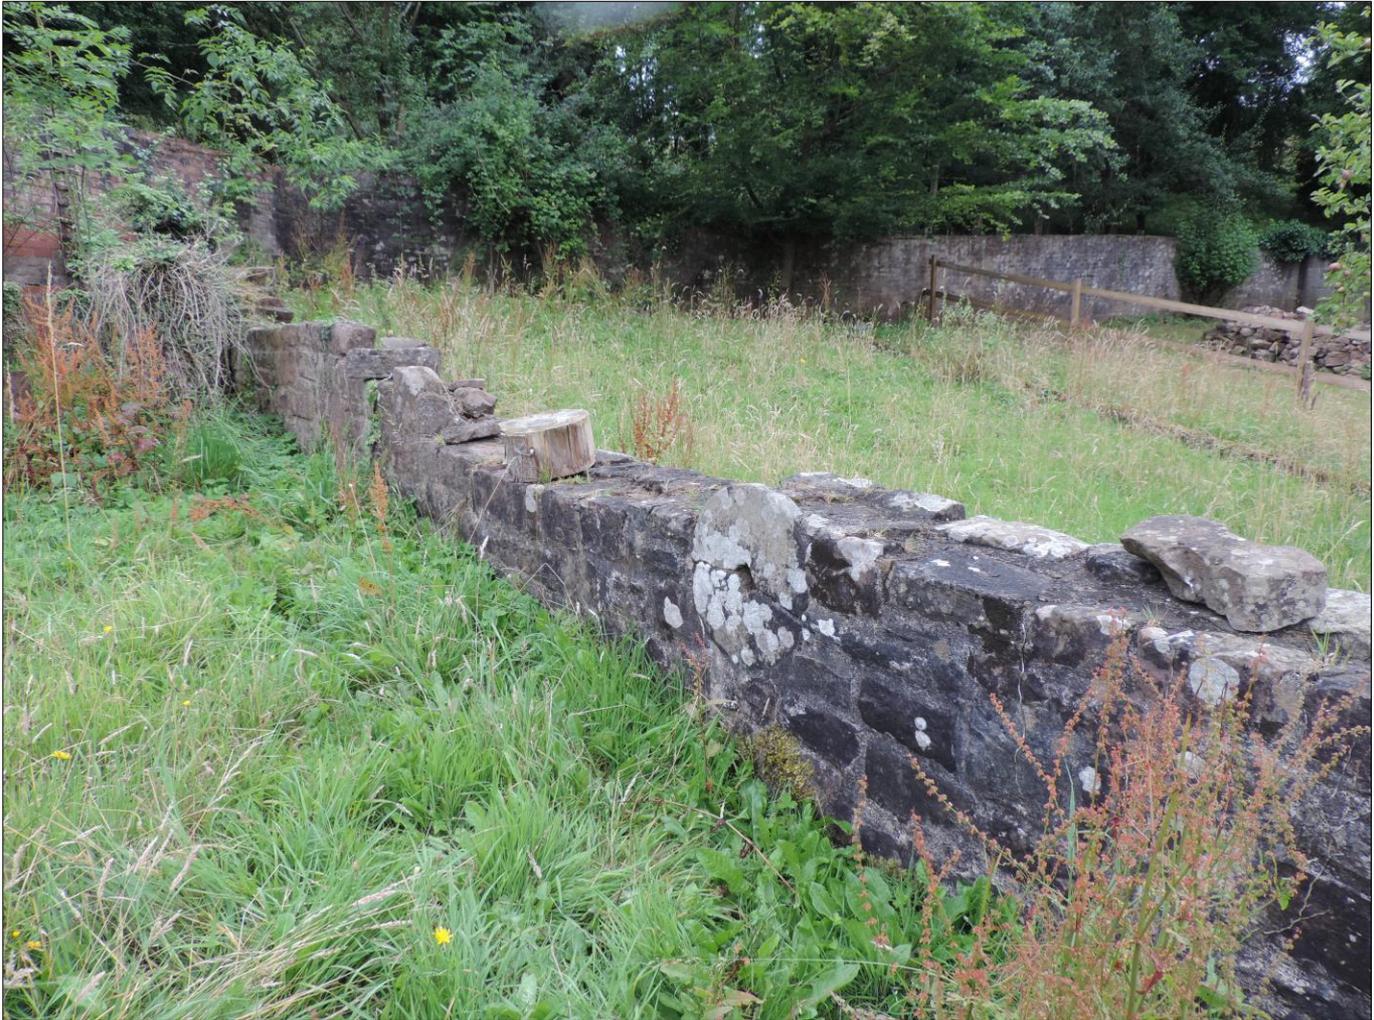
1.17. A smaller garden wall orientated north-south, truncates the terraced garden (Photo 9). This is comprised of reclaimed local sandstone with other masonry features including a Post Medieval quern and boundary stones built into the fabric (Figure 3 purple).

*Photo 9 SSW facing view of garden wall*

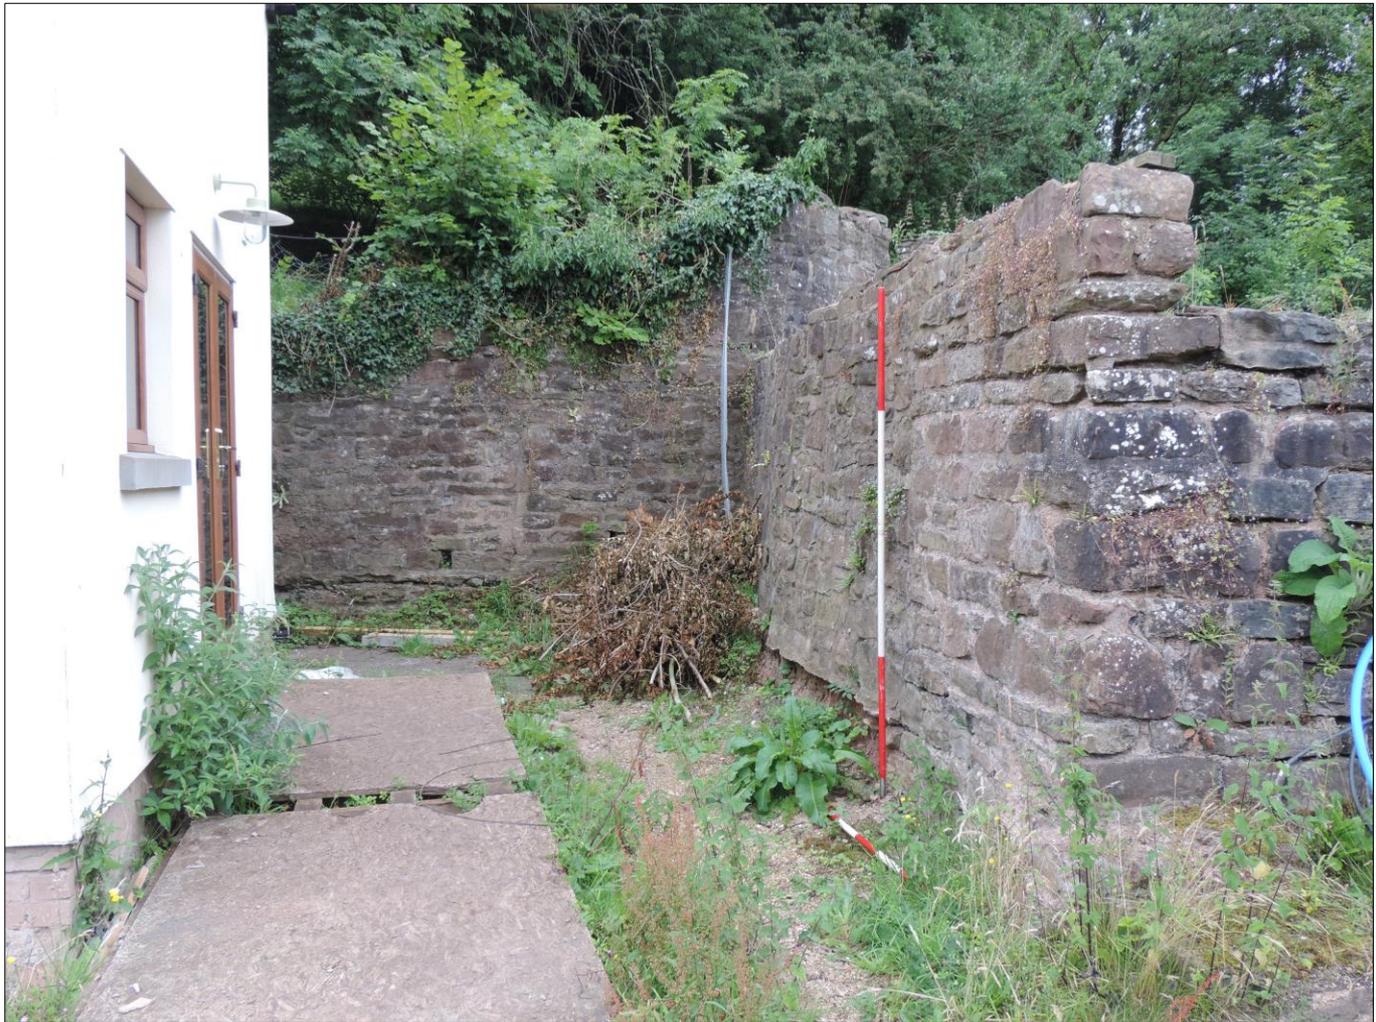
1.18. Lastly, a high sandstone retaining wall separates Bank Cottage from the upper terrace (Photo 10 Figure 3 blue).

*Photo 10 SSW facing view of east retaining wall, with Bank Cottage to the left (Scales 1 x 2m & 1 x 1m)*

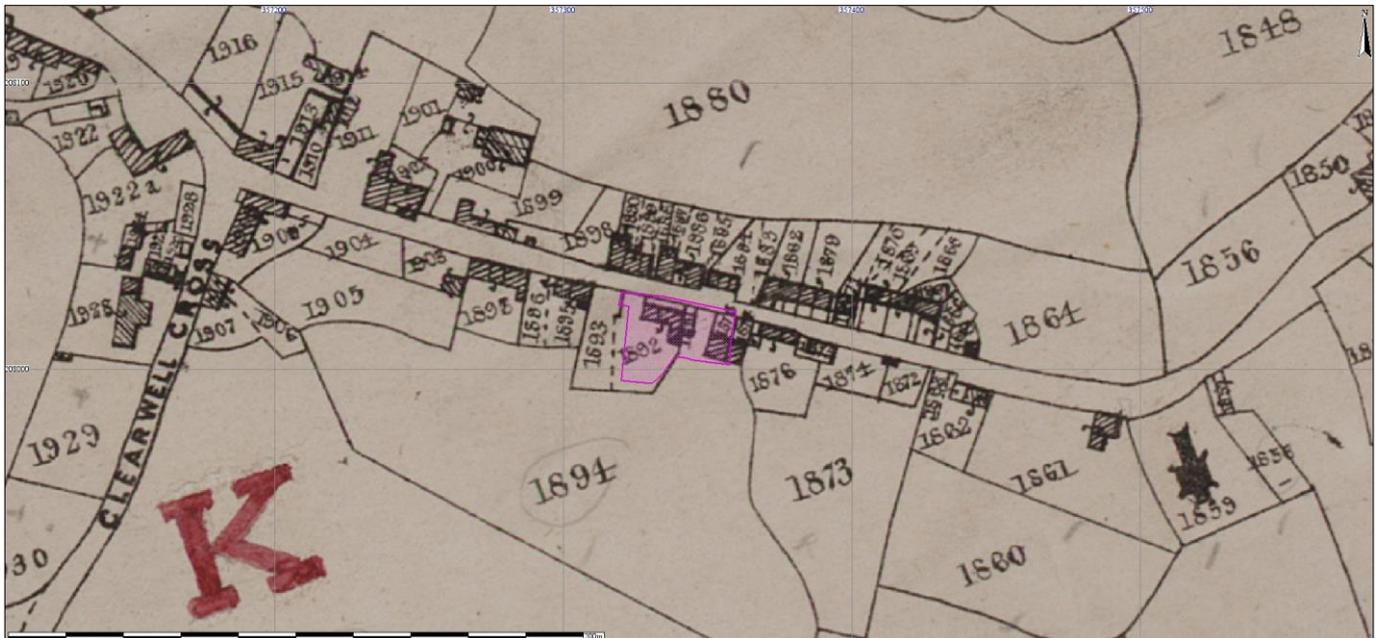
Figure 7: 1842 Tithe Map showing plot division, boundary and buildings. Project site highlighted in purple.

- 7.1. The village of Clearwell has retained its linear form, despite development encroachment in the 20<sup>th</sup> century (HPS Mon ID: 3).
- 7.2. At the time of the production of the Tithe Map in 1842, the Project Site is numbered as 1892 and listed on the Tithe apportionment as Cottage and Garden (Table 1). There is a structure onsite which is L shaped in plan, and there is evidence of a potential partition, suggesting that the property may have been divided to form two semidetached dwellings at this time. However, the plot name doesn't reflect this. The building is located within an enclosure, which is partitioned to the west, creating the annex which was to become the building plot for the Methodist church (Figure 7).
- 7.3. The Project Site boundary to the south is clearly depicted on the Tithe map.

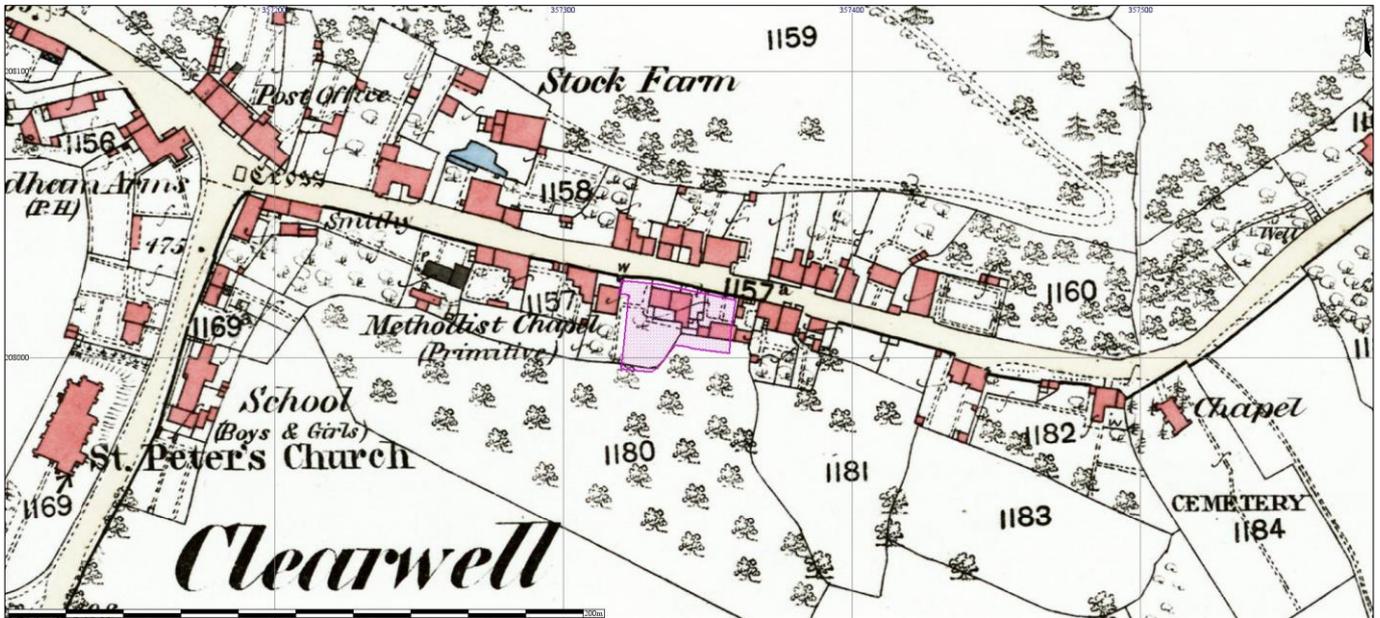
- 7.1. The first edition Ordnance Survey map gives a much clearer image of the properties occupying the Project Site. Here two semidetached dwellings appear to be depicted to the north of the site, with a property in the location of the modern day Bank Cottage, to the east. A wall is depicted to the south of the properties, most likely marking the edge of the terracing, in order to establish a level building plot.

Figure 8: 1881 1<sup>st</sup> edition OS map showing buildings and retaining wall (copyright: Know Your Place)

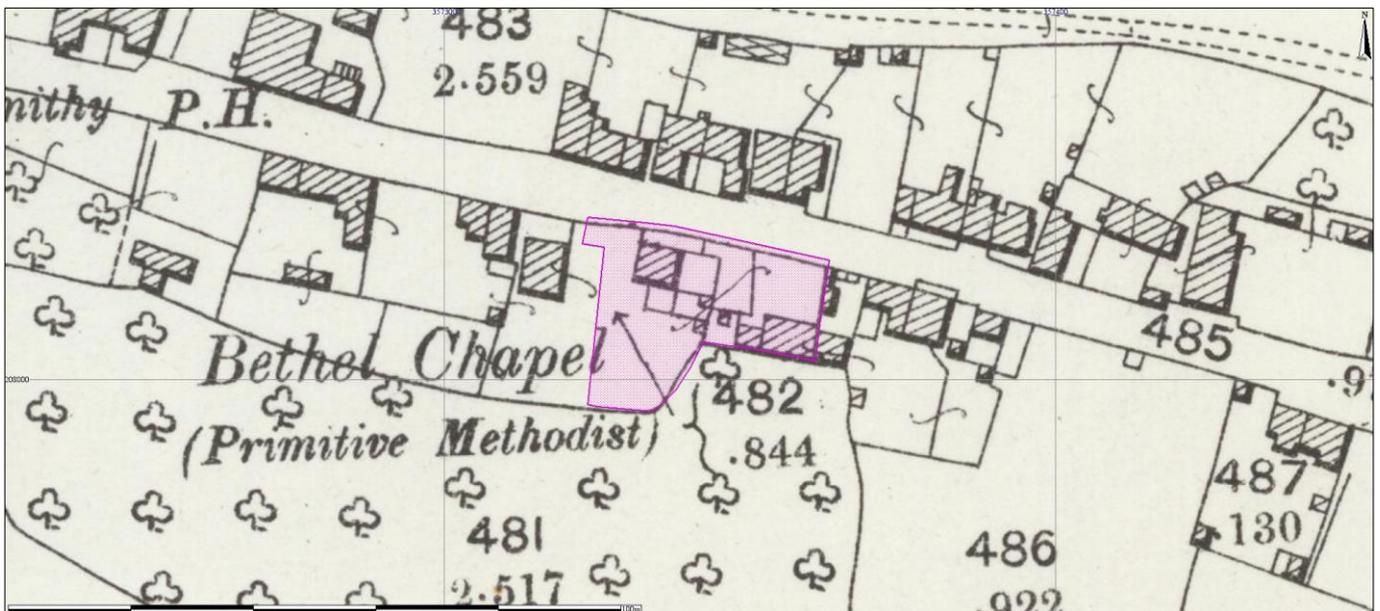
7.4. By the early 20<sup>th</sup> century the eastern property appears to have been removed, however the building plot is still marked on the map.

Figure 9 1902 2<sup>nd</sup> Edition OS Map with Project Site marked in purple.

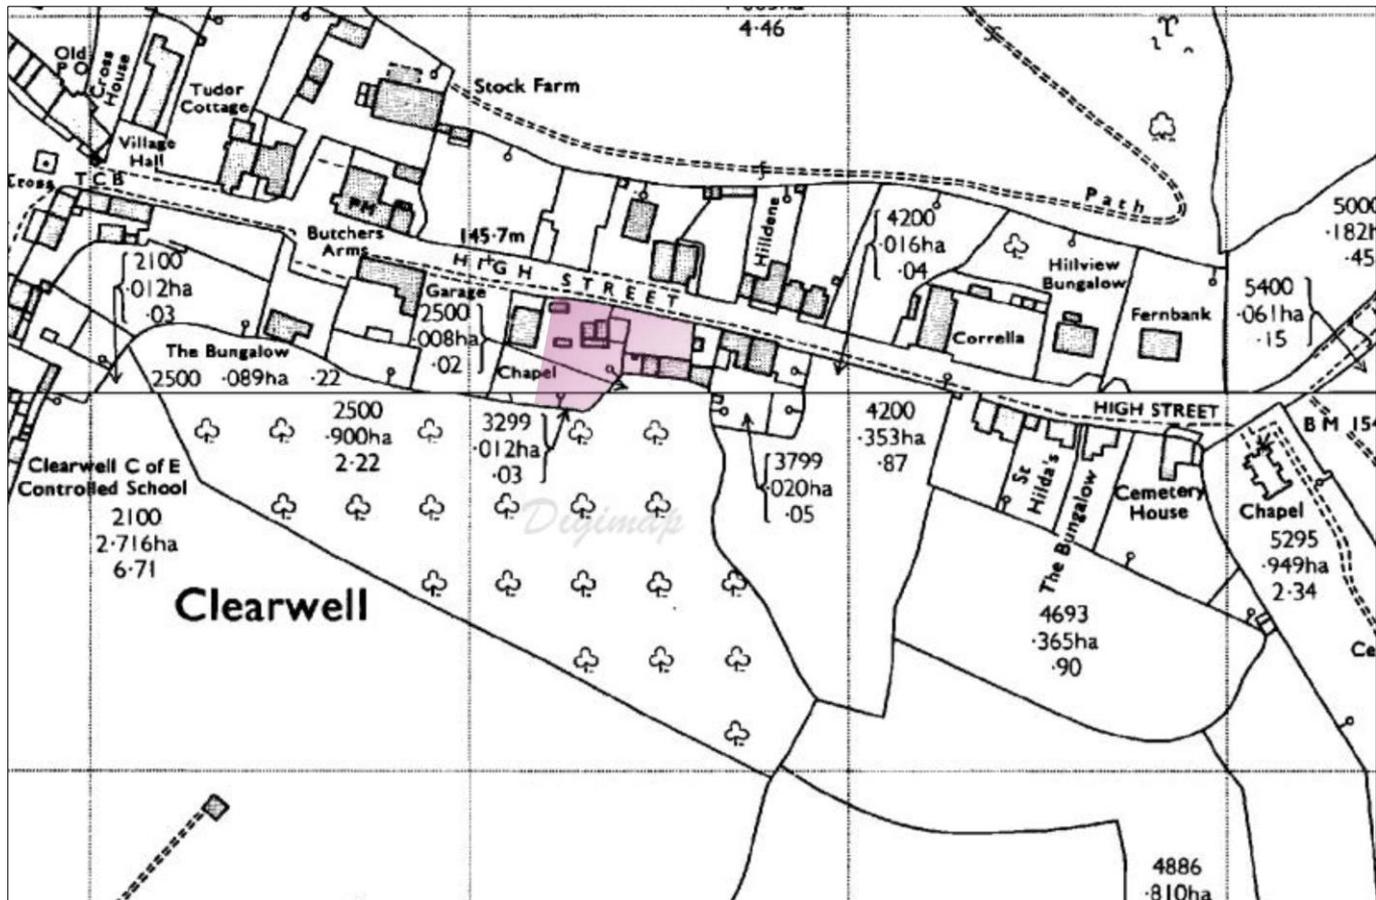
7.5. By 1972 the properties have been demolished and four smaller buildings are shown on the site. The building plot belonging to the footprint of the eastern 19<sup>th</sup> century cottage is still marked out. A boundary appears to be marked to the rear of the Methodist church, however the angle and location does not correspond to the terrace or retaining wall observed on the modern day Project Site.

Figure 10 1972 Landmark Information Group Data with Project Site in purple.

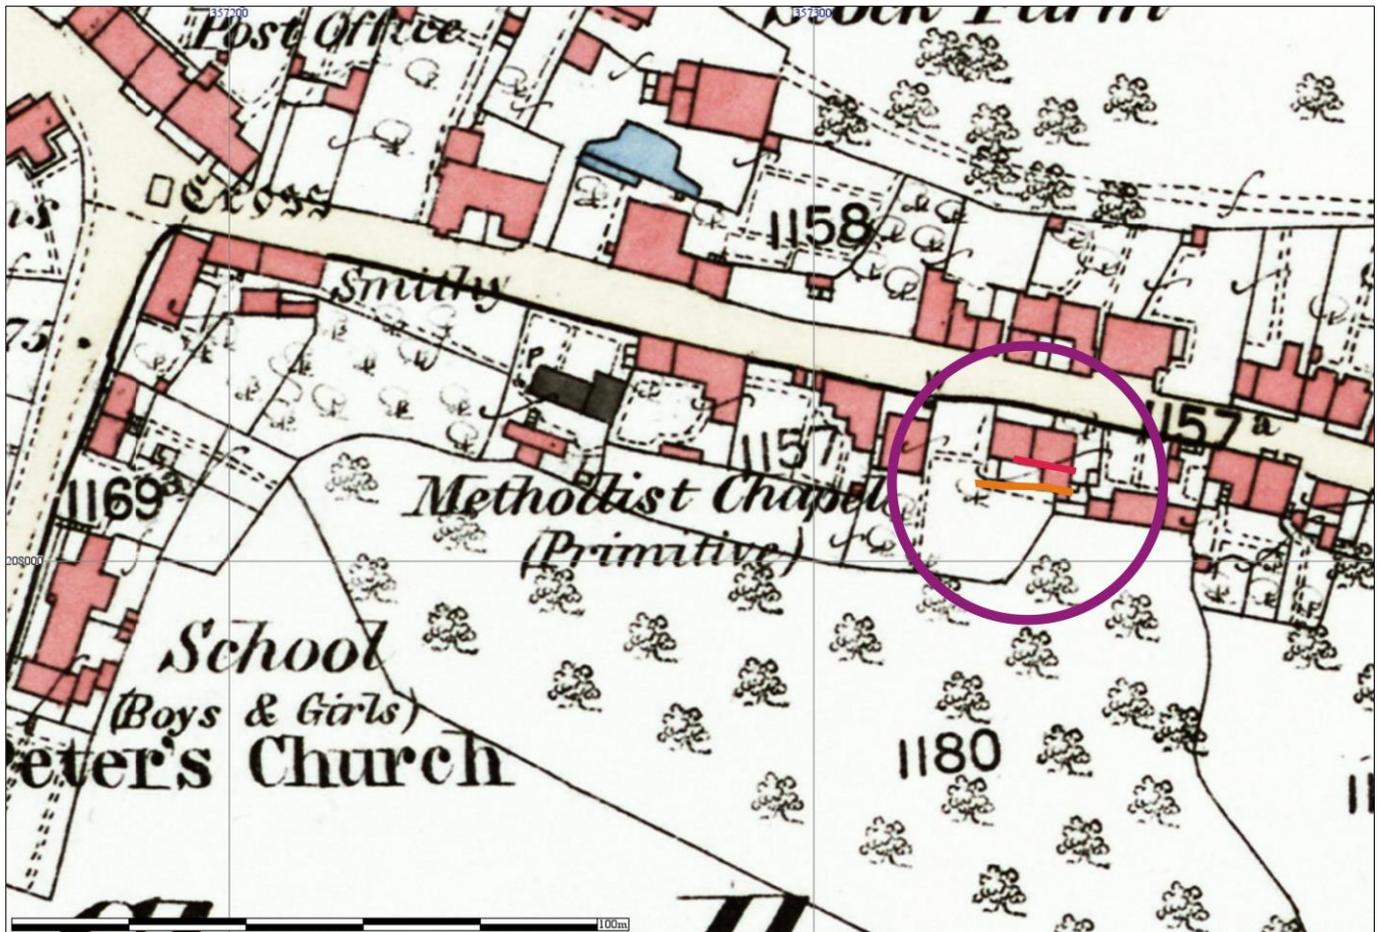
respectively, and that part of the original retaining wall is likely to be preserved in a small section of masonry to the eastern terminal.

Figure 11 1881 1<sup>st</sup> Edition OS with approximate wall locations overlaid in red and orange

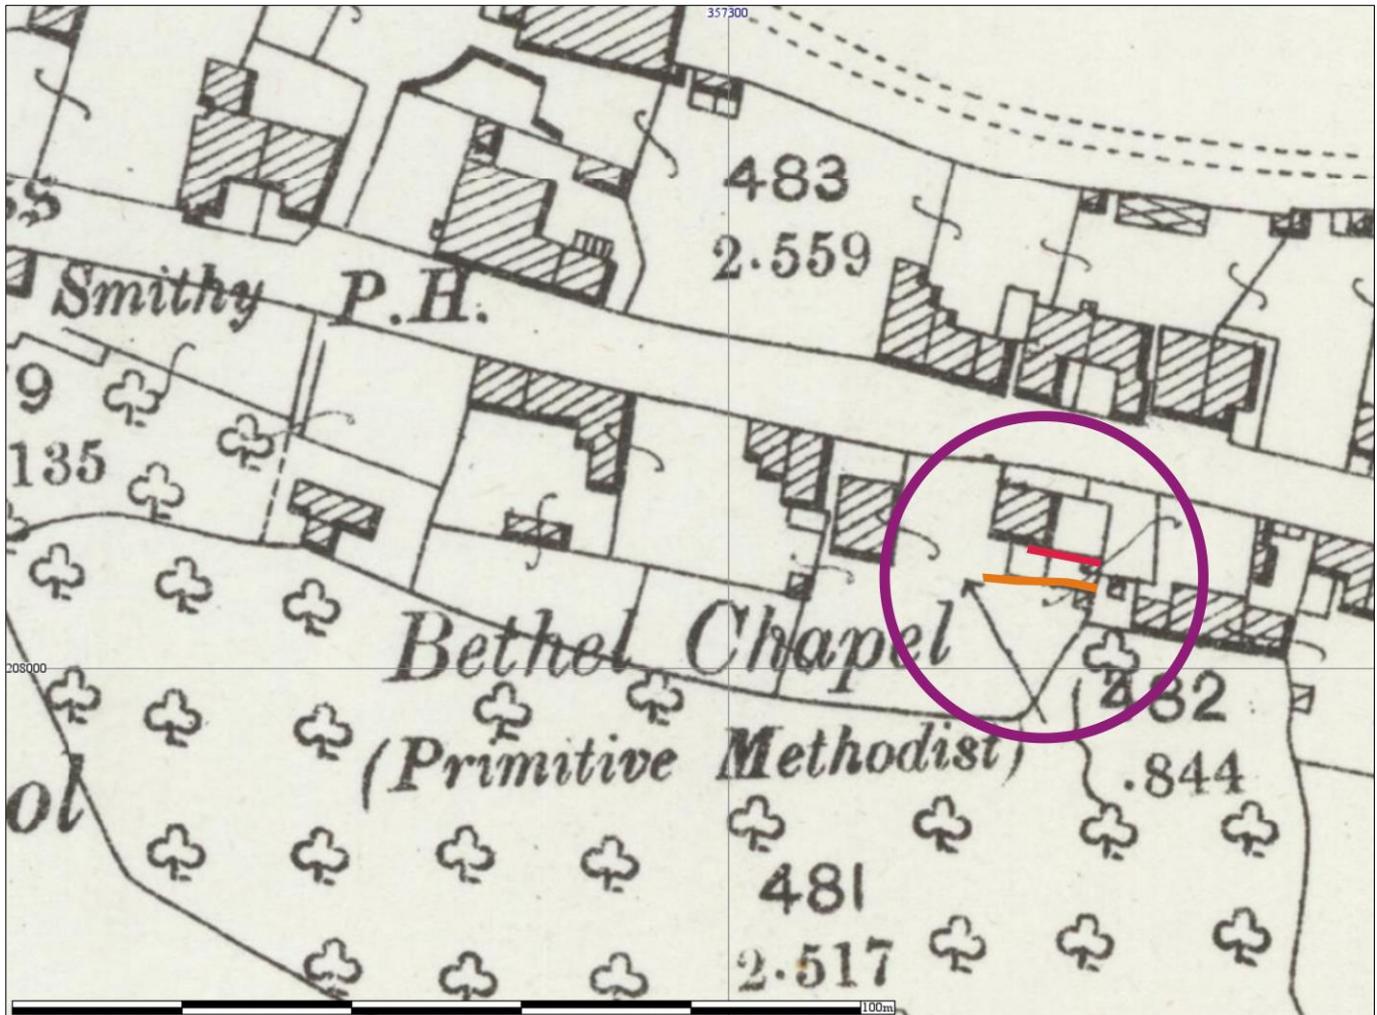
- 8.3. However, the return noted at the eastern terminal of the retaining wall more accurately fits the plan of the early 20<sup>th</sup> century site. By 1902 only the western property remains, however the plots are still outlined and probably defined by physical boundary walls. The evidence of reused material in the return and the correspondence of the masonry with the corner of the plot strengthens this theory.

Figure 12 1902 2<sup>nd</sup> Edition OS map with approximate wall locations in red and orange

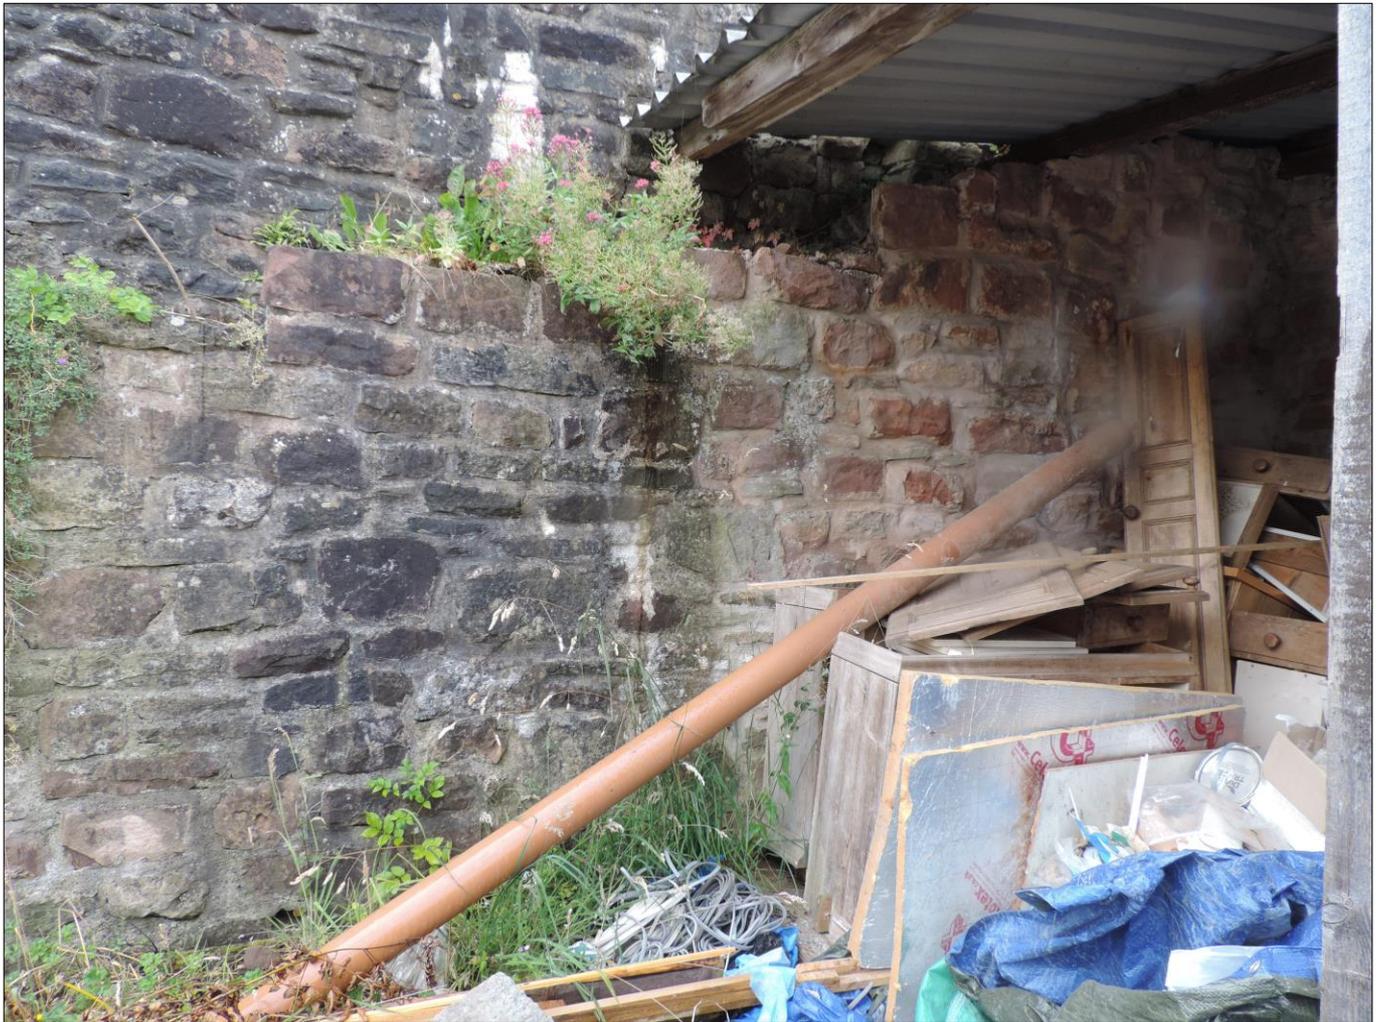
- 8.4. Whilst the roadside wall (yellow) marks the location of the historic boundary, evidence suggests that the remaining structure has undergone major repair or rebuilding at some time in its history.
- 8.5. The retaining wall which is located in the region of the rear of the historic properties (red), is buttressed by a lower sandstone wall, which has been truncated (green). This is thought to be a later addition, and probably constructed in the 20<sup>th</sup> century.

Photo 11 SSW facing view of retaining wall to the west showing evidence of truncated upper courses.
