Royal Fort House Drains, Clifton, Bristol, BS8 1UH

**Project:** Archaeological Watching Brief Report

Applicant Name / Agent: University of Bristol  
Project Site: Royal Fort House Drains, Clifton, Bristol, BS8 1UH  
NGR: NGR ST 5827 7338  
Document Type: Archaeological Watching Brief Report  
Issue ID: v1.0  
Date of Preparation: 19 November 2018  
Local Planning Authority: Bristol City Council  
Application Reference: N/A  
HPS Site Code: HPS-281  
Oasis ID: heritage10-327428  
OS Licence: 100048201

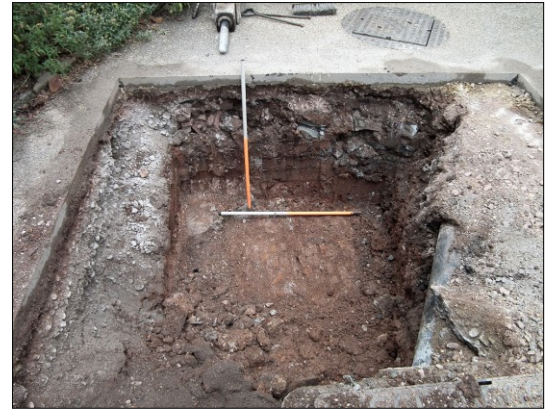
*Photo b. Surface of brick roof prior to removal, looking WSW. Scales 1m x 2.*

4.5. In the western section of the trench, beneath a layer of general demolition rubble, a lime mortared brick surface was encountered at c. 900mm below present ground surface (see Photo b). This was broken through by machine and was found to be the roof of a rectangular stone-built subterranean chamber, c. 2.45m square, rendered internally. No obvious entrance to the chamber was observed; the roof appeared to be intact, except in the northwest corner, where the chamber had been truncated by the construction cut for an inspection chamber associated with the route of the broken drain. Although the interior of the inspection chamber appeared to have been constructed in the last 60 years, the exterior lining of mortared sandstone (see Photo d) indicated the presence of an earlier, probably later 19<sup>th</sup> century, inspection chamber.

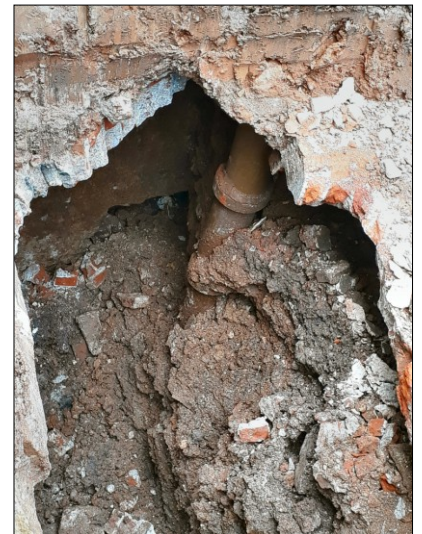
*Photo c. Vertical ceramic pipe in chamber, looking west.*

4.7. Towards the western end of the chamber, which lay slightly beyond the western edge of the trench, was a vertical ceramic drain pipe (see Photo c), the origins of which could not be determined; it is possible this represents drainage into the chamber. A further hole had been made in the wall near the southwest corner at or near original floor level, while another hole at a similar level had been made in the north wall. The exact purpose of these holes could not be ascertained, but it seems likely they were inserted to facilitate drainage out of an otherwise watertight structure that was no longer required for that purpose.

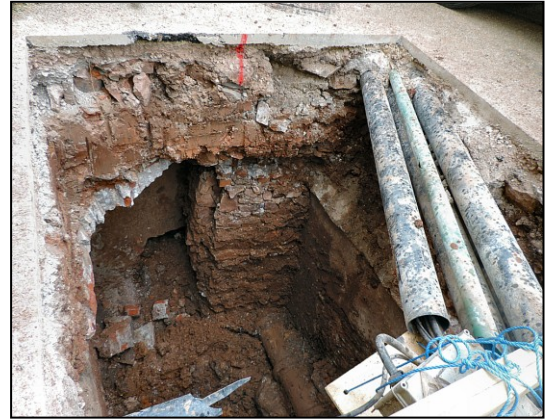
*Photo d. View of the chamber after excavation and removal of vertical pipe, looking west.*

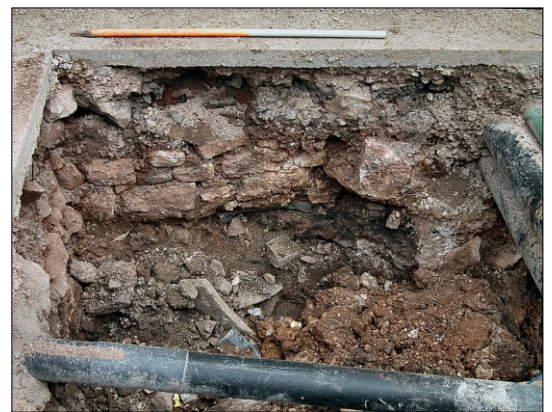
*Photo e. Truncated section of walling in the south face of the trench, looking south. Scale 1m.*

4.11. Immediately east of the eastern wall of the chamber, a short section of truncated walling (see Photo e) was exposed in the north facing section of the trench. A length of approximately 1m of walling was exposed, with only the northern face visible in the trench section. The alignment appeared to be similar to that of the cistern, which was slightly more to the southwest of the trench alignment. The wall was constructed of roughly hewn blocks of sandstone, of varying sizes, surviving in up to three irregular courses. No bonding material was observed.

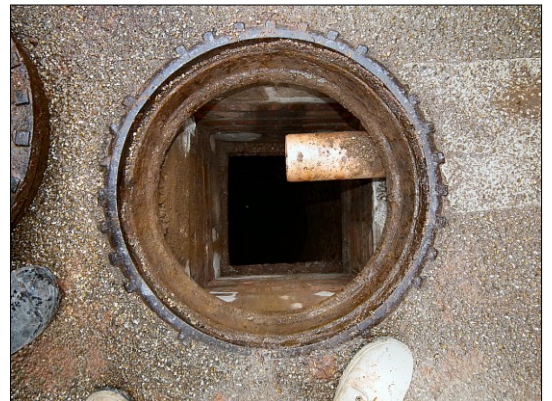
*Photo f. Detail of the well access hatch.*

4.13. In the northeast corner of the original length of the trench a well is located. This well is known and has been sealed by a cast iron access hatch (see Photo f). Below the hatch and concrete cover is a stone lined well of significant depth, with water at the base (see Photo g). The southern side of

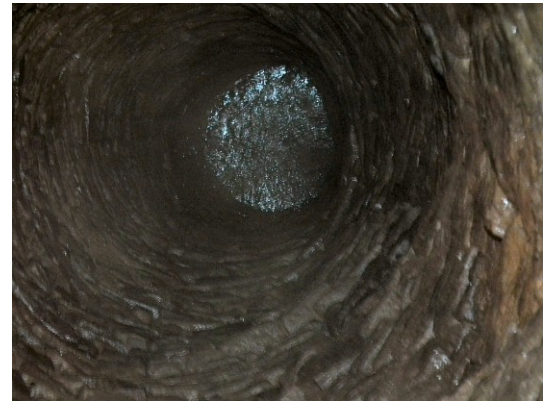
*Photo g. Interior of the well, looking down from the surface.*

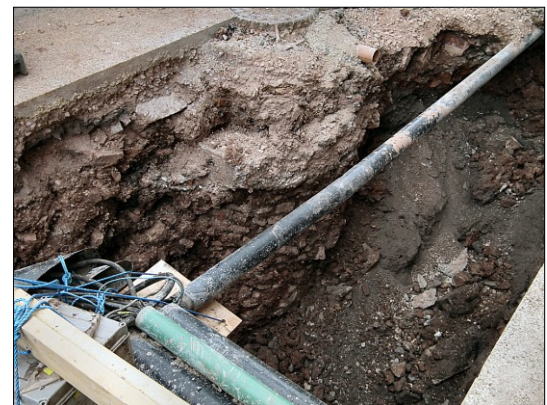
*Photo i. Exterior of the well as exposed in the northern section of the trench, looking northeast.*

this well lining was exposed in the trench during the extension of the trench eastward (see Photo i).

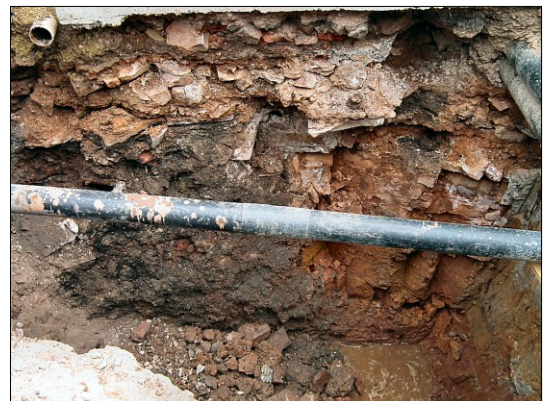
*Photo h. North facing section of trench showing ash-filled cut into bedrock overlain by the remains of two culverts.*

4.14. For a short stretch east of the chamber the sandstone bedrock was encountered at c. 3.5m depth. However, this rapidly gave way to a loose grey ashen looking fill, indicating the stone had been quarried away at depth (Photo h). In the southern section of the trench, east of the chamber, the truncated remains of a stone-lined culvert on a roughly E-W alignment sealed the backfilled quarry pit (Photo j). The roof of the culvert was located c. 700mm below present ground surface. This culvert extended eastward for about 750mm, where it was intersected by a lime-mortared brick-built culvert with sandstone roof, on a roughly north-south alignment (Photo k). This was sealed

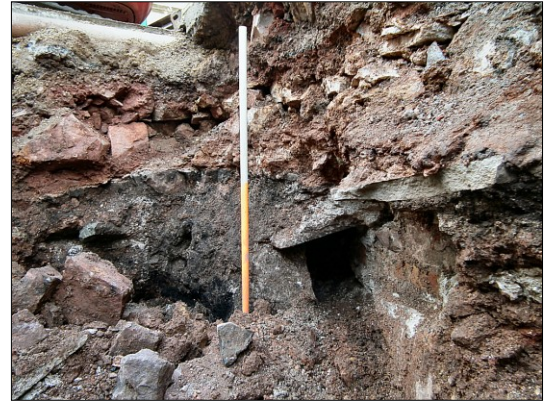
*Photo j. View of stone lined culvert in north facing section, looking east. Scale 1m.*

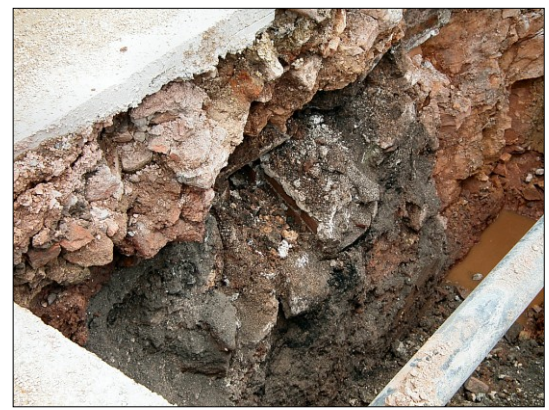
*Photo i. Truncated brick-lined culvert in north facing section, looking southwest.*

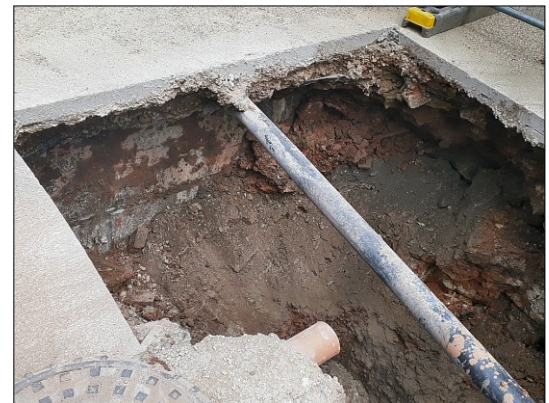
*Photo k. The eastern end of the trench, looking southeast, showing the western wall of the underground boiler room.*

4.15. The fill of the quarry pit extended as far as the eastern end of the trench, where it was truncated by the construction cut for the concrete underground boiler room (Photo I).
