DESK BASED ASSESSMENT & HERITAGE IMPACT ASSESSMENT

Clifton House, Church Street, Clifton, Shefford, SG17 5ET

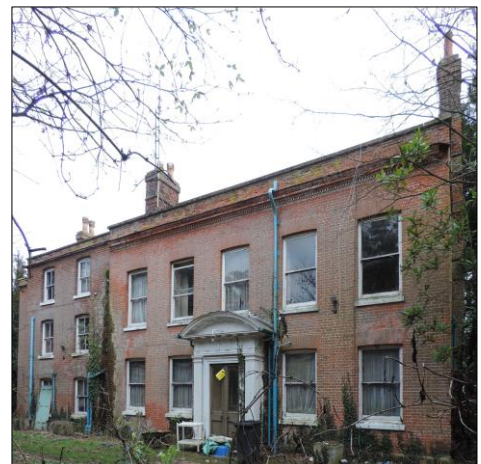
4.3. The earliest part of Clifton House is located to the southwest of the Project Site. The double pile plan dwelling is two storeys in height with garret. The principle (front) elevation

Photo 1 ENE facing view of Clifton House front elevation. Main Block in the foreground.

has a five window range of sash windows, with recessed sash boxes. The absence of glazing bars indicates that the windows likely date to the second half of the 19th century or later. A decorative dentilled brick cornice runs the length of the façade and is topped by a brick parapet. A Doric style doorcase is positioned centrally at ground floor level. A similar doorcase is known from Rutland Lodge, Petersham⁴ (dated 1740).

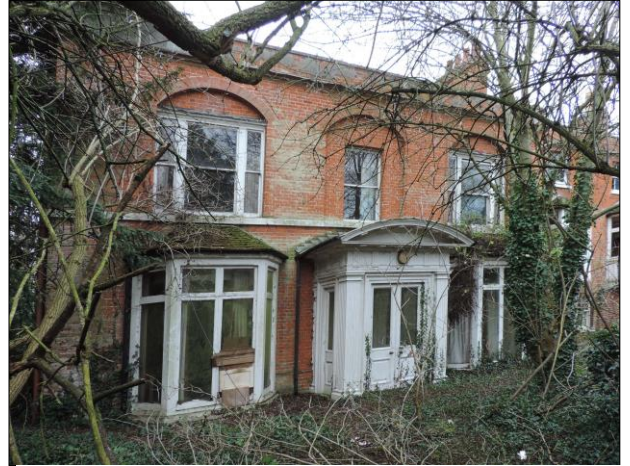
- 4.4. The rear elevation has a three window range, with two tripartite sash windows flanking a single central sash. All first floor windows are housed within decorative segmental arch brick recesses. The first and second floor is divided by a plain stringcourse. Two canted bay windows with tiled roofs flank the Doric style doorway, similar in design to the front porch. A plain cornice runs the length of the rear elevation and is topped with a plain brick parapet.

Photo 2 North facing view of rear elevation, Main Block. Two large cantilever windows flank a Doric style doorcase. Windows are thought to be 19th century additions.

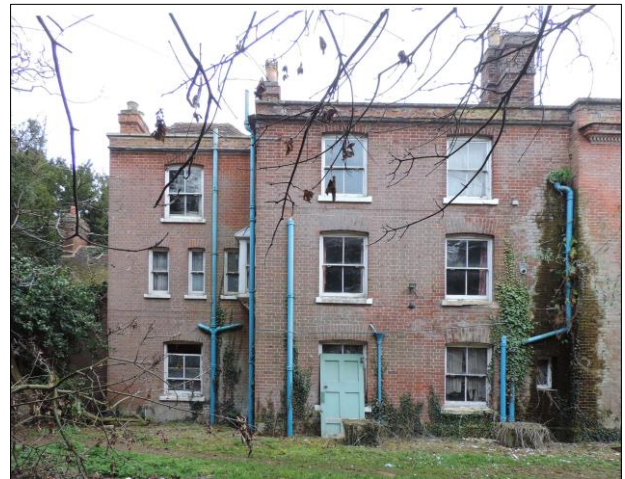
- 4.5. The main building has been extended to the northeast by a series of stepped bays of varying heights. The principle block comprises a three storey building equal in height to the Main Block, but stepped back a small distance from the principle elevation. The brick extension has a two window range of two over two sash windows with recessed sash box and plain cornice, similar in style to the rear elevation of the Main Block. The plain brick parapet is continued from the southwest range to preserve the visual impact of the roof line. The cornice is set higher than the earlier decorative example and the stepping back of the extension goes some way to compensating for the asymmetry caused by attaching a three storey extension to the two storey Main Block.

Photo 3 ESE facing view of extensions to the northeast of Main Block

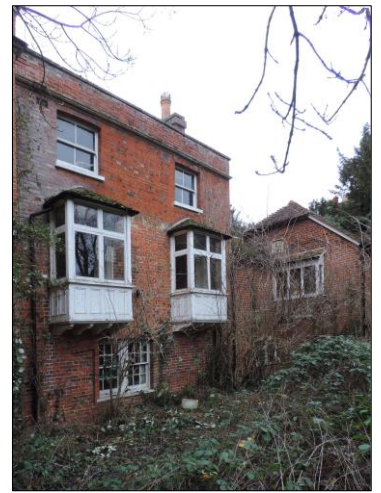
4.6. To the rear the extension would appear to preserve brickwork belonging to an older part of the building. Evidence of a brick recess beneath a segmental arch at ground floor level may show the location of an older window opening, moved to the northeast. Following this the upper floors appear to have been reconfigured to include a pair of bay windows to the north and south of the ground floor opening. The ground floor window is not centrally located, demonstrating that the opening and upper bays are not contemporary.

Photo 4 Northwest facing view of rear extension.

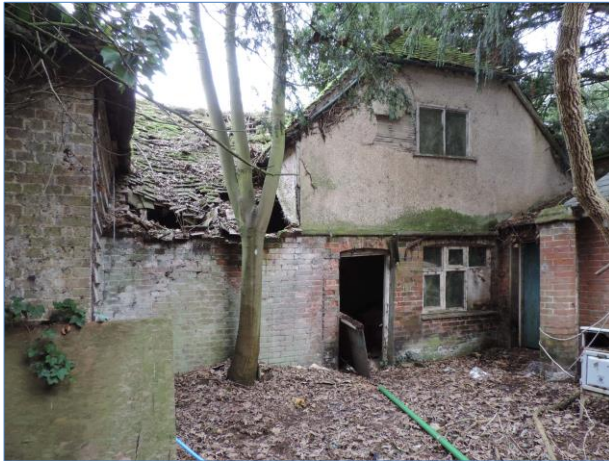
4.12. The 19th century Coach House, adjoining stores and covered link are orientated northwest – southeast at the northeast end of the plot. The Coach House is described as comprising a single storey structure with habitable attic space and hipped roof. A semi-circular arch gives access to the Coach House. Two decorative half circular windows were noted to the northwest of the entrance. The remainder of the building was not visible at the time of the site visit.

Photo 7 East facing view of Store attached to Coach House via link to the northwest.

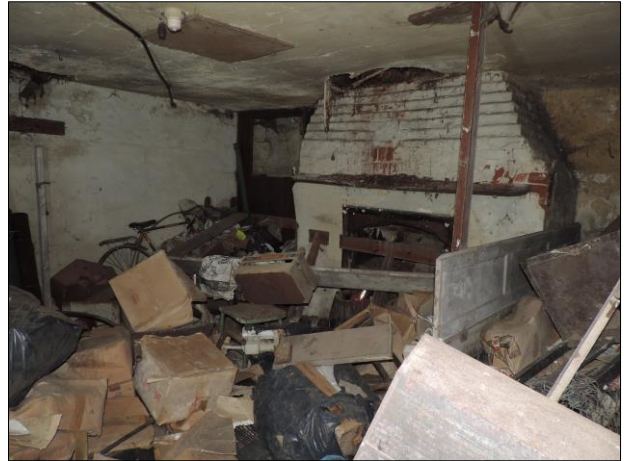
Photo 6 Bread? oven in converted store.

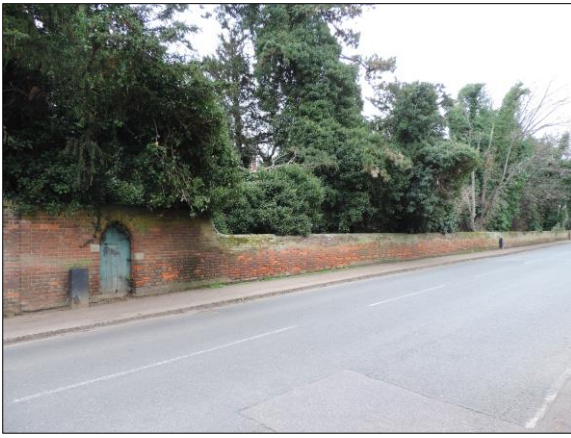
4.14. The property boundary to the northwest comprises a high brick wall featuring a Gothic style lancet wooden door at the northeast end, giving pedestrian access to the Coach House from Church Street. The boundary to the southwest was partially visible and featured a modern timber panel fence. The boundaries to the northeast and southeast could not be viewed due to restricted access.

Photo 8 South facing view of brick property boundary from Church Street.

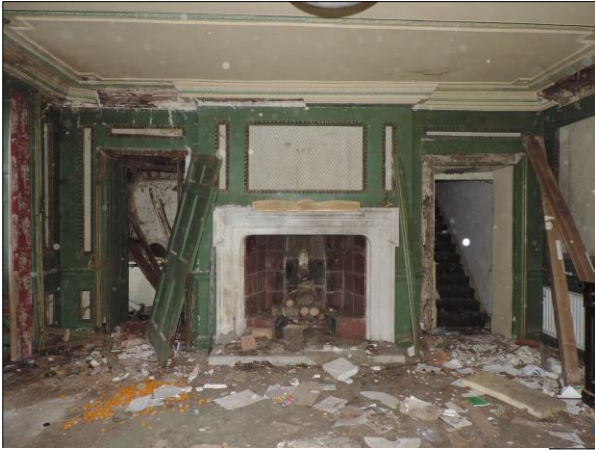
providing access to a later servant hall and stair, accessed via the northeast entrance. The plaster cornice is badly damaged but preserves its dentilled decoration mirroring that of the external cornice. This is likely to be original.

Photo 9 Northeast facing view of Room A, with stone fire surround and dentilled cornice.

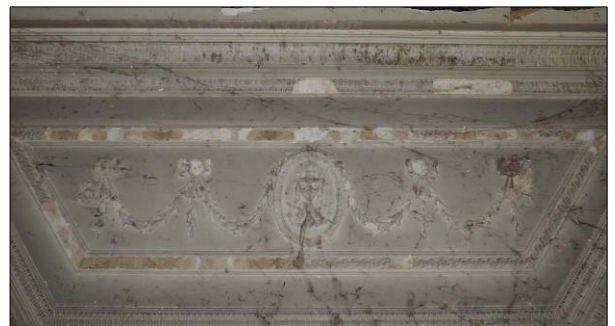
4.19. The rear Drawing Room (Room C) decoration is detailed in lighter moulding more in line with the second half of the 18th century. A Neo-classical fire surround is positioned centrally against the southwest wall. A large cantilever bay window (see Photo 2) located to the southeast (rear of the room) is believed to be a later feature. The bay window ceiling is decorated with

Photo 11 Ornate plasterwork above cantilever bay window in the rear Drawing Room (Room C).

ornate plasterwork in the Adam's⁵ style popular in the late 18th century. Husks are depicted hung from ribbons and strung as plaster festoons around a central urn. Whilst most homes still had relatively plain ceilings in the later 18th century, the grander houses exhibited the latest styles, especially in the Drawing Room. Whilst the decoration would suggest a late 18th century date, the wooden bay and glazing appear to be later in date. Water ingress into Room C from the area of the bay window has caused significant damage to the plasterwork in this area of the Drawing Room.

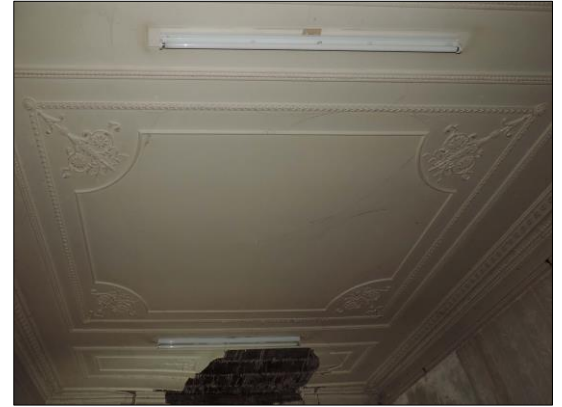
Photo 12 View of Room C ceiling looking towards the bay window and water damage to plasterwork.

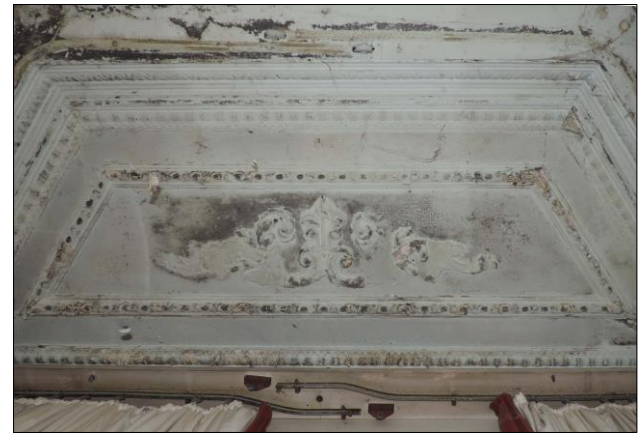
4.20. The Morning Room / Family Room (Room D) is adjacent to Room C, overlooking the grounds to the rear of the house. Room D has a matching cantilever bay window to the southeast. It is noted that the plasterwork in this room is plainer with wide panels cornered with botanical decoration. The ceiling within the bay alcove does not display a matching design to the Room C. This is common, in that the Family Room was not intended for the purpose of impressing guests. The ceiling in this room is noted to be (on appearance) in a relatively good state of repair, however water ingress in the region of the bay window was noted and damp has caused significant damage to the plasterwork in the bay window alcove.

Photo 13 Water damage to plasterwork above cantilever bay window in the rear Family Room (Room D).

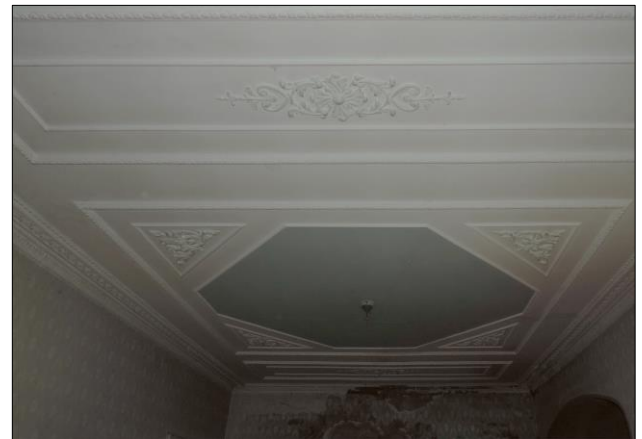
4.21. A dark wood fire surround is positioned centrally against the northeast wall and a doorway set within a partially blocked arch leads through to the Kitchen (Room F).

Photo 14 Northwest facing view of ceiling Room D.

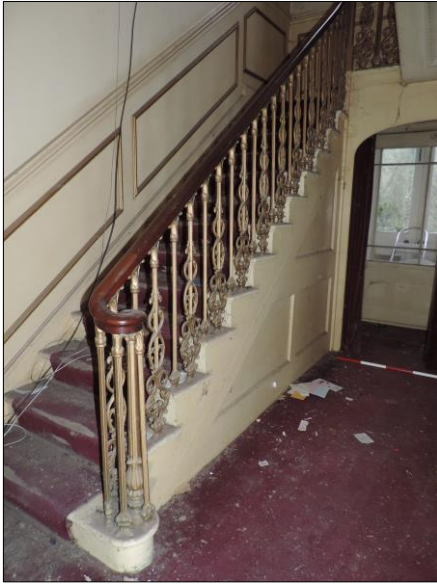
4.22. The hallway (Room E) dividing Rooms C and D houses the stair leading to the bedrooms on the first floor in the Main Block (Room E). The ceiling decoration is preserved in good condition, with dentilled cornice framing a geometric pattern with corner roses. The staircase comprises cast iron balusters, polished hardwood handrail, finished at the base with a curtail step. Similar examples are known from the 1750's to the Regency Period.

Photo 16 staircase comprising cast iron balusters, polished hardwood handrail, finished at the base with a curtail step

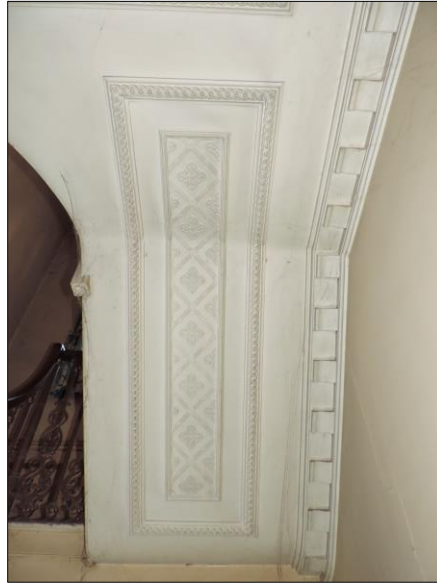
Photo 15 Detail of dentil cornice and geometric plasterwork in stairwell.

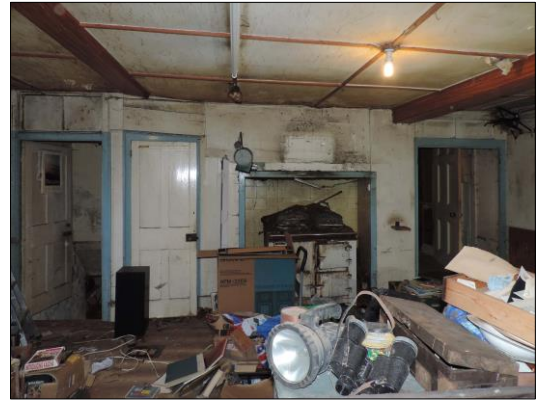
4.23. Entrance is gained to the Kitchen (Room F) on the ground floor via the northeast door leading from the courtyard. Access is also gained via the Morning Room / Family Room (Room D) through a much altered doorway in the northeast wall. In this area a single door opens in a blocked-up archway into a small recess which appears to have been created by the insertion of a large alcove for a range which stands against the adjoining wall.

Photo 17 Southwest facing view in Kitchen with range. Stair to the basement to the left of shot.

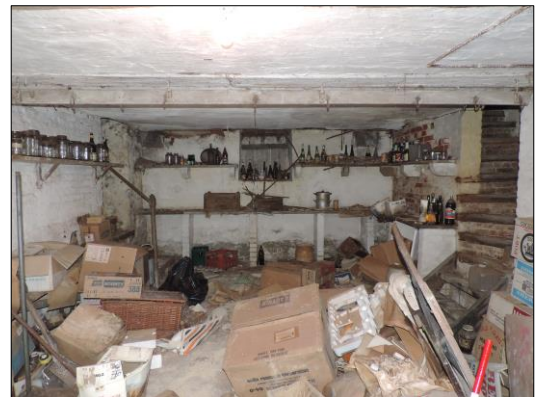
4.24. A brick stair leads down to the cellar to the left of the range and a second stair leads down to the opposite side of the basement from beneath the main stair. The bottom two treads of the latter are of wood, whilst the remainder is in the same style as the kitchen flight. The cellar is located beneath the Morning Room. Projecting from the cellar, beneath the Reception Room are two smaller stores with vaulted roofs.

Photo 18 Southeast facing view of cellar with stairs to Kitchen to the left of shot.

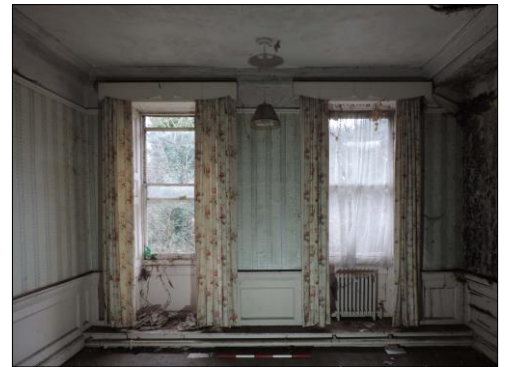
4.26. Room G has a pair of recessed sash windows overlooked the ground to the front of the house. This part of the Main Block has suffered badly from damp causing major damage to the ceiling and walls. Wainscoting around the base of the wall and a plain fire surround represent the most significant features in the room. Three doors give access to the former bedroom. The principle hallway door would have been the only point of access when the Main Block was set out in the first half of the 18th century. At this time serving staff did not tend to be segregated from the main house as was the custom in the late Georgian / Regency period and continuing throughout the Victorian era. As the house was extended to the northeast, access was added from the hall (K). An interconnecting door has also been added adjacent to the fireplace between Room M and Room G. The hallway and principle entrance doors are six panel examples and

Photo 20 Northwest facing view of double window. Scale 1m.

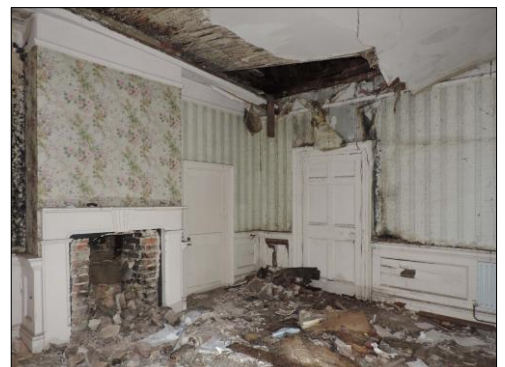
Photo 19 East facing view of Room G.

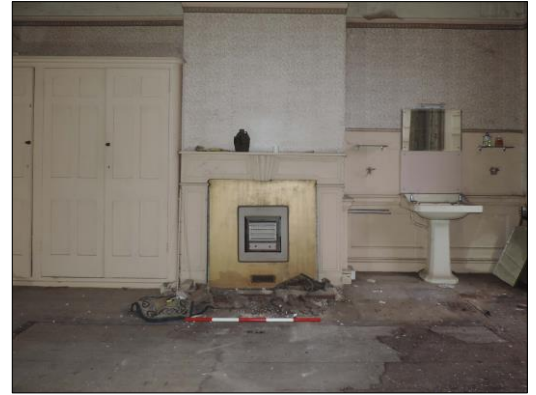
4.27. Room H has a pair of recessed sash windows overlooked the grounds to the front of the house. Again, wainscoting around the base of the wall and a plain fire surround represent the most significant features in the room. A Modern fireplace has been inserted into the period fire surround and a sink with mirror to the right, demonstrating the use of the property as a hostel / rented accommodation following the Second World War. To the left, the period wainscoting has been concealed by a fitted cupboard. The principle access is located opposite the doorway to Room G, which would look to be the original location. A second door in the northeast wall has been boarded shut. Behind this is the location of the 20th century bathroom.

Photo 21 southwest facing view of Room H (Scale 1m)

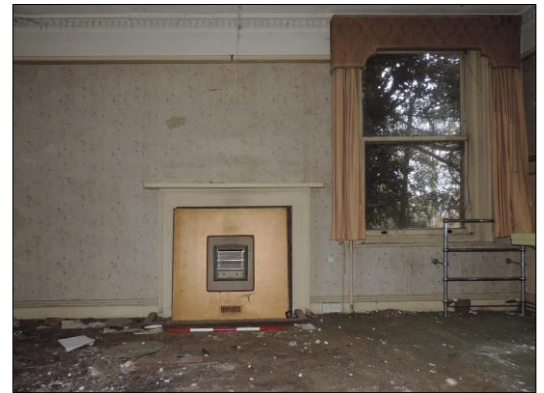
4.28. Room I has a single tripartite sash window overlooking the garden to the rear and a sash window overlooking the grounds to the southwest. A decorative cornice survives, although modern pelmets fitted to both windows may have caused damage to the plasterwork. A plain fire surround has been fitted with a Modern fire and a sink unit has been installed in the corner of the room.

Photo 22 southwest facing view Room I

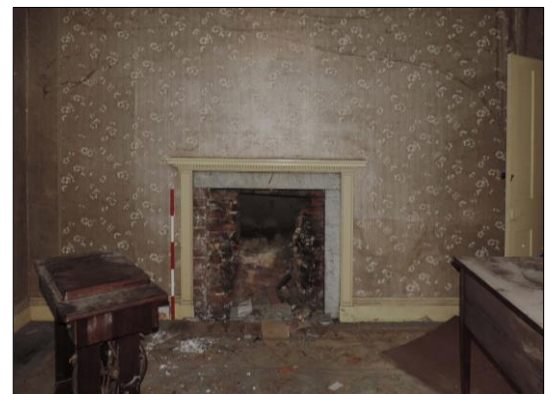
4.29. Room J has a single tripartite sash window overlooking the garden to the rear. The original door location has been moved to accommodate the shortening of the room to create a passage linking the Main Block to the 19th century extensions to the northeast. Wooden panelling survives around the window recess and an 18th century fire surround is preserved, although the fire grate has been removed.

Photo 23 Northwest facing view of 18th century fire surround Room J

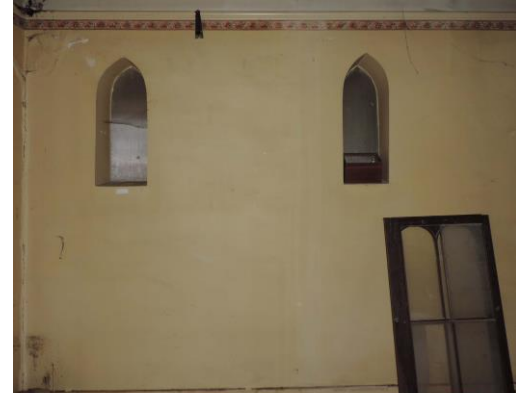
4.33. Rooms N and O overlook the garden to the rear of the house. Room N contains a decorative fire surround and grate. The wood panelled canted bay contains a casement window. Room O contains the matching wood panelled canted bay with casement window. A decorative door gives access to the room. An interesting feature of Room O are two Gothic style windows against the northeast wall, which would have originally been an outer wall.

Photo 24 Northeast facing view of Gothic windows in original external wall.

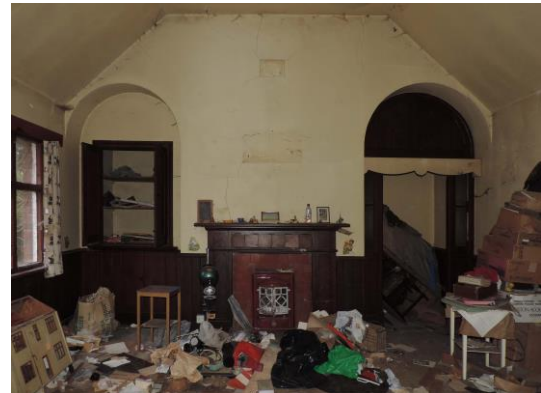
4.35. Room R is dominated by a large bay window overlooking the garden to the east. The lower portion of the wall is covered with slated wood panelling and the fire surround is similar to the example in the ground floor Morning Room (Room D). As a departure from the rest of the house, the wooden fixtures and fittings in this room are stained dark brown. The décor in this room would appear to date to the later 19th to early 20th century.

Photo 25 Northeast facing view of Room R with dark wood panelling and fire surround.

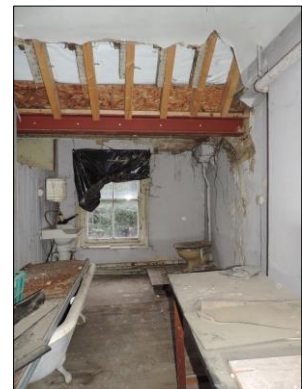
4.36. A stair leads up to the second floor / garret from the 19th century extension to the northeast of the Main Block. The stair gives access to the upper floor of the extension, which would have provided living space for serving staff in the 19th / early 20th century. Rooms to the front of the house have an exposed roof truss with modern joists and RSJ. A partition wall has been partially removed to allow for the roof repairs.

Photo 26 northwest facing view of second storey room. Looking out over the front courtyard.

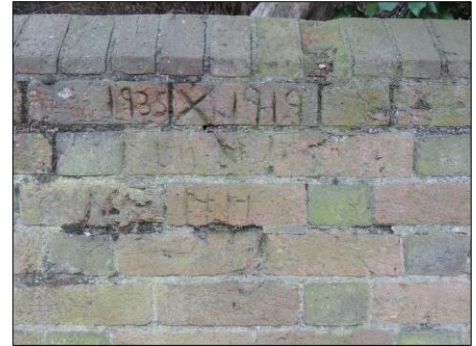
Photo 27 Date reputed to mark the death of Norman Earl 1919.

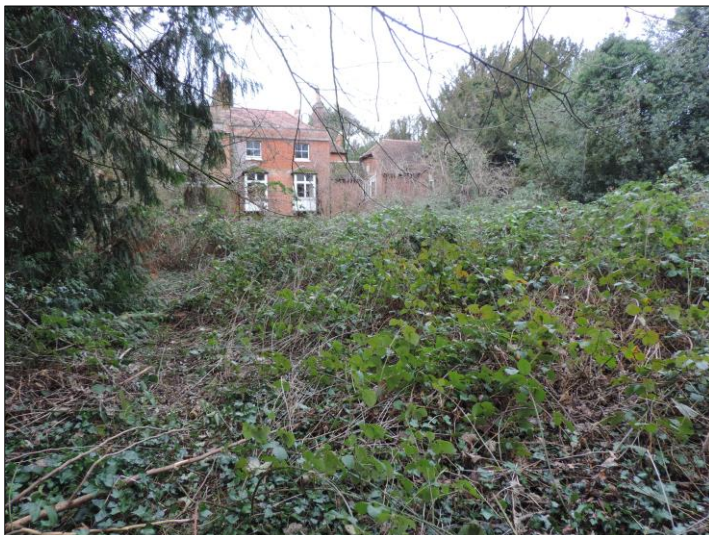
4.41. To the rear of the property the grounds are overgrown and were largely inaccessible at the time of the site visit. It is likely the remnants of historic outbuildings and evidence of landscaping will be preserved within the grounds.

Photo 28 North facing view of Clifton House from grounds to the rear.

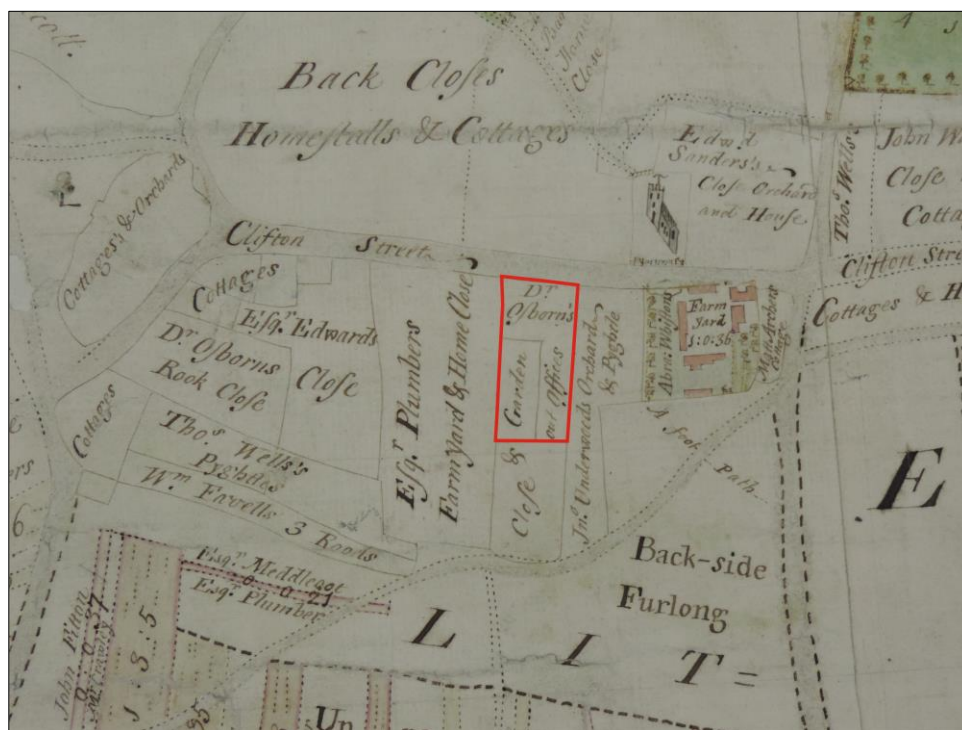
Figure 12 Torrington Estate Map 1745 (Source Bedfordshire Archives and Records Service)

however *Offices* suggests that the site was developed. Furthermore, the land designation is stated as *Dr Osborn's*. The Rev. Dr. Osbourne held the position of Rector of Clifton prior to 1790. Therefore, it is likely that the map does document a rectory on the Project Site at this time.

- 6.8. Based on the above accounts it is likely that Clifton House preserves part of the new Rectory building that was referred to in Philip Oddy's letter of 1712 and that is described in the 18th century Terrier.
- 6.9. In 1790 the Rev Daniel Stephen Olivier was initiated to the Rectory of Clifton, following the death of Rev Osborne.¹⁰ Rev D S was still incumbent when a second Terrier was written in 1822. This document is considered to describe the Rectory that occupied the Project Site in the early 19th century:

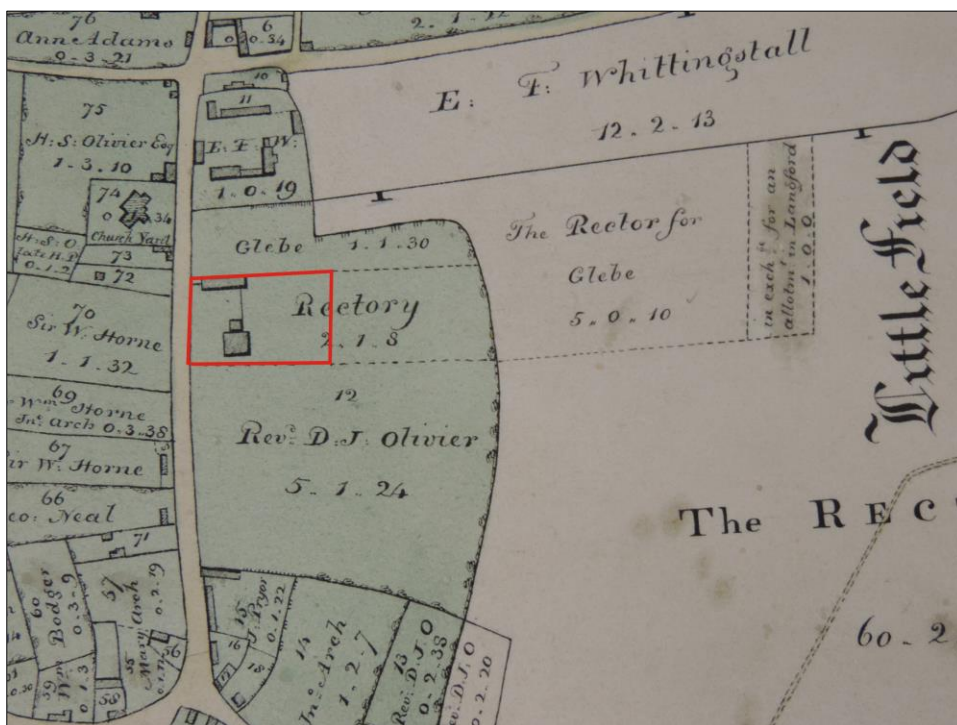
Figure 13 Plan of the Parish of Clifton in the County of Bedford Inclosed under an Act of Parliament in the Year 1832 (Source Bedfordshire Archives and Records Service)

6.10. The Parish of Clifton was subject to enclosure c. 1832 and the corresponding map¹² depicts the Rectory as a single dwelling house with projecting building, which corresponds to the description above as the house and pantry. The building containing the barn, stable and Coach House is shown orientated northwest / southeast and it not attached to the main dwelling at this time. The map gives little attention to outbuildings; however, it is assumed that the site was developed as stated in the 1822 Terrier. Land to the southwest of the Project Site is named as occupied by Rev. D. Olivier.

6.11. In a subsequent plan of the Parish of Clifton dated 1832 the Rectory is clearly shown occupying the Project Site, with land to the southwest documented as being occupied by the Rev D. Olivier, however this must refer to Rev Daniel Josias Olivier who was initiated in January 1827, following the death of Reverend Daniel.

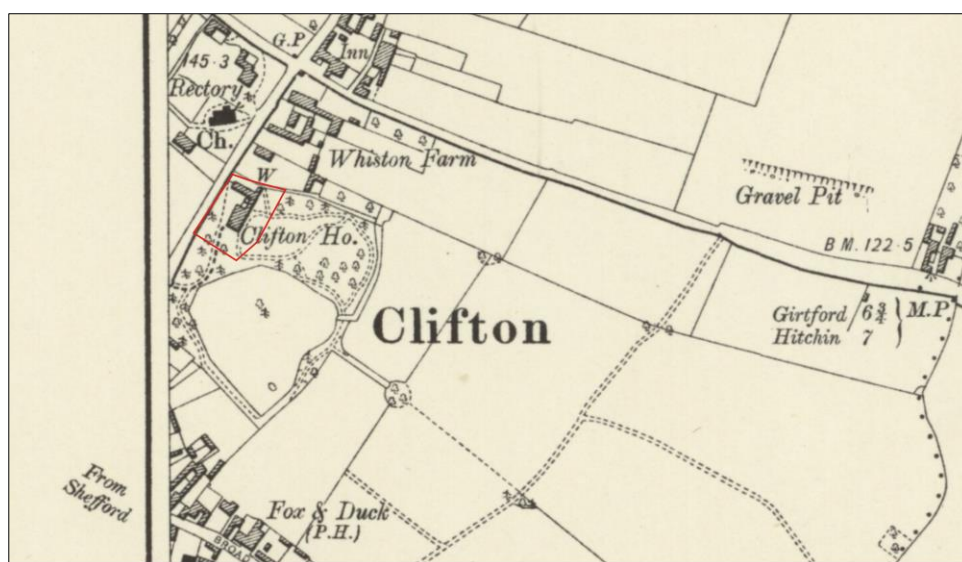
Figure 15 1902 Bedfordshire XXIII.SW (includes Arlesey; Henlow; Langford.) Revised 1900

6.17. In 1900 the revised Ordnance Survey map (published 1902)¹⁵ names the Project Site as Clifton House. This conflicts with the census taken a year later, suggesting that the house continued to be known locally by its former function.
