# Taunton Castle

By Chris J Webster

Somerset Archaeological and Natural History Society

Taunton, 2016

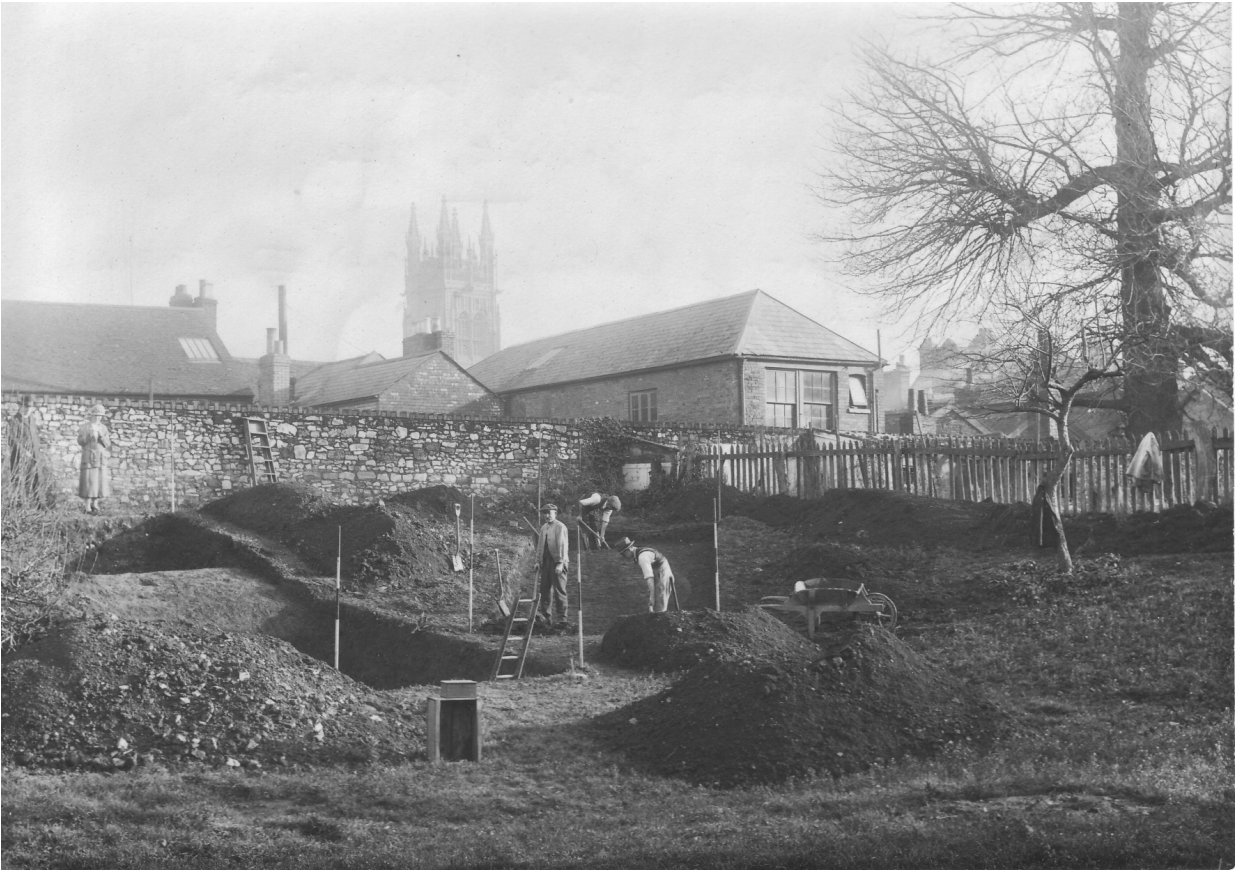
*Figure 3.5: Gray's photograph showing the state of work on Friday 5 December 1924. Cutting II is to the left, exposing the marl bank. The men are working in Cutting III which had been started that morning. SANHS 12544.*

consequence" were discovered. On the following days a circular pit was located on the top of the rampart, which contained building waste, including stone, mortar and pieces of slate. By Thursday, Cutting II was nearly complete and the spoil heap was being moved to allow excavation of Cutting III the next morning. On Friday, Cutting II reached a depth of 8ft and a small extension was made to the E from which medieval pottery (Gray's find No 8) was recovered at a depth of 6.3ft; further pottery was recovered on the following Monday (Gray describes this as "the rest of No 6, pottery" but has not mentioned No 6 before). Also on Friday, Gray took a series of 4 photographs showing the work at this point (Figure 3.5).

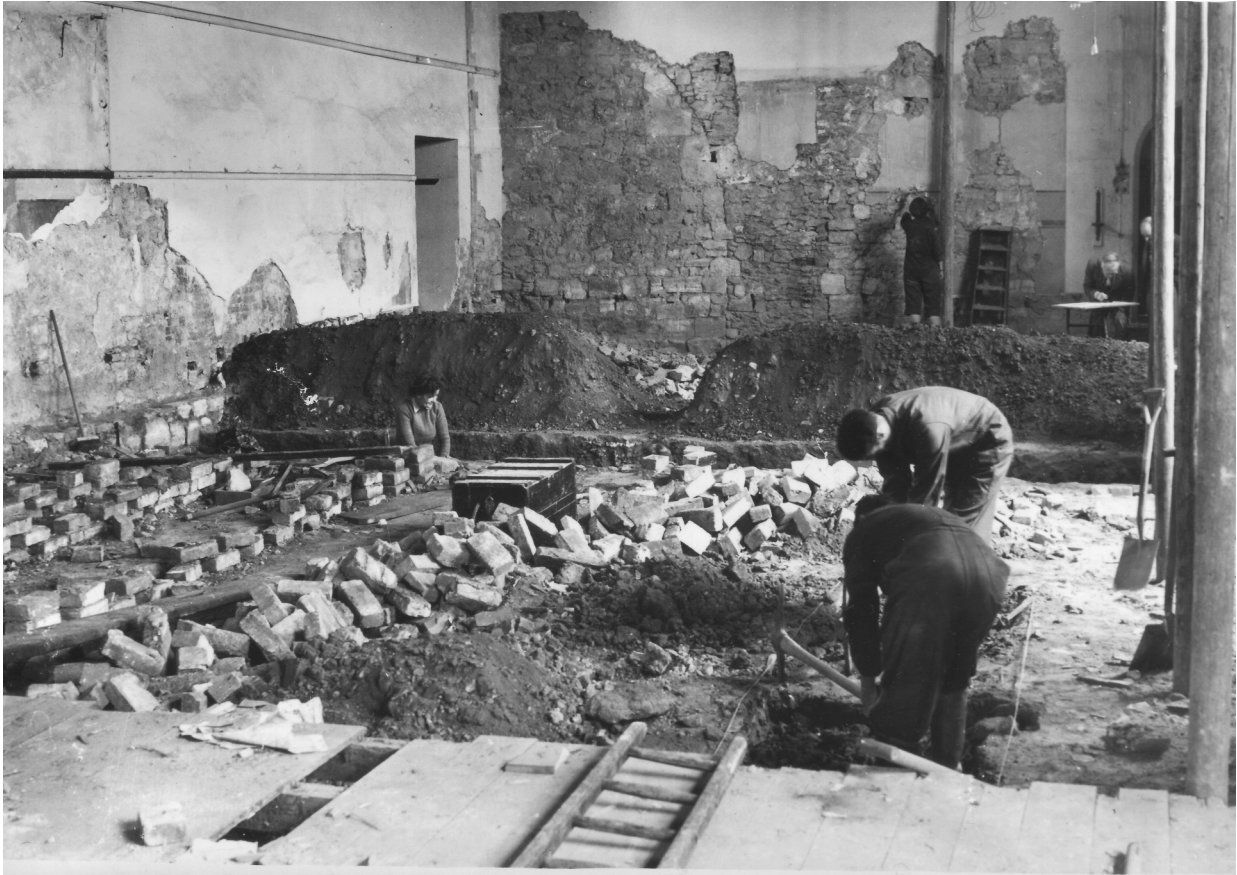
*Figure 3.7: Posed press photograph of the excavations of 1952 with Trench II being started by two labourers. Linda Witherill, who worked on the excavation and is measuring the west wall, suggests that the woman in Trench 1 is Mrs Hallam, with Raleigh Radford and AD Hallam studying a plan to the rear right. The brick supports for the former wooden floor can be seen as can wooden scaffolding poles erected along the north wall. On the rear wall the scar of a vault is visible. SANHS 12569*

The photographs show that the excavation proceeded in tandem with the lifting of the wooden floor (Figure 3.7 on page 48). The floor joists can be seen to have been supported on brick dwarf walls, three courses high, resting on the deposits below. Several trenches were excavated by labourers in these deposits, which suggested to Radford and Hallam that most floor layers had been removed by the digging out of the void for the timber floor. Several walls and robbing trenches were recorded however, which showed an earlier structure on the site (Hall I) and successive lengthenings of the present hall (Hall II) to the east.

the shapes of which could be seen as scars in the present west wall (see Figure 3.7 on page 48). The southern wall lay outside the present hall and joined the southern end of the undercroft of the Somerset Room. The hall was replaced by a ground-floor, narrower, longer hall (Hall II), subsequently extended to the east to form the present structure. Radford reconstructed Hall I as a timber-framed structure standing on the stone vaults with a stone Camera (Somerset Room) to the west. Below Hall I a “marl bank” was encountered which was believed to have formed the earliest defences of the castle.

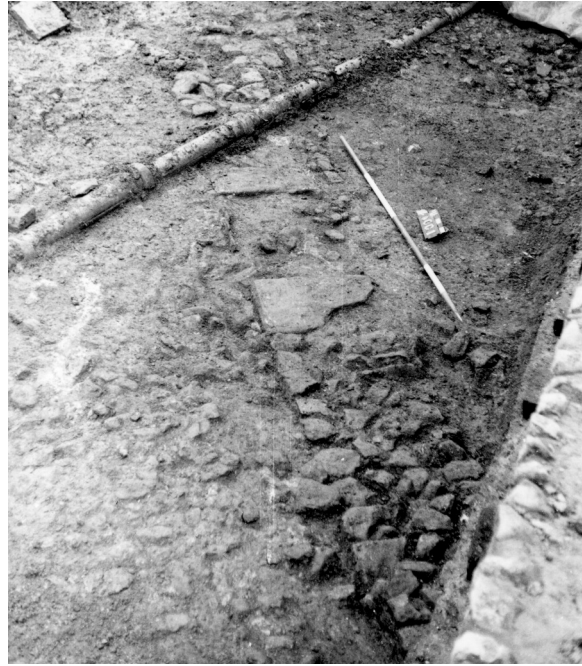
Figure 4.1: Wall found in the Castle Hotel carpark in 1973. Somerset HER image 42854.

In the carpark of the Castle Hotel, deeper excavations than those agreed beforehand uncovered (and removed a large part of) a stone wall (see Figure 4.1 and Figure 6.1 on page 98 for location). The wall, which ran east-west contained a doorway with two large pieces of masonry forming the jambs on the southern side. About three or four courses of wall survived at the west end where the presence of the castle drive wall had prevented its removal. A limited amount of excavation was undertaken around the wall which was found to be 2 feet thick (0.6m) with a stone rubble core that contained reused masonry. The two jamb stones were found to show diagonal tooling characteristic of 12-century work but had clearly been reused. They had been aligned with their best sides to the south and between them, on the line of the south face of the wall, was a line of vertically set slate slabs which appeared to retain a mortar and stone floor. This suggested that the interior of the building lay to the north of the wall. Below the wall and elsewhere was a carefully surfaced mortar floor separated from the wall by a layer of earth. No edge to this floor, which must represent an earlier building, was found.

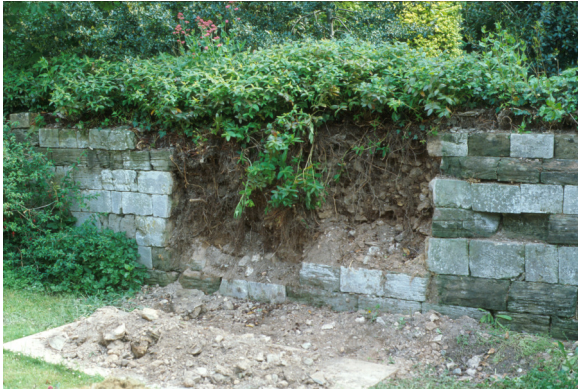
**Figure 4.2:** The collapsed section of Wall C in 1988. See Figure 4.5 on page 58 for location. Note the lack of solid wall core behind the facing stones. Somerset HER image 29721.

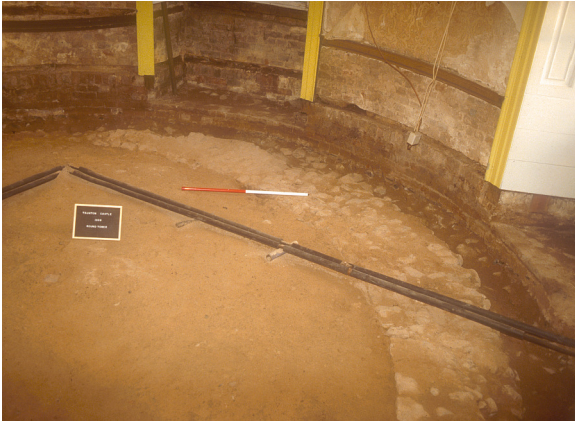
**Figure 4.3:** The lower room of the Round Tower (Room 46) under repair in 1988, looking south-east with Window 65 to the rear. The thicker medieval wall foundations can be seen as well as the late eighteenth-century brick lining to the walls and window reveals with characteristic embedded horizontal beams. Somerset HER image 53542.

Hallam (1965) believed that the St George Gray Room (Room 43), round tower and curtain wall to the east were part of the documented "new wall" constructed in 1209 but the butt-joint seen inside the tower appears to show that there are at least two phases of construction here. Inside the tower, it is clear that Hammet increased the size of the room by cutting back the internal wall and lining the tower, and the inserted window openings, with brick. In its original form the tower appears to have had a flattened back which was probably removed by Hammet and replaced by a thinner curved brick wall. The original wider foundation was seen when the staircase was added in 1910 (Spencer 1910, 39).

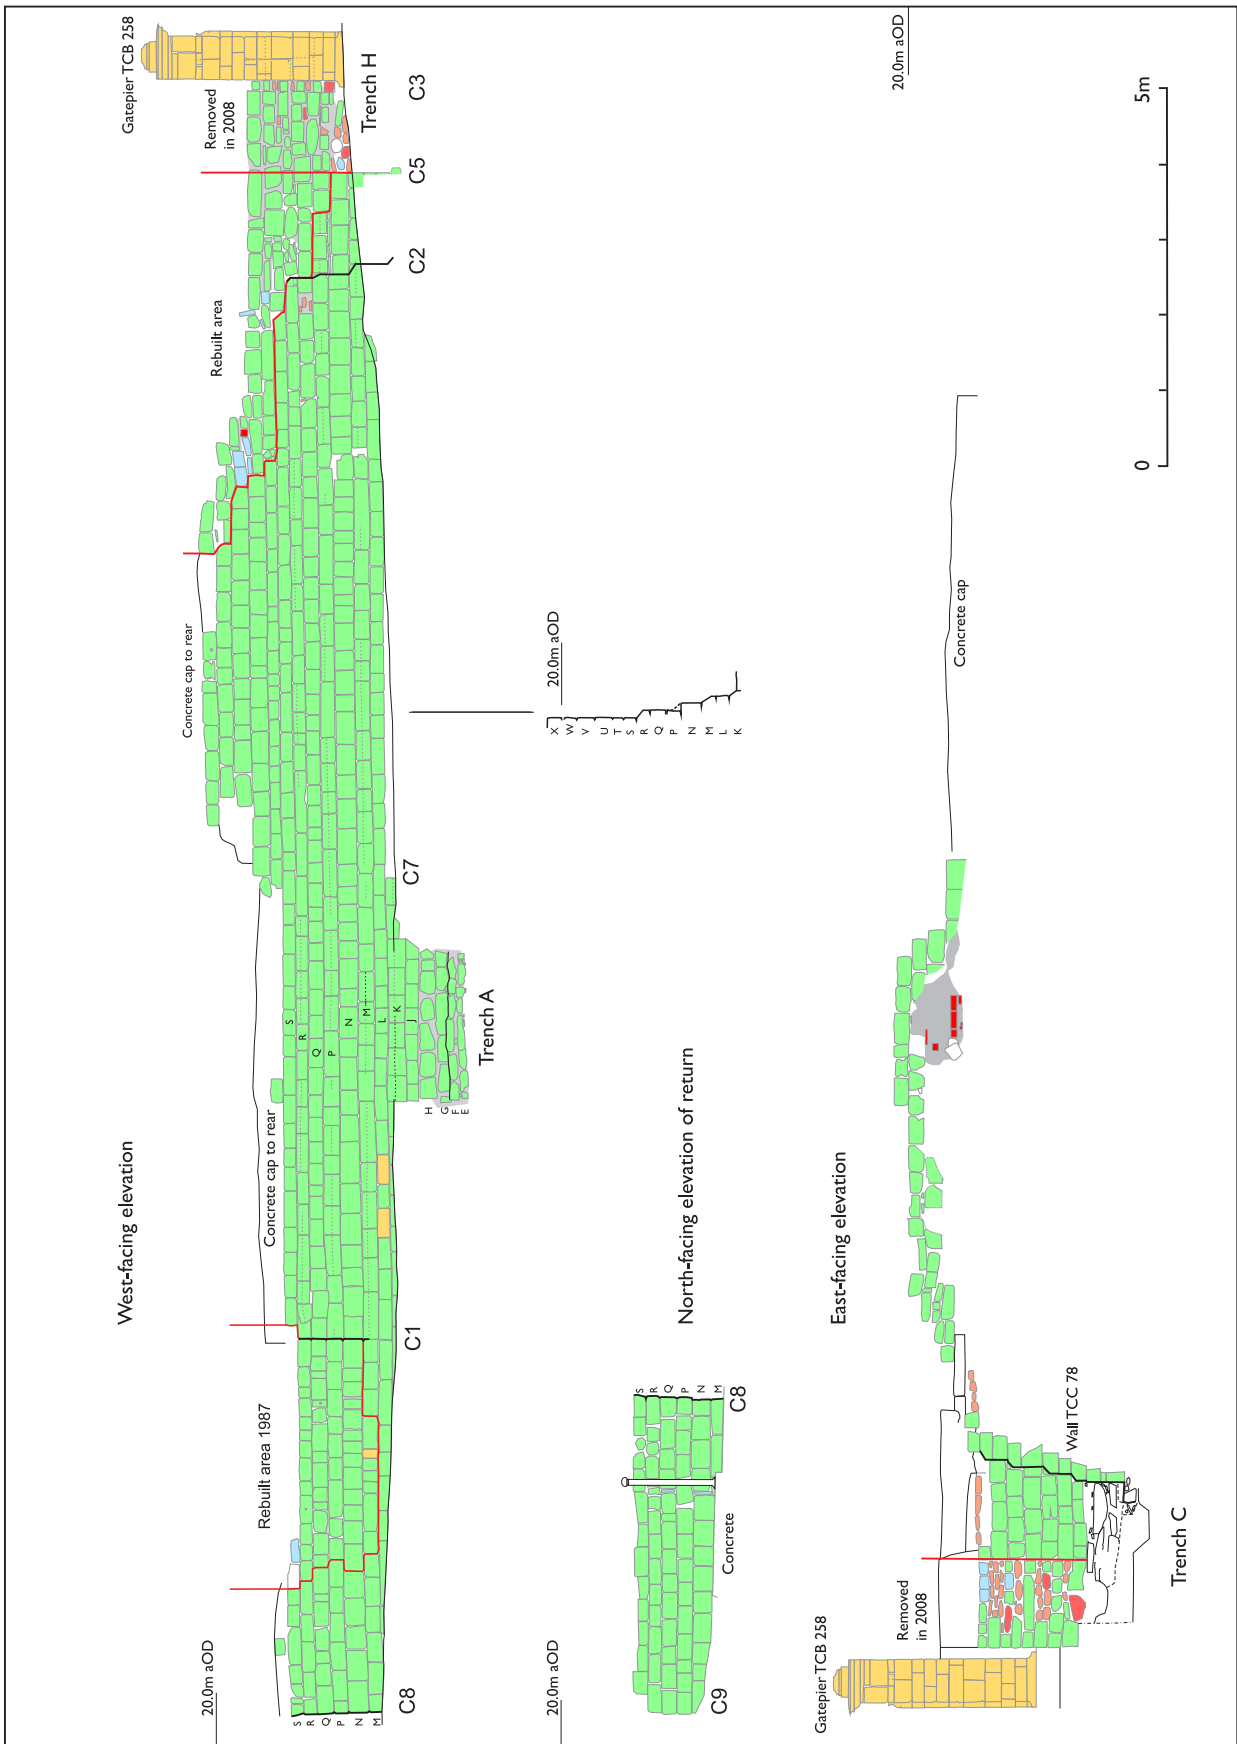
Figure 4.5: Elevations of Wall C. See Figure 3 on page 4 for key to stone colours.

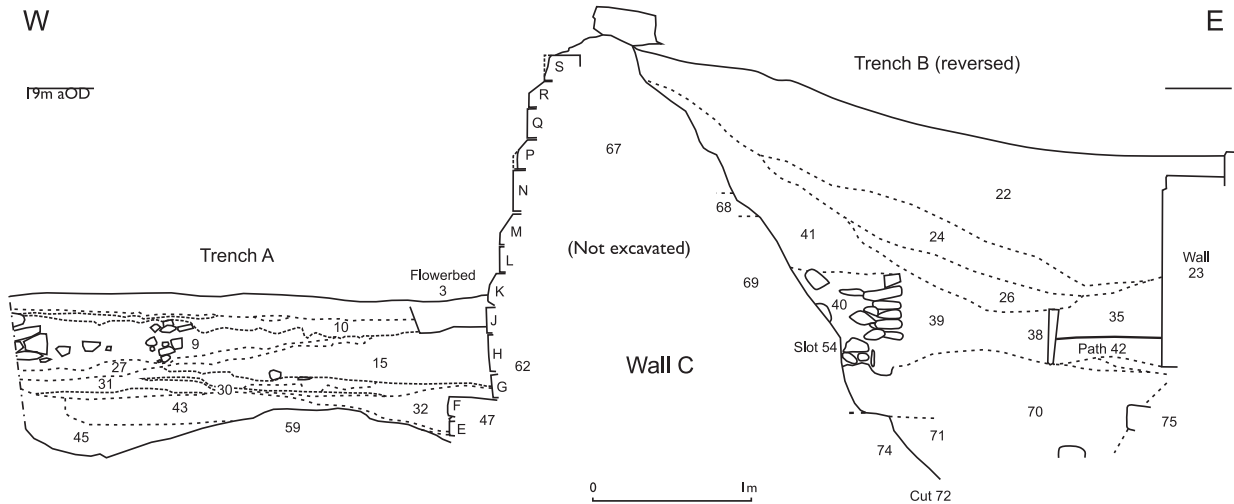
Figure 4.7: South-facing section through Wall C in Trenches A and B

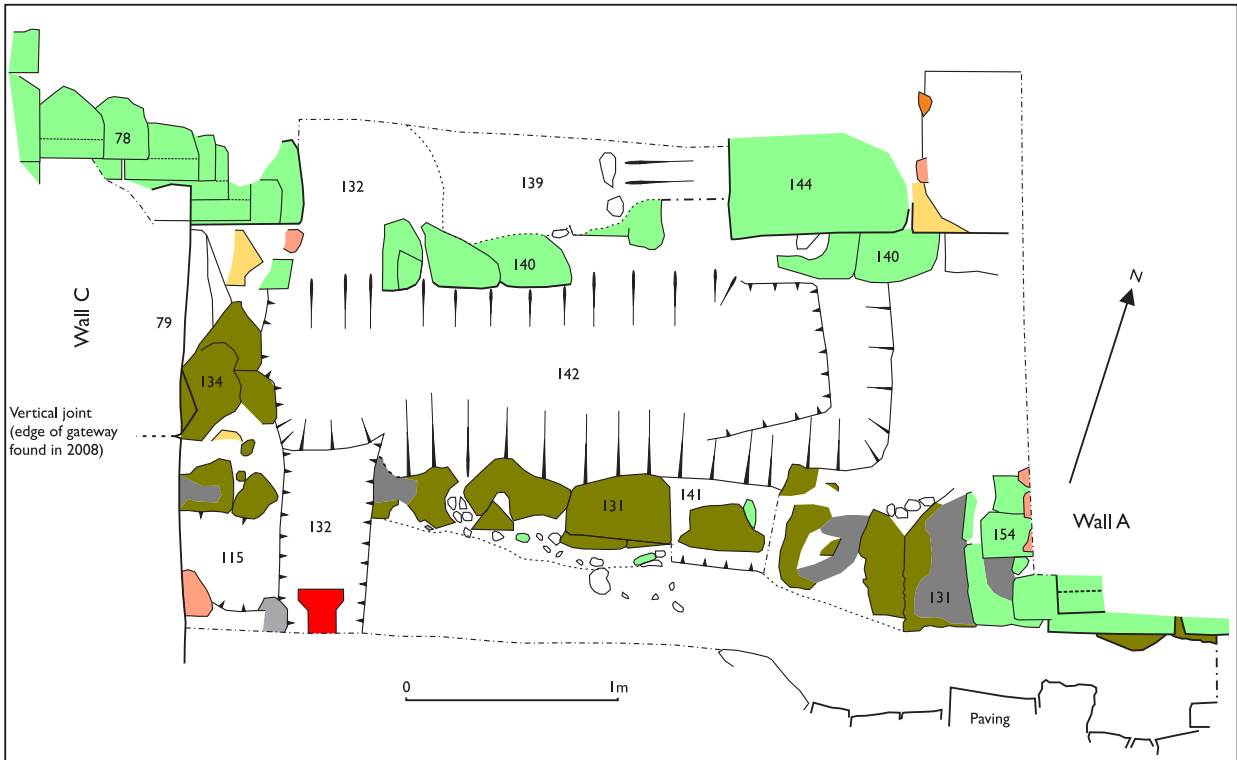
Figure 4.8: Plan of Trench C. For location see Figure 4.4 on page 57. See Figure 3 on page 4 for key to colours.

Four structural elements were exposed by this work: the southern extension of Wall C (here numbered 79) and its foundations (134), the return of Wall C (78) and its foundations (140), Wall A (154), and the foundations (131) of a wall beneath Wall A and seemingly on a different alignment (Figure 4.8 on the preceding page).

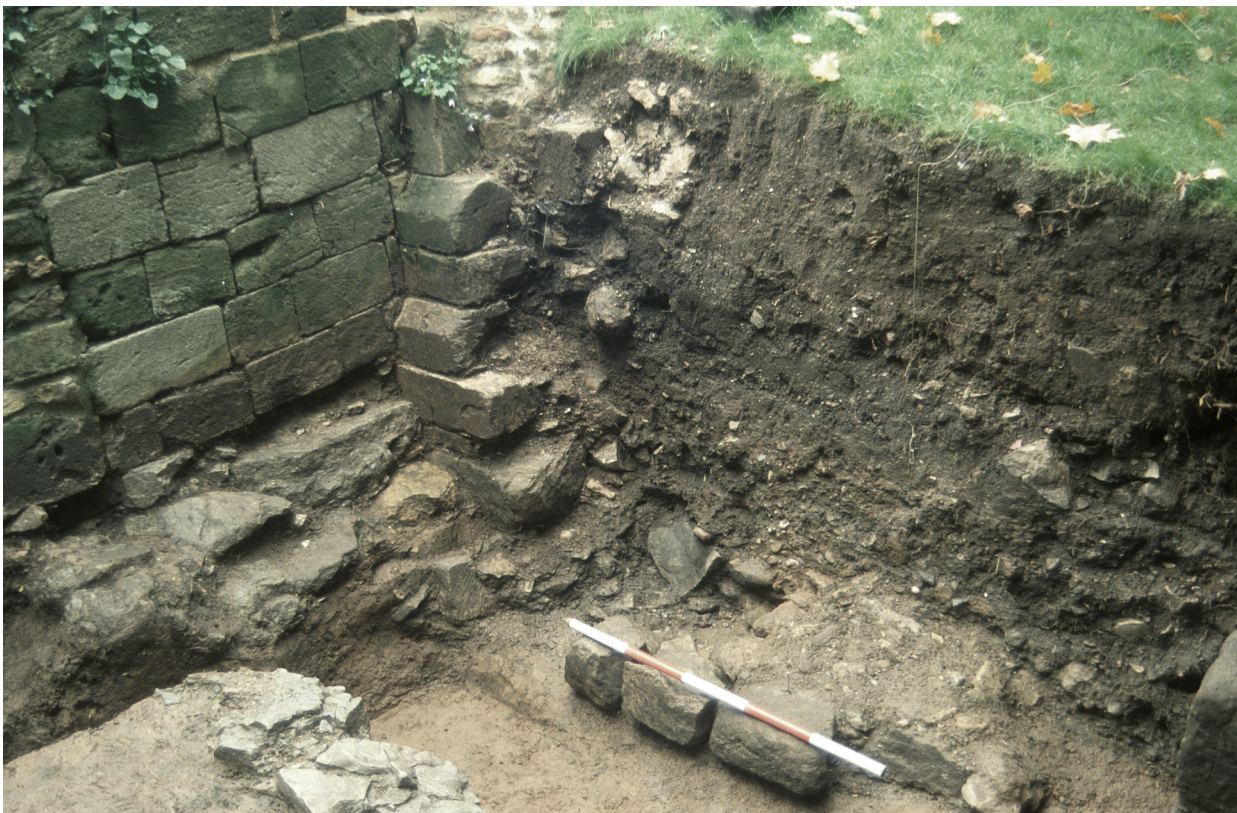
Figure 4.9: The east end of Trench C showing Wall C turning eastwards (Wall 78) behind the extension (Wall 79). The scale lies on the foundations (140) and in the foreground are the foundations of the predecessor to Wall A (131). Scale 1m.

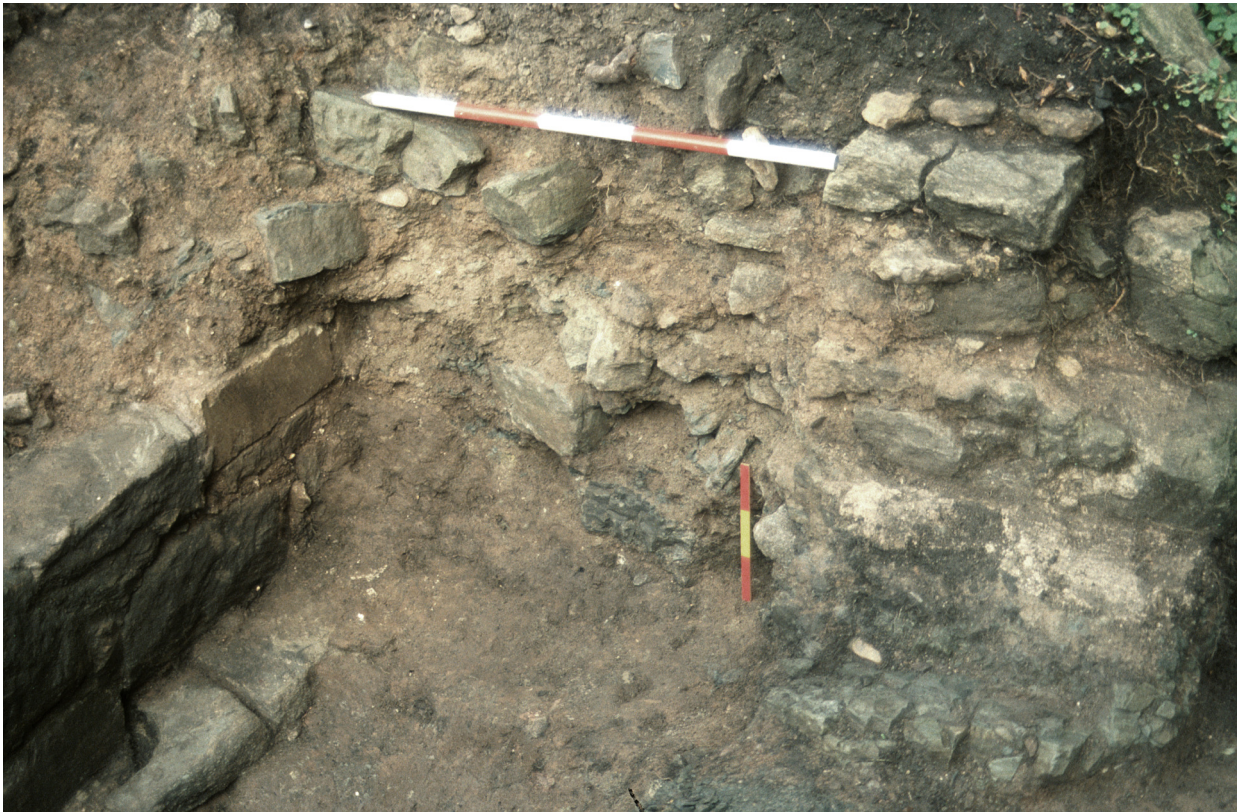
**Figure 4.10:** The west end of Trench C showing the rubble infill of Wall A, whose facing stones are visible to the right. Below these are the foundations (131) and on the left is reconstructed Wall 144. Scales 1m and 30cm.

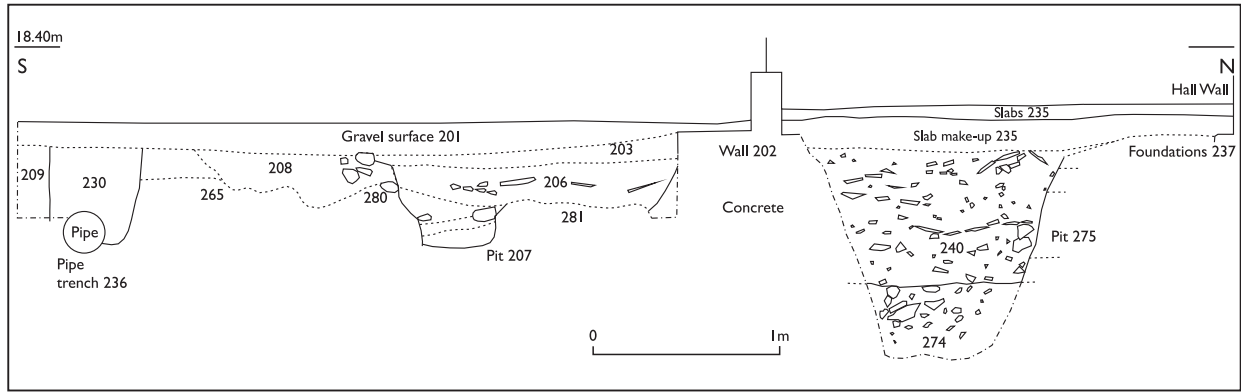
Figure 5.4: Section A–A of Trenches F and G in the West Passage. For location see Figure 5.3 on the previous page.

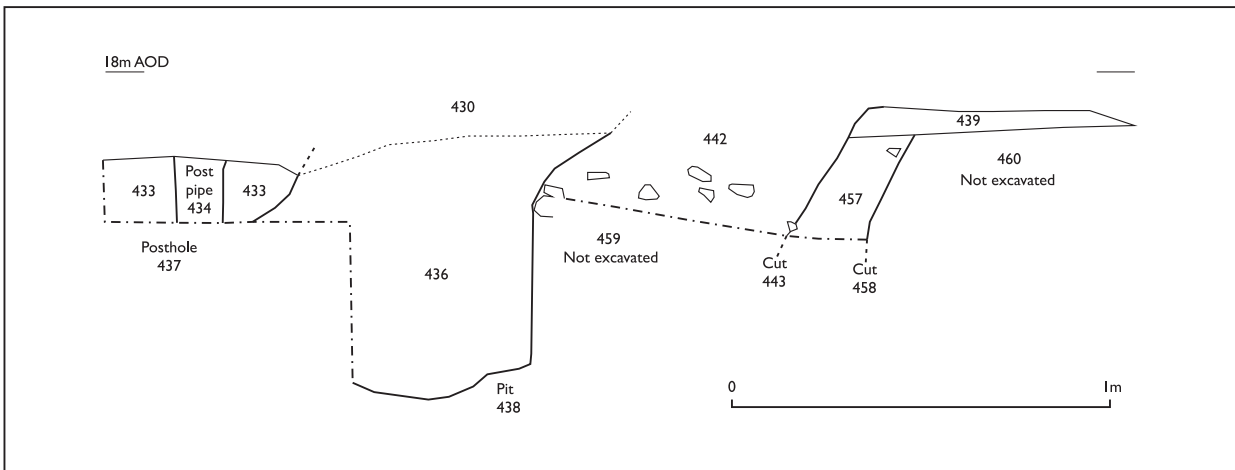
Figure 5.5: West facing section B–B through clay foundations 442 and 457, pit 438 and posthole 437. For location see Figure 5.3 on page 69

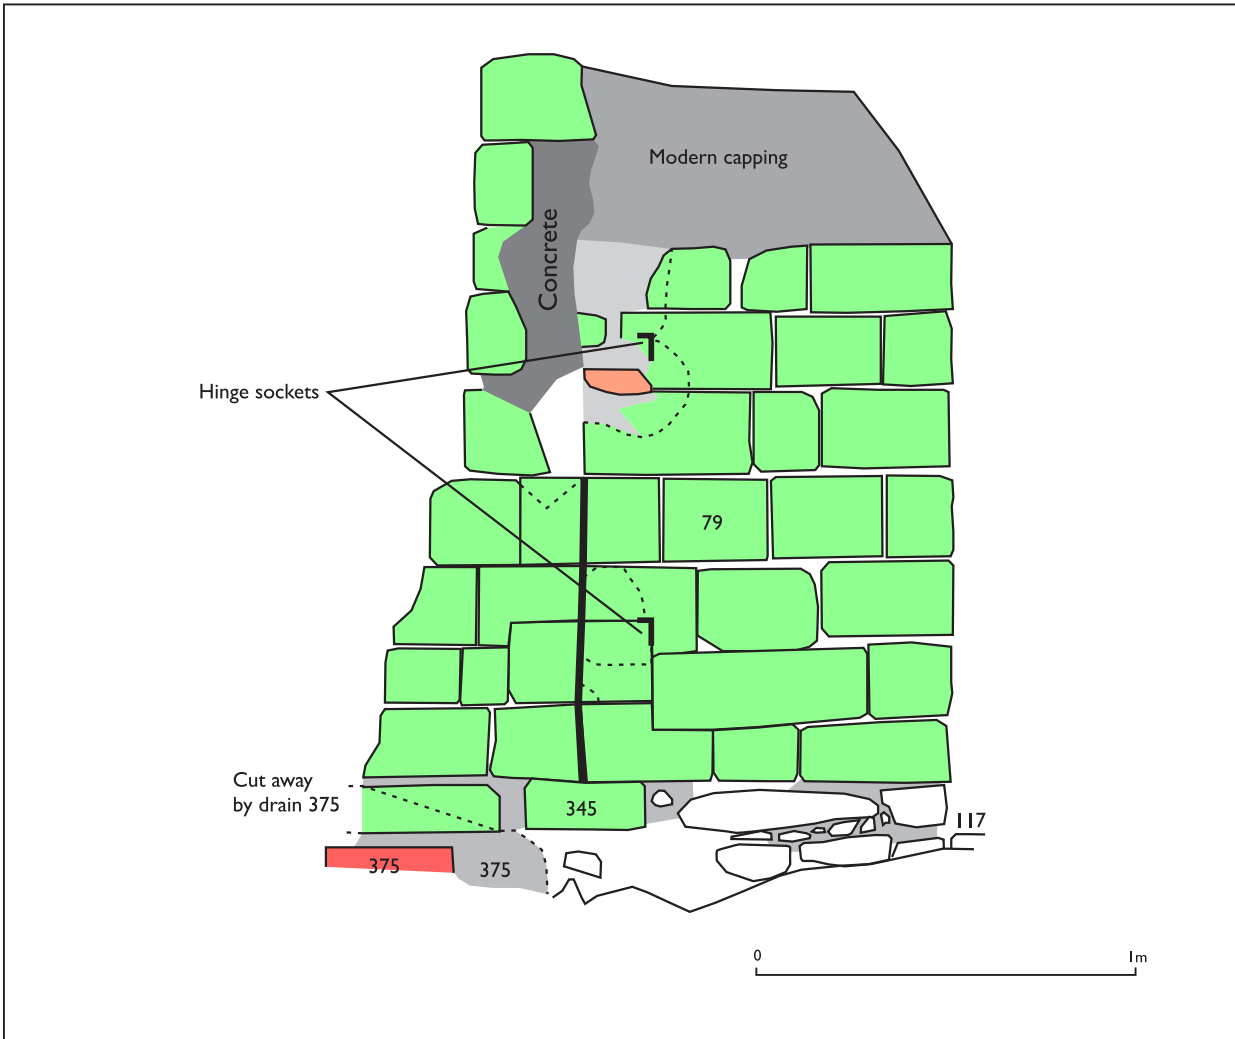
**Figure 5.7:** Elevation of the north side of Gateway TCB 536 at the southern end of Wall C (excavation context TCC 79) showing the rebate for the gate and the locations of hinges.

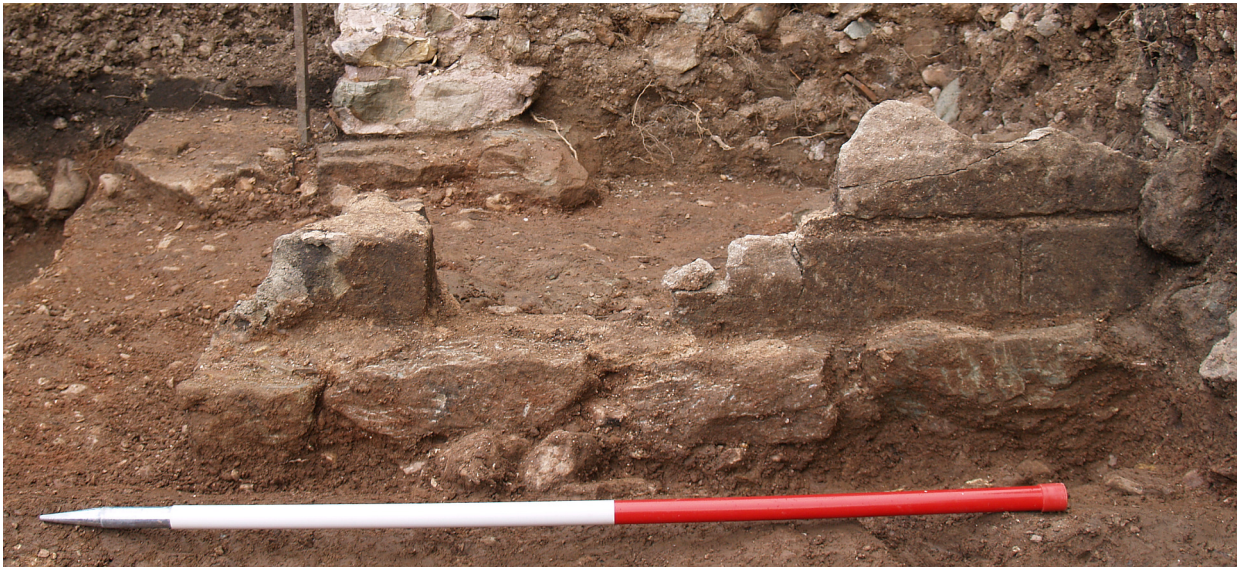
*Figure 5.8: Trench H. Surviving fragments of Wall C (TCC 331) on the south side of Gateway TCB 536, from the west.*

Fragments of the front facing of Wall C (331, Figure 5.8) were found forming the opposite side of the gateway. The wall comprised a maximum

of two courses above a single course of foundation plinth, the top, rear and north all having been cut away by a concrete-filled pit (330). The level of the foundation plinth was the same as that of Wall 79, but the lowest course (K) of Wall 331 was vertical, followed by a chamfered course (L), and thus out of phase with the pattern of Wall 79. The presence of the gateway would have prevented these mismatched courses from meeting and the wall must have been vertical above the battered section or the receding face would have met the rebate for the gate. Wall C suggests that there were two more chamfered courses (P and R) before it became vertical.

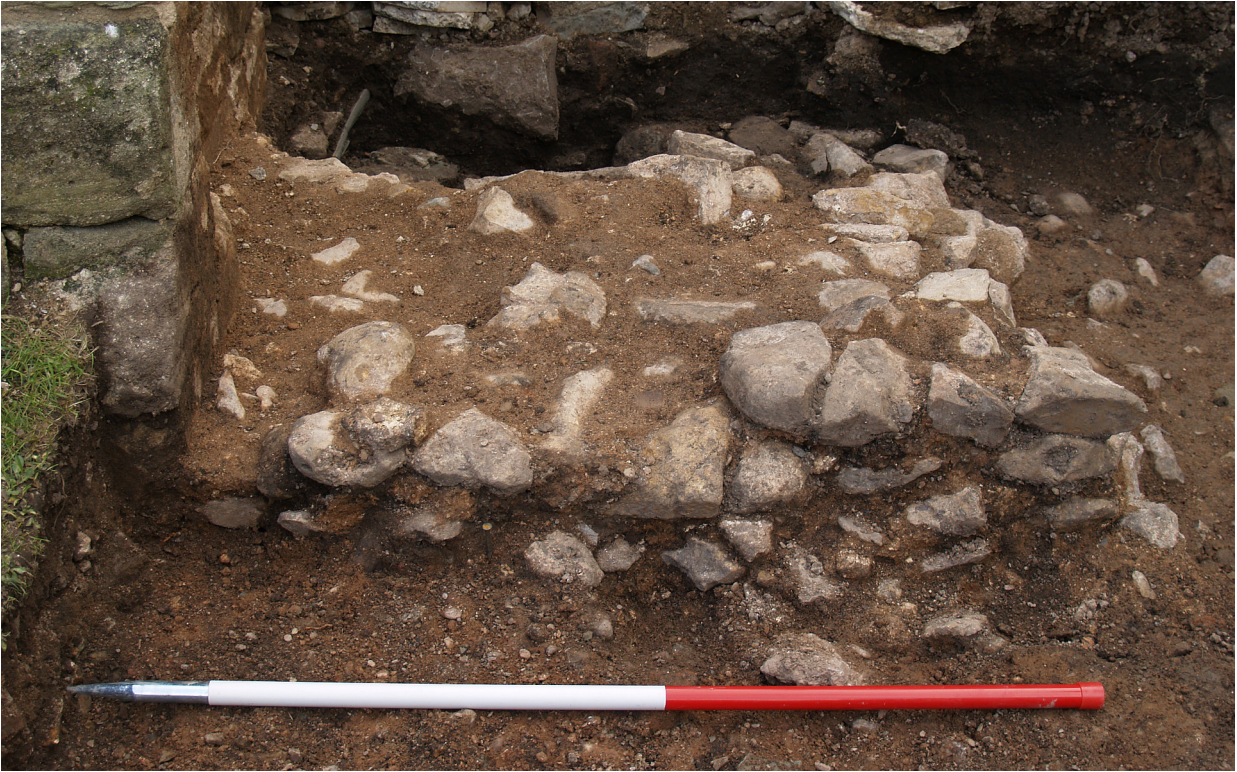
*Figure 5.9: Trench H, walling [318] blocking Gateway TCB 536 from the west.*

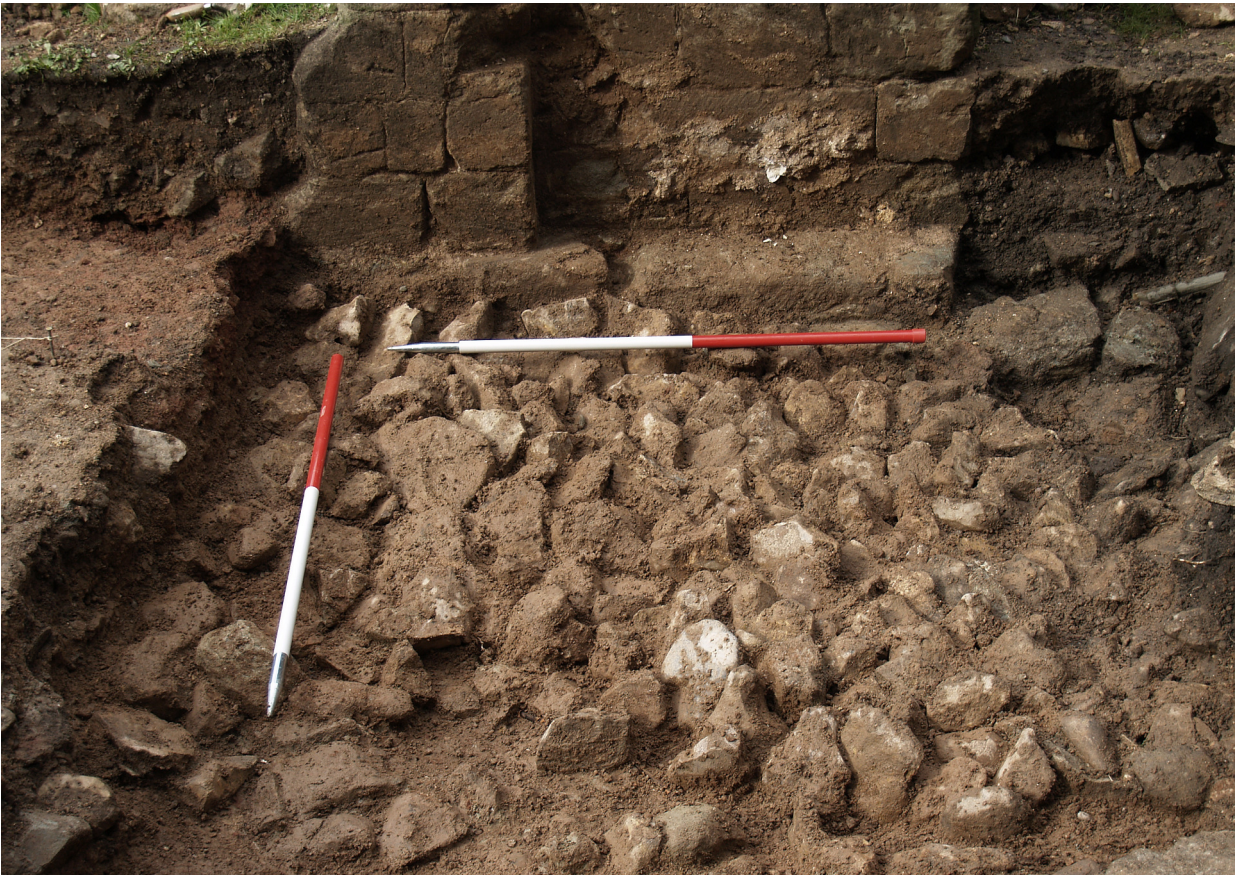
*Figure 5.10: Trench H, pitched chert cobbles 346 from the south with the side of Gateway TCB 536 in Wall C (TCC 79) to rear.*

The area of the gate passage itself was occupied by a pit (344) filled with chert cobbles (346, Figure 5.10). At the base the cobbles were randomly dumped in the pit with numerous voids between them. Above this was a levelling course laid flat in mortar and above that the cobbles had been pitched, starting from the north where they leaned onto the foundation course (345). These were covered by a hard compact layer of gravel bonded with sandy clay (343) that formed the base for a wall (318, Figure 5.9), blocking the gateway. The eastern extent of these features had been removed by the pipe trench (132) seen in Trench C. The faces of Wall 318 had been removed by the insertion of the cement-mortared part of Wall 79, except for a small area on the west side where the face appeared to be formed of chert blocks. The core survived higher but had been cut away to the south by a pit (328, the foundations for Gatepier TCB 258) and it was apparent that it had originally extended still higher as traces of the mortar survived on the southern face of Wall 79 and filled the holes left by the removal of the hinges. It is thus likely that the wall filled the entirety of the gateway.

tion for the blocking-wall 318 as there appeared to be no break between them. As a foundation they seem excessive, particularly given the somewhat rough walling built above. It is possible, therefore, that the chert was intended as a solid base for the path through the gateway. No trace of a surface was seen within these deposits but flagstones may have been laid on the compacted gravel (343) which would have been level with the foundation plinth.

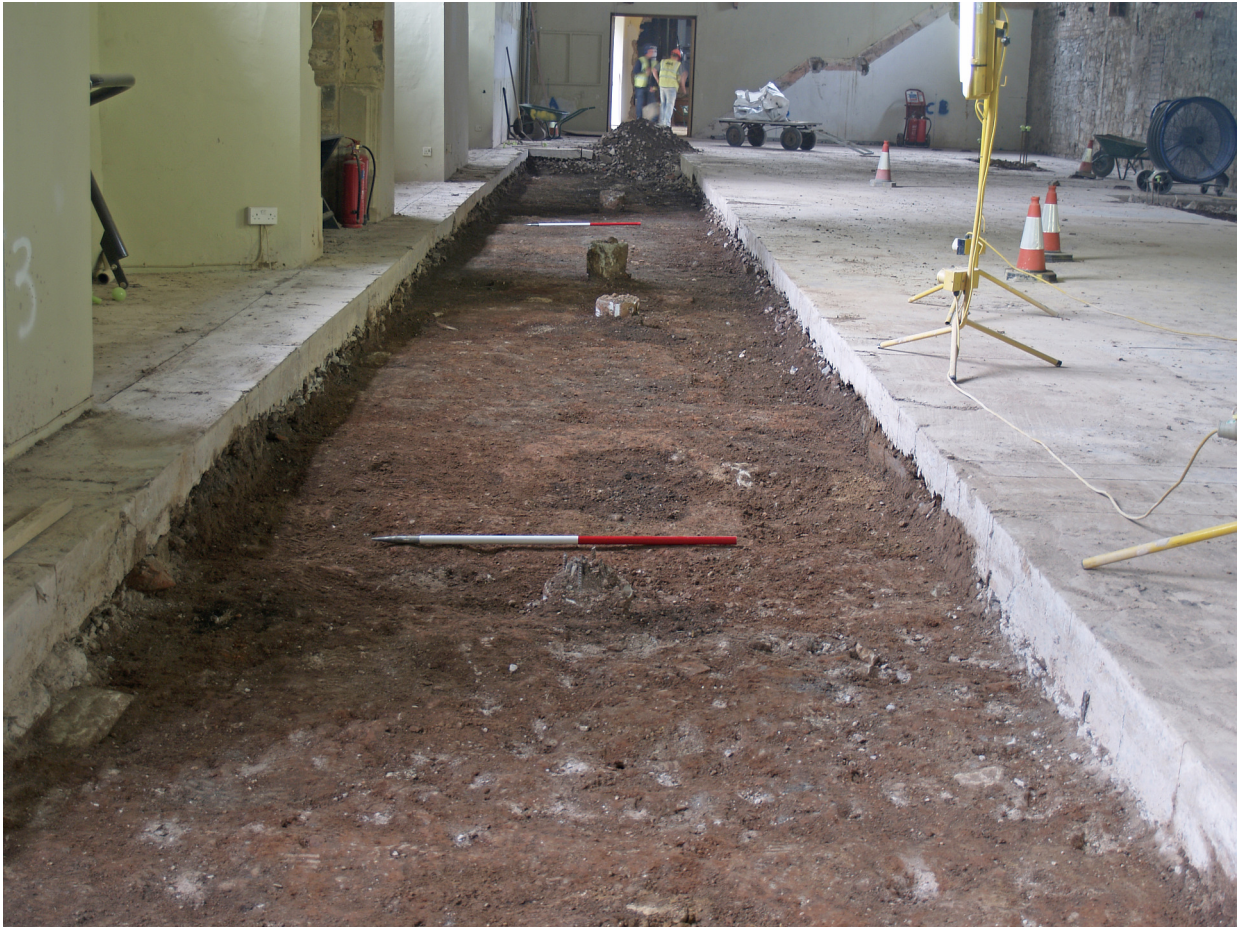
*Figure 5.12: Trench N looking west after removal of concrete and initial cleaning. The rubble-filled backfill of Radford and Hallam’s Trench I can be seen in the foreground.*

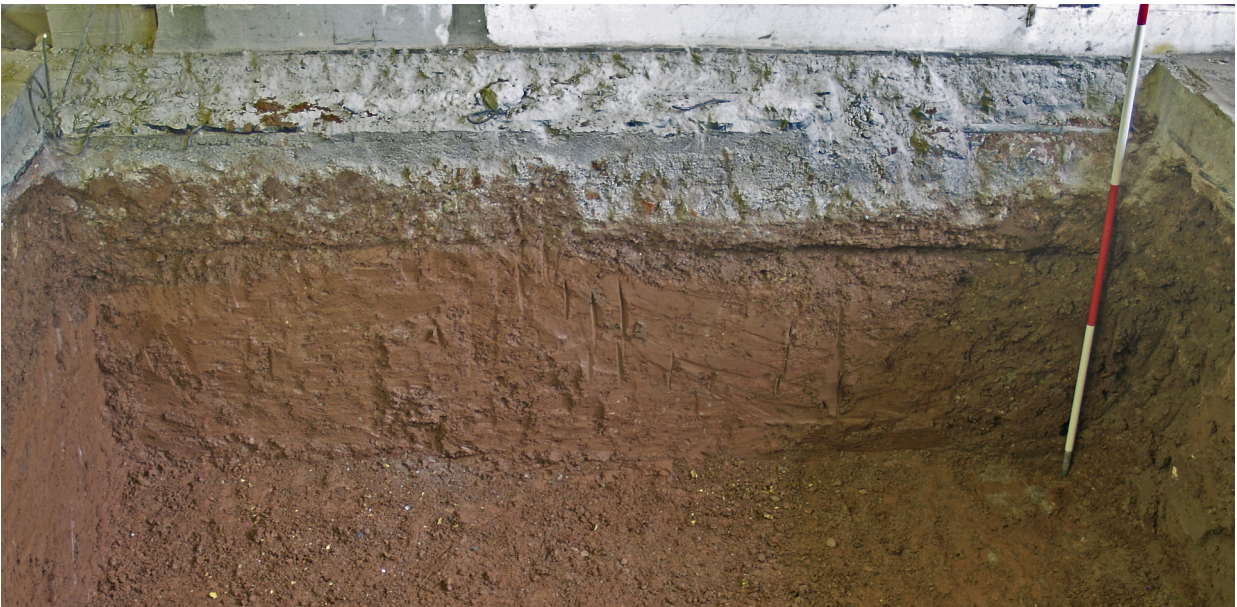
Figure 5.15: The east side of the lift pit excavation in the basement of the Wyndham Galleries (Trench V) showing the natural red clay (778) with lenses of dark red gravel (779). To the right, these are cut by the construction/robbing trench (780) for a large wall (782), probably the north curtain wall of the castle.

Undisturbed solid geology was exposed only in the lift pit excavations, Trench W in the Great Hall and Trench V in the basement of the Wyndham Galleries (Figure 5.15 on page 81), at a highest level of 15.96m aOD. It consisted of hard red marl (571, 778) of the Mercia Mudstone Series overlain by a gravelly-clay with pockets of sand of variable thickness (572, 779). In Trench W the upper, sandy-clay, levels of 571 were found to merge into the base of a horizon of increasingly dark grey clay-sand (570) up to 0.35m in thickness which yielded charcoal, abraded fragments of animal bone and 10th–12th-century pottery, almost exclusively concentrated in the upper, darker, 0.15m of the deposit.

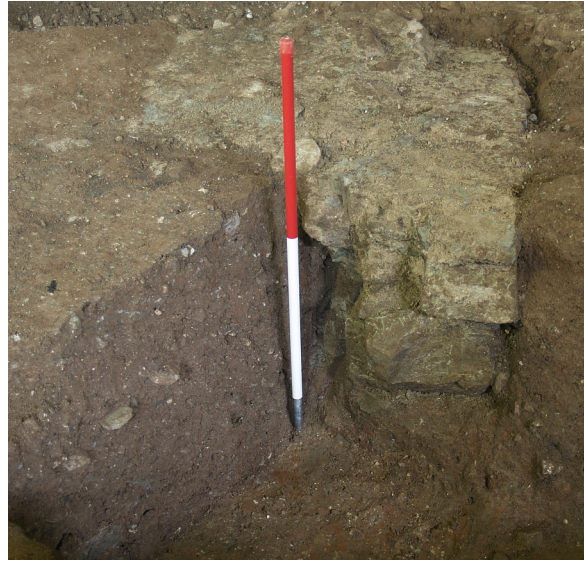
*Figure 5.17: Pier base 895 from the north, where cut away diagonally by 926, whose fill (811) can be seen to the left of the scale. 1m scale.*

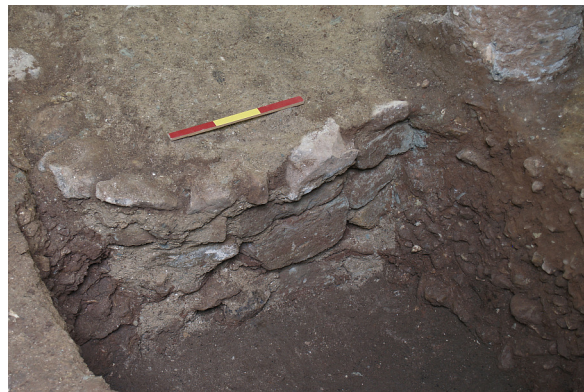
*Figure 5.18: The north side of pier base 657 completely filling the cut through red gravel 668 (seen in section to right and left) and buried soil 570/708 (seen in the base of the excavation). 30cm scale.*

masonry (657, Figure 5.18 on page 83) of near identical construction and size was encountered in Trench N, 3.4m to the north of 895, the construction of which was cut directly through red clay 558 and gravel 668. The masonry was predominantly North Curry stone with some reused dressed blocks, very similar in style to that of Wall 654.

This similarity of character, stratigraphic location and position on an axis parallel to Wall 654 strongly suggests that these three elements functioned as parts of the same structure. That these two masonry foundations were designed to carry load-bearing vertical supports, either timber or, perhaps more likely, masonry, seems certain. It is unlikely that they formed part of a row of columns along the length of the building as no others were seen, either in the present excavation or by Radford and Hallam. It seems more likely that 657 and 895 formed the foundations for a cross passage with three arched openings into the hall to the west and perhaps a gallery over (see page 184).

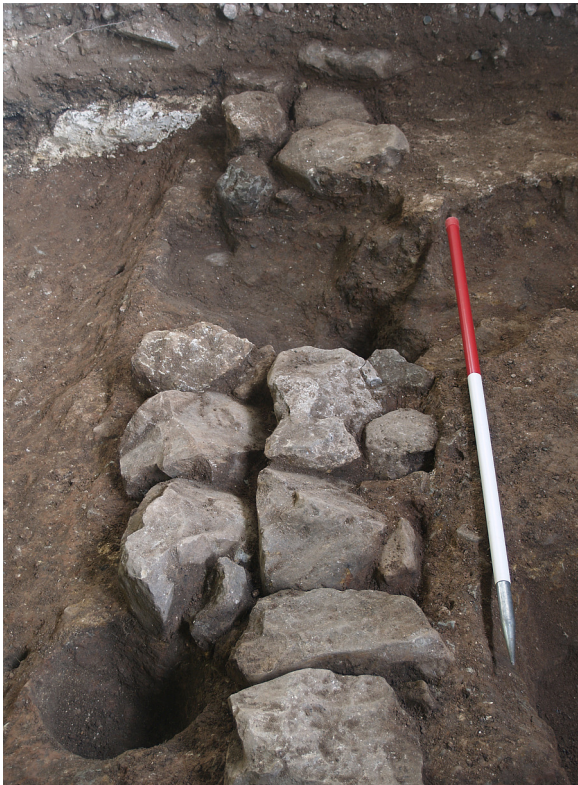
*Figure 5.19: Wall 971 from the south with mortar floor 974 to the right. The white mortar in section to the left is 763/977. 1m scale.*

Wall 1008 was demolished and its foundation partially robbed by cuts 1023, and 1035 (see above) and the holes backfilled. The area was then levelled by a dump of crushed stone and river gravel (1019) to form the base for a mortar floor (974, Figure 5.19 on the next page). The mortar floor ran westwards up to a north-south wall foundation (971) of chert rubble and clay (Figure 5.19) and appeared to be contemporary with it. Three metres to the west of Wall 971, the remains of a second possible narrow north-south wall (774/1032) of clay-bonded slate was identified, the shallow construction cut for which penetrated clay levelling 776/1065 below. This group of contexts appear to be foundations and floor surfaces associated with timber buildings to the east of Hall 2 and serving some form of ancillary function, probably kitchens.

Wall foundation 971 was later cut along its west side by a broad north-south trench (1015), which was filled by a large quantity of hard lime mortar (763/977) into which two square posts of similar dimensions had been pushed before it had fully set, leaving impressions 1002 and 1003. These appear to be the remains of an unusual foundation again supporting a timber structure. The plaster-embedded posts 1002 and 1003 were accompanied by adjacent postholes (1001, 1004) which may indicate the locations of replacement

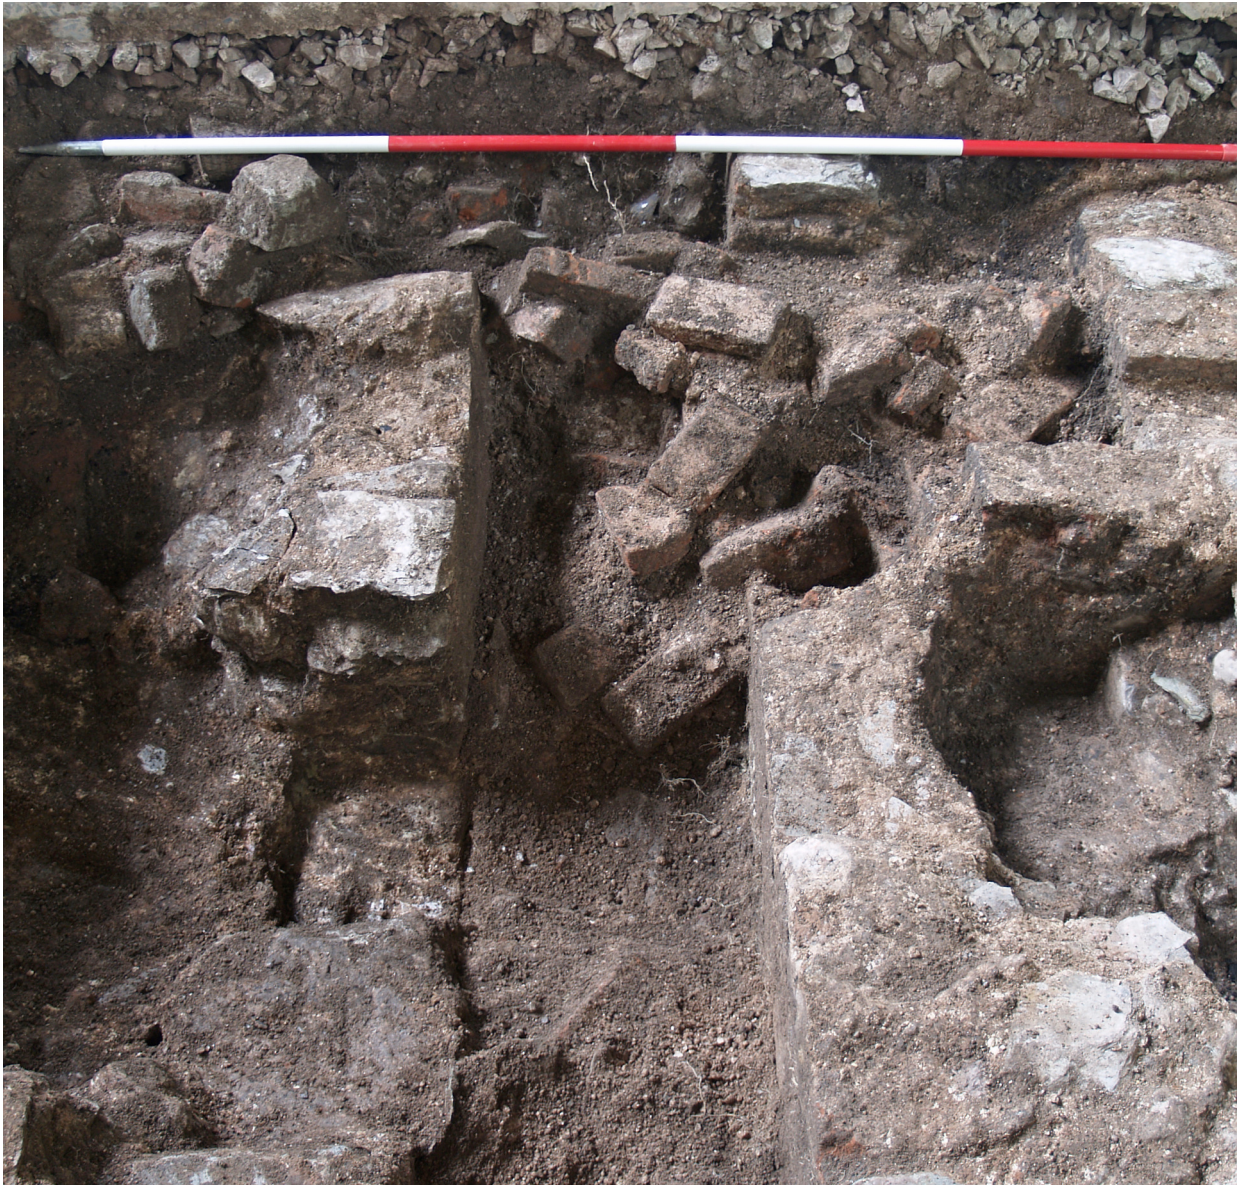
*Figure 5.21: Tumbled bricks (743) filling the southern end of drain 730. 2m scale.*

The drain was found filled and covered with similar bricks and stone rubble (743) appearing to have been dumped from the south-west, an area where Radford and Hallam discovered similar bricks in the back-fill of the well. The top metre of the well had been destroyed by a
