# Taunton Castle

By Chris J Webster

Somerset Archaeological and Natural History Society

Taunton, 2016

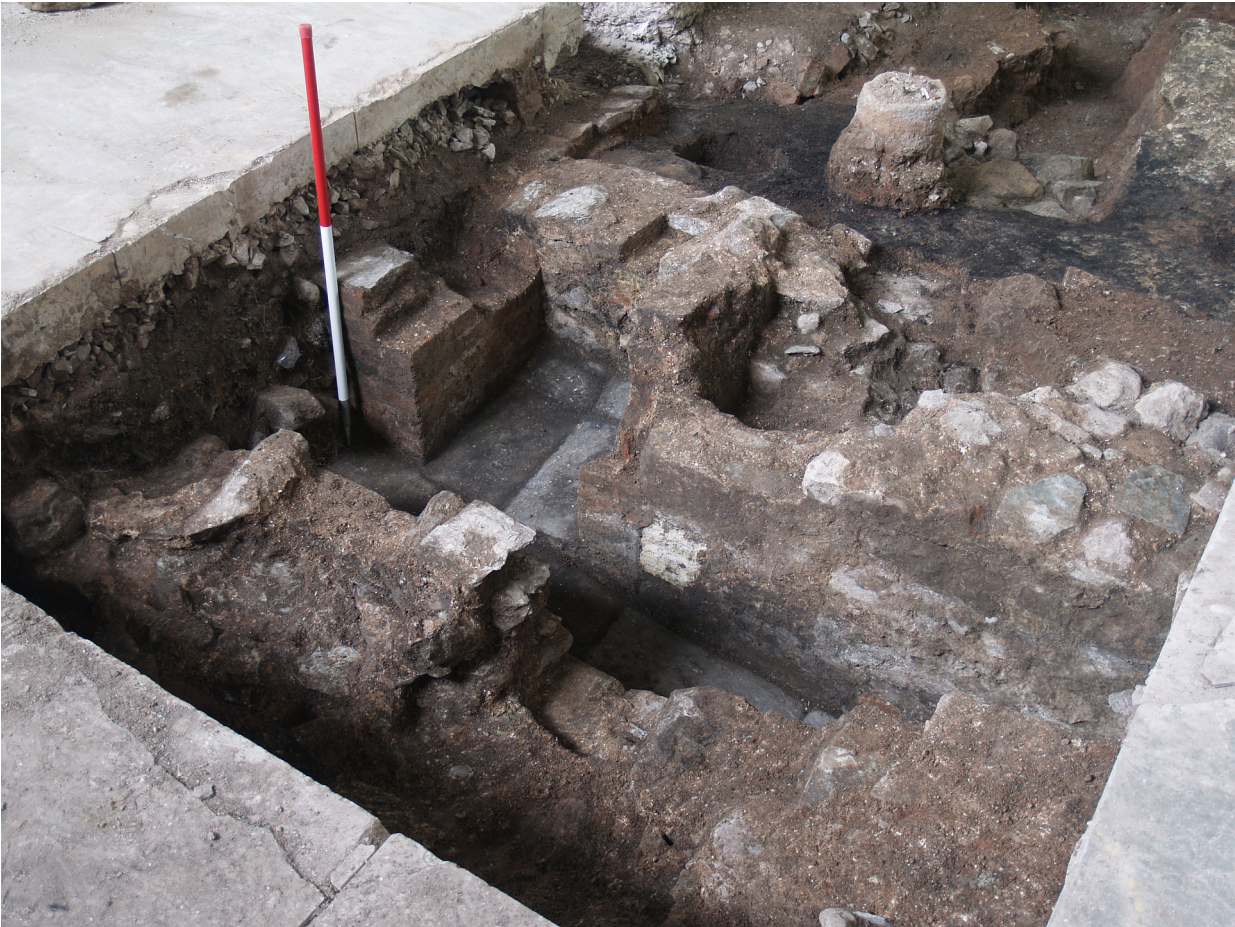
*Figure 5.22: Drain 730 fully emptied. The charcoal (745) covering floor 746 is visible to the right. 1m scale.*

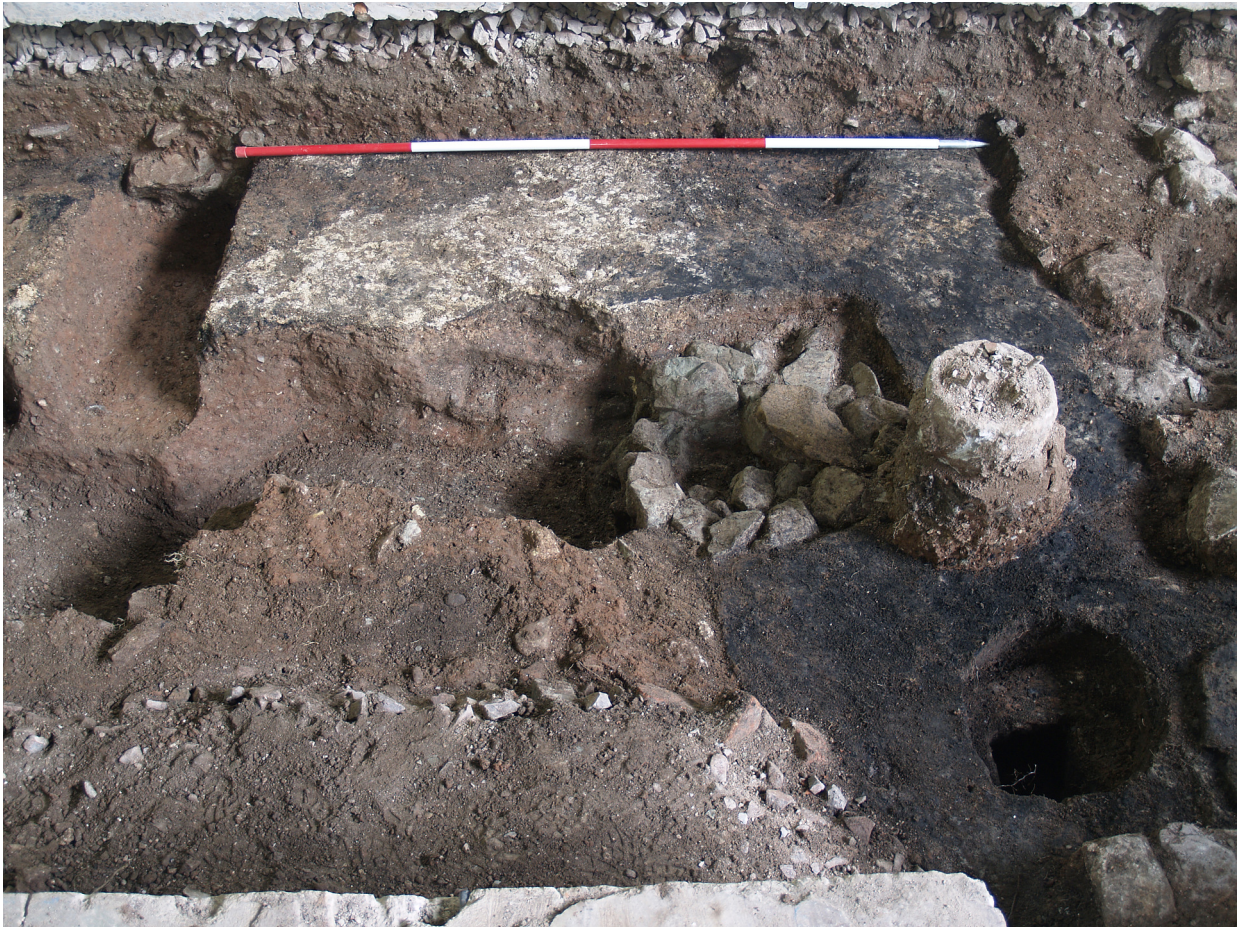
*Figure 5.23: Mortar floor 746 covered by charcoal deposit 745 and cut by slot 742. Later features include stone-packed posthole 731 (next to the modern pile). In the foreground is the infilled eastern end of Radford and Hallam's Trench II. Scale 2m.*

To the west was a hard packed, lime and crushed stone floor (746) which extended 2m to the west, and beyond the excavated area to the south. It was overlain by a continuous thin layer of finely crushed charcoal (745) throughout its exposed extent (Figure 5.23 on page 90). Towards the western edge of these surfaces a steep-sided, north-south aligned slot (742) was cut which contained stone packing (741) of a character consistent with packing for the supports of a timber structure. The charcoal (745) contained a clay pipe of 1630–50 and appeared to have built up against Wall 899. The date suggests that the charcoal is a product of burning during the Civil War, either a direct result of hostilities or from burnt rubbish during clearance.

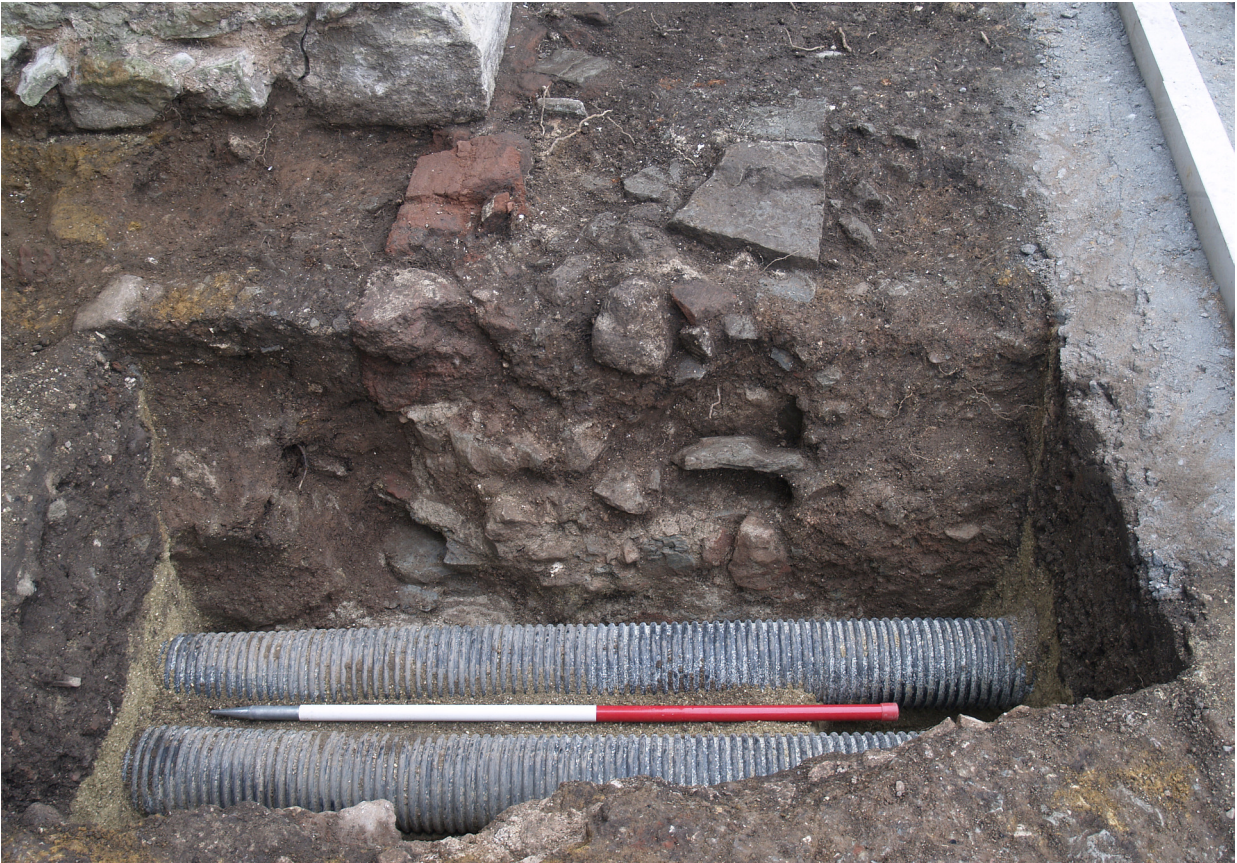
*Figure 5.26: Wall 1187 as exposed in the trench for the heating pipes. The red sandstone face is visible to the left just supporting the north wing of Castle House. 1m scale.*

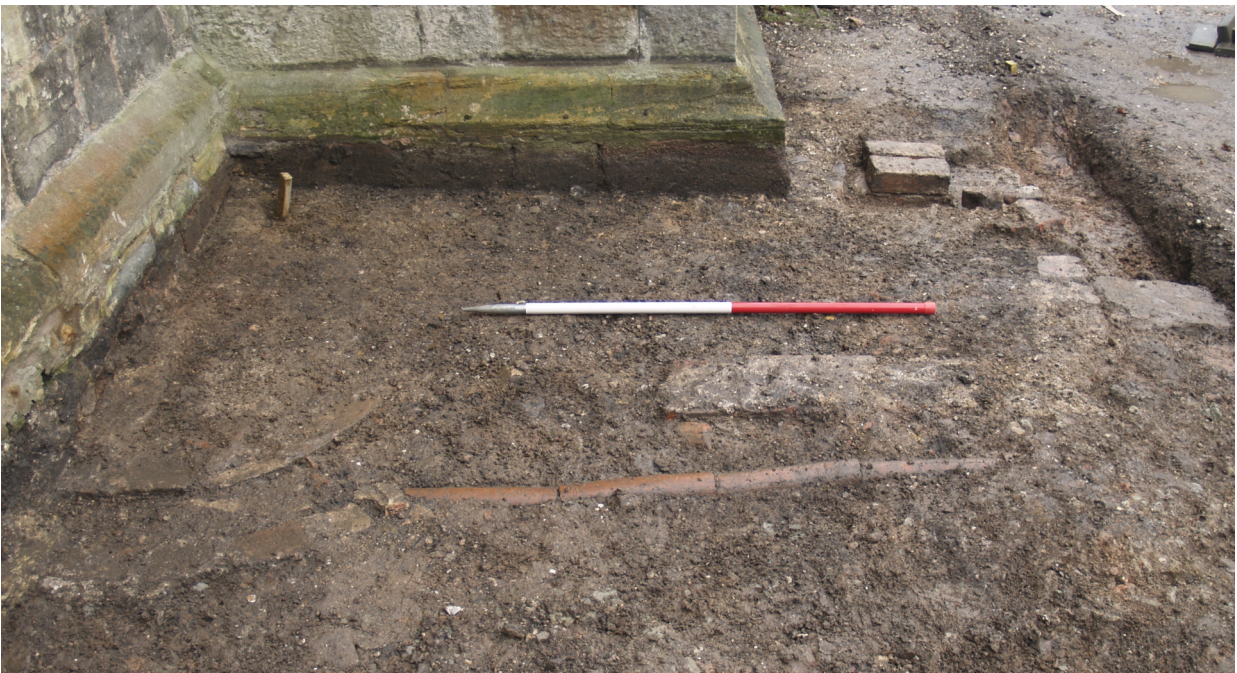
*Figure 5.27: Wall 1177 with quadrant 1193 and drain pipes 1181. Looking west. 1m scale.*

The only other features recorded were late and included another brick V-drain leading to the doorway of Castle House and traces of brick walling to the north and west of the stair turret (Figure 5.27 on the previous page). They comprised a brick wall (1177) running north from the north-east corner of the turret, turning east and then south to meet Castle House. At the south end the wall appeared to curve outwards to form a quadrant (1183) although this may have been a separate feature. Another curving section of brick wall ran parallel perhaps forming a drain. From the northern end of this outer wall, a single line of small diameter tile drains (1181) ran northwards.

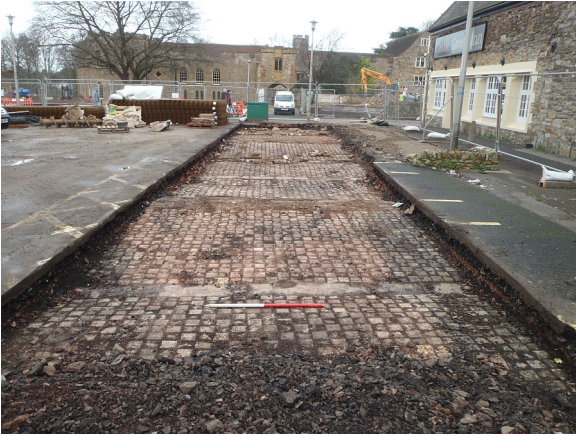
**Figure 6.2:** *The well-preserved paving of the 19th-century cattle market. Photo AC Archaeology.*

page). A large area in front of the Castle Green Inn public house and elsewhere revealed well-preserved brick paving of the former cattle market (Figure 6.2). It was possible to leave much of this in situ with the new surface made up from this level. Elsewhere the paving was removed and the new surface constructed on top of the hardcore present beneath the paving. In the area to the east of the Winchester Arms the deposits had been heavily disturbed by modern services.

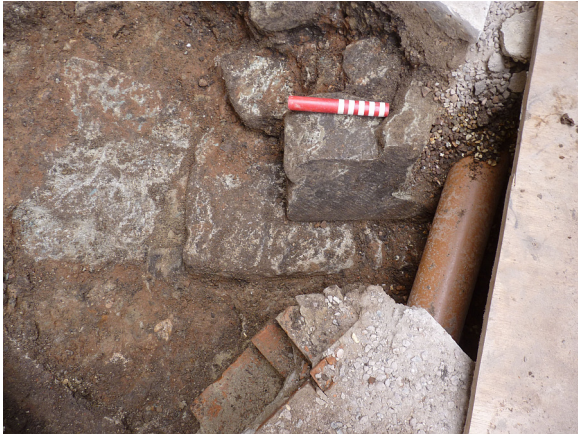
**Figure 6.4:** Wall TCH 12 813 continuing Wall B across the Castle House courtyard. Photo: James Brigers.

Two narrow trenches were excavated across the courtyard for drainage and other services. Much of the area had been disturbed by previous service trenches but small "islands" of medieval stratigraphy remained. The principal discoveries were two stone walls, TCH 810 and TCH 813 (see Figure 8.3 on page 157). The more northerly (813) was 2.6m wide with faces of North Curry sandstone retaining a core of red-brown gravelly clay with North Curry rubble, all bonded by a red-brown lime mortar (Figure 6.4). For the most part, only one course was visible within the

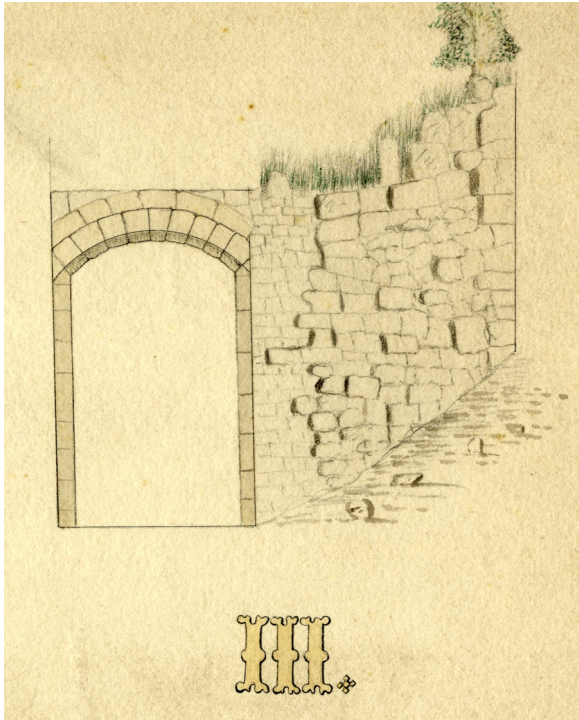
*Figure 8.1: The Watergate from the south in 1853 by John Leversedge. SANHS 3515.*

To the east of the Great Hall stood a gate, the earliest illustration of which (Figure 1.1 on page 13) shows a simple, round-headed doorway (176) in a wall, closed by a low gate. It is described by Spencer (1910, 41) as similar to Door 59 ("a segmental archway, with a plain chamfer") and to Door 69, and this is how it is shown in Leversedge's drawing (Figure 8.1 on the next page) and photographs. Further information is

The Watergate itself must have been demolished with the adjacent wall before the construction of the Wyndham Galleries in 1933. No records appear to have been made but it is just

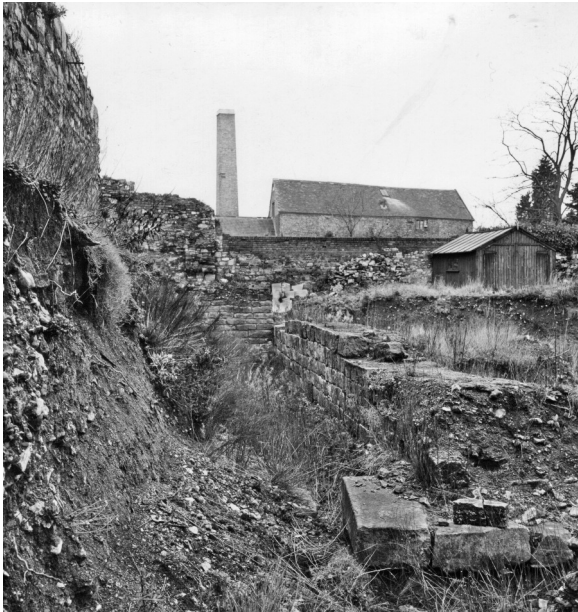
*Figure 8.4: The rear of Wall C looking north after Gray's excavations with Wall 23 in the centre of the picture. Joel 8.*

the photographs (Figure 8.5). The photographs do show that Wall 23 was faced on its west side (Figure 8.4), arguing against Gray's interpretation that Wall 23 formed the inner face of the keep wall.

At the south end of the inner wall face (C12), the Joels' photographs show another return eastwards, this time with very little masonry remaining (Figure 8.5). It cannot be seen at all in Joel 8 (Figure 8.4) which does show that it was not bonded to Wall 23. Nothing is shown at this location on Botterill's plan. Another photograph (Joel 10) shows that Wall 23 continued northwards beyond the excavation and it was seen here in 1992 (see page 56, AC72:7). It was butted by another wall (AC72:4) that ran north-eastwards. The Joel photographs suggest that this wall lay beyond Gray's excavation and it is not shown by Botterill. Both walls were truncated by the construction of the terrace for the Wyndham Galleries without record.

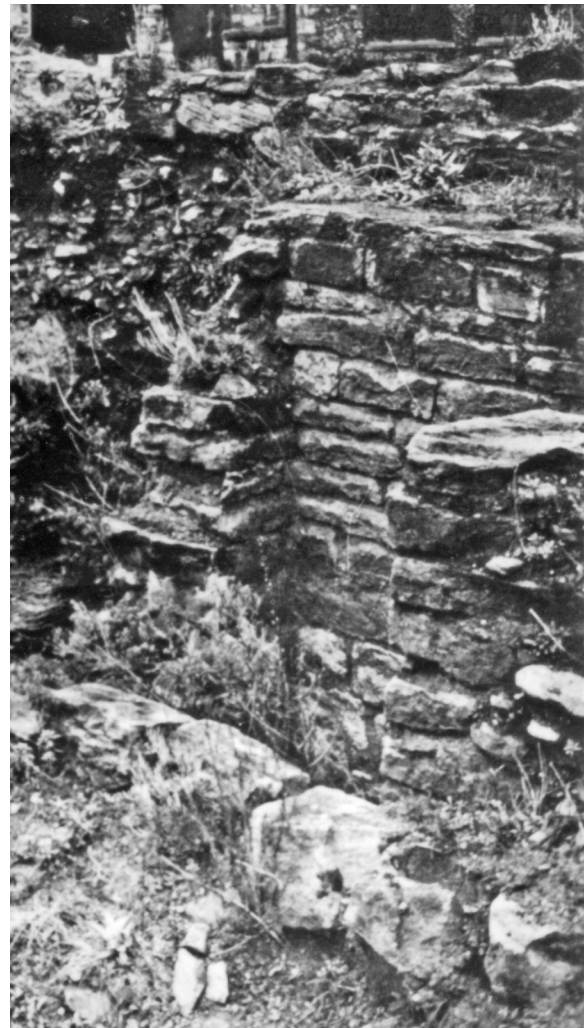
*Figure 8.5: The rear of Wall C looking south after Gray's excavations with Wall 23 in the foreground. Point C10 is on the right with point C12 in the centre. Detail of Joel 22.*

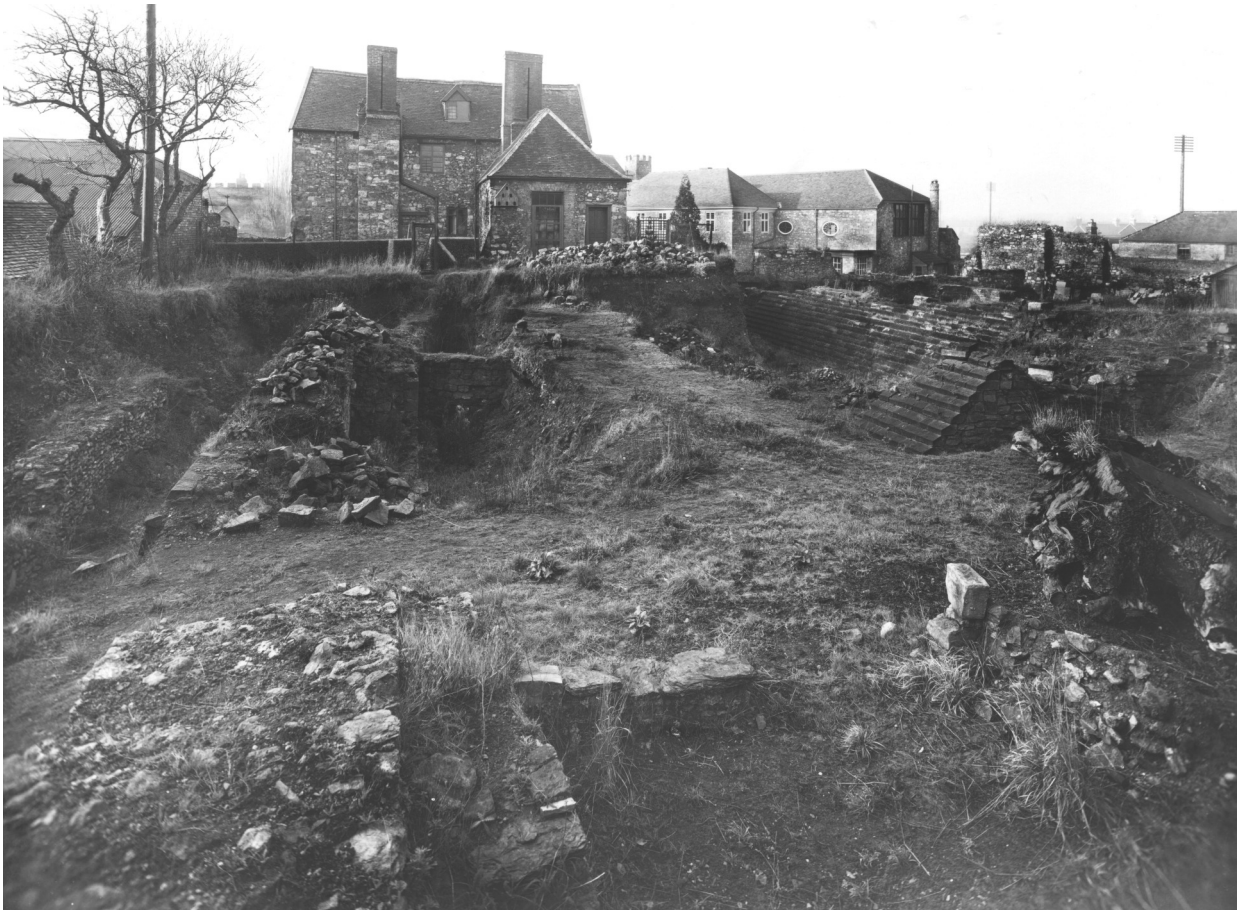
*Figure 8.7: Gray's excavations as left in 1930, photographed in the winter of 1932/33. The photographer is standing on the wall of Room E looking west along Wall B. Wall A with "forebuilding" is to the right and Wall G must lie in the unexcavated area between. To the right of the Great Hall, the large section of wall by the Watergate is visible. Joel 18.*

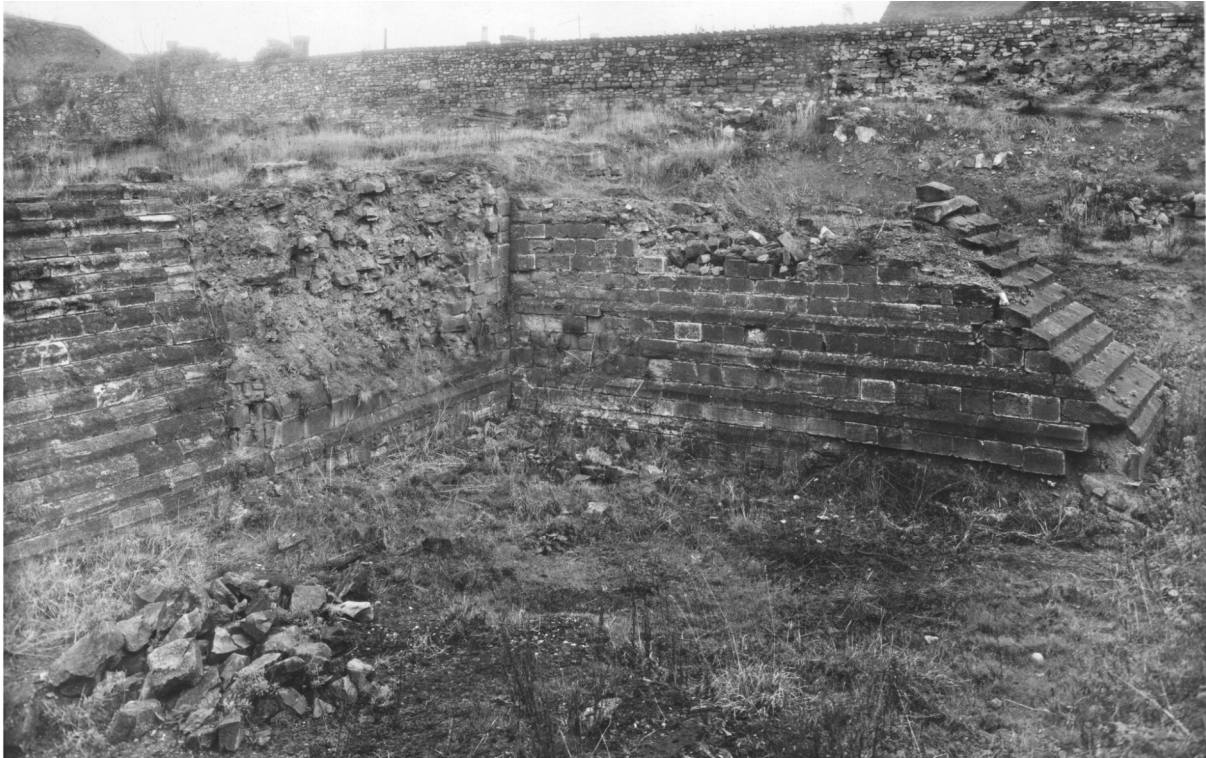
*Figure 8.8: Wall A (A2–A3) and the buttress (A3–A5) in 1932/3. Joel 3.*

To the east, section A2 to A3 had been rebuilt in 1933 preventing Rodwell from commenting much but the evidence of Joel 3 (Figure 8.8 on page 161) is that the reconstruction was correctly done. This section was coursed in the same style as Wall C with alternating courses of vertical and chamfered stone in contrast to A1–A2 where all the courses are chamfered. This means that the batter on the wall is less and thus A2–A3 projects. At A2 the chamfered courses of A2–A3 can be seen to turn northwards with those of A1–A2 cut to shape and butting against them. The eastern part of A2–A3 is very eroded but there was evidently vertical walling above the chamfered lower area and both are continued around the corner and along A3–A5. The similarity in style suggests that this is part of the continuation of Wall 78 and that Wall A1–A2 is a later addition to a retaining wall running from A5 to C9.

Comparison between Gray's photograph of Wall A during its discovery in 1927 (Vivian-Neal and Gray 1940, Plate II), the Joel photographs in 1932/3 (Figure 8.8 on the facing page) and its current condition reveal a considerable weathering of the stonework in 90 years. The pristine condition seen in 1927 suggests that the wall cannot have been exposed for long in the medieval period, indicating that the ground to the south of the wall was raised, protecting it, perhaps extending the raised platform as far as Wall B and perhaps contemporary with the blocking of gateway B3–B4 in that wall (below).

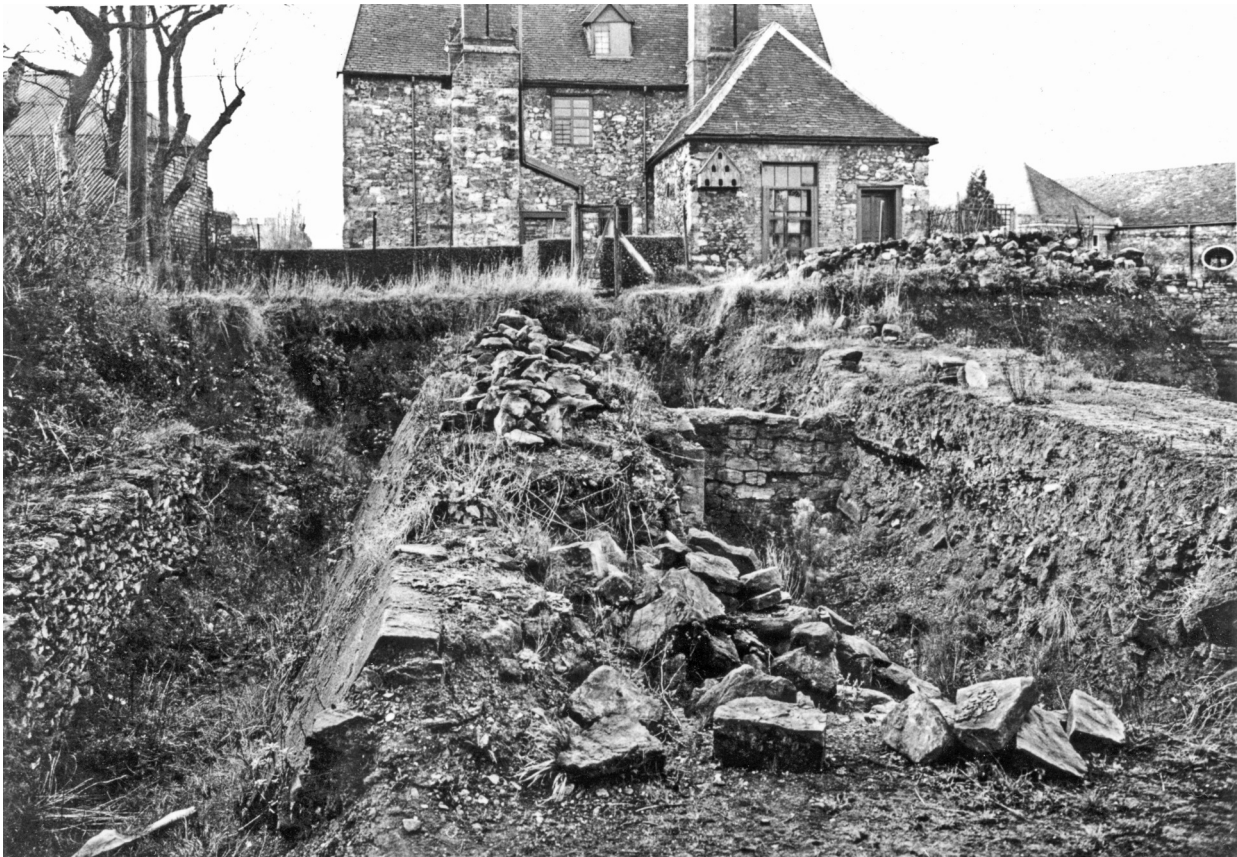
*Figure 8.9: View along Wall B in 1932/3. Wall F can be seen in the trench to the right of the wall and another, now vanished, wall is visible to the left. Joel 4.*

Wall F can be seen in the Joel photographs (4 and 16), crossing Gray's trench, but its northern end is hidden in an unexcavated area between Walls A and B, as is all of Wall G. This area must have been cleared during the landscaping work of 1933. Rodwell (1984a) could see two phases in Wall F, the southern with a foundation

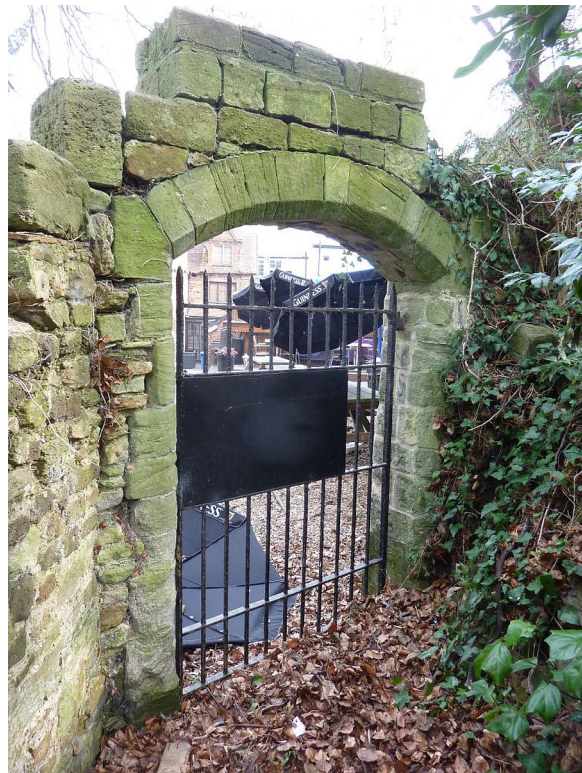
*Figure 8.13: The gateway into Ine’s Garden, possibly reusing masonry from the Water Gate.*

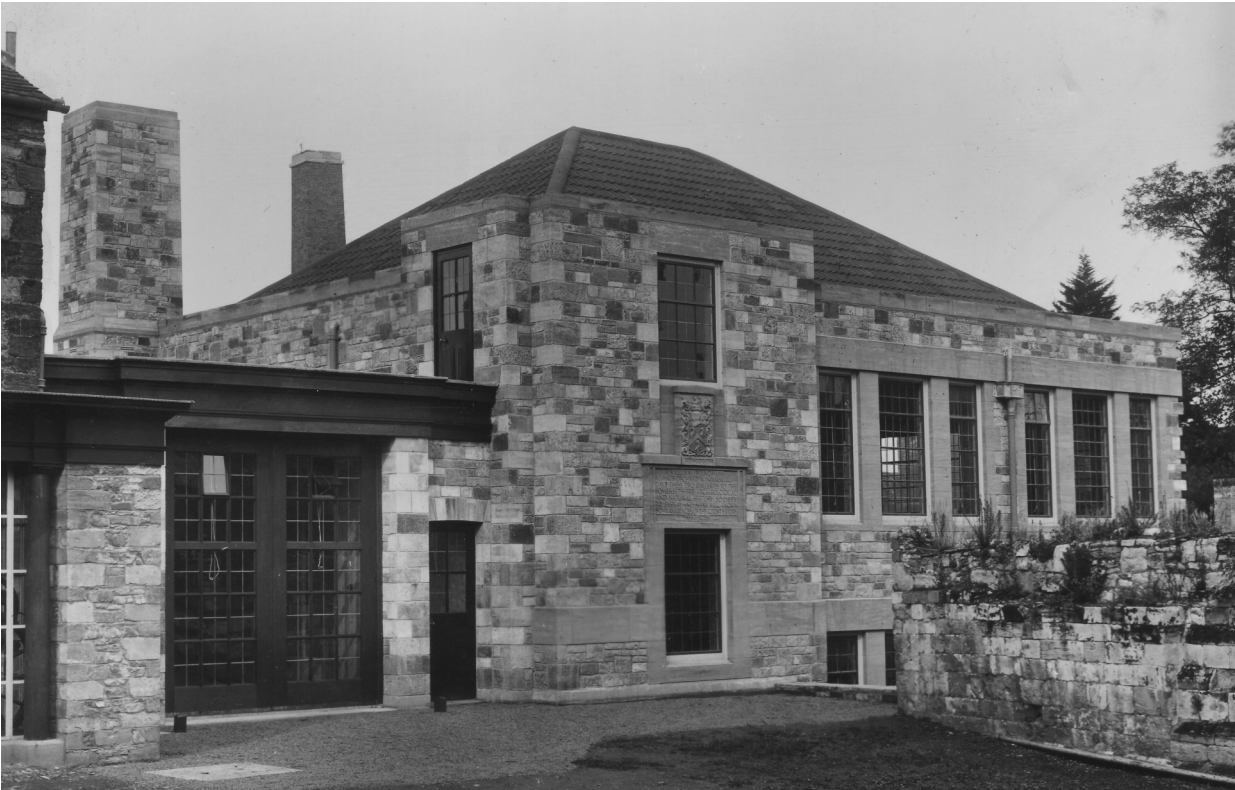
*Figure 8.12: The Wyndham Galleries and link block as built in 1934. Photograph by Harold St George Gray. Note the ragged east end left for completion. SANHS 12572*

No archaeological discoveries were reported, perhaps deliberately after the changes of plan caused by Gray's work. The building was designed to be built in stages and at this time only the western two-thirds and two storeys were constructed (Figure 8.12). The final third had to wait until after the running of the museum was handed to Somerset County Council in 1958, when the museum governors, looking for more space, eventually decided to extend the galleries to the east as originally planned. It was decided to save money by not building the new part to sufficient strength for the third floor. CS Williams were given the job with completion intended by end of September (SANHS minutes: 13/5/1959). The Low Ham mosaic was moved from the Great Hall into a vertical position on the specially heightened east wall (SRO A/CNT/4/1: 1/12/1959). The third storey was eventually started in 1973 to house the regimental museum of the Somerset Light Infantry and opened by the Queen Mother the following year.

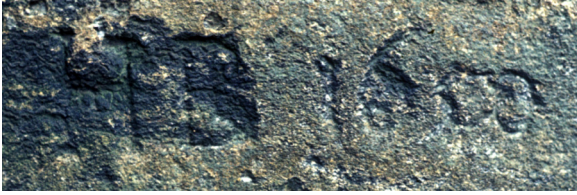
*Figure 9.3: Detail of the date carved on Buttress 375 as shown on an undated colour slide. Somerset HER image 30116.*

There is a further buttress (436) to the east, not on this spacing and not made of Hamstone, that is probably later and another clasping buttress (375) very similar to the western ones at the north-east corner. It lies 24.4m from Buttress 437, on the same 6.1m spacing, and has a plinth at the same level. Carved into the stone in two places are the initials "HB", one accompanied by a date. Radford and Hallam (1953, 73) read the date as 1659 but a colour slide in the HER collection (Figure 9.3) is titled "Date HB 1650". The slide image is not conclusive and neither, when examined in 2009, was the carving on the wall.

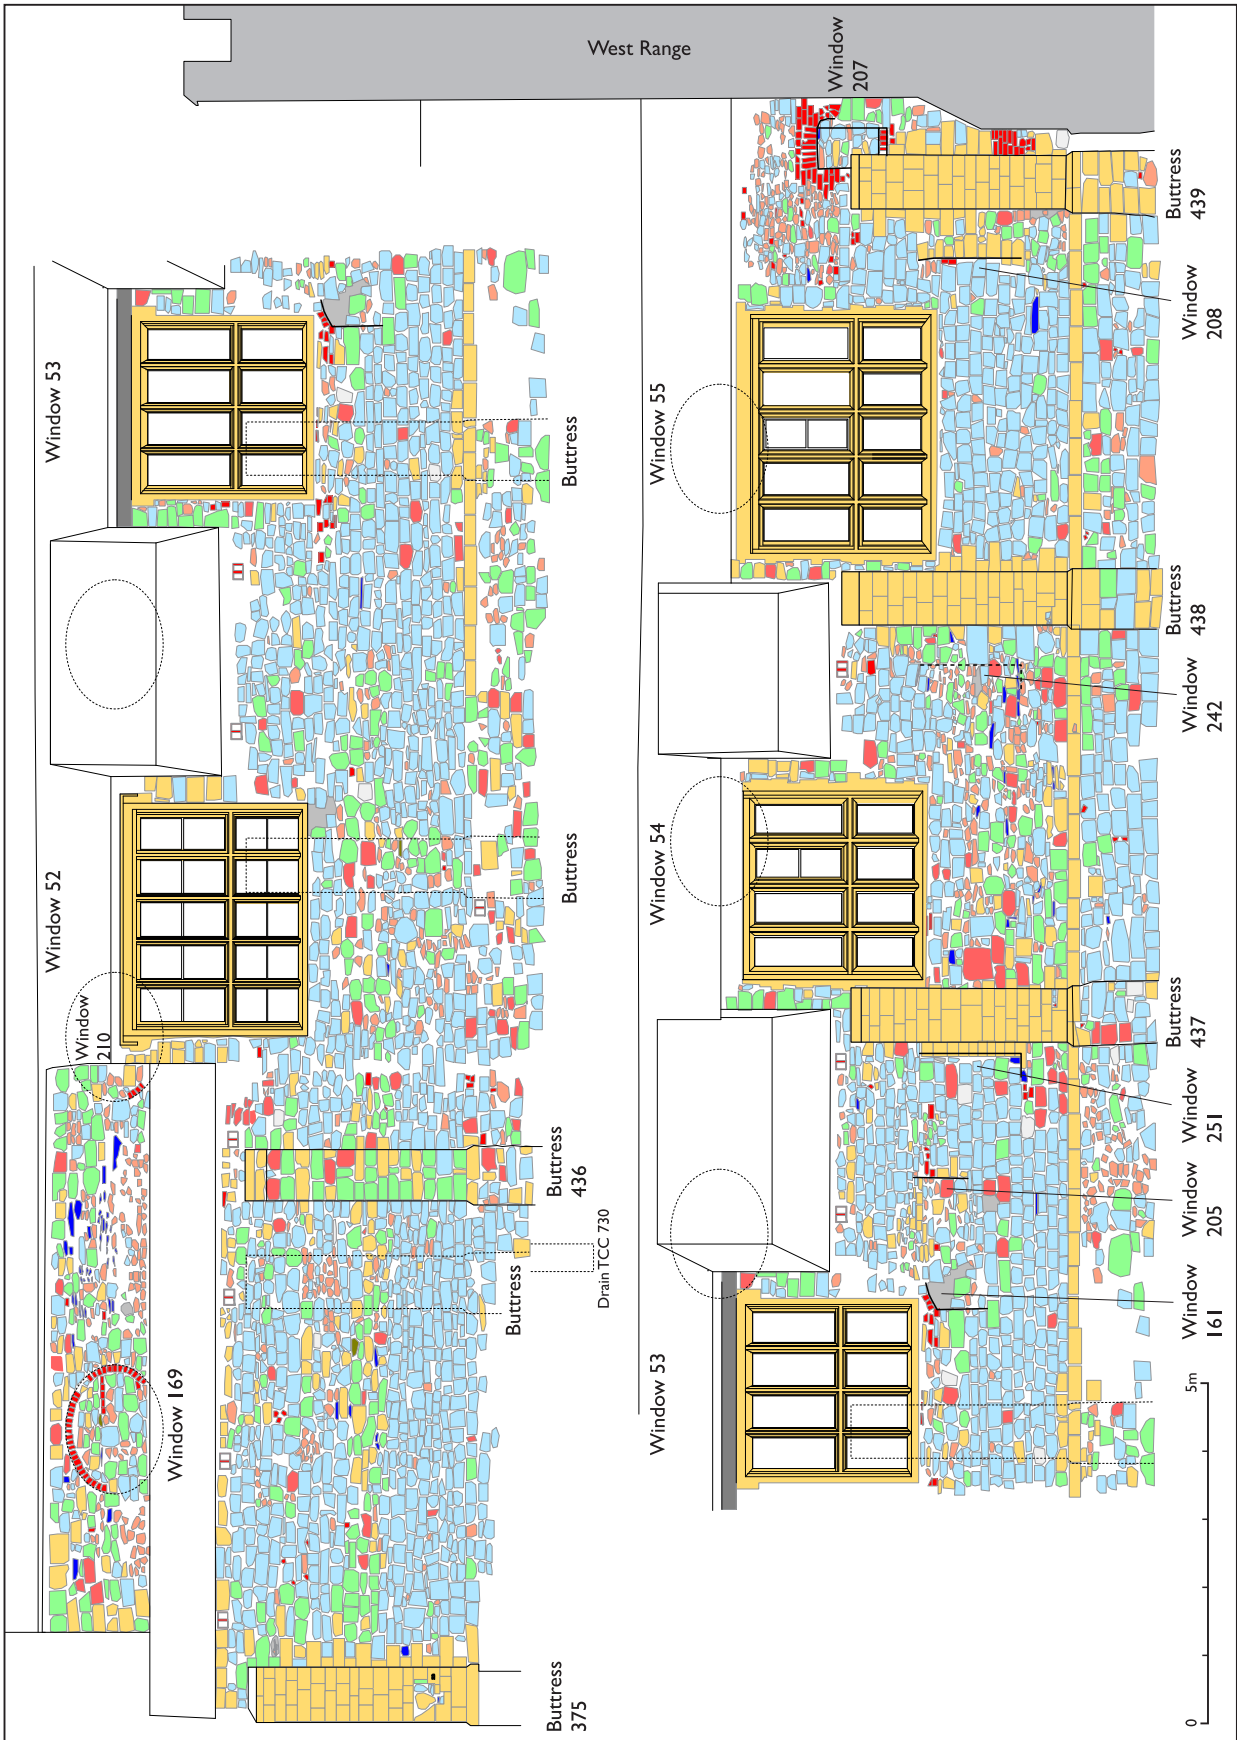
Figure 9.1: Elevation of exterior north wall of the Great Hall, showing (dashed) possible positions of other windows and buttresses, based on spacings. See Figure 3 on page 4 for key to colours. Areas of small chert facing have not been recorded in detail.

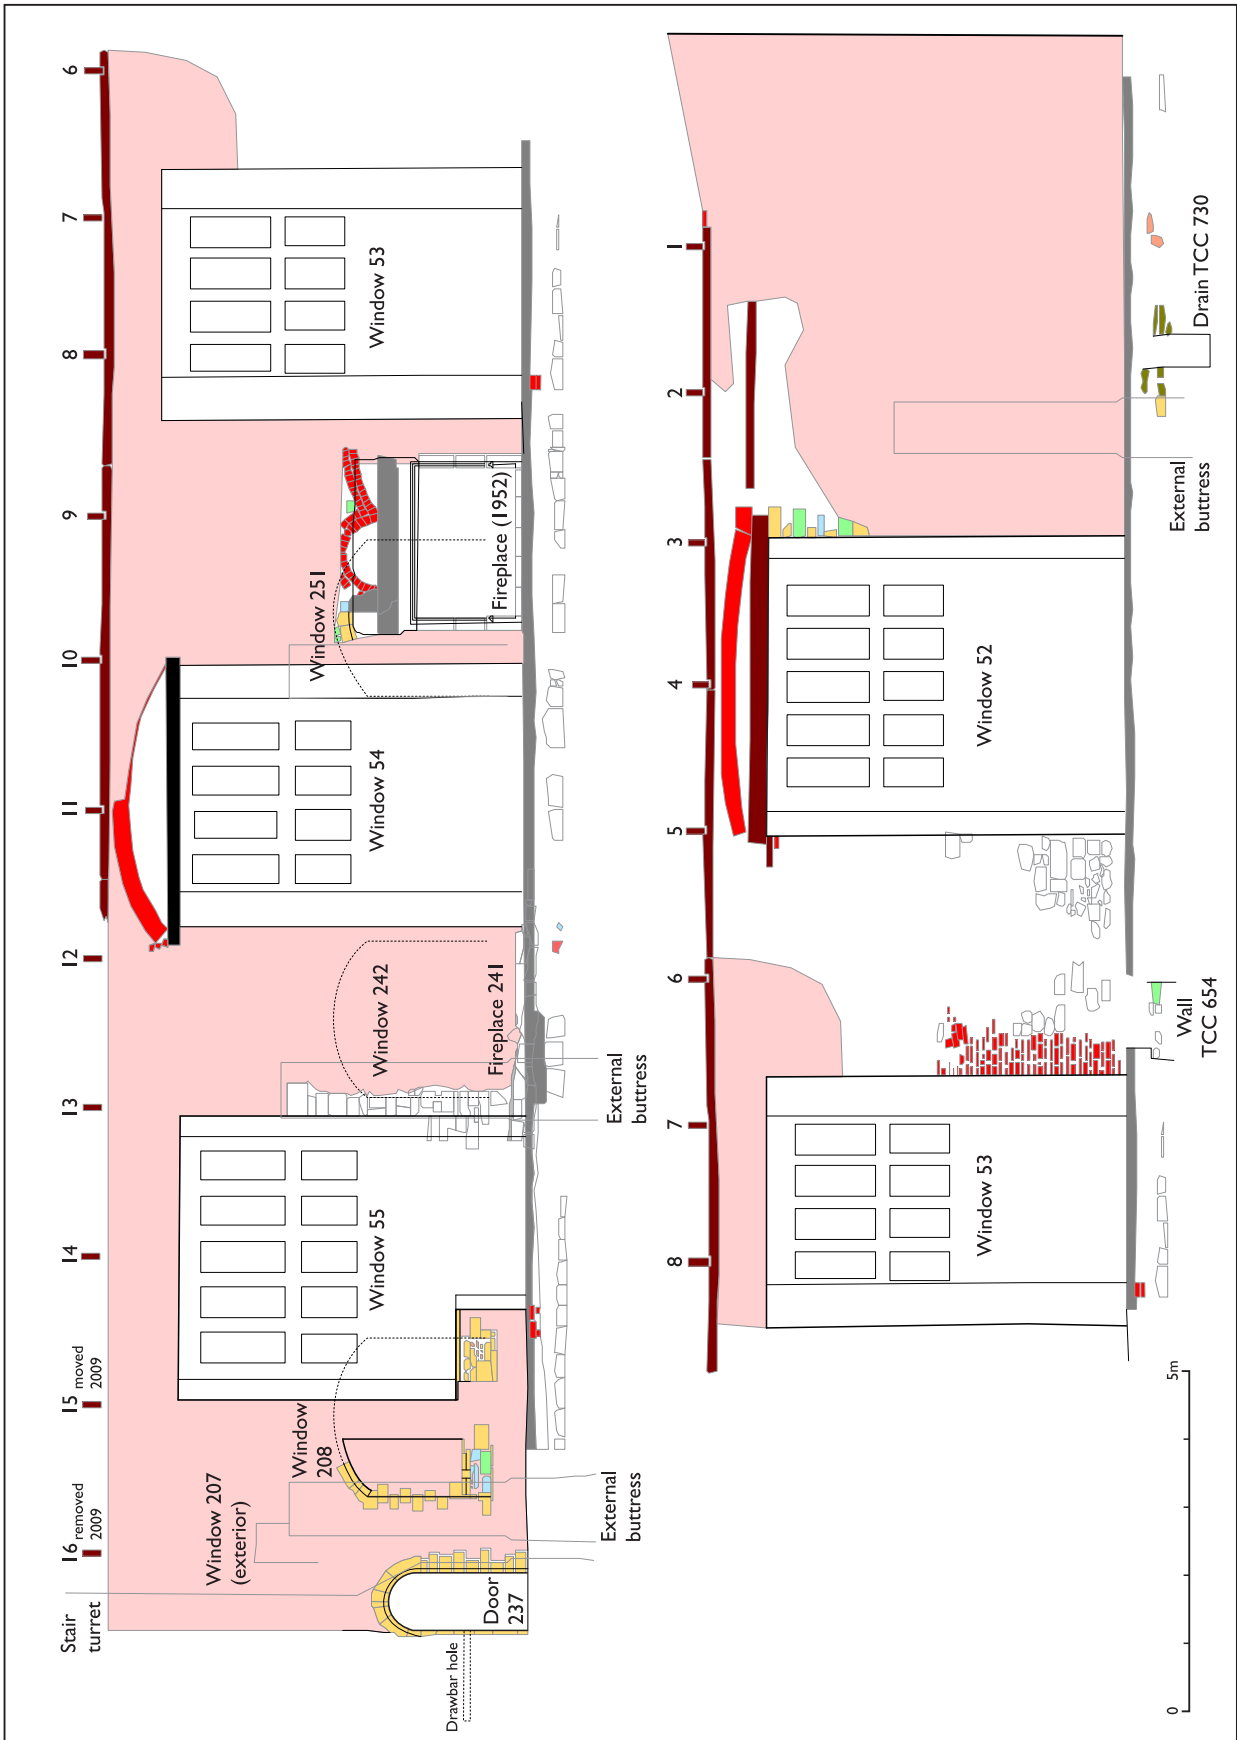
Figure 9.2: Elevation of interior north wall of the Great Hall. See Figure 3 on page 4 for key to colours. Areas of small rubble were not drawn in detail.

The north wall (Figure 9.1 on the facing page; Figure 9.2 on page 170) appears, from its location and thickness to be the curtain wall of the castle. There were few opportunities to examine the wall interior during the recent works, except at the heads of the windows, as little plaster was stripped. The exception was the area between Windows 52 and 53 but this did not produce much new information.

Internally at the west end is a door (237, Figure 9.2 on page 170) leading, via a short intra mural passage, to a spiral staircase (see page 195). Most of the top and east side of Door 237 has been replaced but the west retains medieval work including a draw bar hole 1.3m deep. The door is shown blocked on Spencer's plan and its repair in 1875 is described by Sloper (1876b): "the head of the circular doorway leading to the turret and roof of the keep had been cut away to make room for a small window. The return of the arch was fortunately in situ and this was easily restored according to the original." Radford and Hallam (1953, 16, 68) date the door to either the mid or first half of the 13th century but this may be on the basis of the documented 1247–48 dates. It does appear likely that the door post-dates the removal of the earlier vaulting which would probably have crossed it.

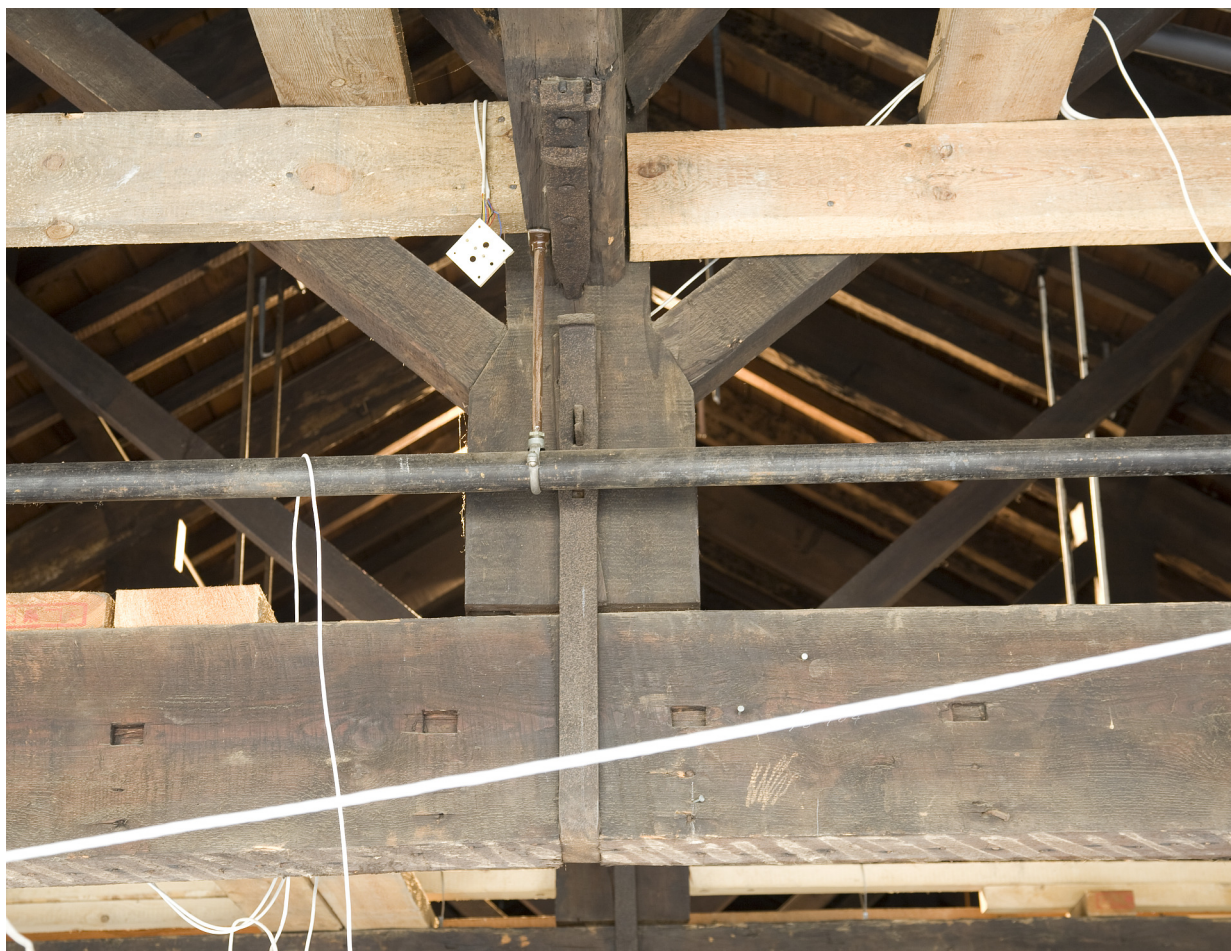
*Figure 9.7: Great Hall roof truss 1 from the east, showing the mortices for the ceiling battens, the iron bands holding the joints and the beam linking to the top of Window 101 to support the hipped roof. The pale timbers are all modern additions.*

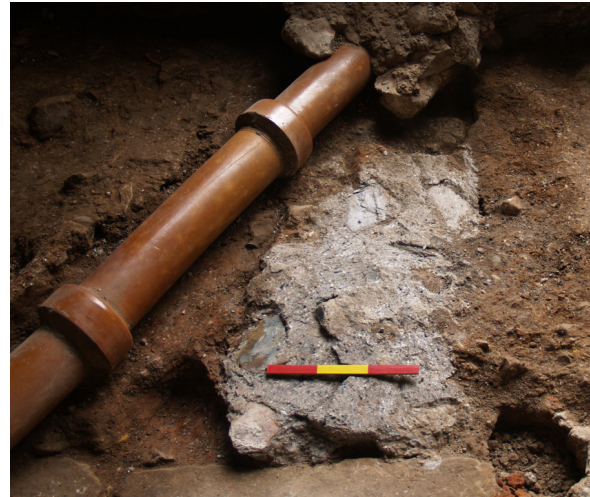
*Figure 9.8: Foundations (484) of porch wall looking south with foundations of Buttress 486 in the foreground.*

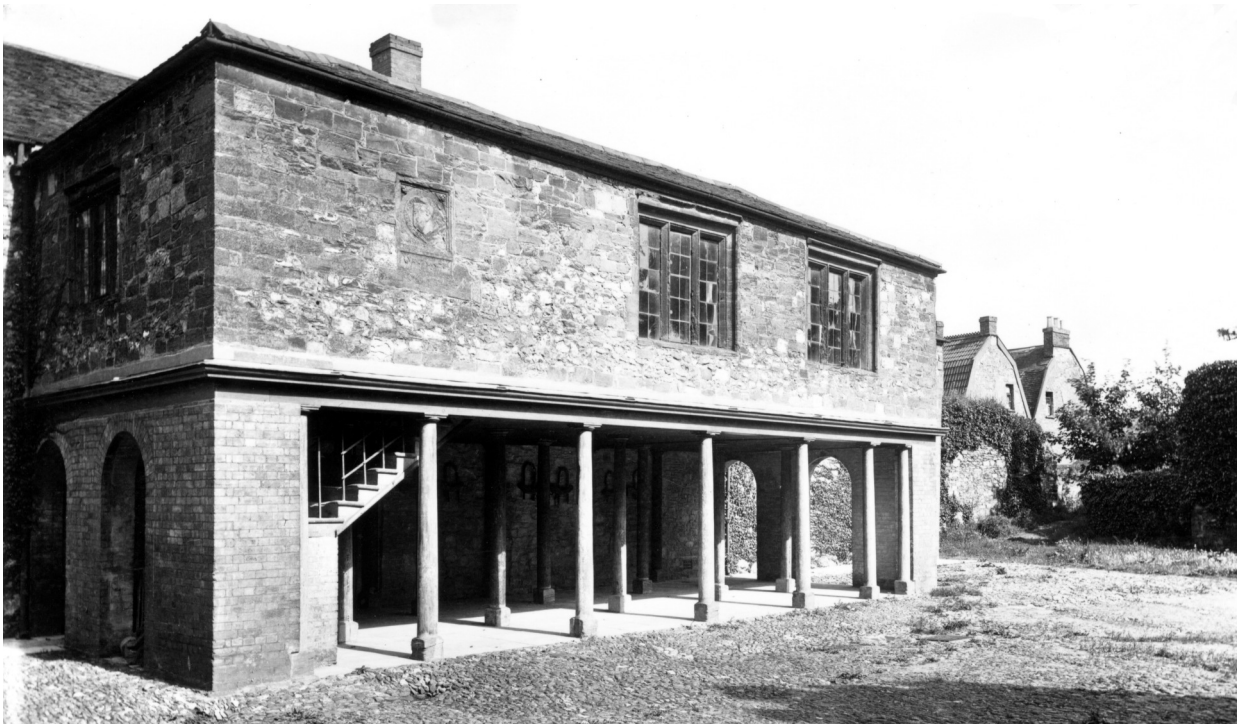
*Figure 9.9: The Grand Jury Room. The gables of Tone House are visible to the right. Undated LEJ Brooke photograph in Somerset Studies Library collections.*

was not demolished until 1931, several plans (the best being Spencer's of 1875, see Figure 12.1 on page 214) and photographs (Figure 9.9 on the previous page) survive. The ground floor was open and the upper floor was supported on wooden columns.

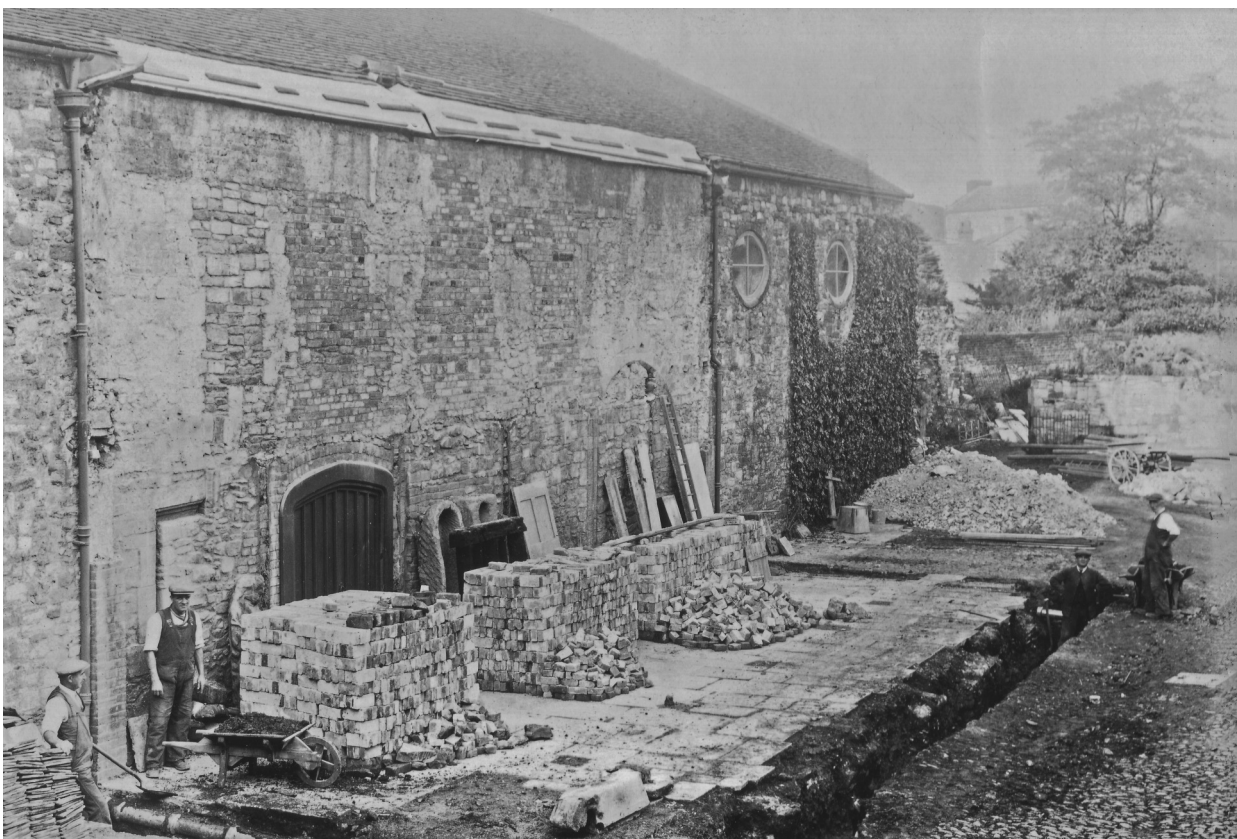
*Figure 9.10: The south side of the Great Hall in October 1931 following the demolition of the Grand Jury Room. The foundations for the Entrance Block are being dug. Door 163 is visible on the left, behind the worker with the wheelbarrow and Door 216 is to the centre by the ladder. An infilled oval window (435) is visible above. SANHS 12250.*
