# Taunton Castle

By Chris J Webster

Somerset Archaeological and Natural History Society

Taunton, 2016

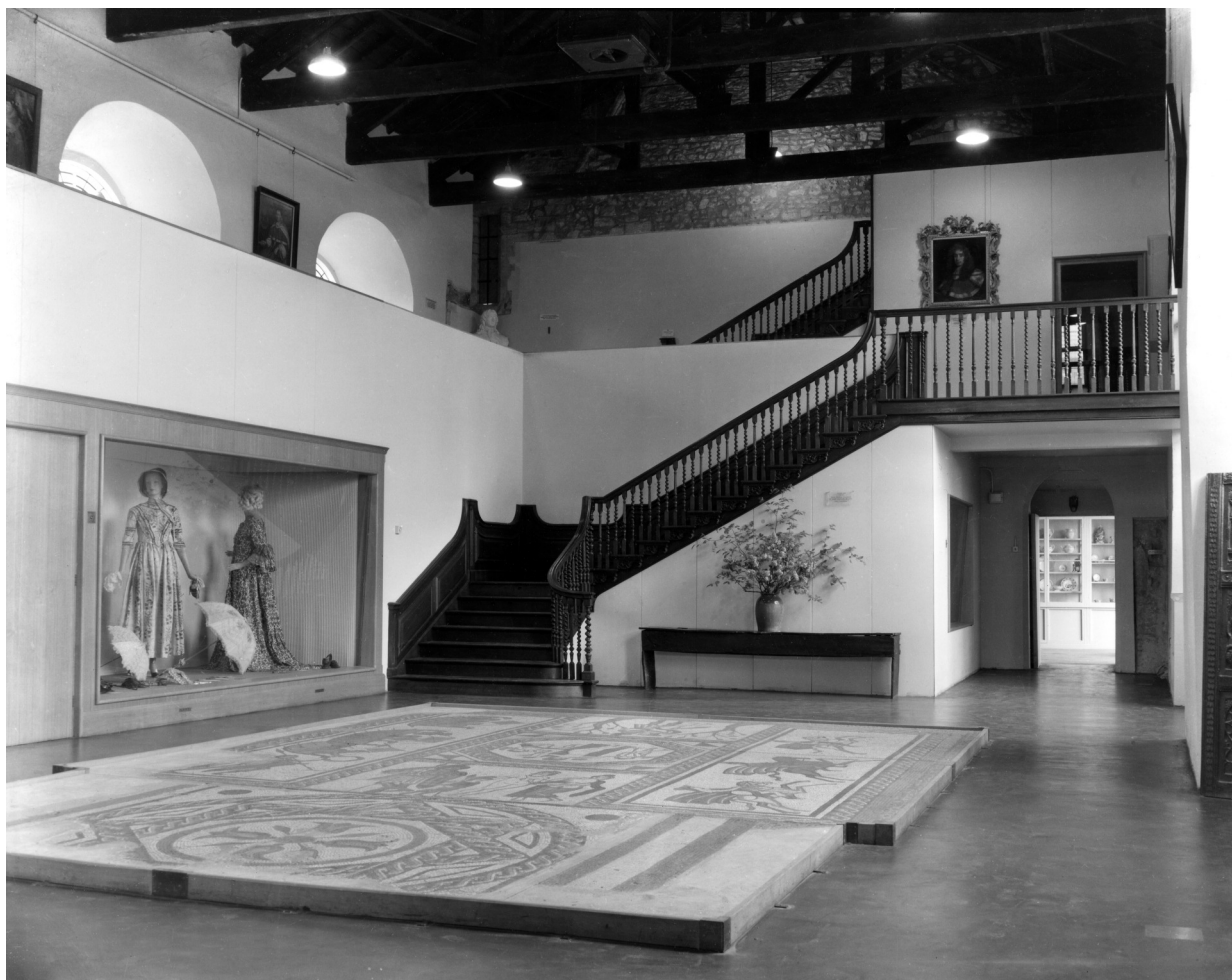
*Figure 9.11: The west end of the Great Hall after the completion of the works of 1952/3. Somerset County Museum.*

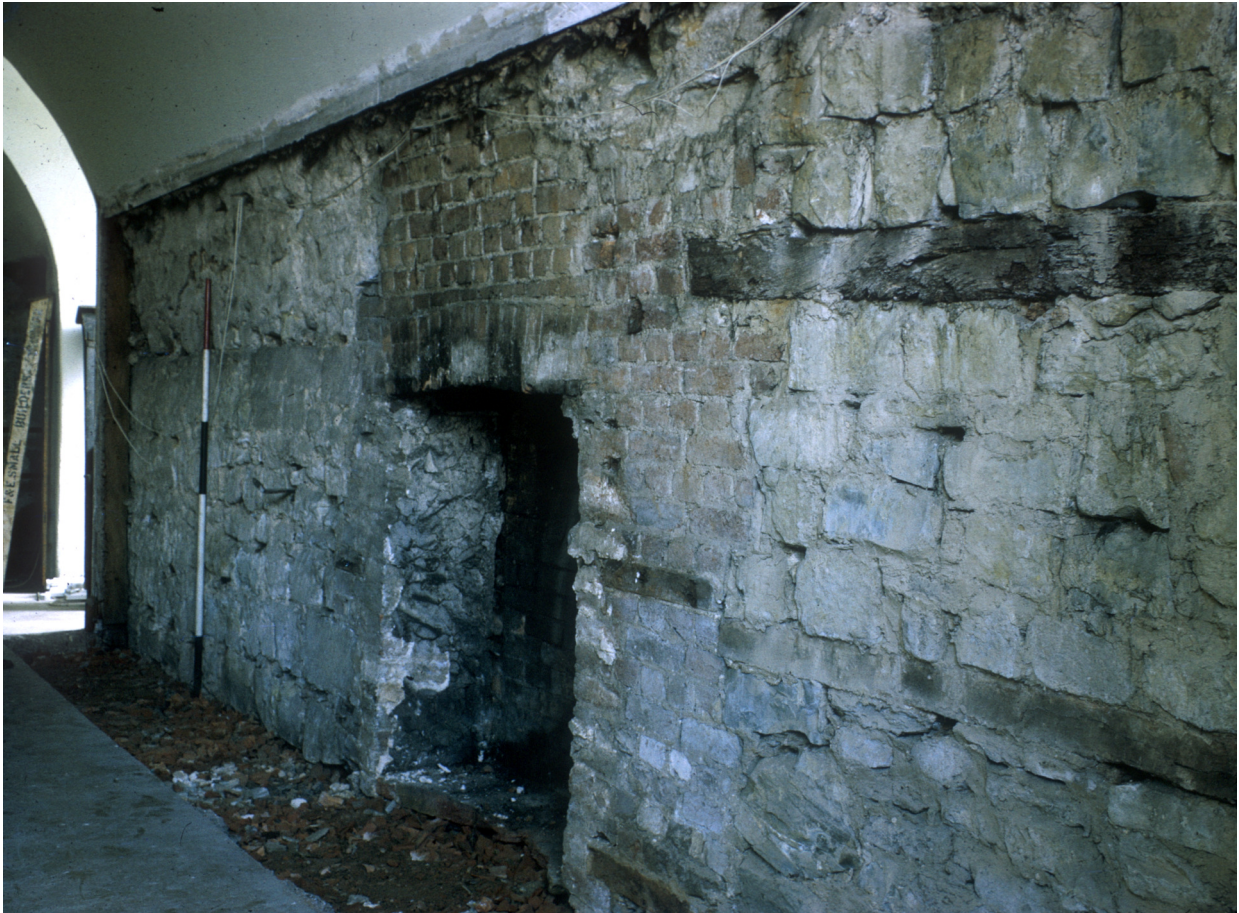
*Figure 10.4: The interior west wall of the Undercroft in 1969. Door 57 is to the far left with Fireplace 238 central. Scale 6 feet (1.8m). Somerset HER image 29806.*

The west wall also contains two fireplaces in the thickened wall. The northern (358) has been inserted with brickwork above and to the north (HER image 29806, Figure 10.4 on the preceding page) and probably post-dates Hammet as no chimney is shown on SANHS 3535 (Figure 2.2 on page 31). The extent of the brickwork suggests that it may have replaced an earlier larger fireplace.

The west wall (Figure 10.4 on page 192) appears identical to the east wall, south of Fireplace 238, but to the north lacks the backward slope and incorporates horizontal timbers to support wooden panelling. Smaller pieces of timber are also incorporated in the brickwork around the fireplace on this side. The incorporation of timbers is seen in Hammet's work in the south range, although there in brick, and may be associated with the insertion of Window 56. Another photograph (HER image 29808) shows timber embedded in brickwork in the adjacent north wall. Spencer's 1875 plan calls this a Dining Room in 1875 so it was probably well-appointed. The floor is shown in the photographs as having a central concrete area with gaps along the edges, presumably where display cases have been removed. This concrete was probably laid in 1952/3 and excavation in 2009 and early photographs indicate a suspended timber floor before this. No signs of medieval floor levels were encountered.

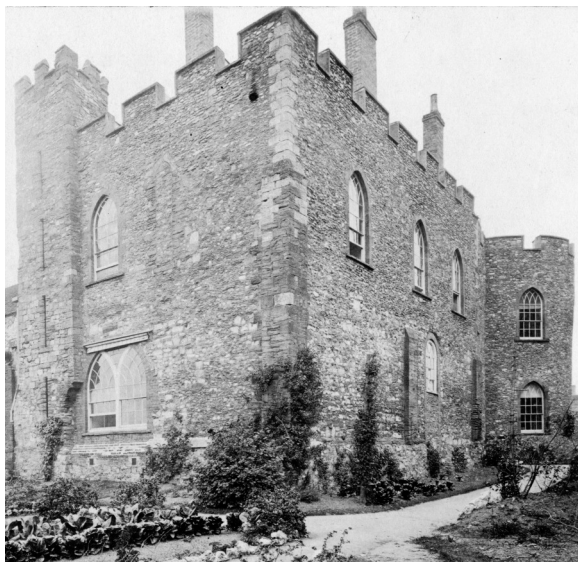
*Figure 10.3: The West Range c.1865–70 showing upper windows before the restorations of 1880. SRO A/BAV/18/5*

At the north-east corner of the West Range is a circular stairway in a turret that projects slightly from the north wall. The upper part of this is vertical but at the bottom it is staggered eastwards by means of moulded corbels for no evident reason (see Figure 10.3 on page 192). The area has now been disturbed by the insertion of Window 56 by Hammet. The stair is entered on the ground floor by a short passage from the Great Hall (see page 168) and leads to the Somerset Room and then to the roof of the west range. The top of the tower was rebuilt in 1953 following structural problems (SANHS Office file C6). Five metres above the ground floor level is a blocked doorway (172, Figure 10.6, Figure 10.2 on page 191) which appears to have led onto the north wall of the Great Hall in Phase 2 but the irregular coursing of the masonry conversely suggests that the doorway is an insertion into the stairwell, probably reused from elsewhere. Low on the south jamb is a neat carving comprising the letters AA and a cross within a truncated triangular surround (Figure 10.7). There are traces of paint on the letters and cross and this together with the neatness and position might suggest that the engraving is associated with the masonry work rather than being graffiti, of which there is plenty in the upper parts of the stair.

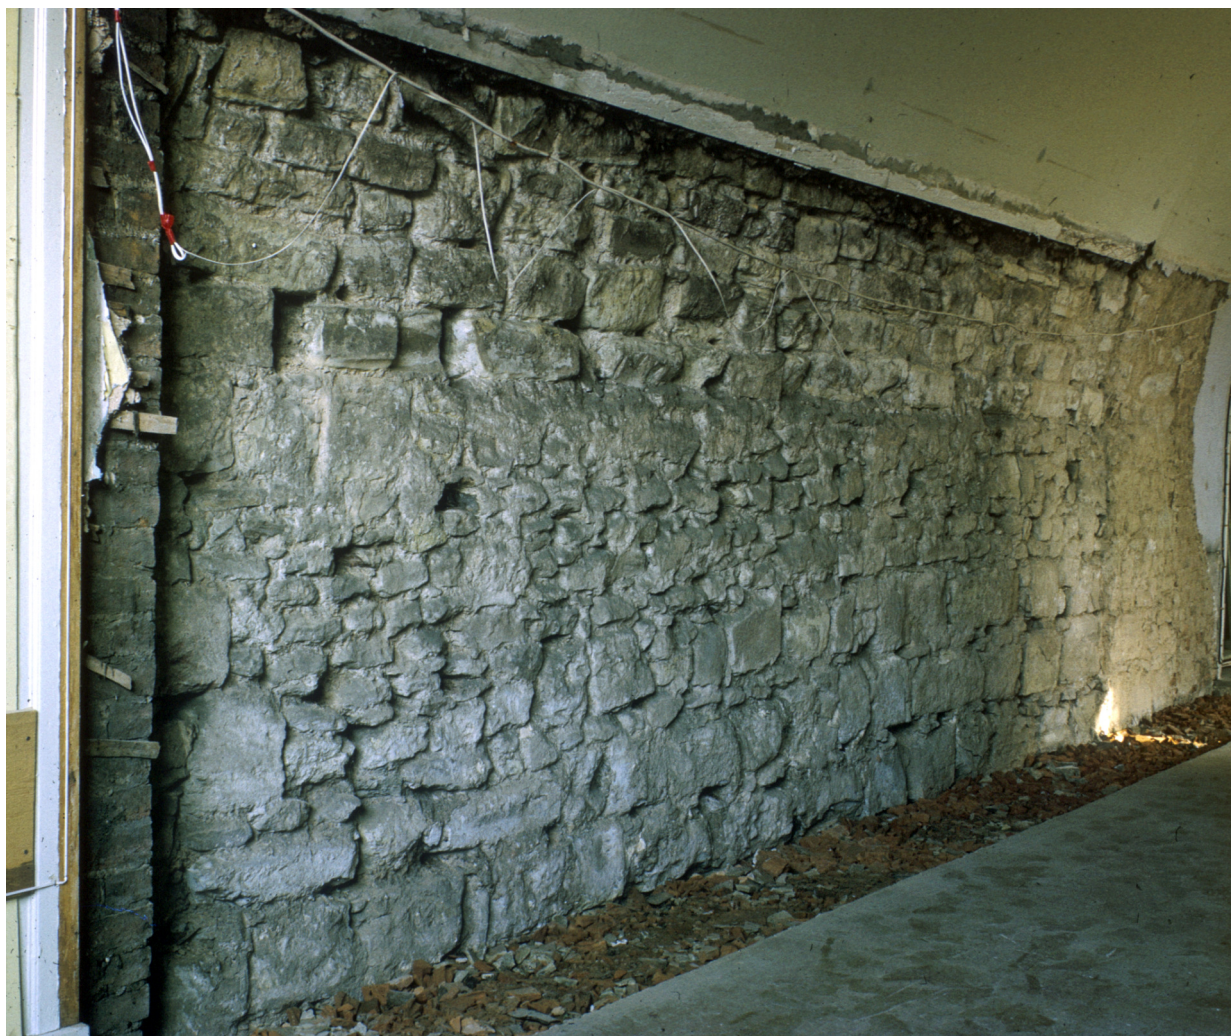
*Figure 10.5: The interior east wall of the Undercroft in 1969. Door 60 is to the far right and the brick surround to Door 236 is visible to the left. Somerset HER image 29807.*

The door (253) into the Great Hall is discussed on page 167 and brickwork visible in a photograph taken in 1969 before plastering (HER image 29807, Figure 10.5 on the facing page) supports the attribution to Hammet. The corresponding door (60) at the south end of the wall is more complex. It is not clear if there was ever a medieval door here but there was one in 1875, narrowed by a partial blocking on the south side. On the north side there was a wide splay, which survives, and there is evidence that the splay was originally wider, as part of the Great Hall wall is cut away on the diagonal (shown in Figure 5.3 on page 69) and in the Undercroft, the photograph (HER image 29807) shows a large, different area of masonry at this end. If not medieval this door

It was not possible to examine the walls in 2009 but photographs in the Somerset HER show them without plaster. The east wall (Figure 10.5 on the previous page) is built of large blocks of lias irregularly coursed, similar to those seen and described by Radford and Hallam (1953, 60) on the other side of the wall in the Great Hall. There is a change in the masonry about 1.5m up where it appears to slope back before the arch of the barrel vault begins. This might indicate the cutting back of the wall to insert the vault but it is also visible in the thickened west wall which is, presumably, the same build as the vault. At the south end and area of different masonry is visible, with smaller stones, browner mortar and without the backward slope. As mentioned above this may represent a wider Door 160 but the join appears to continue vertically up the barrel vault with no sign of an arch over the doorway.

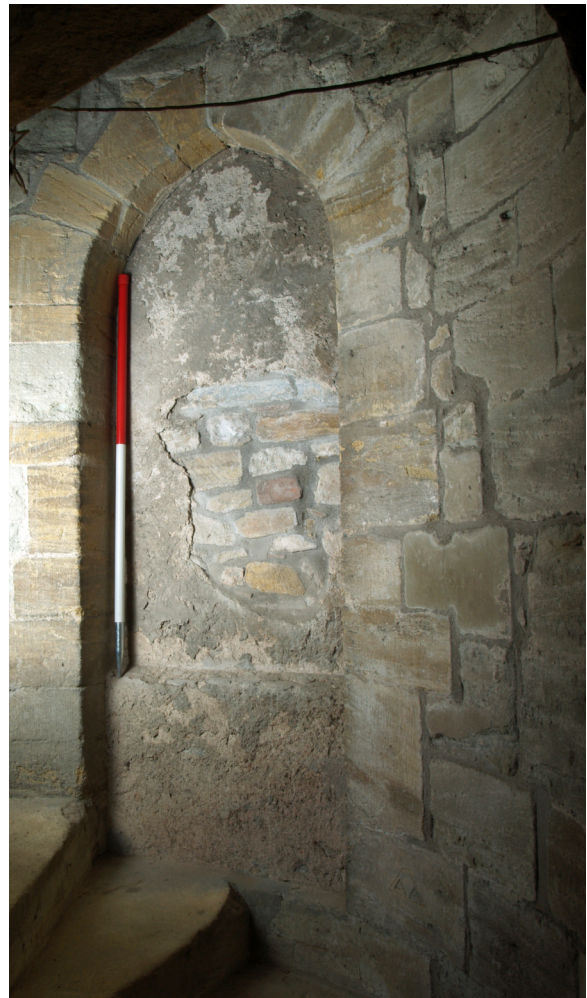
*Figure 10.6: Door 172. The AA carving is on the lowest right quoin. Scale 1m.*

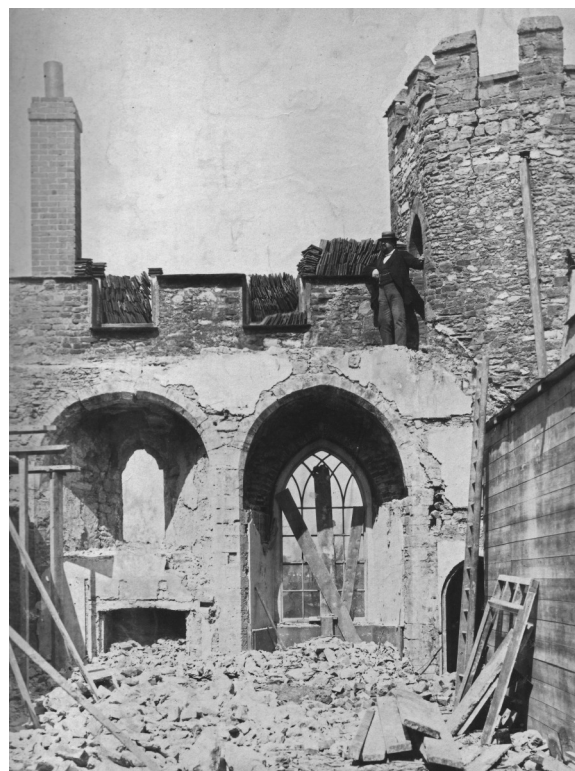
*Figure 10.8: The north end of the Somerset Room in 1884 when the roof was being replaced and the windows altered. The figure is William Bidgood, the curator (1862–1900). SANHS 12556.*

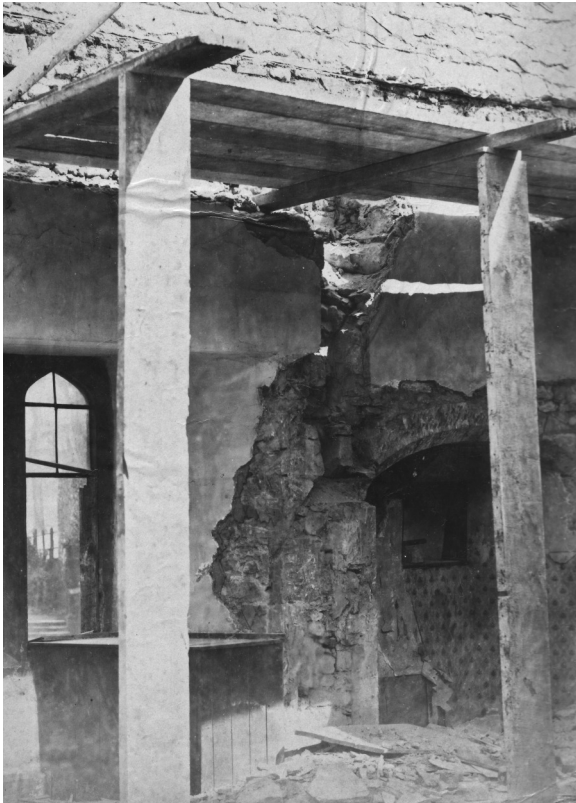
*Figure 10.9: Windows 117 and 118 in 1884. The edge of the 13th-century Window 118 is just visible in the centre. SANHS 12557.*

The next window (220) was discovered and partially unblocked in 1952, although one jamb of the outside was still visible buried in the wall (Figure 10.2 on page 191); the rest was cut away by Window 118. This had also almost completely replaced another early window, a fragment of the south edge is just visible in Figure 10.9.

Window 117 at the southern end appears to have been restored, probably in 1884 (Figure 10.9); its external coursing does not match that of Window 220, it appears in the photograph as a wallpapered alcove, and is described as “where the old water closet was” in Surtees’ letter. Spencer’s plan of 1875 shows the WC with some form of window in the alcove.

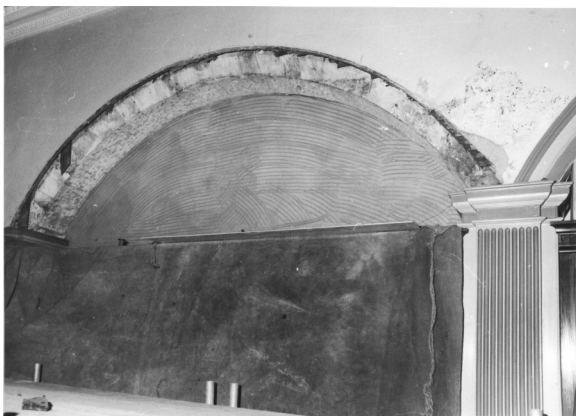
*Figure 11.4: The blind arcading in the Adam Library during repairs, probably in the 1970s. SANHS Hawtin 2.*

stone (possibly tufa, not seen elsewhere in the castle) mixed with some Hamstone. An area of Hamstone below the west end of 414 may mark the side of the window. To the west a further relieving arch (415) seems to be a smaller span over a predecessor to Window 116. The presence of the relieving arches suggests that the windows themselves had flat tops, and therefore were not those of the 13th-century chapel. The rear wall of the arcade appears to be brick but was only seen at the lowest level when skirting boards were removed. The wall next to Door 120 was seen to be brick from floor to ceiling. A photograph taken during earlier repairs shows that the round arches have chamfered, ashlar quoins behind the wooden mouldings with the soffits pecked for plaster (Figure 11.4). They also show that this wall is lined with lath and plaster in the same way as the east wall.

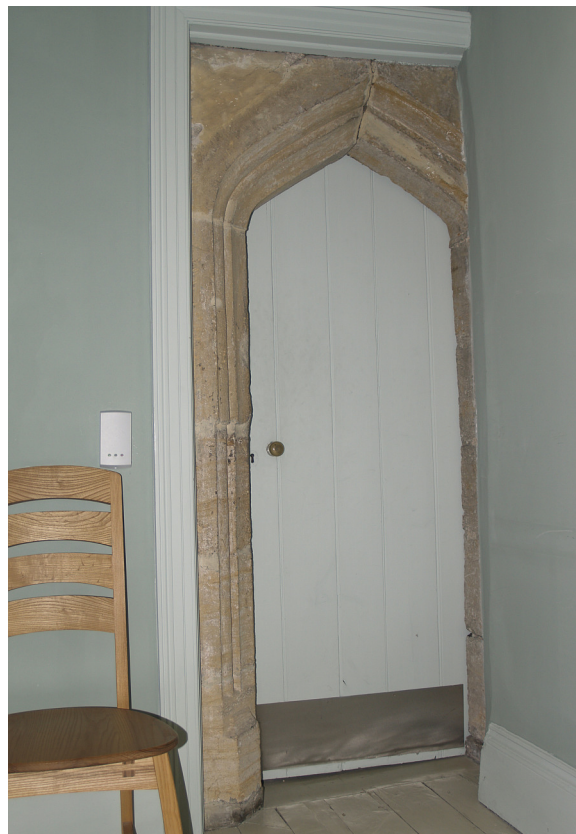
*Figure 11.5: Door 248 at the south-east corner of the Adam Library.*

The east wall can be seen from the outside (Figure 11.1 on page 200) to have formed the end wall of the building and probably contained the east window of the chapel. It is now pierced by a small door (248, Figure 11.5) at the south end leading to a passage (Room 124) partly cut into the curtain wall. Radford (1954, 17) dated the doorway to the 15th-century on stylistic grounds and suggested that it led to the sacristy. Spencer's plan of 1875 shows the passage blocked at the west end forming a "closet" in the next room (Room 125). Limited examination when the plaster was being chased for cables in 2009 showed the ends of laths that would have continued the wall line across the doorway. The laths were supported by battens fixed to a plastered stone wall that aligned with the stone door frame. The lath and plaster aligned with, and is probably contemporary to, the Adam-style fireplace. The moulded frame on the south side of the doorway is buried in the south wall which has been cut back by 20cm to reach the opening suggesting some severe constraint to its location, possibly the chapel east window, to the north. It is not clear, however, where the doorway originally led as it will be suggested below that Room 125 was a late addition after the east window of the chapel had gone out of use.

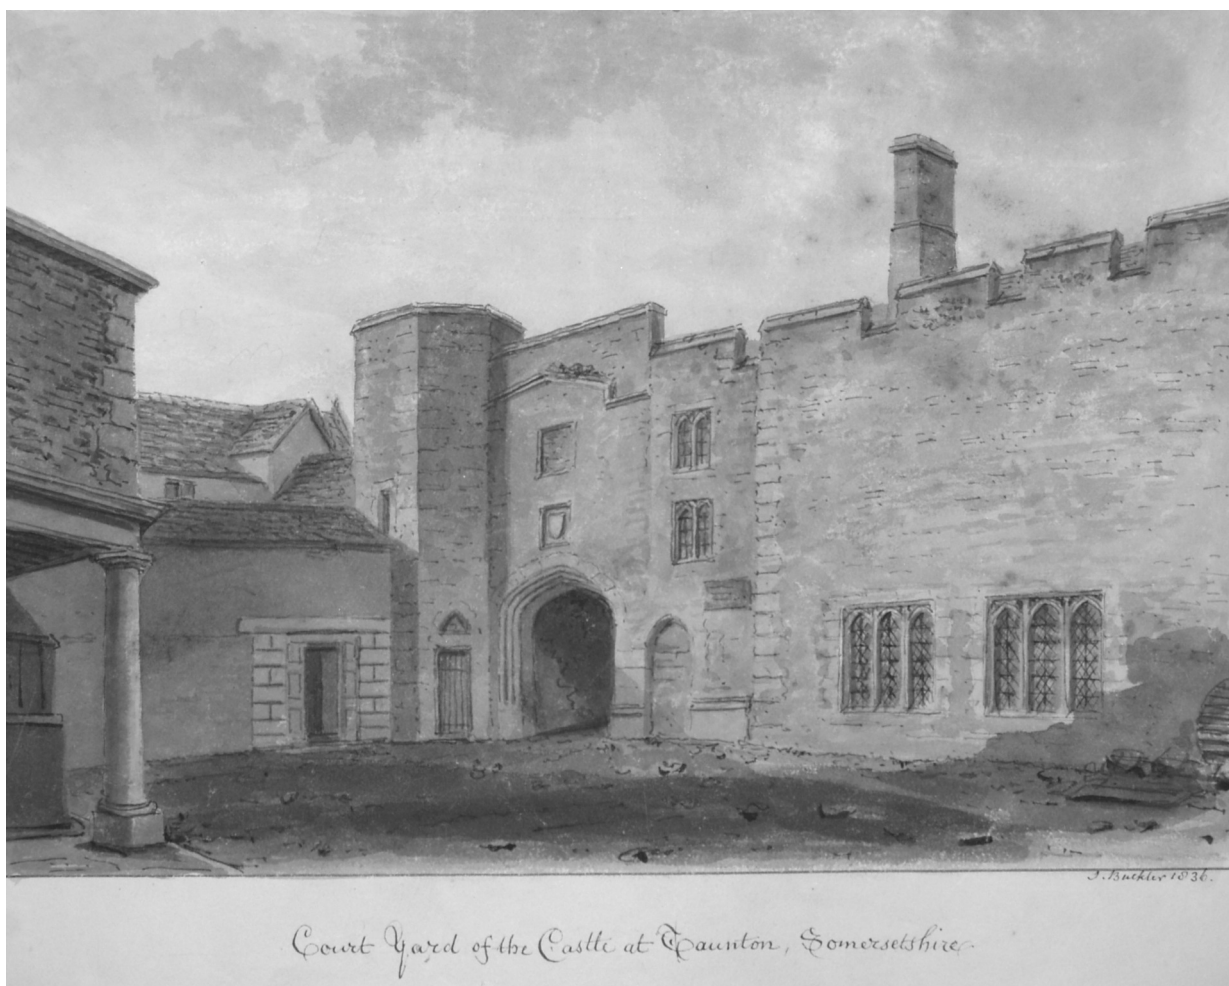
**Figure 12.2:** Buckler's 1836 drawing of the courtyard. On the left is the corner of the Grand Jury Room before the wooden columns were replaced by brickwork. Note that Buckler mistakenly shows the stair turret as octagonal (SANHS Buckler B).

1836 (Figure 12.2) with a pitched roof, evidently covering a building behind. A similar situation is seen in an undated sketch (SANHS Braikenridge Taunton 38) where the roof is clearly seen crossing a window in the stair turret.

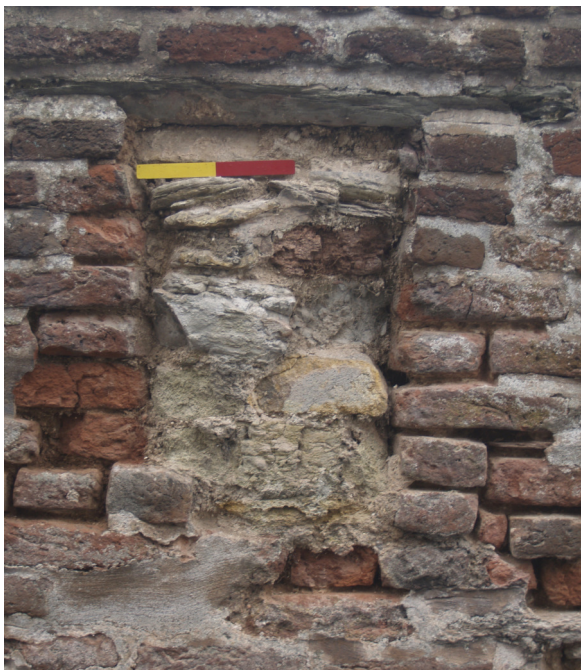
**Figure 12.3:** Loophole 468 in Driveway Wall after removal of cement pointing. Scale 20cm.

The southern end (471/472, Figure 12.4 on the preceding page) is coped with large, triangular-section, Hamstone blocks and within the wall are three, or possibly four, four blocked openings (466–469), only visible on the west side, each about 0.35m wide and 0.5m high (Figure 12.3). The openings seem too small and low down for windows and would appear to be loopholes. They would not have been useful for defending the inner castle gate and they may be a Civil War addition, providing fire across Castle Green against an attack from the west. The gatepier is not contemporary with the brick wall, so the wall may originally have extended further perhaps forming a barricade across Castle Bow. If this interpretation is correct, it may say something about the state, or possible non-existence of the West Gate (see page 238) at the time. Against this interpretation is the evidence of SANHS 3504 (Figure 2.1 on page 28), which shows the area open in 1773. However, the perspective of the drawing is wrong in several ways and it is likely that wall and moat are foreshortened, their true dimensions being shown on early 19th-century plans, such as Carver's of 1832 (SRO Q/AC/3).

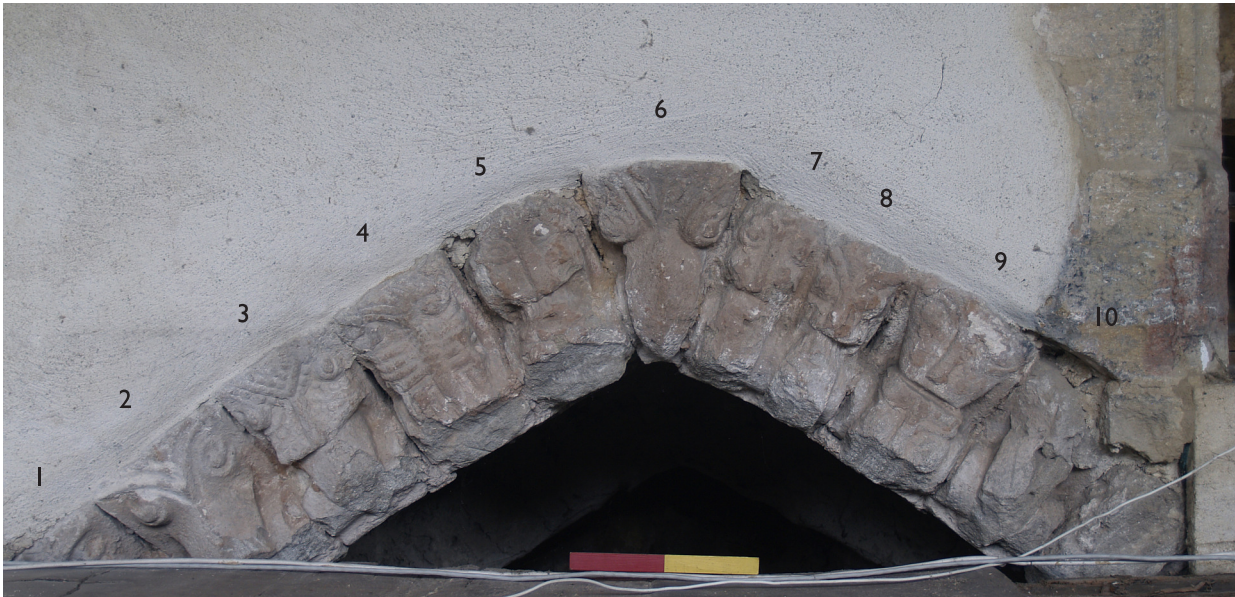
Figure 13.3: The beakhead arch (421) in Room 118. Scale 20cm. TCB10-64.

(SANHS 6095, which shows the fireplace at its present size). Considering the discoveries that must have been exposed at the time (the fireplace, roof structure, wall painting and beakhead arch) it seems astonishing that no record of this work has been found. There is a brief mention by Wood (1965, 267), who refers to the fireplace with its paintings, describing them as “recently discovered”. Unfortunately she gives no source for the information except to acknowledge the help given by “the late Mr AW Vivian-Neal and Mr RC Sansome and his colleagues at Taunton Castle” for “much kind assistance over the Somerset houses” (Wood 1965, xxx).

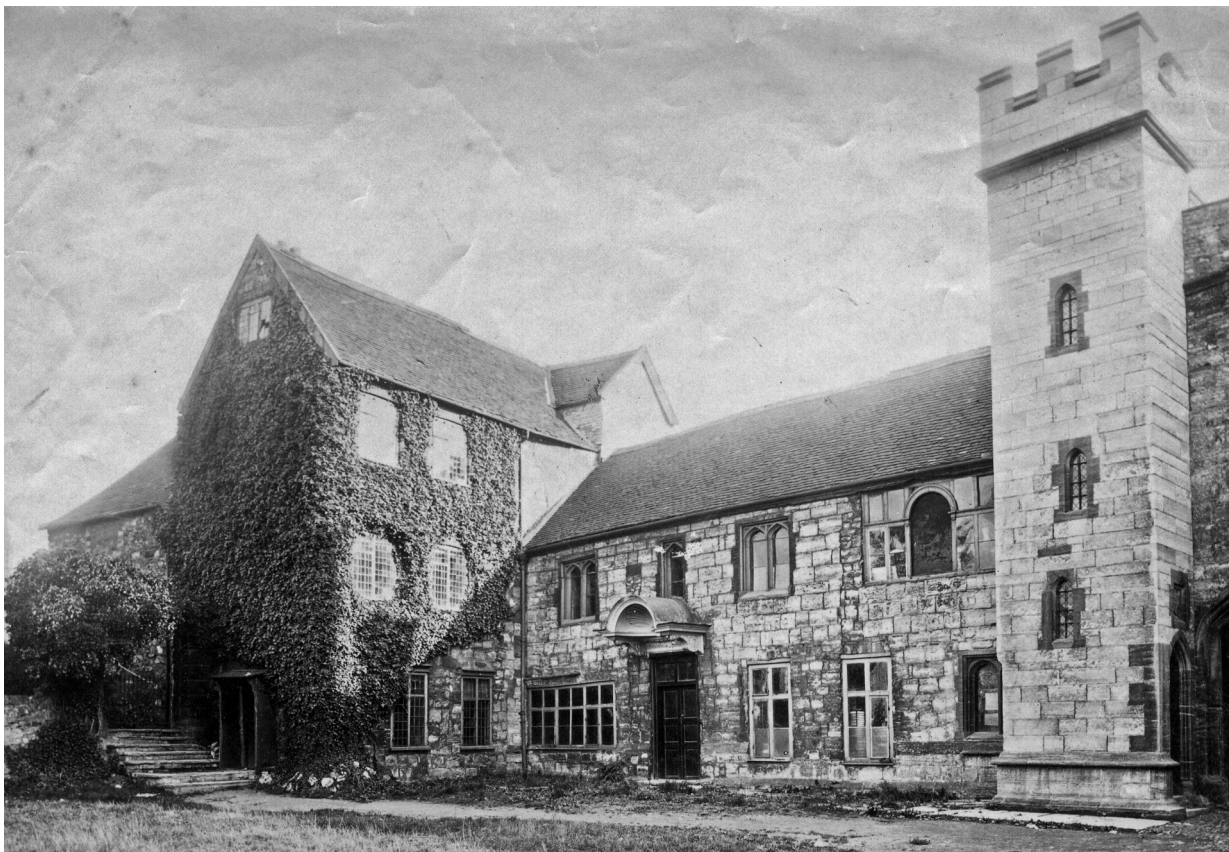
*Figure 13.5: Castle House in 1895. SANHS 12511.*

carried out at the same time to match the new windows but SANHS 6095 shows the window seat in Window 122 as existing and there are no indications of any other planned changes. Early photographs of the outside (see Figure 13.5) show that the position of Windows 120 and 121 was previously occupied by a single large window glazed in Venetian style.

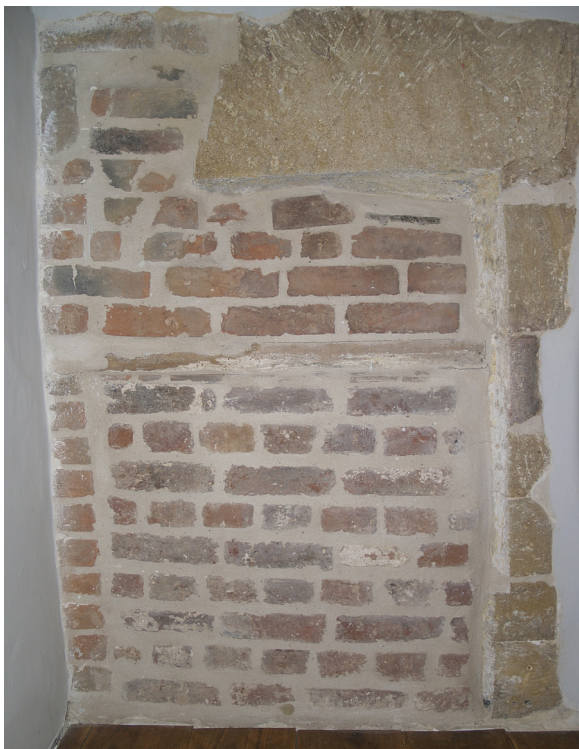
*Figure 13.7: Fireplace 416 after discovery and repairs.*

The south wall is the curtain wall and contains a fireplace (416, Figure 13.7) partly uncovered in 2010. The west side and lintel were hollow-chamfered but the east side had been removed by the thinning of the wall for the stairwell. As there is no evidence of fireplaces in the west part of the 1482 lodging block it is assumed that this one must be later, perhaps mid–late 16th century (Thorp and Cox 2013, 85).

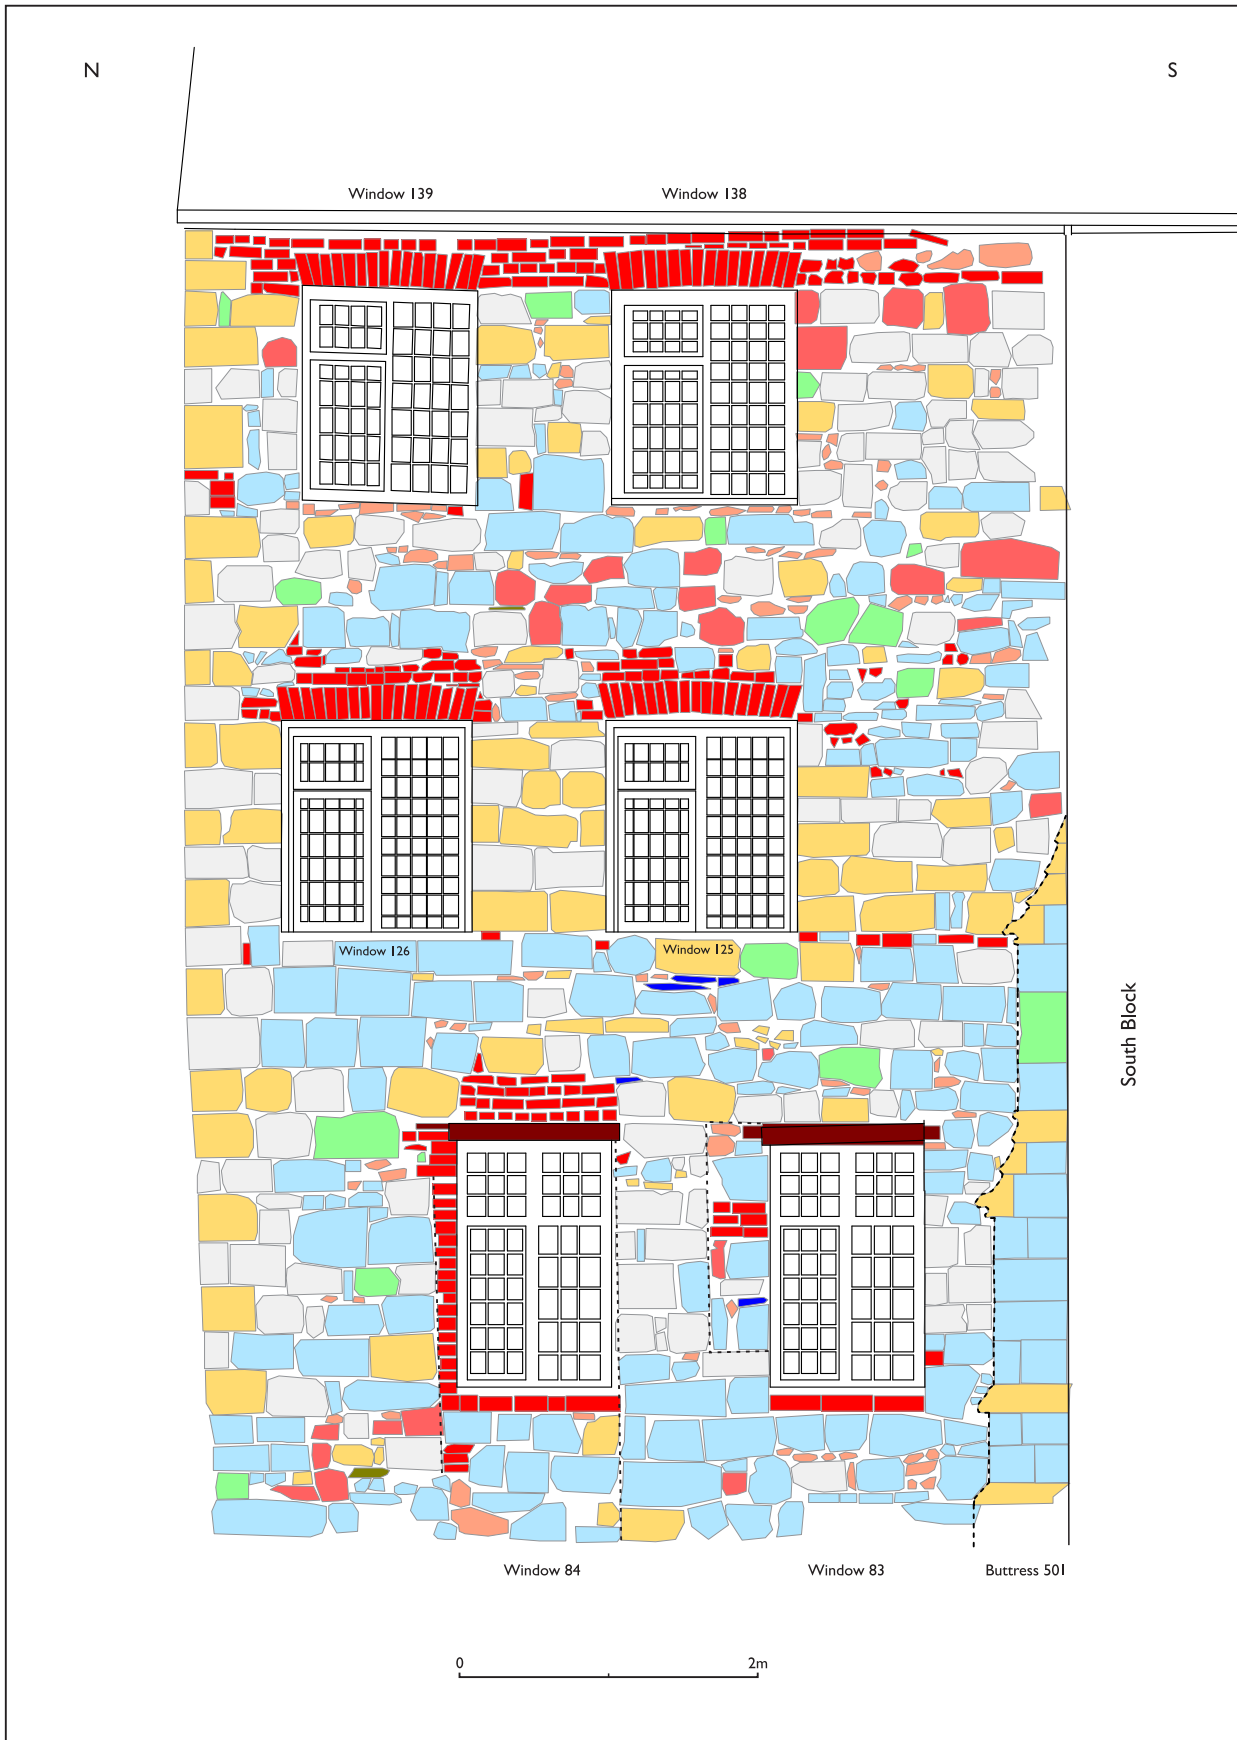
Figure 13.8: Exterior elevation of the west wall of the East Wing of Castle House. Details of Buttness 501 taken from Spencer (1910, Fig. 12). See Figure 3 on page 4 for key to colours.

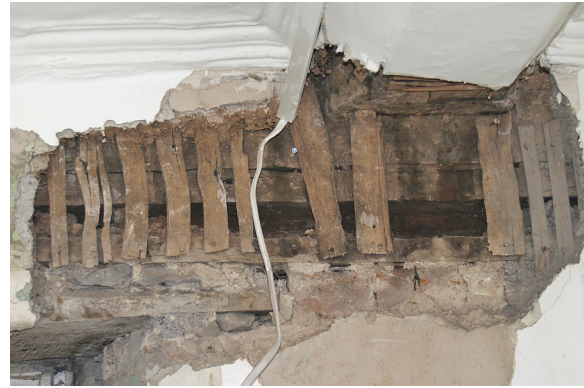
*Figure 13.9: Timber, probably a principal rafter from Frame 8 of the 1482 roof showing the mortise from an arch brace, reused to form a pad for a ceiling beam in Room 110. TCB10-43.*

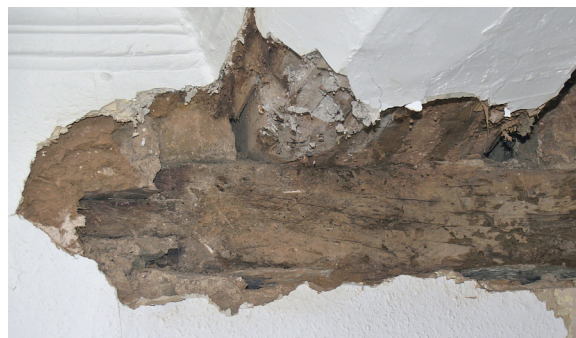
*Figure 13.10: Timber, probably from Frame 8 of the 1482 roof with a tenon for an angled joint to the left, reused to form a pad for a ceiling beam in Room 113. TCB10-41.*

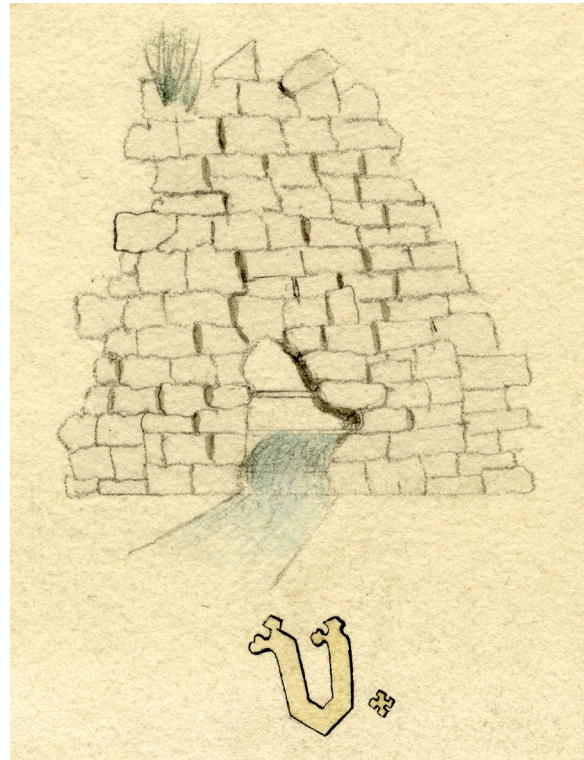
**Figure 14.1:** Liversedge’s 1853 drawing of the masonry at the south-west corner of the outer ward. SANHS 3516.

Warre (1853, 26) mentions a “mass of masonry” at the south-west corner of the outer ward and it is shown on his plan running roughly east-west with its west end touching the stream which follows the line of the moat. The key identifies this as “Mass of masonry in Mr Channon’s garden.” It appears identically on Liversedge’s original plan, which formed the basis of the engraving. No further description is given but one of Liversedge’s elevation drawings (Figure 14.1) shows it as a much-ruined piece of walling with an irregular hole through which water is flowing. The hole is either barred or has steps within. From the positioning of the number “v” on the plan it is likely that this view is from the south but it is not clear what exactly is being shown. There is no indication of the moat by the end of the wall nor any indication on the plan of the water coming out of the hole.

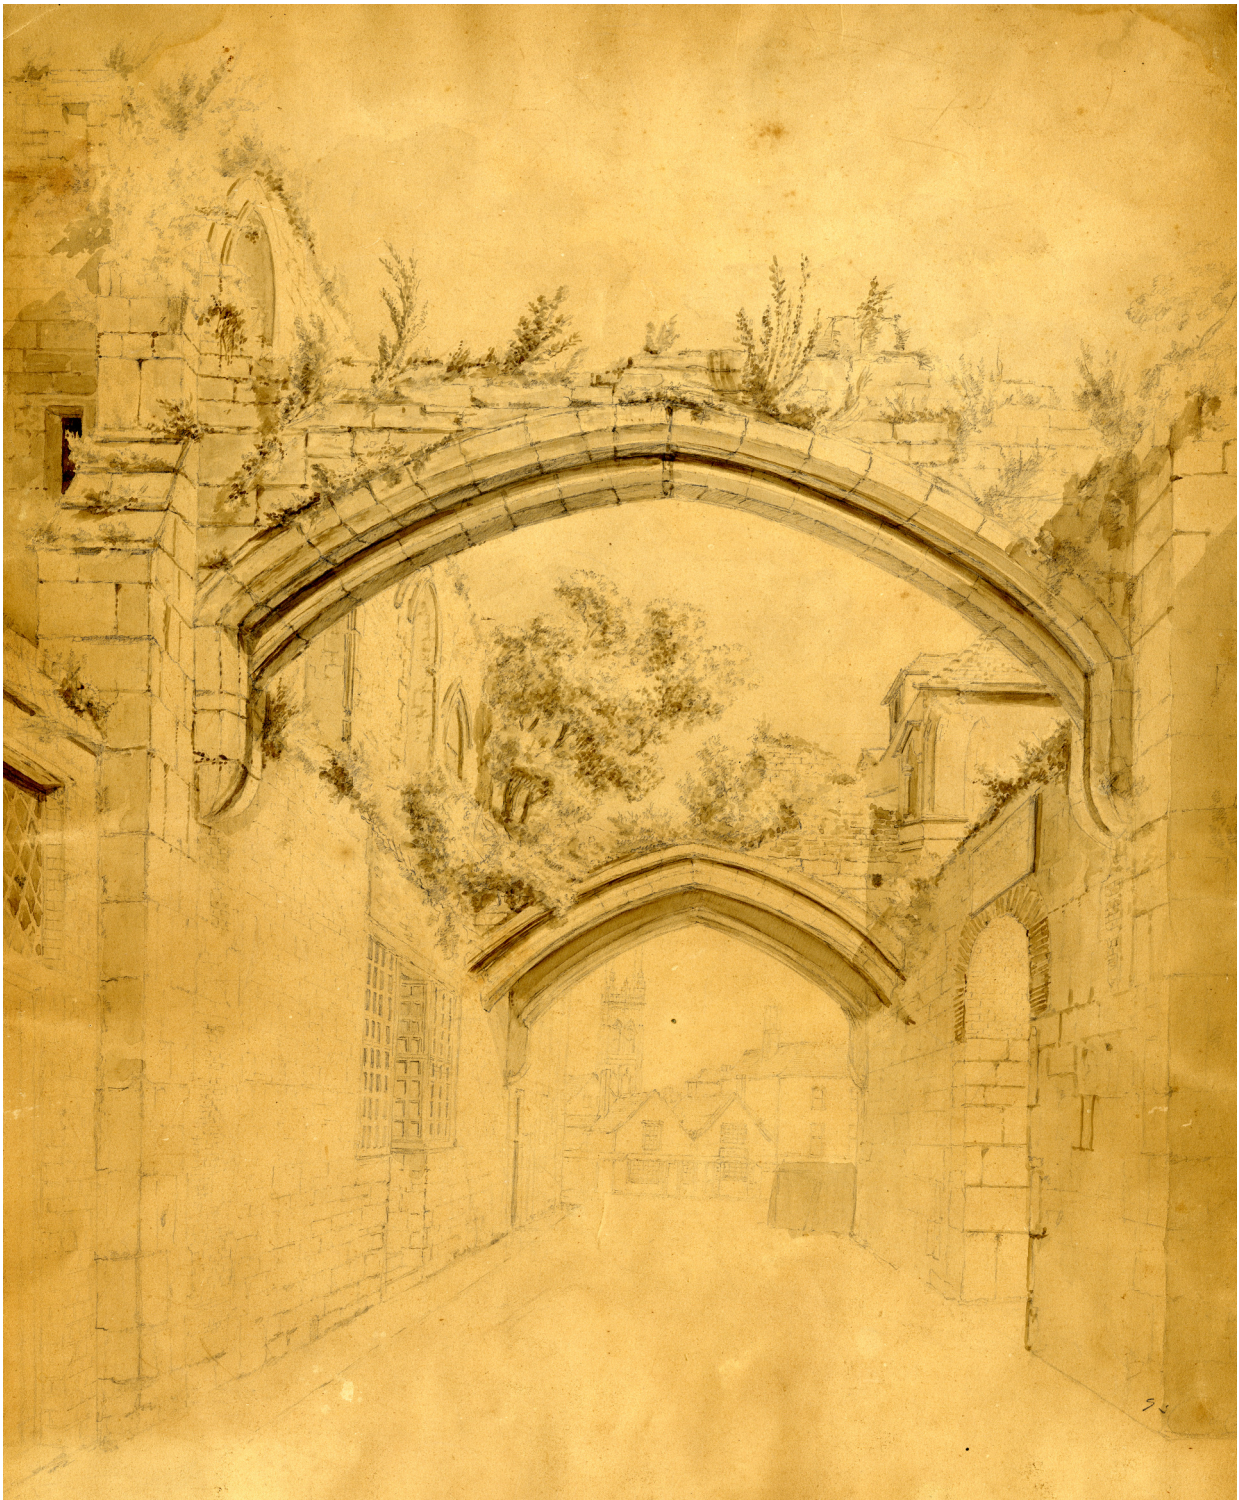
*Figure 15.2: Castle Bow from the west in the late 18th or early 19th century. Door 451 is visible on the right with the remains of Window 462 and the suggested piscina (463) above. The head of Door 458 is visible above the arch to the left and Windows 459 and 460, with the suggested aumbry (461) can be seen through the arch. SANHS 3511*

The present gate passage is 12.8m long with substantial arches at either end. Both are plain, shallow pointed arches with a simple chamfer and both have a substantial flat rib, again chamfered, occupying the central third of the soffit. Behind the eastern arch is the groove for the port-cullis noted by Toulmin, and behind that is a further arch, facing east, with a rebate for the gate visible on the rear (west). The jambs of this arch have been removed, although a hinge pintle survives. It is likely that all the archways have been widened in this way. There is then a gap, with a flat ceiling, before another arch of the same type as those at the east and west ends. The arches appear to have undergone few changes since being drawn in SANHS 3511 (Figure 15.2 on page 245), although obviously the upper floors have been added.

The north wall of the gate passage is now pierced by two doors (455 and 457) and two windows (454 and 456, the latter originally a door) all built as part of the hotel as they are not shown in SANHS 3511. That drawing appears to show a single door, containing steps up, with windows to either side that continue into the doorway, reminiscent of a shop front. Above is a tile-covered offset that would have supported a floor or vault. There is no sign of the

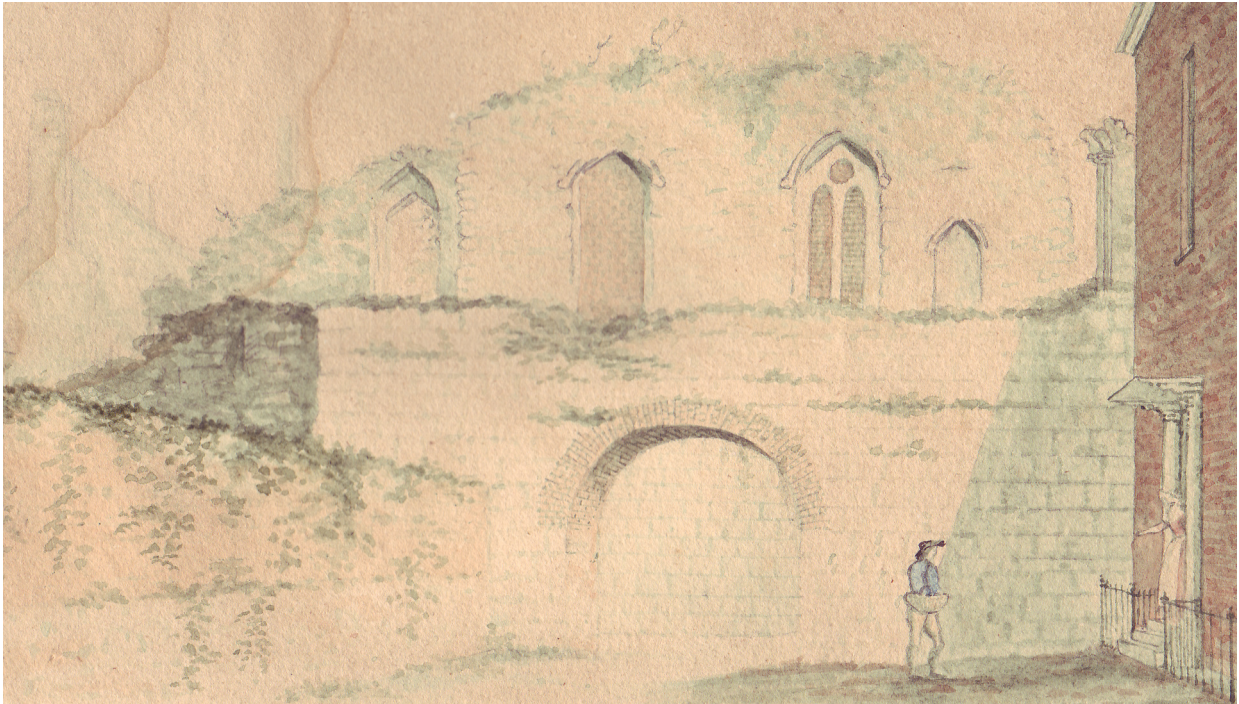
**Figure 15.3:** Castle Bow from the south in 1796. The wide opening on the ground floor is Door 451, and those on the rear wall of the upper floor are 458–461. The remains of Window 462 are at the extreme right. Detail of SANHS 12494.

outside in SANHS 12494 where the moulding has the appearance of attached columns; this is not shown in SANHS 3511 but this area appears incompletely drawn. Beyond this, within the wall is a smaller opening, with columns forming either side and a trefoil head (463). The interior is shown in shadow, suggesting a niche rather than a window. Unfortunately the area is obscured by another building in SANHS 12494 so this cannot be confirmed but a niche in this position would suggest a piscina, and thus that the room over the gate was a chapel. This would be a not uncommon position for a chapel and there are mentions of a chapel somewhere around the East Gate in the pipe rolls (see page 15).

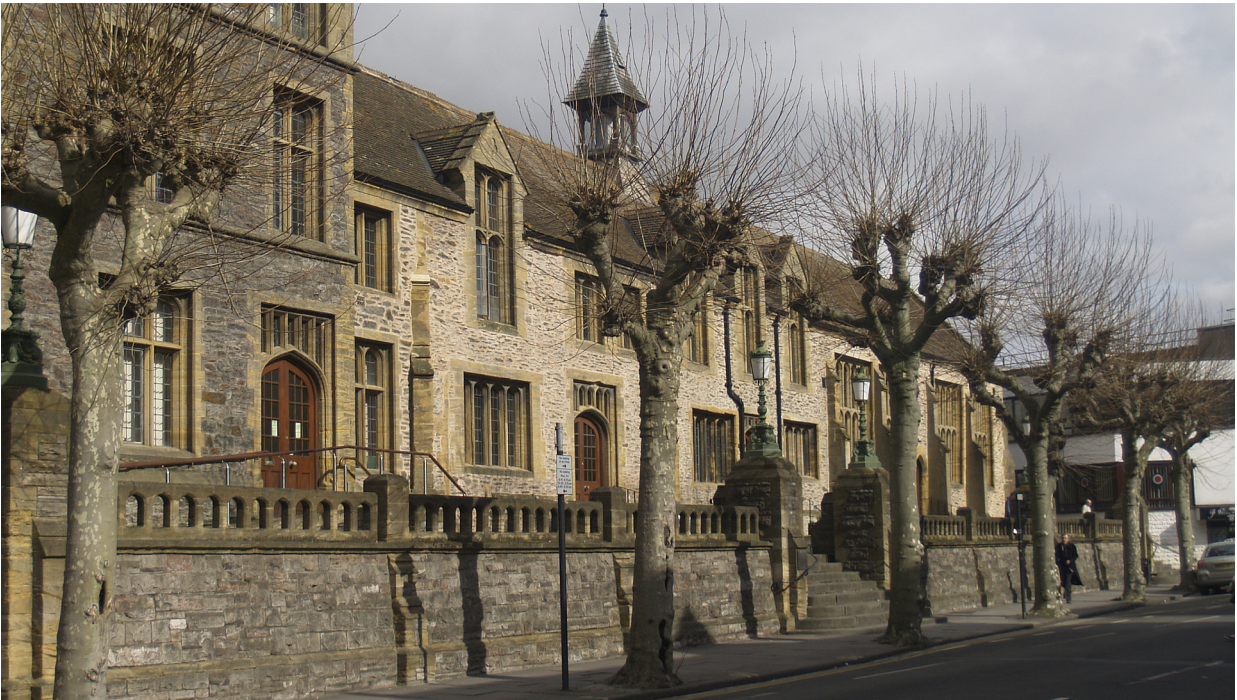
*Figure 16.2: View of the south side of the Grammar School in 2015 with the buttress (515) marking the original west end centre left.*

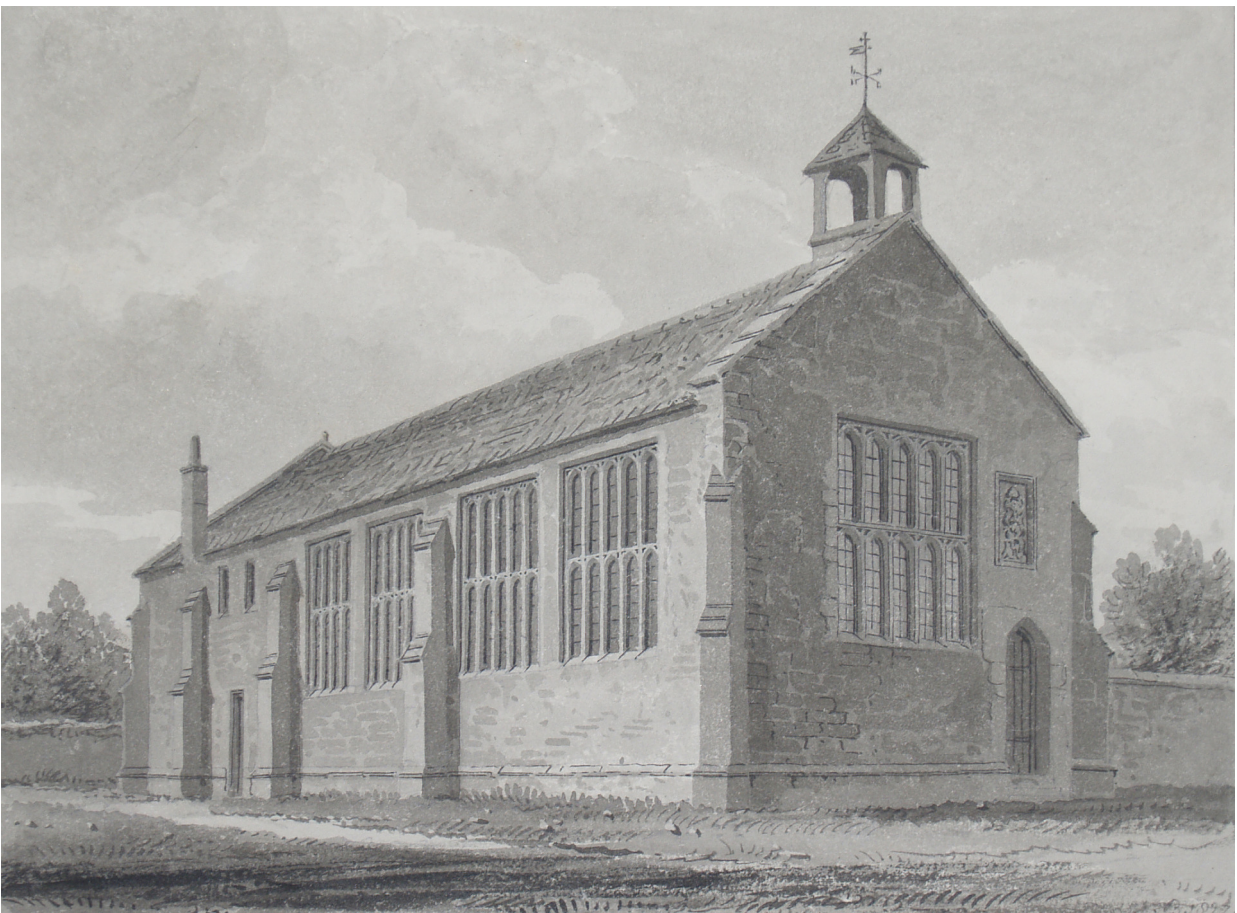
*Figure 16.3: Buckler's view of the Grammar School dated 1837. The view is idealised at the far end where the two western bays are foreshortened and simplified. SANHS Buckler C.*

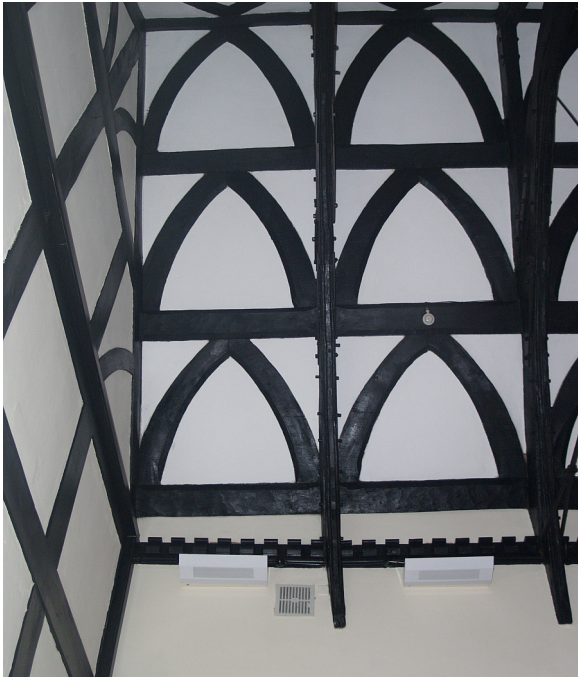
*Figure 16.5: Detail of the westernmost bays on the north side of the schoolroom with the facsimile Truss 12 to the left.*

In each bay, on both sides of the roof, are three levels of purlins, a moulded and decorated wall plate with a brattished or battlemented cornice and a ridge tree. The purlins and the ridge are linked by three tiers of flat, chamfered wind braces, making an exceptionally rich display (Figure 16.5 on page 254). Details of individual trusses and bays are given in Parker (2014).
