# Taunton Castle

By Chris J Webster

Somerset Archaeological and Natural History Society

Taunton, 2016

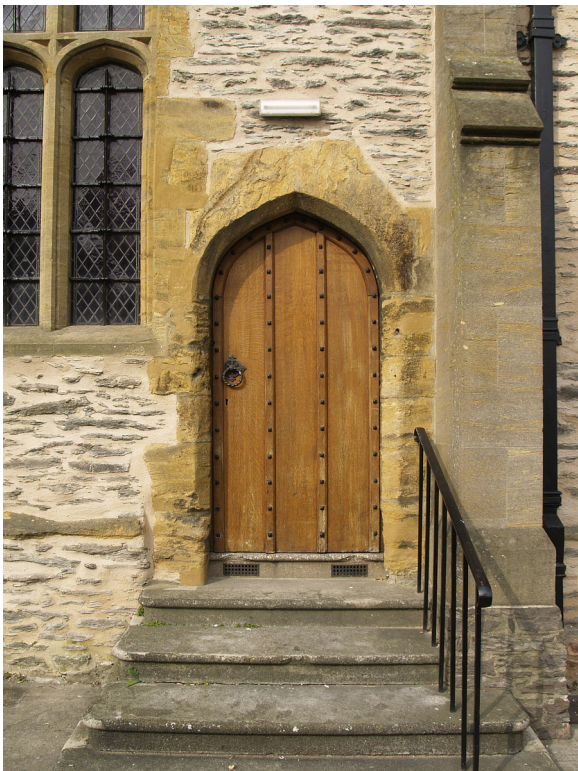
*Figure 16.6: Door 512, the south entrance to the schoolroom, showing the reduced ground level and modern buttress.*

The school was originally *c.*40.8m long by *c.*7.9 wide externally (possibly 8 by 1.5 perches) with diagonal buttresses at the corners. The walls are made of Morte slate rubble with Hamstone details. The building has been extended to the west, destroying the north-west corner, but the original extent is indicated by a buttress (515) half buried in the wall. There are three further buttresses along the south front with two later (post-1863) ones added on the eastern part. The stonework of the buttresses and the cill levels of the doors shows that the ground has been lowered substantially (0.75m at the eastern end), possibly quite recently as the ashlar of the modern buttresses also fails to reach the current ground level (see Figure 16.6 on page 254).

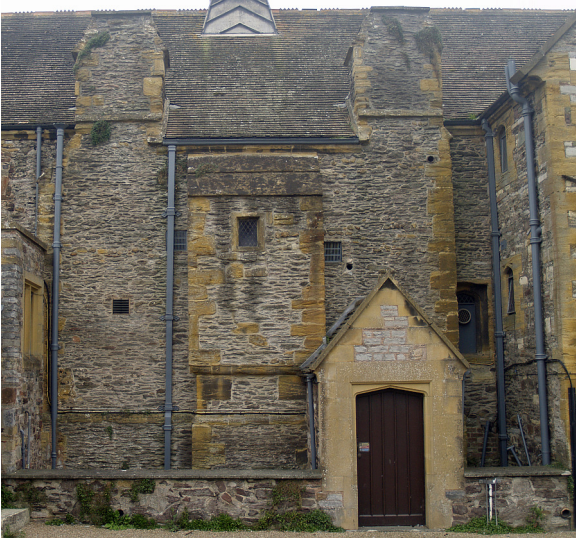
*Figure 16.7: The stair and chimney block on the north side of the school. The porch was added over the steps to the cellar in 1931.*

The stair lies in a substantial projection of the north wall flanked by a pair of chimneys (Figure 16.7). The eastern chimney has two offsets, one below eaves level and the other above, and appears to have served two fireplaces; one on the ground floor in Room 403

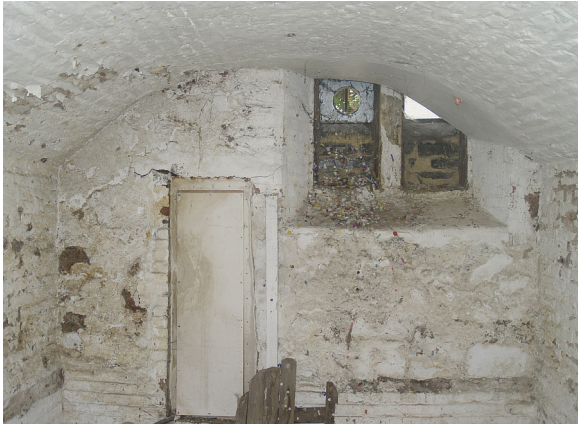
*Figure 16.8: The south wall of the cellar with the half-blocked window and access to service pipe.*

There is a cellar below the eastern half of Room 405 that extends part way below the entrance passage (Room 404). The date of this is uncertain but the entrance is shown on the 1821 plan and it may be an early feature. Internally (Figure 16.8) the cellar is brick with a transverse brick vault over, all heavily painted. There is a window in the south wall that is now partly buried by the paved surface outside and adjacent to that on the east is an inserted door that leads to a large diameter ceramic drain holding the electricity supply. The doorway is lined with larger bricks than the walls of the cellar and these

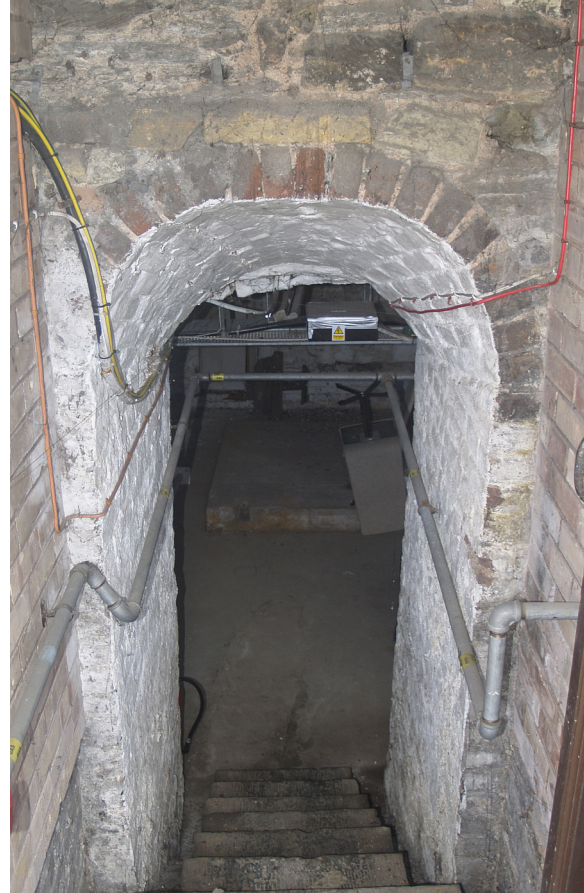
*Figure 16.9: The entrance to the cellar within the 1931 porch.*

appear to also be evident around the base of the wall indicating that the floor has been lowered. The original entrance to the cellar (Figure 16.9) appears to have been cut through the wall: the brick arch has been flattened to fit beneath the Hamstone plinth course.

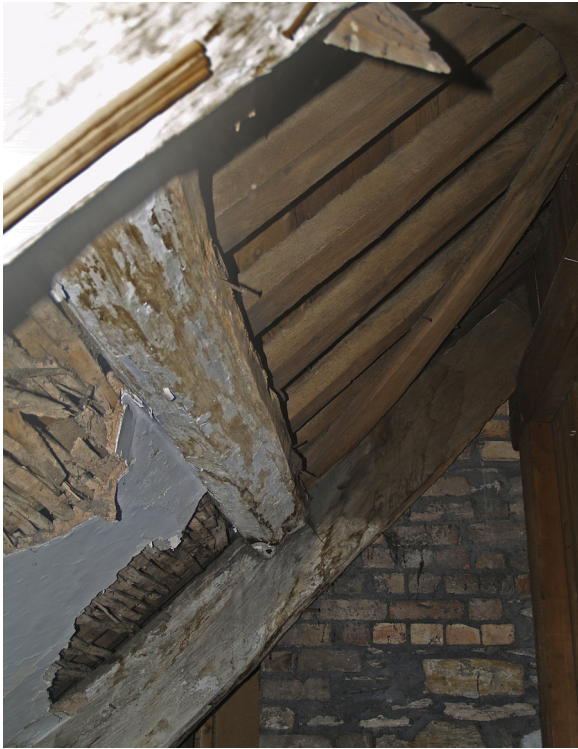
*Figure 16.10: The upper part of the southern side of Truss 24 at the extreme west end of the school roof. Lath and plaster ceilings can be seen below the purlin, and windbraces with clean timber above.*

Upstairs, the end two bays of the roof have suffered the most from alterations but can be seen to be wider than all those to the east. New floor levels have been inserted just below the level of the middle purlins and consequently the lower parts of the roof are entirely concealed. The surviving parts of the trusses, on the south side, show evidence of the collars and arch braces, and retain some wind braces (Figure 16.10 on the next page). The trusses also bear scars of whitewash

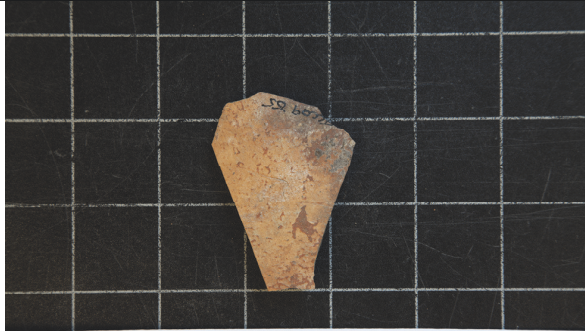
<p>Type TC unclassified, context 09/755: CSM Lab code C05120010.</p>	
(Grid = 3 x 3 cm)			
<b>Fabric description</b>		<b>Mineralogical description</b>	
<p>Fairly hard-fired reduced and reoxidised red earthenware with light grey zone of reduction below inner surface and reoxidised orange buff, outer surface has eroded leaving patches of hard dark red sandy patches; fine granular structure with specks of white and occasional iron-rich particles; olive green lead-glaze with occasional speckles of reduced iron rusty brown</p>		<p>The sherd has 93 vol% matrix and 3 vol% inclusions. The inclusion population is composed of quartz (~88 vol%) with some K-feldspar (5 vol%). Minor Pb-glaze and matrix components make up the rest. The matrix is composed of kaolinite (29 vol%), Fe-Al-K silicates (26 vol%) and quartz (20 vol%), with minor muscovite/illite (8 vol%), plagioclase (6 vol%), K-feldspar (4 vol%) and Fe-Al silicates (6 vol%).</p>

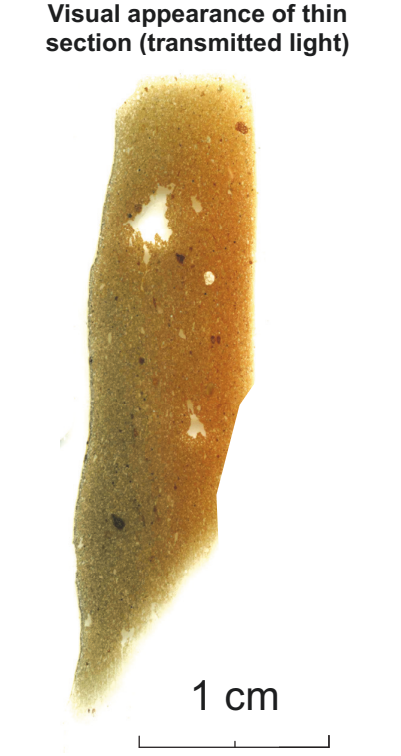
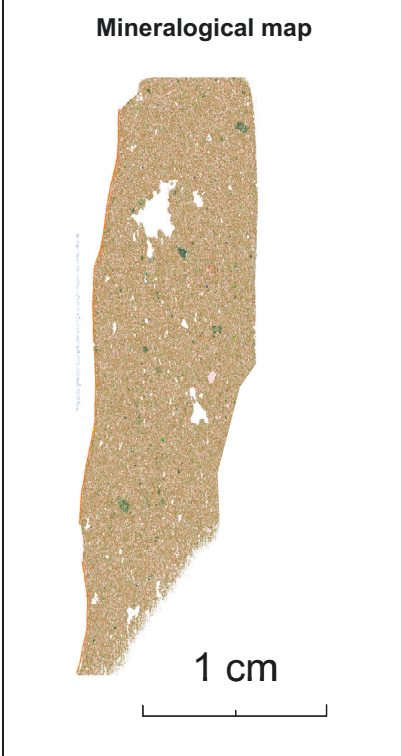
<b>Form</b>		<b>Mineralogical type</b>	
Body sherd of a jar, very competently made		B <sub>1</sub>	
<b>Analogues</b>			
A common post-medieval type from mid and north Somerset			
<b>Visual appearance of thin section (transmitted light)</b>	<b>Mineralogical map</b>	<b>Key to mineral map <sup>1</sup></b>

Sample: TC unclassified, context 755				CSM lab code: C05120010	
Mineralogical composition				Particle size distribution	
	Matrix	Inclusions	Bulk		
Fe sulphides	0.012	0.000	0.012	Matrix (< 63 µm) = 97.0 vol% Inclusions (> 63 µm) = 3.0 vol%	
Pb glaze	0.180	4.276	0.971		
Barite	0.000	0.000	0.000		
Chrome spinel	0.008	0.000	0.007		
Fe Ox/CO3	0.019	0.000	0.018		
Mn phases	0.004	0.000	0.004		
Rutile	0.589	0.062	0.569		
Ilmenite	0.076	0.000	0.073		
Zircon	0.022	0.000	0.021		
REE phases	0.003	0.000	0.003		
Quartz	20.019	87.574	21.897		
Plagioclase feldspar	5.983	0.629	5.783		
K-Feldspar	3.738	4.786	3.744		
Muscovite/illite	7.779	0.109	7.499		
Fe Al K silicates	25.563	0.716	24.652		
Glaucanite	0.181	0.338	0.185		
Kaolinite	29.193	0.624	28.146		
Tourmaline	0.126	0.000	0.122		
Fe Al silicates	6.250	0.758	6.045		
Mg Al silicates	0.007	0.000	0.007		
Mg silicates	0.008	0.000	0.007		
Ca Fe Al silicates	0.009	0.000	0.009		
Calcite	0.206	0.019	0.199

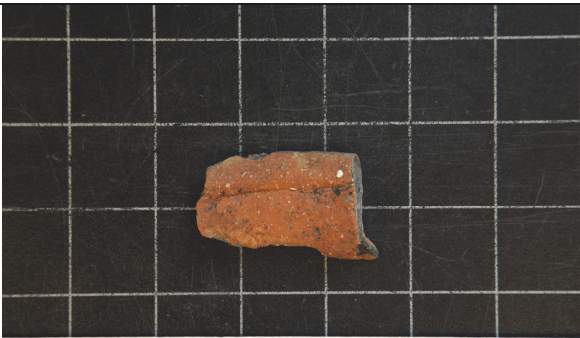
<p>Type TC 023, context 09/93: CSM Lab code COSI20013.</p>	
(Grid = 3 x 3 cm)			
<b>Fabric description</b>		<b>Mineralogical description</b>	
<p>Hard-fired reduced grey fabric with brick red oxidised surface with rough feel to the surface; fabric contains with quantities of crushed chert, quartz, limestone and fossil material &lt;2mm.</p>		<p>The sherd has 83 vol% matrix and 17 vol% inclusions.</p> <p>The inclusion population is dominated by calcite (63 vol%) with some quartz (~35 vol%) and trace K-feldspar (2 vol%).</p> <p>The matrix is composed of Fe-Al-K silicates (54 vol%) with some muscovite/illite (14 vol%), quartz (11 vol%) and calcite (8 vol%) and minor K-feldspar (5 vol%) and plagioclase (4 vol%).</p>	
<b>Form</b>		<b>Mineralogical type</b>	
Rim of hand-built open jar/cooking pot		C

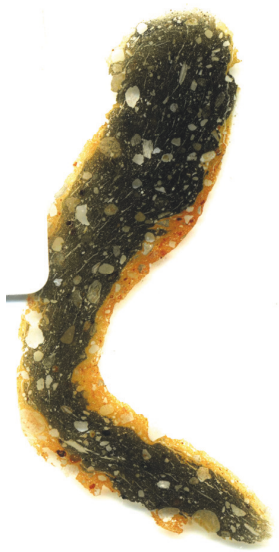
<b>Analogues</b>			
Upper Greensand derived 11th-12th century			
<b>Visual appearance of thin section (transmitted light)</b>	<b>Mineralogical map</b>	<b>Key to mineral map</b>

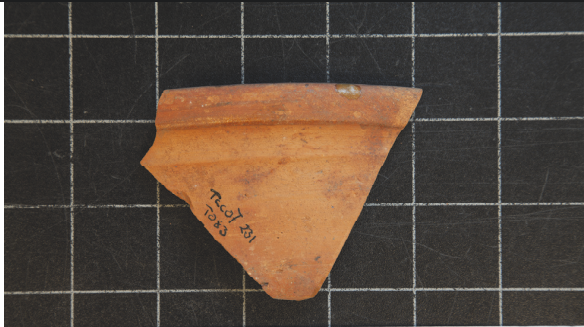
<p>Type TC 083=093, context 07/231: CSM Lab code C05120006.</p>

Figure A.12: Mineralogy report on pottery fabric 083 by QEMSCAN analysis. Camborne School of Mines, University of Exeter, Penryn Campus, Penryn, TR10 9EZ

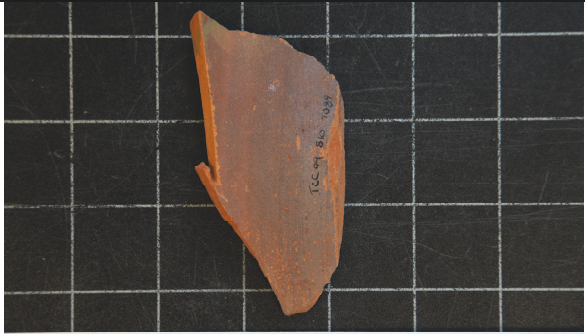
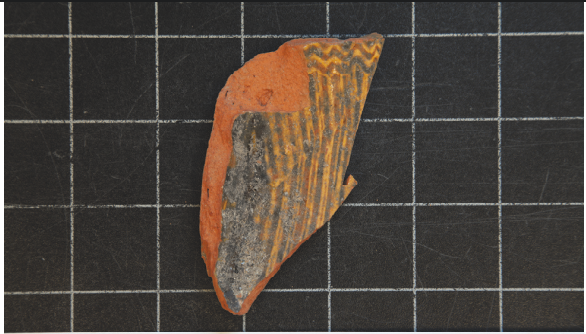
<p>Type TC 089, context 09/810: CSM Lab code C05120011.</p>	
		(Grid = 3 x 3 cm)	
<b>Fabric description</b>		<b>Mineralogical description</b>	
<p>Hard-fired oxidised red earthenware with sandy feel to the dark red outer surface; granular structure with occasional voids, sparsely speckled with mica and ?quartz; glaze shows rich brown over the exposed surface and dark cream over the slip.</p>		<p>The sherd has 91 vol% matrix and 9 vol% inclusions. The inclusion population is dominated by quartz (80 vol%) with 19 vol% K-feldspar. The matrix is a dominated by Fe-Al-K silicates (63 vol%) with some muscovite/illite (14 vol%) but no kaolinite. Minor quartz (9 vol%), and K-feldspar (11 vol%) occurs along with traces of Fe-Al-silicates.</p>	
<b>Form</b>		<b>Mineralogical type</b>

<p>Base of wheel-thrown dish decorated inside with sgraffito through a white slip under a lead-glaze, horizontal combed bands interrupted by vertical combed zig-zags</p>		<p>A</p>	
<b>Analogues</b>			
<p>West Somerset ware 18th century</p>			
<b>Visual appearance of thin section (transmitted light)</b>	<b>Mineralogical map</b>	<b>Key to mineral map</b>

Figure A.13: Mineralogy report on pottery fabric 089 by QEMSCAN analysis. Camborne School of Mines, University of Exeter, Penryn Campus, Penryn, TR10 9EZ

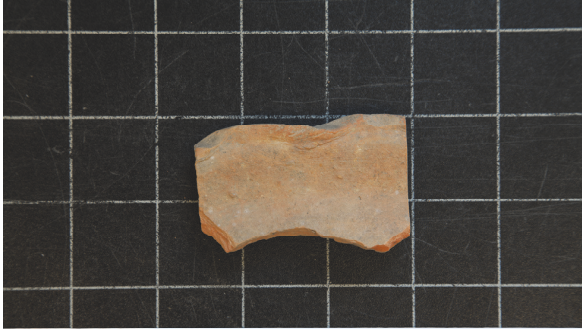
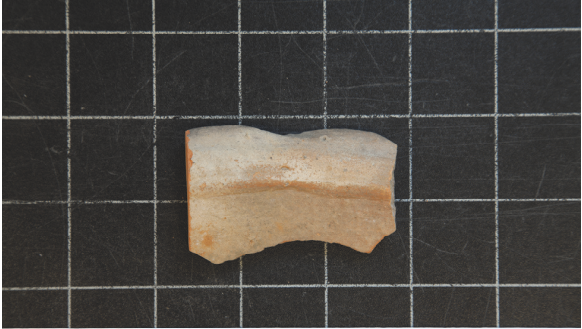
<p>Crowcombe: CSM Lab code C05120019</p>	
(Grid = 3 x 3 cm)			
<b>Fabric description</b>		<b>Mineralogical description</b>	
<p>Fairly hard-fired orange red earthenware with grey reduced smooth surface; fine diagonal laminar structure with moderate fine inclusions of white flecks and larger both orange iron-rich and darker harder grains</p>		<p>The sherd has 94 vol% matrix and 6 vol% inclusions. The inclusion population is composed almost exclusively of quartz (~94 vol%) with some K-feldspar (5 vol%). The matrix is predominantly composed of Fe-Al-K silicates (68 vol%) with some Fe-Al silicates (5 vol%), muscovite/illite (6 vol%), K-feldspar (7 vol%) and quartz (11 vol%).</p>	
<b>Form</b>		<b>Mineralogical type</b>	
<p>Rim sherd of wheel-thrown flanged bowl with thumbled edge; unglazed</p>		<p>A</p>

Figure A.14: Mineralogy report on pottery fabric 55/1992 by QEMSCAN analysis. Camborne School of Mines, University of Exeter, Penryn Campus, Penryn, TR10 9EZ

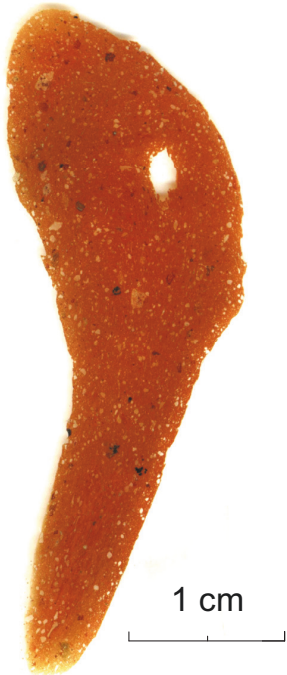
<b>Analogues</b>			
<p>West Somerset type ware 16th-17th century, see Bridgwater George Street</p>			
<b>Visual appearance of thin section (transmitted light)</b>	<b>Mineralogical map</b>	<b>Key to mineral map <sup>1</sup></b>

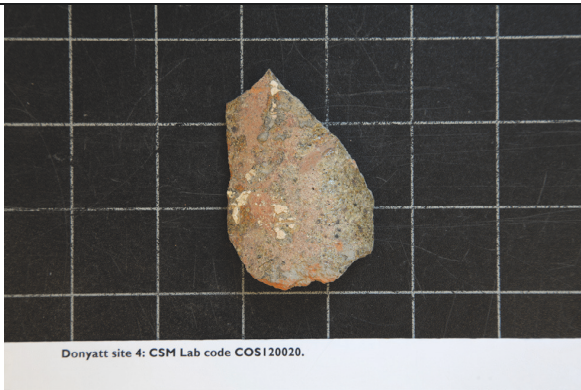
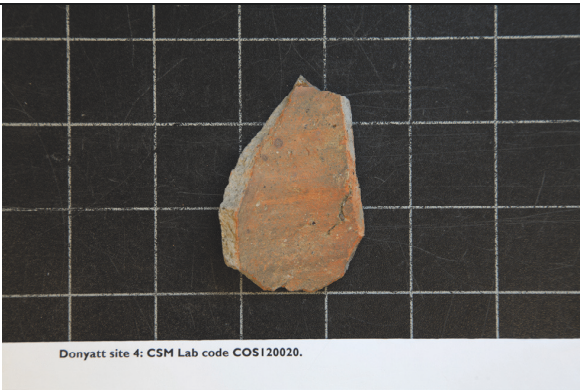
<p>Donyatt site 4: CSM Lab code C05120020.</p>	
		(Grid = 3 x 3 cm)	
<b>Fabric description</b>		<b>Mineralogical description</b>	
<p>Fairly hard-fired earthenware reduced grey with a reoxidised orange red sandy interior surface; granular structure with occasional clear quartz &lt;1mm, limestone and dark iron-rich fragments; glaze is a part burnt-off reduced mottled green with darker green specks where iron in the body has bled into the glaze. Some patches of white slip adhere probably shed by another vessel during the firing</p>		<p>The sherd has 86 vol% matrix and 14 vol% inclusions.</p> <p>The inclusion population is predominantly quartz (89 vol%) and glauconite (6 vol%) with minor K-feldspar.</p> <p>The matrix is a mixture of Fe-Al-K silicates (52 vol%) and kaolinite (24 vol%) with some muscovite/illite (10 vol%). The matrix also has minor quartz, plagioclase feldspar, Fe-Al silicates, K-feldspar and glauconite.</p>

<b>Form</b>		<b>Mineralogical type</b>	
Wheel-thrown neck of a tankard or jug with marks of collaring and external lead glaze		B <sub>1</sub>	
<b>Analogues</b>			
Donyatt pottery type 8			
<b>Visual appearance of thin section (transmitted light)</b>	<b>Mineralogical map</b>	<b>Key to mineral map</b>

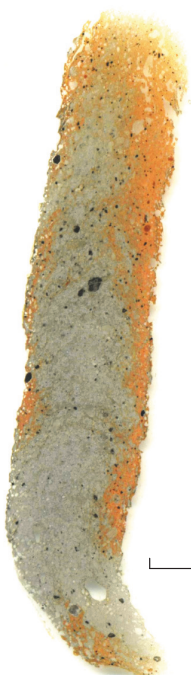
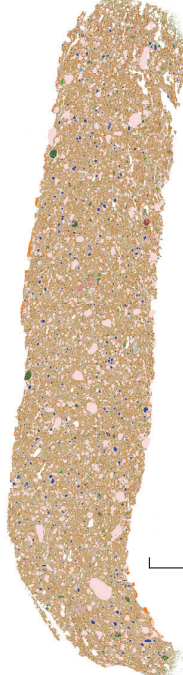
Sample: Donyatt Site 4				CSM lab code: C05120020	
Mineralogical composition				Particle size distribution	
	Matrix	Inclusions	Bulk		
Fe sulphides	0.005	0.000	0.004	Matrix (< 63 µm) = 85.7 vol% Inclusions (> 63 µm) = 14.3 vol%	
Pb glaze	0.129	1.805	0.369		
Barite	0.000	0.000	0.000		
Chrome spinel	0.004	0.000	0.003		
Fe Ox/CO3	0.020	0.000	0.017		
Mn phases	0.056	0.112	0.064		
Rutile	0.294	0.015	0.254		
Ilmenite	0.021	0.056	0.026		
Zircon	0.009	0.112	0.024		
REE phases	0.000	0.000	0.000		
Quartz	4.589	89.496	16.747		
Plagioclase feldspar	2.751	0.000	2.357		
K-Feldspar	1.172	0.729	1.109		
Muscovite/illite	9.733	0.038	8.345		
Fe Al K silicates	52.231	0.335	44.800		
Glaucanite	0.822	6.202	1.592		
Kaolinite	23.992	0.116	20.573		
Tourmaline	0.033	0.000	0.029		
Fe Al silicates	3.954	0.970	3.527		
Mg Al silicates	0.005	0.000	0.005		
Mg silicates	0.009	0.000	0.008		
Ca Fe Al silicates	0.052	0.000	0.045		
Calcite	0.091	0.000	0.078

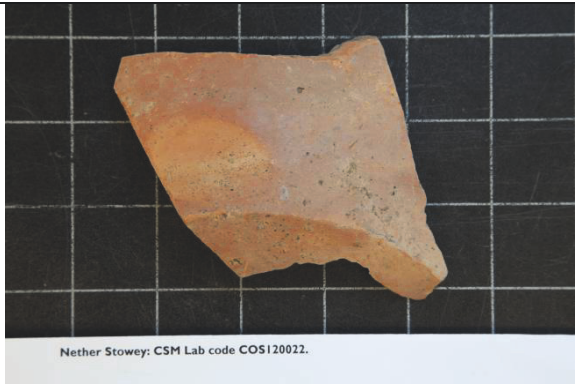
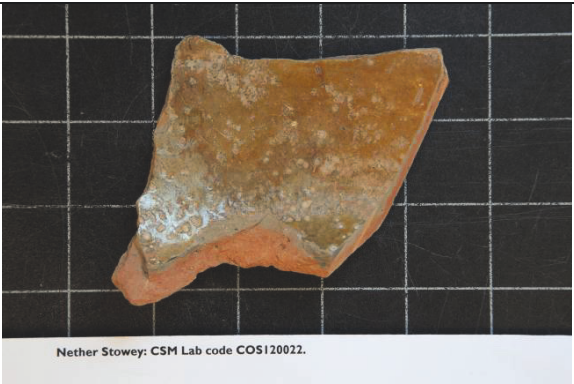
<p>Nether Stowey: CSM Lab code C05120022.</p>			
		(Grid = 3 x 3 cm)			
<b>Fabric description</b>		<b>Mineralogical description</b>			
<p>Fairly hard-fired reduced and reoxidised orange red earthenware with zone of grey reduction below the glaze and flashed darker red smooth surface with patches of orange; irregular granular structure with sparse inclusions mostly specks of lime and scarce lumps &lt;0.5mm of a dark red material (?conglomerate), occasional voids where organic material has burnt out; glaze fired a mottled olive green with pits caused by the lime</p>		<p>The sherd has 98.5 vol% matrix and 1.5 vol% inclusions.                  The inclusion population is composed almost exclusively of quartz (~59 vol%) and K-feldspar (~30 vol%), with minor Fe-Al-K silicates and Ca phosphates.                  The matrix is predominantly composed of Fe-Al-K silicates (56 vol%) with some muscovite/illite (14 vol%), K-feldspar (15 vol%) and quartz (11 vol%).</p>

<b>Form</b>		<b>Mineralogical type</b>			
<p>Part of the base of a wheel-thrown deep bowl with internal lead glaze</p>		<p>A</p>			
<b>Analogues</b>					
<p>West Somerset type ware 16th-17th century, Bristol pottery type 230/284</p>					
<p><b>Visual appearance of thin section (transmitted light)</b></p>

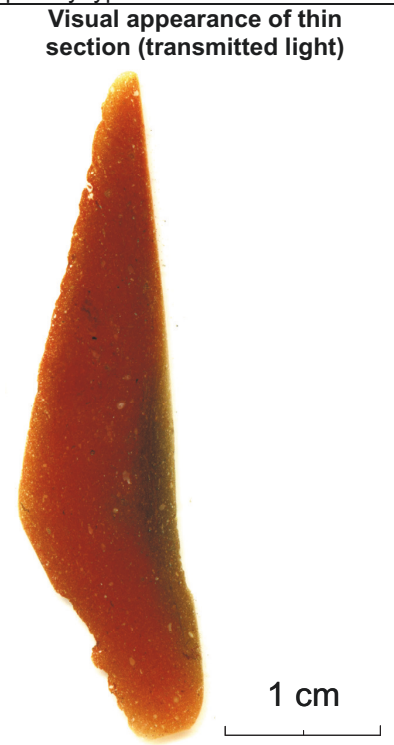
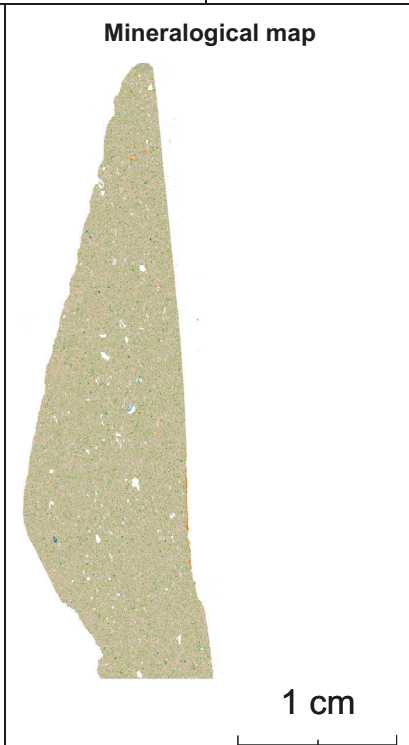
Sample: Nether Stowey				CSM lab code: C05120022	
<b>Mineralogical composition</b>				<b>Particle size distribution</b>	
	Matrix	Inclusions	Bulk	Matrix (< 63 µm) = 98.5 vol% Inclusions (> 63 µm) = 1.5 vol%	
Fe sulphides	0.002	0.000	0.002	<b>Measurement statistics</b>  Total measurement points = 3071954 Measurement spacing = 10 µm	
Pb glaze	0.107	5.981	0.194		
Barite	0.000	0.000	0.000		
Chrome spinel	0.003	0.000	0.003		
Fe Ox/CO3	0.028	0.000	0.028		
Mn phases	0.042	0.179	0.044		
Rutile	0.130	0.000	0.128		
Ilmenite	0.025	0.000	0.025		
Zircon	0.024	0.000	0.024		
REE phases	0.003	0.000	0.003		
Quartz	10.837	59.059	11.558		
Plagioclase feldspar	0.562	0.183	0.557		
K-Feldspar	15.422	29.962	15.640		
Muscovite/illite	14.427	0.591	14.222		
Fe Al K silicates	56.253	2.075	55.441		
Glaucinite	0.063	0.000	0.062		
Kaolinite	0.204	0.000	0.201		
Tourmaline	0.016	0.000	0.016		
Fe Al silicates	1.318	0.011	1.299		
Mg Al silicates	0.002	0.000	0.002

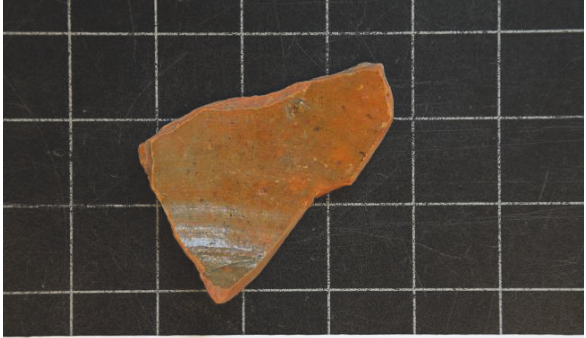
<p>Wanstrow B: CSM Lab code C05120018.</p>	
(Grid = 3 x 3 cm)			
<b>Fabric description</b>		<b>Mineralogical description</b>	
<p>Fairly hard-fired reduced and reoxidised orange red earthenware with grey reduced core; smooth very fine sandy surface with specks of mica; distinctive laminar structure to the fine sandy fabric and occasional iron-rich inclusions; glaze has fired light olive green with splotches of orange and with black speckles.</p>		<p>The sherd has 90 vol% matrix and 10 vol% inclusions. The inclusion population is composed almost exclusively of quartz (~84 vol%) and K-feldspar (~8 vol%) with small amounts of Fe-Al silicates (2 vol%) and plagioclase feldspar (1.8 vol%). The matrix is a mixture of Fe-Al-K silicates (36 vol%), kaolinite (24 vol%) and quartz (20 vol%) with some muscovite/illite (6 vol%); minor Fe-Al silicates, K-feldspar and plagioclase feldspar and traces of rutile.</p>

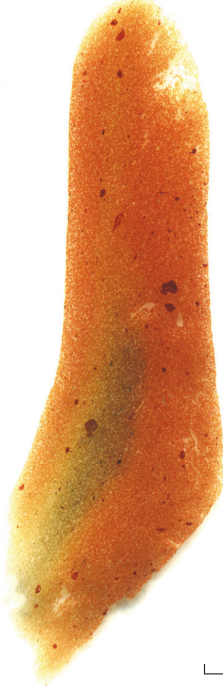
<b>Form</b>		<b>Mineralogical type</b>	
Wheel-throw base of a deep bowl with an internal lead glaze		B <sub>1</sub>	
<b>Analogues</b>			
East Somerset type ware			
<b>Visual appearance of thin section (transmitted light)</b>	<b>Mineralogical map</b>	<b>Key to mineral map</b>

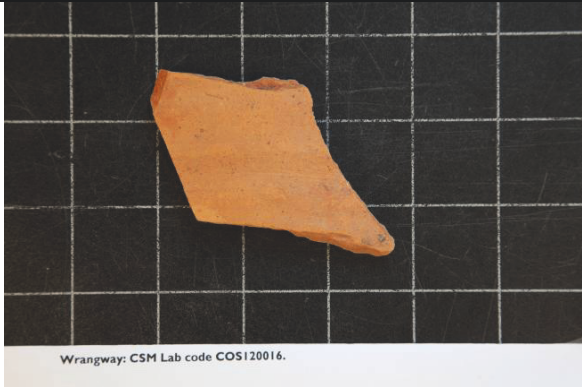
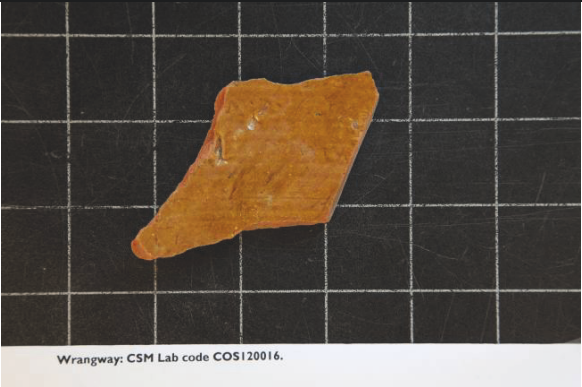
<p>Wrangway: CSM Lab code C05120016.</p>	
		(Grid = 3 x 3 cm)	
<b>Fabric description</b>		<b>Mineralogical description</b>	
<p>Fairly hard-fired reduced and thoroughly reoxidised orange red earthenware with smooth external surface and occasional specks of mica; grainy structure with occasional voids some from burnt-out organic material but others from poorly pugged clay; sparse specks of quartz; reduced light olive green lead-glaze streaked where picking up the throwing lines and with tiny pimples where the quartz projects through the surface.</p>		<p>The sherd has 91 vol% matrix and 9 vol% inclusions.</p> <p>The inclusion population is composed almost exclusively of quartz (~75 vol%) and K-feldspar (~25 vol%).</p> <p>The matrix is predominantly composed of Fe-Al-K silicates (65 vol%) with some muscovite/illite (8 vol%), K-feldspar (10 vol%) and quartz (10 vol%).</p>

<b>Form</b>		<b>Mineralogical type</b>	
Body sherd of a large wheel-thrown jar with internal lead-glaze		A	
<b>Analogues</b>			
West Somerset ware 17 <sup>th</sup> -18 <sup>th</sup> century			
<b>Visual appearance of thin section (transmitted light)</b>	<b>Mineralogical map</b>	<b>Key to mineral map</b>
