Summary of Charterhouse Square Tree Root Test Pits

XTE12

A series of test pits were monitored on 7th July 2014 for the purpose of understanding the extent of tree roots within the footprint of the two proposed community excavation trenches within Charterhouse Square garden. The site has been recorded using the site code XTE12.

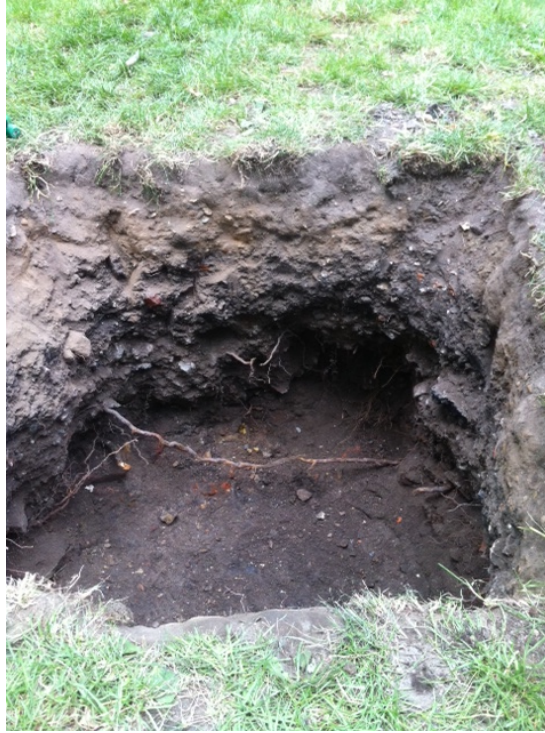
At the base of the test pit was a dump deposit [1008]. It was a mod compact dark grey sandy silt with frequent pebbles and pea grit and occasional cbm fragments. Above which was [1005], a 0.15m thick compact layer of 18th/19th-century demolition debris consisting of frogged yellow stock brick fragments and frogged dark reddish purple brick fragments and grey stone floor slab fragments. This layer was sealed by [1004], a moderately compact dark grey brown sandy silt with lighter brownish yellow patches. It contained frequent cbm, window glass, pottery, ctp and bone fragments. Above [1004] was [1001], a mid brownish grey clay and gravel dumped layer containing frequent cbm, pot, ctp, bone and oyster fragments, occasional large flint nodules and occasional small chalk fragments. Layer [1001] was 0.15m thick and was sealed beneath 0.25m of top soil and turf.

Fig 1 Test pit 1 - looking north

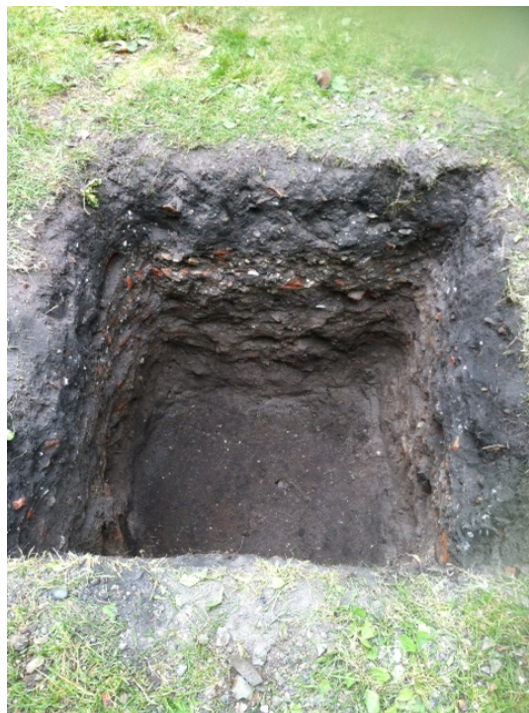
At the base of the test pit was a dump deposit [1007]. It was a mod compact very dark grey sandy silt with frequent pebbles and pea grit and occasional cbm fragments. Above which was [1006], a 0.3m thick mod compact very dark grey sandy silt with frequent cbm (tile) fragments. This layer was sealed by [1002] a mid yellowish brown clay and gravel dumped layer containing frequent cbm, pot, ctp, bone and oyster fragments, occasional large flint nodules and occasional small chalk fragments and was sealed beneath 0.25m of top soil and turf.

Fig 2 Test pit 2 - looking north

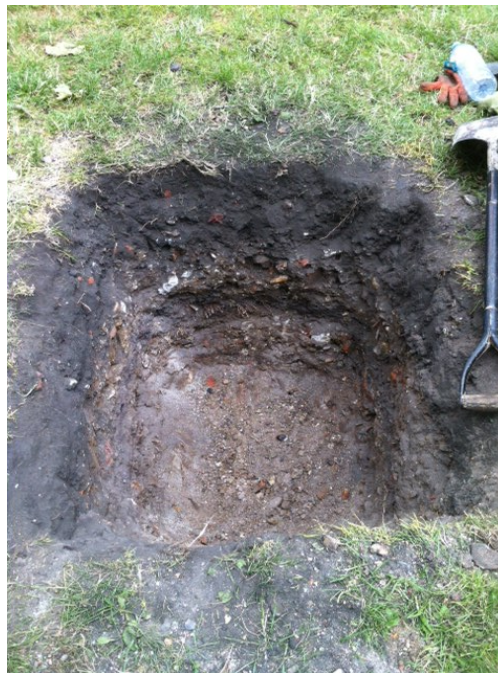
At the base of the test pit was a dump deposit [1003], a soft dark mid grey deposit of fine sand and cinders with black and dark grey mottles. It contained occasional oyster shell fragments and clay patches. It was sealed by [1002] a mid yellowish brown clay and gravel dumped layer containing frequent cbm, pot, ctp, bone and oyster fragments and occasional small chalk fragments and was sealed beneath 0.3m of top soil and turf.

Fig 3 Test pit 3 - looking north

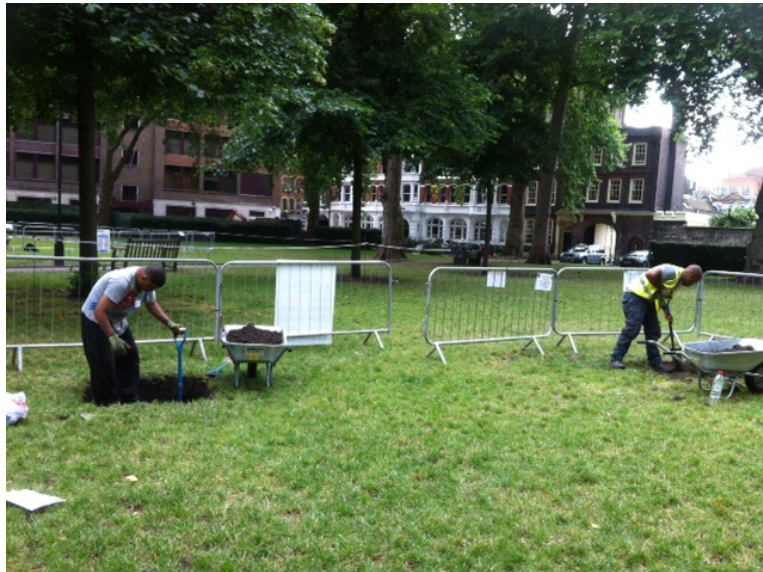
The two test pits at the southern end of the northern community trench had just been started on Monday afternoon.

Fig 4 Test pits at the southern end of the northern community trench - looking south-west

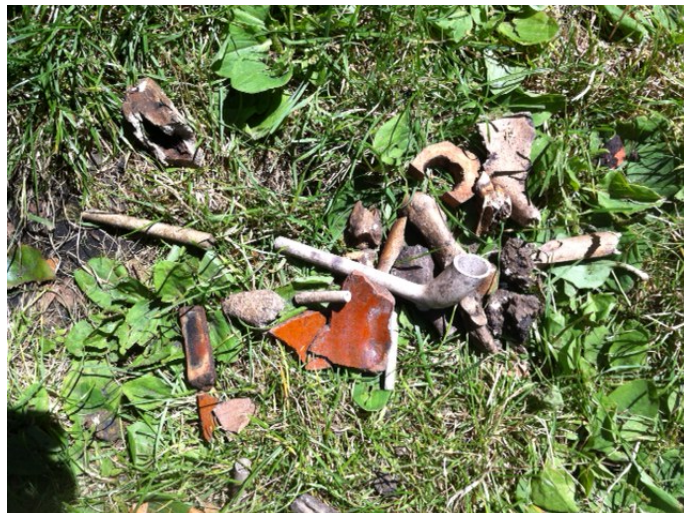
It was apparent from all the test pits that the 18th and 19th century dump deposits which were encountered all contained a varied assemblage of pottery, animal bone, oyster shell, ctp as can be seen from the finds recovered from Test pit 2 in Fig 5 and Test pit 3 in Fig 6

Fig 5 Finds from Test pit 2

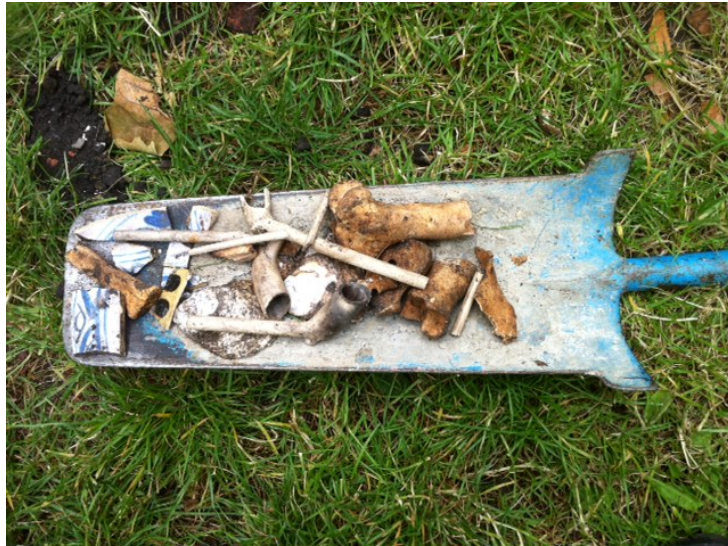
Fig 6 Finds from Test pit 3
