Rapid Appraisal and Assessment Bredon Field Farm Strensham WR8 9BL Authors RDA

3. Rapid Appraisal of Bredon Field Farm and Farmstead

3.3.1 Site Assessment Summary

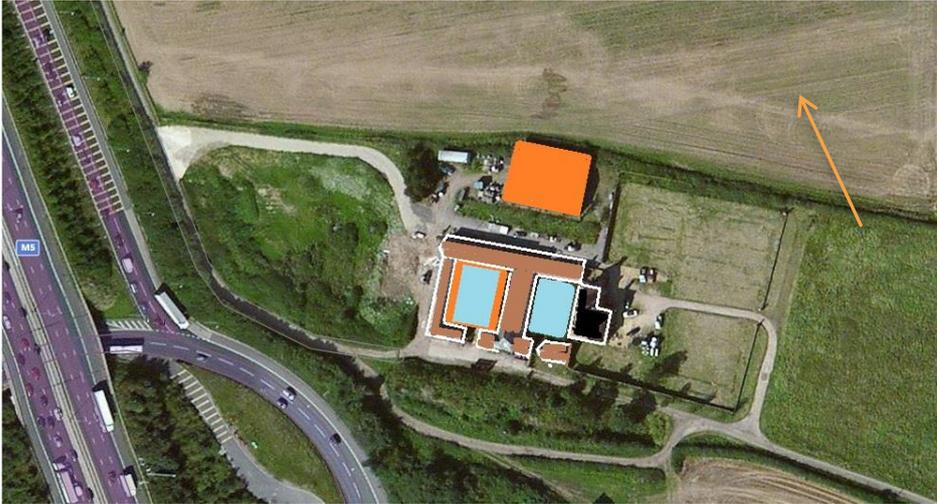
C20 Modern Post 1930

Traditional Buildings	
Yards	
Farmhouse	
<p>SUMMARY</p> <p>This is a E plan farmstead and farm house 1851 with its core group of buildings set around two courtyards. West Courtyard was covered C20 but has had roof removed so only steel frame remains. A new shed to the North with new access road C20 and C21.</p>	
<p>Site management issues</p> <ol style="list-style-type: none"> 1. <i>Site boundary, ownership and use.</i> The farmstead is in single ownership and all the traditional buildings are now redundant for modern farming purposes 2. <i>Site access and services.</i> Historic Access off Mill Lane to the North 3. <i>Designations.</i> None 	
<p>Historic Character</p> <p>Setting</p> <p>The site boundaries link to similar hedgrows and woodland in the surrounding landscape There are views from Mill Lane with the granary and barn being most prominent and the upper storey and chimneys of the farmhouse clearly visible above the courtyards. The farm can also be viewed from the M5 sliproad. The farm house East can be viewed from the lane to River Avon and a Field Barn, now residential.</p> <p>The farmstead and its buildings</p> <p>This is a E plan double yard farmstead with farm house 1851 with its core group of buildings set around two courtyards. All buildings are original 1851 of traditional buildings of brick and tile and slate . To the North is a modern working area with industrial shed C20 with new access created in 2011.</p>

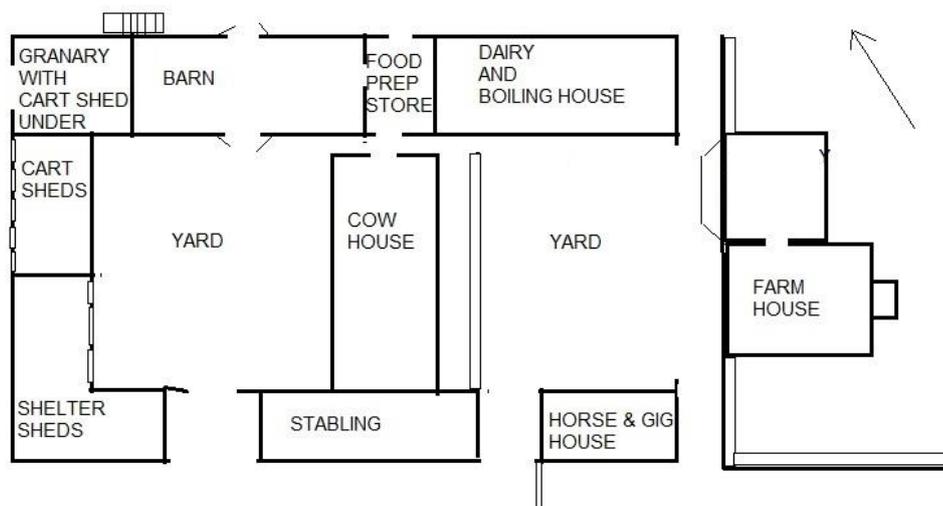
Sketch Plan by RDA describes the farmstead buildings uses. NOT TO SCALE

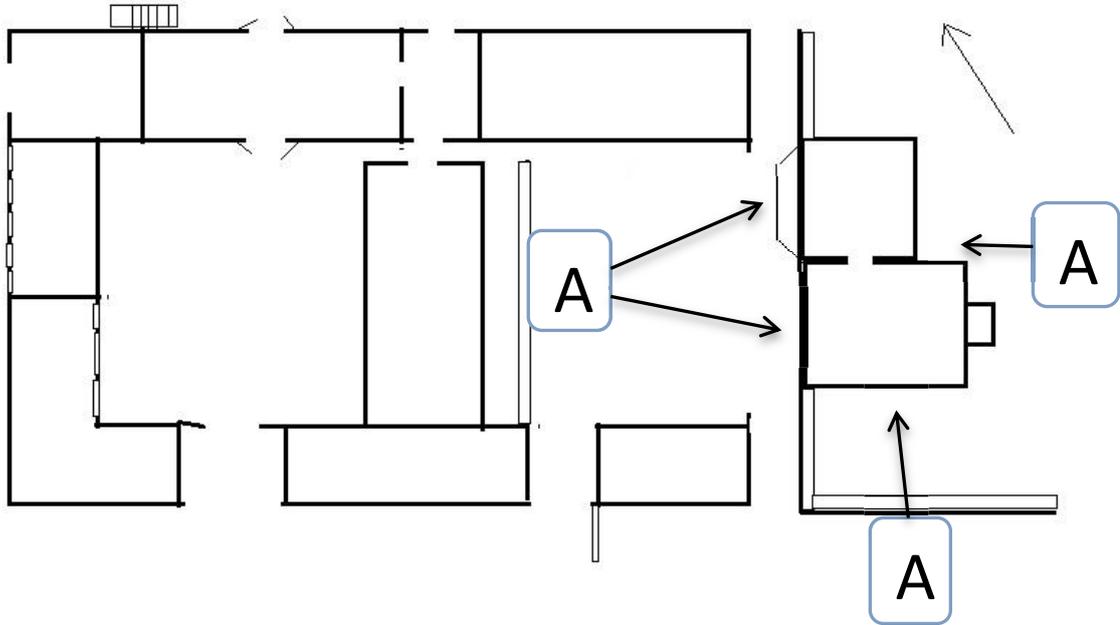
A THE FARMHOUSE

<p>A</p> <p>Front East Elevation of the Farm House views to Bredon Hill. 1851 Old English Tudoresque style [Tiled Roof replaced 2010.] Original tall corbelled conjoined chimney stacks and buff terracotta chimney pots Traditional local brick elevations with dressed sandstone window surrounds and arrow slits to gables. Enclosed portico porch.</p> <p><i>“ 1227 The Old English Cottage Style steep roofs, plain tiles, barge boards at the gable ends, latticed windows” p566 JC Loudon Villa & Farm Architecture</i></p>
--	---

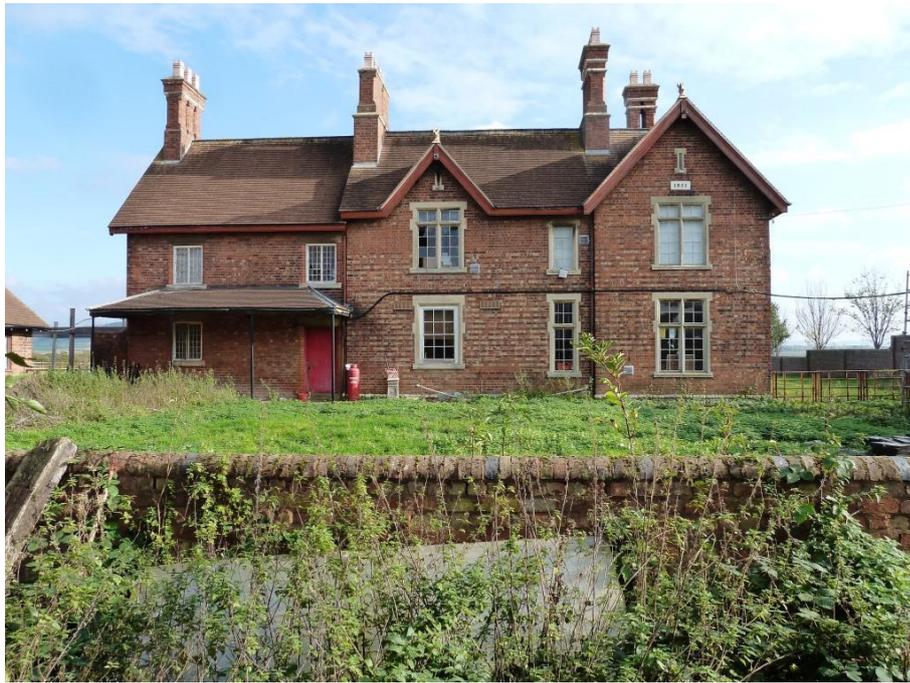
A

Rear West Elevation facing the EAST YARD
1851 Old English Tudoresque style
[Tiled Roof replaced 2010.] Original tall corbelled con joined chimney stacks and buff terracotta chimney pots
Traditional local brick elevations with dressed sandstone window surrounds.
Includes “drying porch veranda”
JC Loudon Villa & Farm Architecture pg 864

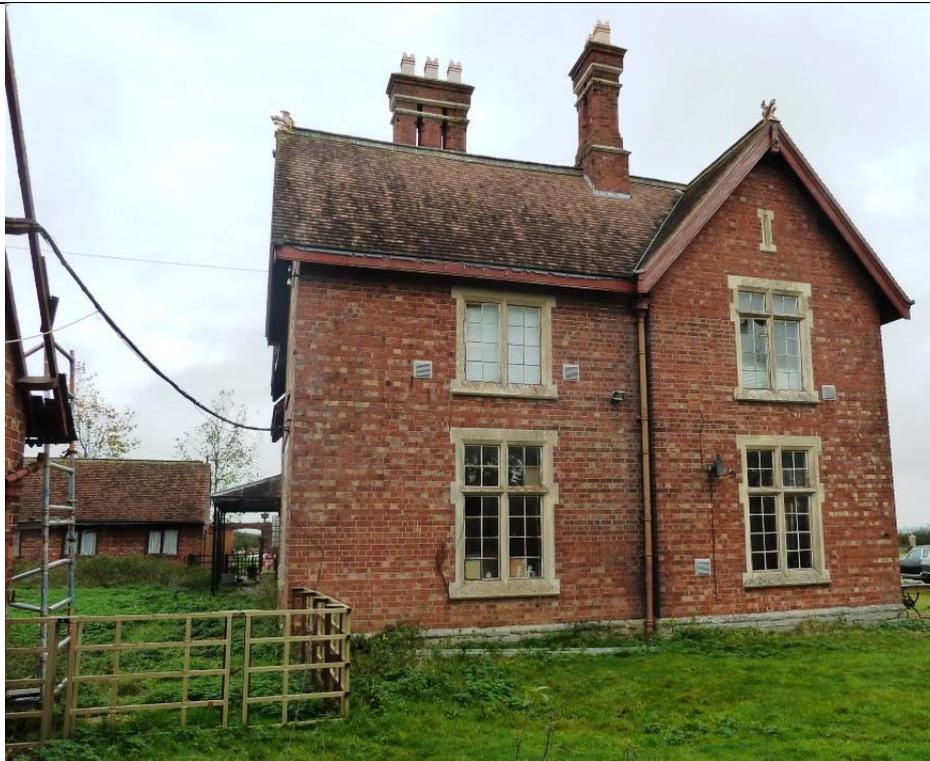
A

Side South Elevation 1851 Old English Tudoresque style [Tiled Roof replaced 2010.]
Original tall corbelled con joined chimney stacks and buff terracotta chimney pots
Traditional local brick elevations with dressed sandstone window surrounds.
NB This was the elevation first seen from the drive in the C19.

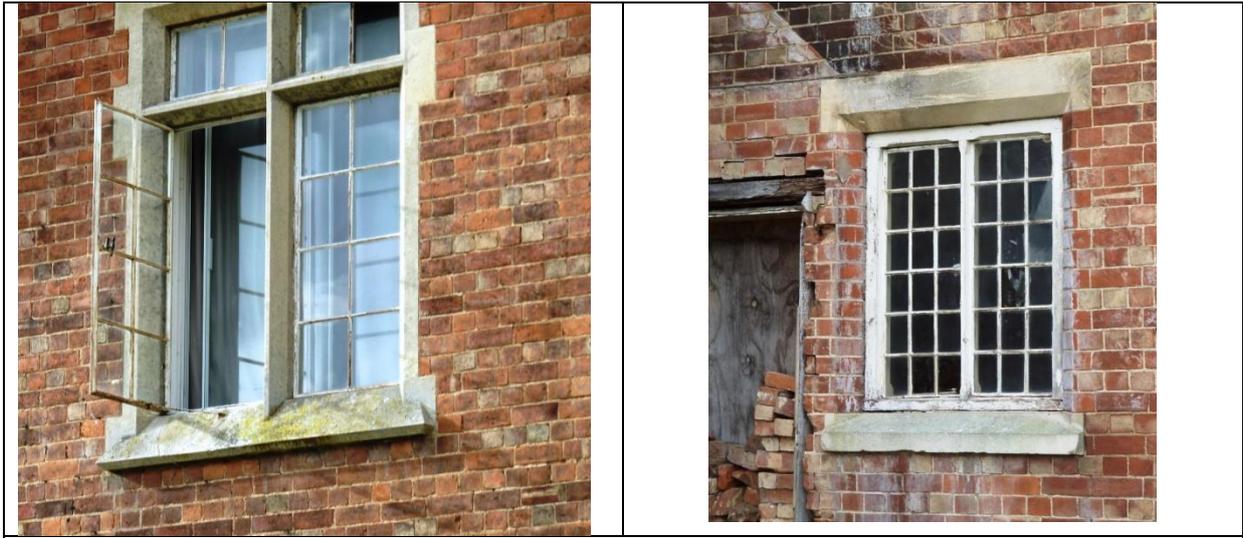
Farmhouse has ALL ORIGINAL cast iron casement window details LEFT on main House RIGHT on North Wing "latticed windows" p566 JC Loudon Villa & Farm Architecture

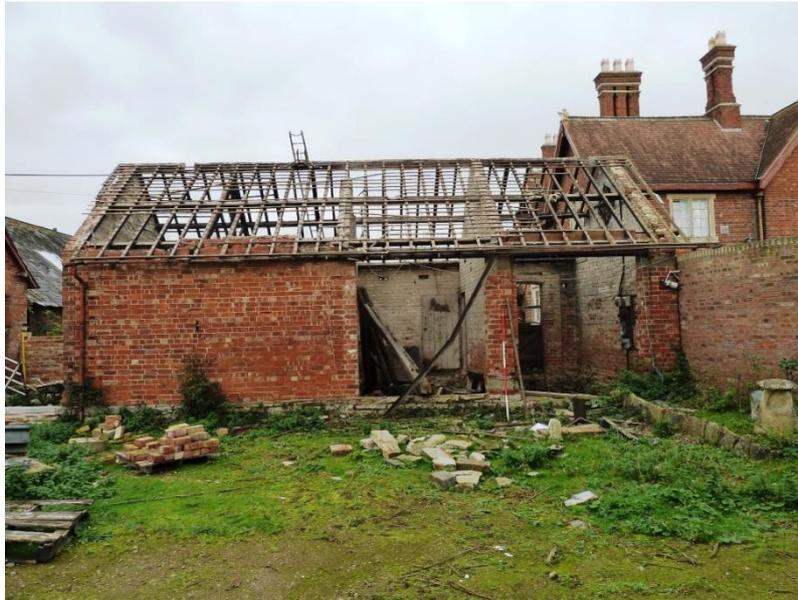
Evaluation 2011. *"There are flues (without their hats) along the ridge"* 2017 These are no longer on the ridges.

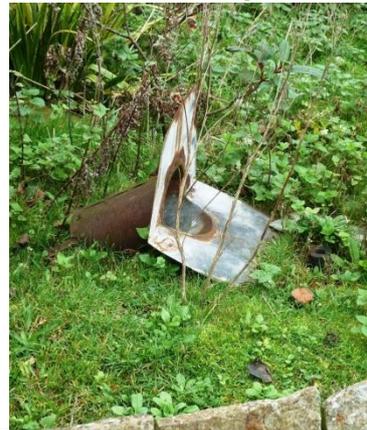
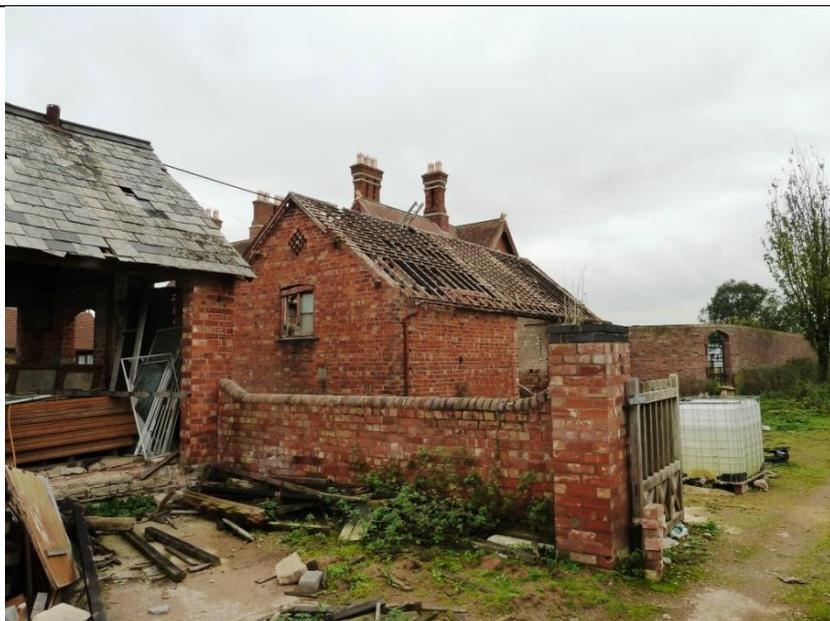
B HORSE GIG HOUSE

Described as Stable & Trap Shed [SWR 20422 HISTORIC BUILDING EVALUATION]
Traditional Brick elevations 4 bays one with timber truss .
Geometric ventilation lozenge in East gable end. Slate Roof missing. Roof was intact in Evaluation 2011.
Flues found on the ground

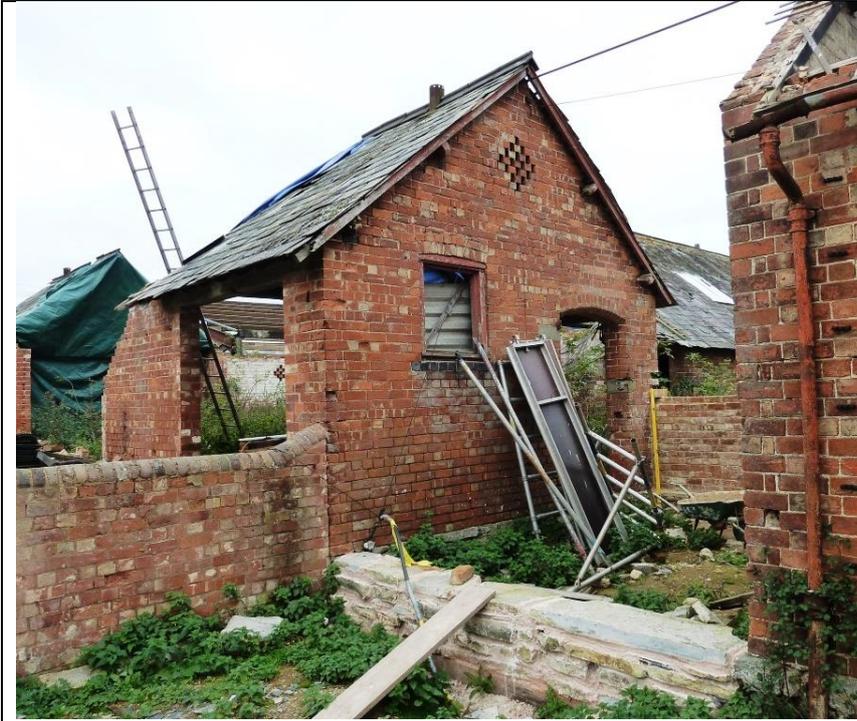
B HORSE GIG HOUSE

Described as Stable & Trap Shed [SWR 20422 HISTORIC BUILDING EVALUATION]
Traditional Brick elevations 4 bays one with timber truss .
Geometric ventilation lozenge in West gable End above a timber casement window.
Walling and pillar rebuilt in reclaimed bricks C20

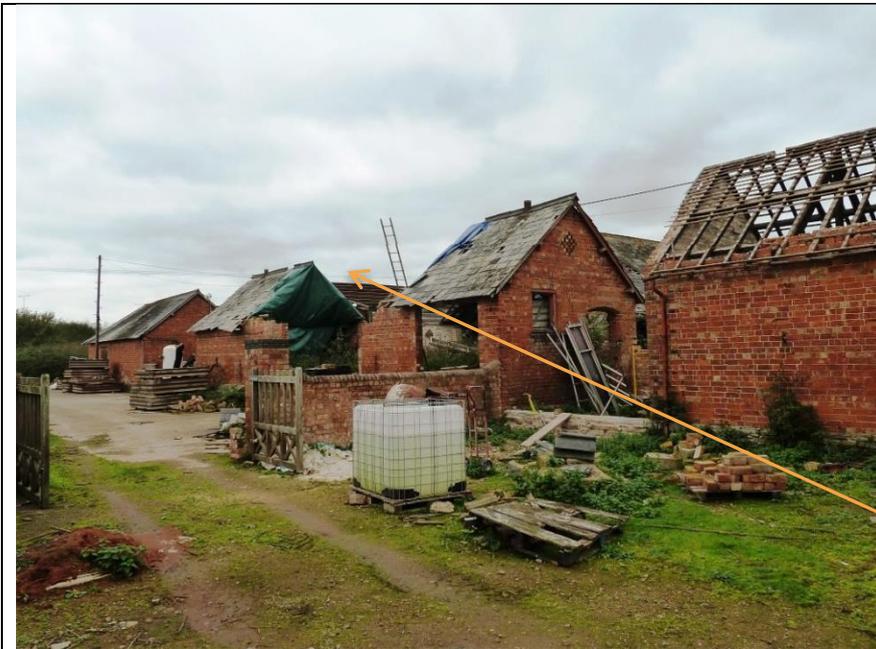
B STABLES

Since 2011 the South End has collapsed due to a fire. The entrance to the East Yard has been partially bricked up with an inner wall and a low stone wall has been built at the entrance.

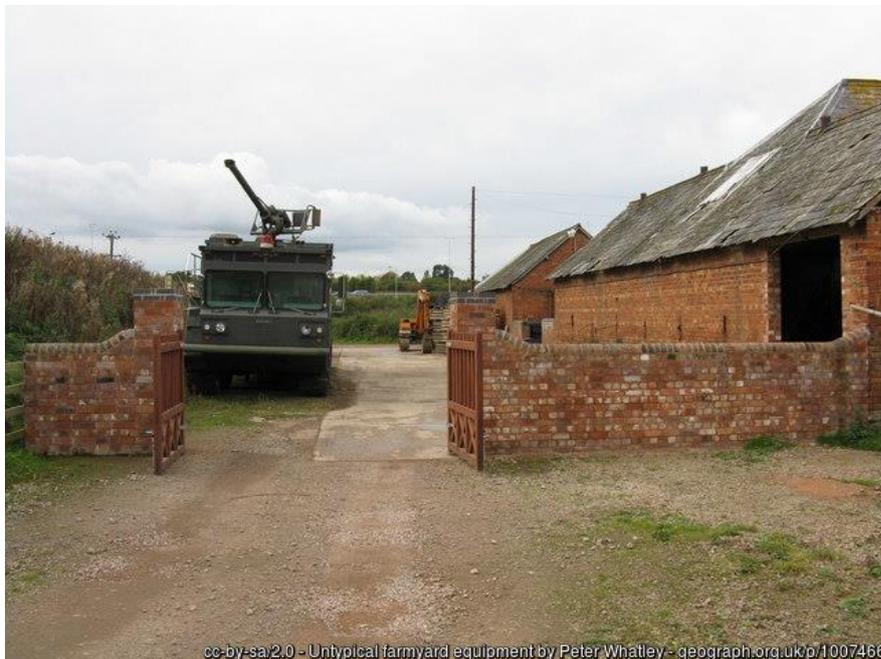
For Reference taken 2009

Since 2011 the (8-bay) South End has collapsed due to a fire

cc-by-sa/2.0 - Untypical farmyard equipment by Peter Whatley - geograph.org.uk/p/1007466

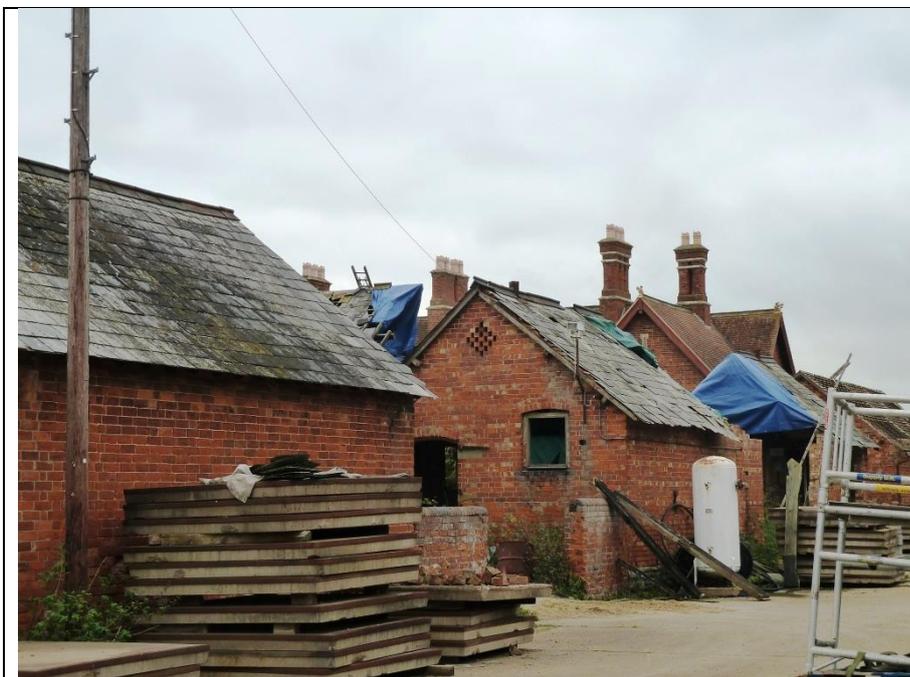
B Entrance to WEST Yard. End Gable of Stabling. Ventilation brick lozenge. End of corner Shelter Shed. Slate Roof intact

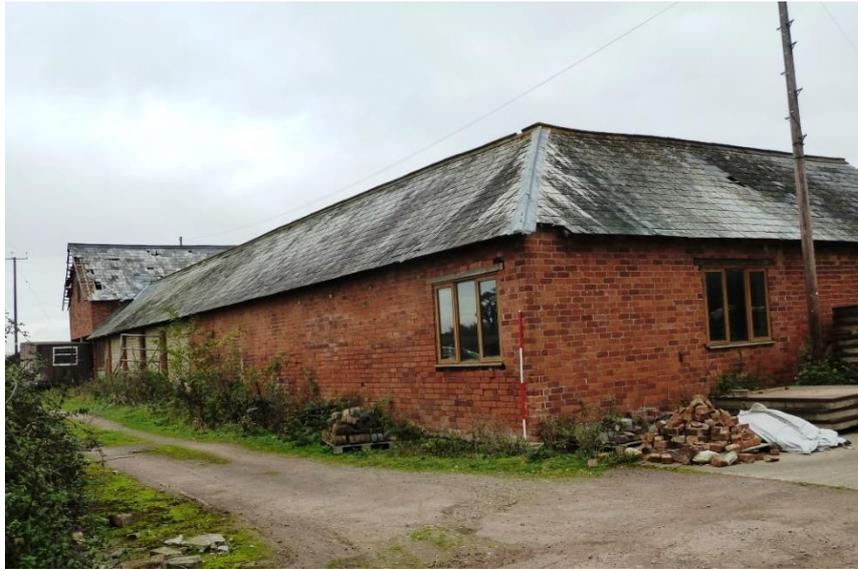
B *The south west corner is open to the west yard, the piers here were replaced by fewer steel posts and additional steel beams in the later 20th century. The roofs are of double-framed King-strut construction with an interesting diagonal frame with half-trusses in the corner. Ref pg 8[SWR 20422 HISTORIC BUILDING EVALUATION] See PLATE 14 SWR 20422*

Photograph Outer Wall to Lane of corner of Shelter Shed. Inserted C21 windows

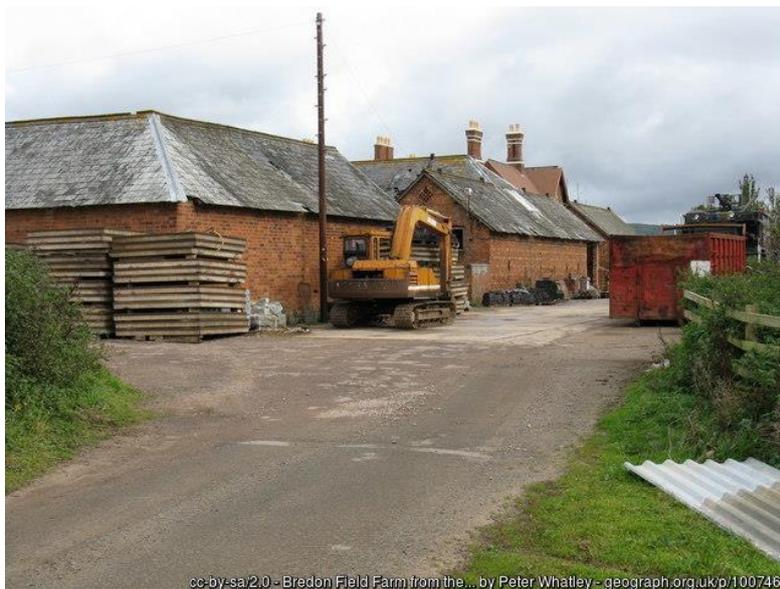
For Reference taken 2009

cc-by-sa/2.0 - Bredon Field Farm from the... by Peter Whatley - geograph.org.uk/p/1007460

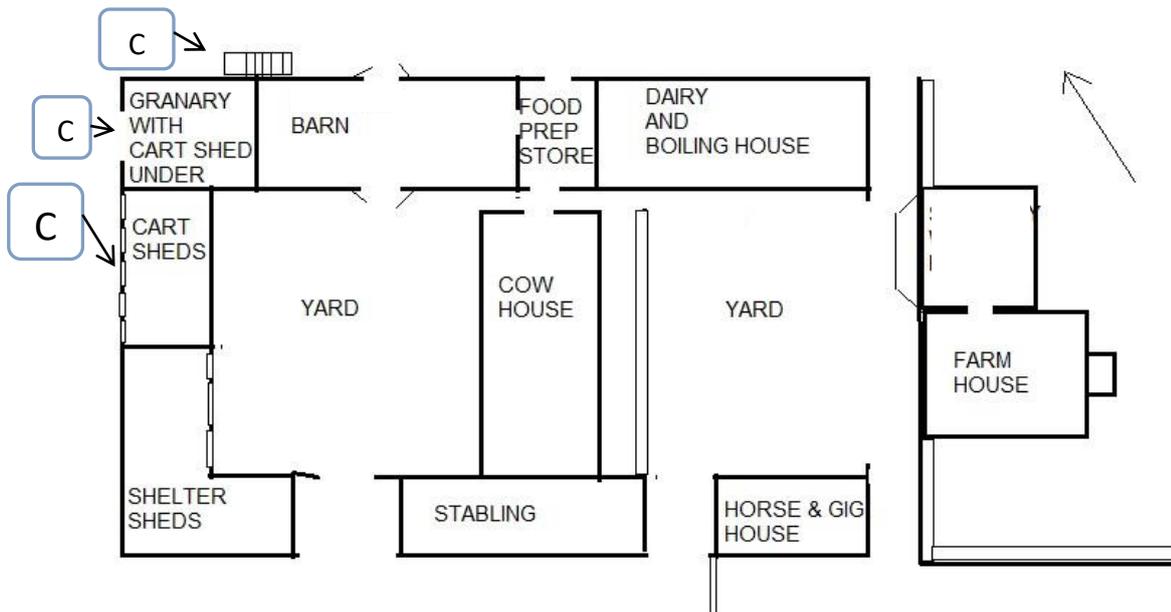
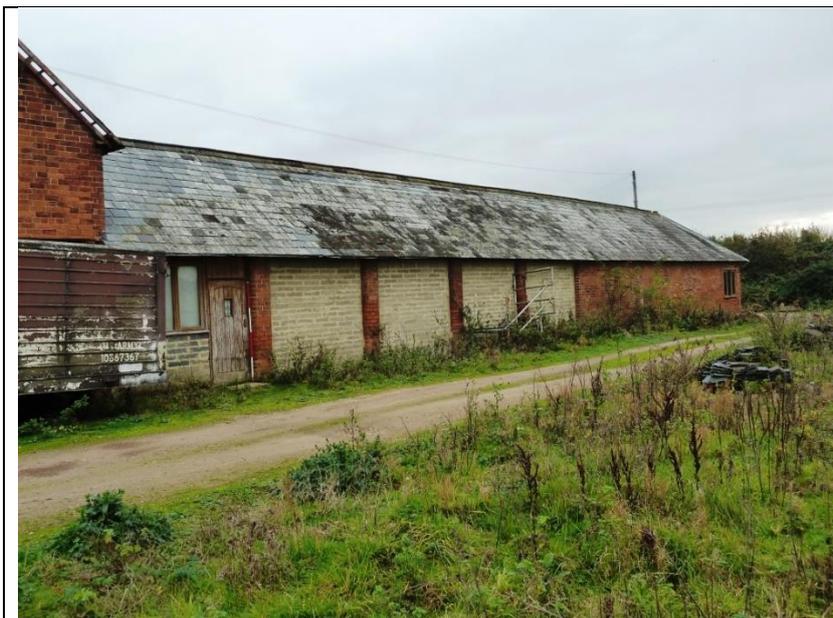
C CART SHEDS

The buildings bounding the west side and south west corner of the western yard are open fronted. The (5-bay) Wagon-shed to the north is open to the west, with piers like those under the grain store, [SWR 20422 HISTORIC BUILDING EVALUATION] See PLATE 15 2011
 The 5 bay openings have now been filled in with Breeze Blocks and 1 bay with a window and door. 2017

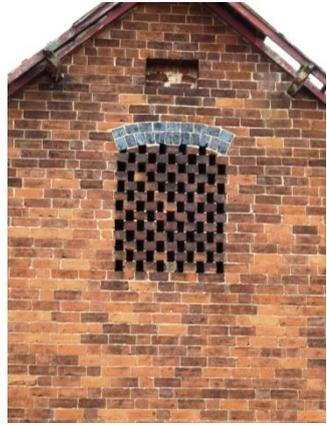
<p>C GRANARY</p>

<p>Ventilation window under segmental arch and empty date plaque in gable end.</p> <p>Lower Openings blocked by Trailer” stout brick pier and steel joists (inverted T section) support the upper wall” SWR 20422 HISTORIC BUILDING EVALUATION 2011 See PLATE 15</p>
<p>Slate roof in poor condition especially at eaves. Traditional brick elevations intact. Cart/engine shed beneath not accessible due to trailer.</p>

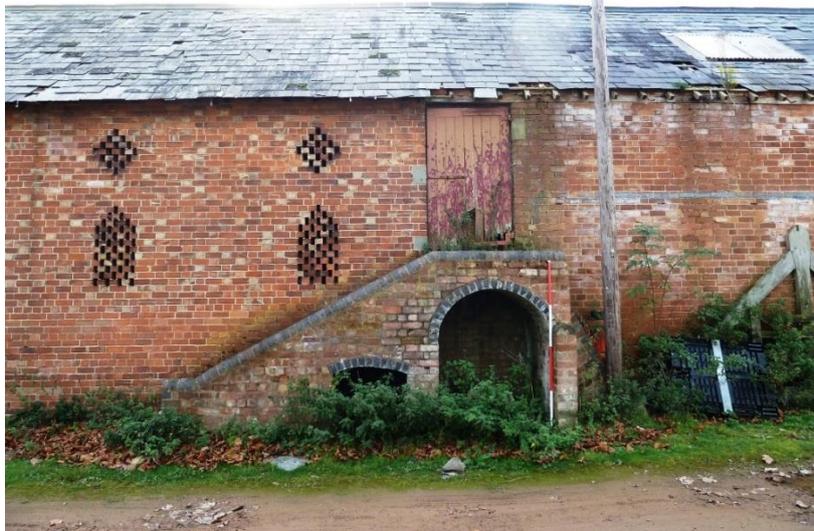
<p>C Entrance to Granary.</p> <p>Approached by external brick staircase. Recess often formed under for a dog kennel as in this case. Dressed with blue bricks to segmental arch and stair wall.</p> <p>Timber Ledge & brace door deteriorated due to slipped slate above</p>

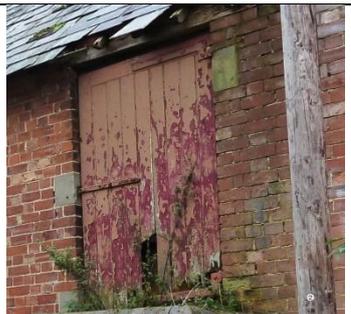
<p>Internal Inspection not possible 2017 <i>The four-bay roof is formed by two (interrupted) base-cruck trusses</i> SWR 20422 HISTORIC BUILDING EVALUATION 2011</p>

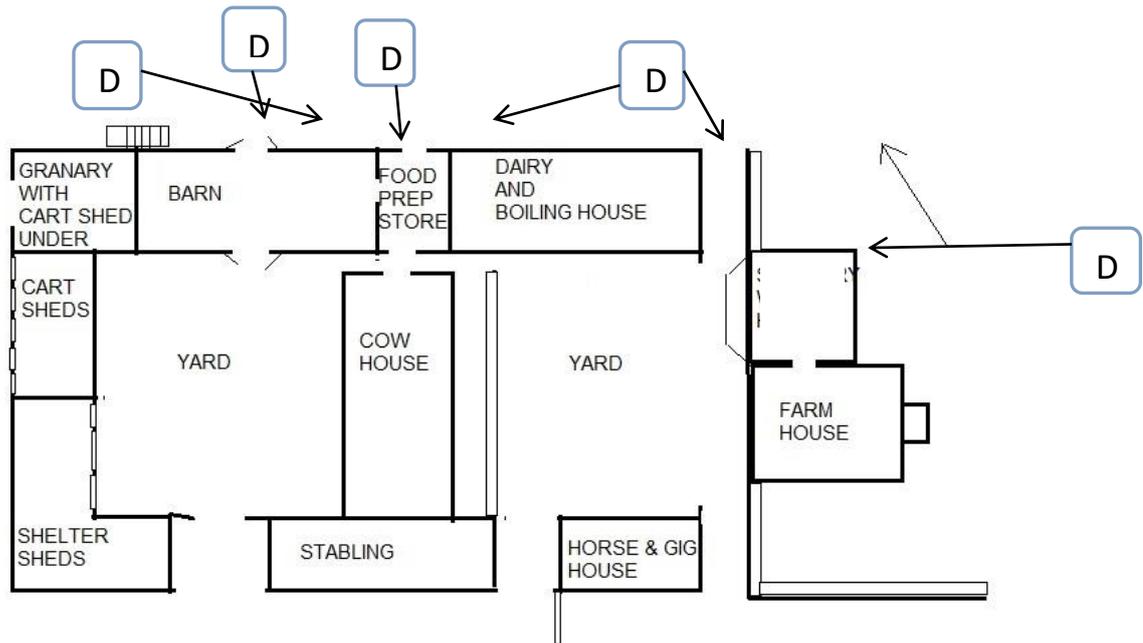
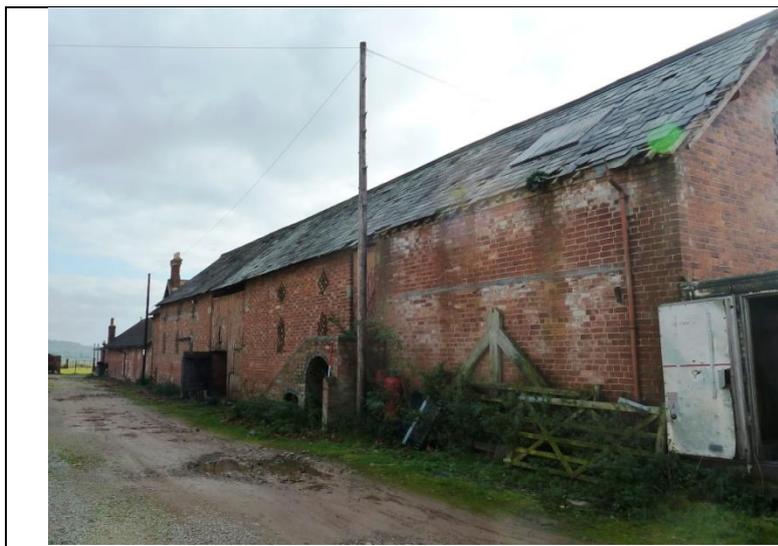
D BARN *The 8-bay barn, wider than the building to the east, occupies most of the northside of the western yard. It is ventilated, and poorly lit, by a double row of panels and the eastern leaves of the massive double doors are halved. A mezzanine floor was inserted into the eastern part of the barn in the later 20th century. SWR 20422 HISTORIC BUILDING EVALUATION 2011 Plates 17-20 No changes in 2017*

D BARN Large double leaf doors and hinges [deteriorating] on stone blocks deteriorating to North. South doors in better condition. Slate roof in poor repair.

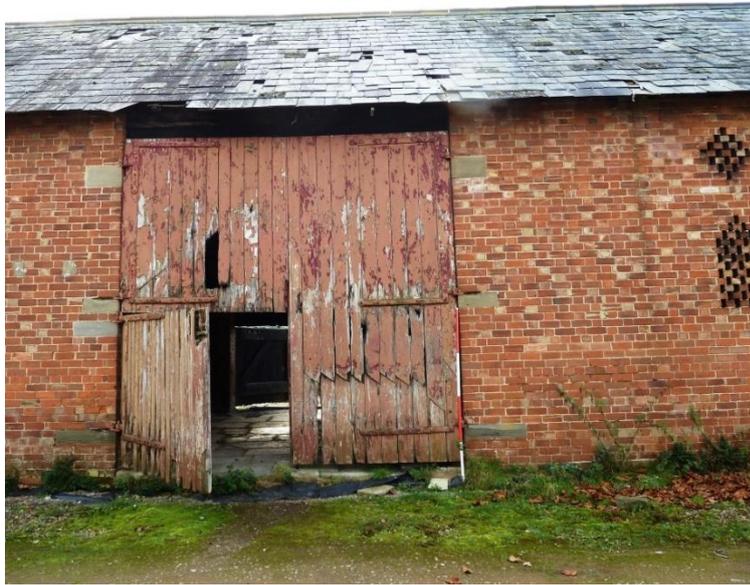
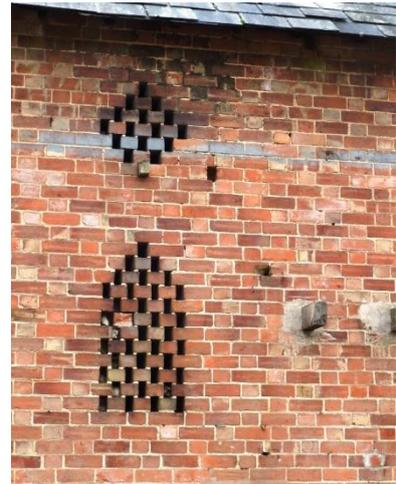
Lozenge diamond and uncommon Straight sided pentagon ventilation panels. Evidence of timbers protruding from C20 mezzanine floor LEFT side of Barn

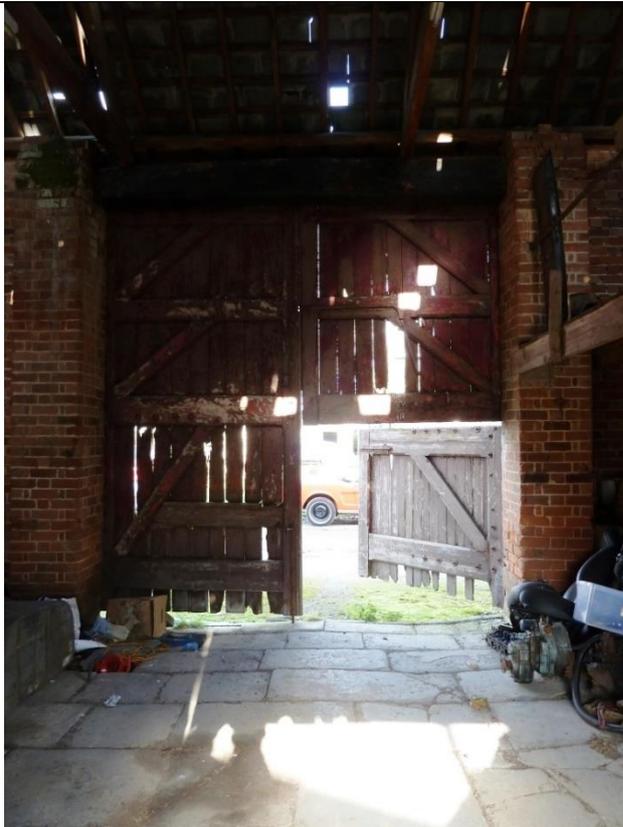
D BARN
LEFT Inside view of double leaf NORTH doors and hinges. Flagstone floor

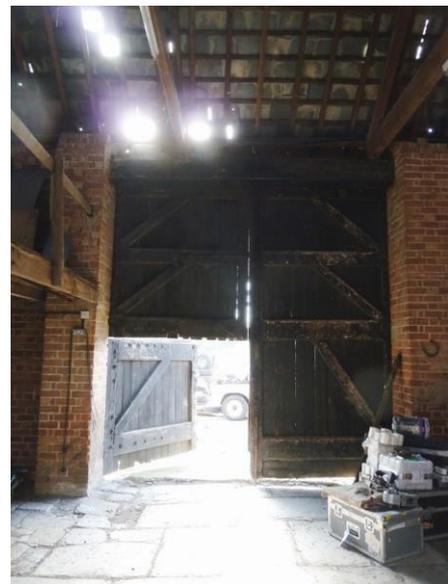
ABOVE Inside SOUTH double leaf doors In good condition.

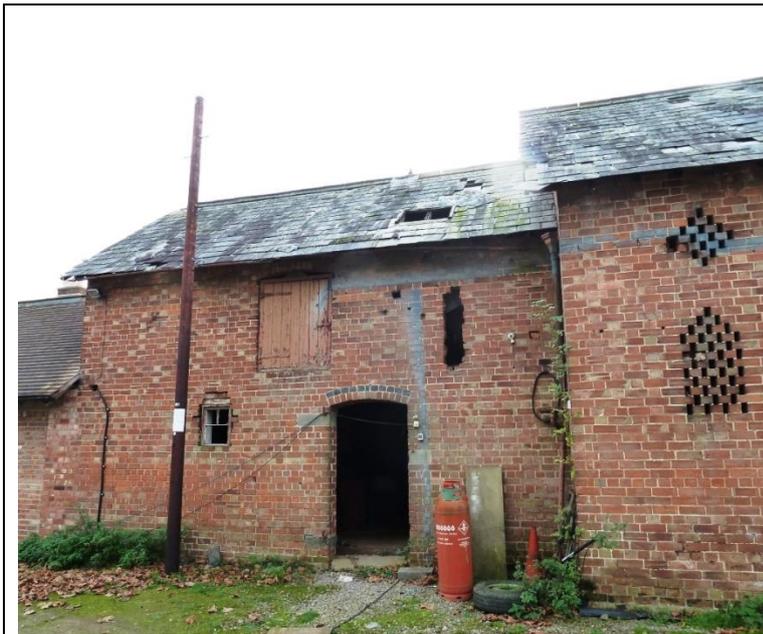
D STORE

“one and a half storey building which has doors in the north and south walls in line with the central walkway of the cow shed... There is a low door in the (short) north wall and the room is lit by two windows in the east (gable) wall, one of which retains its louvers” SWR 20422 HISTORIC BUILDING EVALUATION 2011 PLATES 1,5 &6

Small side window nearly collapsed. Slate roof in poor repair with roof light missing causing internal water ingress.

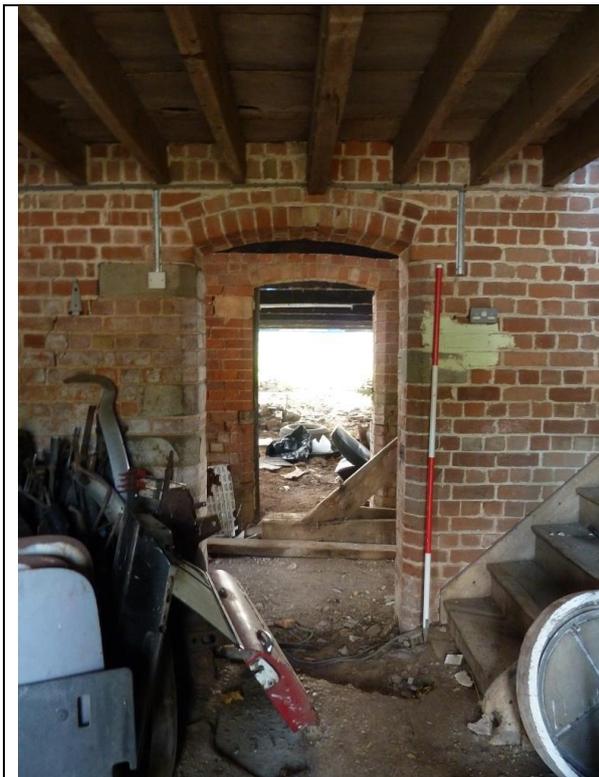
D lower STOREY STORE Door openings in the north and south walls in line with the central walkway of the cow shed

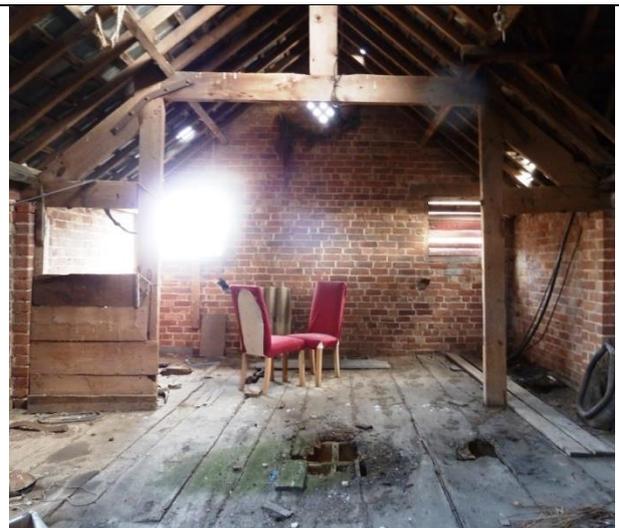
D STORE Upper Floor

Louvre window in East Gable end still intact. Floor unsafe to stand on. Approached by a C19 quarter-turn stair, with landing, in the south west corner. Interrupted frames of the three-bay upper floor.

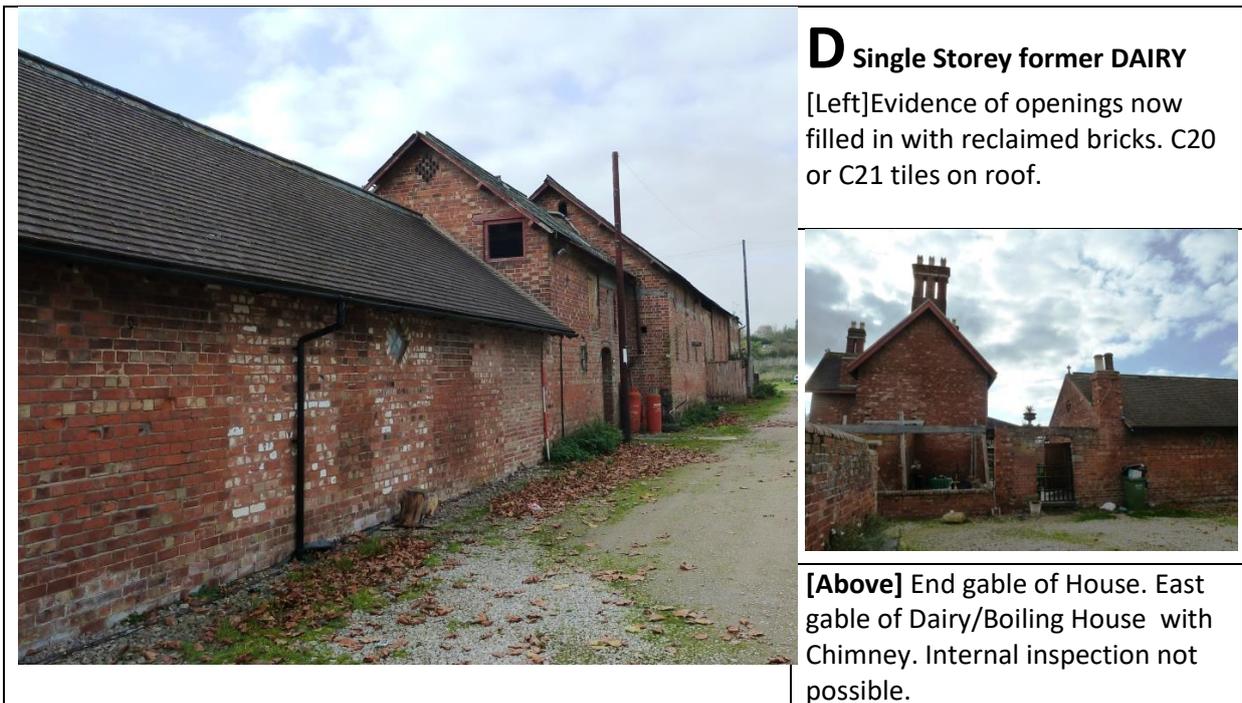
D Single Storey former DAIRY

[Left] Evidence of openings now filled in with reclaimed bricks. C20 or C21 tiles on roof.

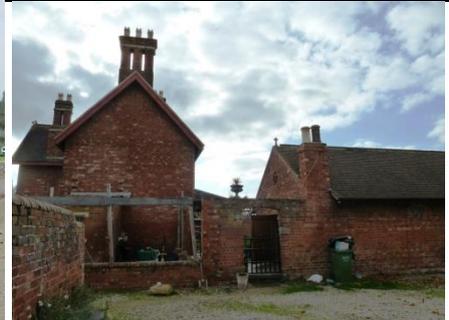
[Above] End gable of House. East gable of Dairy/Boiling House with Chimney. Internal inspection not possible.

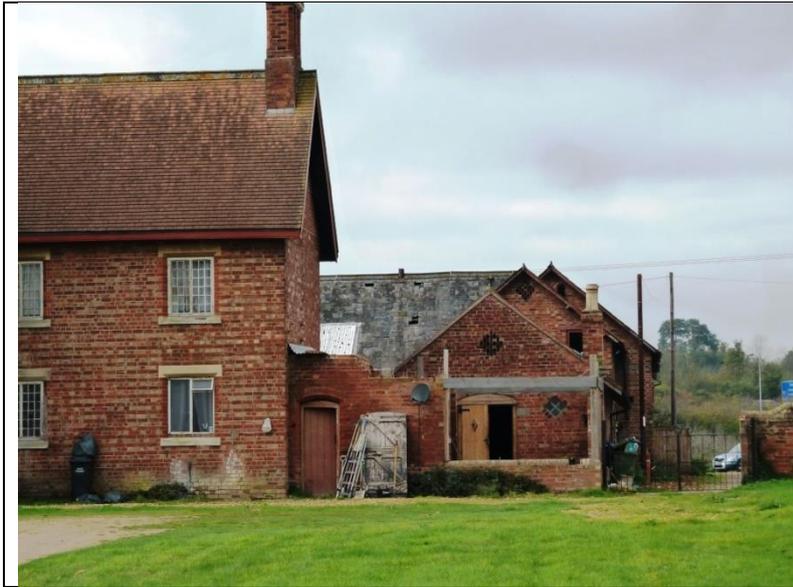
D Single Storey former DAIRY

View showing the North Wing of Farm house facing East. To the side evidence of smaller buildings/structures. Attractive Gable ends of Dairy followed by 2 Storey Store House followed by Barn. Cow House slate roof in between the East and West yards.

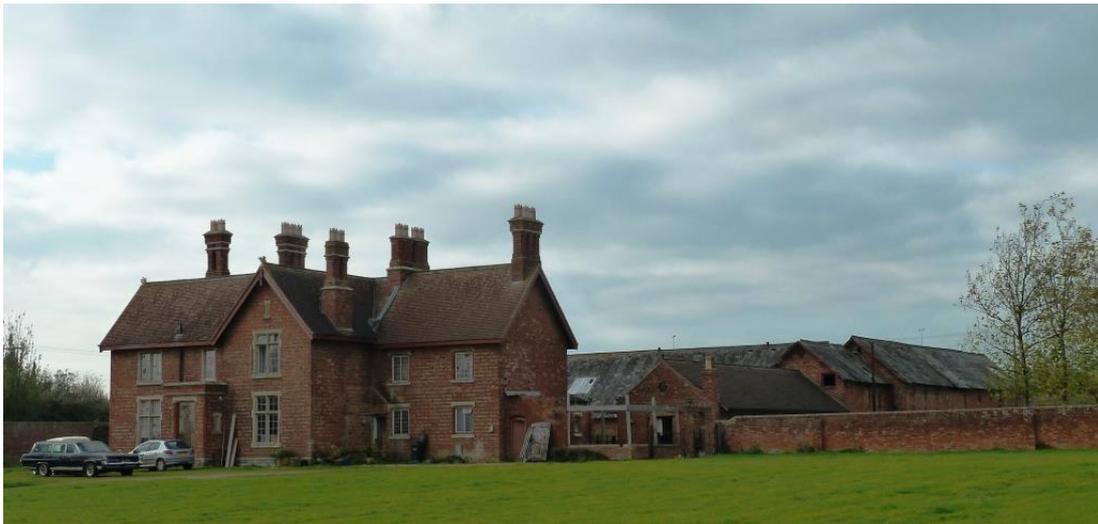
The possible former Dairy building seen as the side of East Courtyard setting

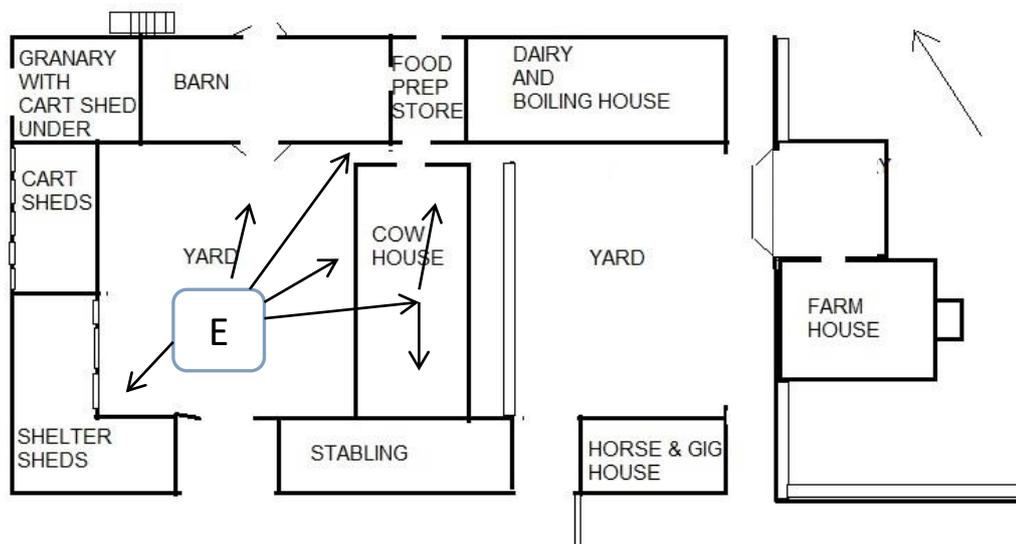
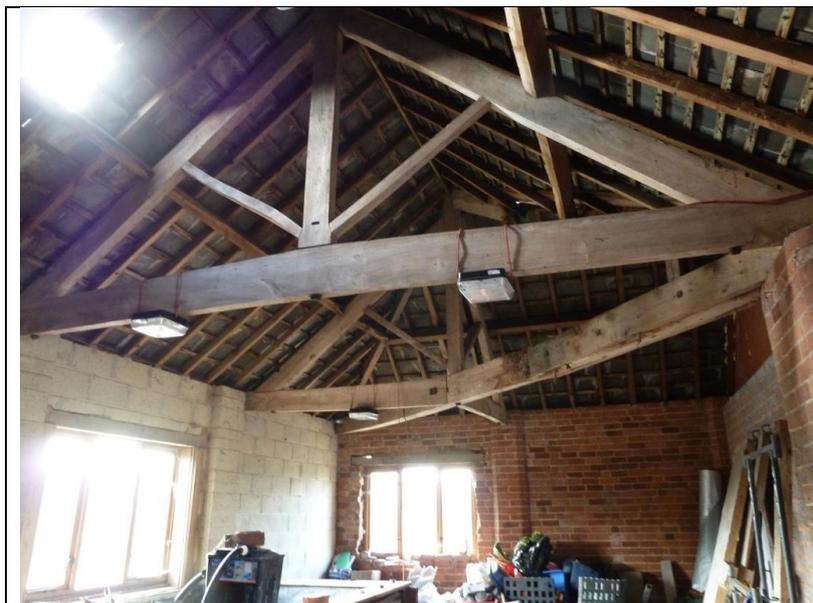
E WEST YARD SHELTER SHEDS

Since 2011 these have been blocked and windows inserted but the corner diagonal substantial king strut remains [Ref Plate 14 SWR 20422 HISTORIC BUILDING EVALUATION 2011]

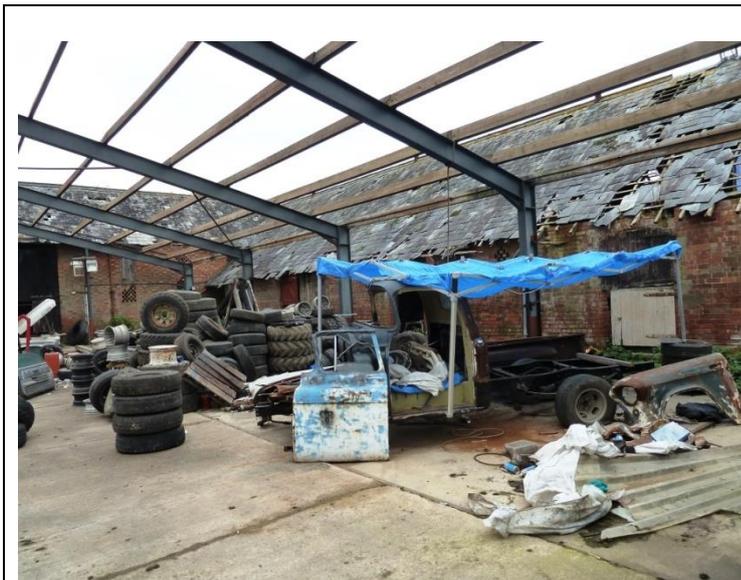
E A 10 bay cow-shed, the great span of which required a Queen-post roof, with additional very long bolts alongside the Queen-posts connecting the tie-beam and the strainer-beam. There are flues (without their hats) along the ridge. Roof-lights were inserted into the east roof-slope in the later 20th century. A seven foot wall, with central door, across the north end separates the shed proper from a narrow cross-passage, with little gates at each end, connecting the west and east yards. SWR 20422 HISTORIC BUILDING EVALUATION 2011

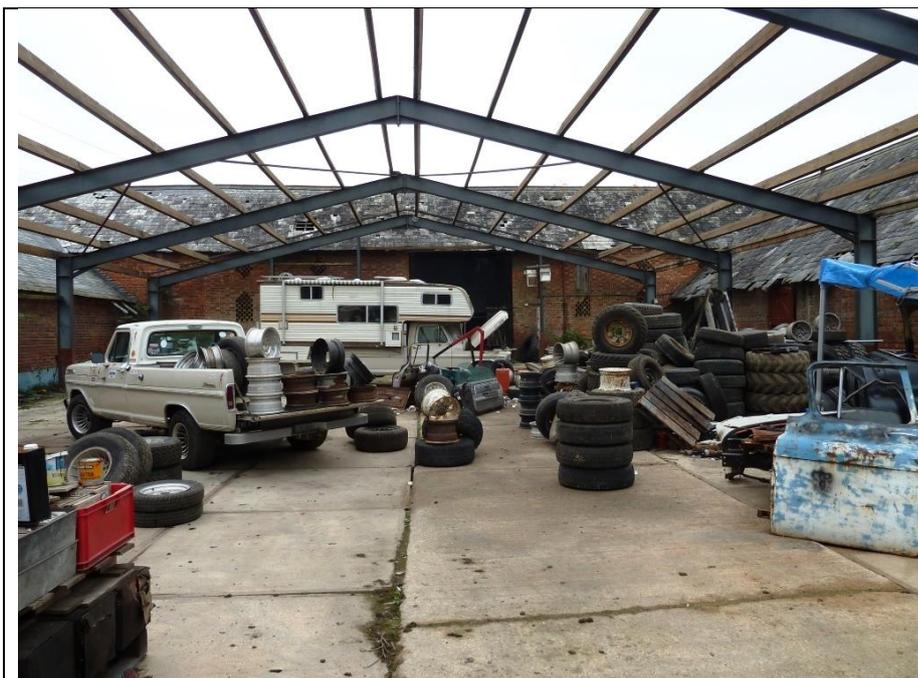
E Looking from the **West Yard** entrance towards the Barn, Cow House to the right [E] Covered roof removed from the Yard. In 2011 it was covered [See Plate 8 SWR 20422] Yard concreted over probably in the C20

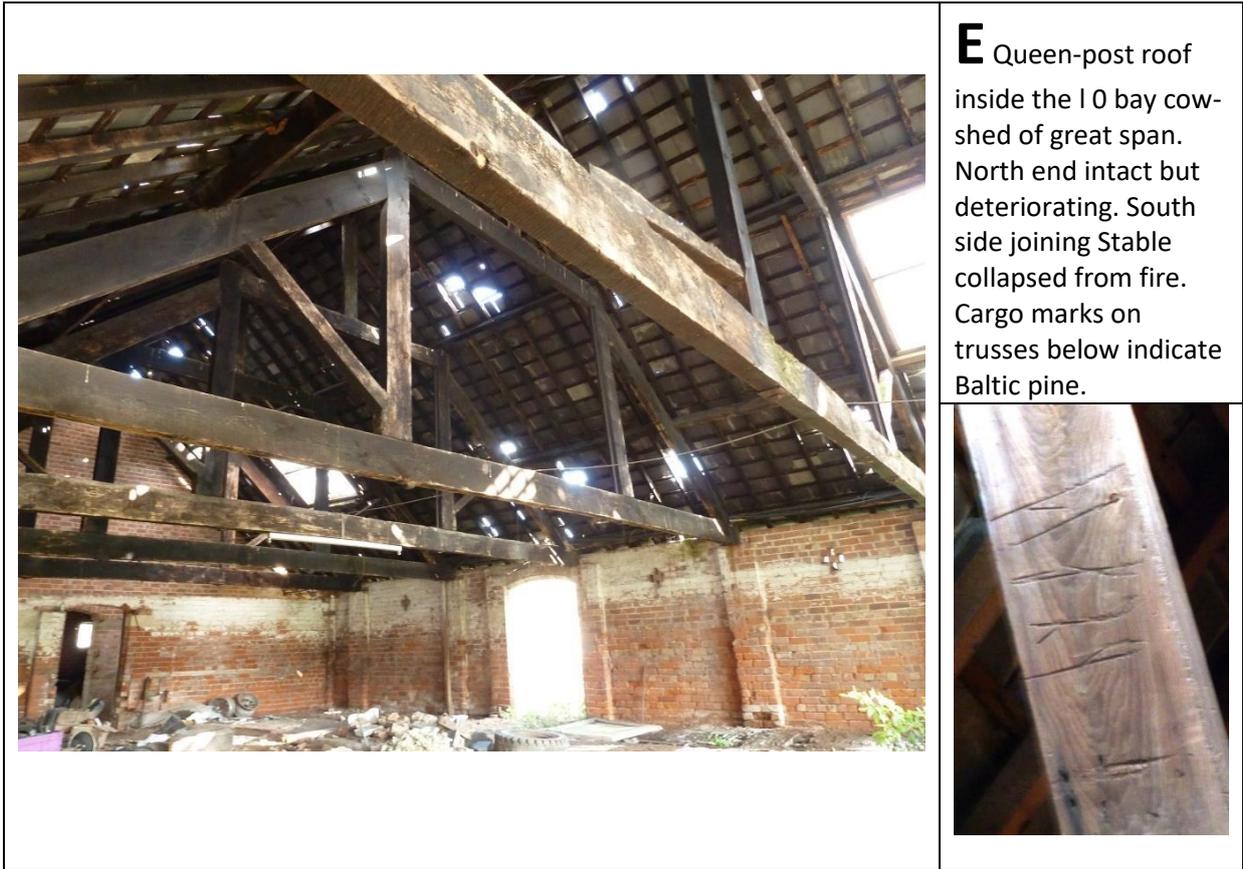
E Queen-post roof inside the 10 bay cow-shed of great span. North end intact but deteriorating. South side joining Stable collapsed from fire. Cargo marks on trusses below indicate Baltic pine.

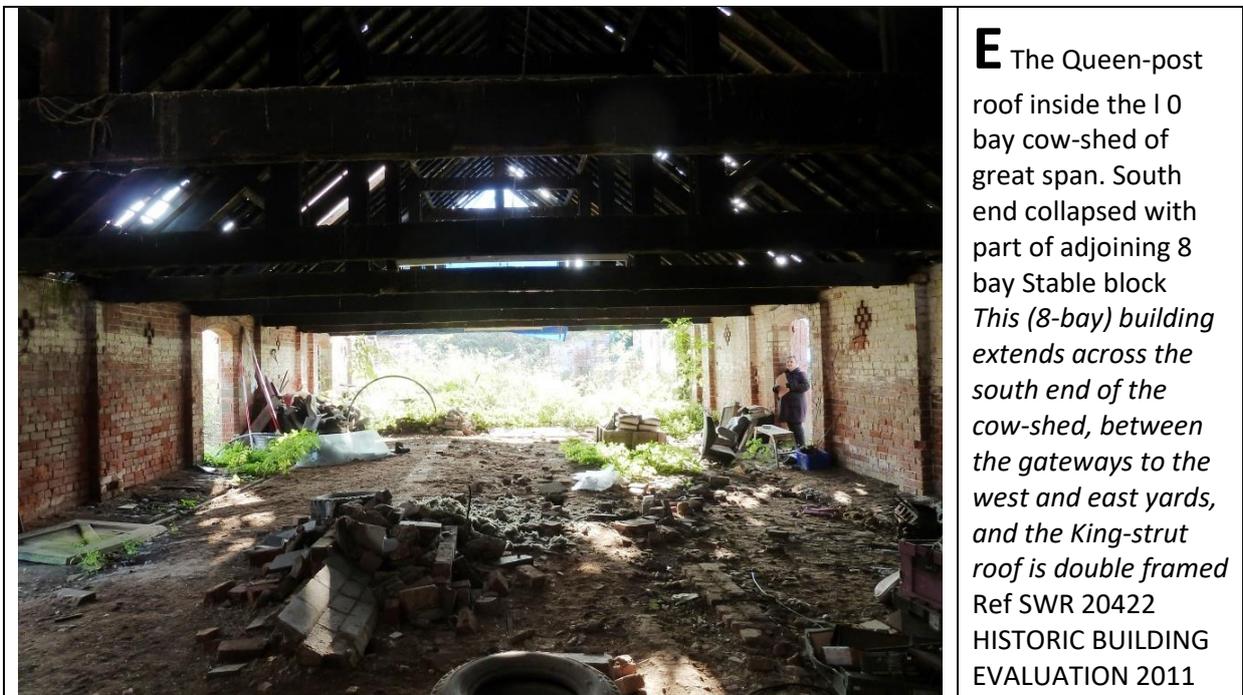
E The Queen-post roof inside the 10 bay cow-shed of great span. South end collapsed with part of adjoining 8 bay Stable block *This (8-bay) building extends across the south end of the cow-shed, between the gateways to the west and east yards, and the King-strut roof is double framed* Ref SWR 20422
HISTORIC BUILDING EVALUATION 2011
