Rapid Appraisal and Assessment Bredon Field Farm Strensham WR8 9BL Authors RDA

3. Rapid Appraisal of Bredon Field Farm and Farmstead

3.3.1 Site Assessment Summary

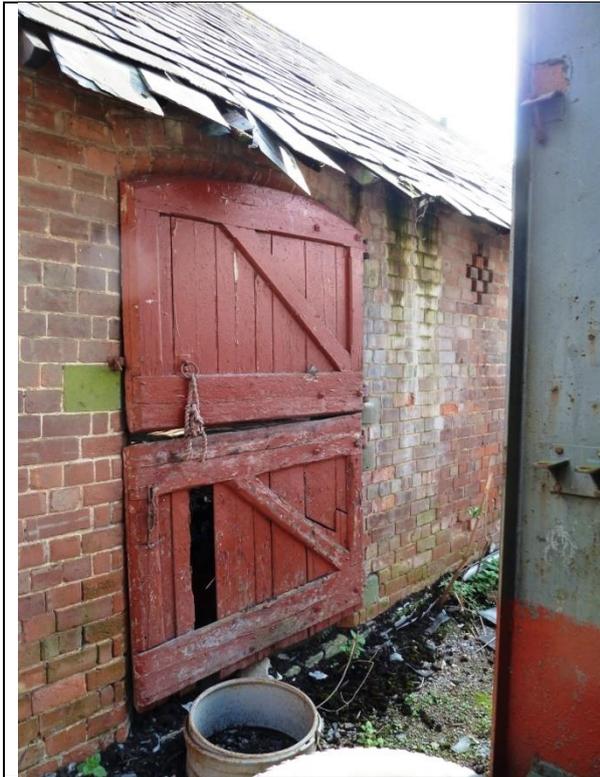
E COW HOUSE STABLE DOOR

A remaining Cow House door facing the West yard

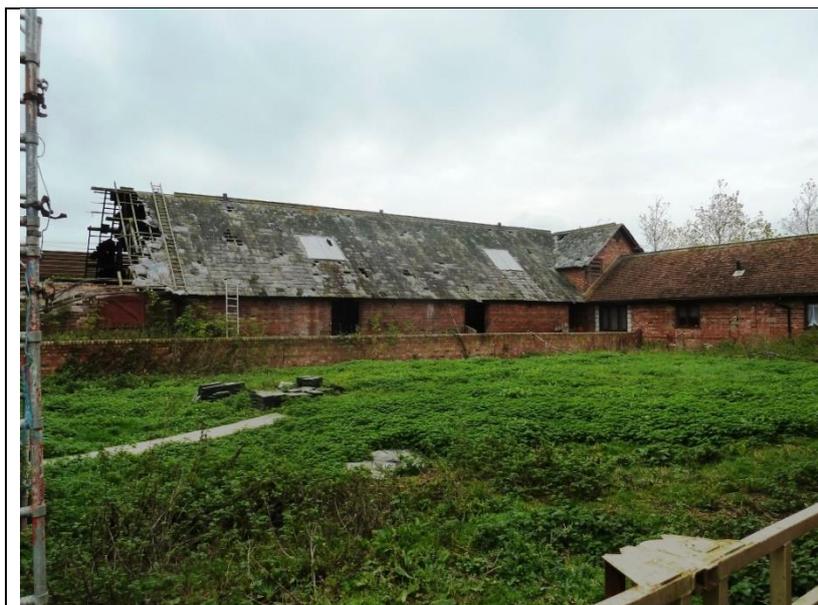
F EAST YARD

East side of Cow House with original brick wall in front of Cow House openings. South end of Cow House having collapsed by the fire.
