RDA Heritage Assessment/Statement of Significance, The Counting House, Bill Mil on-Wye. HR9 5TH	lls, Pontshill, Ross-	
6.2.3 Historical Value	28	
6.2.4 Aesthetic /Setting/Group Value	28	
6.2.5 Community Value	28	
6.3 Statement of Significance The Counting House	29	
Bibliography		
Appendix I HER report	30

5. 2019 Photographic Record and Descriptions Building Recording Level 1 at The Counting House Bill Mills HR9 5TH

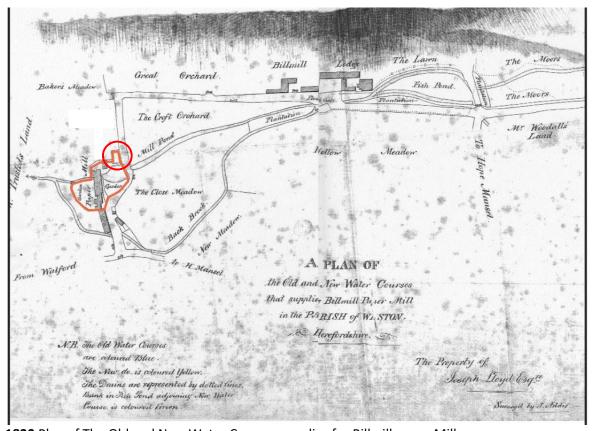
1820 Plan of The Old and New Water Courses supplies for Billmill paper Mill

The tithe map of 1839 describes the site as Bill Mill with houses, garden and buildings, with Thomas Bright still in residence and living on the site. By this time the mill pond had been increased in size with the addition of the stone-built retaining wall. In 1891 there was much building work conducted on the site and by the time of the Ordnance Survey of 1904, this was completed, with the buildings much as they are today. In 1989 a modern factory was built at Bill Mills, and this included the addition of the brick and steel framed structure at the northern end [Ref Building Recording dated 2005 'Bill Mills, Pontshill, Ross-on-Wye, Herefordshire Building Recording For H. E Coombes by Clare Challis and Dave Fellows Thames Valley Archaeological Services Ltd]

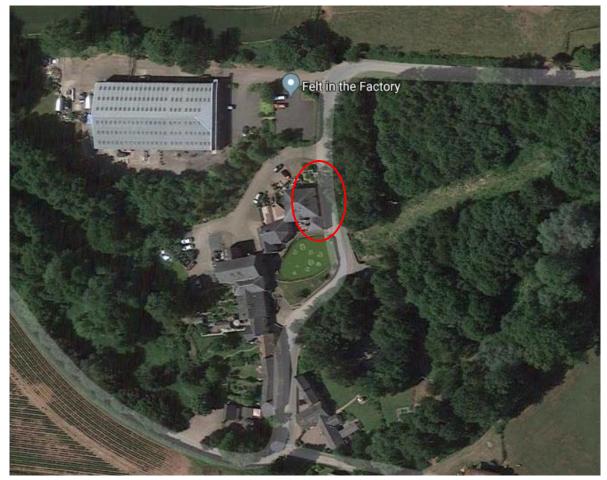
2019 Google Satellite Map

The map regression above shows that the building that is now The Counting House and Wintles [See 2019 Satellite map] and dates from the 19th Century post-dating the Mill that is described and shown on earlier plans and maps

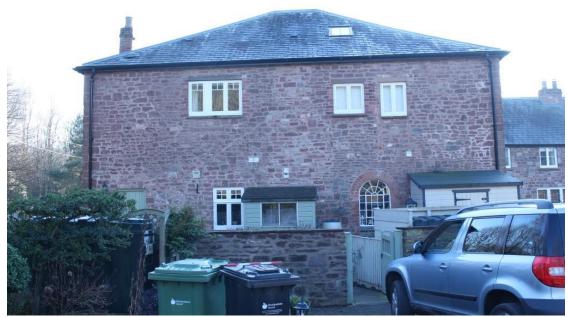
Photo North Elevation

North elevation under slate hipped roof, and is of stone construction, old red sandstone, coursed, undressed rubble masonry with dressed quoins to north side. It has flush pointing with hard cement.

There is evidence of historic variation in the stonework and a shadow line of a now demolished offshot structure that stood against this elevation pre 2006 conversion, that contained a staircase to the first floor of the building. [See 3.1.2 and Plate 20 Photo]

At first floor level is X1 timber three light casement window. Each casement has two lights at top, sited three stone courses below eaves with painted stone lintel and double tile sill, alternating header and stretcher brick jambs. This window is part of the 2006 conversion and replaced an earlier window in the same position.

Ground floor is a plain ledged door with a timber two light mullion casement window with four light square heads. Both have steel lintels. This window is part of the 2006 conversion. Lean-to mono pitched wooden shed to side.

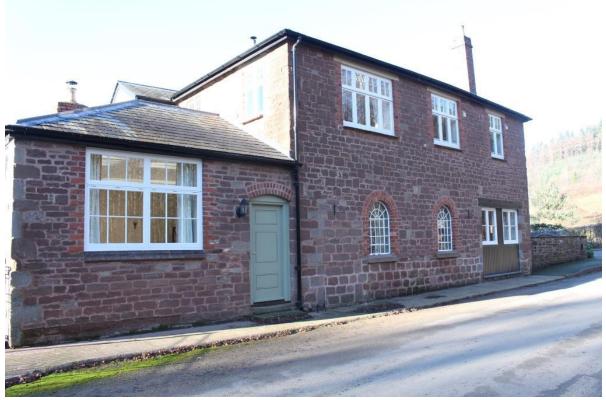
Photo East Elevation

East elevation under a slate hipped roof and is of stone construction, old red sandstone, coursed dressed masonry with dressed quoins to each side. It has flush pointing with hard cement. Tall brick Chimney stack rises from this elevation.

On the first floor at eaves level there are three timber-framed mullion windows with brick jambs, one 4-light, one 3-light and the last 2-light, each casement has four fixed lights at its top section. These windows are part of the 2006 conversion and replaced earlier windows in the same position.

On the ground floor two timber casement windows with glazing bars set in vertical timber panelling within a former door opening with a timber lintel and stone jamb, part of the 2006 conversion. To the south of the door within double header brick segmental arches are two original cast iron casement windows with central opening section and fanlight heads and cast-iron glazing bars. Stone sills. Evidence of historic blocked doorway is visible to the side of these windows.

The east elevation continues with an attached single storey stone building, old red sandstone, coursed dressed masonry under a hipped slate roof. Three panel door set in original opening with double header segmental arch with a large timber mullion casement window in brick jambs and double brick sill with bottom opening top hung 3 over 6. This window and door date from the 2006 conversion. Replacing an earlier window and door in the same position

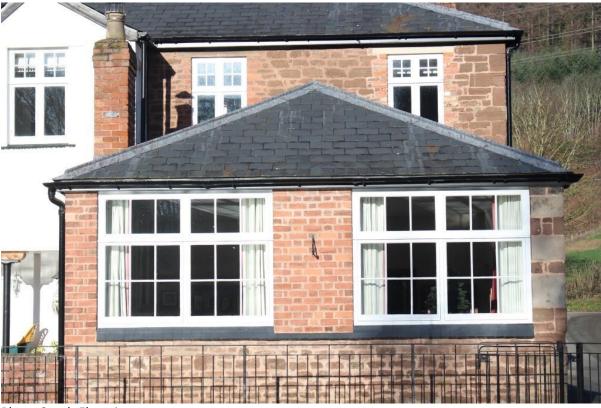
Photo South Elevation

The 1st floor of the two-storey building is the south elevation under a slate hipped roof and is of stone construction, old red sandstone, undressed rubble masonry with dressed quoins to the north side. It has flush pointing with hard cement. At eaves level are two timber side hung mullion casement windows with fixed top lights divided into four small panes. They have stone lintels and set in brick jambs. These windows date from the 2006 conversion and replaced earlier windows in the same position.

The single storey building attached is mix of red brick and stone construction, in Flemish bond between windows and old red sandstone coursed dressed masonry, to East side of windows interspersed with grey limestone, and below windows. Two large timber mullion casement windows in brick jambs and double brick sill with bottom opening top hung 3 / 6, with brick sills. These windows date from the 2006 conversion and replaced earlier windows in the same position. A Brick chimney stack rises from the west side.

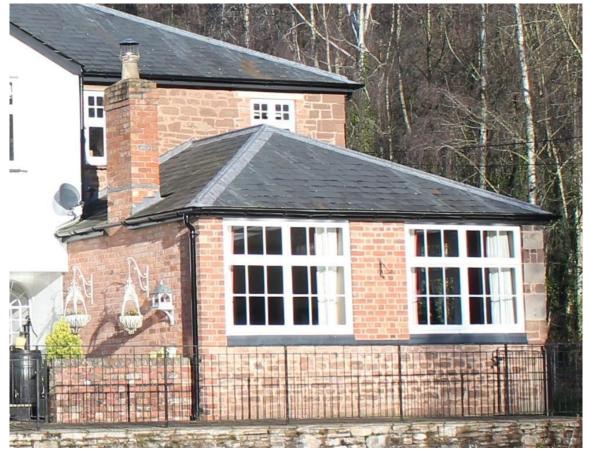
Photo West Elevation

West elevation comprises just of the West wall of the single storey extension, brick with chimney stack.
