ARCHAEOLOGICAL

WATCHING BRIEF

WB/GD/11

Huntsham Court Farm, Entrance Barn

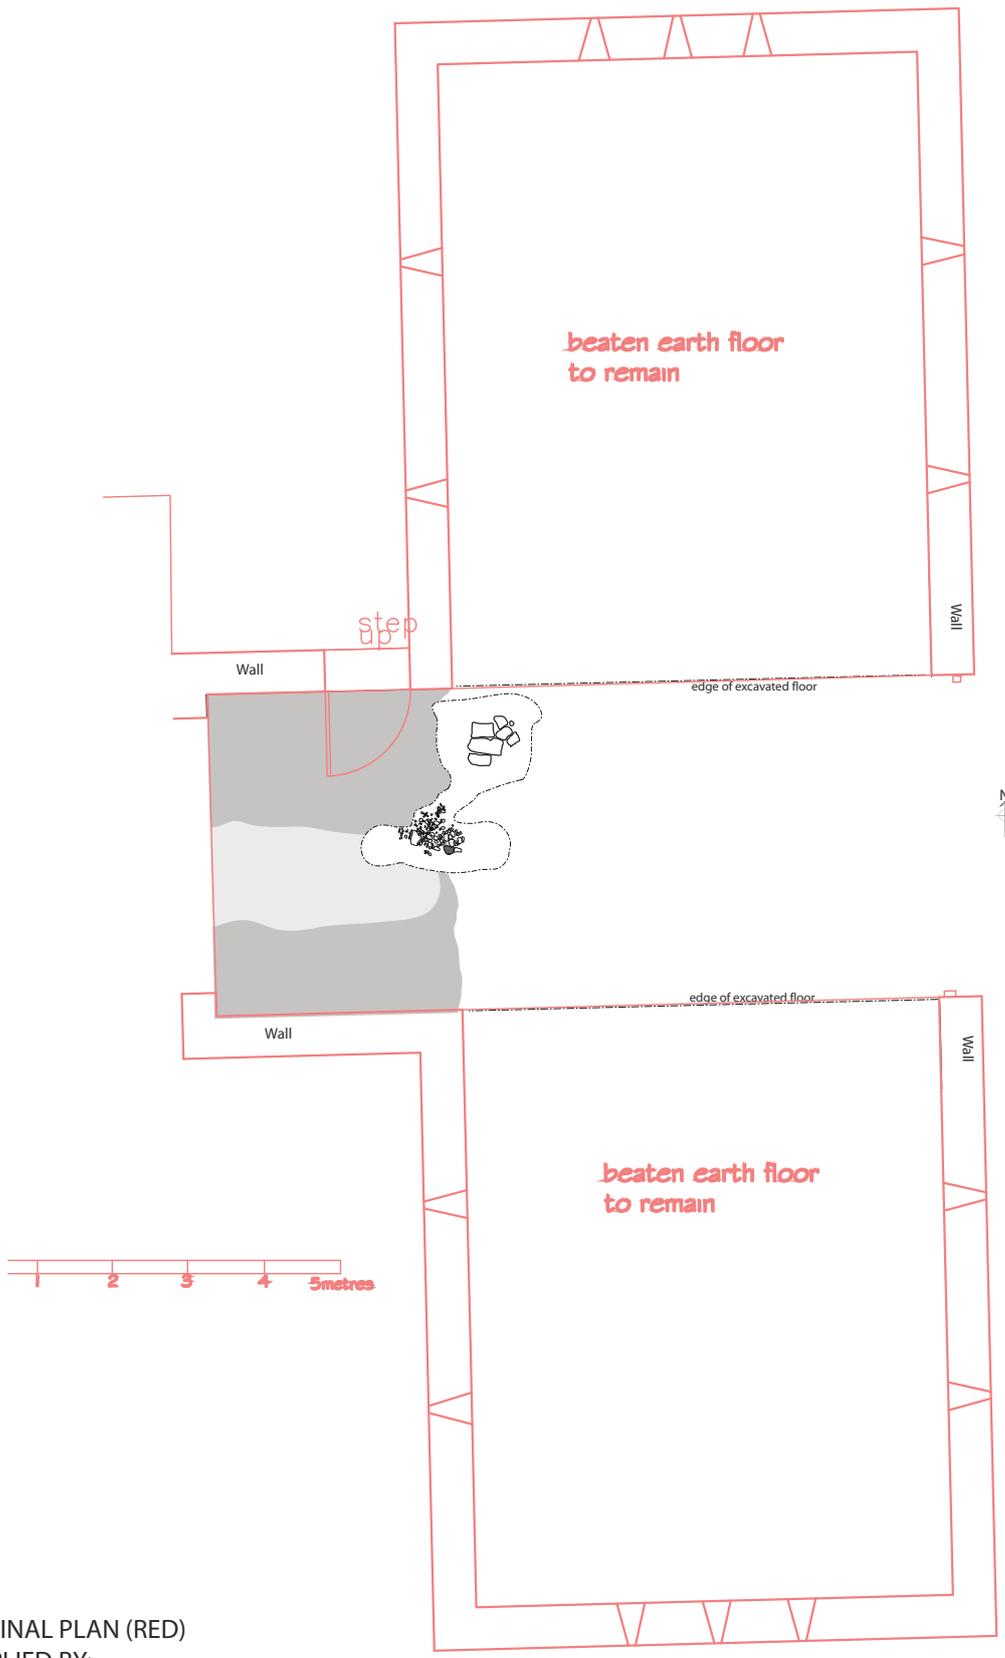
Fig 02: Site plan

The barn is mainly constructed of dressed stone with some brick embellishments, Plate 01. The floor plan is 'T' shaped having an additional porch/cart shelter on the western side, fig 02, Plate 01. The external dimensions of the barn are approximately 21.5m x 7.4m for the main barn, (Hernon a 2075-EB08). The porch measures 5.3m x 3.1m. The area of excavation; the internal passage way through the barn, Plate 02, measures 4.2m x 9.5m giving an area of 40m².

The survey record was undertaken using a Leica A 6 Disto. Data collected was recorded in field notes and imported into Auto Cad for initial processing. The processed data was then imported into Adobe Illustrator along with plans supplied by Heron Associates. Figs 02 & 03 were generated during this process.

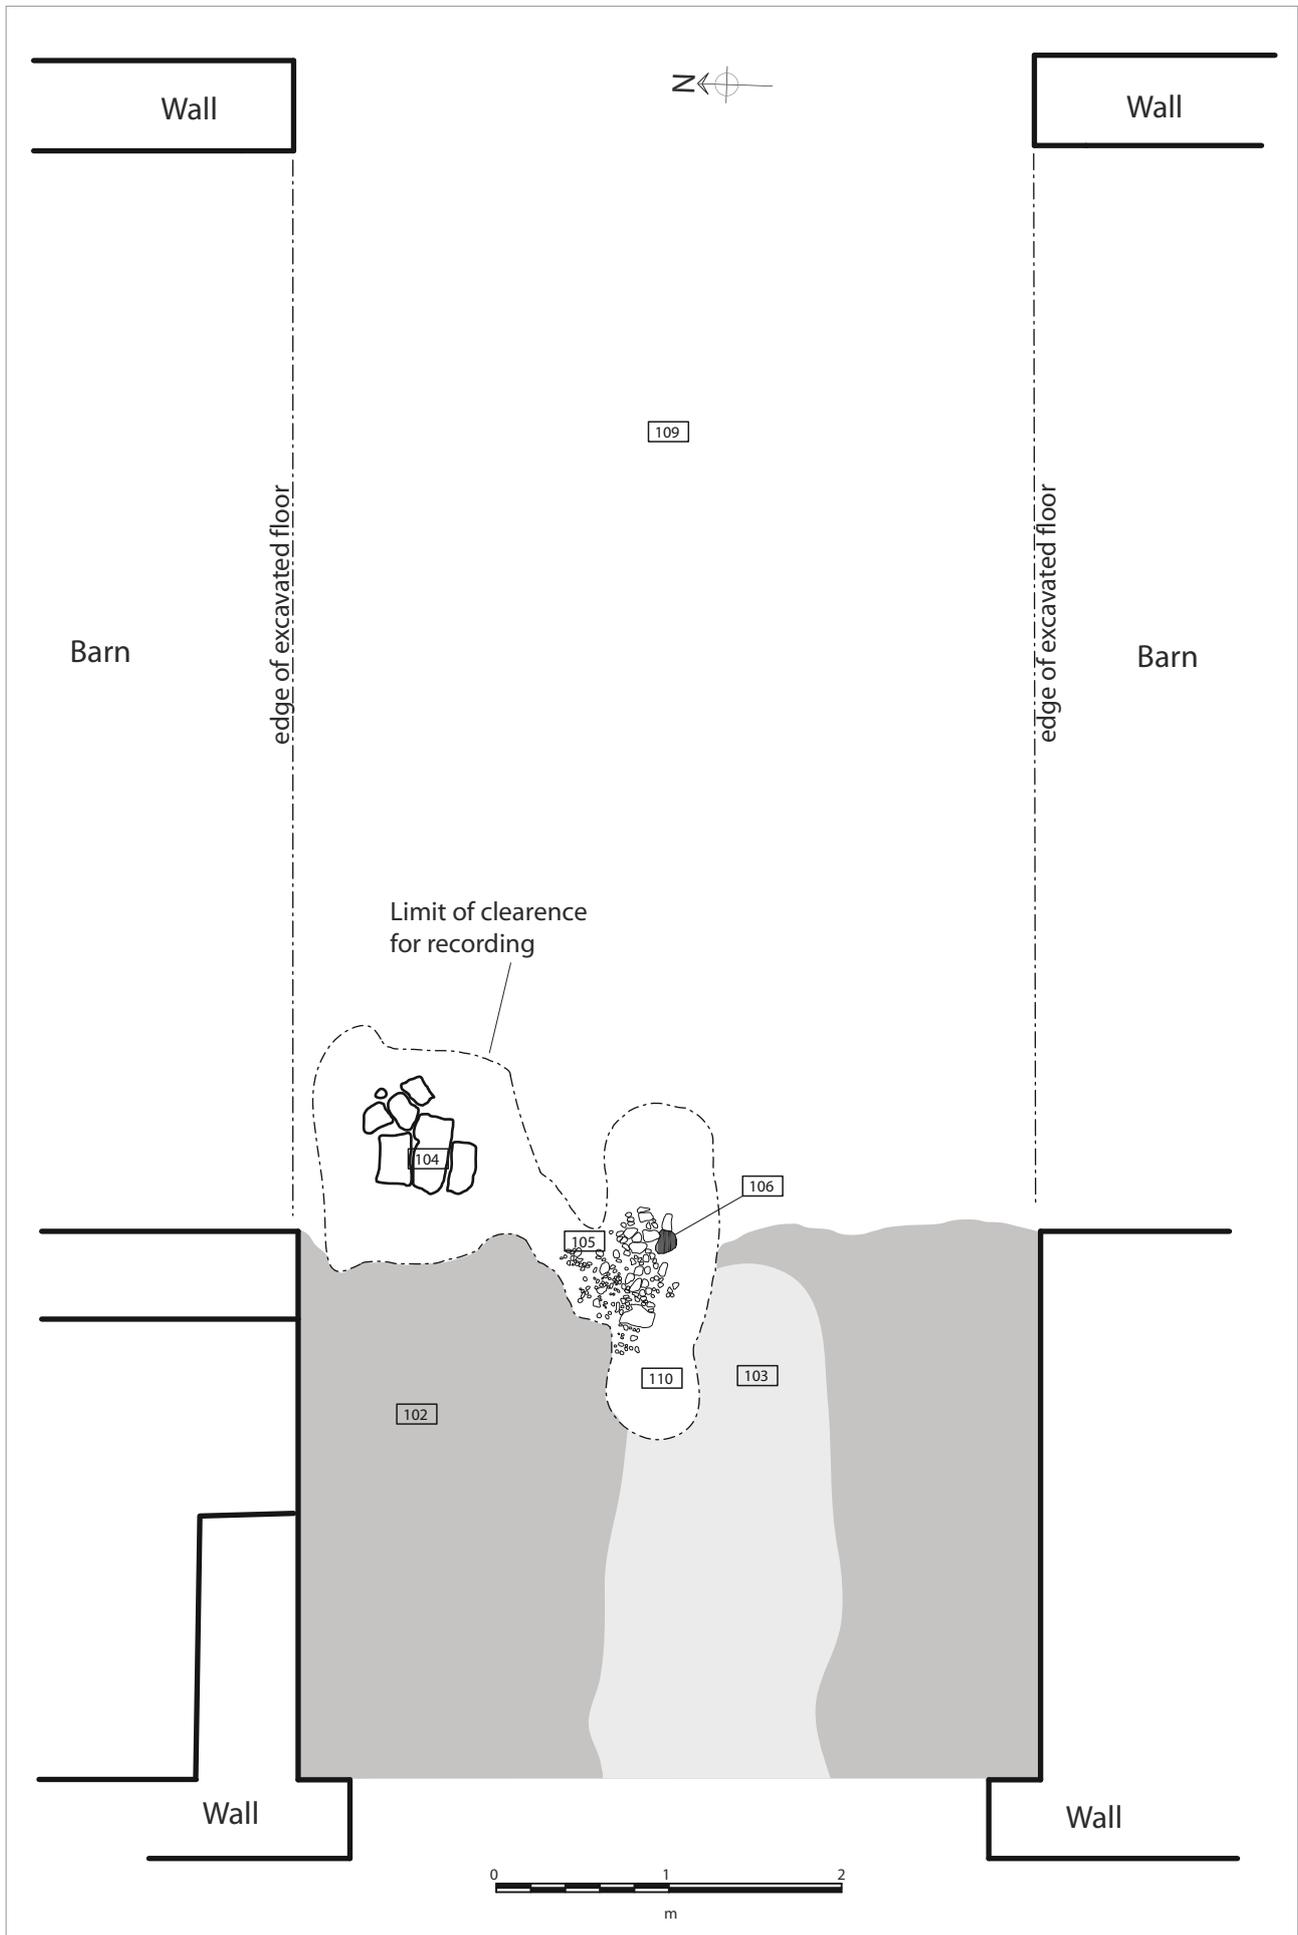
Fig 03: Plan of archaeology

The east, west and north range of [105] continued beyond the extent of the excavated area and below the limit of the work being undertaken. The southern end however had a definite edge which did not mirror the alignment of the present barn, fig 03. Furthermore a large angular post hole, [106]: 0.14m x 0.10m < 0.38m depth, opened up to the south edge of [105] during digging. The posthole had a noticeable flat edge against the south edge of [105], Plate 07.

There is a difference in sequence within the main area of the barn and that of the area of the porch. This is shown by the dividing line which falls roughly along the inside of the barn wall fig 03. It is possible that the dividing line was a cut made for the original barn foundation but subsequent development has blurred the edge of the sequence.

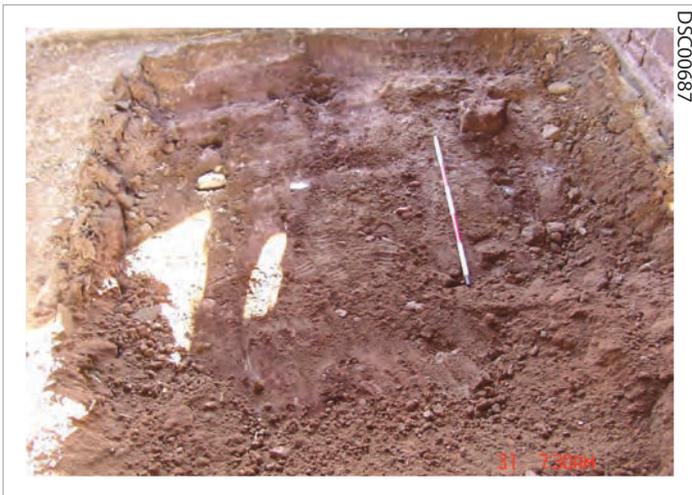
Plate 03: Initial scrape west edge of former threshing floor

The flagstones [100] had been removed from the passageway prior to the beginning of the watching brief. The exposed surface at the start of the excavation was therefore [101], a mixture of mortar and soil; the bedding for the former floor [100]. This can be seen to the left of Plate 03 which shows the first part of the soil removal. The main area of Plate 03 shows the underlying deposit [102] but to the left of the cut is the north edge of [103]. One of its characteristic chunks of lime can be seen just above the left shaft of sunlight.

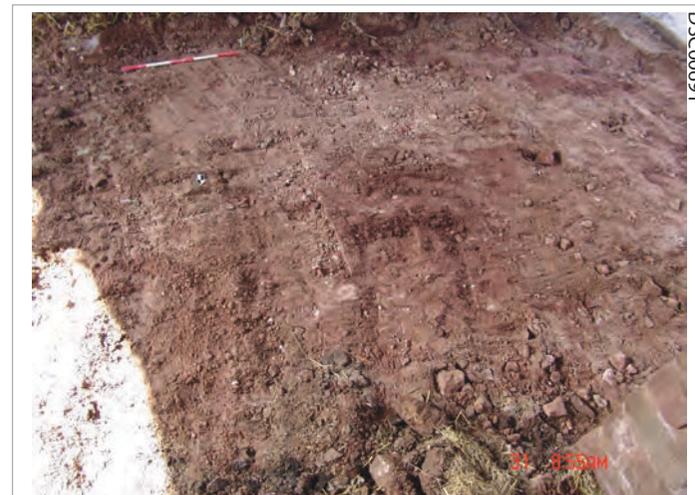
Plate 04: Second scrape west edge of former threshing floor contexts [101] & [103]

The [101] [103] interface can be seen again in Plate 04 taken just after completion of the first layer of excavation.

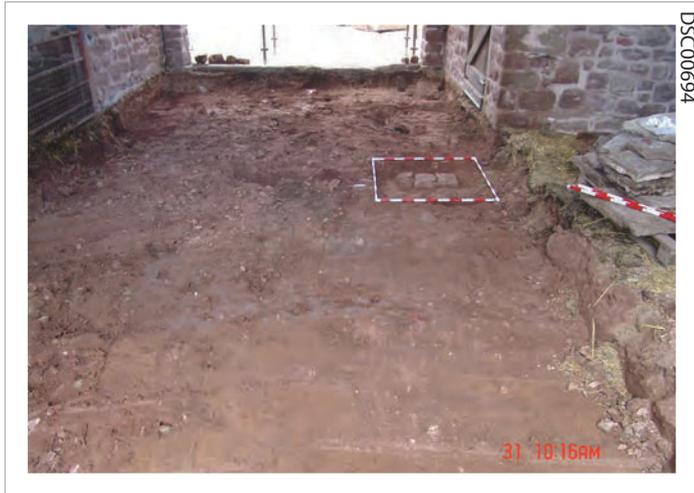
Plate 05: Position of [104]

Towards the north edge of the passageway and close to the corner of the internal wall, figs 02 & 03, Plate 05, were the remains of a floor, [104]; consisting of 3 squared, red sandstone blocks with 3 more smaller ones to the side, Plate 06. The stones were not mortared together but the intervening spaces were extremely compacted with a fill indistinguishable from [110] upon which [104] was situated.

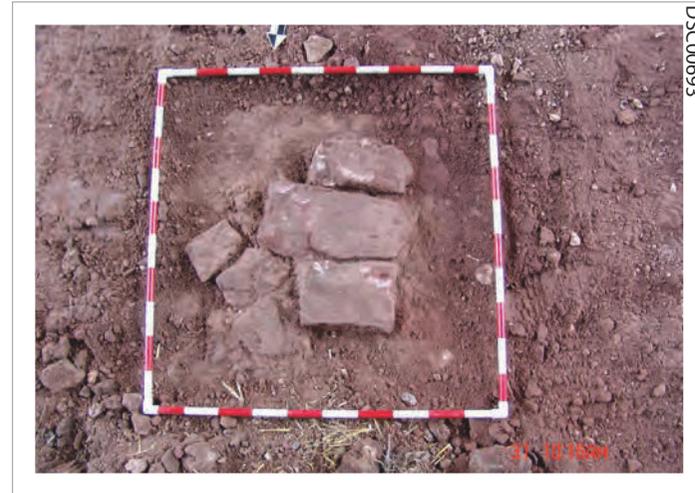
Plate 06: Vertical shot of earlier block oor [104]

The nature of the alignment to each other of the stones in [104] would tend to suggest that this had once been a floor, Plate 06. The fact that the stones stood in isolation; the rest of the surrounding area having been reduced in depth, show that these few stones were all that remained of this previous surface.

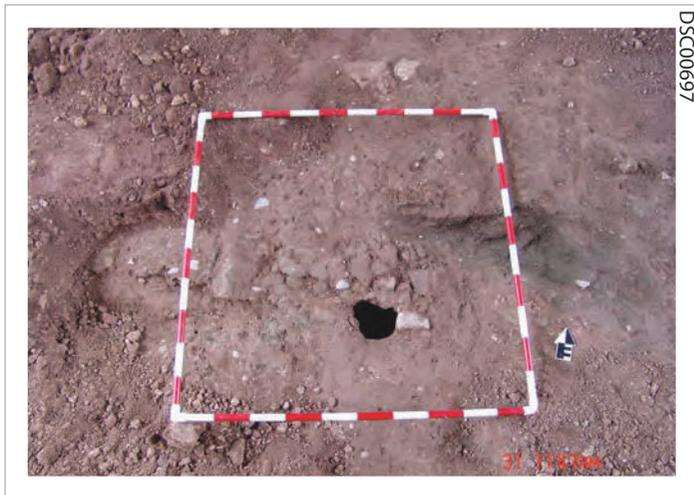
Plate 07: Extent of clearing for recording around area [105] [106]

Further towards the south, at less than a metre distance but deeper than the bottom of [104] was an area of compacted, green sandstone [105], figs 02 & 03, Plate 07. In Plate 07, the area of [104] is just outside the top left corner. The top left corner of the ranging frame rests on the surface [110] under [104]. Plate 08 shows the depth of [105] beneath [104] as approximately 0.2m. As the photograph is orientated west, the stratigraphy shows [103] not [110].

The compacted floor of [105] however cannot be concluded so succinctly. [105] would appear to have an edge that at some time had an association with a post hole Plate 07. Whether the post hole was a single event or part of a defining structure cannot be understood. It is likely however that the surface [105] had no direct association with the present barn due to the misalignment of its edge with any standing walls.

As this structure was below the depth needed for the proposed work the structure remains *in situ* for future investigation.
