REPORT

ARCHAEOLOGICAL WATCHING BRIEF

Planning Application No: P1507/12/FUL

FDDC P1507/12/FUL. Reinstatement of outbuilding to provide occupational staff accommodation for use in conjunction with the ASHA Centre. Full permission.

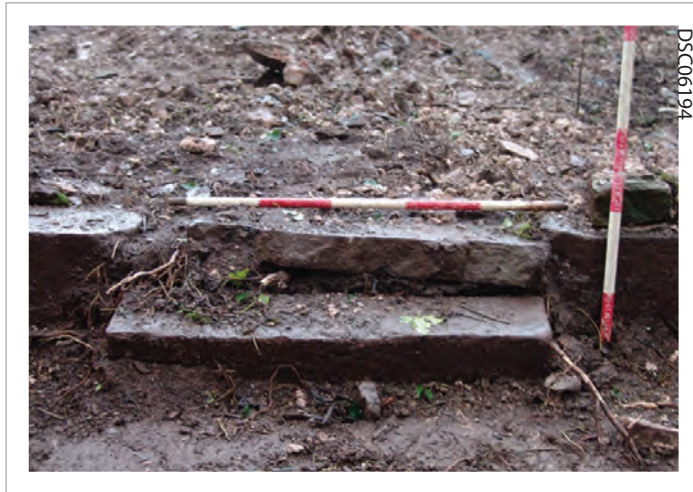
Careful clearance work had revealed the presence of the two steps and a pair of chamfered ashlar door jambs at the south east gable, Plates 01 & 02, (*It was suggested in the building recording survey (Phasing BS/FLX/13) that there may have been a central window or door.*)

Plate 01: Original steps to south east gable entrance, Two chamfered door jambs, either side

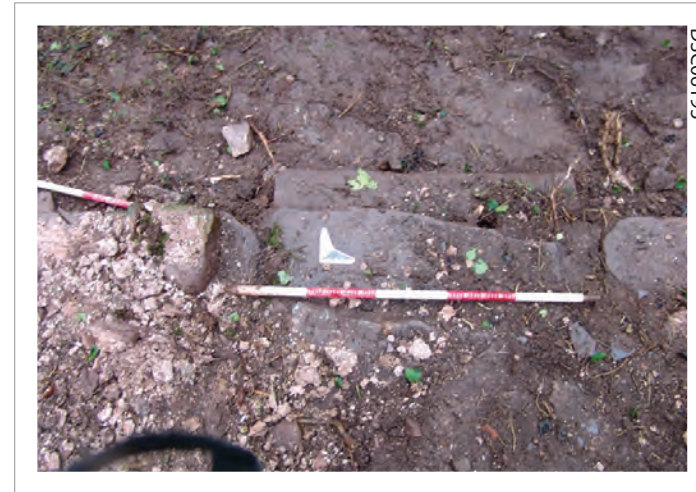
Plate 02: Vertical view of steps at original south east gable entrance

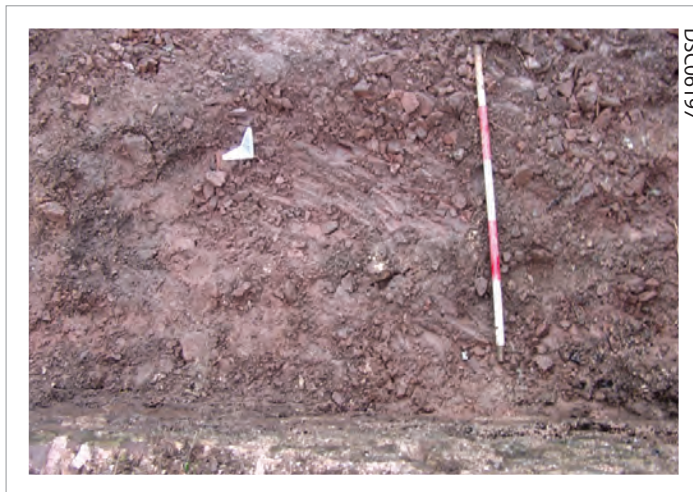
Actual excavation within the building was to reveal nothing to distinguish any soil cover over the natural surface [102], Plate 03, once the overburden of modern deposit [103], Plate 04 had been removed.

Plate 03: Inside of north east wall. Brown soil/debris removed to reveal red sandy soil on top of red sandstone bedding

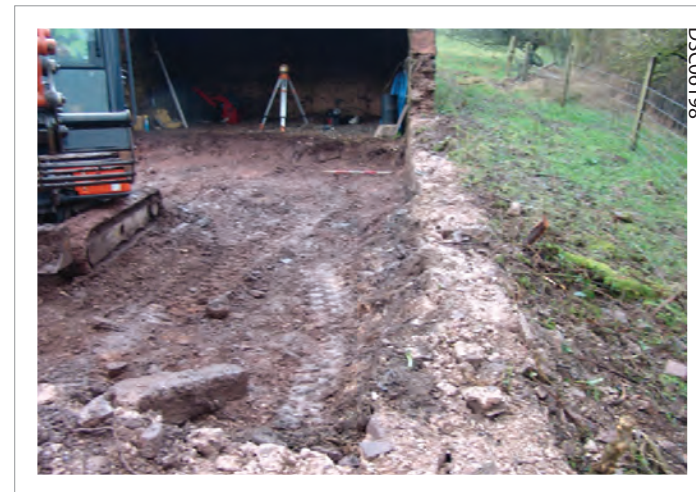
At the rear of Plate 04, the higher level of ground is a relatively recent floor (*Gifford pers comm.*) of compacted soil [104] over coarse gravel [105] to a depth of $\leq 200\text{mm}$ before [102] was reached.

A defined boundary did exist suggesting that the new floor [104]/[105] had been added to rather than dug into the natural [102].

Plate 04: View along north east wall showing debris removal internal and soil build up external

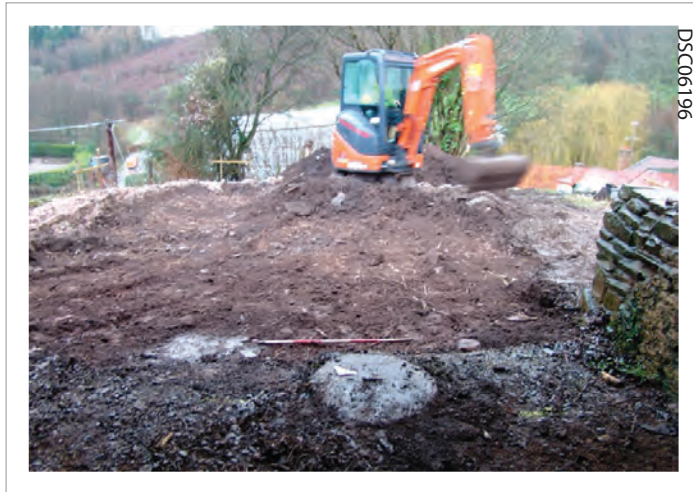
This was further confirmed when the concrete post shown in Plate 05 was removed to provide a section into the underlying natural, [102]. *No photograph was taken as the removal of the large mass of concreted was a non delicate operation resulting in an ill defined crater.*

Plate 05: View across site from covered north west end, Concrete post foundation in foreground (not a mill wheel)

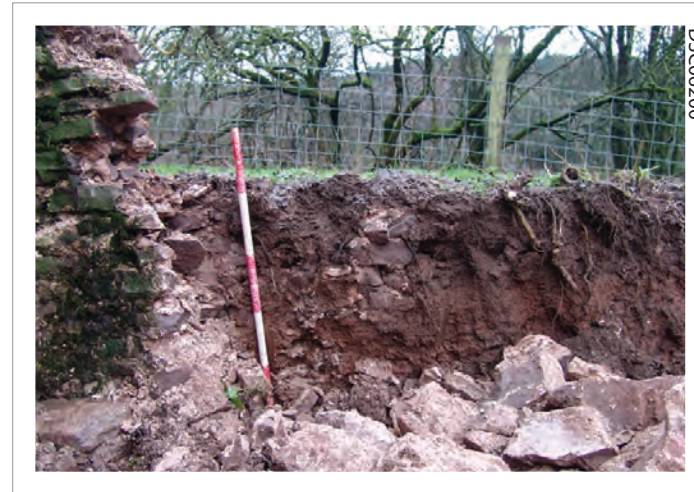
The building's walls [109], where they were excavated, sit on the natural [102] and were originally dug through [101] to a depth of $\leq 600\text{mm}$.

Externally, the outer $\leq 300\text{mm}$ surface of soft brown deposit has accumulated within the lifetime of the building, Plate 06.

Plate 06: Former north east wall section. Foundation to 860mm. External sequence [100] [101] [102]. Internal [103] [102]

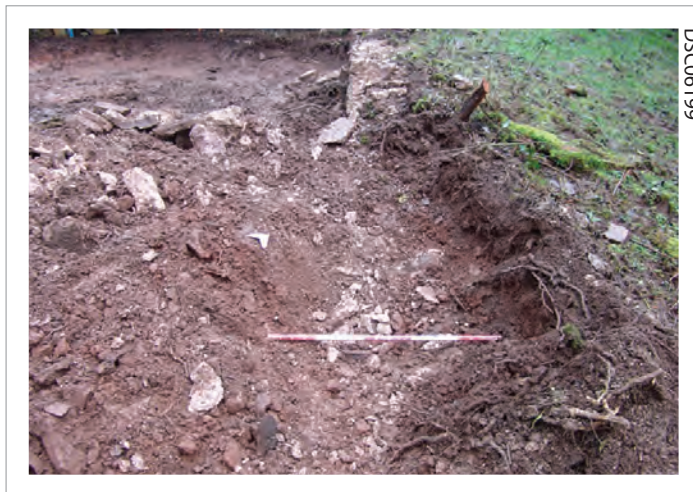
The width of the walls at foundation were $\leq 600\text{mm}$ reducing to $\leq 300\text{mm}$ at around original ground level, Plate 07.

Plate 07: View along north east wall showing debris removal internal and soil build up external and depth of foundations

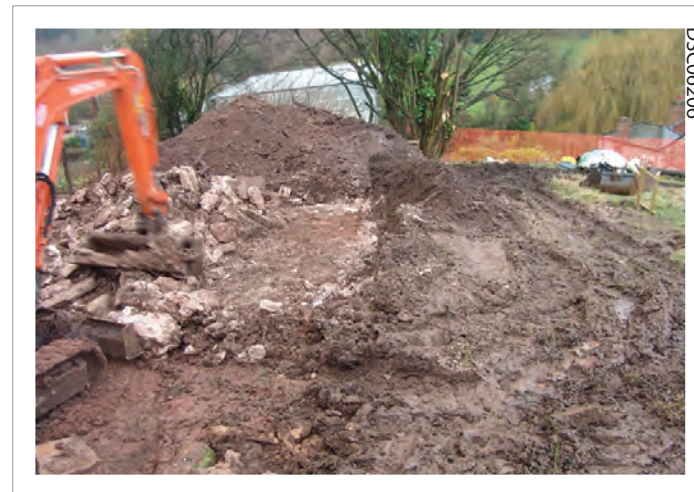
This was to be achieved by removing the very narrow muddy path to the south west and replacing it with compacted scalpings as a temporary measure, Plate 08.

Plate 08: View along former access track to the south east during surface removal prior to path construction. 2

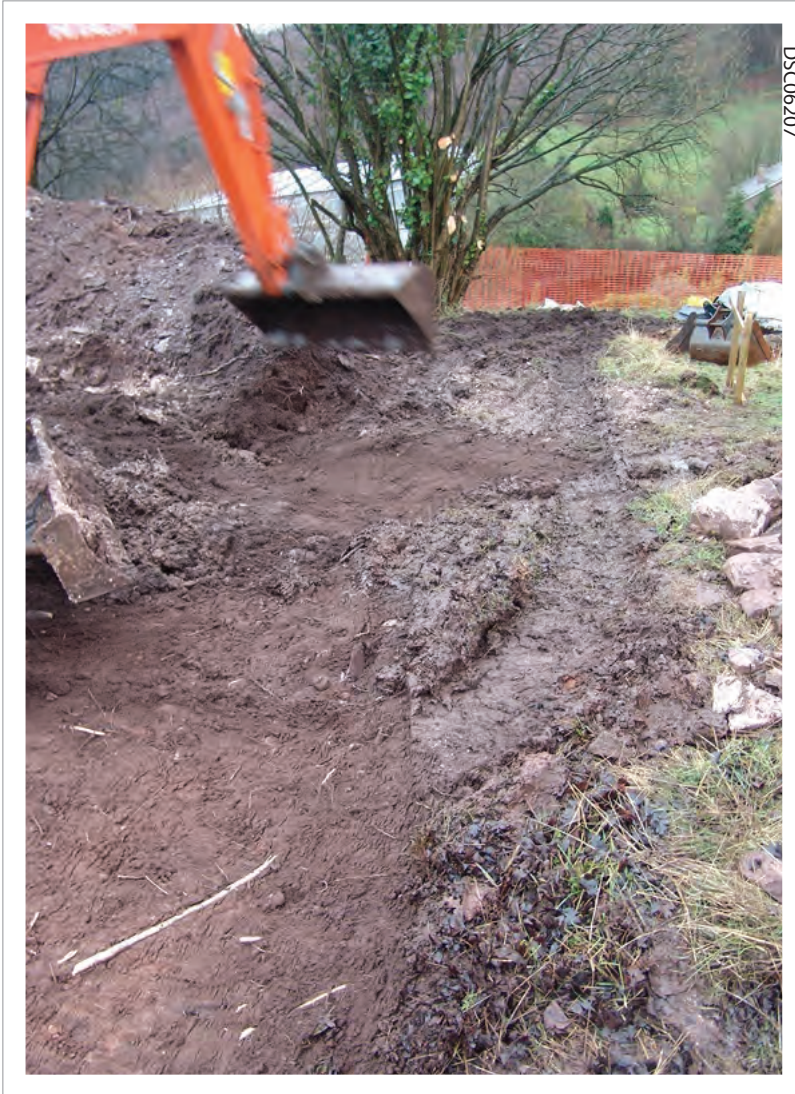
It came as something of a surprise when the thin cover of topsoil [108] quickly revealed natural [102] just beneath the surface, Plates 09 & 10.

Plate 09: View along former access track to the south east during surface removal prior to path construction [102] exposed

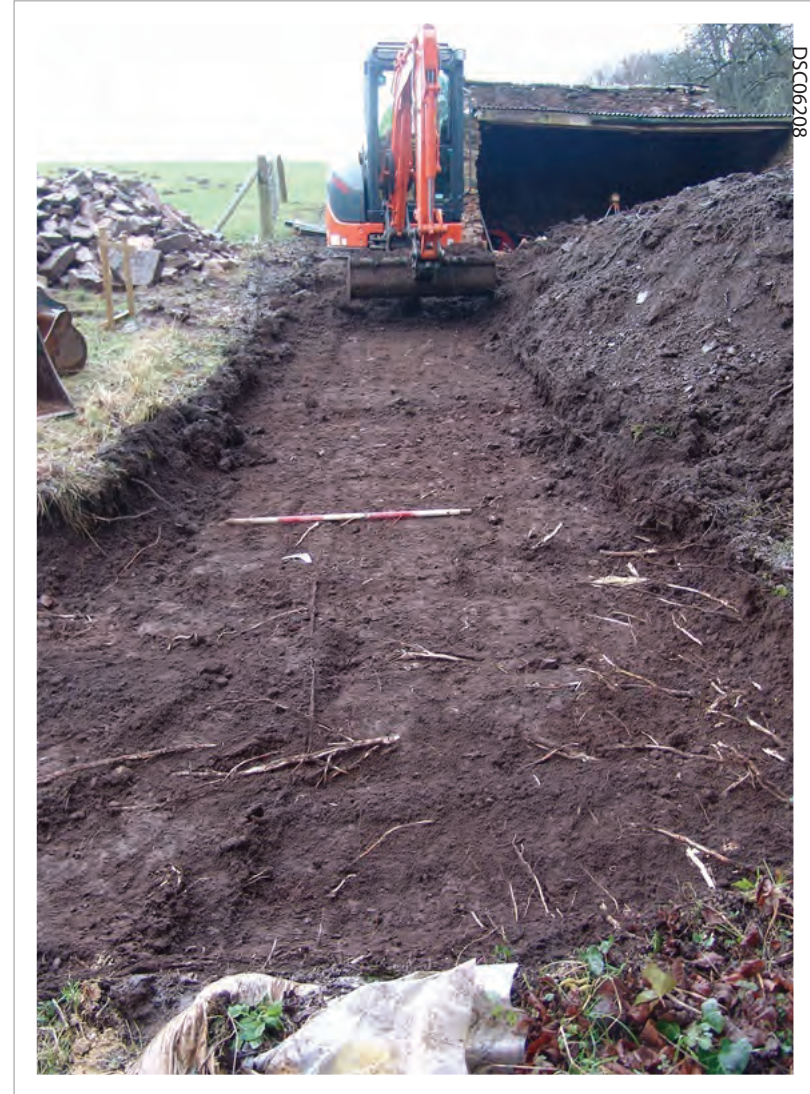
Plate 10: View along former access track to the north west during surface removal prior to path construction

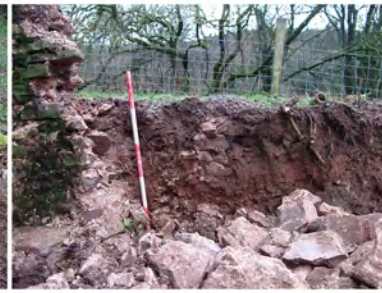
DSC06200.jpg

DSC06200	28/01/2014	DSC F828	3264x2448	NE	Former north east wall section. Foundation to \leq 860mm. External sequence [100] [101] [102]. Internal [103] [102]	PI 06
DSC06201	28/01/2014	DSC F828	3264x2448	NW	View along north east wall showing debris removal internal and soil build up external and depth of foundations. With scale	
DSC06202	28/01/2014	DSC F828	2448x3264	NW	View along north east wall showing debris removal internal and soil build up external and depth of foundations. With scale. 2	
DSC06203	28/01/2014	DSC F828	3264x2448	V	Squared, isolated stone with cut recess. Displaced	
DSC06204	28/01/2014	DSC F828	3264x2448		Squared, isolated stone with cut recess detail view	
DSC06205	28/01/2014	DSC F828	3264x2448	SE	View along former access track to the south east during surface removal prior to path construction.	
DSC06206	28/01/2014	DSC F828	3264x2448	SE	View along former access track to the south east during surface removal prior to path construction. 2	PI 08

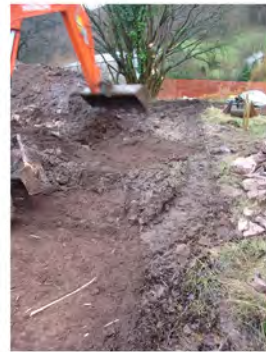
DSC06207.jpg

DSC06207	28/01/2014	DSC F828	2448x3264	SE	View along former access track to the south east during surface removal prior to path construction [102] exposed	PI 09
DSC06208	28/01/2014	DSC F828	3264x2448	NW	View along former access track to the north west during surface removal prior to path construction	PI 10
DSC06209	28/01/2014	DSC F828	3264x2448	SE	View across site from covered north west end, Concrete post foundation in foreground (not a mill wheel)
