**DESK BASED ASSESSMENT
& SITE WALKOVER**

DBA/LML/18

Land at Ludford Mill, Ludford, Ludlow, Shropshire

This desk based assessment and walkover report has been drawn up by APAC Ltd in support of a forthcoming planning application at Ludford Mill, Ludford, Shropshire. The application concerns the proposed erection of a garage and workshop structure to the rear of Ludford Mill, a grade II listed building.

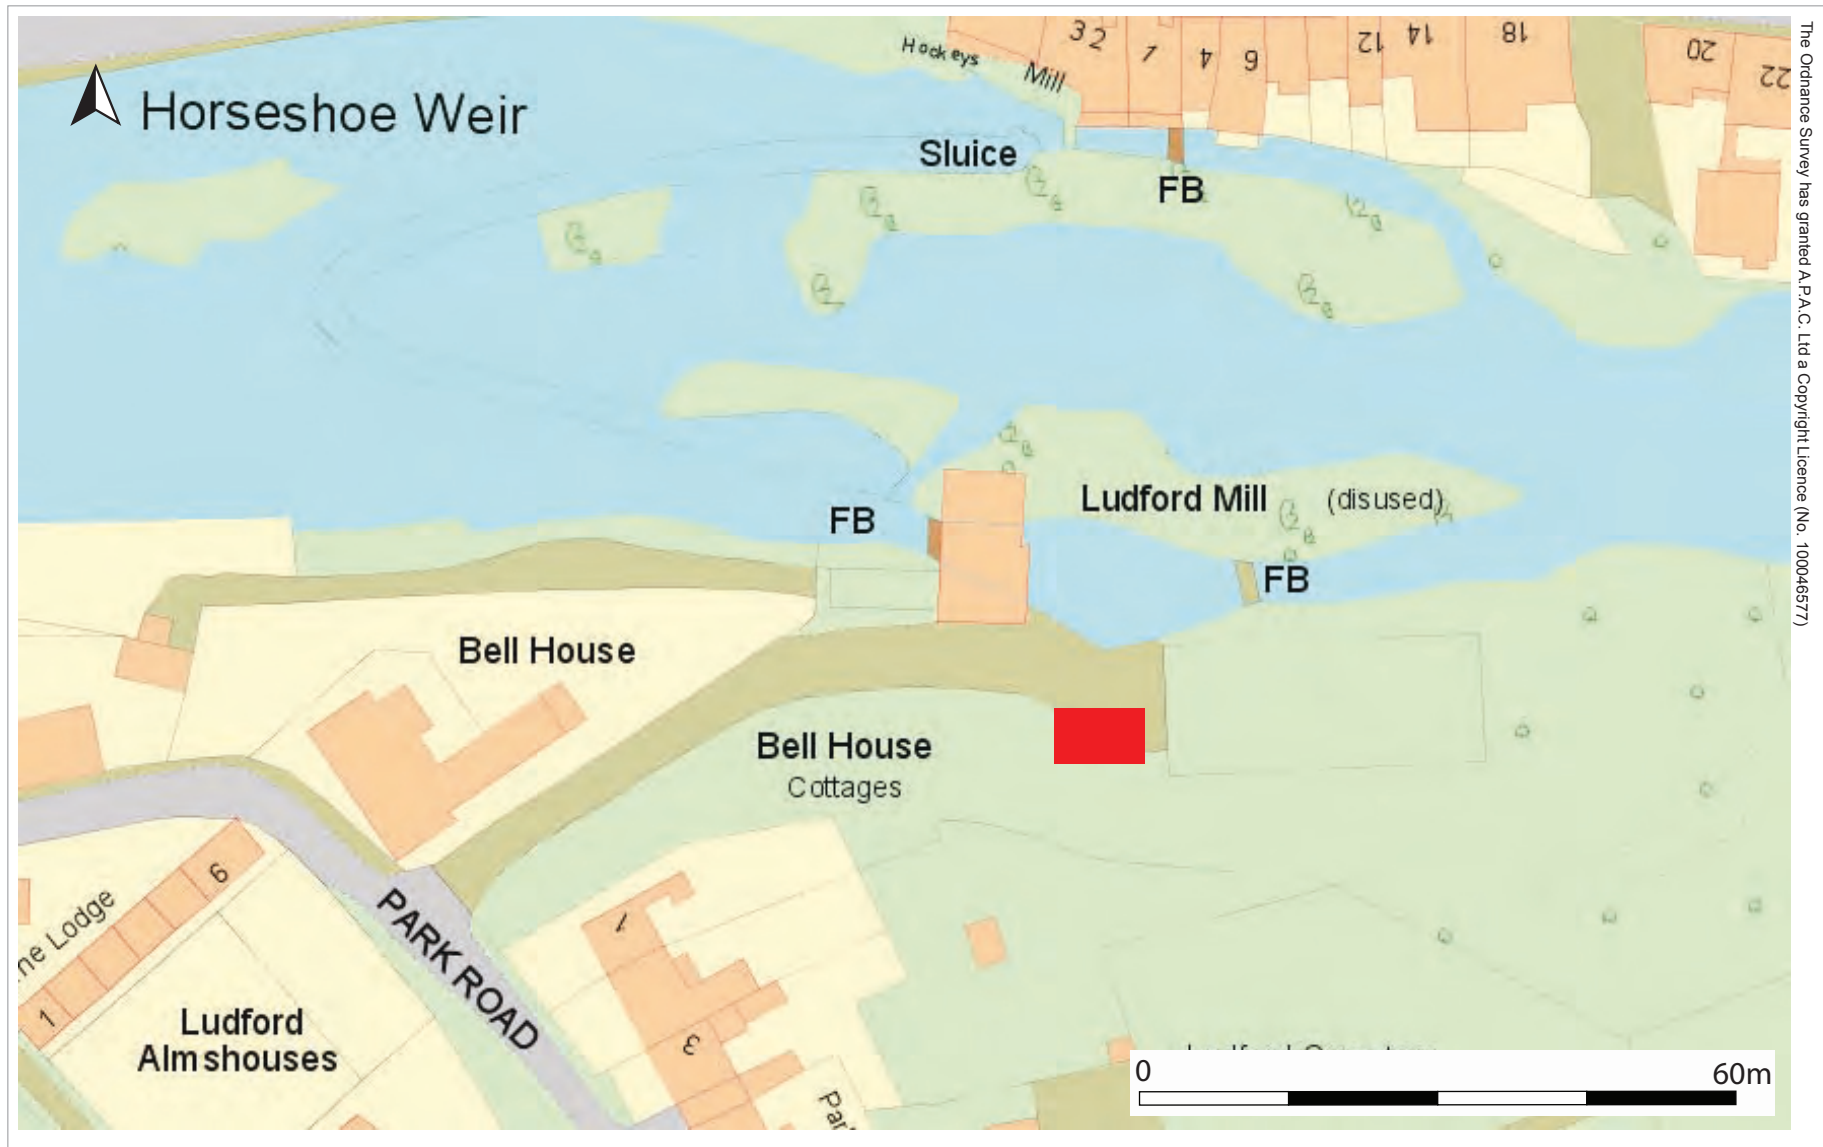
Fig 2: OS Mastermap showing assessment area with proposed structure marked in red

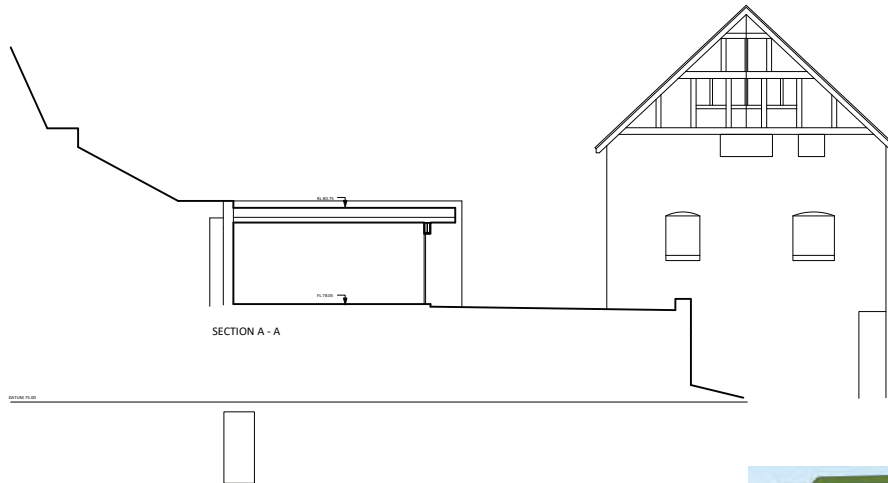
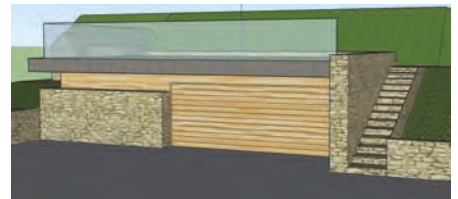
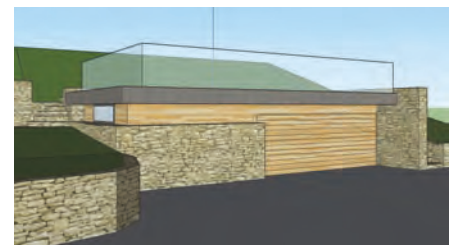
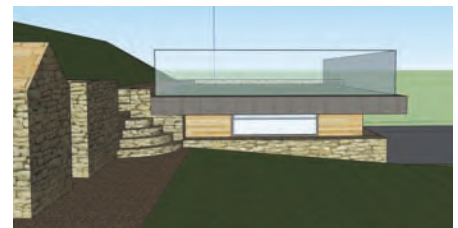
NORTH ELEVATION

SECTION A - A

Fig 3: Development proposals for Ludford Mill site as supplied by Nick Joyce Architects

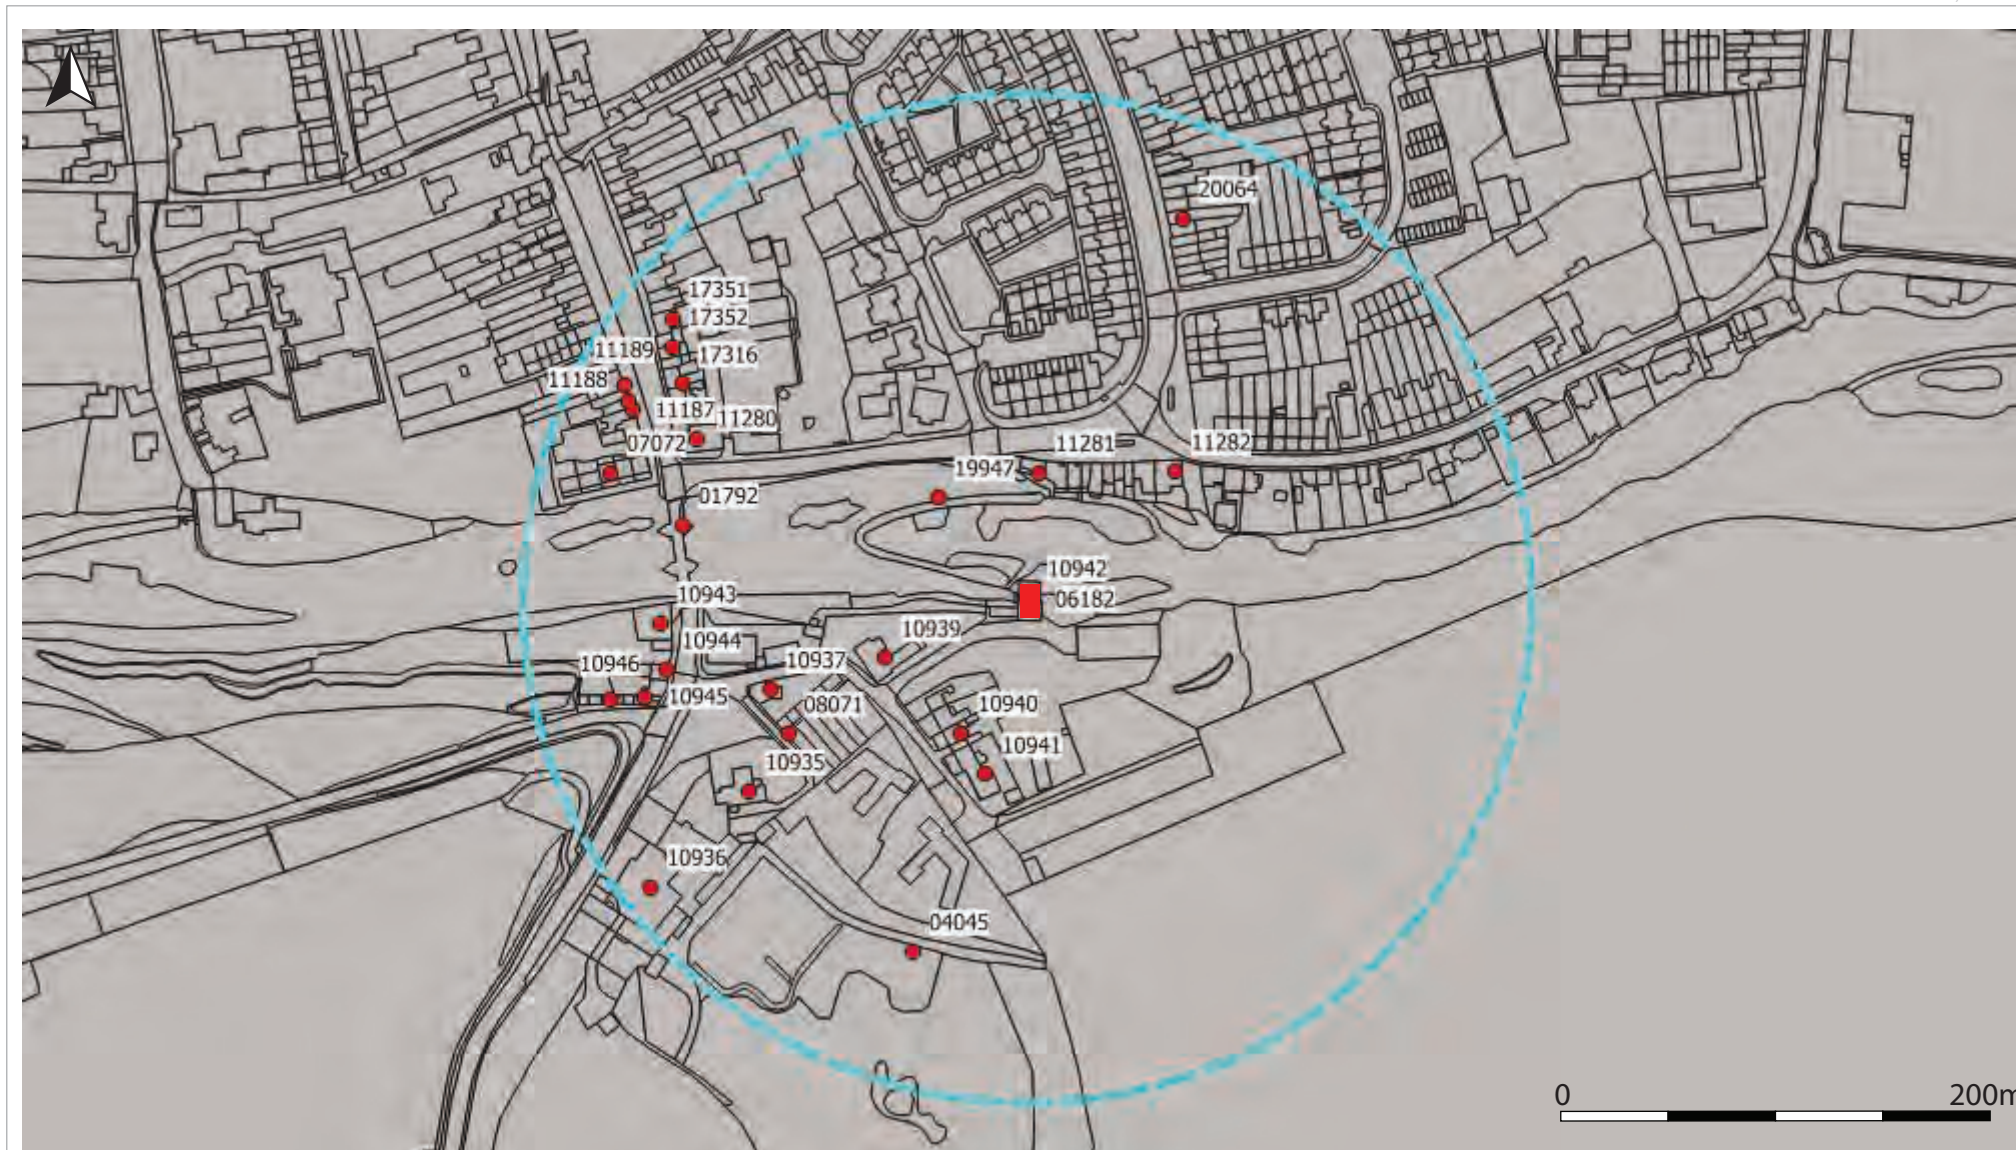
Fig 4: GIS plan showing location of HER sites (red) within 200m radius of assessment area (red)

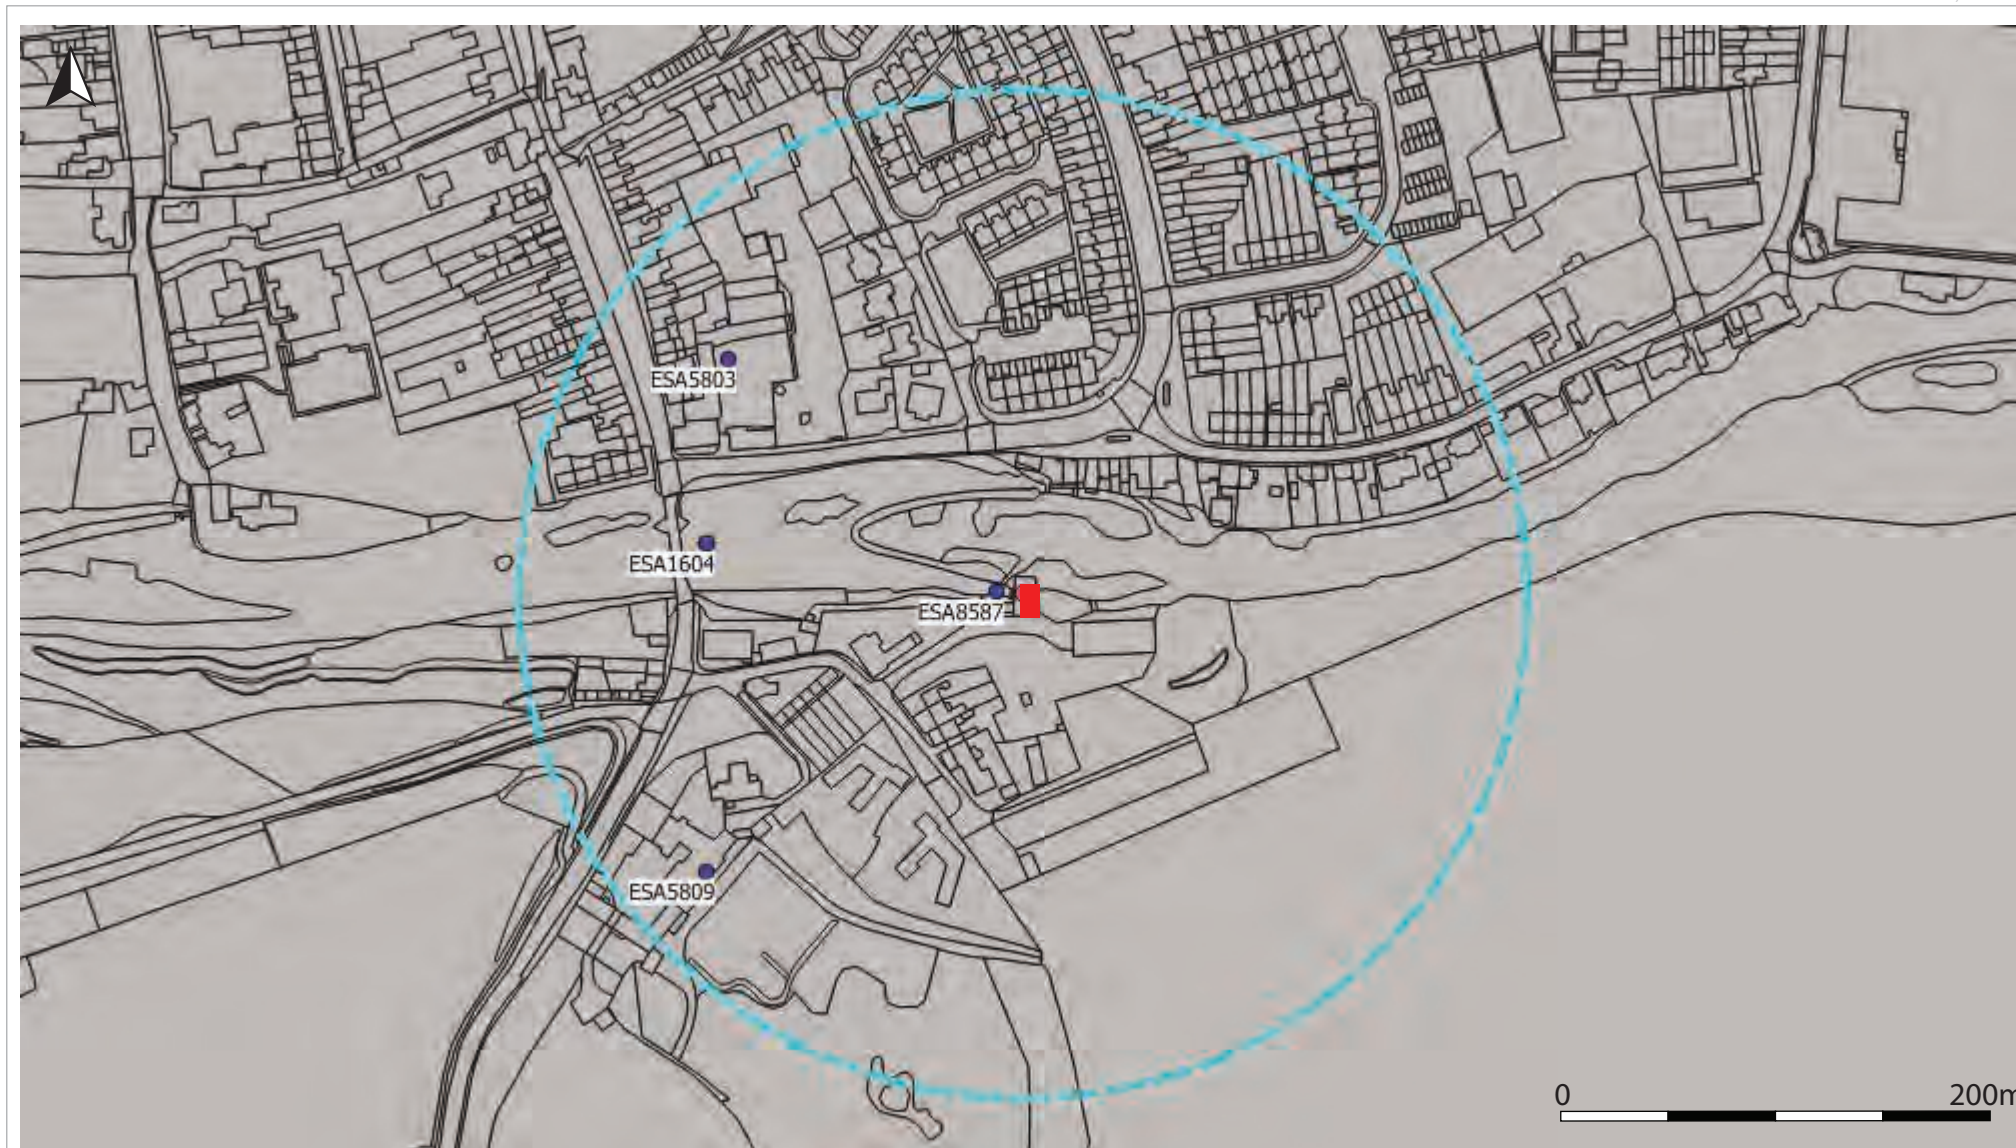
Fig 5: GIS plan showing location of HER events (blue) within 200m radius of assessment area (red)

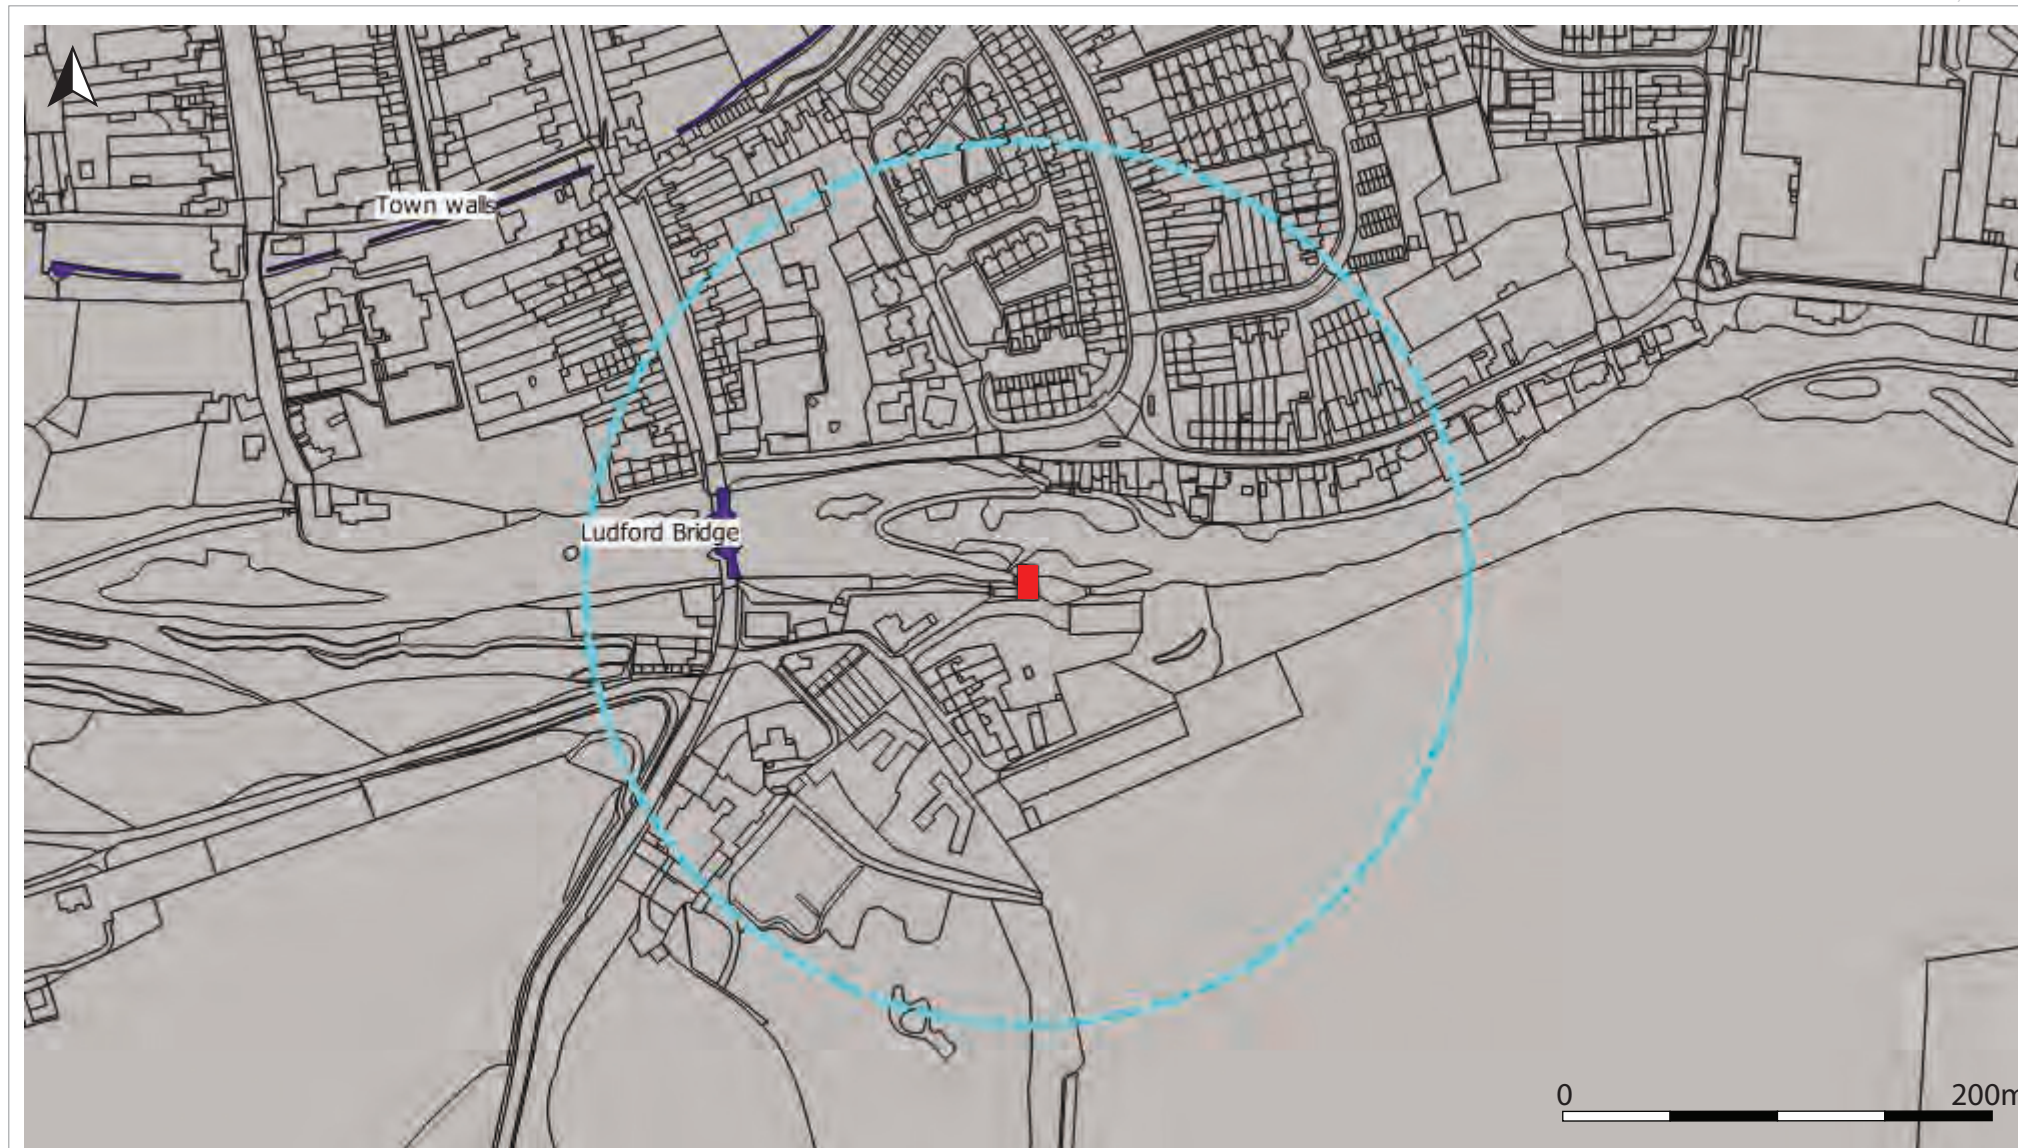
Fig 6: GIS plan showing location of SAM sites (blue) within 200m radius of assessment area (red)

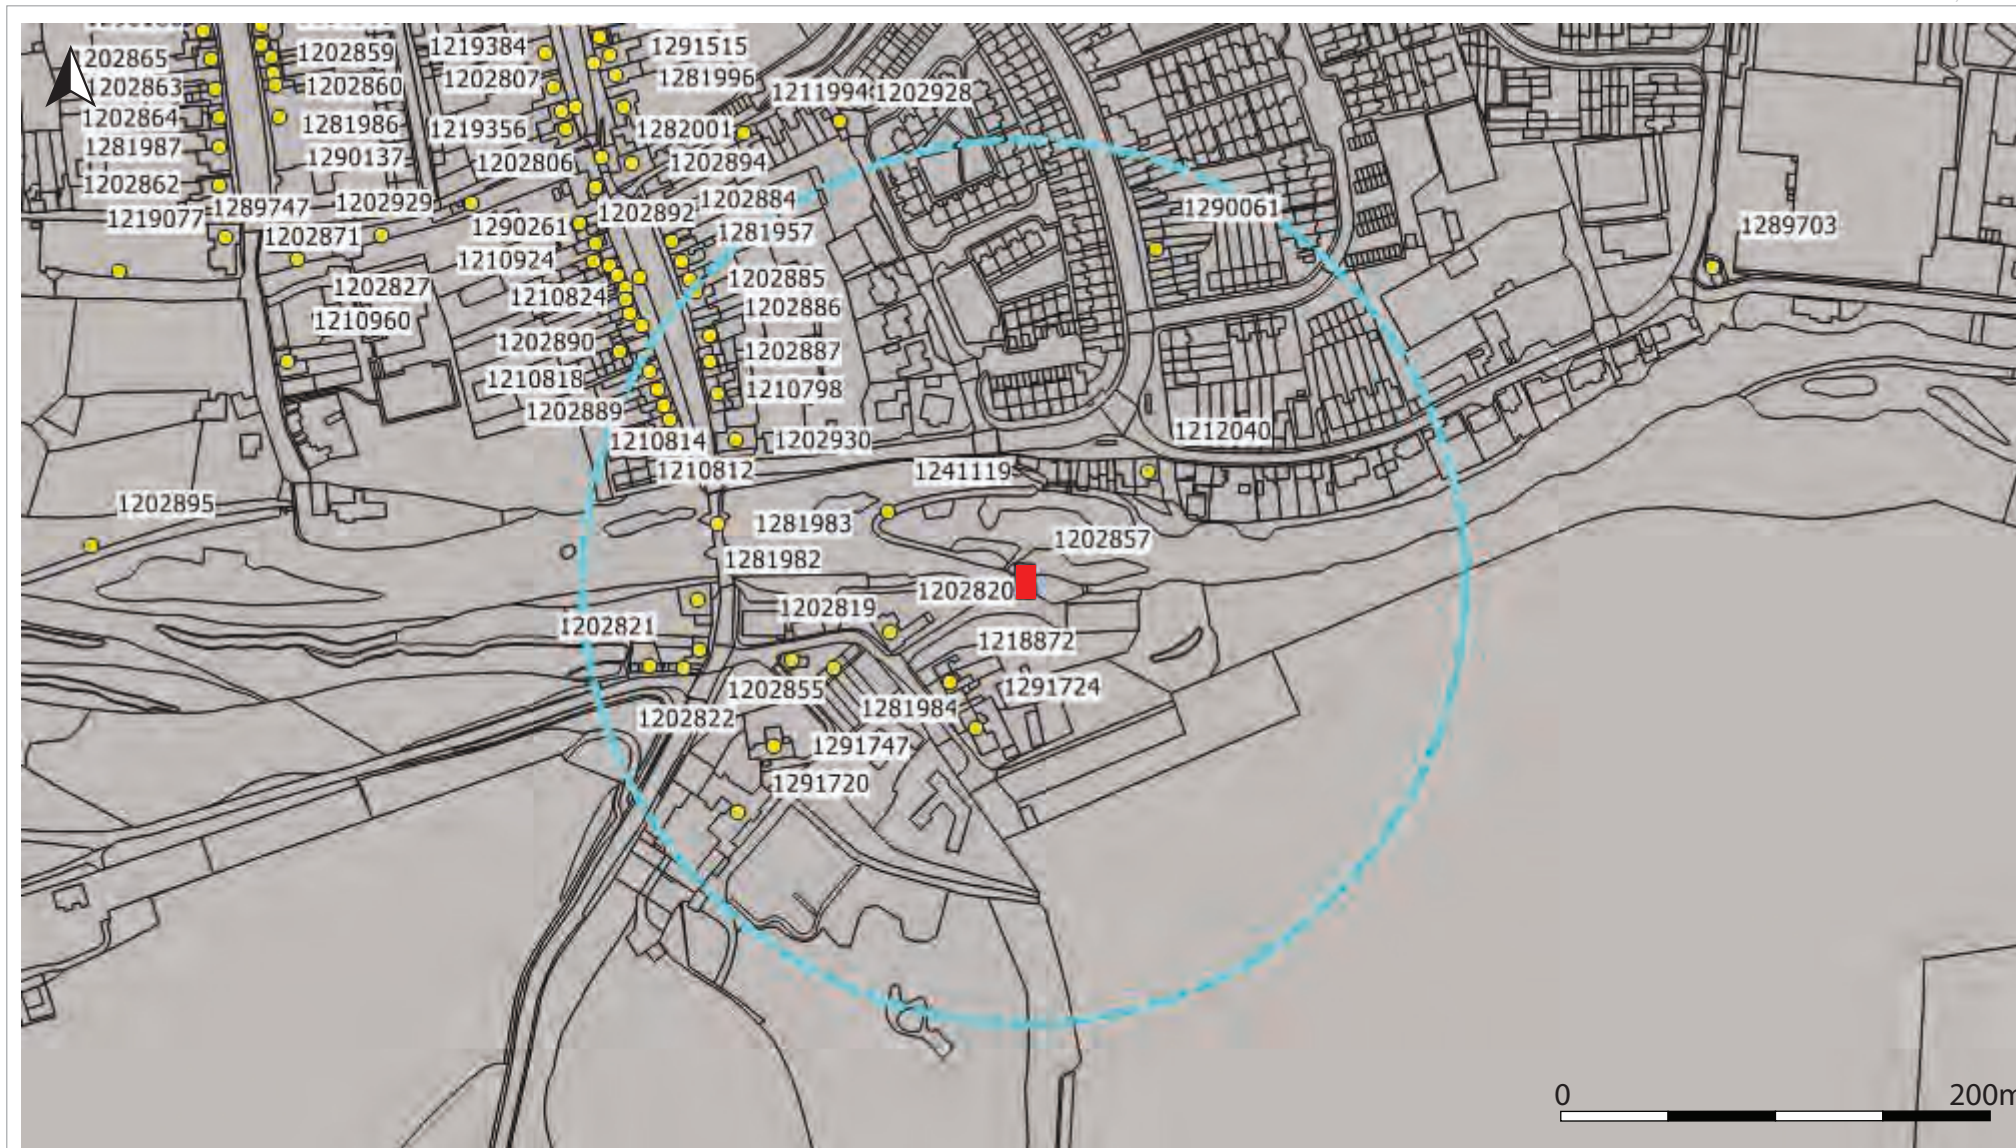
Fig 7: GIS plan showing location of LB sites (Yellow) within 200m radius of assessment area (red)

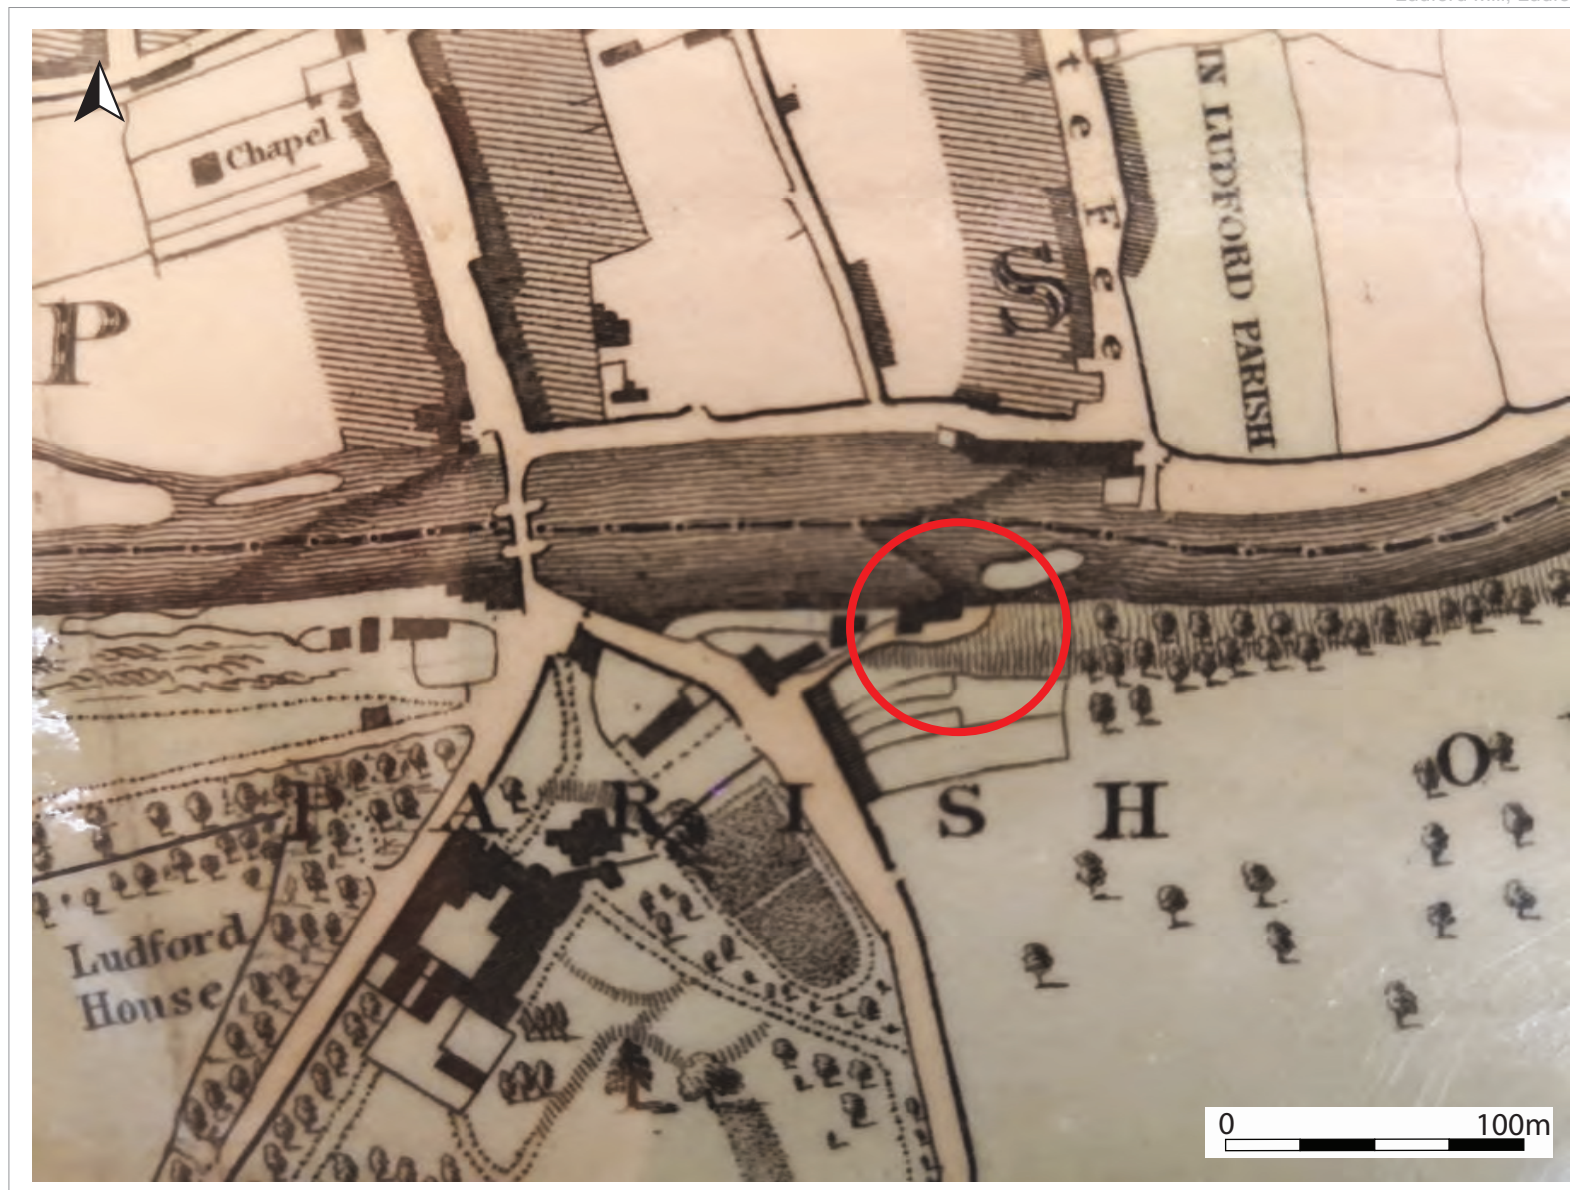
Fig 8: 1832 King William IV Plan of Ludlow showing assessment area (red)

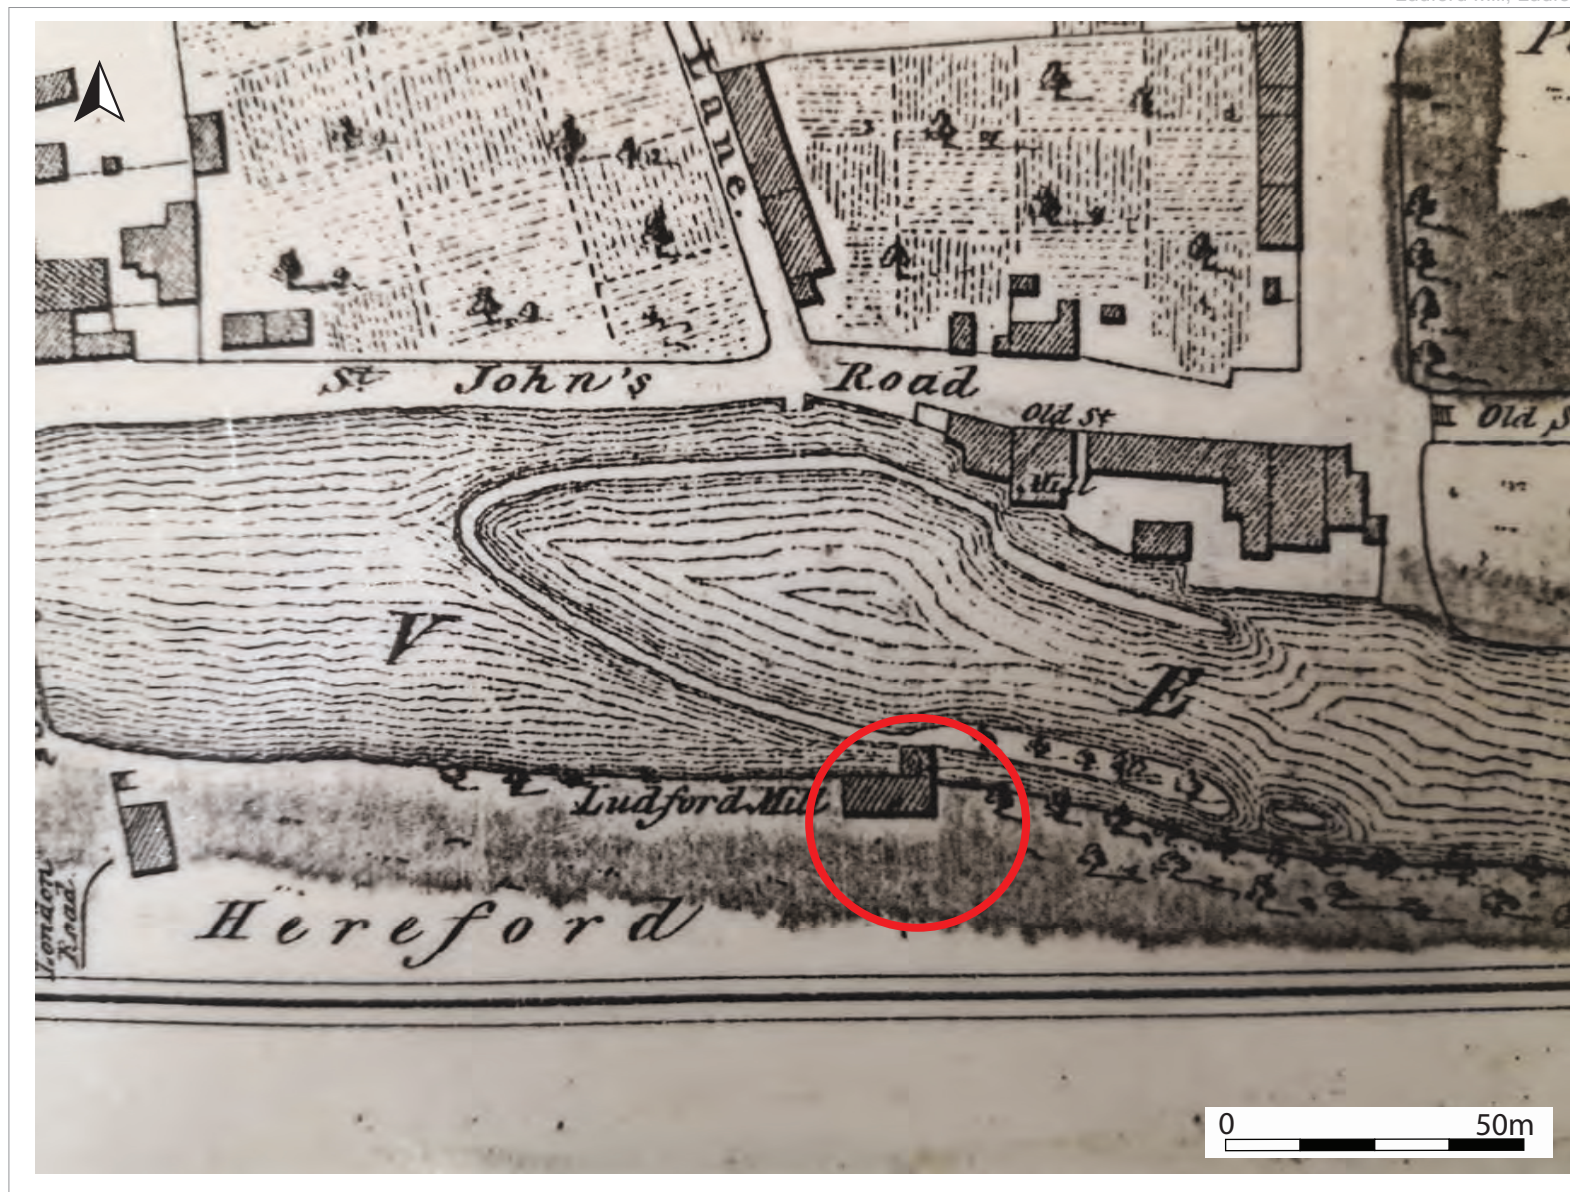
Fig 9: 1835 Plan of Borough of Ludlow showing assessment area (red)

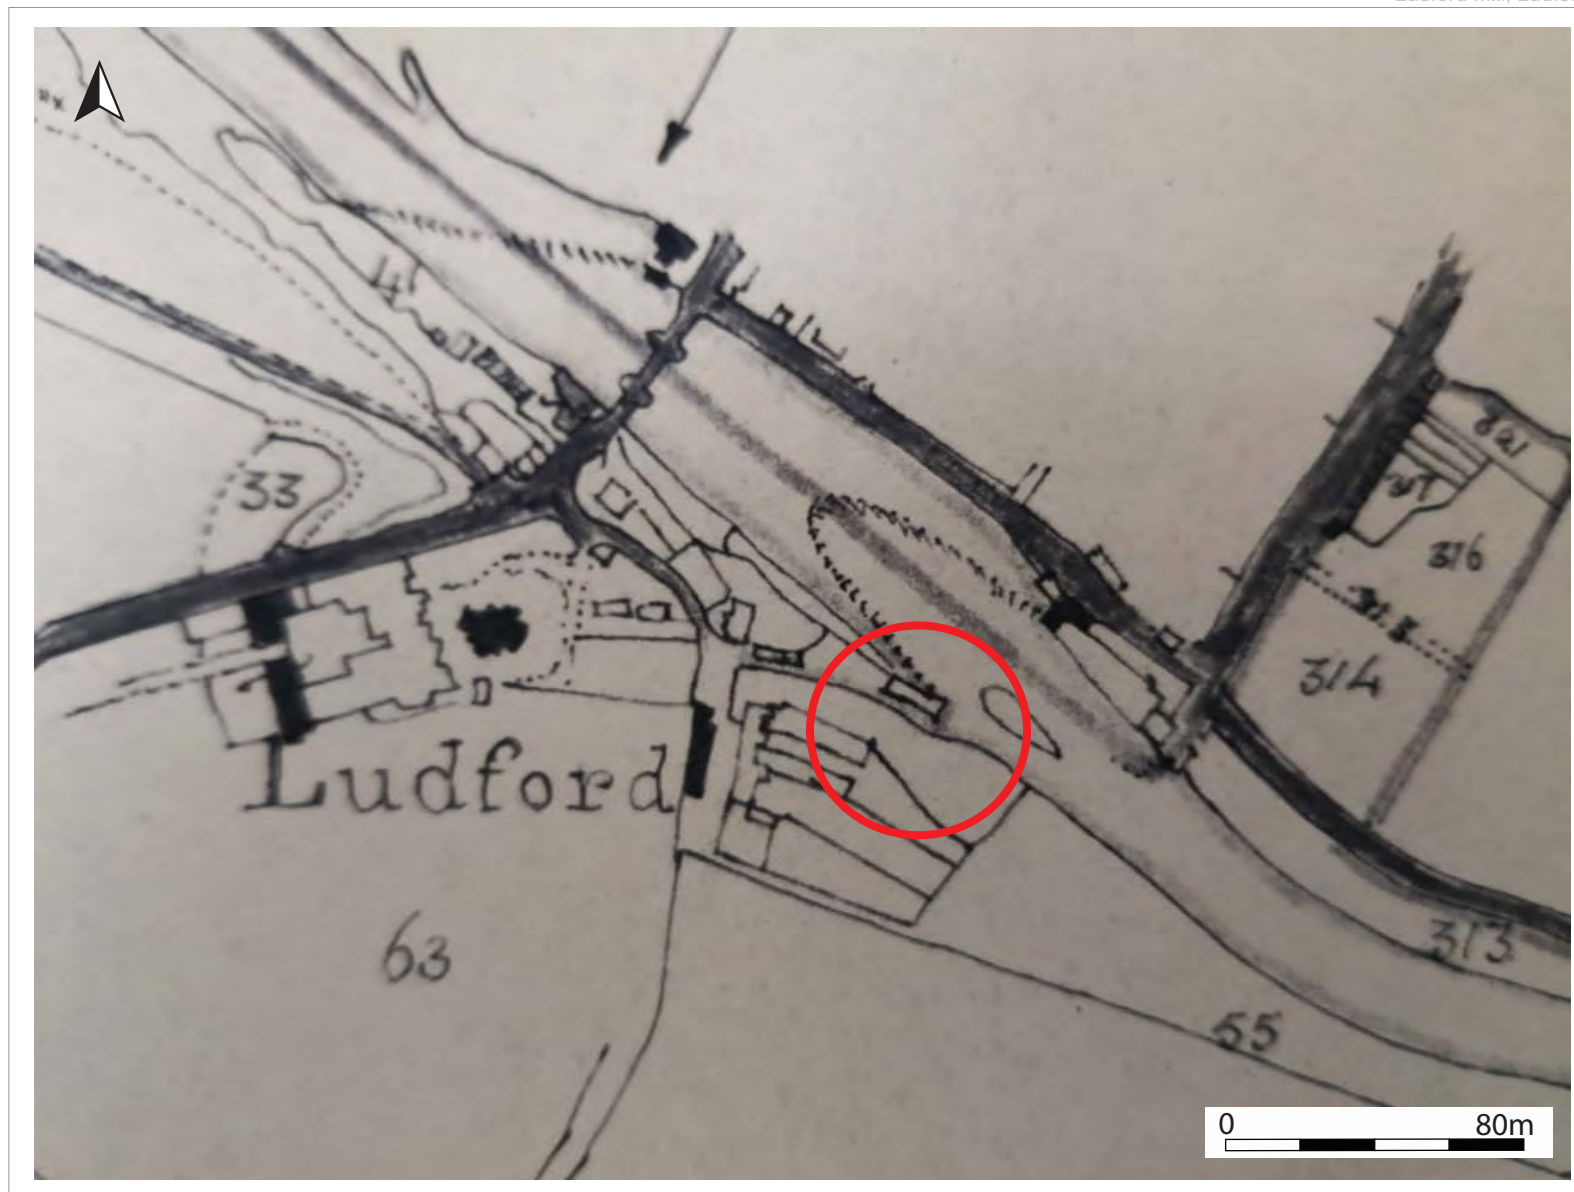
Fig 10: Transcribed 1847 Ludford Parish Tithe map showing assessment area (red)

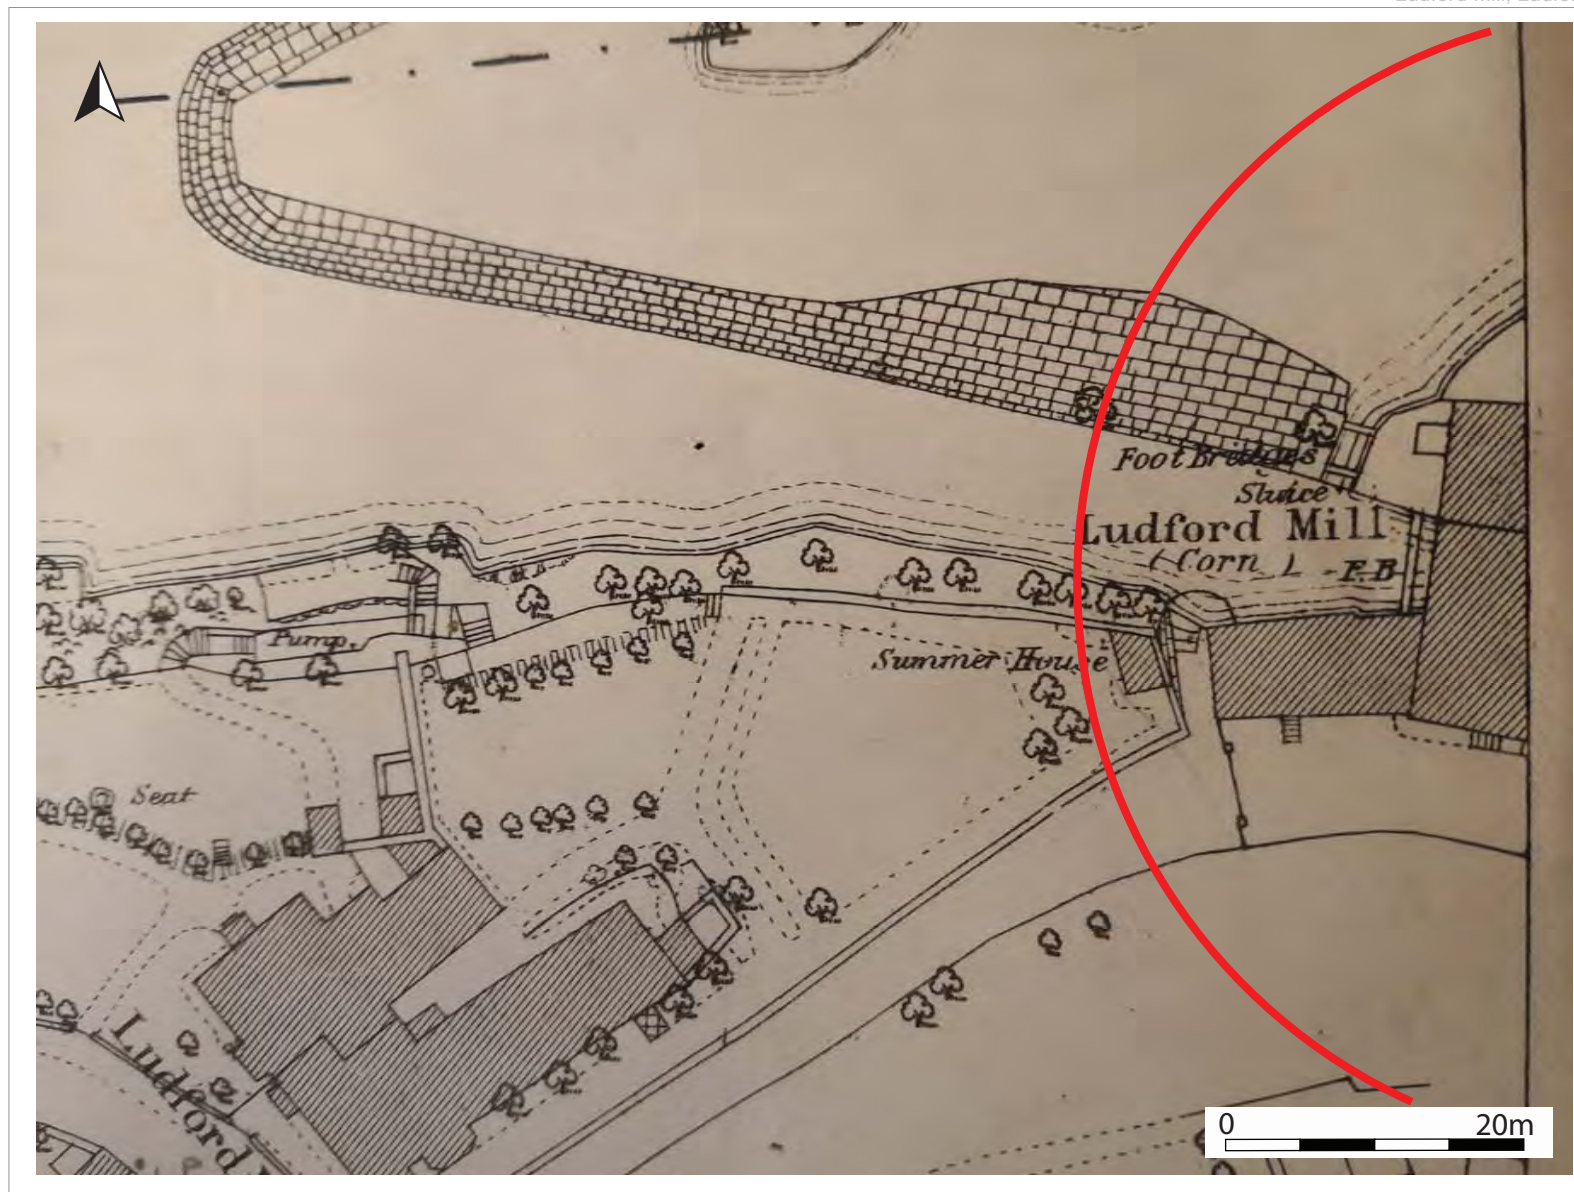
Fig 11: Partial 1885 1:500 Ludlow Town Plan showing western side of assessment area (red)

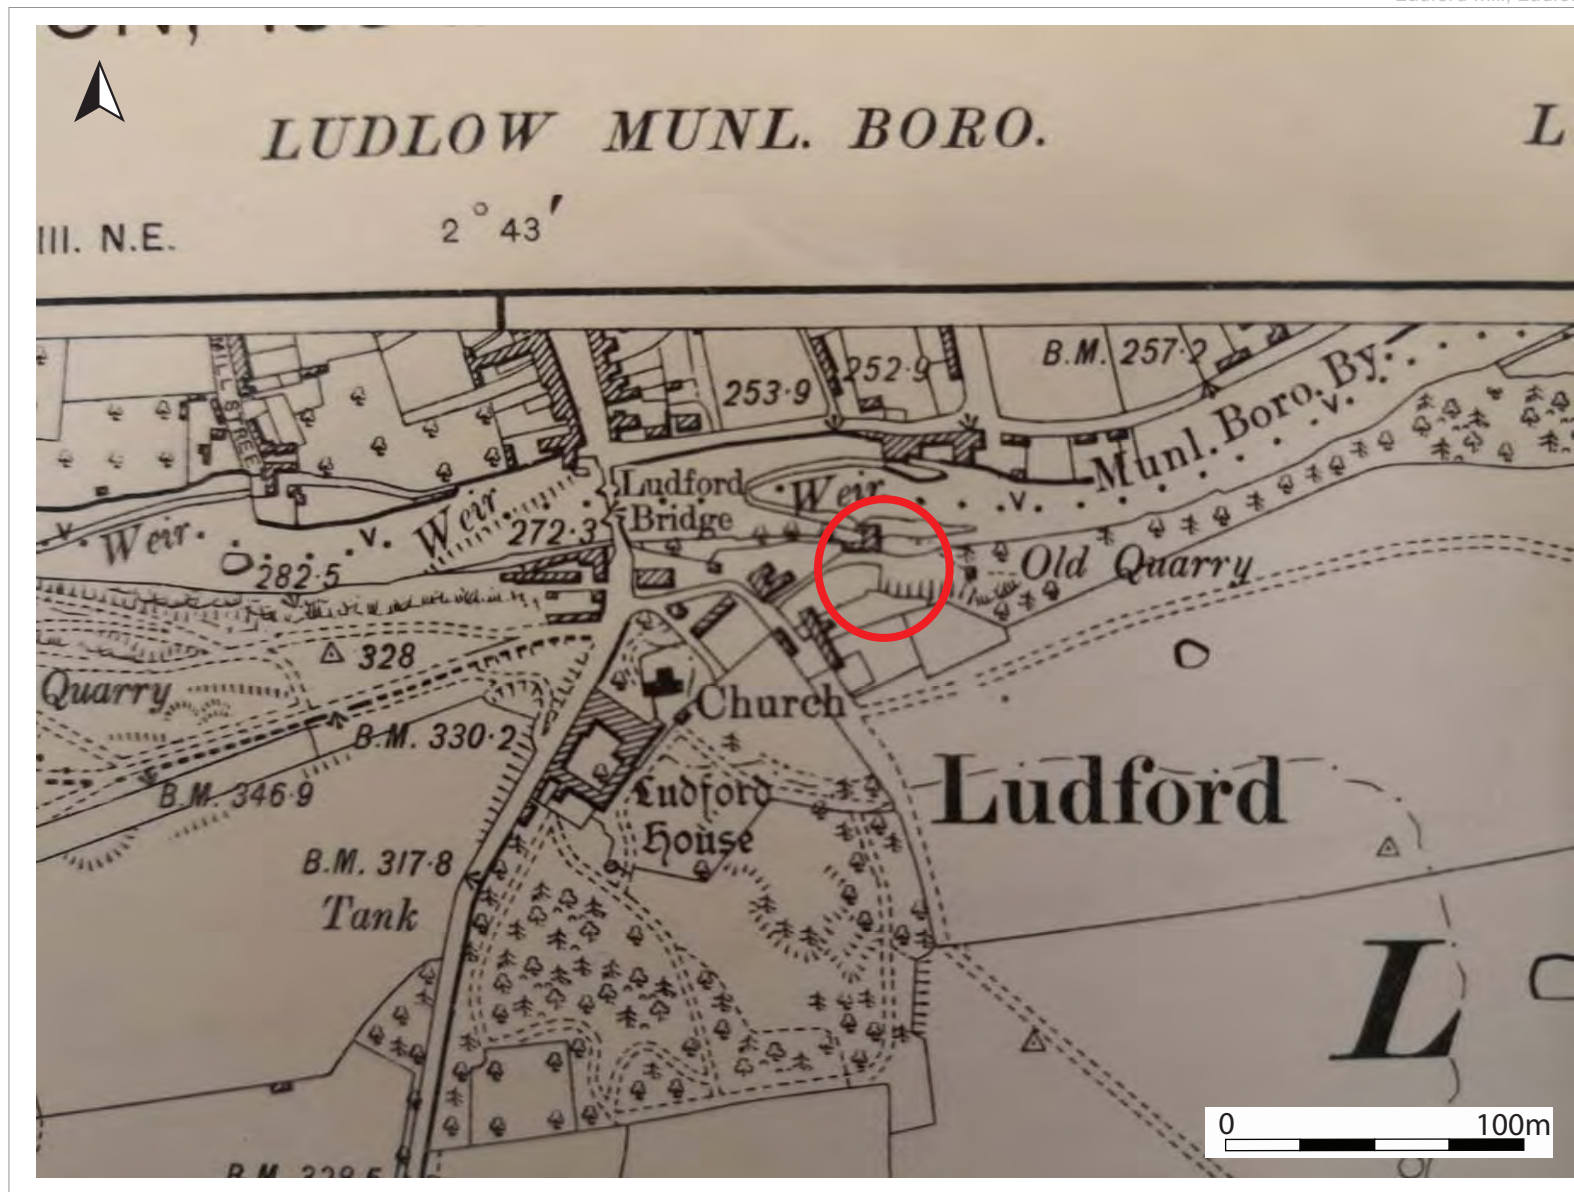
Fig 13: 1903 2nd Edition 6 Inch OS map showing assessment area (red)
