**DESK BASED ASSESSMENT
& SITE WALKOVER**

DBA/LML/18

Land at Ludford Mill, Ludford, Ludlow, Shropshire

This desk based assessment and walkover report has been drawn up by APAC Ltd in support of a forthcoming planning application at Ludford Mill, Ludford, Shropshire. The application concerns the proposed erection of a garage and workshop structure to the rear of Ludford Mill, a grade II listed building.

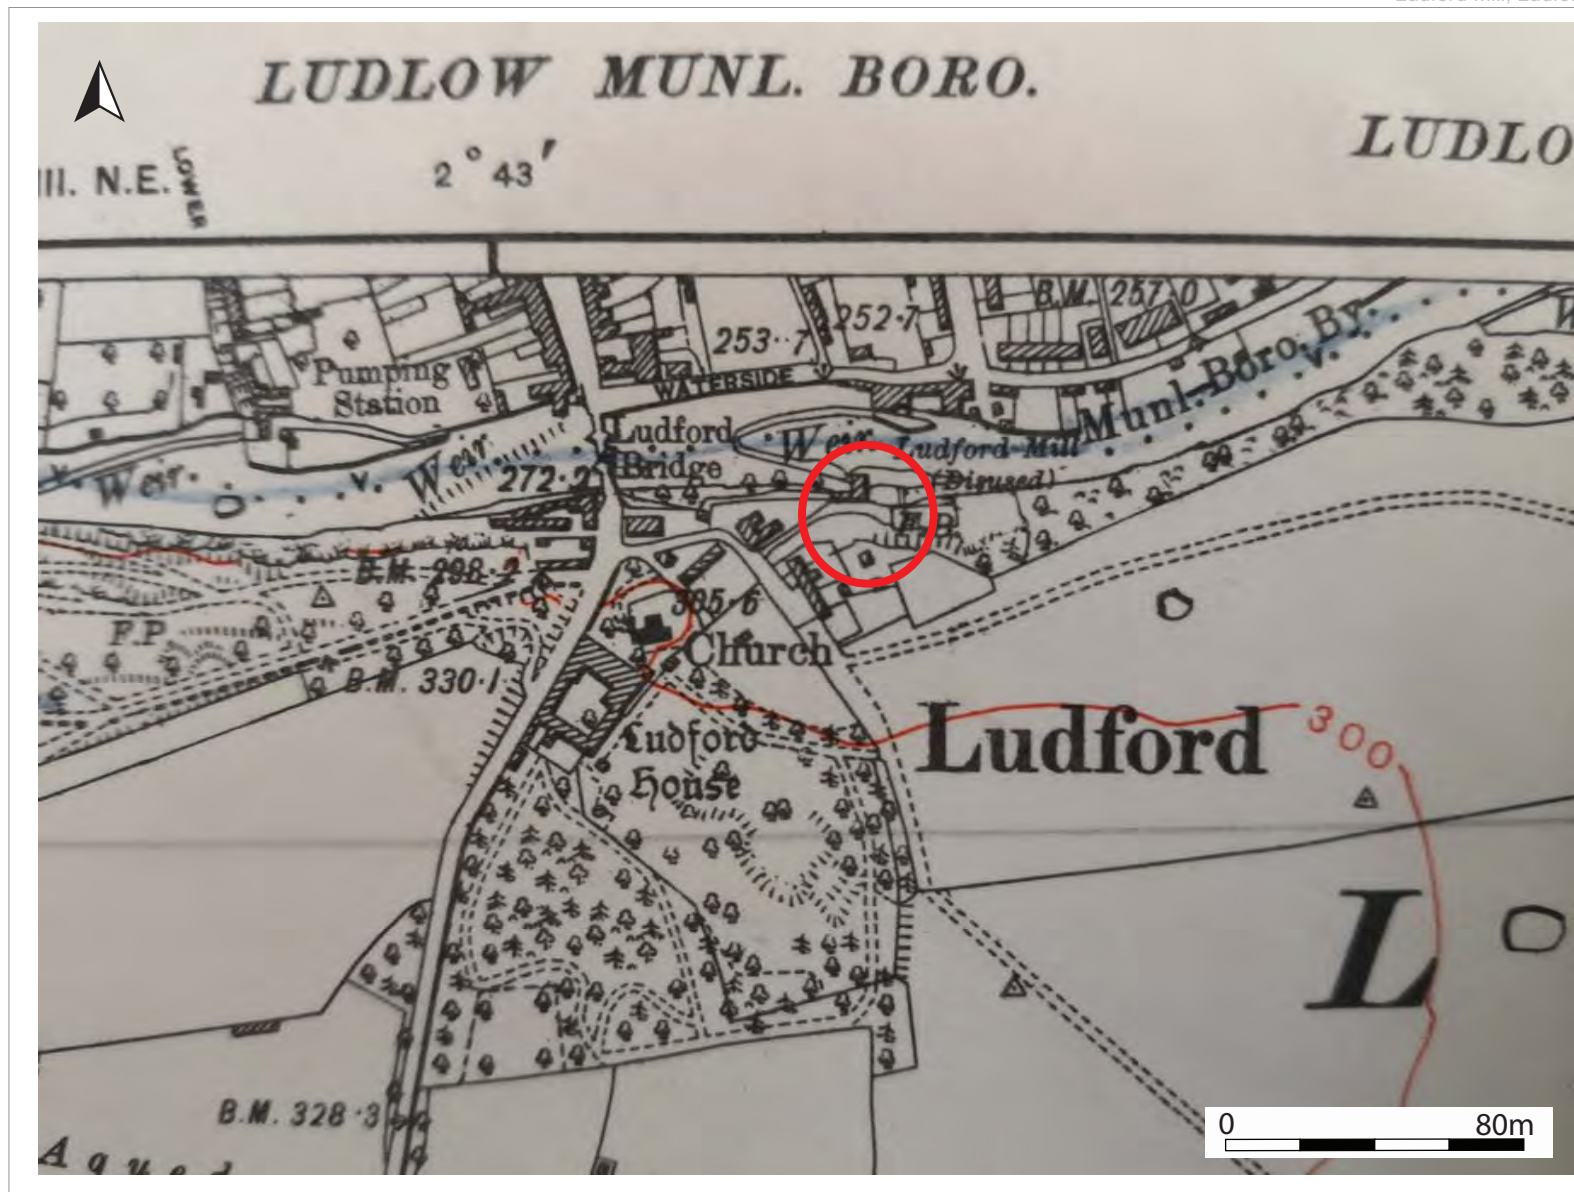
Fig 14: 1928 3rd Edition 6 Inch OS map showing assessment area (red)

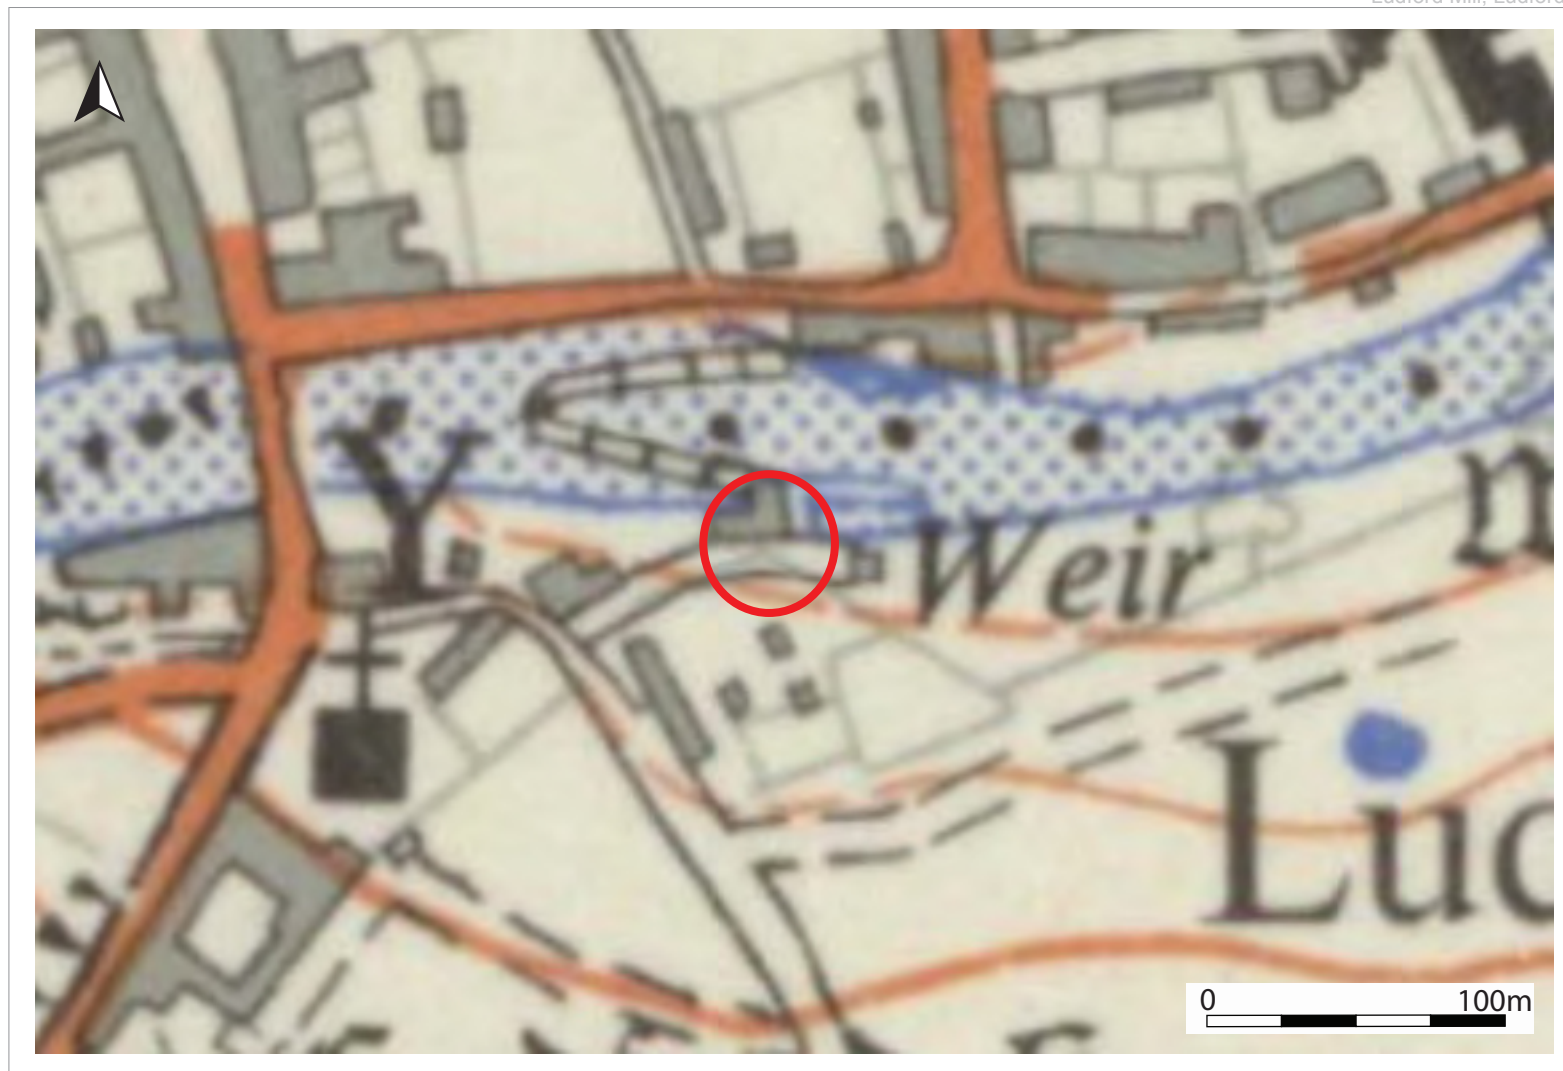
Fig 15: 1945 New Popular Edition 6 Inch OS map showing assessment area (red)

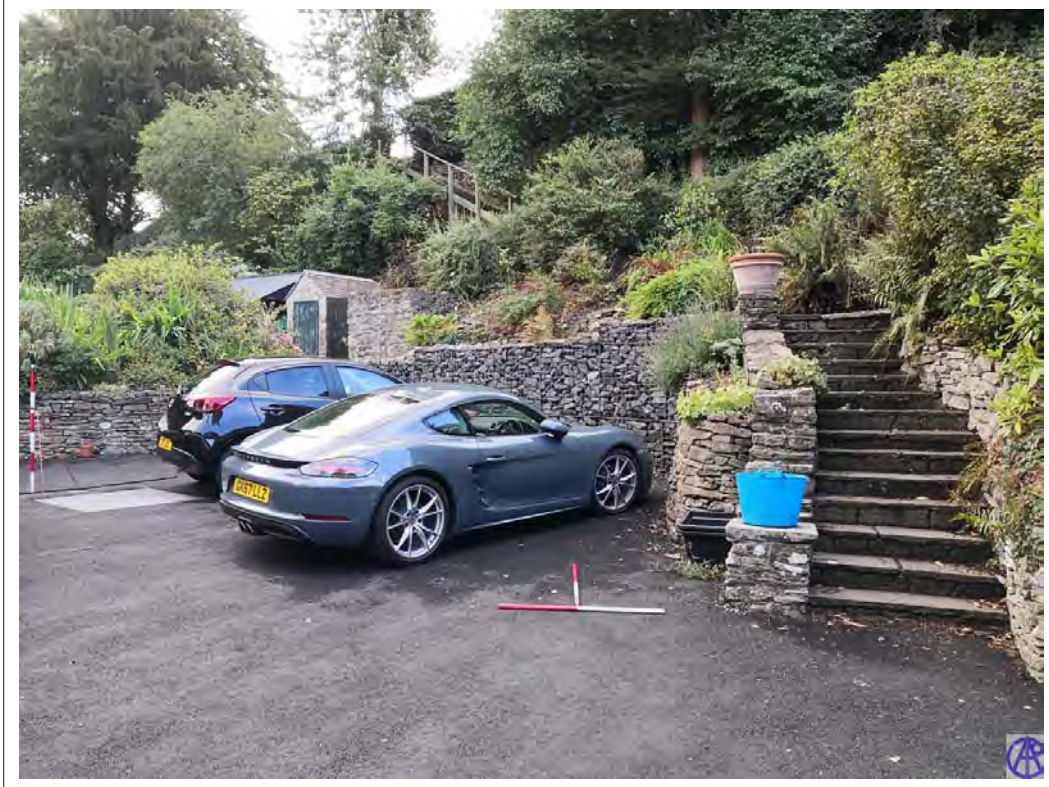
Plate 1: View south east from Ludford Mill building into area of proposed development
Scales 2x1m

9.2 The area of proposed development was found to be in use as a car parking area to the rear of the mill site. A tarmac surface forms the upper horizon with several services evident within the area, including large new installations by Severn-Trent.

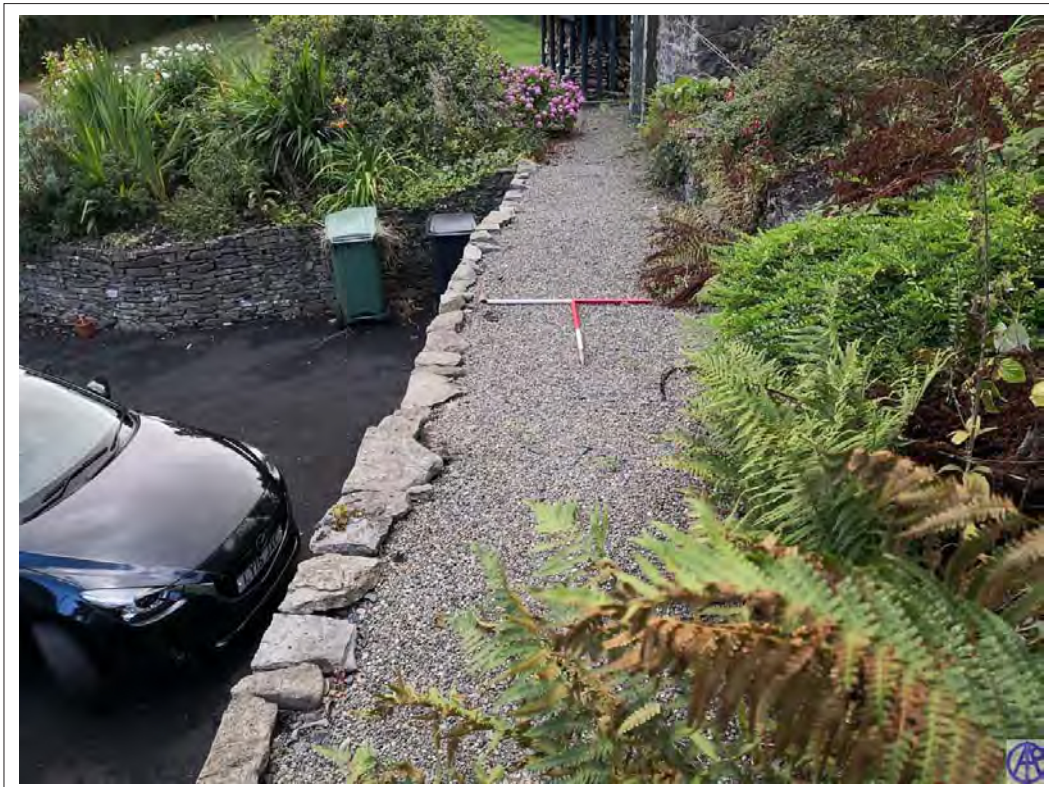
Plate 2: View east across path on top of stone filled gabions retaining sloping ground to south
Scales 2x1m

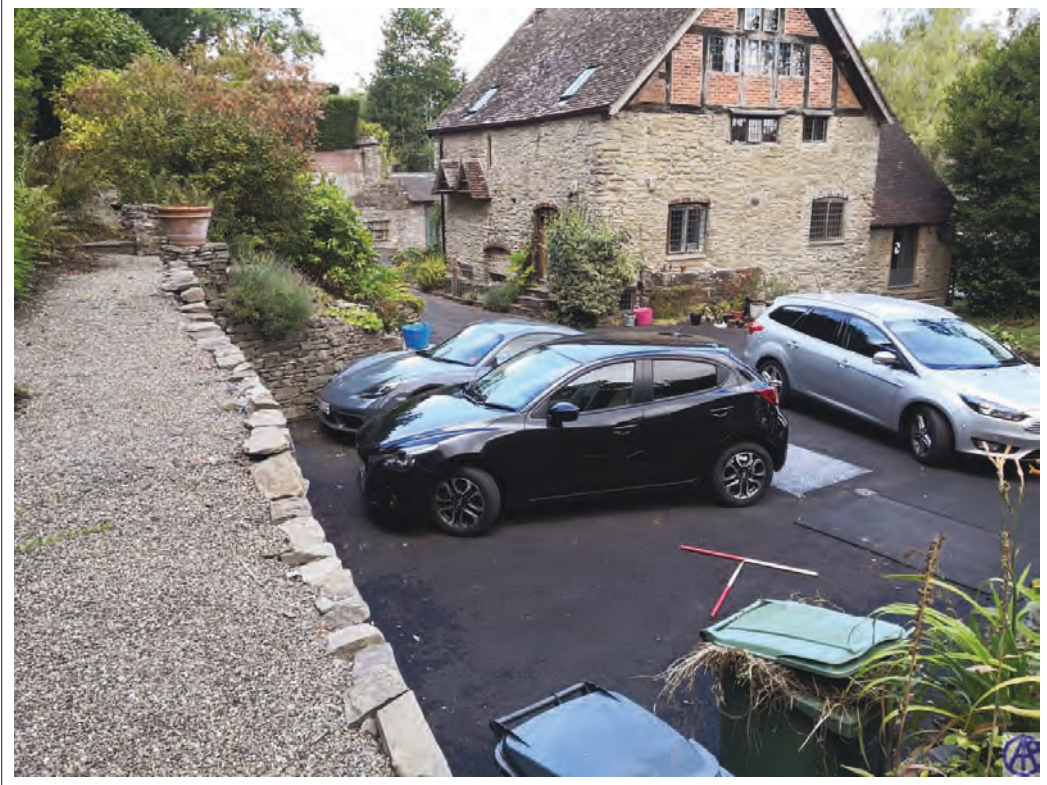
Plate 3: View north west towards Ludford Mill building from area of proposed development
Scales 2x1m
