Bosloggas St Just-in-Roseland  
Cornwall

An Archaeological Watching Brief  
During Renovations and Excavations  
of Bosloggas

An Archaeological Watching Brief During Renovations and  
Excavations of Bosloggas St Just-in-Roseland

Historic Building Recording: (Condition 5: PA 10/08735)

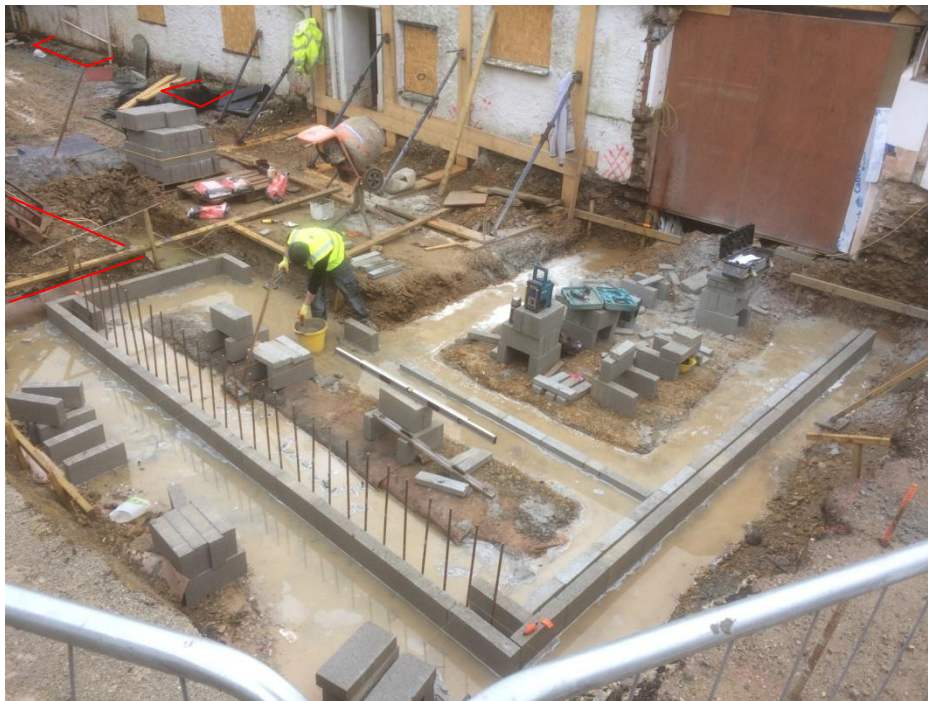
Figure 3. Area to the north-west (rear) of farm house during construction.  
area watched from excavation to start of building work.

5.2 Figure 3 above shows the building work in progress with the remaining excavated trench's still visible (from centre of photograph towards top left of picture). In addition trench'/inspection pits were opened during building work next to main building as highlighted in 'red' in the above photograph (figure 3). These latter excavations were associated with services and drains connected with the main house and the extension and while they were open it was felt prudent to examine them. Neither of these excavations revealed anything of archaeological significance. The watching brief for this part of the work was carried out on the 8<sup>th</sup> and 9<sup>th</sup> February 2017.

- 1.3 PH was on site on the 8<sup>th</sup> & 9<sup>th</sup> February 2017 when preliminary work was carried out on the slip trenches for the foundations of the extension to the north-west of the property (figure 3).

- 1.6 Visits were also made during April and May when work was being carried out on both of the extensions in order to determine any disturbance to the ground within the buildings (figure 3).

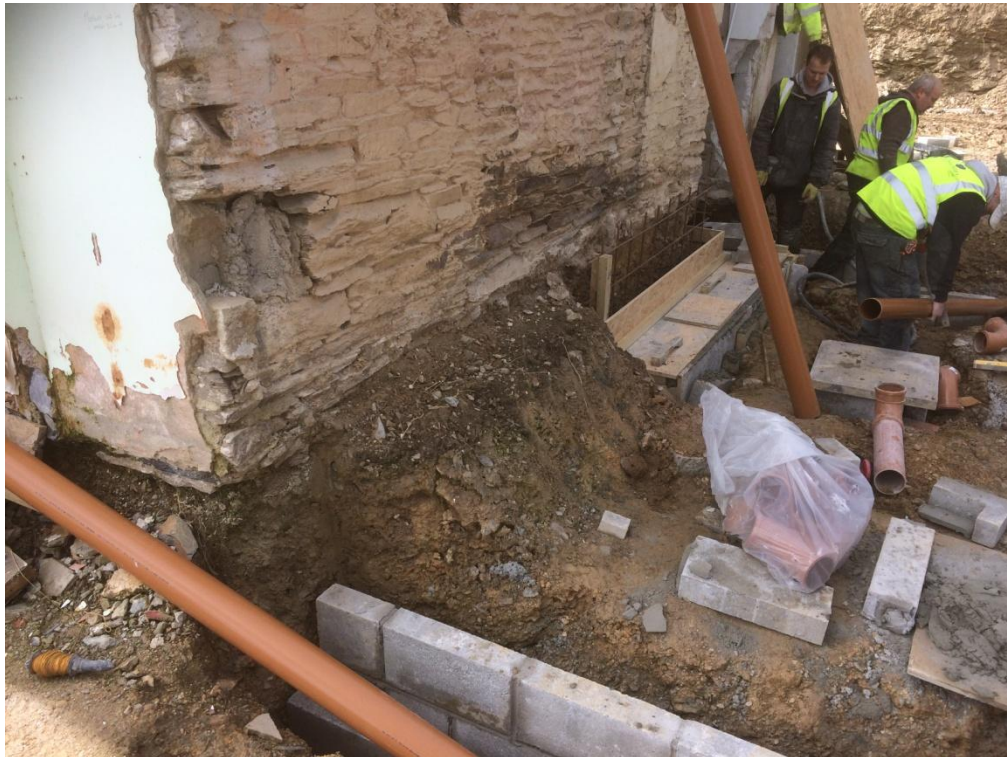
Figure 4. Area to the north-east (side) of farm house during construction.  
area watched from excavation to start of building work.

5.3 Figure 4 above provides an overview of the trench's being excavated for the foundation and service trench's for the extension to the side of the farm house. The watching brief for this part of the farm house was carried out on

the 1<sup>st</sup> and 2<sup>nd</sup> March as with the trench's on the rear extension the work was initially carried out by machine and completed by hand

- 1.5 PH was also on site during 1<sup>st</sup> & 2<sup>nd</sup> March 2017 when preliminary work was carried out on the slip trenches for the foundations of the extension to the north-east of the property (figure 4).

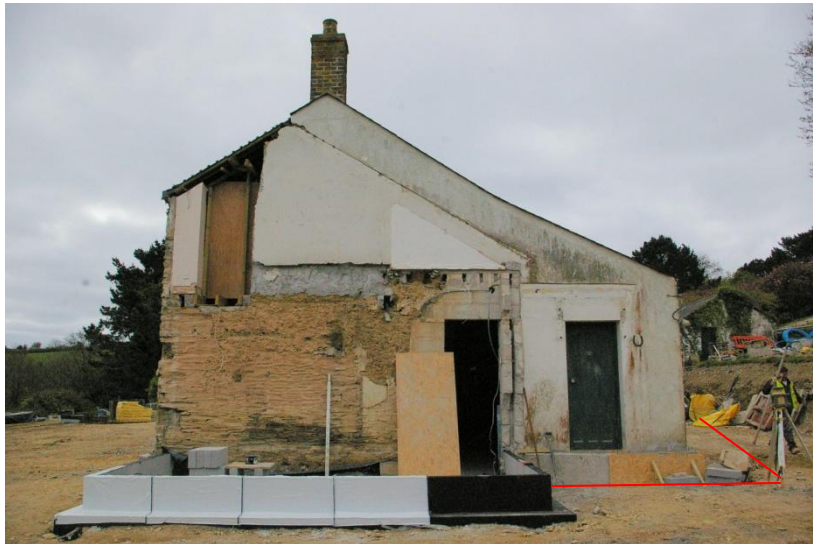
Figure 5. Side extension showing start of new construction.

- 5.4 Figure 5, above has been included as it clearly shows the differences in construction of the farm house, providing clear phases in the design and development of the property. In addition the gable end of the barn can be seen on the bank to the right of the farm house. The trench's outlined in red (in figure 5 above) which runs adjacent to the property and the trench's outlined in 5.3 above revealed nothing of archaeological sequence.
- 5.5 Figure 6 below, provides an overview of the trench's excavated for the installation of service (pipes) associated with the farm house. These trench's run around the outside of the barn situated to the left and rear of the main farm house.

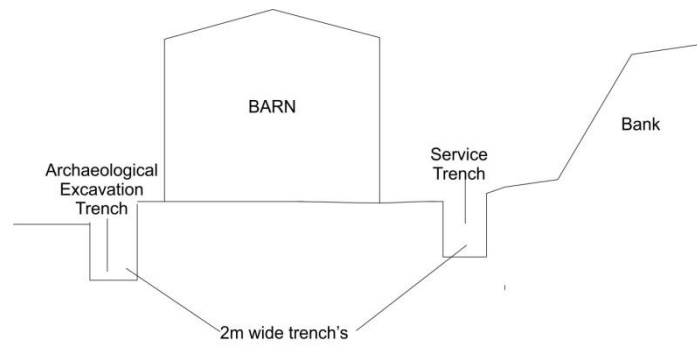
Figure 6. Section view of service trench's adjacent to barn (not to scale).

- 1.9 PH visited the site again on the 13<sup>th</sup> September 2017 and 3<sup>rd</sup> October 2017 when service trenches were being excavated to the front and rear of the detached barn (storage/workshop). These were taken down to bedrock and nothing of archaeological significance was uncovered (figure 6-7).

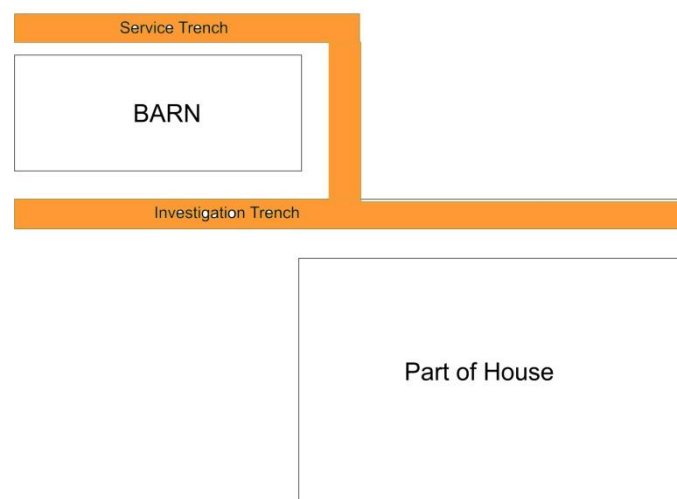
Figure 7. Plan view of service trench adjacent to barn (not to scale).

- 5.6 A service trench was excavated from the rear of the barn adjacent to the farm house which then ran at right angles around the outside of the barn. It then took a further right angle and ran the full length of the farm house. In addition an (archaeological) investigation trench was dug along the front of the barn to determine if there was any associated structure with the barn.
- 5.7 The trench's excavated were approximately 2 metres wide and 2 metres deep. Overall the depth was taken down through the natural shillet of the area to the bedrock. Nothing was uncovered during the excavation work that would suggest there was any previous occupation of the area. No footings to previous buildings or any archaeological finds were uncovered during this

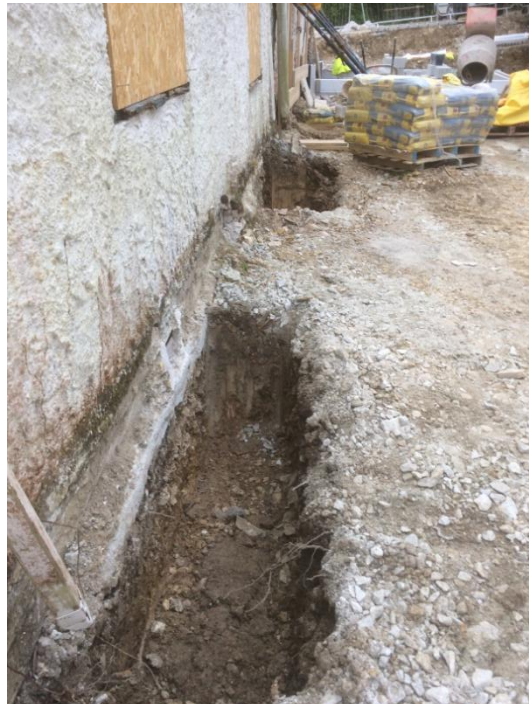
- 5.8 Figures 8, 9, 10 & 11 are photographs of the actual trench's excavated for the services stated in 5.7 above and the additional trench's that were excavated around the main farmhouse.

Figure 8 - archaeological investigation trench outside barn.

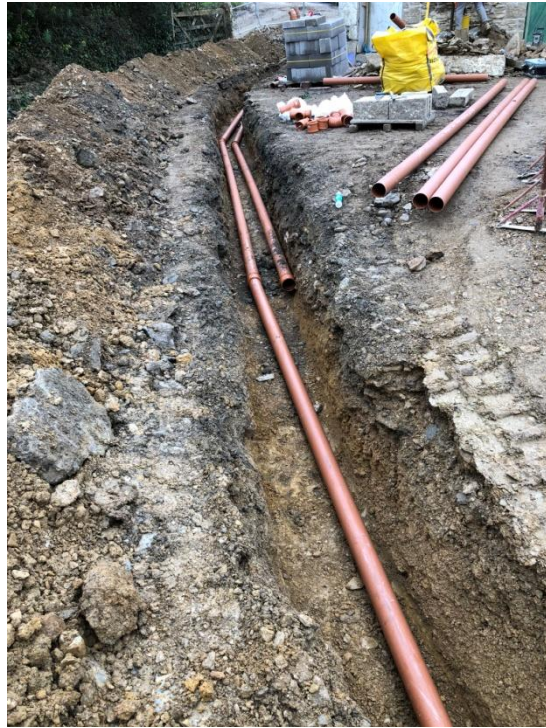
Figure 9. Service trench running next to rear of farm house.

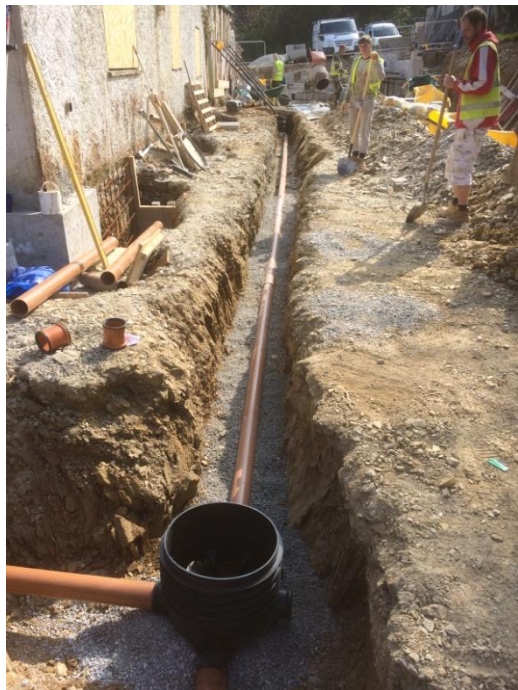
Figure 10. Service trench adjacent to rear of farm house.

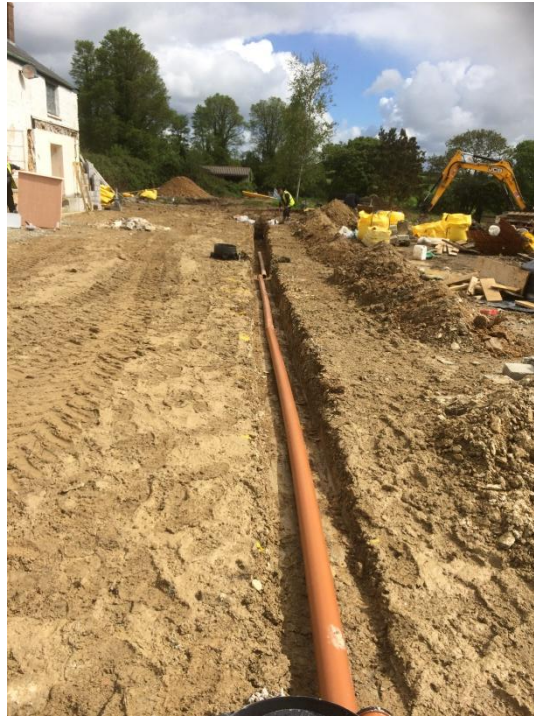
Figure 11. Service Trench in front of house.

- 5.9 [Context 001] After removal of turf there was a layer of topsoil approximately 100-150mm deep followed by a layer of compacted shillet and soil (80/20%).

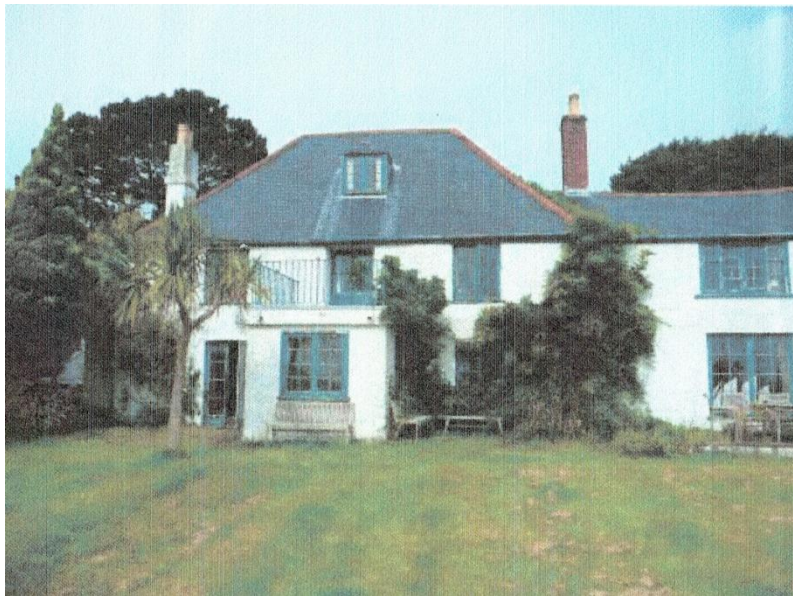
have been raised from the height of the adjoining building making it a continuation of the adjoining building(s) seen in Figures 12 & 14. Considering the height of the chimney breast to the left, this is below the height of the hipped roof and it could have been a fire hazard. If the roof had been in line with the other buildings and if it had originally been lower than the fire risk would have been reduced as the chimney pots would have been above the line of the roof.

Fig 12. Front view of building - 1 (Author 2017).

Also it should be noted that the chimney breast on the left is stone built on the outside of the property and may also have been constructed at a later date to the main house. Although if the Historic England date of 18<sup>th</sup> century is considered then it is possible that the chimney breast is contemporary with the main house and not a latter addition. On the other-hand the brick chimney breast on the right in Figure 12 implies that this was a latter addition and from the design of the fireplaces internally shown in the photographs above it would suggest that this is the case. Figure 13 below clearly shows the outside of the building with its stepped chimney breast allowing for the fireplaces on the first floor.

A point worth noting is that porch with the balcony shown in Figure 12 above has now been removed. From this photograph it should be pointed out that there is the possibility that the chimney breast was heightened over time as indicated.

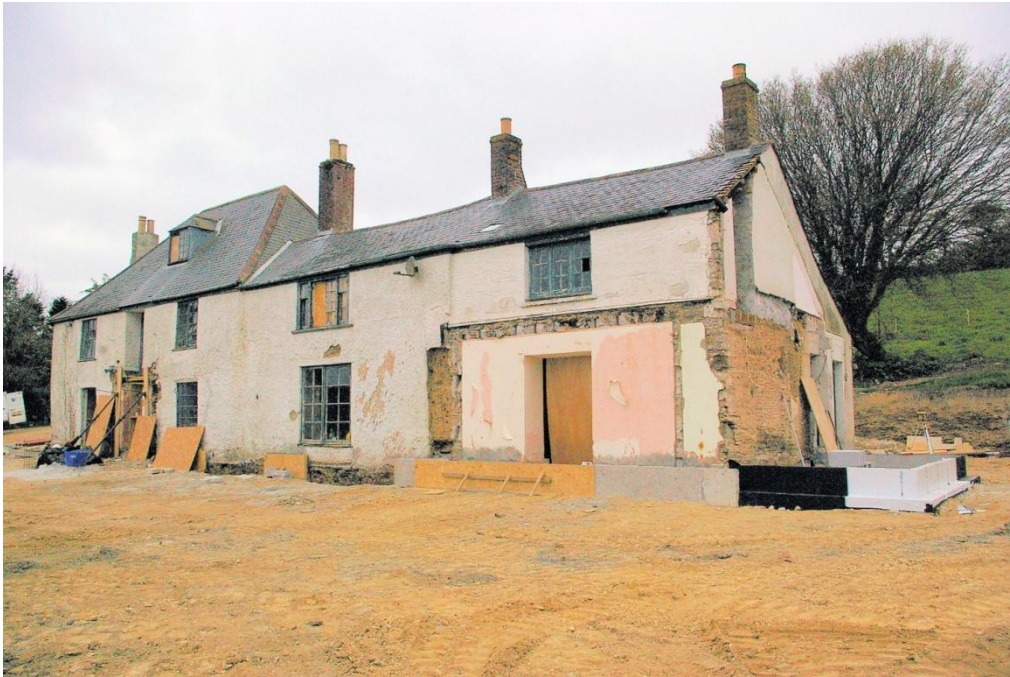
Fig 14. Front view of building - 2 (Author 2017).

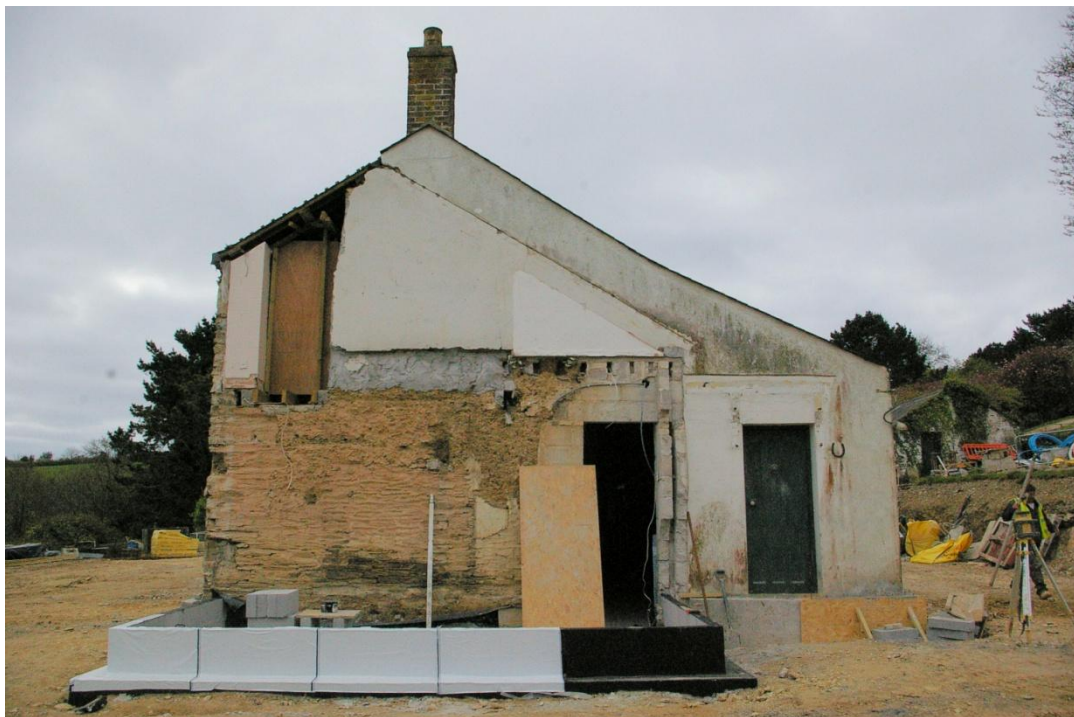
Figure A2.1. Gable end of the original building (Author 2017).

Figure A2.1 above clearly shows the cob wall and the 20<sup>th</sup> century construction work of manor including the footings for the reconstruction of the original annexe. In addition the concrete block modifications around the door(s) to the right can also be seen. It is thought that this was carried out during the 1960's during updates/improvements by one of the previous owners. In the background (to the right) can be seen the gable end of the 18<sup>th</sup>/19<sup>th</sup> century barn.

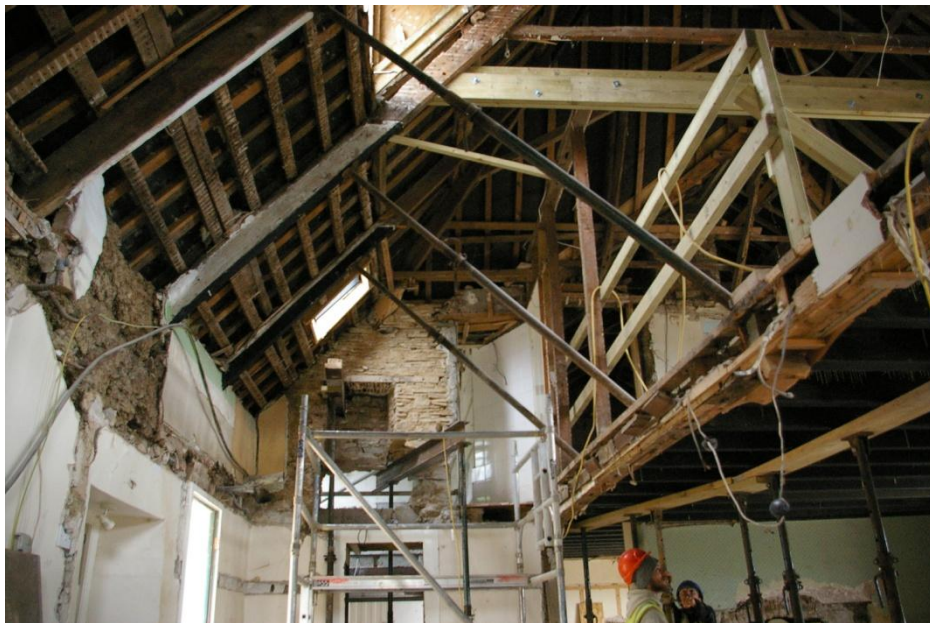
roof in places has obviously been replaced at some time, again the timbers for the purlins vary in date as can be seen by some which show signs of being covered with laths which were probably plastered at one time. However the evidence suggest that many of the alterations to the property took place in the mid 1960's.

The pitch of the roof in the main building suggest that the original building may have been thatched and was not hipped at that time. It is also possible that when the roof was probably repaired or modified typically for aesthetic reasons it was raised and changed to the hipped construction. Unfortunately there is no evidence surviving to support this.

Figure A2.2. Internal view of the manor/farm house during renovation (Author 2017).

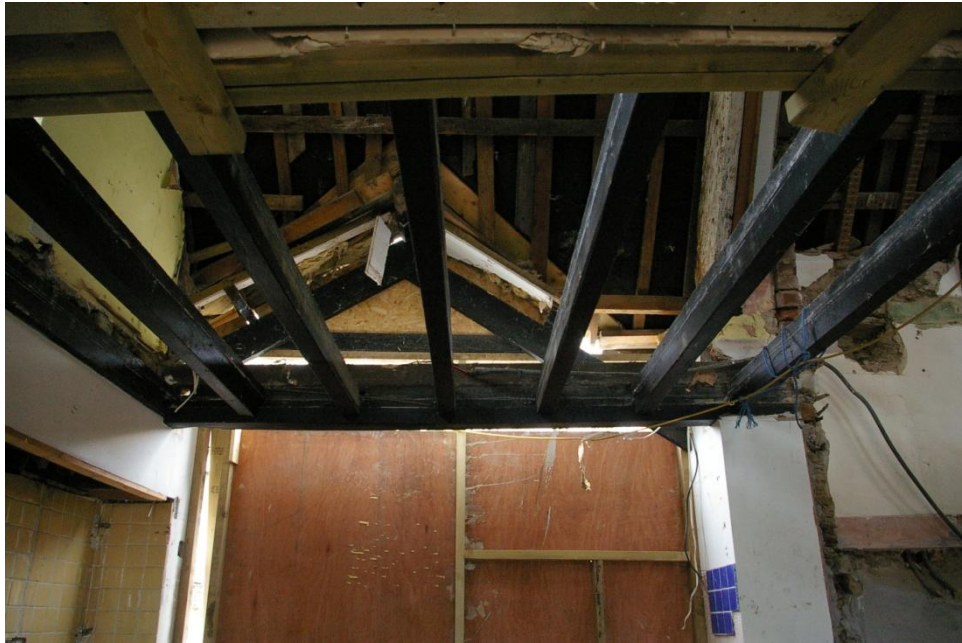
In Figure A2.3 below, the floor joist appear to be of an 18th/19<sup>th</sup> century date probably dating from when this extension was constructed.

Figure A2.3. Close up of 1<sup>st</sup> floor timbers.

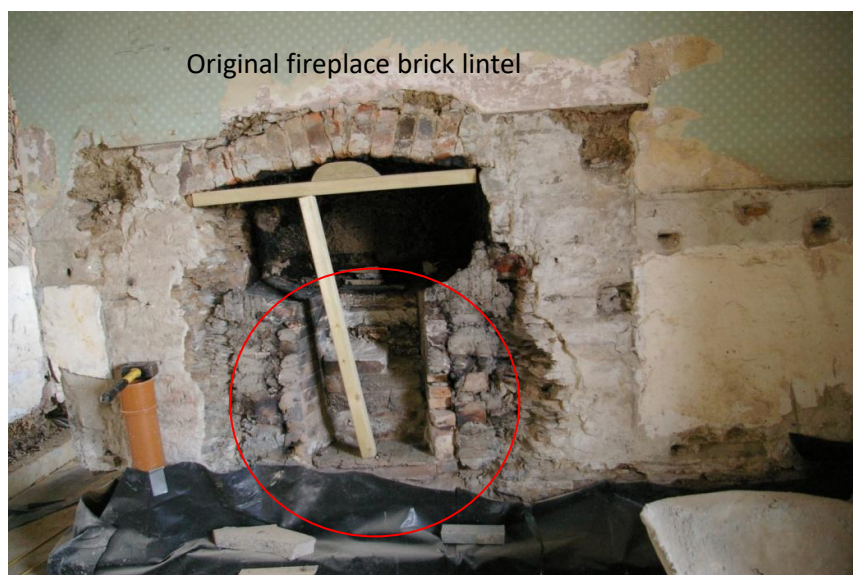
There appears to have been various phases of changes being carried out throughout the property. With the internal plasterwork being removed from the walls during renovation the fireplaces clearly show the changes that had taken place. In Figure A2.4 the fireplace illustrates the major changes, with the original brick arch being supported by the timbers. The final changes were its reduction in size by the addition of stonework and a brick finish to the inside of the fireplace. This final change has been circled in red, Figure A2.4. The top level of the bricks that have been circled would have been the height of the final fireplace. Above this level on the rear wall can be seen the blackened stonework caused by smoke from the original fireplace.

Figure A2.4. Overview of fireplace with its changes over time (Author 2017).

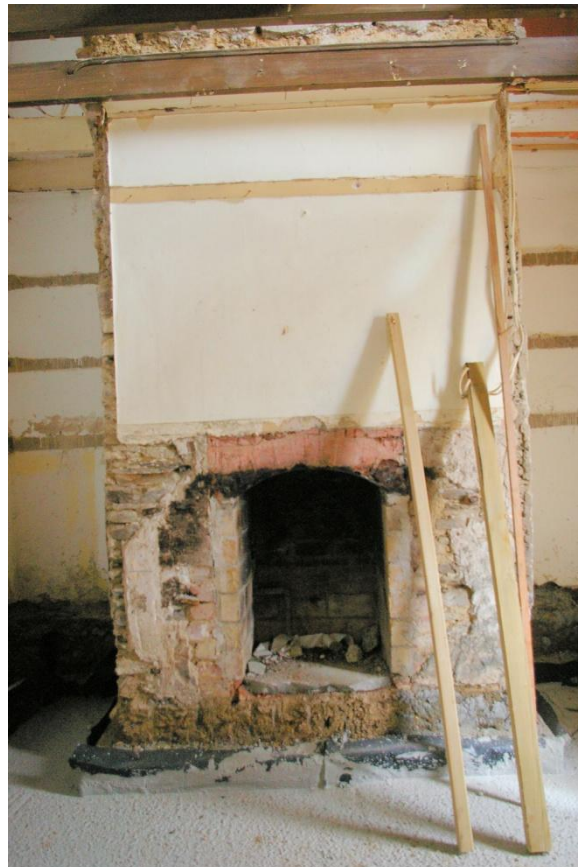
It is not unusual for fireplaces to be installed at a later date particularly as it is thought that this may have been an Hall House originally. In addition it is not always the case that chimney breast that are installed at a later date are constructed on an external wall. Many within the south west are installed internally even though this may be reducing the room size, the construction becomes easier as the external wall does not have to be cut through. This is particularly important where the main construction is a cob wall. The internal chimney breast can then be of a stone construction which was then rendered.

Figure A2.5. A fireplace thought to be installed at a later date (Author 2017).

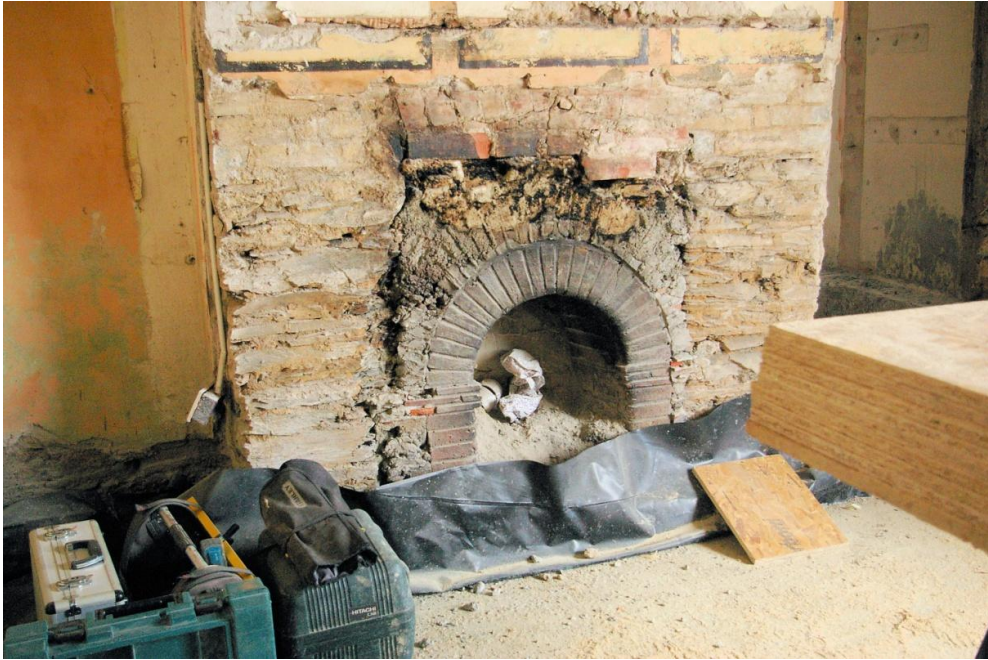
breast implies that it was originally panelled, although there are no longer any further traces of this. The evidence for this is further strengthened by the presence of timber within the walls adjacent to the chimney breast. As with the fireplace in Figure A2.5 above, it is also possible that this fireplace was also constructed at a later date other than the building's main construction.

Figure A2.6. Arched fireplace reduced from original size. (Author 2017).

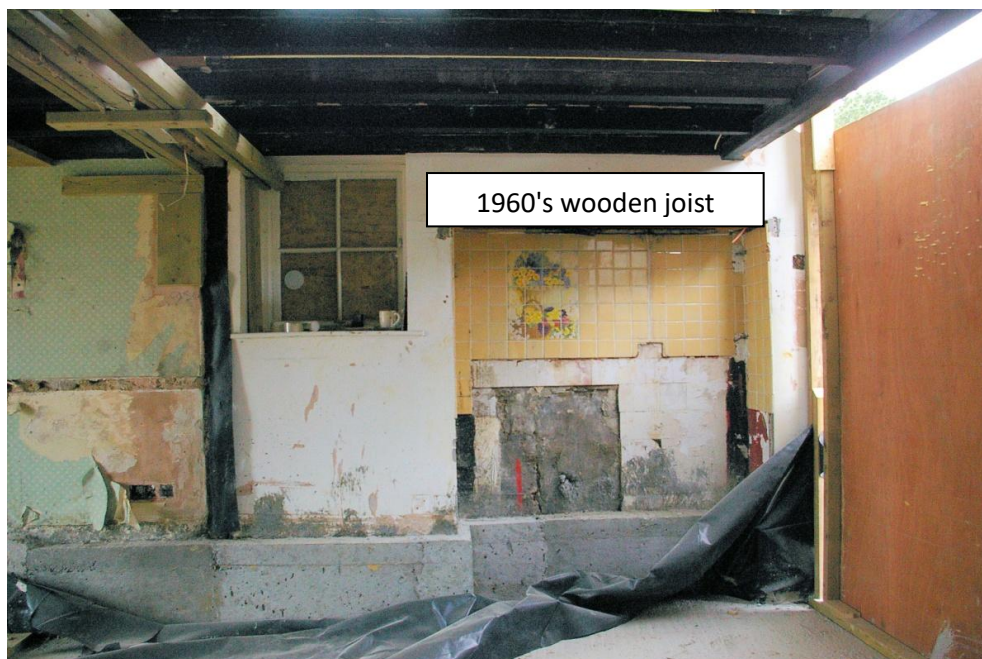
Figure A2.7. A fireplace in the kitchen area for Aga [1960's?]. (Author 2017).

In Figure A2.7, above, it can be seen from the tiling on the rear wall that it would appear that at one stage there was a kitchen range/Aga fitted within this alcove. However the tiles behind do look relatively clean considering the cooker was probably coal fired and general use does not seem to have affected it. Perhaps it was not used for several years? or the previous owners may have preferred electric cooking?

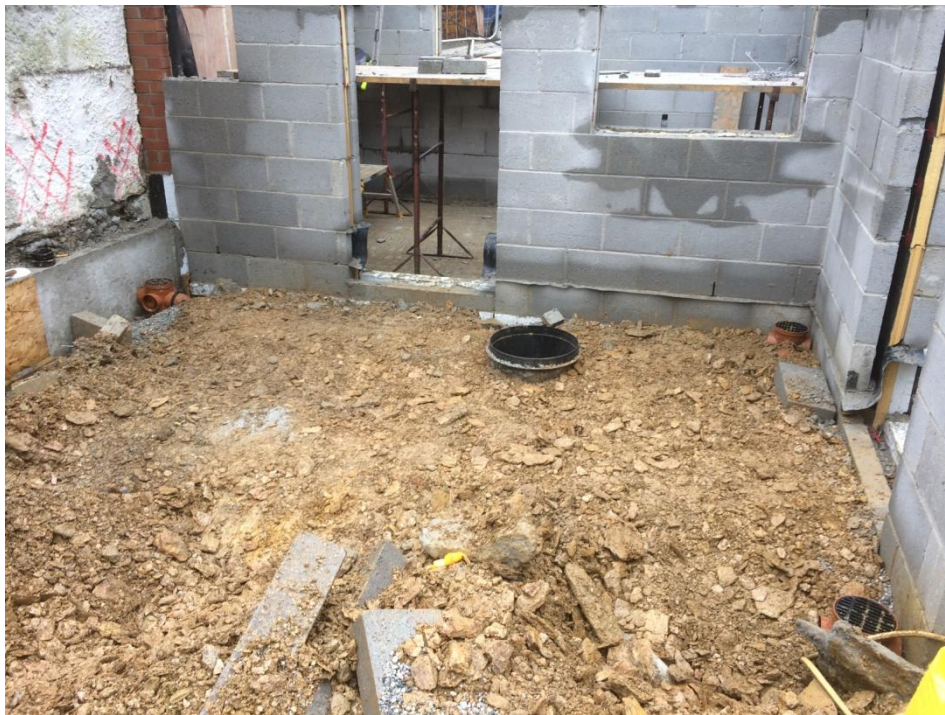
Figure A2.8. Room in rear extension prior to floor being laid (Lilly-Lewarne: Aug 2017).

During August 2017 a site visit was made and in addition to monitoring the progress of trench's externally areas of the progress in renovation internally were also viewed. Figure A2.8 above provides an illustration of one of the rooms within the extension prior to the floor being laid. This and other areas within the extension was monitored and was nothing of archaeological interest was revealed this time. It would appear from this room and the adjacent ones there was no evidence revealed within the floors that could determine the phasing in construction of the property. It is thought

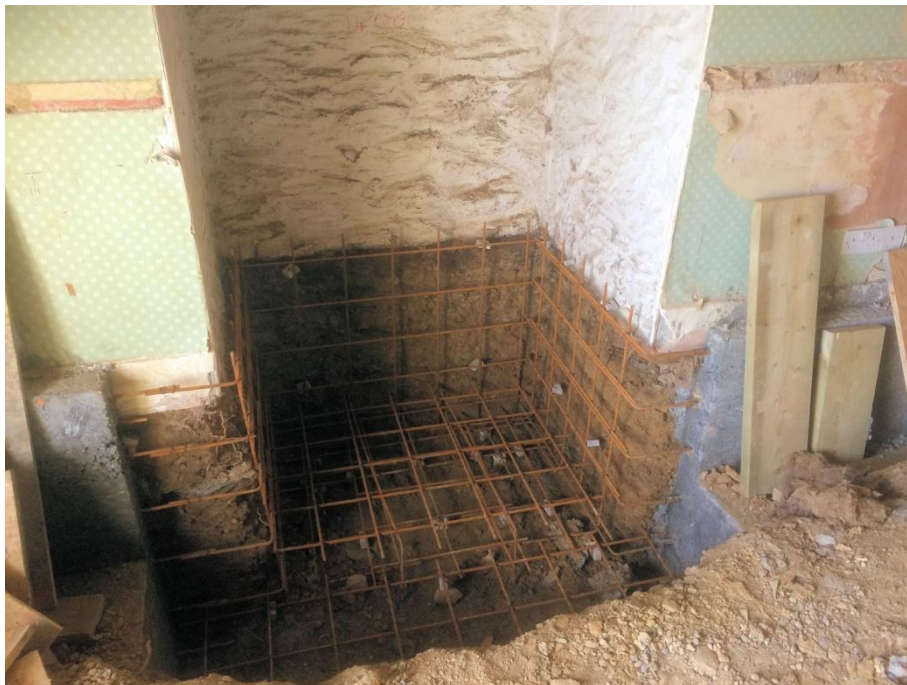
During work on a fireplace, Figure A2.9, it was necessary to remove the soil at its base in order to provide a suitable base/footing for the new fireplace. The area was excavated down to the bedrock level other than the footings for the main fireplace wall and adjoining cob walls no other evidence was revealed. The construction of the fireplace and the adjoining cob walls does imply that the fireplace itself was a later construction than the cob wall which formed the main building construction. However it is difficult to provide a definitive date for its inclusion into the building construction.

Figure A2.9 Fireplace with the base removed to reveal its construction. (Lilly-Lewarne: Aug 2017).

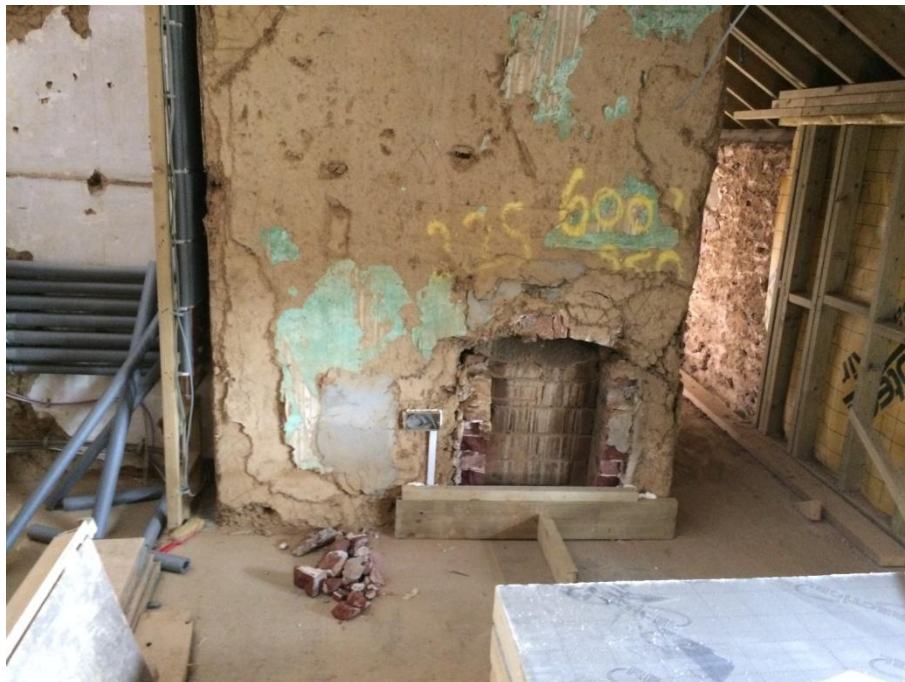
This difference in construction throughout the building is a recurring theme throughout the structure. As stated previously it would appear that overtime ad hoc methods of repairs have been carried out at different periods of time and these are difficult to determine as nothing has been recorded.

A2.10. Fireplace in first floor room and adjoining walls which illustrates differences in construction. (Lilly-Lewarne: Aug 2017).

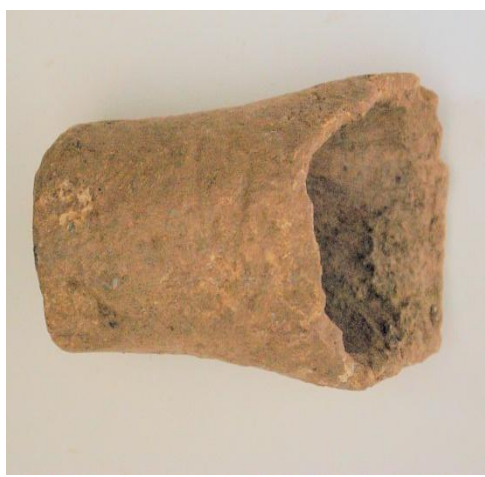
Figure A3.1. Cattle Bone 1

The animal bones were assessed by Dr Wendy Howard during a site visit to a multi-period site at Mount Folly Farm Bigbury-on-Sea Devon. Both of the animal bones were found to show signs of butchery based on the several cuts that were clearly visible on the bones. The bones were identified as being cattle bones and were probably the result of bones being discarded from butchered meat, possibly into a midden. The remnants' from the midden, the bones, pottery and other fragments of finds along with other waste material were then spread at some time onto the field as manure, a common practice of the time. As the artefacts are difficult to give a precise date to and it would be difficult to determine when they were discarded no date or phasing can be provided. In addition as the finds were found over a large area and totally out of any stratigraphical context they can only be classed as residual or stray finds.

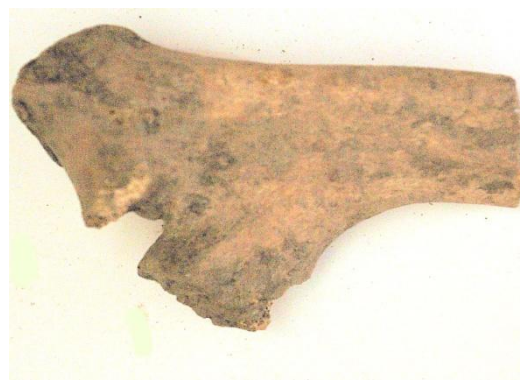
Figure A3.2. Cattle Bone 2.

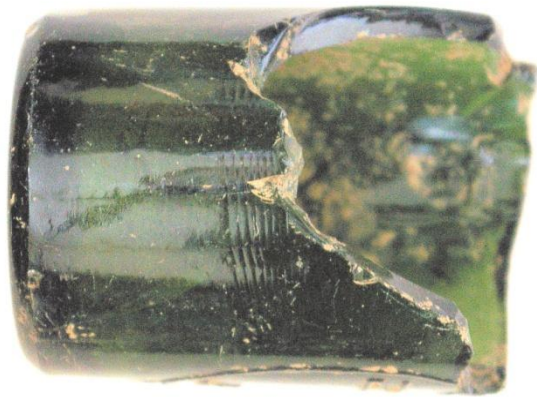
Figure A3.3.

Dark (green) coloured bottom half of glass bottle recovered from the area leading down to the river. There are partial remains of a name 'N.P. ???????? & SONS PAIGNTON' marked on the bottle but to date no name of a manufacturer in Paignton has been forthcoming.

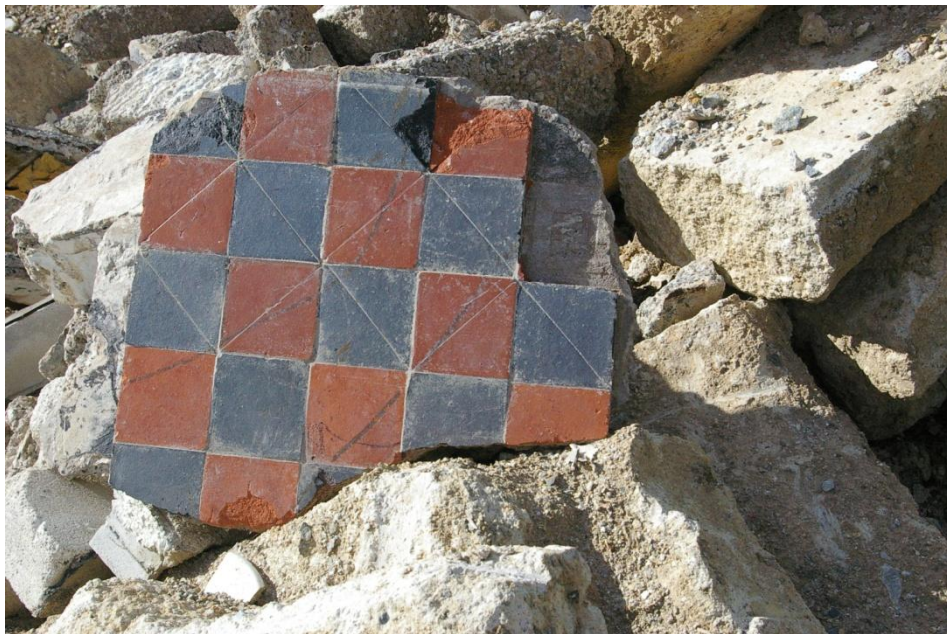
Figure A3.6. Parts of a tiled floor and other waste from farm house.

The spread of the finds suggest that they were probably disposed of through manuring in the late Victorian period.

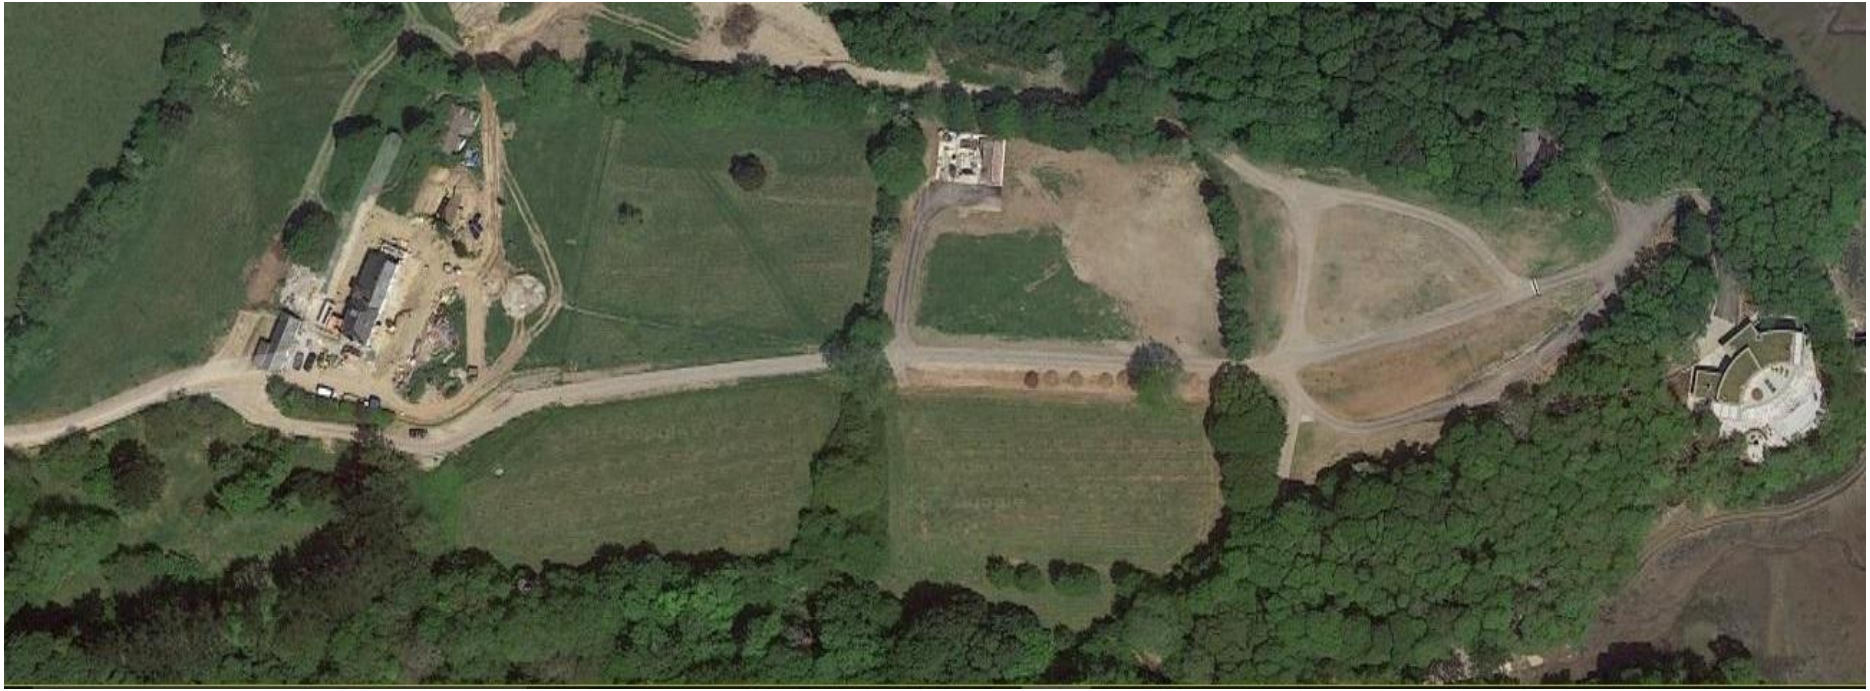
Figure A5.1. Aerial Photograph of Bosloggias (digital-documents - St Mawes Cornwall Aerial Photograph August 2017).

The above photograph shows the area that has been under discussion in this report. Apart from the building works that has been carried out and the levelling/landscaping of the area there are no crop marks present which would indicate any archaeological feature. The only features which are visible in the photograph and on the ground are the remains of the helicopter pad (believed to have been constructed in the 1960's) and the remains of the garden wall in front of the house (to the east). The latter feature is semi-circular in its construction and at the time of the survey the overburden of vegetation would make it difficult to date precisely.
