CHAPTER 3

The Water Supply Lines Outside the City

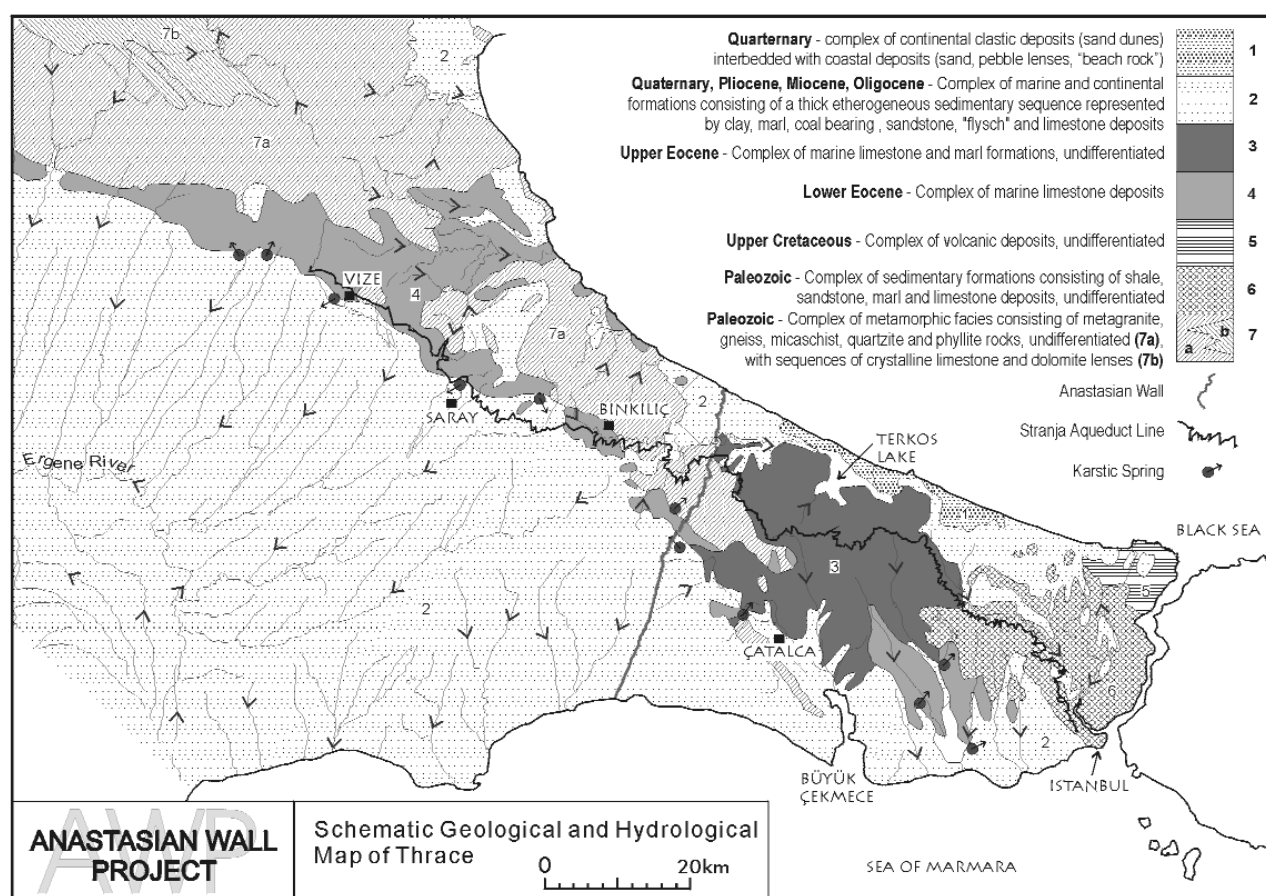
FIG. 3.1 Geological map of Thrace.

The metamorphic range of the Stranja massif defines the north-west–south-east alignment of the Black Sea coast of Thrace. Towards the Sea of Marmara (Propontis), the basement rocks deepen and become progressively buried by sedimentary formations.⁴ Eocene limestones are scattered along the southern flank of the massif, particularly in the region between the Anastasian Wall (to the east and south

of Gümüşpınar) and Vize. Abundant aquifers are formed where the impervious metamorphic basement outcrops below the karst limestone, and it was such sources at Danamandıra and Pınarca, and subsequently near Ergene and Vize, that were tapped for the principal channels for Constantinople. In contrast to the relatively stable but limited hydraulic potential of metamorphic water sources, the

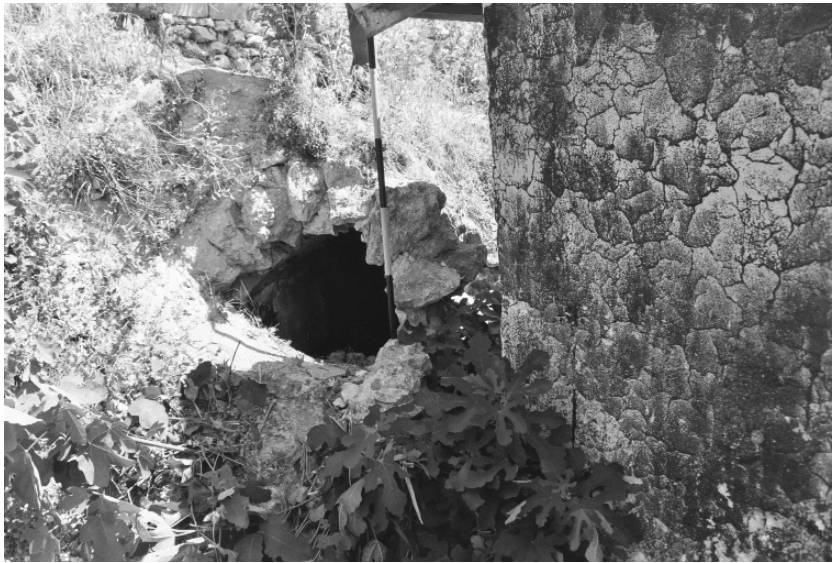
FIG. 3.3 Channel on the outskirts of Vize (Gazi Mahallesi).

In the west suburbs of Vize (Gazi Mahallesi) a length of channel was found outside the garden of No. 10 Çeşme Sokağı, at an elevation of about 225 m asl.¹⁵ The channel was vaulted with rough stones and measured 0.68 m in width at the springing, and 0.60 m in width lower down, due to the lining of hydraulic mortar and accumulated sinter (Fig. 3.3). The outline of a turn in the channel could be seen in section in the garden, 10 m to the north-west. The discovery provided useful evidence for the elevation

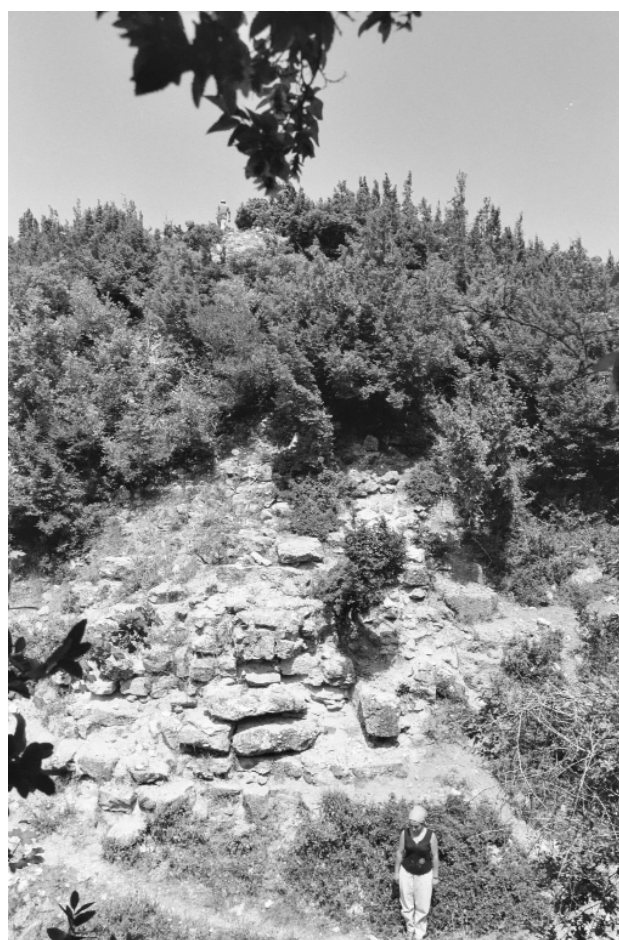
FIG. 3.4 West side of the aqueduct near Okçular (K2).

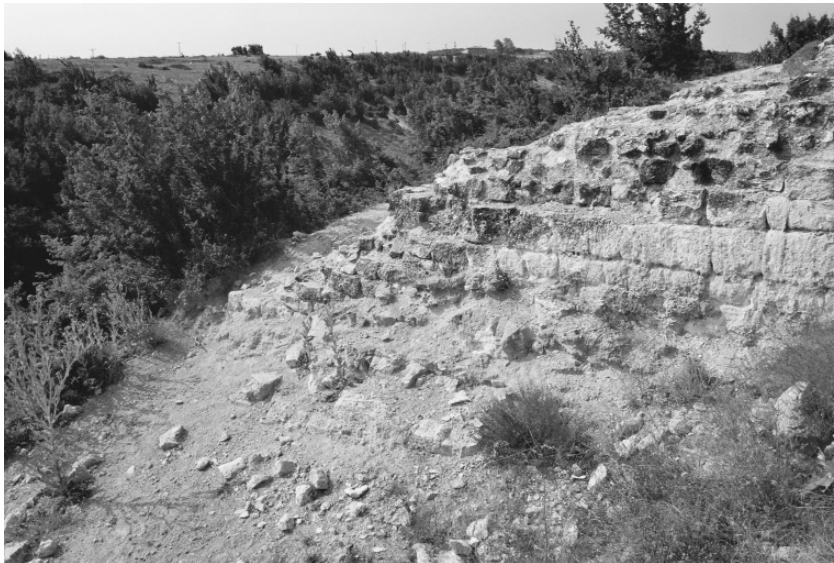
FIG. 3.5 East side of the bridge at Akpınar Dere (K4), west of Evrenli.

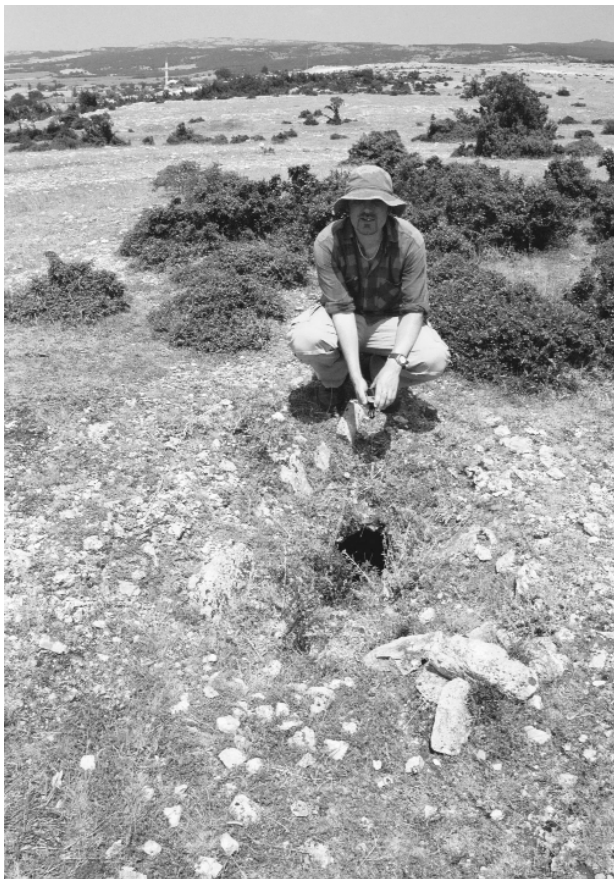
FIG. 3.6 Channel at Kolağıl Mevkii near Çakıllı.

width of 0.78 m. These correspond with the channels noted by Çeçen (Fig. 3.6).²³ The height of the channel is here *c.* 206 m asl.

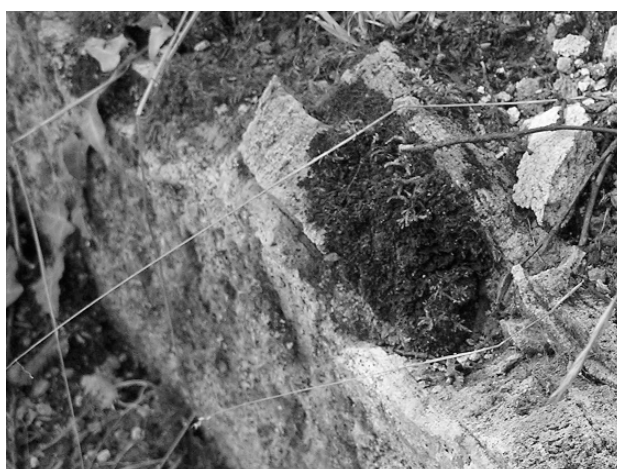
FIG. 3.7 Sinter deposit near Ergene (K4.1).

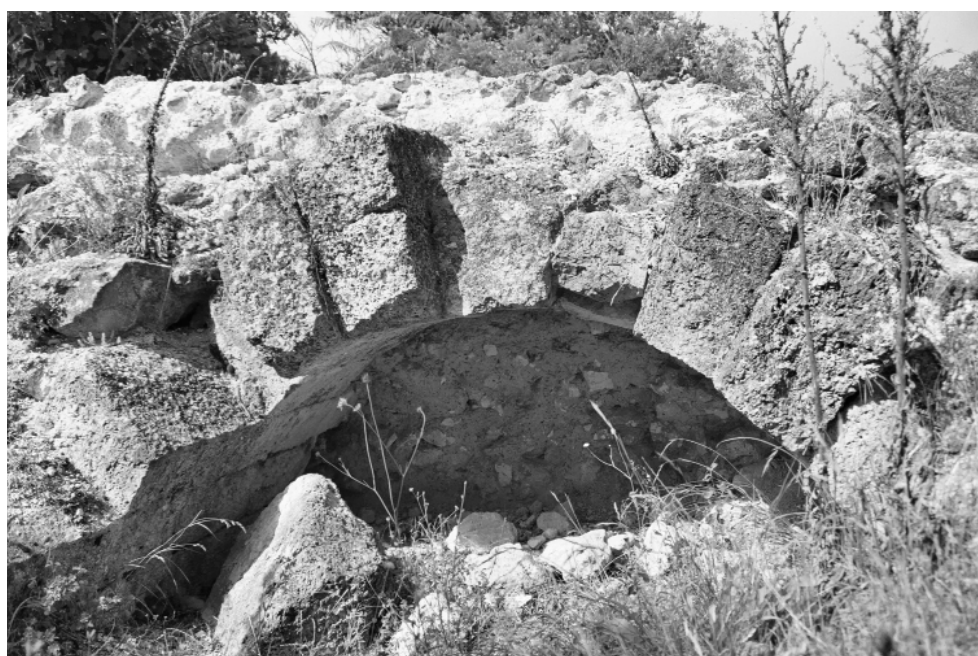
FIG. 3.8 Arch at Gökcesu (K5).

Following a survey using a Total Station, it was possible to establish that the north channel had been blocked and that a second parallel channel had been established to the south. This alteration can be associated with the extensive rebuilding seen on the western part of the bridge surviving across the stream. There, as noted, the north side of an arch had been filled up and strengthened with mortared rubble, probably following flood damage. Çeçen suggests that additional water sources may also have come from the Dedepınar and Gökcesu springs to the north.²⁶ We followed the latter valley but there was no trace of a channel on either side, despite recent clearance and erosion.²⁷

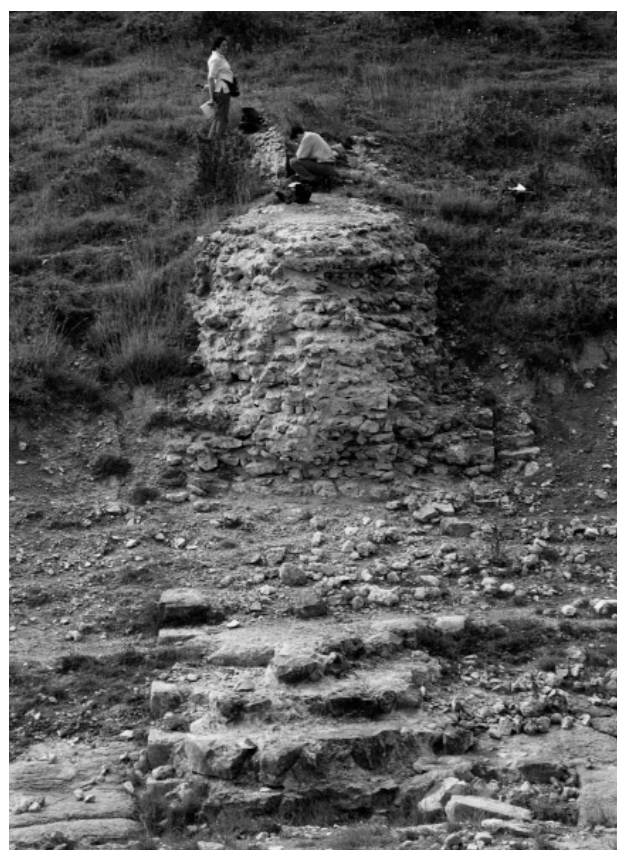
FIG. 3.10 Abutment on the west side of Gelin Dere (K6).

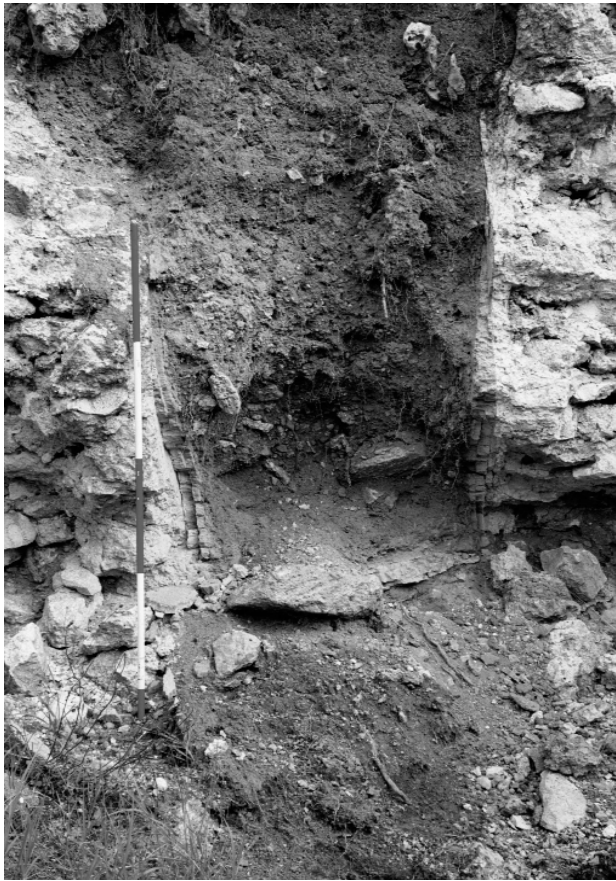
FIG. 3.11 Channel on the east side of Gelin Dere (K6).

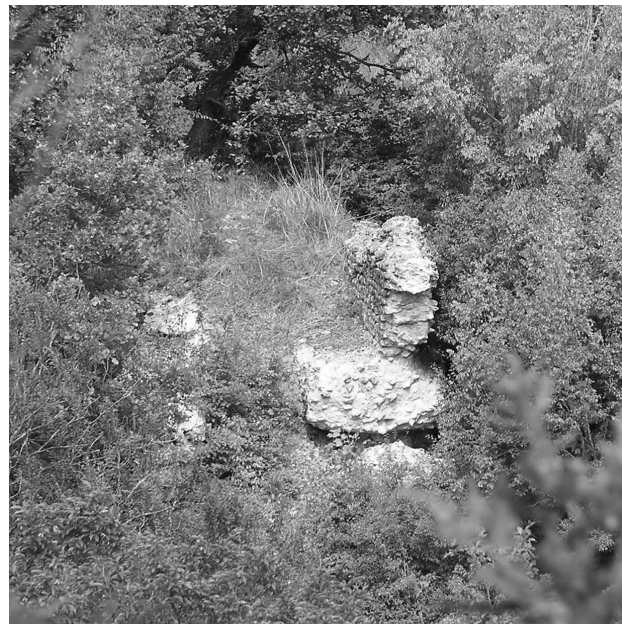
FIG. 3.12 Ayvacık Dere, north abutment (K7).

The abutment on the north side of the valley comprises part of the base, the east wall, and part of the west wall (Fig. 3.12). The fragmentary remains of the lower abutment with large blocks survive down the slope and represent the pier for the first arch. The upper remains are 3.40 m wide and project 4.40 m from the hillside. The structure consists of three main elements: to the east (upstream) there is a high, standing section of wall, 0.60 m wide; the outer

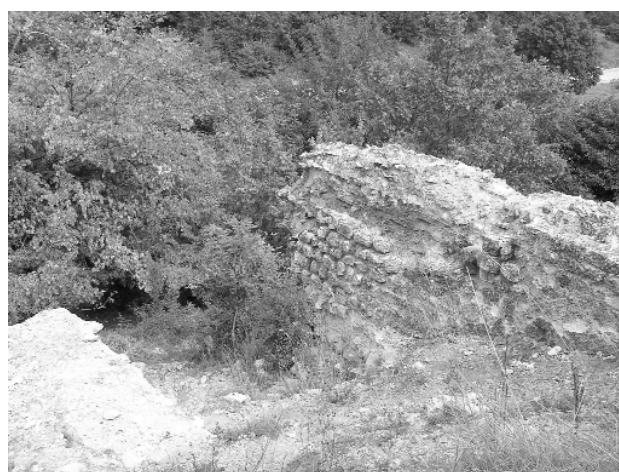
FIG. 3.13 South abutment at Ayvacık Dere (K7), showing the inner face of the east wall.

facings are mostly robbed away to a depth of 0.45 m. A level base is structurally part of this wall on the west side and the level core survives to a width of 0.70 m to the west where it is broken away; there is no clear evidence for a plastered channel base. The middle of the abutment appears to have been robbed away for 1.10 m and only soil fills this space. A section of core and fallen wall survives to the west. There is no clear trace of a channel base on this side.

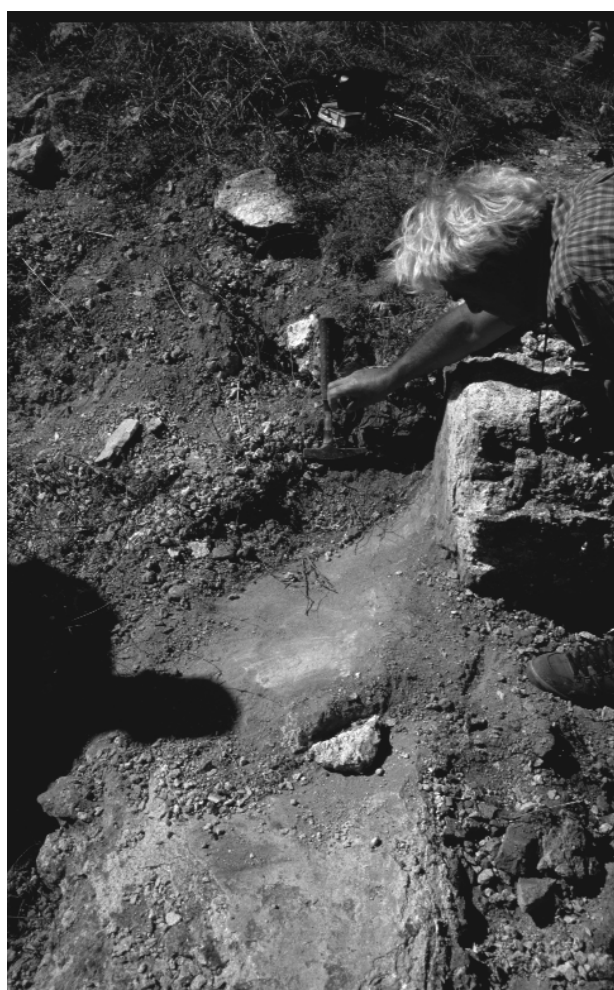
FIG. 3.14 Ayvacık Dere (K7), detail of west abutment showing the two layers of the channel base.

On the south abutment of **K7**, the waterproof plaster base of the west channel was particularly well preserved and at its junction with the side wall we observed that the surface was drawn up at 45 degrees — common practice on Roman aqueducts and intended to ensure water flow and reduce turbulence. A similar feature was also noted in the base of the high-level channel at Kurşunlugerme (**K20**) and Büyükgerme (**K29**).

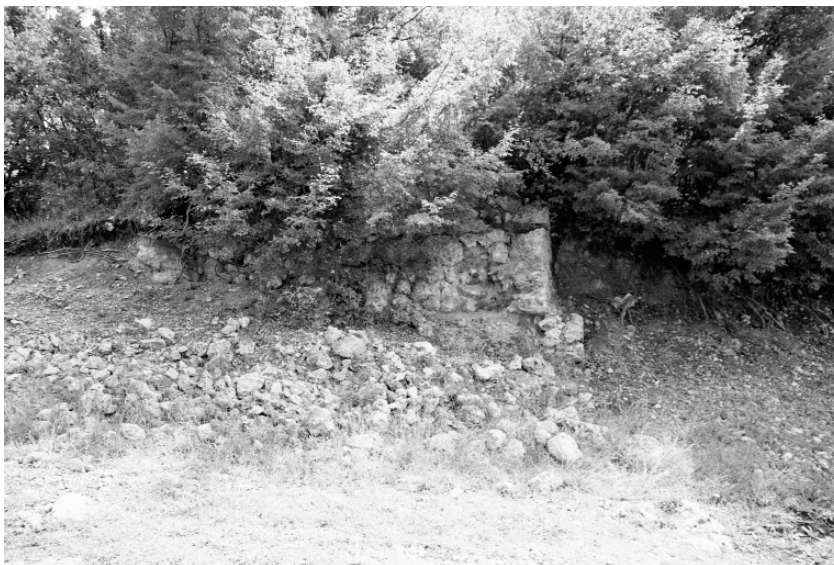
FIG. 3.15 Bridge abutment (**K7.2**) at Çingene Dere.

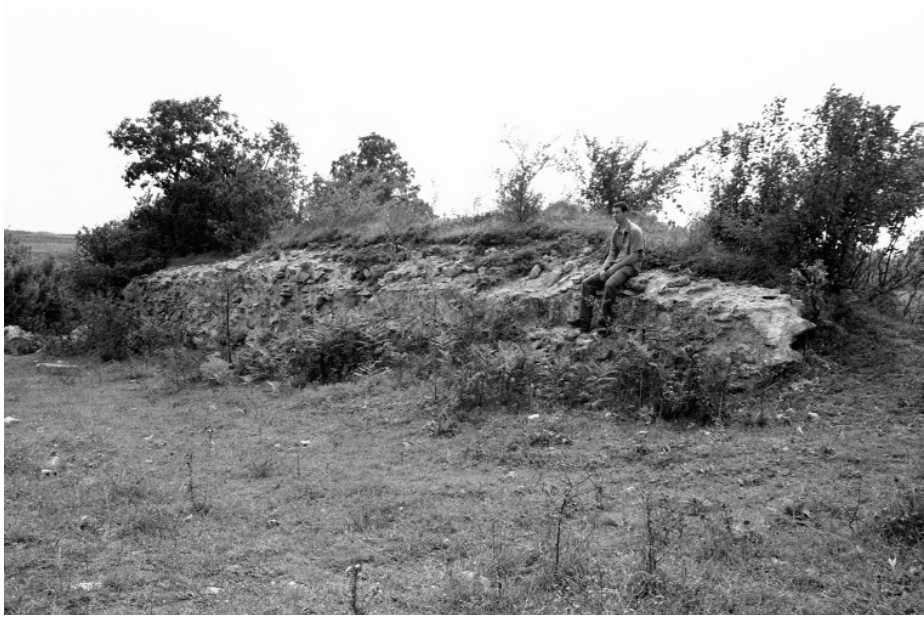
FIG. 3.16 West abutment at Manganez Dere (K9).

The channel turns south off the main valley into the Manganez Dere. In 2002 we were able to record the west abutment of an aqueduct bridge (K9),⁴⁴ 26 m long, surviving as mortared core-work (with large limestone blocks in the core) and standing to a height of 1.5–2 m (Fig. 3.16). This represents the surviving remains of an 80 m-long bridge, *c.* 10 m in height. Revisiting the site in 2004 at the request of the local Jandarma, we observed extensive piles of cut stones and rubble with pink mortar attesting the recent total destruction of the upstanding remains and the buried foundations of the bridge (Fig. 3.17). Amongst the rubble which survived were large squared blocks with quarry-faced work and drafted margins, characteristic of the monumental bridges seen elsewhere on the system. The Jandarma also drew our attention to construction work at the

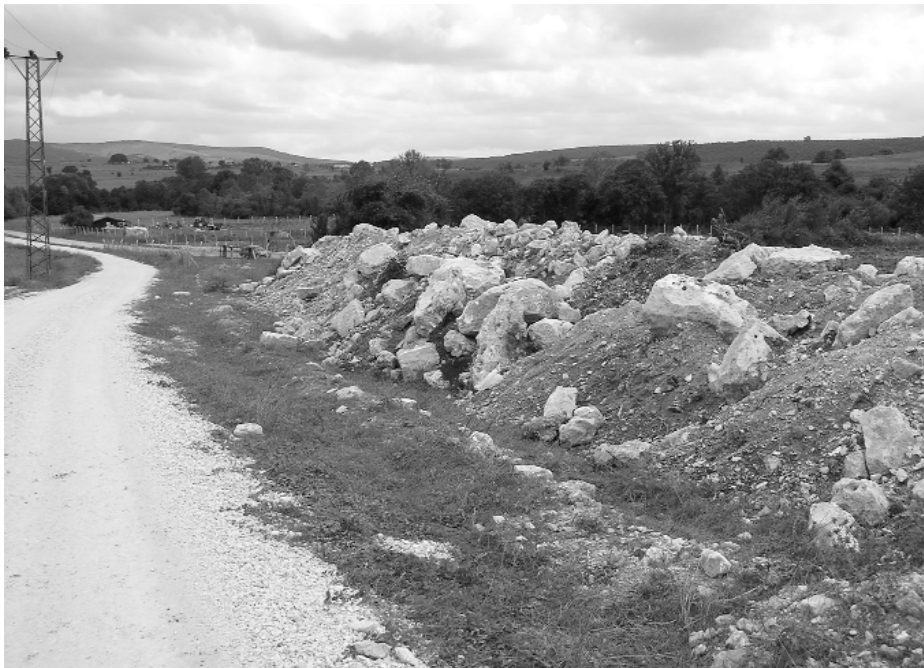
FIG. 3.17 Ruined abutment at Manganez Dere (K9).

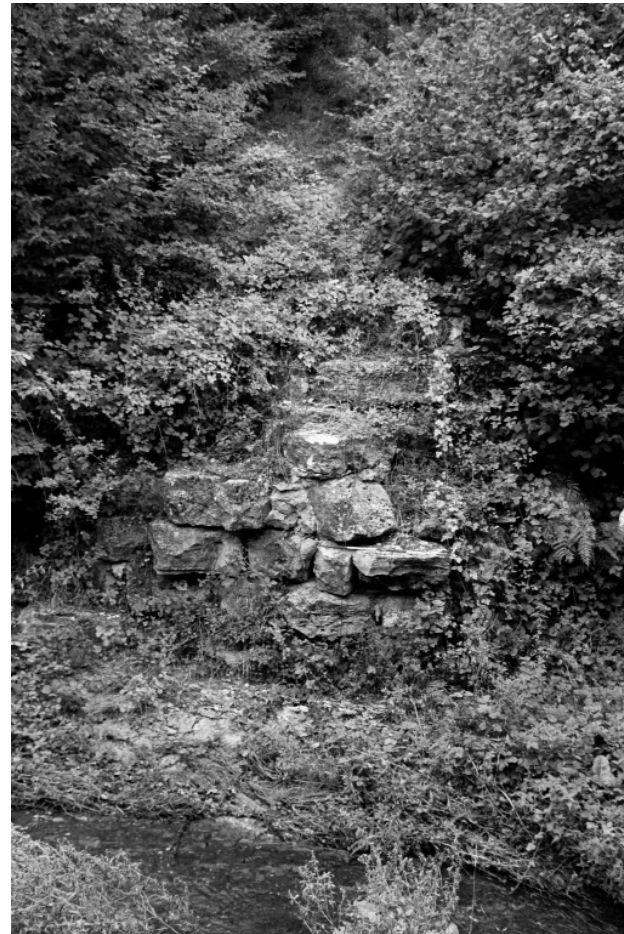
FIG. 3.19 Cineviz Dere (K11), view of west abutment.

The remains lie 1.3 km north of the village of Aydınlar.⁴⁷ An active stream flows between two surviving piers of the bridge, which was constructed of rough blockwork masonry with a rubble-work core. We estimate that the bridge would have been 20 m long and the height of the channel about 10 m. The west pier is c. 6.1 m wide, with a span between piers of 10.6 m. Clamp sockets are visible on some blocks and there is evidence for rebuilding, since facing-blocks with drafted margins are re-used in the west pier (Figs 3.19; 3.20). Midway between K11 and the Babadar Dere a well-preserved length of broad channel is visible in the hillside (G17.1). The channel survives to a height of 2 m for a length of 40 m and is 1.55 m wide, although the base is not clear. The

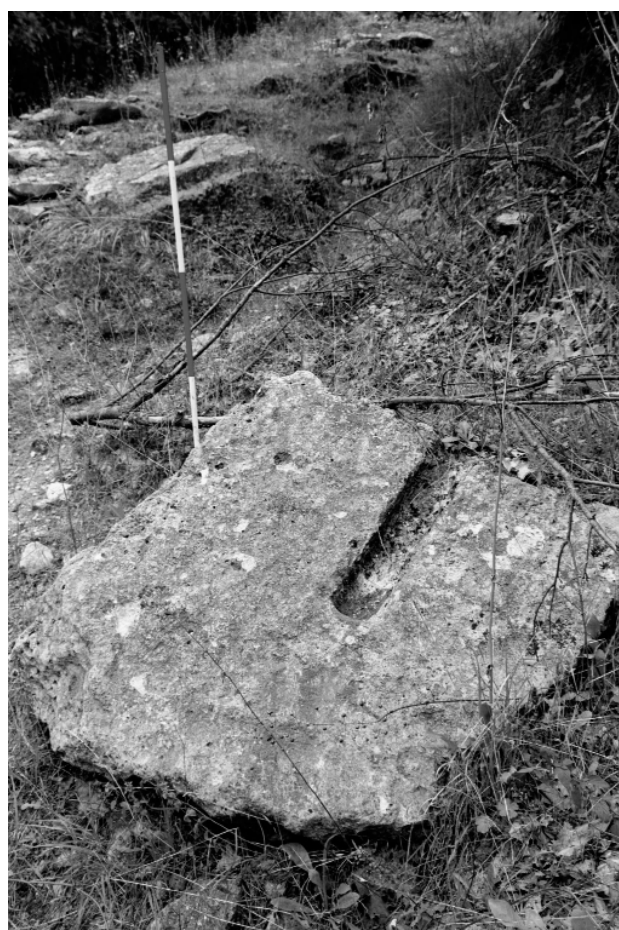
FIG. 3.20 Evidence of clamp socket at Cineviz Dere (K11).

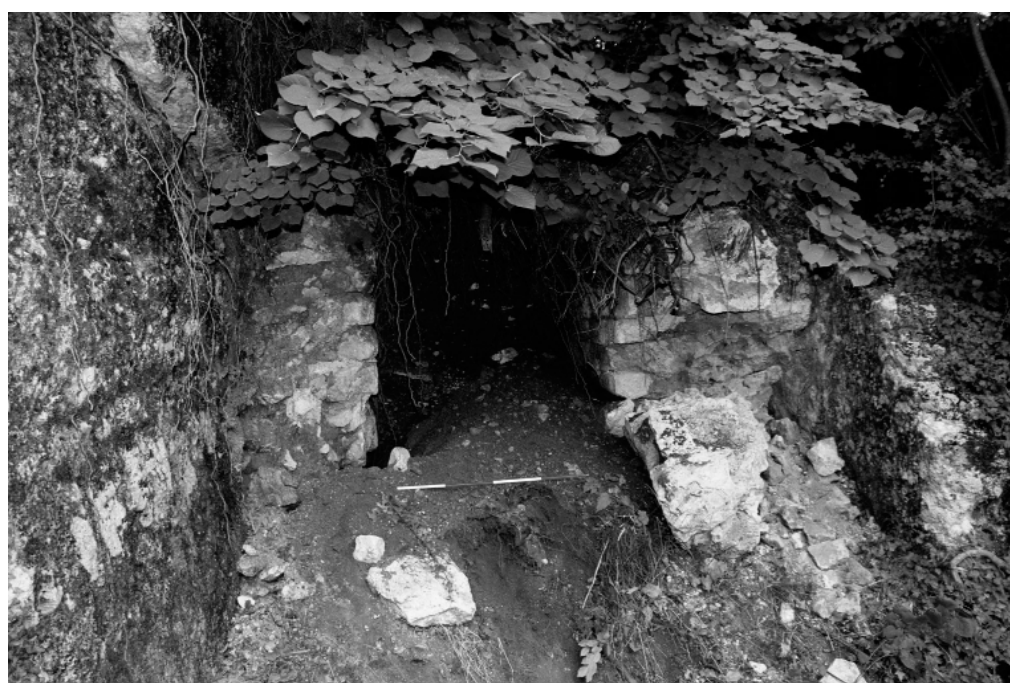
FIG. 3.21 Channel above Babadar Dere (G17.2), seen in a stone cutting in the hillside; note the small blockwork facings.

length of tunnel, 1.60 m wide. We assume that the gully had been formed by quarrying stone for the bridges, such as those at the crossings of the Ceneviz (K11), Babadar (not found), and Elmalı Dere (K12), and it was then crossed by an embankment left on the unquarried rock when the channel builders had reached this part of the system. The quarry face, however, was dug away towards the hillside, indicating that the quarry-men continued to work, respecting the line of the channel. The remains of the continuation of the channel survive to the south-east, with a very clear profile of the base of the channel (Figs 3.21; 3.22).

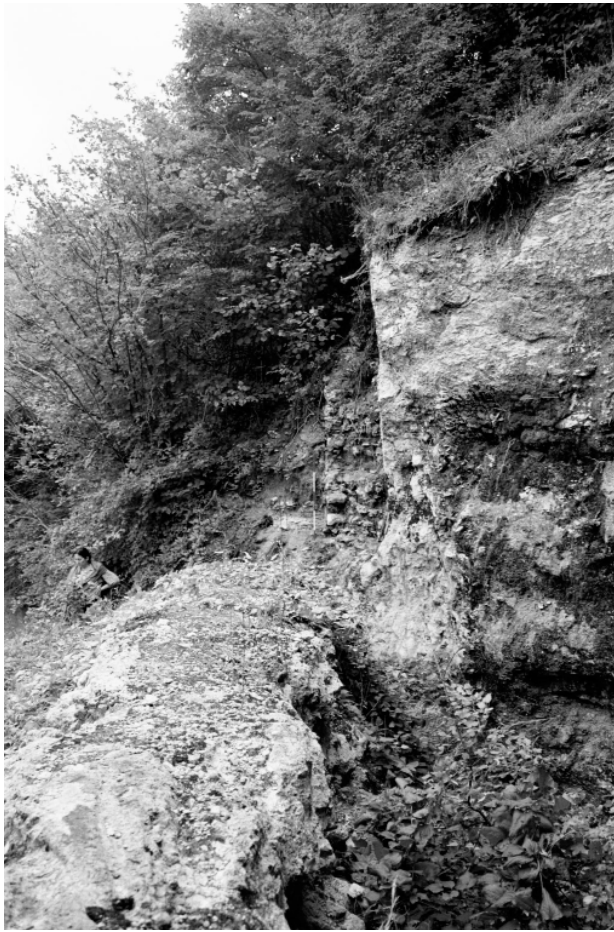
FIG. 3.22 Channel above Babadar Dere (G17.2), showing the east side and the raised stone platform.

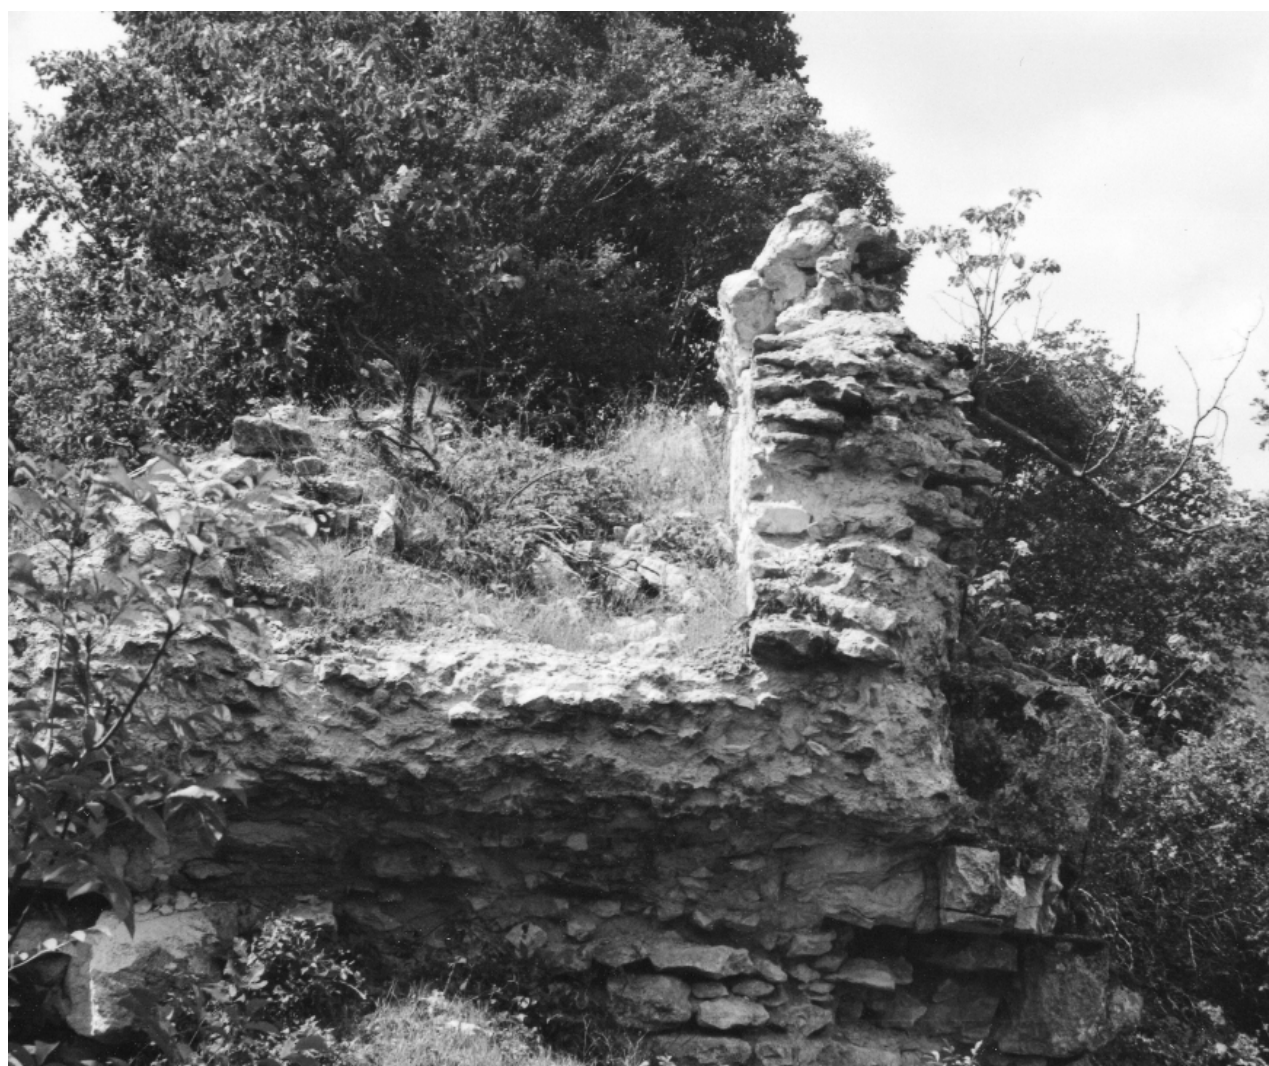
FIG. 3.23 Karamanoğlu arcade (K13), cross-section across the broad channel.

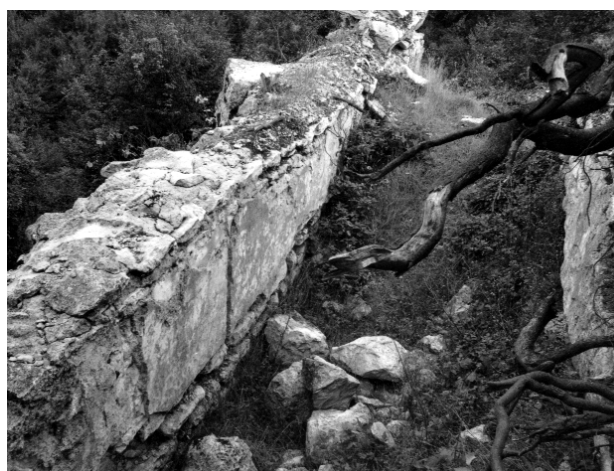
FIG. 3.24 Karamanoğlu arcade (K13), interior of the channel showing fine-mortar facings.

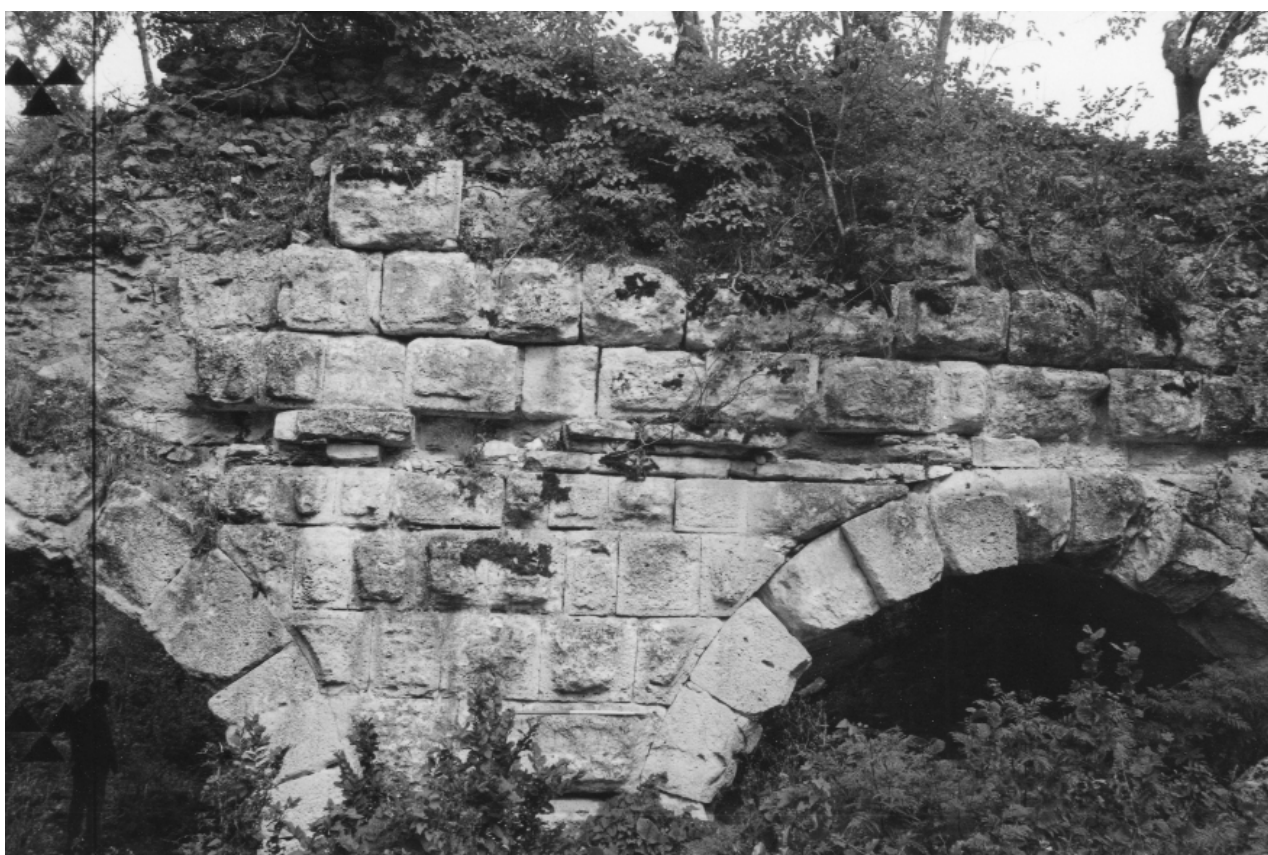
FIG. 3.25 Karamanoğlu arcade (K13), thin levelling courses above the arch.

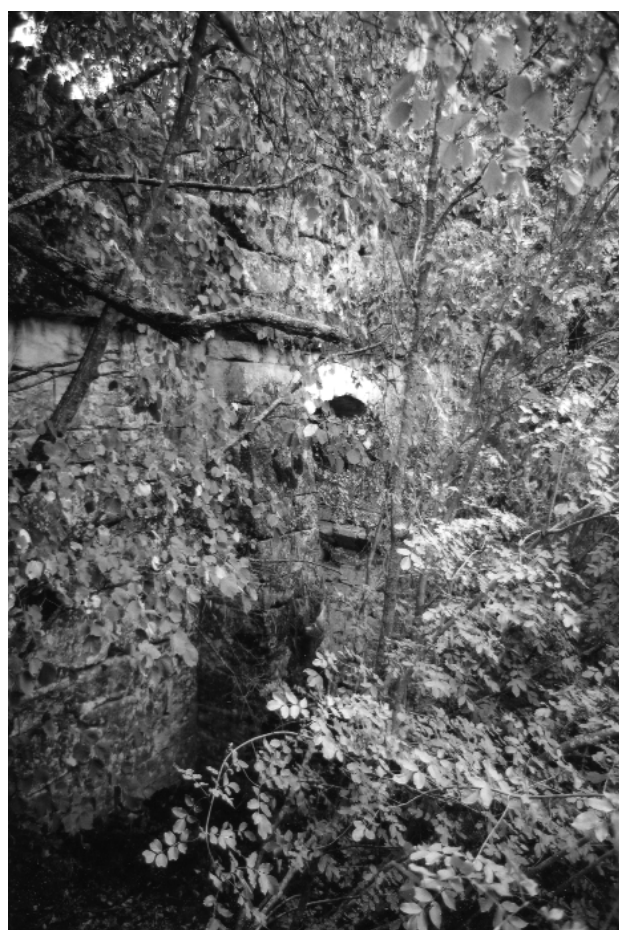
FIG. 3.26 Luka Dere (I7.1), central arch and tapering buttress.

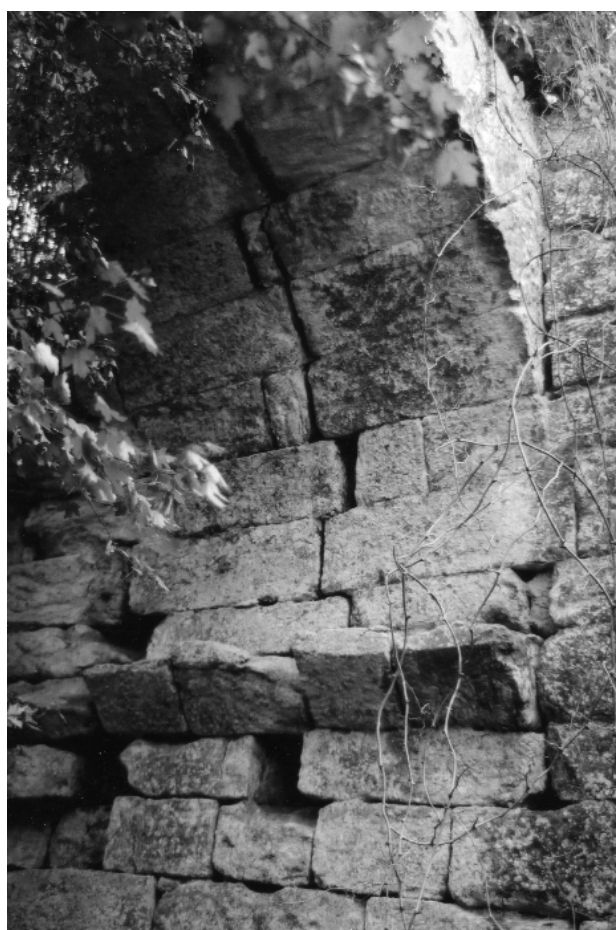
FIG. 3.27 Luka Dere (I7.1), chamfered string-course at the springing of the arch.

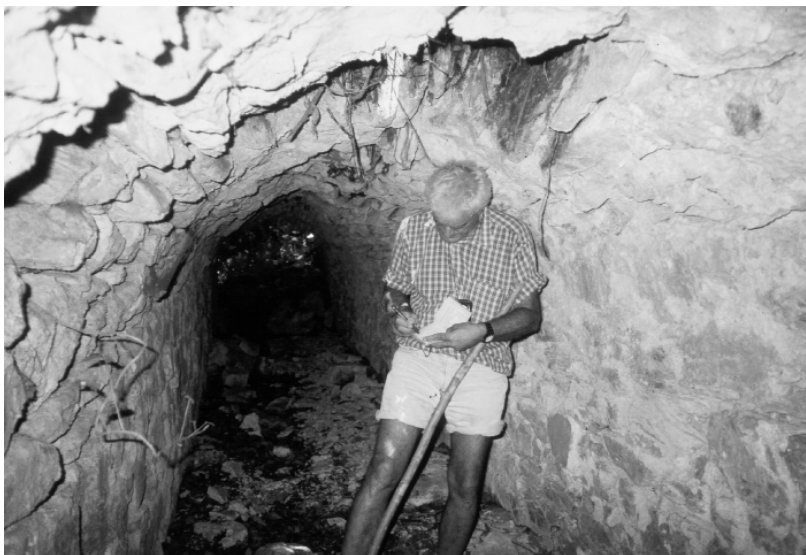
FIG. 3.28 Tunnel near Balligerme Tepe Çiftliği.

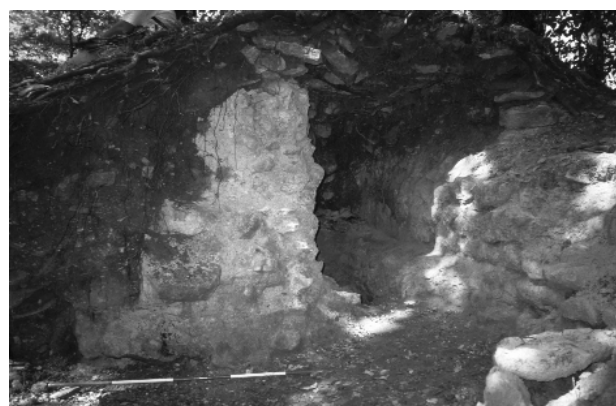
FIG. 3.29 Narrow channel north of Hasan Dede Çiftliği.

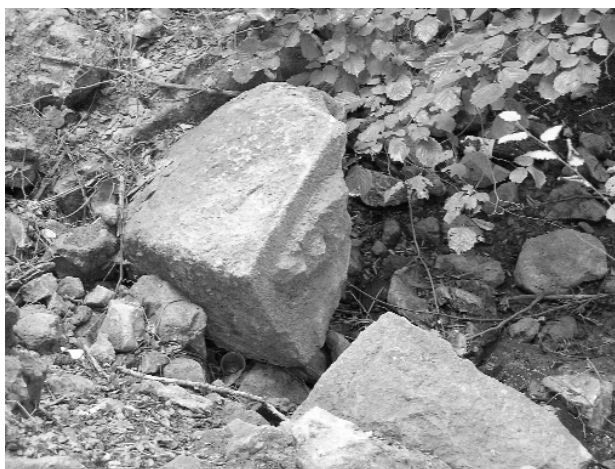
FIG. 3.30 Bossed blocks at the bridge in a gully near Hasan Dede Çiftliği.

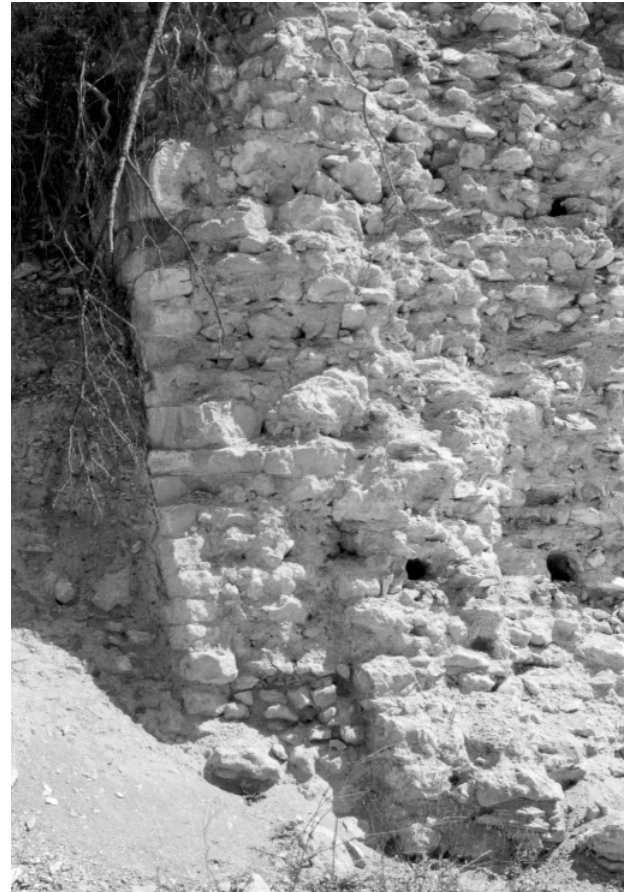
FIG. 3.33 Added facing to the north-east of the east abutment at Gümüşpınar Dere (K19).

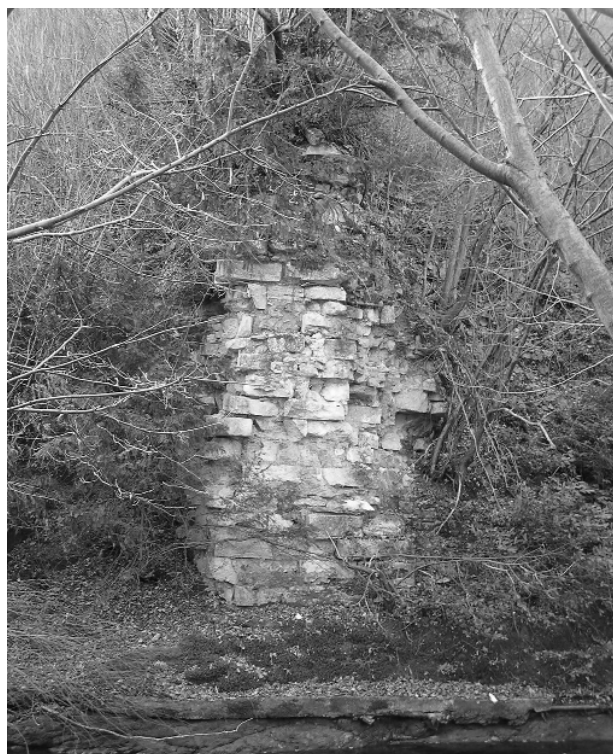
FIG. 3.36 South abutment of the primary bridge at Kurşunlugerme.

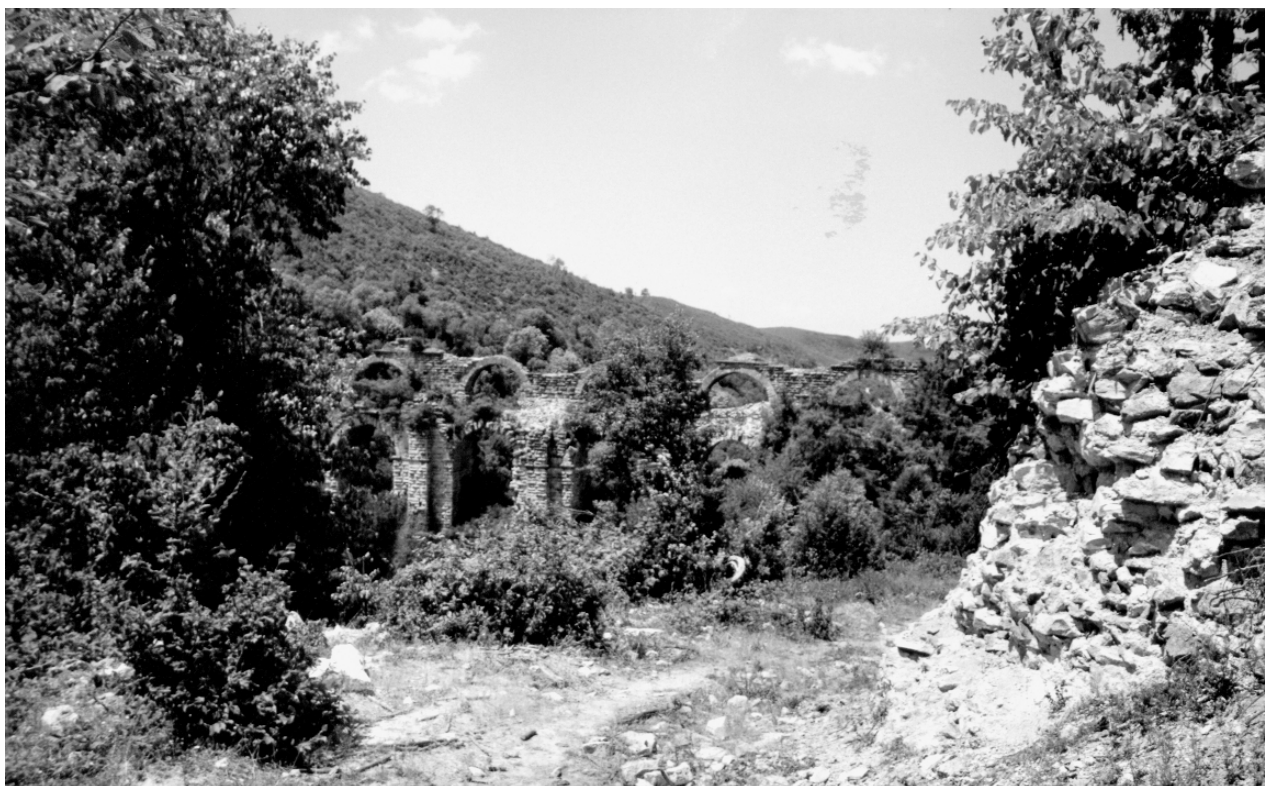
FIG. 3.35 Kurşunlugerme (K20), with the ruined north abutment of the early bridge in the foreground.

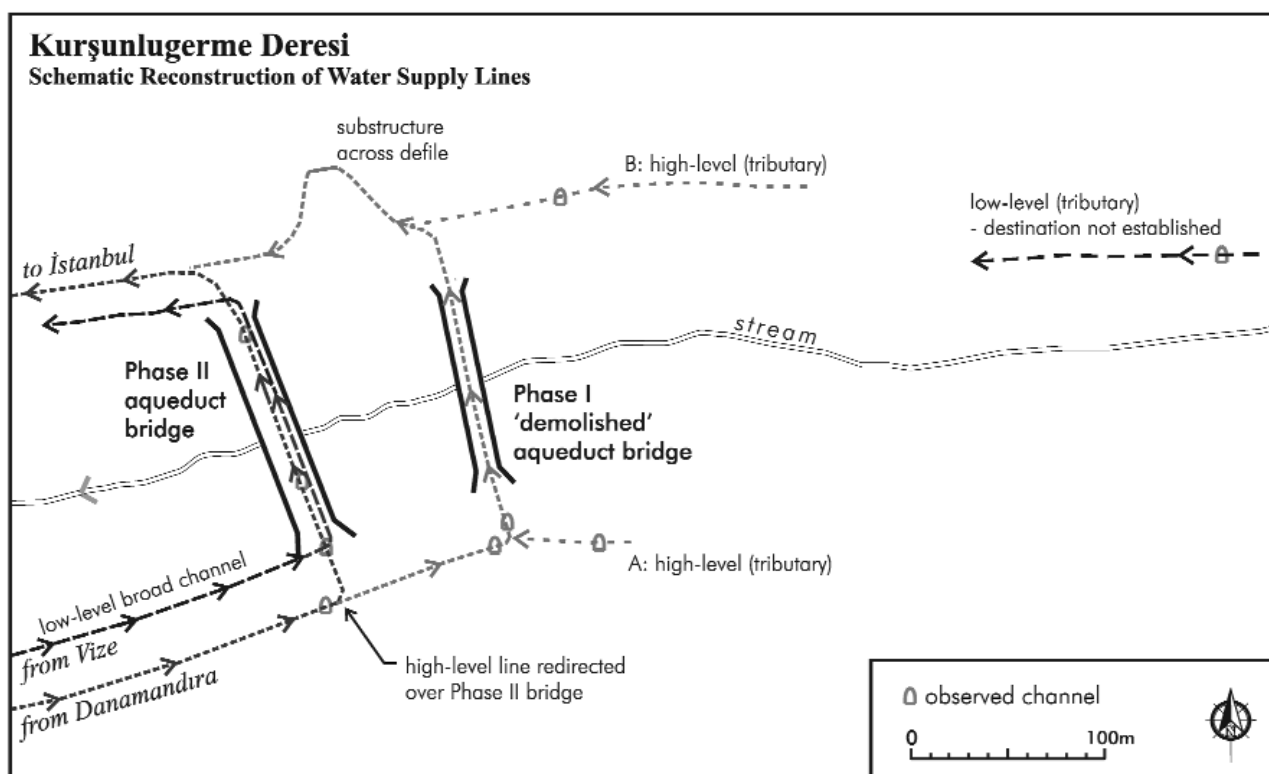
FIG. 3.37 Kurşunlugerme Deresi (valley); schematic reconstruction of the water supply line.

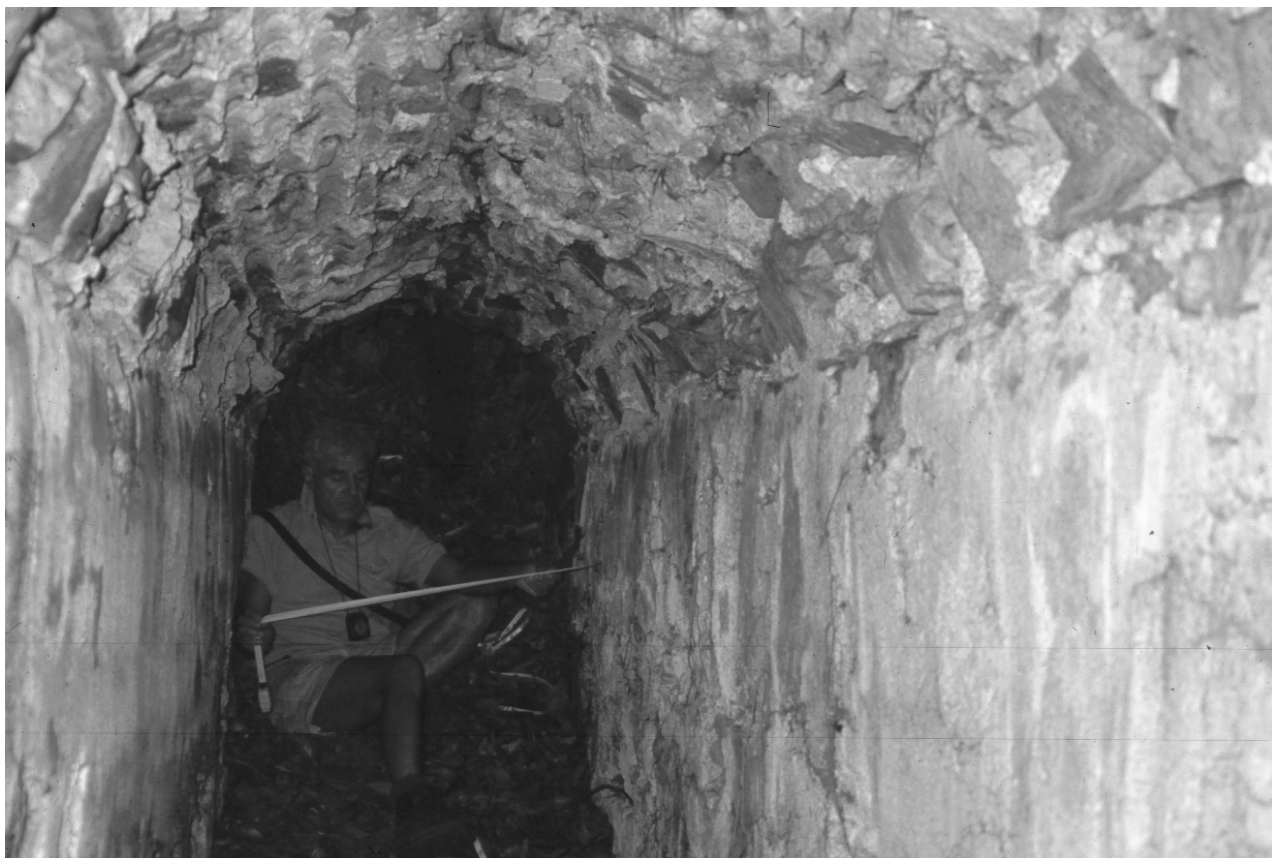
FIG. 3.38. Narrow channel on the south side of Kurşunlugerme valley (see Fig. 4.7).

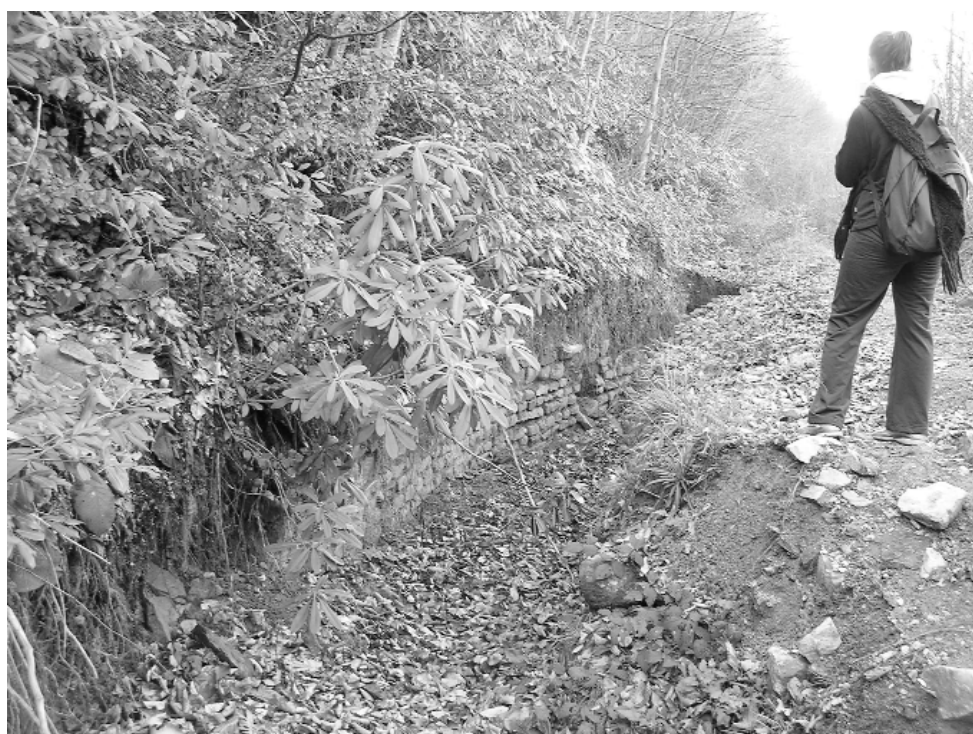
FIG. 3.39 Excavated course of the broad channel on the south side of Kurşunlugerme valley, west of the main bridge (K20).

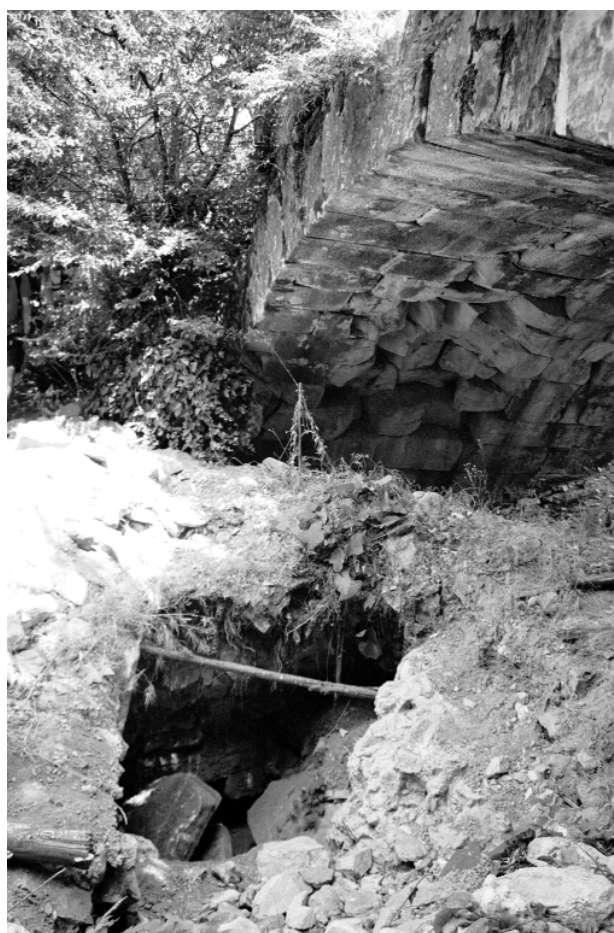
FIG. 3.40 Remains of the broad channel passing below Arch 11 of Kurşunlugerme (K20) as it begins to turn along the east face of the bridge.
