CHAPTER 3

The Water Supply Lines Outside the City

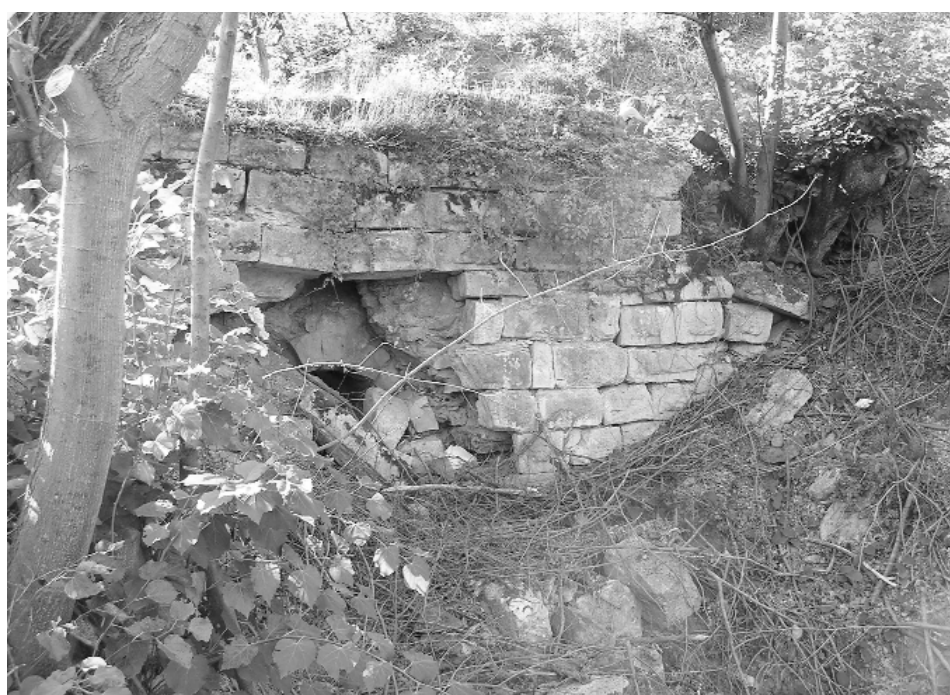
FIG. 3.41 Elkaf Dere north (K20.2), showing bossed-work facing-stones.

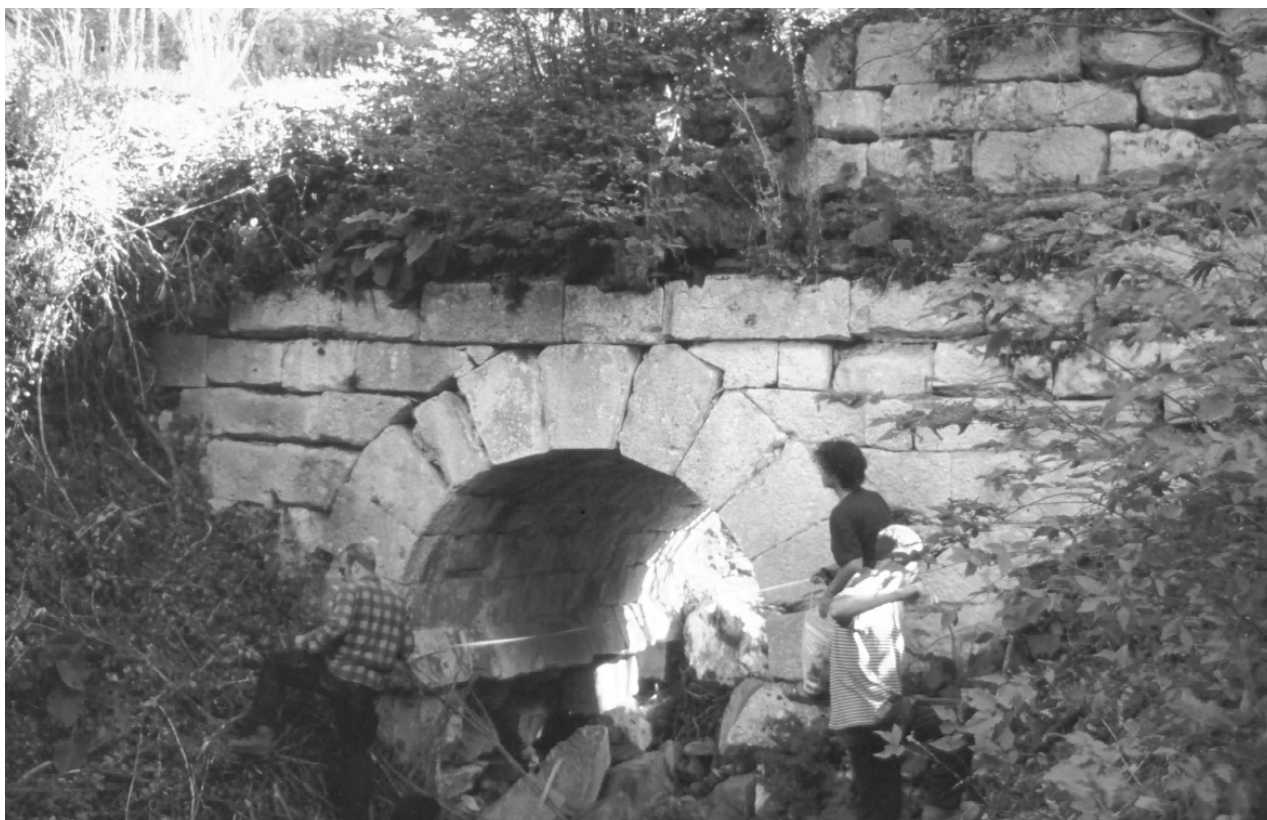
FIG. 3.42 Elkaf Dere (K20.3); the inscription is carved across a single stone course above the arch (see Fig. 2.4).

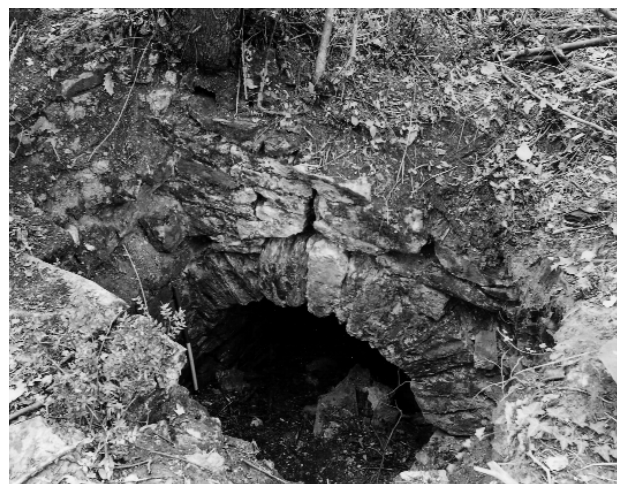
FIG. 3.44 Ömerağa Geçidi, inspection shaft east of the Anastasian Wall.

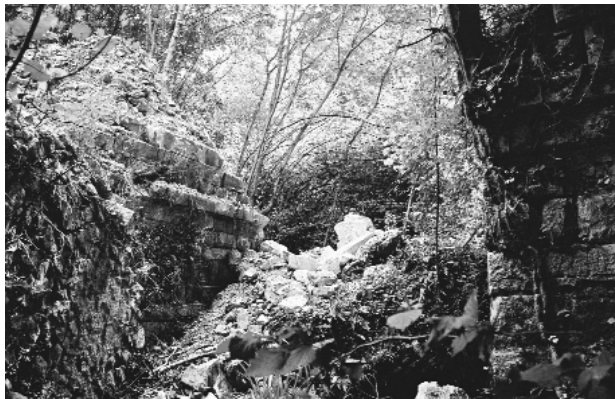
FIG. 3.46 Maçka Dere (K20.5), primary abutments.

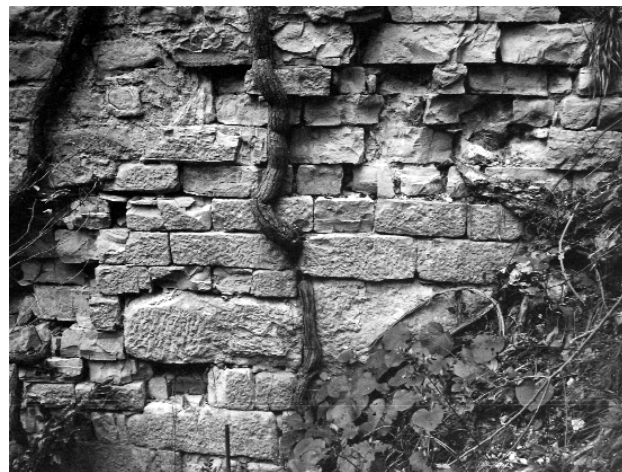
FIG. 3.48 Maçka Dere (K20.5), second phase pier (north); detail of masonry.

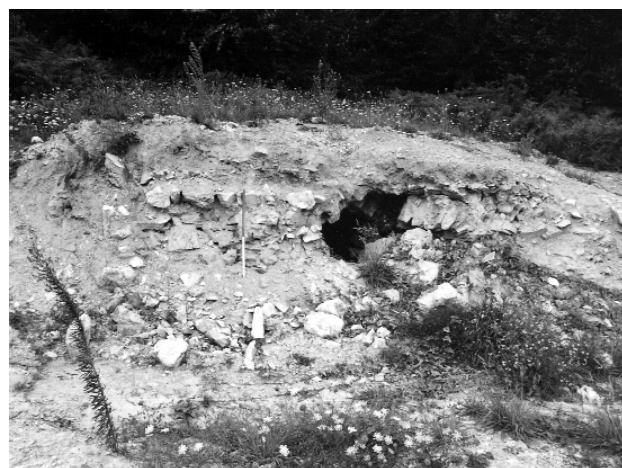
FIG. 3.49 Maçka Dere (K20.5), platform for the broad channel on the west side of the second bridge.

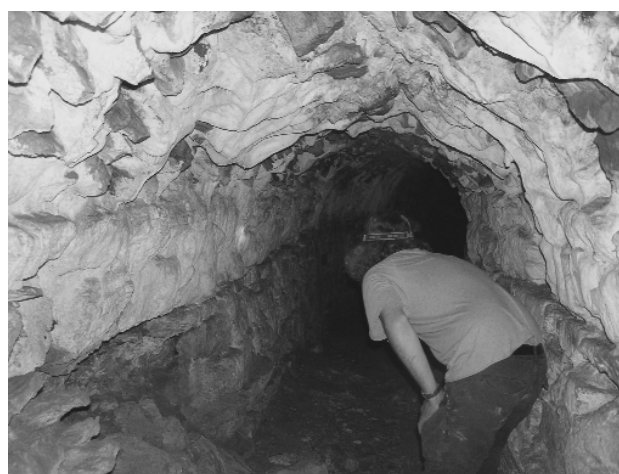
FIG. 3.50 Broad channel west of Maçka Dere (K20.5).

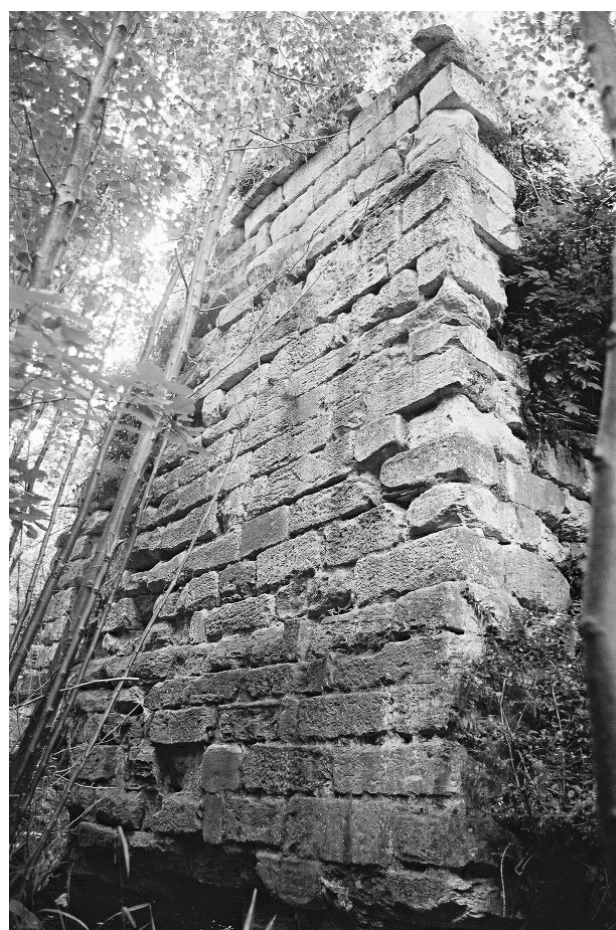
FIG. 3.51 Ortabel (K20.6), west pier of the main bridge showing string-course.

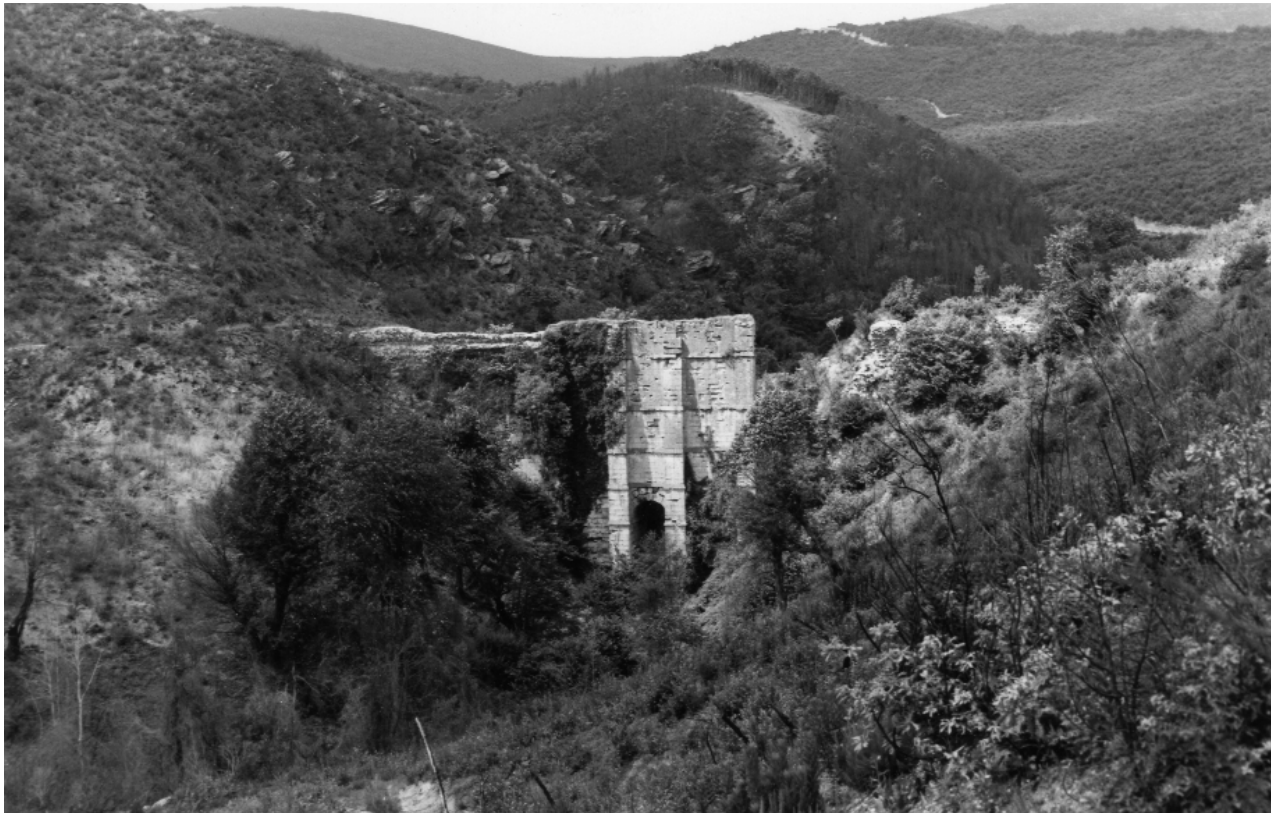
FIG. 3.52 General view of the later bridge at Talas (K22) (1994); note the line of the broad channel on the hillside to the right; above can be discerned the faint line of the upper channel from the earlier bridge (K21).

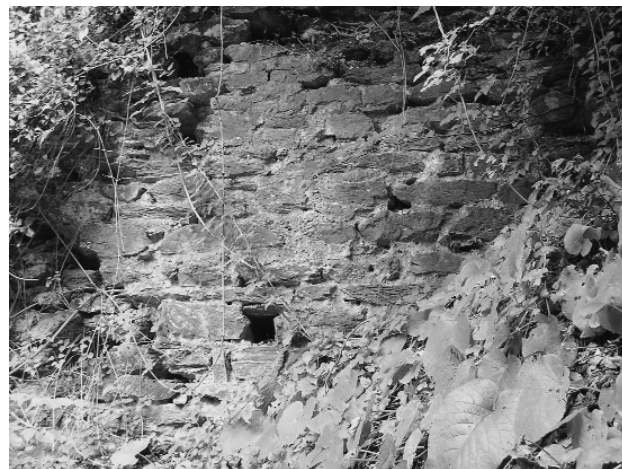
FIG. 3.53 Coarse rubblework on Talas bridge (K21).

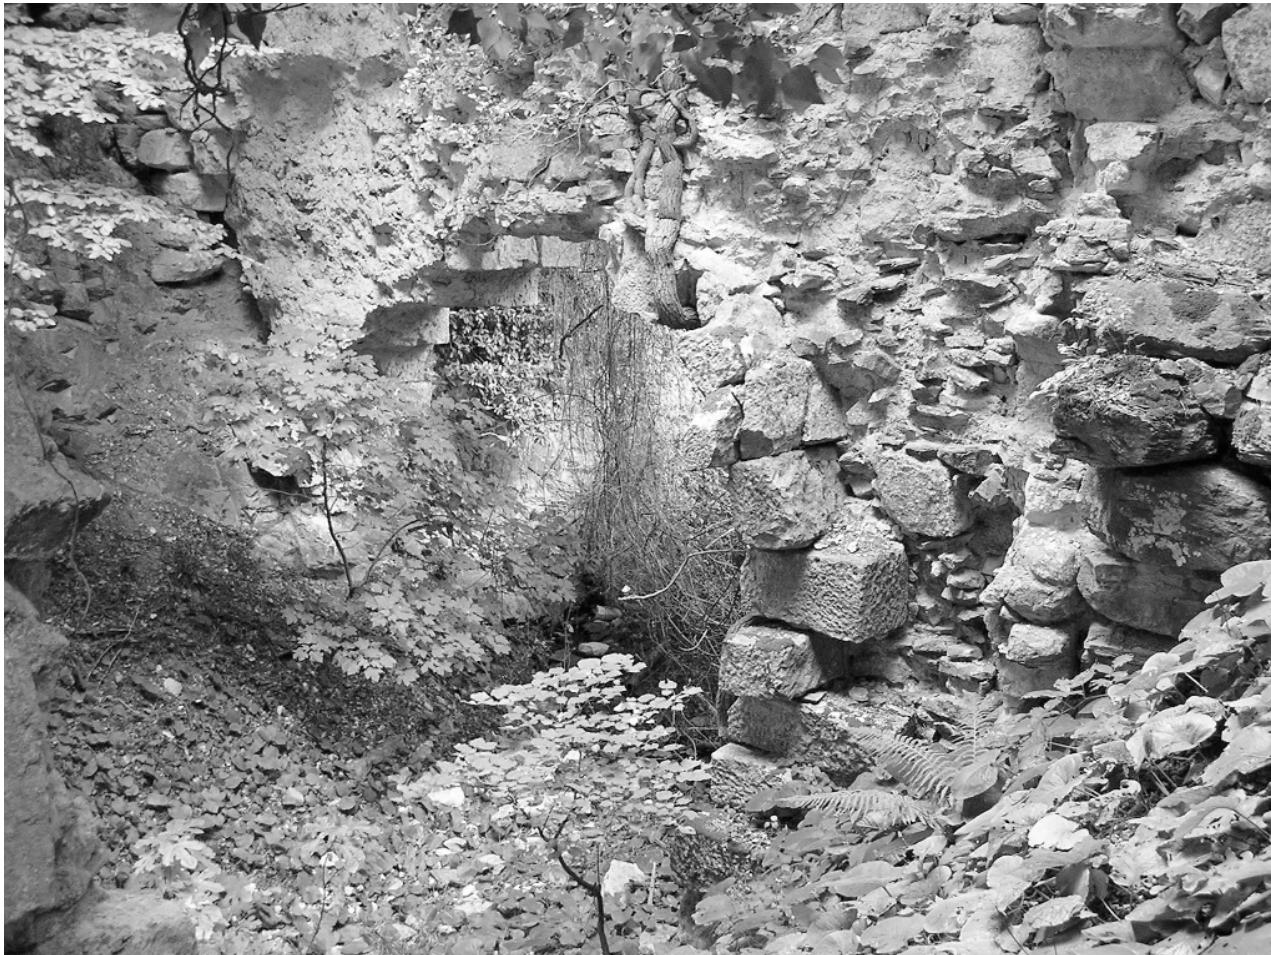
FIG. 3.56 Leylek Kale (K23), the interior of the bridge, showing the outline of the south arch, the robbed core of the primary bridge and the outer facings.

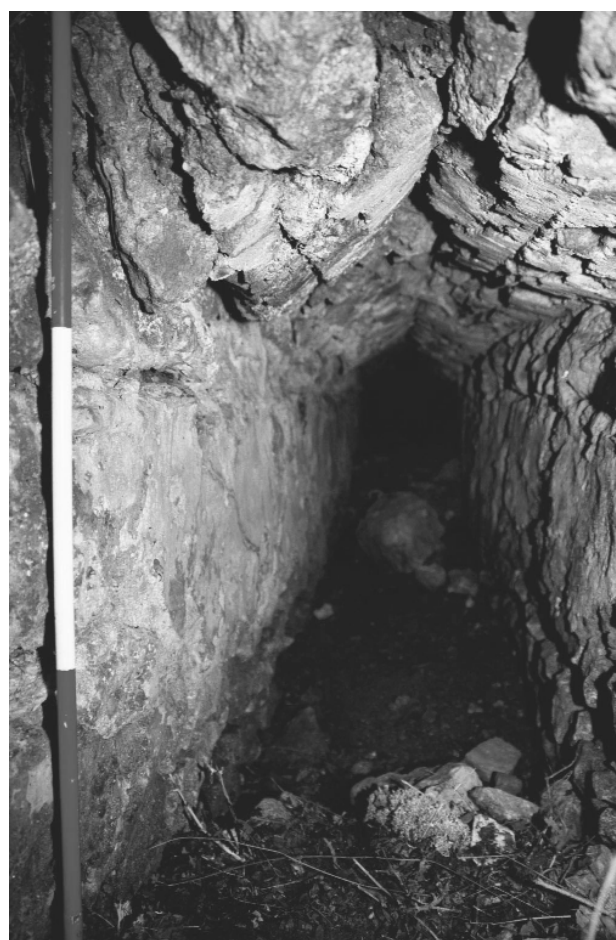
FIG. 3.57 Merdiven Dere (K29.1), the narrow channel east of the bridge.

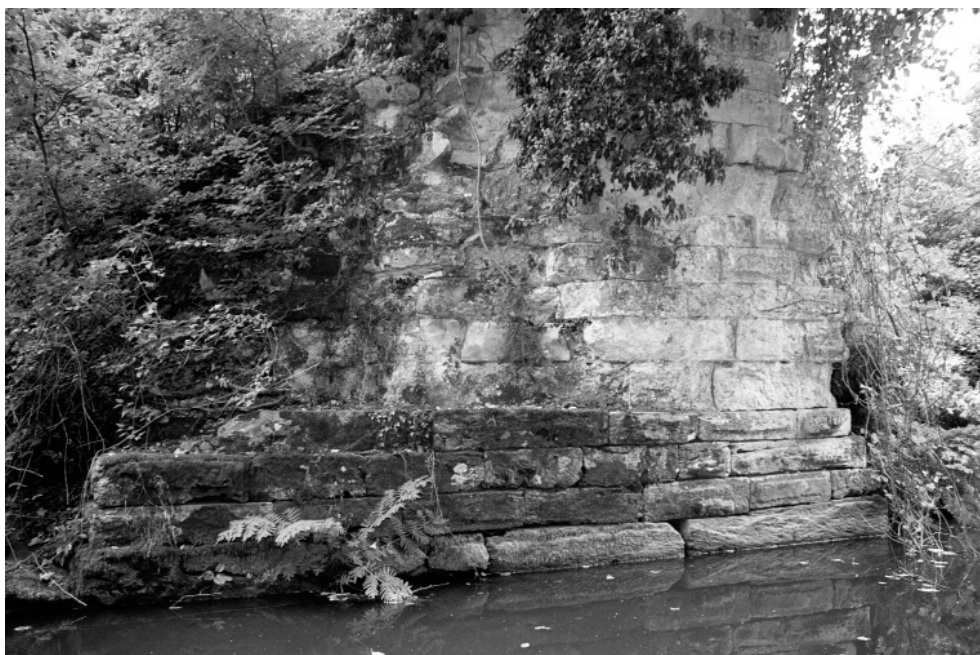
FIG. 3.58 South-west bridge pier at Merdiven Dere (K29.1).

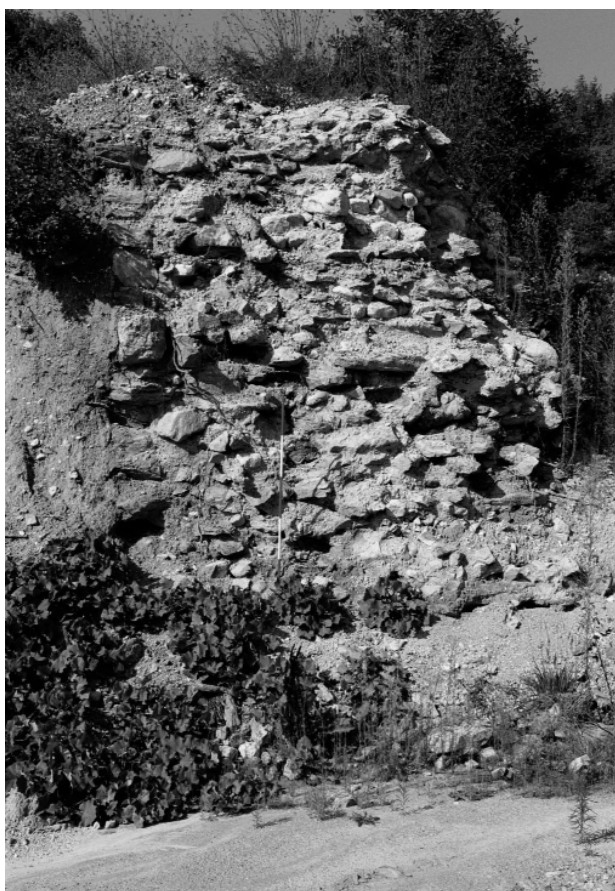
FIG. 3.59 Abutment on the north side of bridge K29.2.

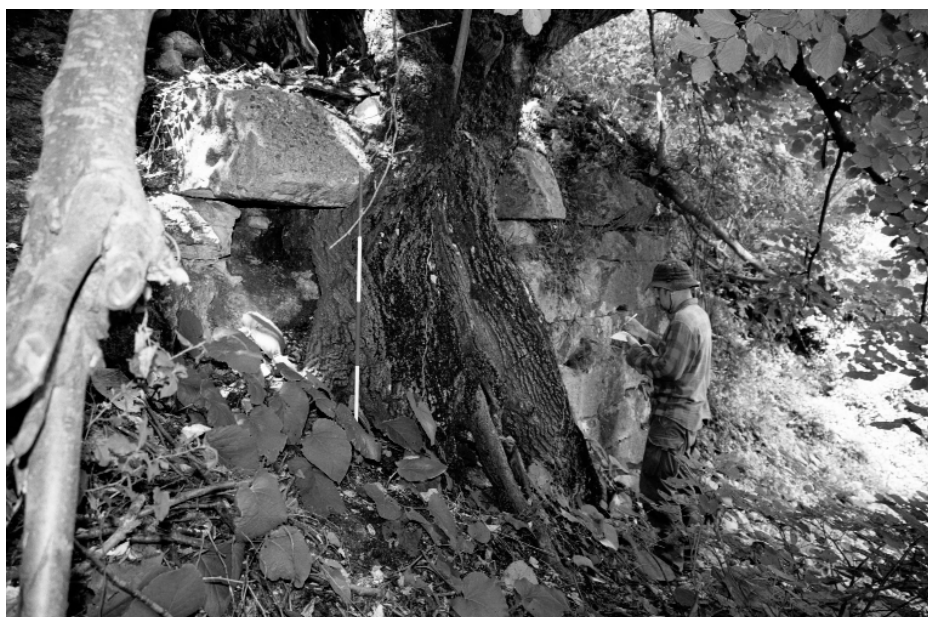
FIG. 3.60 Karatepe A (K29.4), east face showing downward-sloping chamfered string-course.

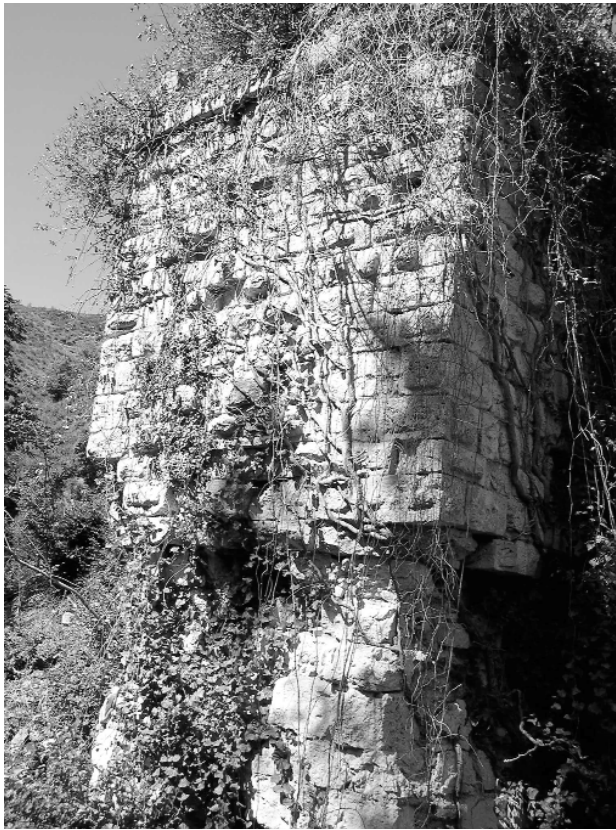
FIG. 3.61 Early bridge at Keçigerme (K30.1), north side.

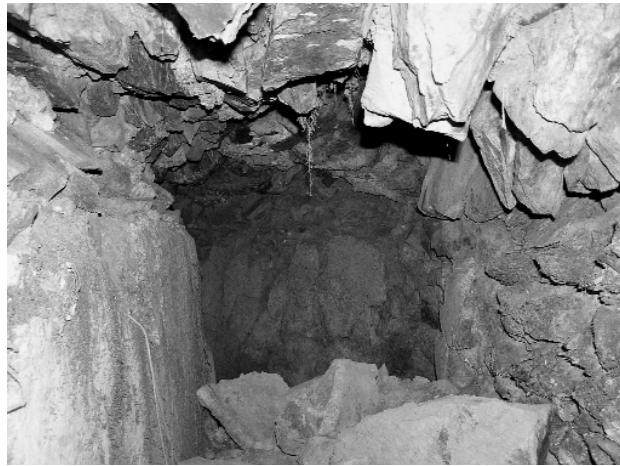
FIG. 3.62 Keçigerme (K30.1), tunnel to south-east of the early bridge.

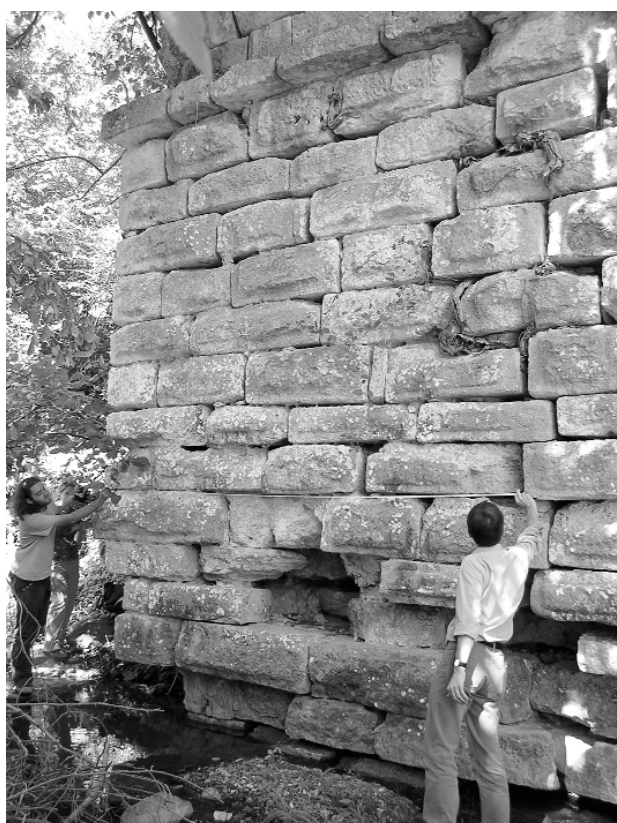
FIG. 3.63 Kumarlıdere (K31.1), early bridge on Şarap Dere.

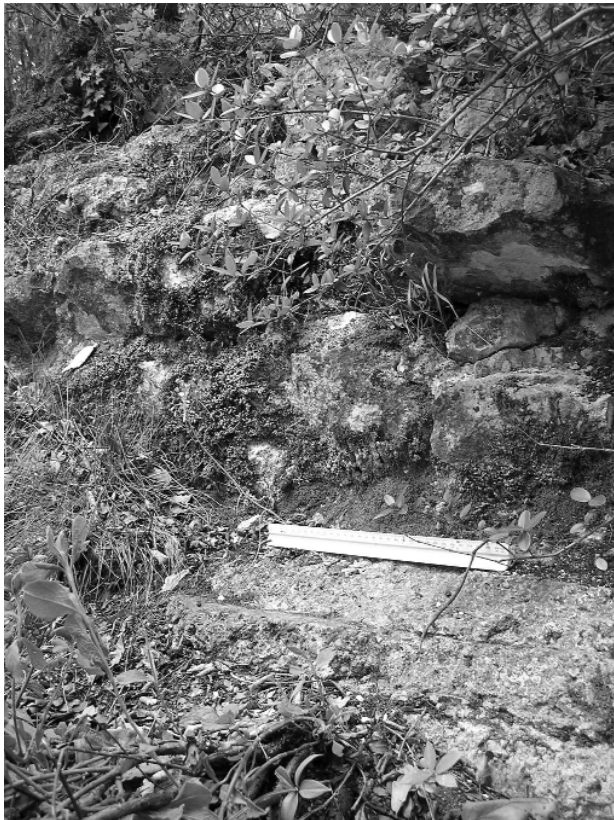
FIG. 3.64 Kumarlıdere (K31), mortar rubble fill of earlier narrow channel.

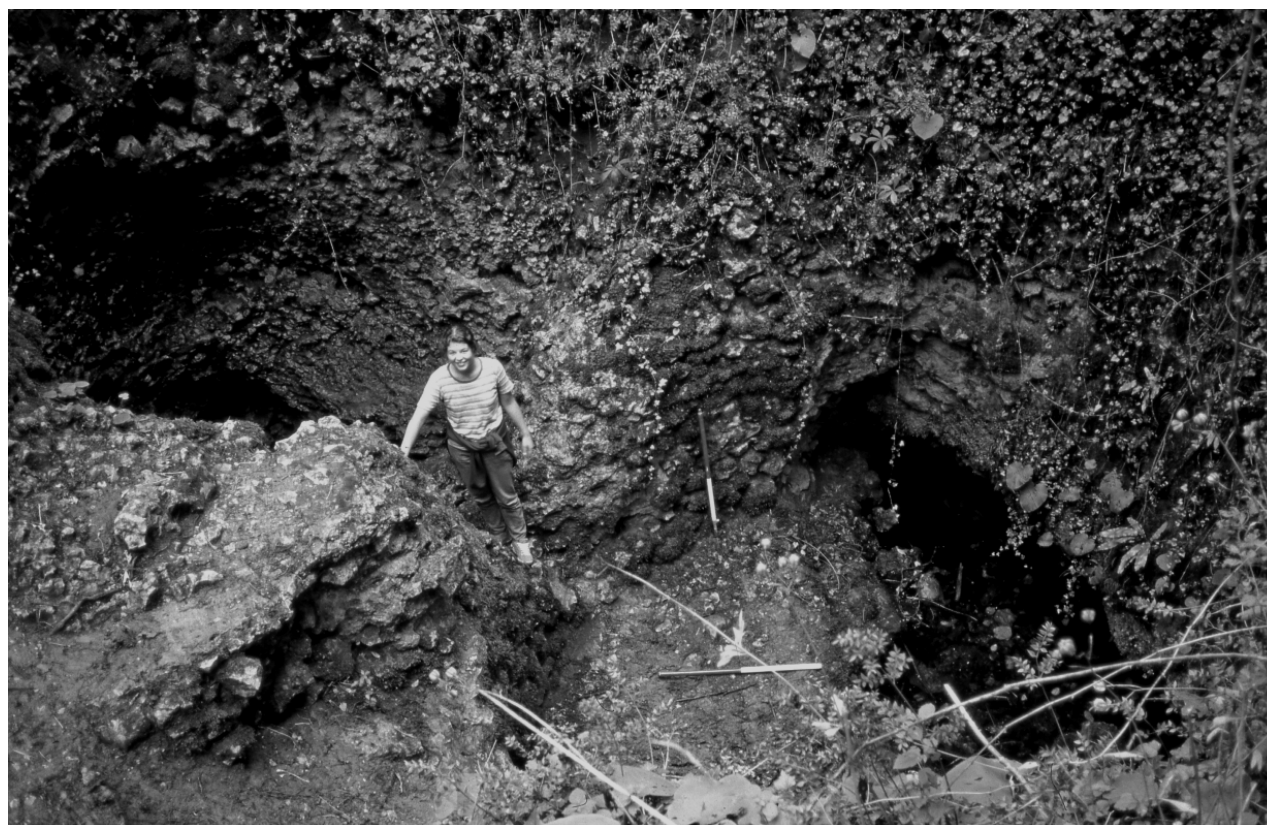
FIG. 3.65 Pınarca first cave, İkgöz Mağara, showing built collecting pool.

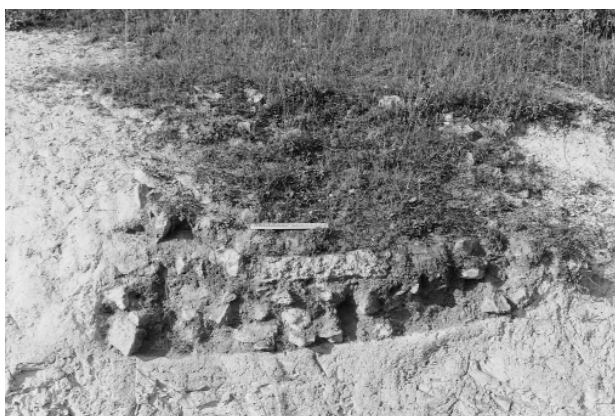
FIG. 3.66 Base of the narrow channel near Pınarca, revealed in road cutting (north side).

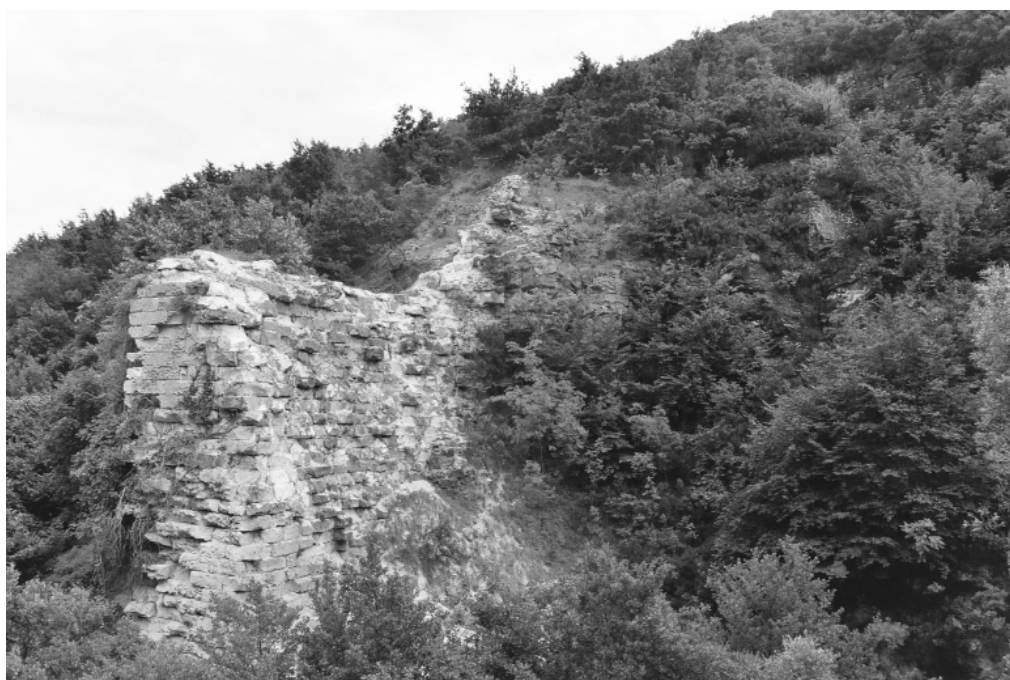
FIG. 3.67
South-east main
bridge on Kale Dere.

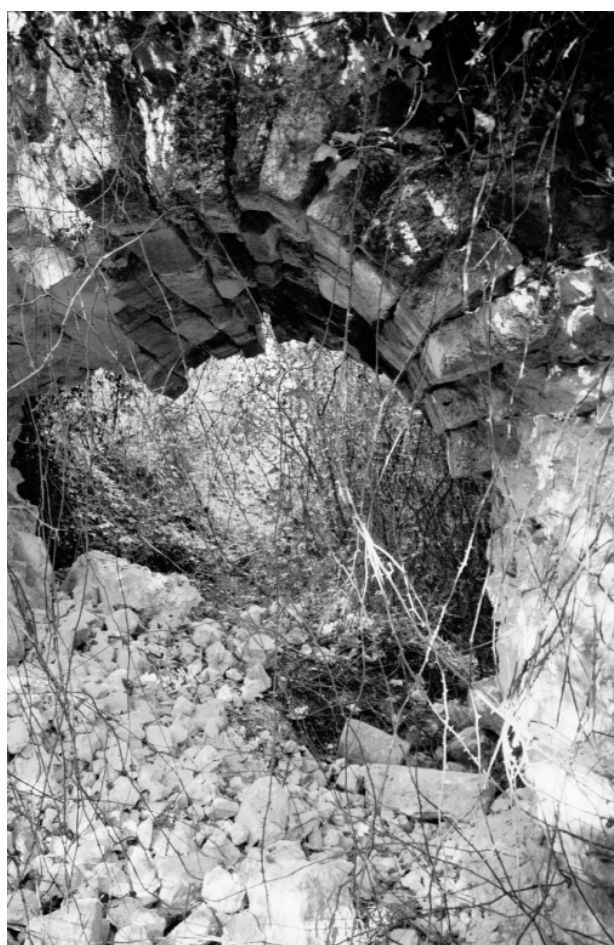
FIG. 3.68 Remains of Büyük Kemer bridge (K35).
