CHAPTER 4

The Architecture and Archaeology of the Aqueduct Bridges and Channels

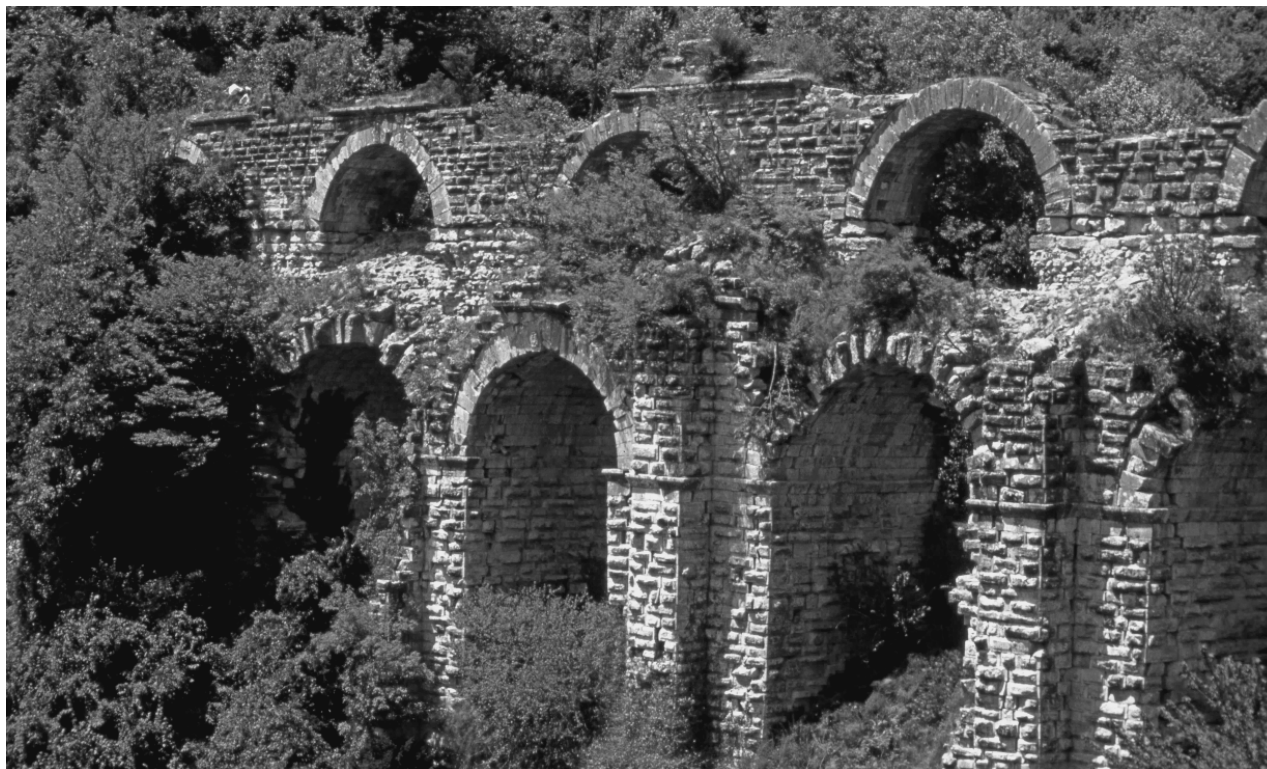
FIG. 4.1 The main bridge at Kurşunlugerme (K20) from the north-east.

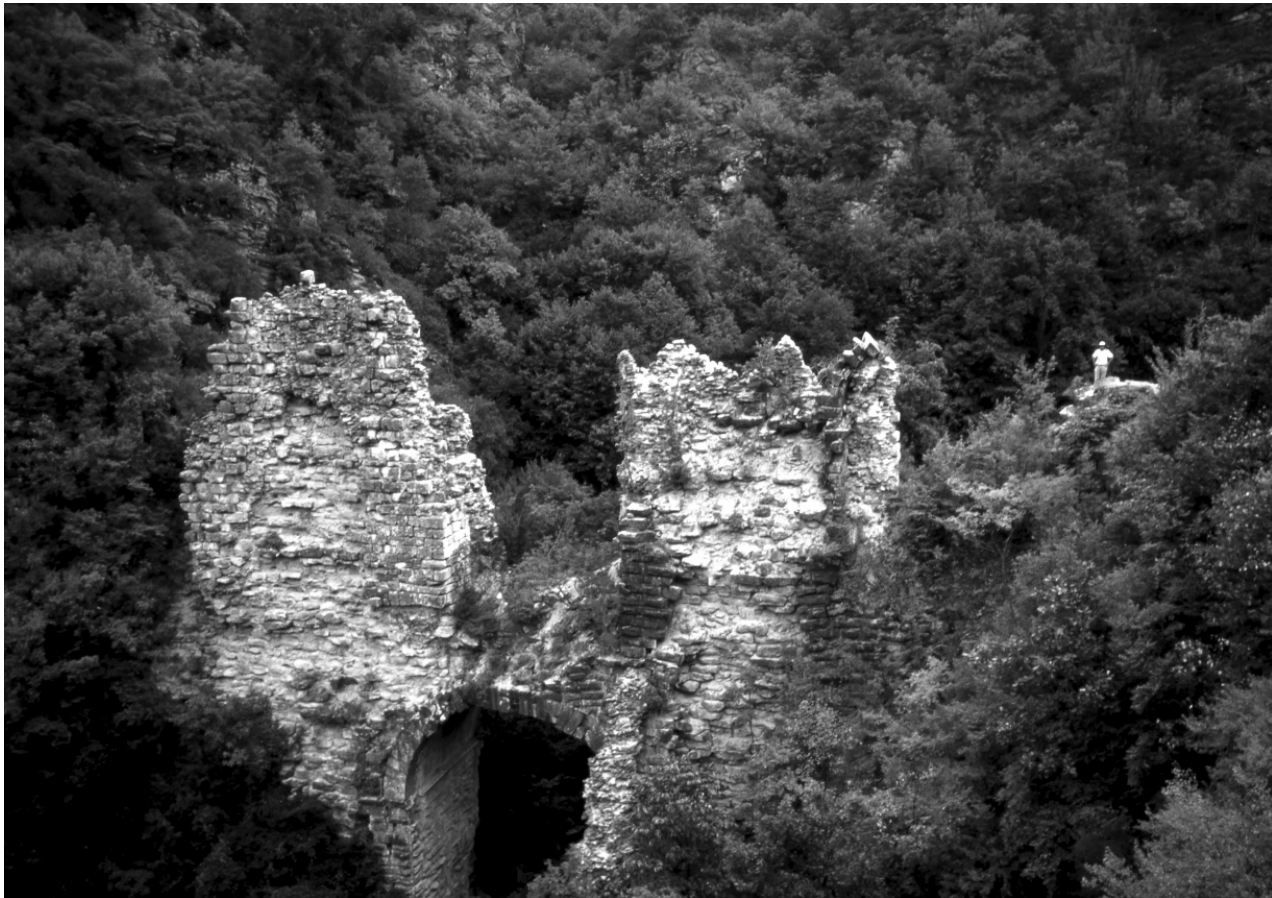
FIG. 4.3 The bridge at Balligerme (K18) from the north-east.

The bridge at Balligerme carried the second-phase broad channel across the gorge created where the Karaman River cut across the line of the Stranja ridge. It is one of the most dramatic and severe valleys crossed by the water supply line. At the south end (towards the city) of the bridge the broad channel runs parallel to but below the level of the fourth-century narrow channel from Danamandıra (see Map 5). The bridge is aligned approximately south-east to north-west (Fig. 4.2). It survives to a height of 30 m, but the total height including the 2.60 m-high broad channel can be estimated to have been 37 m above the river bed. The river flowed through a single high arch with a span of 8 m (1), 16 m high and 9 m wide. Above this was an upper tier of four arches, one central (3), above the lower main arch, two to the south (4 and 5) and one to the north (2). Arches 2, 3 and 4 can be estimated to have had a maximum height of 11 m and width of 9 m. The overall length of the bridge may be estimated at 77 m.² The construction of the bridge used large limestone blocks similar to those found at Büyükerme, Kurşunlugerme, Keçiğerme, and Kumarlıdere; these are not seen elsewhere on the surviving bridges of either the Danamandıra (Valens) or Vize systems. The specific feature of this construction technique is both the type of stone and the size and dressing of the blocks. The limestone is a very hard, grey-white, metamorphosed rock which in section appears very similar to a coarse marble (Dirimtekin calls it marble). We have not yet discovered the quarries for this stone, although Professor Bono extended his geological enquires over a wide area of eastern Thrace beyond Kırklareli. The size of the blocks is consistent among the five bridges and all provide masons' marks (see Chapter 8) not seen on the other bridges. The height of the ordinary blocks is between

0.37 and 0.42 m, with greater variety in length, between 0.56 and 0.75 m. The blocks are rectangular and are bedded with a hard pink mortar with large brick inclusions, characteristic of early Byzantine work in Constantinople.³ From fallen blocks and also from the small craters hacked into the face at the joints (to rob out the lead setting of the clamps), it is possible to see that the blocks were also held with iron clamps set in lead; an iron clamp may be seen in a block towards the top of the west face.⁴ The blocks were left with quarry-dressed faces and the margins were cut back, but were not as carefully drafted as a rusticated masonry can be. The core of the piers and the arches is of mortared rubble with a hard pink mortar with brick inclusions, similar to the mortar used for bonding the facings.

At the base of the lower arch (1) there is an offset course with a chamfered plinth, located seven courses above the stream bed. At the springing of this arch there is a string-course with a downward-facing chamfer; because of later reconstruction the string-course cannot be seen to run across the face as can be observed at other bridges. In the upper tier, the base of arch (4) is marked by a clear string-course, but it is absent from the central arch (3) because of rebuilding. The bases of the outer arches (2 and 5) are higher and there is no evidence for a string-course; however it is clearly preserved to the north of arch (2) and south of arch (5). The abutments and original facing are well preserved against the south and north slopes of the valley, including the well-preserved entrance to the broad channel on the south side. For the limited decorative features surviving from the bridge see Chapter 7. It is clear that the bridge underwent two major phases of reconstruction.

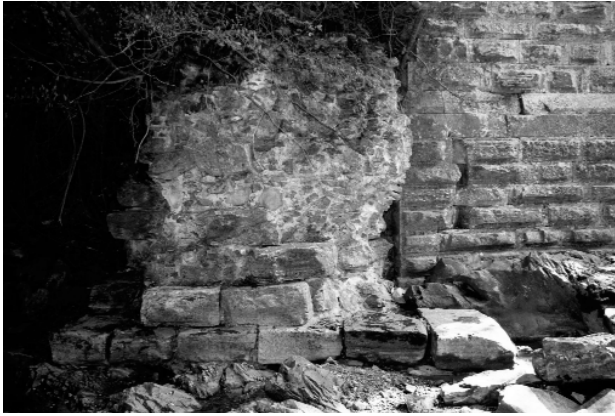
FIG. 4.4 Buttress on south-east face of the lower arch at Balligerme (K18).

The buttresses were constructed of coursed blockwork, that is roughly squared blocks of limestone, clearly from a different source to the Phase 1 blocks and smaller in size (see Figs 4.2 and 4.5). It is not clear how high the buttresses extended, although on the north side the buttress core can be seen to extend 2.5 m above Arch 1. Above this point the face of the south (and possibly also the north) pier was refaced in a similar masonry and the new arch was constructed. Evidence for these repairs is restricted to the central piers and arches of the bridge.

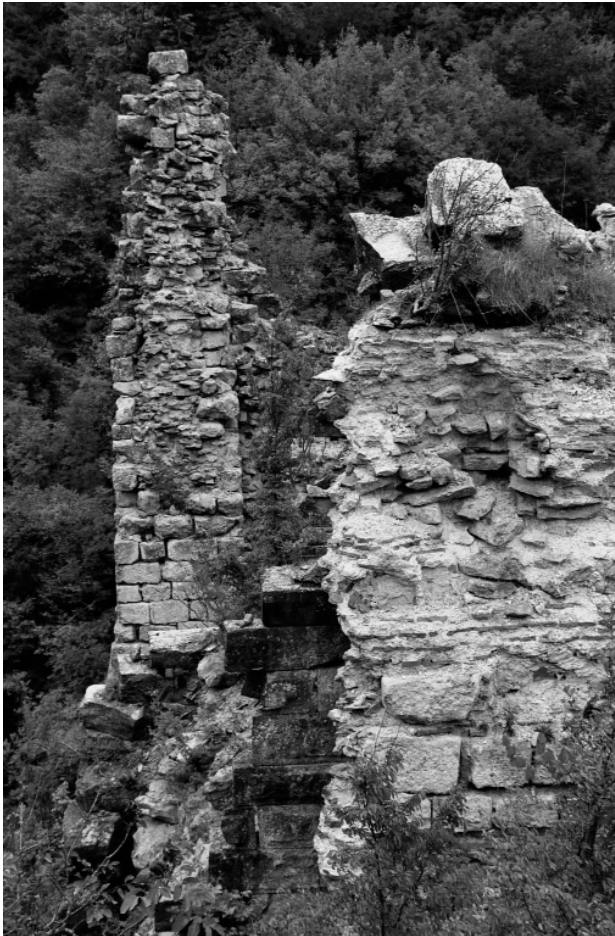
FIG. 4.5 The north pier at Balligerme (K18), with reconstruction using alternate courses of brick and rubble. To the left is Phase 2 blockwork between Arches 3 and 4.

side of Arch 2, where a blocking wall of rubble work and brick bands supports the south side of the Phase 1 voussoirs. In addition to the brick bands, some bricks are set vertically in the rubblework (Figs 4.5; 4.6). The bricks appear similar in size and colour to those re-used in nineteenth-century houses at Karakaköy which were taken from the Anastasian Wall nearby. Fragments of a similar construction are seen on both sides of Arch 3, with a brick arch on the north side. Similar brickwork and core of this phase are seen on the south side of Arch 4 extending on to the west side of the bridge (upstream). As part of this repair it would seem that Arches 3 and possibly 4 were rebuilt as arches, whereas in Arch 2 the primary stone vault was supported by a filling of brick and rubblework.

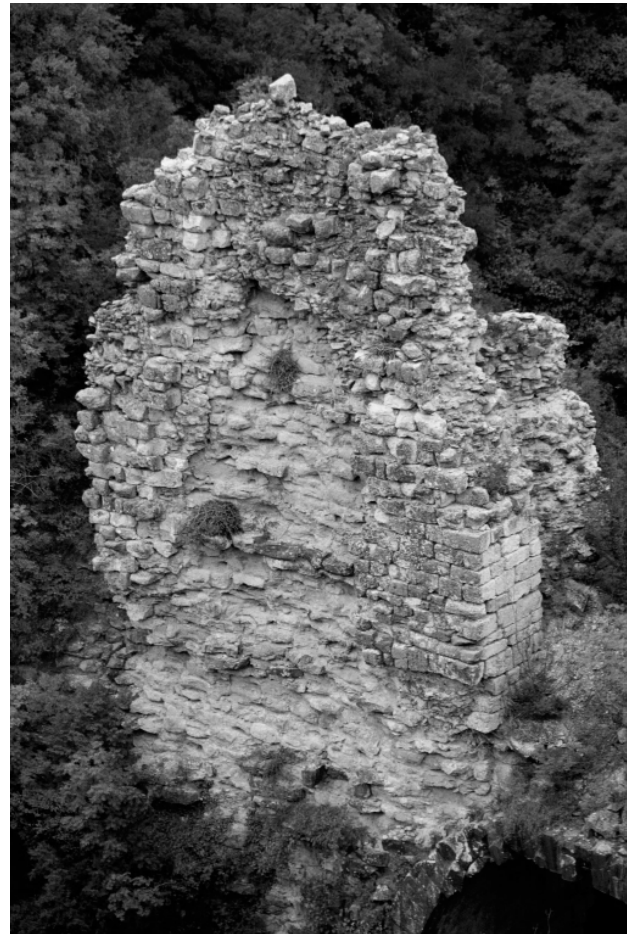
FIG. 4.6 East face between Arches 3 and 4 at Balligerme (K18) showing Phase 2 blockwork.

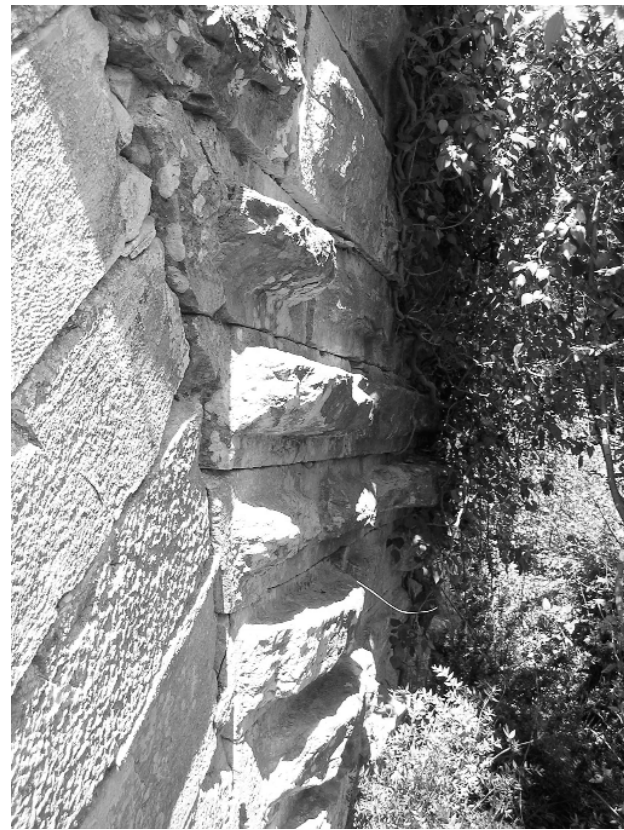
FIG. 4.8 Kurşunlugerme bridge (K20), bossed blocks beside Arch 2; note how the upper faces of the bosses are cut level to support timber scaffolding.

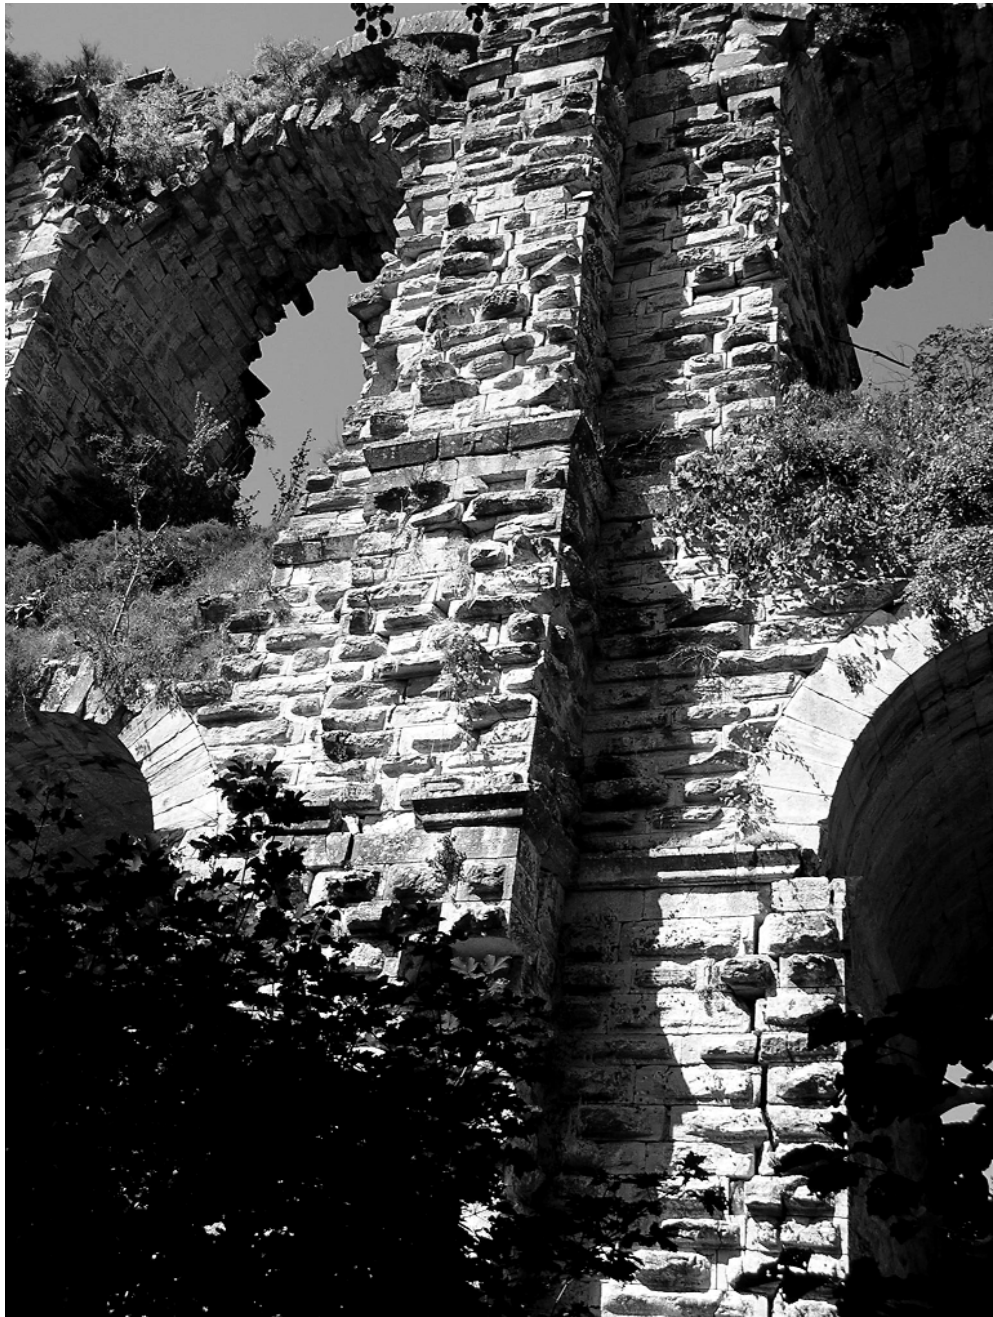
FIG. 4.9 Buttress V, Kurşunlugerme (K20); note the changes in the string-course mouldings.

The block size and building stone are similar to those discussed at Ballıgerme (see Chapter 8 for masons' marks), but in the lowest tier the significant difference is the more elaborate string-course at the level of the impost of the three lower arches with a cyma recta moulding, a feature not seen elsewhere.¹⁰ The lower courses of the main piers are best observed below Arch 18 where the stream flows through. Here there is an offset with a chamfered plinth, and to the

east side of Buttress IV there are the clear remains of a triangular cutwater to protect the pier from erosion. Near Buttress VII there is evidence for an iron clamp inserted to repair a crack in one of the lower facing-stones — an indication of the continued maintenance of the structure, rather than a major programme of rebuilding necessitated by long-term neglect or natural catastrophe.

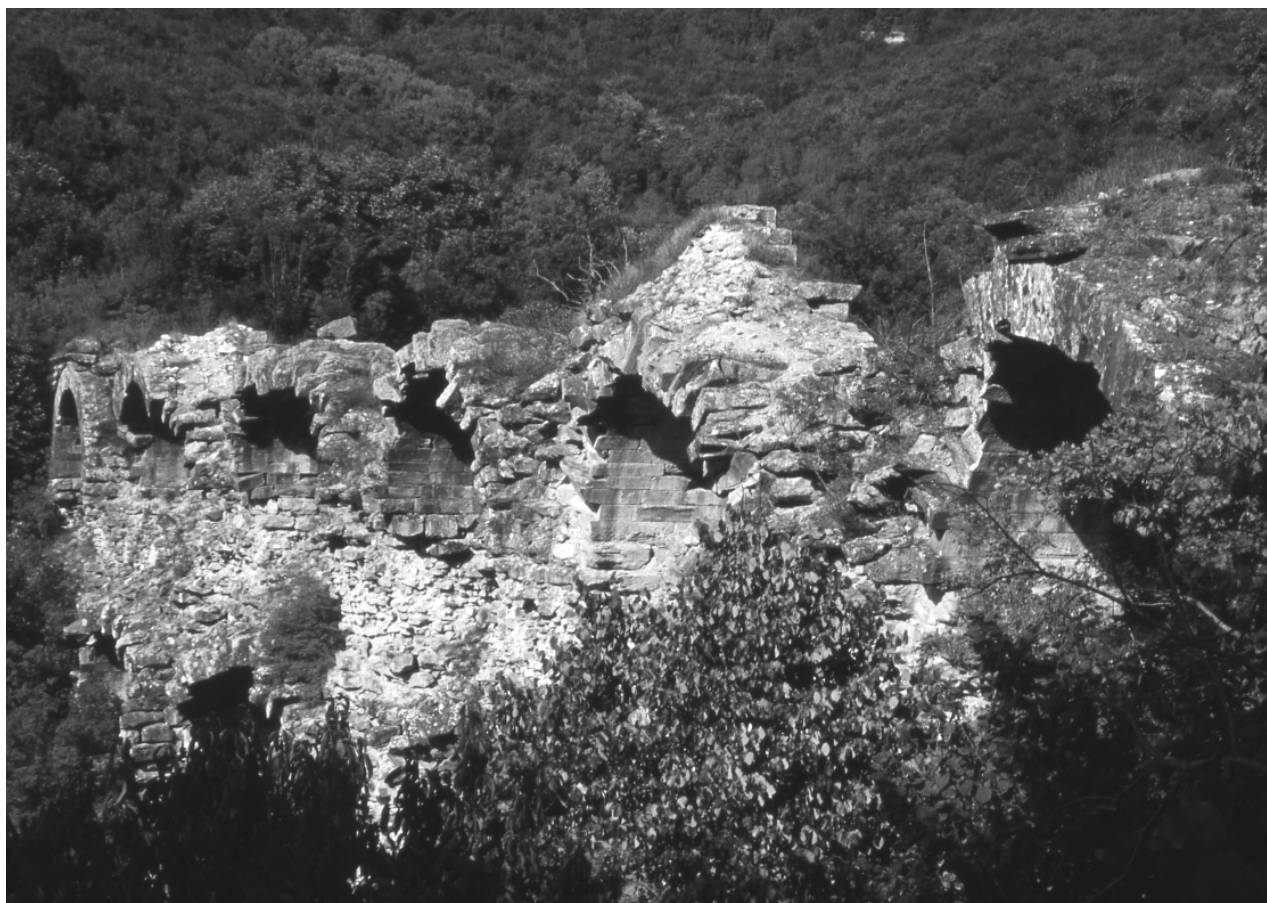
FIG. 4.10 View of the west face of Kurşunlugerme (K20) from the south.

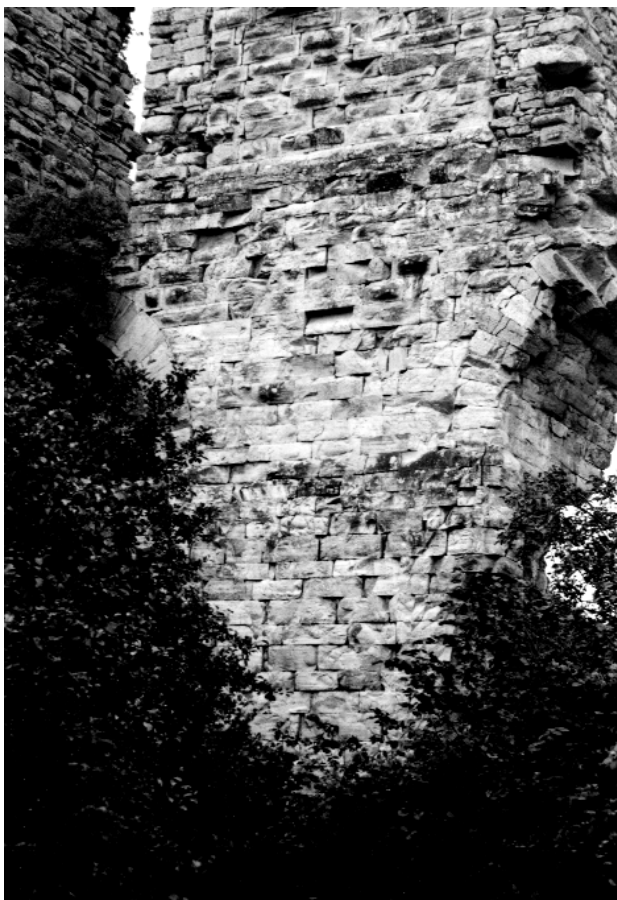
FIG. 4.13 Büyükgerme (K29), the south face of the pier between Arches 10 and 11; note how the string-courses and bossed work on the lower facing-blocks have been cut back.

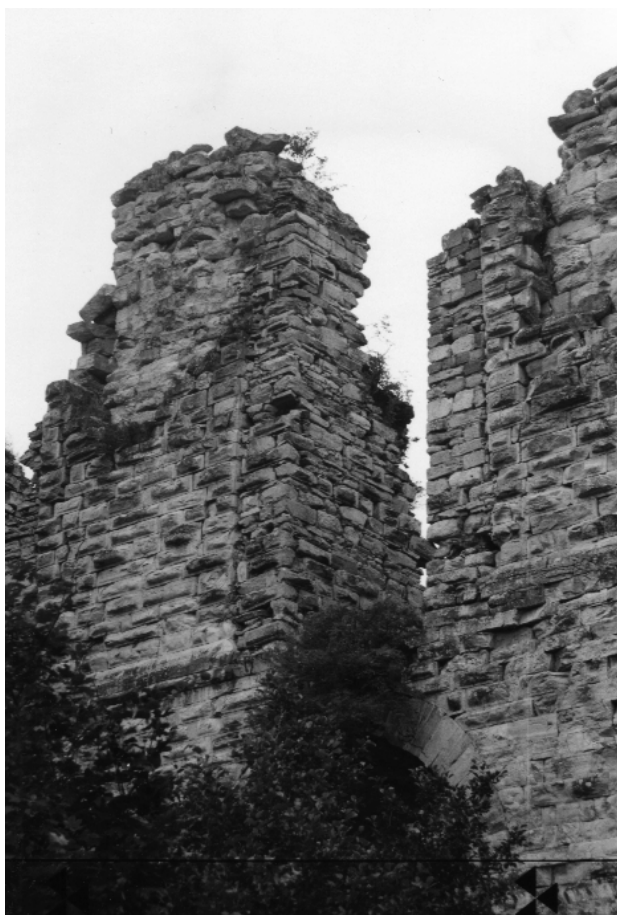
FIG. 4.15 Büyükgerme (K29), Arch 4 from the south-east. The Phase 2 narrowing is clearly visible with the springing of a brick vault on the left side.

square them. This phase of repair survives best in Arches 3 and 4, where the arch has been narrowed; at the top of the blockwork fill are the bricks for the brick vault within the arch.¹⁷ It is possible that the cutting back of the chamfered string-course in the south façade at the springing of the arches may be associated with this work (see Fig. 4.13). The date of this reconstruction is not clear and will be discussed in the conclusion.

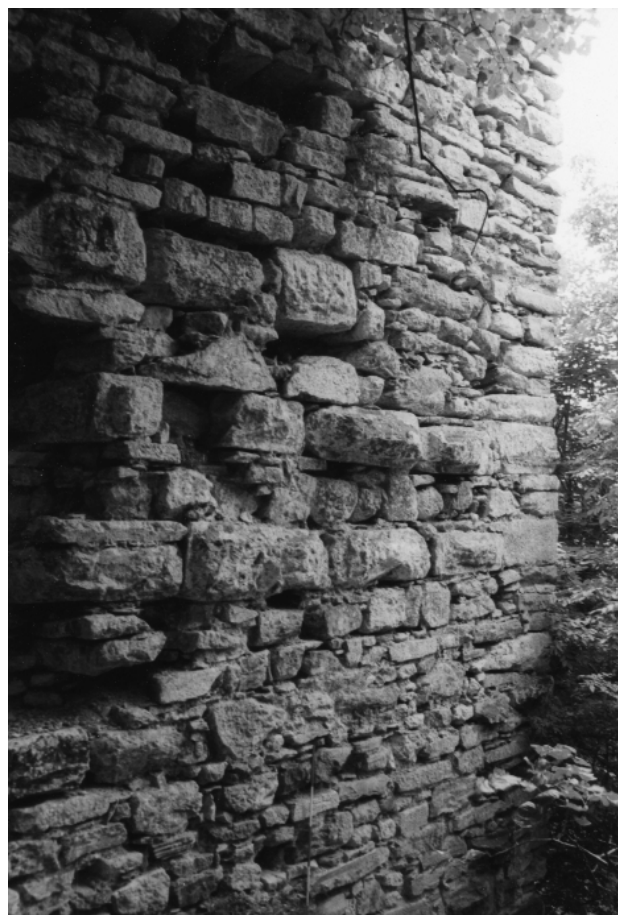
FIG. 4.16 Büyükgerme (K29), the second phase narrowing of the north side of Arch 3, showing the use of coursed rubble and reused bossed facings.

The bridge displays some of the clearest evidence for a major intervention at a later period. This can be seen in the extensive refacing of the north side, especially between Arches 1 and 3, and in the narrowing of many of the arches with new vaults (Figs 4.12; 4.15). As noted before, the face of the bridge requiring most extensive repair was located in the north-west quadrant. The earlier facing had clearly fallen, revealing the pink-mortared rubble core of the primary work. This was refaced by irregular blockwork of varying sizes (Fig. 4.16). These blocks are roughly dressed and there was no real concern to

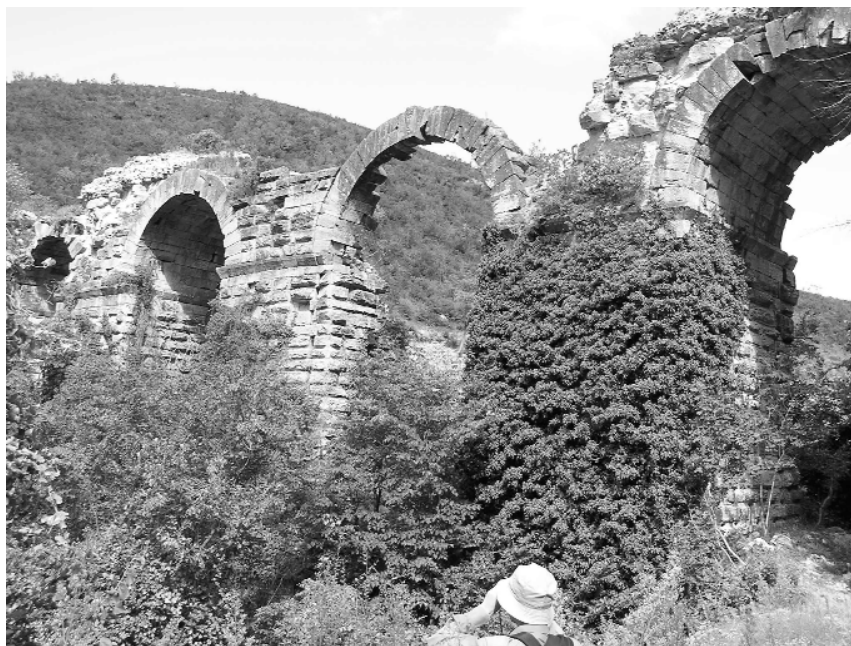
FIG. 4.17 Keçigerme (K30), arches in the upper tier.

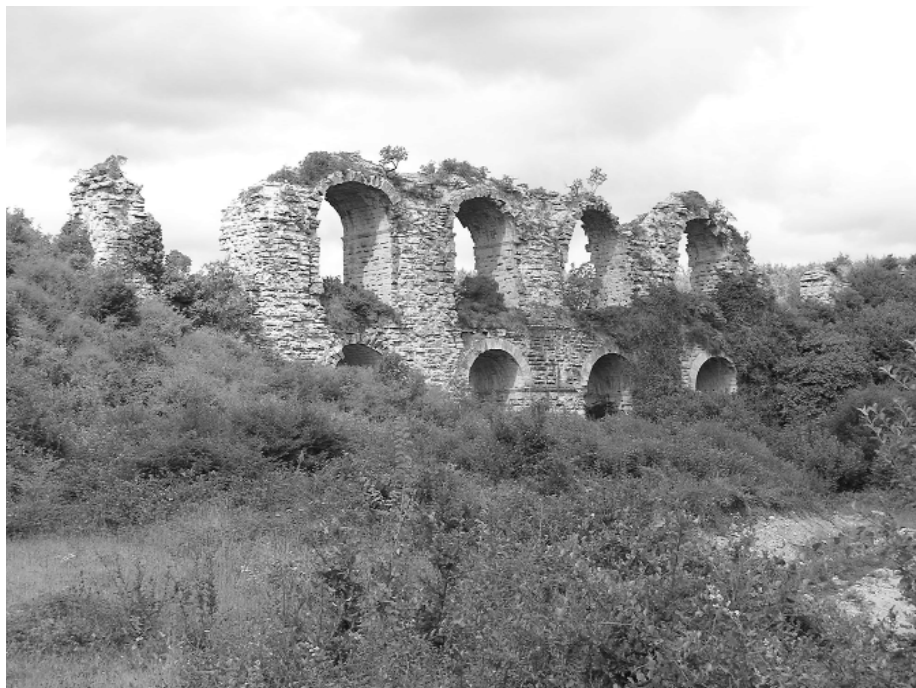
KUMARLIDERE (K₃₁)FIG. 4.19 Kumarlıdere (K₃₁) from the east.

This is the final example of the monumental aqueducts proceeding eastwards.¹⁹ It is difficult to estimate the full length of the bridge since there are long embankments leading up to it; these can be seen from an air photograph as a remarkable straight line in dense green forest. Just taking the arched length of the bridge, the distance was recorded at 130 m with a surviving height of 30 m (Fig. 4.19). The lower tier comprises four tall arches and the upper tier eleven, of which only the central four are nearly complete. The span of the arches was measured at 5.3 m and the width of the piers at 8.1 m. Unlike Keçigerme, where upper and lower arches were of equivalent height, here the upper arches are somewhat shorter (Fig. 4.20). Construction and decoration are similar to the examples already discussed. Evidence for repairs was noted in the rebuilding of the east side of the embankment (Chapter 3) and the decoration is discussed in Chapter 7.

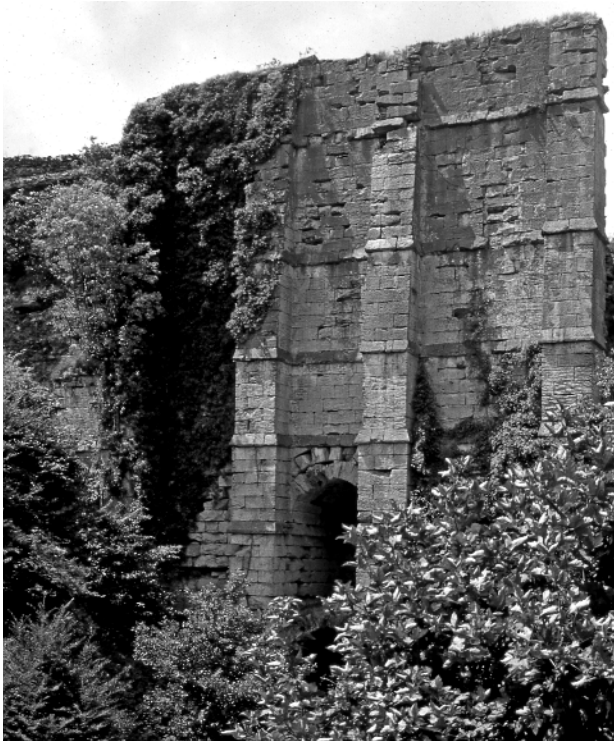
FIG. 4.21 Talas (K22), general view from the east (1994).

Talas does not belong to the group of bridges discussed above, since it is not constructed of the hard metamorphosed limestone characteristic of those bridges and it does not display the same features of structural decoration. Instead it is included in this chapter since it is the best and largest example of a reconstructed bridge of Period III.²⁰ Three major phases of bridges are known in this valley; the first (K21) belongs to the early phase of bridges associated with the narrow channel. This was replaced (or supplemented) by a new bridge for the broad channel, a two-tier bridge with a high, single lower arch and three arches above, 60 m in length and about 25 m high. This is the largest surviving new bridge of Period II not constructed in the distinctive monumental masonry style. The building stone is a soft white limestone, which has weathered poorly, although the block size and the style of bossed masonry are comparable to the bridges discussed above (Fig. 4.22). What distinguishes Talas is that in the next phase the bridge was radically rebuilt with new stonework which clad the bridge on both the east and west sides. The new masonry was very different from the construction of either Phase I or 2;

At Talas this rebuilding strengthened the single lower arch by inserting an intermediate arch to provide additional lateral support (Fig. 4.24). The remaining arches of the upper tier were filled and the north face was uniformly clad in a new wall; this created a solid structure, more like the face of a dam than a bridge, articulated vertically by a series of sloping buttresses rising to the full height of the new wall, across which runs a series of distinctive string-courses with an upward chamfer (see Fig. 4.21, 23).

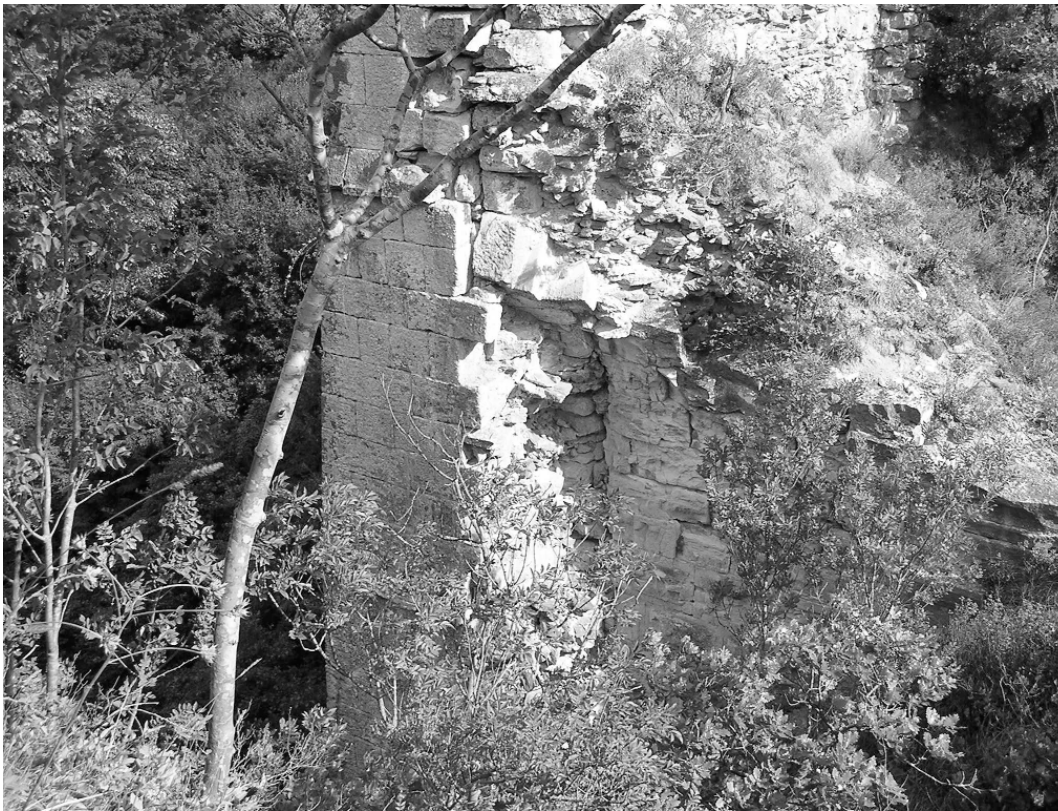
FIG. 4.22 Talas (K22), view from the north-west of a primary upper arch (right) enclosed within the later masonry (left).

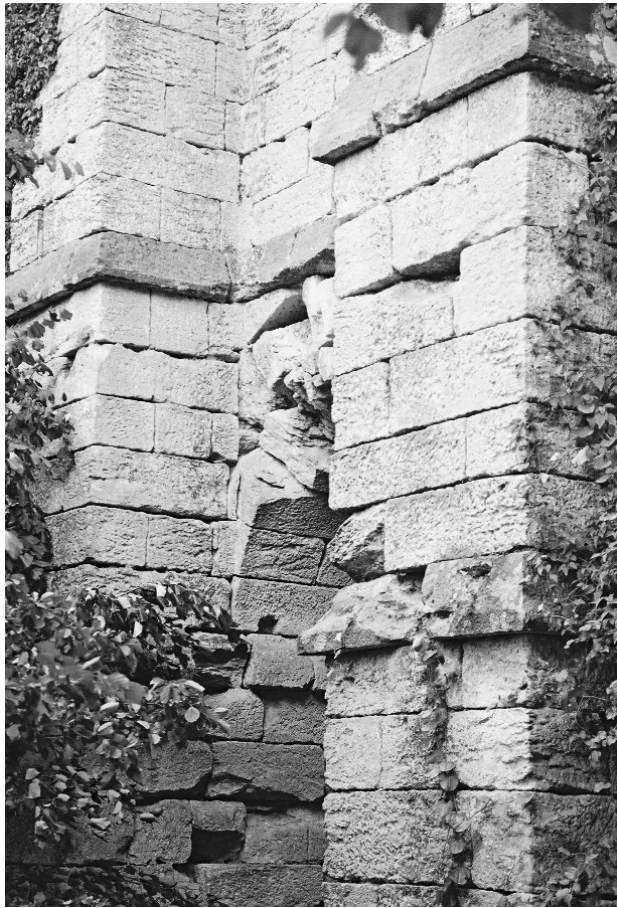
FIG. 4.23 Talas (K22), upper central arch in Phase 3, showing chamfered string-course and buttresses.

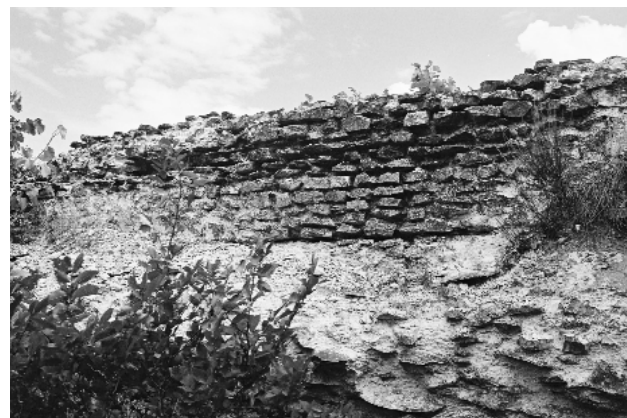
FIG. 4.25 Talas (K22), the inner face of the east wall of the water channel, showing small rubblework masonry; the base is largely eroded away. View from the west.

for the work at Talas.²¹ At the south end of the bridge a high arch survives and there is a clear section of the interior east wall of the water channel crossing this phase of the bridge, with the small block construction seen at Ayyacıkdere (K7) and elsewhere (Fig. 4.25). The west side of the bridge has also been faced, but without the buttresses and string-courses of the east wall. Against the buttress east of the lower arch was a section of later repair using rough blockwork (Fig. 4.26), similar to the work described from Phase 2 at Balligerme (K18) and Büyükgerme (K20).

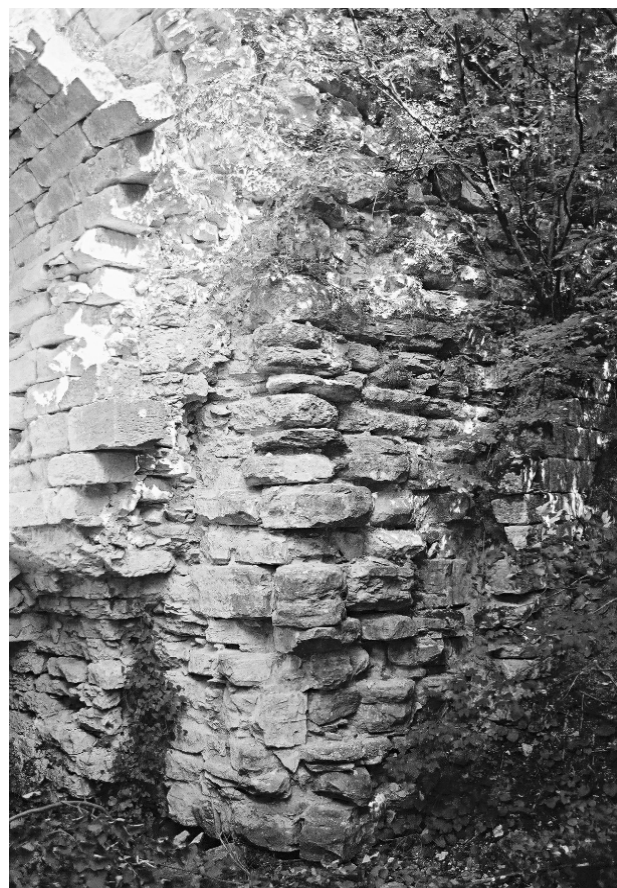
FIG. 4.26 Talas (K22), later blockwork on the west face, south of the central arch.

In places, where there has been later collapse, it is clear that the earlier 'rusticated' work was cut back to receive the new plain cladding. The stone used for this new work is a harder limestone, similar to the limestone used for the building of the northern sector of the Anastasian Wall only 6–8 km to the west. This may help to provide a *terminus post quem*

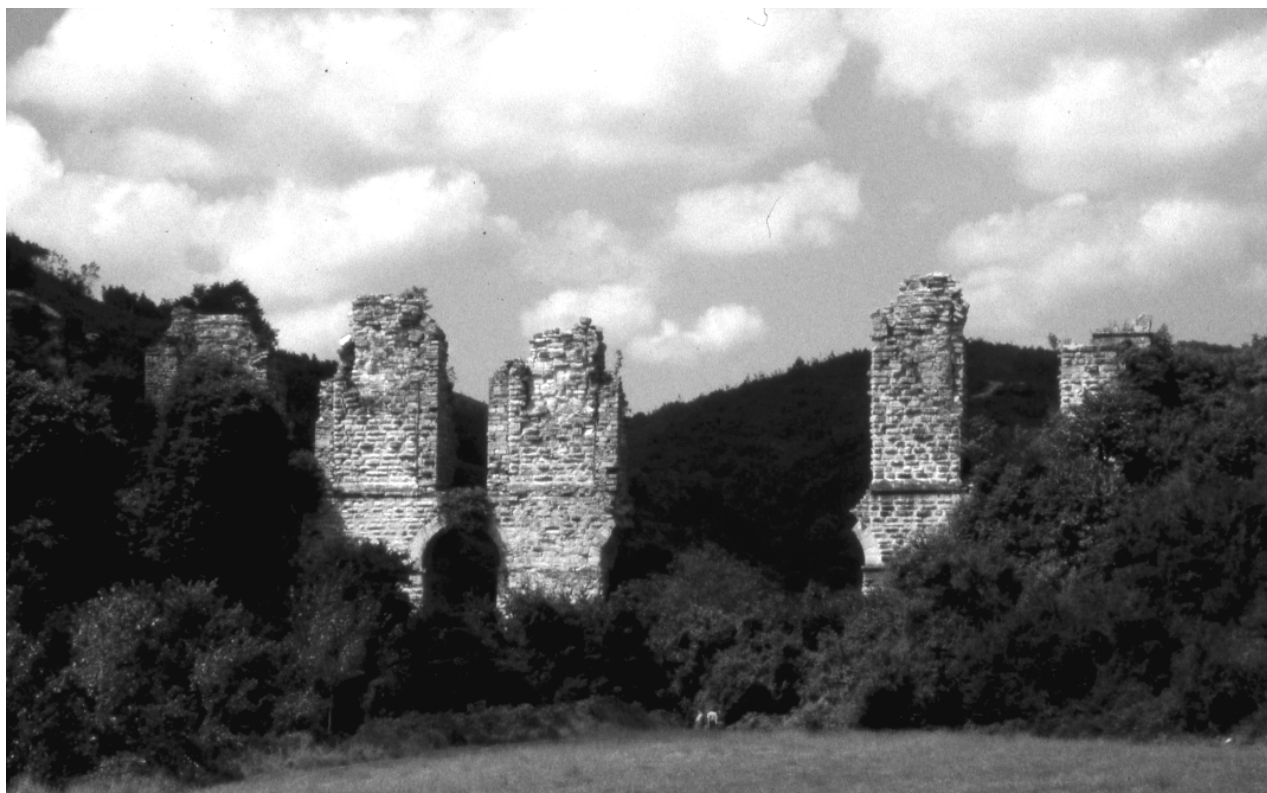
FIG. 4.27 Büyükgerme general view.

Ballıgerme (K18) and Büyükgerme (K29). At both bridges one elevation underwent extensive repairs with roughly-squared blocks laid in courses; at the former bridge there were also unusual clasping buttresses at the corner of the lower arch. Some of the stone is reused, but others blocks may be reworked; similar stone repairs are found at a number of other bridges: Gümüşpınar Dere (K19), (K19.1), Ceviz Dere (K20.1), Maçka Dere (K20.5), and Talas (K22) on the main line, as well as the second bridge at Kale Dere on the Pınarca branch.²⁵ At Talas (K22) the rough blockwork of Period IV is clearly later than the distinctive rebuilding programme seen in Period III, but at both Ballıgerme (K18) and Büyükgerme (K29) the extent of the later work reveals a major programme of rebuilding distinct from Period III. At Büyükgerme there is also evidence surviving for activity on the south elevation where the main string-course at the level of the lower arches has been cut back, possibly in advance of additional facings (Fig. 4.27). Brick vaults are seen springing in Arch 4
