CHAPTER 7

The Christian Symbols and Iconography of the Aqueducts of Thrace

by James Crow

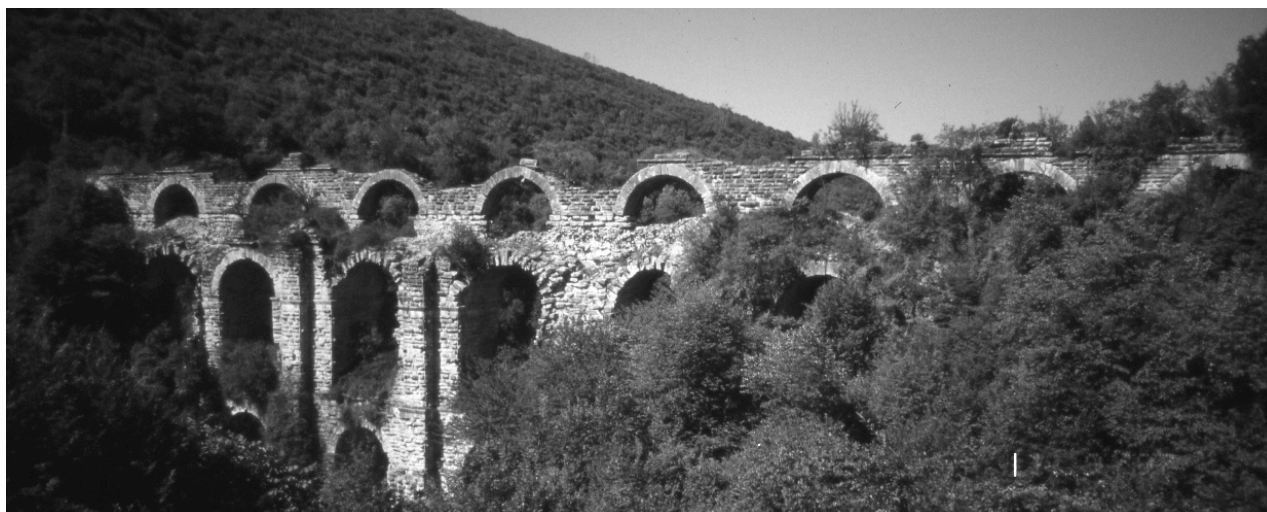
FIG. 7.1 Kurşunlugerme (K20), general view.

No other bridge on the Thracian water supply system or indeed in the Roman world is as extensively decorated with Christian or other apotropaic symbols as Kurşunlugerme (Fig. 7.1; see elevation Fig. 4.7).² Similar symbols are also known from other major bridges in Thrace, especially Karamanoğlu, Balligerme, Keçigerme, and Kumarlıdere, plus one surviving decorated chrismon on a keystone of the Bozdoğan Kemer in Istanbul. This range of Christian symbols from secular monuments is

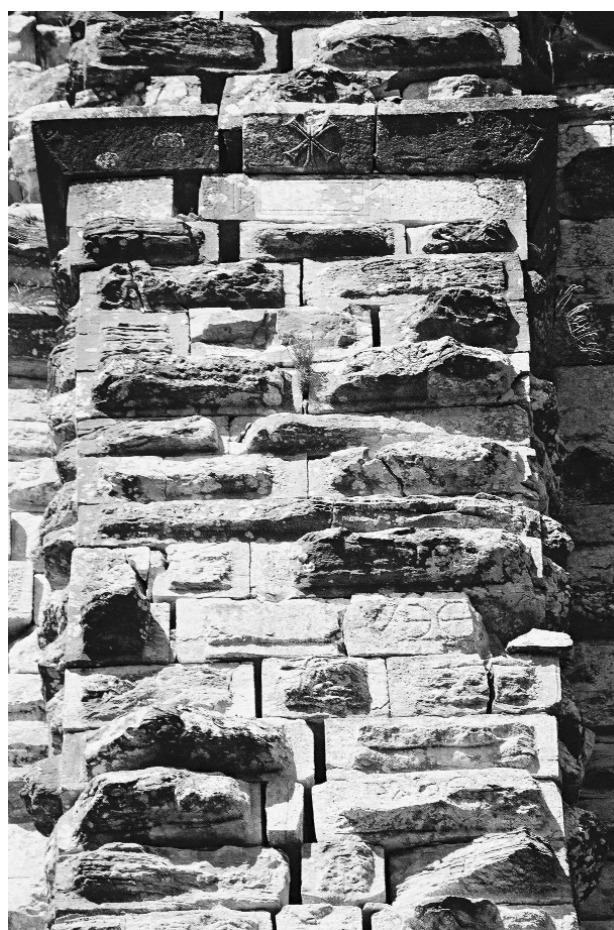
FIG. 7.2 Kurşunlugerme (K20); general view of Buttress V from the east showing the location of crosses and other symbols and masons' marks.

Relief carvings are found on all three tiers of the bridge at Kurşunlugerme, especially on cornice blocks, voussoirs and keystones. The distribution of these symbols is in part affected by the survival of the structure, so that relatively few are known on the west face where there has been very extensive collapse, caused by centuries of earthquakes. Other factors such as accessibility and visibility will be discussed below. The catalogue records all known symbols and inscriptions that we were able to identify and also those recorded in the past. It is unlikely to be complete since parts of the bridge remain inaccessible and are often obscured by vegetation and trees, for instance one of the best preserved crosses with a detailed inscription above Arch 10 (S40) went unrecorded by both Oreshkov and Dirimtekin.

On the bottom tier, no symbols survive from the west face, although an inscription with the invocation beginning *Kyrie Boethe* is set in a damaged *tabula ansata* on the west face of the north pier of Arch 18.⁴ At the south end Arch 20 has an elaborate keystone with a jewelled cross, partly unfinished

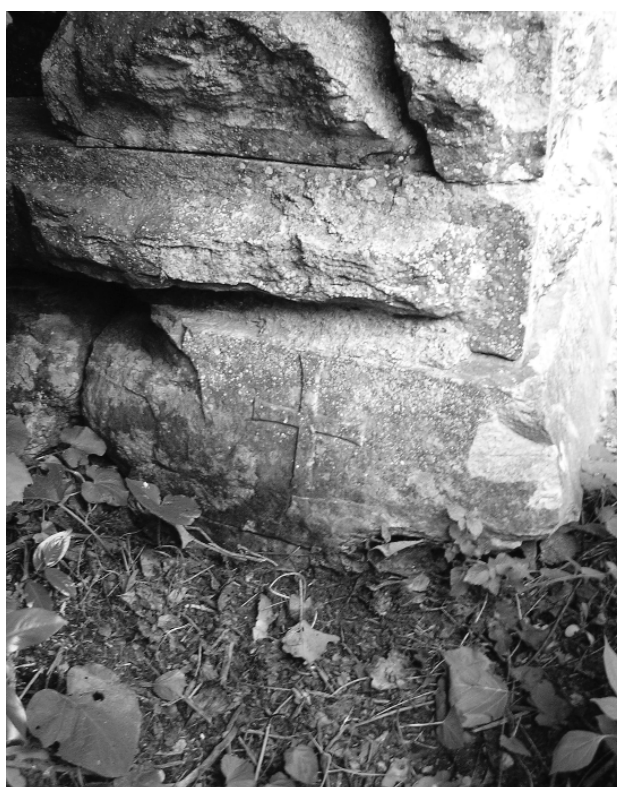
FIG. 7.3 Kurşunlugerme (K20); S1, relief Latin cross, Buttress VII.

Illustrated by Oreshkov (1915), 101, fig. 18, although the hook is omitted. This sketch was copied by Dirimtekin (1959), 233, 1, fig. 32, where it is incorrectly noted that it was on the cornice of the last pier to the north. A similar cross with the inscription ΘΕ ΟΦ was not seen by us (Oreshkov (1915), 101, fig. 19; Dirimtekin (1959), 233, fig. 32, 1).

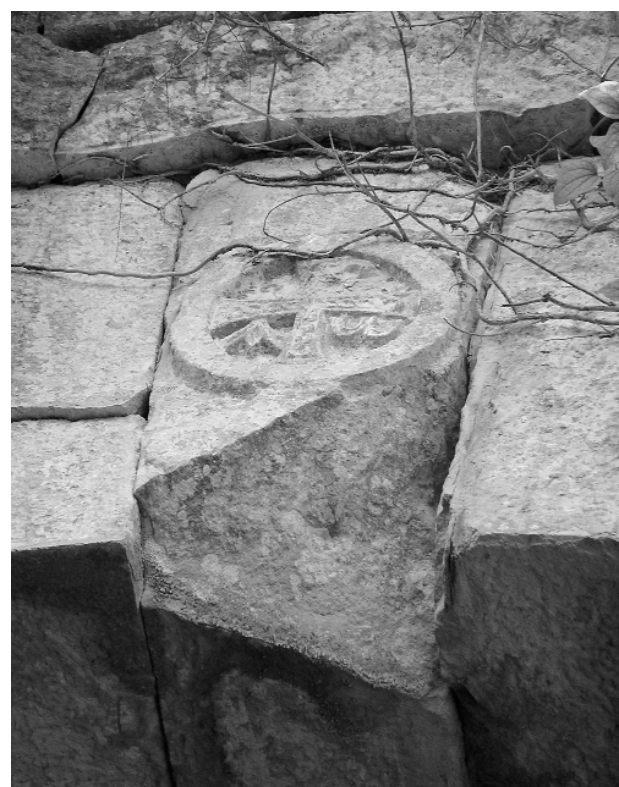
FIG. 7.5 Kurşunlugerme (K20); S3, jewelled cross on keystone of Arch 20.

stauogram). The arms are decorated with an interlace pattern and below the horizontal arm there is a relief Alpha and Omega with channelled carving within the letter forms. The circular border is plain but is proud of the face of the keystone; it represents an unfinished wreath. The raised band of a ribbon can be seen running to the bottom left; the stone is broken to the bottom right. The decoration appears to represent an incomplete form of the 'crux gemmata' or the jewelled cross.

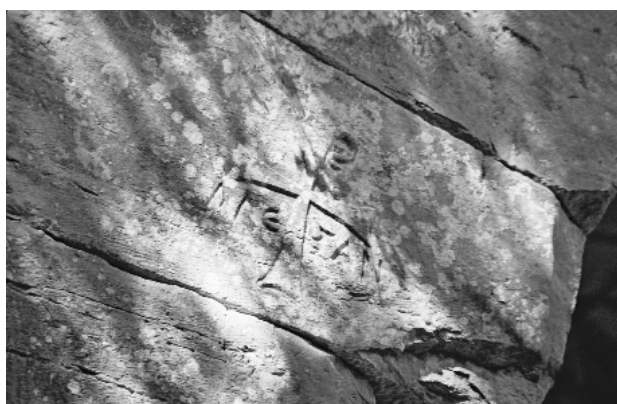
FIG. 7.4 Kurşunlugerme (K20); S2, relief cross with inscription, Arch 20.

(S3). This is complemented by a cross on the voussoir to the left with the name Alexander (S2). The matching voussoir to the right does not survive, but may be an unlocated cross with the name Theophilus noted by Oreshkov.⁵ On the chamfered cornice immediately above the keystone of Arch 20 is a cross (S13), and at the foot of Buttress VII south of the south pier is another simple cross (S1). The lowest cornice at the level of the springing of Arches 18, 19 and 20 is a cyma recta moulding, in contrast with the chamfered string-courses above. On the face of a voussoir on the north side of Arch 19 is a cross in the form of a staurogram (S22). The east face of the vault of Arch

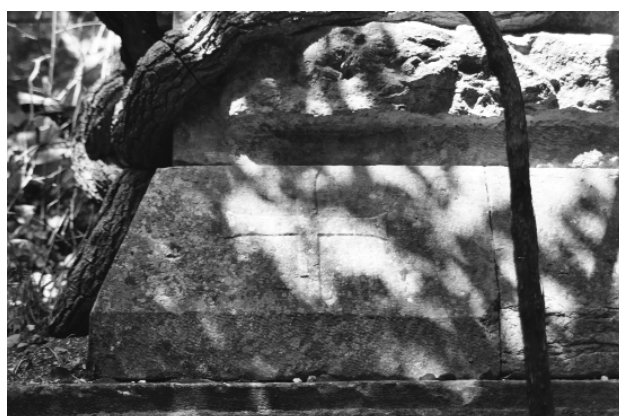
FIG. 7.6 Kurşunlugerme (K20); S7, low relief cross, Arch 18.

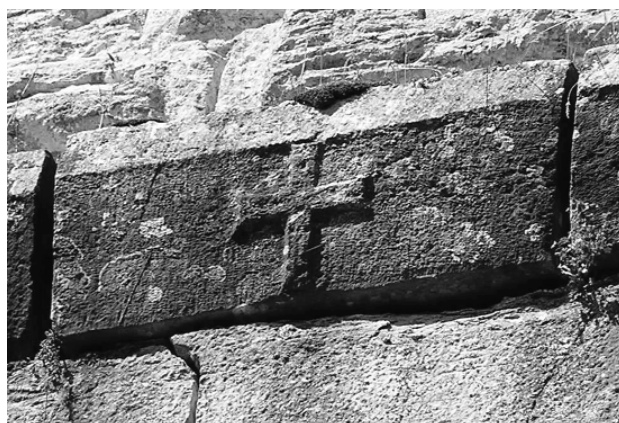
FIG. 7.7 Kurşunlugerme (K20); S12, simple relief cross, Buttress V.

Description (Fig. 7.7): simple relief cross, possibly splayed at the end of the horizontal arms. Carved on the downward-facing chamfer, located on the middle block of

the string-course across Buttress V at the base of Arches 14 and 15.

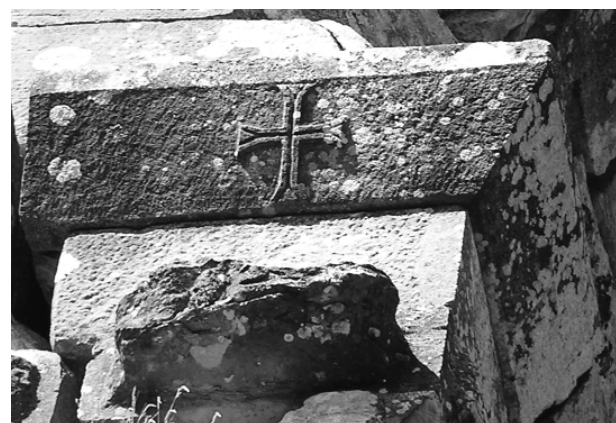
FIG. 7.8 Kurşunlugerme (K20); S14, relief cross on chamfered impost of Arch 14.

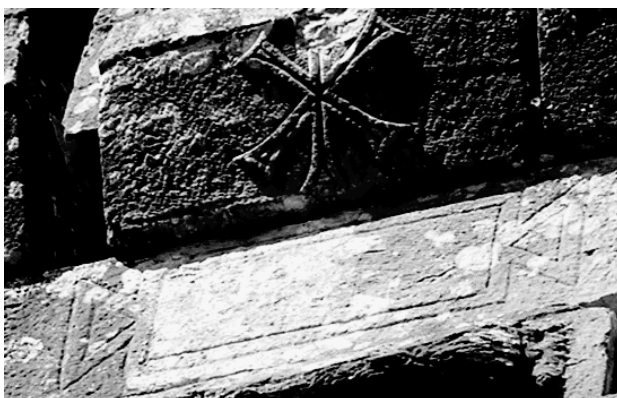
FIG. 7.9 Kurşunlugerme (K20); S15, six-armed chrismon on Buttress V, below is the outline of a *tabula ansata* with no visible text.

Description (Figs 7.2; 7.9): six-armed chrismon carved in relief, channelled and with v-shaped terminals. Carved on the downward-facing chamfer at the centre of Buttress V. A sketch drawing of the symbol published by Dirimtekin shows it as a six-armed chrismon; however the end of the central, upper arm has been damaged, probably by a rifle shot. This is confirmed in the photograph in the DAI archive, c. 1969; it is possible therefore that this arm terminated with a rho or a crook ligature.

Description (Figs 7.2, 7.9): the long quadratic block below the string-course with the chrismon S15 has been dressed back smooth and has the outline of a *tabula ansata* cut into it; there is no text visible within the panel. According to Dirimtekin, (1959), 235, 10, Oreshkov saw an inscription through a telescope; however Dirimtekin seems to have wrongly located a different inscription published by Oreshkov (1915), 102–3, fig. 22.

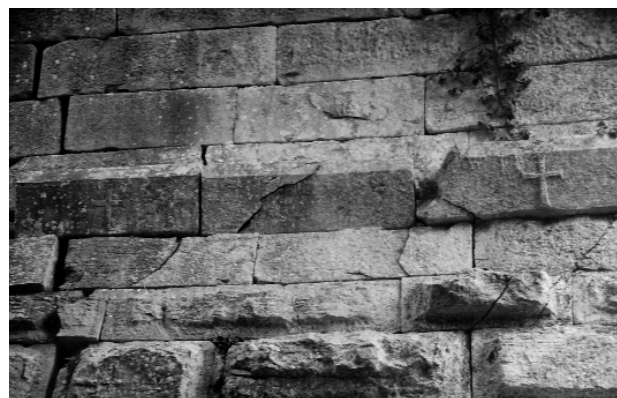
FIG. 7.11 Kurşunlugerme (K20); S23 and S24, relief crosses on chamfered impost blocks of Arch 17.

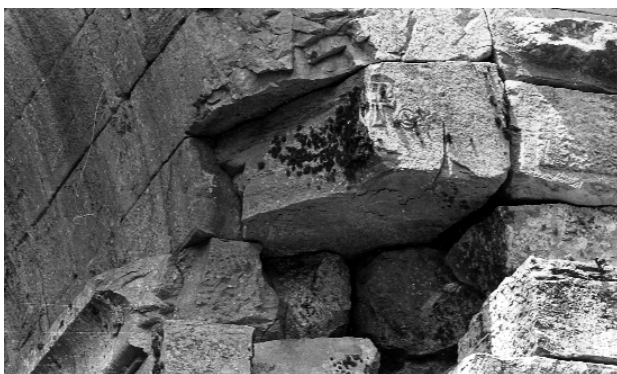
FIG. 7.10 Kurşunlugerme (K20); S22, relief cross, Arch 19.

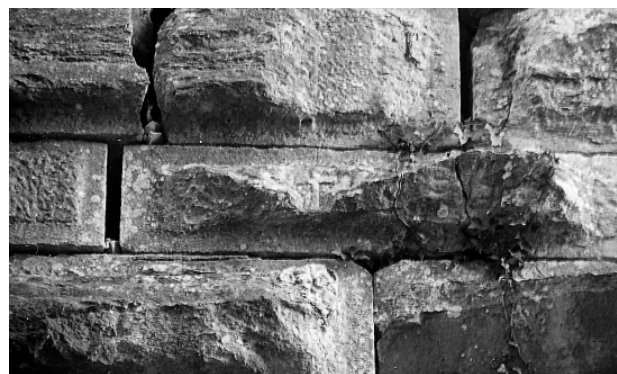
FIG. 7.12 Kurşunlugerme (K20); S25, relief cross carved on the bossed work, Arch 17.

Description (Fig. 7.12): cross carved in relief into the bossed work on the fourth course below the springing, channelled with v-shaped terminals.

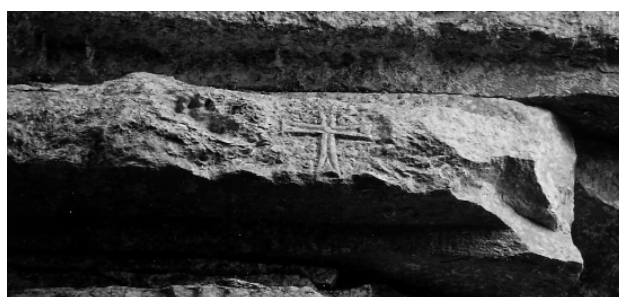
FIG. 7.13 Kurşunlugerme (K20); S27, relief cross carved on the bossed work, Arch 17.

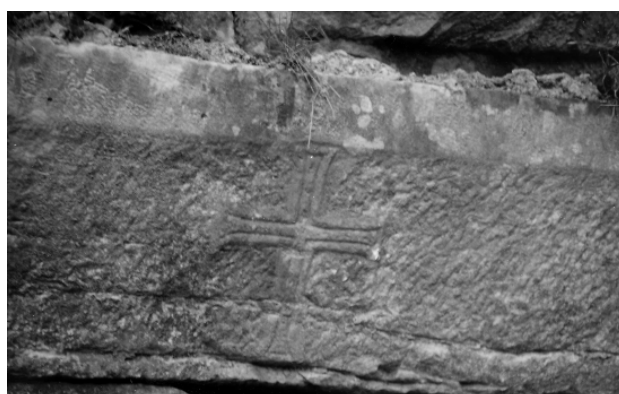
FIG. 7.14 Kurşunlugerme (K20); S29, relief cross from string-course on west face, now destroyed.

Description (Fig. 7.14): channelled cross; the string-course has now been broken and torn from the structure by treasure-hunters.

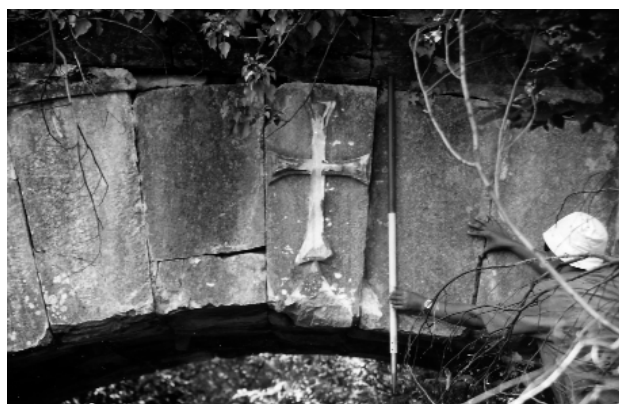
FIG. 7.15 Kurşunlugerme (K20); S31, cross on the east keystone of Arch 1.

Description (Fig. 7.15): a Latin cross carved in high relief, with wide splayed ends and a channelled centre; the cross stands on a triangle in low relief. The cross is set forward on a lower field. The central part of both arms has suffered considerable damage since the DAI photograph in 1969. 200 mm across, 350 mm high; lower triangle 150 mm high. The west keystone of Arch 1 is unworked.

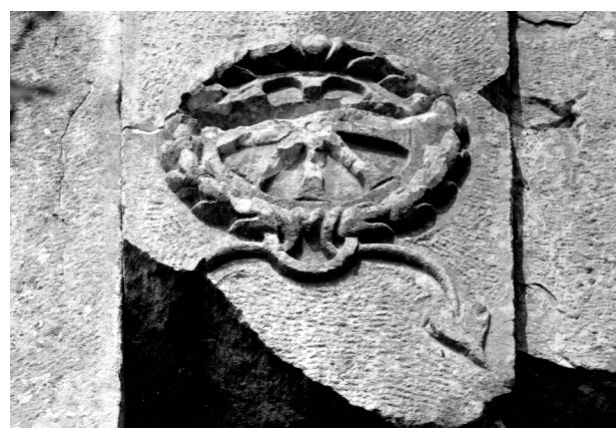
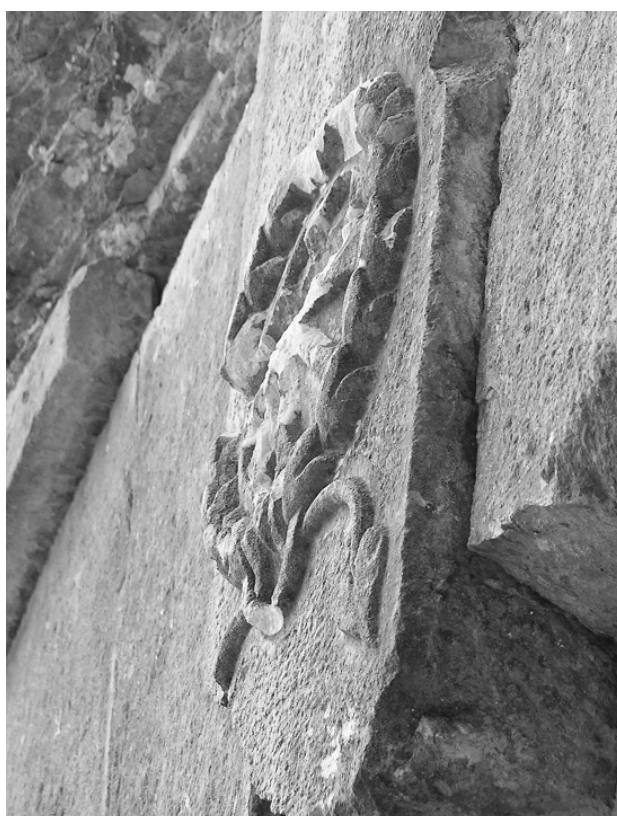
FIG. 7.16 Kurşunlugerme (K20); S32, wreathed chrismon on the east keystone of Arch 2.

FIG. 7.17 Kurşunlugerme (K20); S32, side view showing relief carving on the east keystone of Arch 2.

Description (Figs 7.16; 7.17): eight-armed chrismon set in laurel wreath with ribbons. It is convex in profile and the wreath is shown in segments of a three-pointed design; above the central arm the wreath ends with a small globe. The arms of the chrismon are simply splayed without channelling. At the base a ribbon with two leaf-shaped terminals is tied by a loose knot, identifiable as a 'lark's head' knot. The face of the keystone is set proud of the adjacent voussoirs. The stone is broken on the bottom left side and there is a crack across the centre of the wreath. DAI Istanbul, R 2686; Çeçen (1996a), 167; Crow and Ricci (1997), fig. 13.

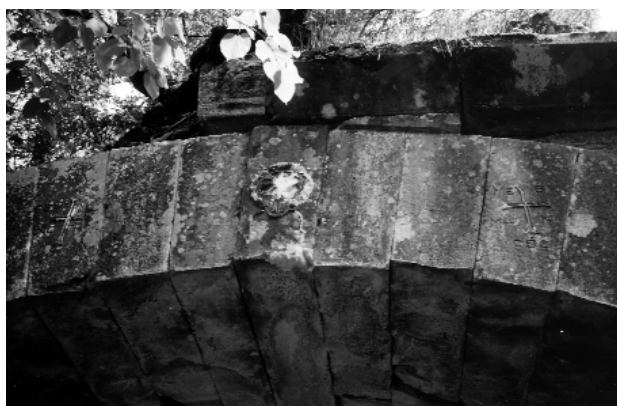
FIG. 7.18 Kurşunlugerme (K20); S33, S34, S35, chrismon and two flanking crosses on the west voussoirs of Arch 2.

Description (Figs 7.18; 7.19): eight-armed chrismon set in laurel wreath with ribbons flanked by two inscribed crosses (S34 and S35). The chrismon is similar to S32 but is more carefully carved, with channelling in the arms and the ribbons. The ribbon is tied by the same knot but an acanthus leaf masks the wreath at the bottom. Until 1969 (DAI photograph) the chrismon was undamaged; however

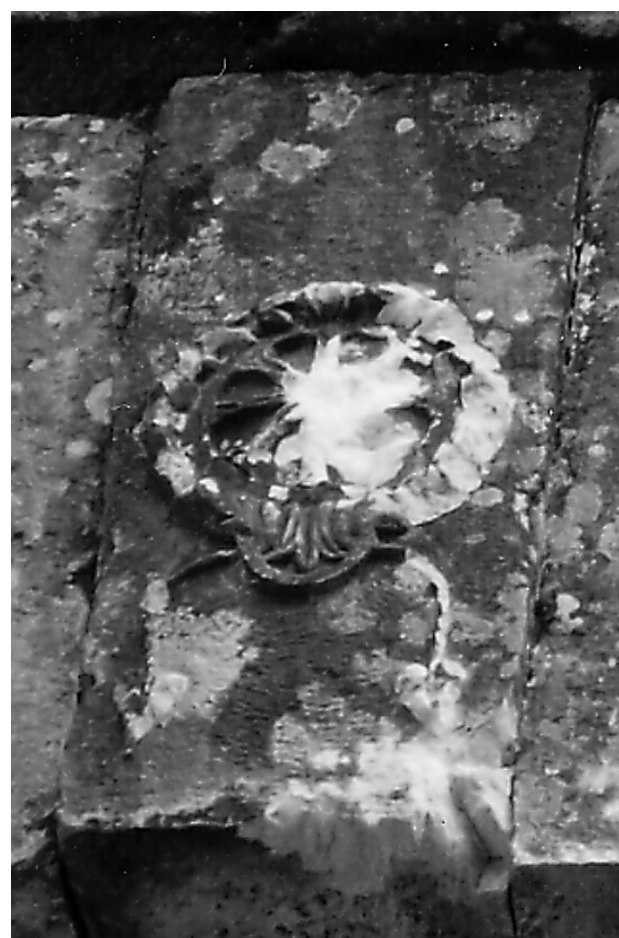
FIG. 7.19 Kurşunlugerme (K20); S33, wreathed chrismon on the west keystone of Arch 2.

before our first visit in 1995 the centre and the base of the keystone were badly damaged, probably by a rifle shot. Oreshkov (1915), fig. 21; Dirimtekin (1959), fig. 32, 4; DAI Istanbul, R 2684, 2685; Çeçen (1996a), 166.

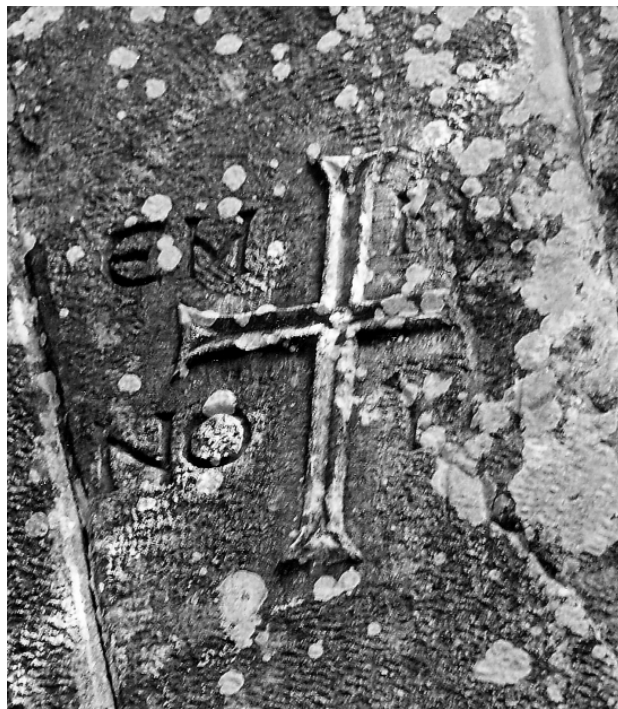
FIG. 7.20 Kurşunlugerme (K20); S34, cross and inscription 'Emmanuel' north of S33, Arch 2, west side.

Description (Fig. 7.20): a Latin cross with letters, located on a voussoir three blocks north of the wreathed chrismon (S33). The cross is carved in relief and has splayed ends, formed by small triangles, with a clear central channel in both the horizontal and vertical arms. On the left side above the arm are the letters EM and below are NO cut into the dressed face of the voussoir. The right side is damaged but has the letter M above and Y below. Dirimtekin reads this as *Emmanouel* (1959, 233). Oreshkov (1915), fig. 21; Dirimtekin (1959), fig. 32, 2; DAI Istanbul, R 2684, 2689; Çeçen (1996a), 166.

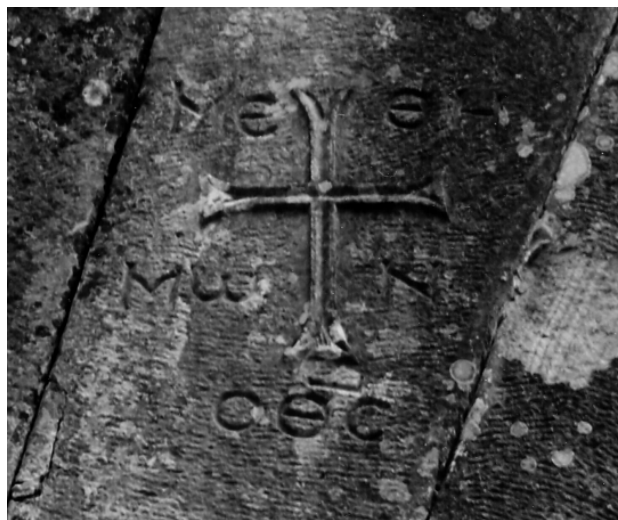
FIG. 7.21 Kurşunlugerme (K20); S35, cross and inscription 'God with us' south of S33, Arch 2, west side.

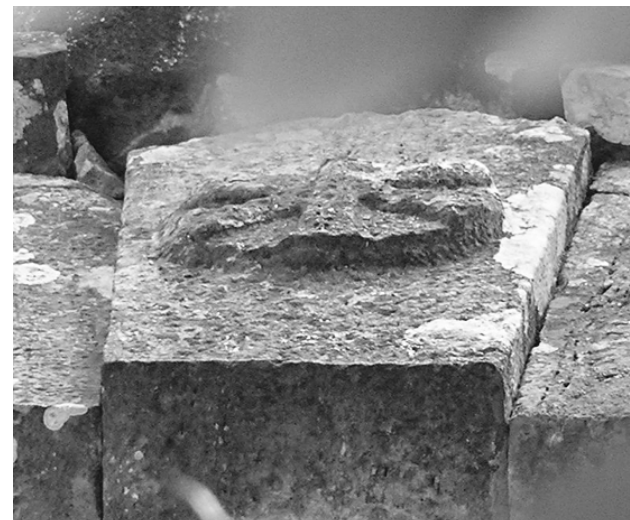
FIG. 7.22 Kurşunlugerme (K20); S38, roughed out chrismon with six arms, Arch 4, west side.

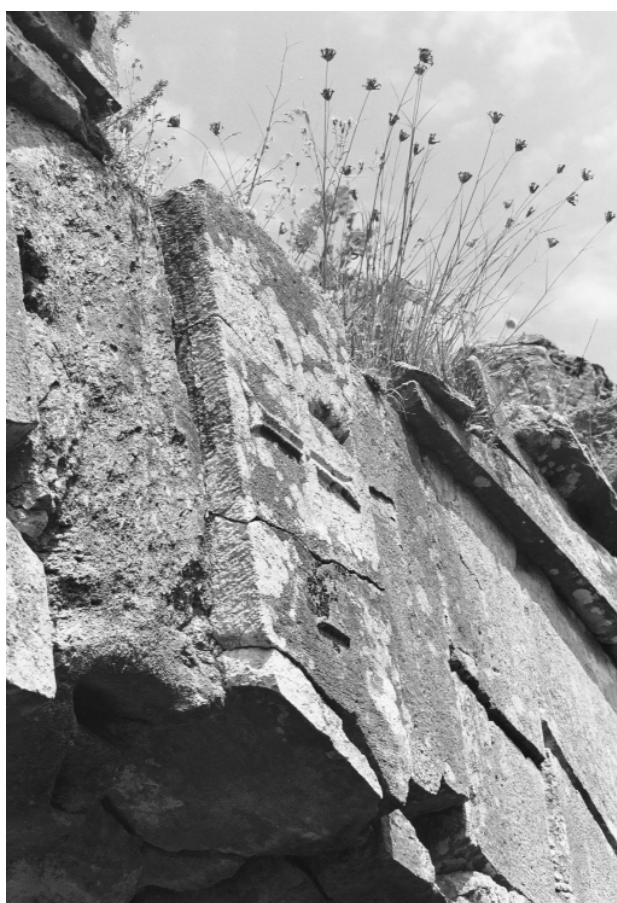
FIG. 7.23 Kurşunlugerme (K20); S39, Latin cross on the east side of Arch 10.

Description (Fig. 7.23): tall Latin cross carved in relief with splayed ends and deep channelling, on the east keystone of Arch 10.

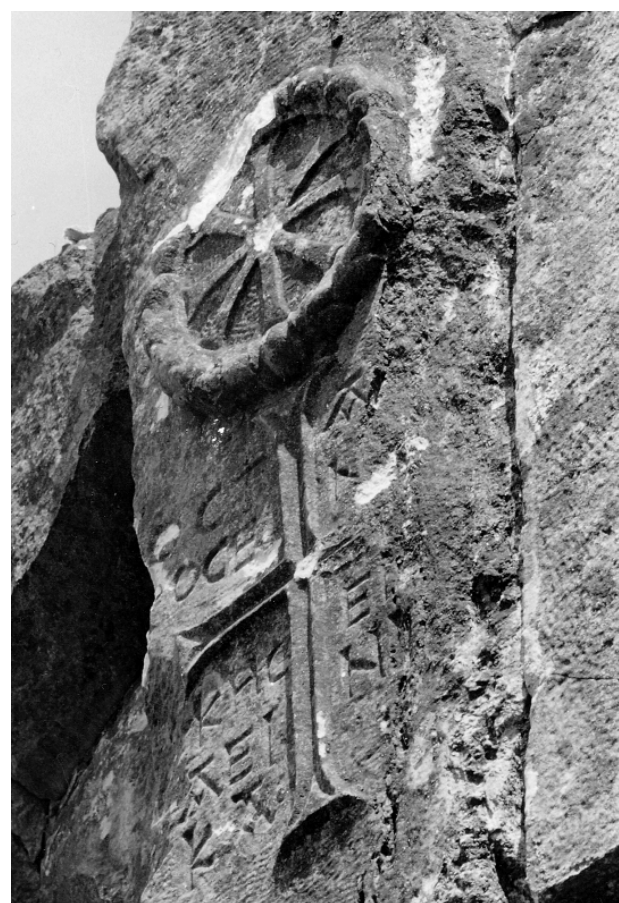
FIG. 7.24 Kurşunlugerme (K20); S40, wreathed chrismon and Latin cross with the text 'The Cross has conquered. It always conquers', Arch 10, west side.

The relief carving of cross and chrismon with an inscription 'The Cross has conquered. It always conquers' on Arch 9 (S40) is again very unusual, since the Latin relief cross clearly supports the wreathed chrismon, although unlike the other chrisma on the aqueduct the wreath does not have ribbons. Within the arms of the cross is the inscription quoted above. What is explicit in the imagery and what reinforces the text is that the cross is the Cross of Christ. The combination of a relief cross with this text is known from Egypt amongst the images associated with the physical conversion of the temple of Isis at Philae, dated 535–37. Nautin observes that this acclamation is first recorded in the Coptic version of the Acts of the Council of Ephesus in 431, although its first use as an inscription is not till a century later.¹³ Also reminiscent of the combined chrismon, cross and text at Kurşunlugerme, although with a different combination of words and images, is the ivory of Anicius Petronius Probus,

Description (Fig. 7.24): wreathed chrismon with a Latin cross below. The cross is carved in relief, with splayed ends and deep channelling, on the west keystone of Arch 10. The chrismon has eight arms and the wreath, although it is partly damaged, does not appear to have had ribbons below. At the base the wreath terminates in a globe. The cross is very similar to the cross on the east keystone (S39) but the right arm is damaged; there is an inscription in the four quadrants formed by the cross: top left OCT OCE; top right A N; bottom left KHC AEI KA; bottom right EN NI the right side is damaged and hence letters are partly missing. The inscription reads: ὁ σταυρὸς ἐν[ι]κησεν. αἰεὶ νικᾷ. The stone is now obscured by trees and was seen by us from above.

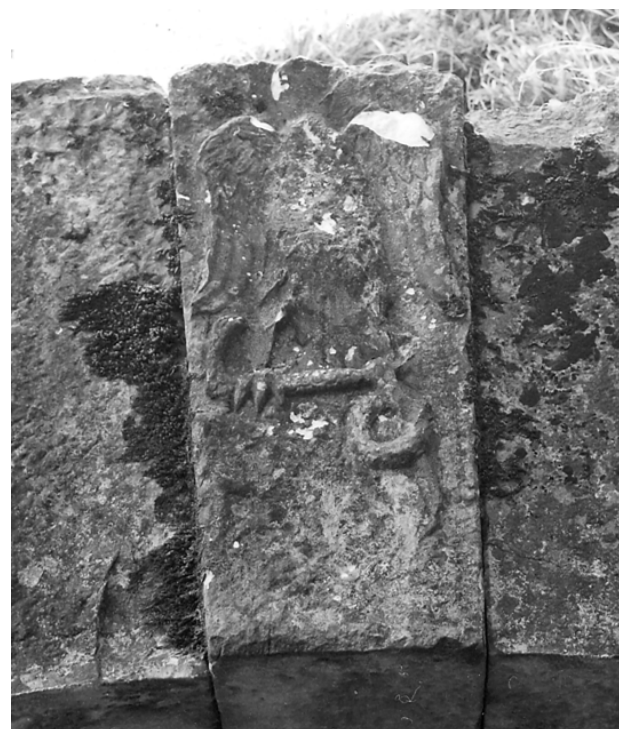
FIG. 7.25 Kurşunlugerme (K20); S41, eagle and snake relief on the west keystone of Arch 11.

On the western keystone of Arch 10 there is a relief carving of an eagle and serpent (S41); the bird is shown with open wings and holds a serpent across its talons with a victor's wreath in its right talon. Images such as this are known in early Byzantine art but are not common. A well-known example from Constantinople is from the Great Palace mosaic showing the violent struggle of the eagle and the snake. It has been considered to symbolize the

Description (Fig. 7.25): keystone for Arch 11, decorated with the relief carving of an eagle. The eagle's head is lost, but is shown in Oreshkov's sketch looking down. The wings are open, but not spread; it holds a snake between its talons with the head rearing to the left. In the right talon

is a laurel wreath with a single ribbon falling to the right. The bird is shown complete in Oreshkov's sketch (c. 1912), whilst the DAI photograph shows the loss of the head and the right shoulder (1969). The top of the keystone and the right voussoir are now further damaged, but the right wing is still sound. The left foot is clearly shown with three talons around the snake's body. Dirimtekin merely copies Oreshkov's sketch.

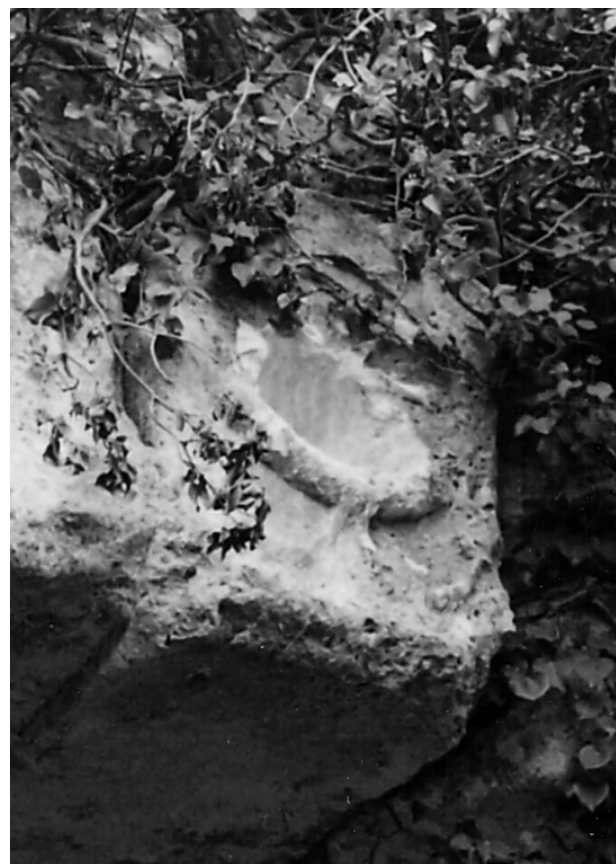
FIG. 7.26 Karamanoğlu (K13); S4, relief chrismon, now damaged, on the keystone of Arch 3, south side.

Description (Fig. 7.26): relief chrismon in the form of an eight-armed star, set within a circular frame, at the base are two ribbons. Photographs have been published by Çeçen; however when we visited in 1997 the central star had been hacked out and a hollow remained. No keystone was visible on the north side.

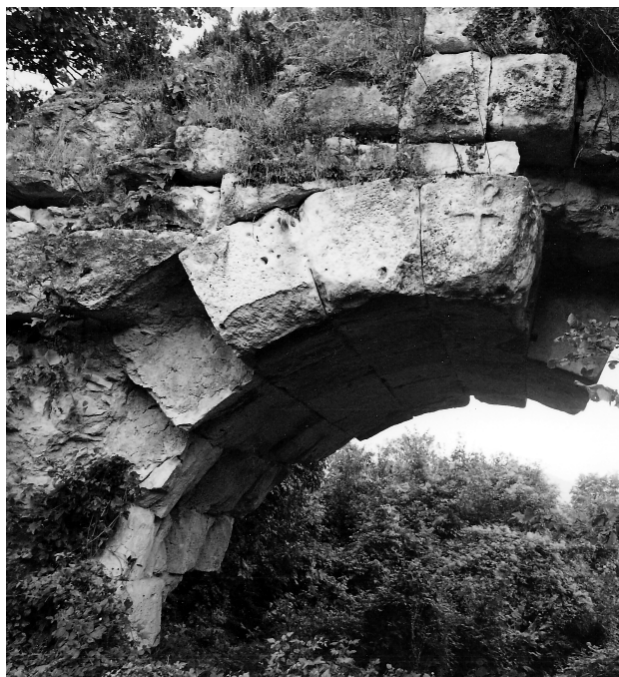
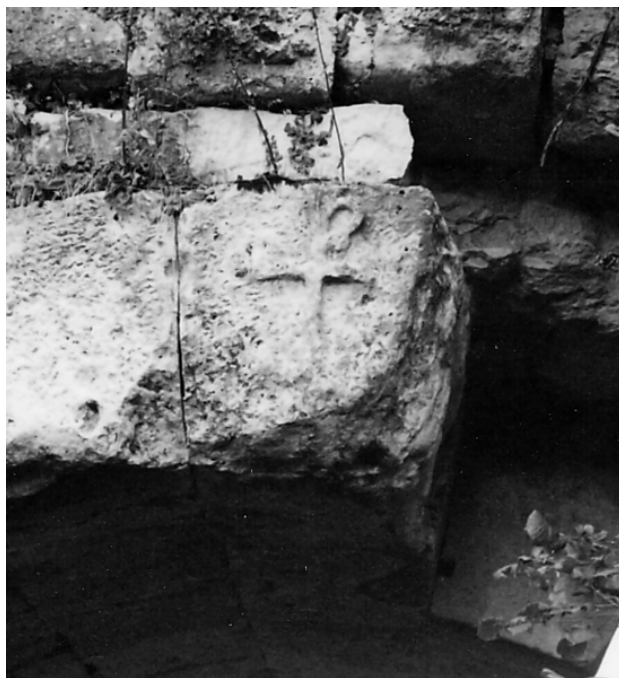
FIG. 7.27 Karamanoğlu (K13); S5, Arch 4 south side, showing relief staurogram.

FIG. 7.28 Karamanoğlu (K13); S5, detail, Arch 4 south side, showing relief staurogram.

Description (Figs 7.27; 7.28): relief staurogram with hooked ligature to the right, slightly splayed arms, and broken at bottom.

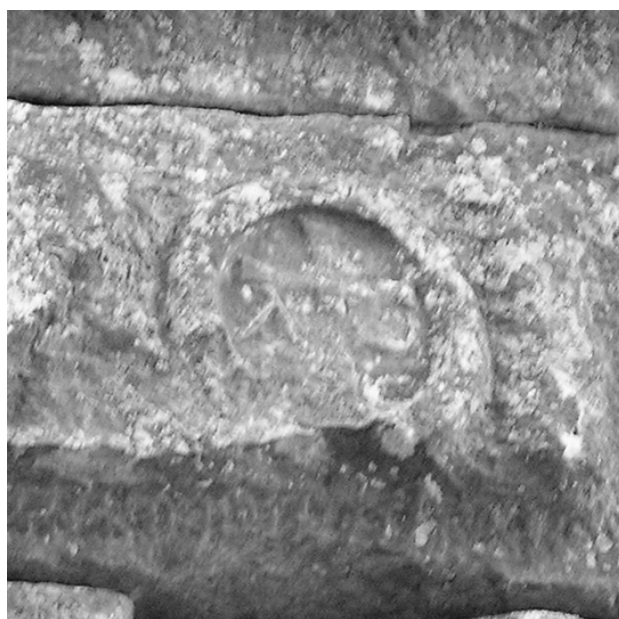
FIG. 7.29 Keçigerme (K29); S2, relief Latin cross within a plain circle with A and Ω, Arch 1.

Description (Fig. 7.29): Latin cross carved in relief within a plain circle; in the lower quadrants are the letters A and Ω. Located on the east face of the east pier, on the socle two courses below the chamfer on a long bossed block. Loop of the rho is not visible. In the centre of the block is another raised roundel but it is not carved out.

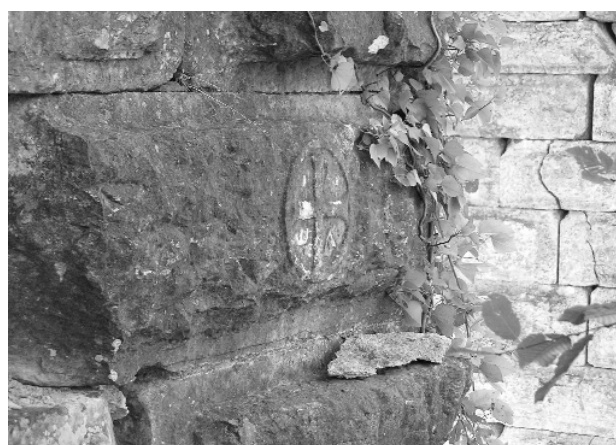
FIG. 7.30. Keçigerme (K29); S4, relief Latin cross with ligature and Ω and A in Arch 2.

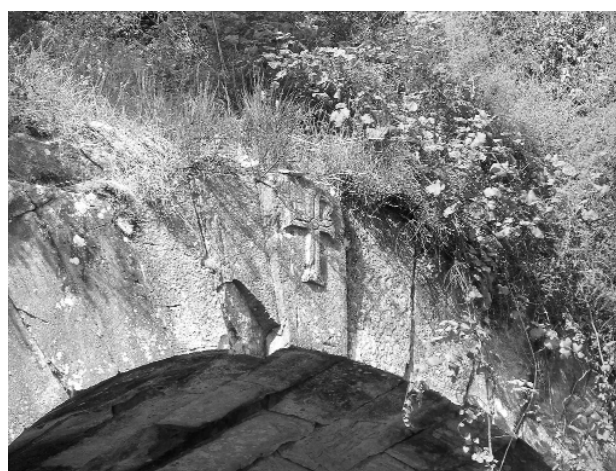
FIG. 7.31. Kumarlidere (K30); S1, high relief Latin cross with ligature on the keystone of Arch 2, east side.

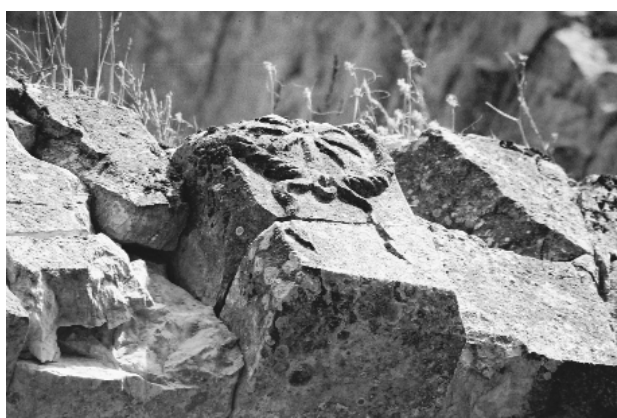
FIG. 7.32. Kumarlıdere (K30); S2, relief wreathed chrismon, Arch 2, west side.

Description (Fig. 7.32): eight-armed chrismon, in high relief, broken at top left, with trailing fillets and similar knot to Kurşunlugerme S32.

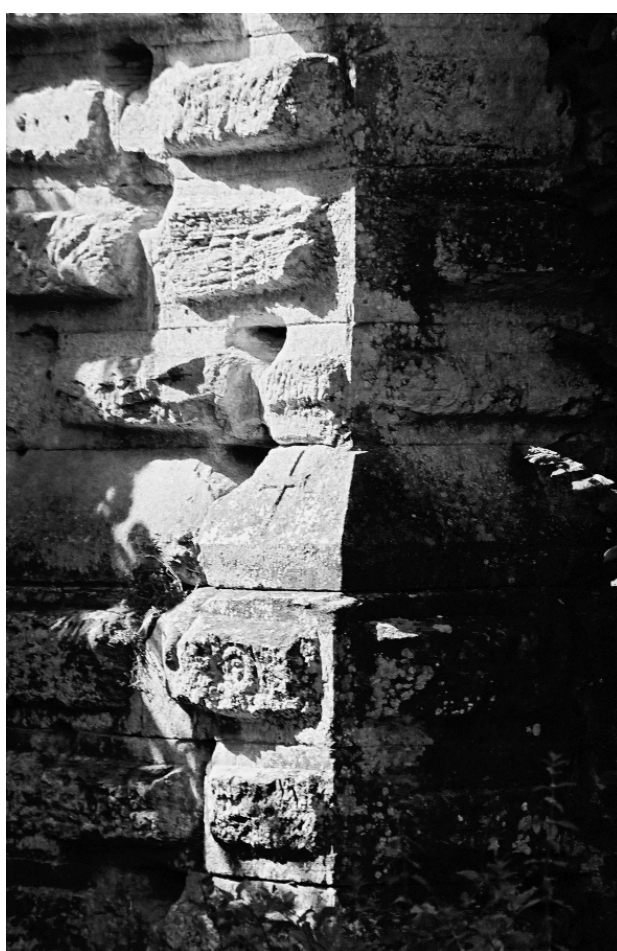
FIG. 7.33. Kumarlıdere (K30); S3, low relief cross on the chamfered plinth at the top of the socle of Arch 2, west side.

Description (Fig. 7.33): low relief cross with plain, parallel arms and slightly splayed ends. The cross is located at the

angled face of the chamfered corner plinth, above the socle of the bridge pier, compare Kurşunlugerme S7.

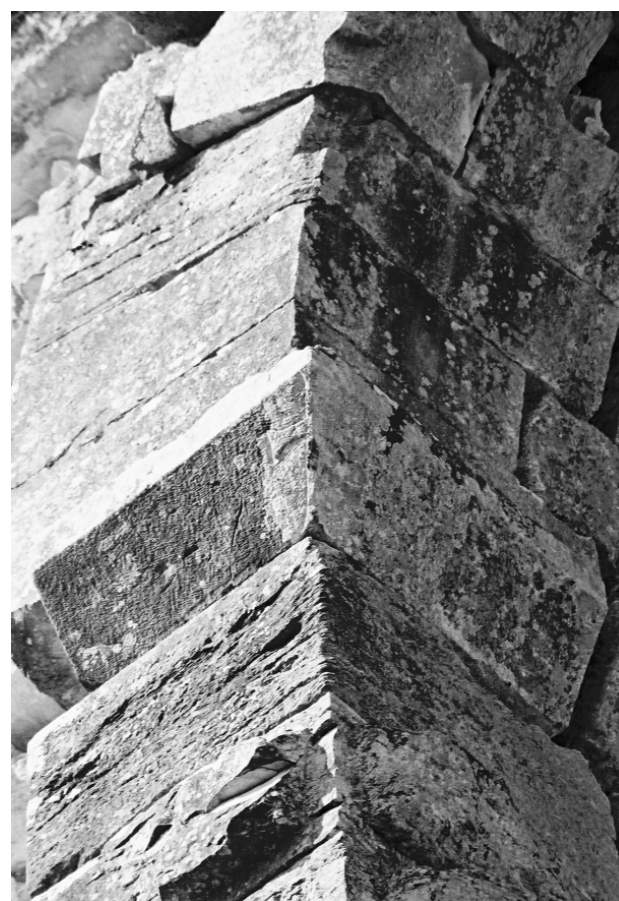
FIG. 7.34. Kumarlıdere (K30); S4, cross straddling the impost on the north side of Arch 2, west face.

Description (Fig. 7.34): low relief cross straddling the angle of the impost block, compare Kurşunlugerme S19.

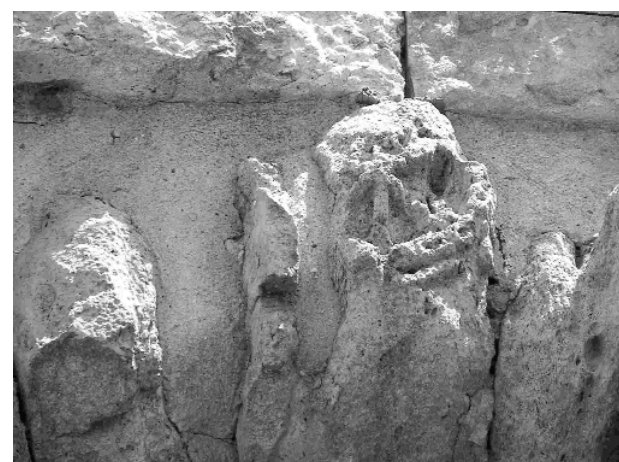
FIG. 7.35. Bozdoğan Kemerî, fragmentary chrismon on the keystone of Arch 30.

Description (Fig. 7.35): damaged chrismon on the keystone of Arch 30.

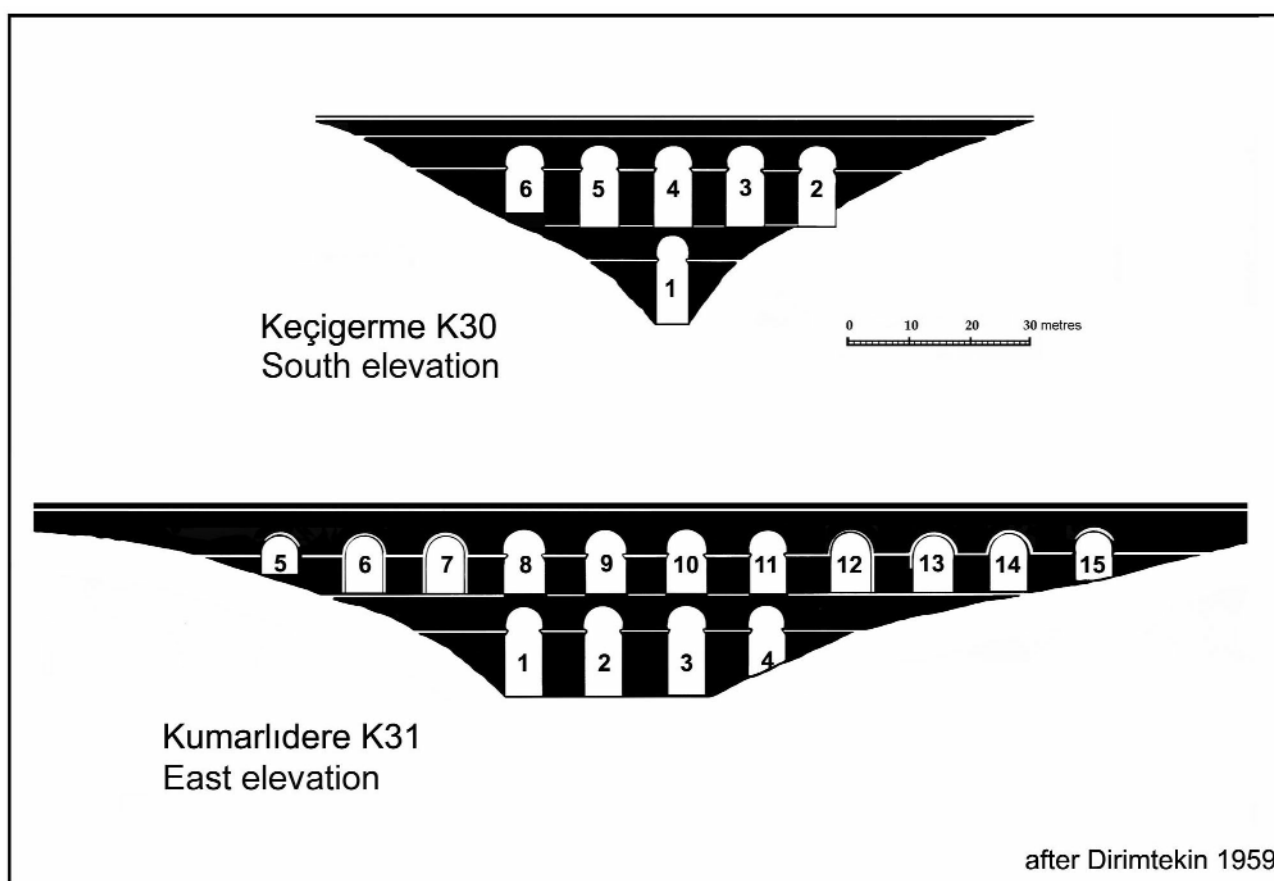
FIG. 7.36. Restored outline elevations of the Keçigerme (K30) and Kumarlidere (K31) bridges showing arch numbers.
