# The Water Supply of Byzantine Constantinople

James Crow, Jonathan Bardill  
and Richard Bayliss

SOCIETY FOR THE PROMOTION OF ROMAN STUDIES  
JOURNAL OF ROMAN STUDIES MONOGRAPH NO. 11  
2008

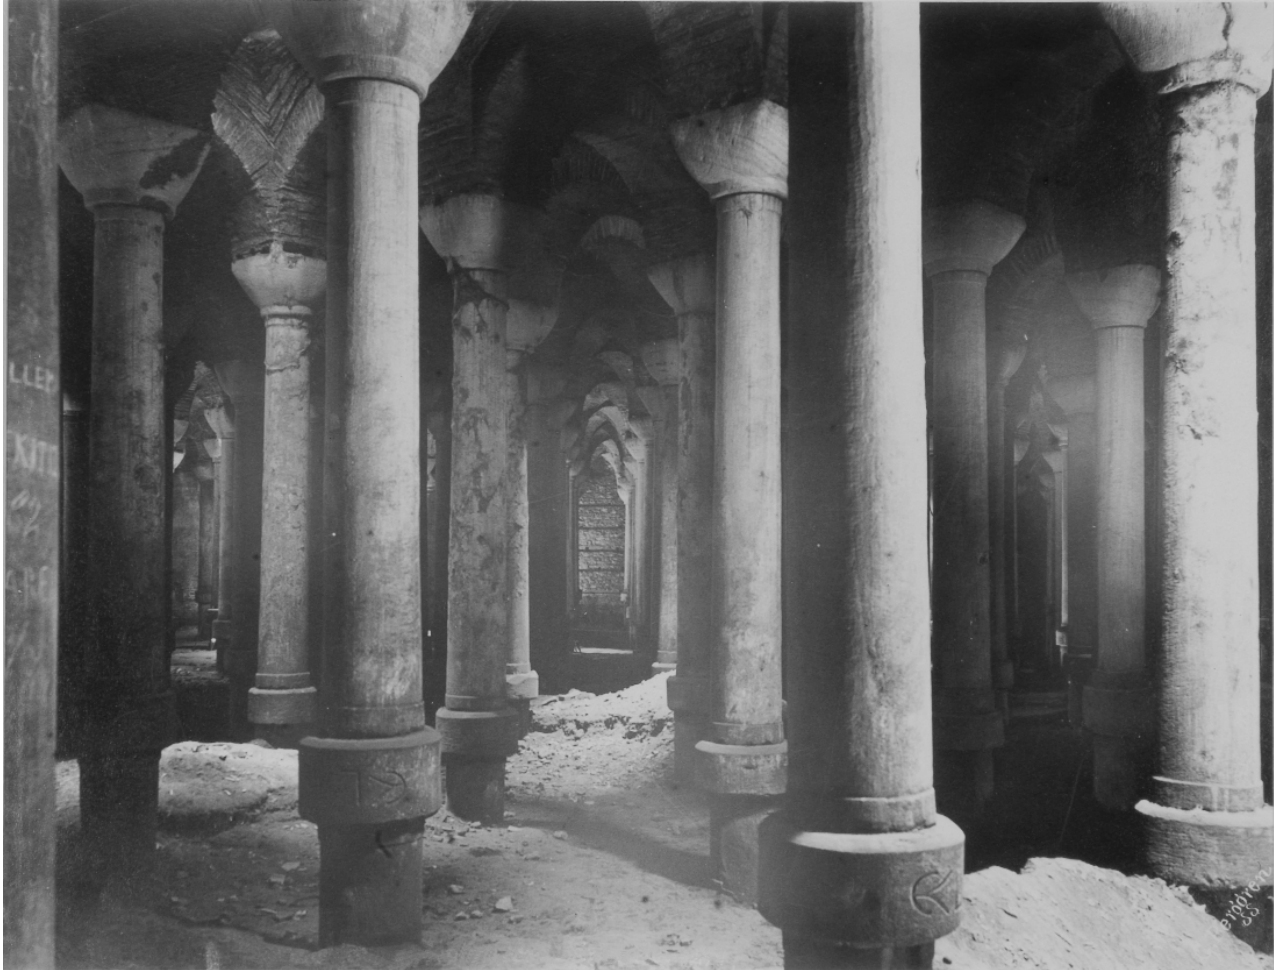
The interior of the Binbirdirek Cistern taken by Guillaume Berggren. The photograph shows the interior of the cistern half filled with soil and debris. In the foreground are clear examples of masons' marks.
