*NICOPOLIS AD ISTRUM:*  
A ROMAN, LATE ROMAN, AND  
EARLY BYZANTINE CITY

EXCAVATIONS 1985–1992

ANDREW POULTER

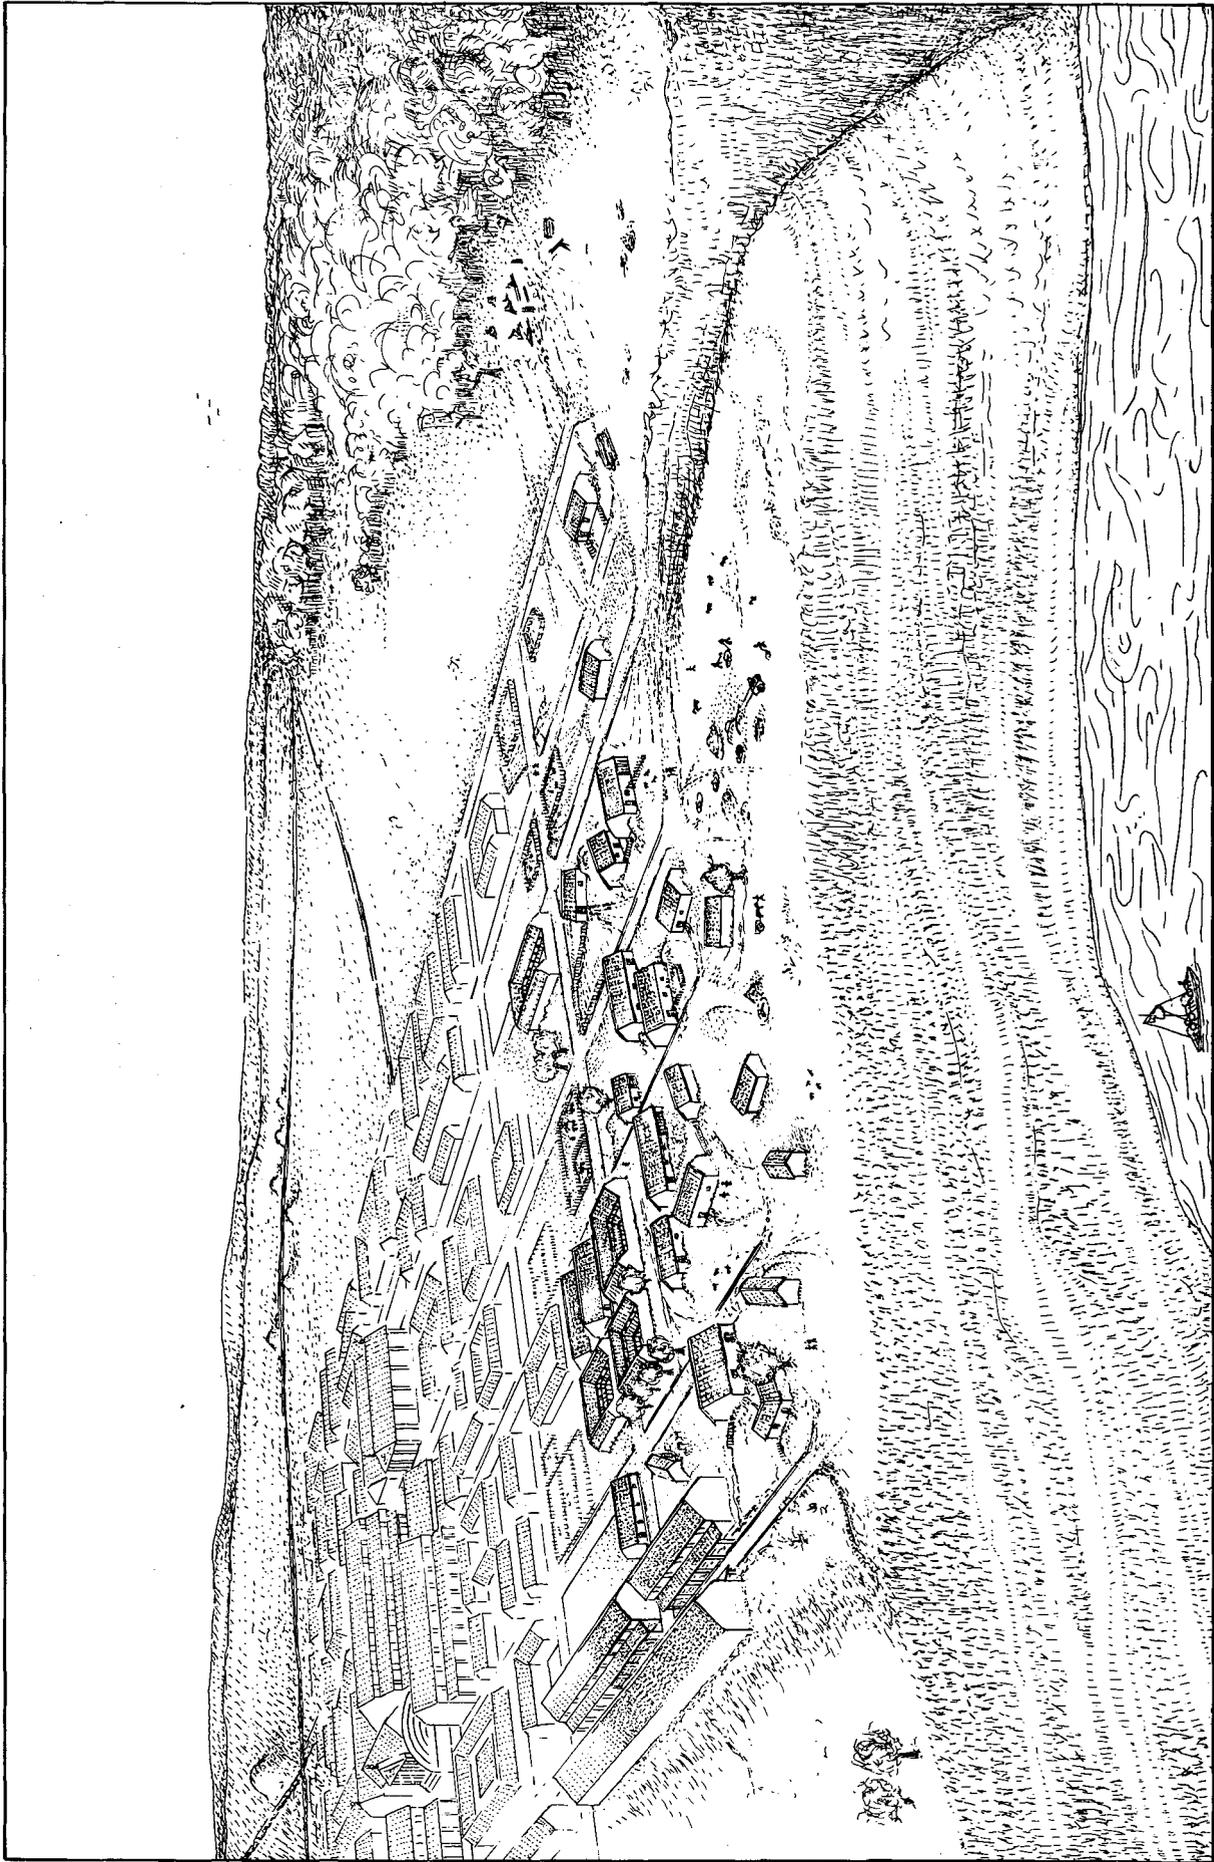
Fig. 7 Reconstruction drawing of the site, c. 150.

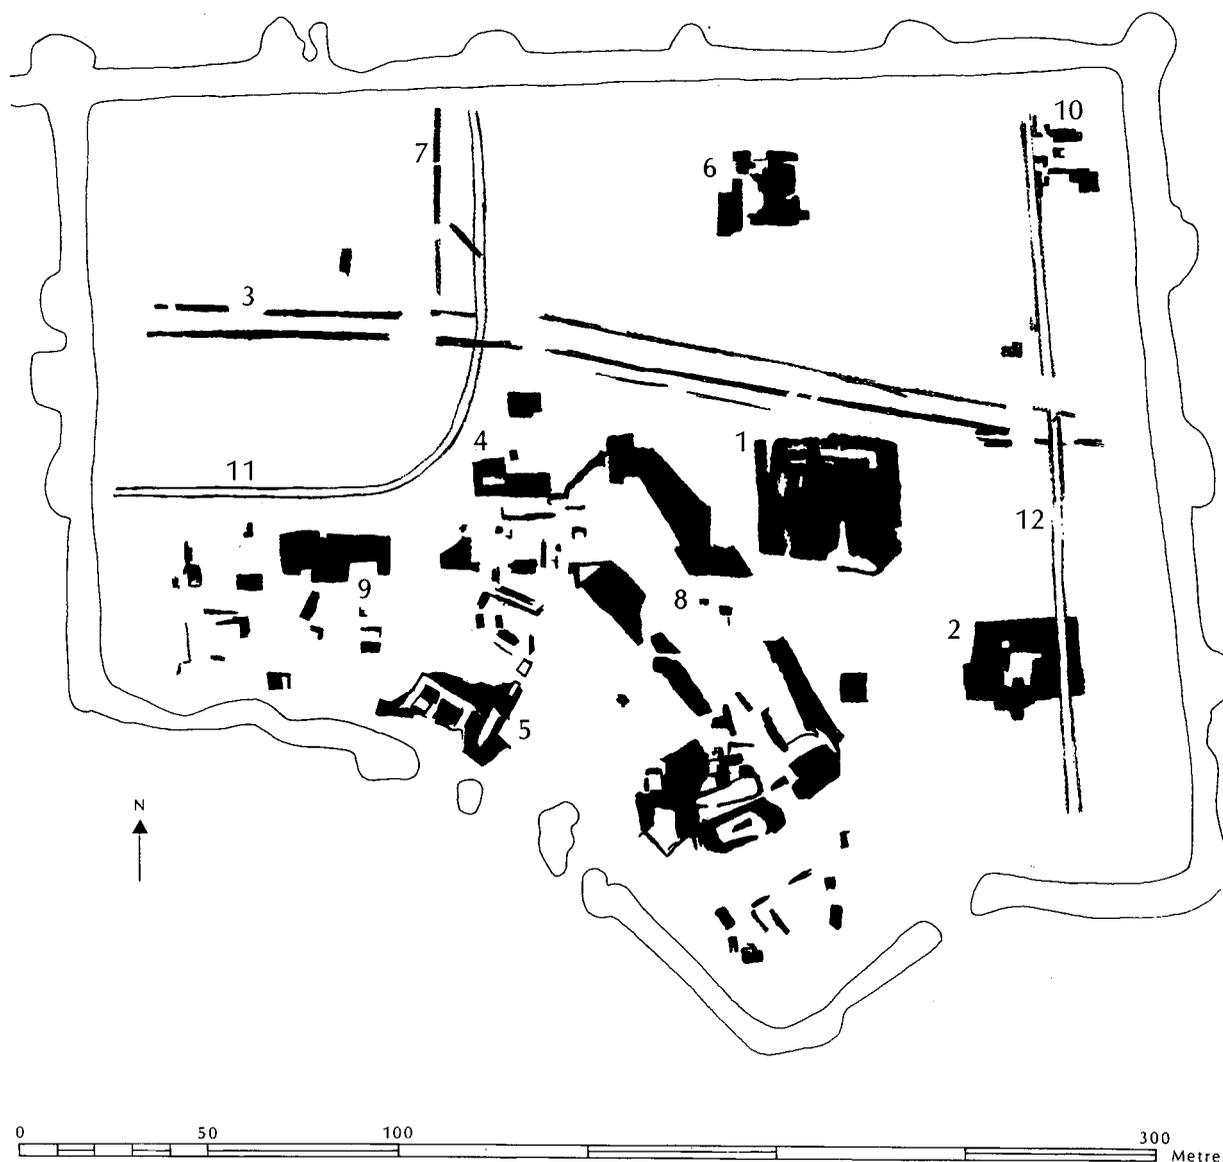
Fig. 10 Interpretation of the resistivity survey.

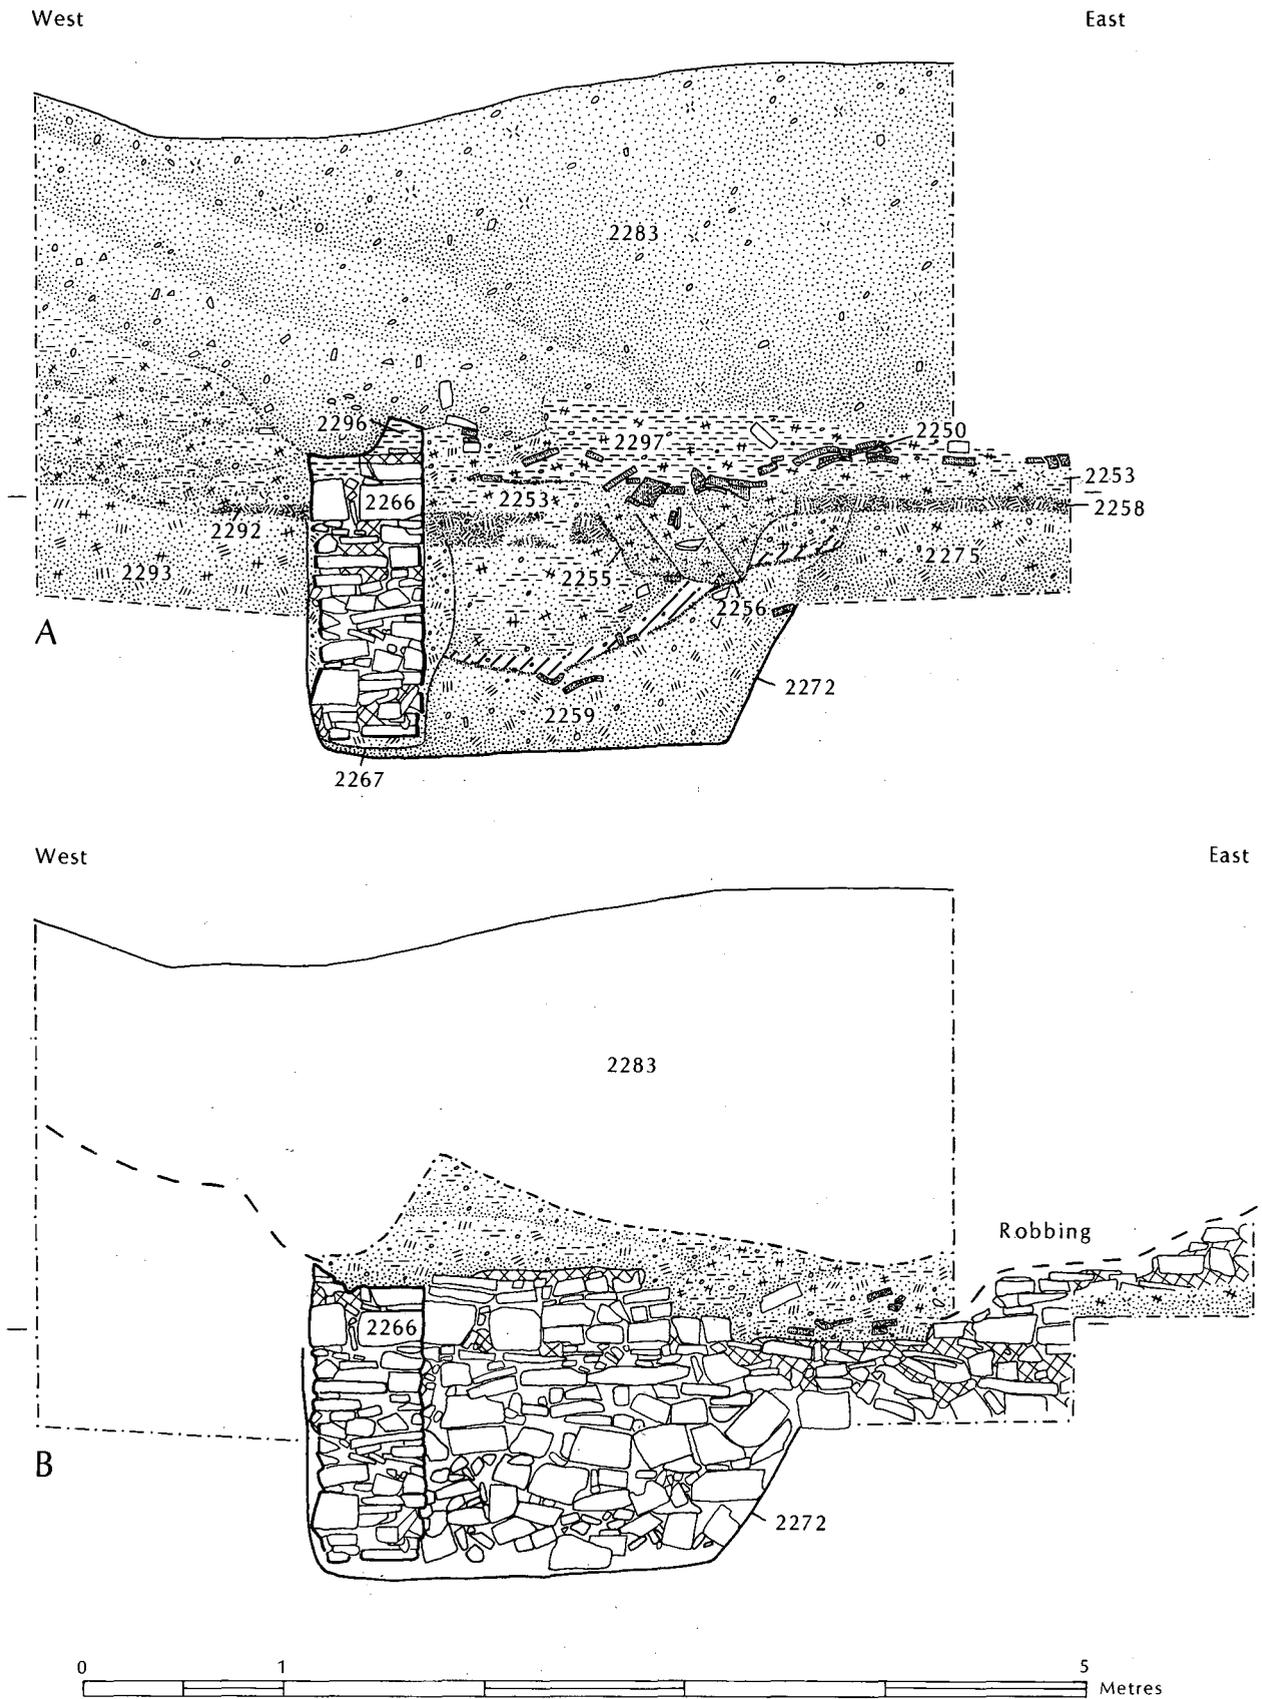
Fig. 13 Area A. A: the Roman house, north section. B: the Roman house, north section after cleaning revealed the west/east wall, Period I.

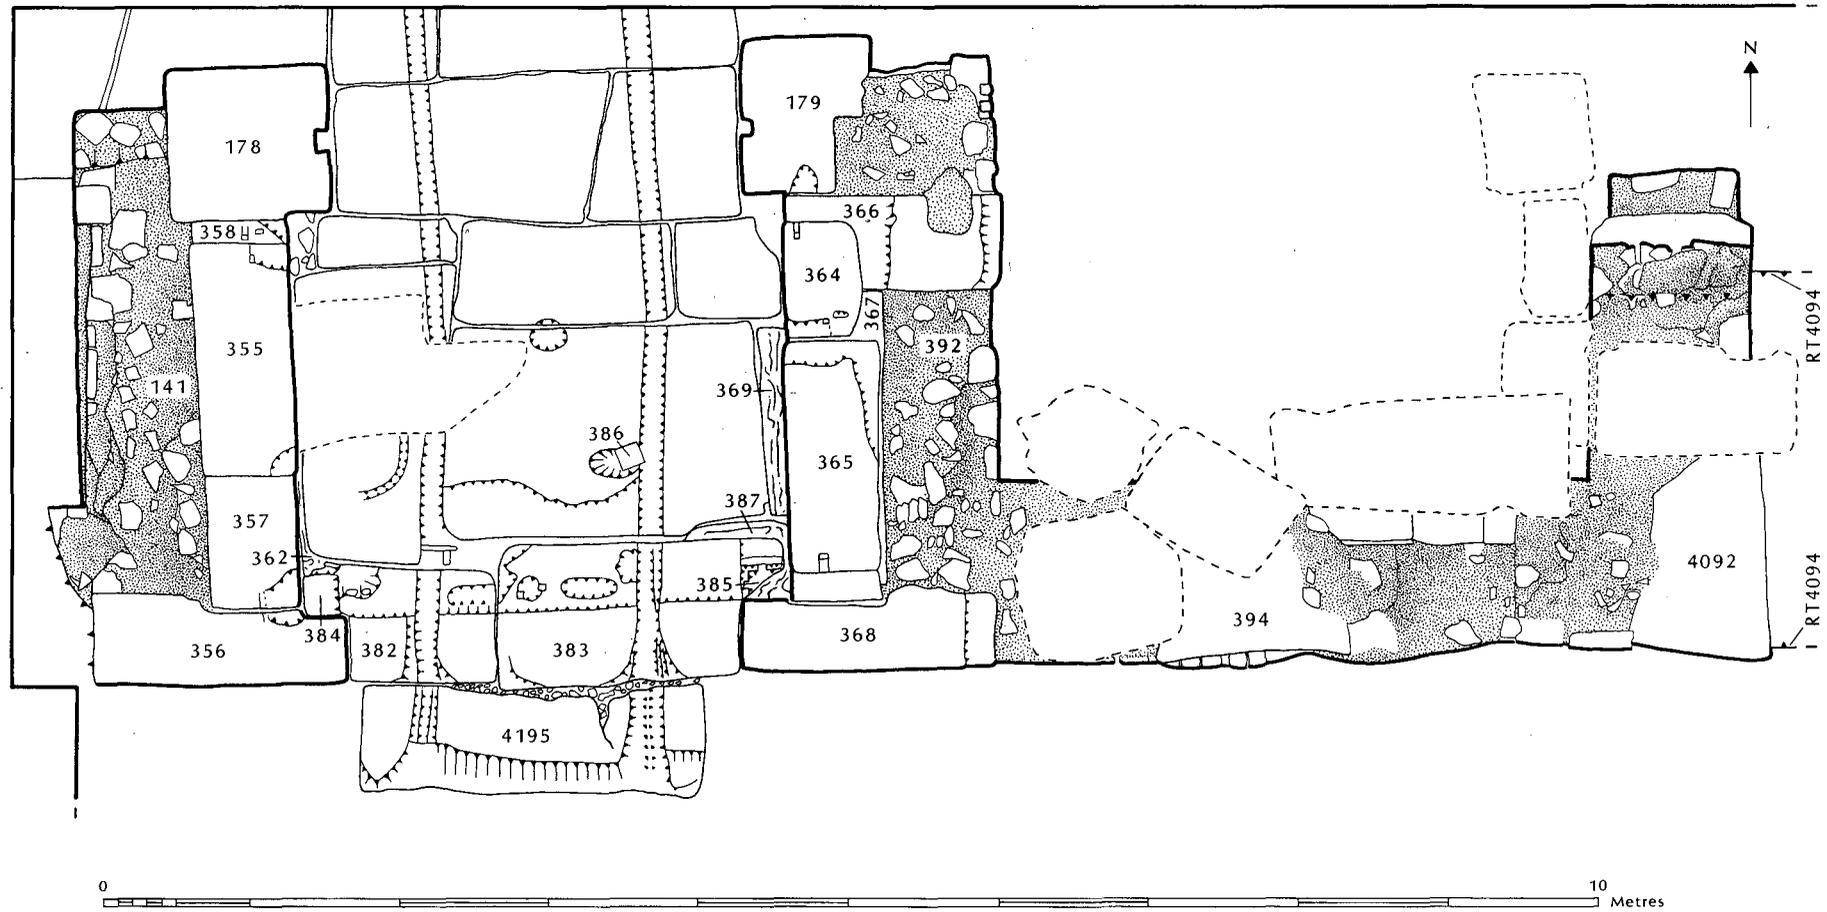
Fig. 30 Area C. The Roman gate and curtain-wall, Period 2.

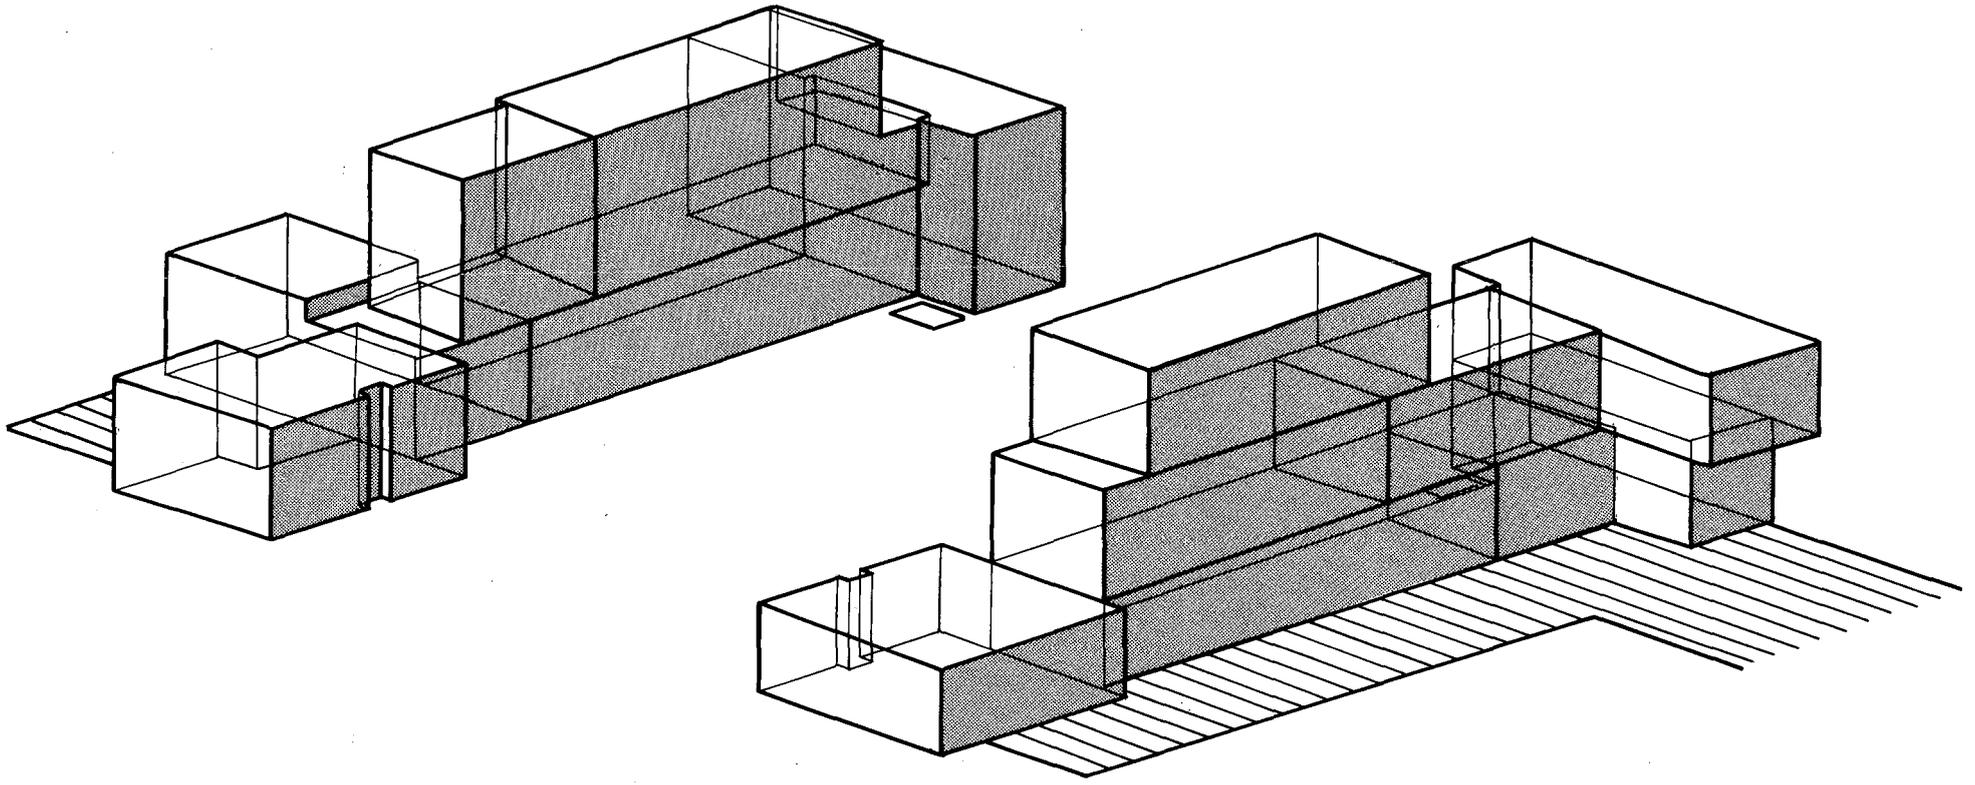
Fig. 32 Area C. Axonometric view of the Roman gate, looking south-east. Scale approximately 1:30.

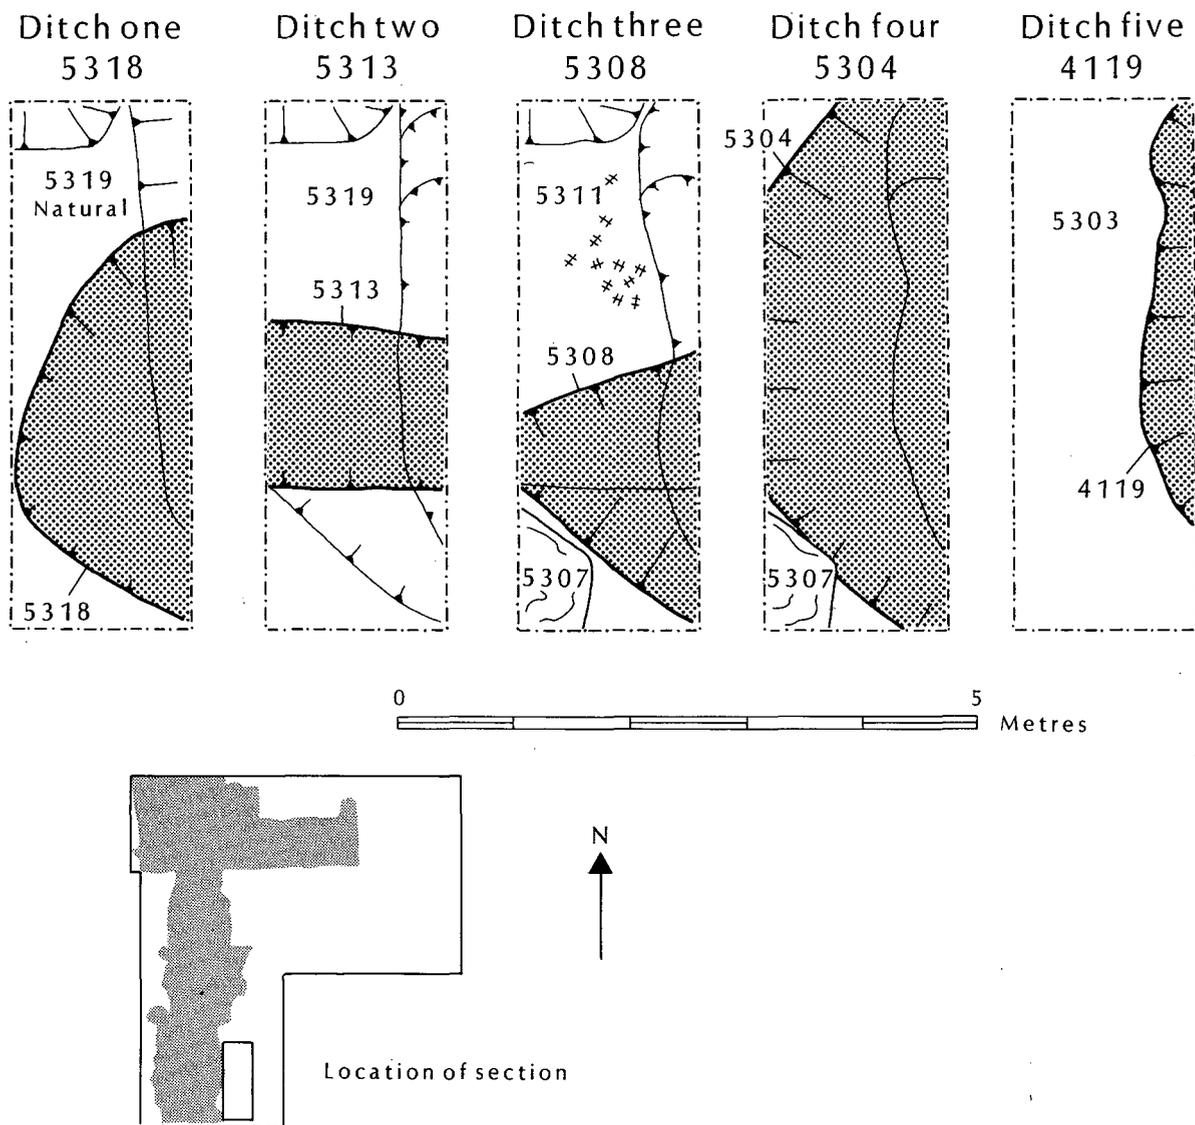
Fig. 33 Area C. Plans of Ditches 1-5, east of the causeway, Periods 2-4.

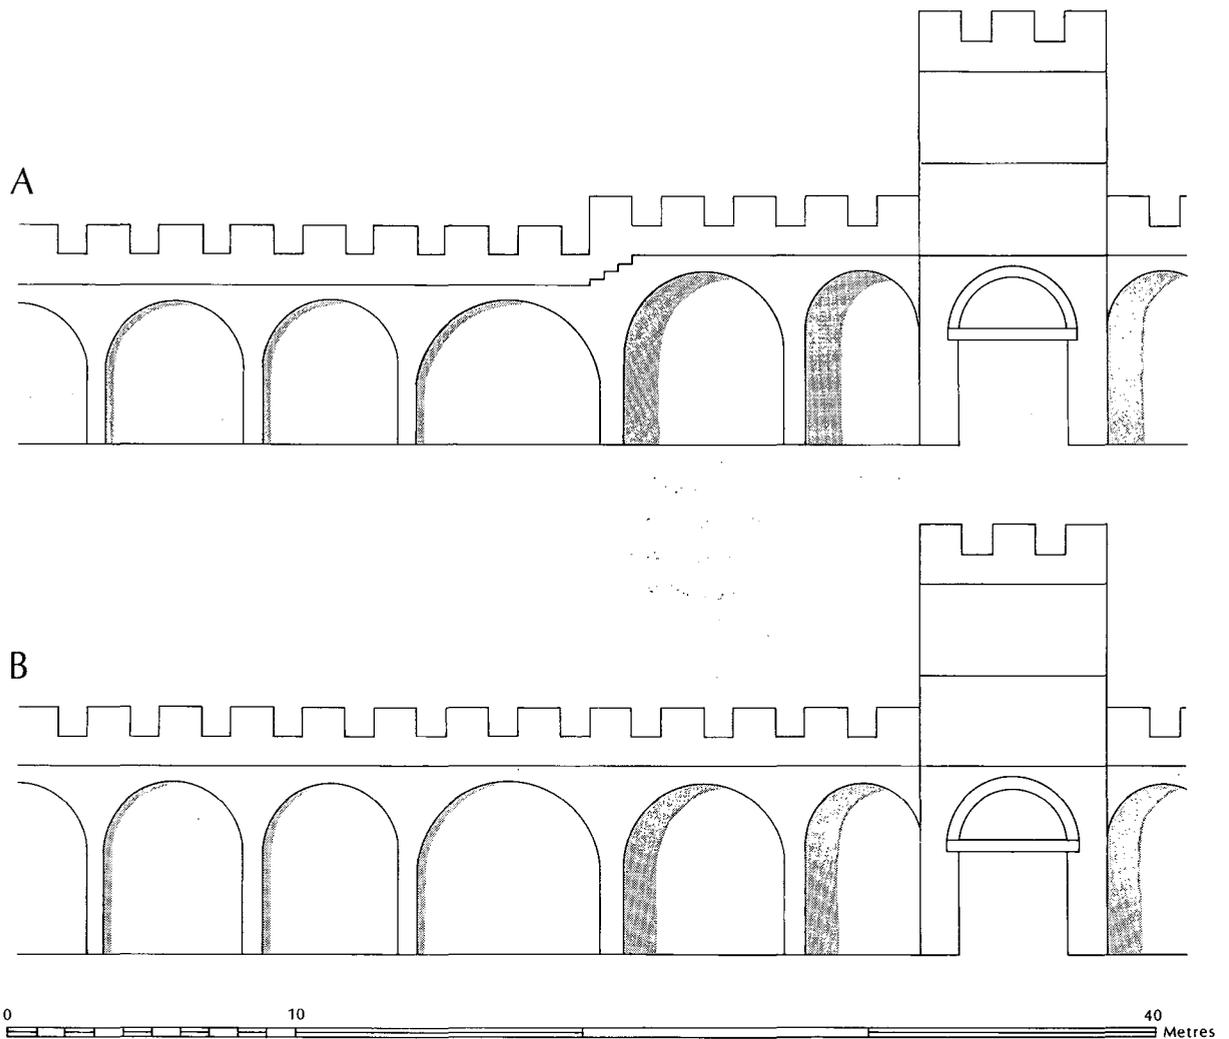
Fig. 34 Two alternative reconstructions of the inside of the Roman curtain-wall. A. To support a higher wall-walk close to the gate; B. To support dividing walls for chambers either side of the northern portal.

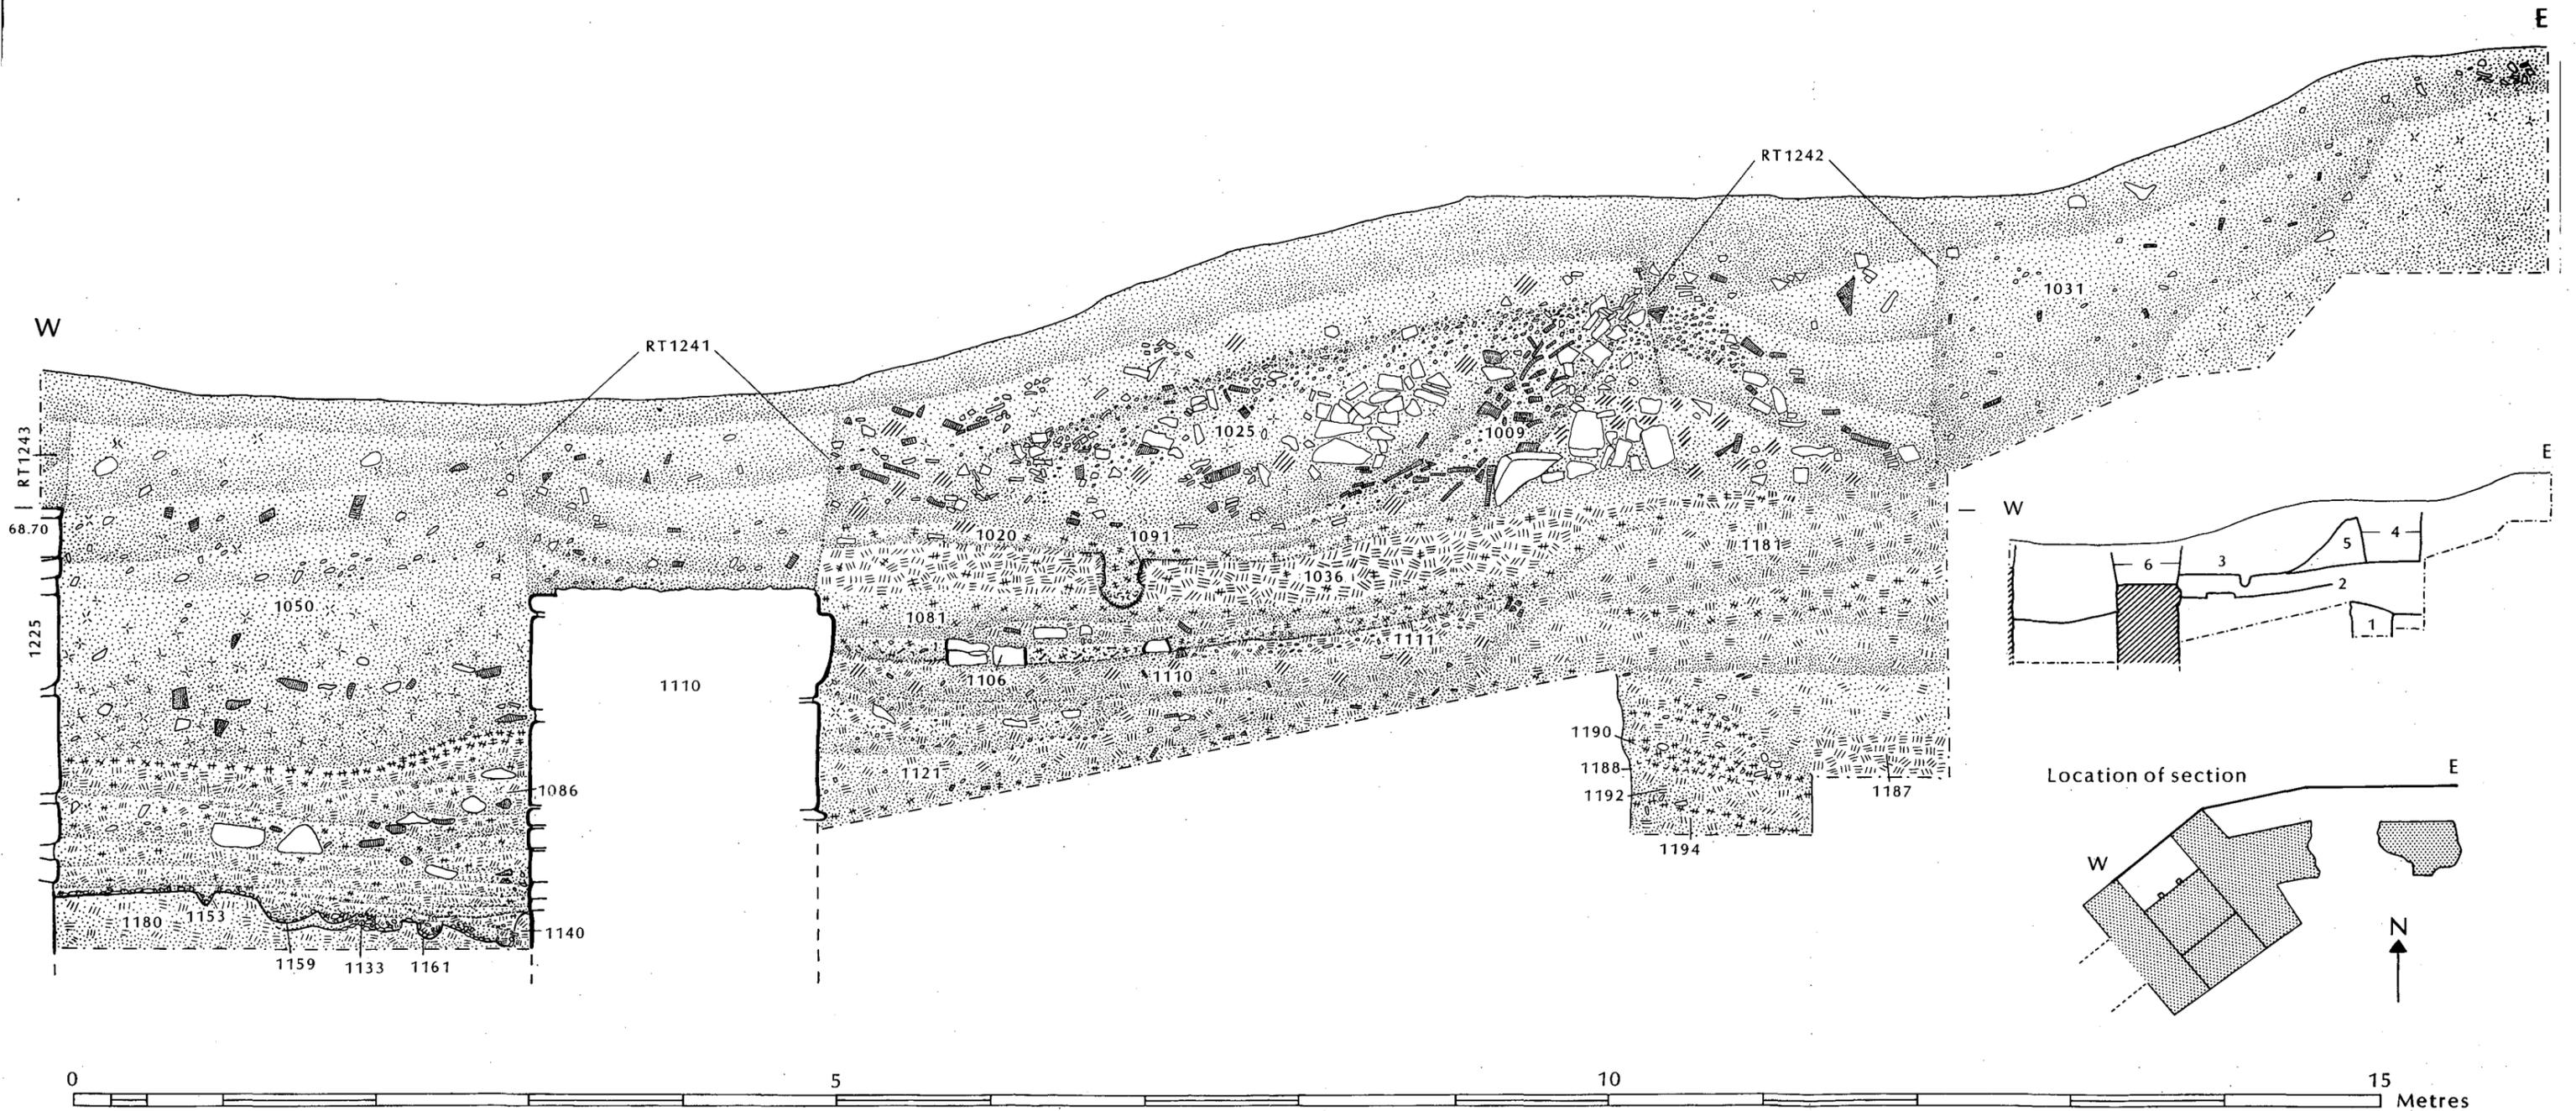
Fig. 50 North section, Area E. Key to interpretative section; 1 = Period 1 pit; 2 = Period 2 occupation level; 3 = Period 3 occupation level; 4 = robbed revetting wall, Period 3; 5 = collapsed remains of Period 3 revetting wall; 6 = Period 4 robber-trench.

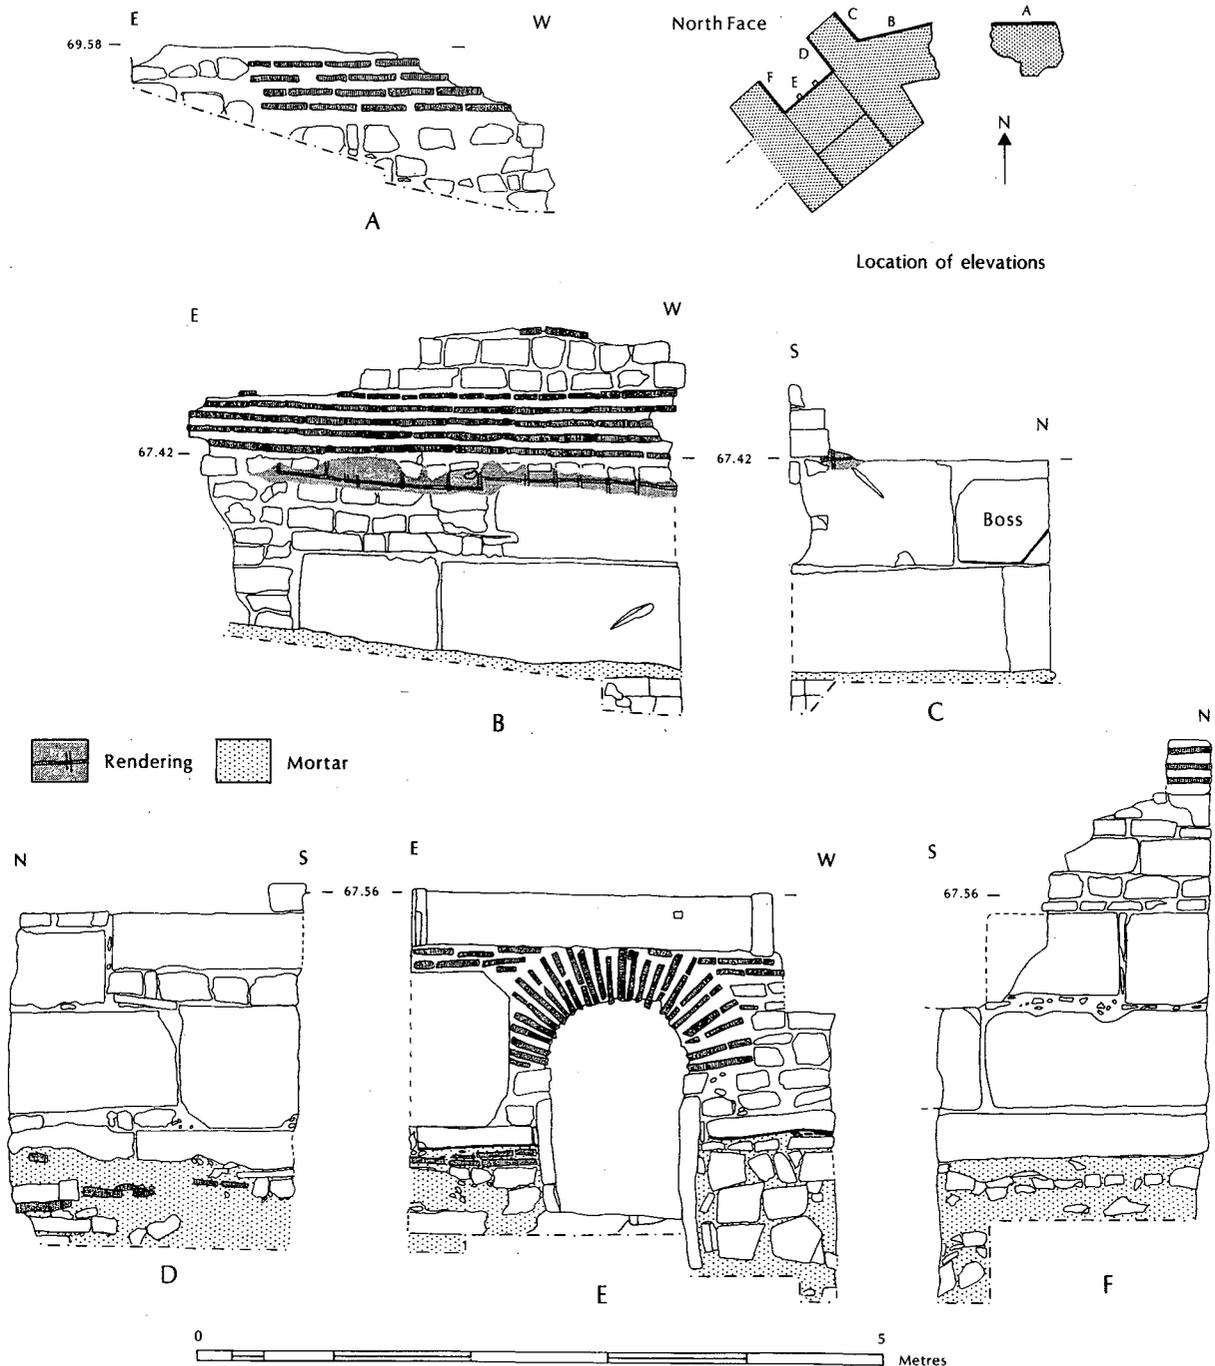
Fig. 51 Area E. Elevations of the north side of the curtain-wall.

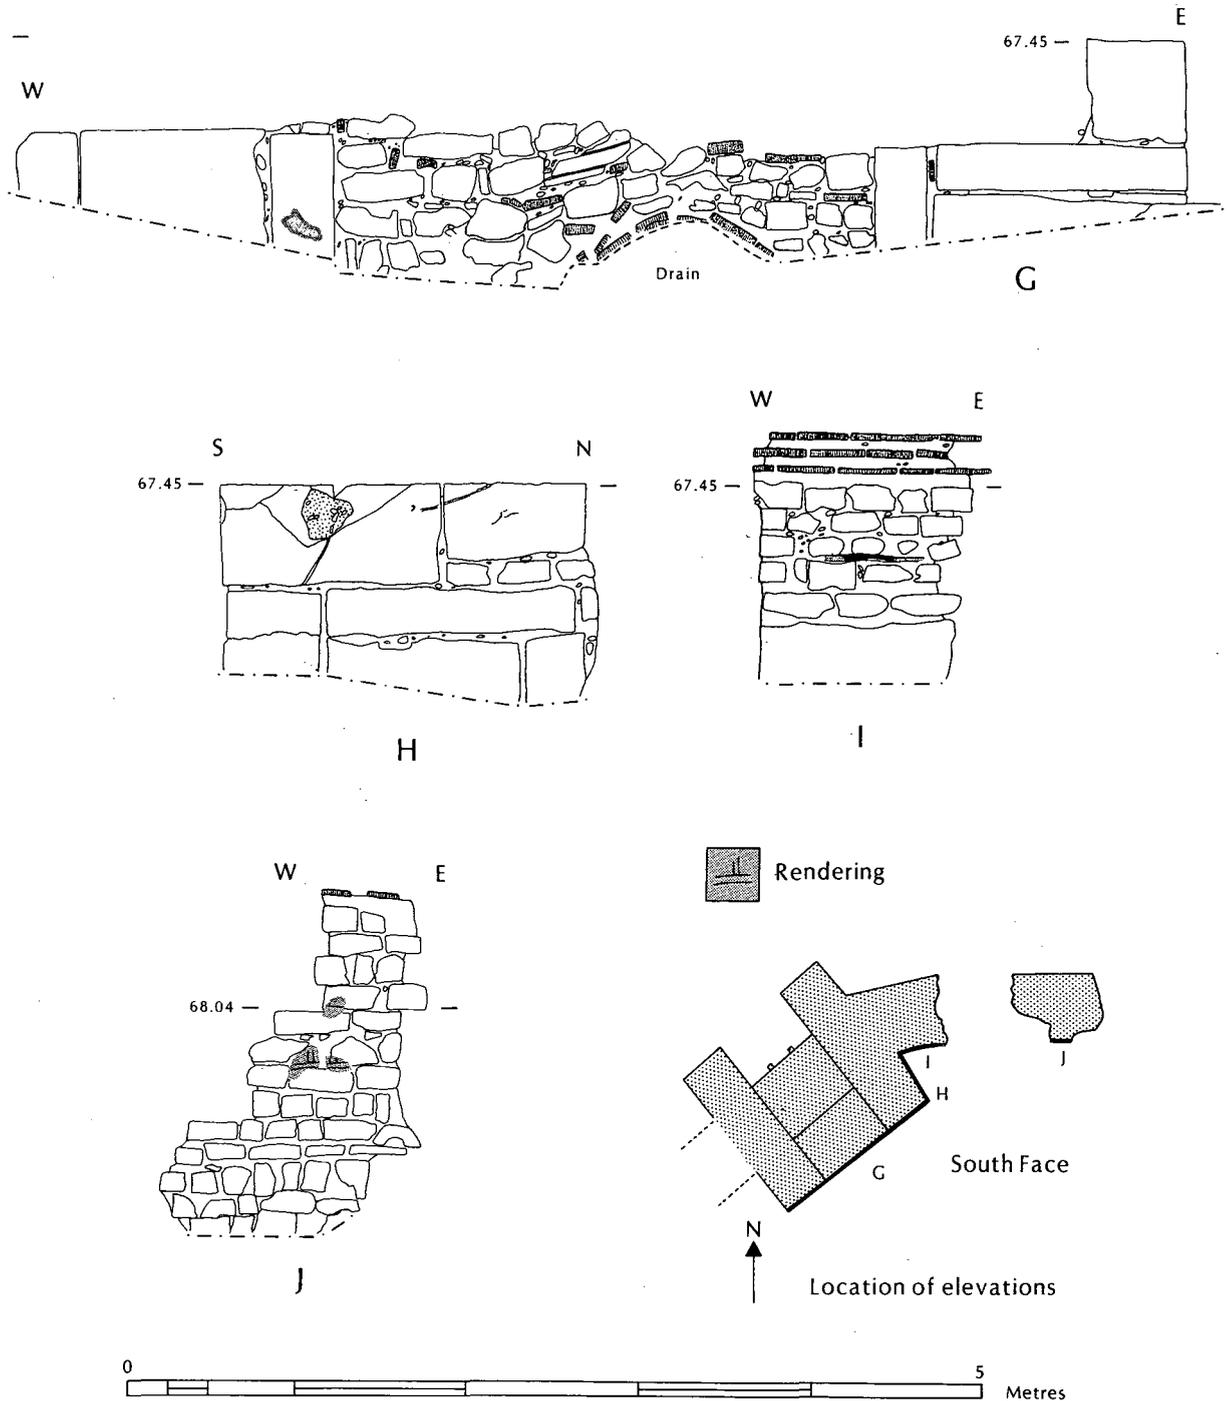
Fig. 52 Area E. Elevations of the south side of the curtain-wall.

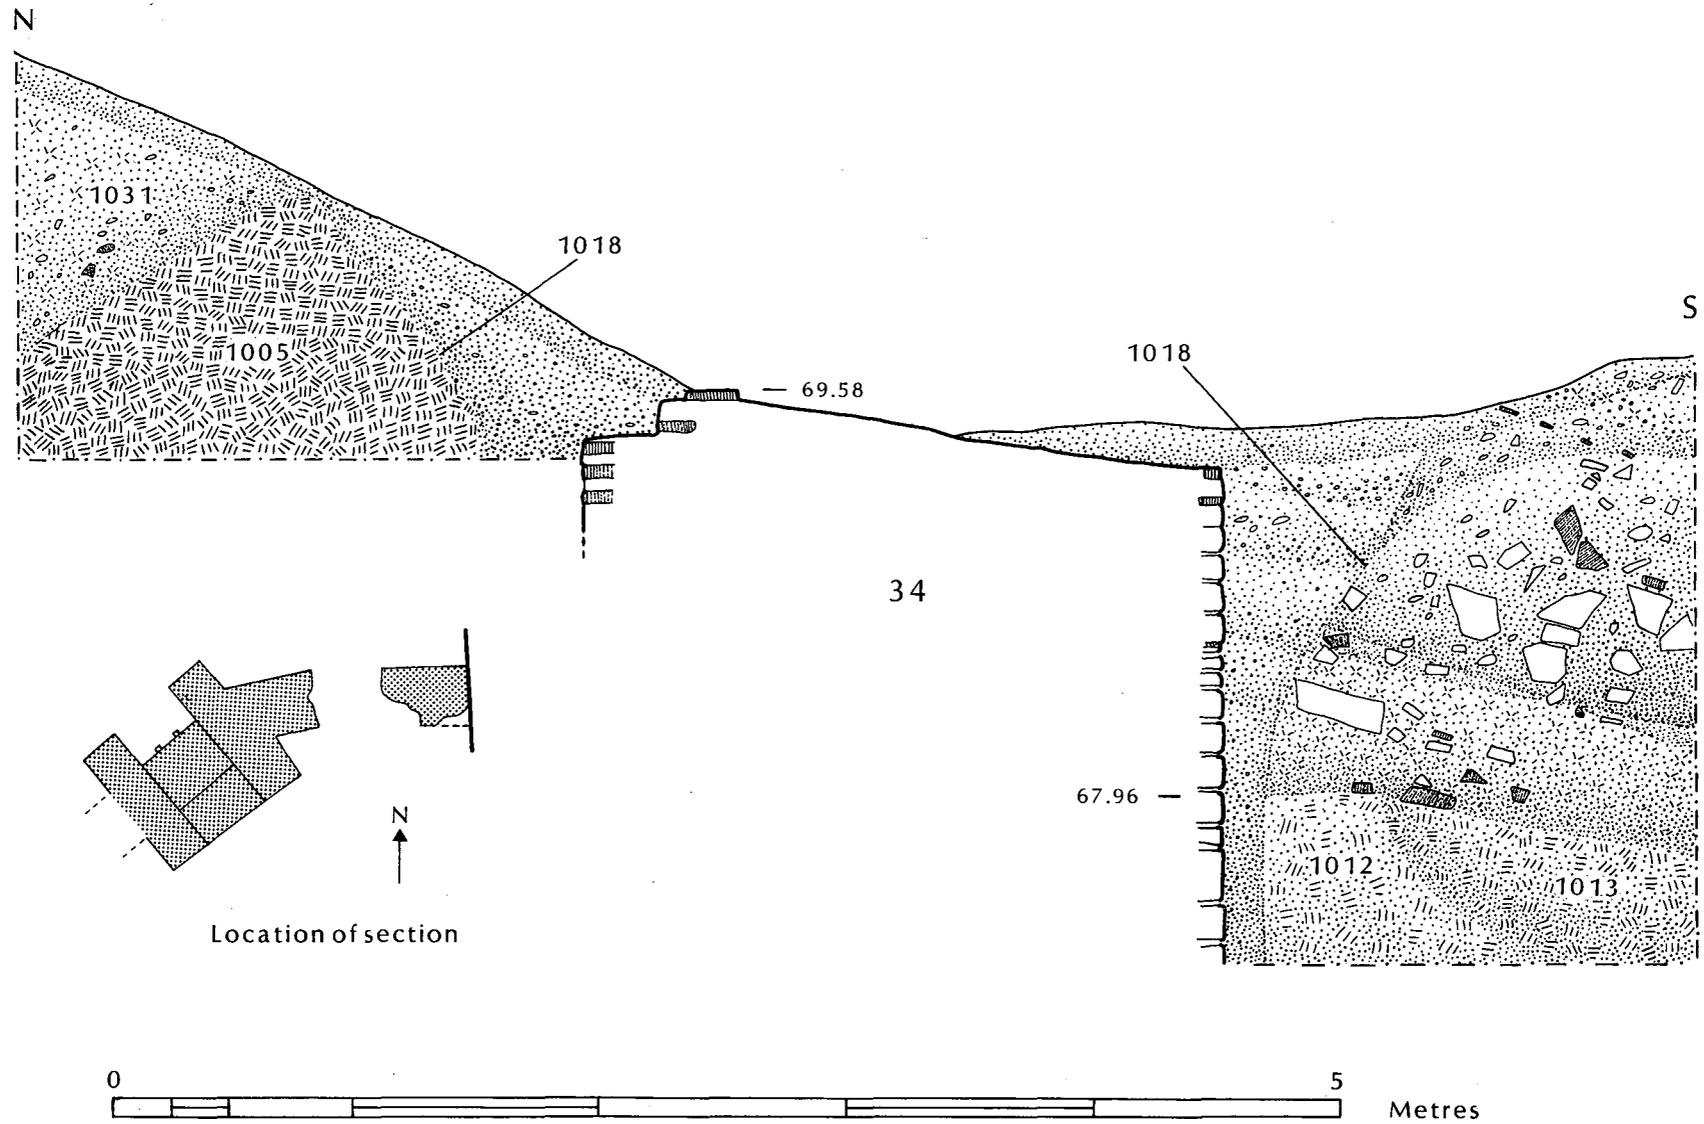
Fig. 53 Area E. Eastern section across the curtain-wall (34).

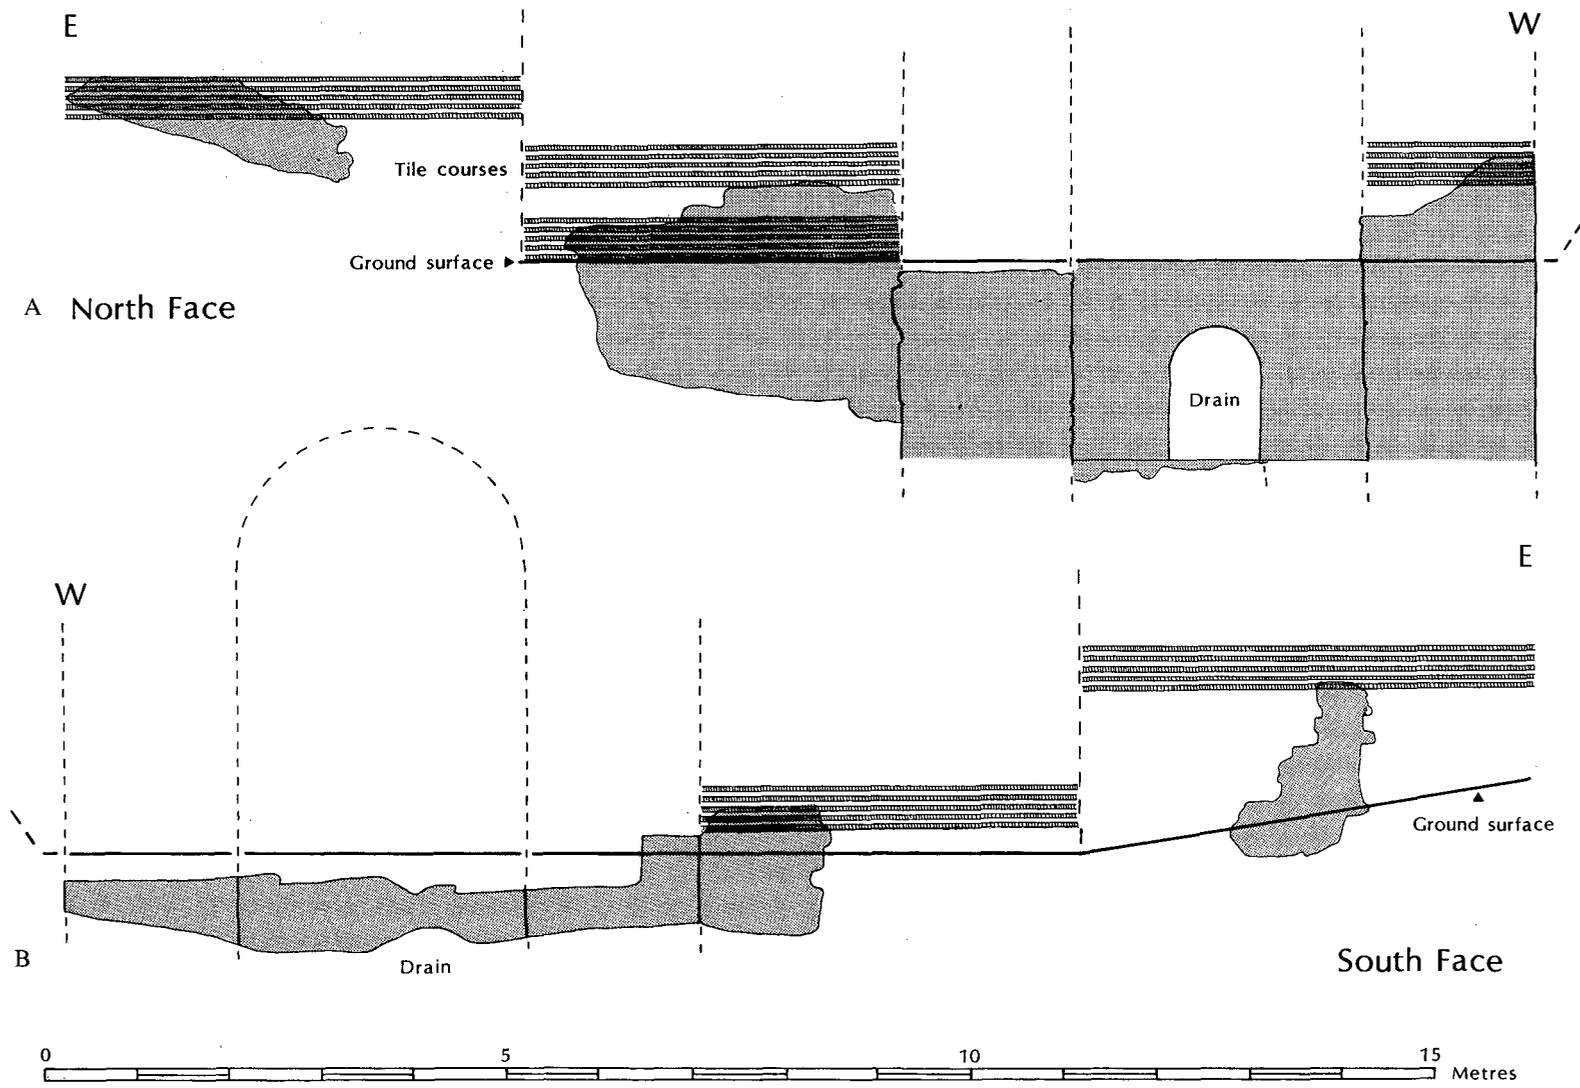
Fig. 55 Area E. Reconstruction of elevations: A. Inside face of the defences; B. Outside face of the defences.
