*NICOPOLIS AD ISTRUM:*  
A ROMAN, LATE ROMAN, AND  
EARLY BYZANTINE CITY

EXCAVATIONS 1985–1992

ANDREW POULTER

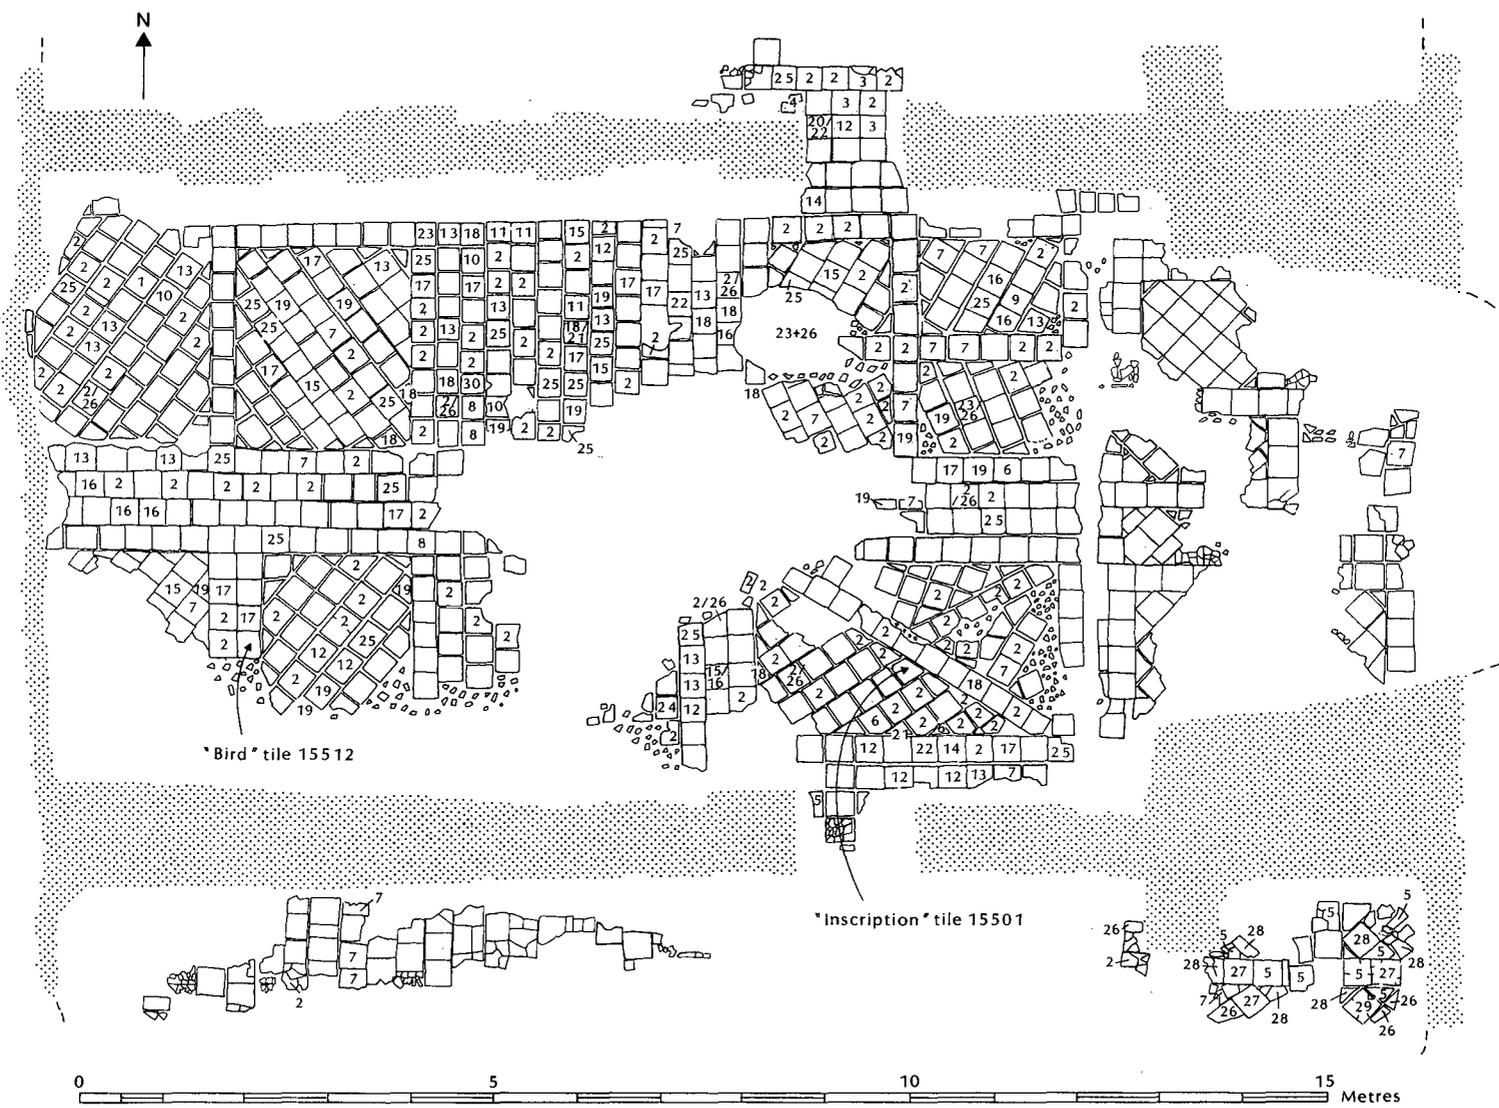
Fig. 62 Area F. The brick floor of the Large Basilica and the distribution of brick signatures. For key to signatures see facing page.

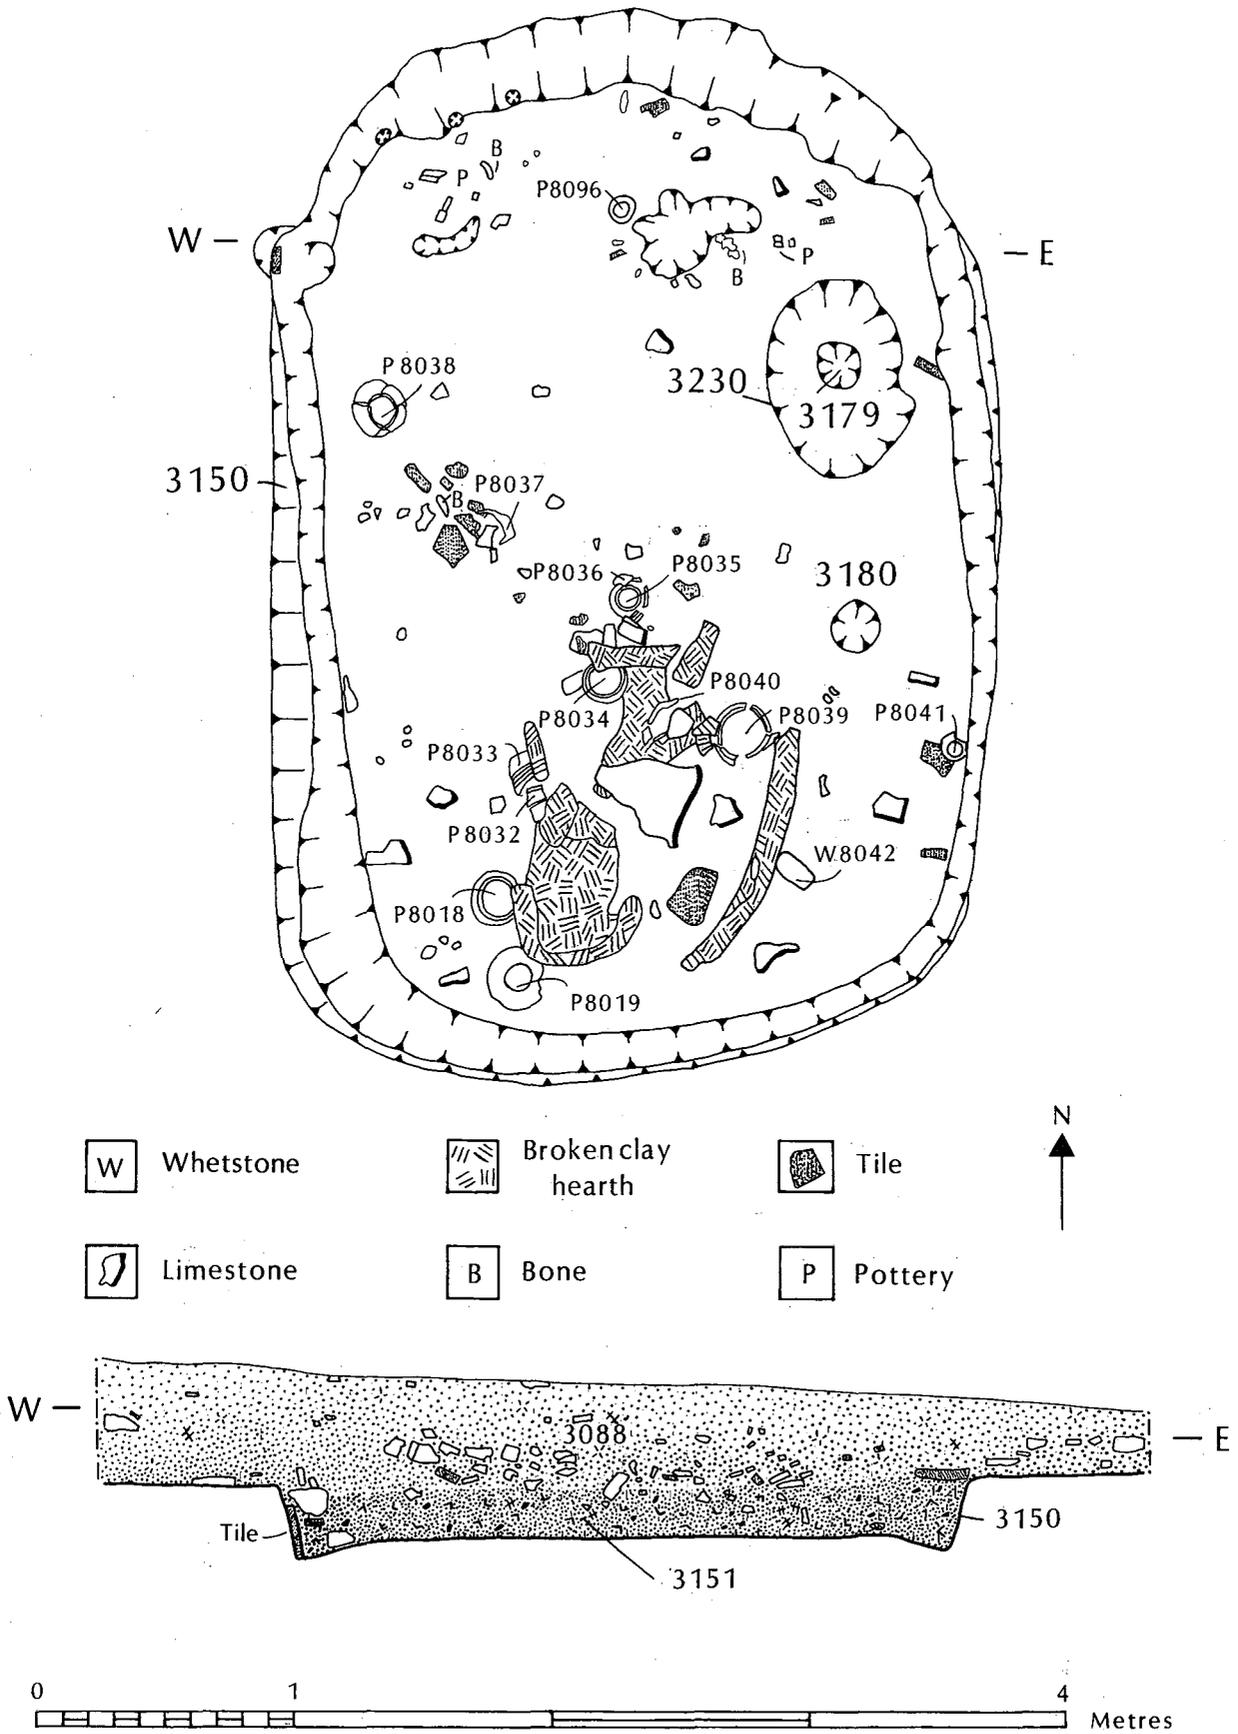
Fig. 64 Area F. Plan and section of the Slav grubenhaus.

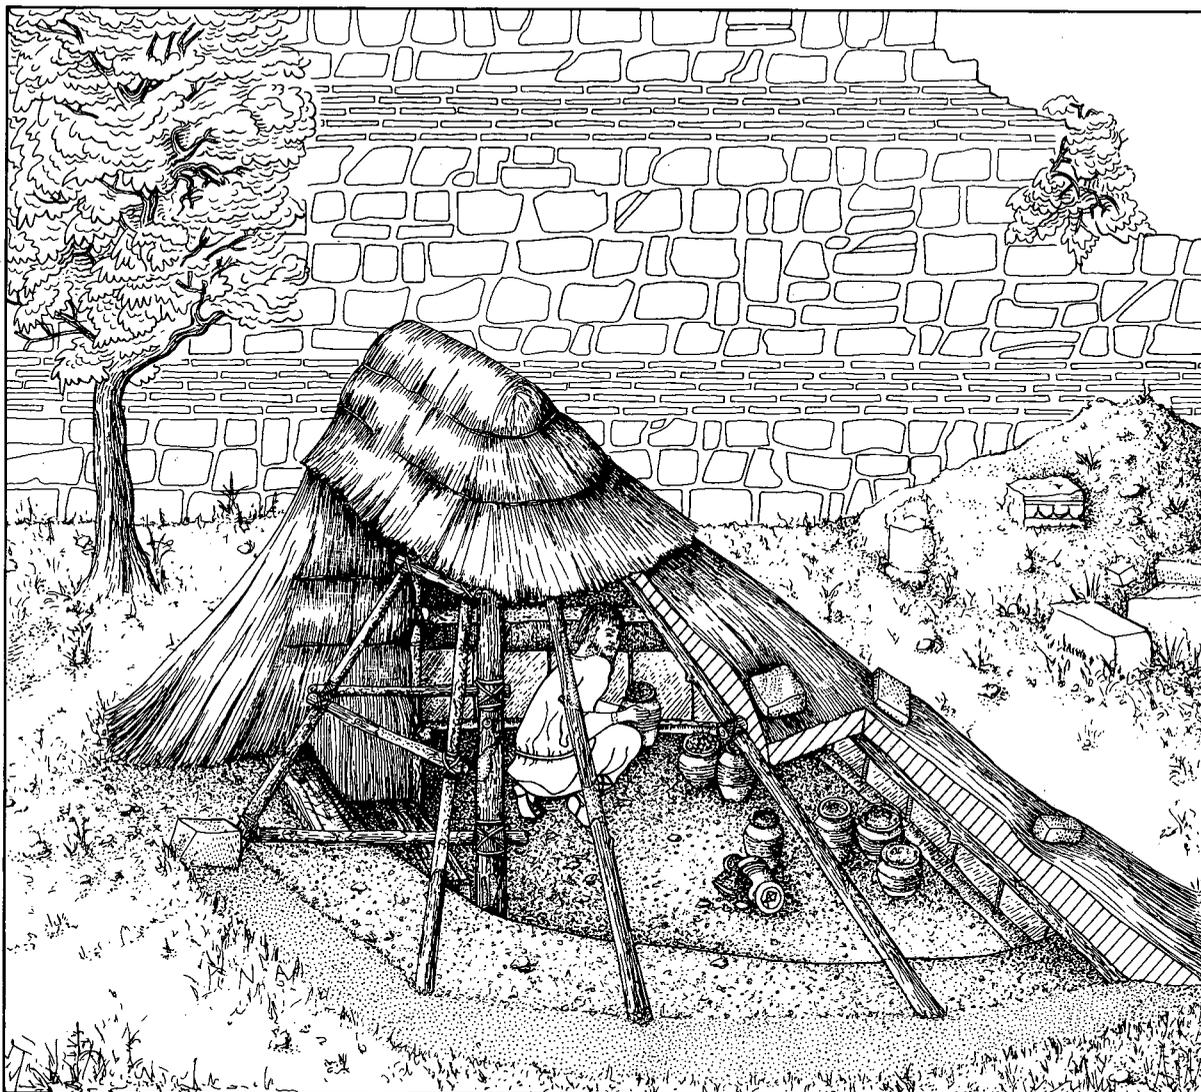
Fig. 65 Area F. Perspective reconstruction of the Slav *grubenhaus*, looking south.

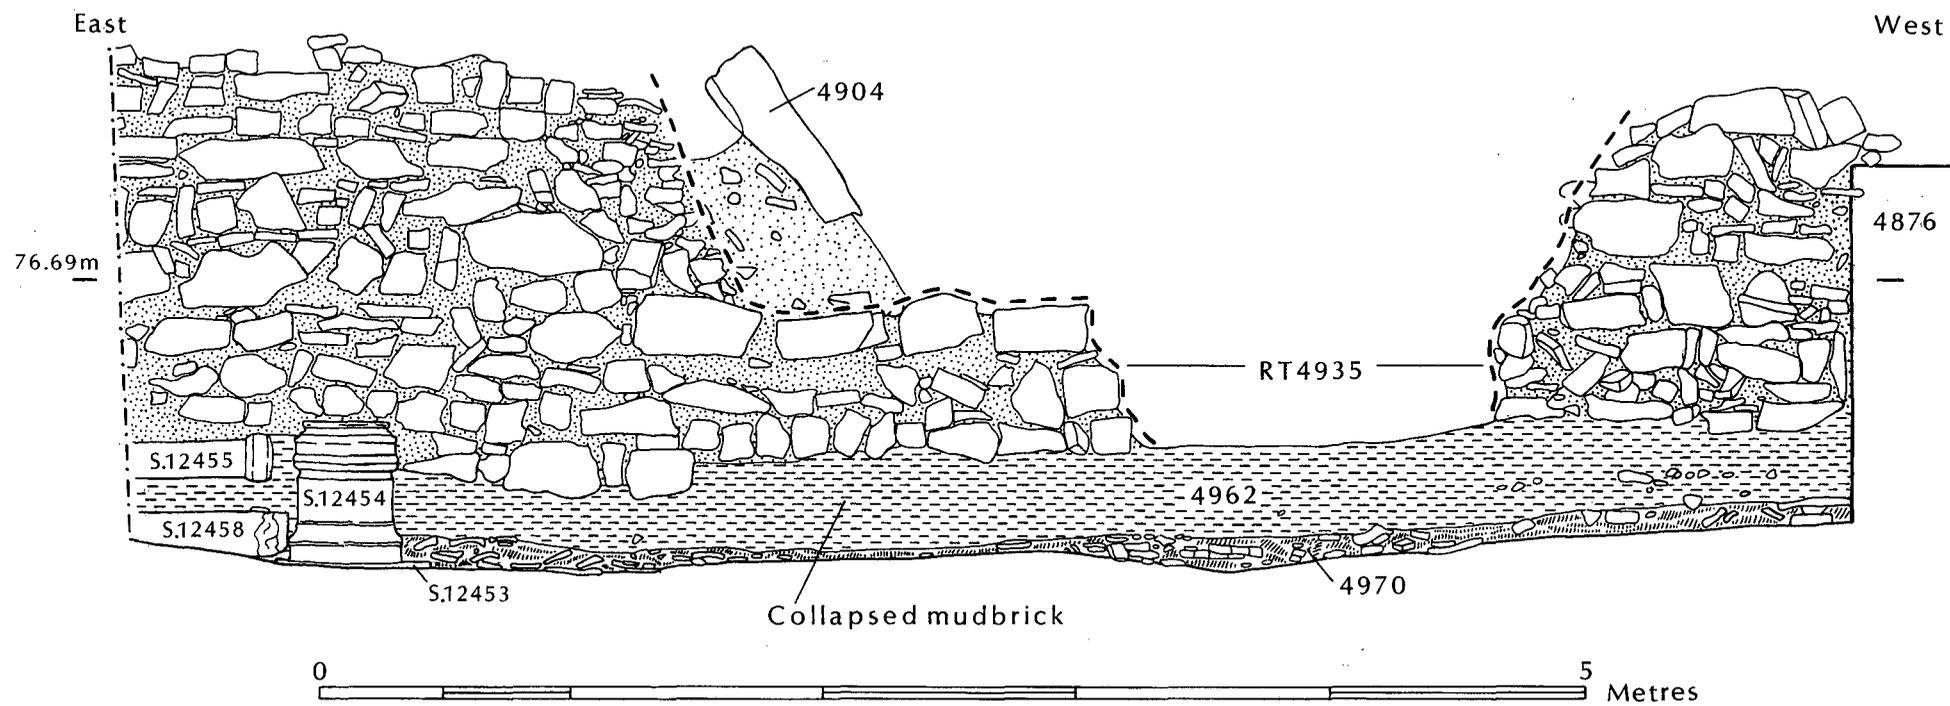
Fig. 71 Area M. Elevation of the northern face of the Period 4 foundation (4939), above the peristyle (Room 3) and Room 4 of the Period 2 house.

| Fig. 71 | Area M. Elevation of the northern face of the Period 4 foundation, above the<br>peristyle (Room 3) and Room 4 of the Period 2 house | 192 |

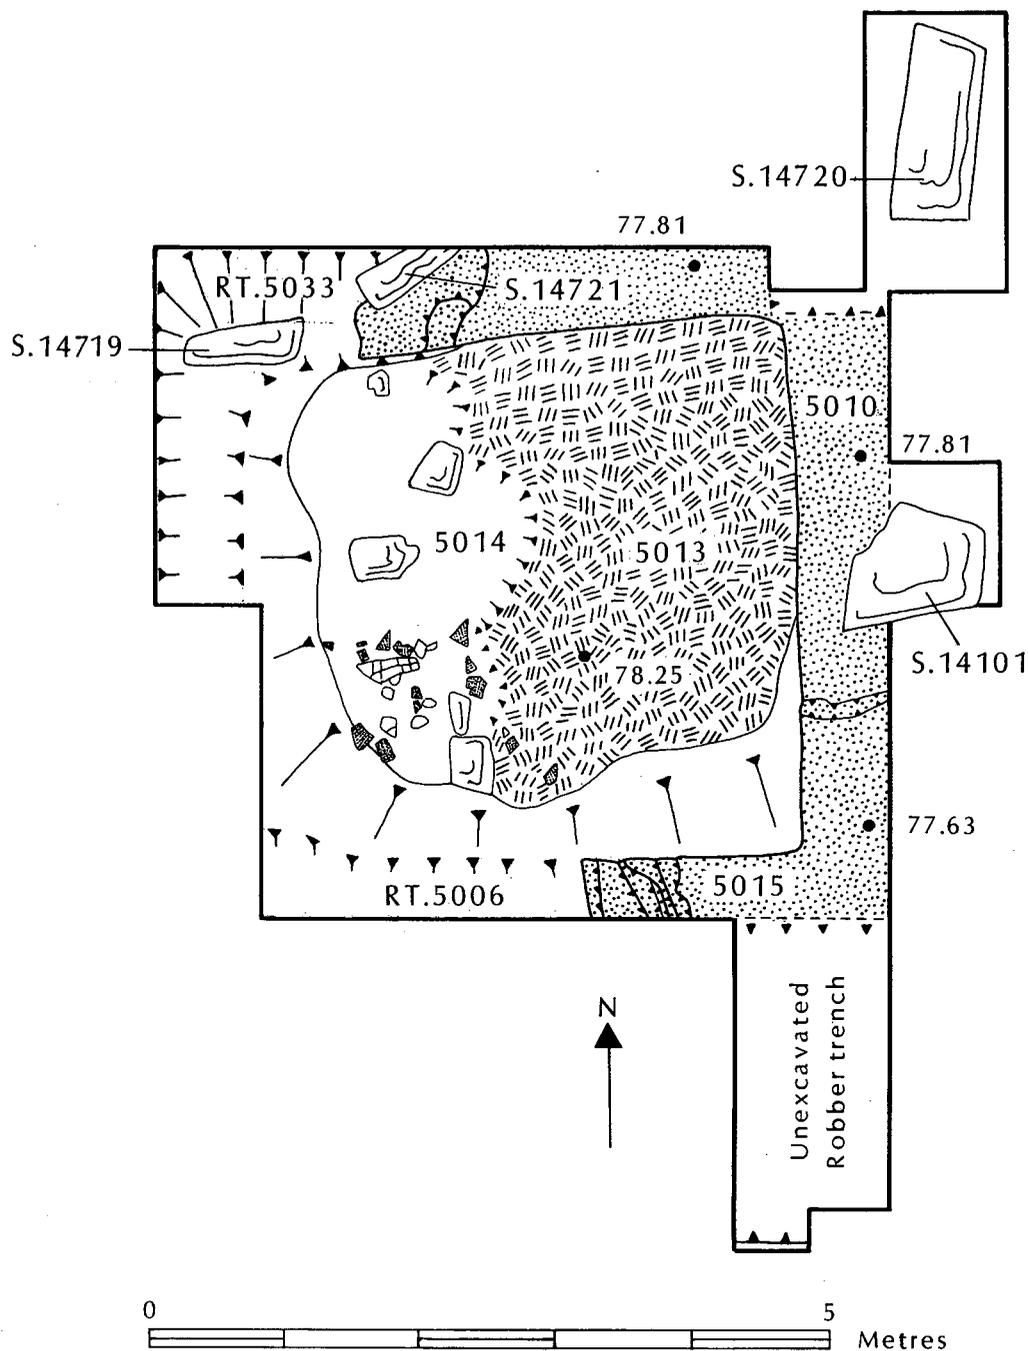
Fig. 81 Area P. The primary floor and foundations of the tower and adjacent curtain-wall, Period 2.

| Fig. 81 | Area P. The primary floor and foundations of the tower and adjacent curtain-wall,<br>Period 2 | 212 |

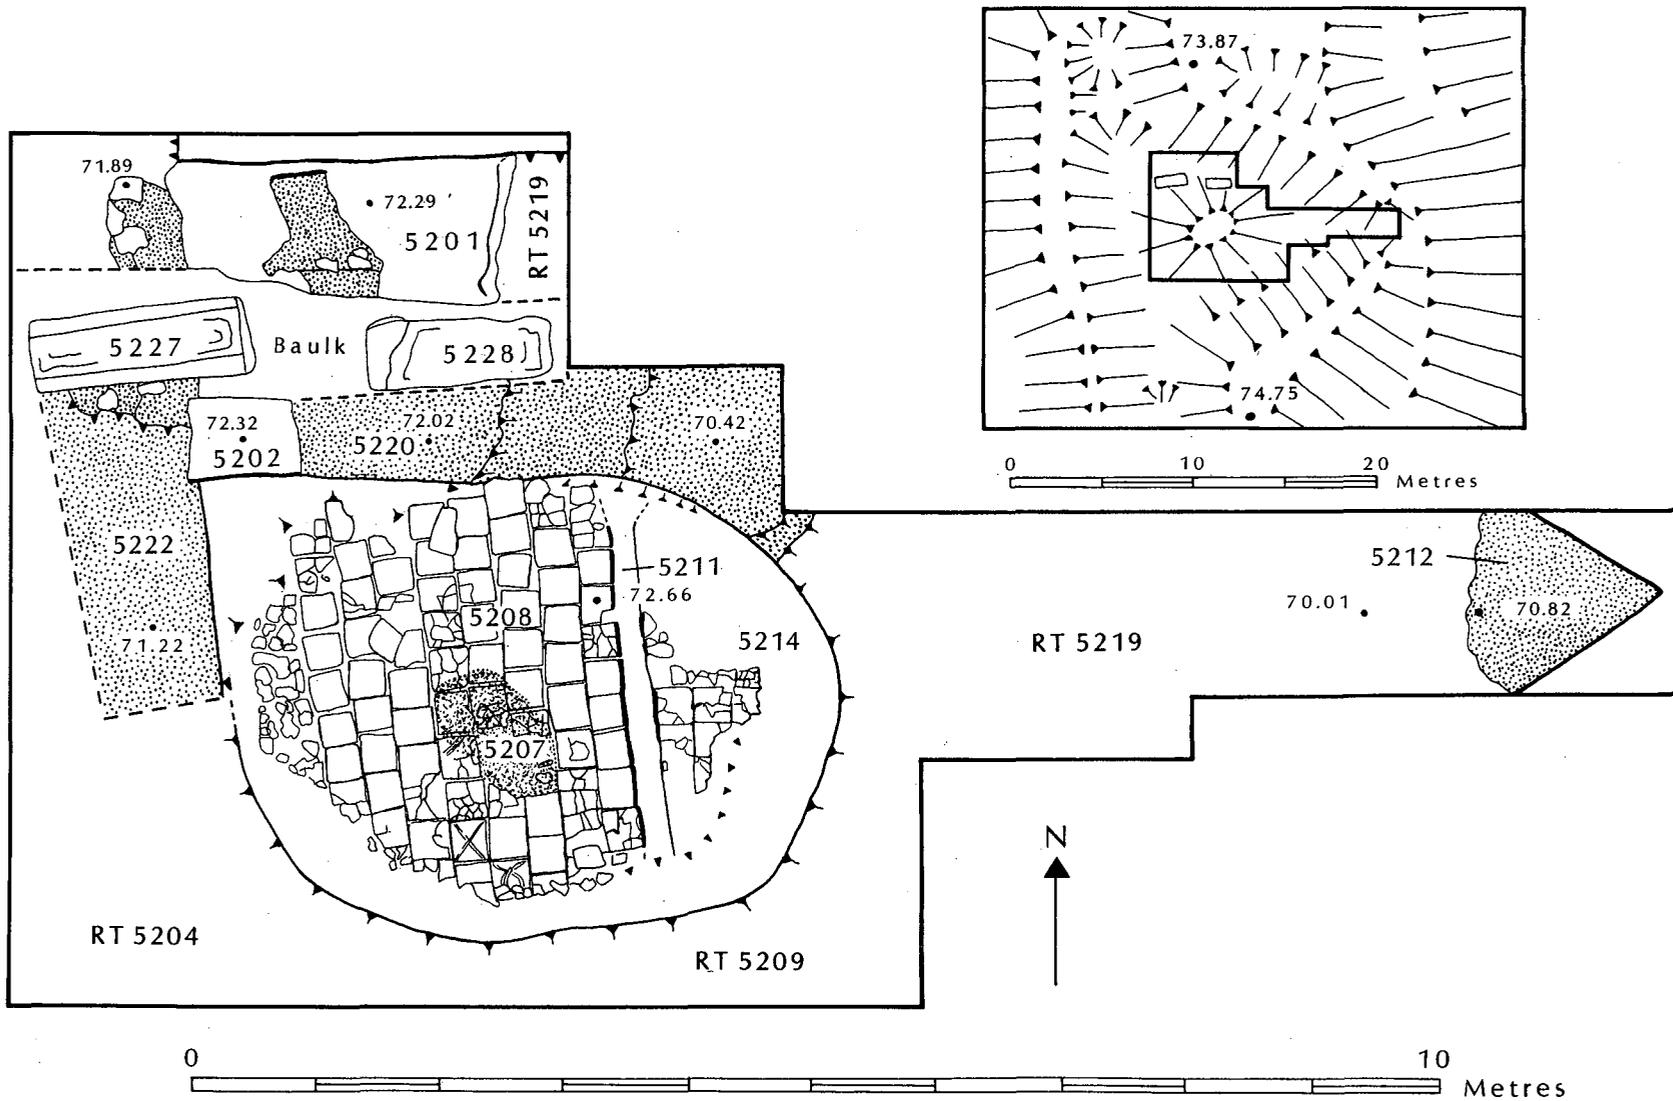
Fig. 84 Area R: The pentagonal tower and inset showing location of the excavations within the 'triangular'-shaped robber-trenches, east of the curtain-wall.

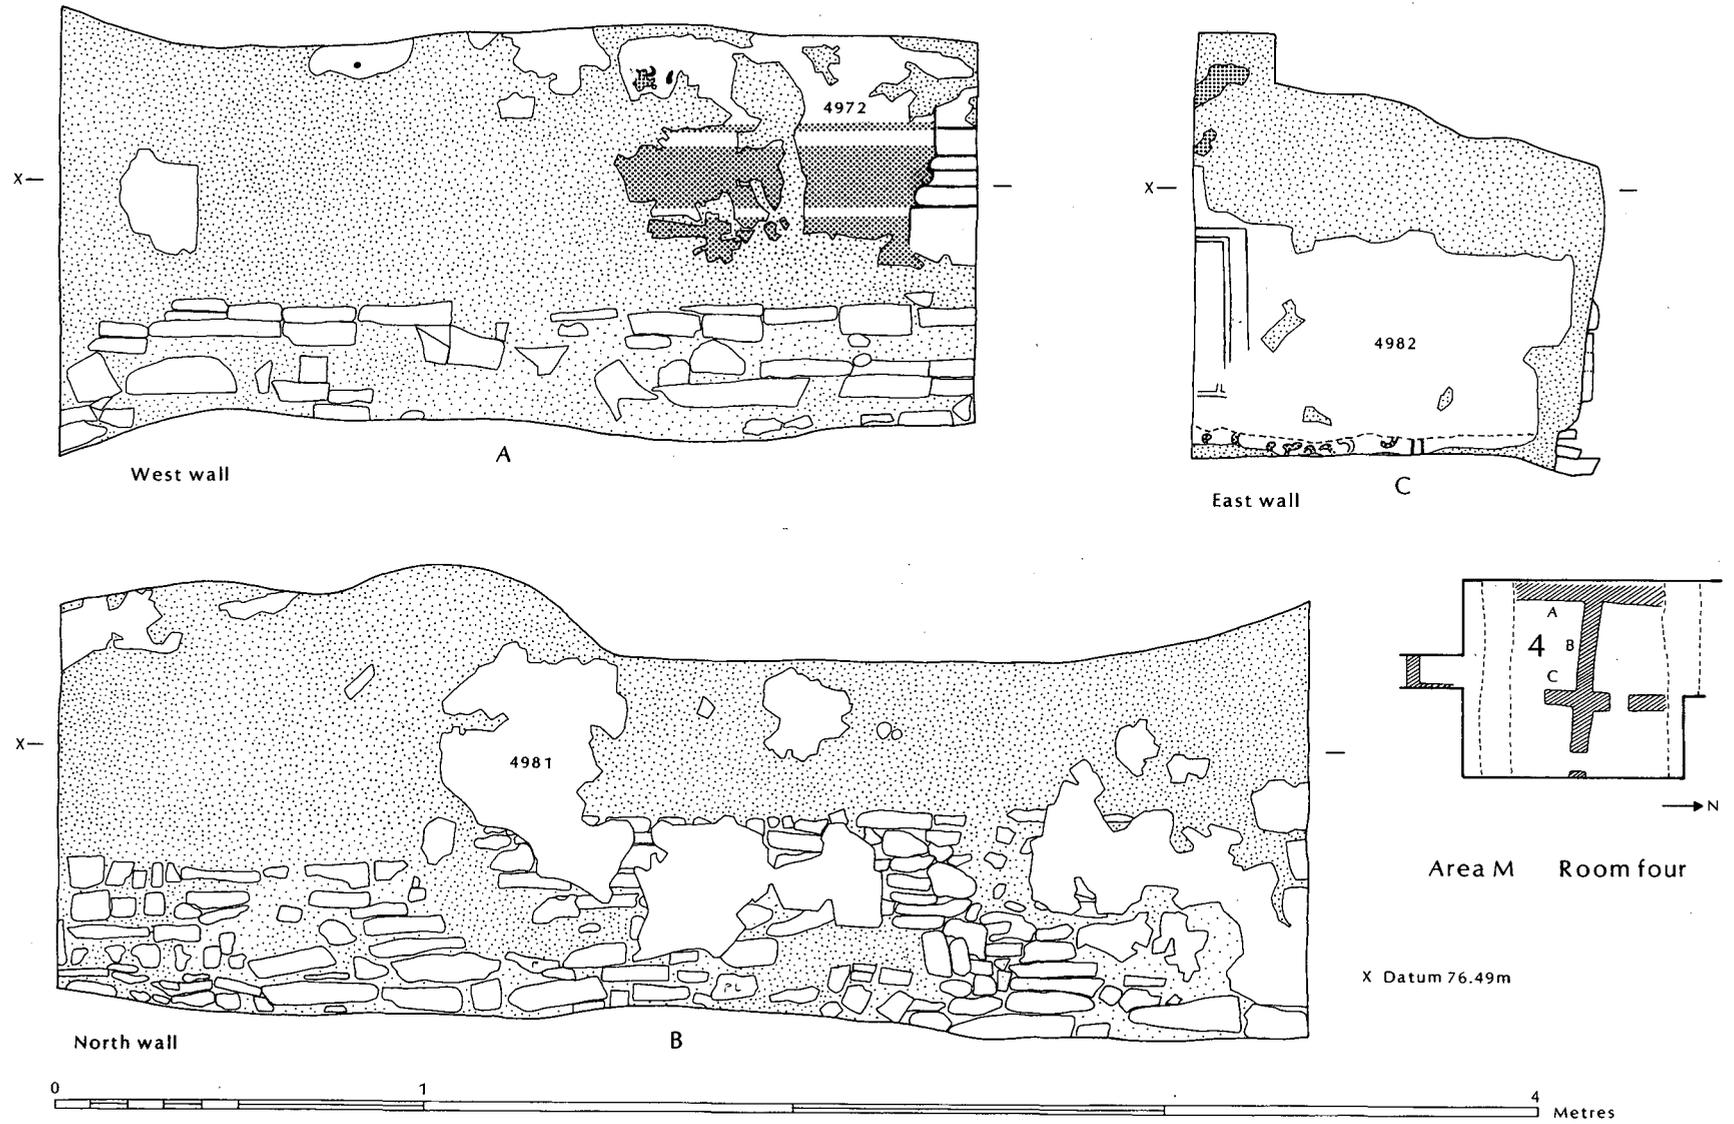
Fig. 96 Elevations of the walls, Room 4.

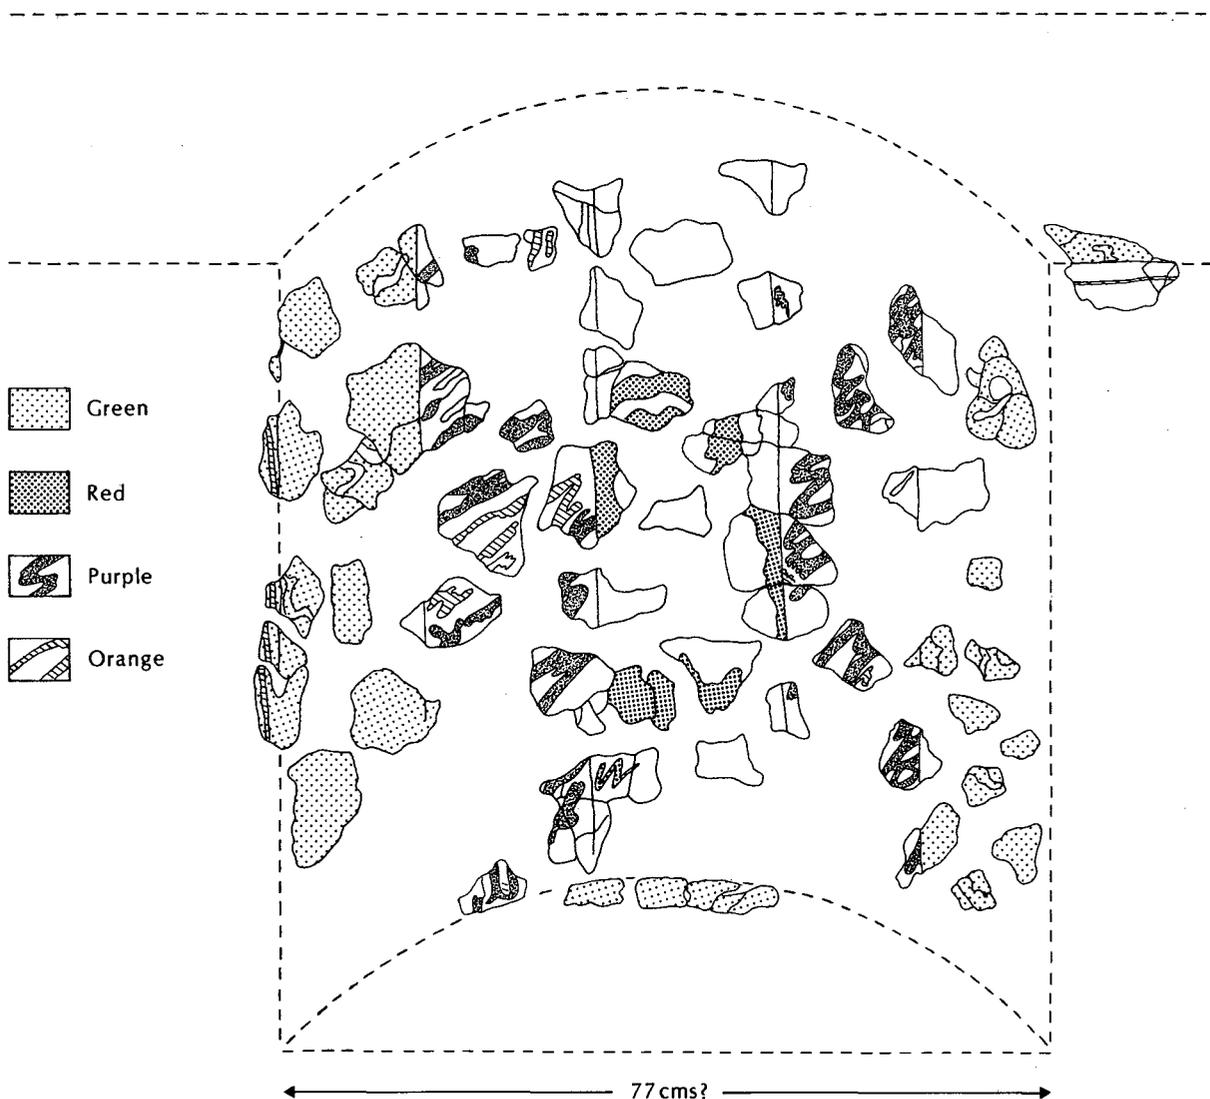
Fig. 101 Reconstruction of the niche fragments from Room 1.

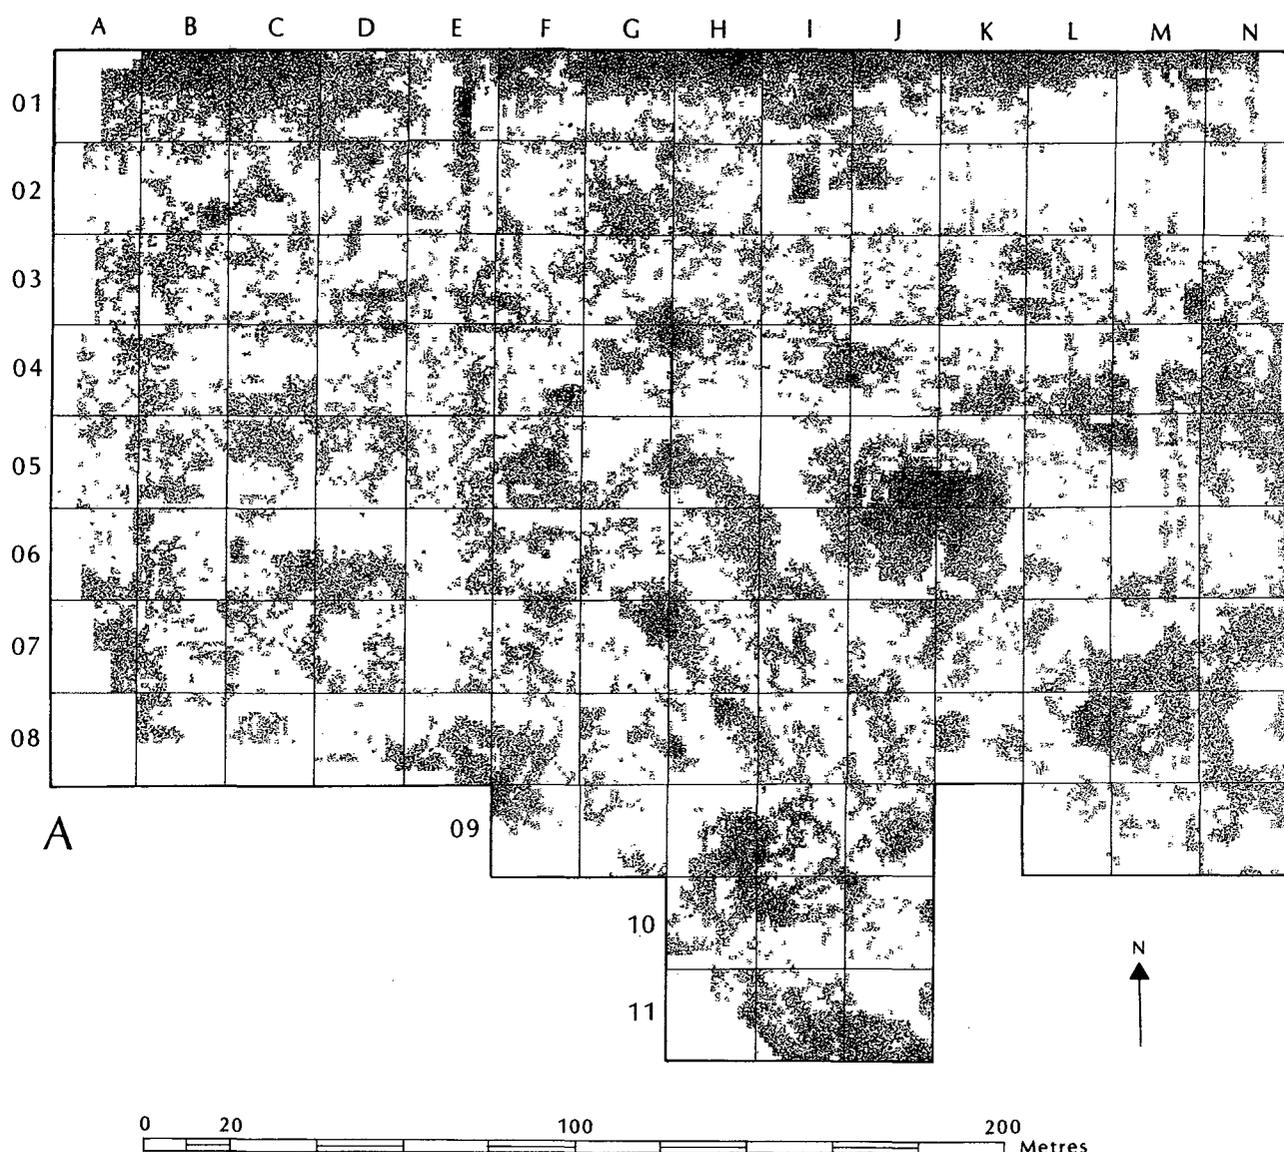
Fig. 104 Dot-density plot of the resistivity survey showing major positive anomalies.

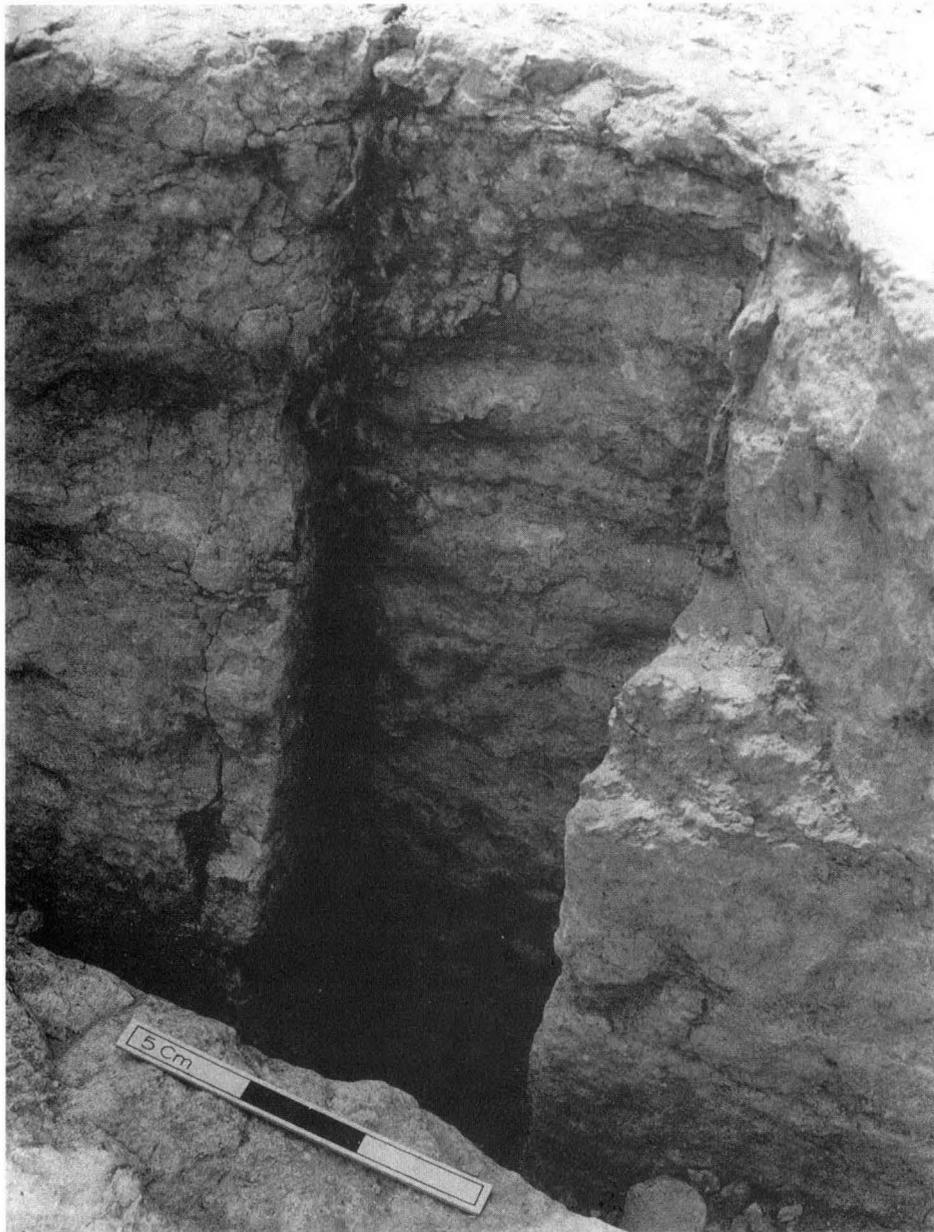
A. Portcullis slot in the western respond at the northern entrance to the Roman gate, Area C, 1991.

- Plate XV A. Portcullis slot in the western respond at the northern entrance to the Roman gate, Area C, 1991.  
B. The pilaster, foundation and superstructure, Area C, looking south, 1991.

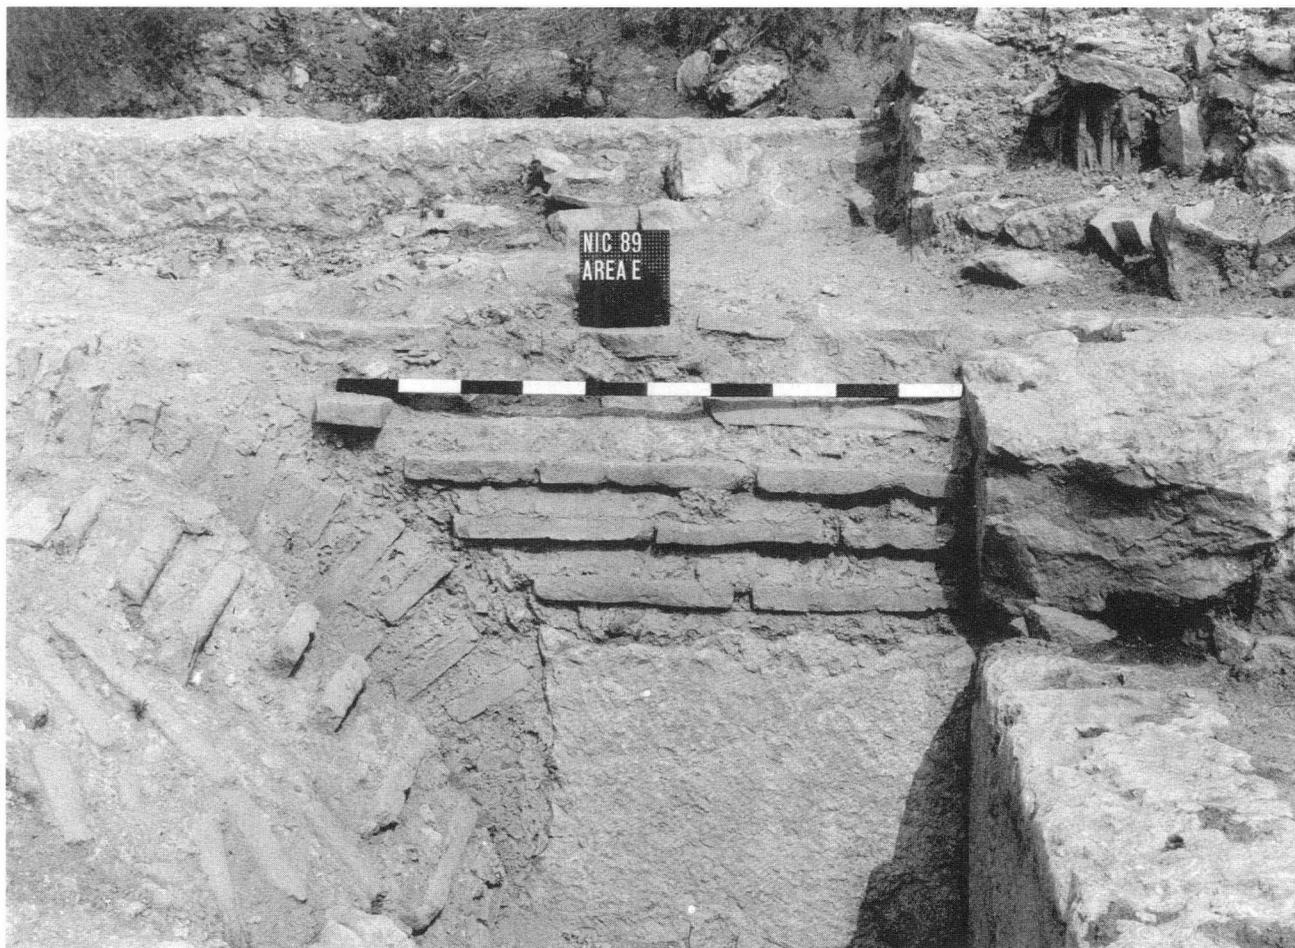
A. The north face of the central foundation for the gate, on the east side of the drain, Area E, looking north, 1989. Note the change in alignment of the bricks used in the drain vault.

B. Northern entrance to the drain, below the central foundation of the gate, Area E, looking south, 1989.
- Plate XXI A. The north face of the central foundation for the gate, on the east side of the drain, Area E, looking north, 1989. Note the change in alignment of the bricks used in the drain vault.

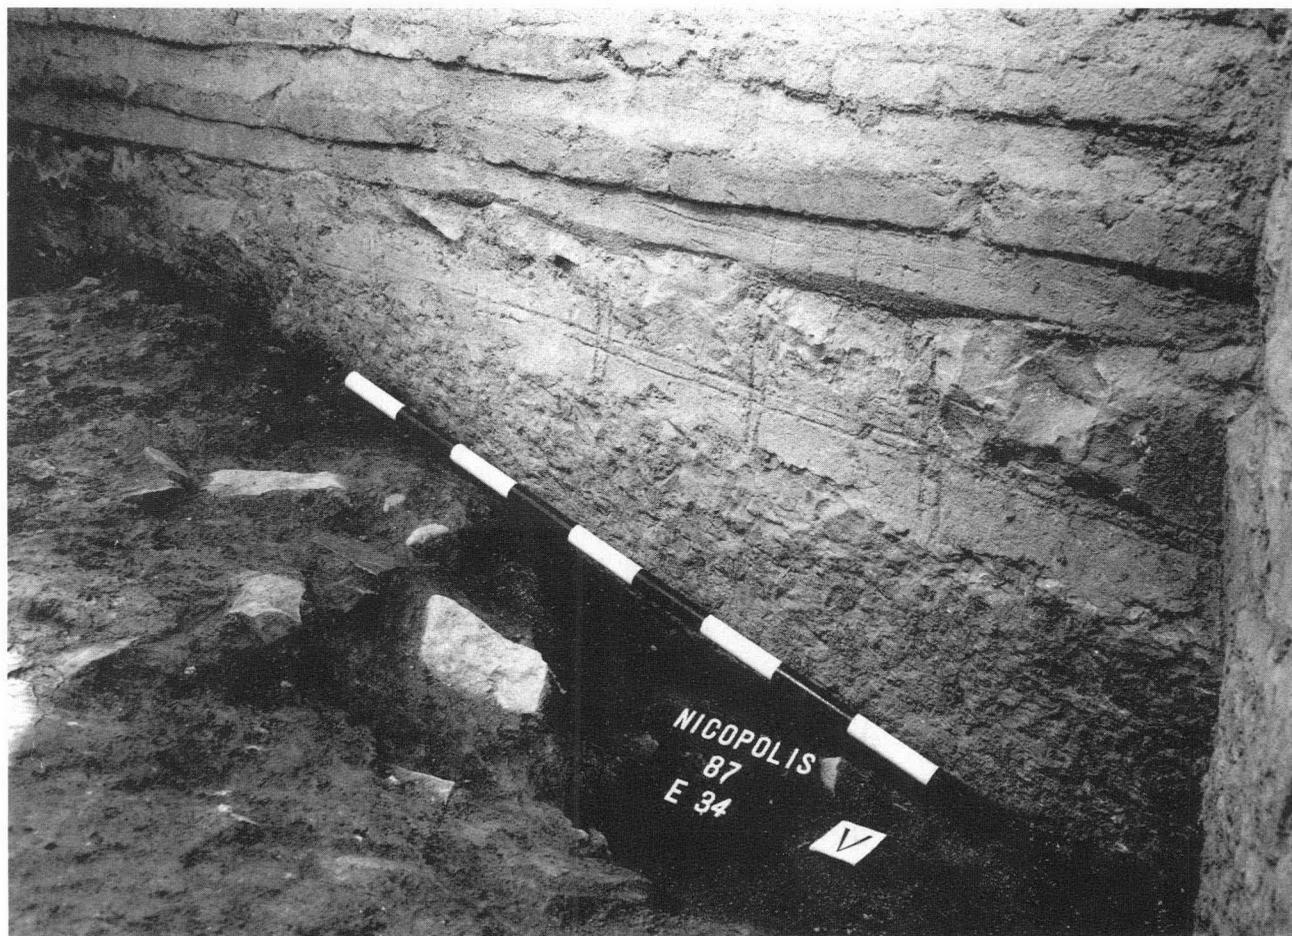
B. Lime mortar rendering on the inner face of the curtain-wall, east of the gate, Area E, looking south-east, 1987.
