ELGINHAUGH: A FLAVIAN FORT AND ITS ANNEXE

VOLUME 1

By W.S. Hanson

Britannia Monograph Series

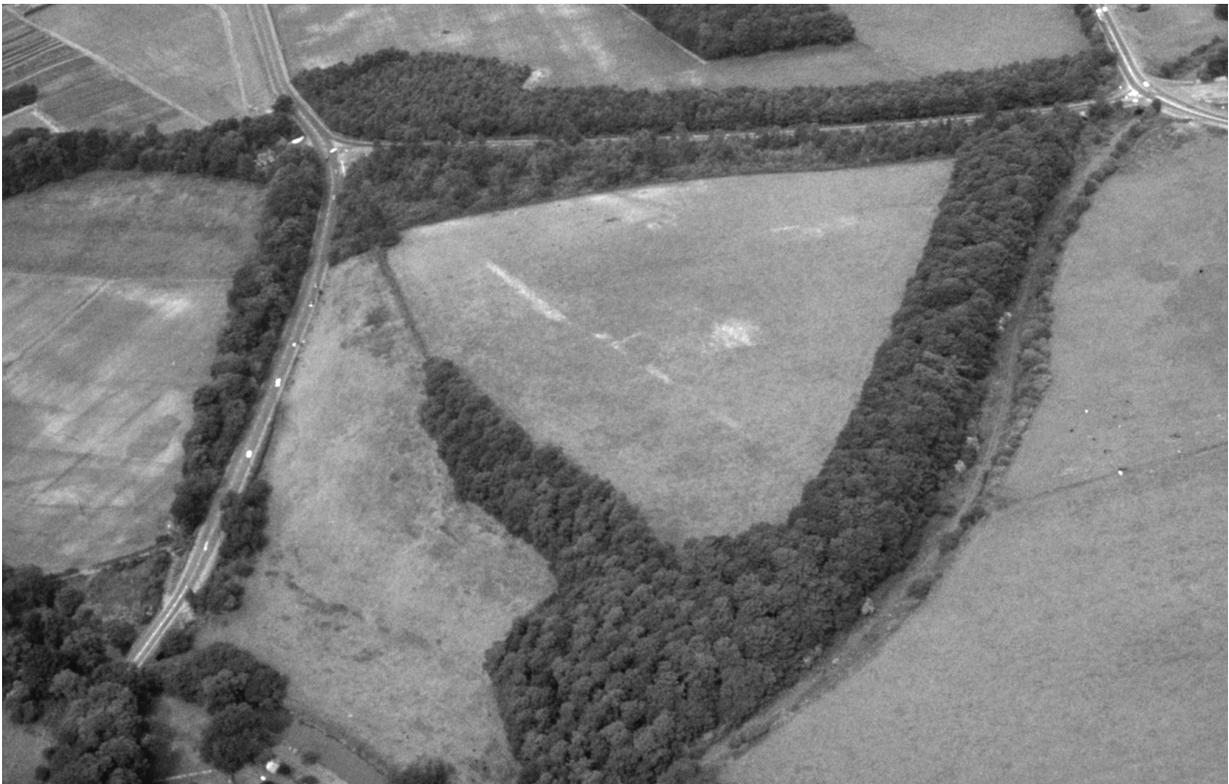
PLATE 1.1 Aerial photograph of the site in 1979 showing Roman road with T-junction; view north-west

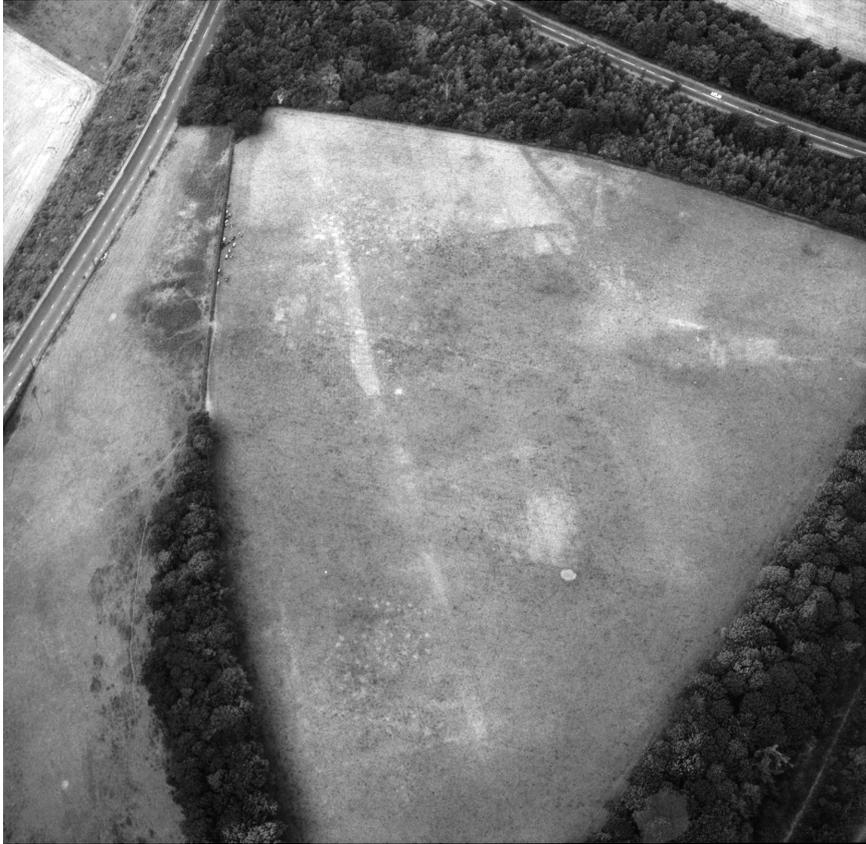
PLATE 1.2 Aerial photograph of the site in 1984 showing the main Roman road, *intervallum* road and annexe ditches (Crown copyright: © Royal Commission on the Ancient and Historical Monuments of Scotland); view west

Subsequent aerial reconnaissance by the RCAHMS revealed traces of other activity around the fort. A number of ditches, showing as positive cropmarks, indicated the presence of an annexe or annexes attached to its north-west side, and the outline of the stone walls of a bathhouse, showing as a parchmark in the grass, was recorded in the next field to the south by

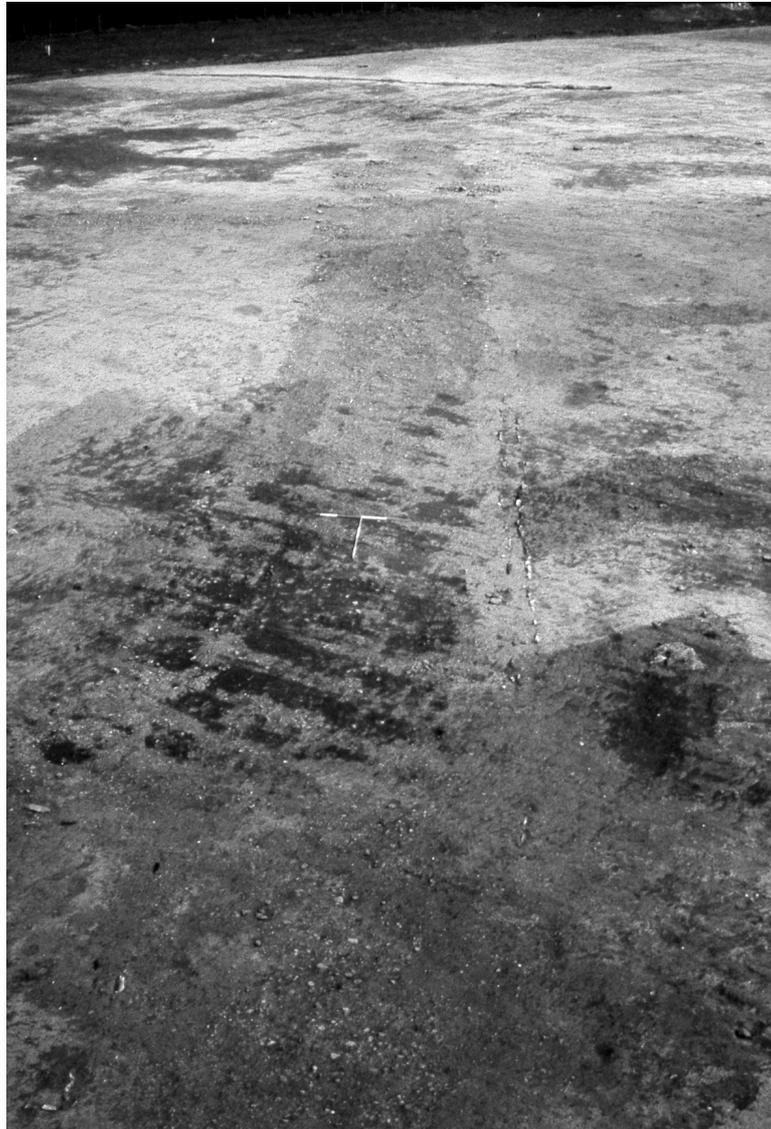
PLATE 1.4 View across the fort after first stage machine stripping and manual cleaning, with only the *via principalis* and adjacent drain visible; view east

The *principia* was best preserved towards the front; the rear had suffered considerably from plough damage as the differential preservation of the surrounding drain indicates (PLATE 1.4; below 7.4 for discussion of drains). But even in the areas of best preservation, post-holes and post-trenches were virtually impossible to discern in the worm-sorted upper soil horizon (below 11.4) and so up to 0.4m was removed by machine. Accordingly, this should be added to the recorded depths of all negative features unless otherwise stated.

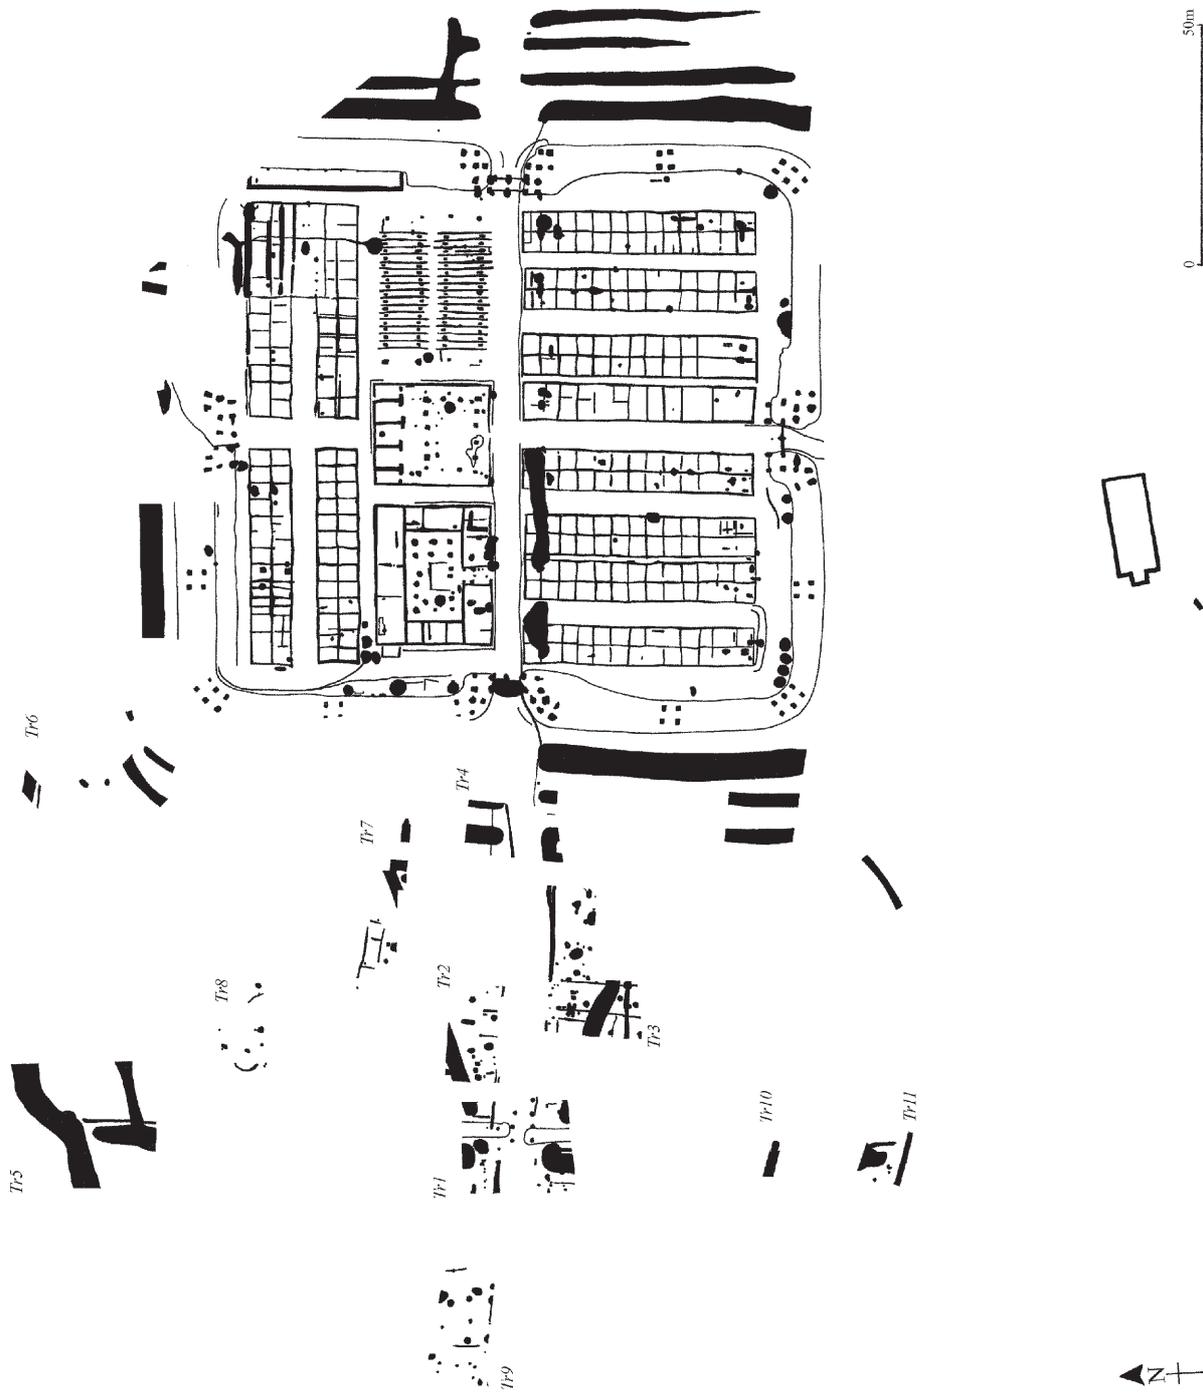
FIG. 1.2 All excavated features

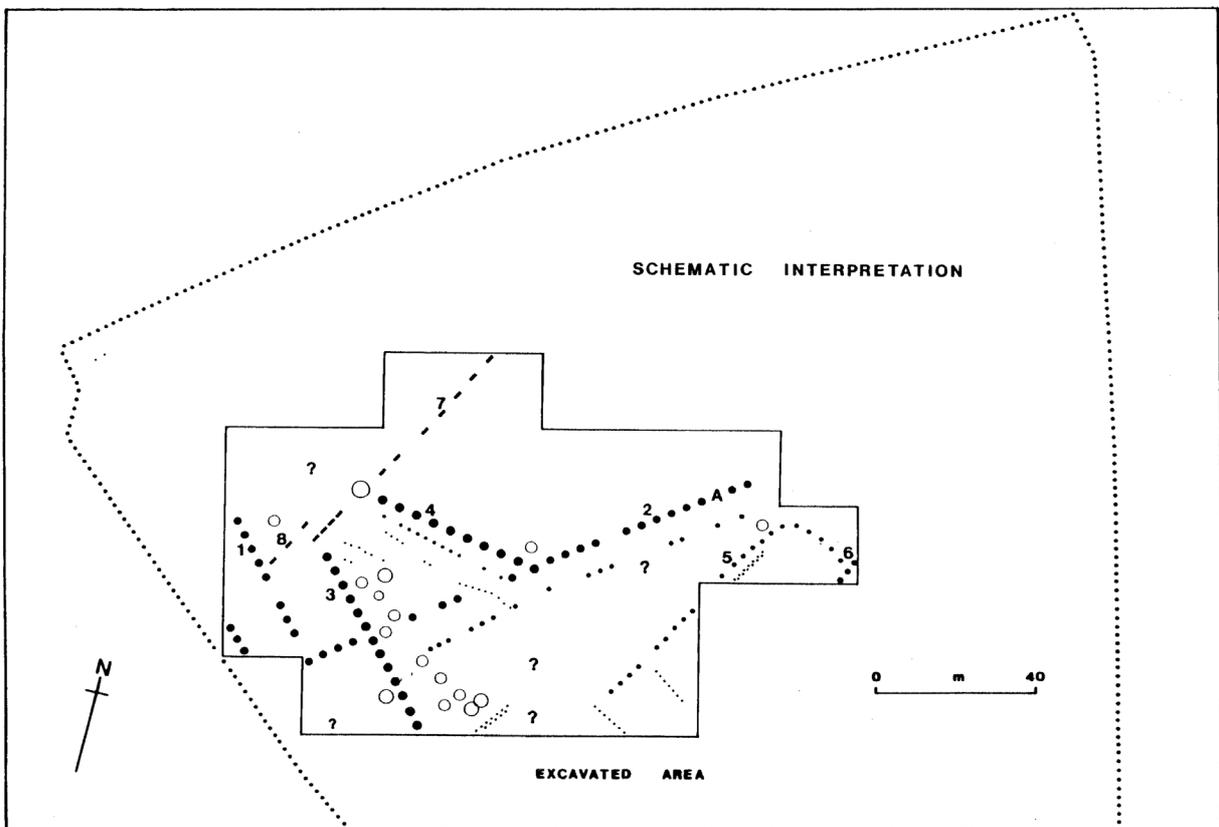
FIG. 2.5 Schematic interpretation of the geophysical survey

Linear ditches (FIG. 2.5: features 1–8) are most easily recognised, some more strongly than others. This is probably due to the differing amounts of rubbish in ditches, which accounts for the somewhat broken nature of the features. The ditches furthest away from the fort (7 and 8) are poorly defined, as is quite common on such sites. Where the initial natural magnetic contrast between the soil layers is weak, it is sometimes found that ditches and other features are clearly detectable close to dwellings, in this case the fort, where enhancement has occurred through the disposal of domestic refuse, but fade beyond the limits of the settlement. The strength of the anomaly is not necessarily indicative of the size of the feature, hence trends can be archaeologically significant. Interpretation is very subjective in such circumstances.

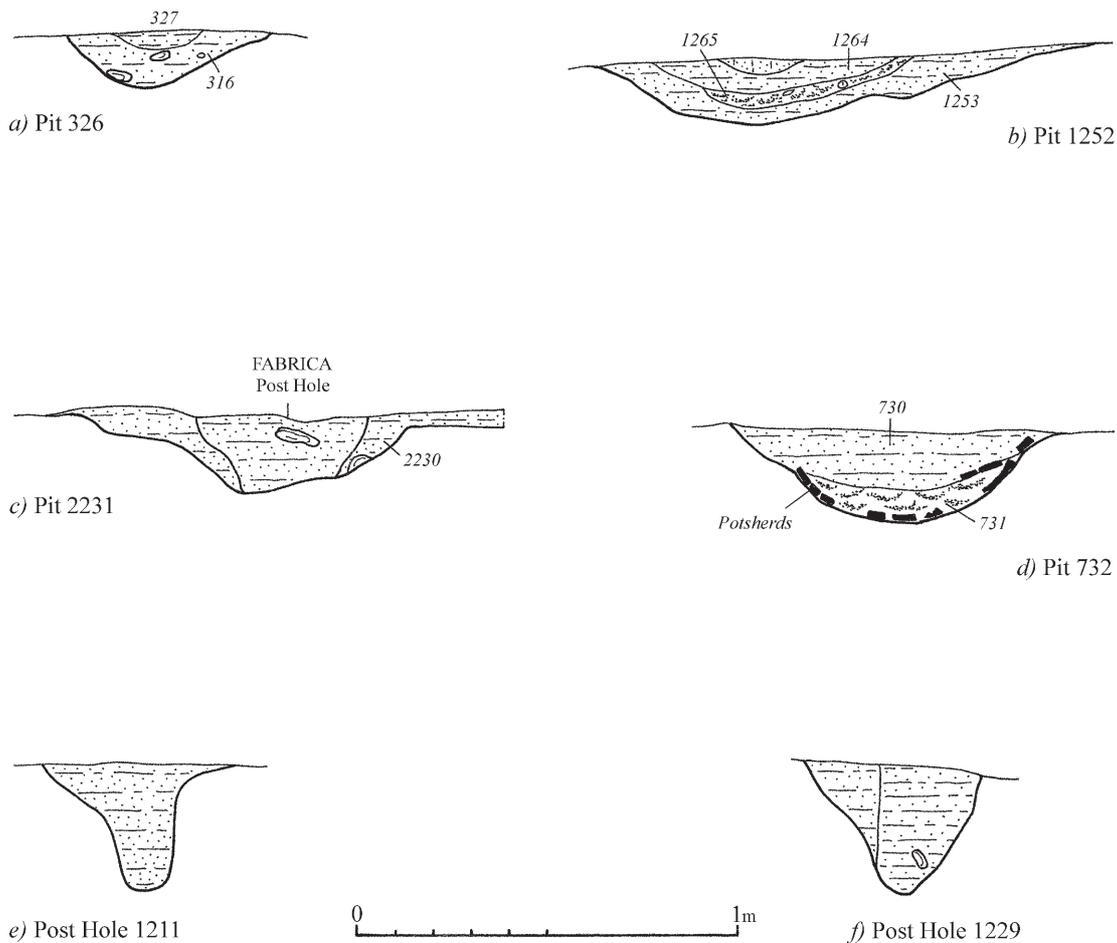
FIG. 3.4 Sections of prehistoric pits and post-holes: Neolithic, a. pit 326; b. pit 1252; c. pit 2231; Neolithic/Bronze Age, d. pit 732; e. post-hole 1211; f. post-hole 1229

Pit 326 was oval and measured 1.6m by 0.53m. It was shallow, only surviving to a depth of 0.3m, with a bowl-shaped profile (FIG. 3.4a). Two separate fills of dark-stained, silty sand were distinguished, but the presence of pottery sherds from the same vessel in both suggests that their distinction does not have substantive chronological or functional significance. The lower fill was rich in charcoal and the upper very rich in carbonised cereal remains, mainly indeterminate cereal fragments, though both wheat and hulled barley were attested (below 11.2.2). Situated less than 1m to the north was a considerably larger pit or hollow (1252), measuring at least 5.3m by 1.4–2.3m, which was no more than 0.35m deep with a similar bowl-shaped profile (FIG. 3.4b). Its second fill was rich in charcoal, though charcoal was present in all three of its lower fills. Very little pottery was recovered, mainly in small fragments, but rather more flint and some carbonised cereals and remains of edible fruits (raspberry and bramble) came from the charcoal layer.

Pits 2231 and 2232 lay adjacent to each other some 5m to the east. Pit 2231 was subcircular and measured 0.85m in diameter but was, like pit 326, shallow with a bowl-shaped profile

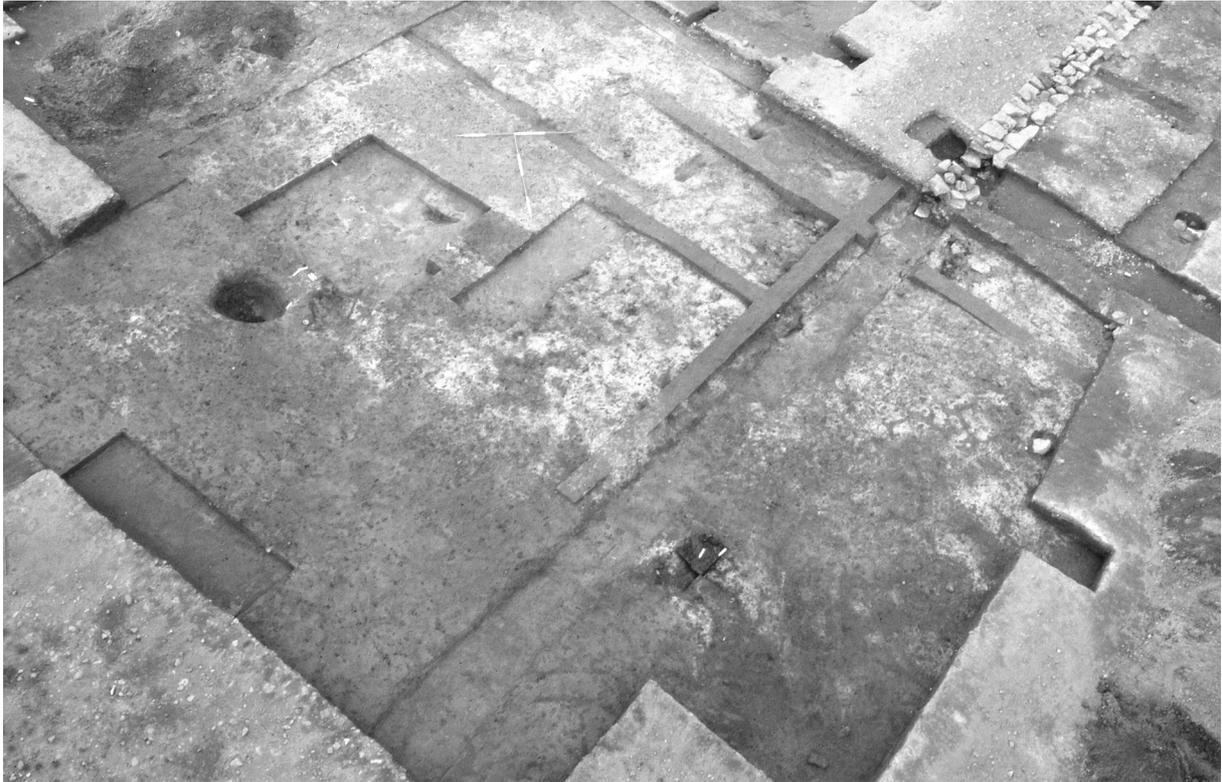
PLATE 3.1 Neolithic pits cutting old ground surface beneath *intervallum* road, *fabrica* and Barrack 3/4; view north-west

Within the north-east quadrant of the fort, partly sealed by the *intervallum* road and the *fabrica*, were a series of adjacent pits or hollows and more amorphous spreads (FIG. 3.3) distinguished by their dark grey/black colour, probably stained by burning (PLATE 3.1). Most produced evidence of Neolithic date either in the form of pottery or lithics (below 3.5, 10.12 and 10.13). An associated buried soil horizon (1254 and 1255) seems to have survived, through which the

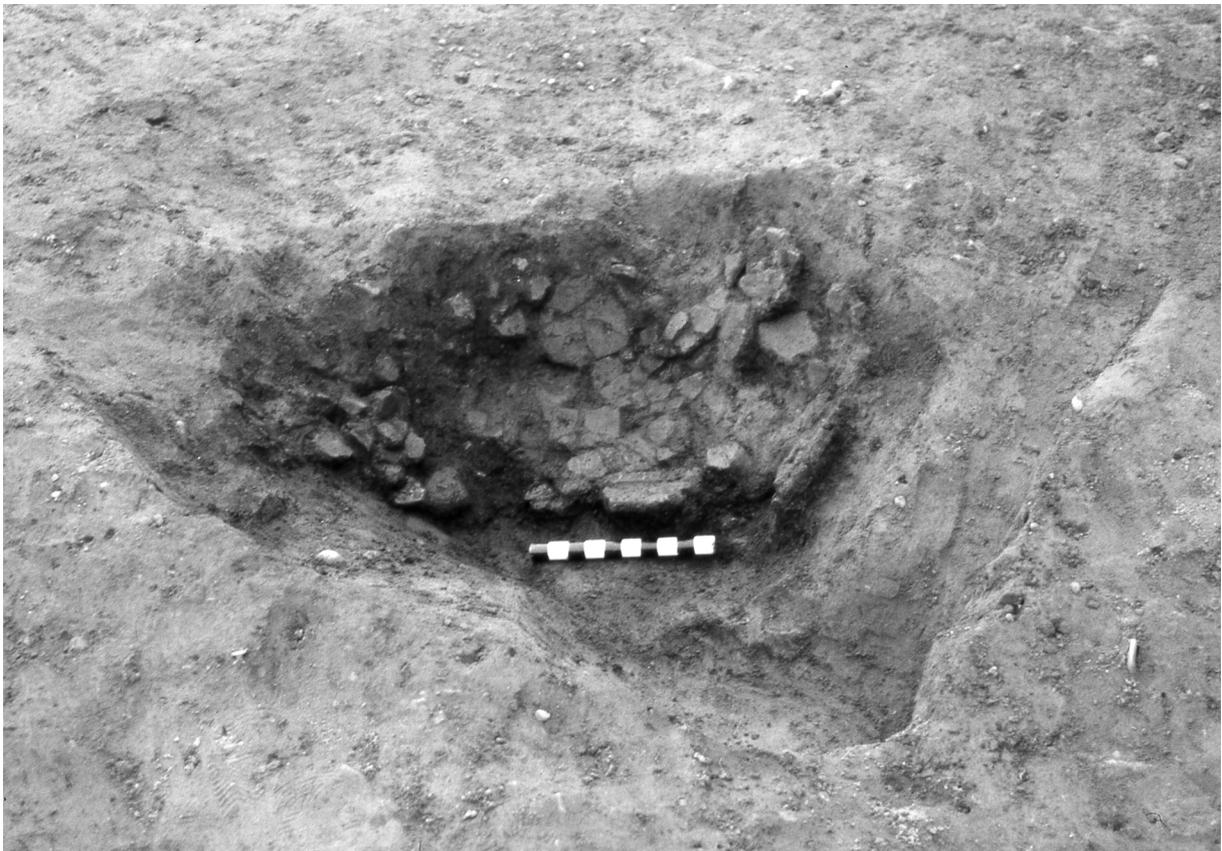
PLATE 3.2 Late Neolithic/Early Bronze Age pit (732) with pottery lining, annexe Trench 3; view north-west

Remains of late Neolithic/early Bronze Age date were recovered at several discrete points across the annexe. At the eastern end of Trench 3 (FIG. 3.5) a circular pit (732) was revealed sealed beneath a buried soil layer (733). It was some 0.85m in diameter, and 0.25m deep with a bowl-shaped profile (FIG. 3.4d). Excavation of the primary fill (731), a black, silty loam containing ash and charcoal, recovered over 135 sherds almost exclusively from a single, large rusticated beaker. This had been broken and the sherds used to line the base of the pit

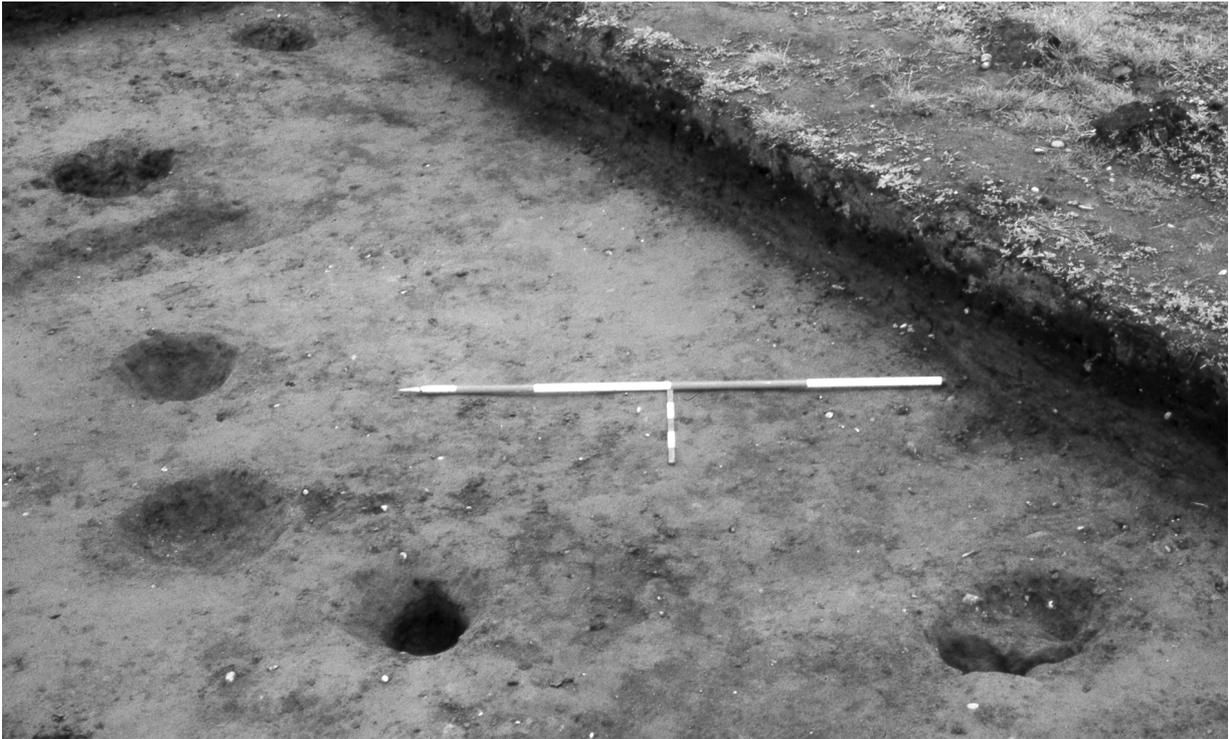
PLATE 3.3 Semi-circle of post-holes of probable prehistoric house, annexe Trench 7; view north-west

In annexe Trench 7, an arc of six post-holes was noted forming almost a complete semi-circle up against the northern edge of the trench (FIGS 3.1 and 8.17; PLATE 3.3). If restored as a circular structure, it would have measured some 6.2m in diameter to the centre of the post-holes. Only one (1227) did not exactly fit that restored ground plan. All the post-holes were sectioned (e.g. FIG. 3.4e and f), but no finds were recorded nor were any environmental data recovered.

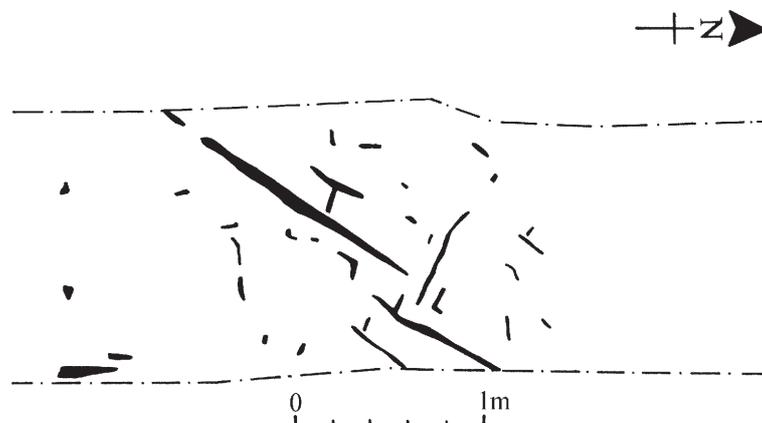
FIG. 3.6 Ard marks cutting the old ground surface; for location see FIG. 3.1

Finally, two distinct patches of ard marks were recorded cutting through the mid-grey, sandy loam of the buried soil into which the Neolithic pits were cut in the north-east corner of the fort. The main marks were up to 0.06m wide, running in an east–west direction, straight and parallel, some 0.2m apart centre-to-centre separated by a slight ridge, though traces of marks at right angles were also noted (FIG. 3.6; PLATE 3.4). The marks were V-shaped in profile, cut into the subsoil to a depth of between 0.02m and 0.07m and were filled with grey silty sand.

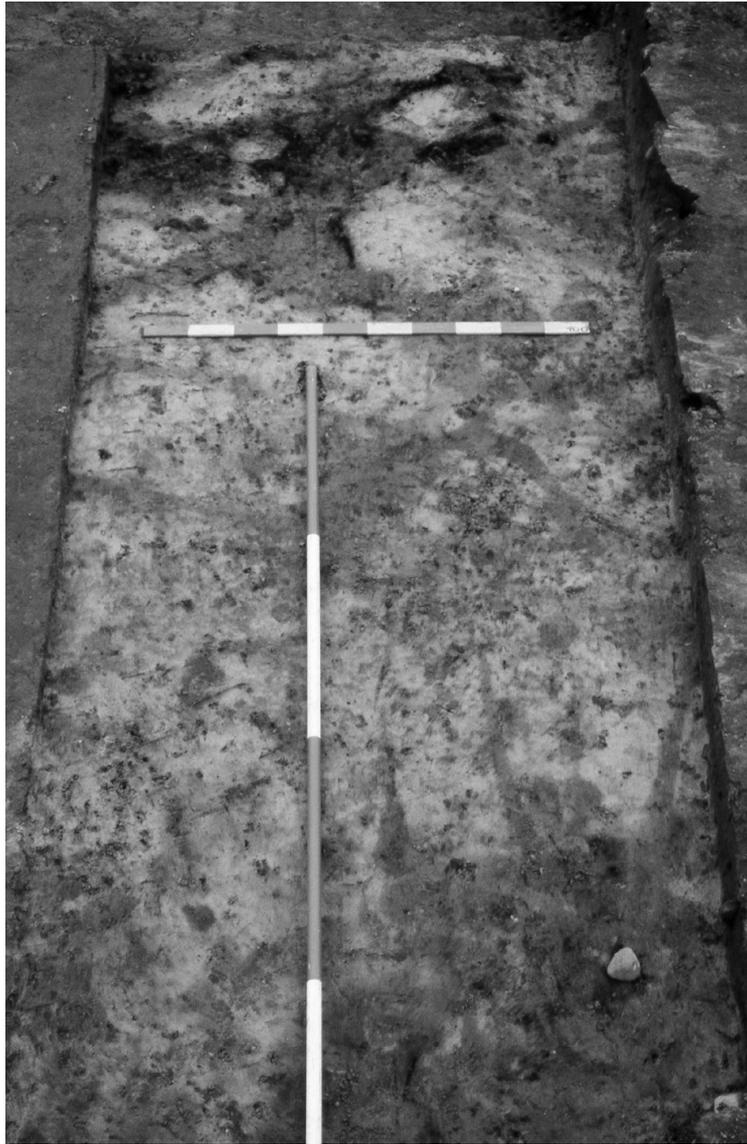
PLATE 3.4 Ard marks in the north-east corner of the fort; view north

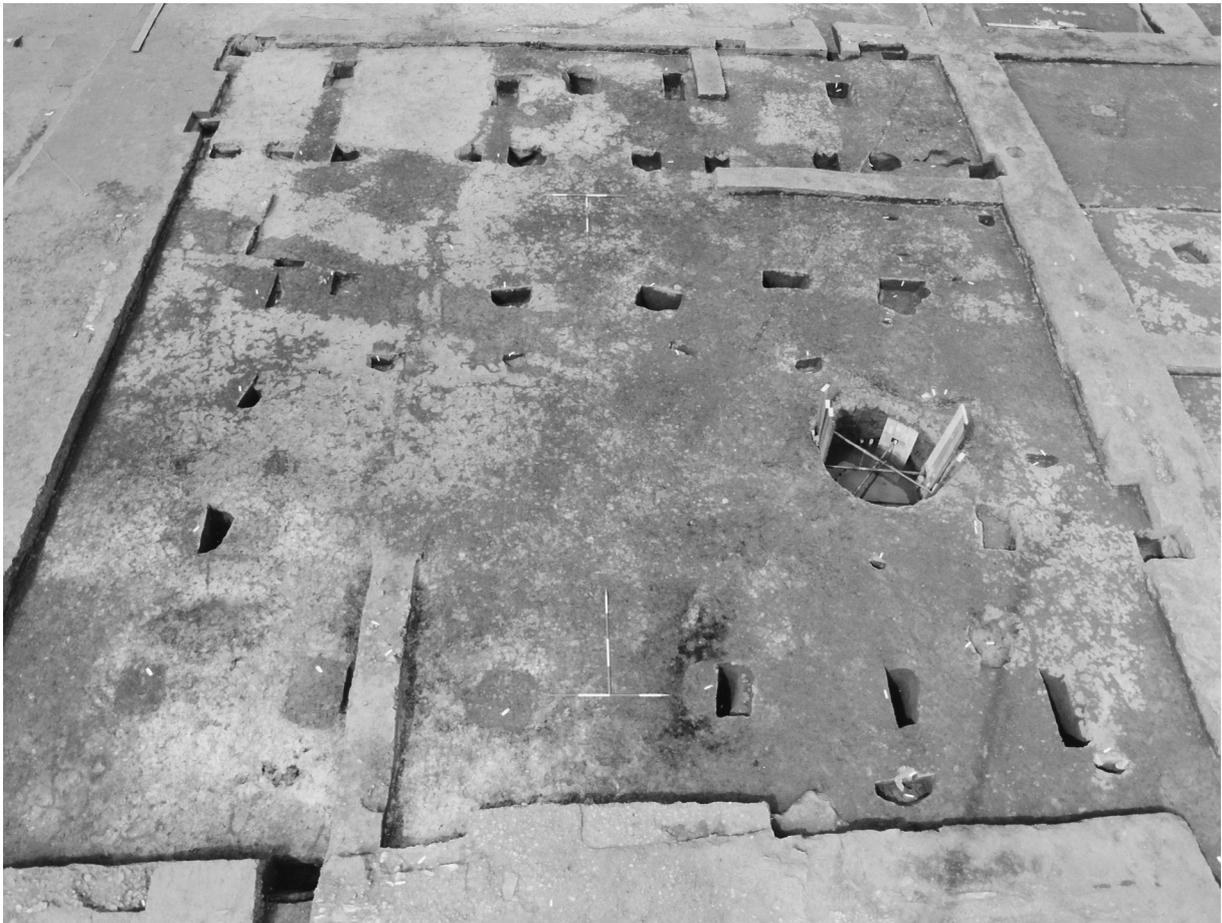
PLATE 4.1 General view of the *principia* under excavation; view north

The *principia* faced almost exactly due south and measured externally 23.6m by 21m (FIG. 4.1; PLATE 4.1). It was centrally located within the fort and completely surrounded by roads, though these were well preserved only towards the front. It was one of the only two buildings within the fort also to be surrounded by drains. The main entrance to the *principia* was defined by a narrow break in the centre of the construction trench for its south wall. The actual doorway would, however, have been rather wider since the metalling of the *via principalis* continued across the ends of the trenches to merge with the metalling (1430) in the southern ambulatory. By far the most important discovery related to the *principia* was a coin hoard from the south-west corner of the building, not only because of its intrinsic interest and value for dating

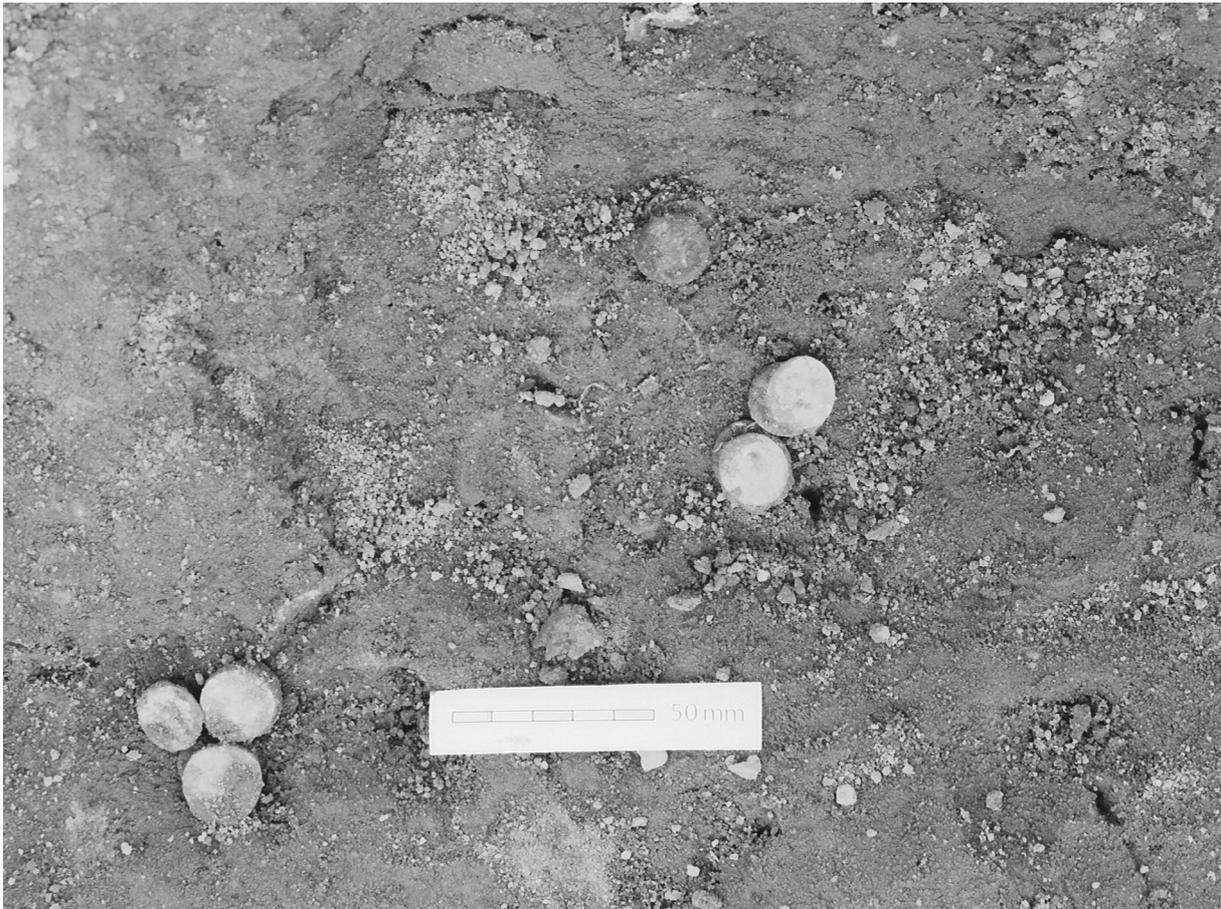
PLATE 4.2 Coins from the hoard in situ, stacked one on top of another, in the construction trench of the south wall of the *principia*

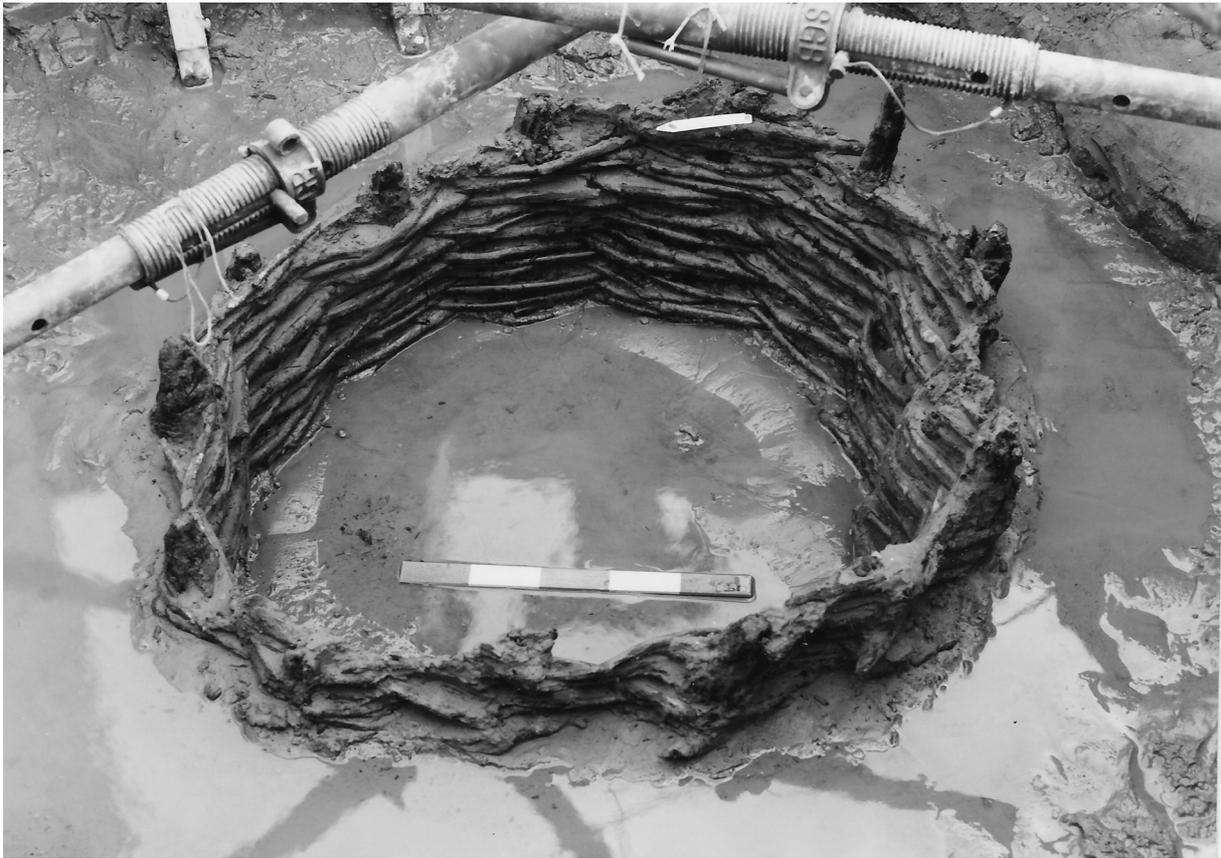
PLATE 4.3 Woven-wattle lining of the well

The construction shaft was some 2.5m in diameter, its sides nearly vertical. It had been packed with quite stony material, particularly towards the top, to provide additional revetting of the unstable sandy soil through which it was dug. Within the fill at the bottom was a broken piece of structural timber (below 10.9.1: 1428 AF), presumably discarded during construction of the fort buildings. Three small post-holes (494, 1454 and 548), the latter impinging on the eastern ambulatory, formed a triangle with the well at its centre and probably supported the legs of a tripod which would have housed some form of lifting mechanism. A similar arrangement is apparent around a water tank in the annexe (below 8.2). In the extreme south-east corner of the courtyard was a shallow, irregularly shaped pit (484) containing substantial amounts of charcoal and fragments of cremated bone of indeterminate species (FIG. 4.5e). This may be the

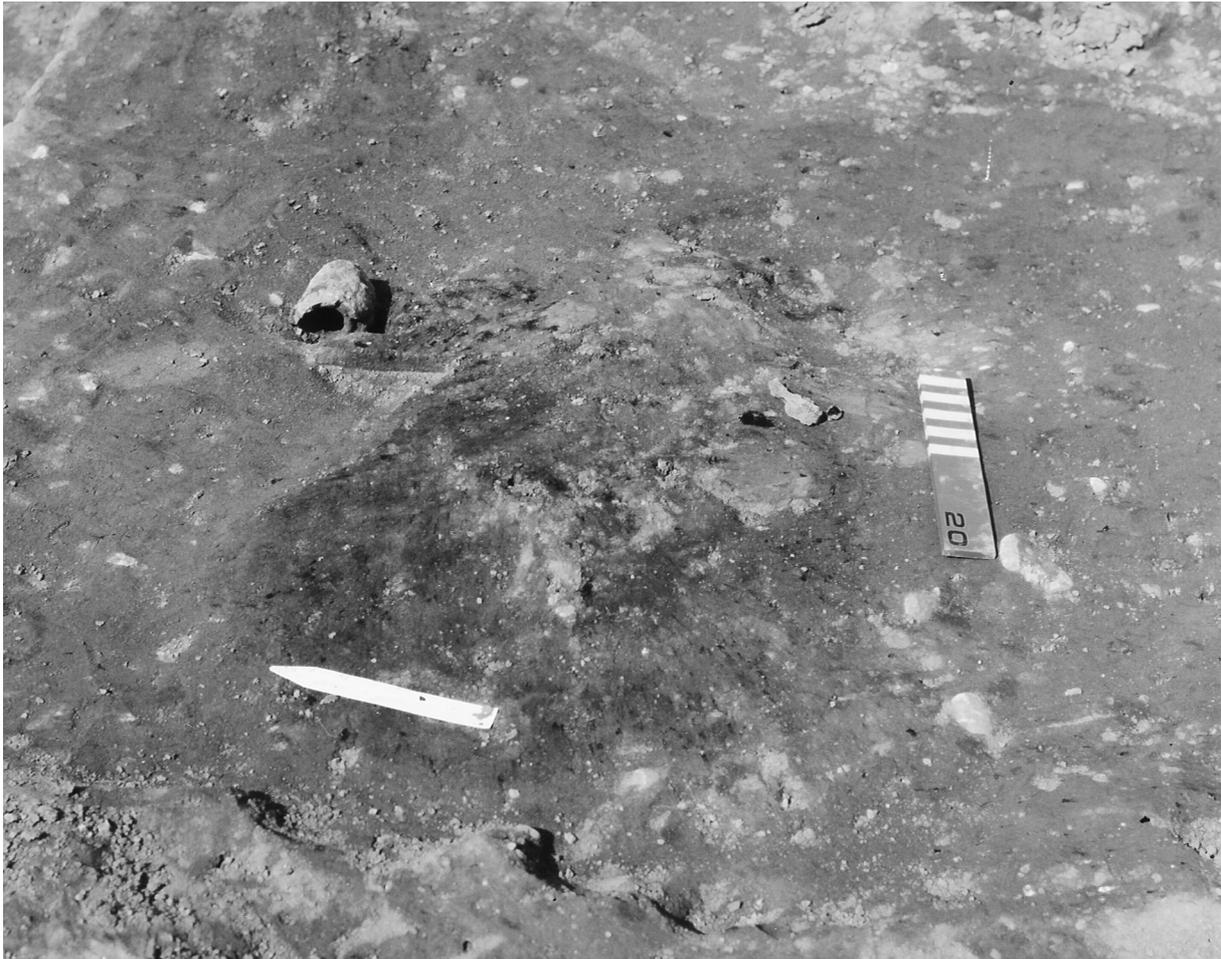
PLATE 4.4 Hearth (1404) with crucible for copper-alloy working

The floor of the ambulatory would have been metalled, though the surface of rammed gravel and pebble was recovered only around the main entrance to the building and adjacent to the kerb (481) at the edge of the courtyard. A small but concentrated deposit of copper-alloy metalworking residues was found towards the western corner of the southern range of the ambulatory (1404). Within a spread of fired and partially fire-reddened clay, intermixed with charcoal, nails and other iron fragments, was a small cylinder-shaped crucible containing copper-based residues (PLATE 4.4; below 10.11).

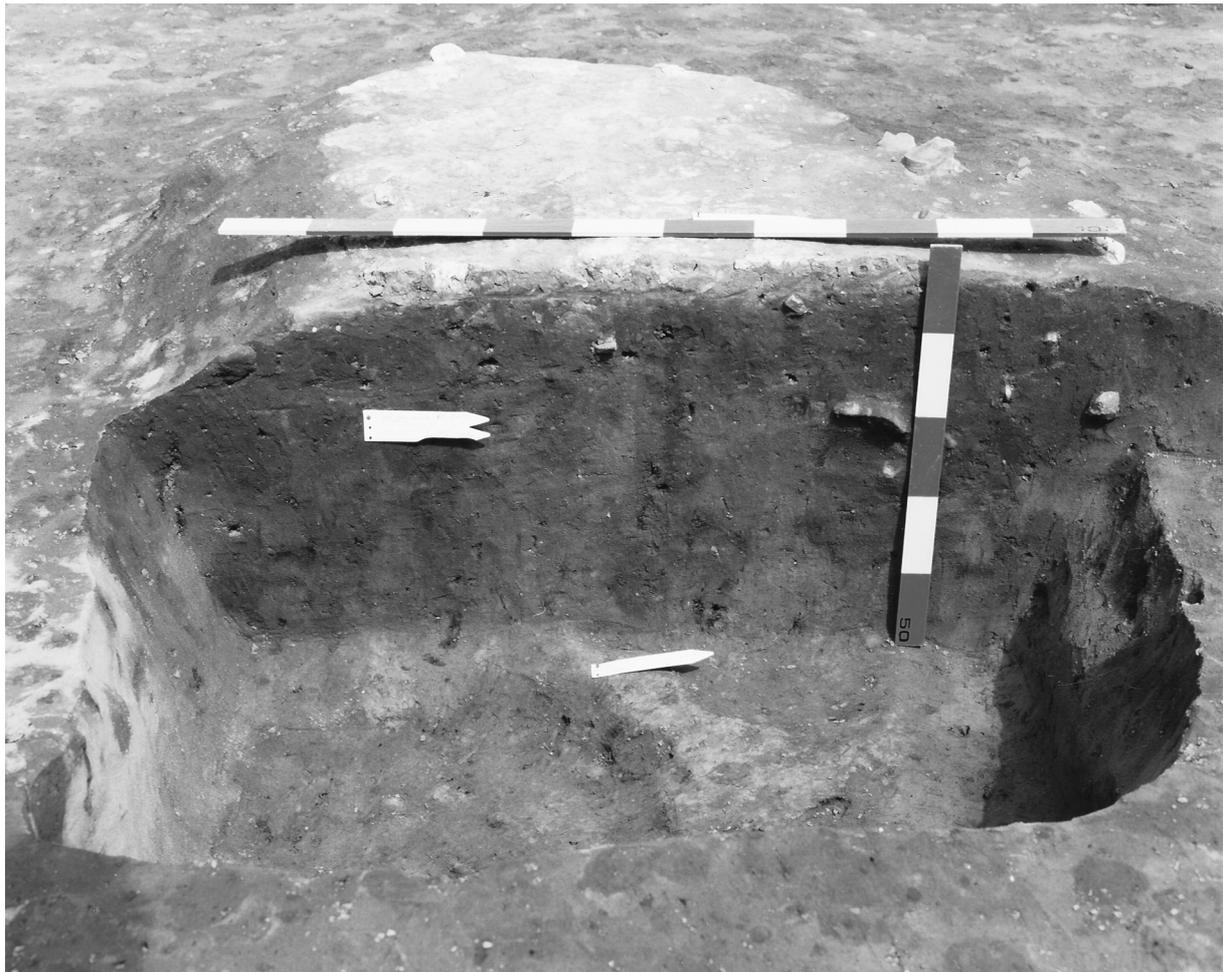
PLATE 4.5 Section through the clay-lined pit (574) in the *aedes*; view north

Centrally placed towards the rear of the middle room (C) was a thin spread of clay which sealed a pit (574) 0.85m in depth filled with silty sand containing daub. At the bottom of the pit, which had near vertical sides and a U-shaped profile, was a compacted mass of clay (PLATE 4.5) and, on the south-west side, a possible timber socket was detected. These features probably represent the remains of a timber and clay lining and the pit is best interpreted as having housed the unit's strong-box.

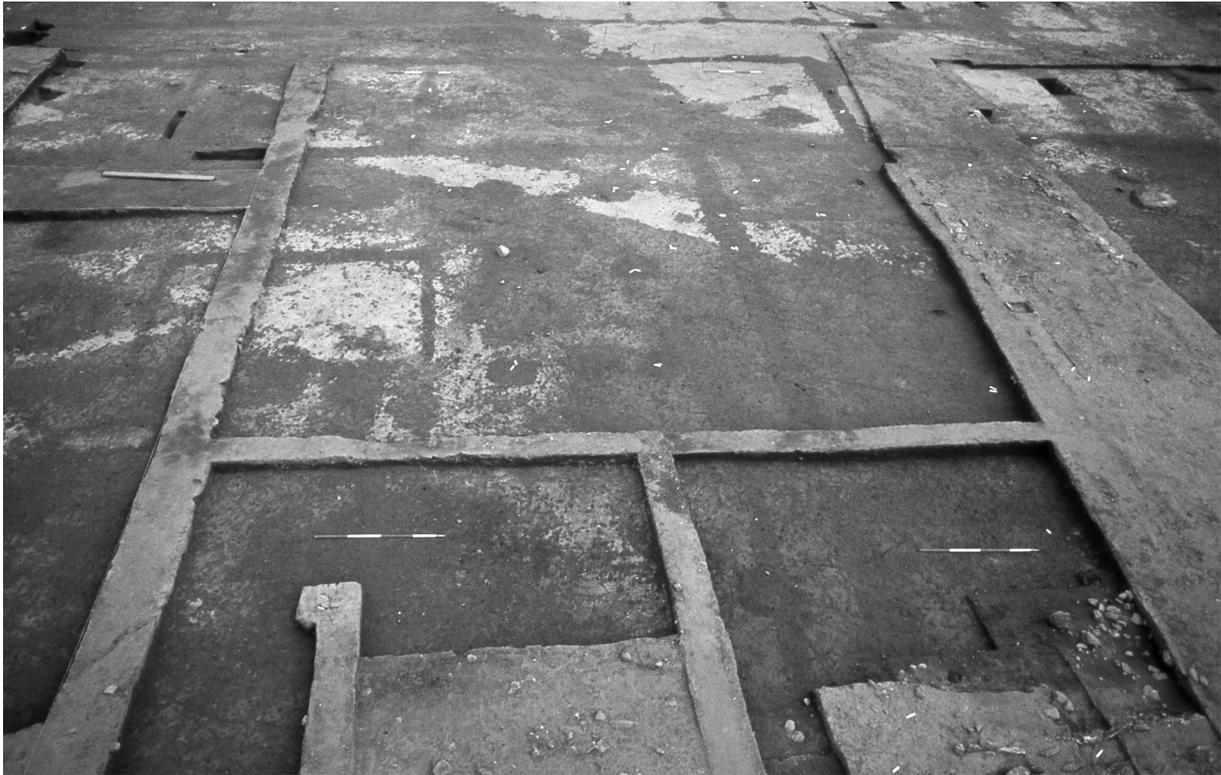
PLATE 4.6 General view of the eastern part of the *praetorium* under excavation; view north

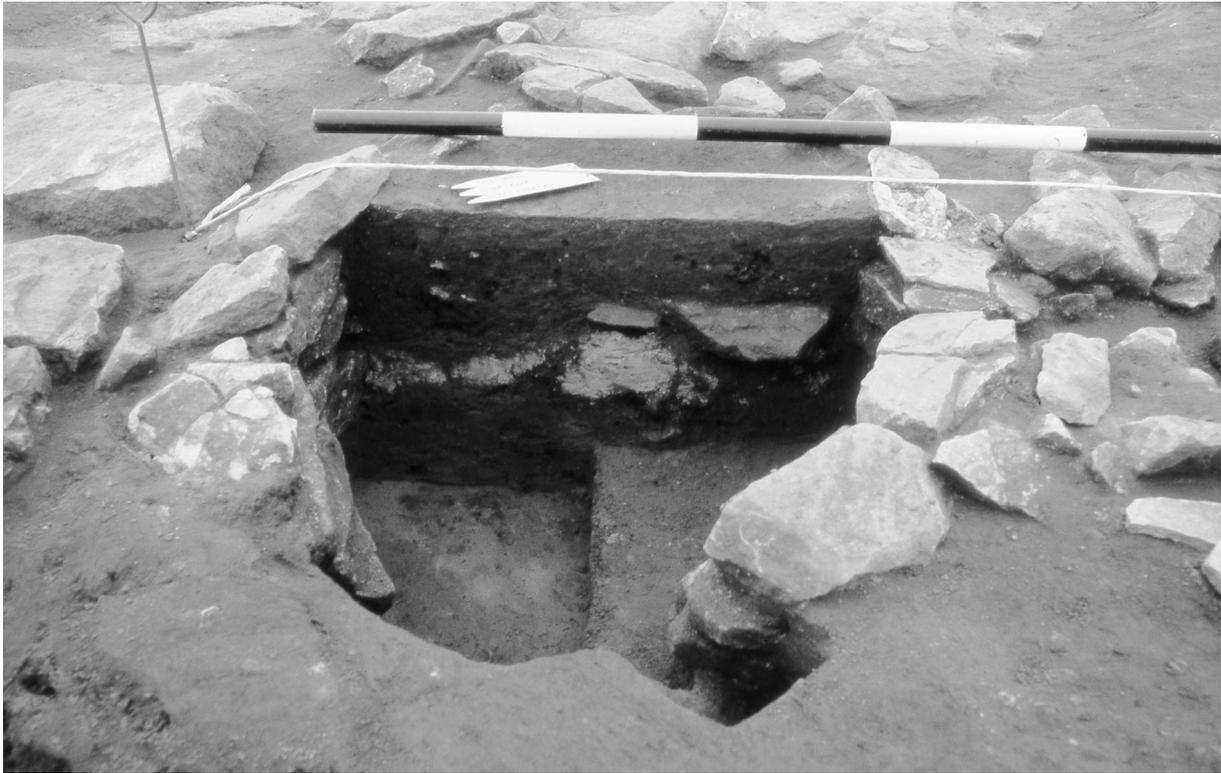
PLATE 4.7 Latrine pit and stone base in Room 5 of the *praetorium*; view north

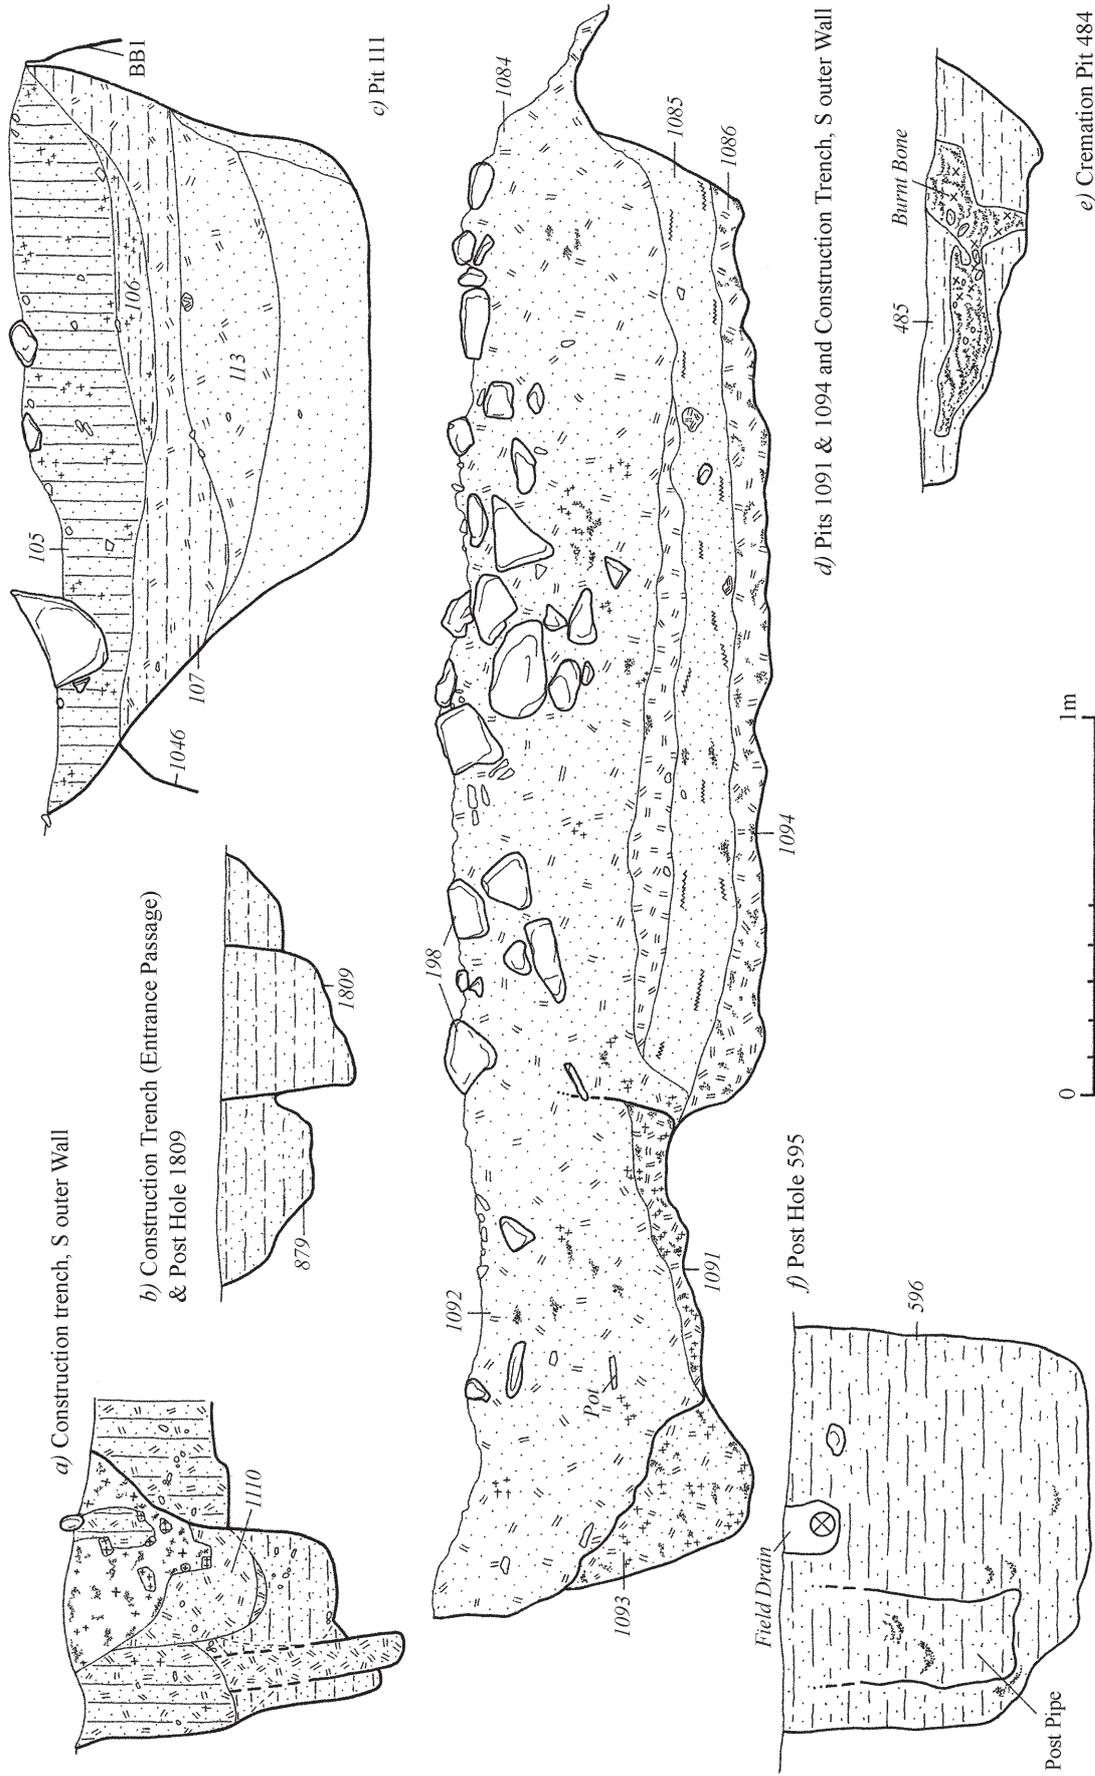
FIG. 4.5 Sections of structural features and pits in the *praetorium* (a-f): a. construction trench, south wall; b. construction trench, entrance passage, and post-hole 1809; c. pit 111; d. pits 1091, 1094 and construction trench, south wall; e. pit 484; f. post-hole 595
