ELGINHAUGH: A FLAVIAN FORT AND ITS ANNEXE

VOLUME 1

By W.S. Hanson

Britannia Monograph Series

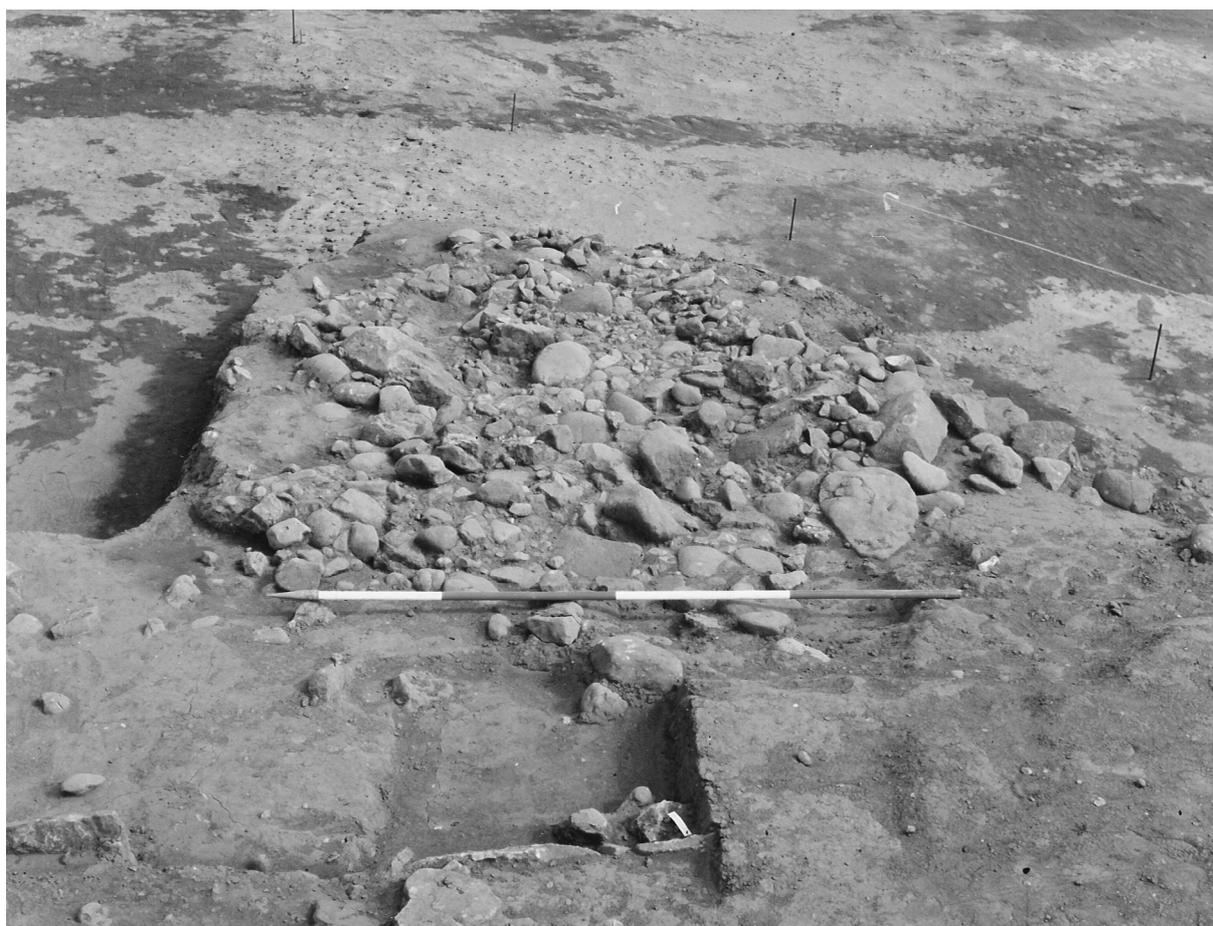
PLATE 4.8 Cobbling sealing pits 1091 and 1094 in the *praetorium*; view north

After the demolition phase at least part of the area was cobbled over, though traces of this process were slight. Both demolition pit 1091 and the earlier storage pit 1094 were sealed by an area of heavy, rough cobbling (198) (FIG. 4.5d). The cobbling spread out from the north side of the drain along the edge of the *via principalis*, where it was some 5m wide, petering out towards the centre of what had been Room 1 (PLATE 4.8). It was thickest, up to three layers, where it sealed the pits. The cobbling may originally have been more extensive across the area of the demolished *praetorium*, for similar cobbles formed the uppermost filling of two of the cess pits between the *praetorium* and Barrack 2 (75 and 111) (FIGS 4.5c and 5.1) and patches of lighter cobbles and sandstone slabs were recorded, admixed with demolition material, across the western half of Room 5 in the early stages of the excavation (37). The cobbling was deeper and more substantial where it had subsided into the pits in Room 1 and also been protected from subsequent plough damage by its proximity to the solid mass of the *via principalis*. Similar cobbling is also seen overlying the north end of Barrack 12 (below 6.4) on the south side of the road. Remains of such secondary cobbling and other traces of post-demolition use of the site were widely scattered around the fort (below 12.1).

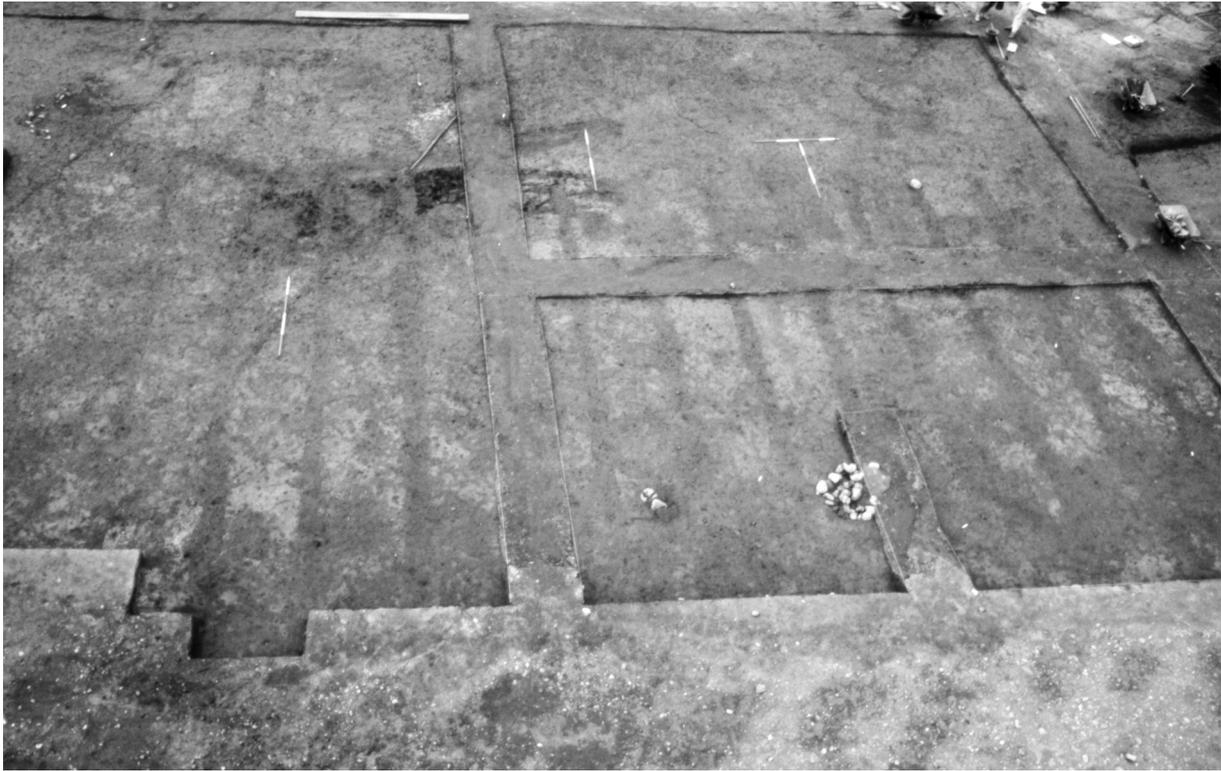
PLATE 4.9 Granary 1; view north

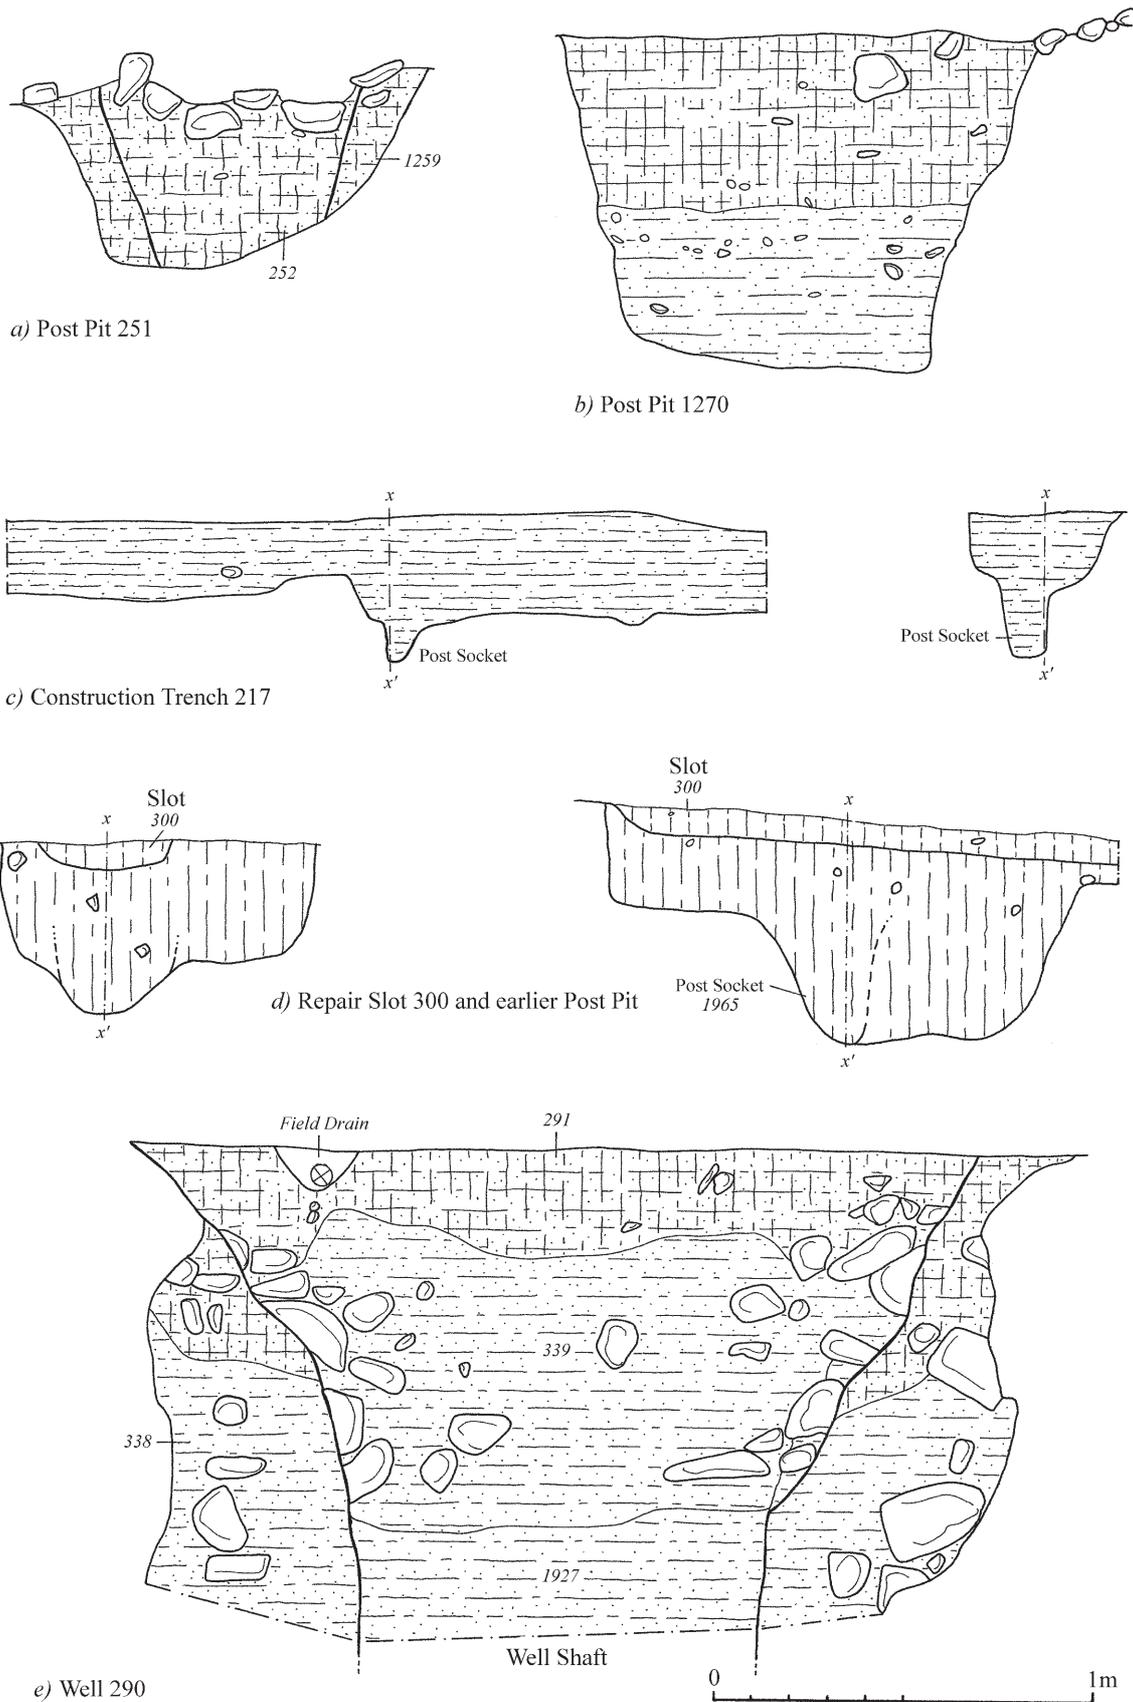
FIG. 4.8 Sections through features in the granaries: a. post-pit 251; b. post-pit 1270; c. construction trench 217; d. repair slot 300 and earlier post-pit; e. well 290

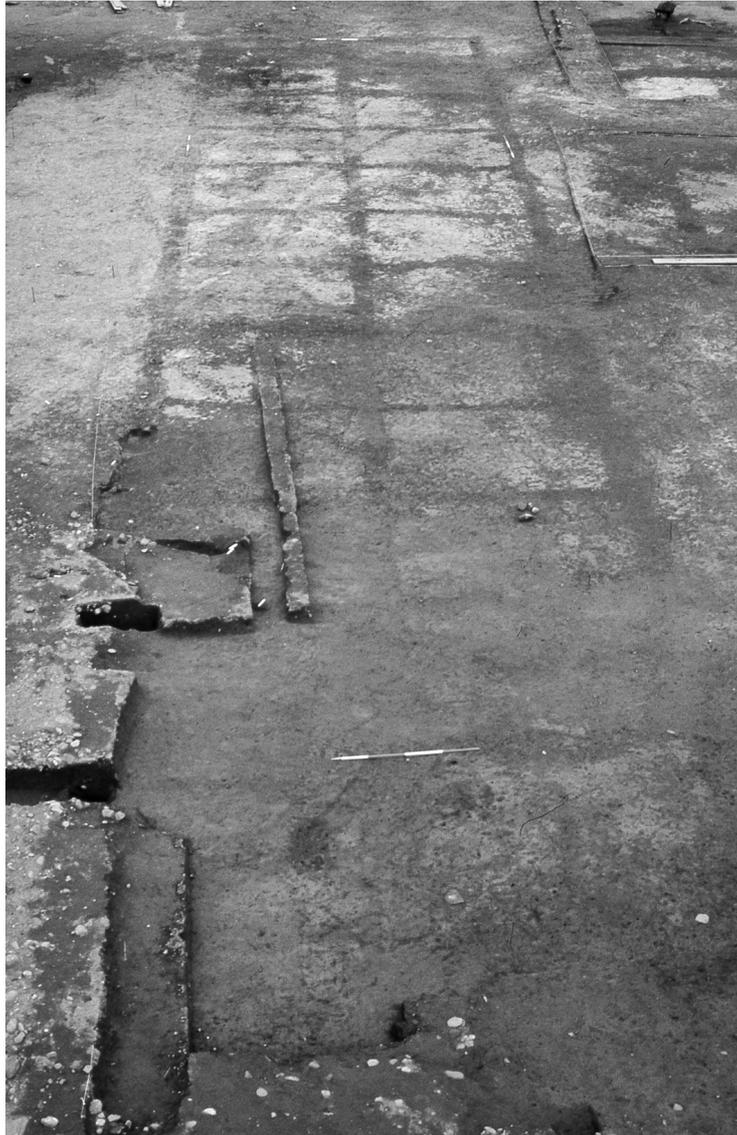
PLATE 5.1 Barrack 2; view east

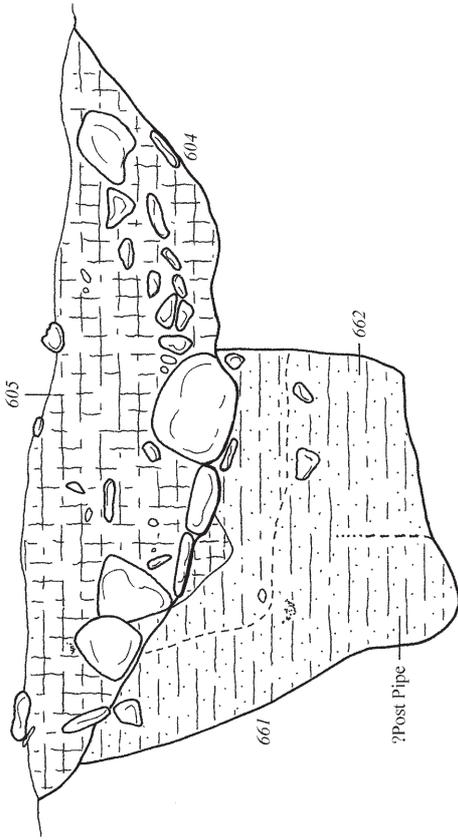
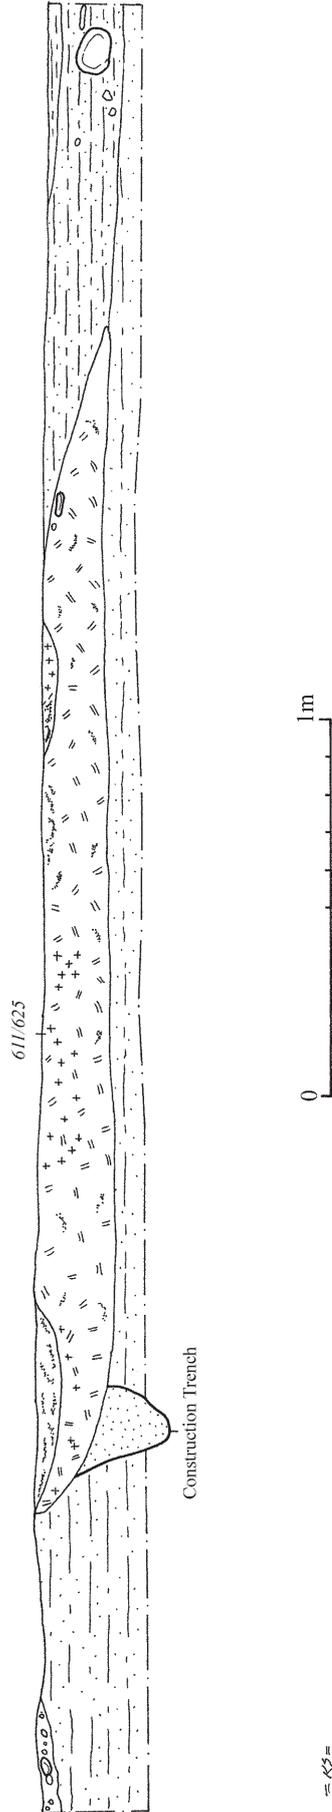
FIG. 5.3 Sections through pits and structural features in Barrack 1: a. pit 439; b. repair post-hole 604; c. collapsed walling 611

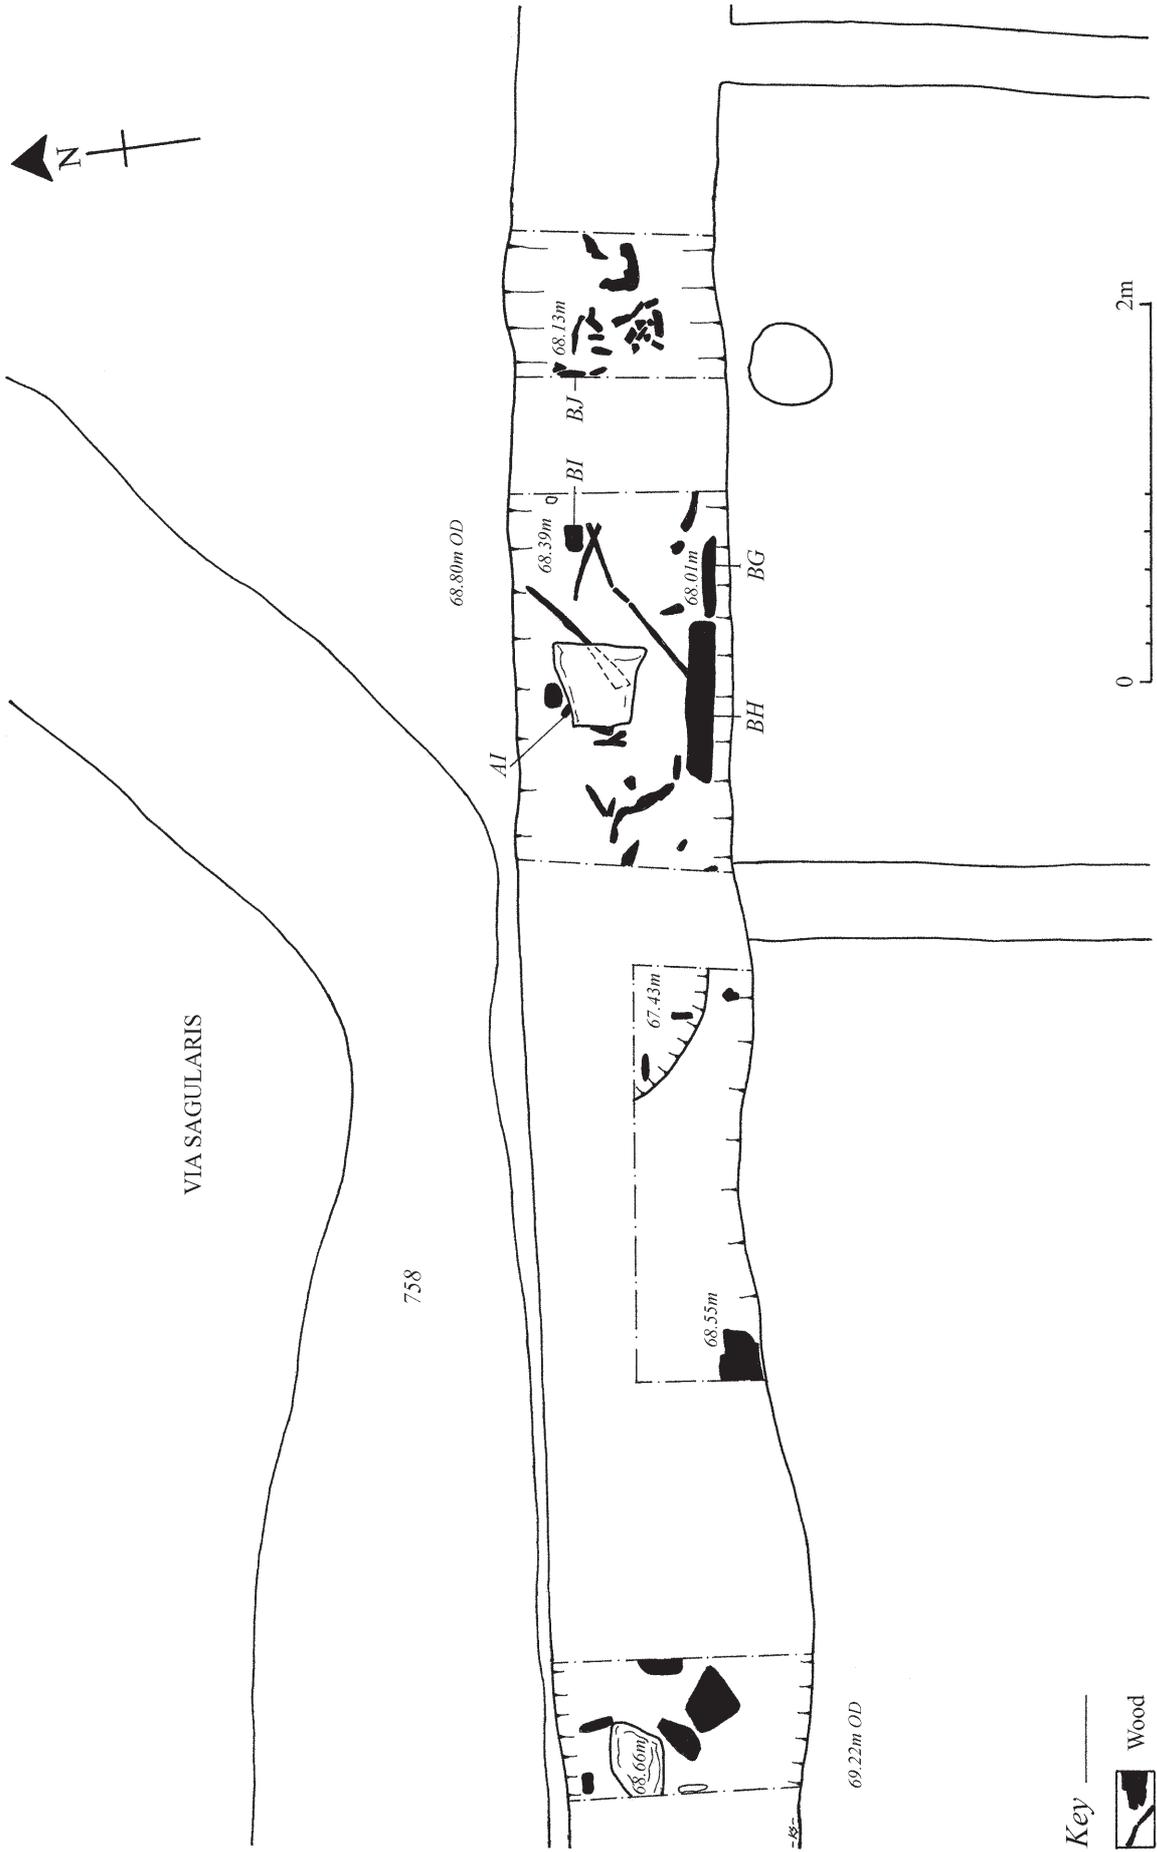
FIG. 5.6 Detailed plan of repair trench 783, Barrack 3

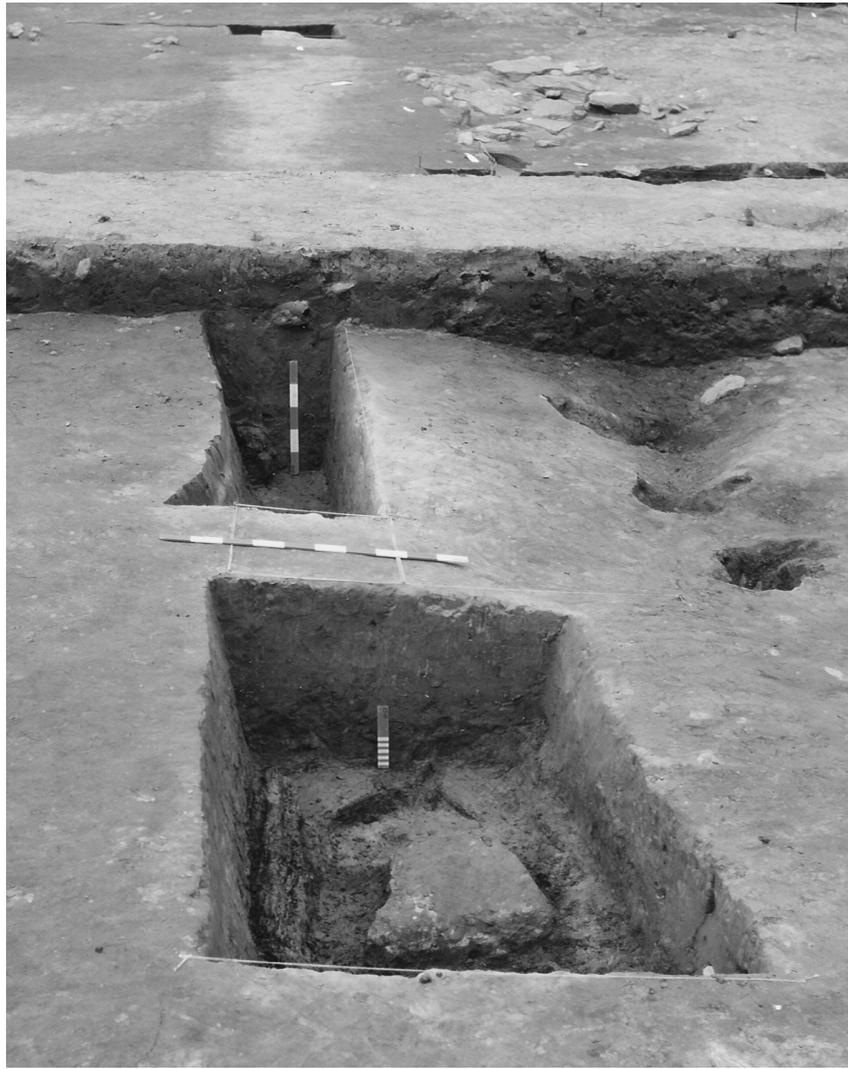
PLATE 5.2 Repair trench 783, Barrack 3; view west

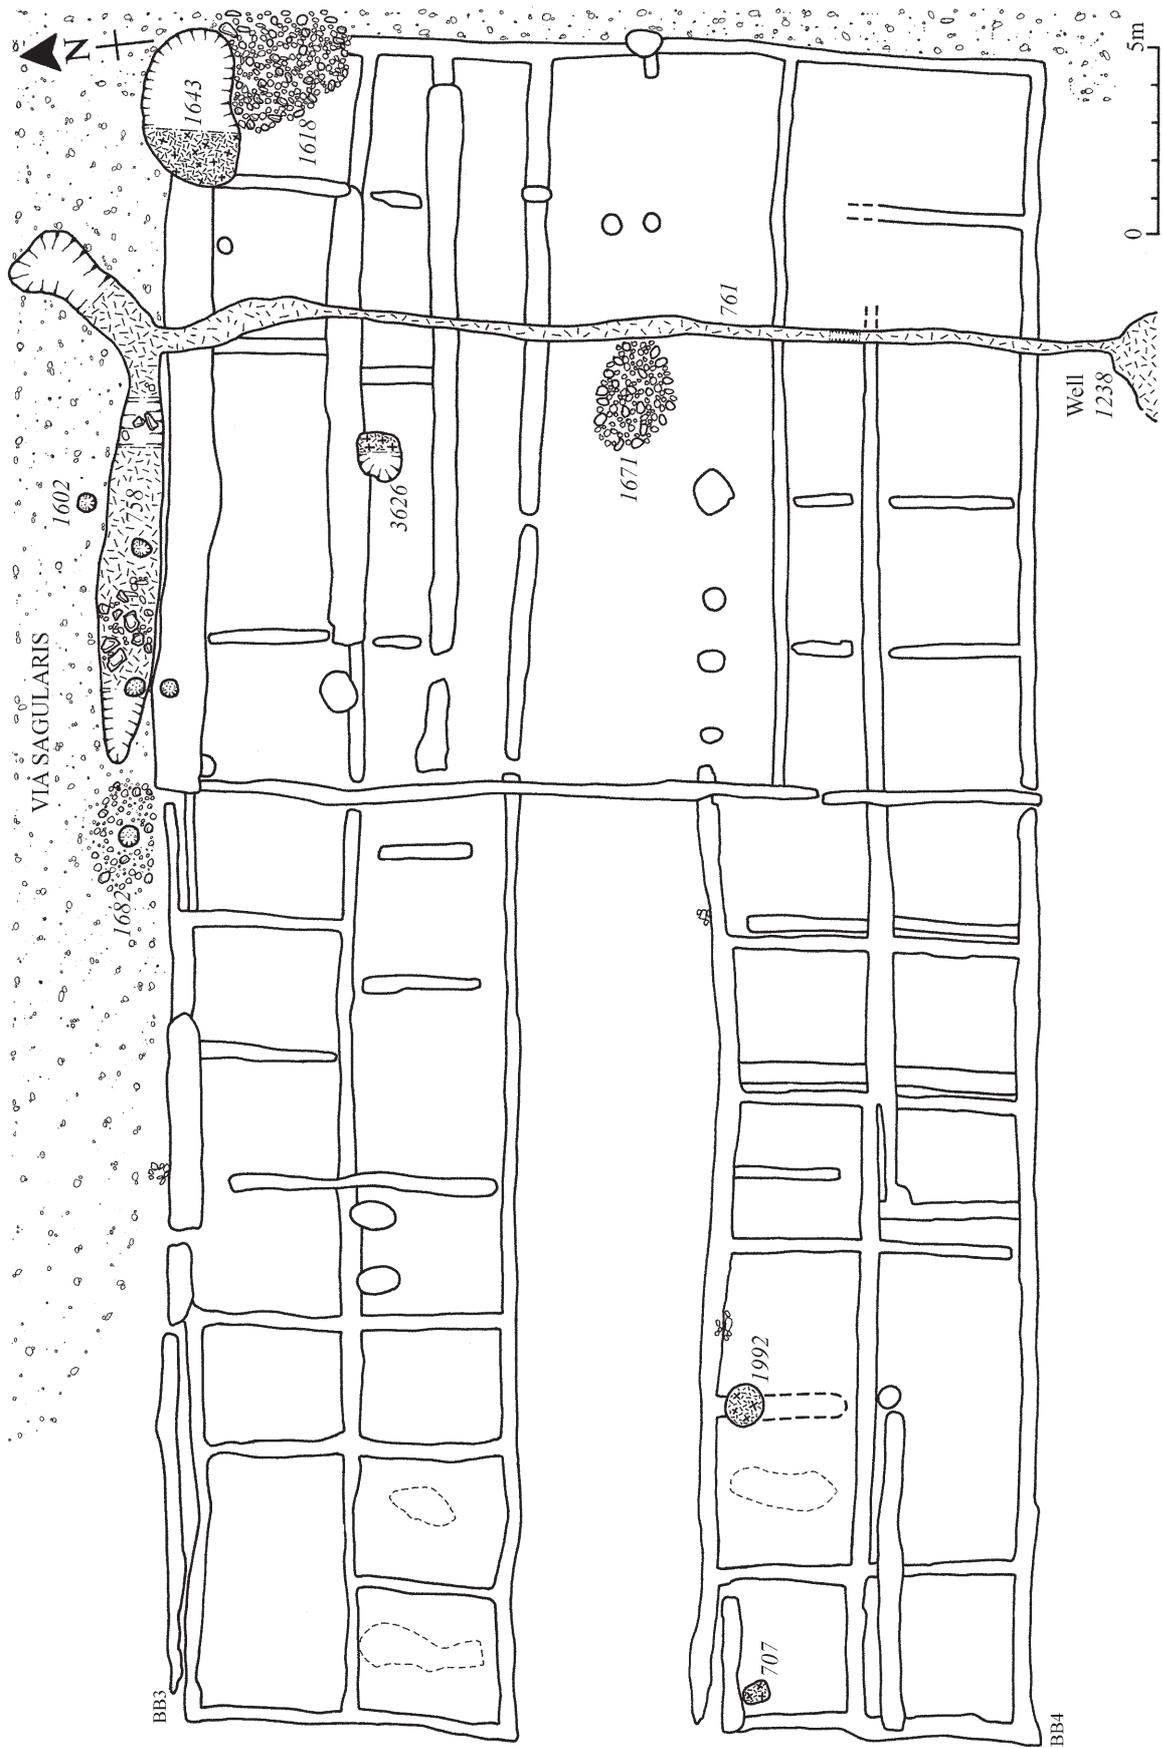
FIG. 5.7 Plan of Barracks 3 and 4: post-building and demolition phases

After the building had been demolished, continued use of the area is indicated by a number of features (FIG. 5.7). A shallow U-shaped gully (761) only 0.08m deep ran from the well (1238), located between Barrack 4 and Granary 2, across the site of the officers' quarters of

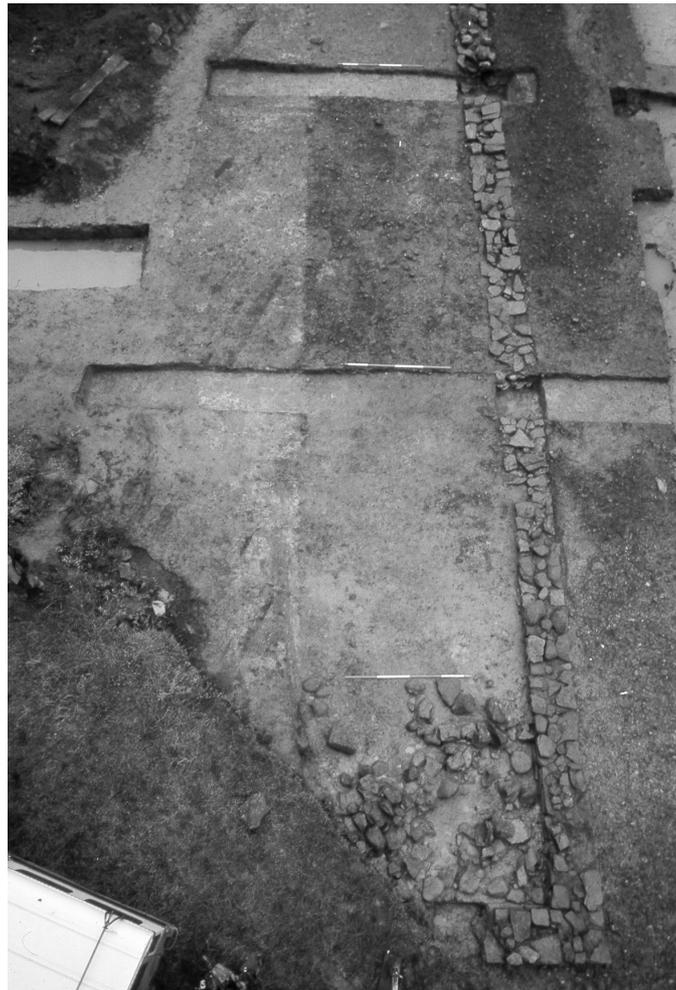
PLATE 5.3 *Fabrica*; view south

The *fabrica* was a simple rectangular structure measuring 32.2m by 4.2m externally (FIG. 5.8). Its long and narrow shape was dictated by the space available, for it was situated in the north-east corner of the fort, set into the rear of the rampart opposite the end wall of Barracks 3 and 4 (PLATE 5.3). Although the rampart had been cut back by 2.7m to accommodate it, the building still projected out into the *via sagularis* reducing the width of that road at the narrowest point to 2.3m.

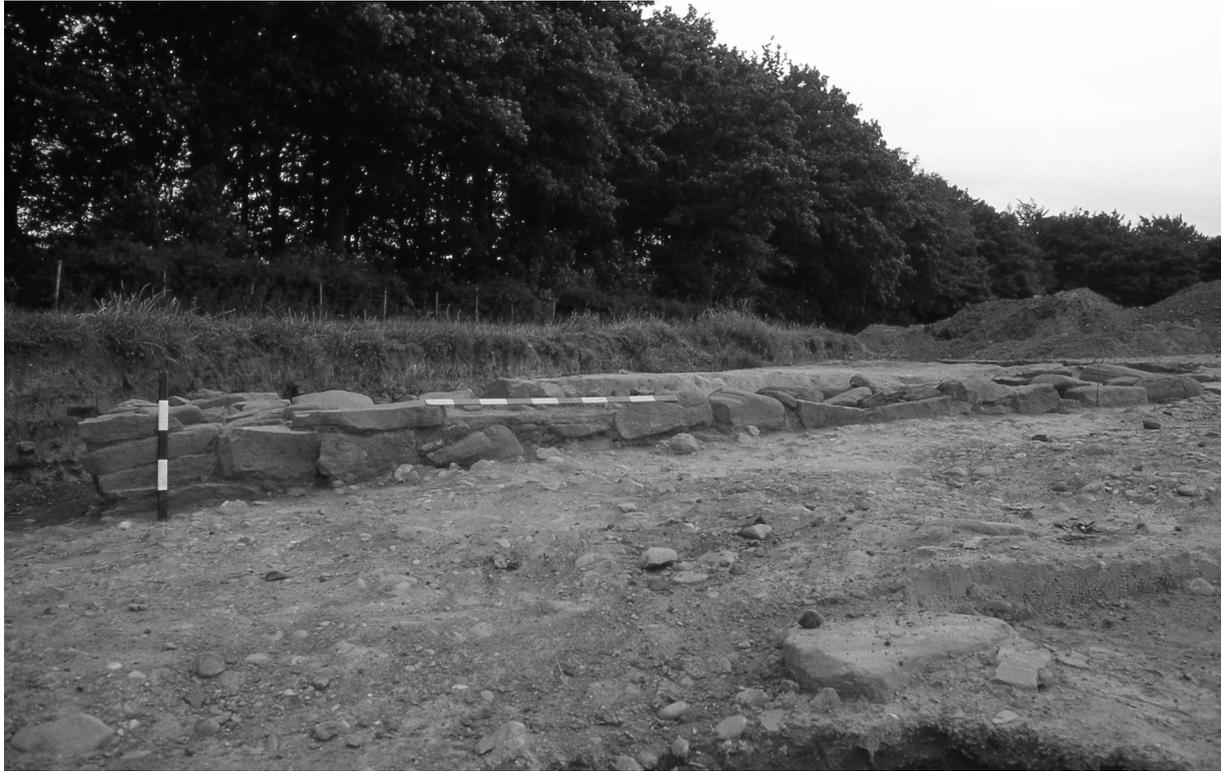
PLATE 5.4 North-west corner of stone wall footing of *fabrica*; view south-east

The building was defined on three sides by stone footings that survived to a maximum height of 0.5m (PLATE 5.4) at the northern end, where they had been protected by the build-up of silts which had accumulated in this corner of the fort as a result of the natural drainage pattern. The southern end had, however, been considerably truncated by ploughing. The rampart of the fort formed the east side of the building, the roof supported by a line of six apparently irregularly spaced post-settings. These proved difficult to detect and so there is good reason to believe that some may have been missed, particularly at the southern end. An average spacing of *c.* 3m would fit both the surviving examples and the gaps.

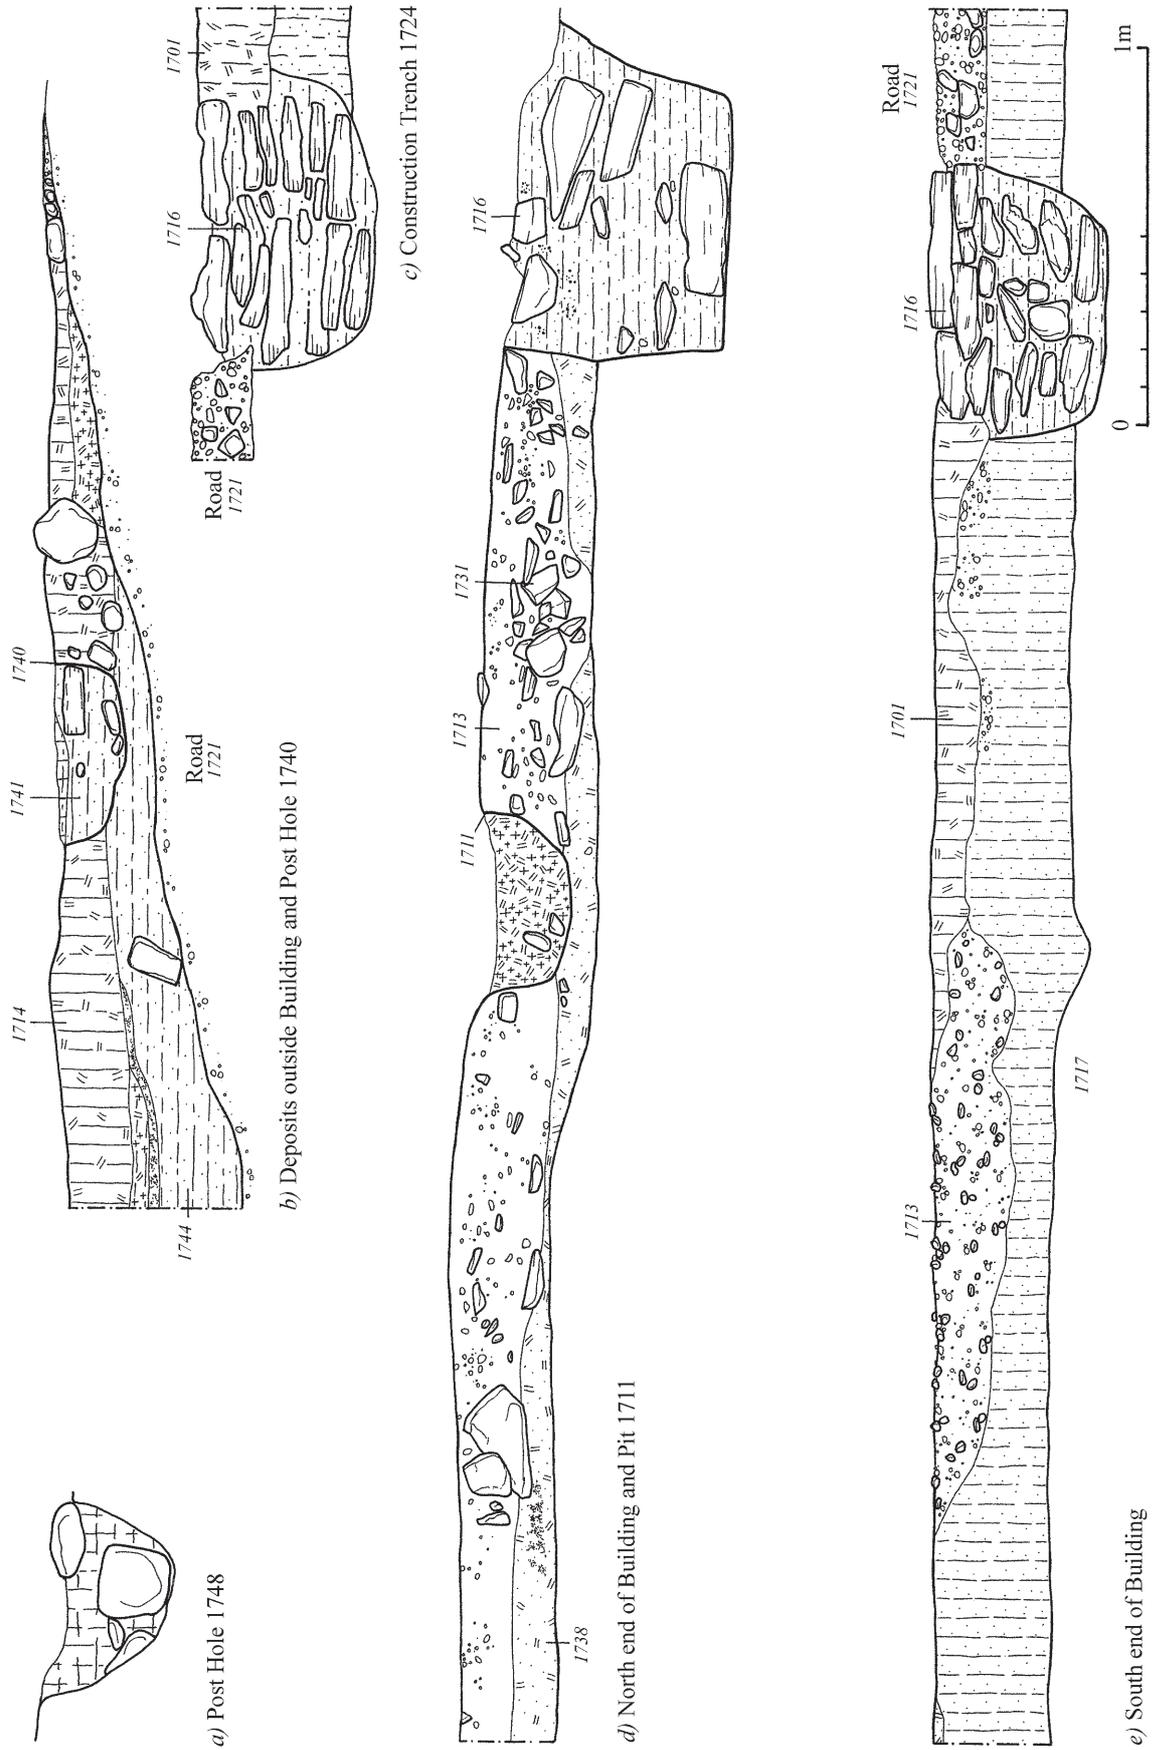
FIG. 5.9 Sections across the *fabrica* and associated deposits: a. post-hole 1748; b. deposits outside north end and post-hole 1740; c. construction trench 1724; d. north end of building and pit 1711; e. south end of building

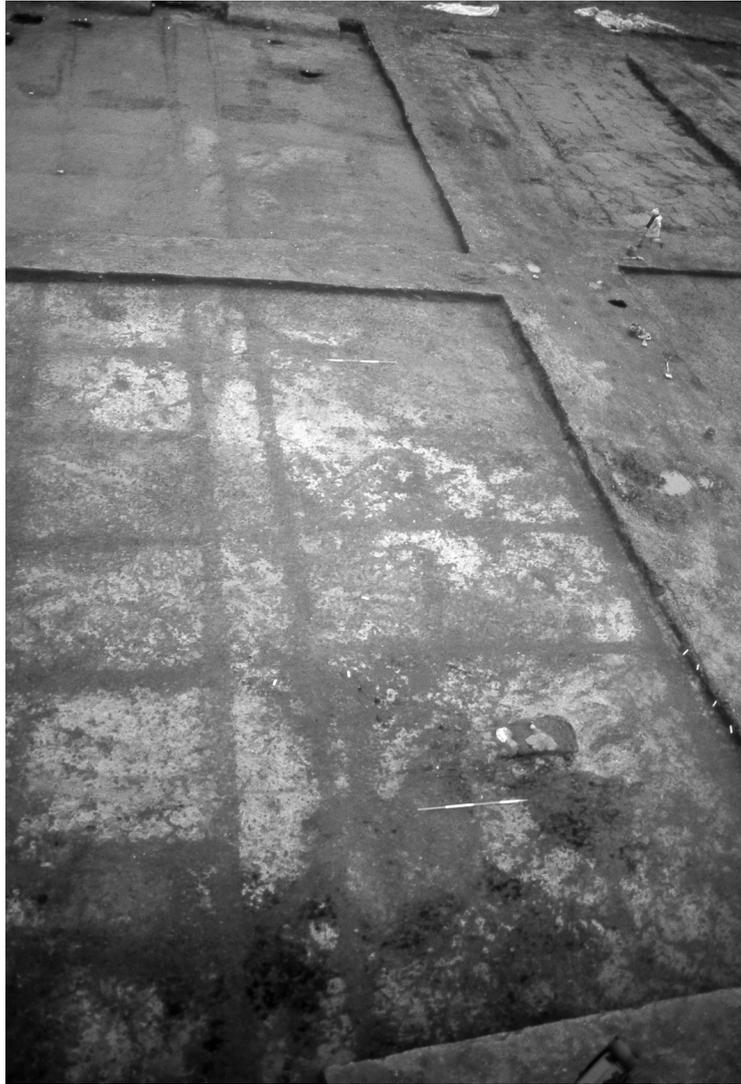
PLATE 6.1 Building 8 (with pits 2664, 2666 and 2669) and Barrack 7; view south

After removal of the ploughsoil, excavation of the upper layers at the south end of Barrack 5 was started by hand. However, because negative features proved virtually impossible to discern (above 1.2) and time was pressing, the whole surface was lowered some 0.3–0.4m further by machine (PLATE 6.1). Pit 1357 in the officers' quarters (27), for example, was recorded during the primary hand-digging stage only as a differential concentration of stones and brick: no soil colour differentiation was visible until the level was taken down. Accordingly, at least 0.3m should be added to the recorded depth of all negative features unless otherwise stated, and the possibility noted that some shallower features, particularly secondary structural elements, may have been lost in the process.

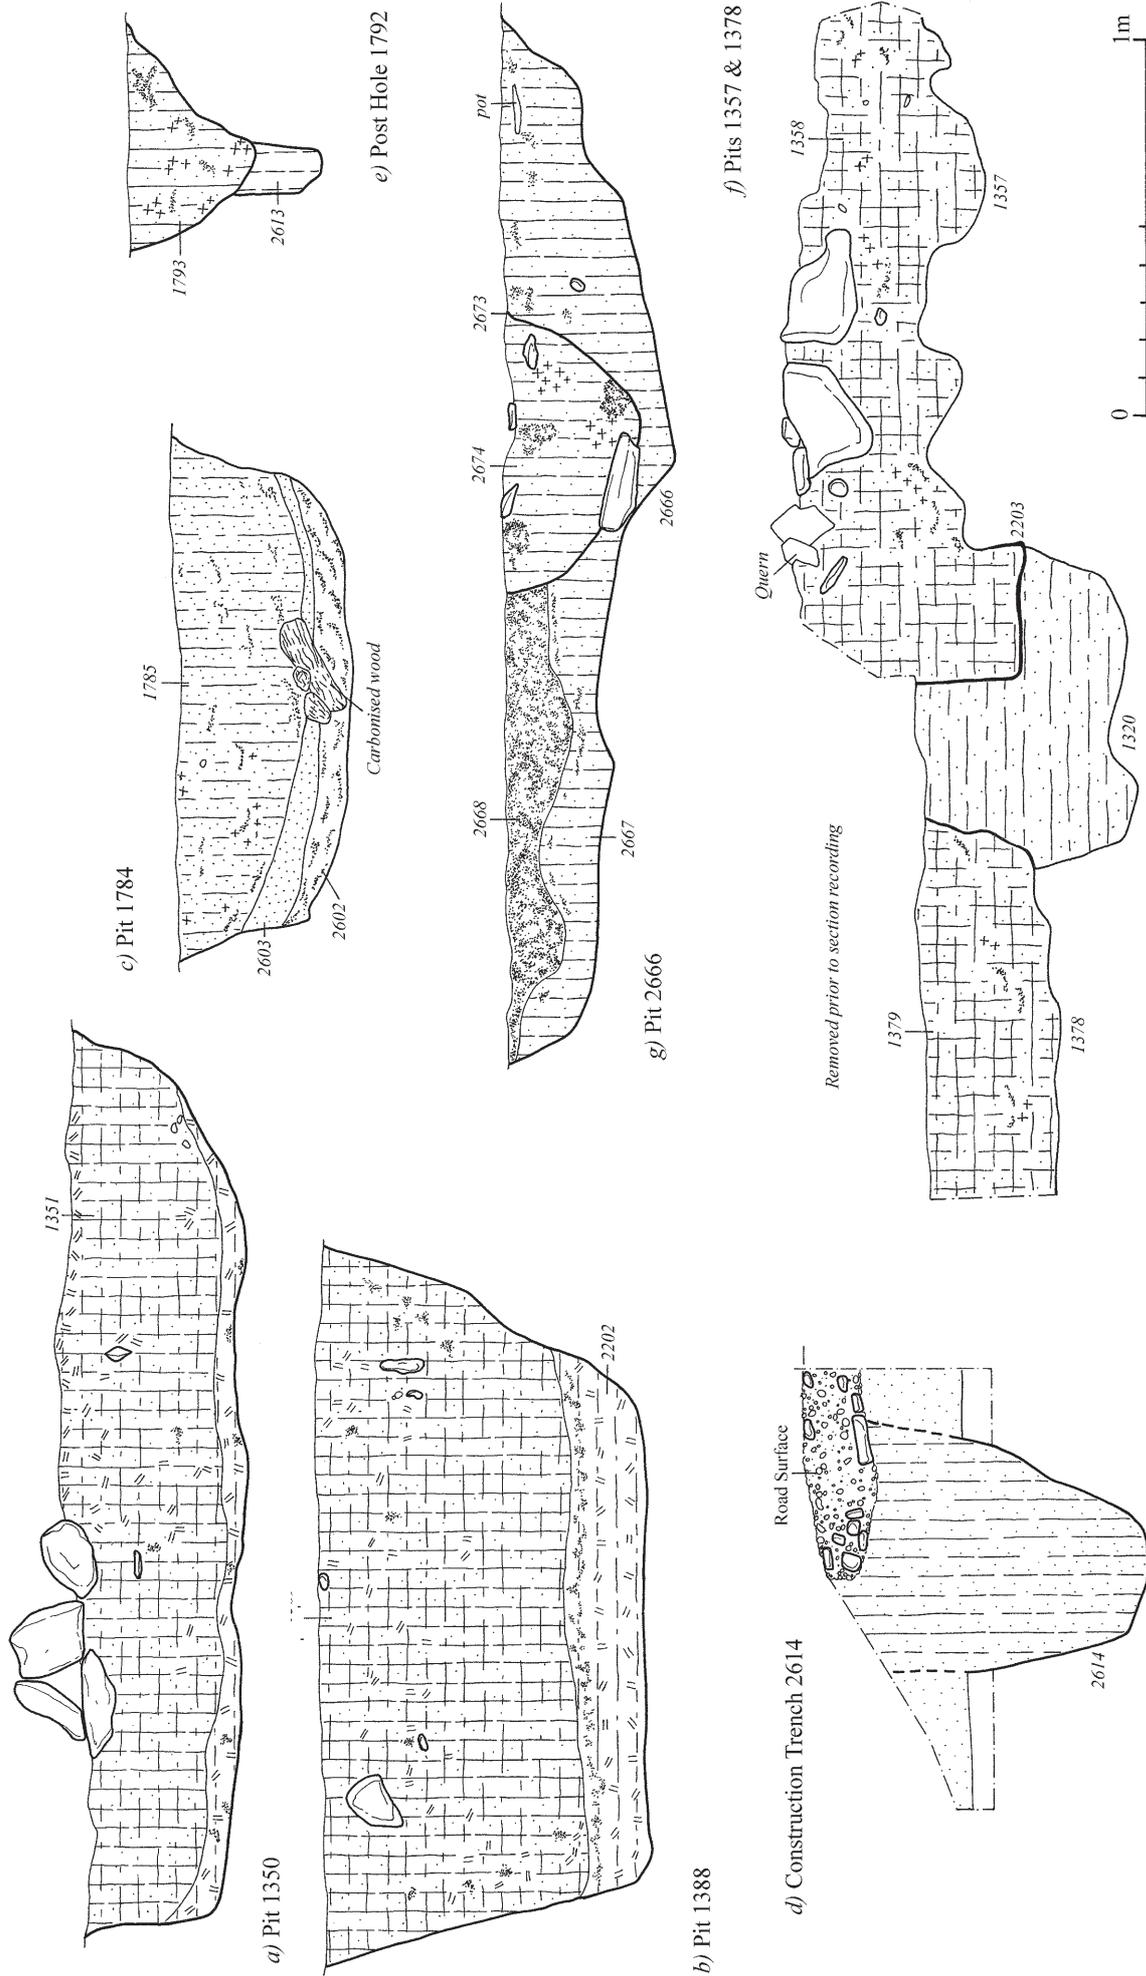
FIG. 6.3 Sections of pits and structural features in the eastern *praetentura*: a. pit 1350, Barrack 6; b. pit 1388, Barrack 6; c. pit 1784, Barrack 7; d. construction trench 2614, Barrack 7 and *intervallum* road; e. post-hole 1792, Building 8; f. pits 1357 and 1378 and construction trench 1320, Barrack 5; g. demolition pit 2666, Building 8

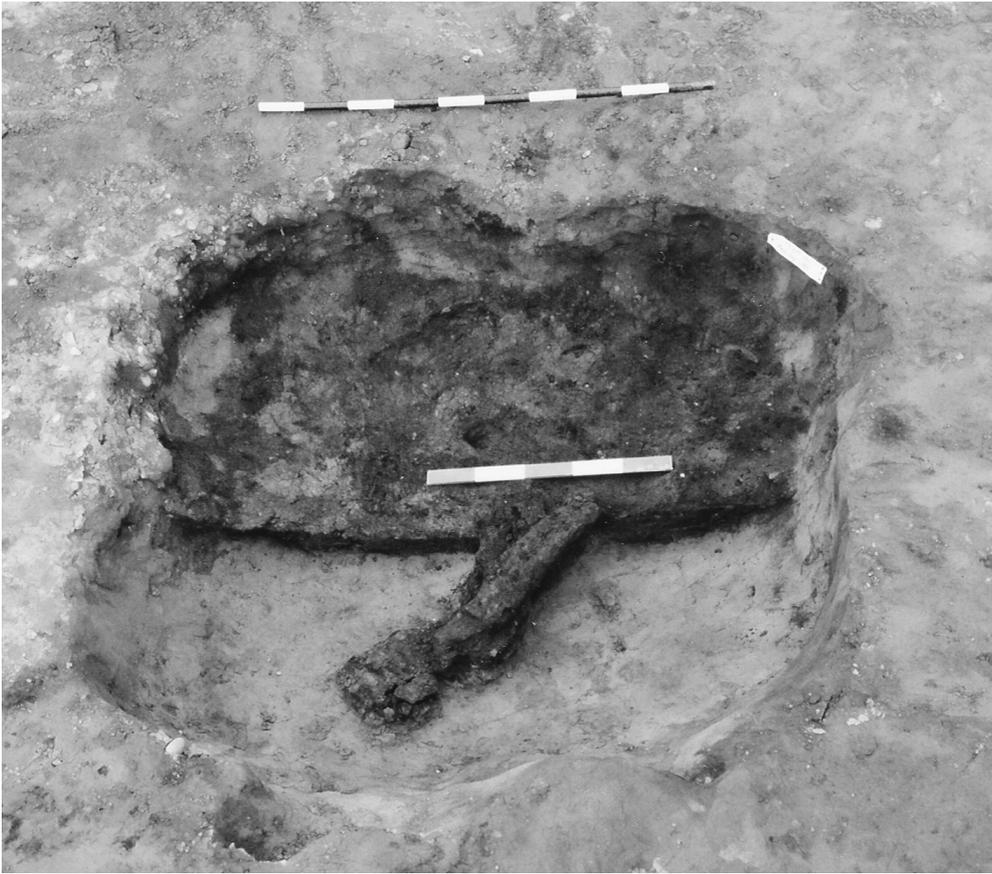
PLATE 6.2 Burnt turf in pit 1784, Barrack 7; view south

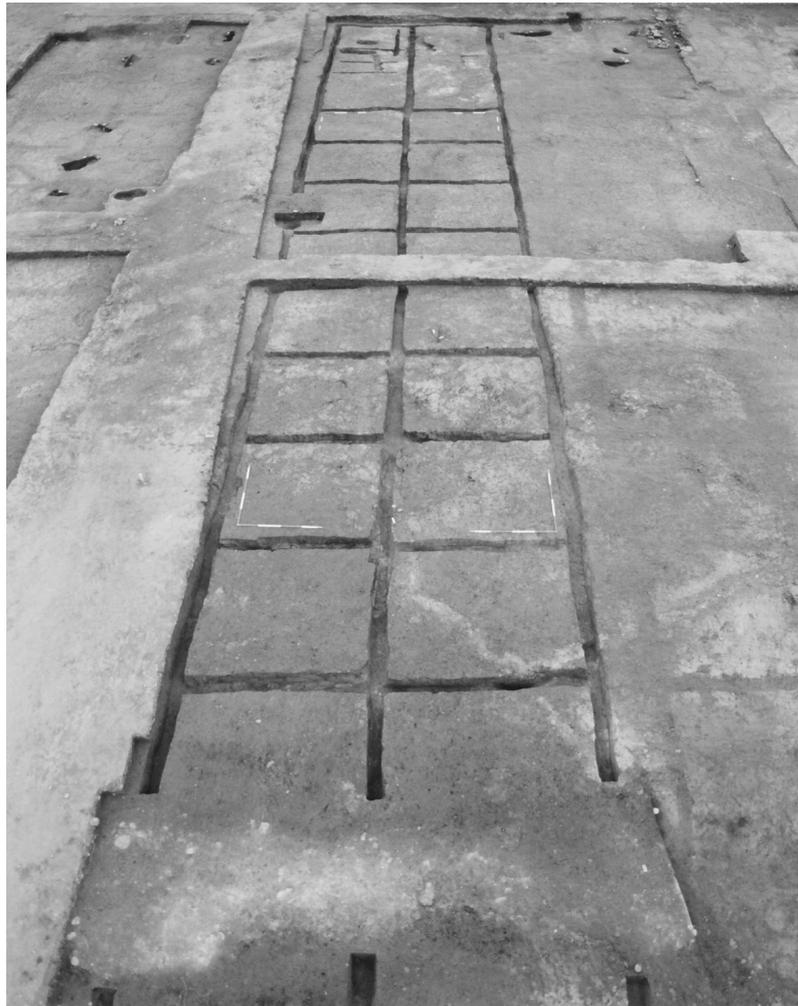
PLATE 6.3 Barrack 10 completely excavated; view south

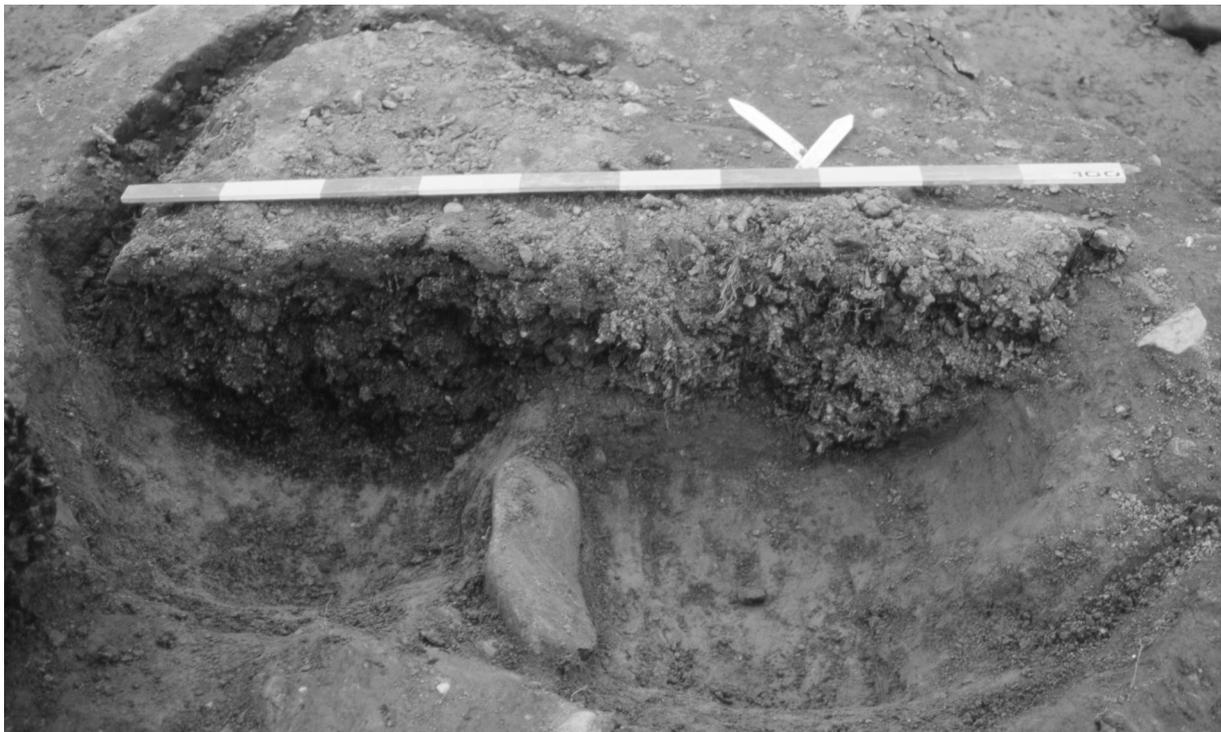
PLATE 6.4 Nail pit 1541 under excavation, Barrack 9; view north

Finally, an unusual pit (1541) was discovered in the eighth *contubernium* on the west side of Barrack 9. It was quite shallow, surviving to a depth of only 0.32m from the bottom of the worm-sorted horizon, but was filled by a mass of unused iron nails (below 10.9.2) mainly corroded together into large lumps (PLATE 6.4). Though the pit cut through a general spread of demolition material, it seems best interpreted as dug to dispose of stock that was surplus to requirements within the area of the recently demolished fort. Even in their corroded state the nails weighed over 160kg and would have constituted a considerable burden for the evacuating

troops. The circumstances are directly analogous, if on a considerably smaller scale, to the contemporary burial of some ten tons of nails in the *fabrica* of the legionary fortress at Inchtuthil (Pitts and St Joseph 1985, 109–13). Though it is argued there that the burial was to prevent later recovery of the nails by the natives, it is possible that it was merely part of the general tidying up process on evacuation of the fort.
