ELGINHAUGH: A FLAVIAN FORT AND ITS ANNEXE

VOLUME 1

By W.S. Hanson

Britannia Monograph Series

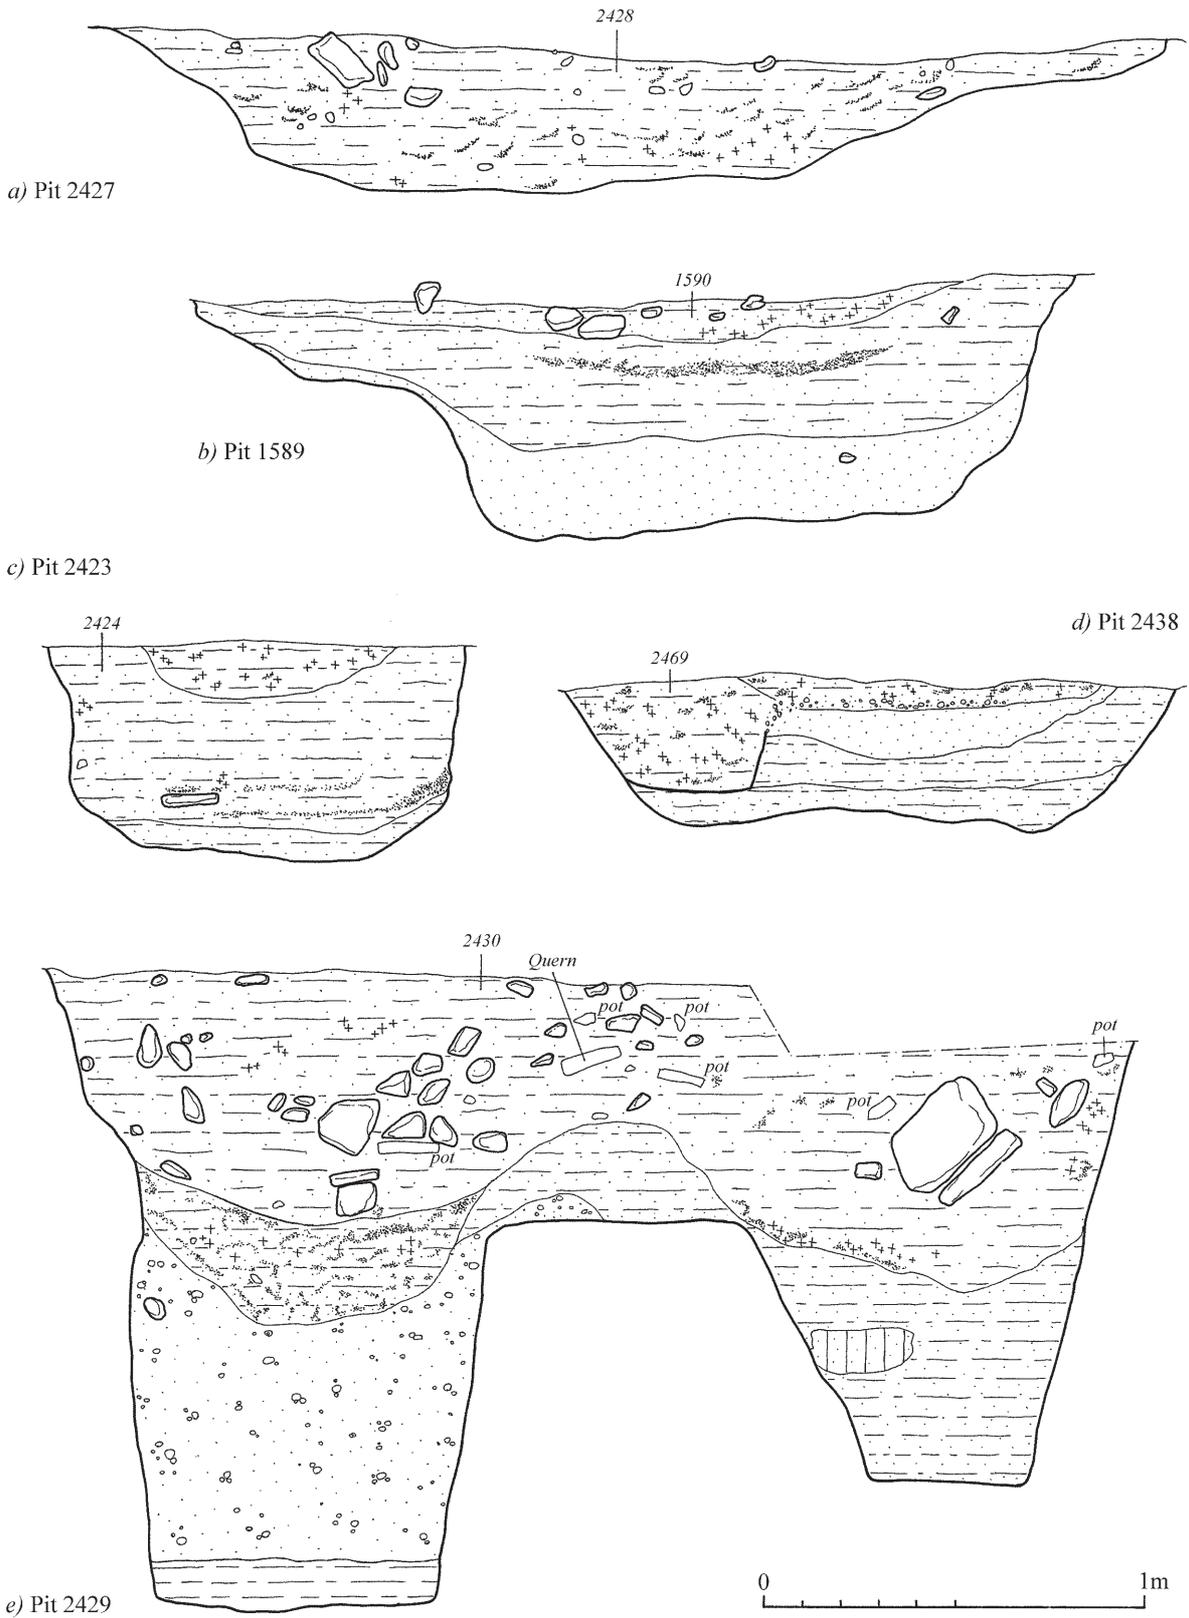
FIG. 6.8 Pit sections in Barracks 11 and 12: a. pit 2427, Barrack 12; b. pit 1589, Barrack 11; c. pit 2423, Barrack 12; d. pit 2438, Barrack 12; e. latrine pit 2429, Barrack 12

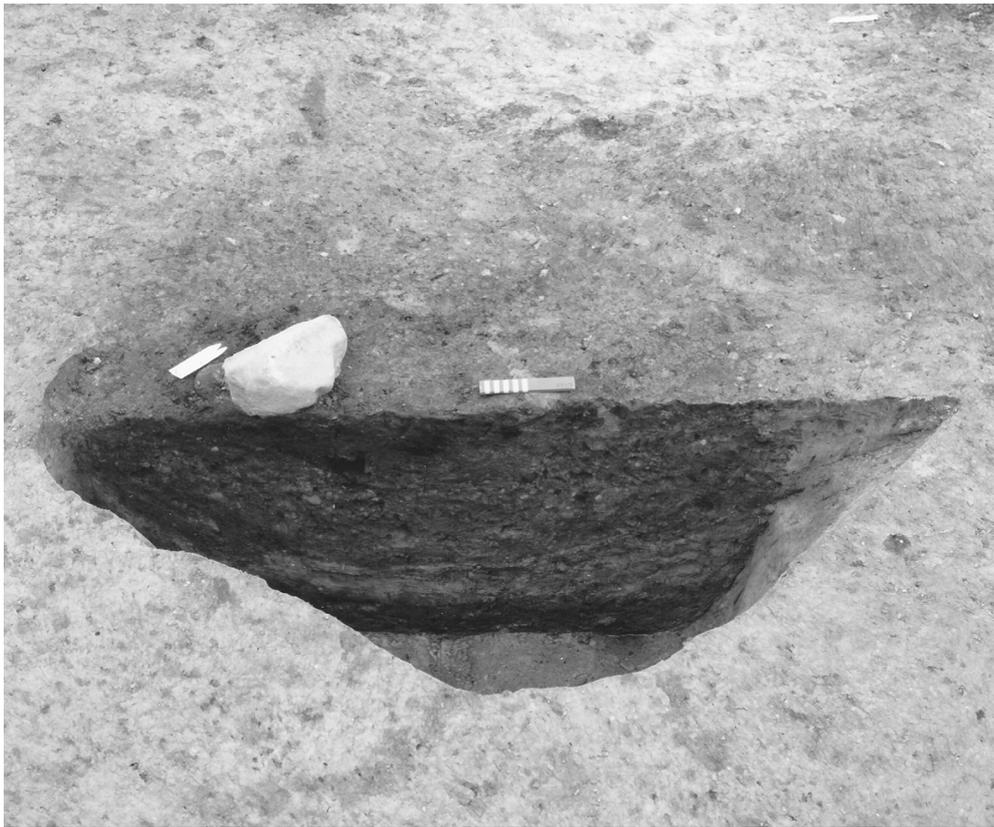
PLATE 6.5 Pit 2425 in Barrack 12 showing upper demolition fill; view north-west

and burnt daub indicating that it had been open, or perhaps its filling disturbed, during the demolition of the building. It has some of the characteristics of a urine soakaway pit, but is situated rather too close to the partition wall and might alternatively be interpreted as structural, either supporting some internal fitting or a repair.

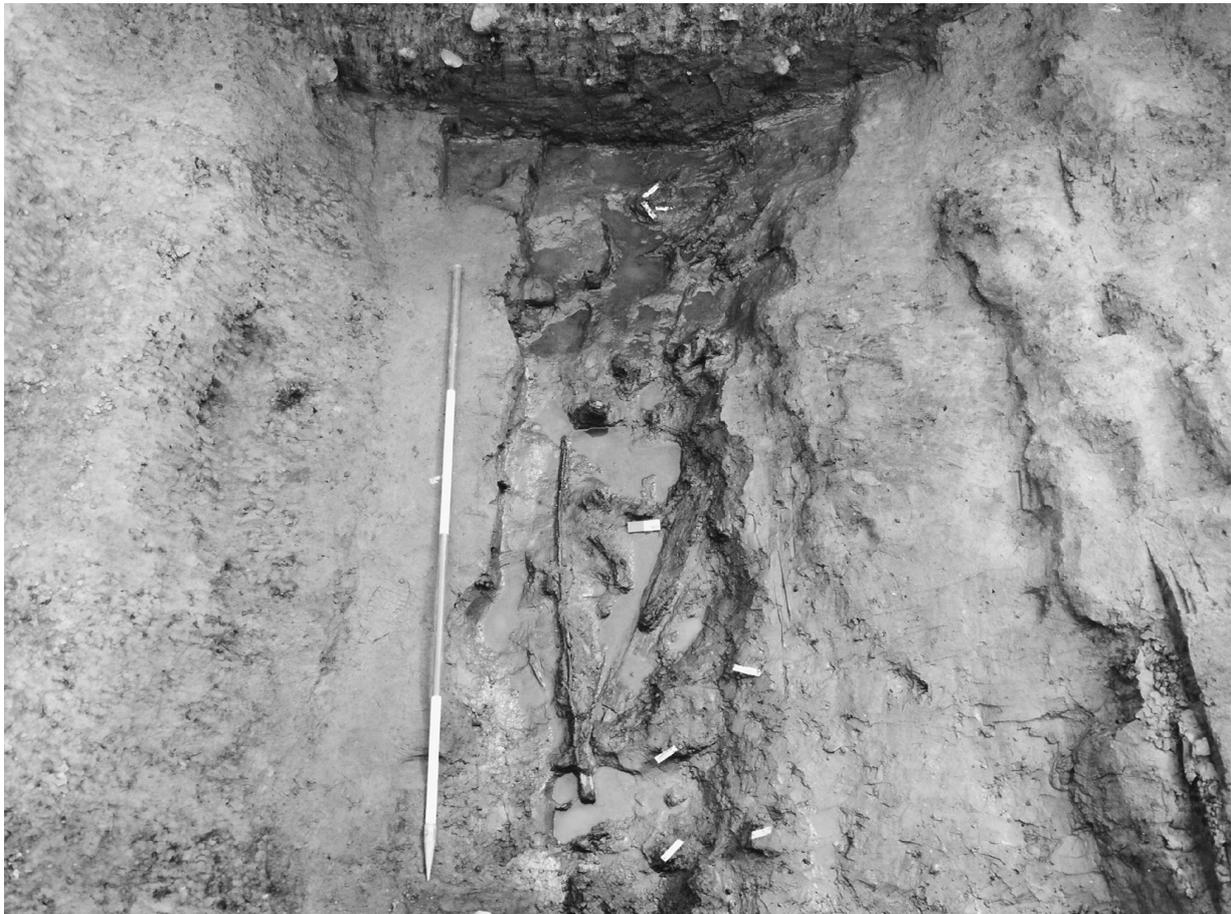
PLATE 7.1 Waterlogged base of inner east ditch 891 with surviving organic material; view south

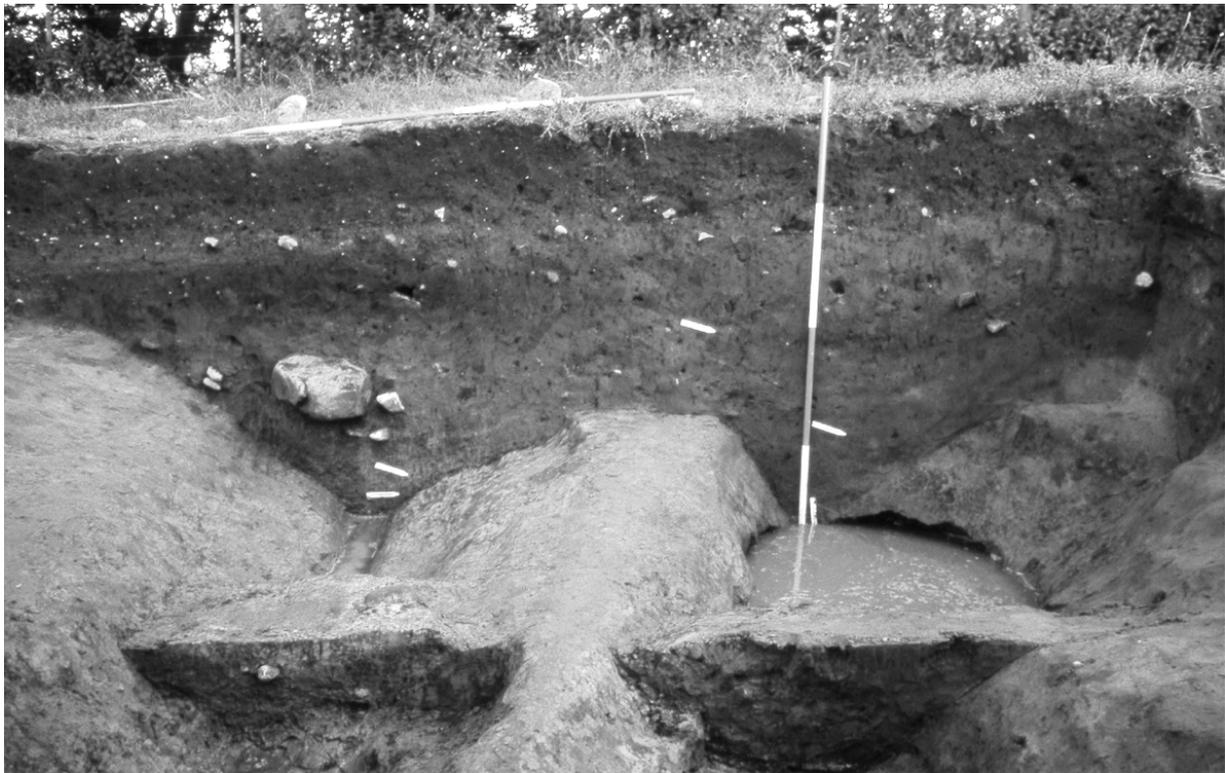
PLATE 7.2 Recut inner ditch (right) at south-east corner deviating from original ditch line; view south

There are slight indications that the ditches represent two phases of defensive provision. The general characteristics of the outer ditches are consistent, but contrast sharply with those of the inner ditch which is much wider and deeper. Indeed, its size is consistent with it being the sole enclosing ditch, for multiple systems tend to utilise smaller ditches (Jones 1975, 112; Johnson 1983, 48), as is well illustrated by the outer examples at Elginhaugh. What is uncertain, however, is whether the outer ditches were a later addition to an original single ditch, or whether the width of the inner ditch was increased in a secondary phase, either incidentally, as it is likely to have been subject to regular cleaning, or deliberately, to augment or replace the original multiple system. In the annexe the third ditch to the north of the West Gate (601) cuts an earlier pit (1281) containing Roman finds (below 8.3), which would support the suggestion that the outer ditches were a slightly later addition. On the other hand, the inner ditch had clearly been extensively recut along much of the east side of the fort. At the south-east corner the recut inner ditch deviated entirely from the original alignment (PLATE 7.2), while its profile as it approaches the East Gate is suggestive of a more extensive recutting process (FIG. 7.3a and b). Indeed, the whole of the inner ditch on the north side of that road (1702) seems to have been recut for, though the relationship was not tested by excavation, it clearly cut the transverse ditch (1762). The third ditch on the east side of the fort (918, 1760) had also been recut at its butt ends on either side of the road (FIG. 7.2).

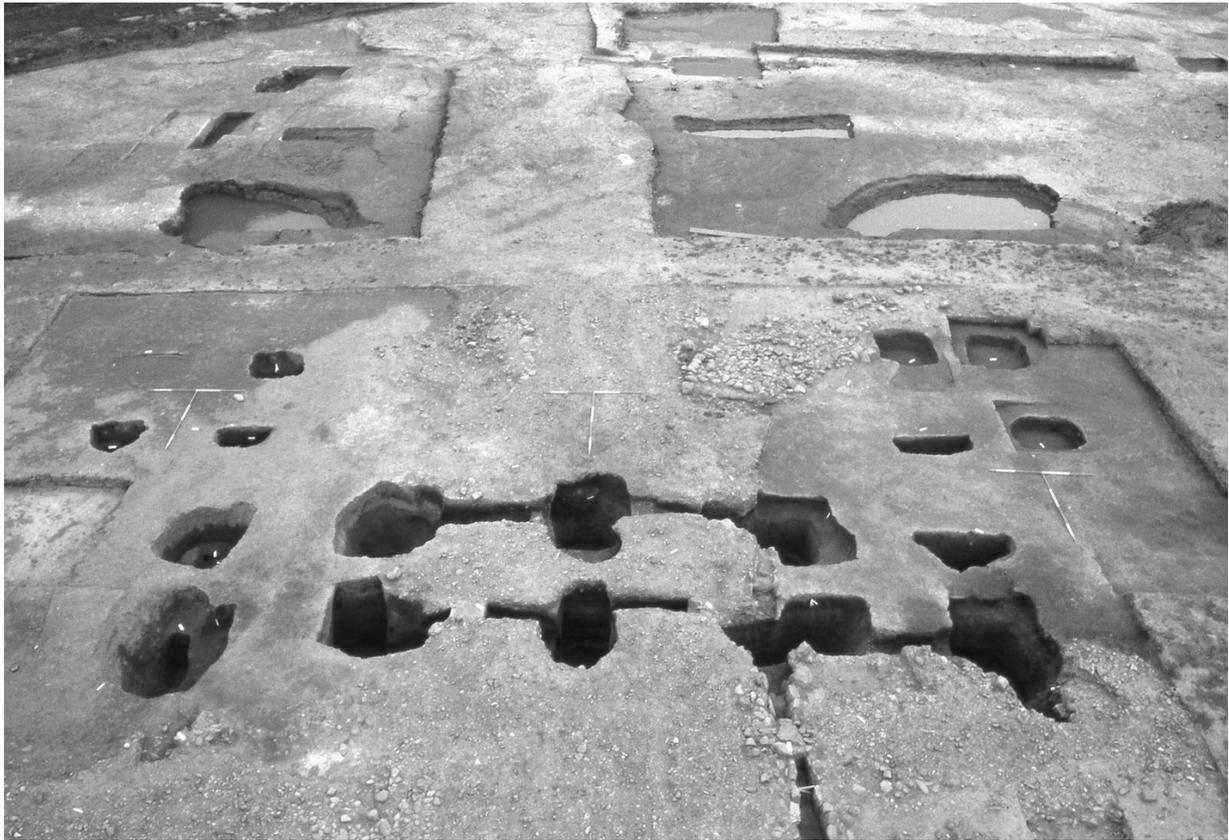
PLATE 7.3 East Gate and water-filled ditches beyond during excavation; view east

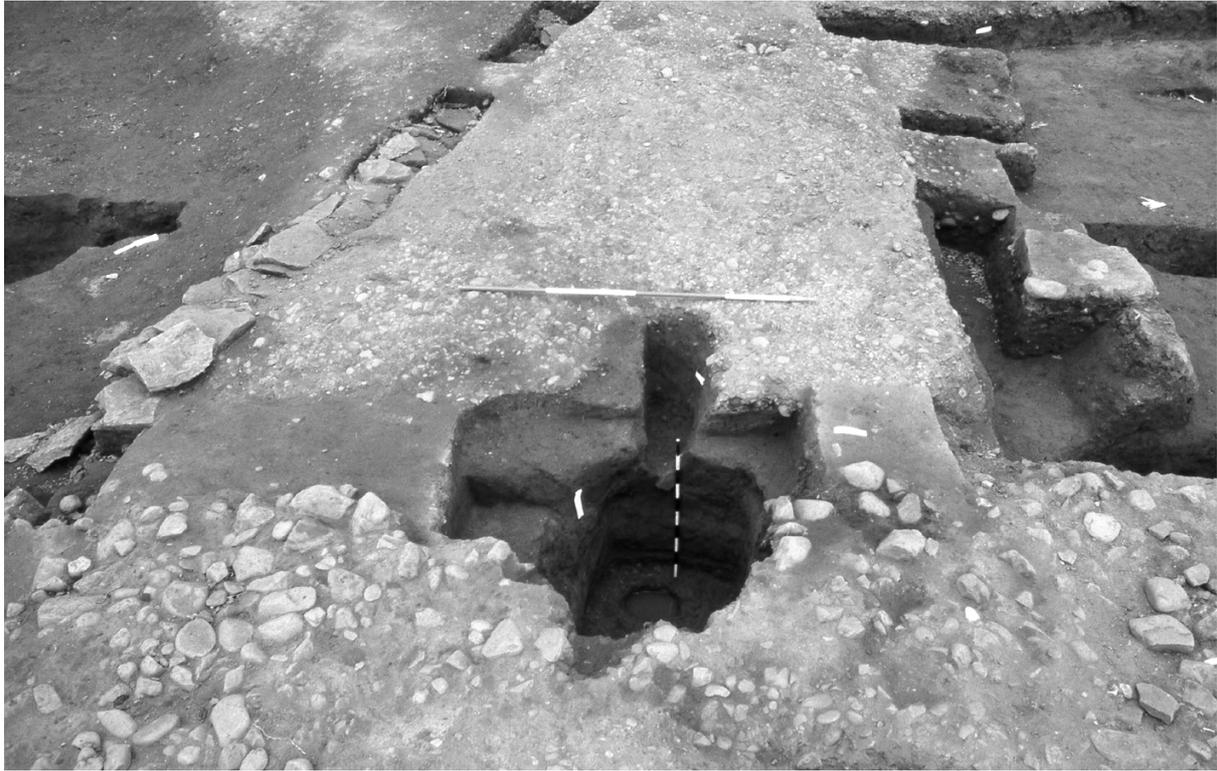
PLATE 7.4 South Gate, central post-holes 2744 and 2740, slot 2726 and later cobbling 2787; view south

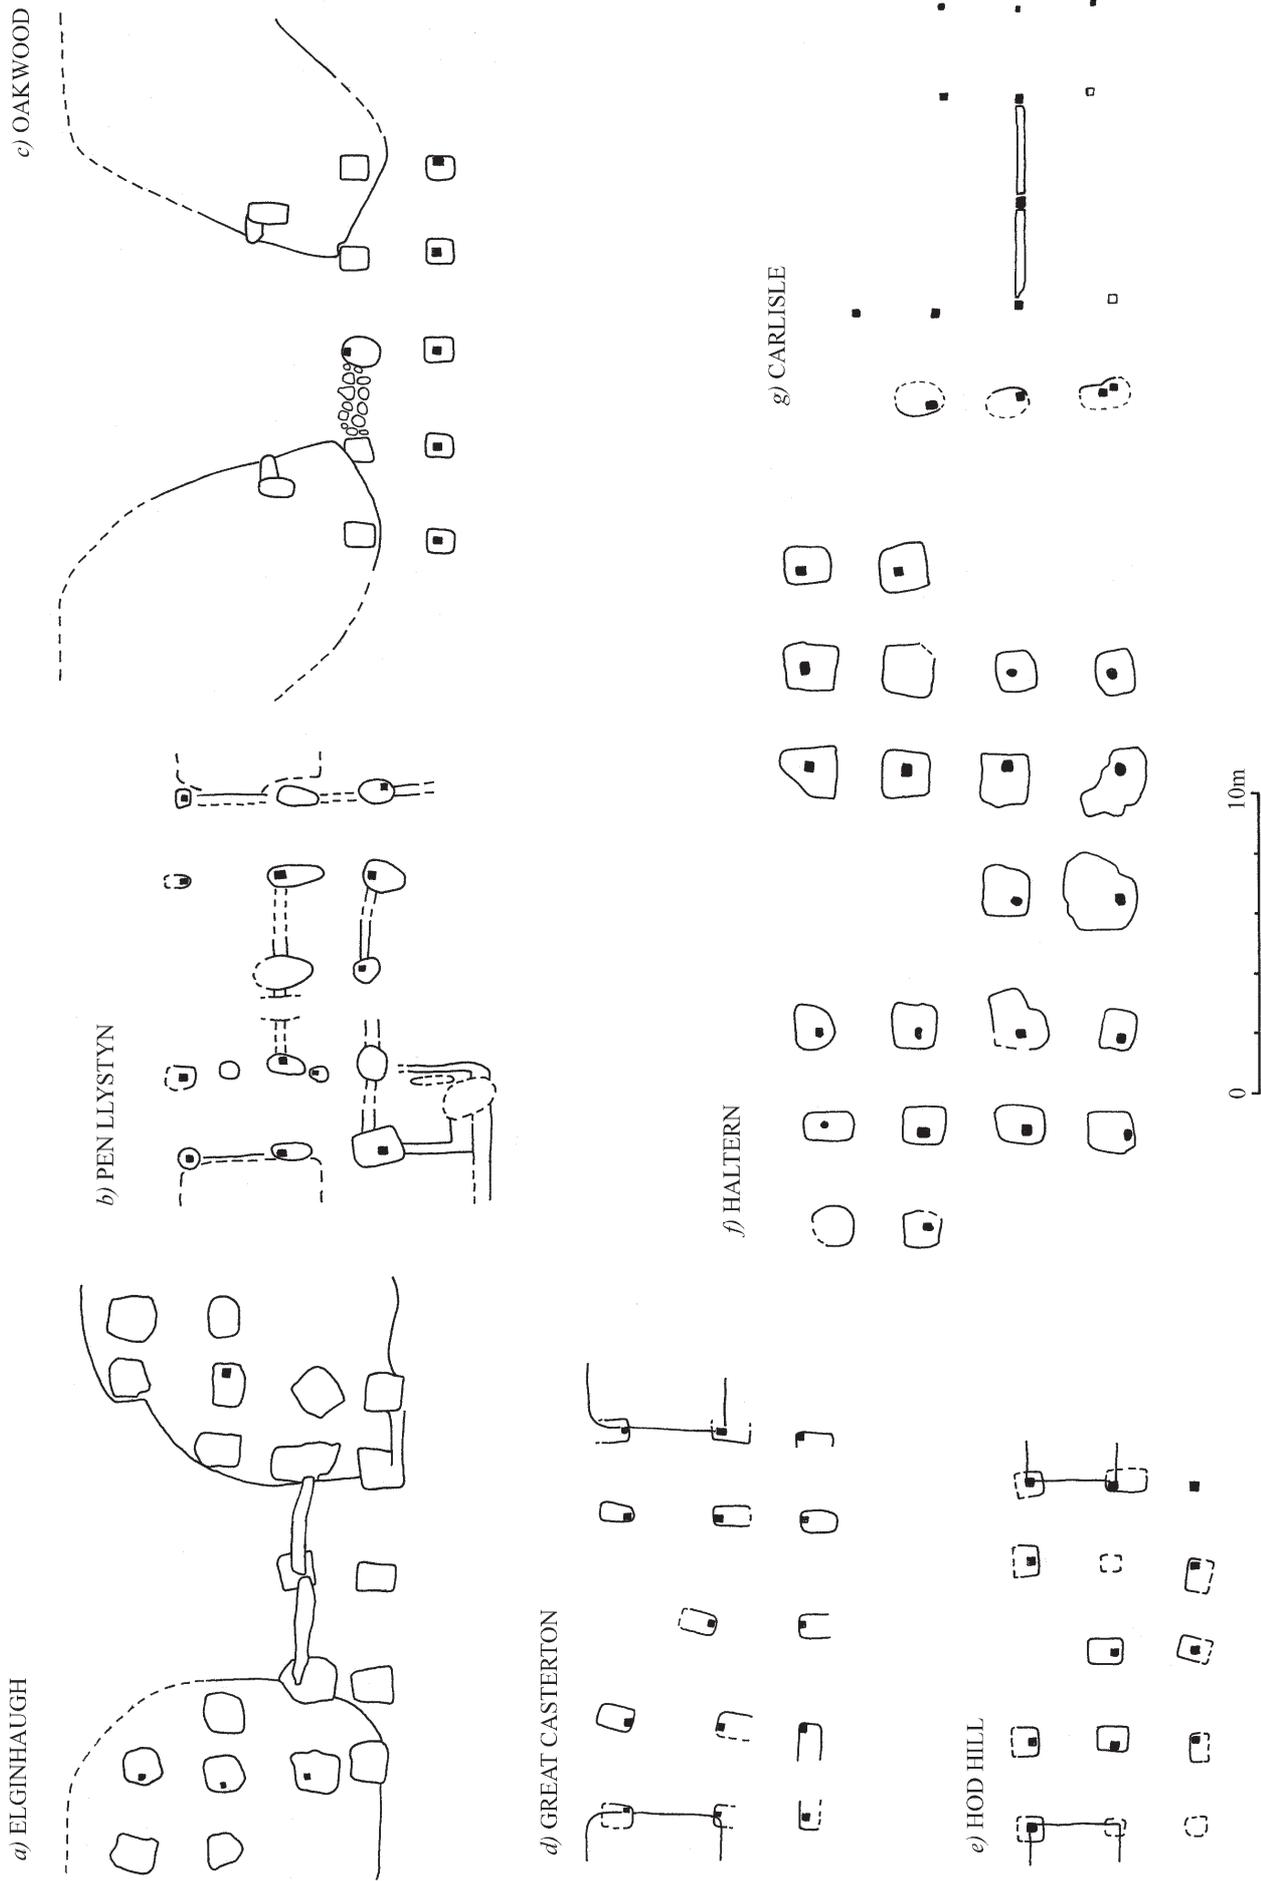
FIG. 7.13 Comparative gateway plans: a. Elginhaugh, East Gate; b. Pen Llystyn; c. Oakwood; d. Great Casterton; e. Oakwood; f. Haltern; g. Carlisle

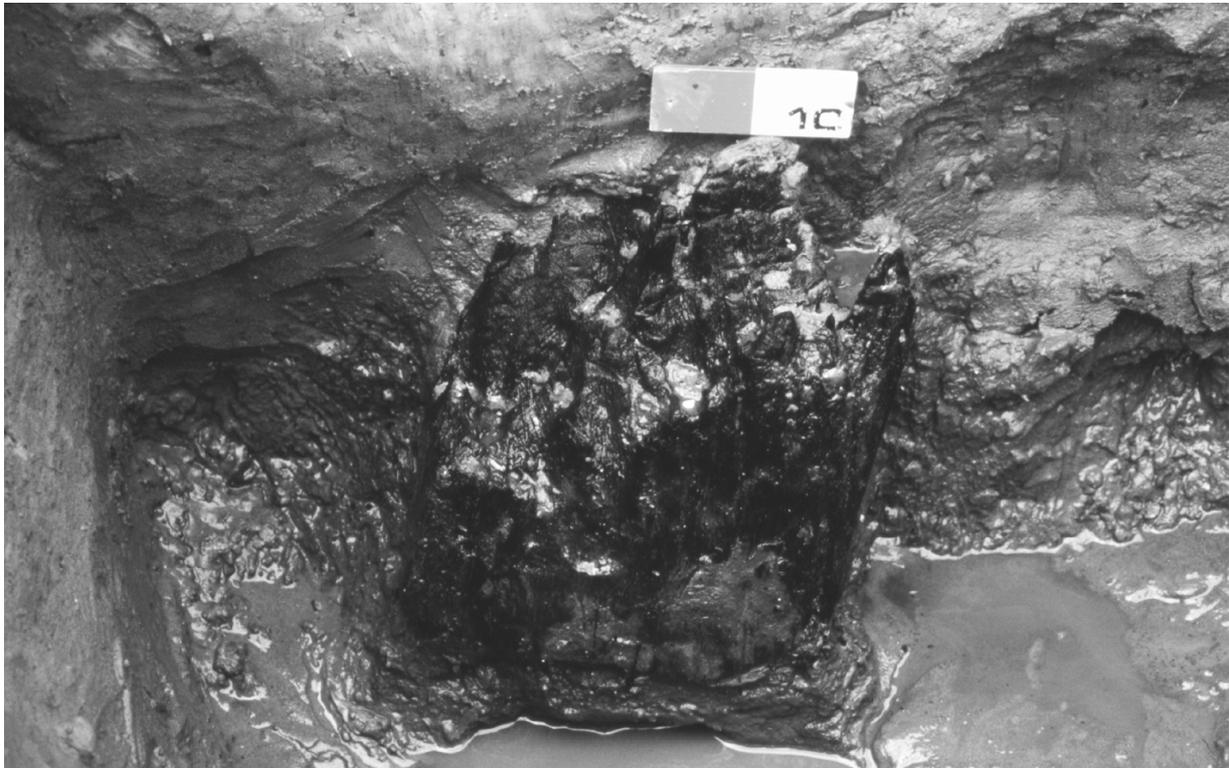
PLATE 7.5 Extant oak post within post-pit 1497, North Gate; view south

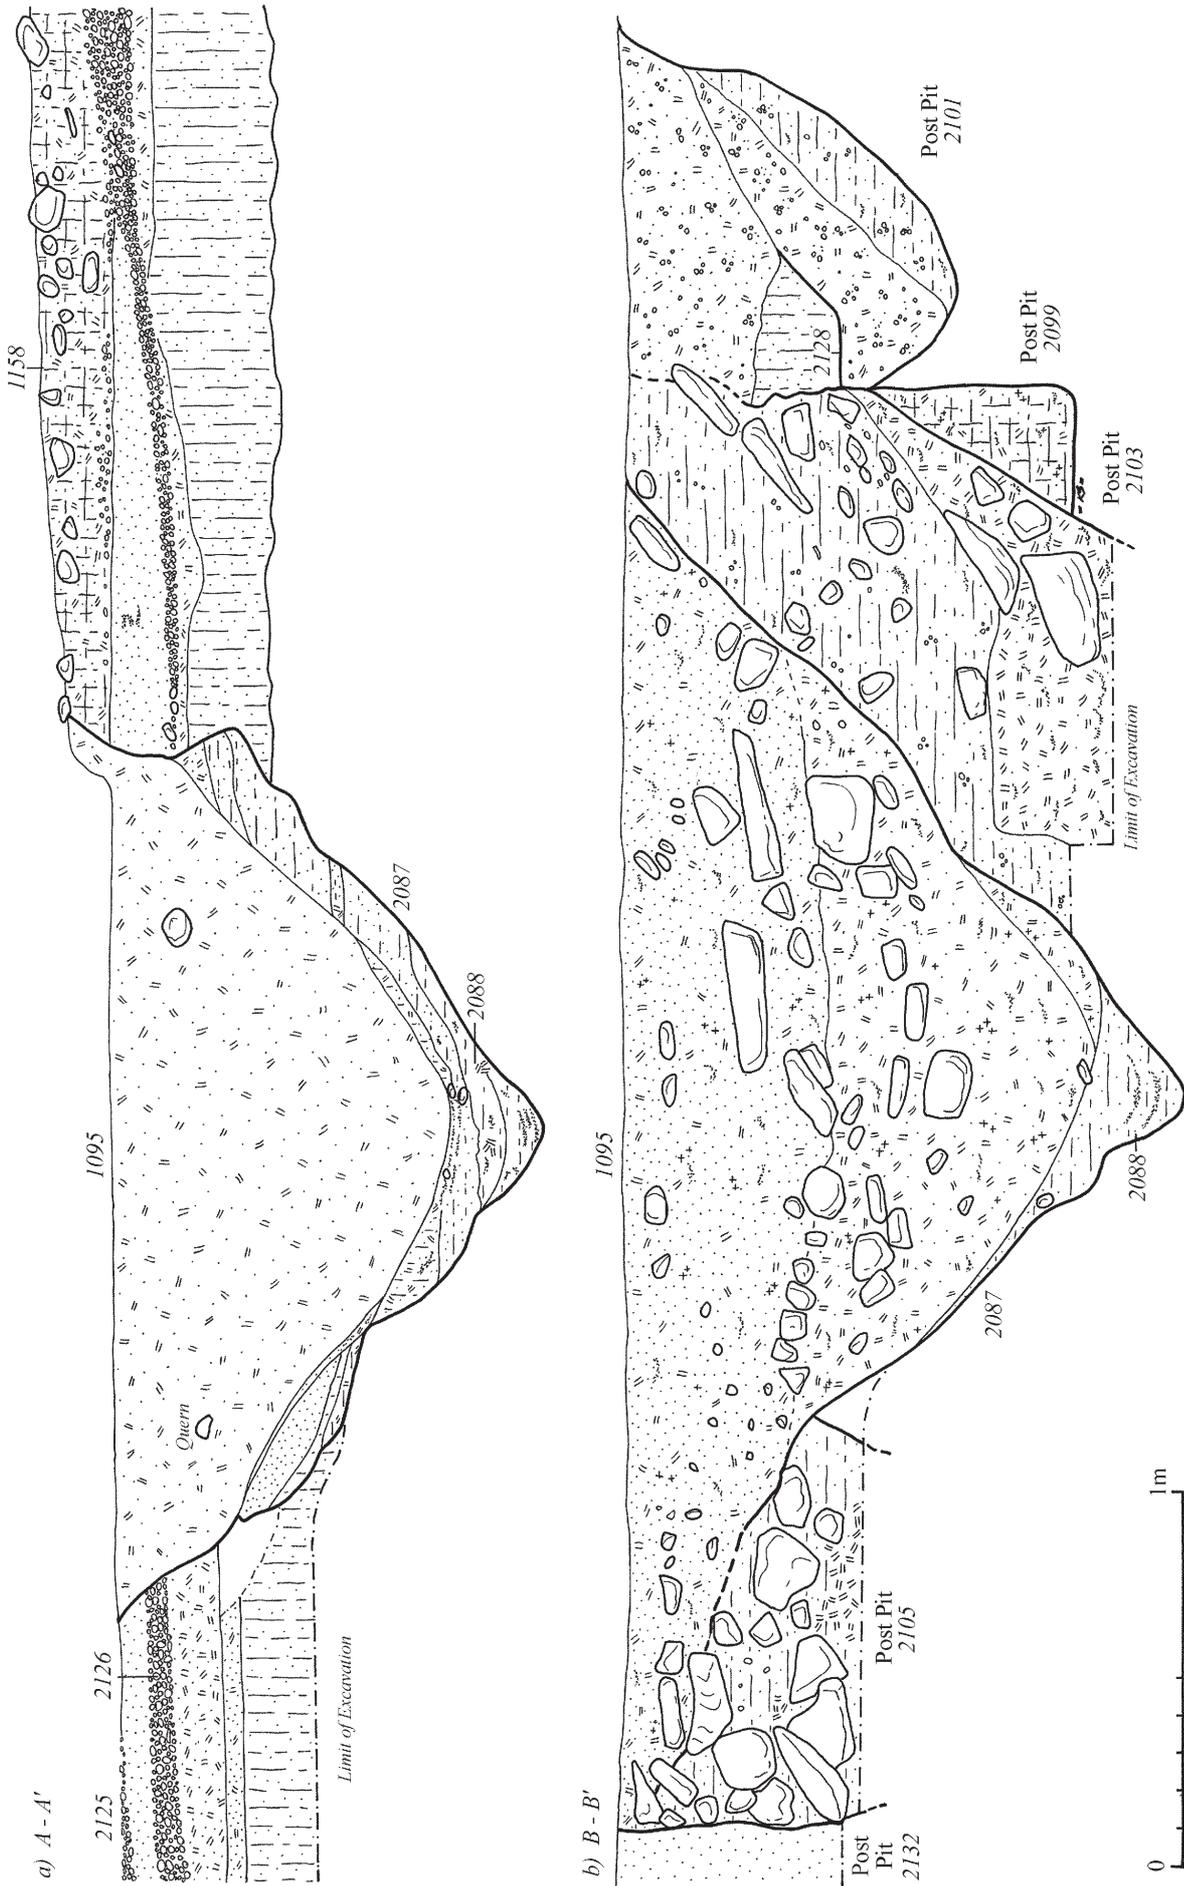
FIG. 7.18 West Gate: sections through the road (2125/6) and later cobbling (1158), post-pits (2099, 2101, 2103, 2105 and 2132) and blocking ditch (2087); for locations see FIGS 7.12 and 7.17

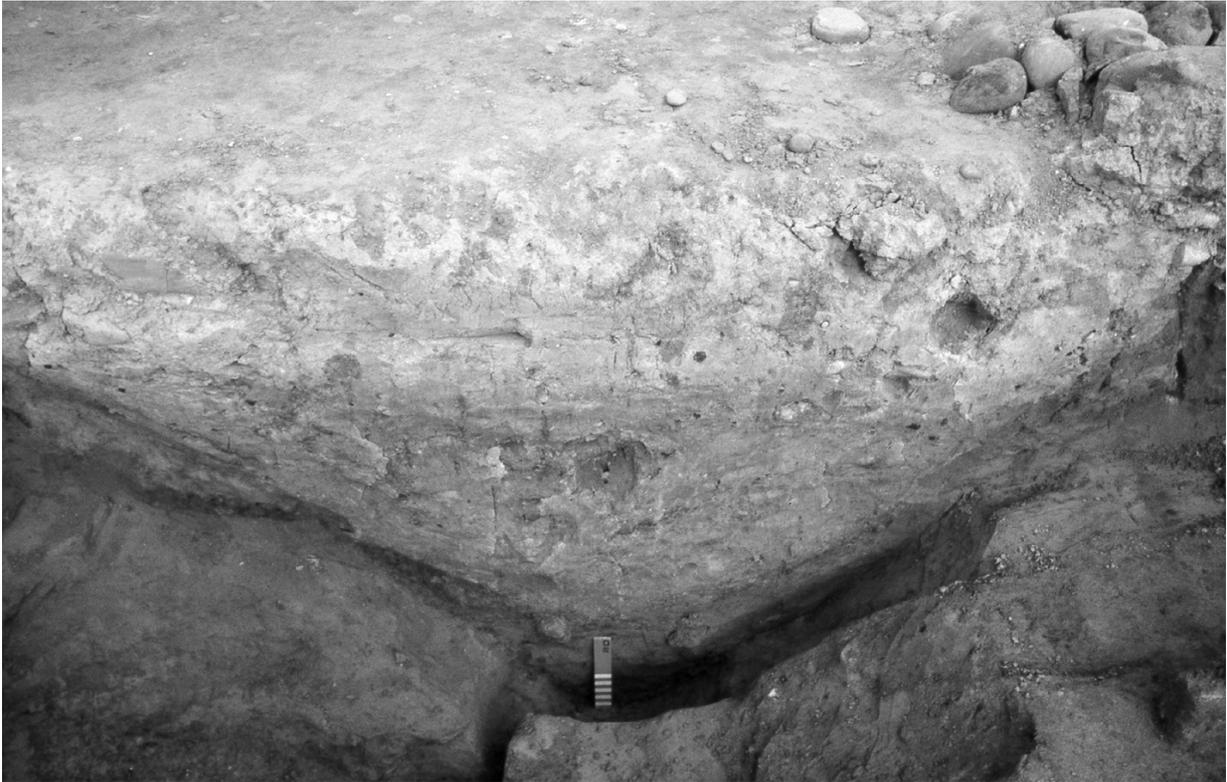
PLATE 7.6 Clay-packed slighting ditch 2087, West Gate; view south

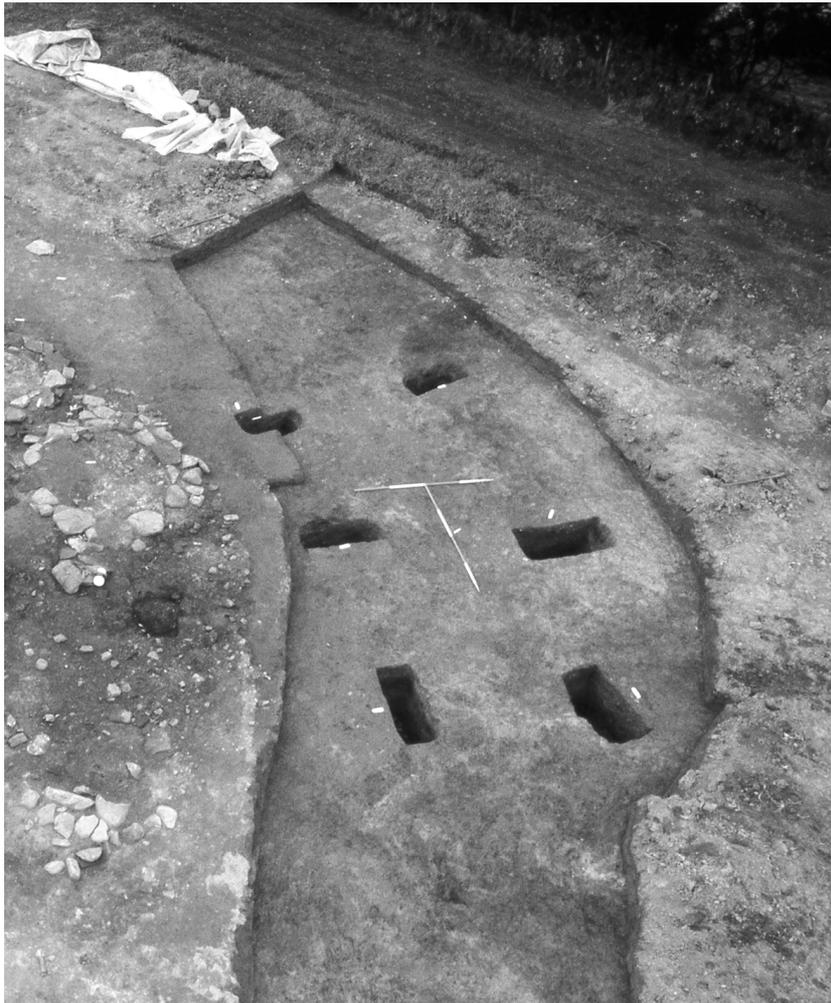
PLATE 7.8 South-west corner tower; view south

The corner towers were subrectangular, six-post structures, the posts set in a chevron pattern to follow the curve of the rampart (PLATE 7.8). Insufficient post-impressions were evident to allow precise dimensions of the towers to be given but, assuming that the posts were centrally located within their pits, they would have measured 6–6.2m by 2.7–3.3m externally. In the one example, in the south-west tower, where post-impressions were identified, a width of 2.8m was recorded (FIG. 7.19). In one case, in the north-west corner, the distance between the inner three post-pits was over 1m less than between the outer three, which would have resulted in a slightly fan- or wedge-shaped tower (FIG. 7.21).

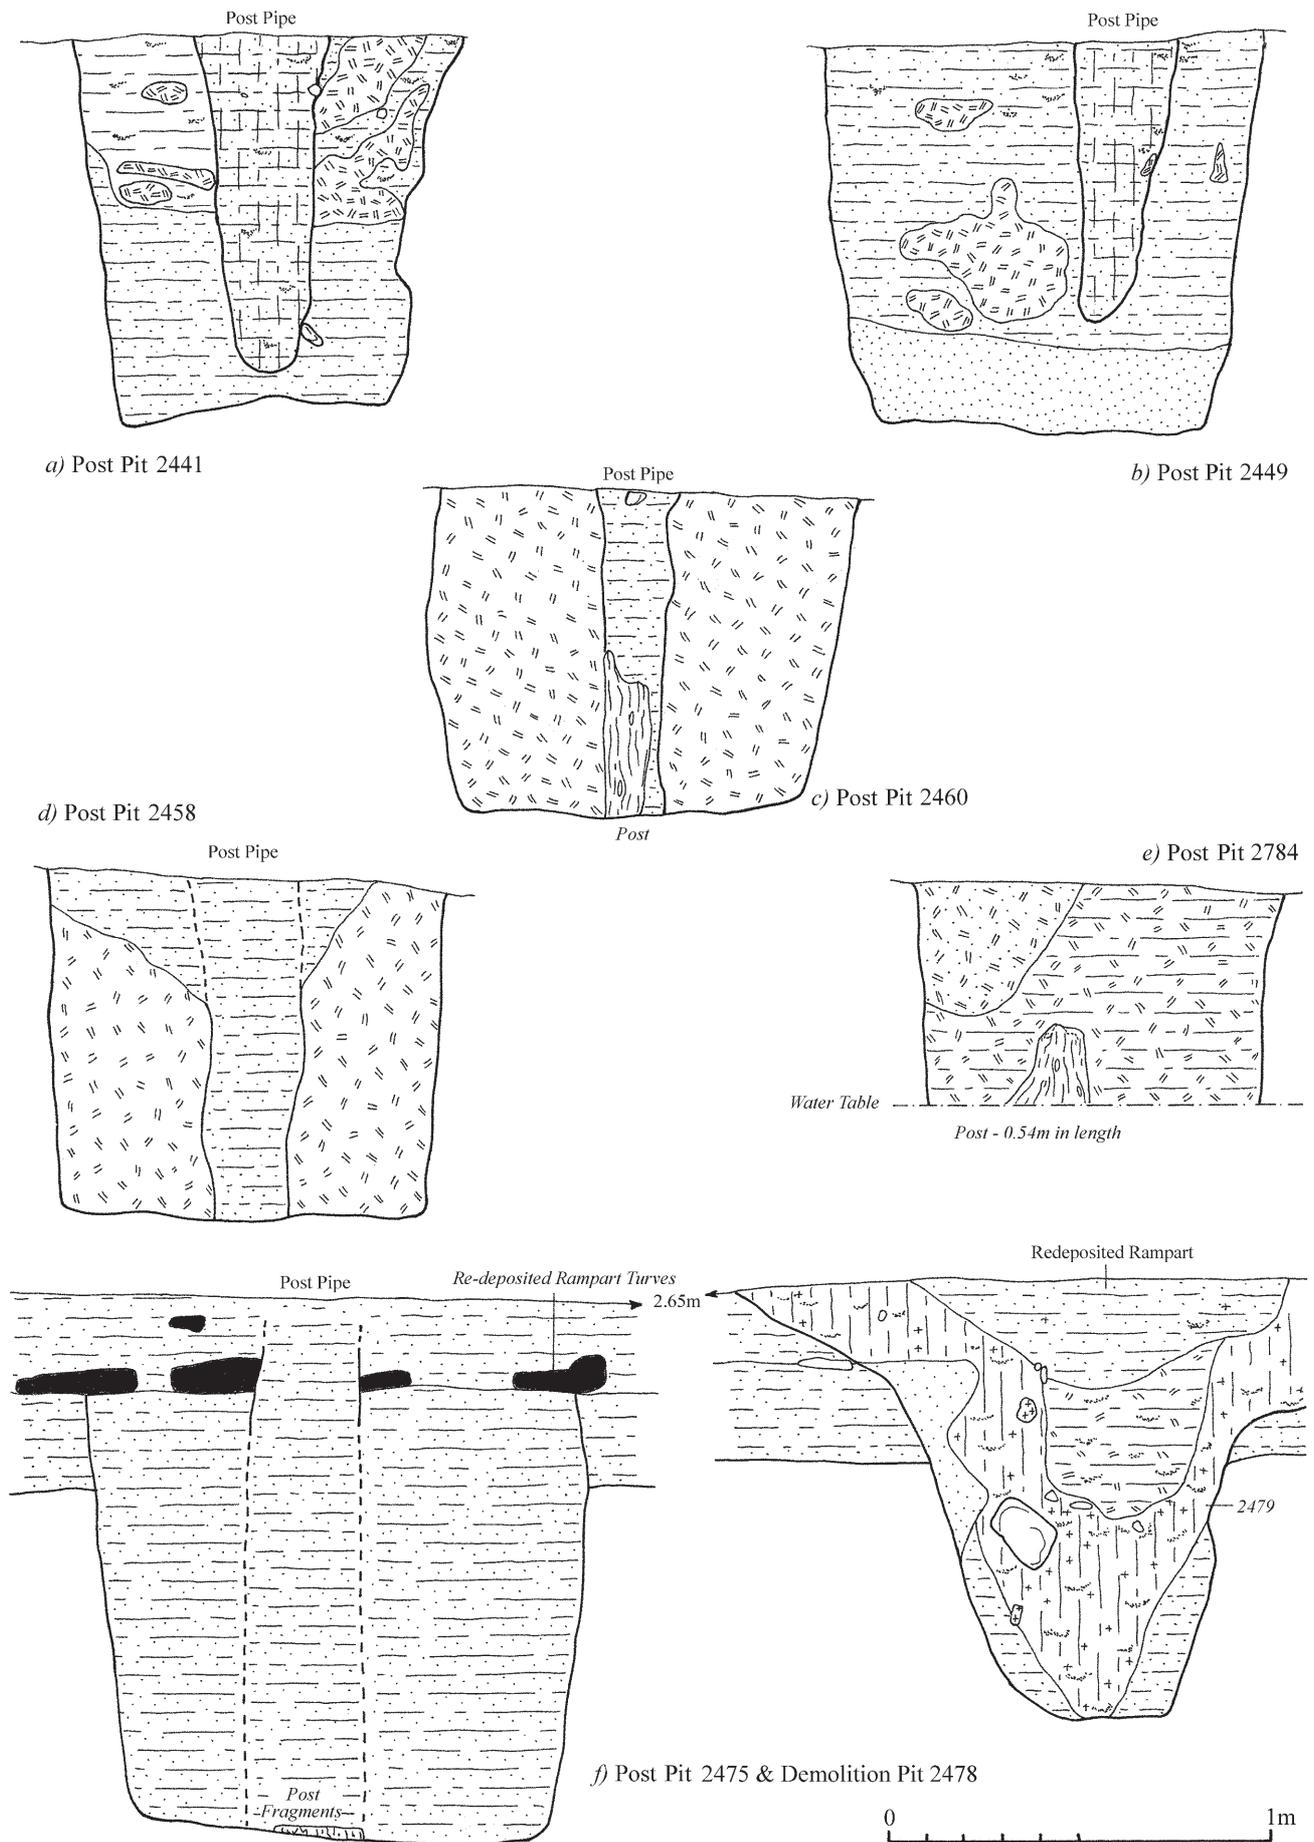
FIG. 7.23 Sections of post-pits in interval and corner towers: a. post-pit 2441; b. post-pit 2449, both south-west corner tower; c. post-pit 2460; d. post-pit 2458, both west-south-west interval tower; e. post-pit 2784, north-north-west interval tower; f. post-pit 2475, east-south-east interval tower and pit 2478

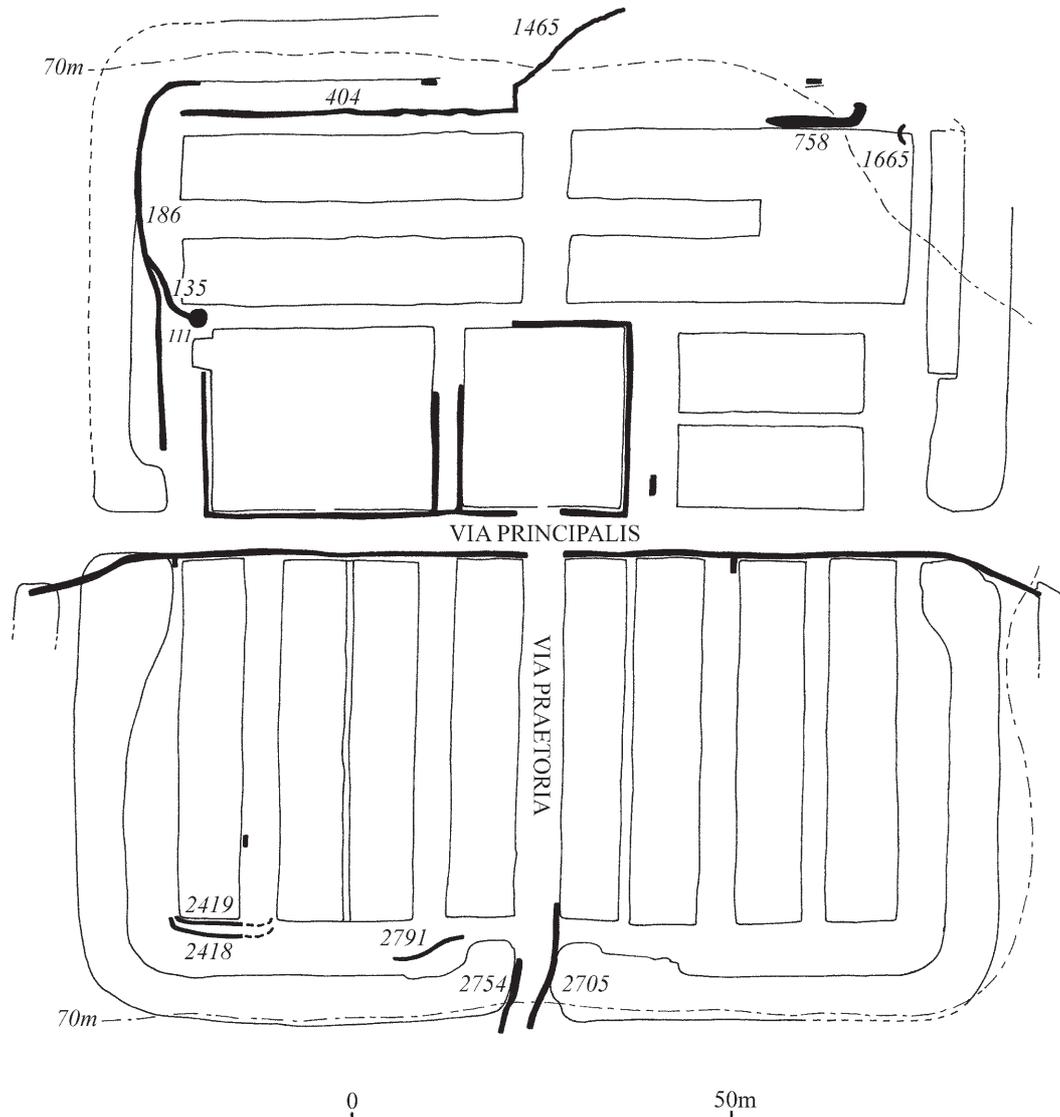
FIG. 7.24 The pattern of drains within the fort

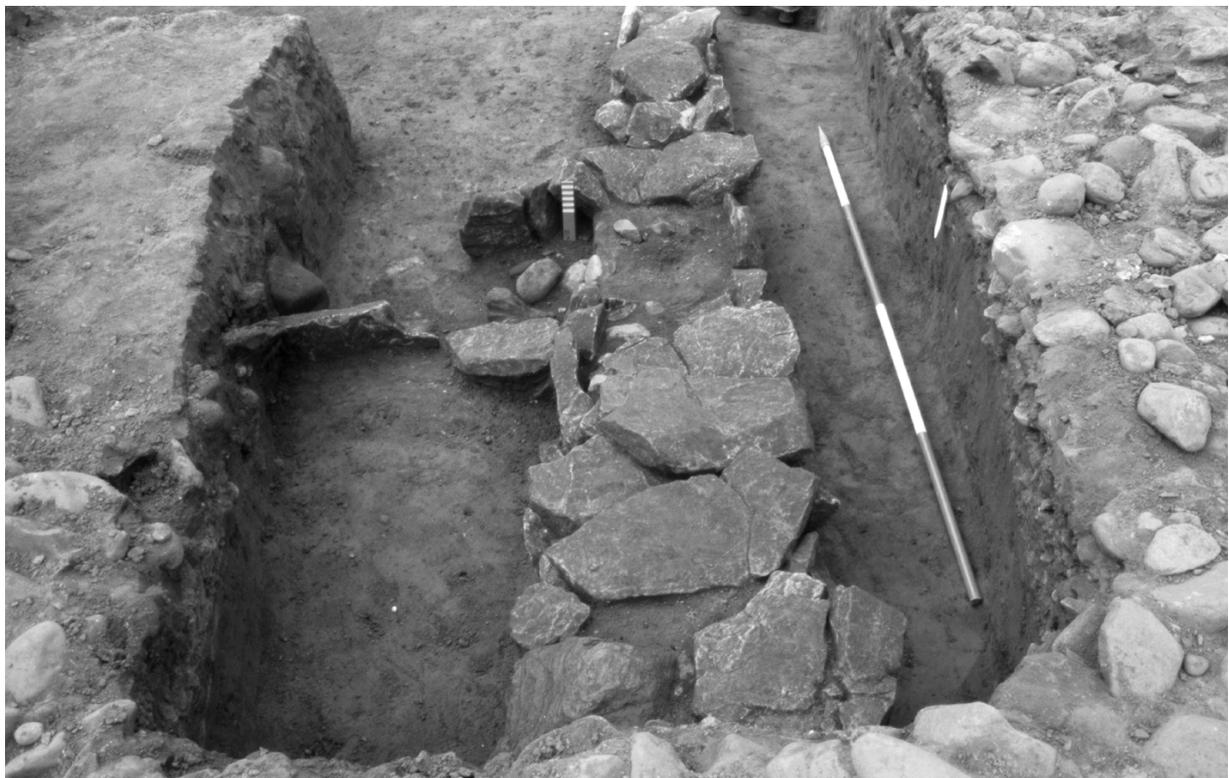
PLATE 7.10 Drain 1186 with T-junction at rear of the West Gate, partially disturbed by second phase of post-hole 2095; view west

There was no standard position for the posts within the pits. Though a marked preference for the location of each post against one side of its pit was noted in the East and North Gates, presumably to give added support, the posts in the South and West Gates were positioned predominantly in the middle of their pits. Stone packing was generally not employed, though one secondary pit (939) in the East Gate had a flat stone pad at the bottom (FIG. 7.16) and one primary post in the West Gate (2095) appeared to be defined on two sides by similar slabs, but this simply reflects its position against a T-junction of an adjacent drain (1186) (PLATE 7.10). It

Drains ran east and west along the south side of the *via principalis* from either side of the *via praetoria*, draining out through the East and West Gates, following the edge of the rampart and issuing into the inner ditch (FIGS 7.4 and 7.6; PLATES 1.4 and 7.10). This provision drained the northern ends of all the barrack blocks in the *praetentura*, though at only one point, on the west side of Barrack 6, was there any sign of a connecting drain running alongside any of those barracks. How far down the length of the barrack this continued was not established. In addition, one fragment of drain was recorded alongside the officers' quarters on the eastern side of Barrack 12, though this is more likely to have drained to the south, perhaps linking into one of the open gullies at the south end of that block. A T-junction identified in the drain (1186) at the rear of the West Gate (FIG. 7.12; PLATE 7.10) suggests that there may have been some provision for drainage along the back of the rampart opposite Barrack 12. It is uncertain how long-lasting or effective these arrangements to drain the *praetentura* were, since the drain through the East Gate was cut away by a deep slot (1851) which blocked the gate and was not subsequently reinstated (FIG. 7.11), while that through the West Gate seems to have been cut away by a post-pit (2091) of phase 2 (FIG. 7.12; above 7.2.4). A drain (2705) also ran out through the east side of the South Gate (FIG. 7.9), apparently originating by the south-west corner of Building 8. A second apparently unlined drain (2754) starting by the threshold of the same gate on the west side of the road must originally have been lined with timber if it was to work at all.

Most of the drains within the fort were constructed of rough sandstone slabs forming a channel some 0.25–0.4m square internally (FIGS 7.25, 7.26; PLATE 7.10). The basal slabs were set in

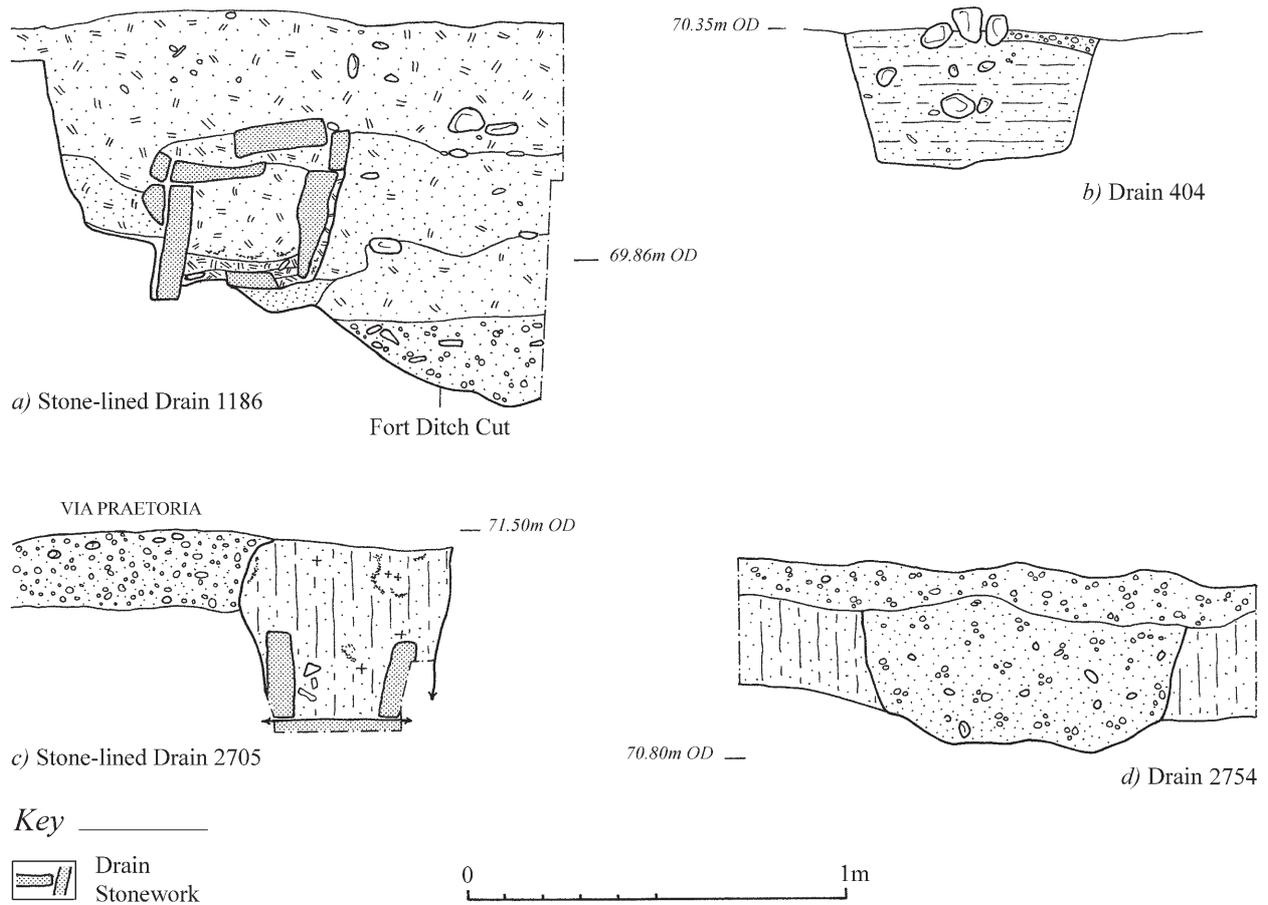
FIG. 7.26 Sections through drains: a. drain 1186 outside the West Gate; b. drain 404 beneath *via sagularis* north of Barrack 1; c. drain 2705 at South Gate; d. drain 2754 at South Gate

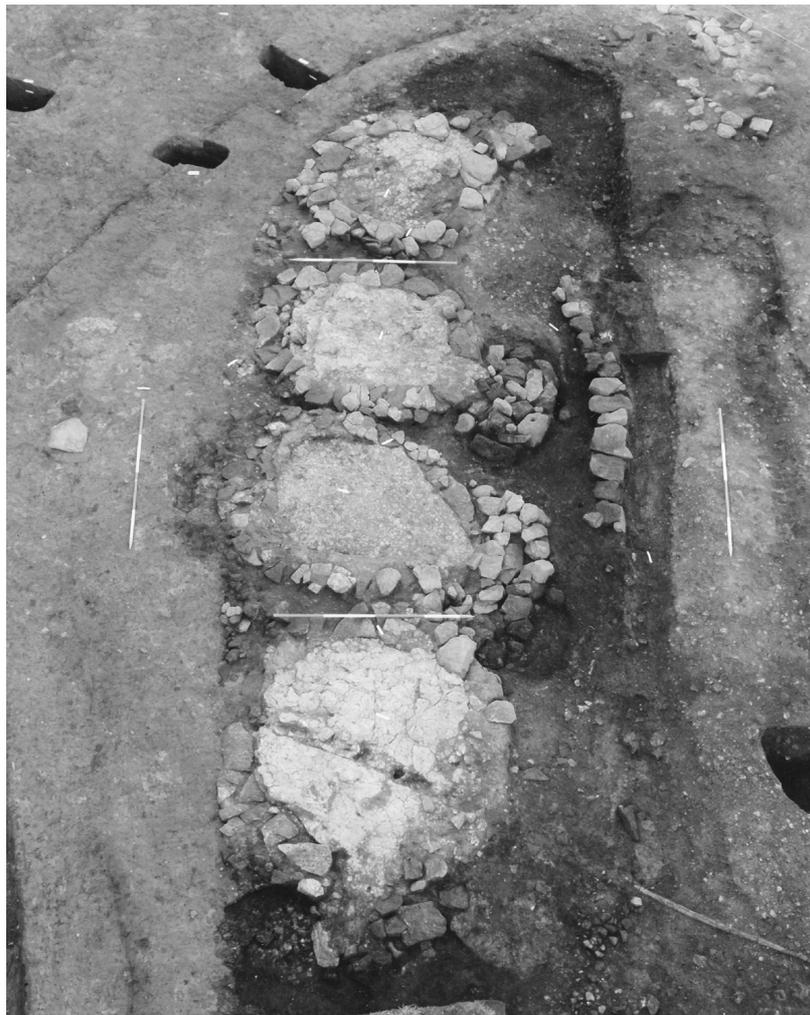
PLATE 7.11 Bank of ovens 2403, 2405, 2407 and 2409 and associated features, dry-stone wall 2417 and gully 2418, in south-west corner; view west

The best-preserved group of ovens were the four in the south-west corner (2403, 2405, 2407 and 2409) (FIGS 7.19, 7.27 and 7.28; PLATE 7.11). They were circular or oval in plan, at least 1.6m and up to 2.1m in internal diameter, the larger dimensions running from front to back. Each oven was provided with a projecting, approximately rectangular, stone platform or hob at the front measuring *c.* 1.1–1.8m wide by 0.8–1m deep (e.g. 2413), around which was a halo of ash and charcoal debris up to 0.9m in diameter. The two central ovens faced north, while those
