ELGINHAUGH: A FLAVIAN FORT AND ITS ANNEXE

VOLUME 1

By W.S. Hanson

Britannia Monograph Series

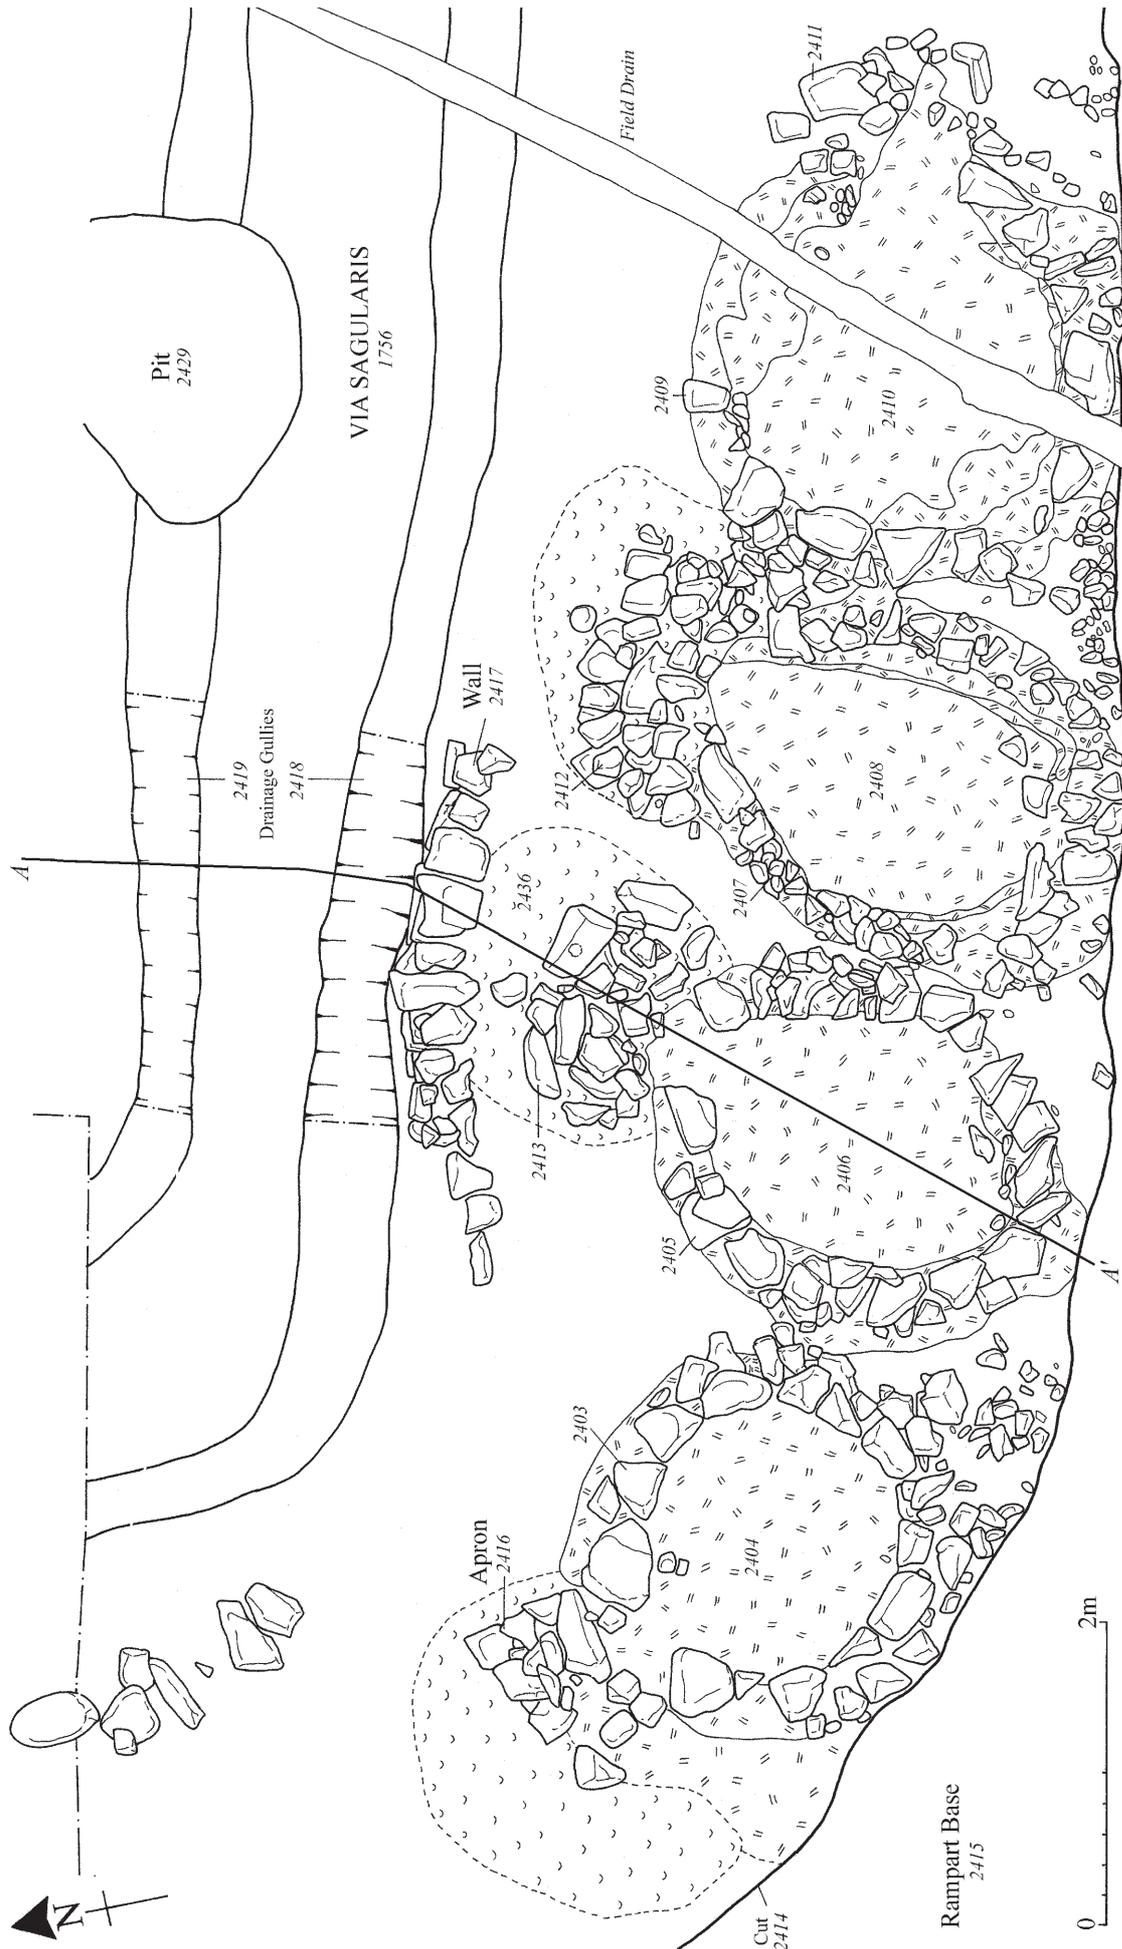
FIG. 7.27 Detailed plan of ovens in south-west corner

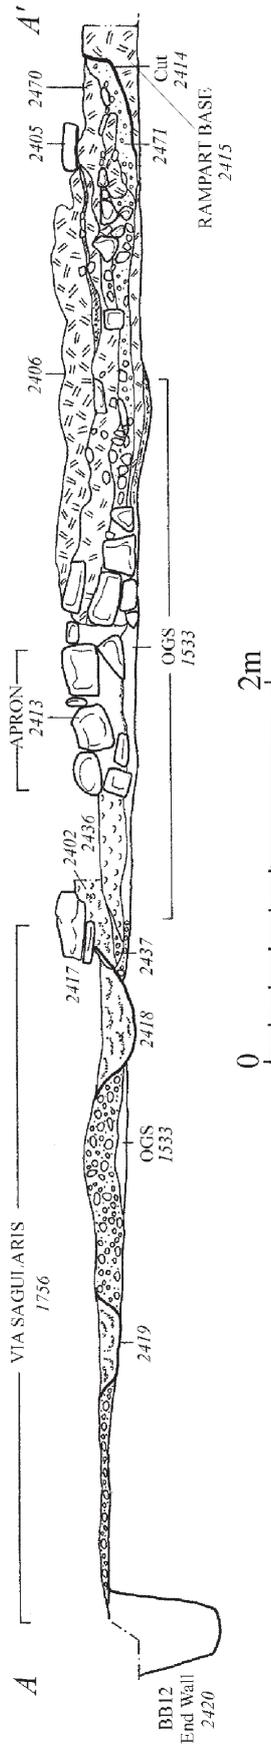
FIG. 7.28 Section through oven 2405, associated stone wall 2417, drains 2418 and 2419, *via sagularis*, 1756 and end wall of Barrack 12, 1720

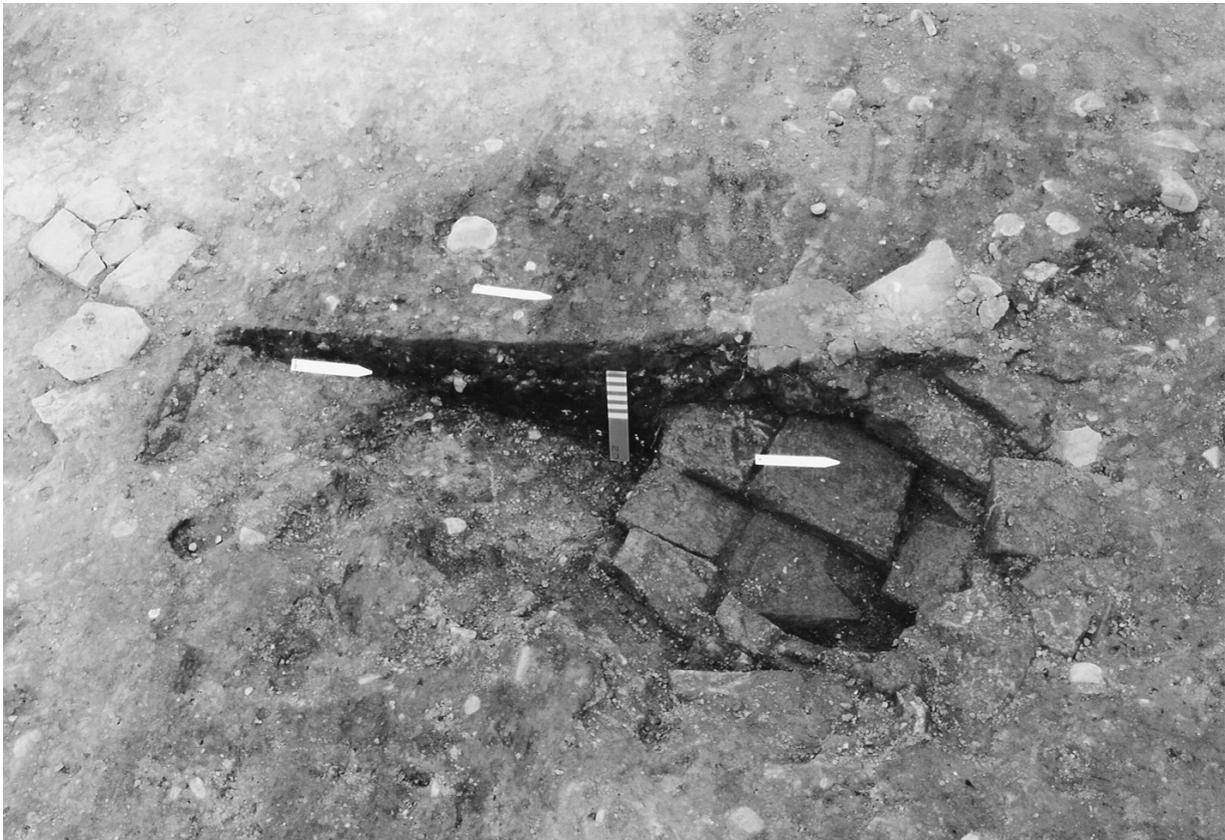
PLATE 7.12 Post-fort oven (2432) overlying *via sagularis* to the south of the West Gate; view north

Finally, a series of ovens of rather different character and later date were revealed in the *retentura*. One (2432) was located on the *via sagularis* at the back of the west rampart adjacent to the west-south-west interval tower (FIGS 7.20 and 7.32d; PLATE 7.12). It consisted of an oval, or rather kidney-shaped shallow depression, some 1.25m long and up to 0.9m wide. The western end served as a stokehole, with the flue or body of the oven to the east constructed of re-used tiles, bricks and quernstone fragments. The stokehole was filled with wood ash, charcoal, carbonised cereals and burnt bone.

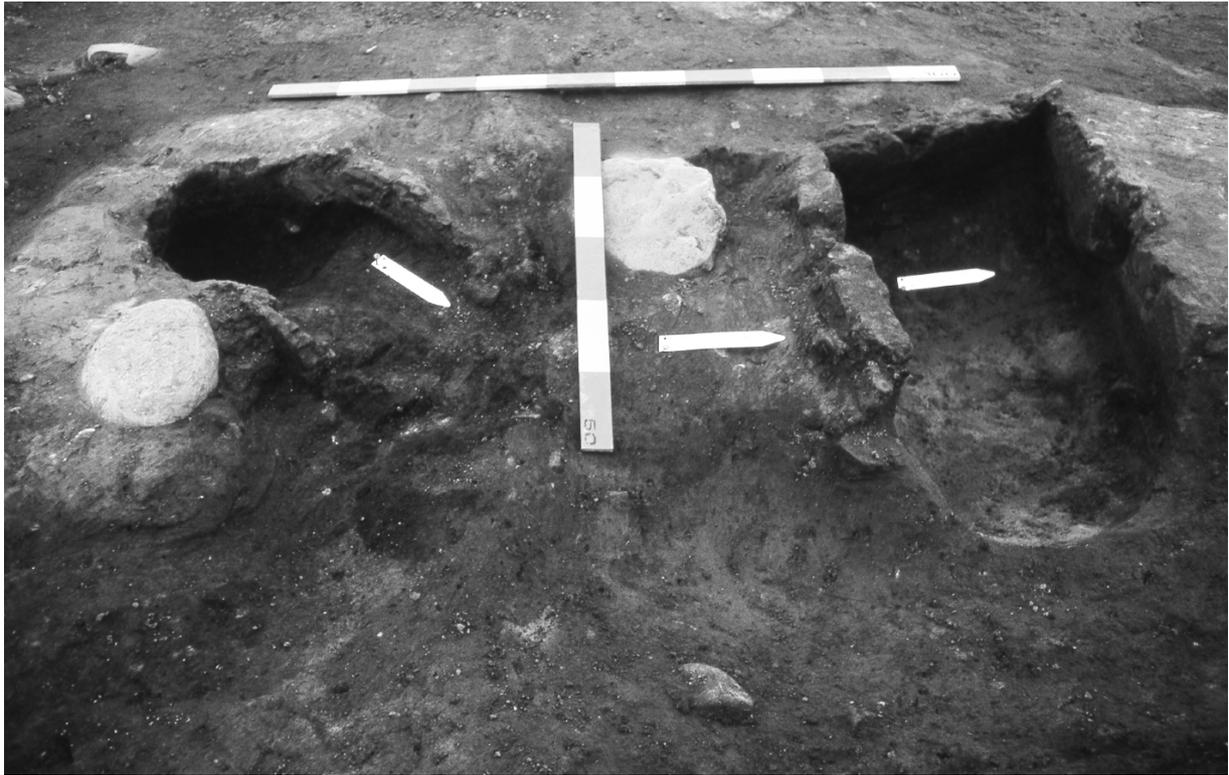
PLATE 7.13 Rectangular ovens 1544/46 overlying Barrack 9; view south

Two pairs of ovens (1539 and 1544/1546) were situated near the centre of the fort, overlying the northern end of Barrack 9 and adjacent to a wide, shallow gully (1545) which ran parallel to the *via principalis* (FIG. 6.4). Of the first pair (1539) only the rather battered floors had survived, one of which was set on a cobble base *c.* 0.8m in diameter. The better preserved pair of ovens (1544/1546) were rectangular or nearly so, measuring 0.5 by 0.35m and 0.35 by 0.24m respectively. Each was set within an amorphous dump of clay, but shared a common stokehole formed by an irregular scoop or hollow (FIG. 7.30; PLATE 7.13). The stokehole

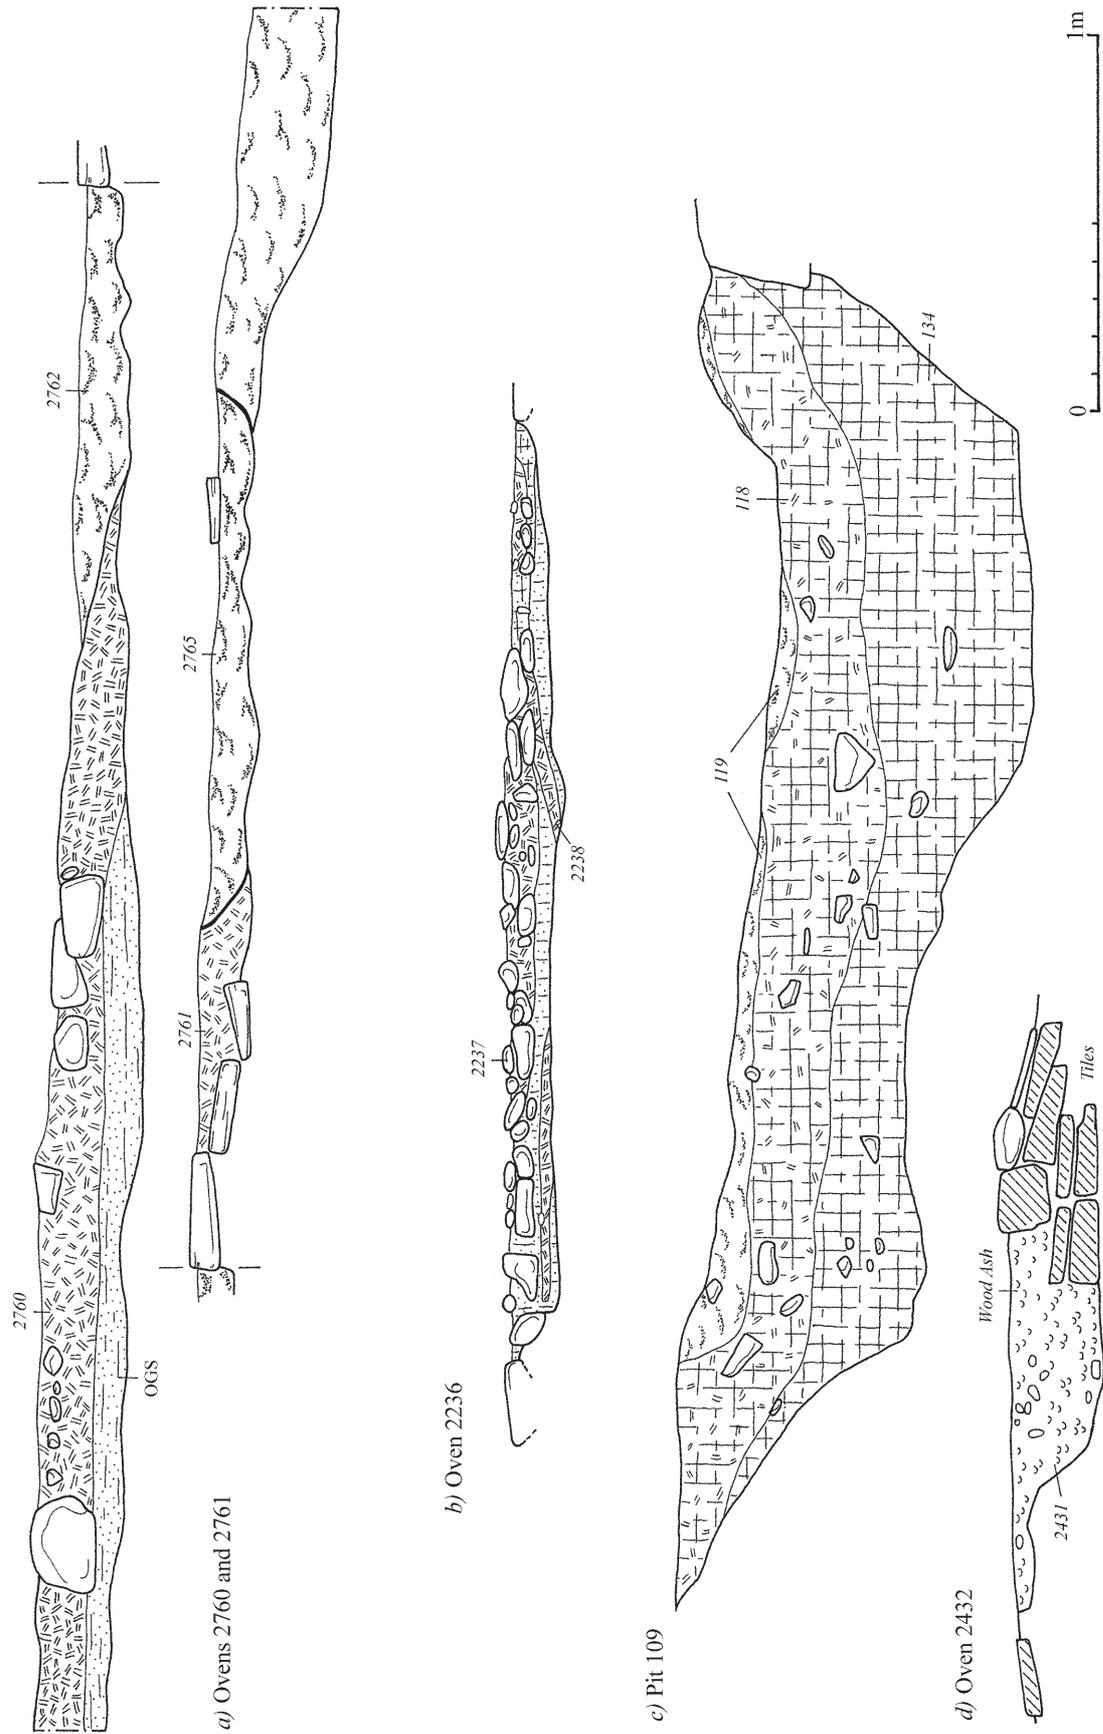
FIG. 7.32 Sections through ovens and related features: a. 2760/2761 by the South Gate; b. 2236 in the south-east corner; c. pit 109 on the north-west side; d. 2432 post-fort oven on the south-west side

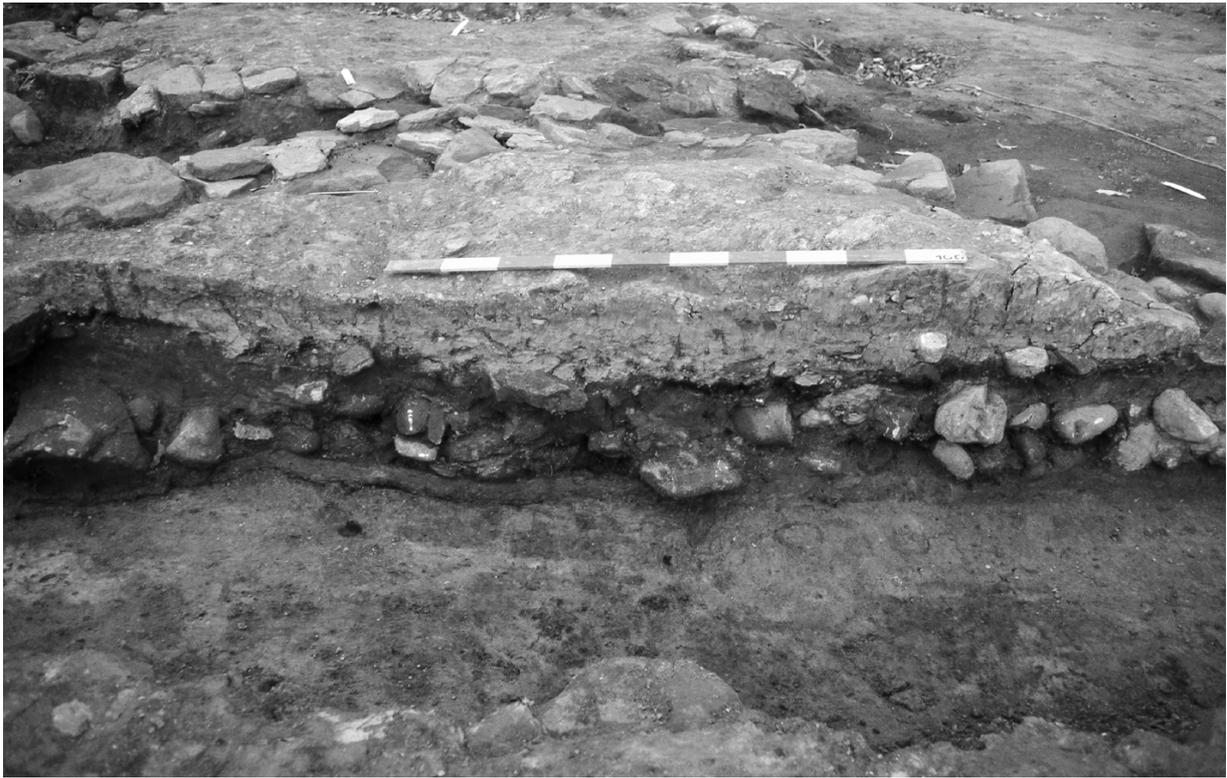
PLATE 7.14 Section through oven 2405/6 showing relining; view south-east

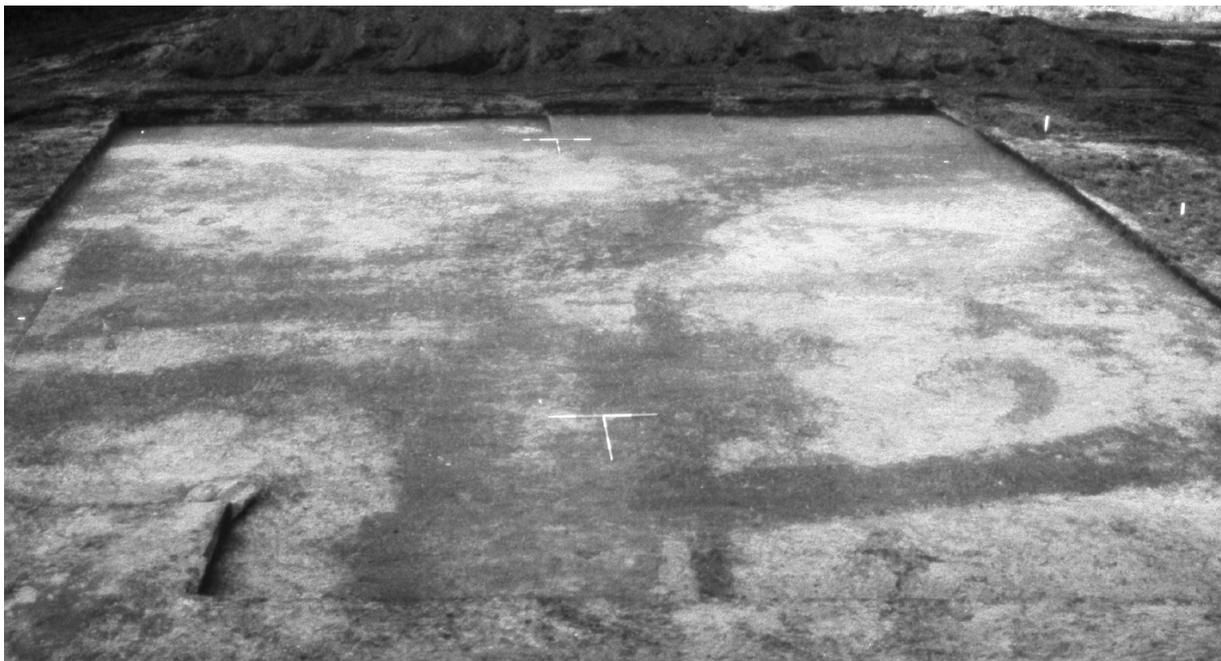
PLATE 8.1 Ditches 801, 803, 805 and 807, and gully 811, at north-west corner of Trench 5; view north

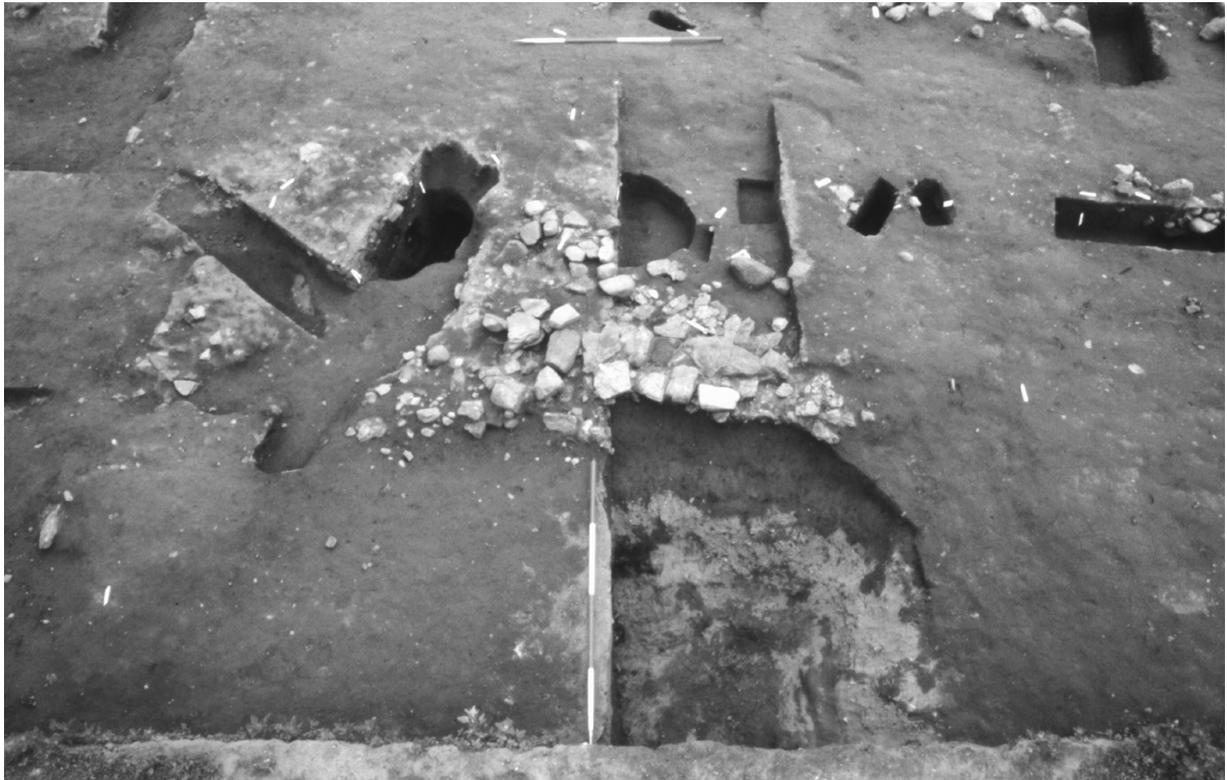
PLATE 8.2 Butt end of dividing ditch 801 cutting flagged surface 49 which overlies pit 56, with the pit/oven complex, 65, 53 and 48 to the left, Trench 1; view south

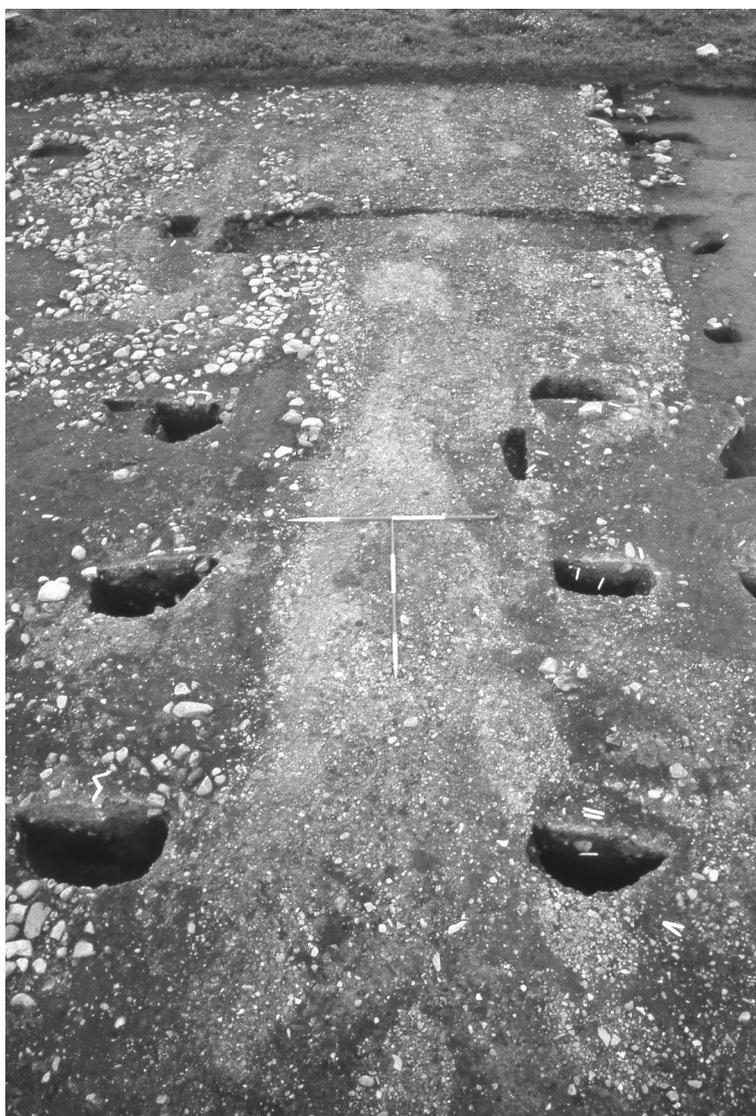
PLATE 8.3 Annexe gateway post-holes cutting through road surface, Trench 1; view west

The rampart abutted the front third of a simple single-portal gateway constructed on probably eight post-holes (FIG. 8.6; PLATE 8.3). The width of the portal varied between 3.1m and 3.8m, as measured between the inside edges of surviving post-impressions, and the overall external length of the gate was 8.3m. Seven of the eight posts were revealed and sectioned, but there was no time at the end of the excavation to investigate the presumed eighth post at the rear of the gate on the north side, which lay outside the limits of the trench. Post-impressions were recorded in four of the post-holes (below 8.1.3), though only in section.

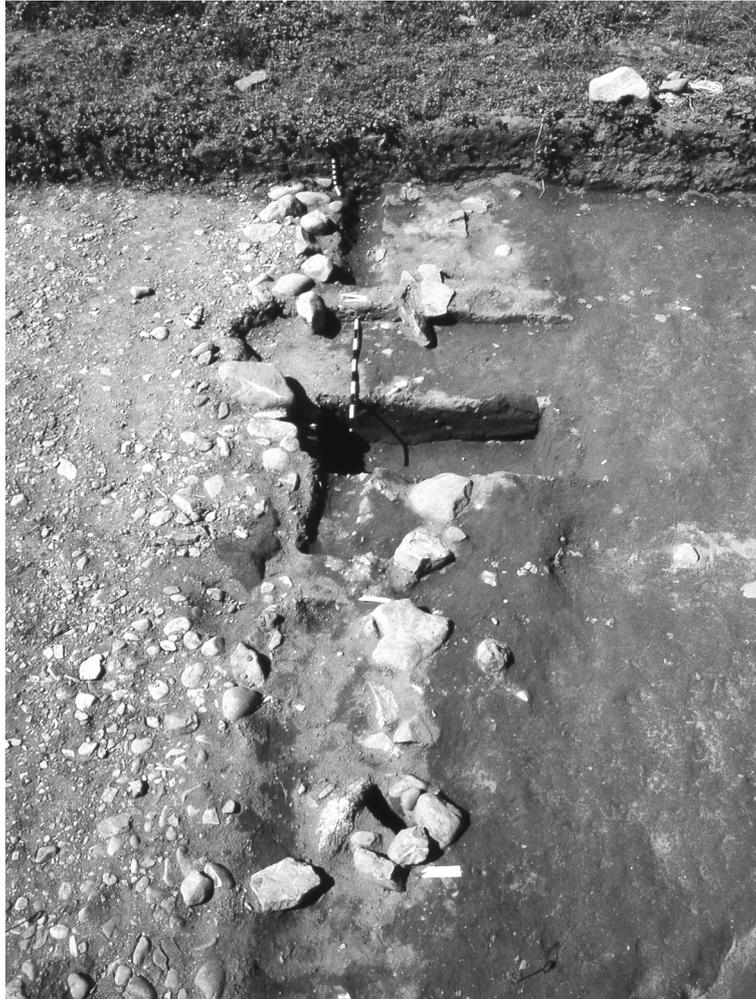
PLATE 8.4 Gully 34, adjacent road surface and post-hole 62, Trench 1; view west

Immediately outside this gate, along the north side of the road, a construction slot (34) and series of post-holes (62, 76 and 80) indicated the presence of a fence or similar barrier preventing immediate access to this side of the outer annexe (PLATE 8.4). Five further post-holes (68, 70, 72, 74 and 84), including two sets of pairs, ran in a parallel line some 3m north of the edge of the road and may also go with this phase, or possibly with the buildings of Phase 1b (below 8.2). A short length of construction trench (107) running for some 2m parallel

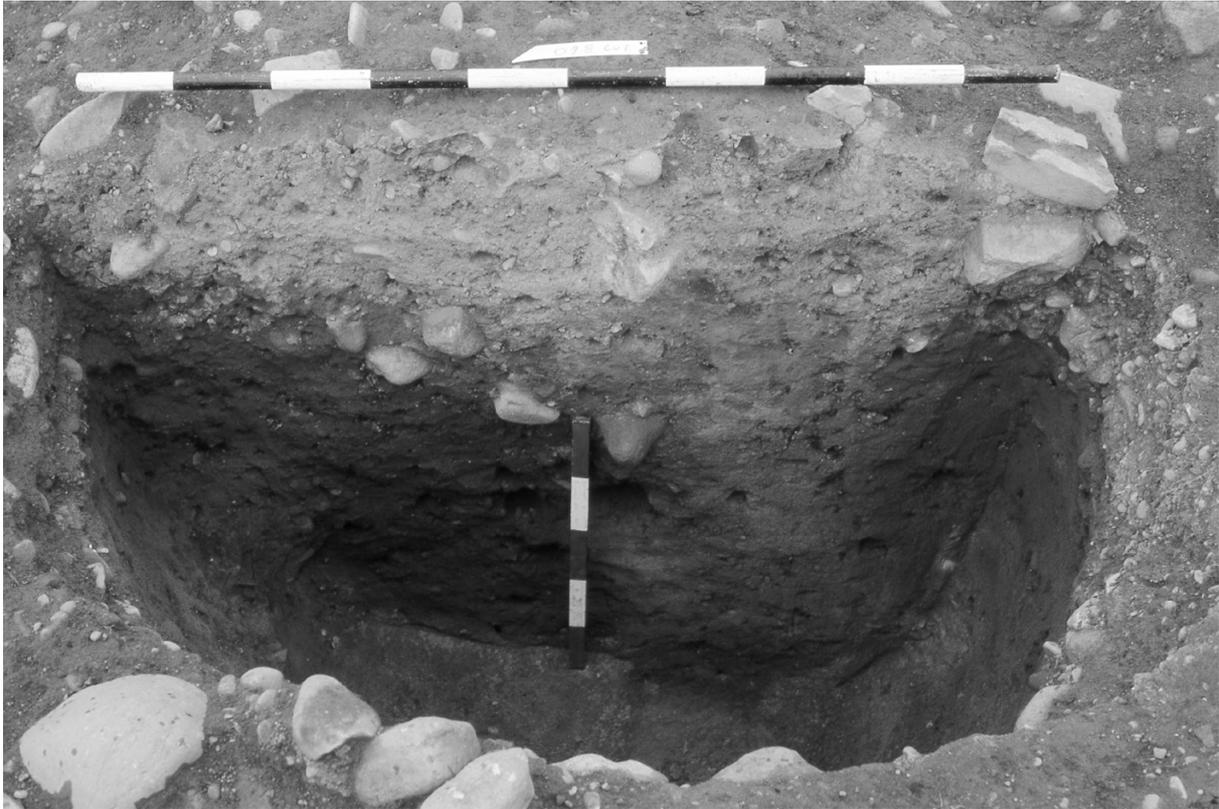
PLATE 8.5 Section of post-hole 98 showing post-impression, Trench 1; view west

side (149). Post-impressions survived in four of the post-holes and indicated posts of cross-section equal to, or even larger than, those employed in the fort gates (compare TABLES 8.1 and 7.1). Despite this correlation, the implication of the relatively shallow depth of the post-holes in the annexe gate, which average only just over half that of the fort gates (compare FIGS 7.14–15 and 8.8), is that the superstructure is unlikely to have risen above the level of the first storey. A height of approximately 3m is assumed, as for the fort gates, to allow sufficient clearance for loaded wagons or mounted riders. Any linkage at that level from one side of the gate to the other is more likely to have been designed to ensure the stability of the structure and prevent

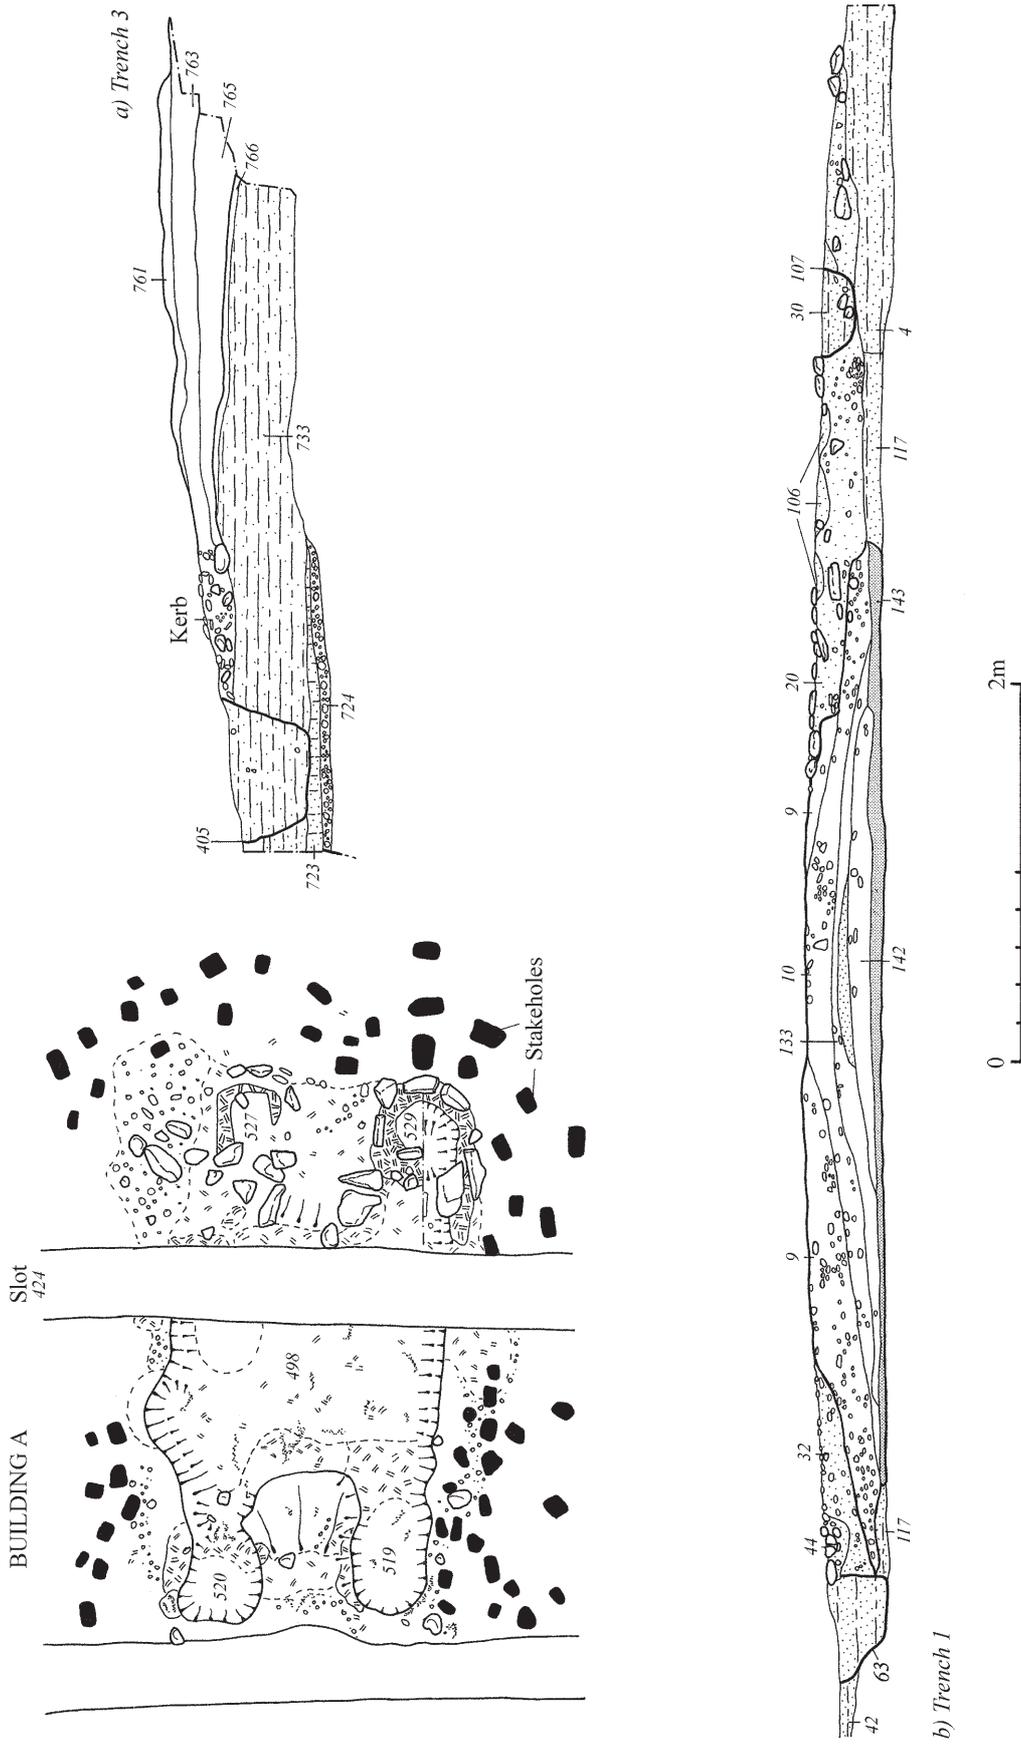
FIG. 8.9 Annexe road sections and detailed plan of oven 496 (Trench 3)

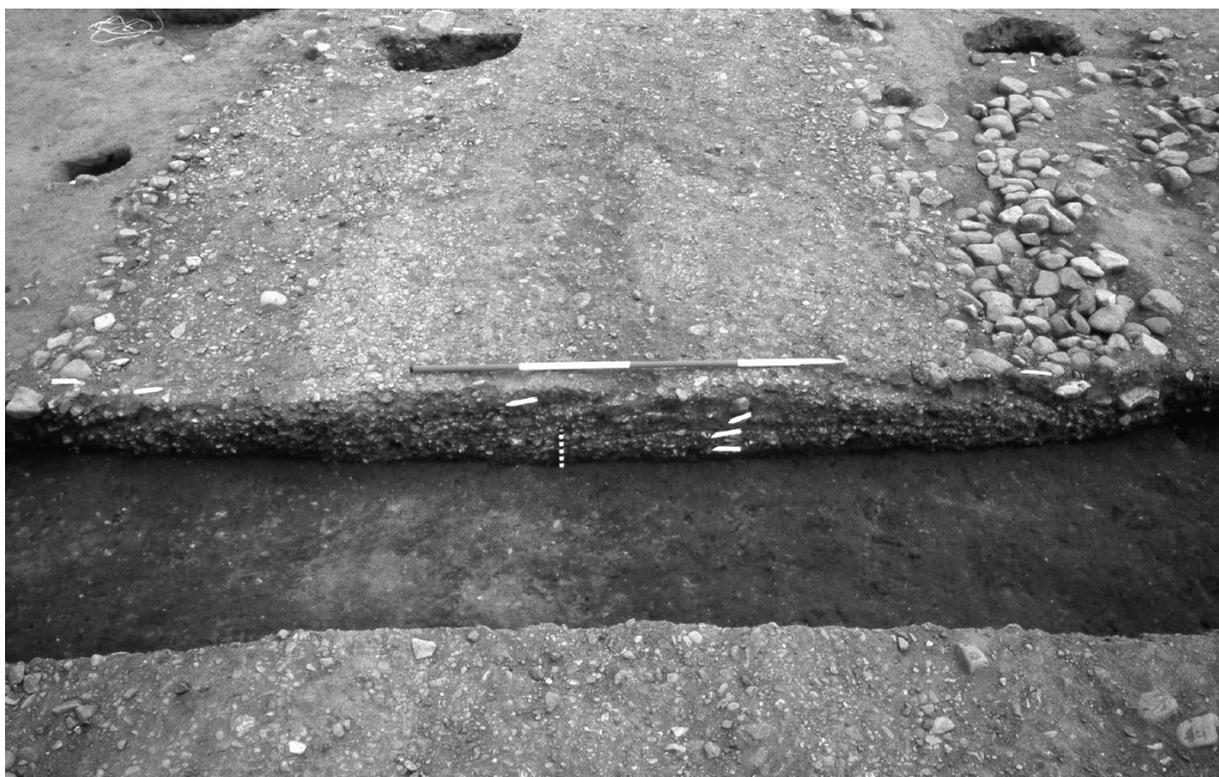
PLATE 8.7 Section through road, Trench 1; view east

The road was sectioned in two places, in the centre of Trench 1 and at the eastern end of Trench 3. It was extremely solidly constructed, though slight differences were noted between the two sections (FIG. 8.9a and b; PLATE 8.7). In Trench 3 the road was made up of a primary dump of compacted sandy gravel and pebbles (765) up to 0.21m thick with a concreted upper surface laid directly above the turf of the old ground surface. In Trench 1, however, there were indications that a shallow cut had been made, perhaps to level the ground, though this had then been deliberately filled with turf (143) before the primary dump of compacted sand and gravel, up to 0.12m thick, had been placed on top (142). This in turn was sealed by a further layer of similar material (133), up to 0.11m thick, concreted to form the road surface. The original width of the road, recorded in Trench 1, was 4m. The road was extensively resurfaced during this phase, as attested in both Trenches 1 and 3 (below 8.2.4). An additional layer of compacted gravel (10) some 0.15m thick had the effect of widening the road to some 4.9m where the full width was uncovered in Trench 1, as well as increasing the height of the camber (FIGS 8.9b and 8.10).

The road through the annexe was clearly a primary feature and directly overlay the old ground surface. During the course of Phase 1a this road was extensively resurfaced. In Trench 3 a second layer of compacted gravel and pebbles (763) up to 0.15m thick was dumped on top of the earlier surface, while in Trench 1 a layer of fine, well-packed gravel (10) up to 0.16m deep had been laid over the earlier surface (133) (FIG. 8.9a and b; PLATE 8.7).

A second resurfacing of the road was attested in Trenches 1 and 3, similar to the first. A layer of slightly larger stones (9 and 761) up to 0.25m thick, but somewhat less well compacted, sealed the first resurfacing, but survived only towards the sides of the road (FIG. 8.9a and b; PLATE 8.7). Excavation of the make-up layer (9) produced a very slightly worn *aes* of Domitian, probably dating to A.D. 85 (below 10.1, no. 37) providing a *terminus post quem* for this phase. This resurfacing was accompanied by a more general spread of gravel on both sides of the road (12, 18, 408 and 210). Though this surface was cut by a number of the construction trenches and post-holes for the buildings of Phase 1b, this stratigraphic relationship is here assumed to represent no more than phasing within the construction process, with a new surface being provided prior to the erection of the buildings.

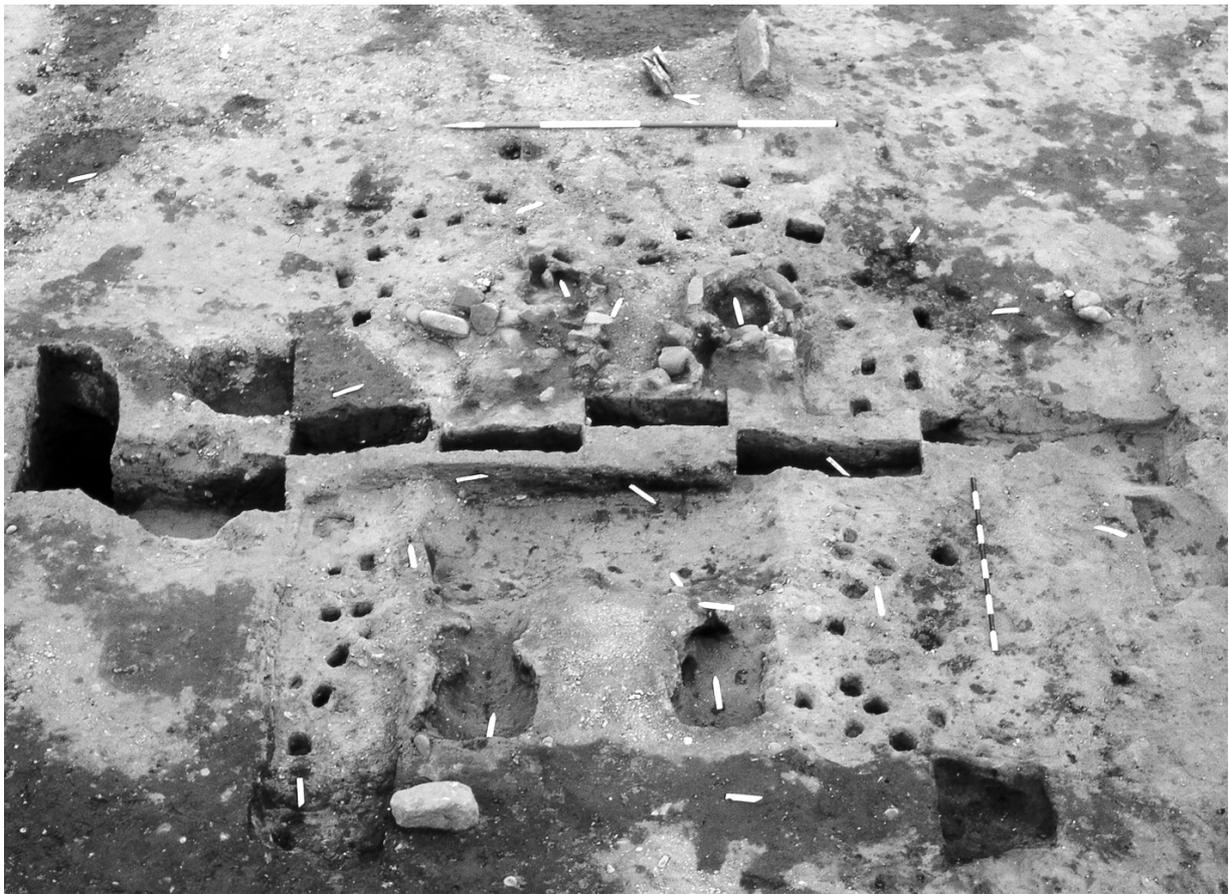
PLATE 8.8 Probable grain-drying oven 496, Trench 3; view east

deep with flues at each corner forming an H-shaped structure with its long axis east–west (FIG. 8.9; PLATE 8.8). The flues were best preserved on the eastern side (527 and 529). They were partly defined by sandstone slabs and clay-lined, the lining continuing a short distance into the firing pit (498), narrowing the connecting neck. The kiln had clearly been used, probably on several occasions (see below). The clay lining was fired orange-red and the firing pit full of ash, charcoal and small quantities of carbonised seeds (see below). The temperatures attained, however, were relatively low, for only the first 0.03–0.04m of the clay lining had been fired and discoloration of the subsoil beyond from heat penetration was limited. Moreover, the superstructure, of unfired or partially fired clay, appeared to have been pushed down into the flues. Immediately surrounding the structure, except where they had been removed by a later wall trench down the west side, was an irregular double row of stakeholes averaging 0.1m in cross-section and 0.1m deep. The fact that the stakeholes were close to the edge of the kiln and completely surrounded it suggests that they were intended to support some form of raised platform or floor rather than merely a wind-break. This, and the presence of charred emmer, spelt, barley and oats in the firing pit (below 11.2), would seem to indicate that the most likely function of this structure was a grain-drying oven. Indeed, the H-shaped layout is not dissimilar to the surviving sub-floor remains built in stone of grain-drying ovens from villa sites of the third and fourth centuries A.D. in lowland England (Morris 1979, 5–22, figs 9–10, 14).

The stoke-hole and flues of the grain-drying oven were dug into the subsoil, the flues lined with clay and partly revetted with pieces of sandstone (PLATE 8.8). The absence of any quantity of burnt clay or stonework either deposited in the stoke-hole or evident in the immediate vicinity suggests that these features did not project much above the contemporary ground surface. The oven does not seem to have been enclosed within any substantial structure, but the surrounding stakeholes suggest the provision of some light hurdling at the sides. These would give some protection from the wind, without excluding airflow entirely, and also provide some support for a raised platform of similar material on which sacking might be spread to prevent the grain falling into the drier. Similar arrangements are attested in accounts of medieval and early modern examples of grain driers from Ireland and northern Scotland (e.g. Gailey 1970; Fenton 1978). Any attempts to reconstruct grain-drying ovens are severely hampered by the survival of only sub-floor remains, but even the well known examples from southern England with stone flues probably had superstructures of wattle and daub, given the absence of stone debris in their vicinity, while many were probably free-standing platforms contained within much larger buildings (Morris 1979, 11–12).

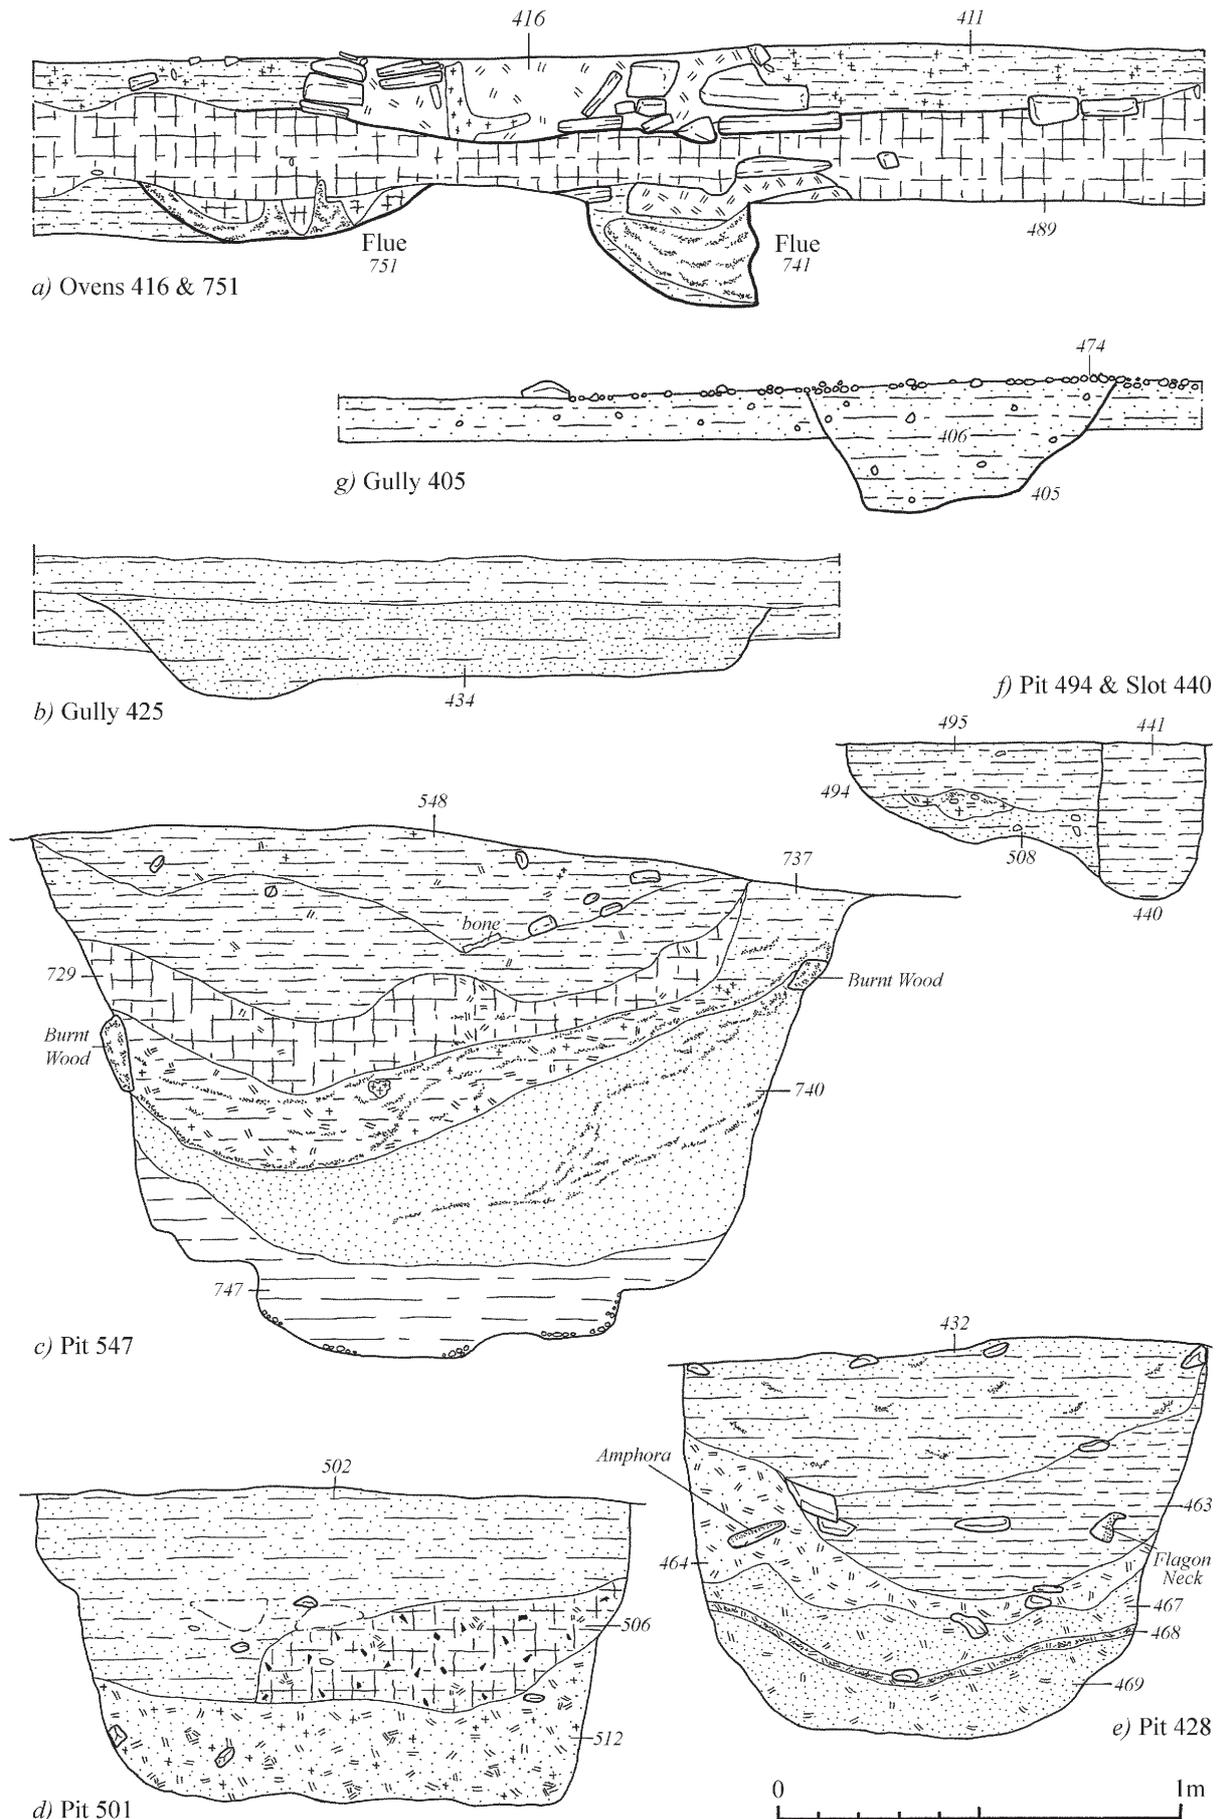
FIG. 8.12 Sections through pits, ovens and other features: a. ovens 416, 741 and 751; b. gully 425; c. pit 547; d. 501; e. pit 428; f. pit 494 and construction trench 440; g. gravel surface 474 overlying gully 405 (Trench 3)

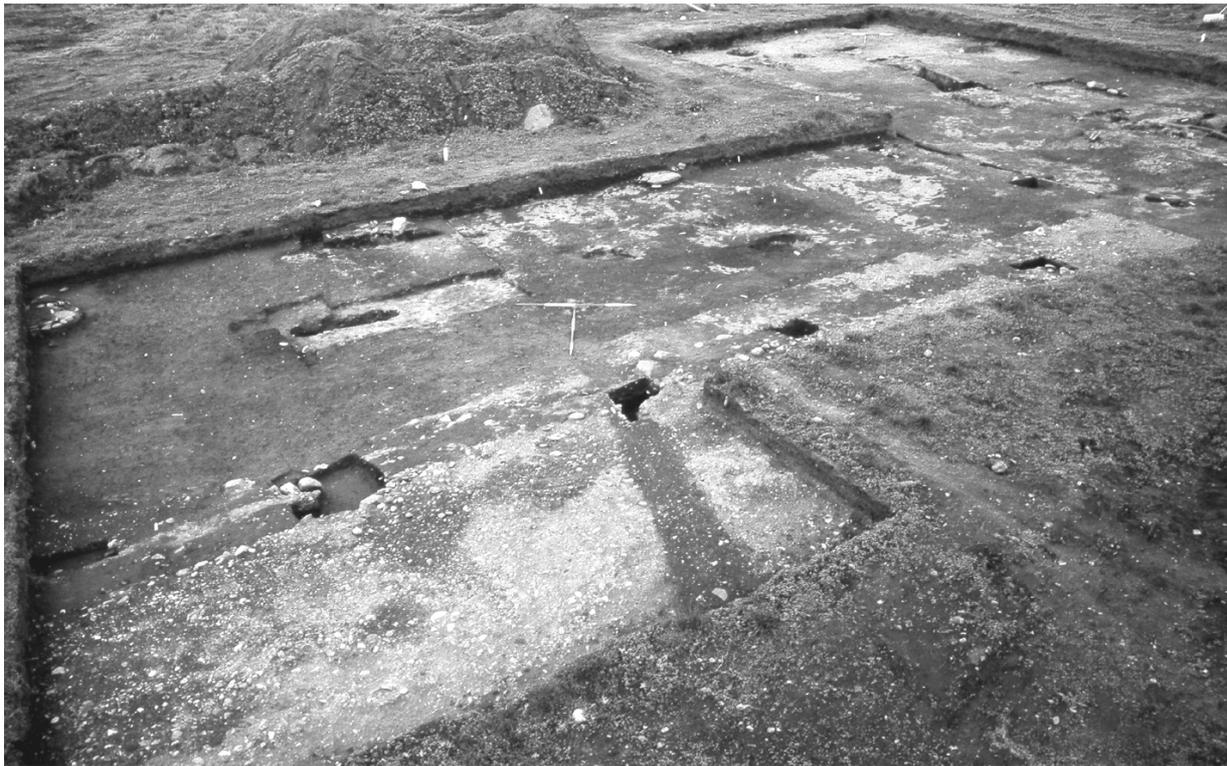
PLATE 8.9 Road with gully 405, Phase 1a oven 403 and later ovens 413, 414 and 416, and unexcavated pits, east end of Trench 3; view south-west

A group of simpler oven or kiln-like structures was situated at the eastern end of Trench 3 (FIG. 8.11), though only one was completely exposed as the rest lay largely, or in part, beyond the area under excavation. The most completely excavated example (403) consisted of an oval stoke-hole or firing pit, 2.4m by 1.5m and up to 0.25m deep, with a channel or flue, 1.8m long and 0.5m wide, dug some 0.25m deeper extending out from its west side (PLATE 8.9). Both the stoke-hole and the flue were filled with ash and charcoal and showed clear signs of burning in situ, for the sandy subsoil surrounding the flue and the west end of the stoke-hole adjacent to it had been reddened by the heat to a depth of up to 0.09m.

Four oven-like structures (413, 414, 416 and 423) seemed to be spaced at regular intervals running in a line not quite parallel with the road and some 6–8m distant from its southern edge in Trench 3 (FIG. 8.11; PLATE 8.9). Assuming a fifth example in an area not examined, the spacing between the ovens was almost exactly 6m centre to centre. The most completely exposed example (423) consisted of a subcircular base 1.5m in diameter made up of rounded cobbles embedded in clay reddened by oxidisation, though not entirely baked through. The other three (413, 414 and 416) were only partly visible as they extended beyond the edges of the trench. The latter two were broadly similar in character to 423, but utilised sandstone blocks in their bases rather than water-worn cobbles, and ranged in diameter from 1.4m to 1.9m (e.g. 416, FIG. 8.12a; PLATE 8.11). They are similar in form and construction to the
