ELGINHAUGH: A FLAVIAN FORT AND ITS ANNEXE

VOLUME 1

By W.S. Hanson

Britannia Monograph Series

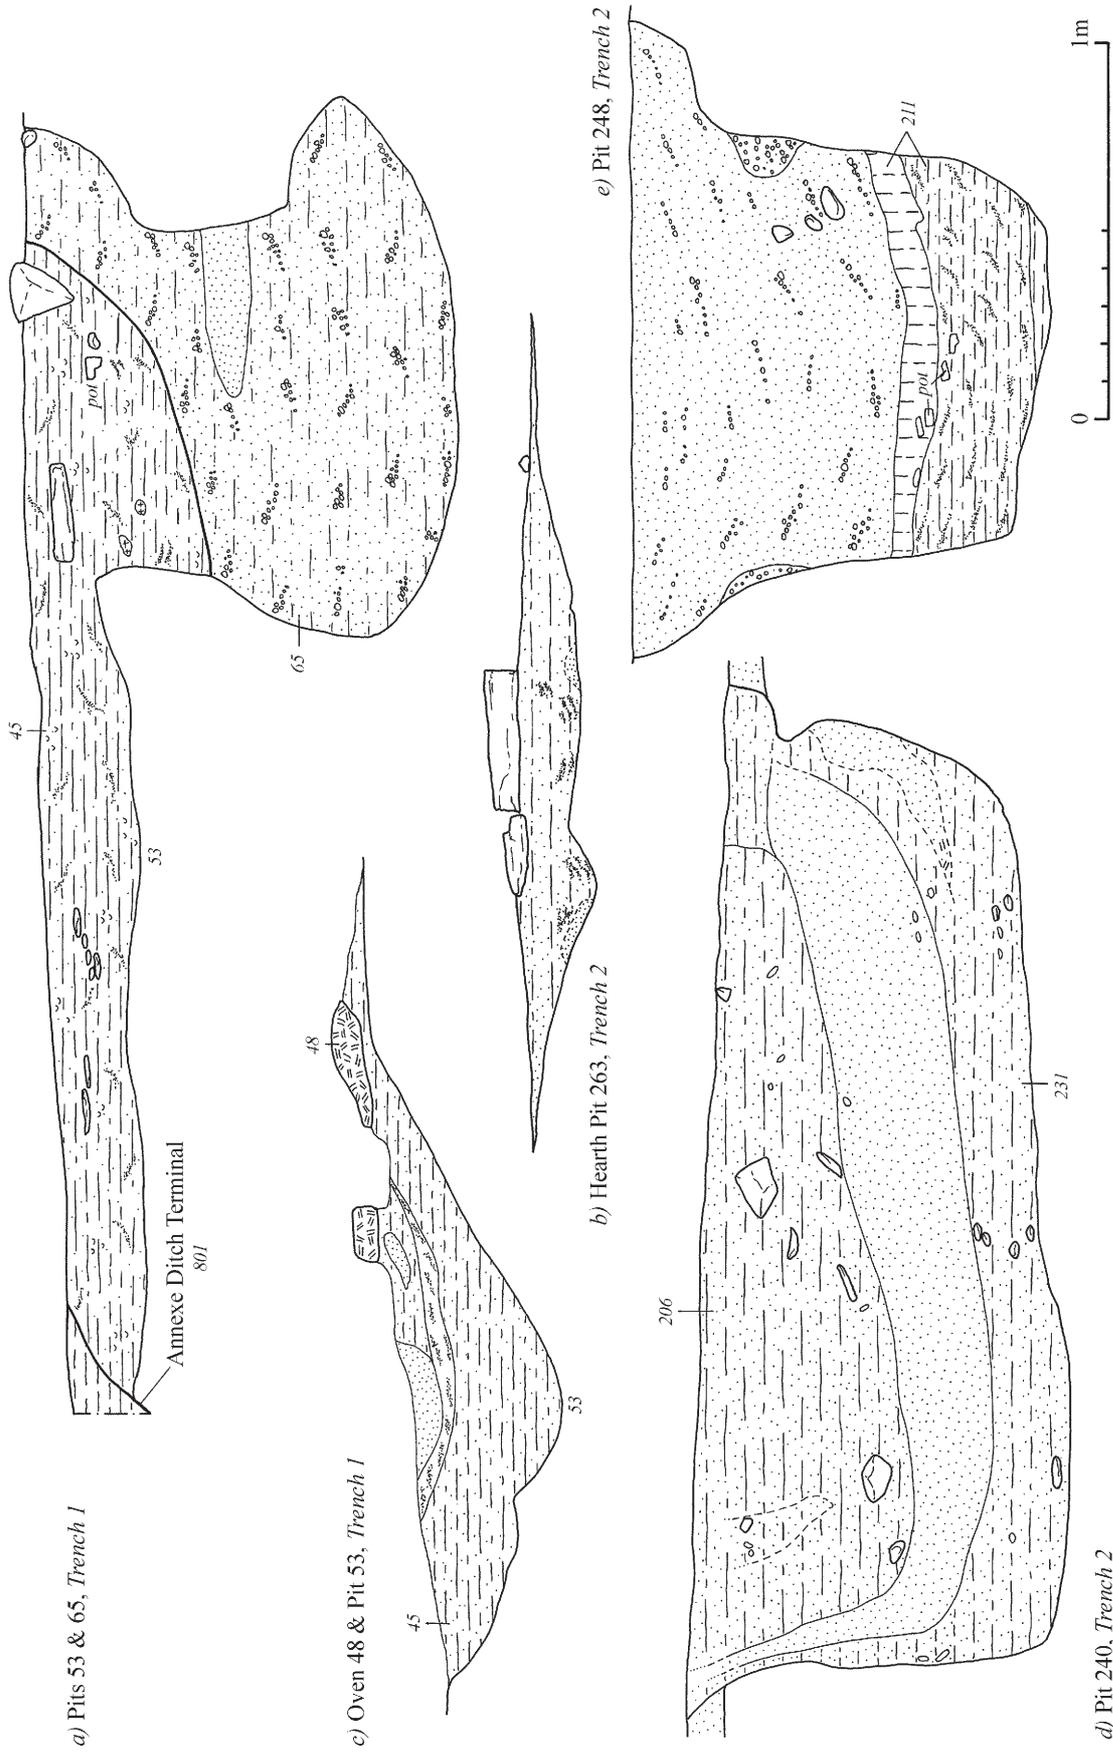
FIG. 8.13 Sections through pits and ovens: a. pits 53 and 65 (Trench 1); b. hearth pit 263 (Trench 2); c. oven 48 and pit 53 (Trench 1); d. pit 240 (Trench 2); e. pit 248 (Trench 2)

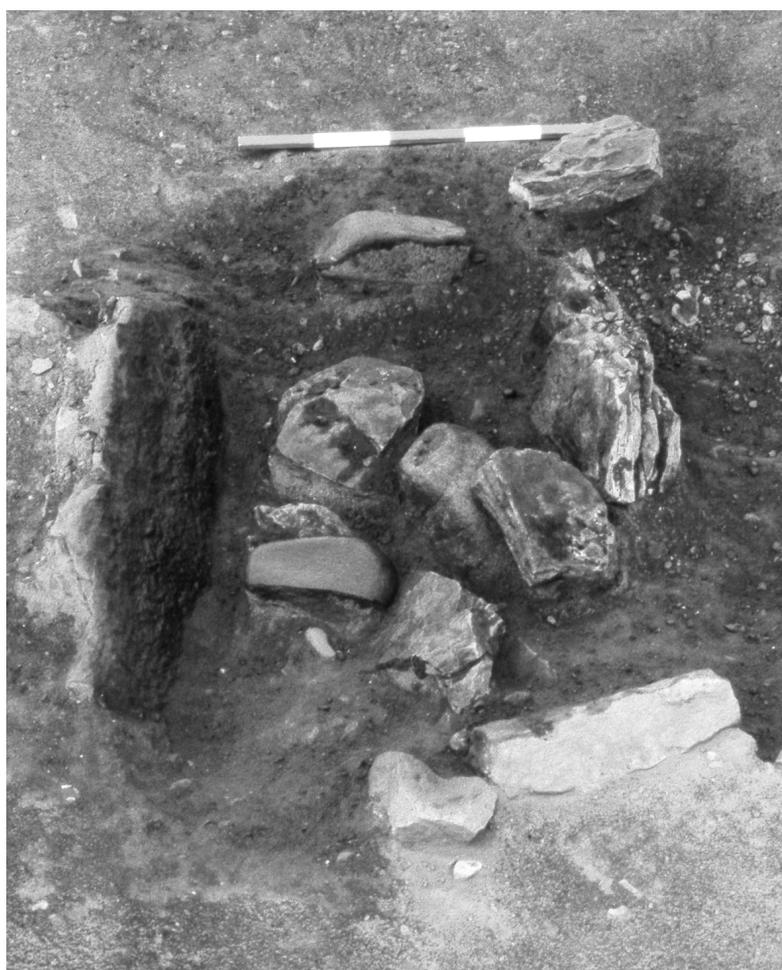
PLATE 8.10 Collapsed stone-lined pit 409, Trench 3; view west

The only internal feature associated with the building was a rectangular pit (409), measuring 1m by 0.68m and 0.25m deep, lined with sandstone slabs some of which had collapsed into its interior (PLATE 8.10). It was almost centrally positioned in Room 1, its sides aligned with those

of the building. Its original function is unclear, but its fill contained quantities of carbonised grain, some of which had sprouted (below 11.2.6), fragments of lava quern and what may have been copper alloy metalworking debris, though unfortunately no samples of the latter were retained. The filling (509) spilled out across the floor of the building suggesting that it represents material dumped during demolition. Similar material was also recovered from the contemporary roadside gully (405) and a nearby pit (547).

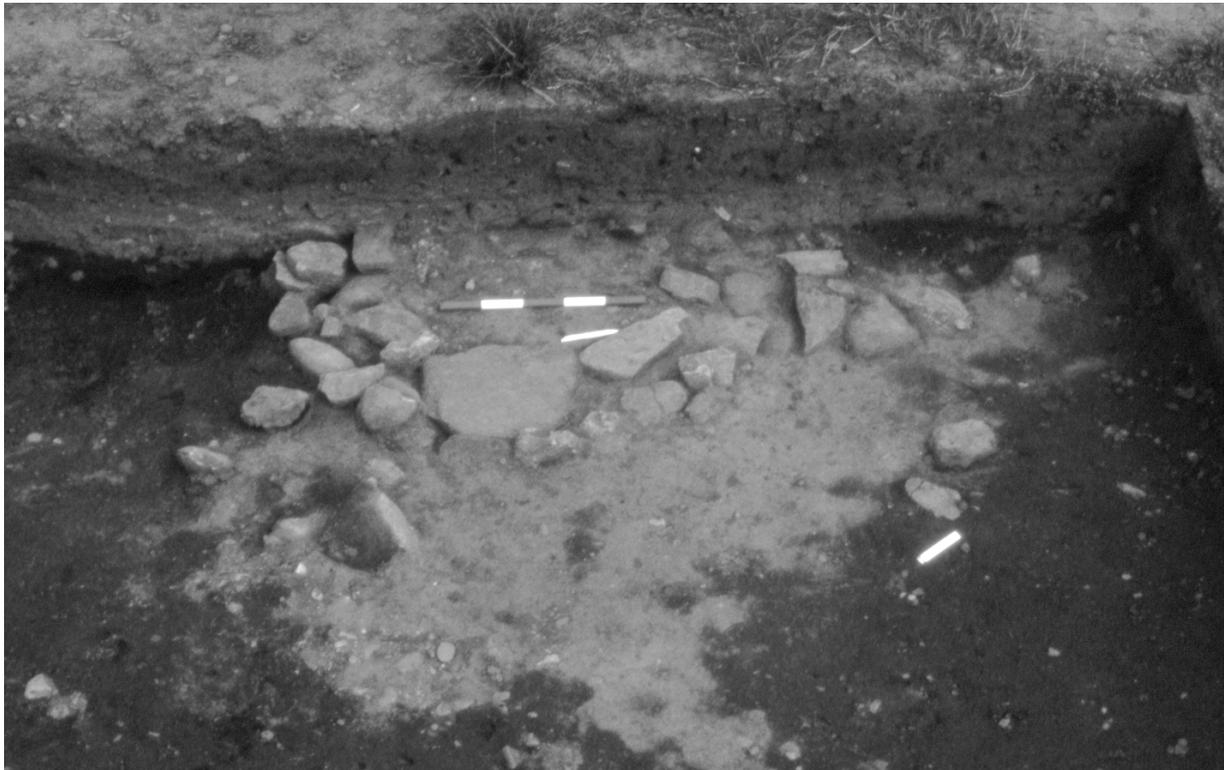
PLATE 8.11 Oven 416, Trench 3; view east

Four oven-like structures (413, 414, 416 and 423) seemed to be spaced at regular intervals running in a line not quite parallel with the road and some 6–8m distant from its southern edge in Trench 3 (FIG. 8.11; PLATE 8.9). Assuming a fifth example in an area not examined, the spacing between the ovens was almost exactly 6m centre to centre. The most completely exposed example (423) consisted of a subcircular base 1.5m in diameter made up of rounded cobbles embedded in clay reddened by oxidisation, though not entirely baked through. The other three (413, 414 and 416) were only partly visible as they extended beyond the edges of the trench. The latter two were broadly similar in character to 423, but utilised sandstone blocks in their bases rather than water-worn cobbles, and ranged in diameter from 1.4m to 1.9m (e.g. 416, FIG. 8.12a; PLATE 8.11). They are similar in form and construction to the

standard cooking ovens regularly found within forts (above 7.5). The fourth example (413) consisted of a large sandstone slab, 1m across, set directly on the subsoil, which showed clear signs of having been affected by heat.

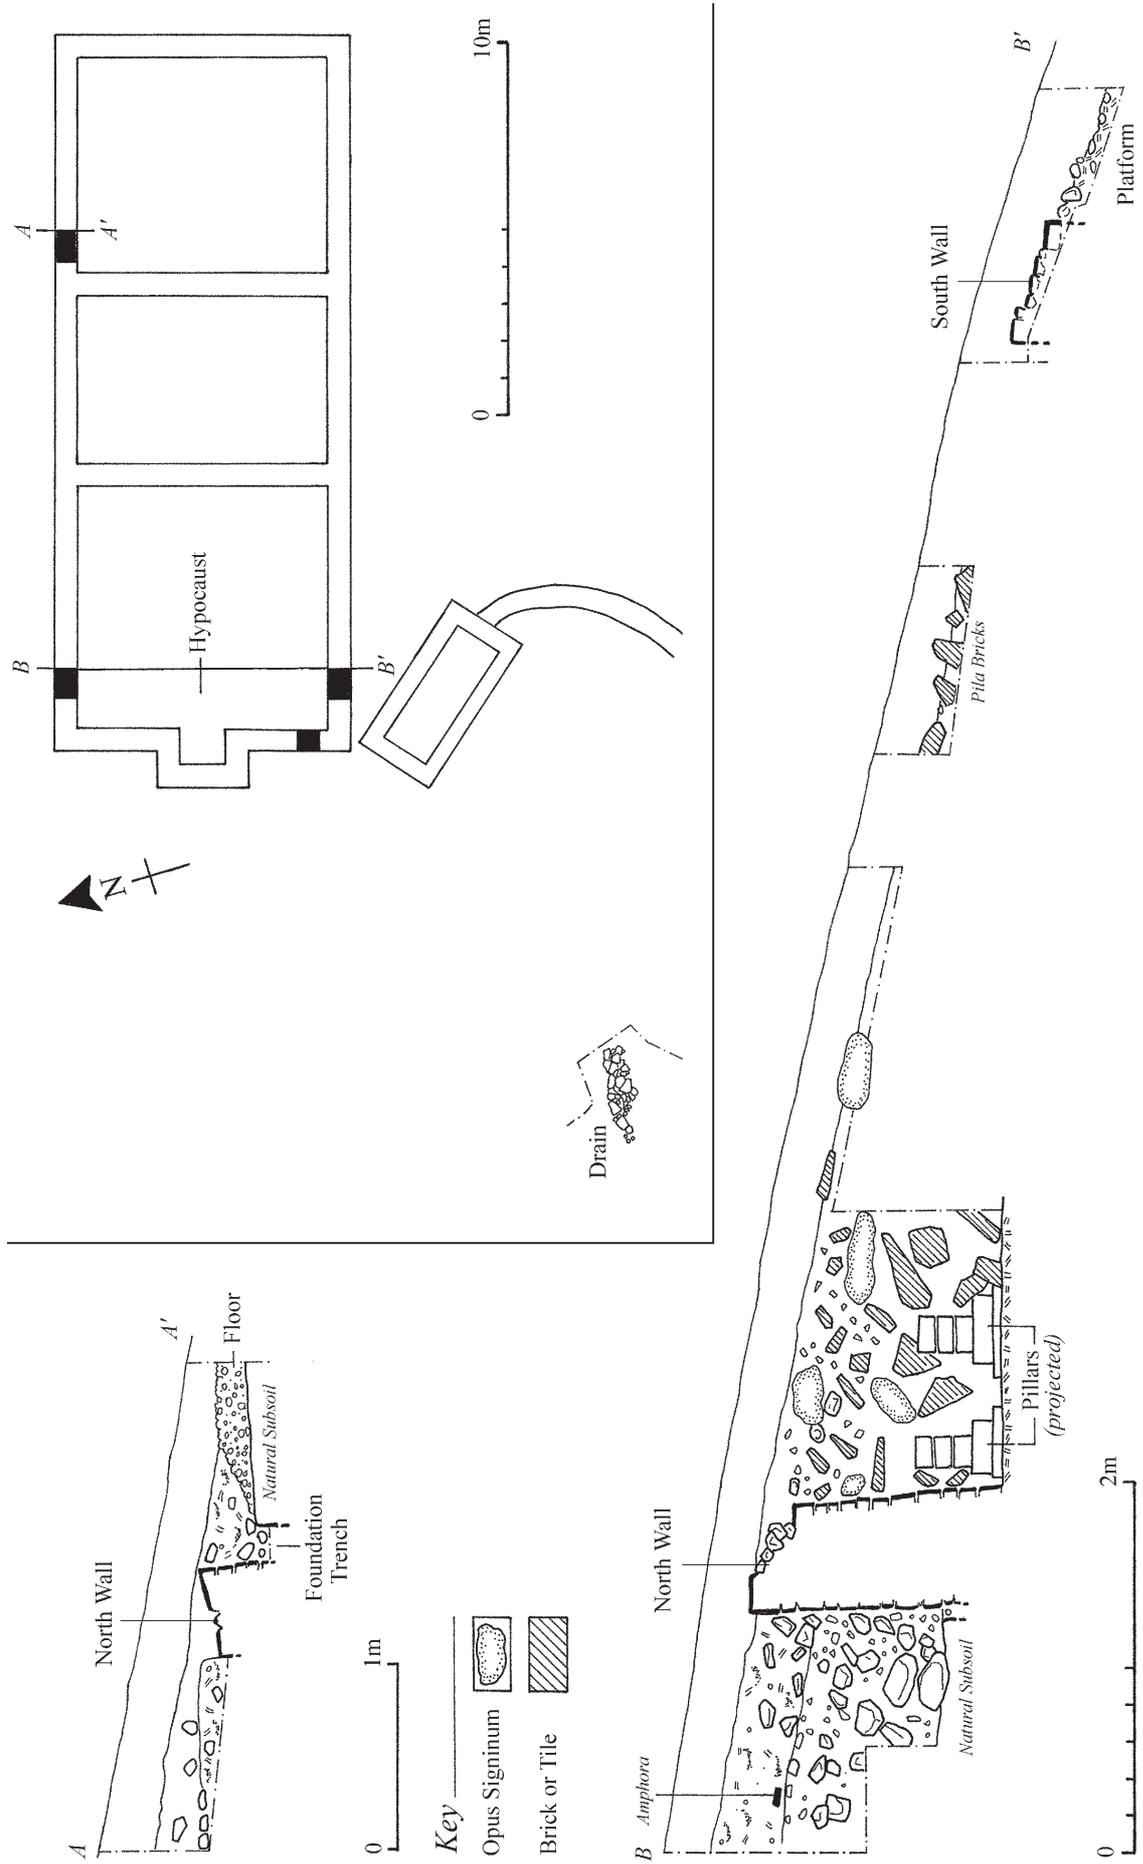
FIG. 9.1 Bathhouse plan and sections

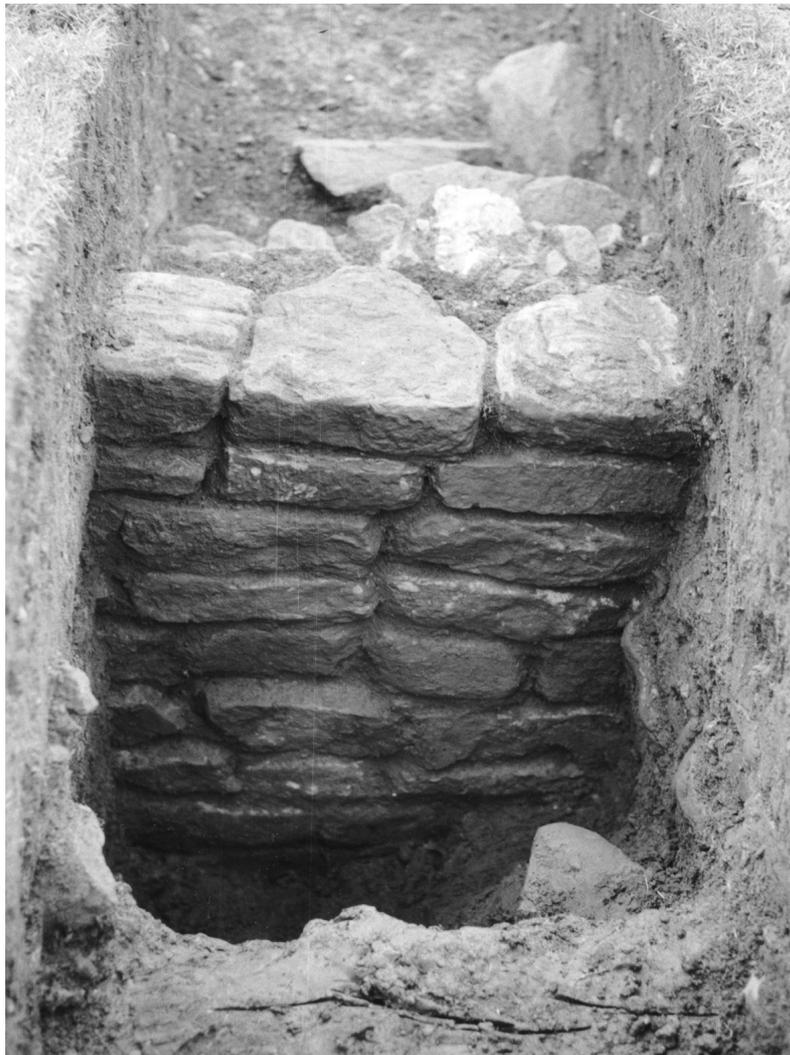
PLATE 9.1 Surviving north wall of bathhouse (Crown © Royal Commission on the Ancient and Historical Monuments of Scotland); view south

It was, therefore, fortunate that it had been decided to draw the main section (B–B) across the building from a point near the north-west corner, where the inner face of the north wall stood to a height of over 1.1m in eleven courses and the outer even higher (FIG. 9.1, section B–B; PLATE 9.1). Immediately outside the building, the Roman ground level was covered by a mass of tumbled rubble 0.75m thick, while this in turn was overlain by a spread consisting mainly of smaller stones, burned debris, and fractured tile or brick (but also containing scattered flakes and crumbs of amphora and coarse pottery), which, like the first, had accumulated against the outer wall-face; both here and in section A–A, some 12m to the east, stone-robbing had cut into this upper layer.
