WALKOVER SURVEY AND ASSESSMENT
OF

**Weston Airfield,
North Somerset**

Report No. ISRAEL 04/2009

Walkover Survey and Assessment
of
**WESTON AIRFIELD,
NORTH SOMERSET**

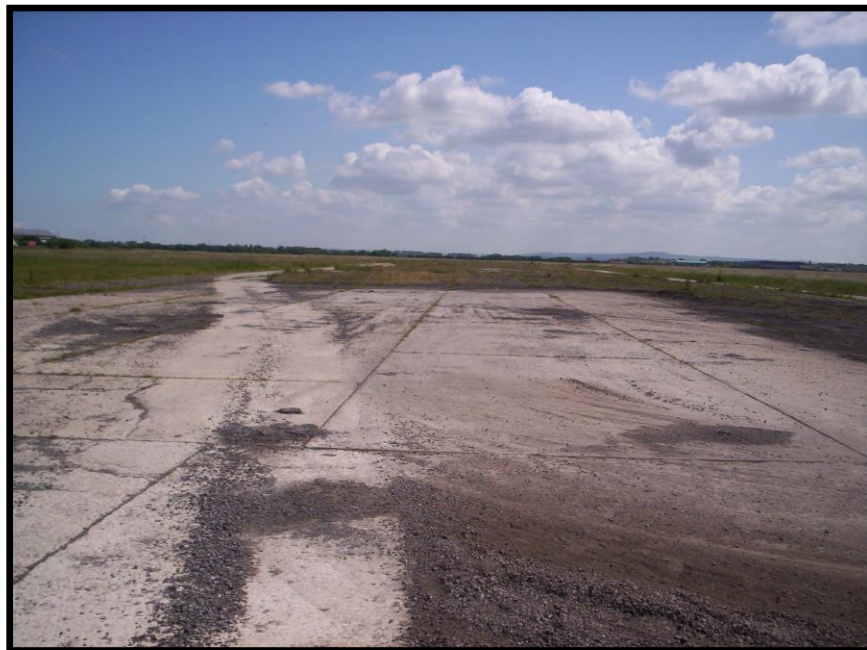
Cover: HER 41486 Concrete Runway 4200 feet (facing East).

HER 41486 Concrete Runway 4200 ft ST 3458 6036

Current Land Use: Permanent Pasture

The runway is in a reasonable condition, as it is probably still in use, (not as a runway), but as a goods track for the nearby industrial estates. However, grass has encroached the runway, possibly damaging the feature.

Recommendation: Current management is acceptable, and should continue, however the overgrowth should be removed.

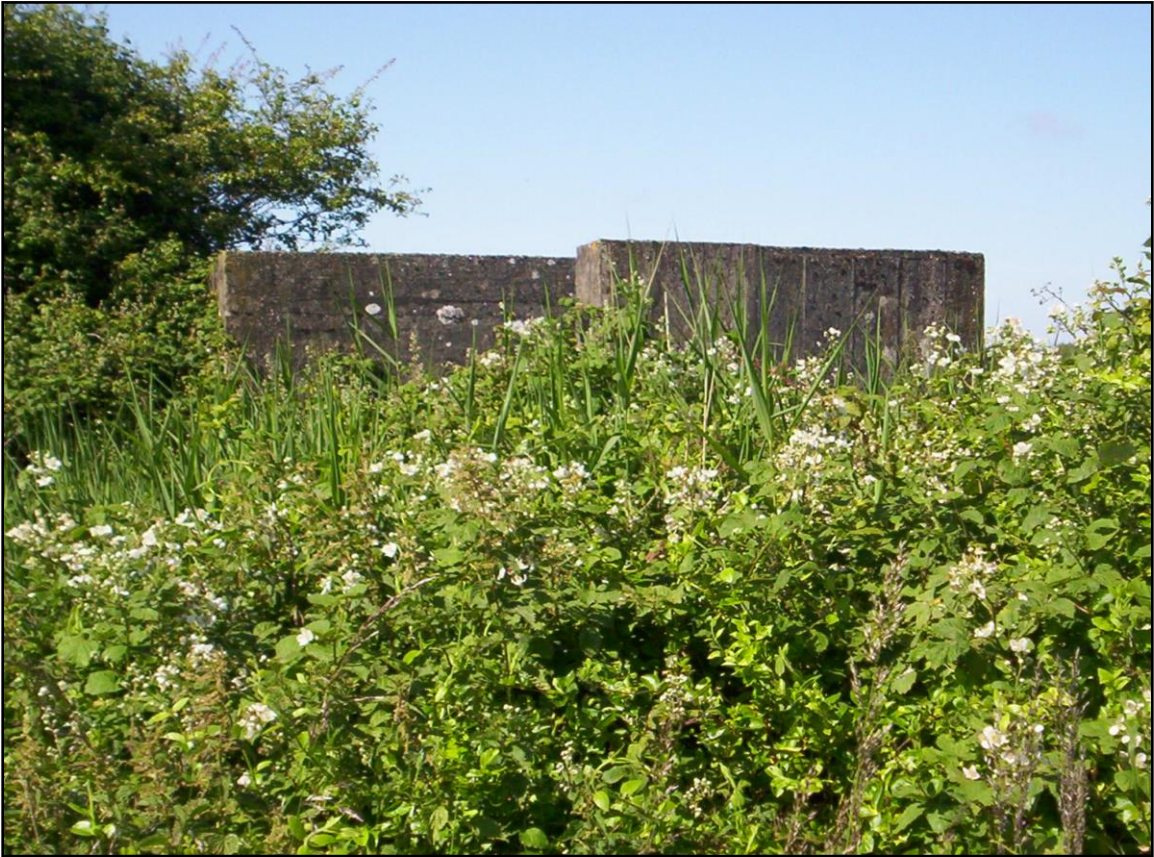
Plate 1: Current condition of HER 41485 (facing south-west).

HER 41485 Pillbox Type 3/26 ST 3416 6045 (Plate 1)

Current Land Use: Scrubland

This type 3/26 pillbox is located south to Hutton Moor Lane and the Caravan Park. Access to the structure is unavailable due to vegetation surrounding the monument. The overgrowth is so extreme that it cannot be ascertained what condition the loopholes and gun port shuttering are in. There should be one in each of the three walls.

Recommendation: Scrubland must be removed, so that a full appraisal can be made.

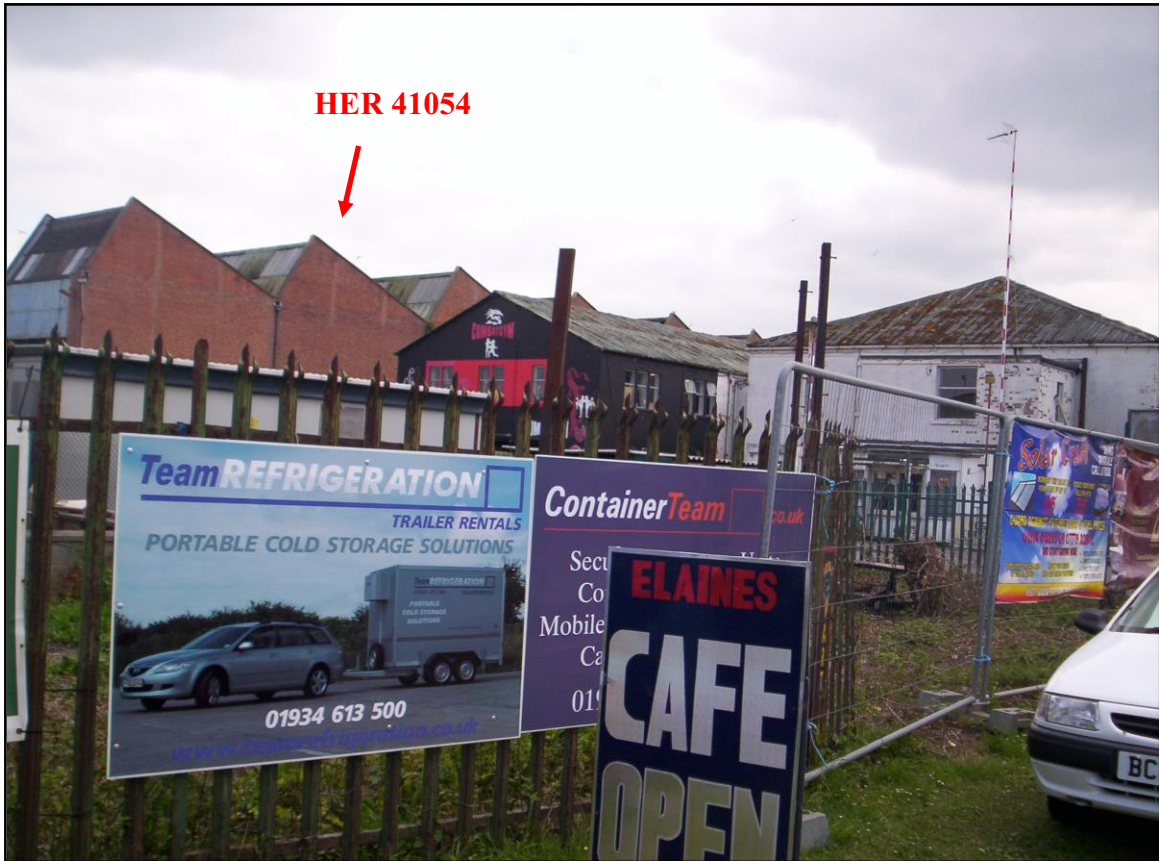
Plate 3: HER 41054 - a possible Type A or Type B Hanger (facing East).

HER 41054 World War Two Aircraft Factory ST 3376 5943 (Plate 3)

Current Land Use: Industrial Building

The building is a survival from the Second World War. Appears to be either a Type A or Type B Aeroplane shed (Osbourne 2004, 120).

Recommendation: Internal examination and propose listing of the building.

7.2 Many sites, such as pillboxes are surrounded and overgrown by vegetation, this is the most pressing concern, and this vegetation must be removed as soon as possible. It is therefore recommended that a Community Archaeology Group be established, to coordinate the removal of the vegetation and restoration of the structures. Further to this, the study area should be proposed as a Conservation Area to help maintain this fragile archaeological resource. It is further recommended that HER 41054, a possible Type A or Type B aircraft hanger be proposed for listing.

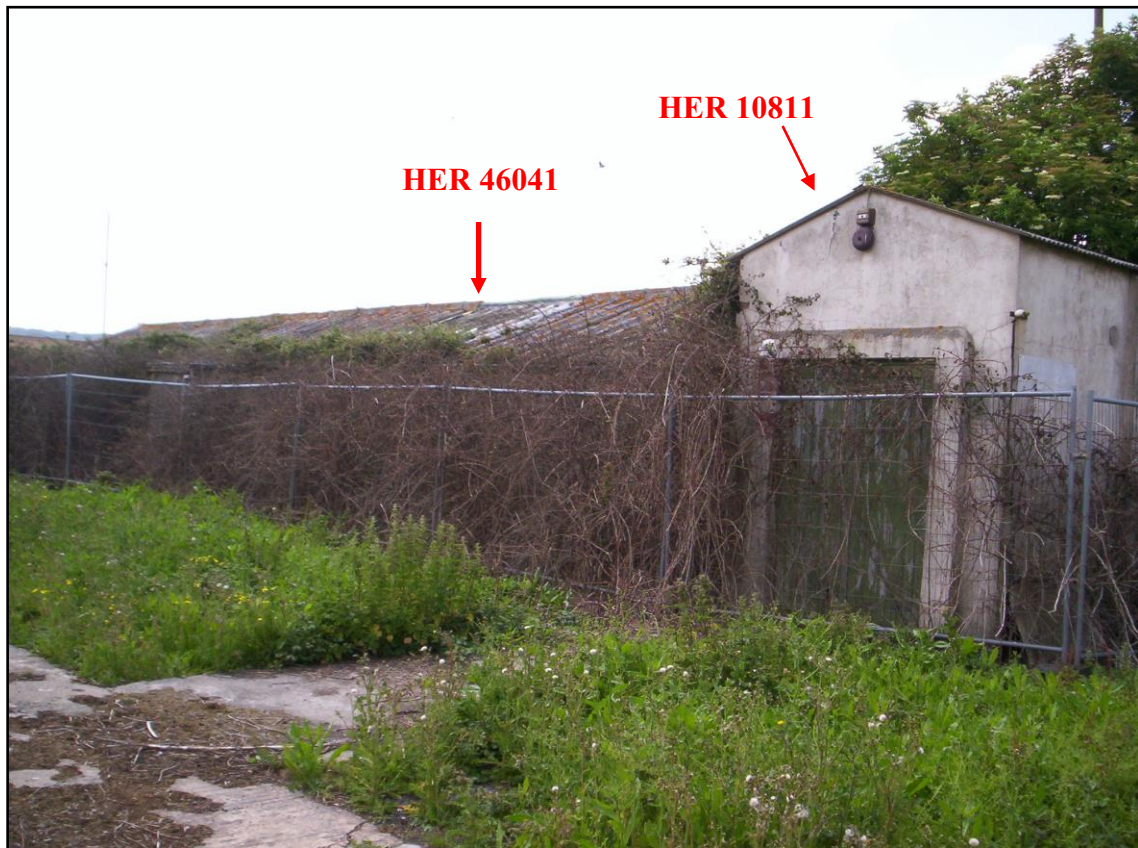
Plate 6

HER 10811 Weston Airfield Control Tower ST 3525 6054 (Plate 6)

Current Use: Scrubland

Since last inspected by County Archaeologist the site has significantly deteriorated (V. Russett pers. comm. June 2009) and therefore access is unavailable. The structure is in a poor condition.

HER 46041 Flight Hut Type 5740/37 adjacent to Control Tower ST 3526 6053

(Plate 6)

Current Land Use: Scrubland

This structure is also completely invisible due to vegetation overgrowth, and is therefore in a poor condition.

Current condition of HERs 10811 and 46041 (facing south-west)

Recommendation: Remove scrubland and make further assessment

Recommendation: Remove scrubland and make further assessment.
