# Brockington House and Associated Buildings.

## *Historic Building Recording.*

*For the Heritage Collective.*

*MAY 2017*

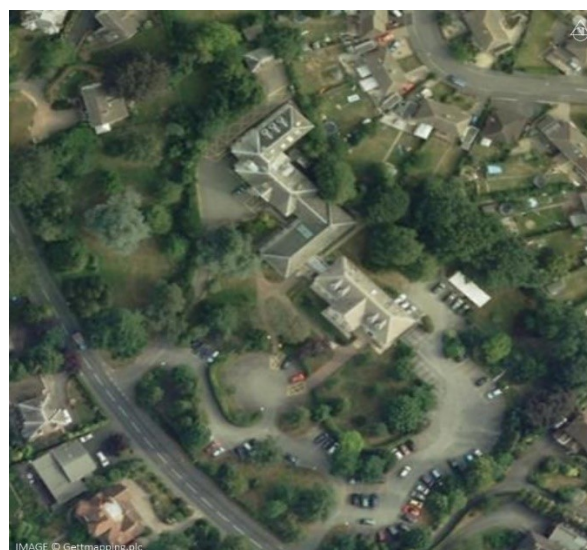
The former house forms only a small part of a large building complex which sits within a sizable

*Plate 1 Aerial view Of Brockington House and associated buildings*

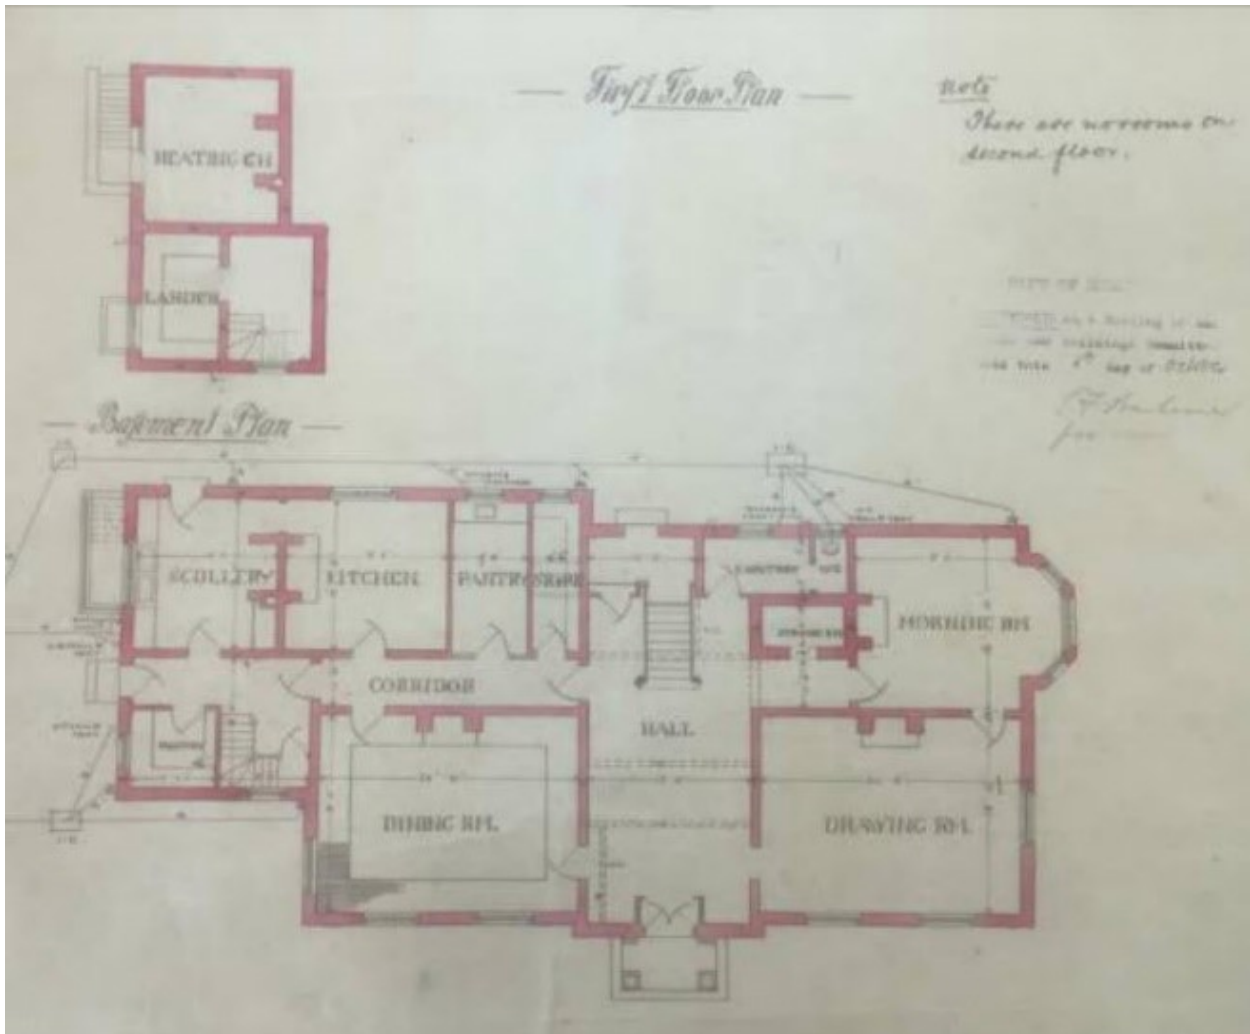
*Illus. 2 Ground Floor Plan (1909).*

rooms. The form of the original house is documented in the original drawings, held as a matter of public record at the Herefordshire Records Office. (*Illus. 2 & 3*)

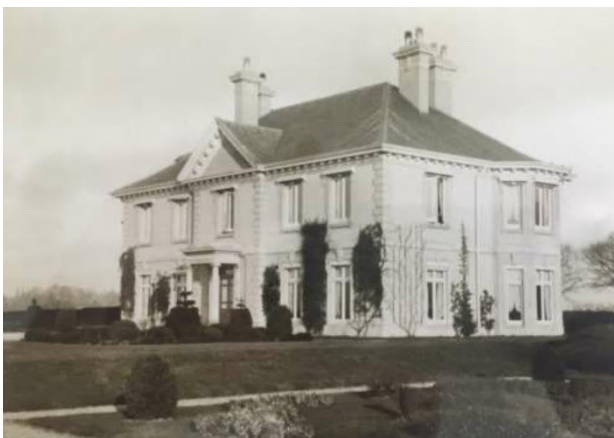
*Plate 2 Undated Photograph showing the exterior of Brockington House.*

Undated photographs show the form and character of the exterior and interior shortly after its construction. (*Illus. 5 & 6*) (BJ21/165-166, Houses; Photographs, Brockington, Hafod Road: photographs (Herefordshire Records Office))

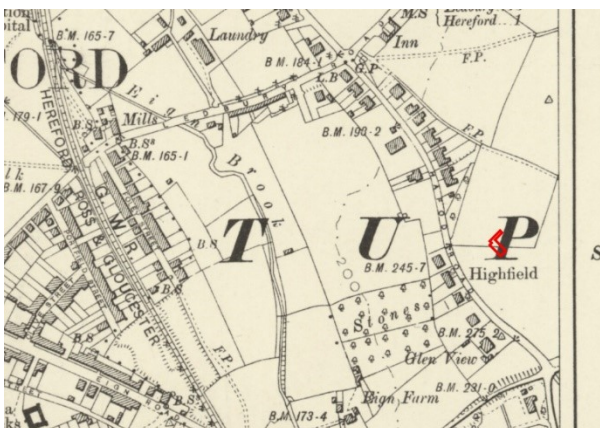
The earliest available detailed map is the 1902 Ordnance Survey Map (*Illus. 5*). This broadly shows a landscape of open fields within the study area, prior to the construction of Brockington House in 1909.

*Illus. 5* Extract from the Six-inch England and Wales OS map 1902

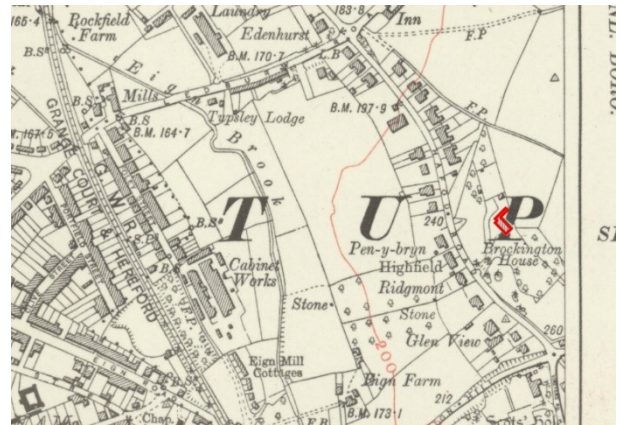
The 1930 Ordnance Survey Map (*Illus. 6*) identifies that the main house sits within a

landscaped garden. The building is shown with an extension running from the rear of the main house, this has previously been identified as a period extension to the property but more likely reflects the construction of a green house or orangery to the rear of the property, a feature common with buildings of this date.

*Illus. 6* Extract from the Six-inch England and Wales OS map 1930

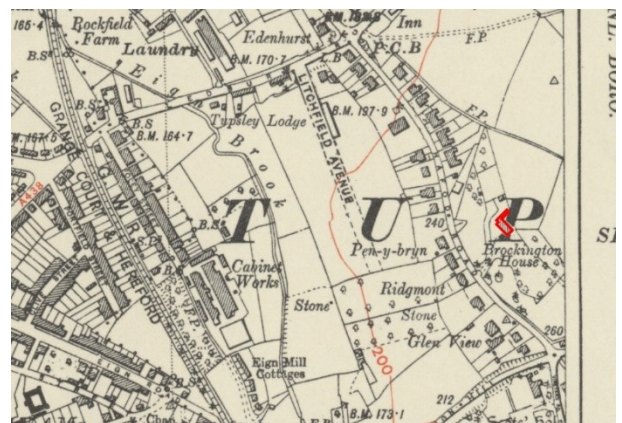
Examination of the 1948 Ordnance Survey map illustrates that the building remains unchanged from the 1930 Survey (*Illus. 7*). This period of non-development is also reflected in the 1953 Ordnance survey mapping when again no changes are recorded. (*Illus. 8*)

*Illus. 7* Extract from the Six-inch England and Wales OS map 1948

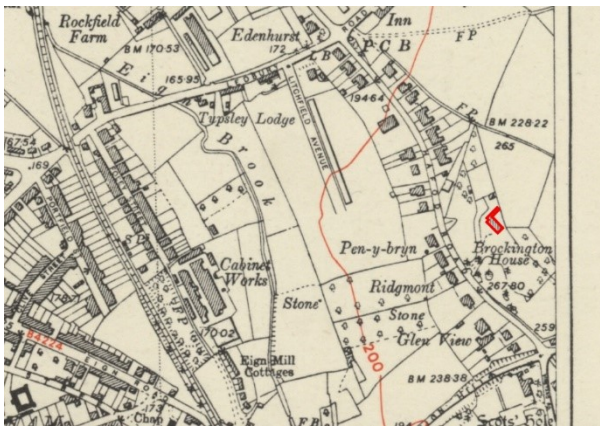
*Illus. 8 Extract from the Six-inch England and Wales OS map 1953*

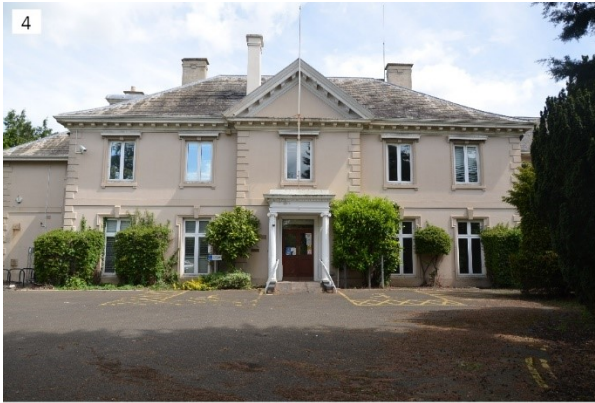
*Plate 4 Main façade of Brockington House.*

The Main House was constructed in 1909, stylistically the house is of a simple classical appearance possibly taking its influence from Italian renaissance architecture. The main façade of the building retains a symmetrical balance, a central bay with single window below a triangular pediment, flanked by 2 bays of windows, while chamfered quoins laid in an alternating long-short pattern reinforce the structural presence of the building. (*Plate. 4*)

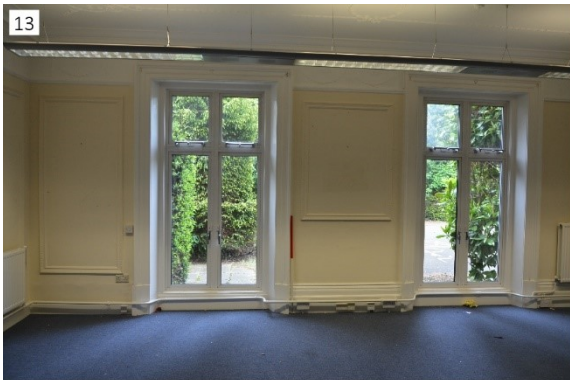
mirrors the external window mouldings. Room G.1 also retains the original eight panel wood doors although the door furniture has been updated (*Plates. 13, 14 & 15*).

Plate 13 Internal detail showing decorated panels and modern window installations, Room G.1

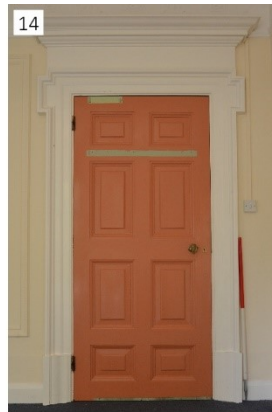
Plate 14 Internal detail showing original eight panel door with lobed architrave and hood moulding reflecting external window styles, Room G.1

The original ornamental plaster ceiling decorations have been retained along with moulded wall panels, moulded architrave, and an element of original skirting board (*Plates 11 & 15*). Room G.1 also retains the original eight panel wooden doors, although the door furniture has been updated (*Plate 14*).

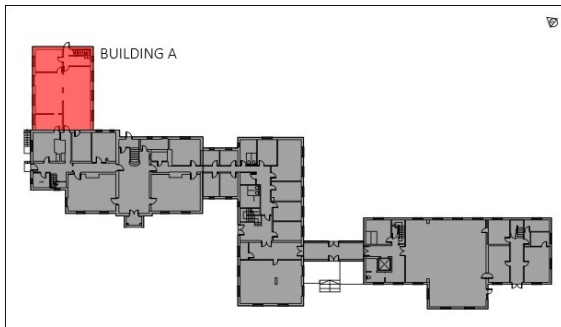
Building A forms an extension to the rear of the Main House aligned north south (*Site North*). The building measures approximately 12.30m in length with an external width of 12.30m, an eaves height of 6.15m and a roof line of 10.20m. (*Plate. 26*)

The building is constructed from lightweight masonry aggregate blocks and concrete, with a painted render finish matching the main house, stylistic details of Brockington house have been adopted to unify the construction, for example the lower stepped foundation course, the first-floor moulding band and corbeled window sills. (*Plate. 27*)

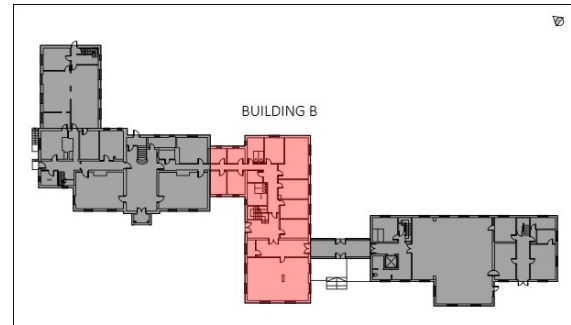
Building B forms an “L” shaped extension to the east face of the Main House, aligned north south (*Site North*), the construction of Building B necessitated the removal of the two-story canted bay window seen in the historic record.

The building measures approximately 25.02m in length with a maximum external width of 15.00m, an eave height of 6.33m and a roof line of 10.50m.

The building is constructed from lightweight masonry aggregate blocks and slab concrete floors with a painted render finish matching the main house, stylistic details of Brockington house have also been adopted to unify the construction, for example the lower stepped foundation course, the first-floor moulding band and corbeled window sills

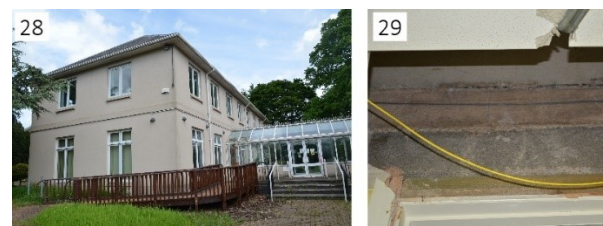
Plate 28 South facing elevation Building B showing connection with Building D.

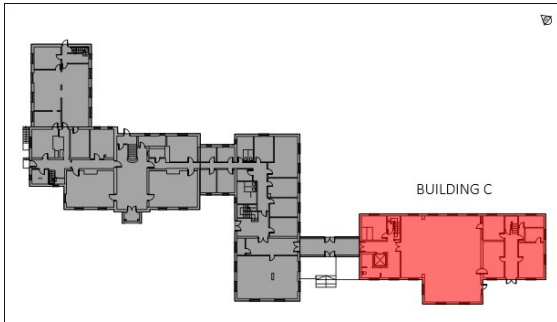
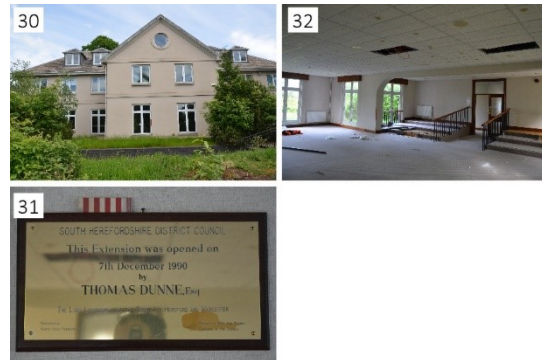
Plate 30 Main elevation of Building C.

Building C represents the final major construction phase within the development, a commemorative plaque placing the dedication of the building to 1990 (Plate.31). The building is linked to the complex via the glass corridor (Building D).

The building measures approximately 27.97m in length with maximum width of 12.90m, eave height of 6.50m and roof line height of 12.90m.

The building is constructed from ash blocks, steel frame and concrete slab flooring, with a painted render finish matching the main house, stylistic details of Brockington house have also been adopted to unify the construction, for example the lower stepped foundation course, the first-floor moulding band and corbeled window sills, to further the connection the main elevation was constructed with a projecting central pediment containing a bull's eye window. (Plate 30)

The internal layout of the building contains three floors, with storage space in the roof space and office space on the first and second floors as well as a council debating chamber on the ground floor (Plate.32).

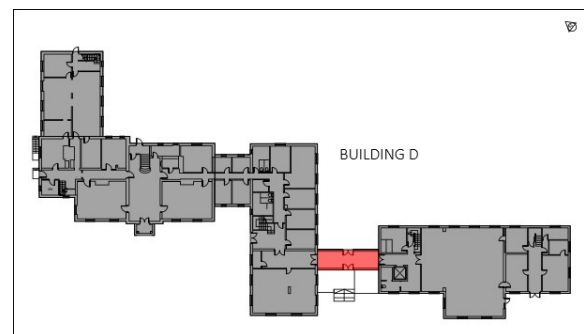
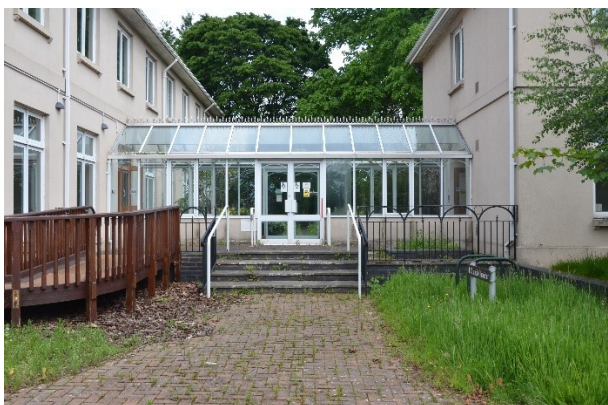
*Plate 33 Building D.*

Building D forms, a link block / access corridor between Buildings B and C, aligned west east (Site North). The building measures approximately 8.95m in length with an external width of 2.99m, internal width of 2.42m and a height of 3.19m. The building is constructed from two low aggregate block walls with an aluminium framed greenhouse structure above. Internal flooring is formed from cast concrete.

The building has two external doors, located centrally to the cross passage, providing points of entry and egress. (Plate. 30)
