Archaeological Monitoring  
of a  
Residential Development

CATHERINE STREET  
HEREFORD  
HEREFORDSHIRE  
HR1 2DU

Archaeological Monitoring

**TAC. Ref:** CSHF-18  
**NGR:** SO 5112540286  
**Event No:** EHE 80368  
**Oasis ref:** thearcha5-328690  
**Local authority:** Herefordshire Council  
**Archive Repository:** Herefordshire Museum Service

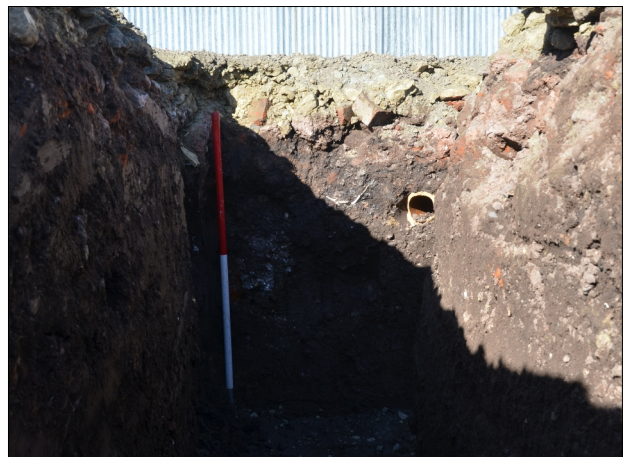
Plate. 3 Sample section detail, showing modern services.

No archaeological features of historic significance were observed during the ground works; however, a series of modern ceramic 6" drainage pipes and evidence of a brick and concrete footing line were observed towards the southern extent of the footing excavation.

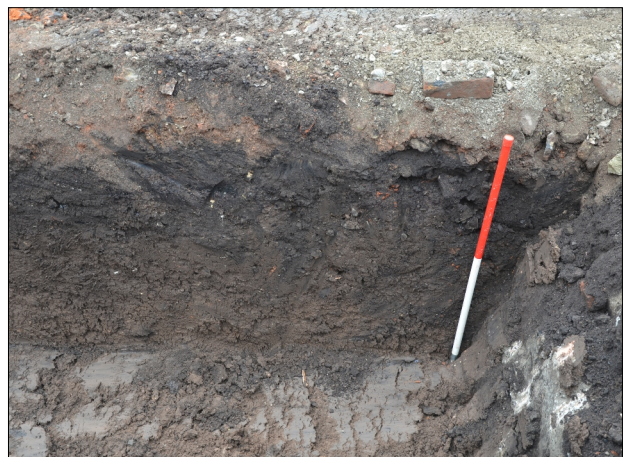
Plate. 4 Sample section detail, facing south

The stratigraphic matrix of the area, when excavated, was represented by three distinct deposits. The earliest deposit encountered, at a depth of 0.50m-0.60m from the ground surface, was a buff brown, slightly silty clay deposit (103).

Immediately overlying this was a layer, 0.30m-0.40m deep, of mid-dark black silty clay (102) which appeared to represent a former mixed levelling deposit, suggesting construction or demolition activity within the site area. Several fragments of modern white china and frequent inclusions of stone and red brick fragments were observed within its matrix.

The uppermost horizon comprised a hard-packed layer of hardcore consisting of crushed brick, stone and scalping's (101), forming an area of hard standing or levelling deposit, approximately 0.20m deep associated with (100).
