Excavations at the Beverley Gate, and other parts of the town defences of Kingston-upon-Hull

by D.H. Evans

Humber Archaeology Partnership
Hull

[Text 2015; updated and revised 2018]

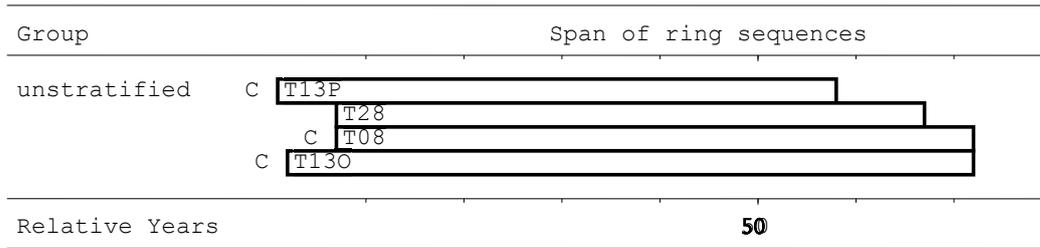
Figure 42: Bar diagram showing the relative positions of the four crossmatched timbers from Beverley Gate, Hull. White bar = heartwood rings; C = centre of tree was present.

A total of 21 samples (16 oak, three pine, two elm) were measured, of which six oak timbers were absolutely dated. Although the number of dated timbers is low, the study was successful in that felling dates were obtained for timbers from Phases II and IV. Additionally, the analysis has indicated that two of the unstratified timbers were probably originally used in a structure with **42C**. The possible bridge from Phase II was constructed after AD1580, but probably before AD 1665, whilst the Phase IV timbers indicate building activity on the site during the period AD1620-1665. These timbers were then reused in the Phase IV timber revetment, indicating that this structure was built sometime after AD1620. Unfortunately, it was not possible to determine felling dates for the timbers from the Phase Ia sub-structure of the timber Gate, or whether the Phase V timbers were related to the demolition of the Gate structure.

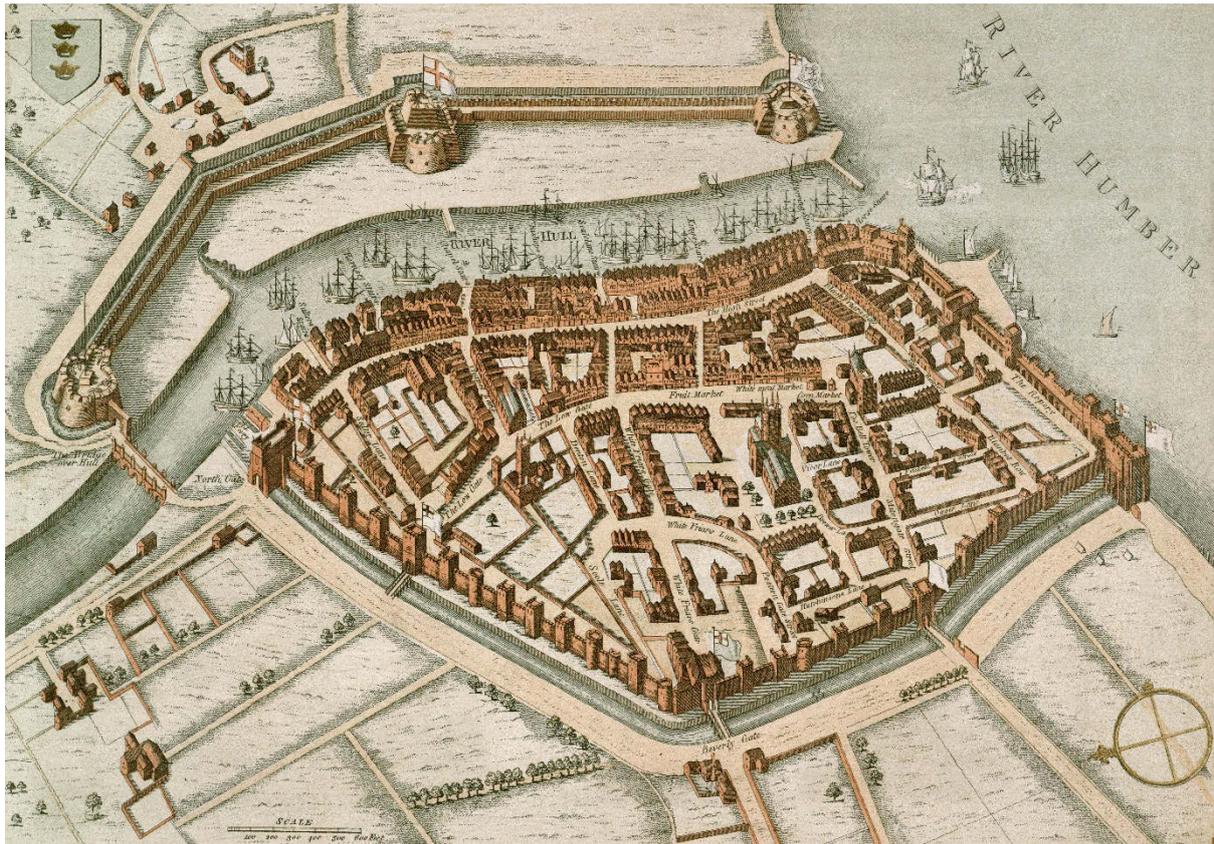
Fig. 4. A view of Hull from the west, drawn by Wenceslaus Hollar before 1640. This version is in colour, and is thought to date to about 1638. [Copyright: Hull History Centre.]

At the Beverley Gate itself, the onset of Phase III is somewhat earlier, and is marked by the construction of two large guard chambers at the rear of the medieval Gate. The precise date of their erection is uncertain, but they are clearly depicted on Wenceslaus Hollar's view of Hull in c. 1638 (Figs 4 and 45), as two-storied towers, with tall side

Hollar's Map of *c.* 1638 (Fig. 4) clearly depicts the rebuilt Gate as a lower squatter structure than its medieval predecessor. The latter's tall tower and steeple has gone. Instead, we have a two-storied Gate, capped with simple crenelated battlements, flanked to the rear by two-storied guard-chambers, with their pitched gables set at right-angles to the Town Wall (Fig. 45); symmetrical tall chimneys project from each of these guard-chambers. The external entrance to the Gate is still through its Tudor-style archway, flanked on either side by its projecting stepped buttresses; and its upper floor is still lit by a single, small, centrally-set rectangular window, flanked on either

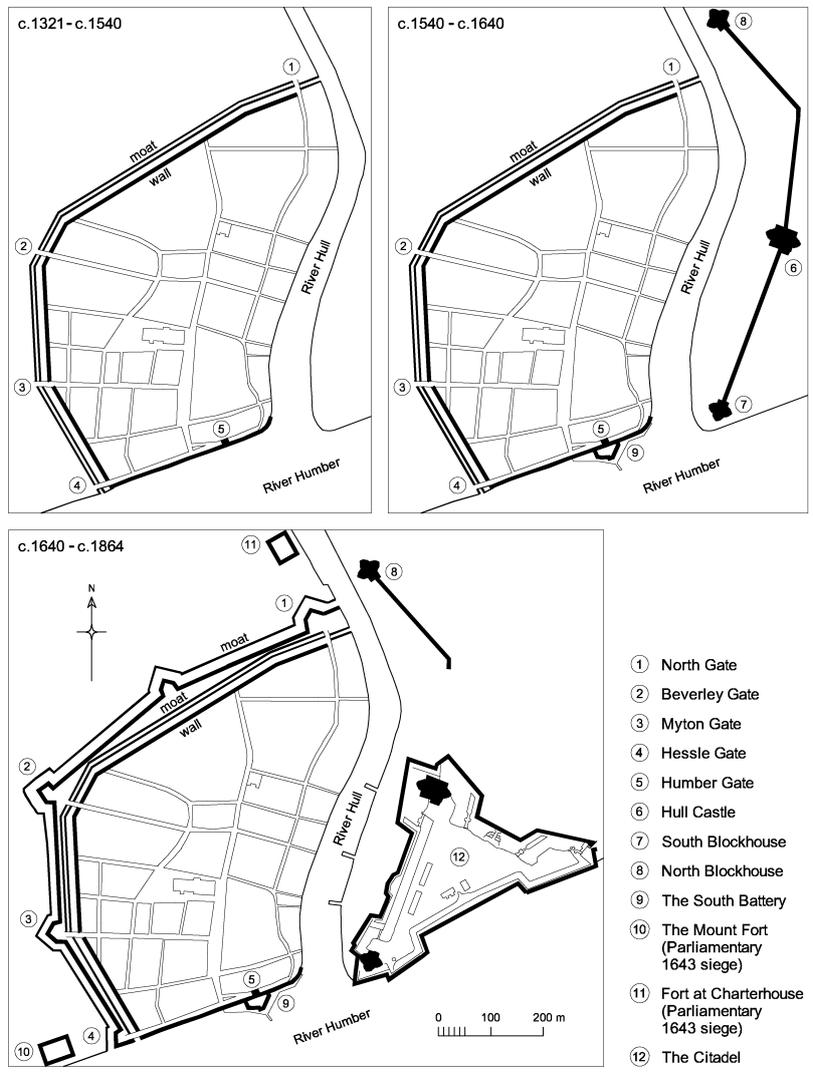
Fig. 6. The schematic development of the Hull Defences between the mid 14th century and the end of the 17th century.

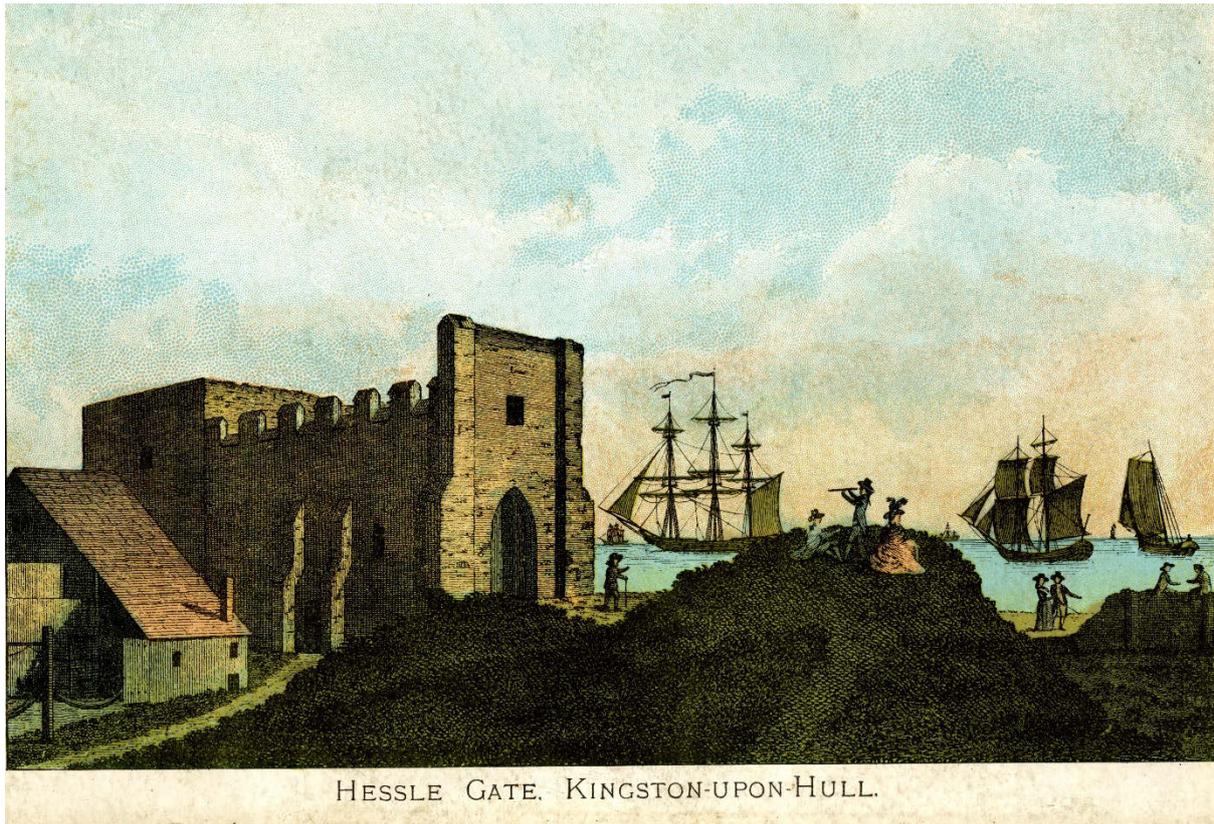
Fig. 7. The Hessle Gate during the 18th century. The remains of one of the English Civil War earthworks can be seen in the foreground. [Topographical print in the collections of Hull City Museums and Galleries. Copyright HCMAG]

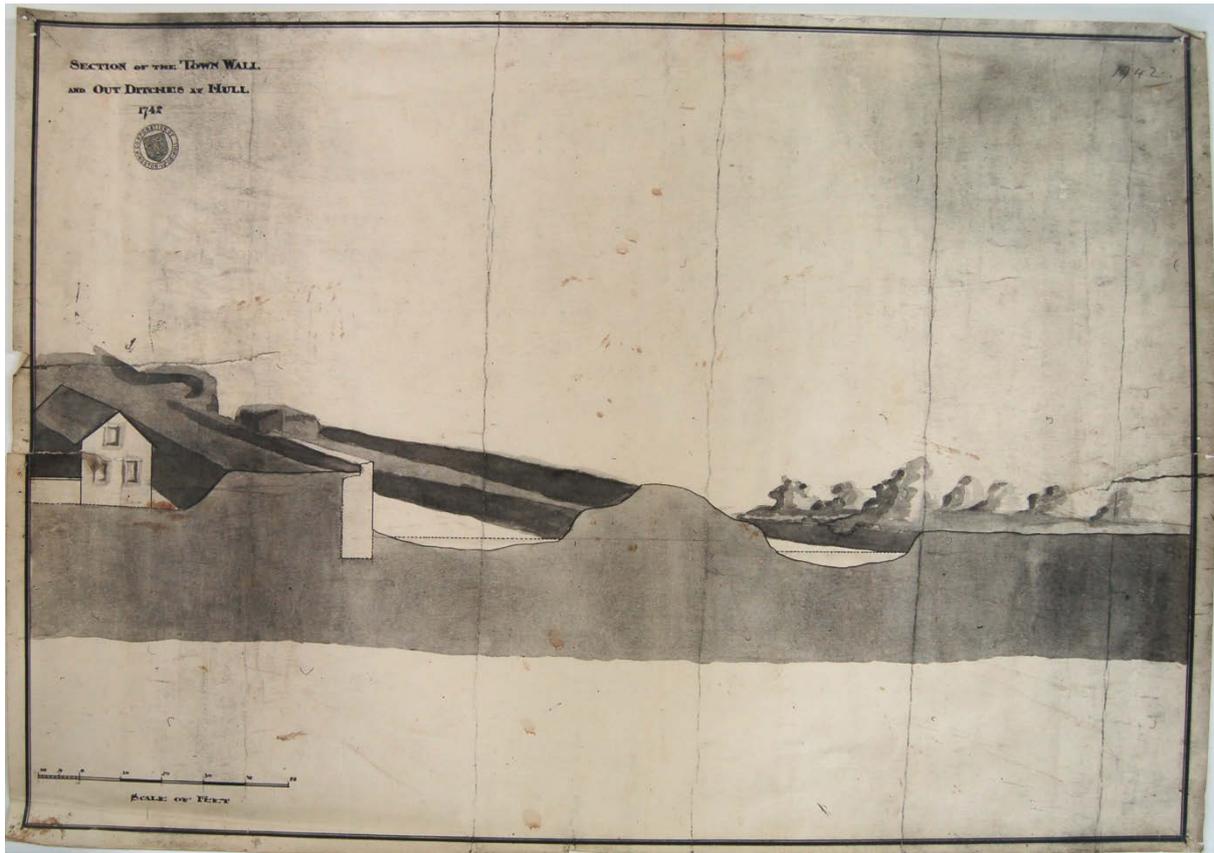
Fig. 10. A profile through the outer earthworks of the Town Defences in 1742. [From the collections of the Wilberforce House Museum, Hull. Copyright HCMAG]

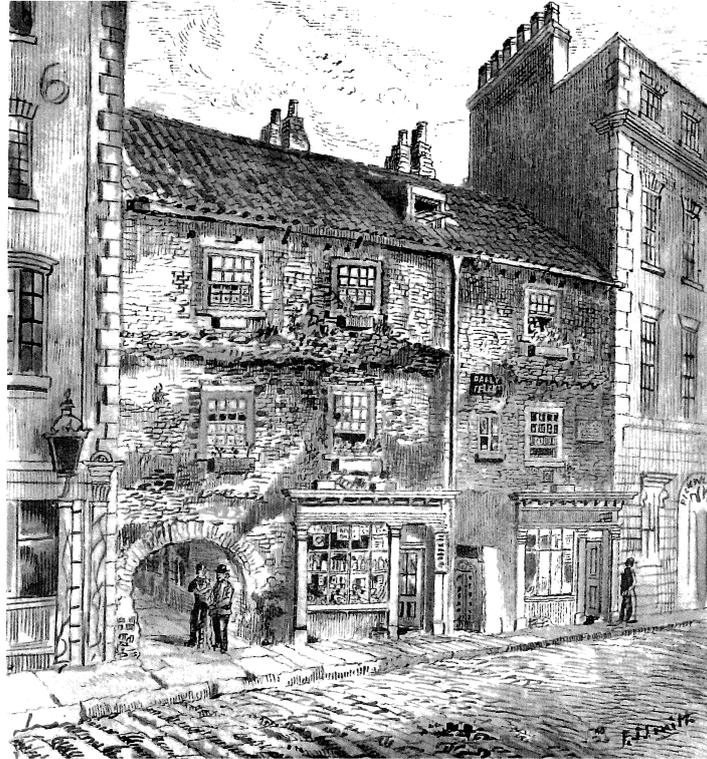
Fig. 11. The archway at the entrance to Little Lane, on the north side of Humber Street, was the last surviving section of the Town Walls. Probably the factor which contributed most to its survival into the mid 20th century was that it became incorporated into the lower part of an 18th-century three-storied building, and so was not demolished at the same time as most of the rest of the circuit. This view, by the celebrated local artist F.S. Smith, dates to about 1885. [Source: Aldridge 1989, no. 63. Copyright: HCMAG]

accurately recorded on the more detailed maps of the first half of the 19th century, let alone the Ordnance Survey. Nevertheless, one of the very last elements of the Town Walls to survive was a postern at Little Lane, which remained standing until at least the mid 1960s (Pl. 2 and Fig. 11; see also Part II, below).

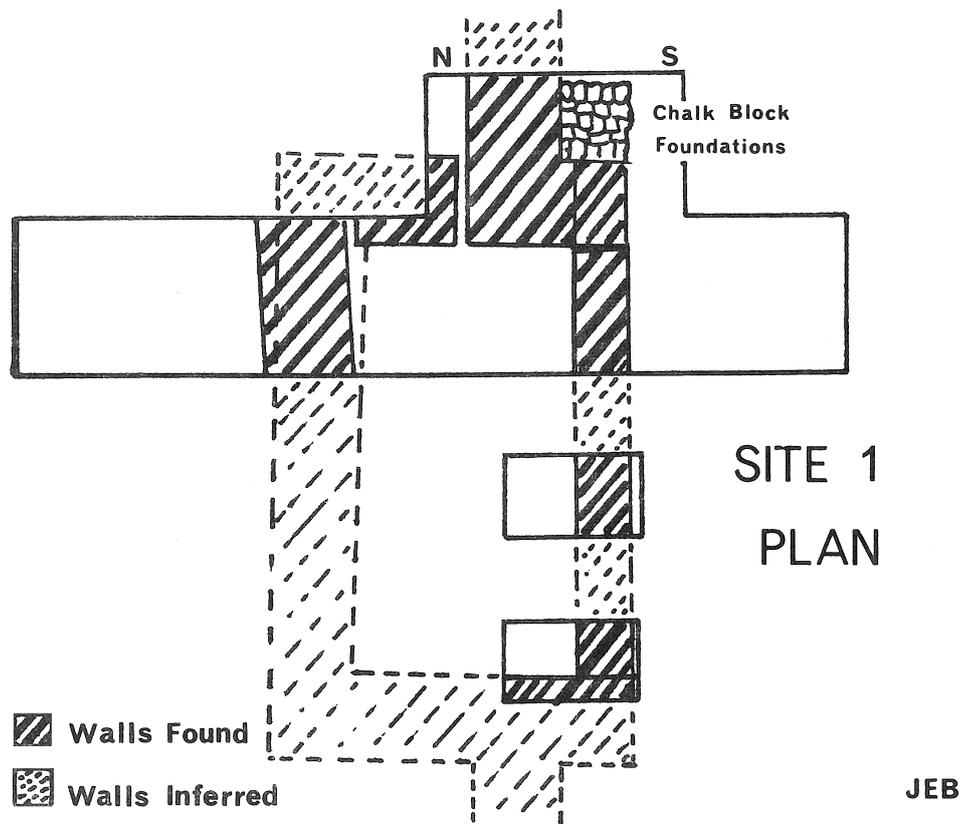
Fig. 13. North Walls 1969. Plan of interval tower in Trench 1. [Copyright Hull Museums]

fresh course of brickwork set slightly back from that beneath (e.g. Pls 16 and 18-19). Above this height, the Wall rises vertically. [Similar evidence for an external batter on the basal courses of the brick Wall was observed at North Walls (e.g. Pl. 6 and Fig. 14): Bartlett 1971, 8, 11, and section drawing on p. 10.]

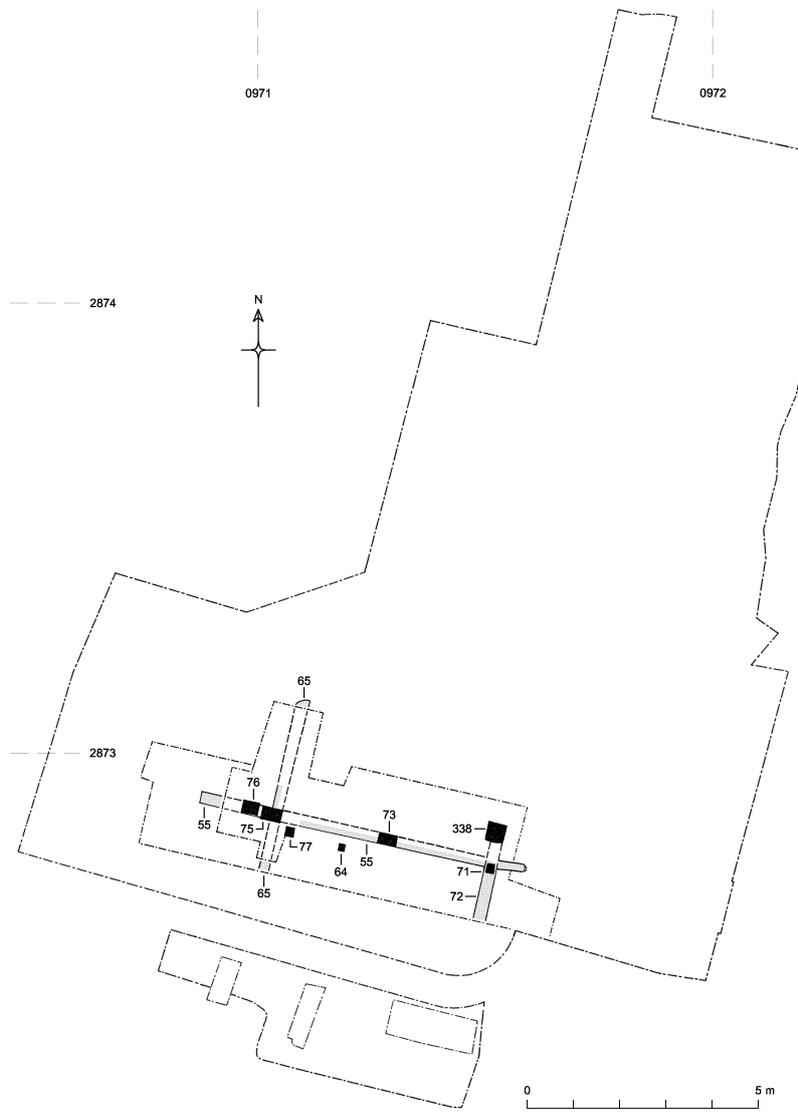
Fig. 16. Plan of the excavated Phase Ia timber structures at the Beverley Gate. [Early to mid 14th century]

Excavations on the site of the Beverley Gate have shown that the earliest Gate structure was of timber, and most likely dated to the second quarter of the 14th century. It was a freestanding structure which projected forward from the line of the clay Bank with its timber palisade (Figs 6 and 16): in this respect, it was rather similar to the form of defences found at nearby Beverley, where freestanding timber Gate structures controlled access in and out of the town (one of these, which was rebuilt in brick in 1409, is still standing today: the North Bar at Beverley).

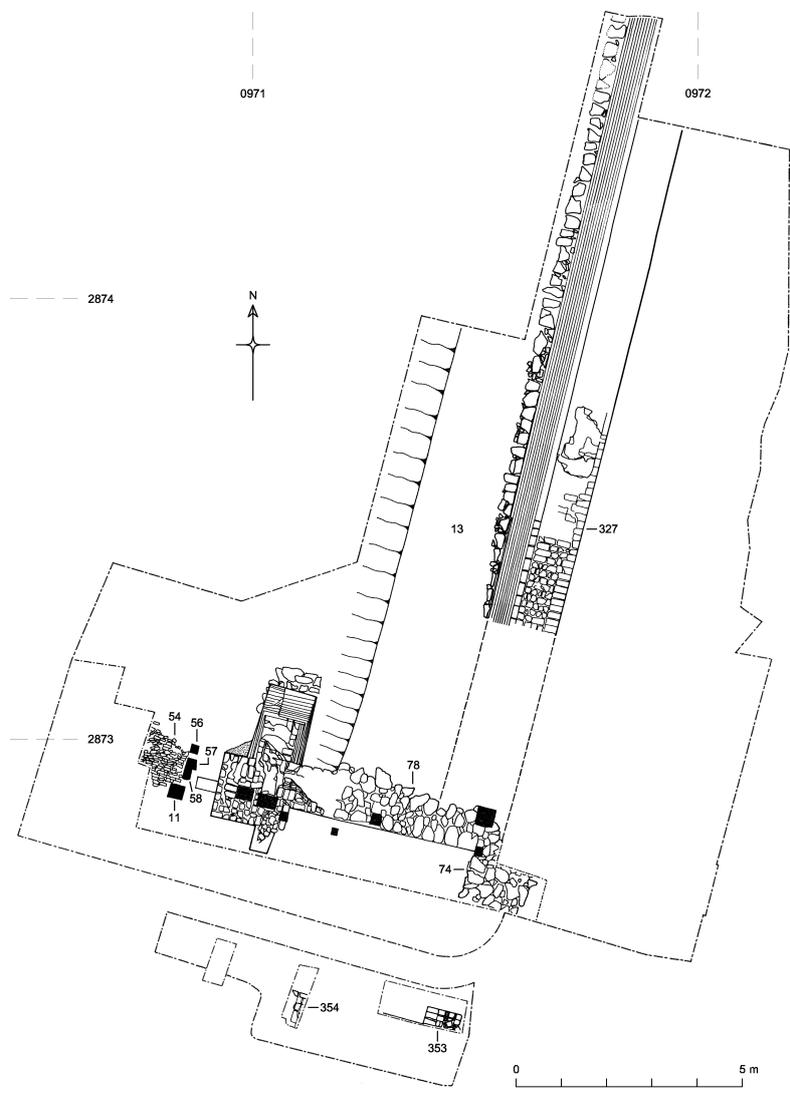
Fig. 17. Plan of the excavated \Phase Ib and Phase II structural remains at the Beverley Gate, and the eastern edge of the adjacent Town Ditch. [Later 14th to later 16th centuries]

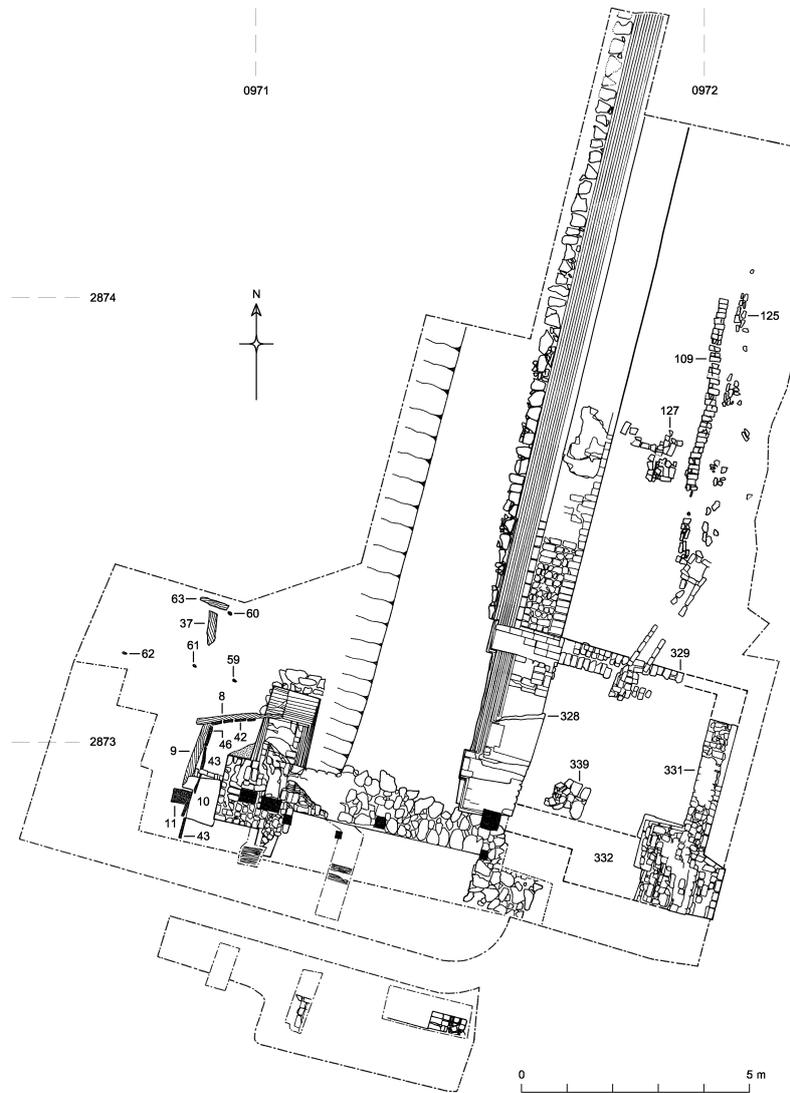
Fig. 18. Plan of the excavated Phase III and Phase IV structural remains at the Beverley Gate. [17th and 18th centuries]

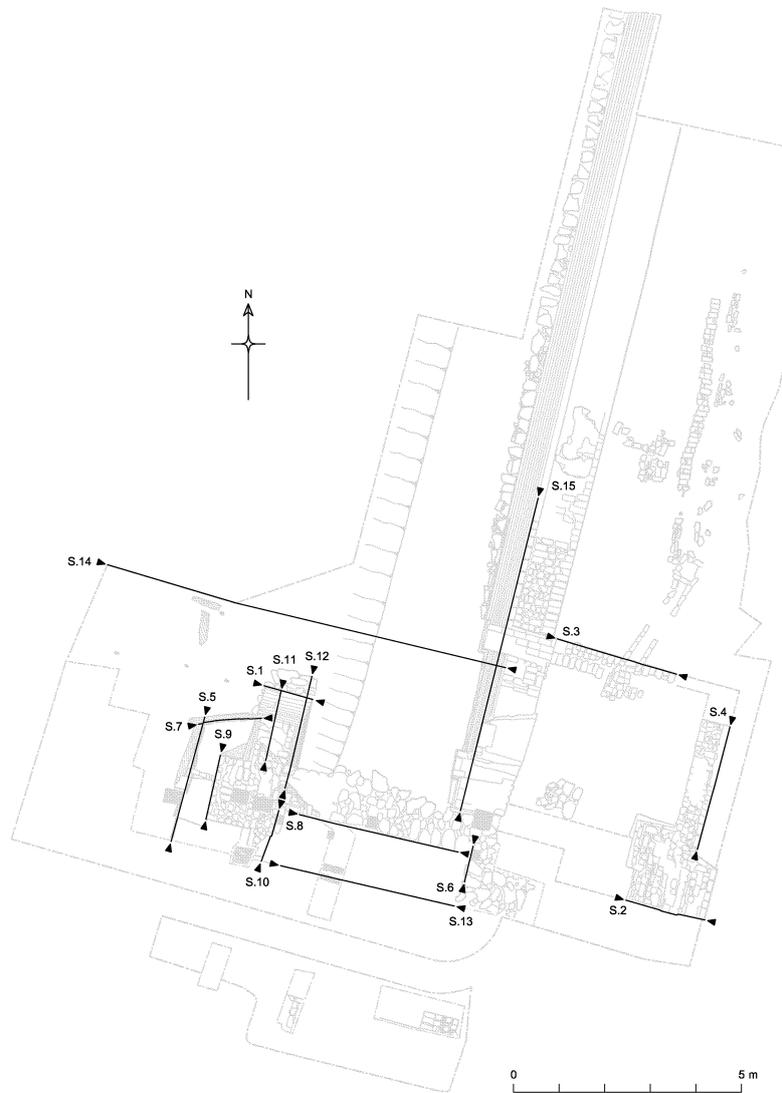
Fig. 19. Plan of the excavated area at the Beverley Gate, showing the location of the illustrated sections and wall elevations.

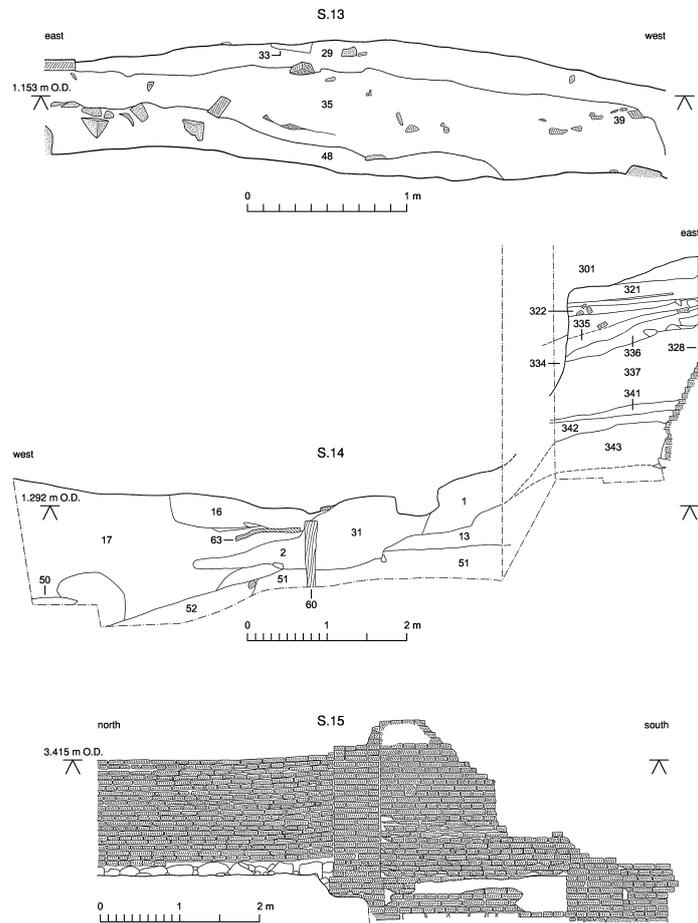
Fig. 23. Selected sections and elevations at the Beverley Gate. Section S13 shows the north-facing section through the deposits which had accumulated within the passage through the Gate. S14 shows a south-facing section across the upper fills of the Town Ditch, and the deposits which accumulated against the west face of the Town Wall. S15 shows an elevation of the west face of the Phase III northern guard chamber) on the right of the drawing), and the adjoining stretch of the medieval Town Wall (to its left); the foundations for the two-storey guard chamber are set much deeper than those of the Town Wall.

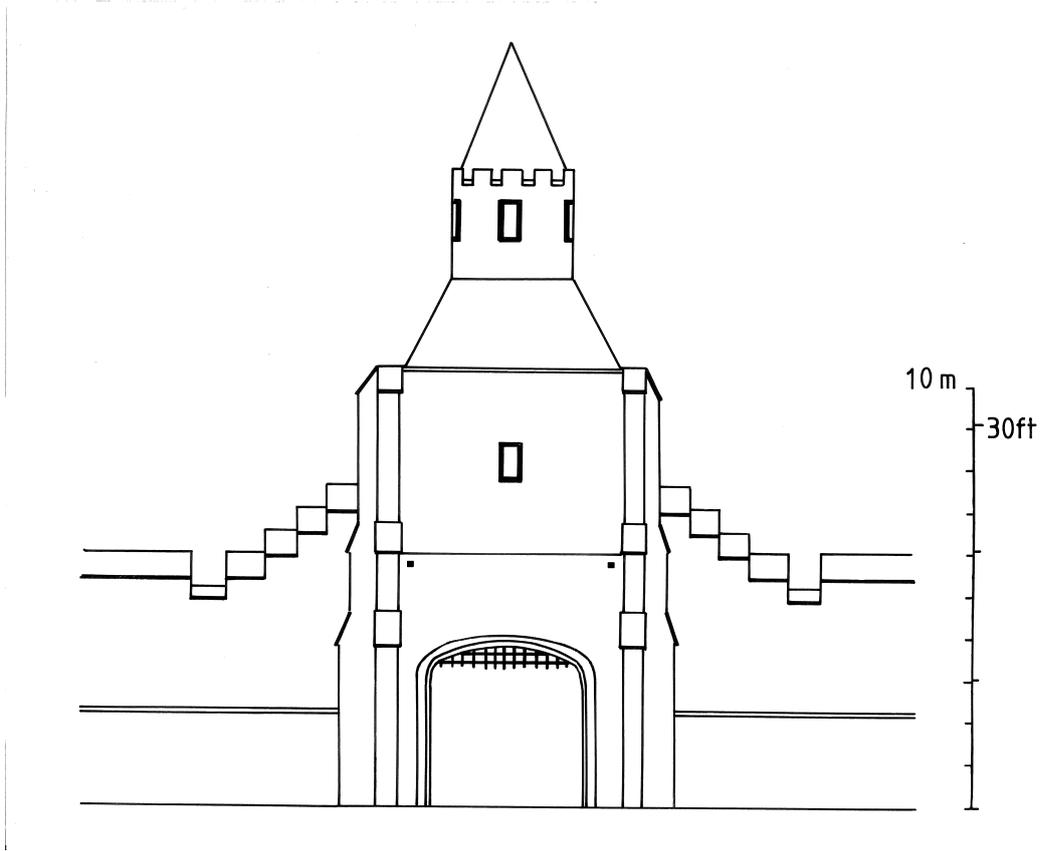
Fig. 44. The front elevation of the Beverley Gate as it might have looked in the late 1530s (based on a reconstruction by Col. R.W.S. Norfolk, and hints given in the *c.* 1538 view of Hull).

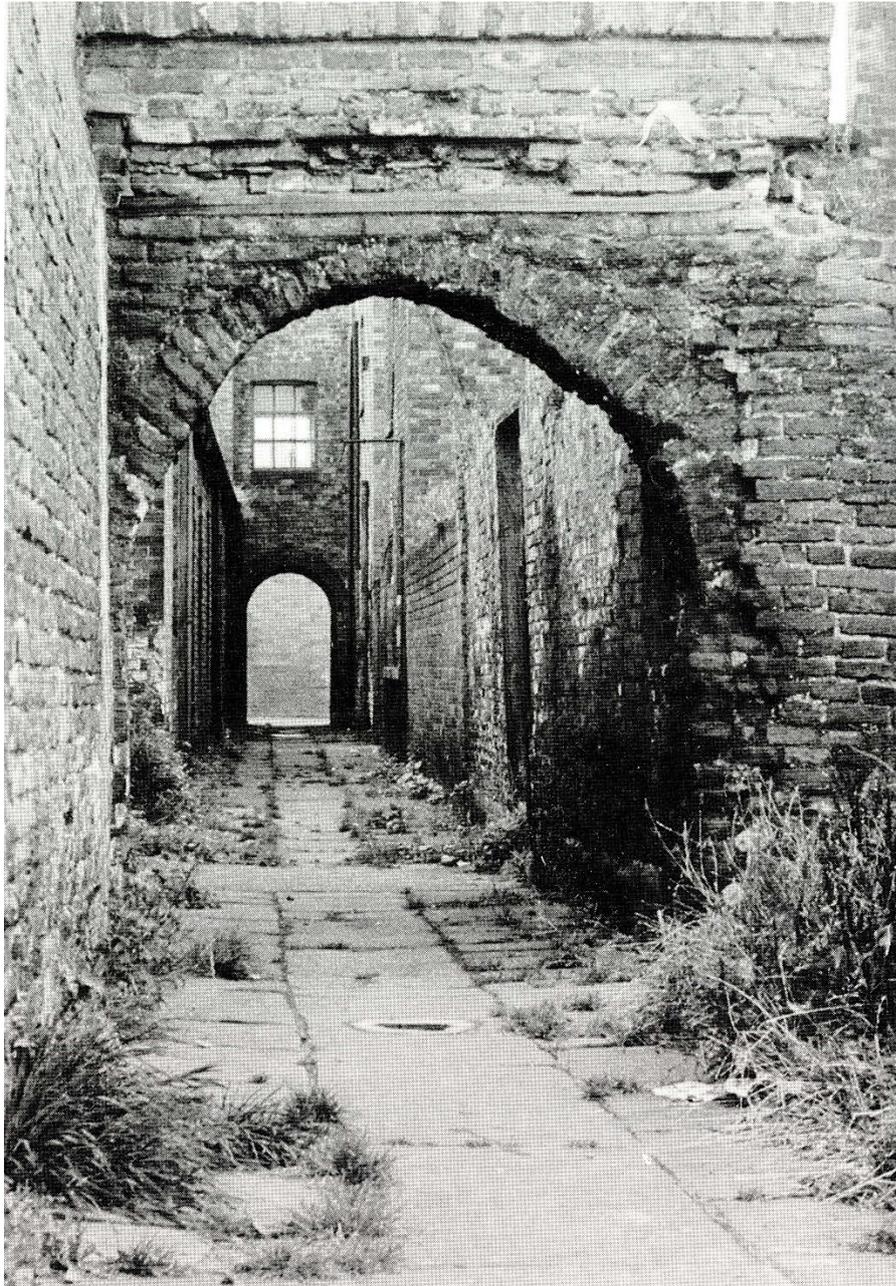
Pl. 2. The last part of the medieval defences to remain standing was an archway at the end of Little Lane – a small alley which ran between Humber Street and Blackfriargate – seen here in about 1964. It is thought to have been demolished in the mid 1960s. [From a photo by Alan Tuxworth: Tuxworth 1991, 10]

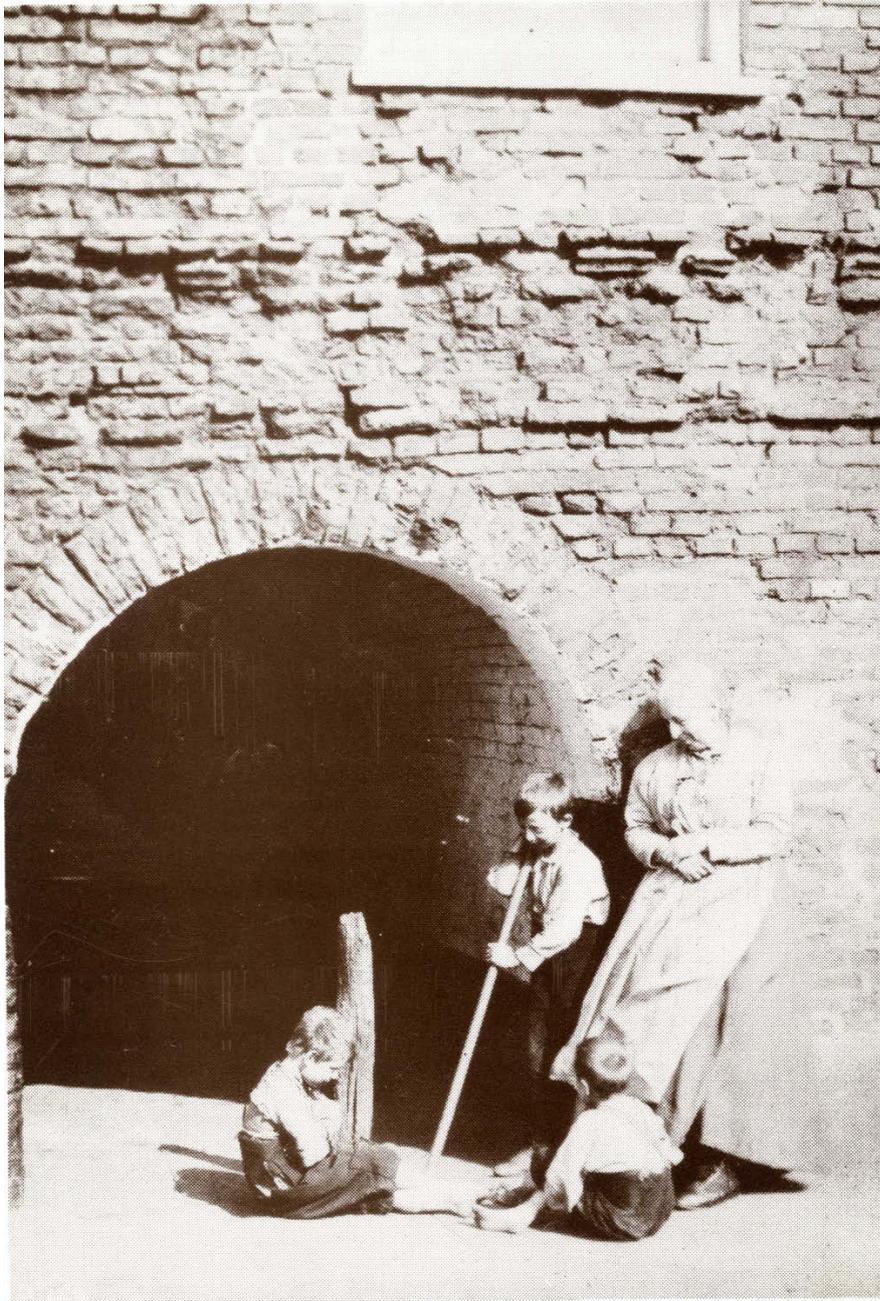
Pl. 3. A postern, or small arched doorway for pedestrians through the wall, off Humber Street, photographed in 1905. [From an old postcard in the possession of the late Chris Ketchell. Copyright: The former Hull Local History Studies Unit.]

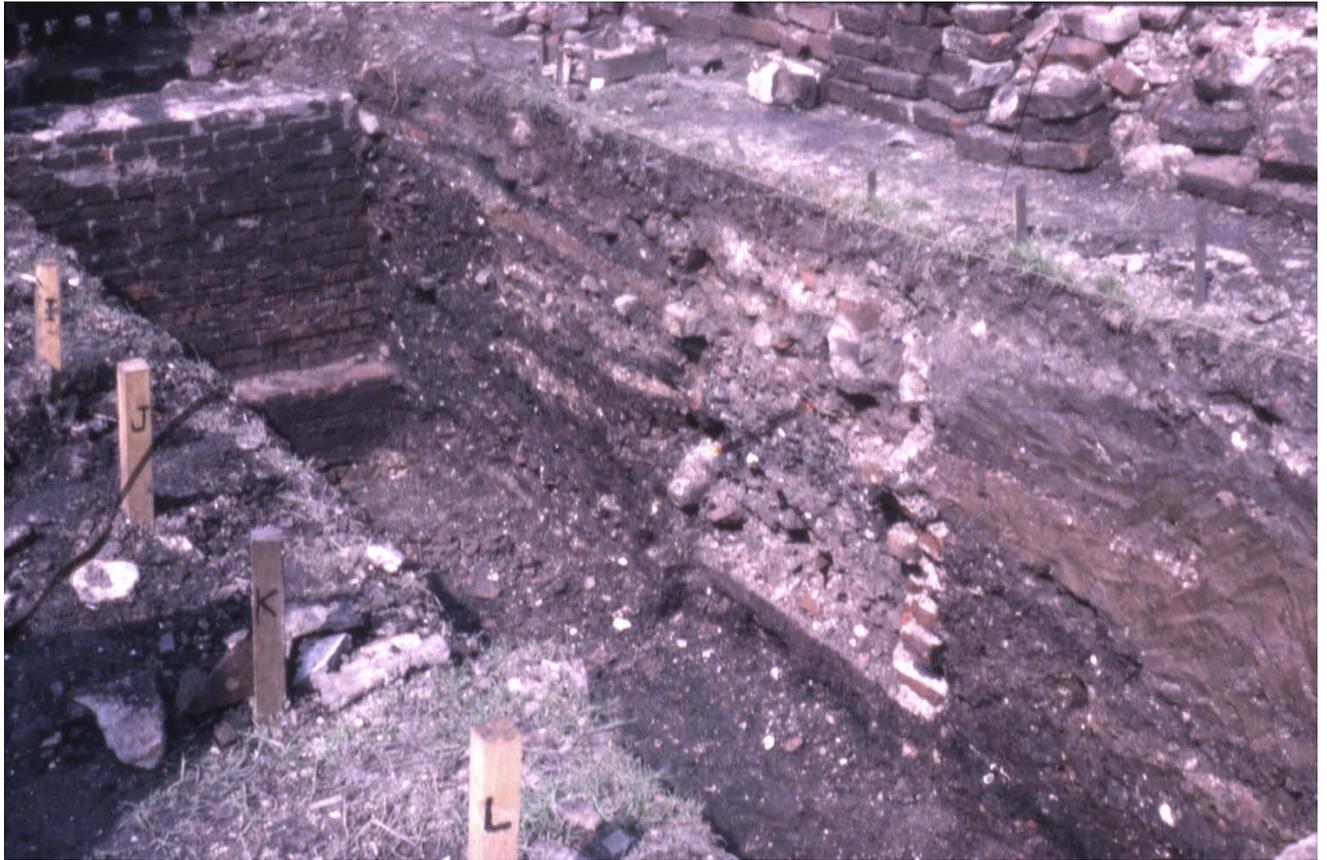
Pl. 4. Humber Street 1964: excavations off Queens Alley. View from the south-west of the deposits which had built up against the exterior of the south wall of the Interval Tower; the brickwork of the latter can be seen at the far end of the trench, on the left of the photograph. [Copyright Hull Museums.]

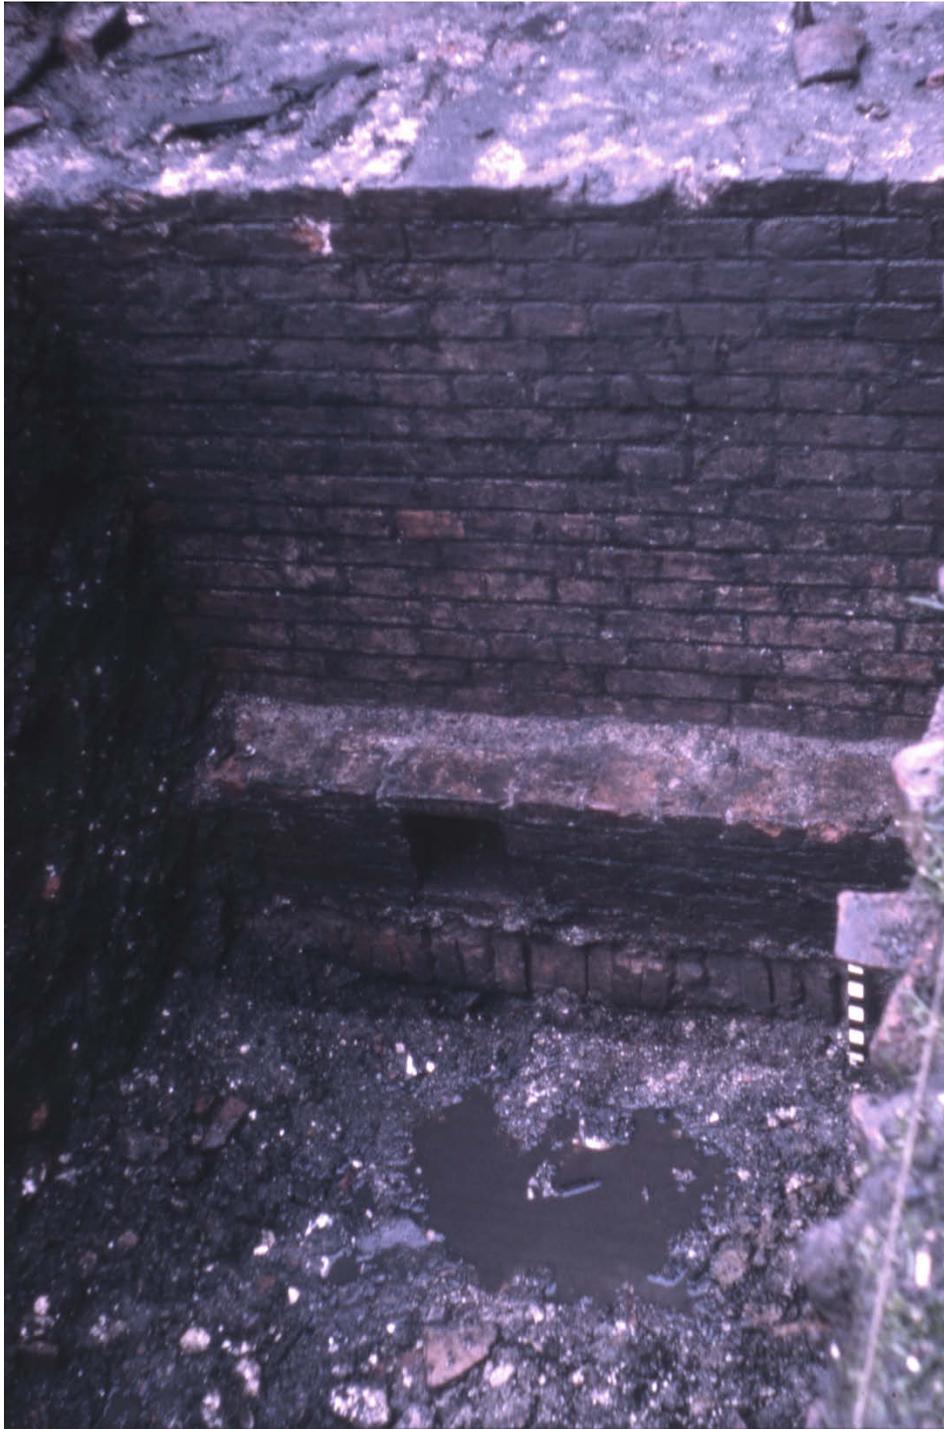
Pl. 5. Humber Street 1964: excavations off Queens Alley. External face of south wall of Interval Tower; seen from the south. Sixteen courses of brickwork are visible above the offset foundations; another five courses can be seen in the broader basal footings. [Copyright Hull Museums.]

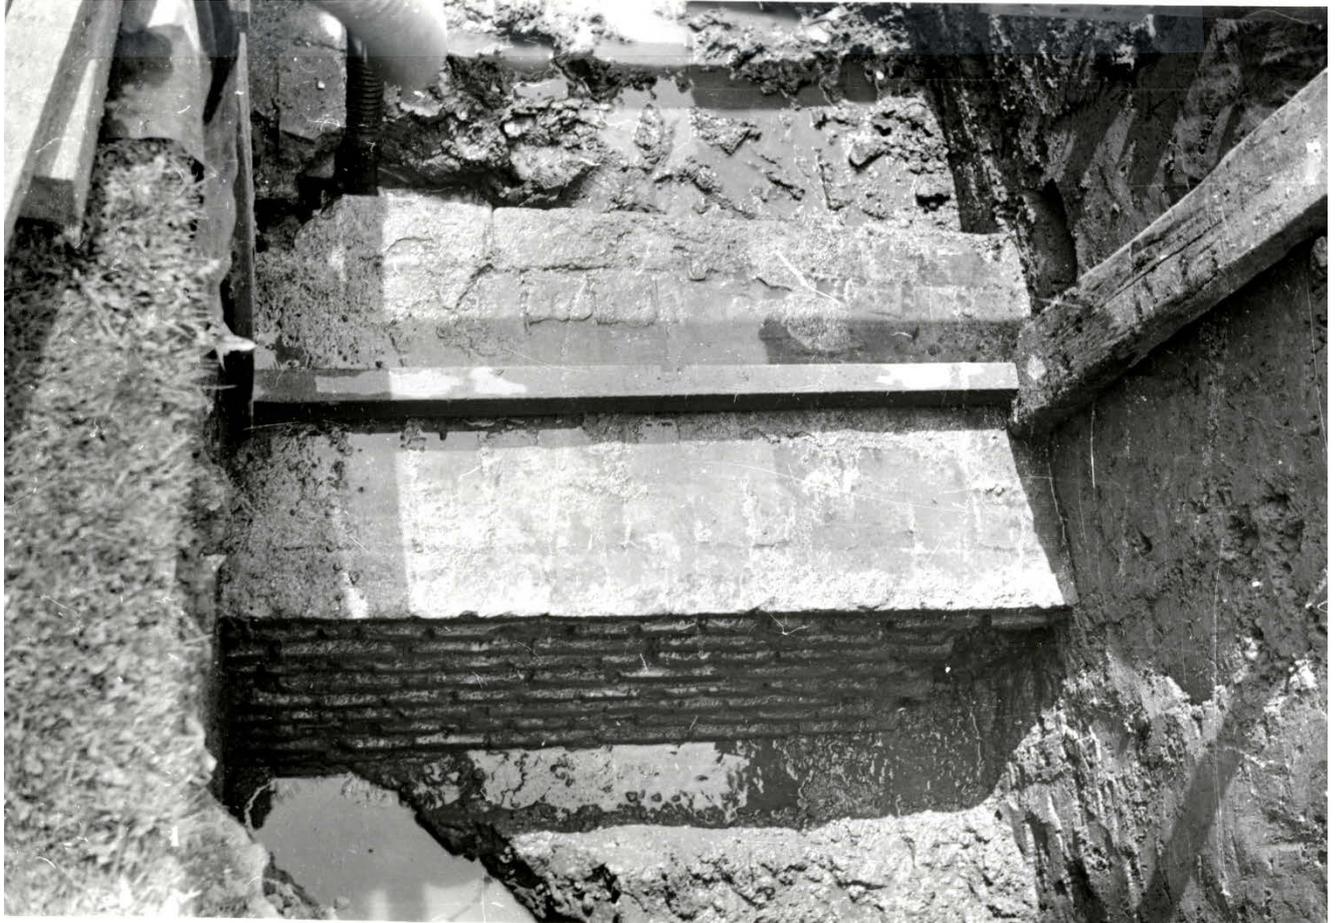
Pl. 6. North Walls 1969. Trench 1, viewed from the north-north-east. The external batter of the front face of the Interval Tower can be seen in the foreground; the internal deposits which built up within the tower are in the background. [Copyright Hull Museums.]

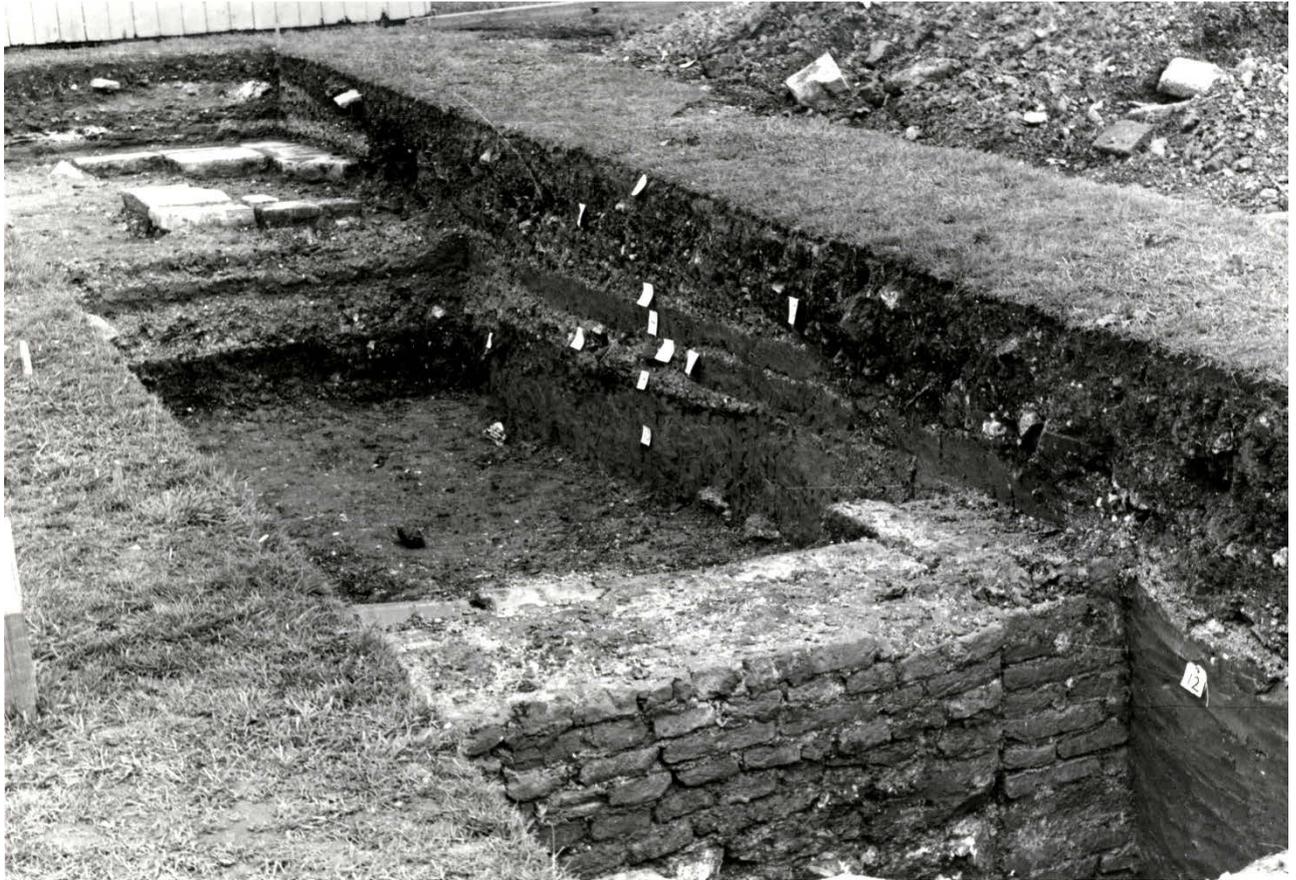
Pl. 7. North Walls 1969. The northern end of Trench 1, viewed from the south-south-west. The southern external face of the Interval Tower is in the foreground, the top of the rear face of its north wall is visible in the far background, behind the timber shoring; some of the deposits filling the interior of the tower are visible in the section on the right of the photograph. [Copyright Hull Museums.]

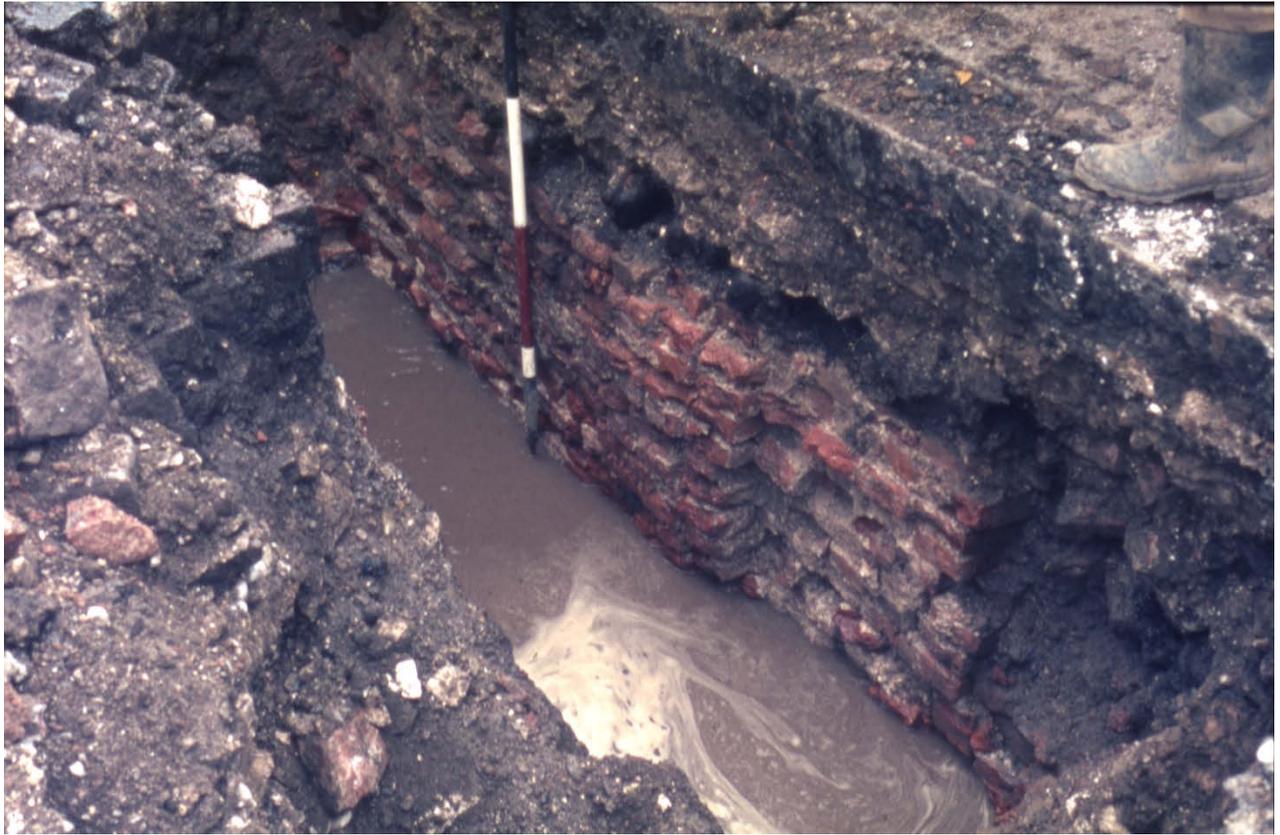
Pl. 8. Part of the Town Wall exposed in a machine trench during building work in Humber Street in 1973. This appears to be running alongside the edge of the pavement. Some 14 courses of brickwork were visible in the two surviving slides, but, apparently up to 22 courses were recorded in some sections of the trench. [Photo: Peter Armstrong. Copyright Hull Museums.]

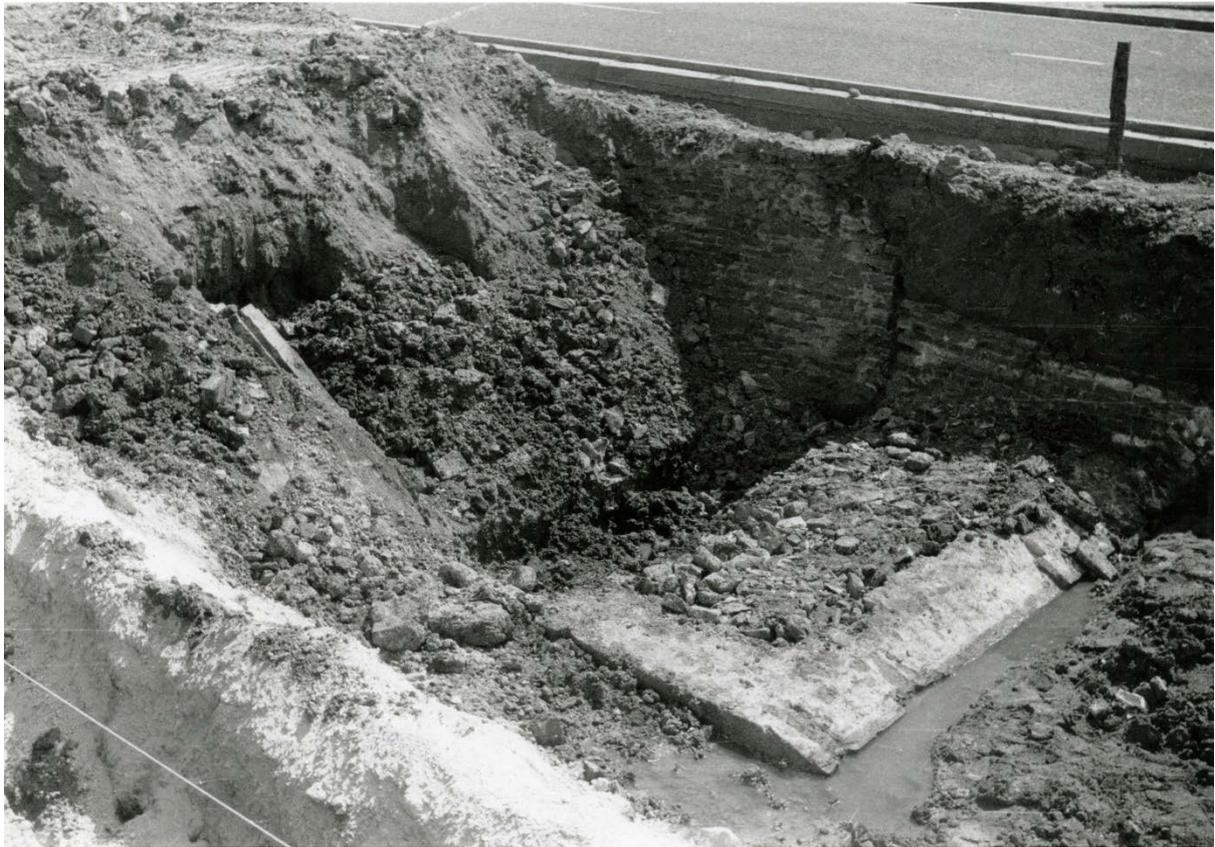
Pl. 10. The initial cleaning of the top of the counterweight pit at the Myton Gate, viewed from the north-west. In the southern baulk section behind the pit can be seen at least nine courses of brickwork belonging to the medieval Gate, and surviving to within about half a metre of the then existing ground surface. [Photo: Humberside Archaeological Unit.]

In 1976 work on the construction of the new South Orbital Road (what is now Castle Street) fleetingly revealed part of the foundations of the medieval Myton Gate at TA 0970 2845 (Pls 9-11, and Fig. 15. For a detailed report and description, see Ayers and Evans 2001). This discovery confirmed not only the position of its arched passageway, but also exposed the top of a drawbridge-pit directly in front of the Gate.
