Excavations at the Beverley Gate, and other parts of the town defences of Kingston-upon-Hull

by D.H. Evans

Humber Archaeology Partnership
Hull

[Text 2015; updated and revised 2018]

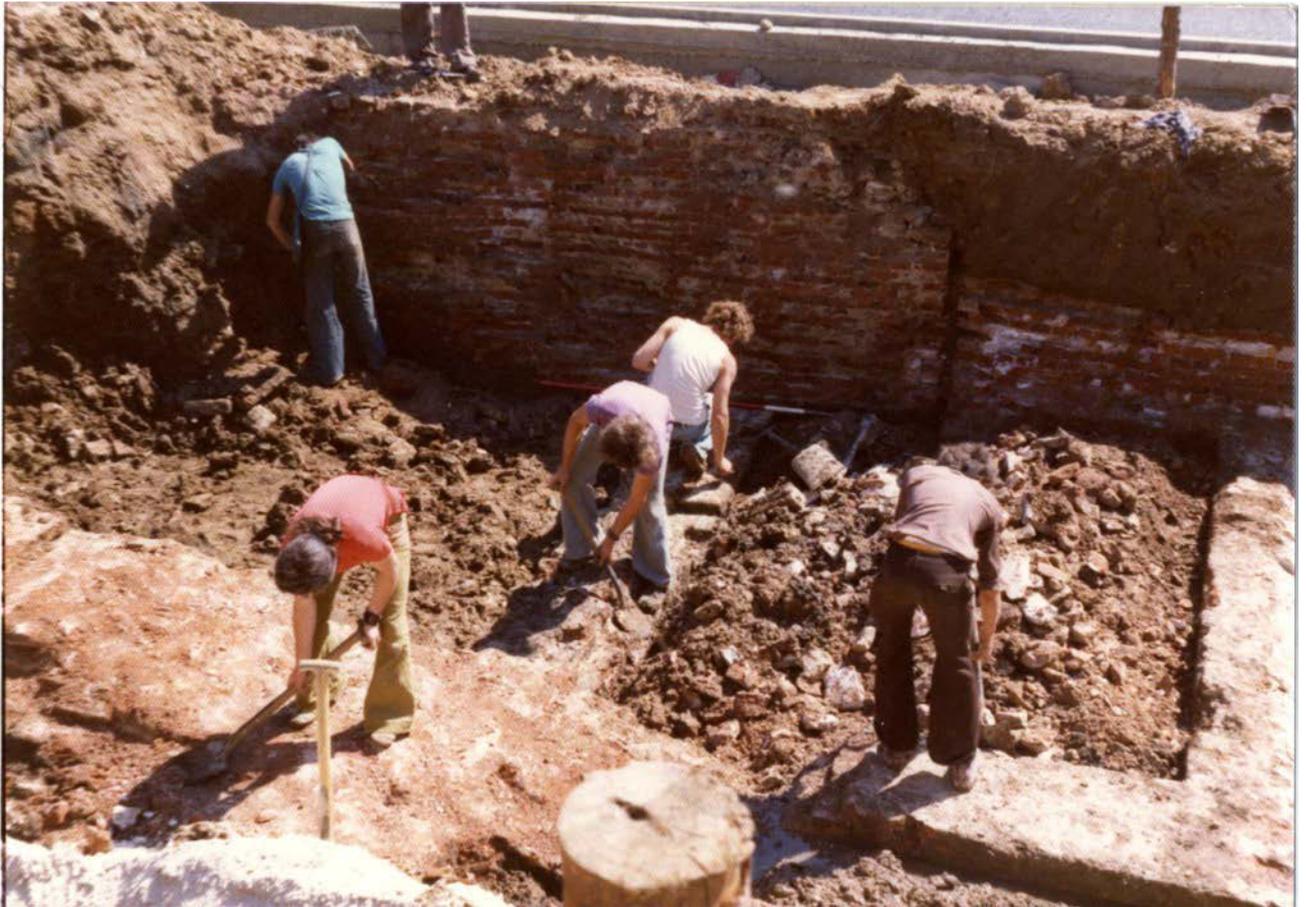
Pl. 11. A record shot of the cleaning of the exposed brickwork of both the counterweight pit, and the north-west corner of the Myton Gate; viewed from the north. At least eleven courses of brickwork can now be seen in the baulk section. [Photo: Humberside Archaeological Unit.]

In 1976 work on the construction of the new South Orbital Road (what is now Castle Street) fleetingly revealed part of the foundations of the medieval Myton Gate at TA 0970 2845 (Pls 9-11, and Fig. 15. For a detailed report and description, see Ayers and Evans 2001). This discovery confirmed not only the position of its arched passageway, but also exposed the top of a drawbridge-pit directly in front of the Gate.

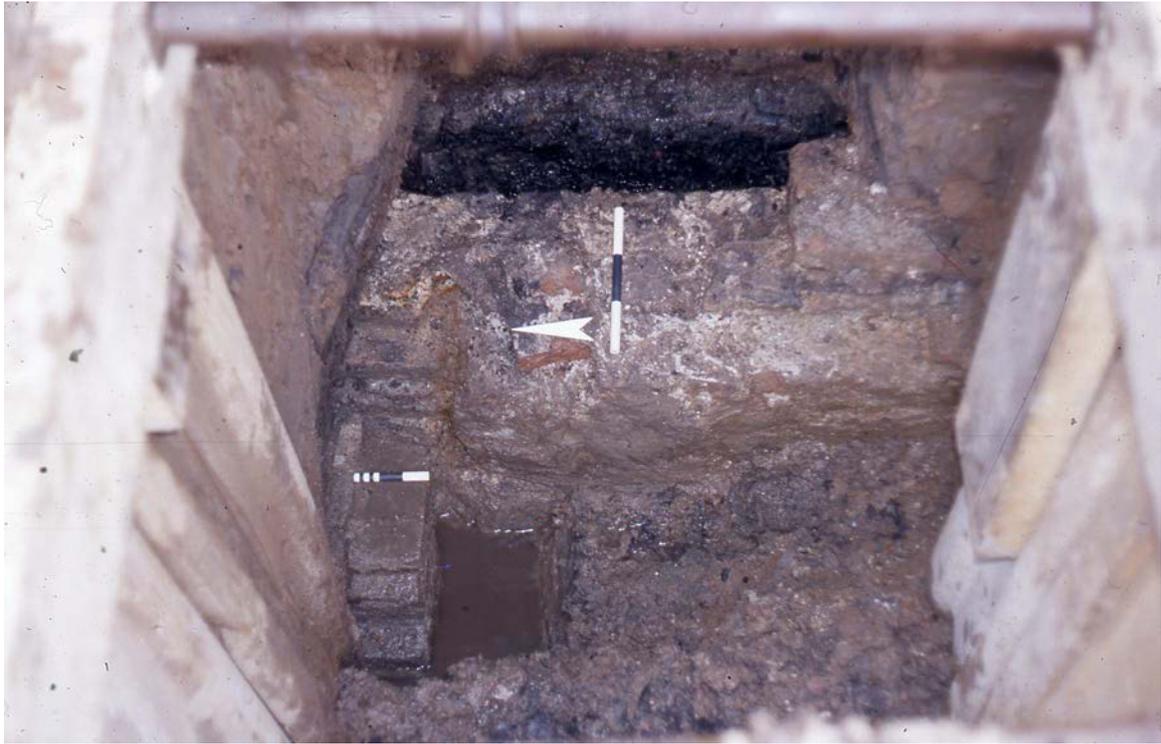
Pl. 12. Humber Dock Street August 1986, Trench 3. The top and western face of the footings of the Town Wall, viewed from the west. [Scan of a slide now in the collections of the Humber Archaeology Partnership; but original photo source currently uncertain]

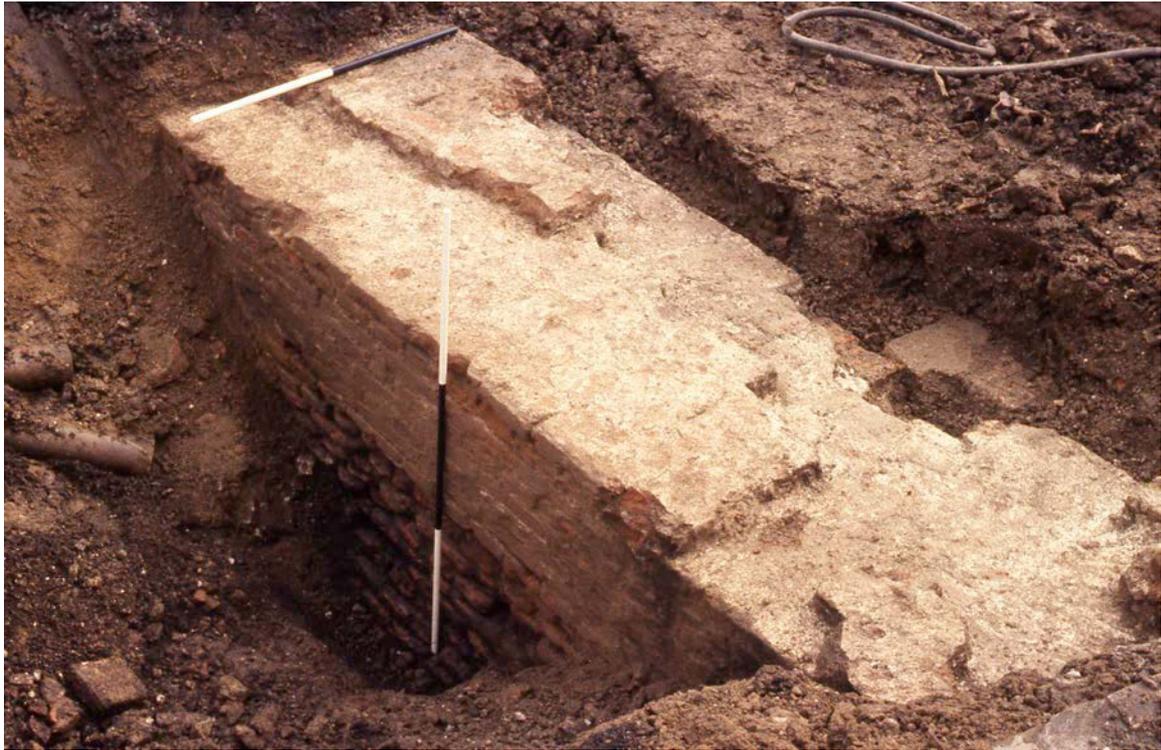
Pl. 13. Guildhall Road, near junction with Alfred Gelder Street, 1987. The top and front face of a section of the Town Wall, seen from the north-west, during the pedestrianisation works. [Copyright Hull City Council – originals taken either by HAU or by the staff of the Planning Department.]

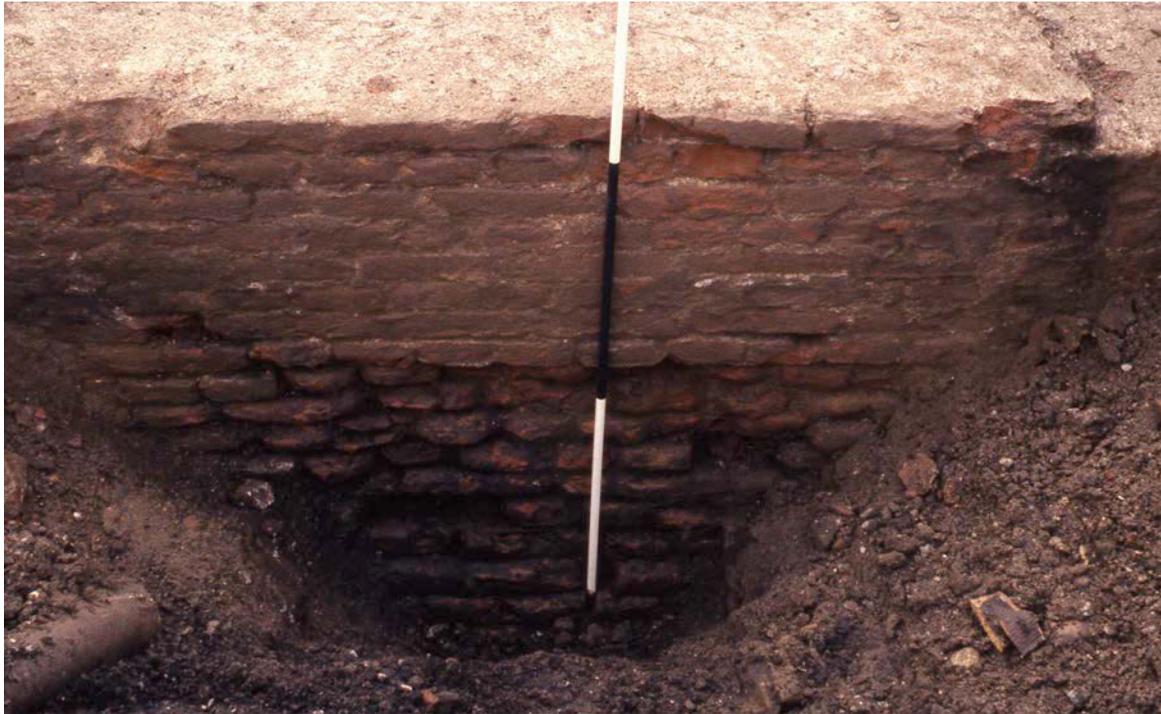
Pl. 14. Guildhall Road, near junction with Alfred Gelder Street, April 1987. The front face of the Town Wall, seen from the north. [Copyright Hull City Council – originals taken either by HAU or by the staff of the Planning Department.]

Also as part of these overall improvement works, a series of watching briefs were undertaken in 1987, and, whenever the construction work looked likely to result in the exposure of parts of the Town Walls, the Humberside Archaeological Unit was called in to record the remains. Between April and June 1987 four separate trenches were observed and recorded along the line of the defences where they crossed Alfred Gelder Street and ran into Guildhall Road / North Walls — three between the Beverley Gate and the tower investigated in 1969, and one immediately to the north-east of the latter (Pls 13-14). In the most successful of these investigations, the brickwork of the north side of the Town Wall was shown to survive to a depth of at least 10 courses, and the overall width of the wall was thought to be 1.10m; the top of the surviving section of wall was encountered within 0.75m of the modern street surface (Pl. 14, and see Part III, below).

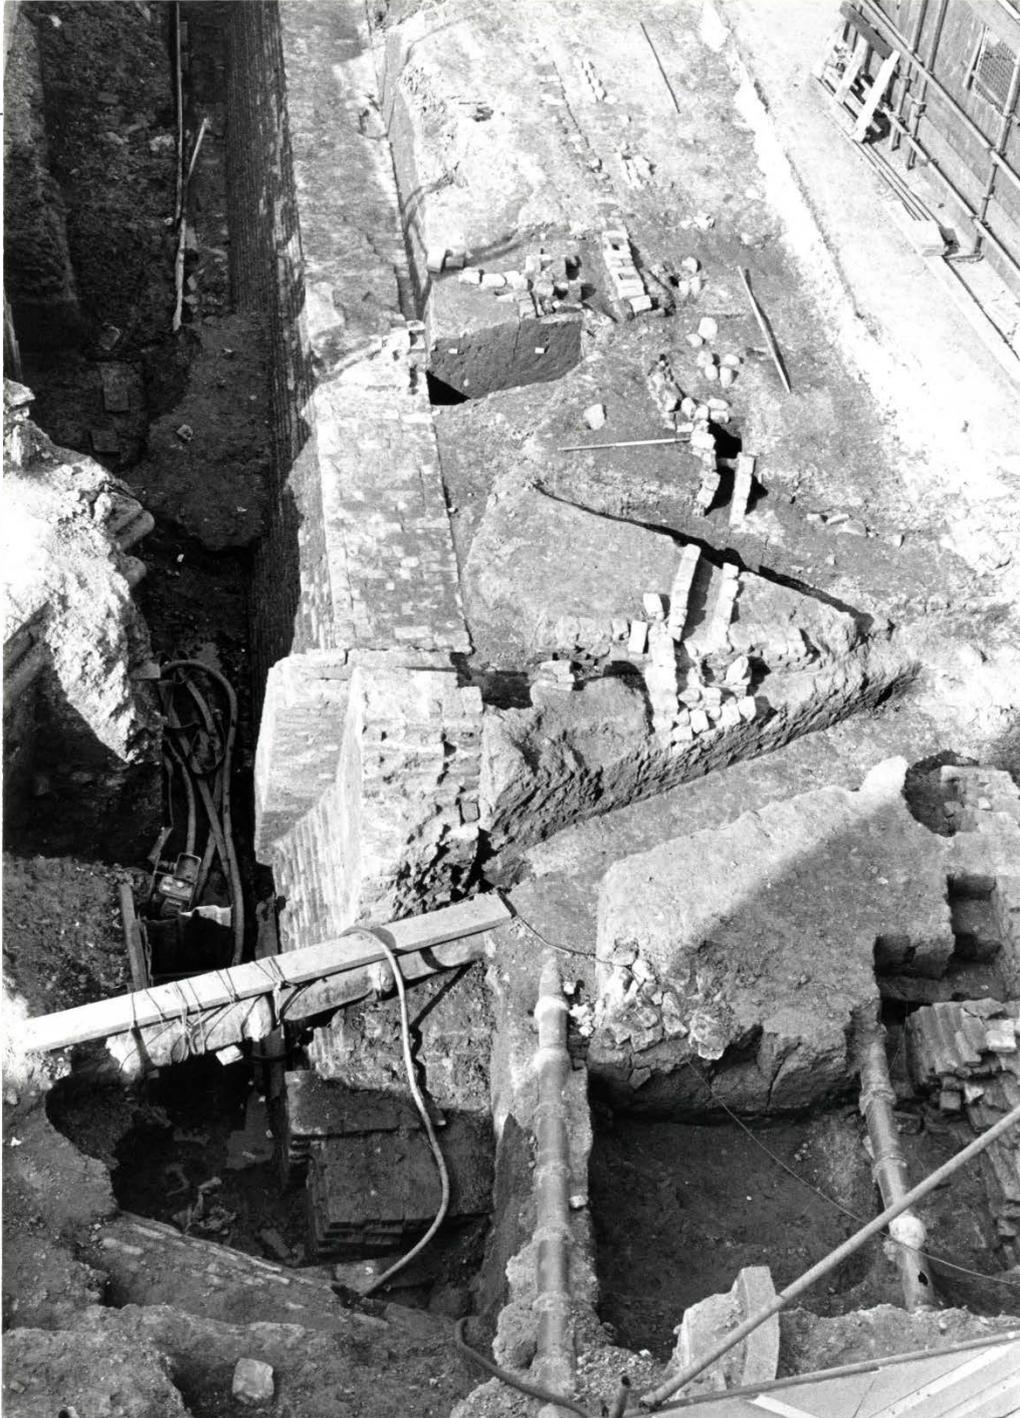
Pl. 15. An overhead view of the excavations in progress at the Beverley Gate site in spring 1988, taken from the south, and showing the degree of disturbance to the uppermost layers caused by the insertion of services. The upper layers of the northern guard chamber lie in the foreground; the line of the Town Wall is clearly visible in the left half of the photograph, whilst a series of 18th-century drains and other features built onto the top of the clay rampart can be seen to its right. [Photo: Humberside Archaeological Unit]

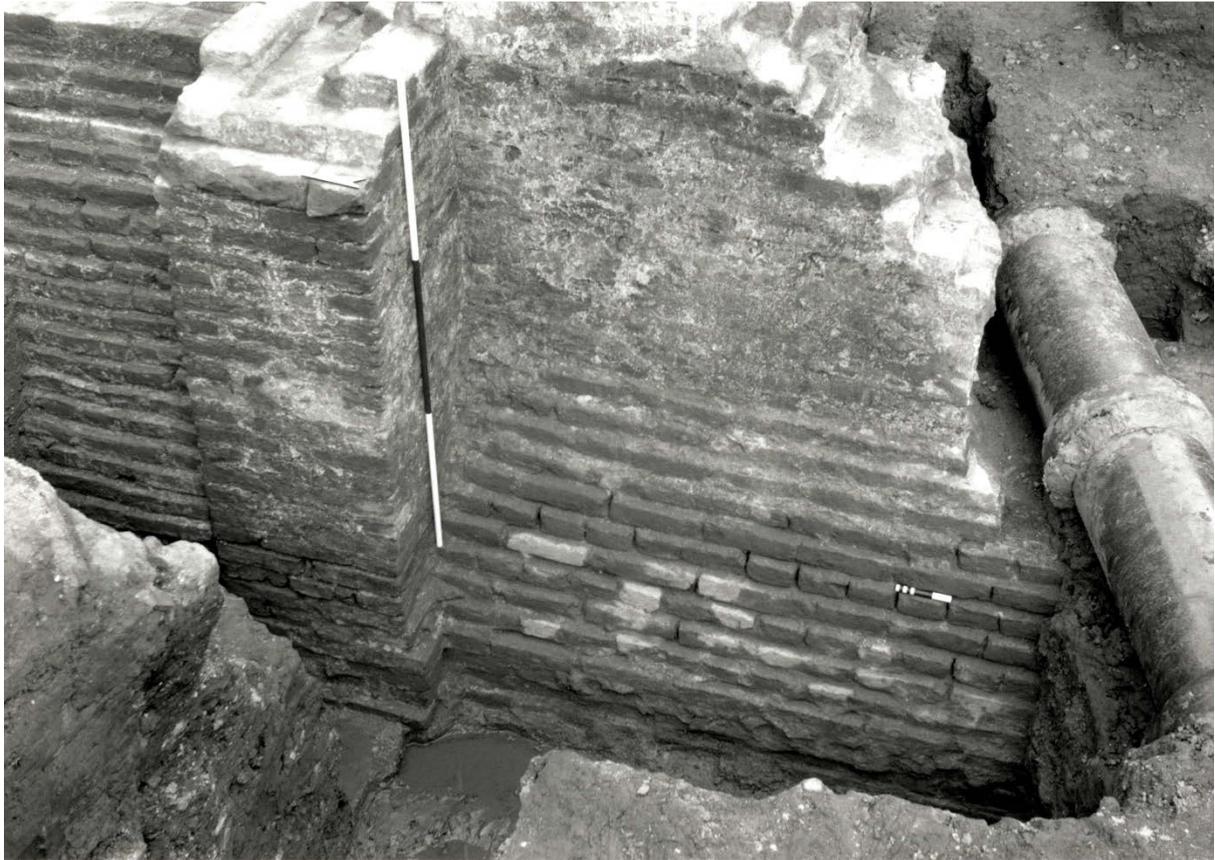
Pl. 16. Beverley Gate, 1986. The battered courses of brickwork in the external western face of the 17th-century northern Guard Chamber, with its flanking corner buttress, viewed from the west. Part of the adjoining medieval Town Wall can be seen to the left of this buttress, on the far left of the photograph. An early 20th-century sewer trench has removed much of the south-western corner of the Guard Chamber. [Photo: Humberside Archaeological Unit]

fresh course of brickwork set slightly back from that beneath (e.g. Pls 16 and 18-19). Above this height, the Wall rises vertically. [Similar evidence for an external batter on the basal courses of the brick Wall was observed at North Walls (e.g. Pl. 6 and Fig. 14): Bartlett 1971, 8, 11, and section drawing on p. 10.]

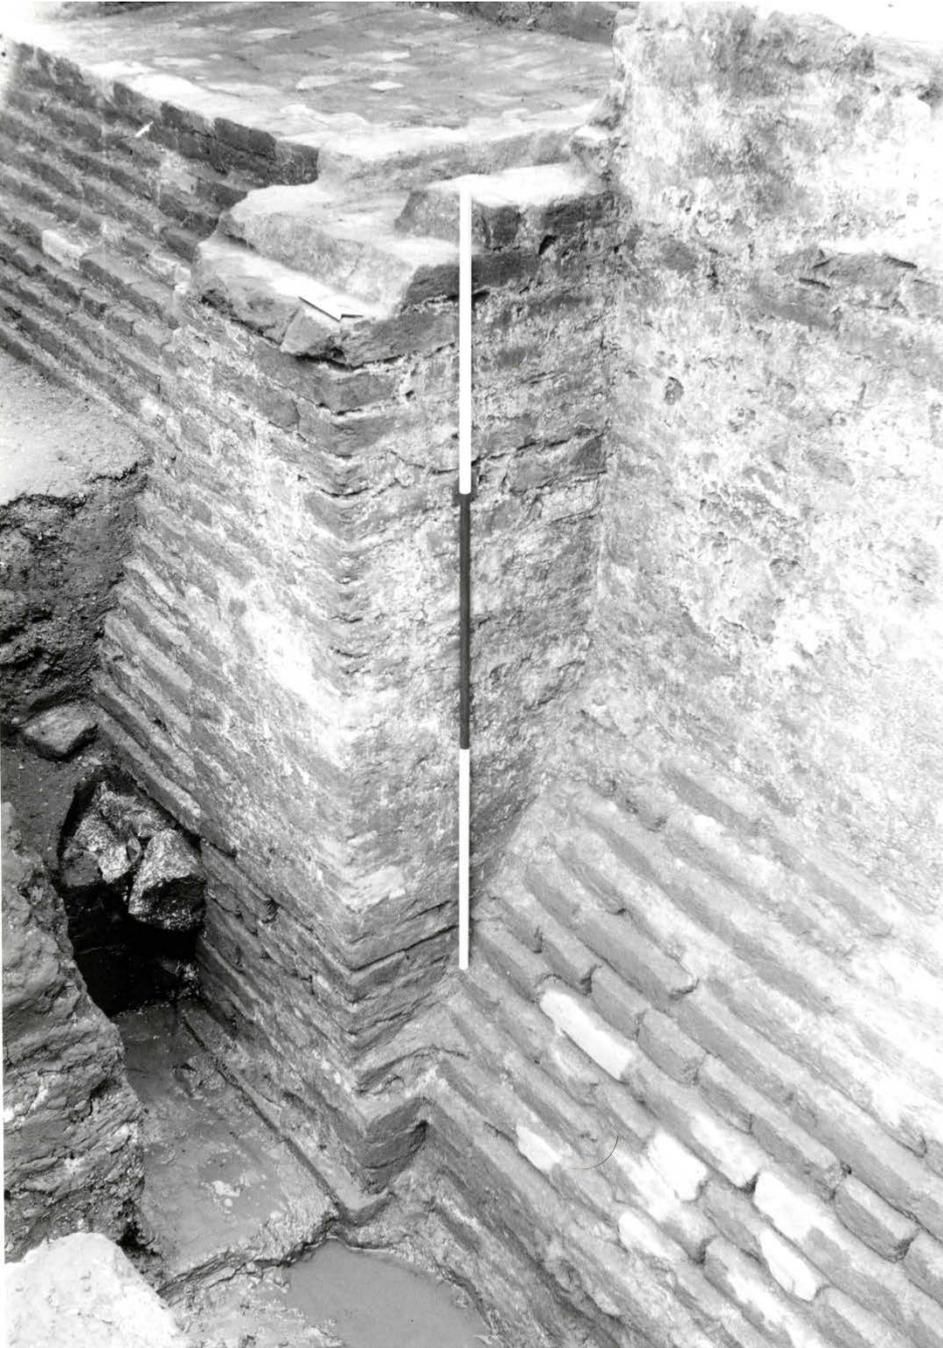
Pl. 17. Beverley Gate, 1986. An oblique view of the same remains, here seen from the south-west. The vertical face of the corner buttress dominates the left centre-ground of the photograph, whilst the pronounced batter of the lower parts of both the external wall of the Guard Chamber (in the right foreground) and the external face of the medieval Town Wall (in the left distance) is emphasised in this oblique view. Part of the chalk footings beneath the base of the Town Wall is just beginning to be exposed. [Photo: Humberside Archaeological Unit]

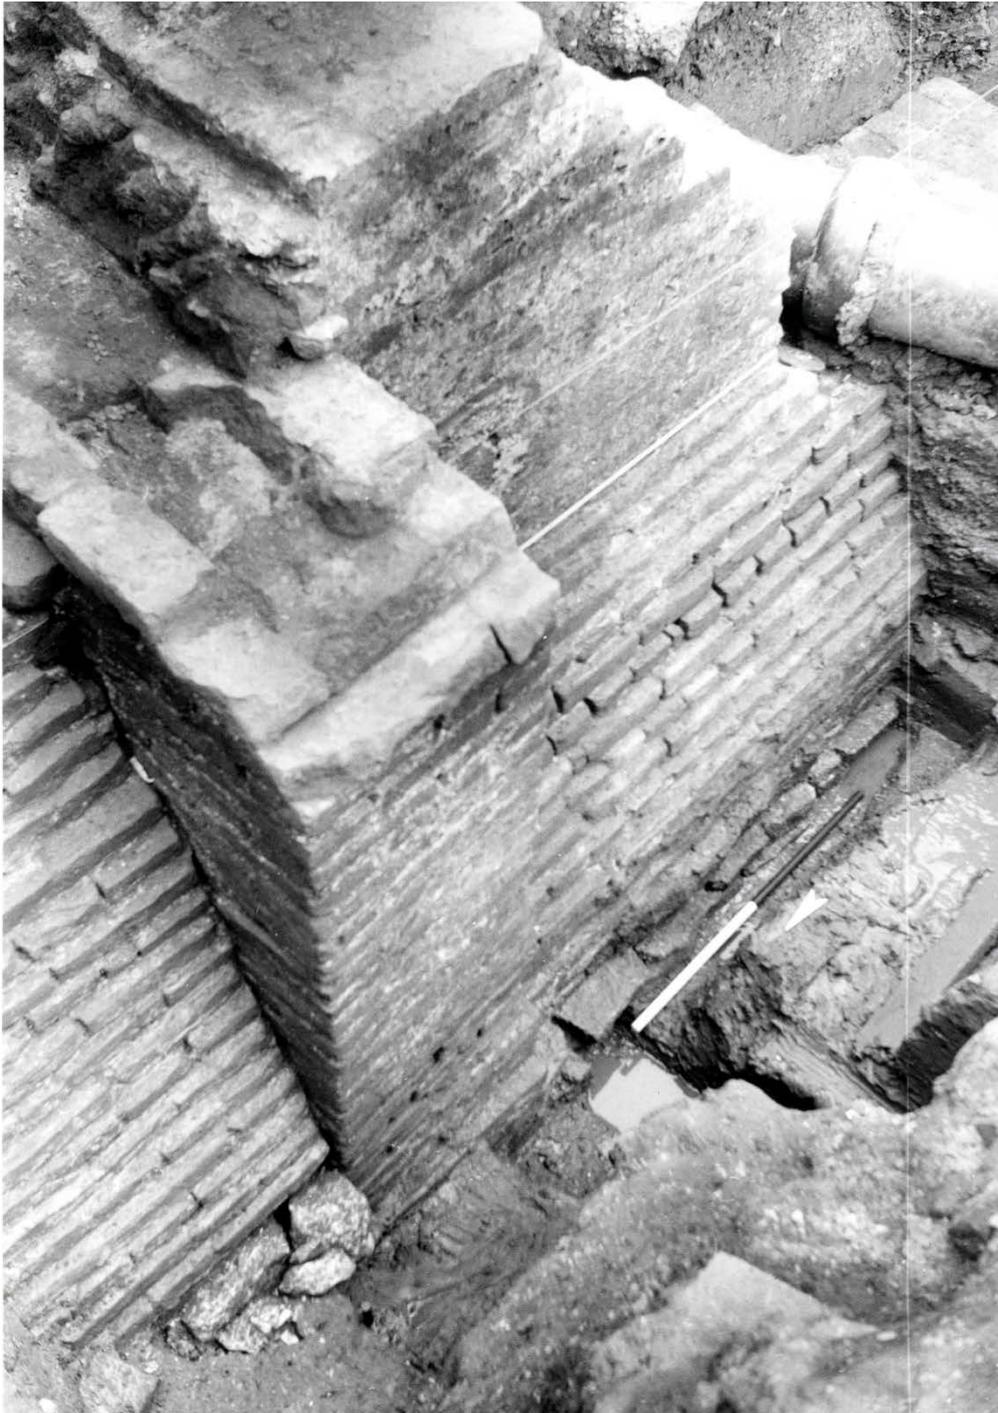
Pl. 18. Beverley Gate, 1986. An oblique overhead view of the junction of the medieval Town Wall (to the left) with the north-west corner of the 17th-century Guard Chamber; there is a butt joint, where the Town Wall has been cut back to form a clean vertical face against which the new corner buttress can be built. The pronounced external batter of the lower sections of both the Town Wall and the Guard Chamber can be clearly seen. [Photo: Humberside Archaeological Unit]

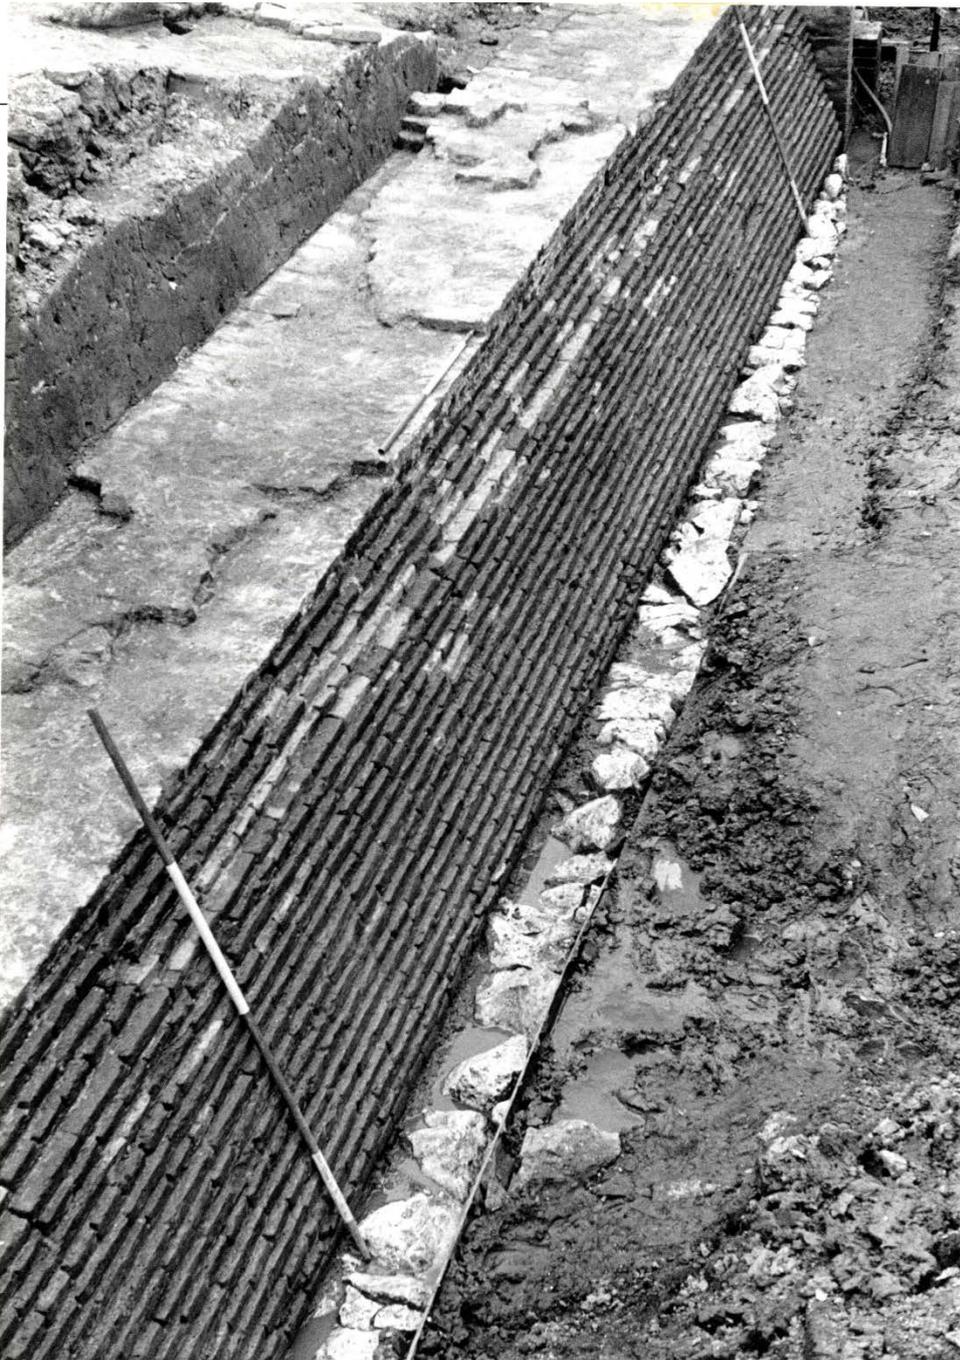
Pl. 19. Beverley Gate, spring 1988. A view along a section of the medieval Town Wall to the north of the Beverley Gate, seen from the north-north-west. The top of the exposed brickwork marks the level to which the Wall was dismantled in 1774-6, in preparation for the construction of Queen's Dock. The external batter of the lower courses of the Wall can be clearly seen, whilst projecting forwards from its base is the leading edge of its chalk footings; a berm would have lain to the west, with the Town Ditch beyond the right-hand edge of this photograph. [Photo: Humberside Archaeological Unit]

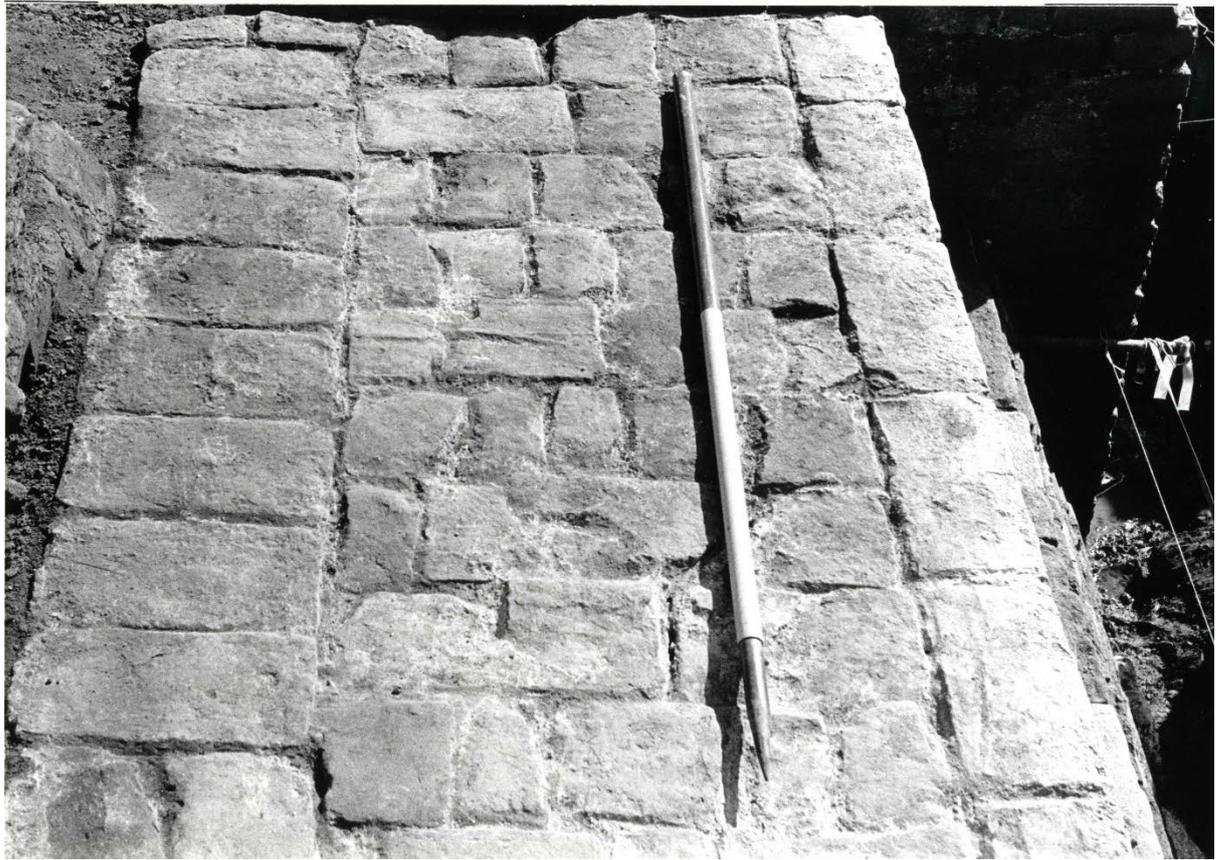
Pl. 20. Beverley Gate, spring 1988. A section of the brickwork in the top of the Town Wall, fully cleaned, and after the removal of vestiges of mortar from the slighting of the defences in the 1770s. [Photo: Humberside Archaeological Unit]

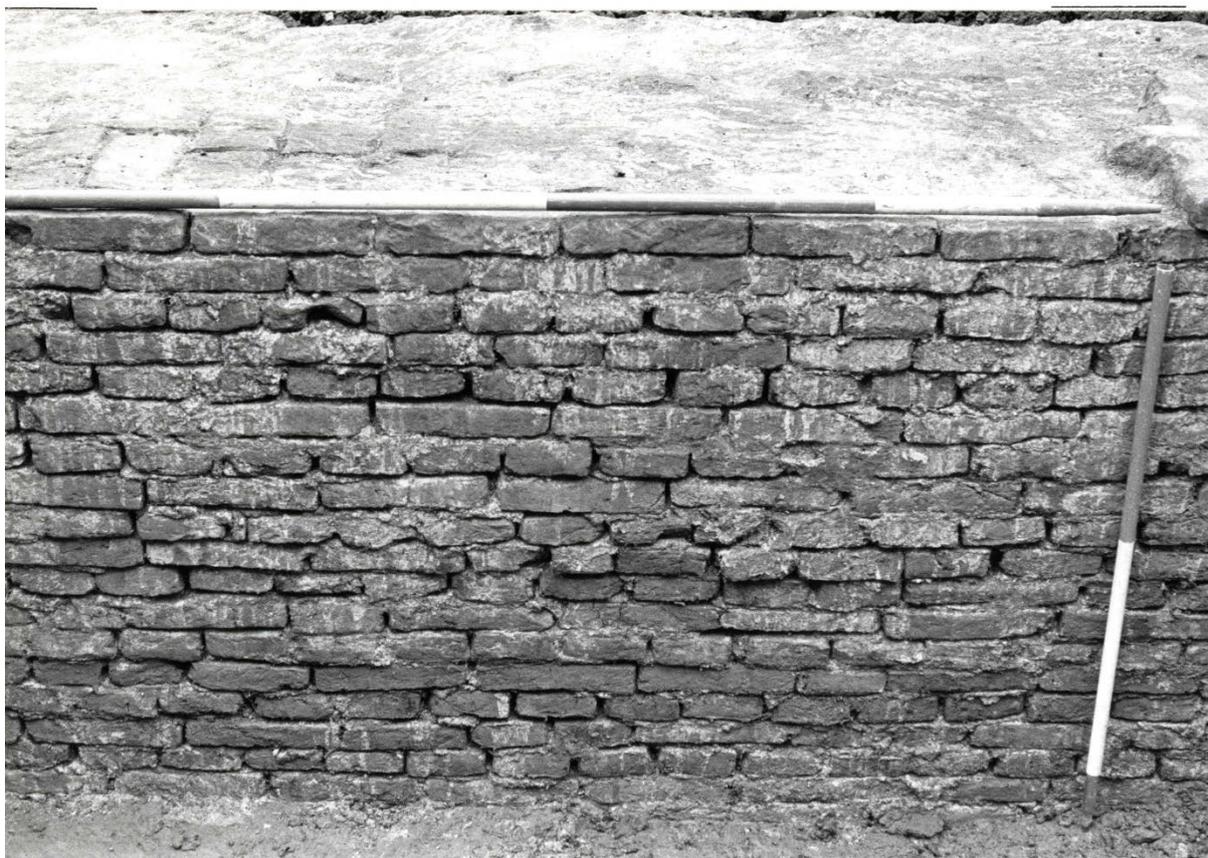
Pl. 21. Beverley Gate, spring 1988. A section of the vertical internal face of the Town Wall, after part of the clay rampart had been removed to expose this. [Photo: Humberside Archaeological Unit]

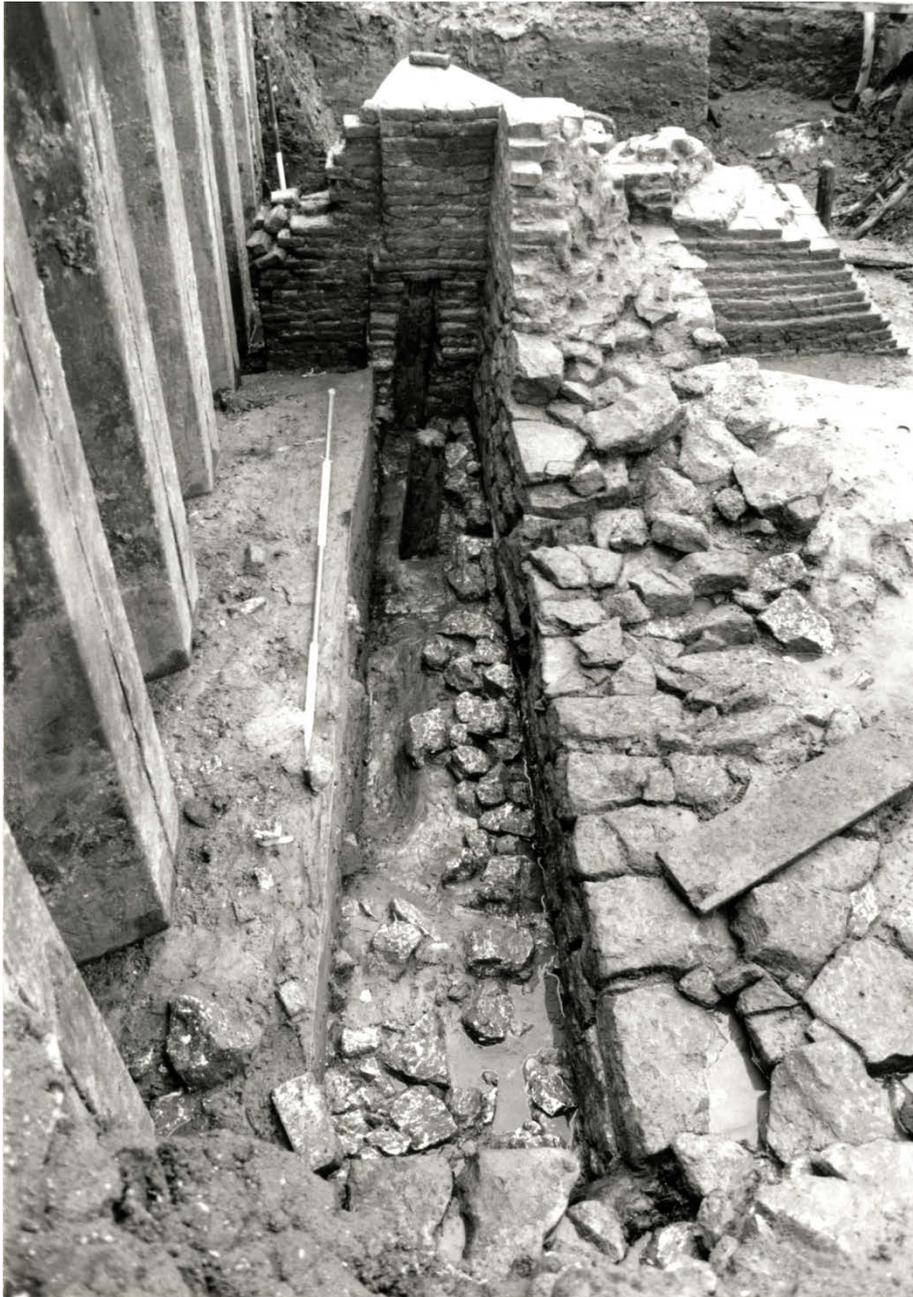
Pl. 22. Beverley Gate, winter 1988-9. The remains of the medieval Gate projecting forward from the Town Wall; this had been dismantled to a much lower height than either the Town Wall or its adjacent Guard Chambers. This photograph looks along part of the central passage-way through the Gate, with the stone footings of the northern side of the Gate Tower visible on the right-hand side of the photograph, and the brick footings of the western or front wall of the Gate in the background; view from the west. The sheet-piling of the coffer dam for the amphitheatre can be seen on the left-hand side of the photograph; this illustrates how close the piling came to destroying part of the surviving vestiges of the medieval Gate. [Photo: the author]

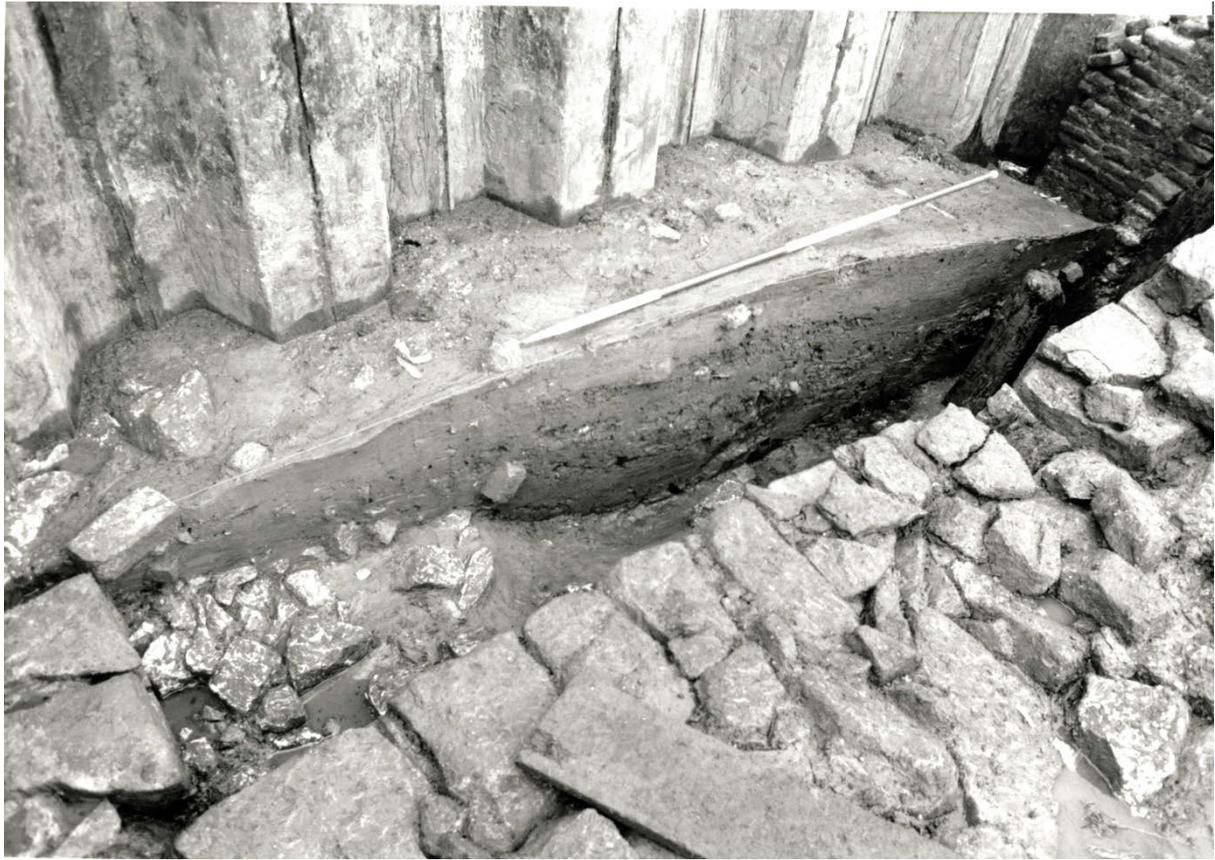
Pl. 23. Beverley Gate, winter 1988-9. The southern baulk of the excavated area of the medieval Gate, viewed from the north-east. This offers a longitudinal section through the internal surfaces and deposits within the passageway through the Gate. The tops of the stone footings of the north wall of the Gate (78) and its eastern return (74) are visible in the foreground, whilst parts of the brickwork of the west wall of the Gate can be seen in the right distance. [Photo: the author]

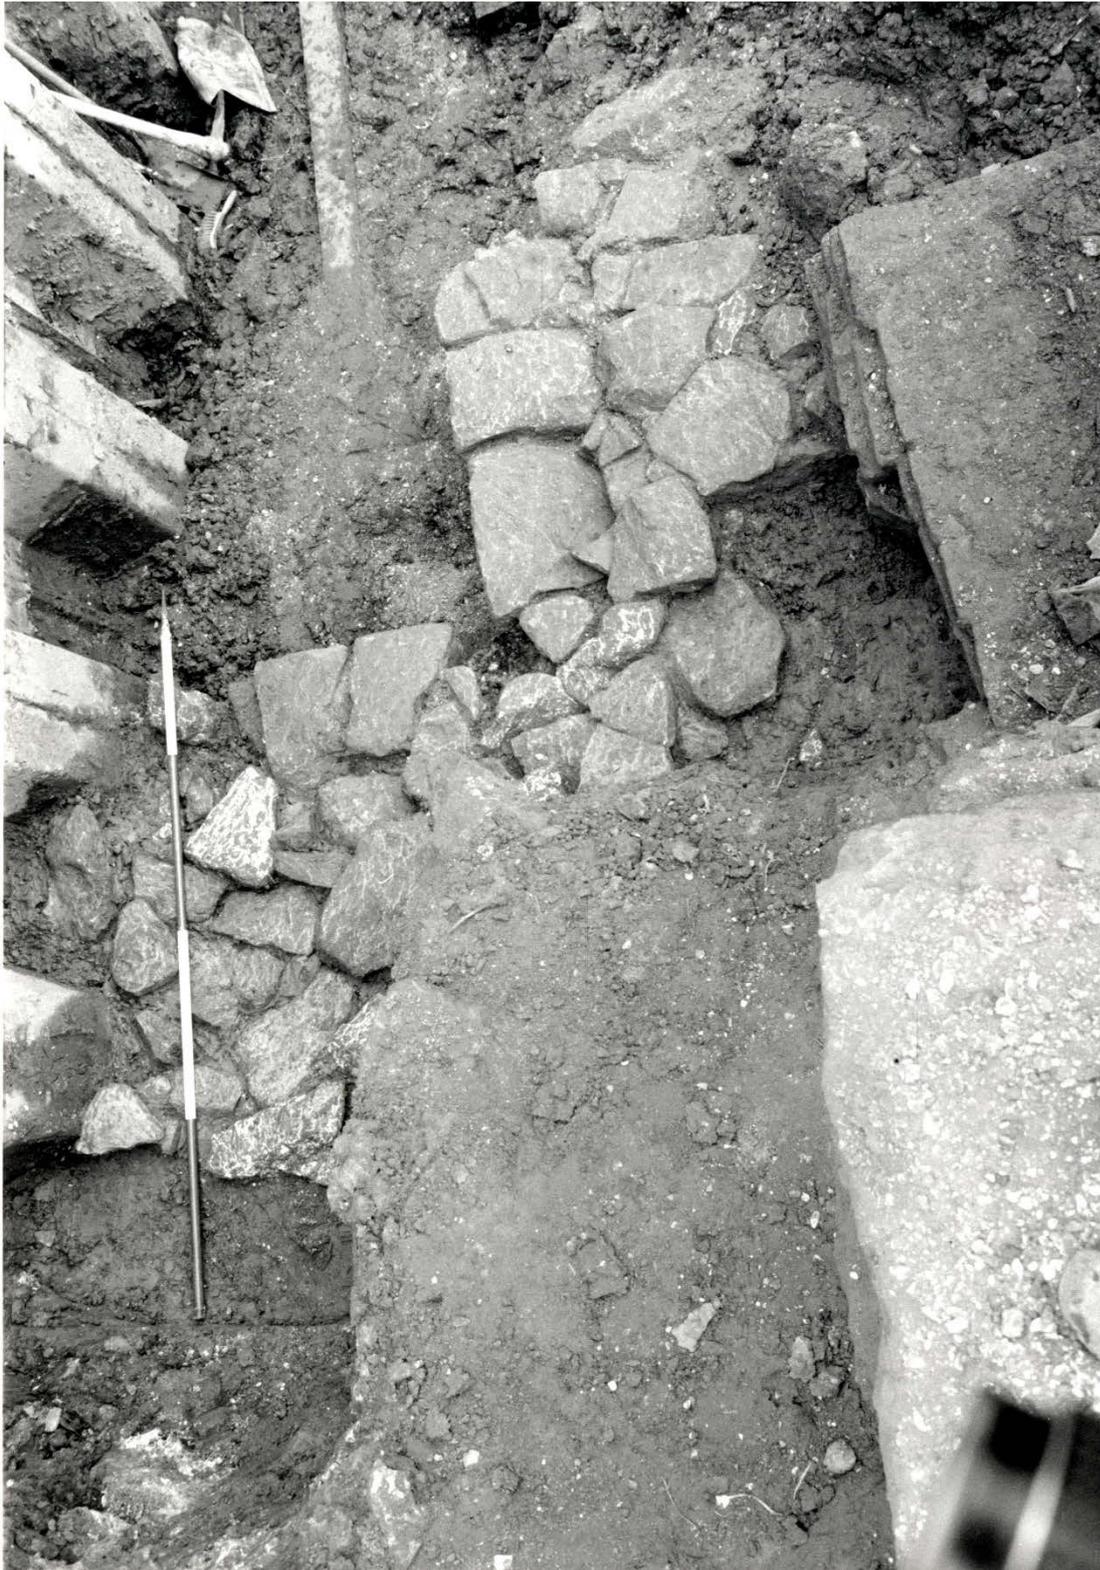
Pl. 24. Beverley Gate, winter 1988-9. Overhead view from the east of the junction of stone wall footings 78 and 74. [Photo: the author]

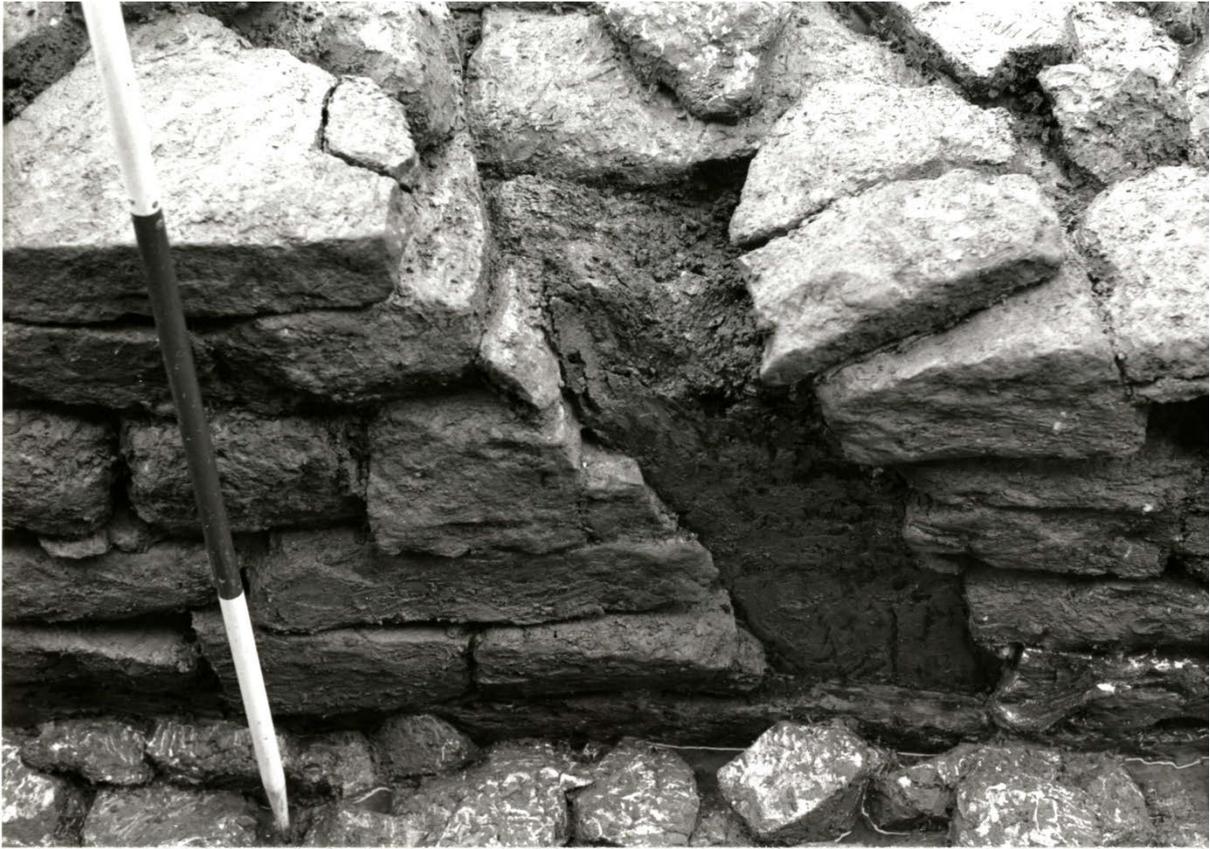
Pl. 25. Beverley Gate, winter 1988-9. Detail of internal face of the stone wall footing of the north wall of the Phase Ib Gate (78), seen from the south. The base of a horizontal timber sole-plate (55) with a diagonal brace (73) can be seen encased within the stonework. [Photo: the author]

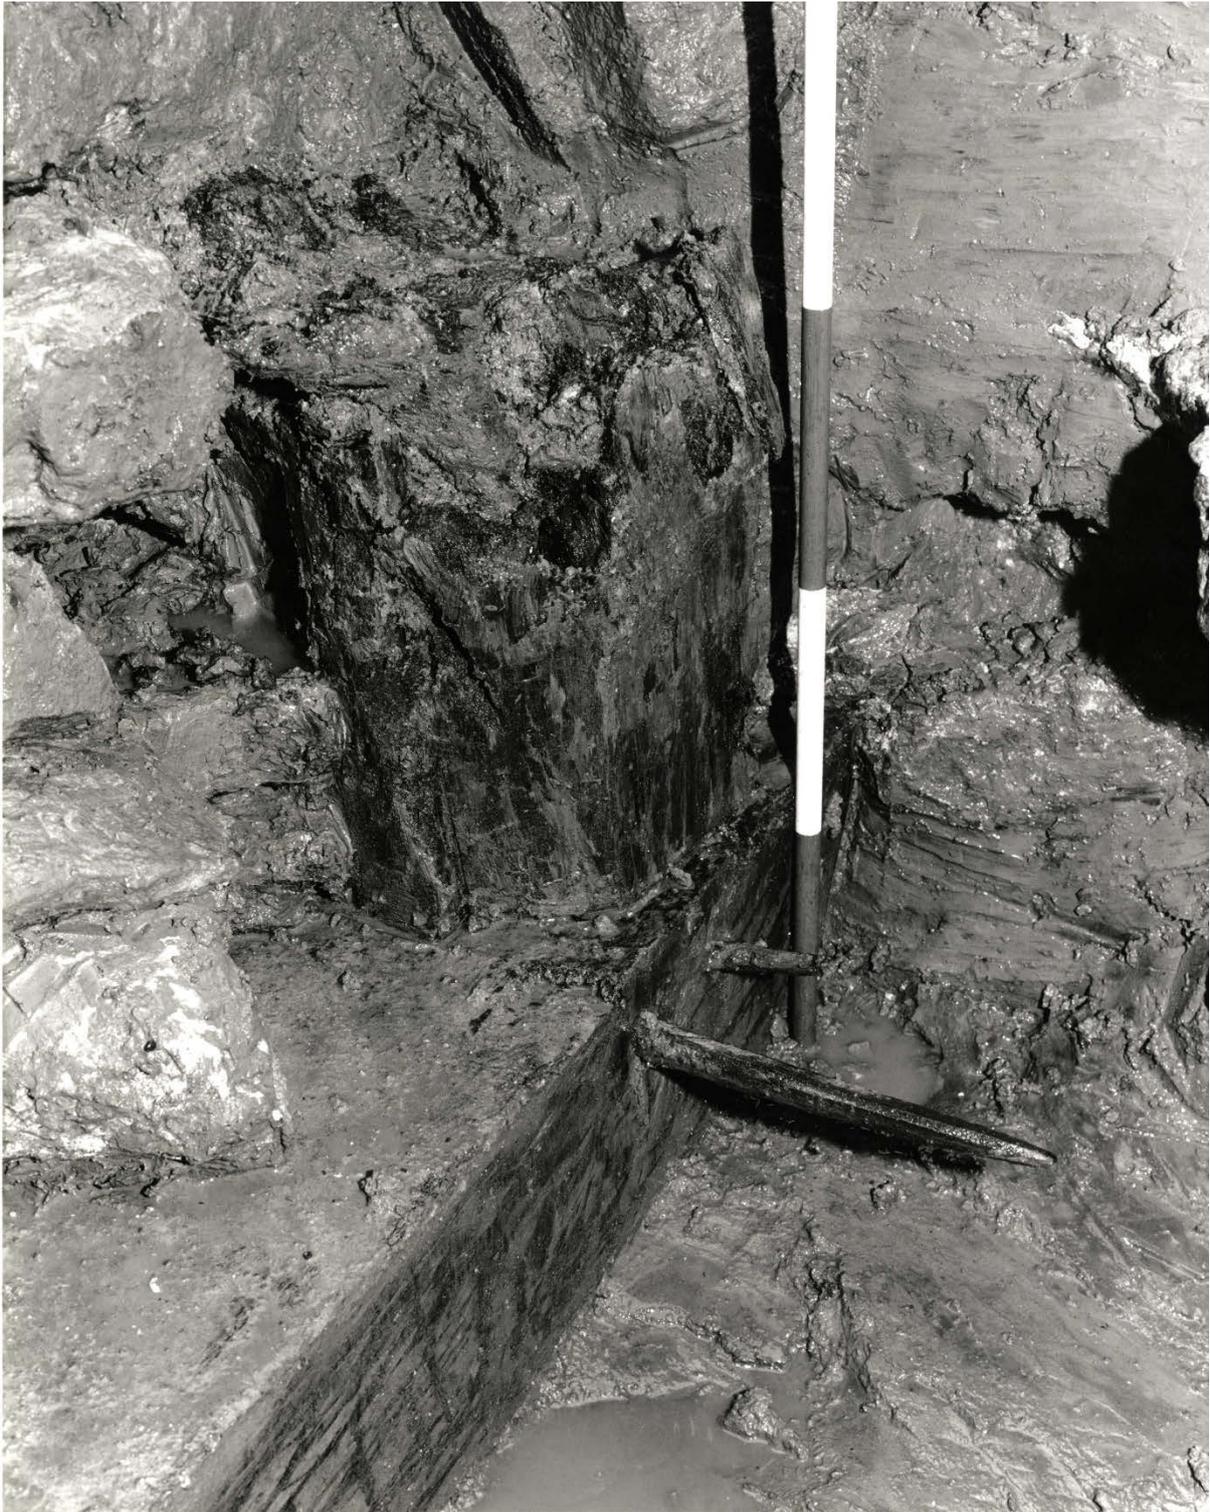
Pl. 26. Beverley Gate, winter 1988-9. Oblique view of the junction of a Phase Ia timber sole-plate with a diagonal brace; seen from the south-west. Note the projecting end of a long roundwood dowel projecting from the joint. [Photo: Bill Marsden]

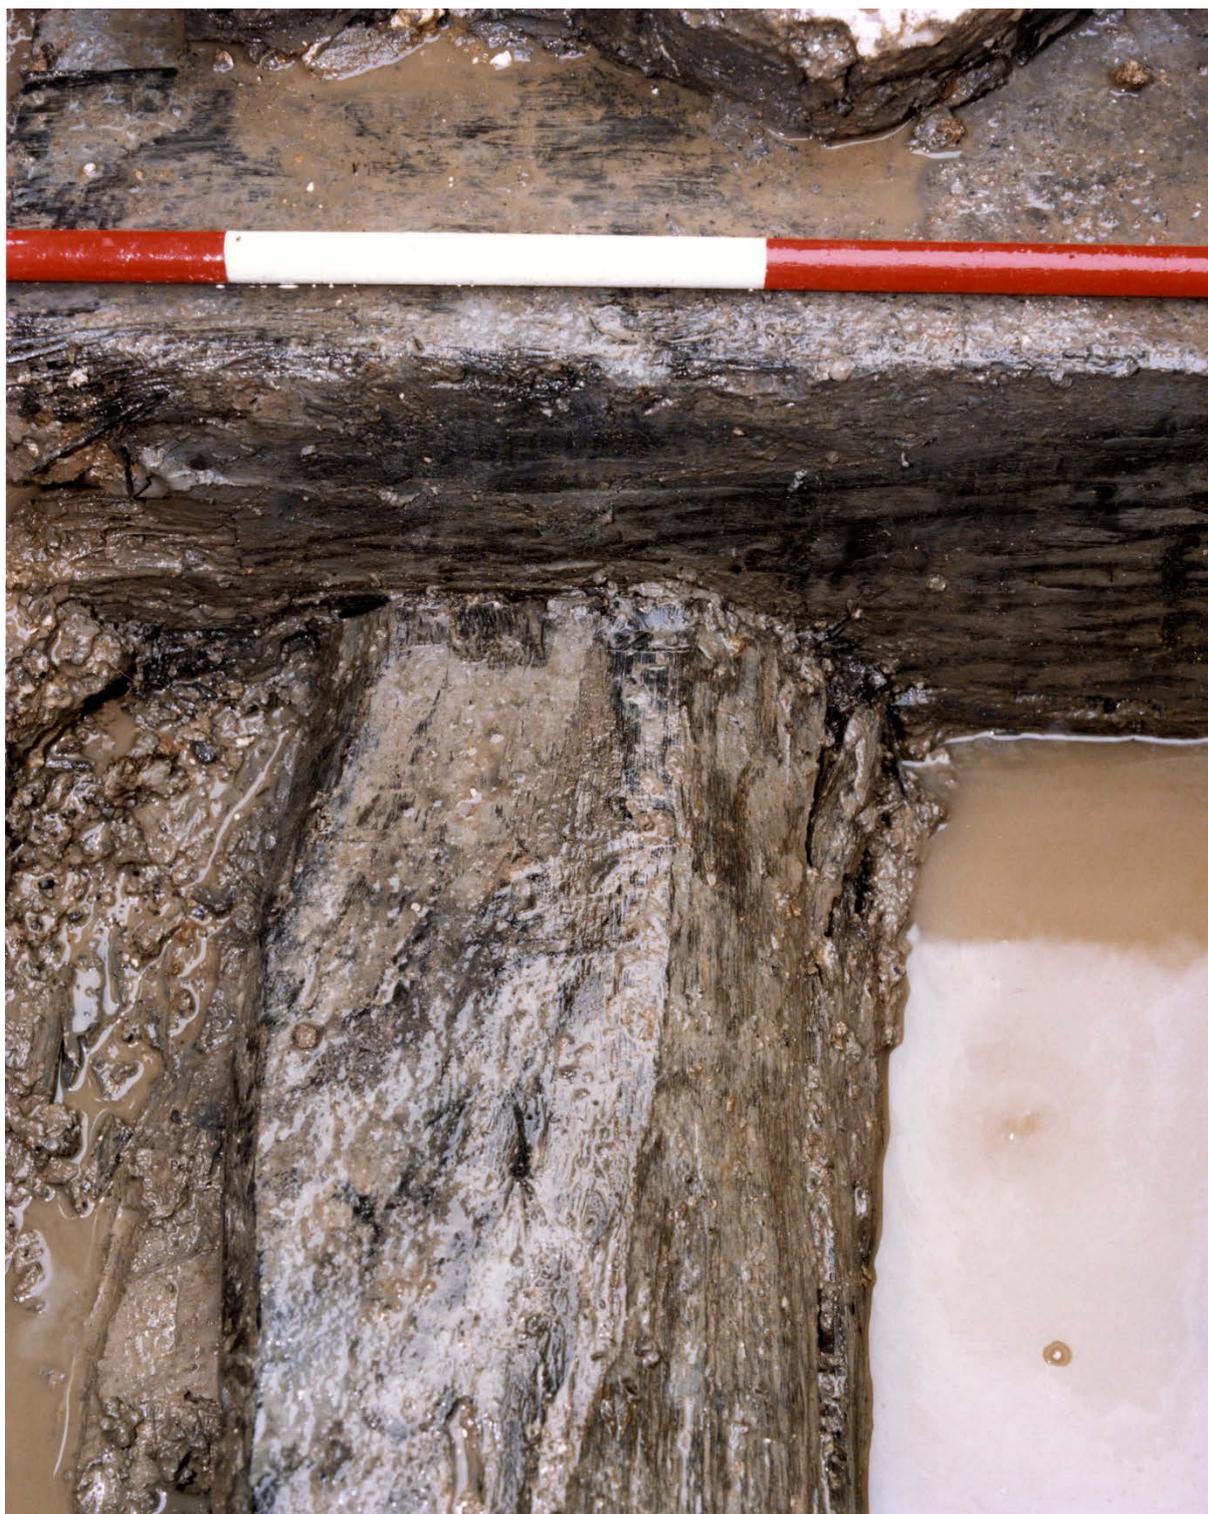
Pl. 27. Beverley Gate, winter 1988-9. The eastern end of sole-plate **55**, where it joined with sole-plate **72**. Viewed from the west, after the overlying stonework had been dismantled to reveal this. [Photo: Bill Marsden]
