Excavations at the Beverley Gate, and other parts of the town defences of Kingston-upon-Hull

by D.H. Evans

Humber Archaeology Partnership
Hull

[Text 2015; updated and revised 2018]

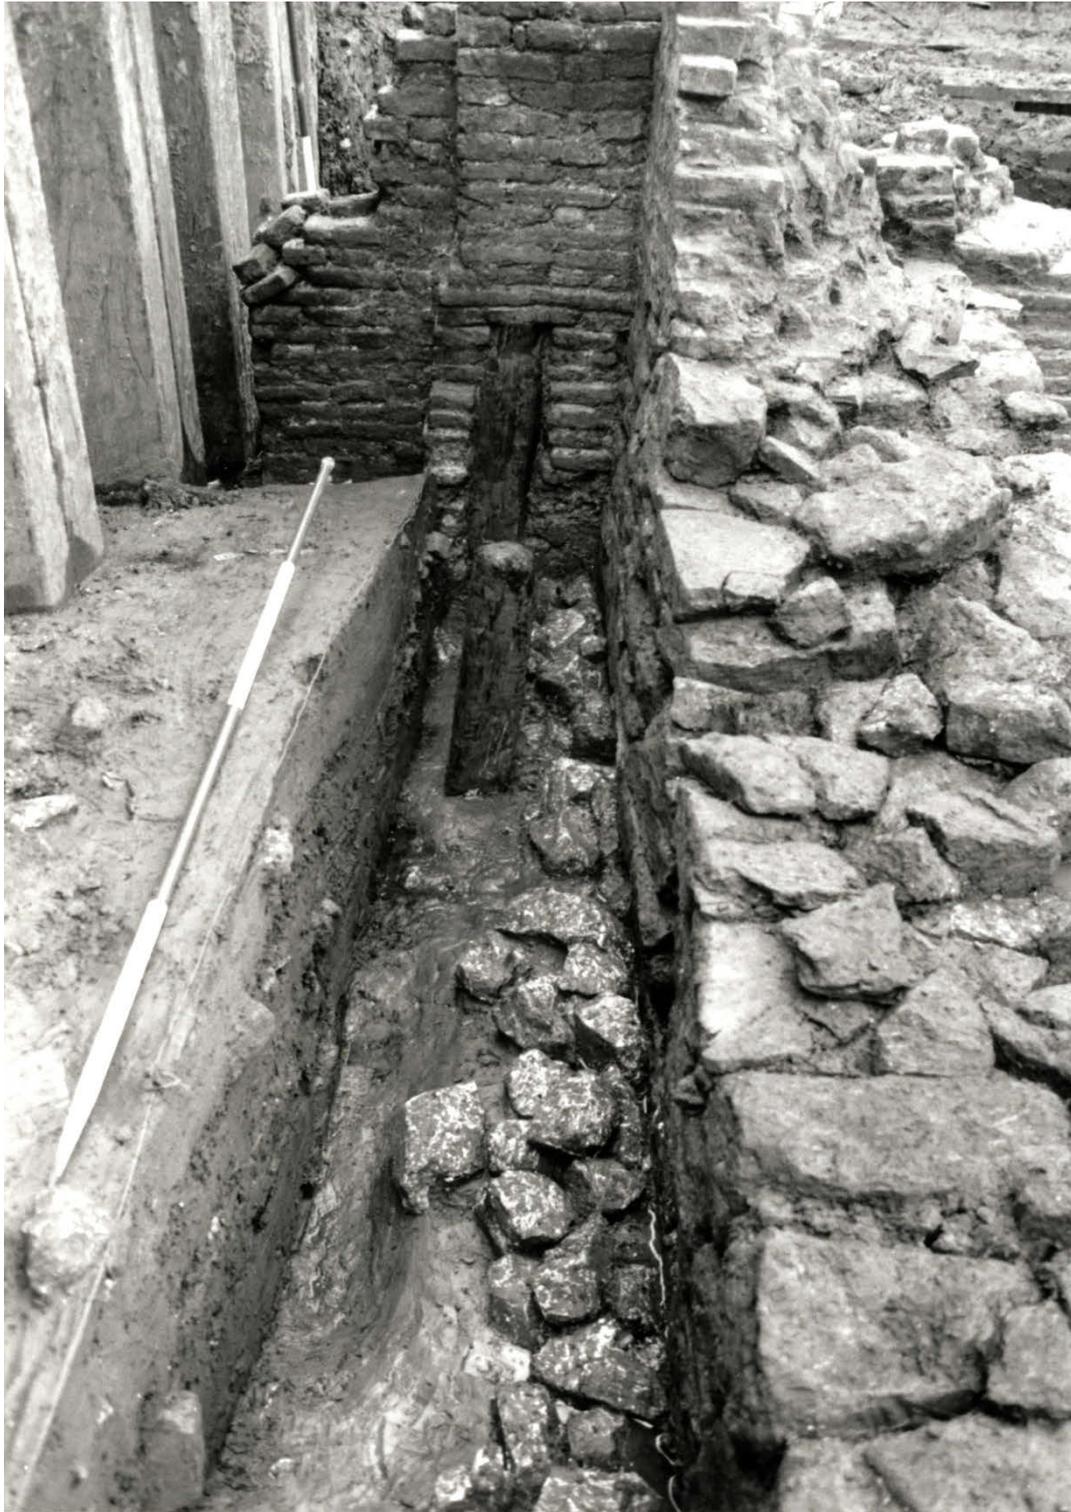
Pl. 28. Beverley Gate, winter 1988-9. The northern end of the Phase Ib passageway through the medieval Gate, seen from the south. The top of wall 73 can be seen on the right-hand side of the photograph; in the centre-ground are parts of the stone levelling at the base of the Gate passageway, and the sawn-off remains of a timber post, 64. The brickwork of the front of the Gate lies beyond. [Photo: the author]

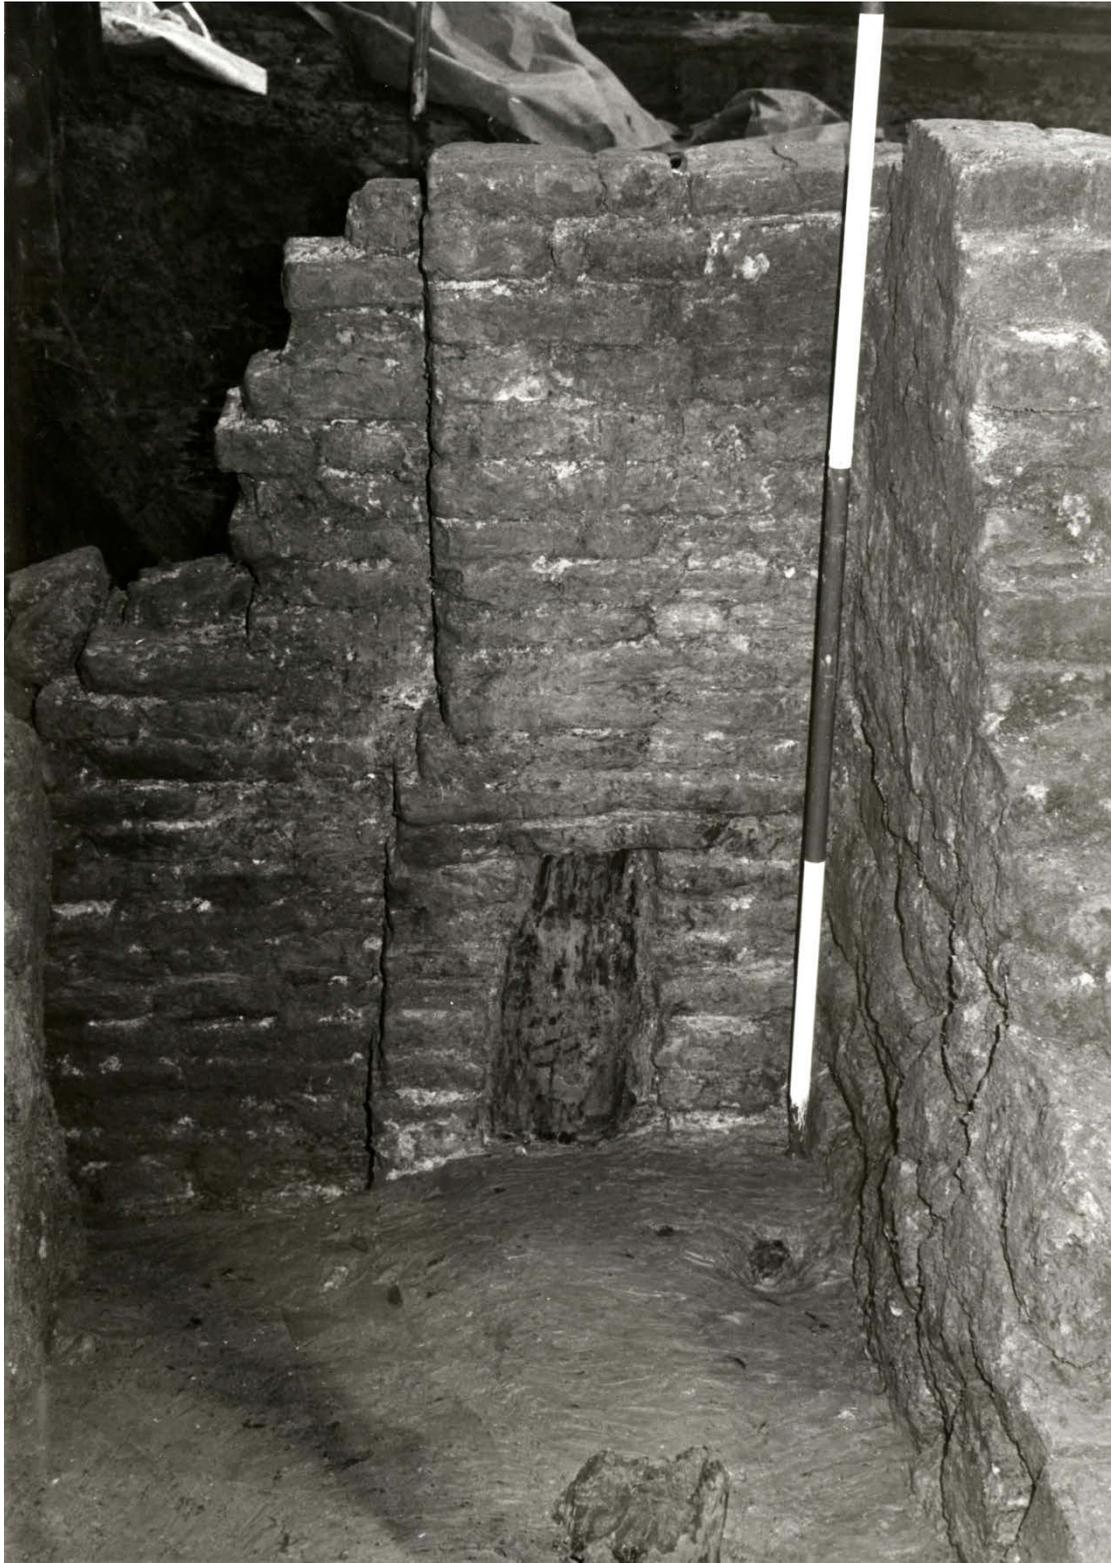
Pl. 30. Beverley Gate, winter 1988-9. Rear face of the western return to the end of the north wall of the Phase Ib Gate passage; viewed from the east. The brickwork encases at its base the sawn-off stump of a Phase Ia timber upright, 77. [Photo: the author]

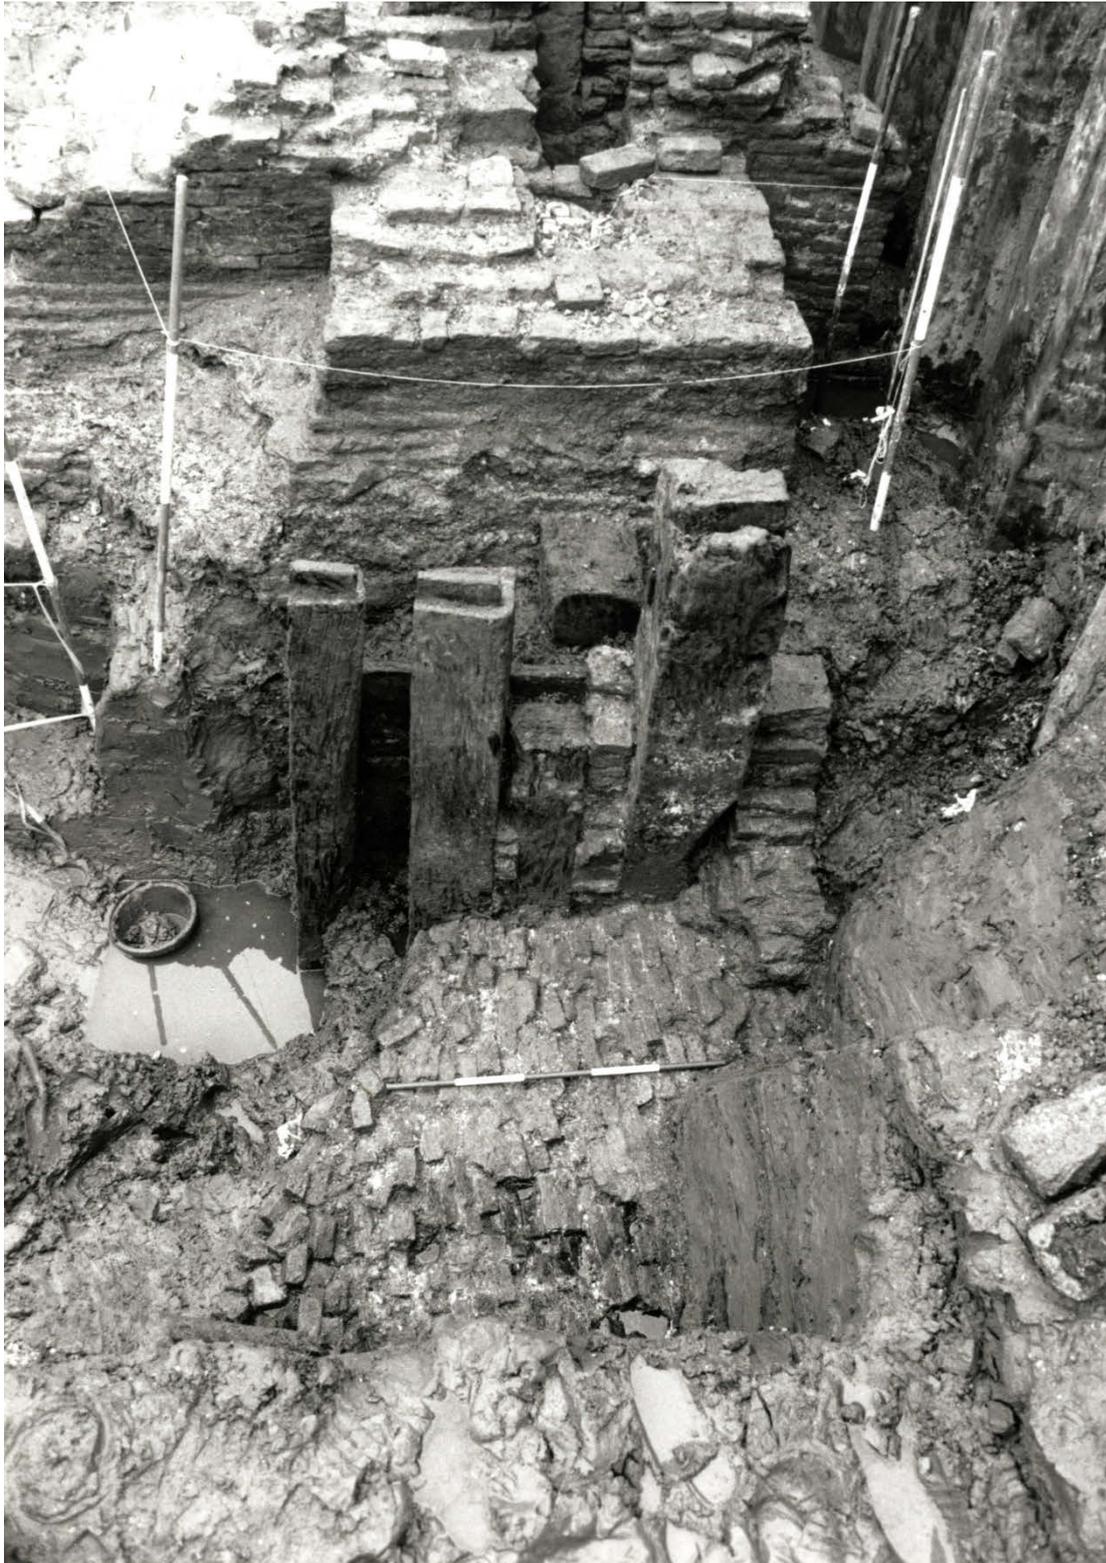
Pl. 31. Beverley Gate, winter 1988-9. The tops of the wooden uprights for the Phase II bridge in front of the northern half of the Gate; note the projecting tenons. The Phase Ib brickwork can be seen behind these timbers. Viewed from the west. [Photo: the author]

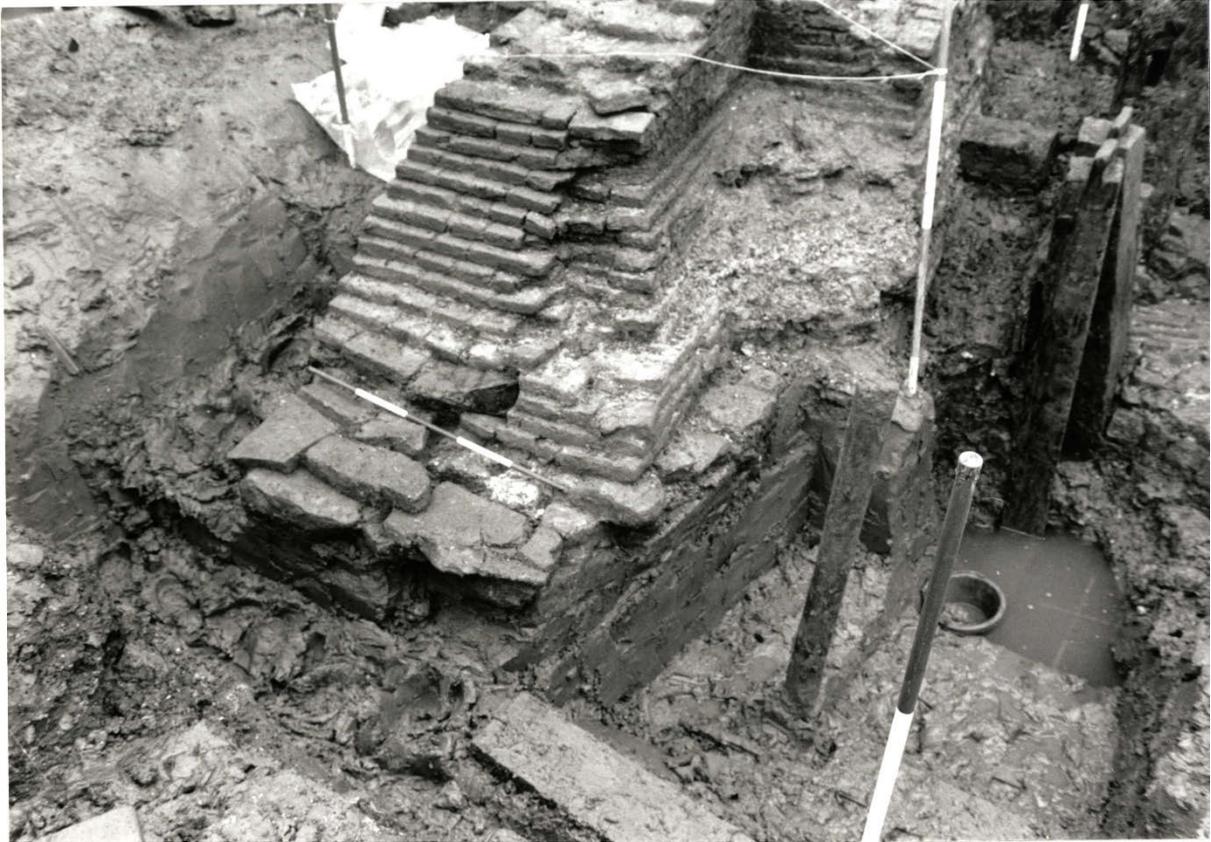
Pl. 32. Beverley Gate, winter 1988-9. The north-western corner of the Gate took the form of a substantial buttress with cross-shaped projecting arms to both the west and north (cf. Gale's engraving of *c.* 1770). Here, we see the northern projecting arm, viewed from the north-west. The lower courses of brickwork are battered outwards at its base, whilst the bottom course has been laid on a bed of flat stone slabs. The remains of the Phase 1a sole-plate can just be seen in the centre of the north face, encased in the basal courses of brickwork. [Photo: the author]

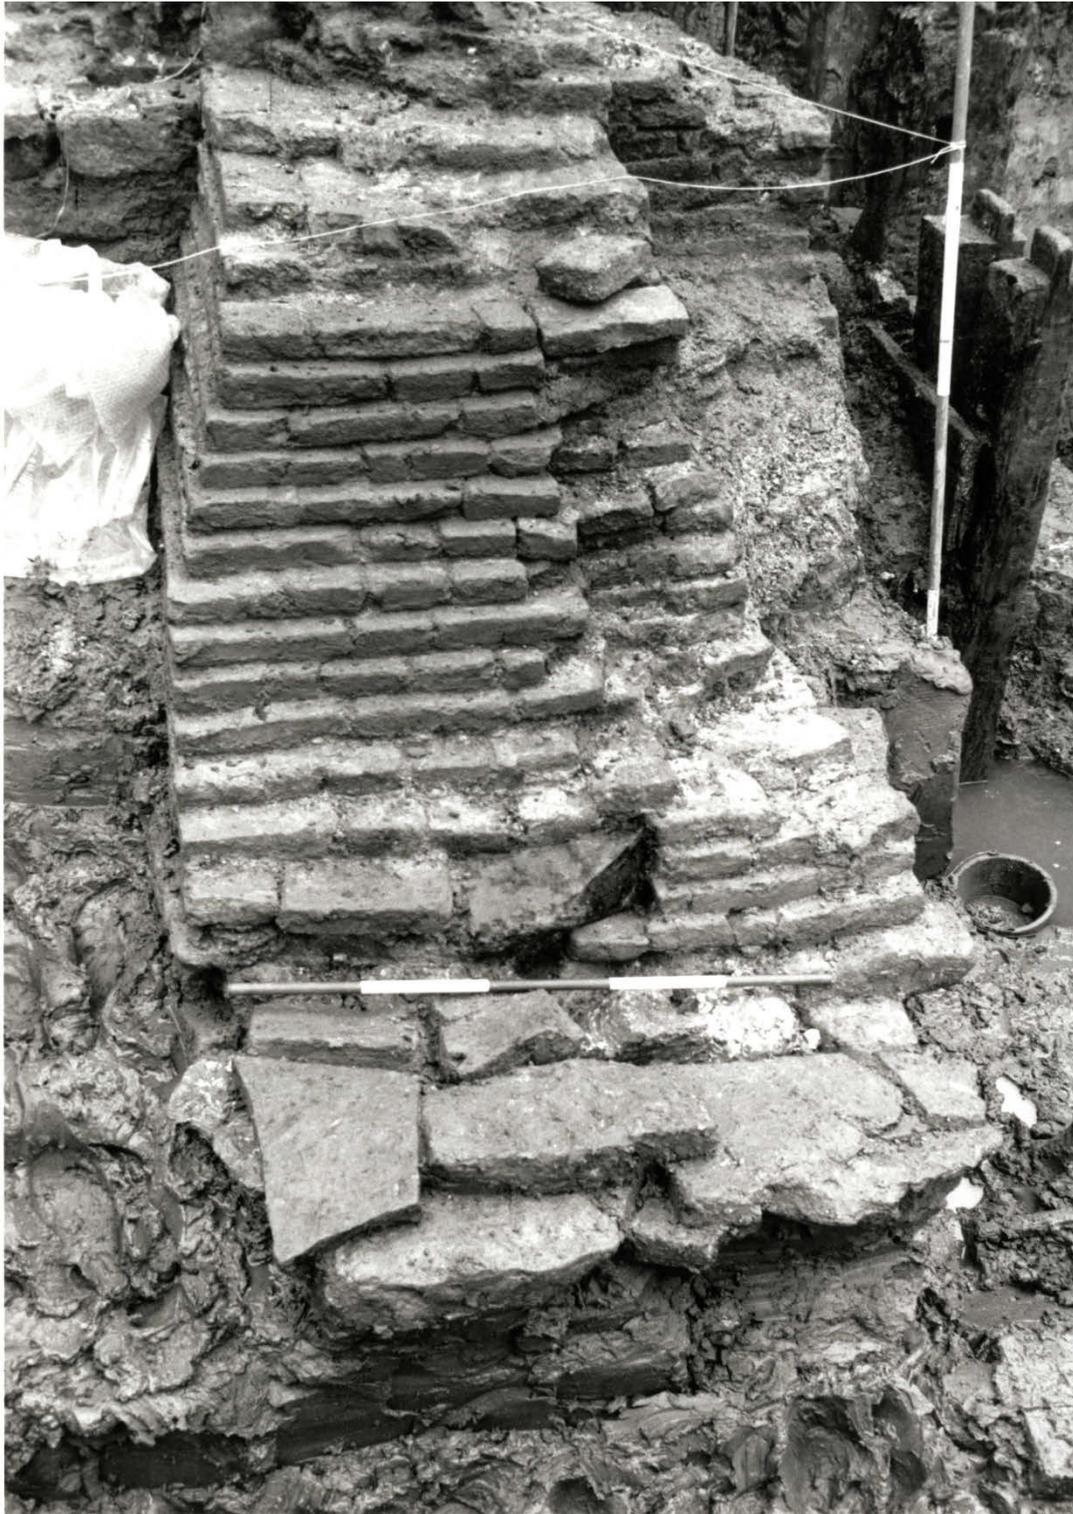
Pl. 33. Beverley Gate, winter 1988-9. The north face of the northern projecting arm to the front of the Gate, seen from the north. The stepped courses of brickwork can be clearly seen to have been set on a flat bed of stone slabs. The remains of the Phase 1a sole-plate can just be seen in the centre of this face, encased in the basal courses of brickwork. [Photo: the author]

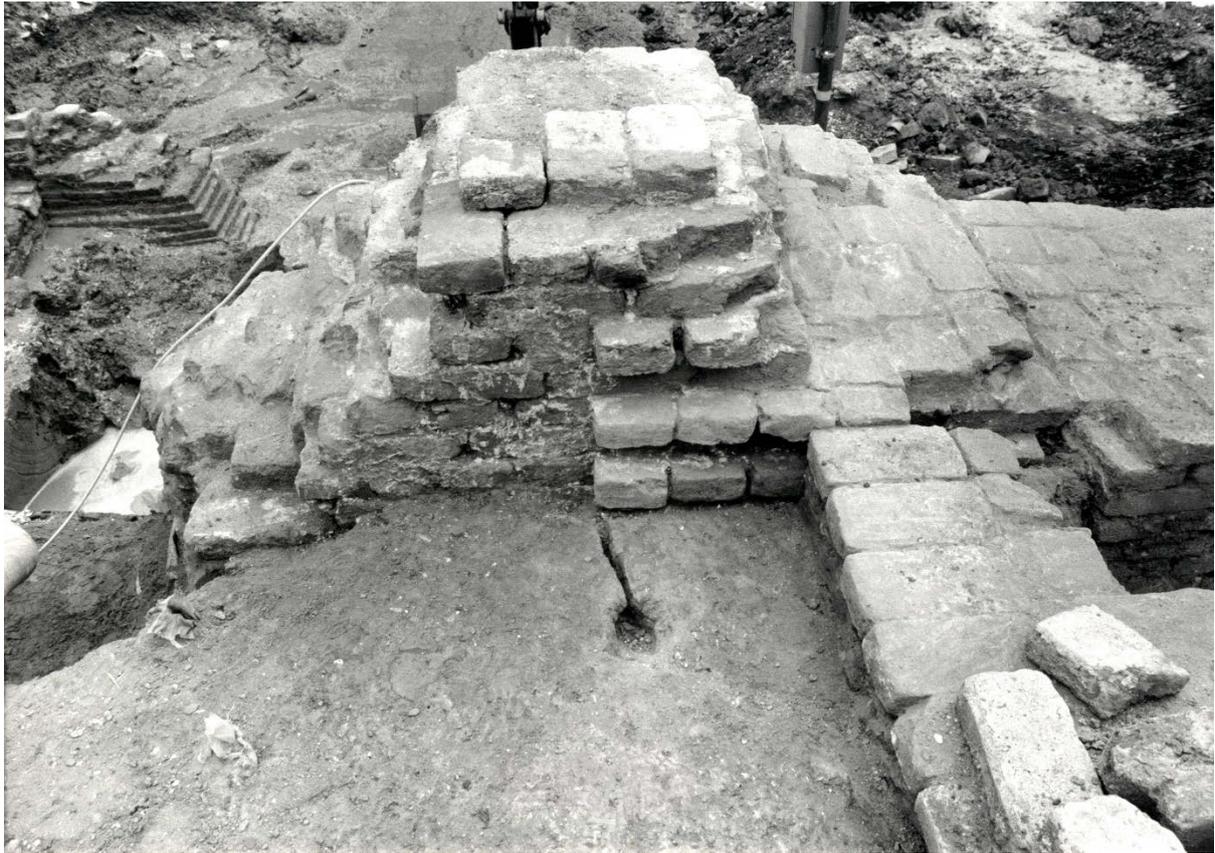
Pl. 34. Beverley Gate, 1986. The north-western corner of the Phase III northern Guard Chamber, viewed from the east. In the right foreground is its north wall (329); just beyond is the junction with its west wall (328), whilst the adjoining section of the medieval Town Wall (327) lies to its right. [Photo: Humberside Archaeological Unit]

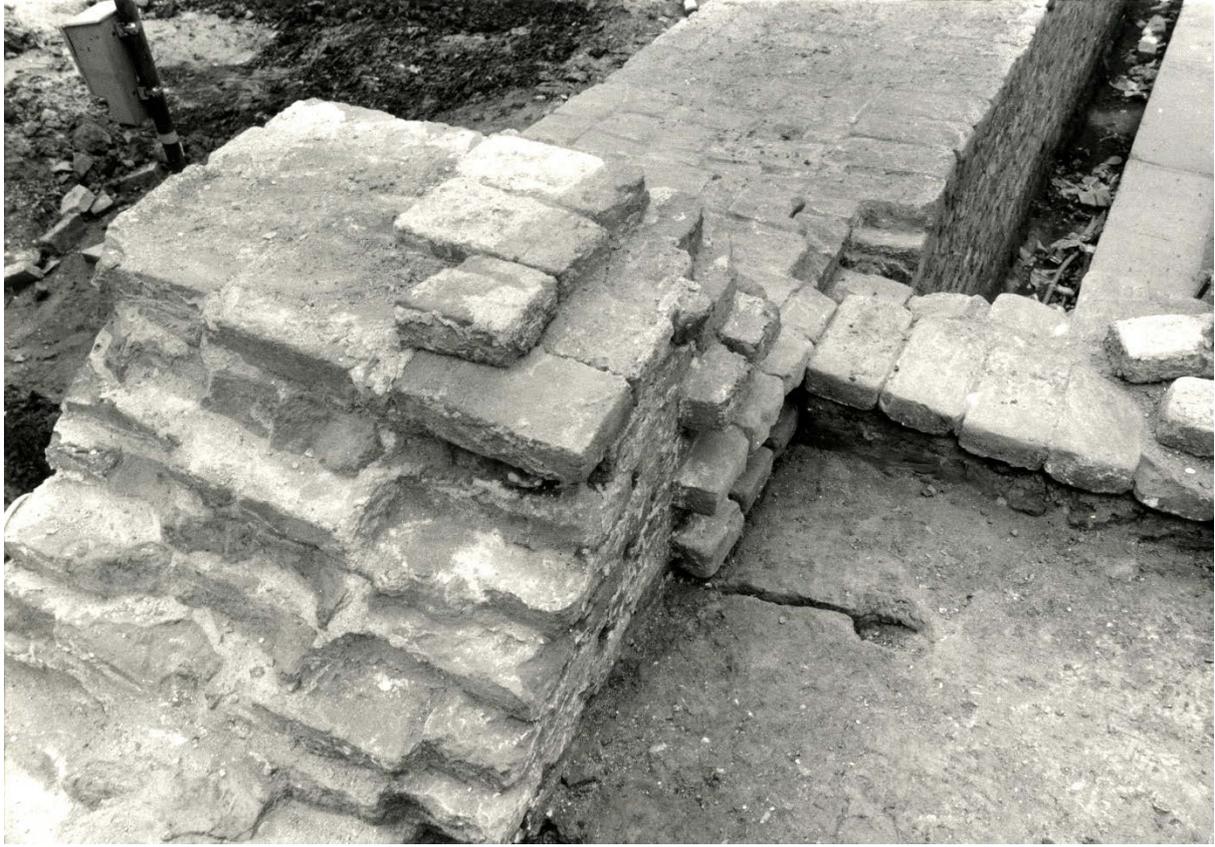
Pl. 35. Beverley Gate, 1986. The same junction, viewed from the south-south-east. Wall **328** is in the left foreground, wall **329** in the centre right, and the medieval Town Wall (**327**) can be seen in the background. [Photo: Humberside Archaeological Unit]

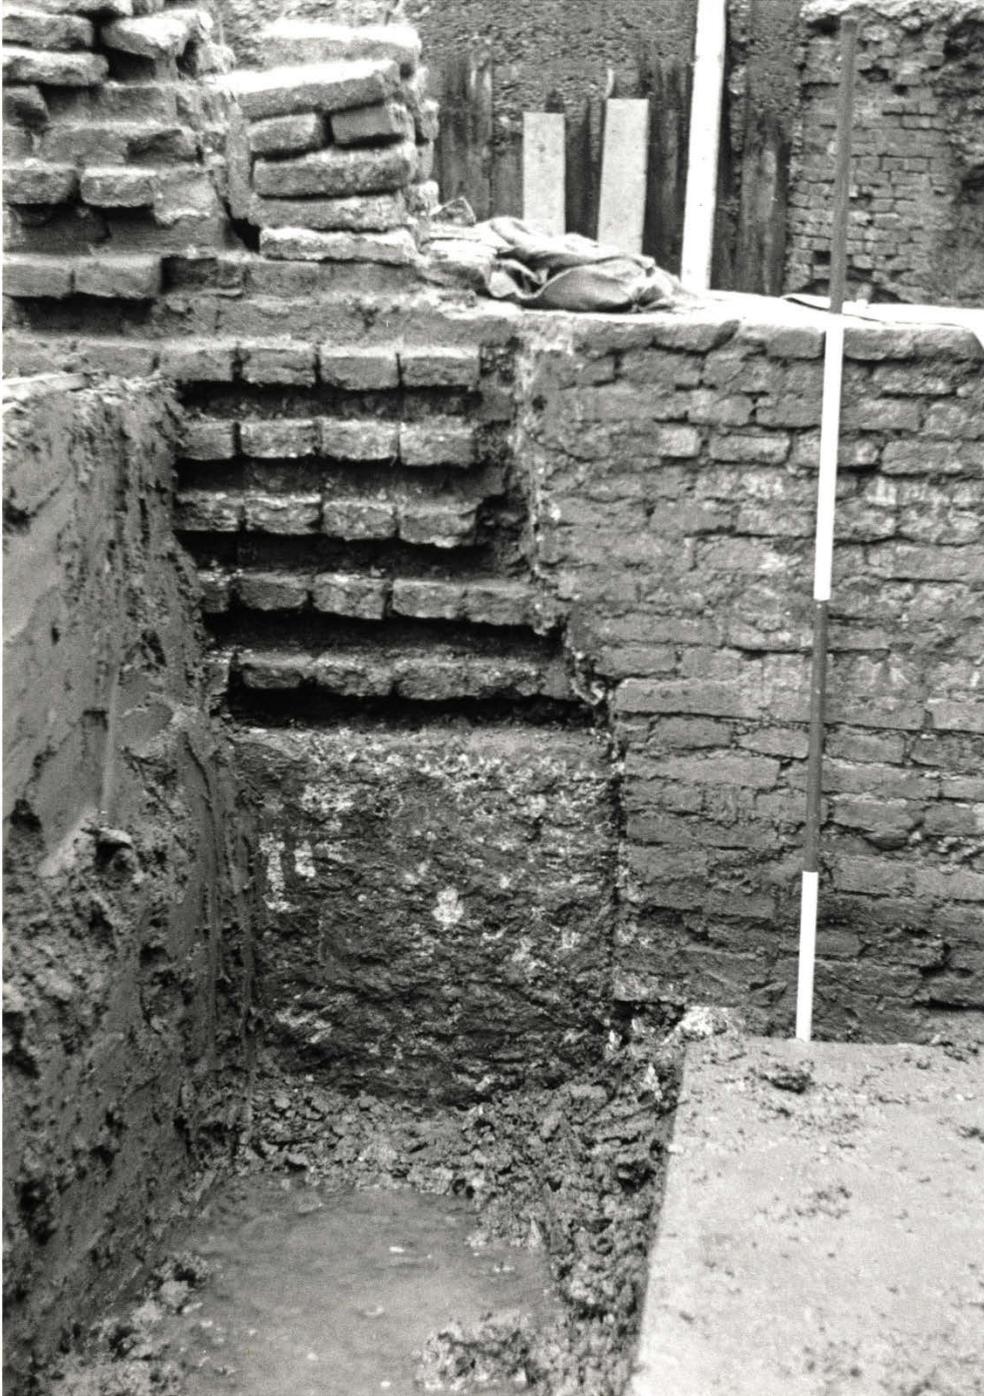
Pl. 36. Beverley Gate, 1986. An elevation through the junction of the Phase Ib Town Wall (327) with the Phase III northern Guard Chamber; seen from the east. The medieval wall (in the right-hand side of the photograph) has been partially dismantled to permit the insertion of the Guard Chamber. The lower courses of the former have been cut back to form a vertical face against which a clay construction dump has been piled; the section of brickwork above this is more irregular, but has been cut back to allow the construction of the walls of the Guard Chamber. [Photo: Humberside Archaeological Unit]

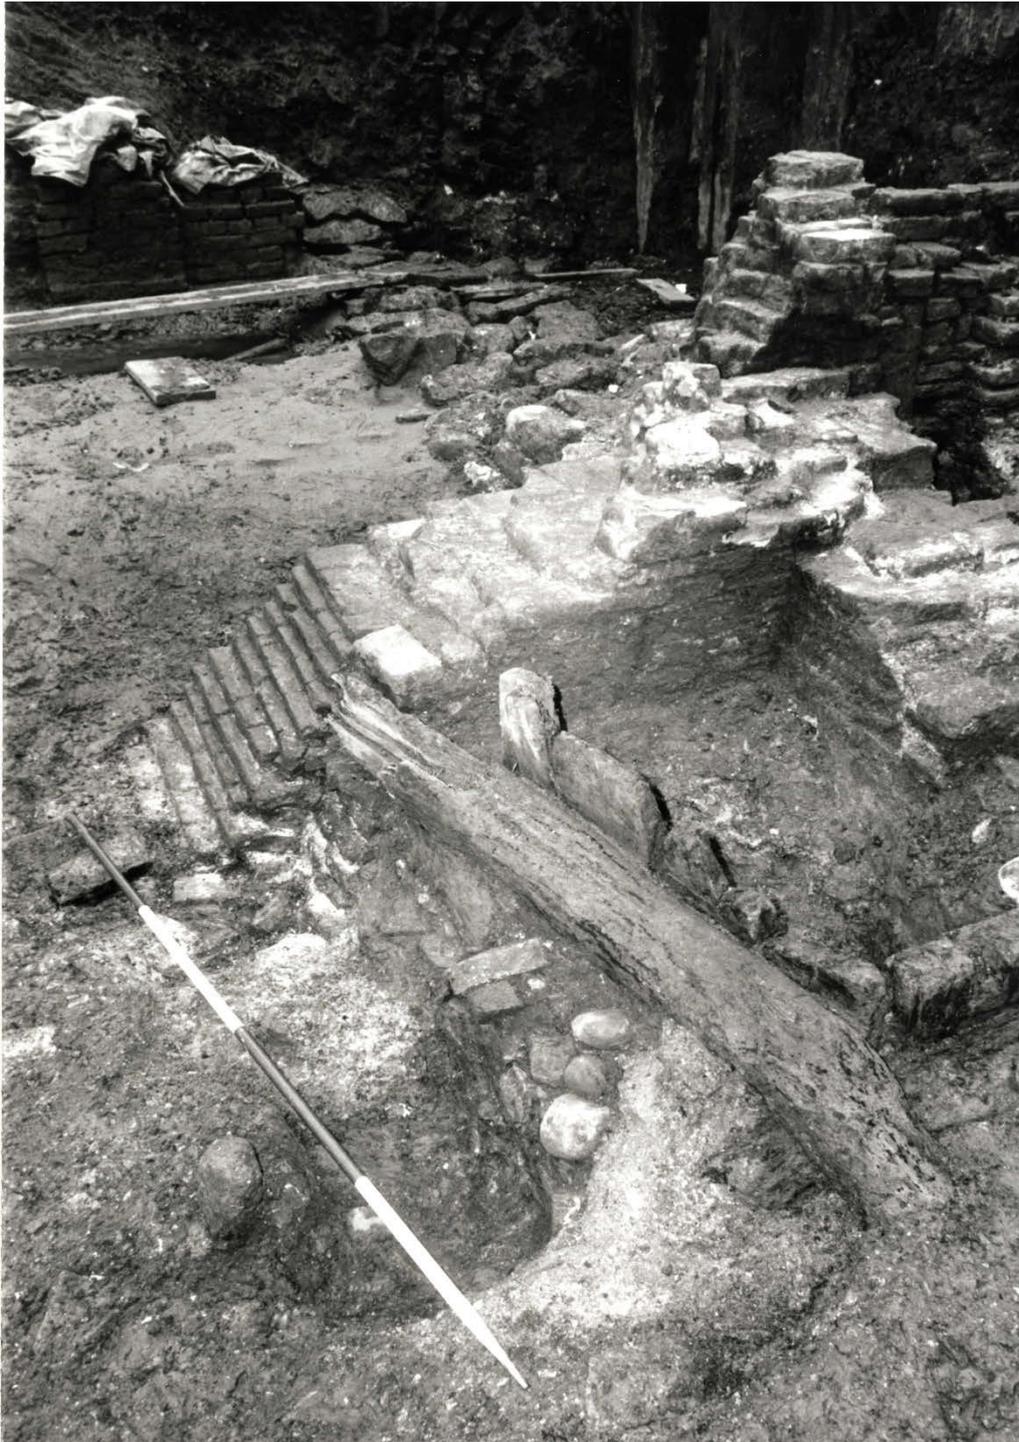
Pl. 37. Beverley Gate, winter 1988-9. The Phase IV timber revetment or shuttering erected in front of the north-west corner of the Gate Tower; viewed from the north-west of the Gate passage. A substantial horizontal oak beam (8) can be seen retaining the front of a series of broad upright planks (42A-D), set diagonally between the two projecting brick arms of this part of the Gate; the northern end of its western counterpart, beam 4 is just visible on the right of the photograph. [Photo: the author]

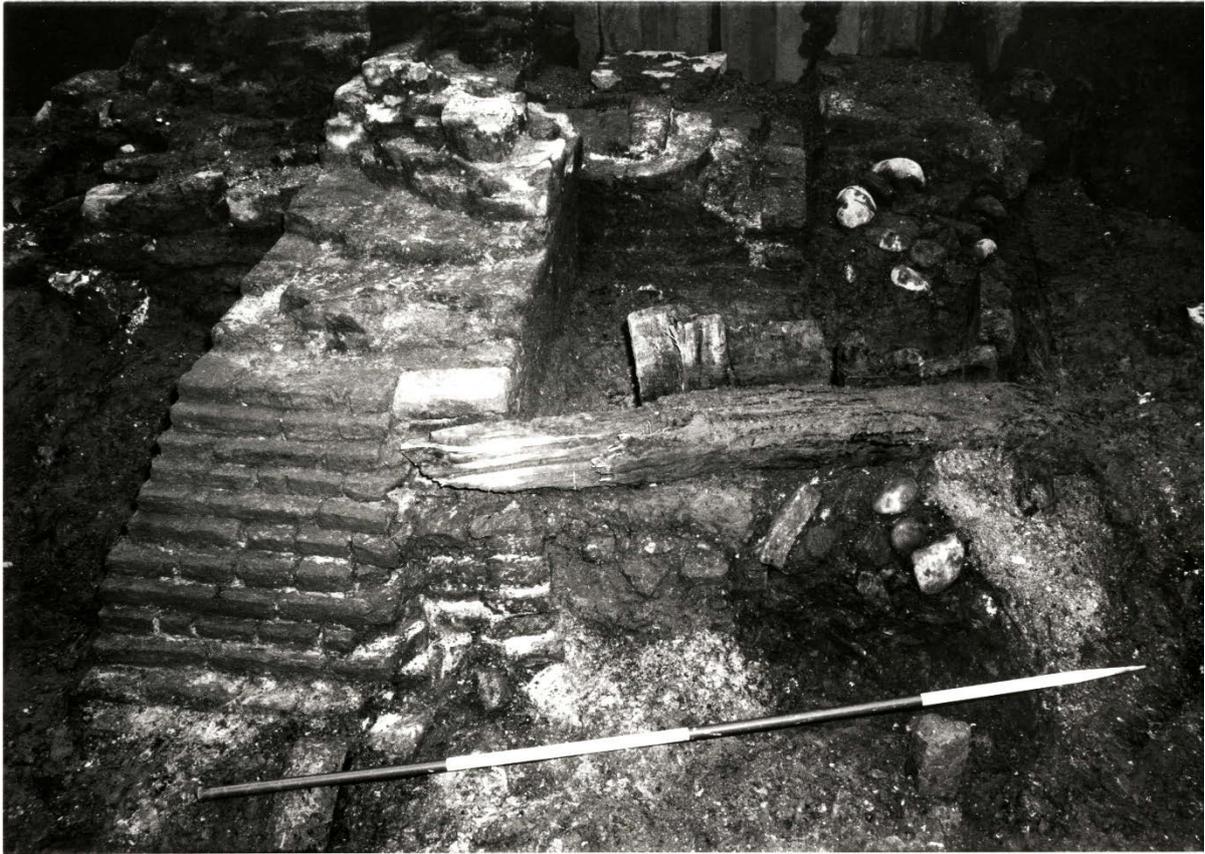
Pl. 38. Beverley Gate, early January 1989. The same Phase IV timber revetment, viewed from the north. The north-eastern end of beam **8** is supported by the upper courses of the projecting brick arm of the medieval Gate; the tops of the vertically-set planks (**42A-D**) can be seen behind the beam. [Photo: the author]

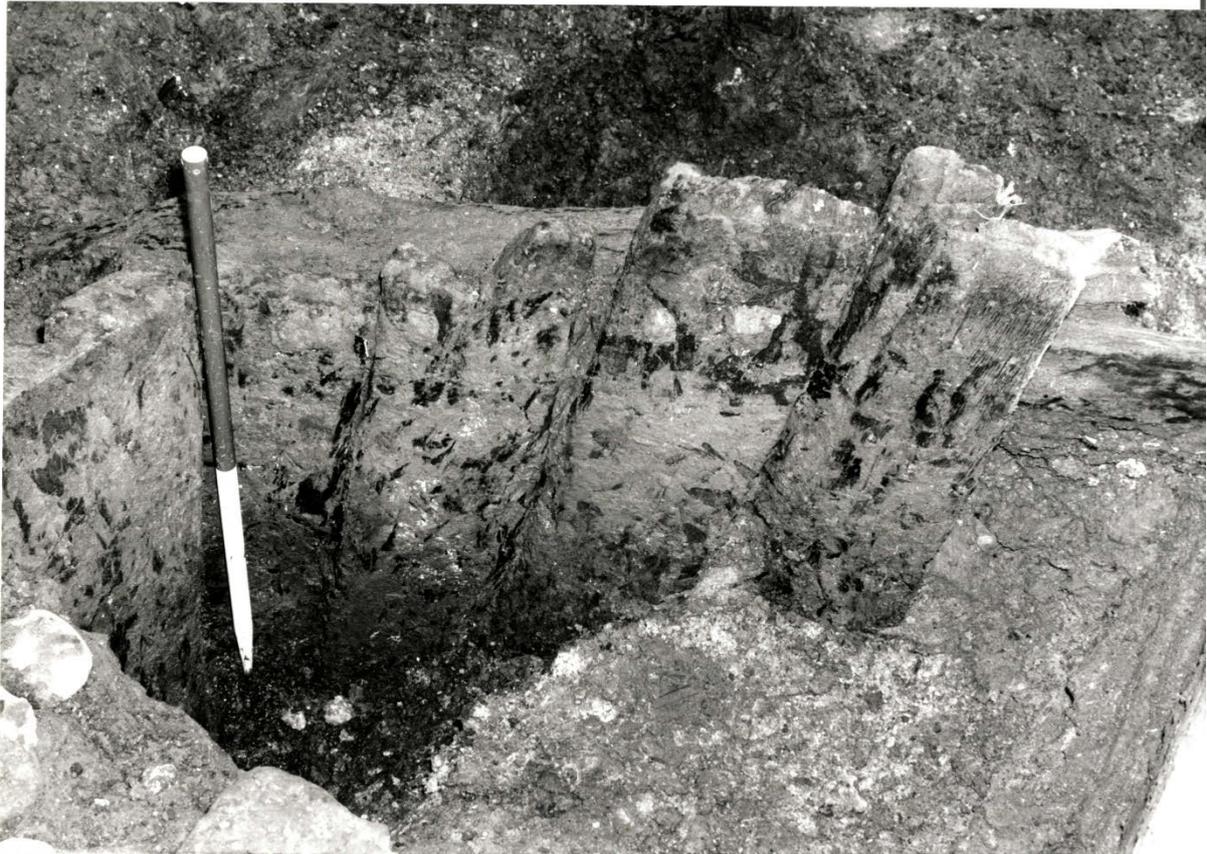
Pl. 39. Beverley Gate, early January 1989. The internal face of the Phase IV timber revetment, viewed from the south-east. Planks **42 A-D** can be seen in the centre of the photograph, with planks **43** to the left. [Photo: the author]
