**A former barn at Carew  
Manor, Beddington  
Excavations in 2015 and 2016**

Carshalton & District History & Archaeology Society  
Occasional Paper 12

Site code	BDD15
OASIS ID	Carshalt1-253494
Site address	B3eddington Park, Wallington, Surrey
Borough	Sutton
Grid ref	TQ 2950 6543
Organisation	Carshalton & District History & Archaeology Society
Excavation date	13-19 July 2015 and 1-9 August 2016
Revised	4 June 2018

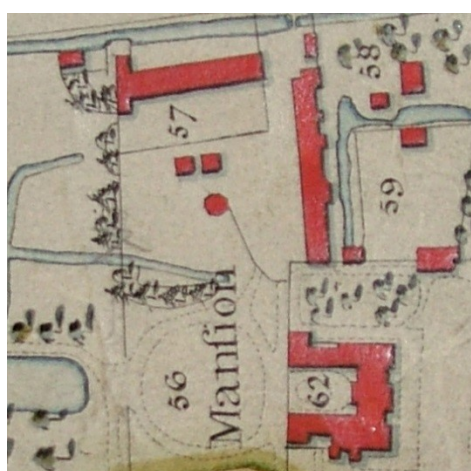
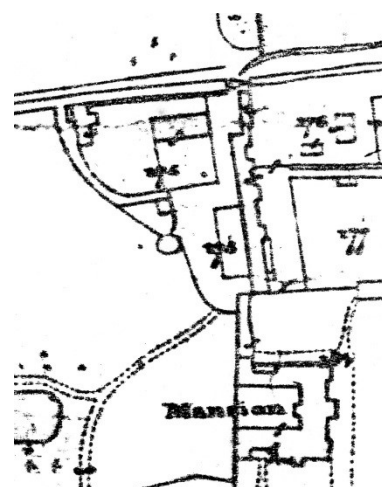
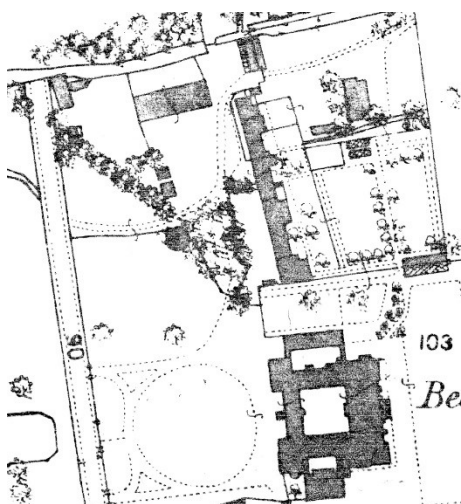
Figure 1. The outbuildings to the northwest of the house from the enclosure award map of 1820 (above left) and the tithe map of 1840 (above right) and the first 25 inch Ordnance Survey map of 1868 (left). Beddington Park Cottages are the long north-south aligned range. The suspected stable is shown on the 1820 map top centre. It had been partially demolished by 1840.

Carew Manor was a former country house which dates back to at least the late medieval period. The enclosure award map of 1820 shows a group of outbuildings forming a courtyard to the northwest of the house (figure 1). These consisted of:

The foundation [5] appears to relate to the north wall and northwest corner of the building shown on the enclosure award map of 1820 (figure 1). Foundation [208] is almost certainly the south wall. If so, the building had an external width of 11.56m and an internal width of 10.49m. On the north side the projections running inward from the north wall probably underpinned the principle trusses giving the lengths of three bays:

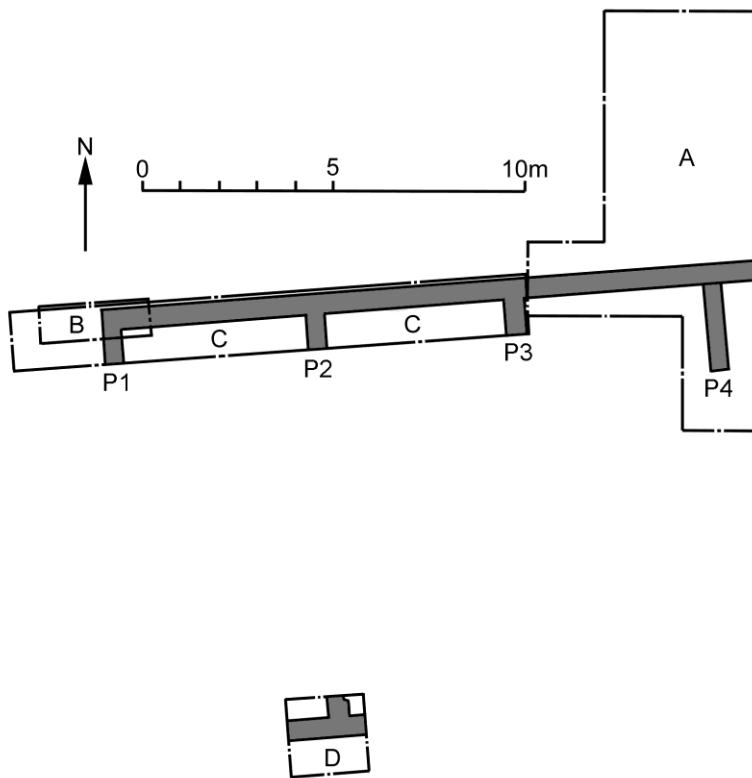
Figure 3. The BDD15 trenches and foundations (grey). There was no surviving floor.

The trench was subsequently extended to expose more of a foundation. An area 3m north-south by 2m east-west was added to the east end of the south side and another area 2m by 2m was added to the south end of the west side as shown in figure 3. These are referred to as the south and west extensions.

Layer [102] rested on foundation [5] which was aligned approximately east-west with three southward running projections as shown in figures 3 and 11 and described in (section 3.4) below.<sup>14</sup> The western most projection (P1) appeared to be the end wall of the building while the centre and eastern ones marked internal divisions.

There were four projections (P1 to P4) running southward from the foundation in the positions shown in figures 3, 10 and 11. One, at the western end of the trenches, appeared to be the west wall of the building.<sup>16</sup> It had a width above the offset of 0.53 to 0.56m. The outside corner had been damaged by a cut of uncertain date.

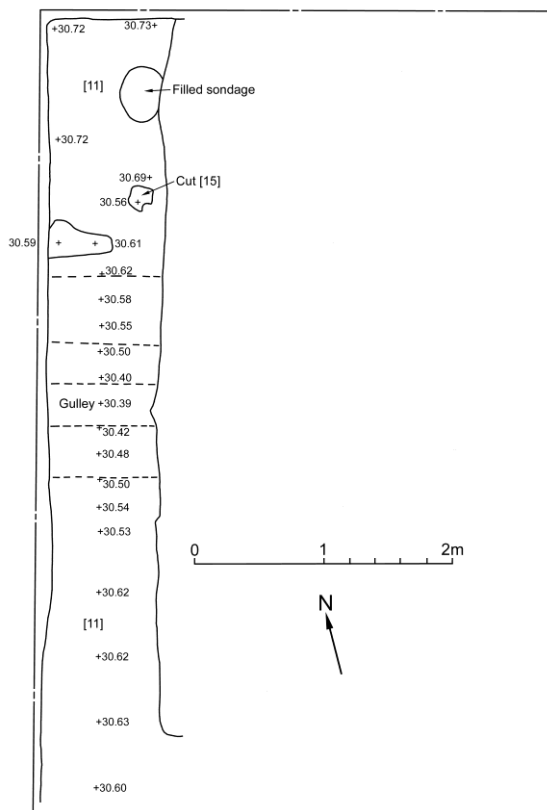
Figure 4. The section excavated along the west side of north end of the trench where the top of [11] was exposed.

Layer [6] rested on [11] which consisted of flint cobbles mostly around 7 to 10cm across but up to 15cm in a loose matrix which was dark brown at the top but passed into clean gravel. The top had some appearance of a cobbled surface but it was uneven and a sondage on the north side of foundation [5] showed that the deposit was natural gravel. The upper part of the deposit

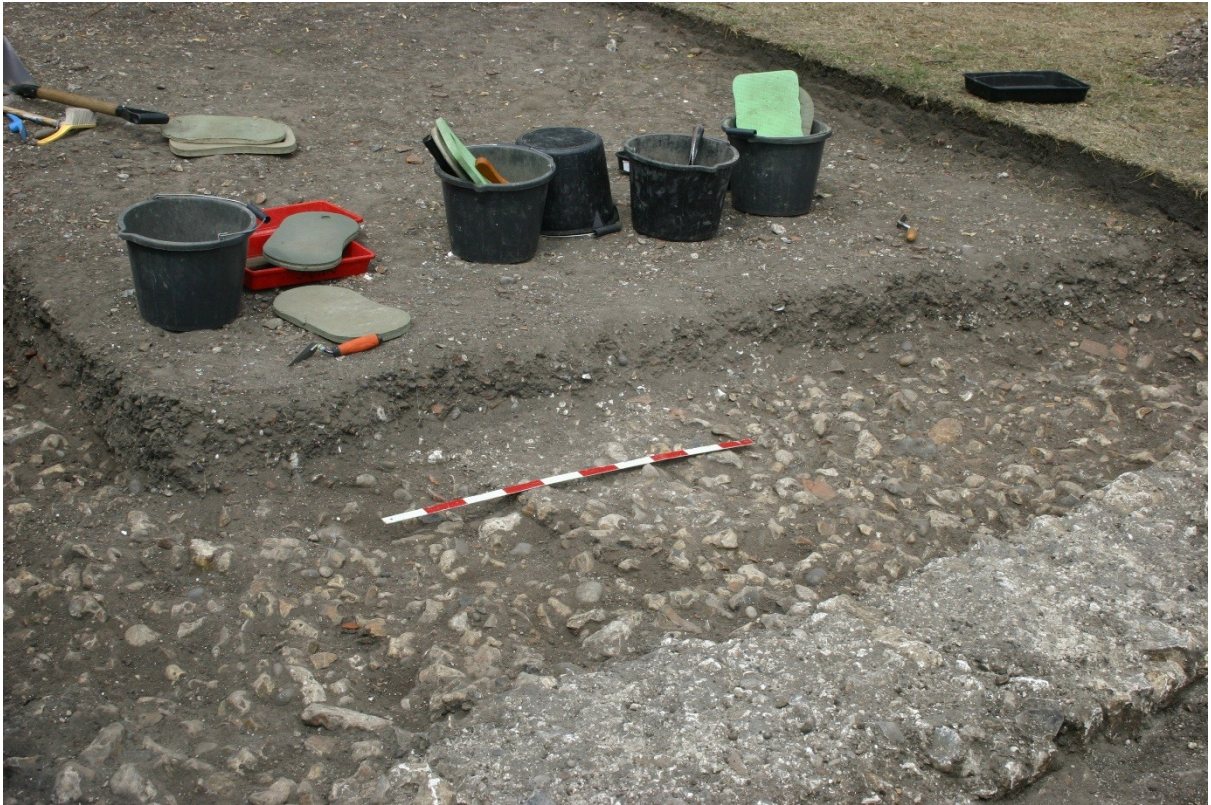
Figure 5. Trench A: the top of natural gravel layer [11] looking northeast.

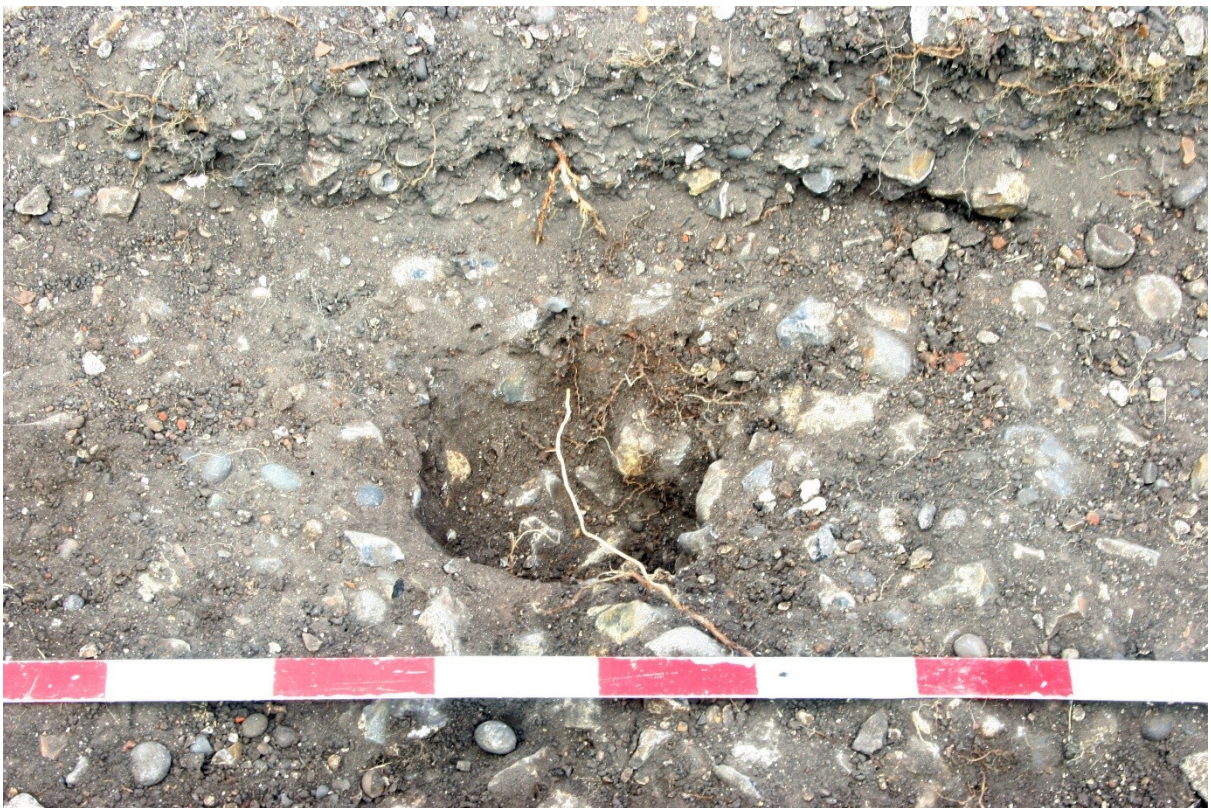
Figure 6. Trench A: cut [15] in the top of layer [11]. Scale on the west side.

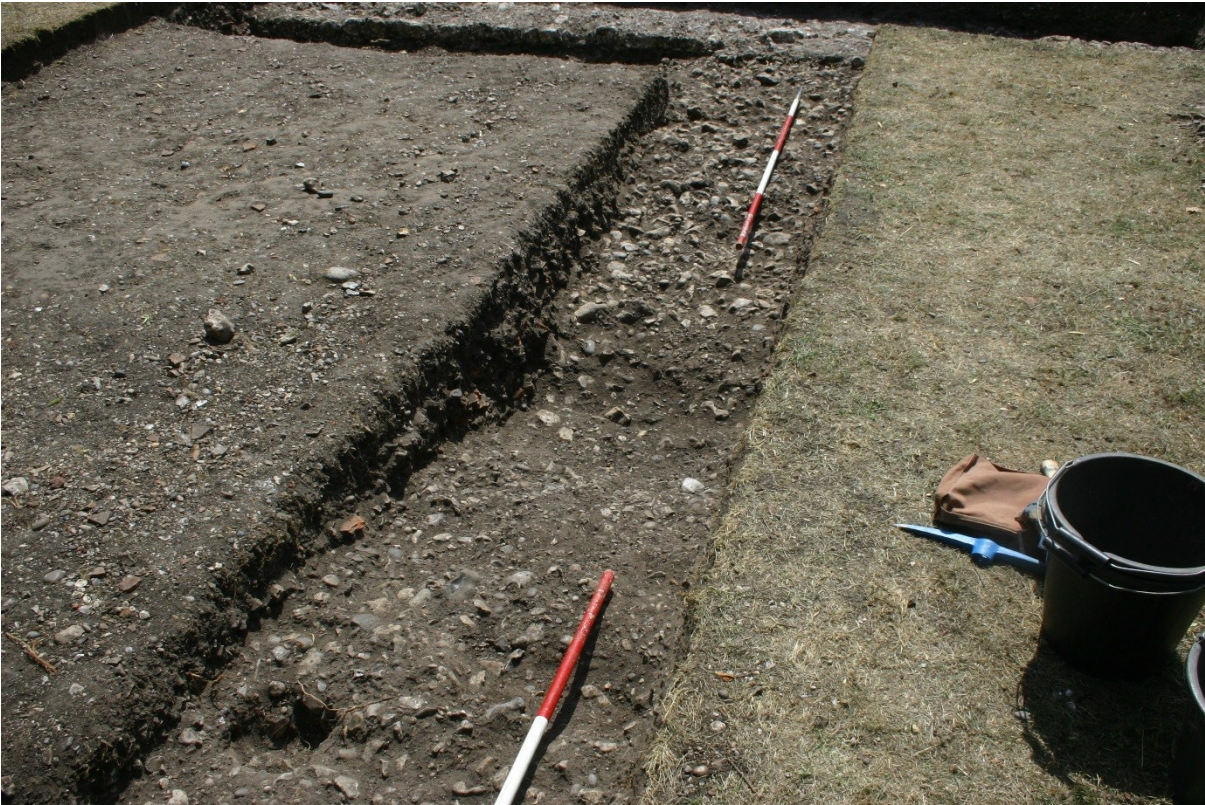
Figure 7. Trench A: west side of the trench with the top of layer [11] cut [15] in the foreground and the gully between the scales.

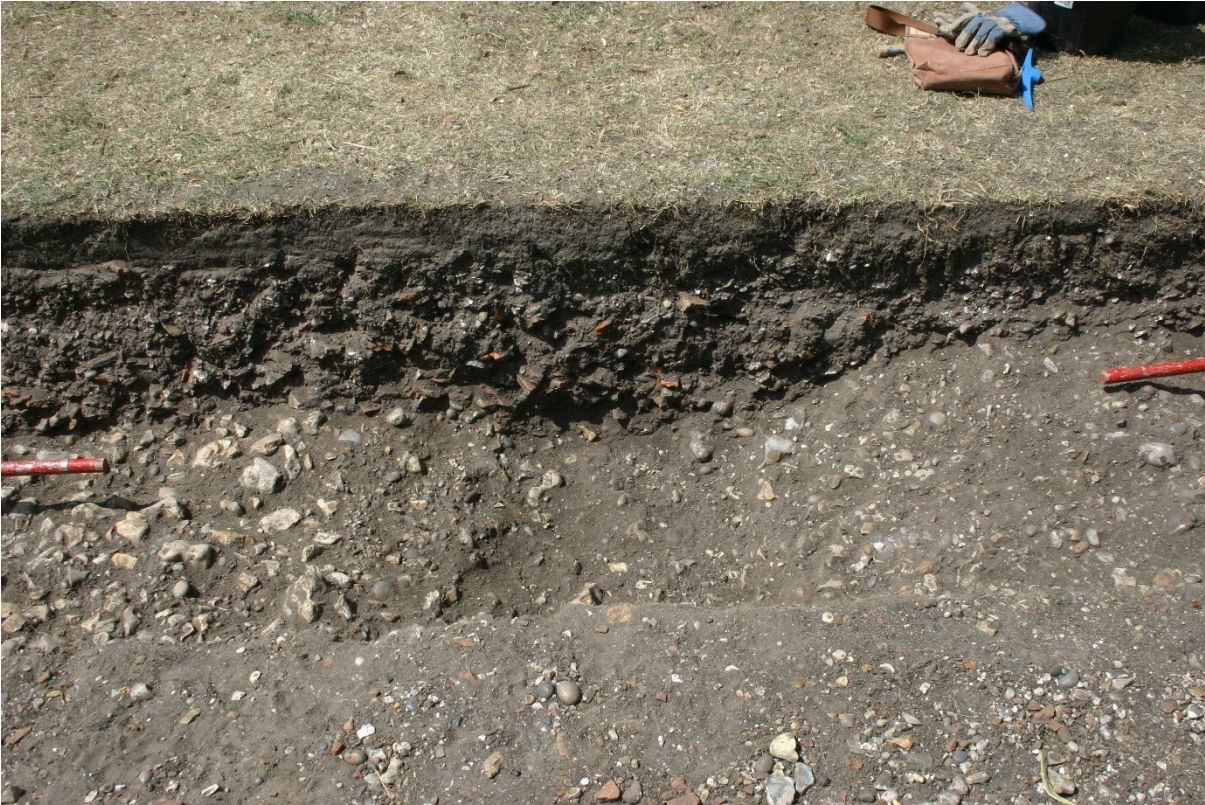
Figure 8. Trench A: west side of the trench with the gully in the top of layer [11]. Looking east.

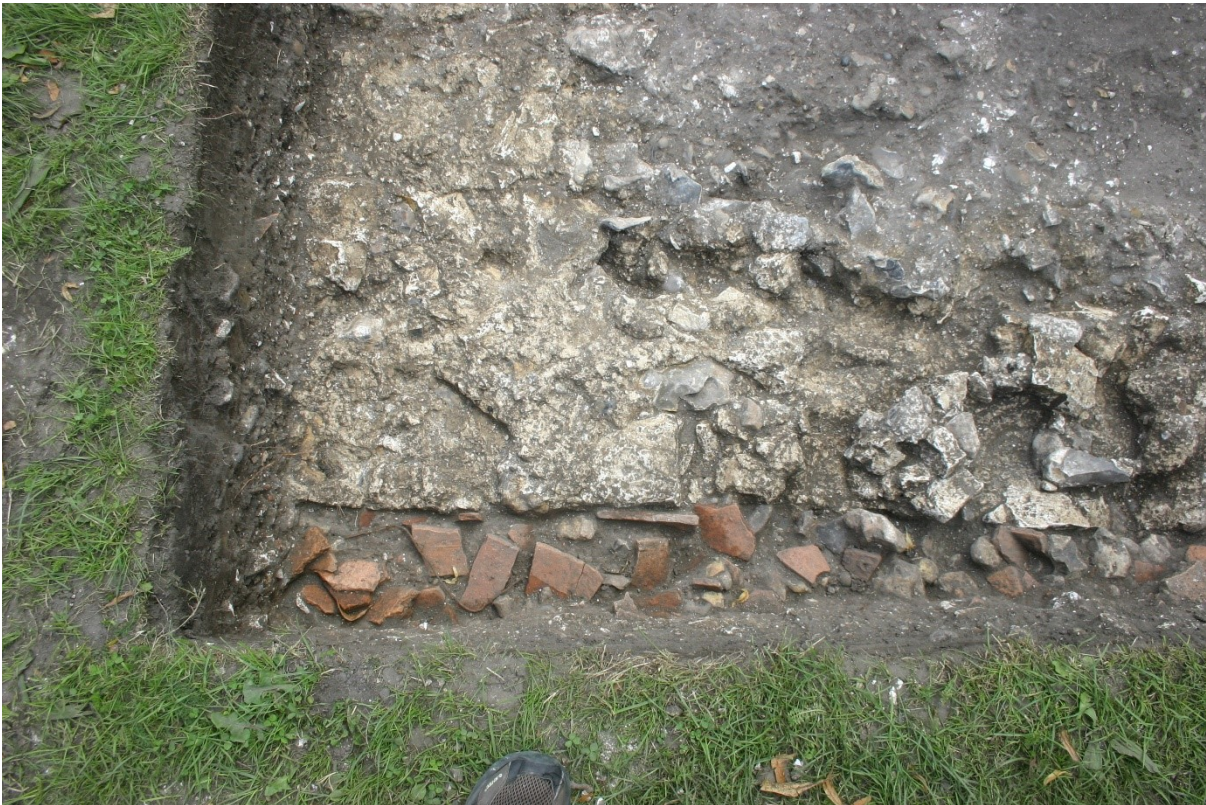
Figure 9. Trench C: the northeast corner showing the top of foundation [105] and the tile-rich deposit [103].

Deposit [106] was exposed in a narrow strip between the foundation [5] and the north edge of the trench. It consisted of about 50% broken roof tile in a brown soil matrix. The tiles were at all sorts of angles, some flat, some on their edge resting against [5] and some at other angles (figure 9). The deposit was not excavated.

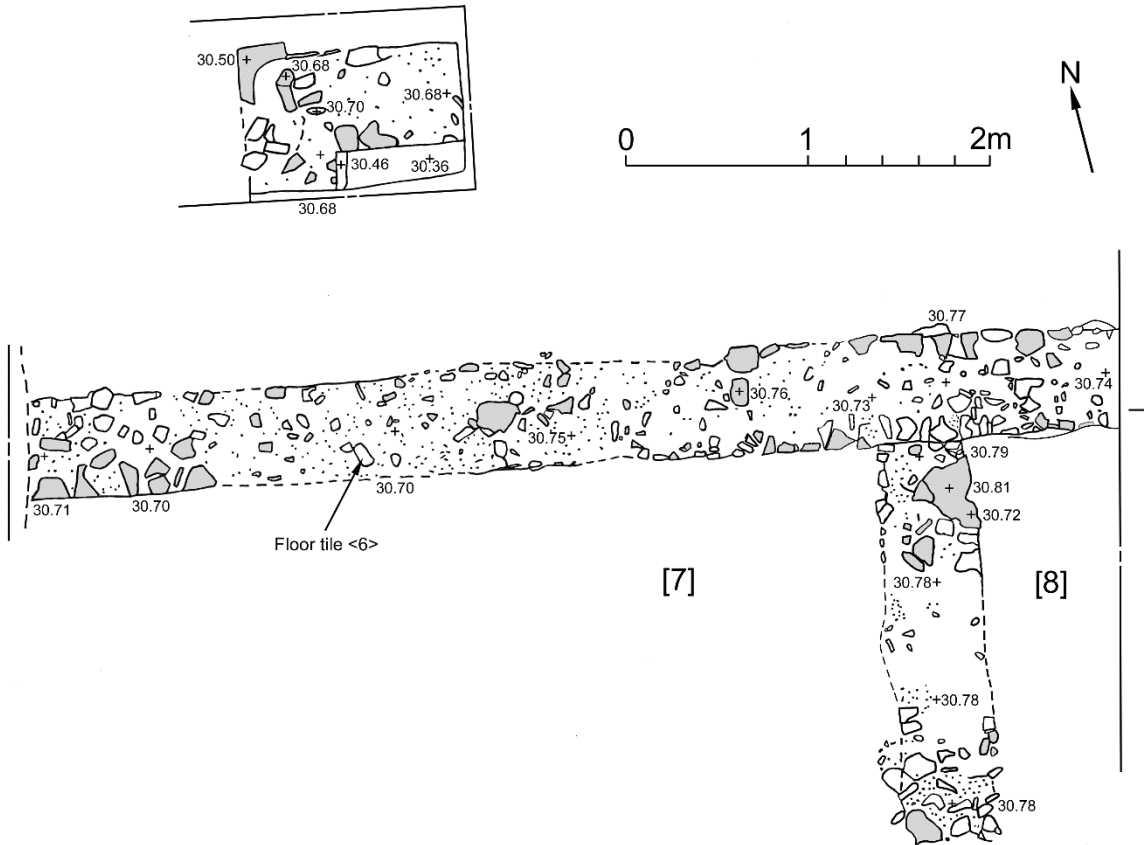
Figure 10. The top of foundation [5] in trench A (bottom) and trench B (top). The grey shaded areas are chalk.

The area to the south of foundation [5] was divided into two by a stub wall which projected from the main foundation. The area to the east of this, below layer [4] was occupied by [7] (figure 10).<sup>13</sup> This consisted of flints of mixed size and shape in a sparse matrix of hard dark brown earth. There was a little chalk and occasional flint knapping flakes probably from a wall. There was no ceramic building material. Layer [7] rested on layer [12] which was very similar and may have been the same deposit. This rested on natural gravel at about 30.52m OD.

There was a clear bonding break between the main foundation and the fourth projection (figures 10 and 19) but the others were integrated with the wall.

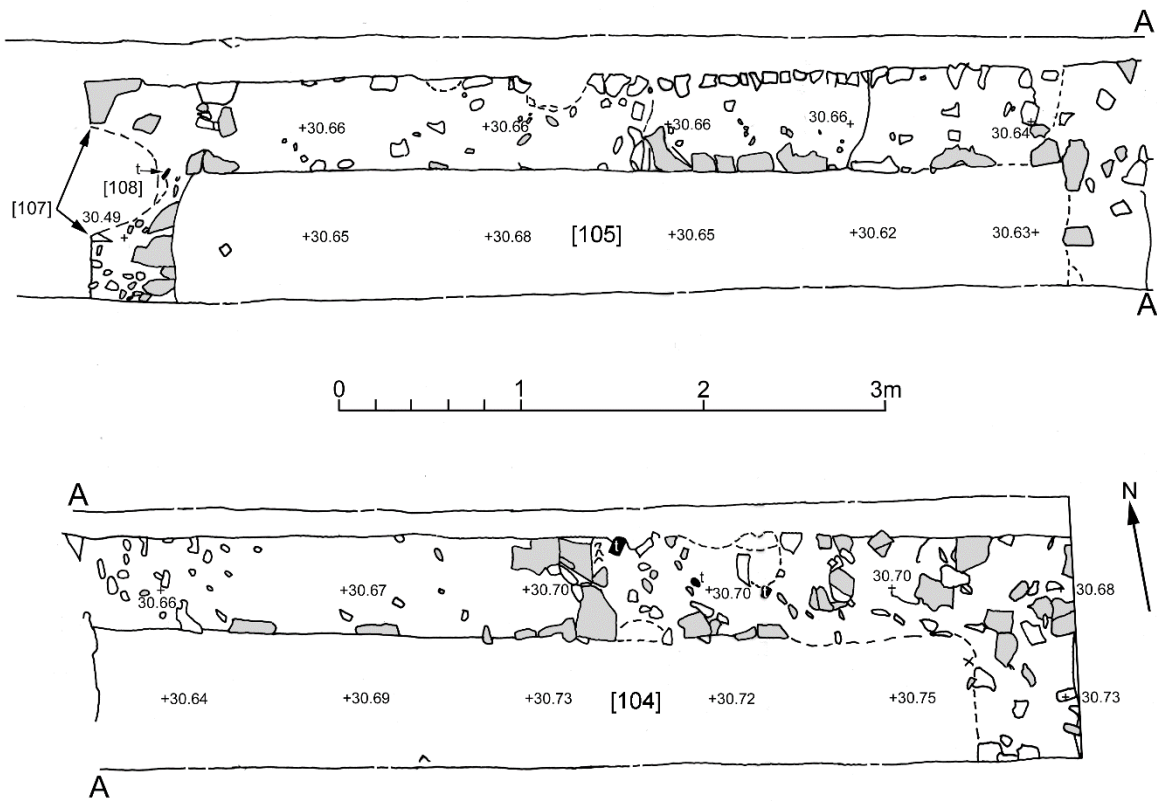
Figure 11. The tops of the foundation [5] in trench C. The grey shaded areas are chalk.

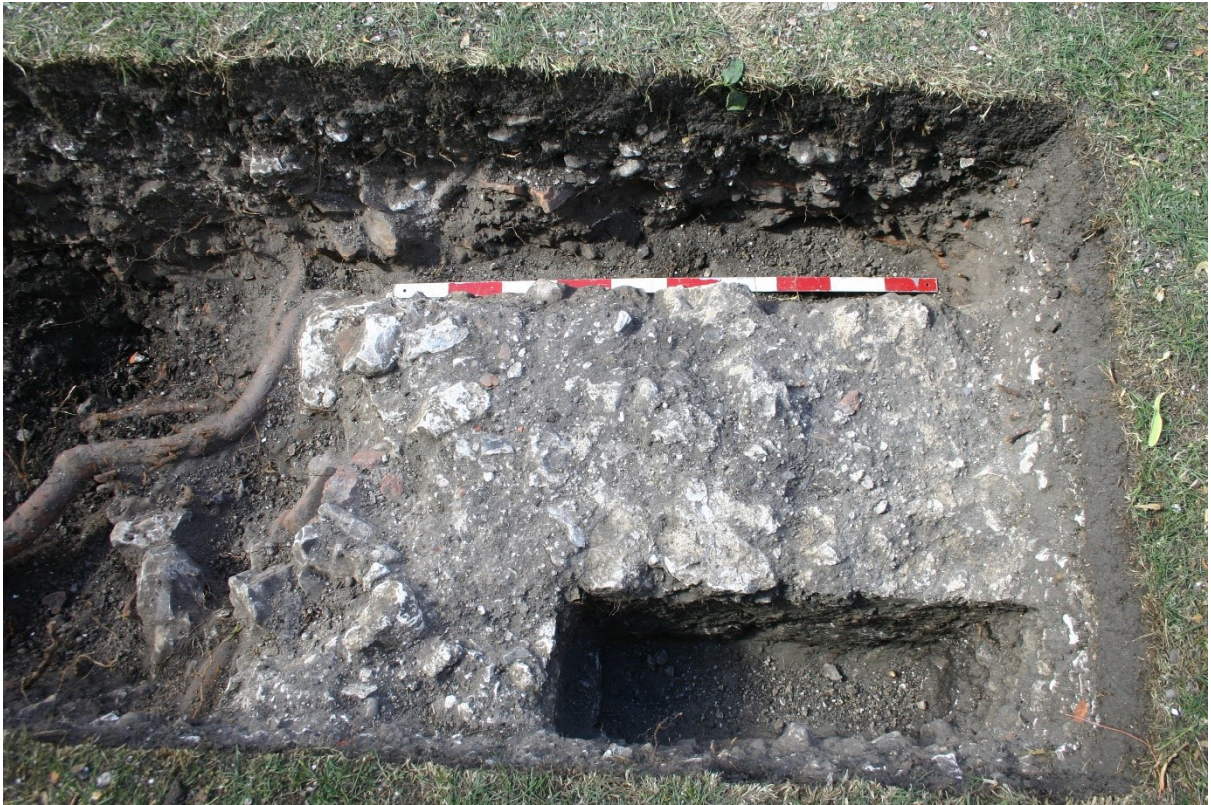
Figure 12. Trench B: the northwest corner of foundation [5]. North at the top.

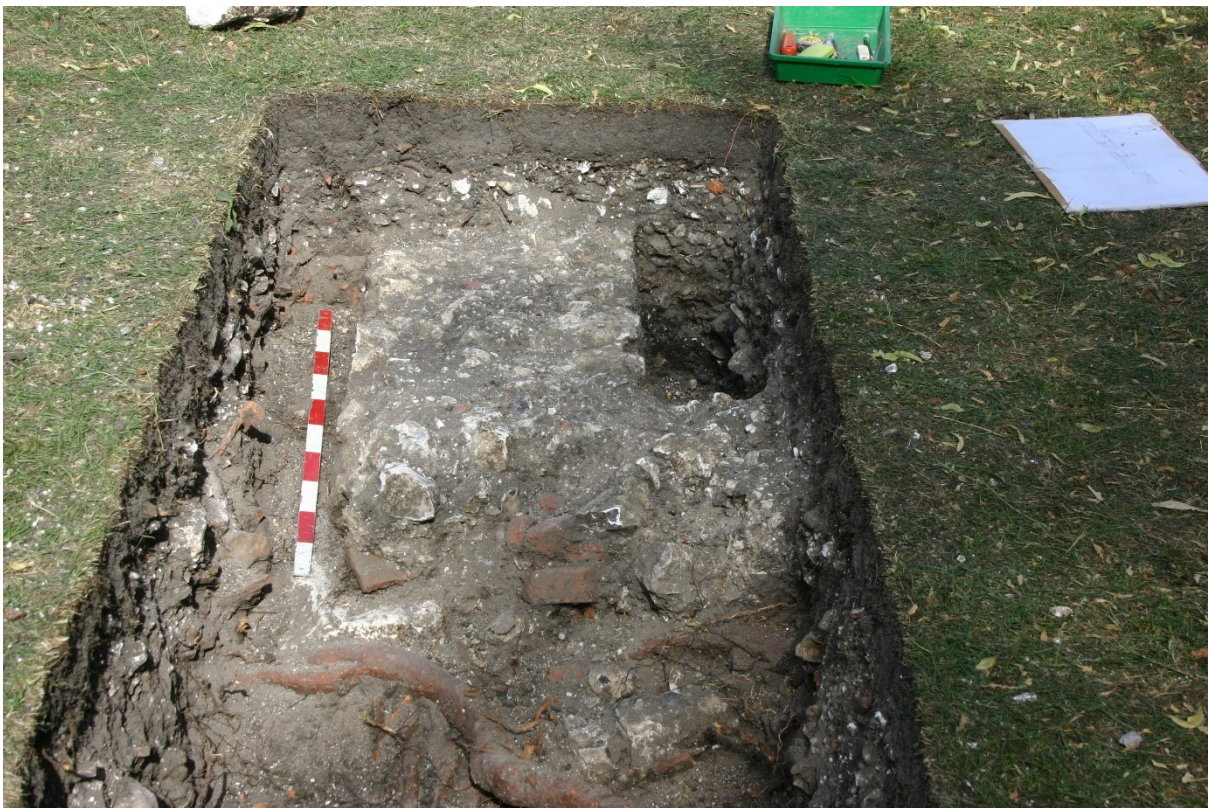
Figure 13. Trench B: the northwest corner of foundation [5] looking east.

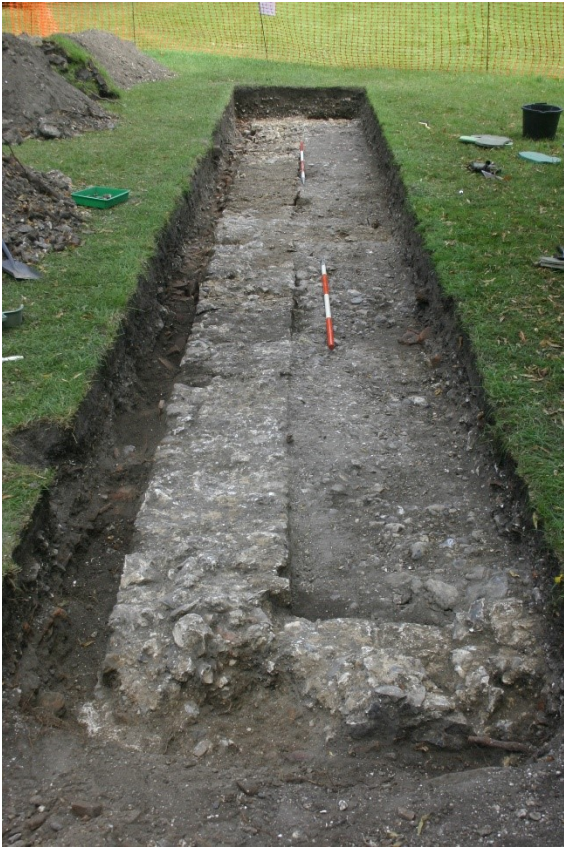
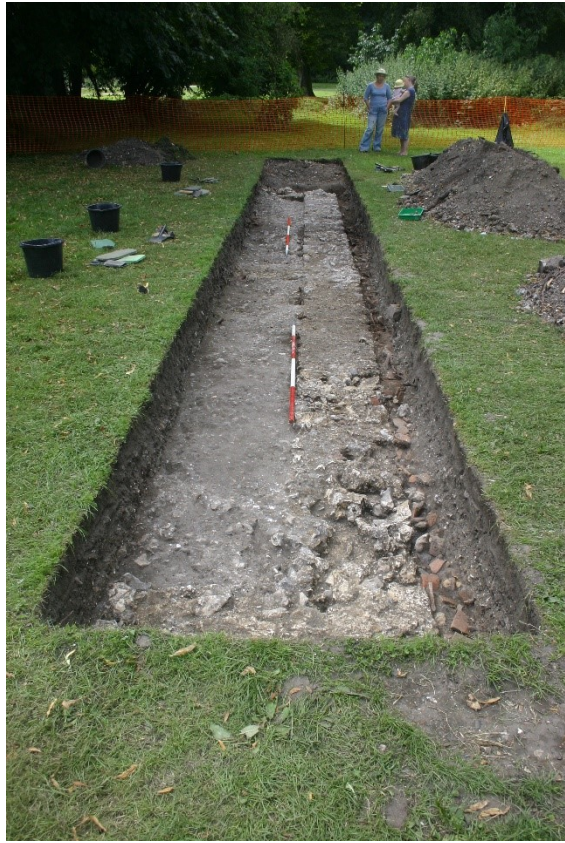
Figure 14. Trench C: foundation [5] looking east (left) and west (right).

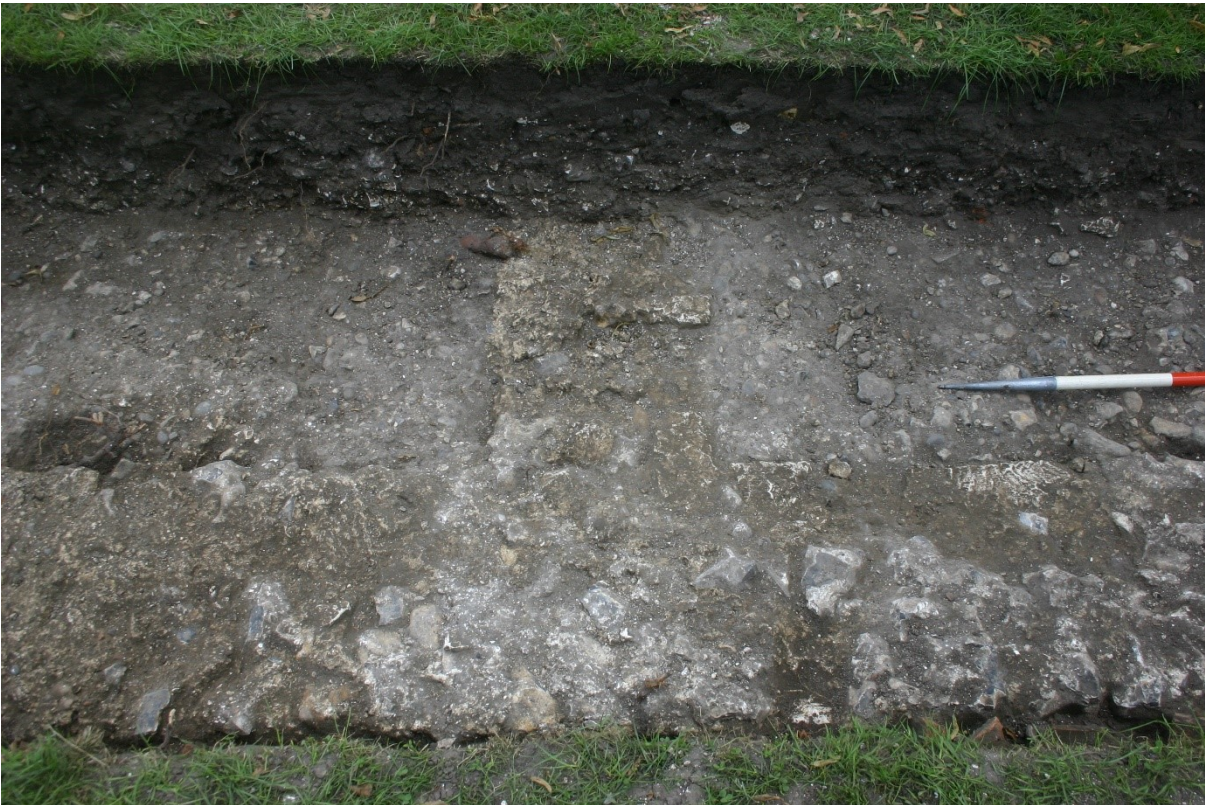
Figure 15. Trench C: foundation [5] with projection P2 looking south.

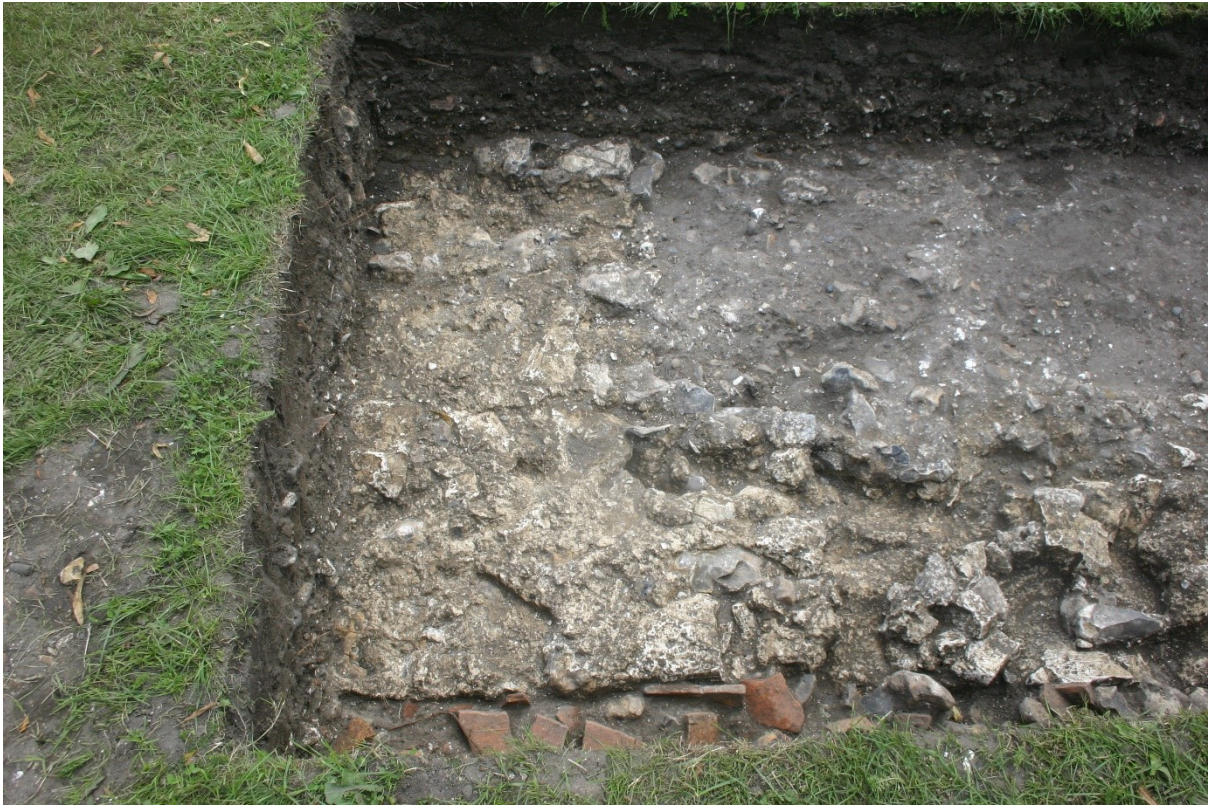
Figure 16. Trench C: foundation [5] with projection P3. South at the top.

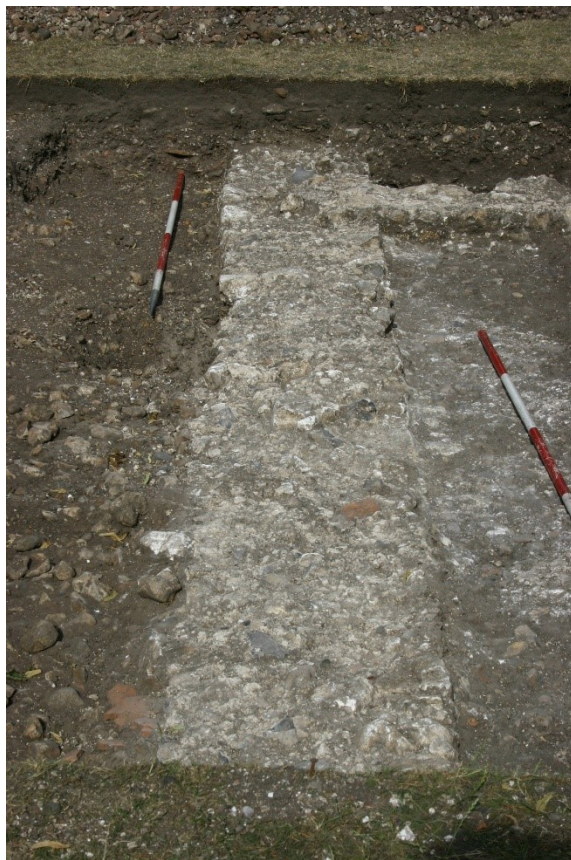
Figure 17. Trench A: foundation [5] looking east with projection P4 in the background.

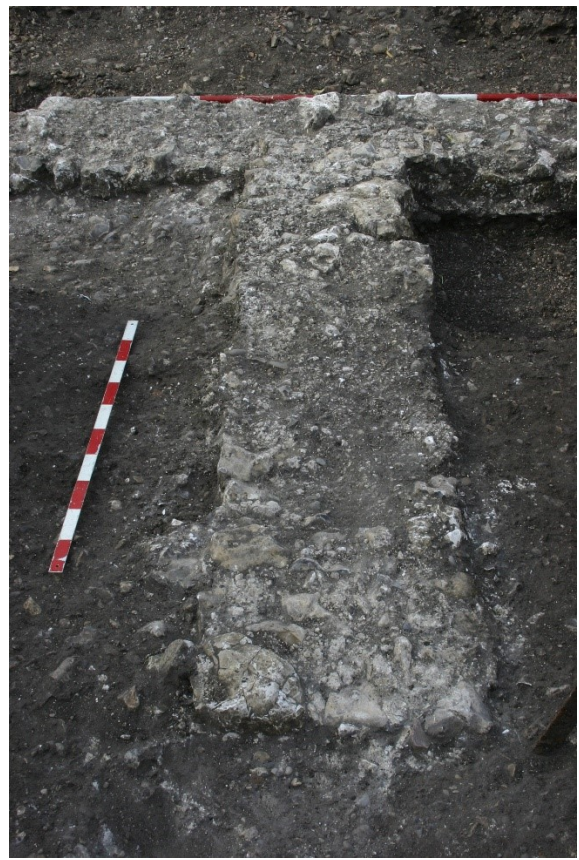
Figure 18. Trench A: foundation [5] and projection P4 looking north.

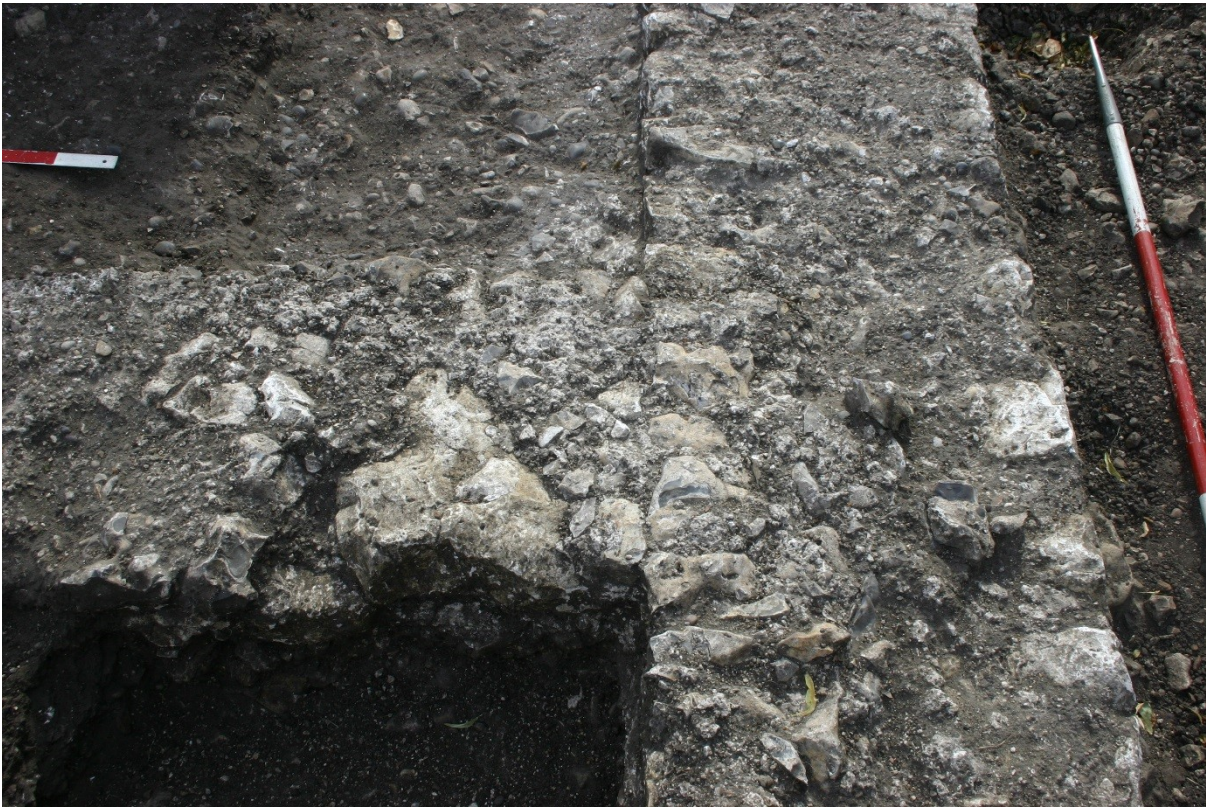
Figure 19. Trench A: the junction between the main wall of foundation [5] (right) and projection P4 (left).

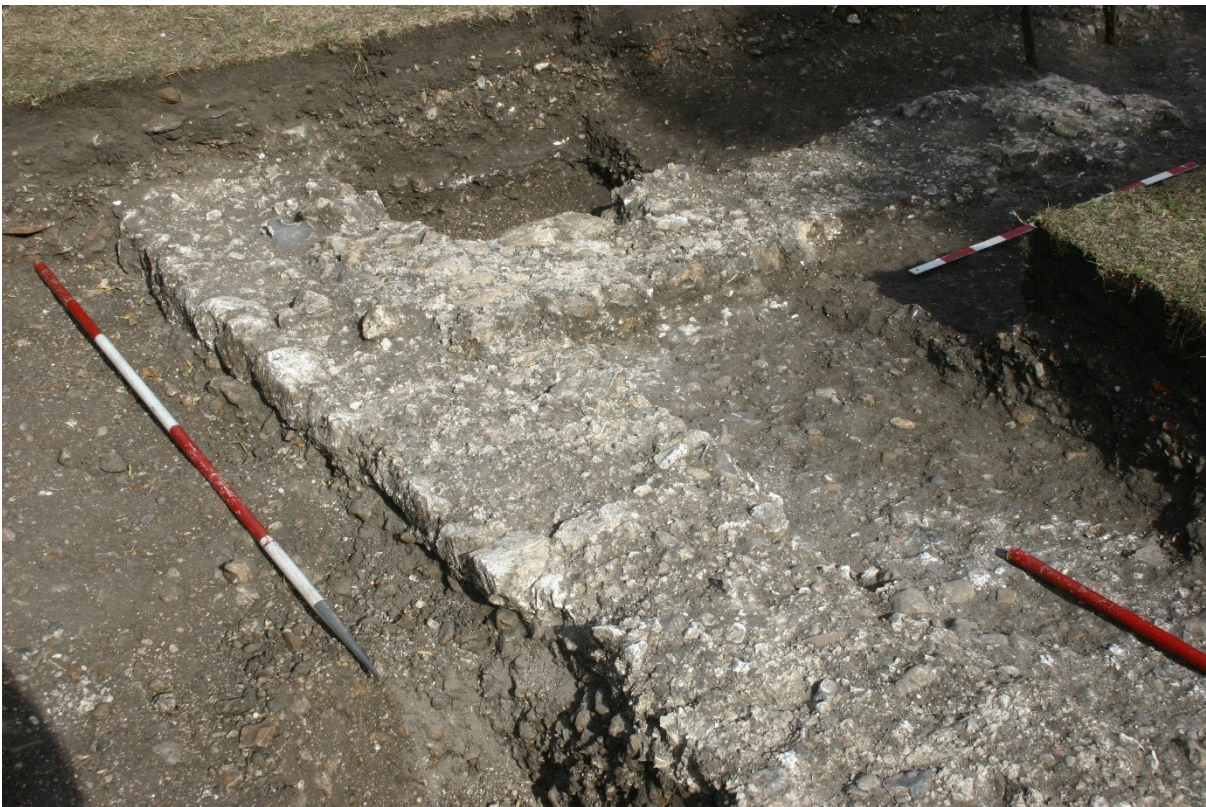
Figure 20. Trench A: foundation [5] with projection P4.

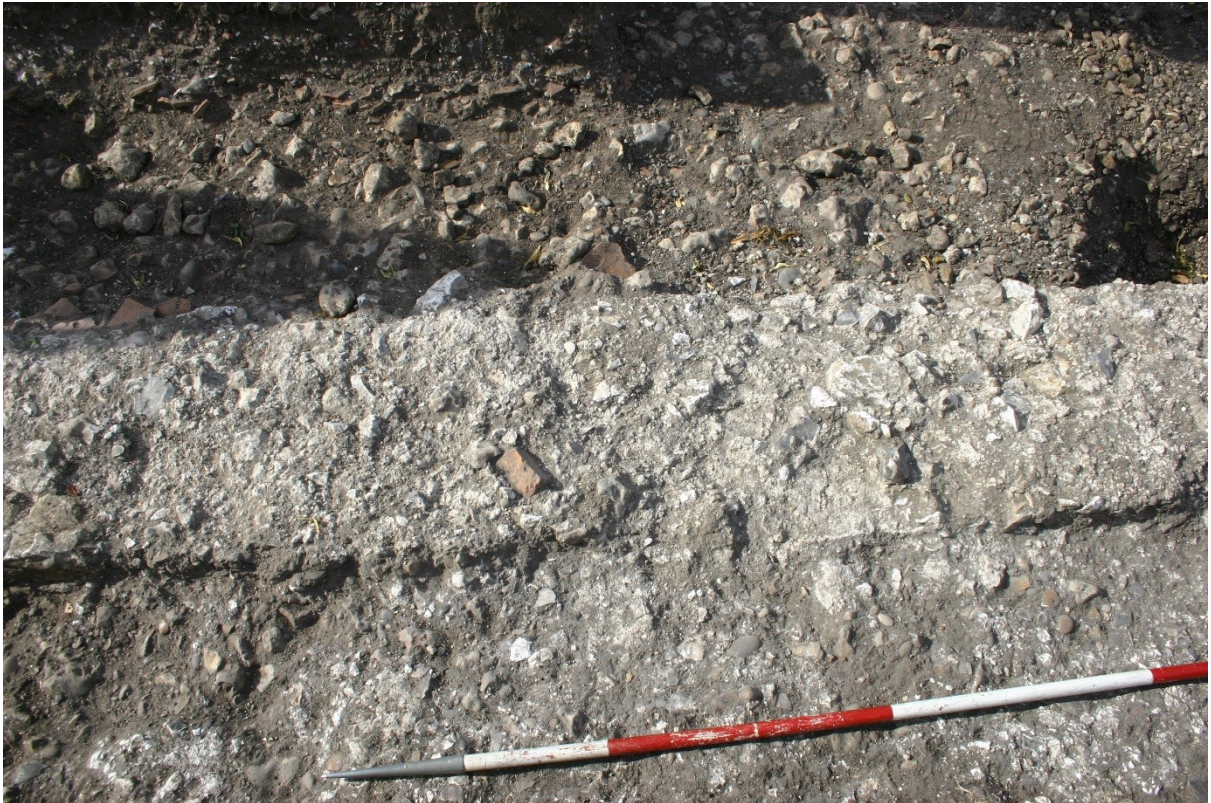
Figure 21. Trench A: paving brick <6> embedded in the top of foundation [5]. North at the top.

There was also a piece of red paving brick mortared into the top of the foundation in trench A. This was hard, 52mm thick, and looked more 18th century than Tudor.

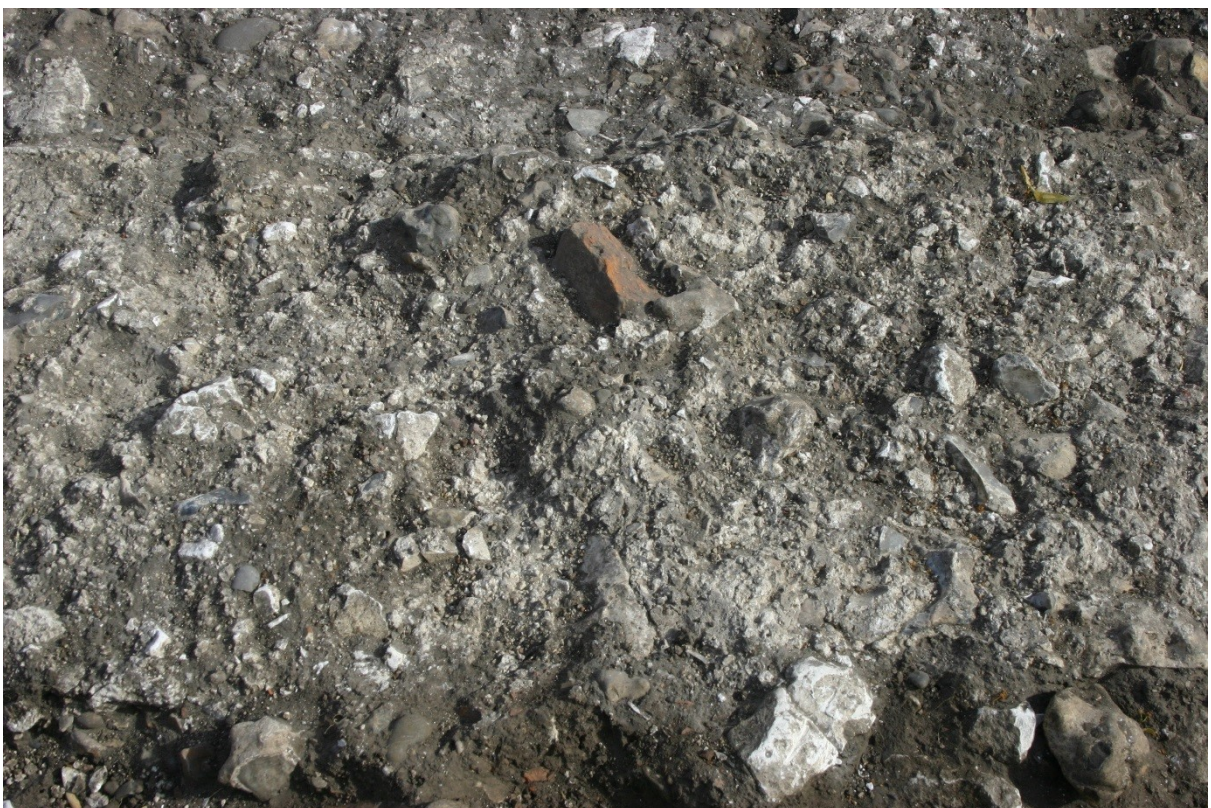
Figure 22. Trench A: detail of paving brick <6>.

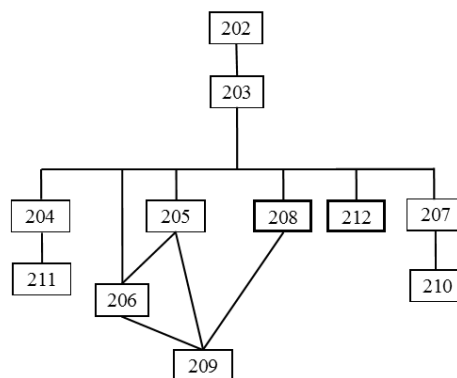
Figure 23. Matrix for trench D. Foundations in thick boxes.

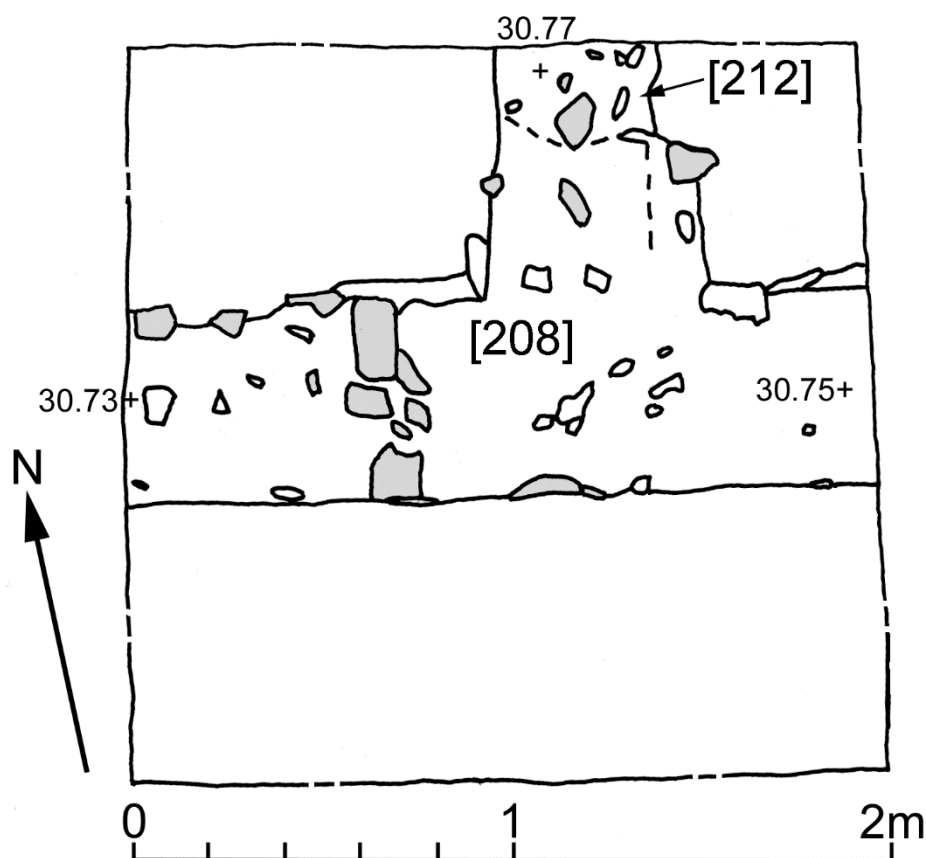
Figure 24. The foundations in trench D.

The removal of layer [203] exposed foundation [208] which ran more or less east-west across the trench with a northward-running projection as shown in figure 24 and described in section 3.6.

Foundation [208] ran roughly east-west across trench D with a northward-running projection. The southern part of the projection was similar to the east-west foundation and was bonded into it but the northern end of it was made with a different mortar and was treated as context [212] as shown on figure 24.

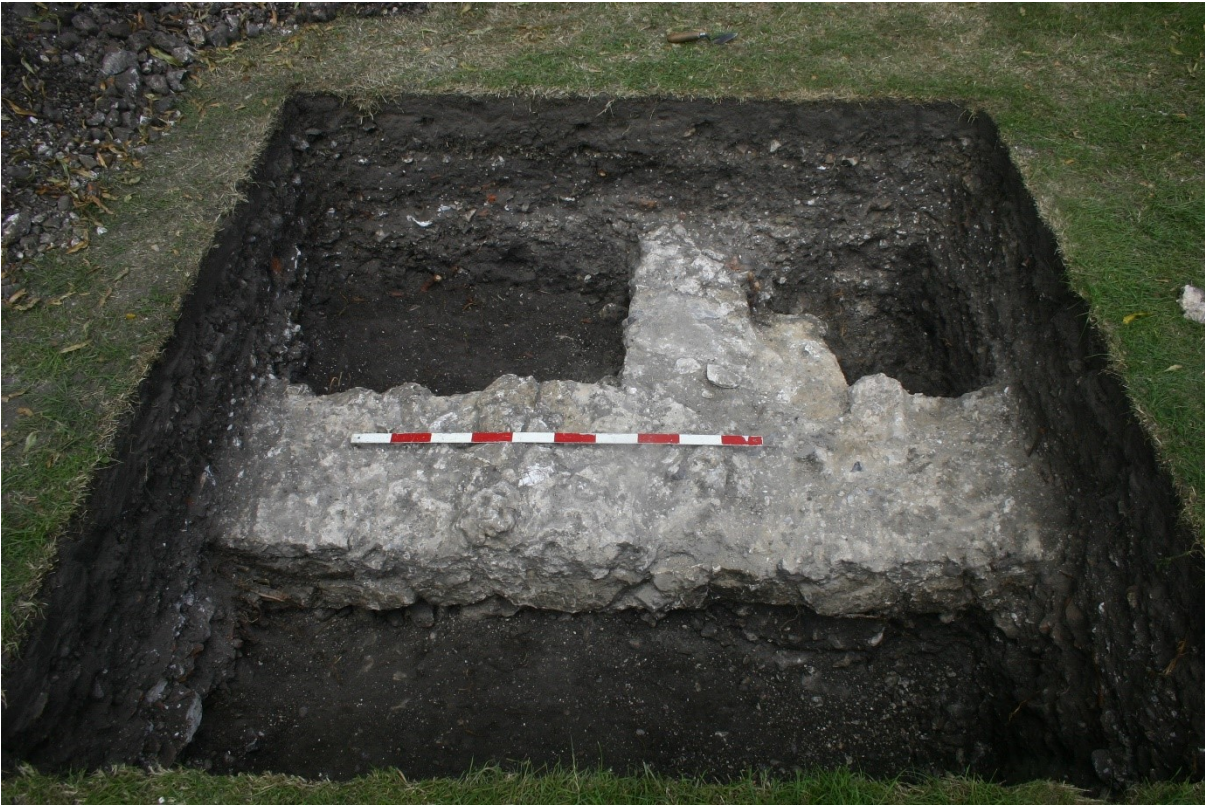
Figure 25. Trench D: foundation [208]. Looking north.

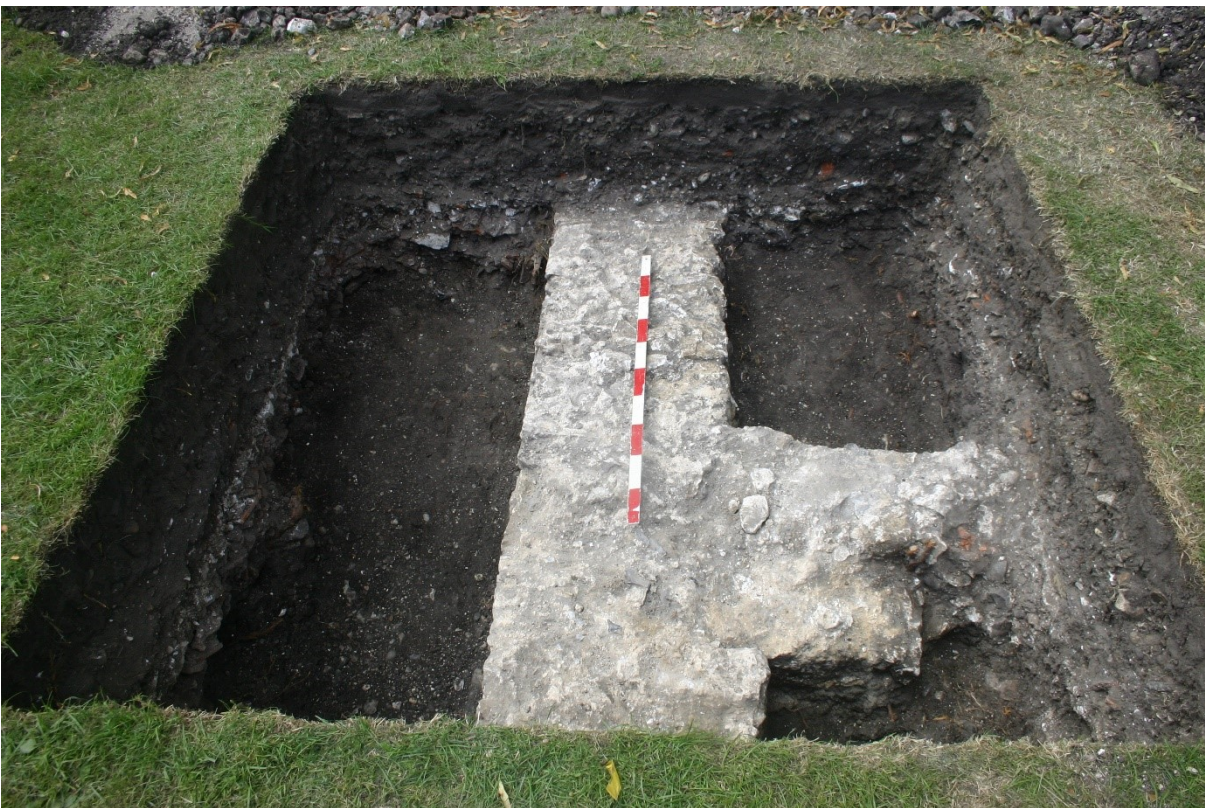
Figure 26. Trench D: foundation [208] in trench D with foundation [212] at the right hand or northern end of the projection. Looking west.
