**A former barn at Carew  
Manor, Beddington  
Excavations in 2015 and 2016**

Carshalton & District History & Archaeology Society  
Occasional Paper 12

Site code	BDD15
OASIS ID	Carshalt1-253494
Site address	B3eddington Park, Wallington, Surrey
Borough	Sutton
Grid ref	TQ 2950 6543
Organisation	Carshalton & District History & Archaeology Society
Excavation date	13-19 July 2015 and 1-9 August 2016
Revised	4 June 2018

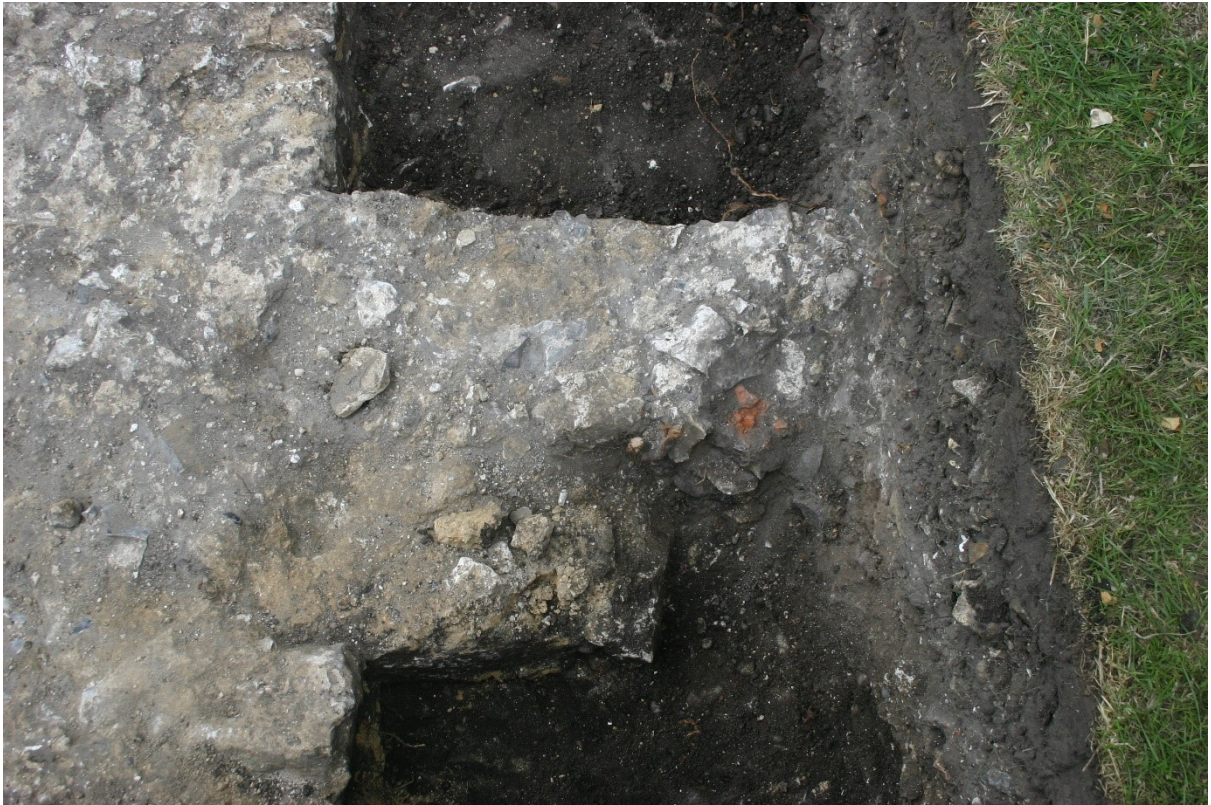
Figure 27. Trench D: the northward projection from foundation [208] with foundation [212] at the right-hand end. West at the top.

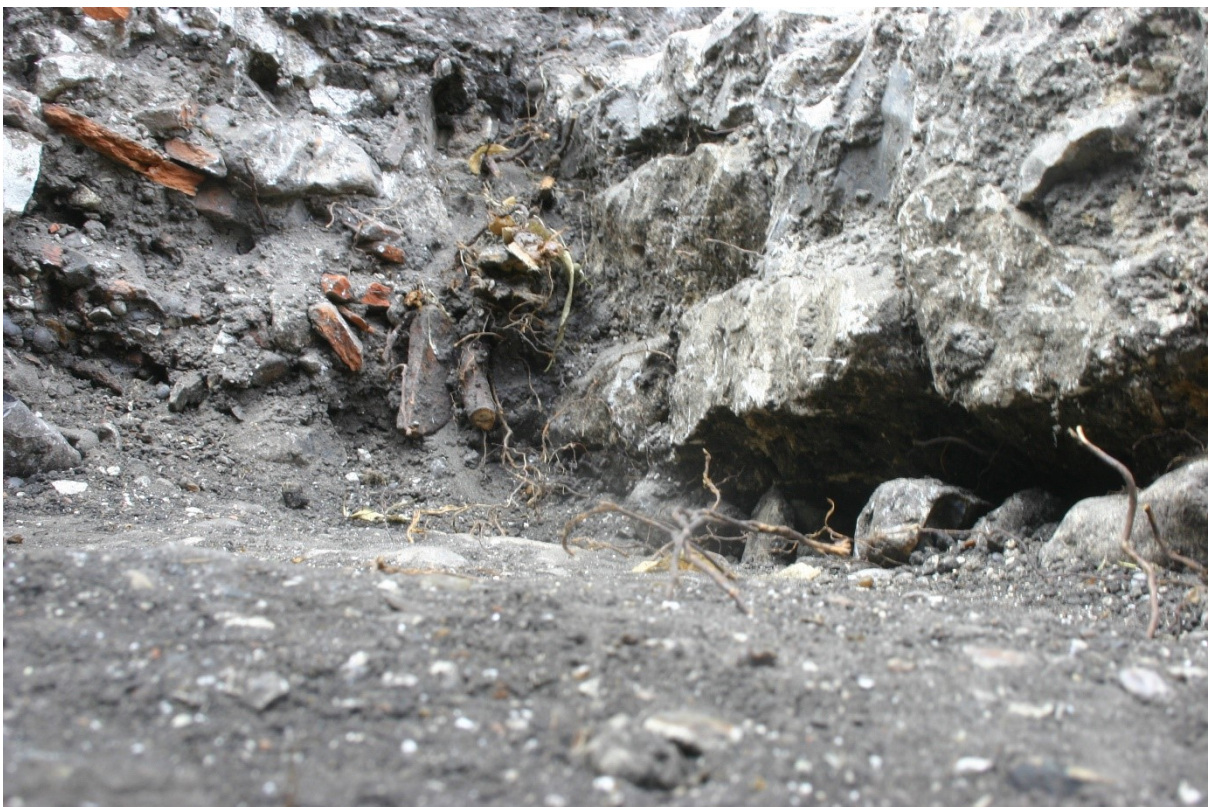
Figure 28. Trench D: the south side of foundation [208] looking west.

The base of [208] was exposed on the south side where it appeared that a trench had been dug to the width of the foundation. Large flints had been rammed into the bottom of this. A layer of mortar had been placed on top and then the first course of roughly-faced chalk blocks with struck flints in the gaps between them.
