# **The Oaks Park Mansion House**

## **Report on an excavation in July 2009**

| Organisation | Carshalton & District History & Archaeology Society |

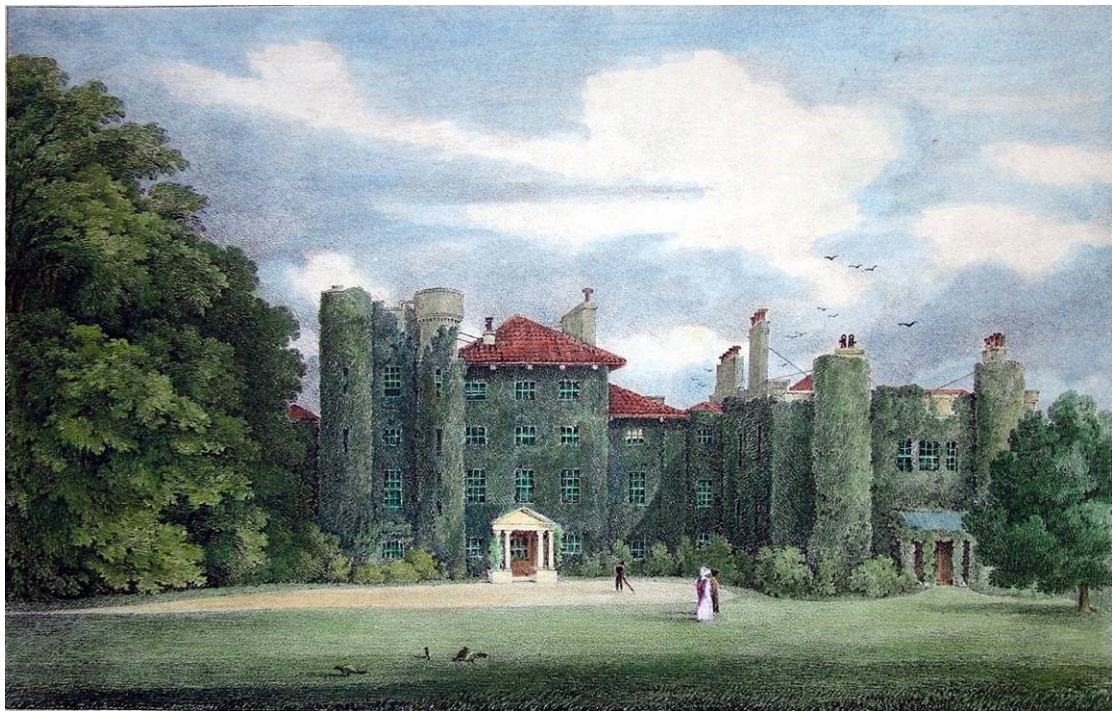
Figure 2. The south front of the house from Prosser's *Select illustrations in the County of Surrey*, 1828.

curious mixture of classical villa and gothick 'castle' shown in early nineteenth century prints (figures 1, 2 and 3).<sup>9</sup>

Prosser's view of 1828 shows a red pan tile roof (figure 2) but it is a print to which water colour has been added, possibly long after it was made. It is not, therefore, a reliable guide to the colour of the roof which, at some point, seems to have been black rather than red. It is not clear if this was Taylor's work for Burgoyne, Adam's work for Derby or a later repair. However, a significant number of tiles remained when the house was demolished.

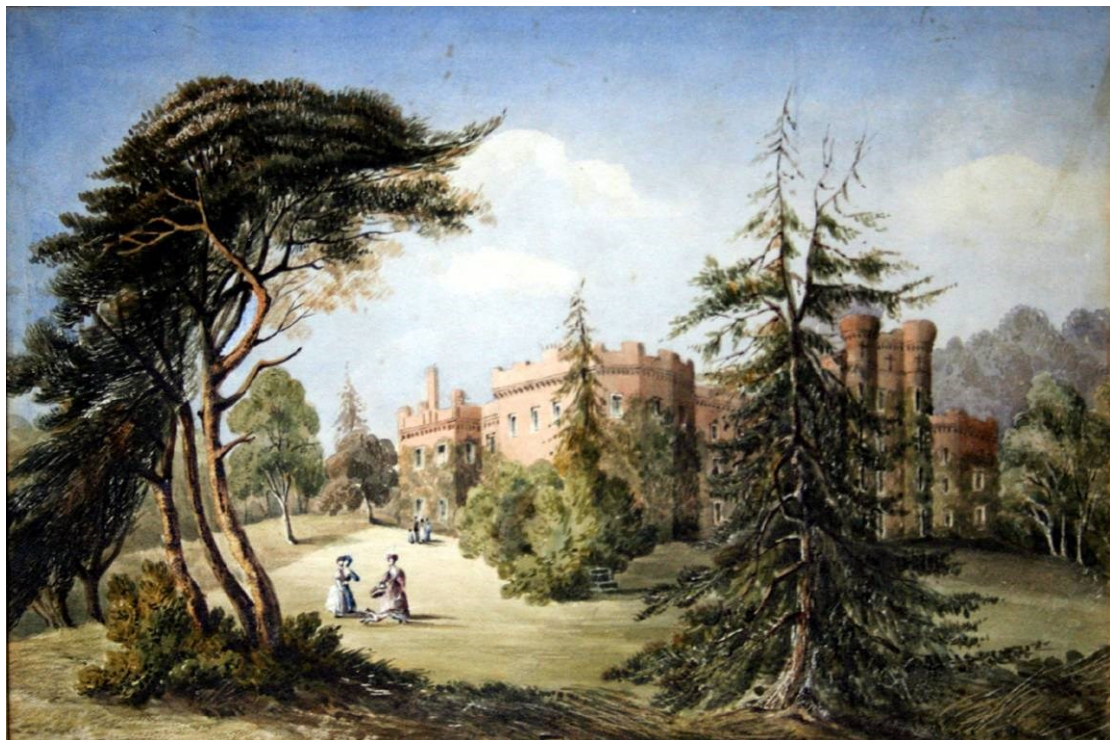
Figure 4. The Oaks from the north east. Sutton Museum Collection CA.454.

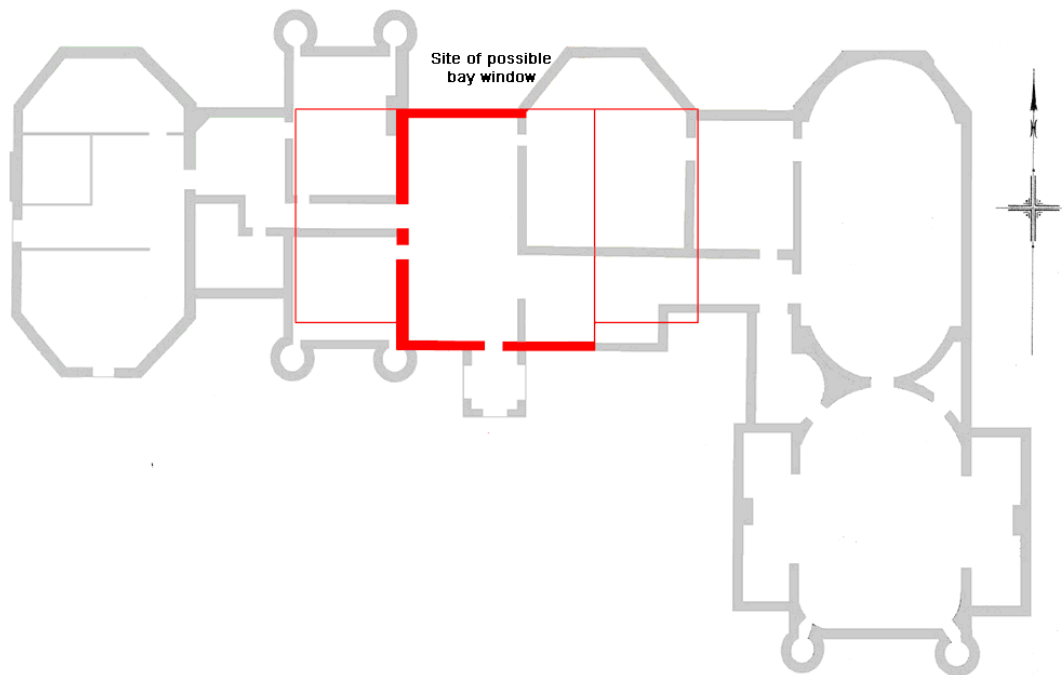
Figure 5. The footprint of the mid-18<sup>th</sup> century building extrapolated from the early views of the west front. The walls marked in heavy red still existed in 1876 although they may have been rebuilt. The outline of the two wings was more uncertain as their widths were estimated from the prints. When the excavation was planned we did not know if the north side of the wings was aligned with the central block or whether there was a large central bay on the north side. The subsequent discovery of two watercolours of the front and back of the house by John Collet showed that there was a large central bay on the north side.<sup>26</sup>

One of the objectives of the excavation was to test a model of the development of the building and the dates of the various sections of foundation as here described. The plan of the building is based on the map in the 1876 sales particulars. This postdates the mid-19<sup>th</sup> century changes made by Joseph Smith but predates the alterations by Harry Berkeley James around 1890. It is the only plan known at the time of the excavation.<sup>25</sup>

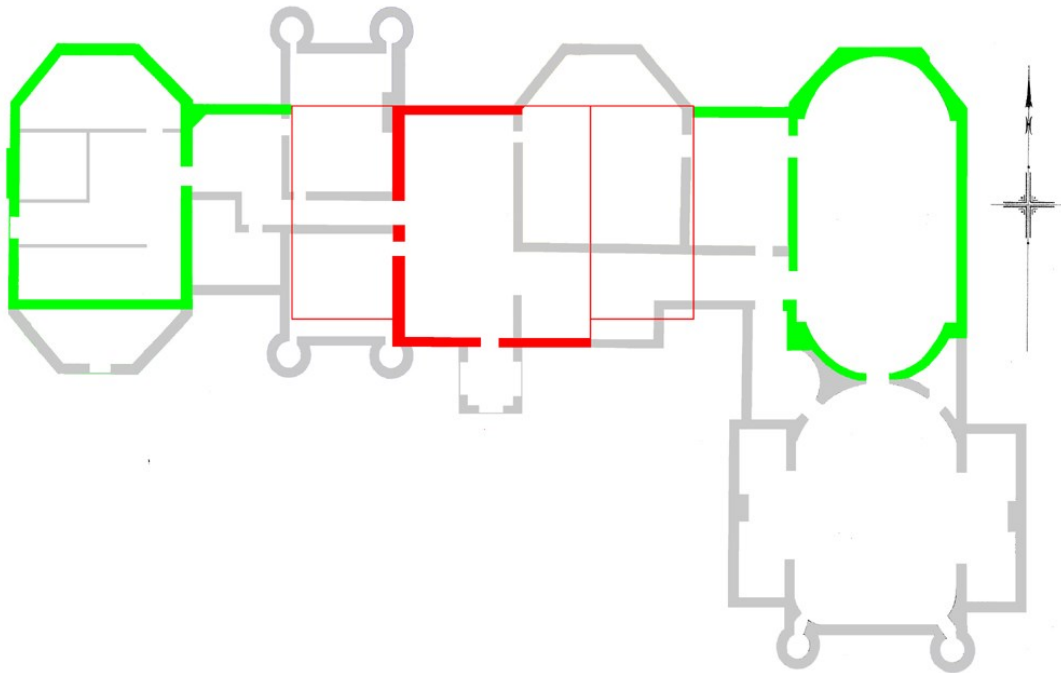
Figure 6. The pavilions and link corridor added by John Burgoyne around 1764. The east pavilion contained Burgoyne's dining room which has been attributed to Sir Robert Taylor on stylistic grounds. The south end of it was probably three sided rather than curved. The Adam drawings suggest that the west pavilion had a straight south wall despite the lack of symmetry.

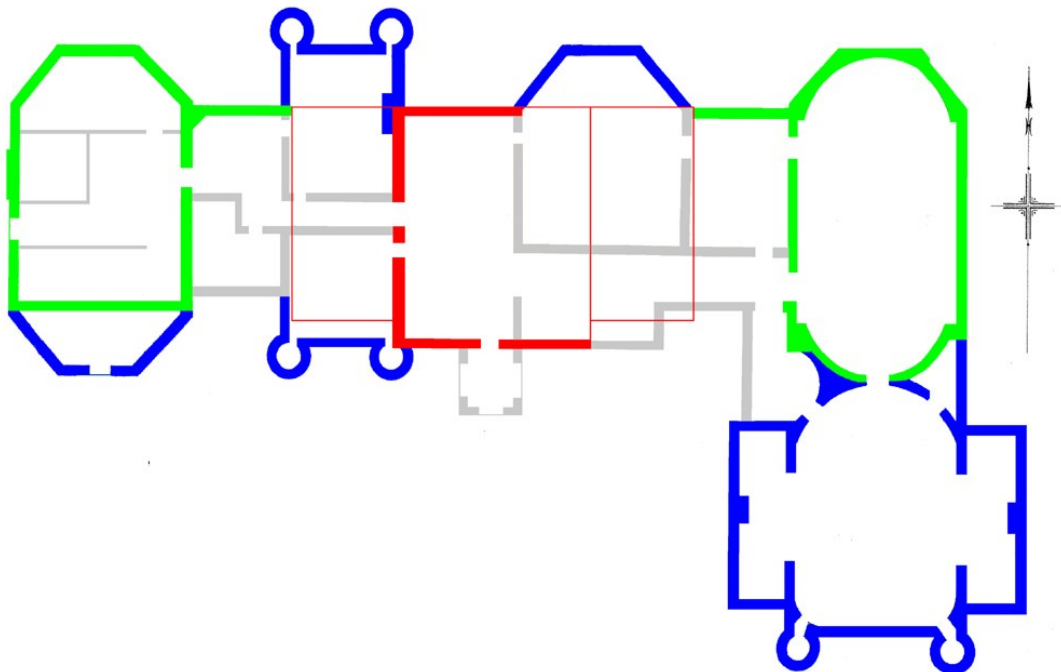
Figure 7. The Adam additions for the Earl of Derby (blue). This includes the castellations, the three sided addition to the west wing and the drawing room at the end of the south wing. The bay on the north front is also likely to be Adam's work as it appears on a print published in 1808 showing house from the east (figure 1). The grey walls are either Victorian or are of uncertain date.

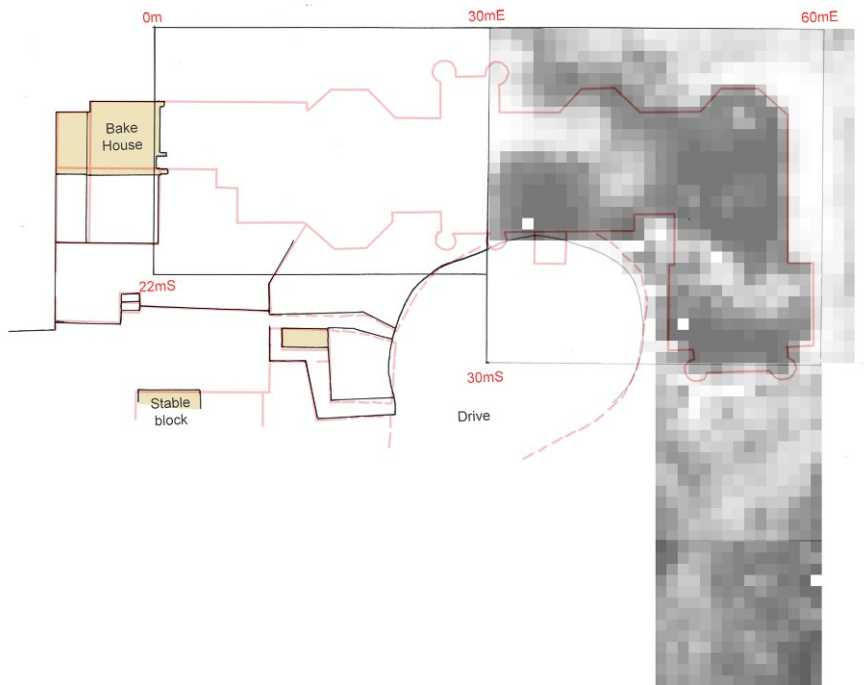
Figure 10. Site plan with the resistivity survey on the outline of the house from the 1955 Ordnance Survey map (in red).

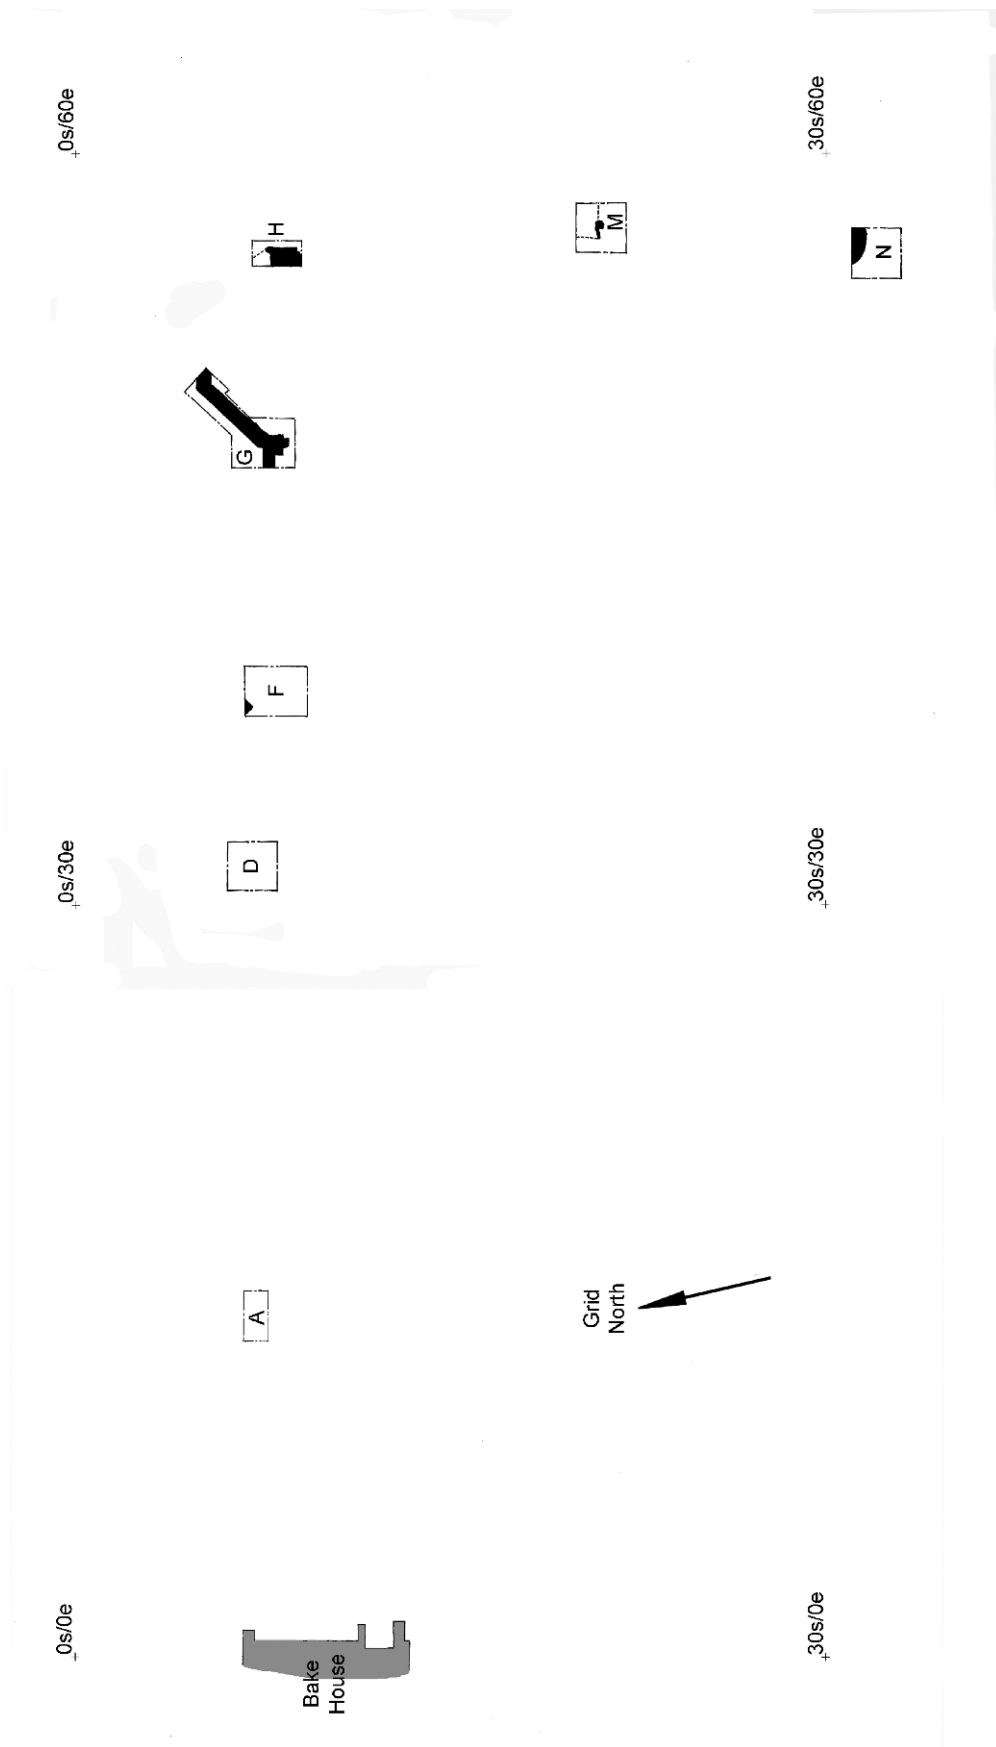
Figure 12. The trenches in relation to the site grid and the Bakehouse.

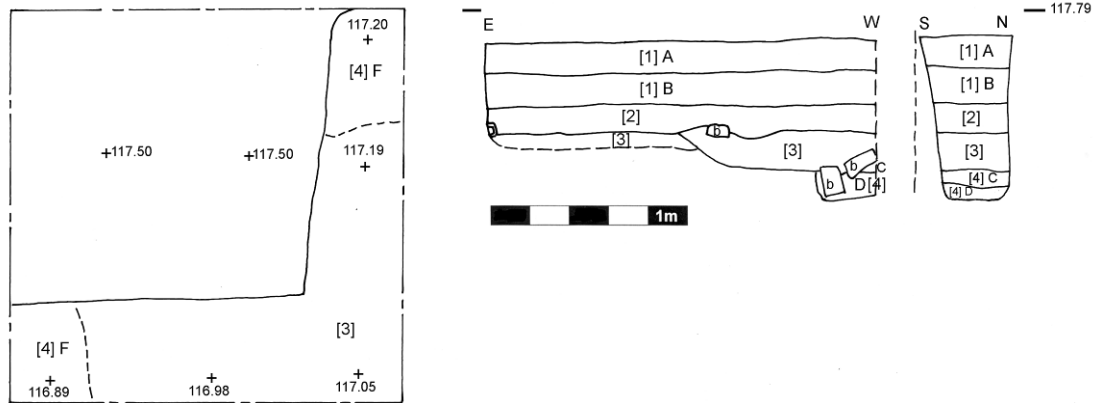
Figure 13. Plan of trench D with the south and west sections. [1] A topsoil; [1] B yellow / brown sandy silt; [2] brown silt with 50% small chalk with occasional small stones, flints mortar and tarmac; [3] dark brown silty soil; [4] D similar to [3]; [4] F loose brick rubble; b = brick.

Trench D was 2 m square and was designed to investigate the northwest corner of the original building and its junction with Adam's additions. It was excavated to a depth of about 0.1 m without encountering any foundations. The excavation was then confined to two sections along the east and south sides of the trench.

Layer [D2] rested on [D3] which consisted of brown silty soil with brick rubble and some chalk and flint. The deposits underlying this were only excavated in small areas in the southwest and north east corners. These areas contained a great deal of brick rubble and some dark brown silty soil but at the southwest corner of the trench they were underlain by a deposit which was essentially the same as [D3]. It is therefore unclear whether the deposits were really a separate context. The presence of tarmac

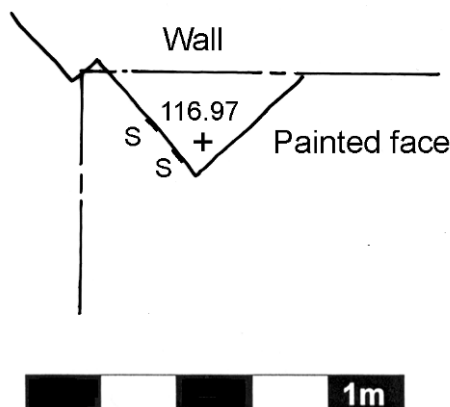
Figure 14. The northwest corner of trench F. S = staple in the brickwork.

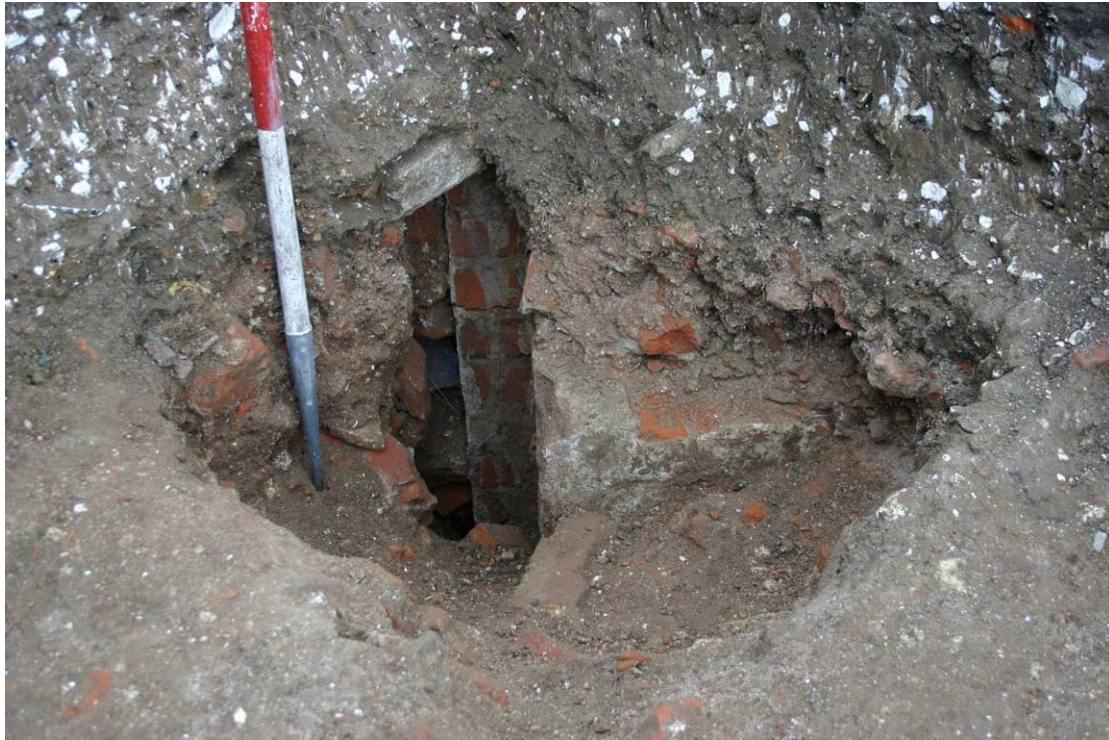
Figure 15. The northwest corner of trench F looking northwest showing the window reveal.

A white stone slab rested on the top of the window opening (figure 15) although it may not have been part of the original structure. The window reveal continued downwards for at least 0.75 m but there were at least three courses of brick below this and bottom was not seen. The deepest point reached was at 116.35 m OD. The sides of the opening were plastered but not the side of the projection which faced the trench.

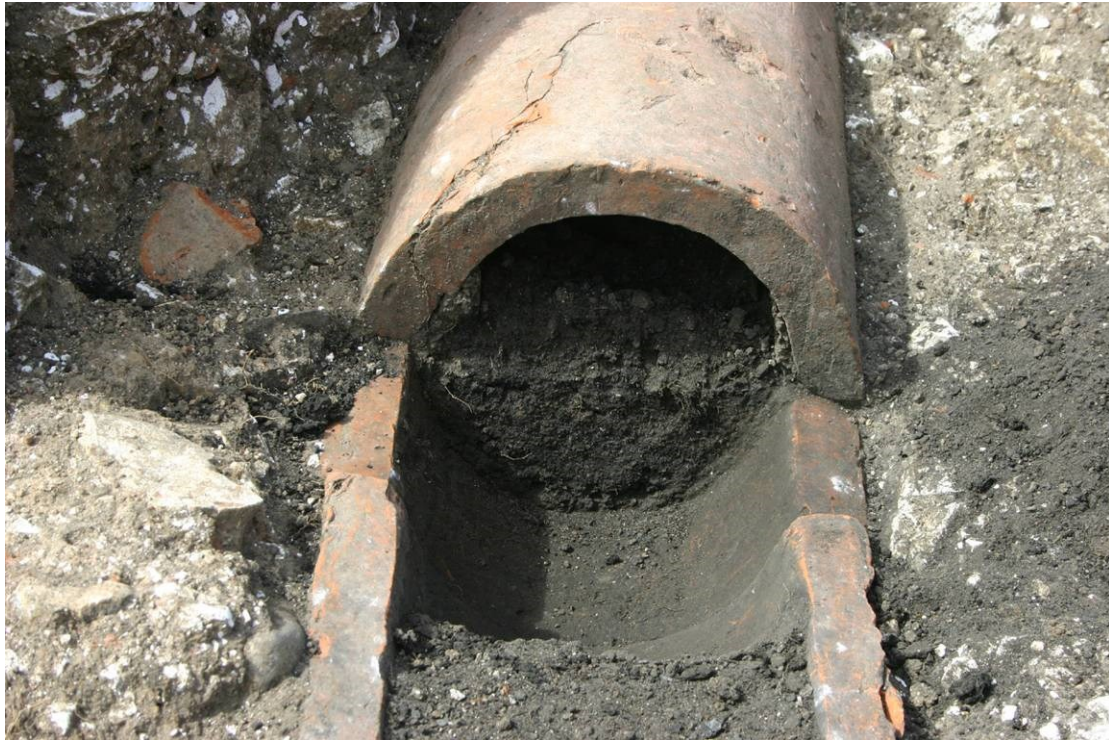
Figure 17. Drain [G6] with silt fill [G7].

A ceramic drain [G6] ran northwest from the corner formed by the west side of the bay and the north wall of the house. It was made of semicircular red clay tiles placed together to form a circular pipe (figure 17). The tiles were about 28 mm thick. The pipe had an internal diameter of 190 mm and an external diameter of 267 mm. The bottom of the inside was at 116.92 m OD. The pipe was filled with fine soft dark brown to black silt with a few tiny scraps of chalk and ceramic building materials [G7].

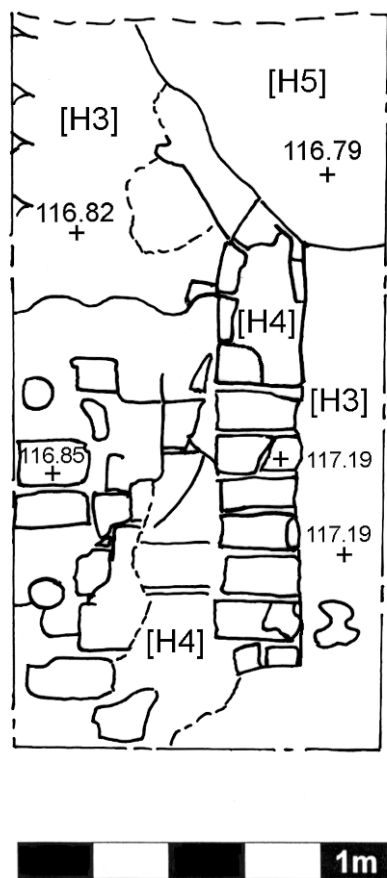
Figure 18. Trench H.

Foundation [H4] was of soft red brick and mortar (figure 18). The top of the east side was formed by a course of headers which suggests that it had been laid in English bond although this was not certain as no lower courses were exposed. At the northern end the east face of the wall turned 48 degrees which was clearly the beginning of the bay at the northeast corner of the house. The wall was at least 0.74 m thick.

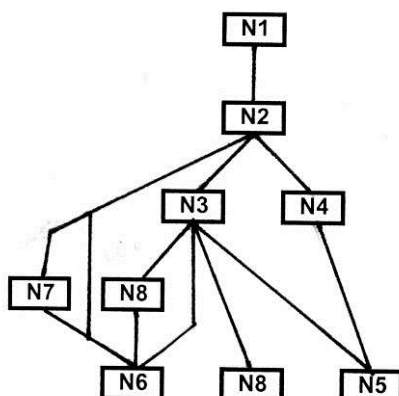
Figure 20. Matrix for trench N.

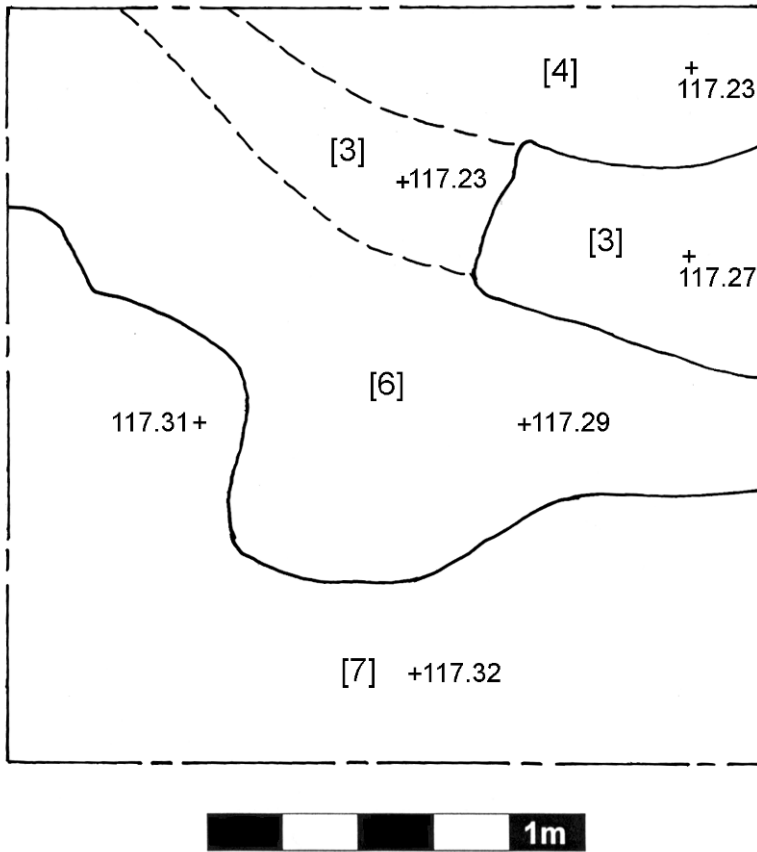
Figure 21. Plan of the trench after the removal of layer [N2].

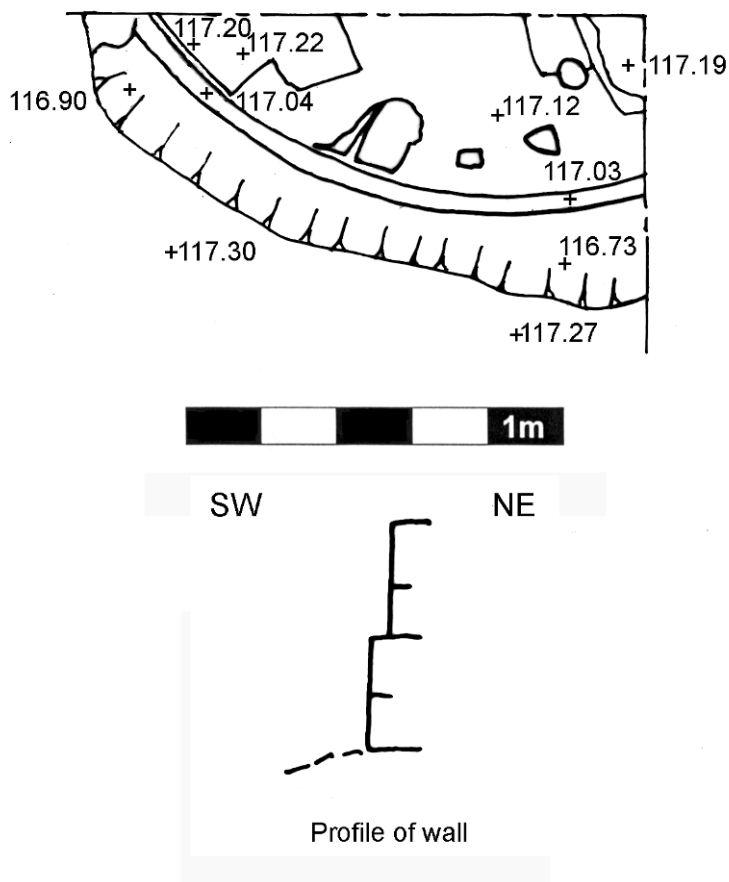
Figure 22. Plan of the turret foundation [N5] and the construction cut [N8] with a profile of the turret wall at the west end of the structure. The plan and scale are at 1:20. The profile is 1:10.

The foundation [N5] consisted of at least four courses of sift red brick and mortar (figure 22). The outer face was headers and there was an off set at the bottom of the second course. The highest point was at 117.20 m OD. It was in the correct position to be the foundation of the circular turret at the south eastern corner of the house. Its diameter was estimated by the chord and offset method which gave a result of 2.19 m plus or minus 0.13 m.

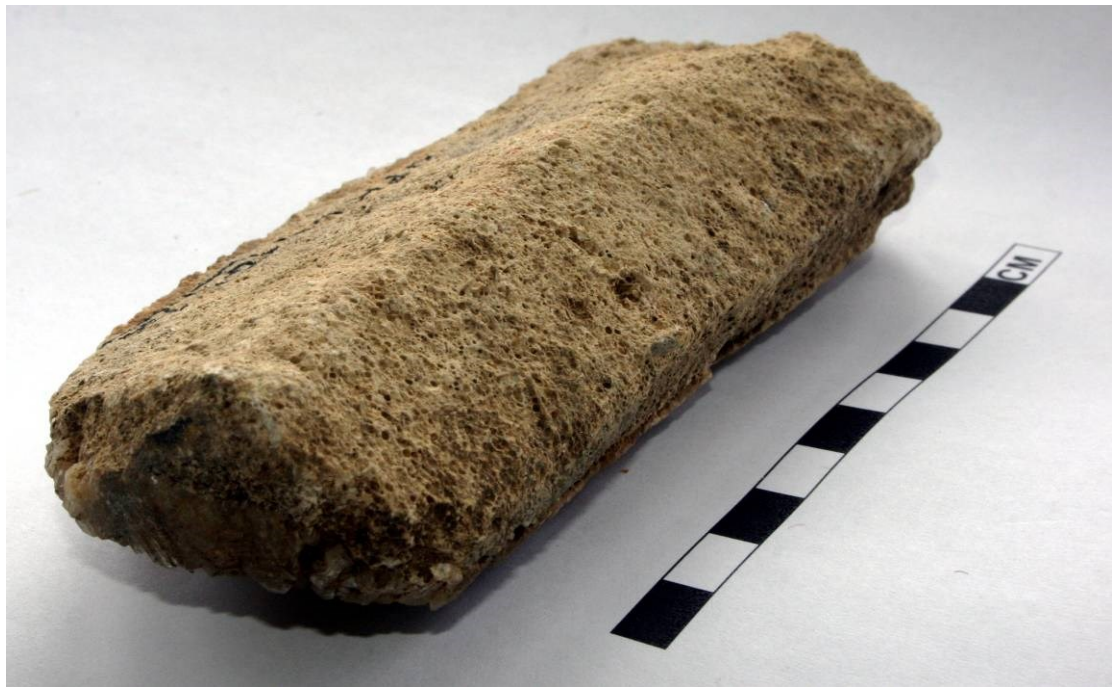
Figure 24. Find <5> from context [G1].

<5> Oolitic limestone. One side squared then turning through 45 degrees. The other side covered with calcite crystals (figure 24). Possibly part of an ornamental cabinet. Surviving length 125.
