# ASPLEY HOUSE FARM BARN.

Level 2 Building Recording and Watching Brief

July 2017

**PROJECT:** Aspley House Farm Barn, Aspley Lane, Slindon, Staffordshire

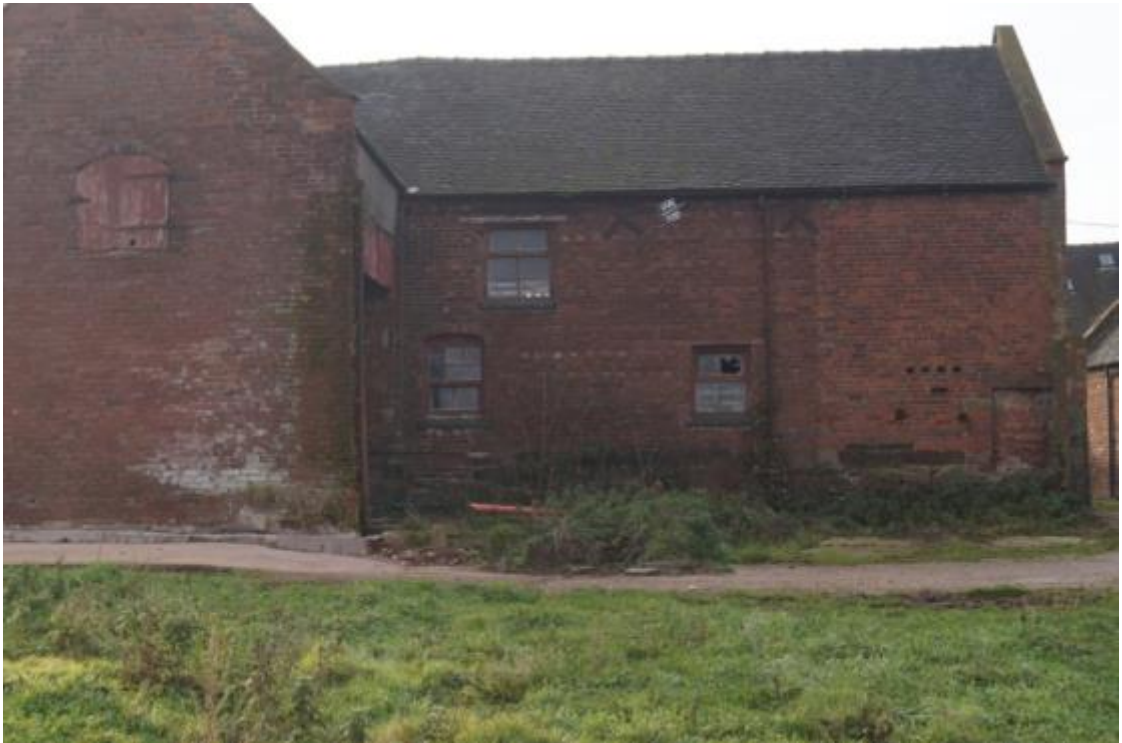
1. North elevation of Range 2, the western end of the range showing phases of patching and blocking. The sandstone foundation is clearly visible. A blocked opening at the western end of the range along with a piece of truncated walling and the lighter coloured bricks on this end of the range suggest the presence of an earlier structure against the north elevation. This is most likely the remains of the small annexe depicted on the 1838 Tithe Map (Figure 3).

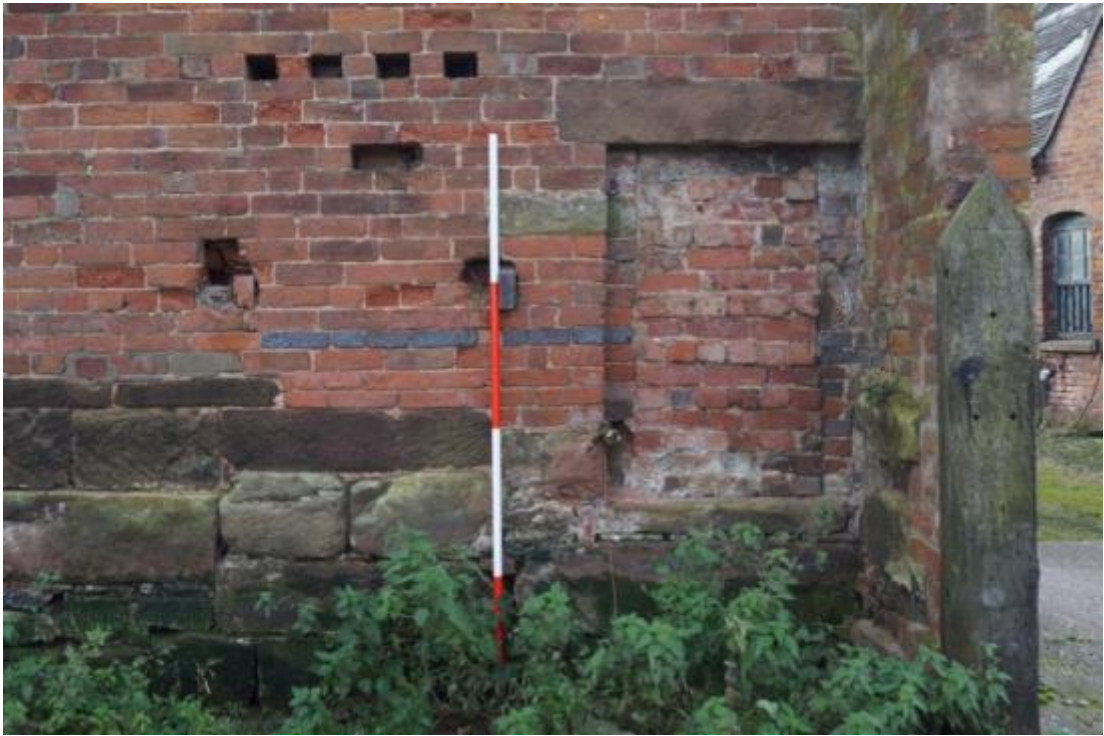
2. Detail of blocked opening, truncated wall and sandstone foundation blocks. The brickwork is patchy and irregular suggesting different phases of activity. Tooling marks are clearly visible on the sandstone blocks. The apertures in the brickwork may be slots for beams and indicate the presence of some kind of structure.

*From 1960 to 2000 there was a fuel tank here to supply the stationery Ford tractor engine that powered the grain dryer in the open sided 'Drift House'.*

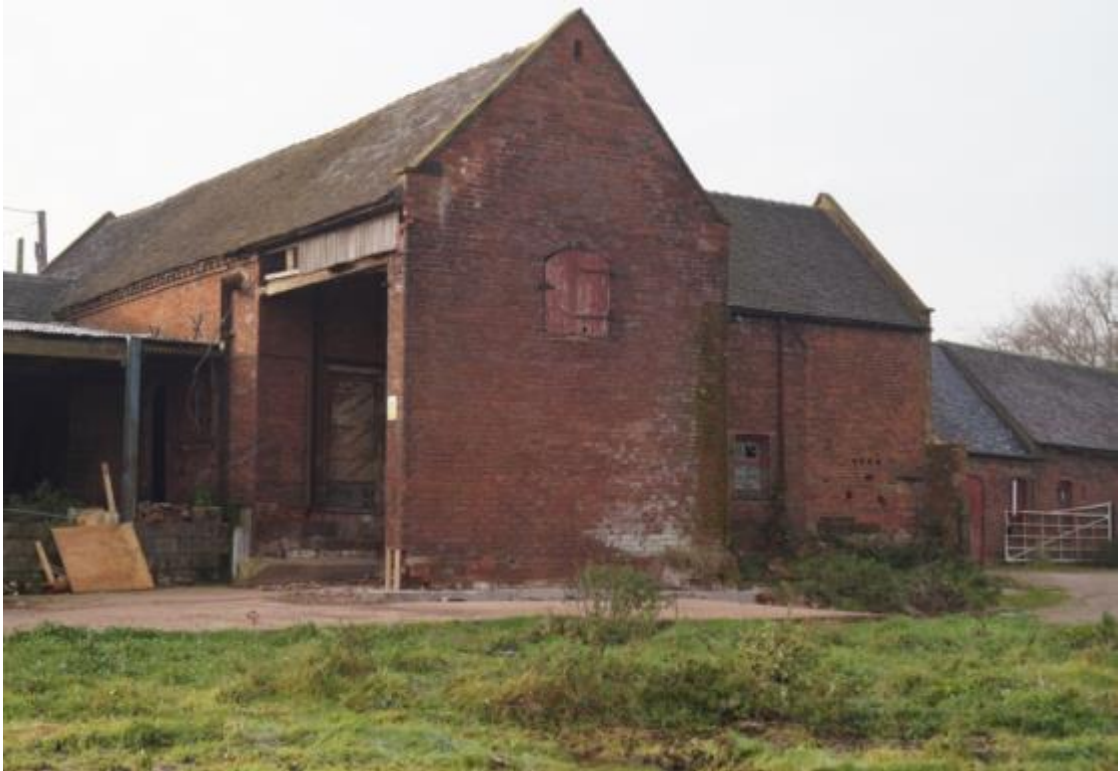
3. North gable end of Range 1. A covered loading bay projects from main body of the barn. The hatch in the gable end is redundant, as loading would take place within the covered area. This indicates that originally the structure of Range 1 extended further north but was later partially demolished to create the covered area. Cartographic evidence supports the location of a solid building where the covered area now stands (Figures 2 to 6).

The raised 20<sup>th</sup> century lean to is visible against the eastern elevation of Range 1.

*Known as the 'Drift House' two perforated metal bins each with a central chimney were erected here in the early 1960s by the current owner's father, plus a grain reception pit and tunnel leading to a fan powered by the Ford tractor engine mentioned previously.*

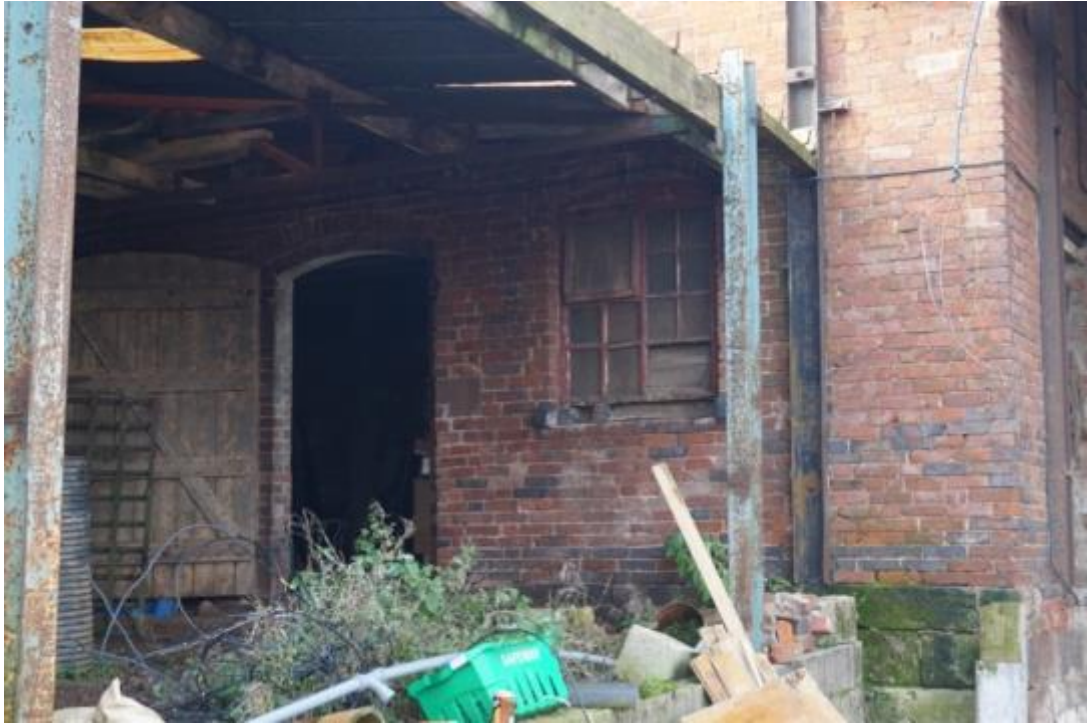
5. Batten and plank door, doorway and window with segmental arches in the eastern elevation of Range 1 now opening out into the 20<sup>th</sup> century lean to structure.

*The lean-to was built of reclaimed materials in the early 1970s.*

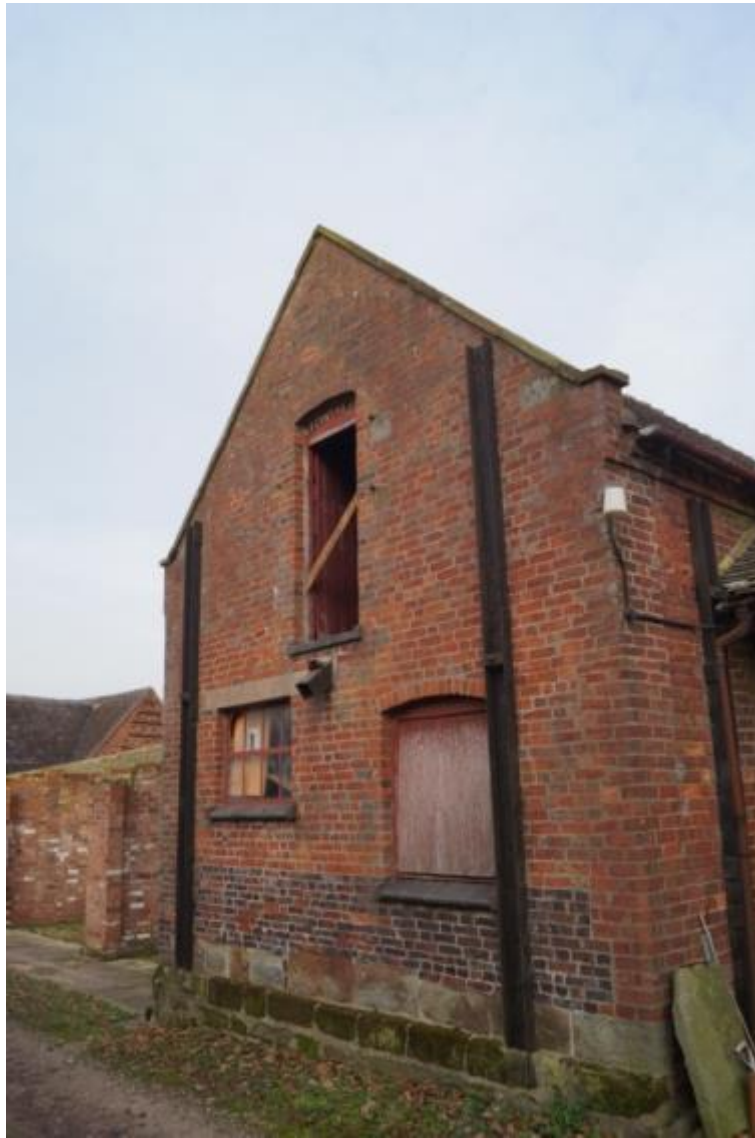
6. The south facing gable end of Range 1. At least three phases of building activity are visible as evidenced by areas of red brick patched with blackened brick along the lower part of the gable end and a later inserted window with a flat concrete lintel. Steel RSJ supports have been fixed vertically to the wall probably to strengthen the structure perhaps because of storage on the upper floor and to counteract outward thrust from the roof. A grain chute protrudes from beneath the doorway on the first floor.

*The steel supports and grain chute were added in the early 1960s when the barn was converted to bulk grain storage.*

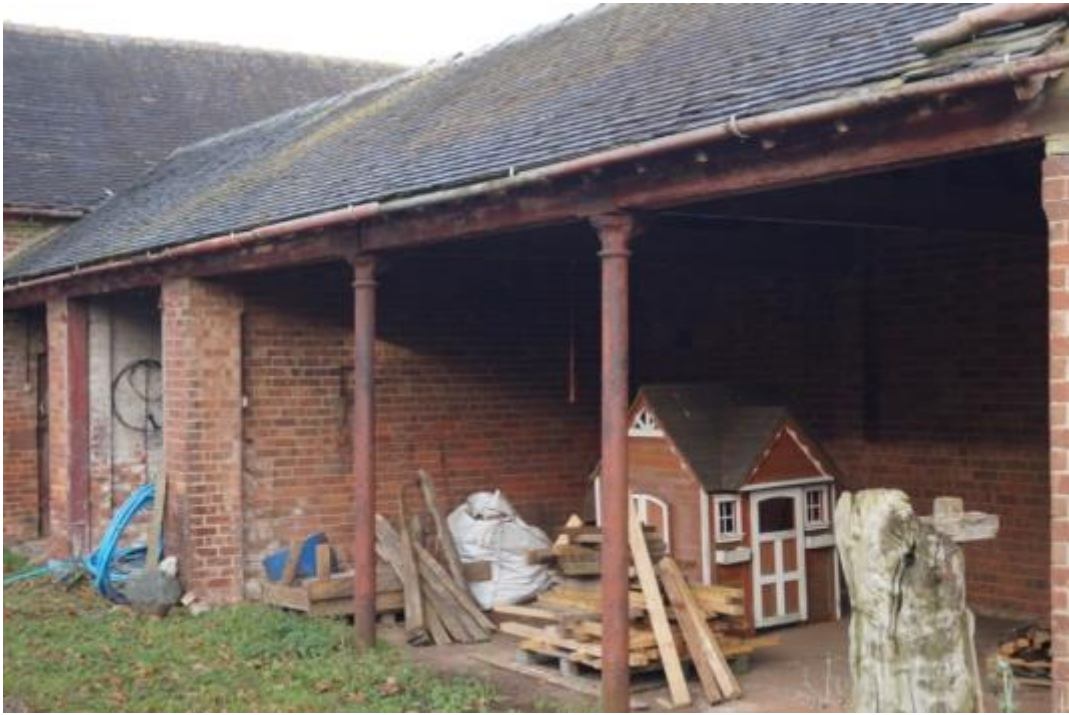
7. Later 19<sup>th</sup>/early 20<sup>th</sup> century additions against the eastern wall of Range 1 as depicted on the OS 25"1901 map. They are represented by an open fronted brick built storage area adjoining another open fronted cart shed with steel pillars.

*This was always referred to as the 'cartshed'. Originally the brick built part of the cartshed had wooden doors and was where the current owner's grandparents kept a trap prior to the purchase of their first car in the 1930s.*

*During the 1970s and 1980s the cartshed was used to house weaned calves*

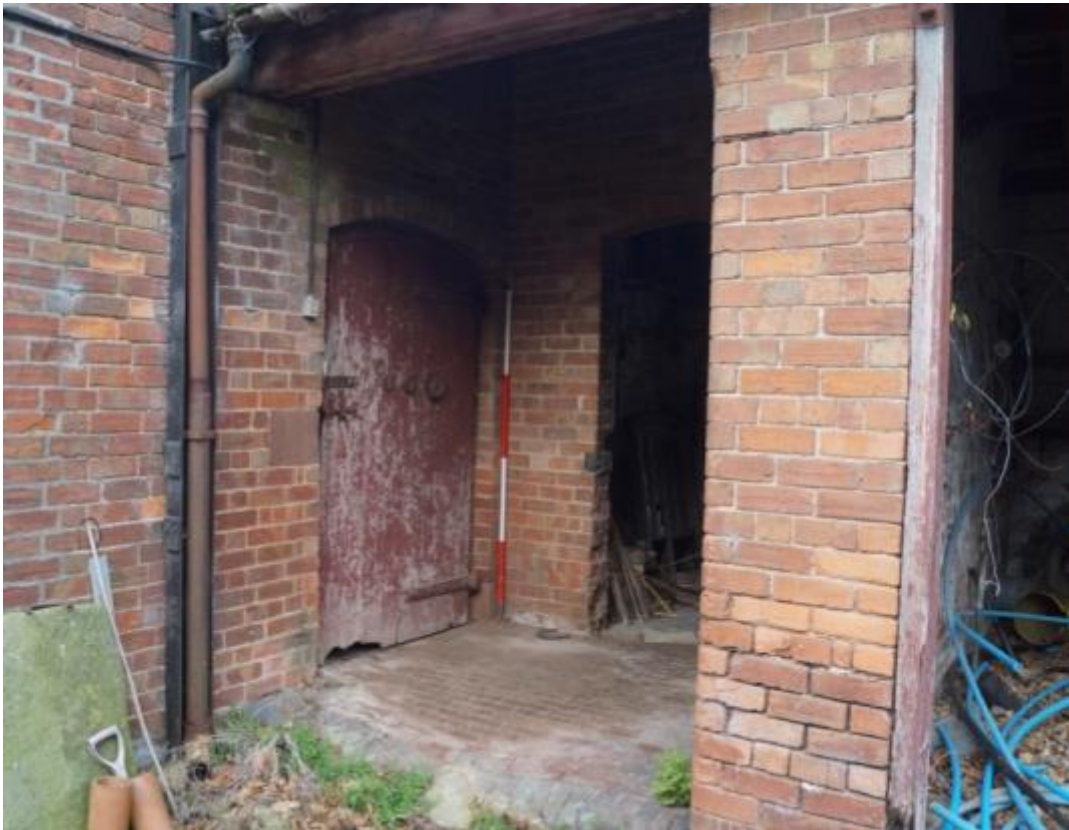
8. Detail of the open fronted brick storage area and of an original doorway into the eastern elevation of Range 1. The door is batten and plank with iron strap hinges attached to iron pintels. The opening to the north of the door now leads through into the 20<sup>th</sup> century lean-to which abuts the eastern side of the range.

*The batten and plank door gives access to what was once the old grain storage area. This part of Range 1 was also used as stables and had a blue brick floor which was removed when the existing concrete floor was laid. The opening adjacent to the door gave access to a tack room which later became a tool store. The stables and tack room were in use during the early part of the 20<sup>th</sup> century.*

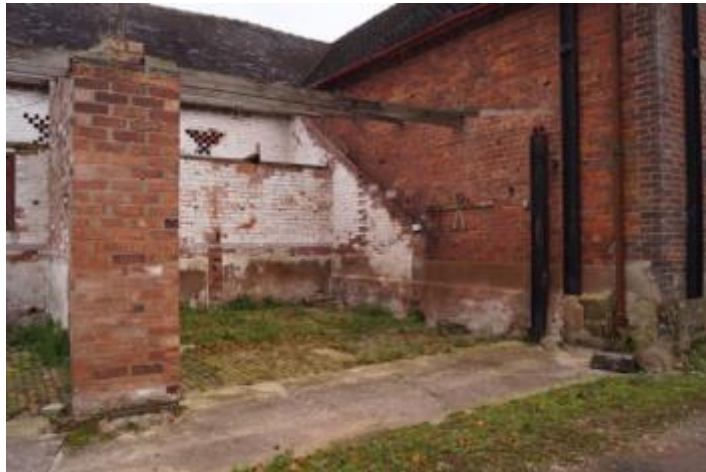
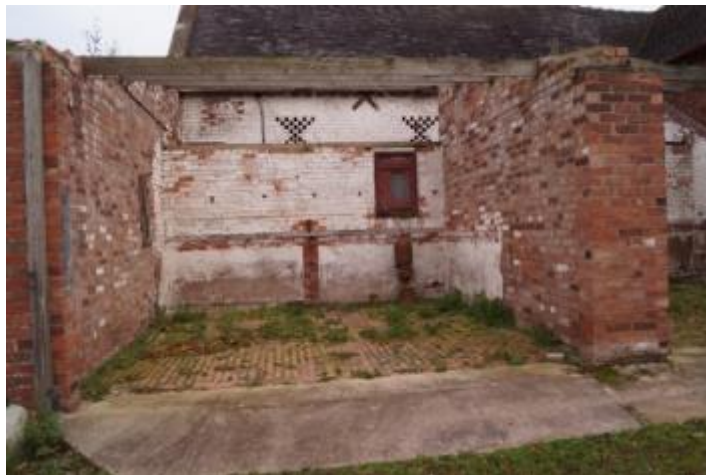
9. Remains of at least two building phases against the western wall of Range 1 and the southern wall of Range 2. The earlier appears to be an outshot delineated by the whitewashed brick. The OS 25" 1901 map depicts this building but also shows stalls fronting it. Truncated low brick walls in the back wall indicate subdivision of the outshot into four bays. The lower parts of the walls have been rendered and the floor is brick built. Note the pump which is located beneath a hatch in the back wall on the second photograph.

The current form of the building with projecting brick walls supporting sloping beams resulted from the conversion of the pigsty into garages in the mid-1960s.

*The earlier building was a purpose built pig sty with four pens and open yard at the front. It was converted into garages/machinery store in the mid-1960s*

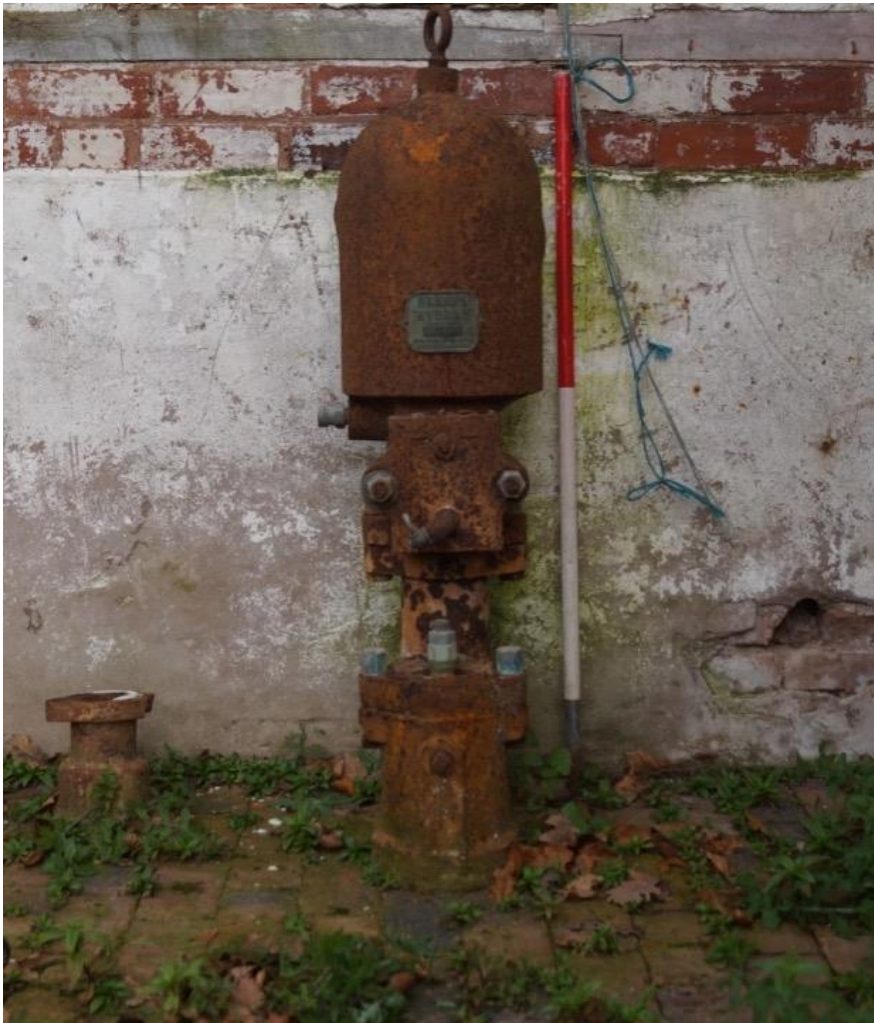
10. Detail of the pump. This is a Blake's Hydrum a hydraulic rams with the trademark *Hydrum* invented in the mid-1800s by John Blake. The Hydrum is capable of pumping water using only the power of the flowing body of water.

*The pump was located in a brick chamber close to the Brockton Brook in the 'Townfield' and was the only water supply before the farm was connected to the mains in the 1950s.*

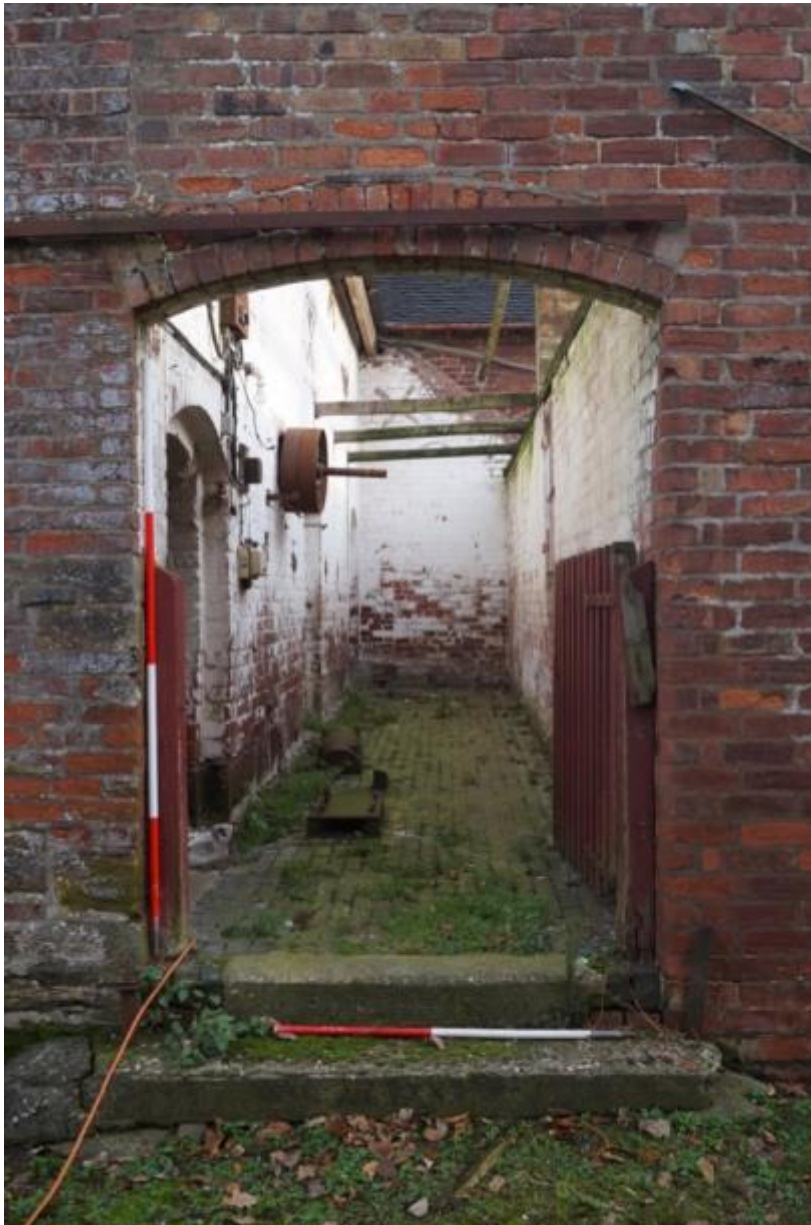
11. At some point the outshut was subdivided by a wall built parallel to the south facing wall of Range 2 to create a corridor which is now open but which was once probably covered. The doorway in the foreground gives access to the ground floor of Range 2. A drive wheel is fixed to the wall and a mounting for some form of associated engine is fixed to the brick floor.

*This area was covered until 2015 when the 1960s roof was removed. The engine mounting was for an electric motor which powered a belt driven bag mixer via the fly wheel and axle in the wall above. This was used continuously during from the 1960s until the early 1980s for rolled barley, beet pulp and fish meal.*

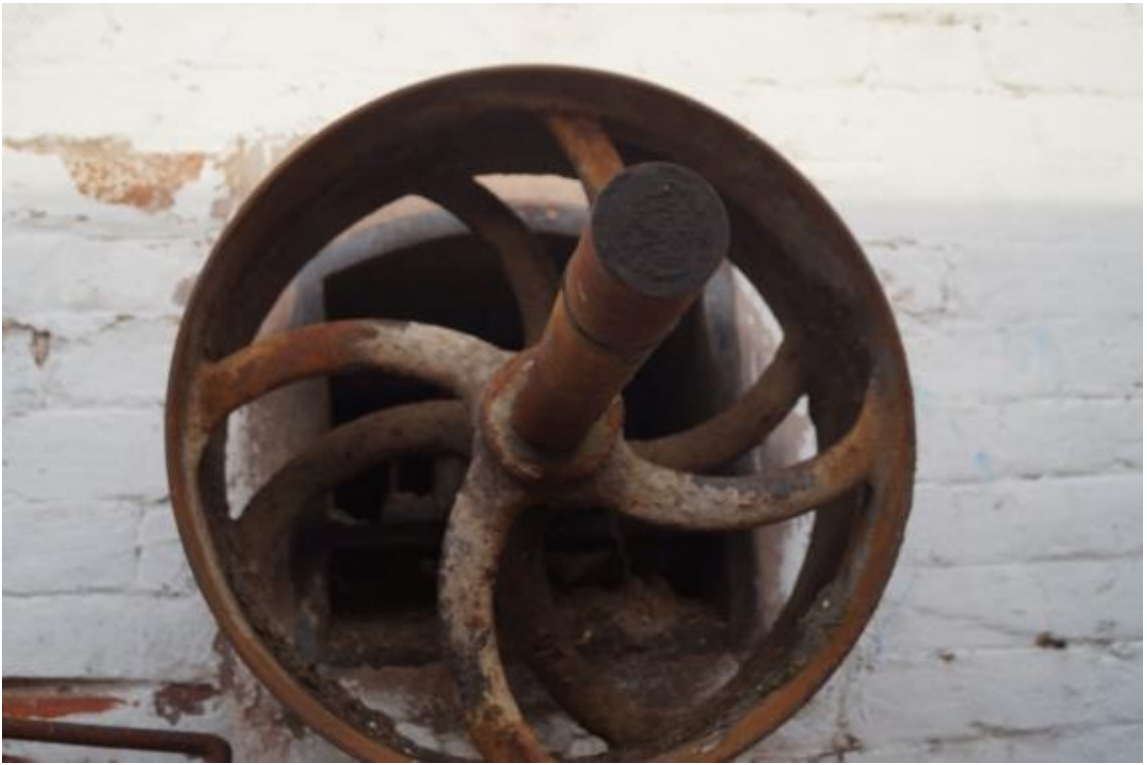
12. Detail of the fly wheel with aperture in the wall for the axle.

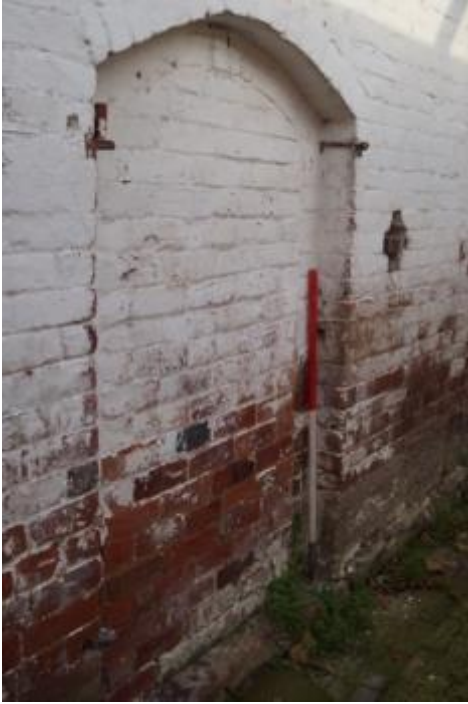
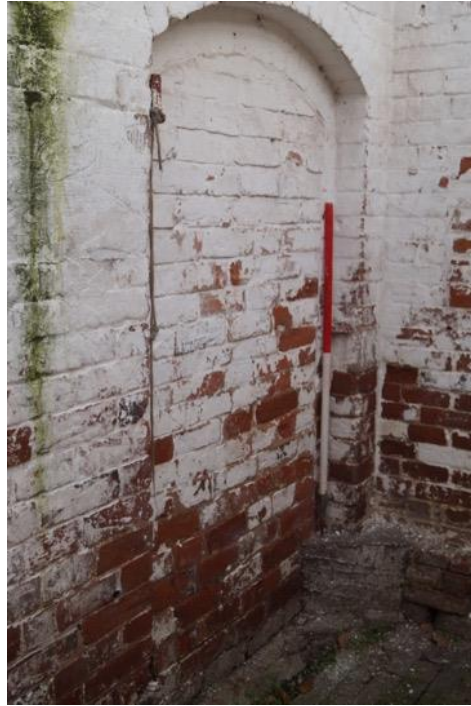
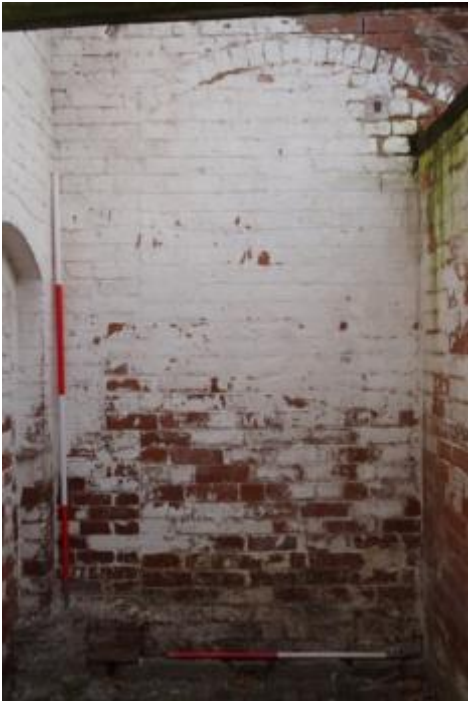
13. Two blocked doorways in the southern wall of Range 2. These may have become redundant when the outshut was subdivided to create the corridor. A third blocked doorway is located in the western wall of Range 1 and the later dividing wall truncates it suggesting again redundancy as a result of the corridor construction.

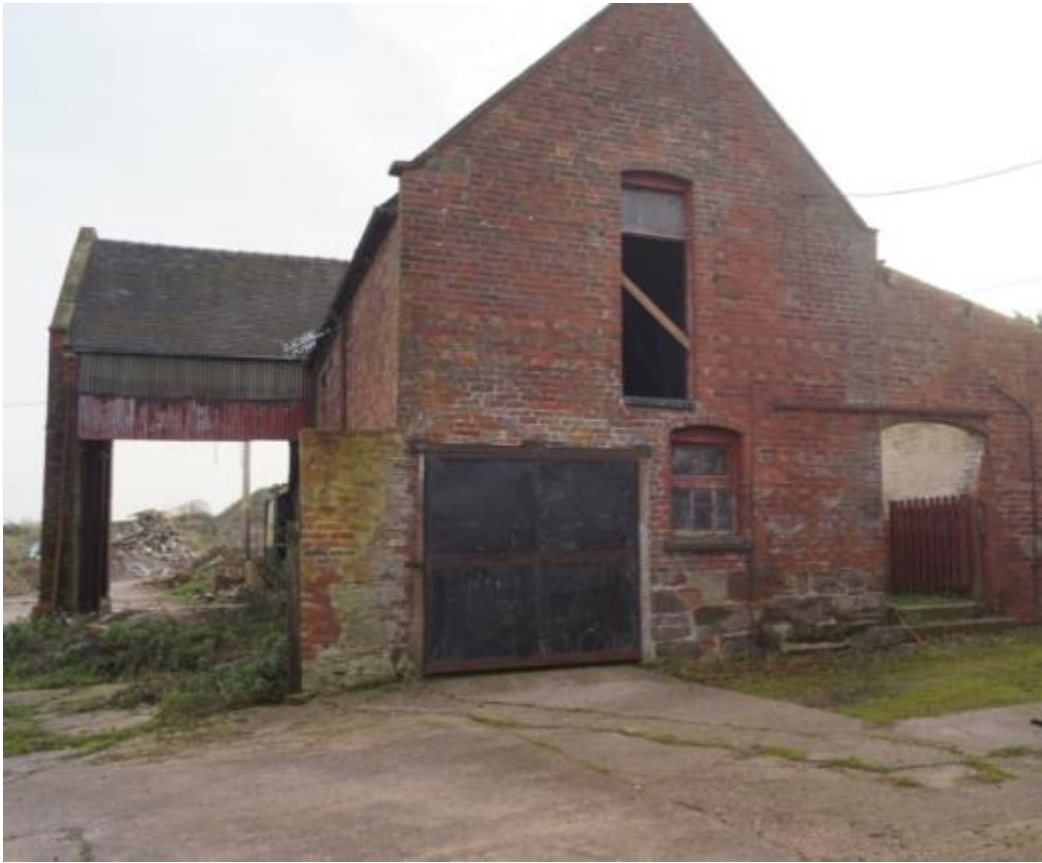
14. Western gable end of Range 2 with the covered loading bay of Range 1 in the background. The stub wall to the side of the entrance is likely to be a vestigial section of the annexe once located against the north elevation of Range 2 as depicted on the Tithe Map of 1838. It may have been left in situ to provide buttressing for the insertion of the larger square doorway. The straight joint is clearly visible where the later outshut was built against Range 2.

*The square metal door replaced the original door in the early 1970s when the bag mixer was installed (see above).*

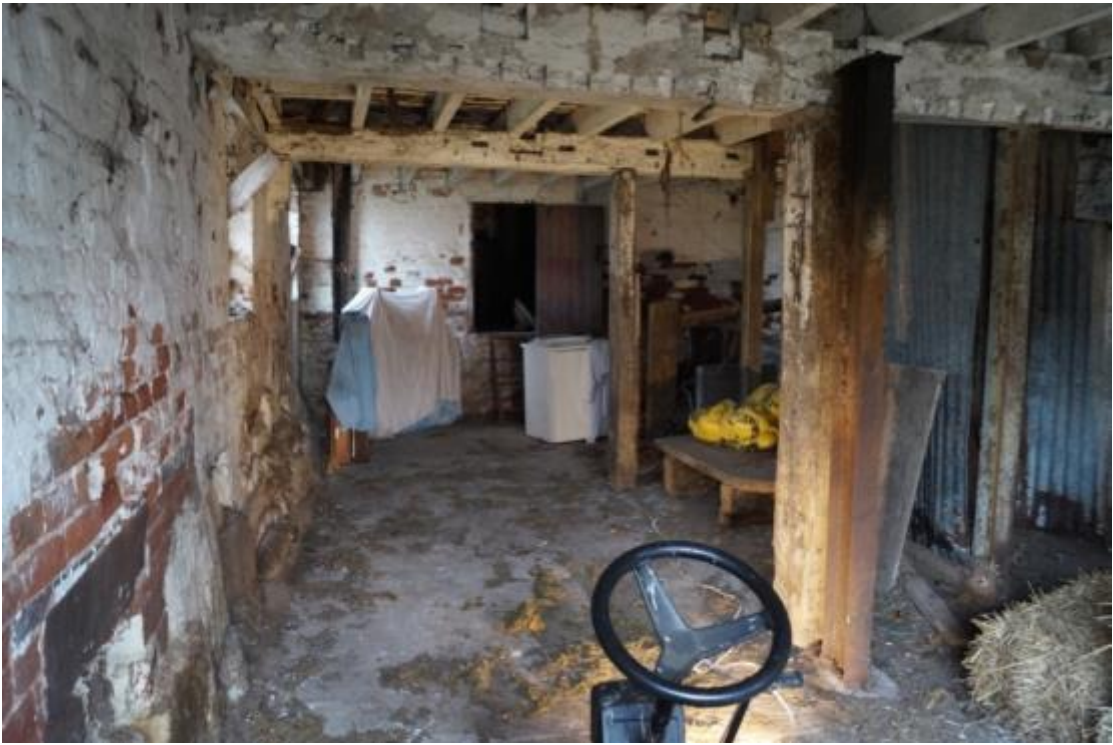
15. Interior of the ground floor of Range 2. There is considerable evidence of phases of alteration and patching. RSJs have been used for additional ceiling support. The hatch into Range 1 is visible in the back wall. In front of the wooden supporting beam is the vertical mounting for the axle leading from the drive wheel outside.

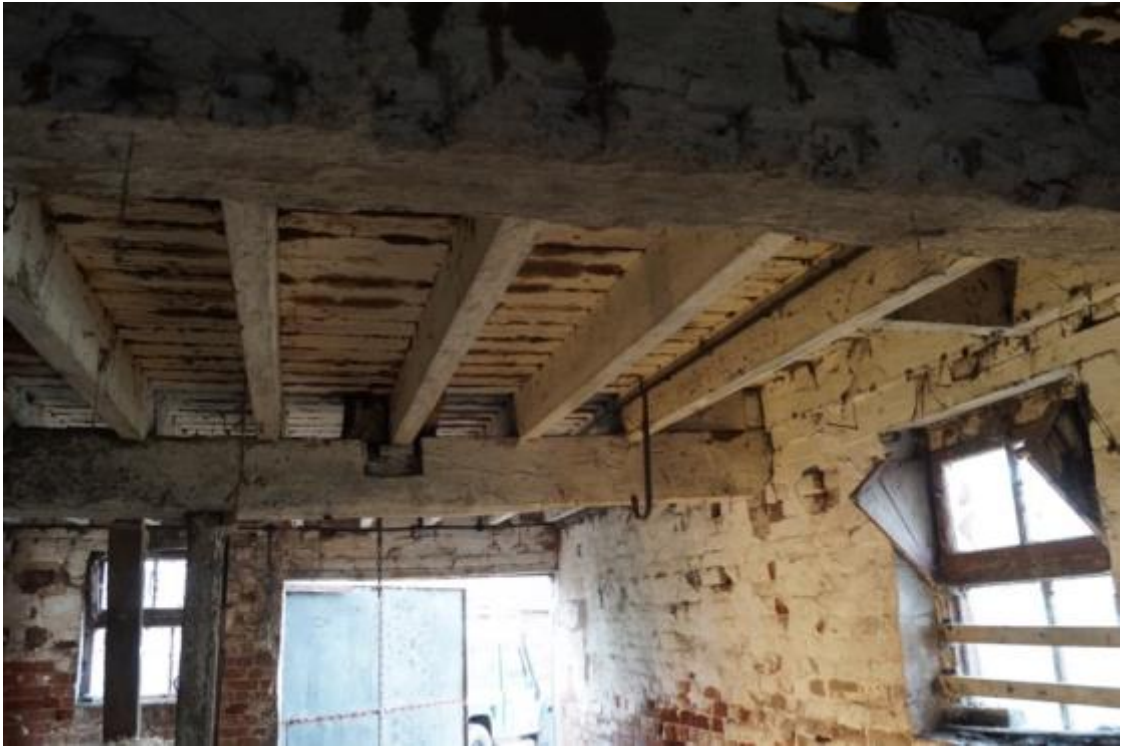
16. Detail of ceiling construction which shows two phases of building activity with a later ceiling of oak planking and support beams superimposed onto the main structural cross beams

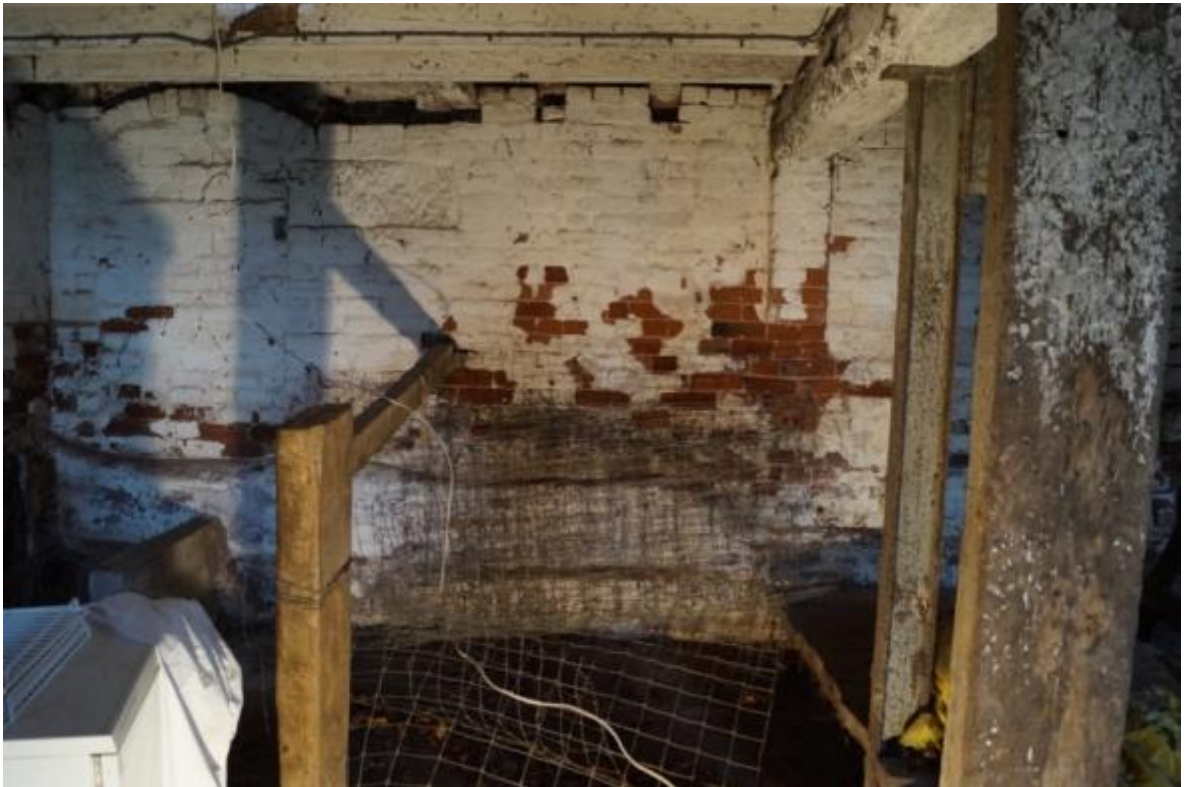
17. Internal face of the south wall of Range 2 showing one of the blocked doorways. The sandstone blocks at the base of the wall show signs of rendering and the entire ground floor room of Range 2 has been lime-washed. There is a wooden stall partition which suggests housing for livestock at some point.

*Pre-1953 this building was a milking shed and was then converted to house deep litter hens both here and in the floor above. In the 1960s the bag mixer was installed and a roller mill installed on the first floor.*

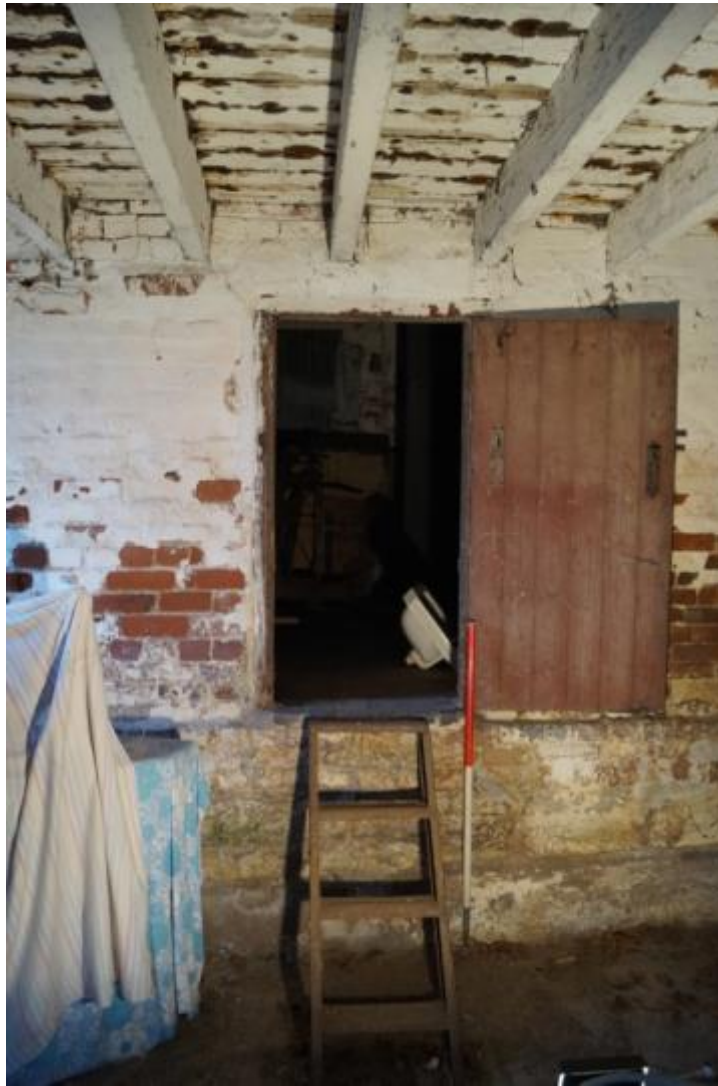
18. Detail of small doorway from the ground floor of Range 2 into the ground floor of Range 1.

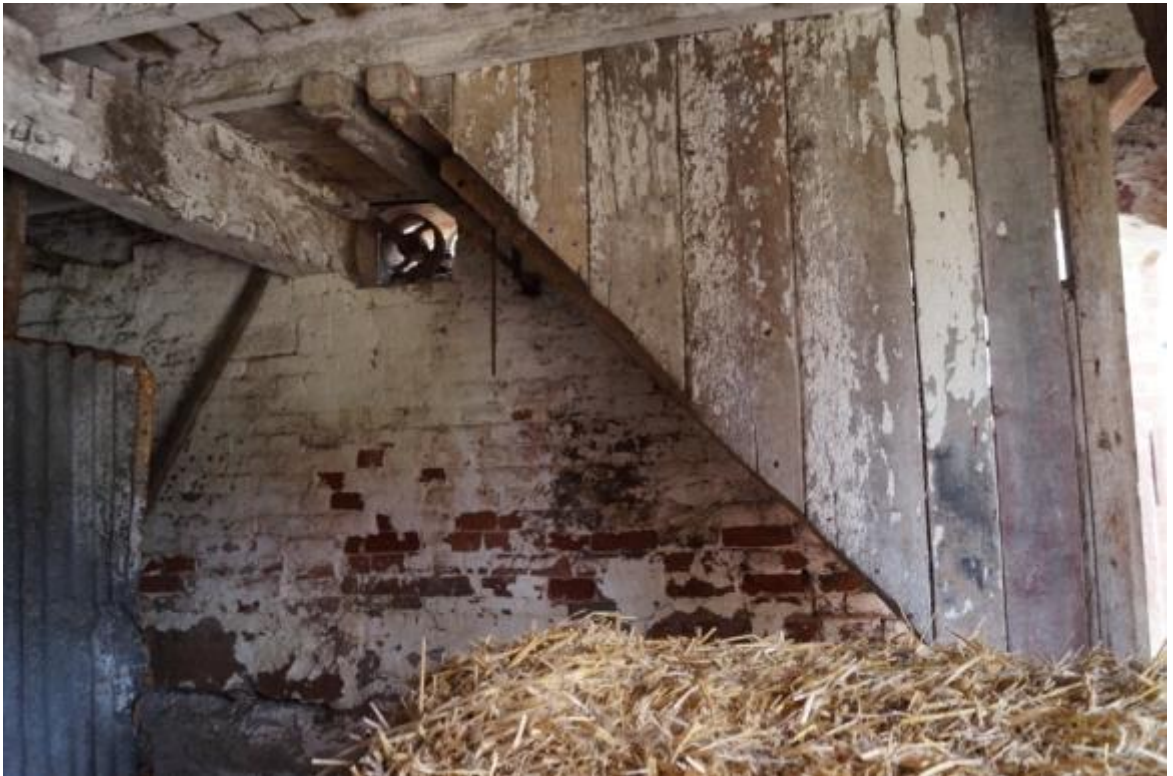
19. Wooden plank housing for the staircase from the ground floor to the first floor of Range 2. Wedge shaped notches have been cut into the lower edge of the cross beam to the rear of the staircase which may indicate that the beam once supported upright partitioning.

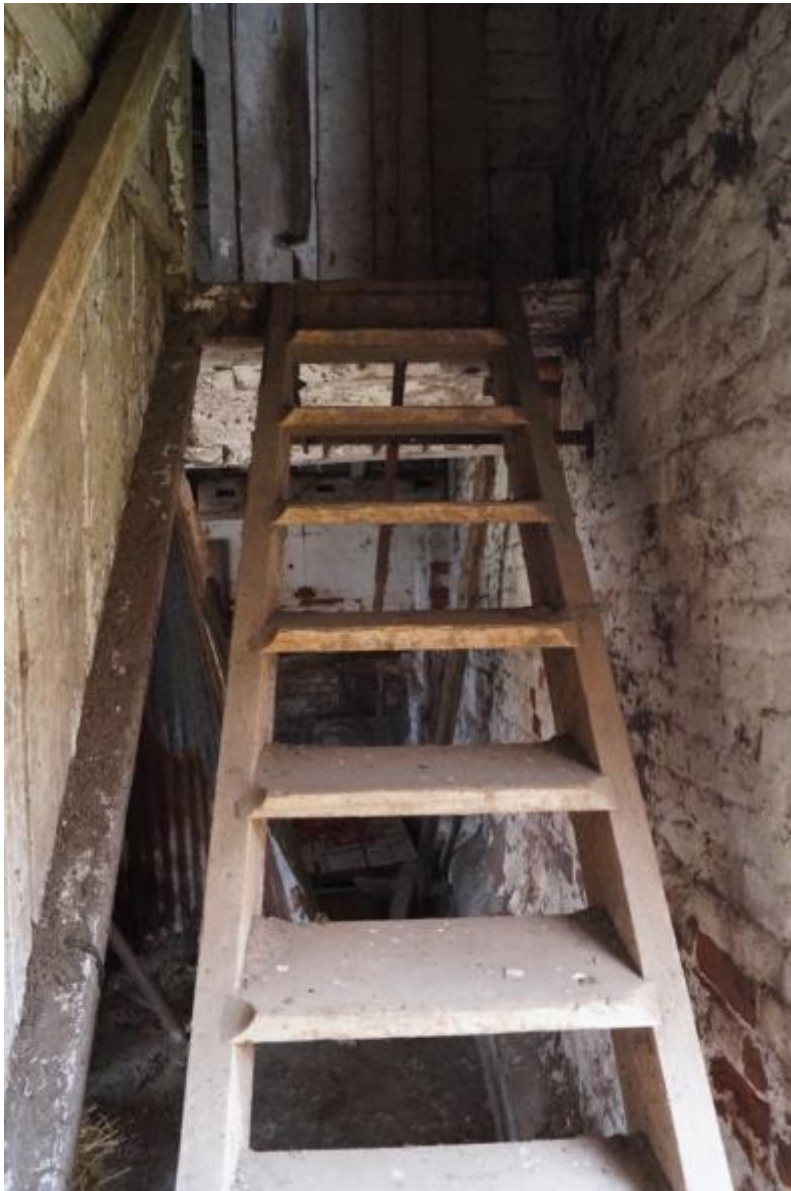
20. Detail of staircase to first floor. This appears to be a later insertion the original stairs having been removed.

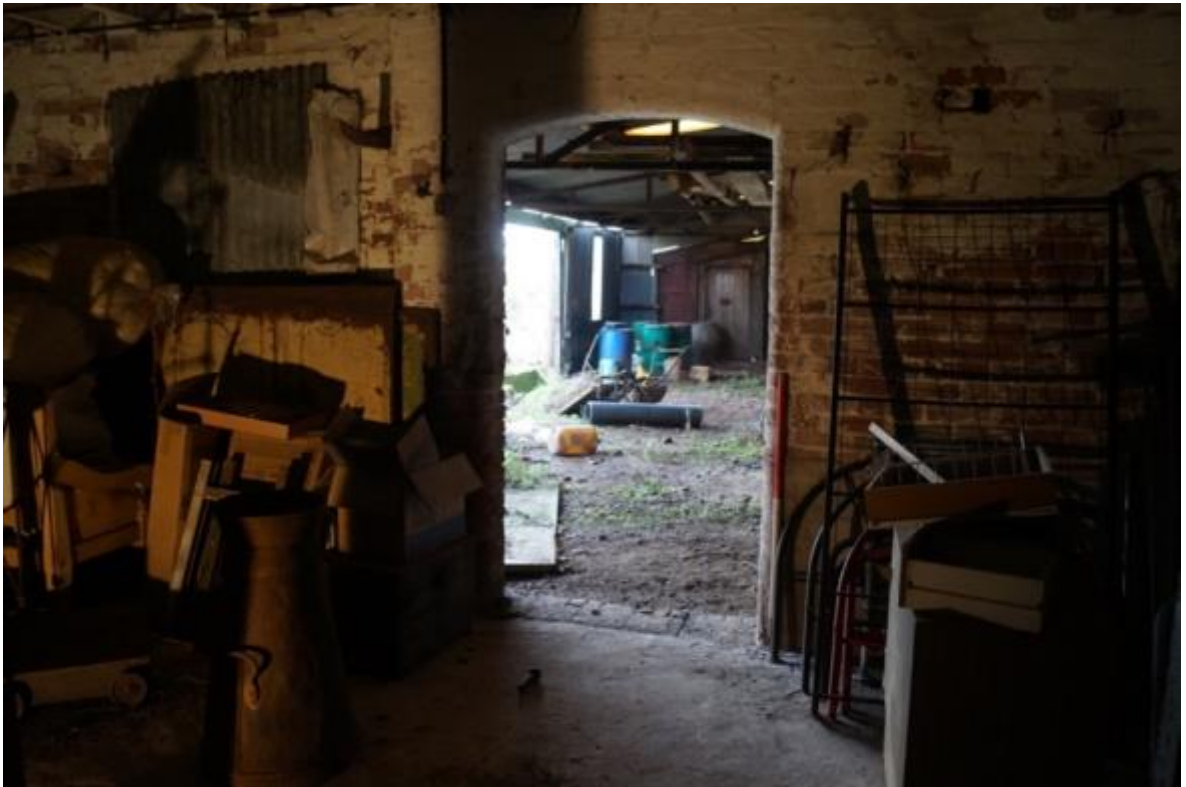
21. Room 1 ground floor of Range 1 looking out into the 20<sup>th</sup> century terraced lean-to. Much of the detail of the interior of this room was obscured by storage. The doorway shown is directly opposite the blocked doorway in the western wall of the range and on stylistic grounds they are likely to be contemporary. The opposing doorways may suggest that threshing activities took place here, though only on a small-scale.

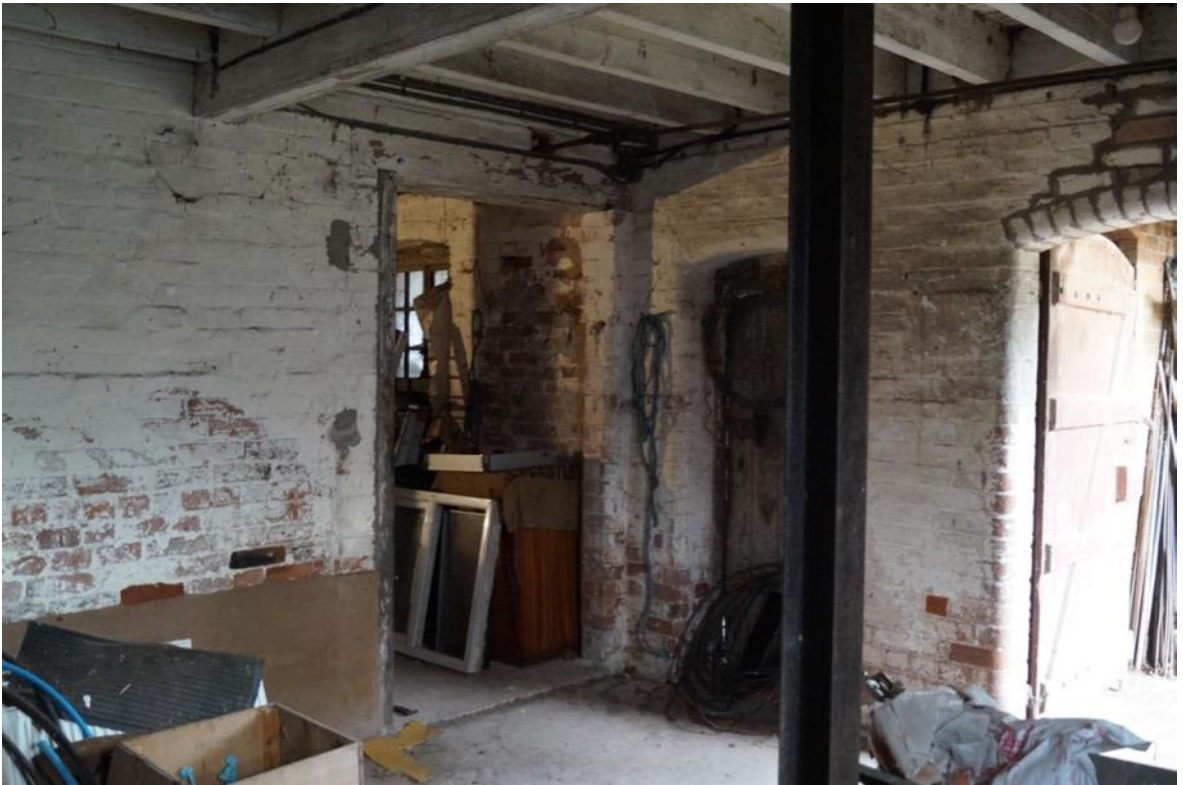
23. Ground floor, Room 2 of Range 1. The main doorway opens out into the open fronted cart shed whilst the smaller doorway obscured by the RSJ opens into the 20<sup>th</sup> century lean-to. The flooring throughout the ground floor of Range 1 is concrete whilst all of the walls have been lime-washed.

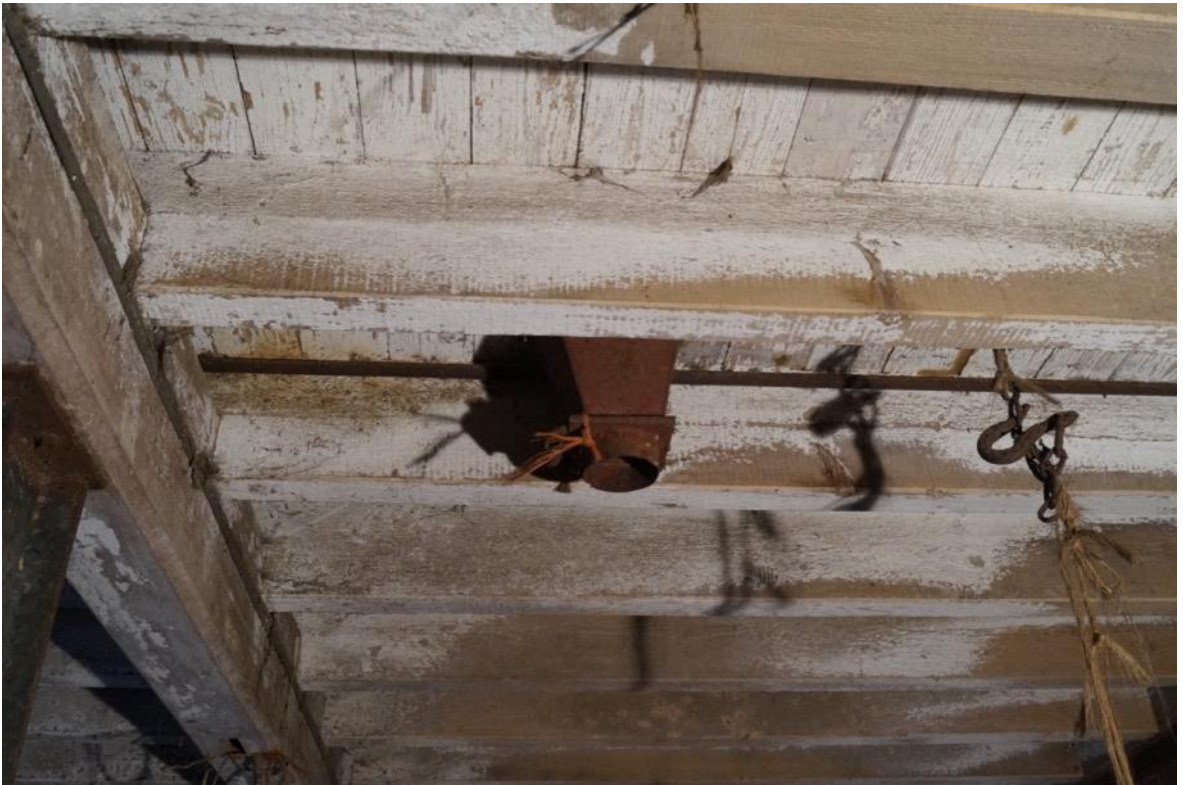
24. A possible grain chute protrudes from the ceiling of Room 2 suggesting the presence of a hopper on the first floor.

*The grain chute was for filling bags/bins from the grain dryer in the 1960s and 1970s.*

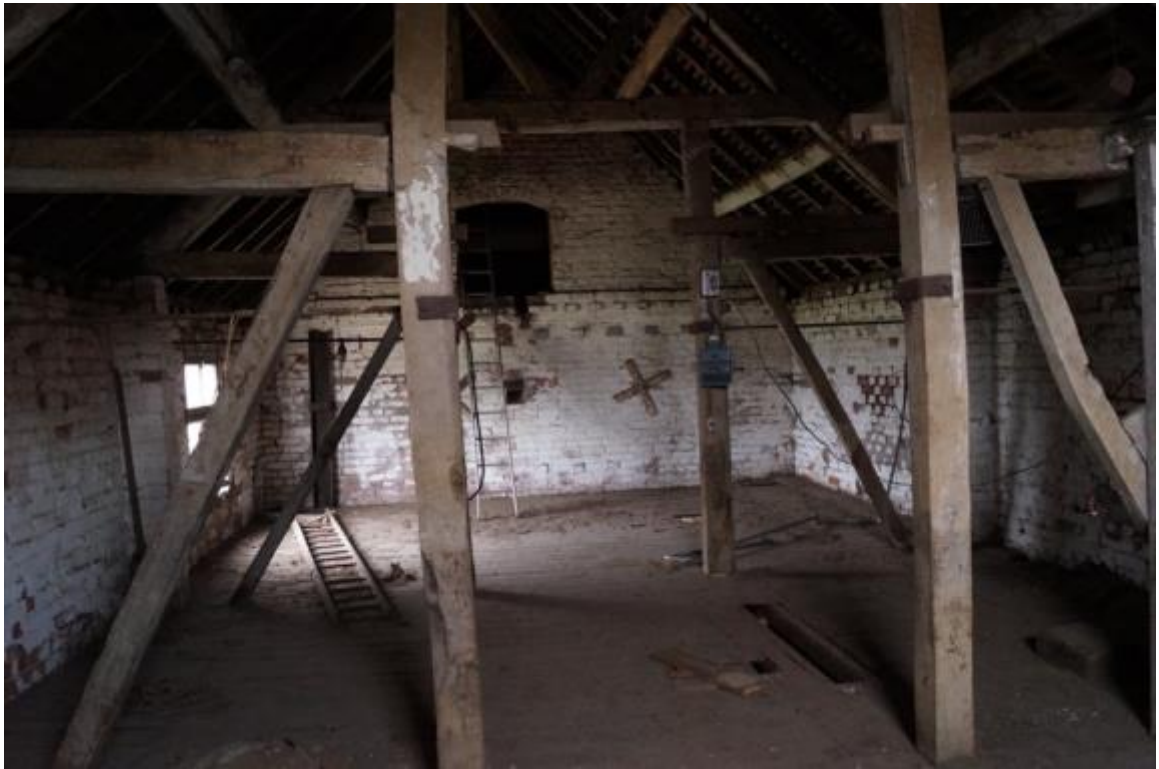
25. First floor of Range 2. The room is divided into three bays with two sets of arcade posts and aisle ties creating a rudimentary aisled type room. The wall plates are set on dentil brickwork. The roofing is lath and plaster. In the back wall is the hatch into the loft area which makes up the upper floor of Range 1.

*The room was used for grain storage, bagged beet pulp storage and also housed a roller mill for crushing popcorn (propionic acid) preserved winter barley.*
