# ASPLEY HOUSE FARM BARN.

Level 2 Building Recording and Watching Brief

July 2017

**PROJECT:** Aspley House Farm Barn, Aspley Lane, Slindon, Staffordshire

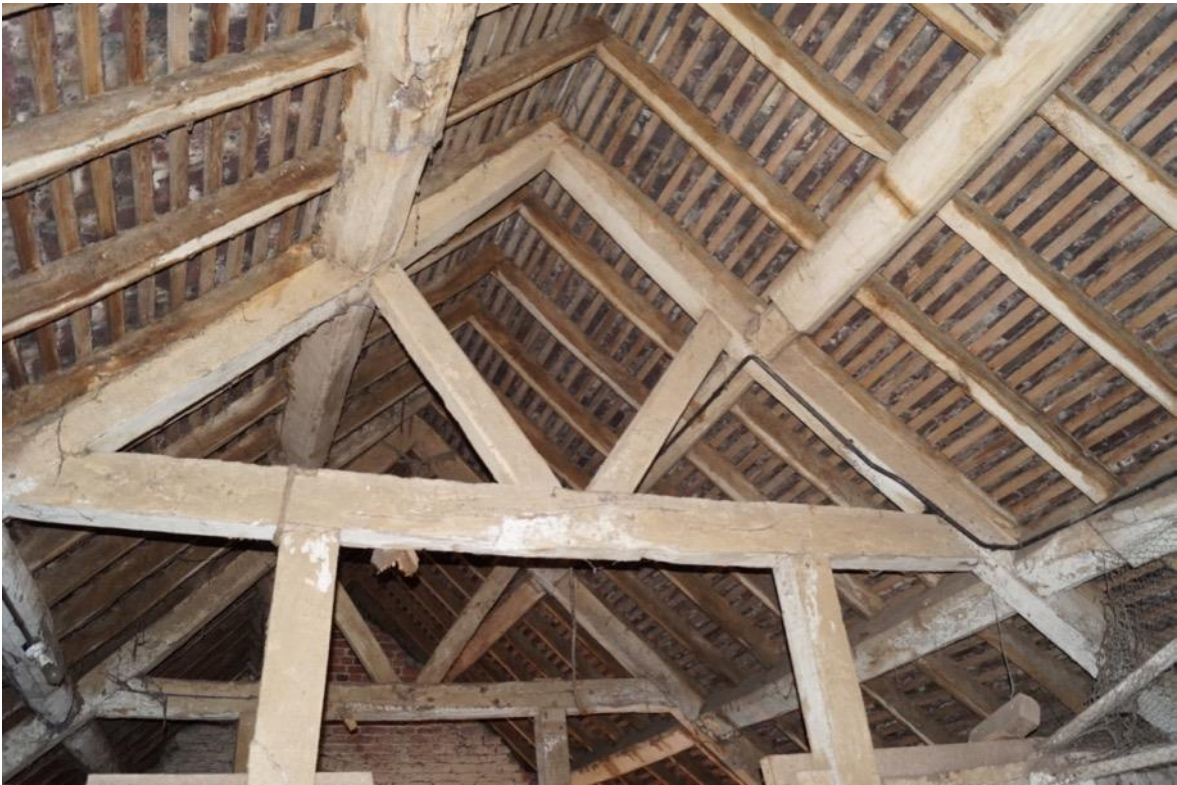
26. Detail of the roof trusses on the first floor of Range 2. The roof is of queen strut construction.

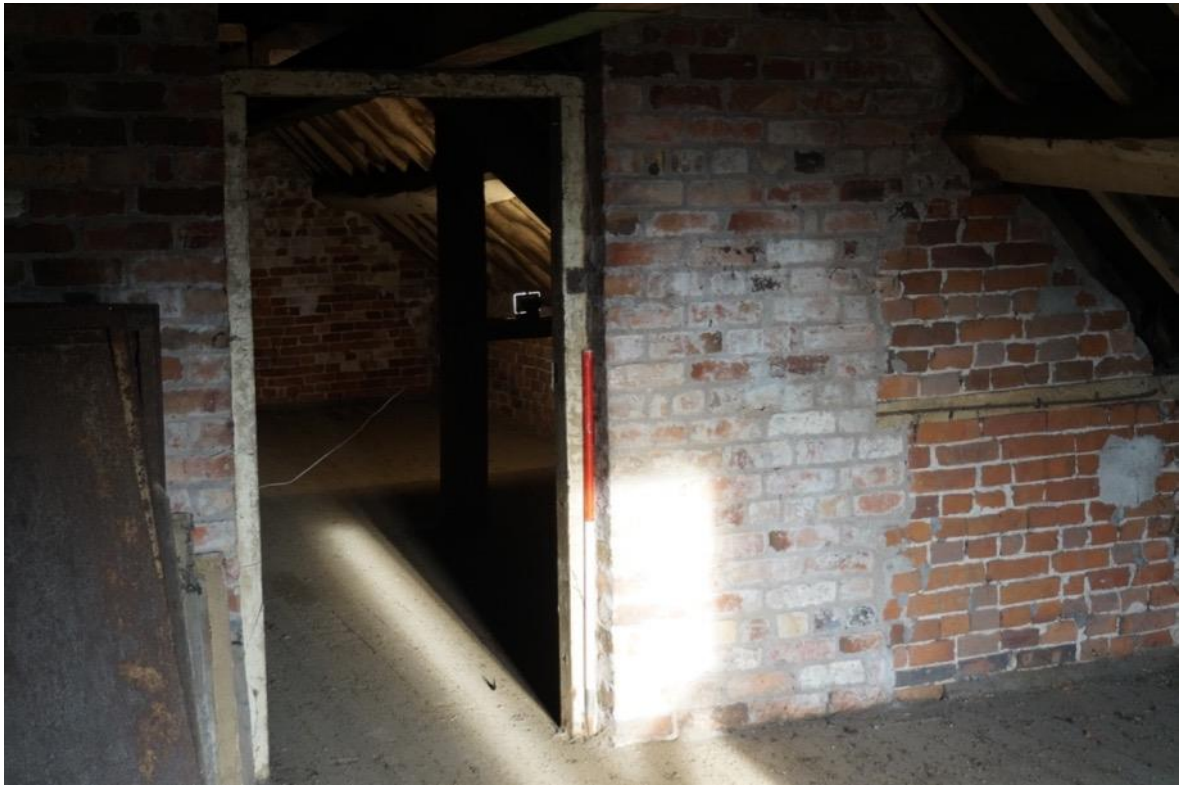
28. General view of the first floor to Range 1 showing a later wall and doorway constructed to subdivide the room. The flooring is again constructed of tight fitting floor boards and is load bearing. Above the doorway a cavity has been created in the walling for the insertion of a modern conveyer belt.

*The first floor of Range 1 was used for bulk grain storage during the 1960s and 1970s but was used for storage of fodder and hay for livestock and horses previous to that.*

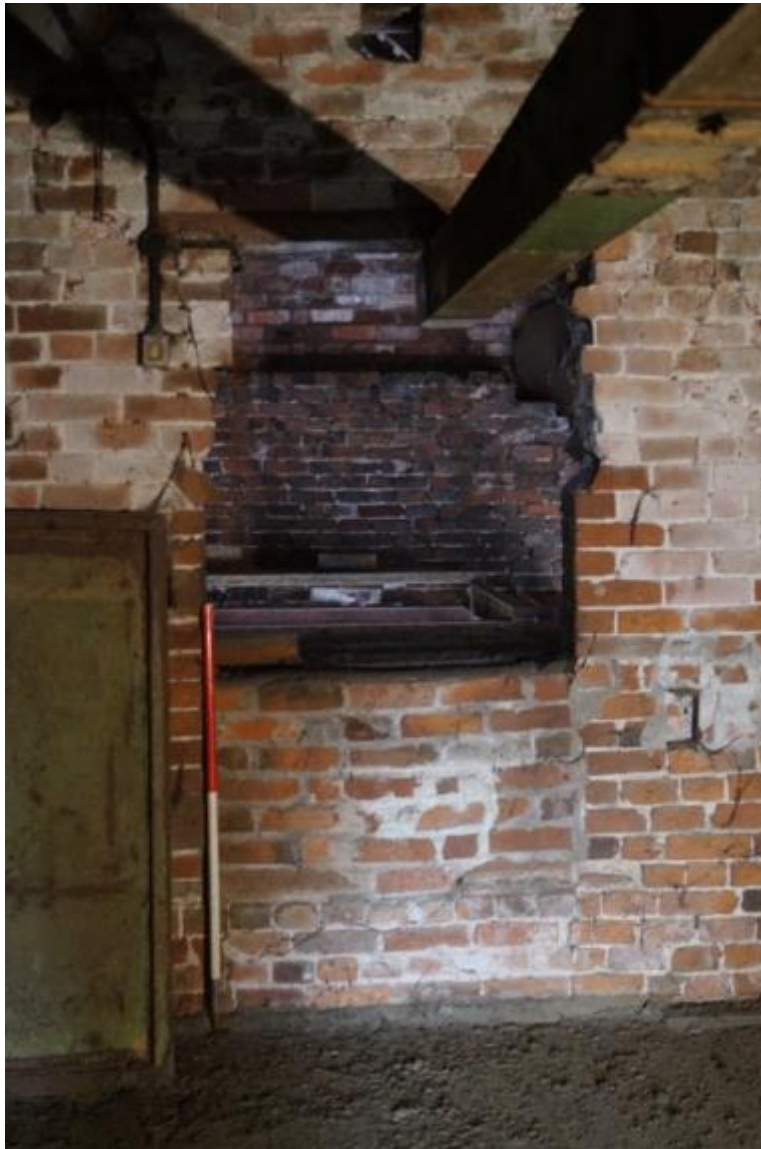
29. Phases of blocking in the northern gable end of Range 1 where the conveyor belt exits into the covered loading bay.

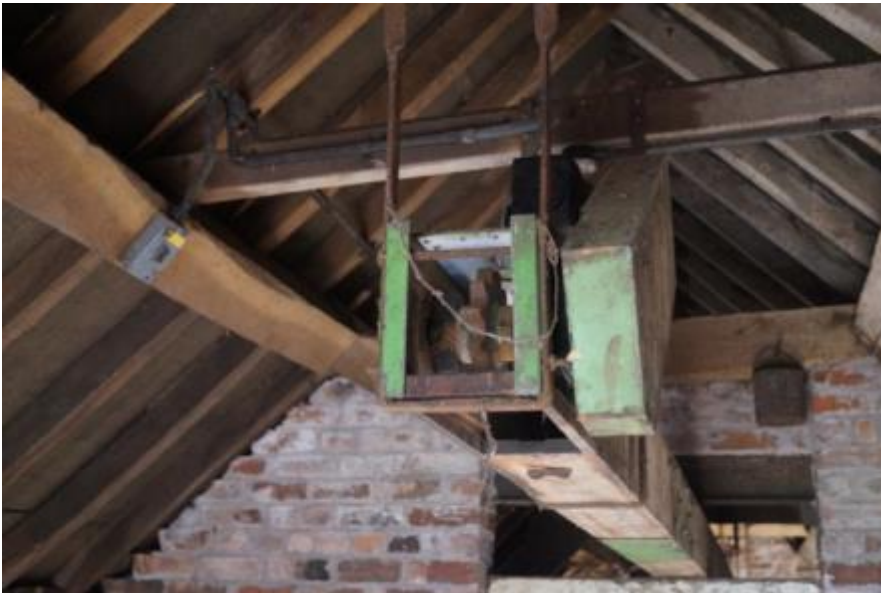
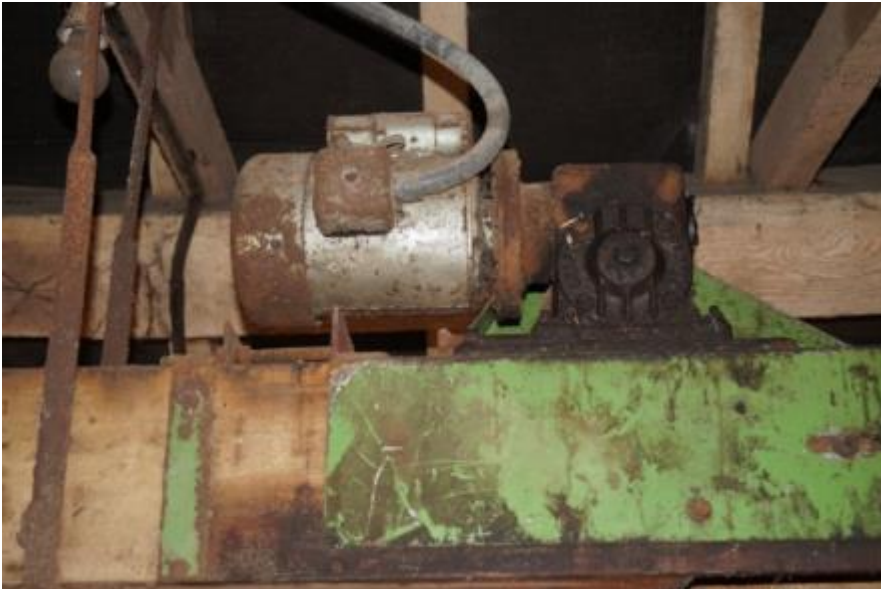
30. Detail of the conveyor mechanism and electric motor.

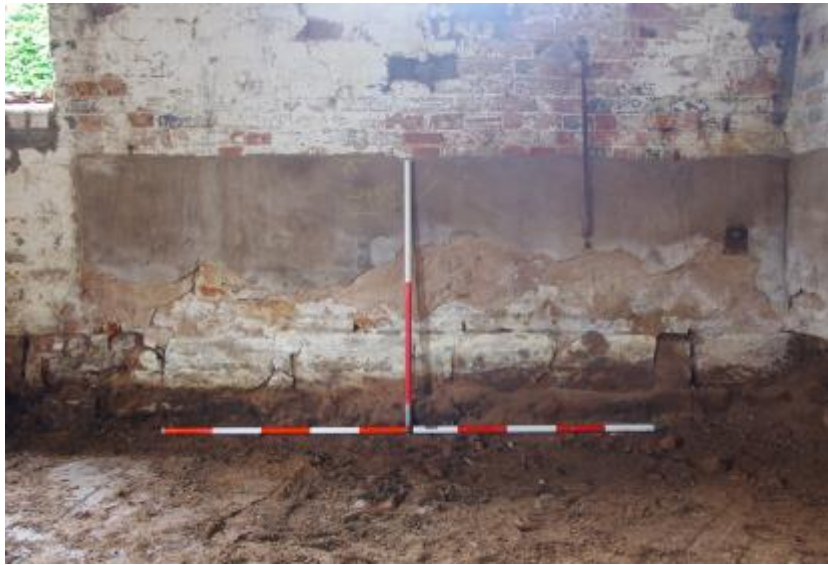
In Rooms 1 and 2 the level of the concrete floor was lowered by approximately 0.7m below ground level which exposed a stratigraphy comprising red brick laid on to sandstone ashlar which in turn were laid on rough sandstone rubble which sealed a mixed levelling layer of grey silty clay (Plate A).

Plate A Construction layers and foundation sequence in Room 1 Range 1 looking northwest.

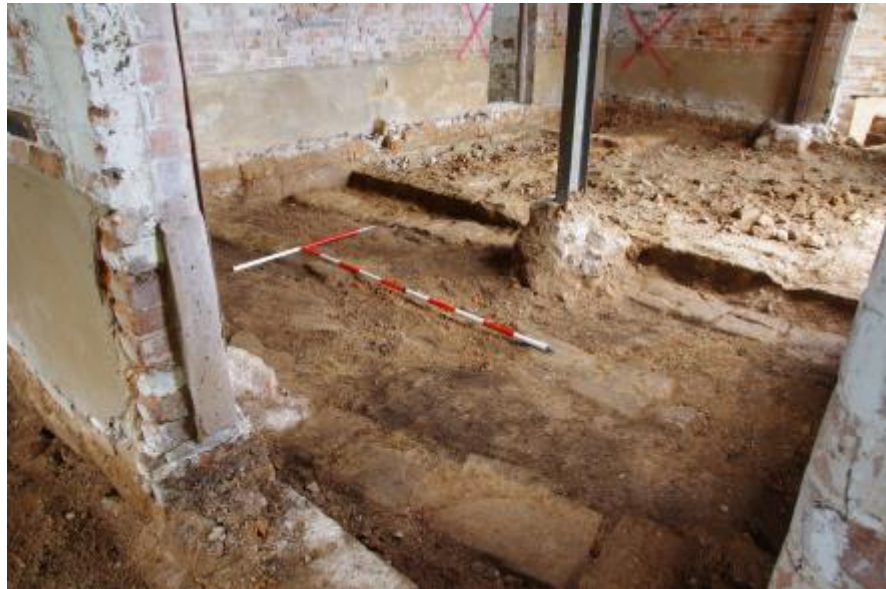
In the southern half of Room 1 was a linear arrangement of three parallel, roughly hewn sandstone foundations aligned east to west. They were laid into a deposit of mixed grey clay and sand which appeared to have formed a levelling layer throughout Range 1 and most likely dated to the construction phase of the barn (Plate B).

Plate B Linear sandstone wall pads in Room 1 looking northwest.

The sandstone foundations did not tie into the walls of Room 1 but butted up to them indicating that they were a similar date to the construction of the range. The sandstone foundations were approximately 0.7m apart which suggested that they formed the base for some form of superstructure. This was unlikely to have been animal stalls as the space between them was too narrow. It is possible that they formed some form of foundation padding for a raised floor perhaps for the storage of grain which would need to be kept dry and ventilated.

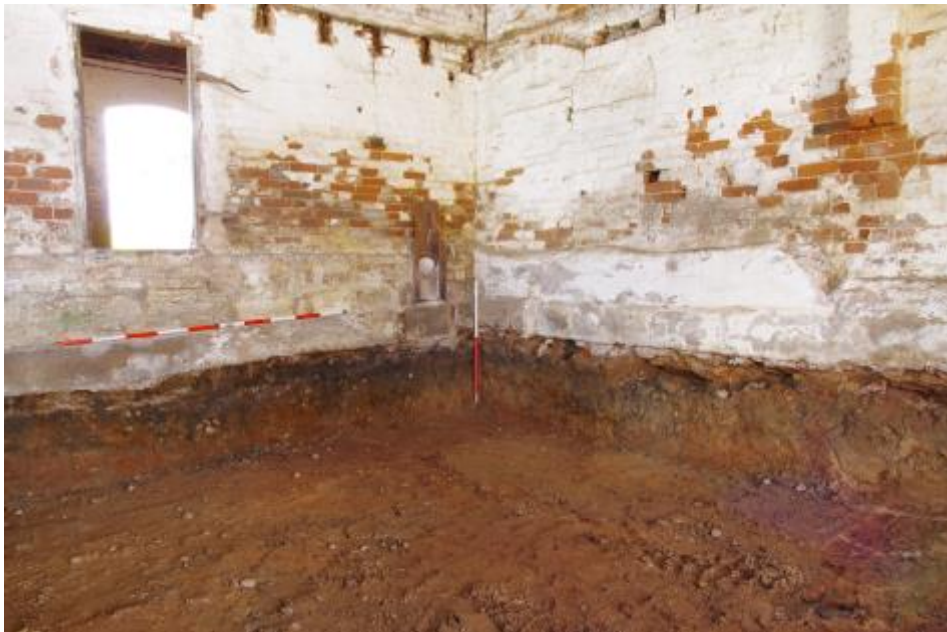
The concrete floor was lowered by approximately 0.7m and this revealed a construction sequence similar to that in Range 1 with large ashlar laid on to a stone and rubble foundation which in turn sat on a grey silt clay levelling layer. In Range 2, it was shown that this levelling layer, which was around 0.10m deep, was laid directly onto the natural sand substrate (Plate C).

Plate C Range 2 showing foundation layers looking southeast.

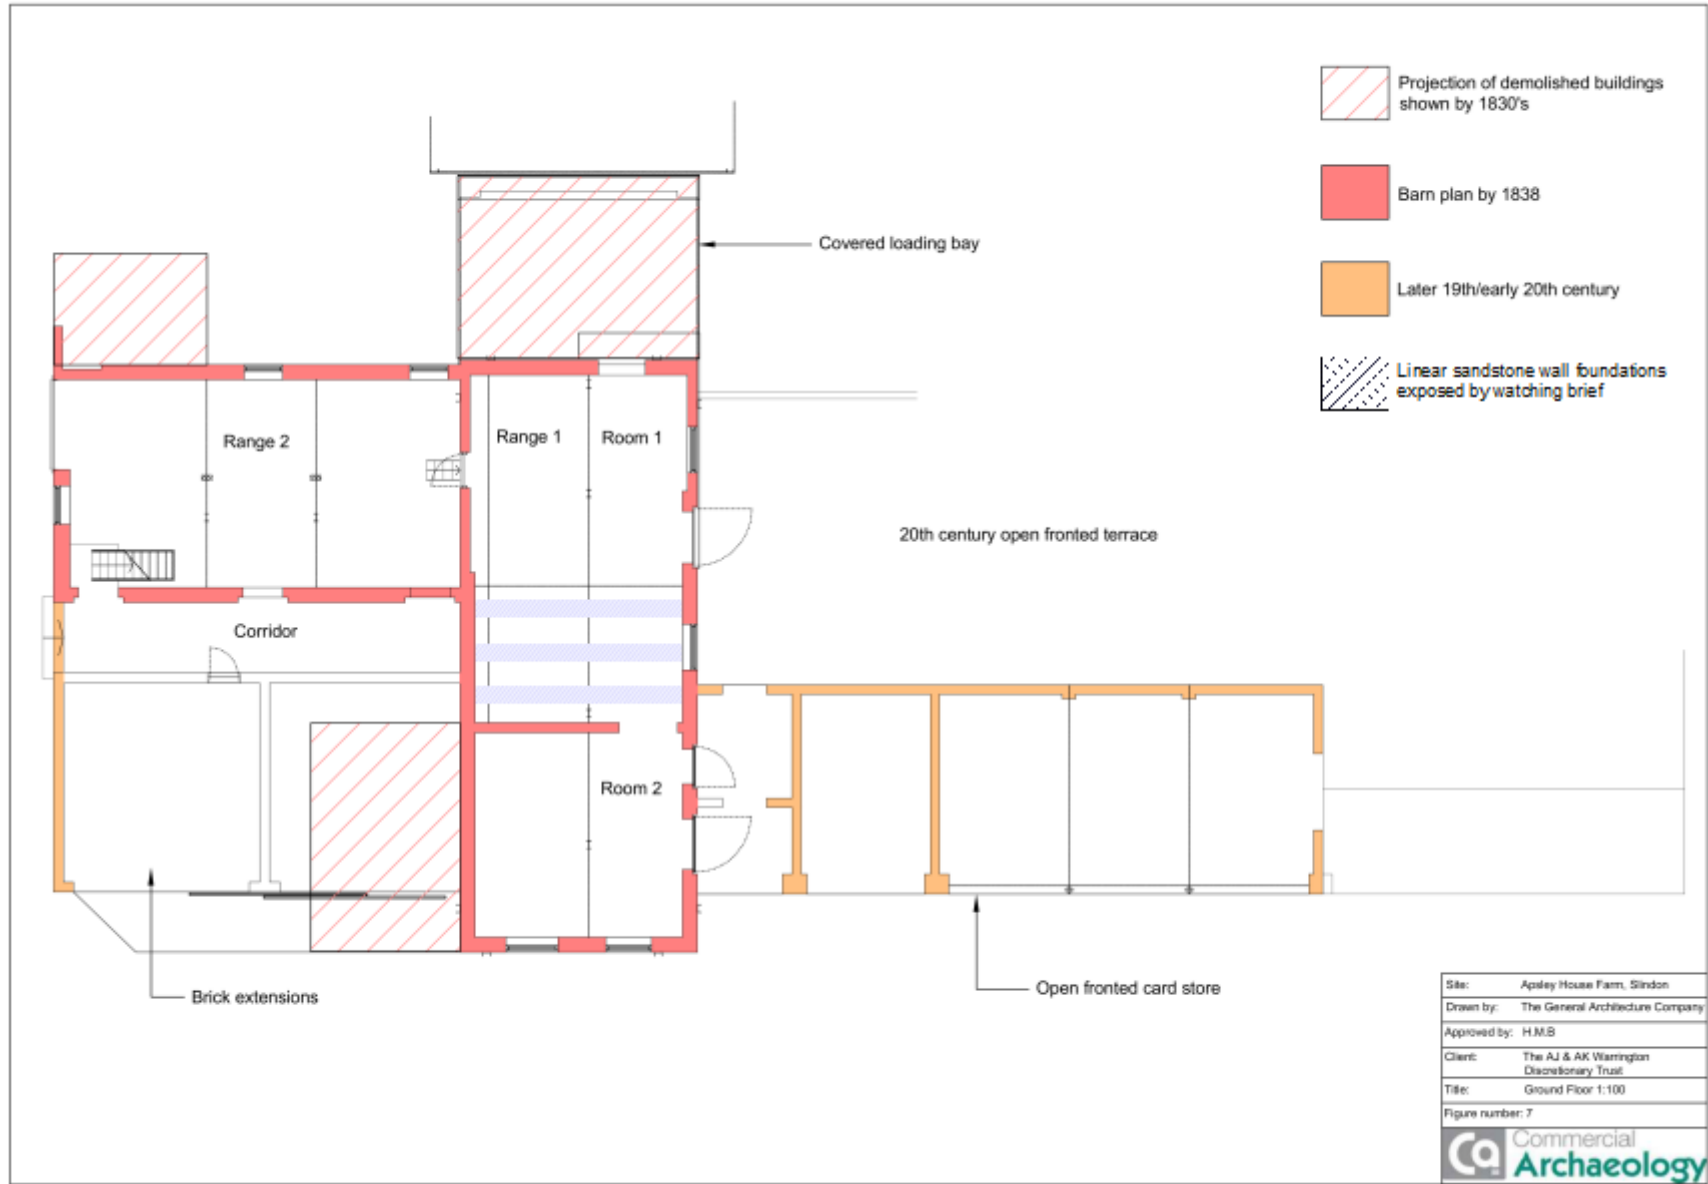
The mid-19<sup>th</sup> century elements of the barn comprise a roughly north to south orientated range (Range 1, Figure 8) which is joined on its western side by a roughly east to west orientated range (Range 2, Figure 9). The ranges are built at different levels with Range 1 located at a higher level than Range 2, access to the former from the latter being by way of an internal raised hatchway.

### Range 1 (Figure 8)
