SPODE COTTAGE PUBLIC HOUSE
RUGELEY ROAD, ARMITAGE
STAFFORDSHIRE

BUILDING RECORDING

REPORT NO. CA138/HMB/smith
OASIS REF. commerci1-317506

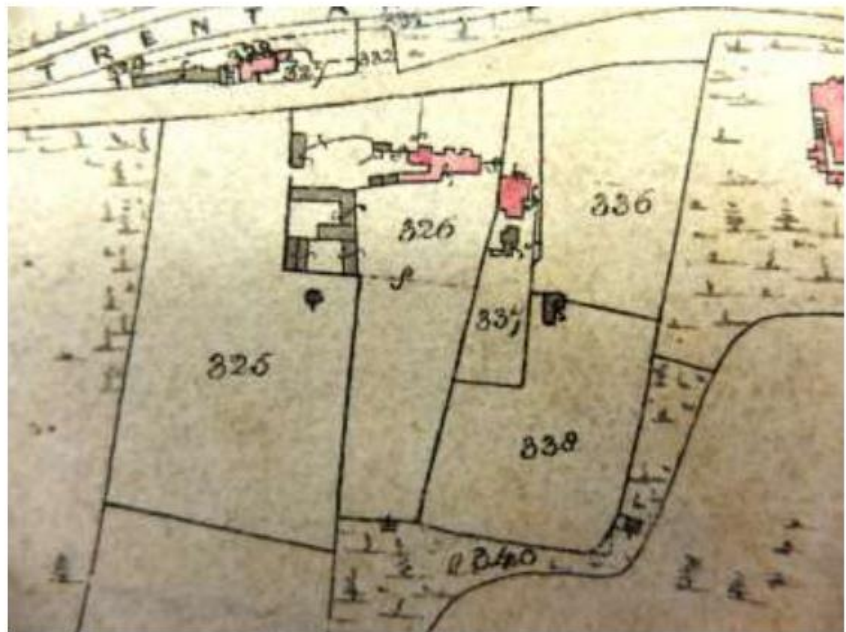
Figure 2 1841 Tithe Map Armitage with Handsacre; detail of Lower Lodge Farm, Staffordshire Records Office, Doc No D/5903/2/1

The earliest Cartographic evidence, 1841 Tithe Map, shows a plan form which is in line with the planform we see today. However, by 1884 the northern elevation had been added to by an extension on its west bay, this outline then continues until 1961 when it returns to its 1841 shape clearly showing the east and west porches. This is a result of its development from a farm to a restaurant and its various uses during the 18th and 19th centuries. It is also shown that the series of outbuildings to the south and west of the 17th century building has changed with only one building remaining.

Cartographic evidence suggests that originally the 17th century building had a cross gable extending from the rear of its western bay (Figure 2). This is confirmed externally by the presence of the upper part of the south wing and confirms that the 17th century building was L-shaped in plan. The south wing is still in existence by 1924 (Figure 5) but by 1988 it has been incorporated into the 20th century restaurant extension (Figure 7). The first-floor gable end is now only partially visible (Plate 2) as the south and west elevations of the building are now extensively obscured by later 20th century additions. Any remaining historic features are not visible.

During its life as a farm in the 1800's if not also the 1700's there were a series of outbuildings to the south and west of Spode Cottage as evidenced by the Tithe Map of 1841 (Figure 2). The outbuildings were in existence up to 1924 as seen on the 1924 OS Map (Figure 5), however, by 1961 (Figure 6) they had largely except for the L-shaped barn which is in existence today. It is possible that the proximity of the Trent and Mersey Canal from at least the mid-18th century gave impetus to the growth and expansion of the farm from its 17th century origins.

It is shown from the map evidence that the northern elevation has undergone various changes in outline, the 1841 Tithe Map shows an outline consistent with the current planform, with the two gabled porches and the eastern bay of the building being in existence by that date (Figure 2). However, over the subsequent years the map evidence indicates that the northern elevation of the original 17th century building could have extended outwards at the west end (see Figures 3, 4 and 5). Interestingly this is evidenced at the western end of the northern elevation by a series of horizontally placed openings that may have contained trusses to support an extension.

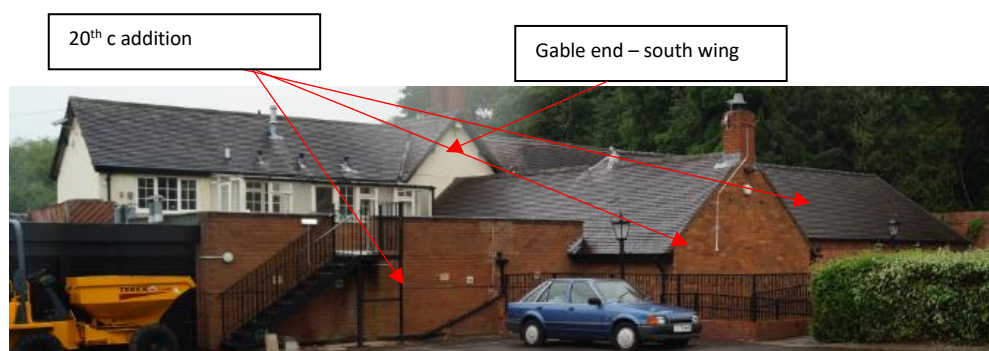
Plate 2. South elevation showing substantial 20th century additions

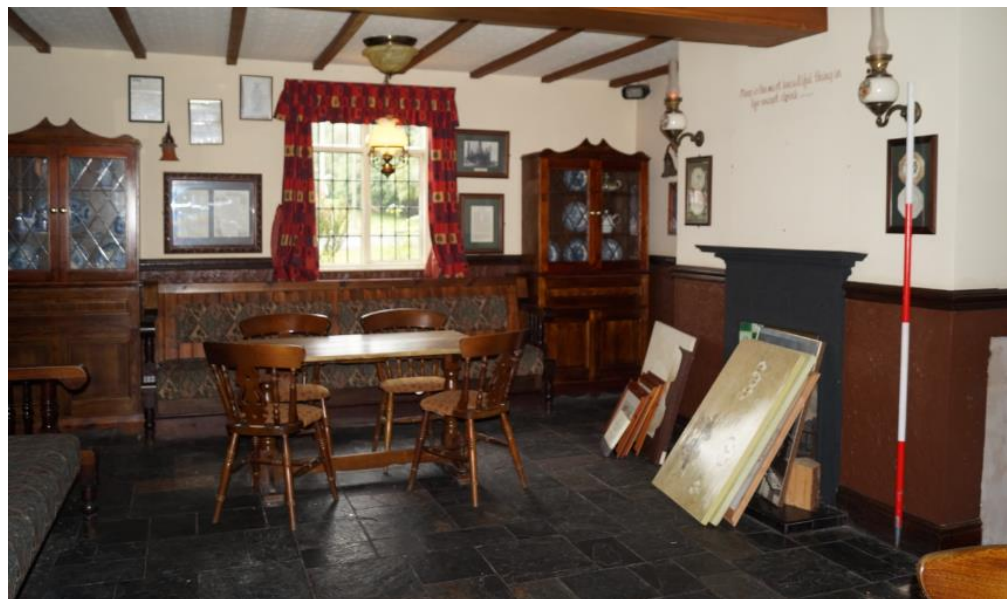
Room 1 Room one which represents the 19th century brick-built extension (eastern bay) has been significantly changed by 20th century additions with none of the original fabric visible. There is a replica fire place (Plate 4) and the windows are later replacements. Modern replica timber framed doorways lead through to the 17th century part of the building (Plate 5) and give access to the eastern porch which was being used as an area to store cleaning items. No early fabric was visible in the eastern porch (Plate 6).

Plate 3. Room 1 in eastern bay shows 20th century additions

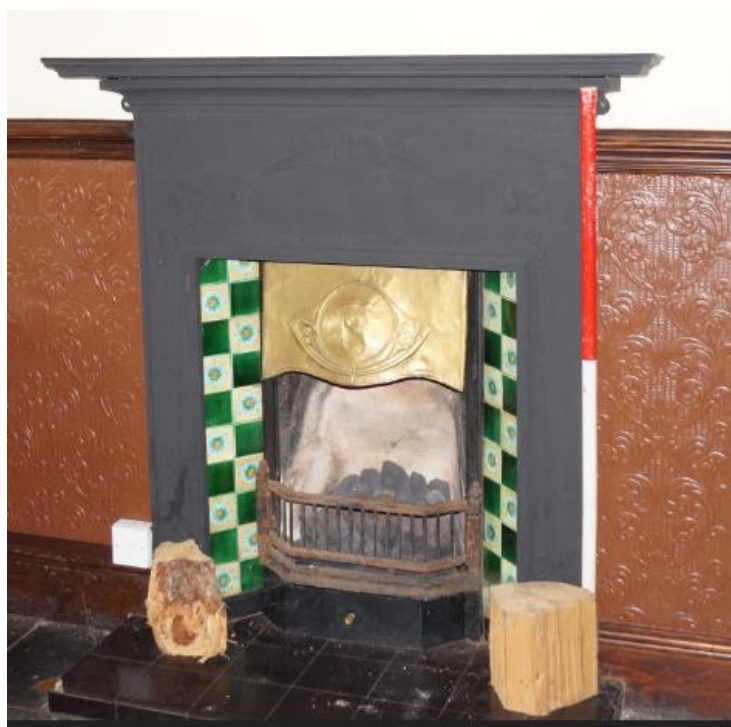
Plate 4. Replica fire surround

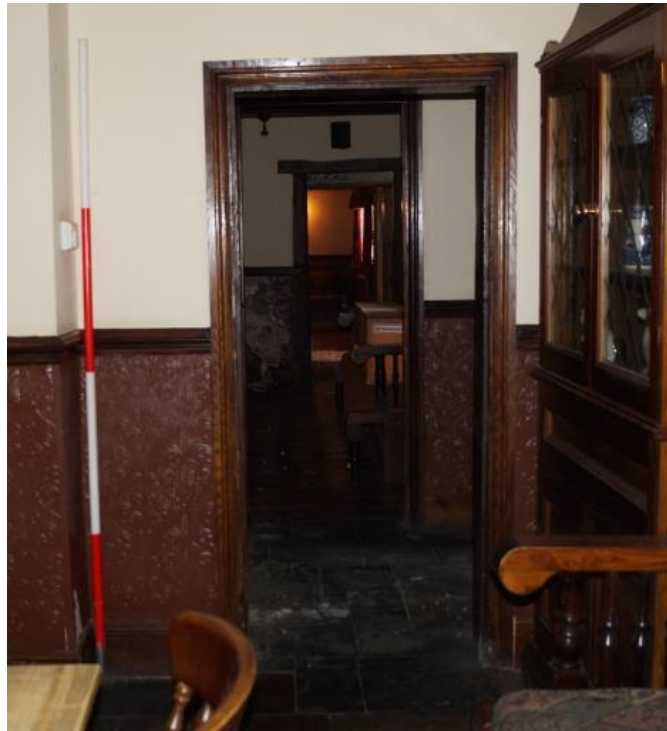
Plate 5. Room 1 doorway to original 17th century building from 19th century addition (eastern bay)

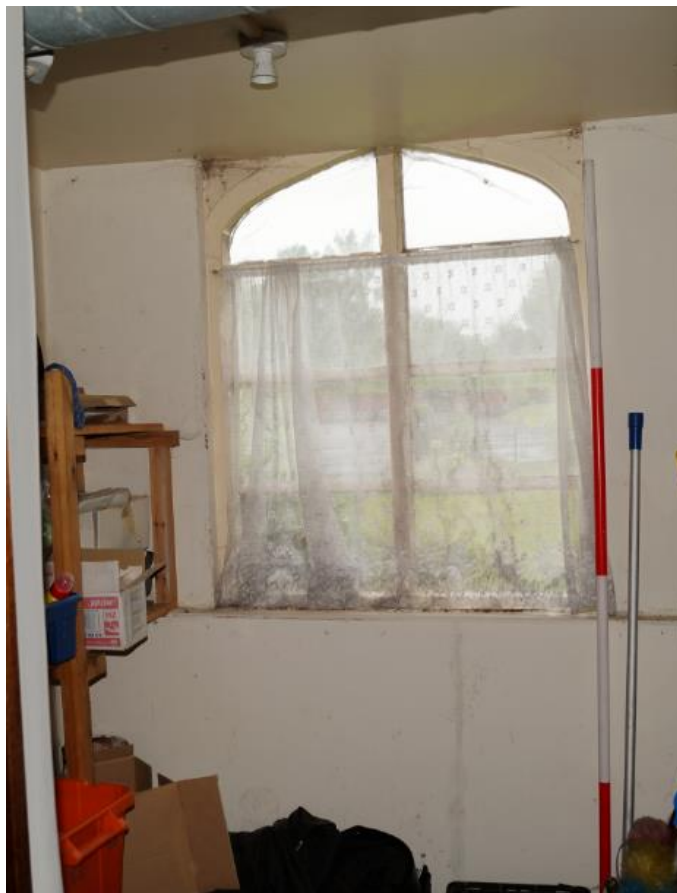
Plate 6. Eastern porch

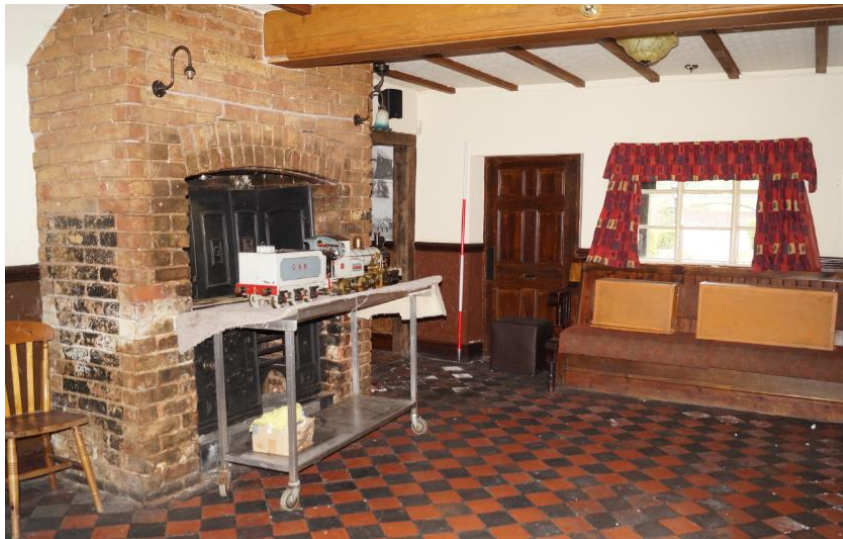
Room 2 forms the eastern bay of original the 17th century building. The chimney stack is located on its western side and has had modern refurbishments represented by new brickwork and the insertion of a replica, 19th century oven (Plate 8) . The main axial beam has been boarded over. The black and red quarry tiled floor is likely to be part of a 19th century refurbishment. (Plate 7)

Plate 7. View of room 3 showing original front entrance

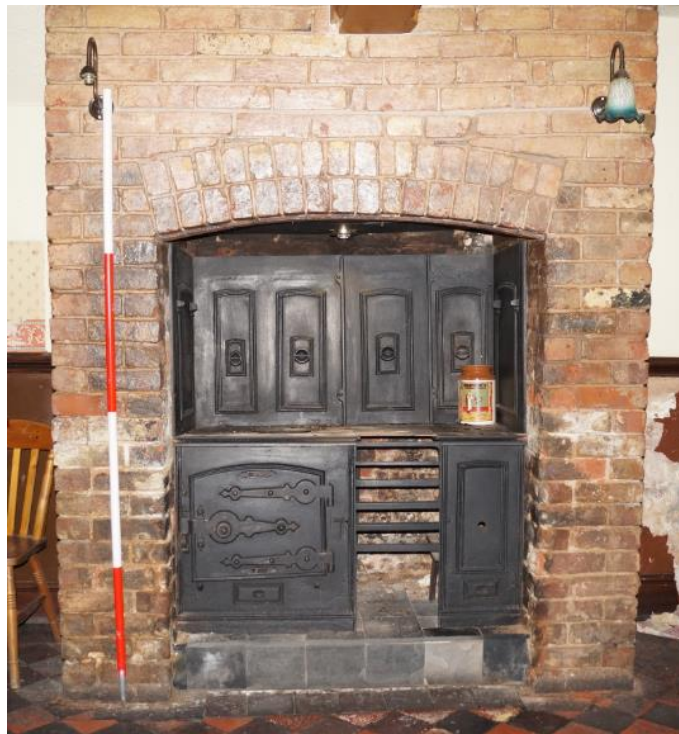
Plate 8. Central chimney stack located in room 7 of 17th century building.

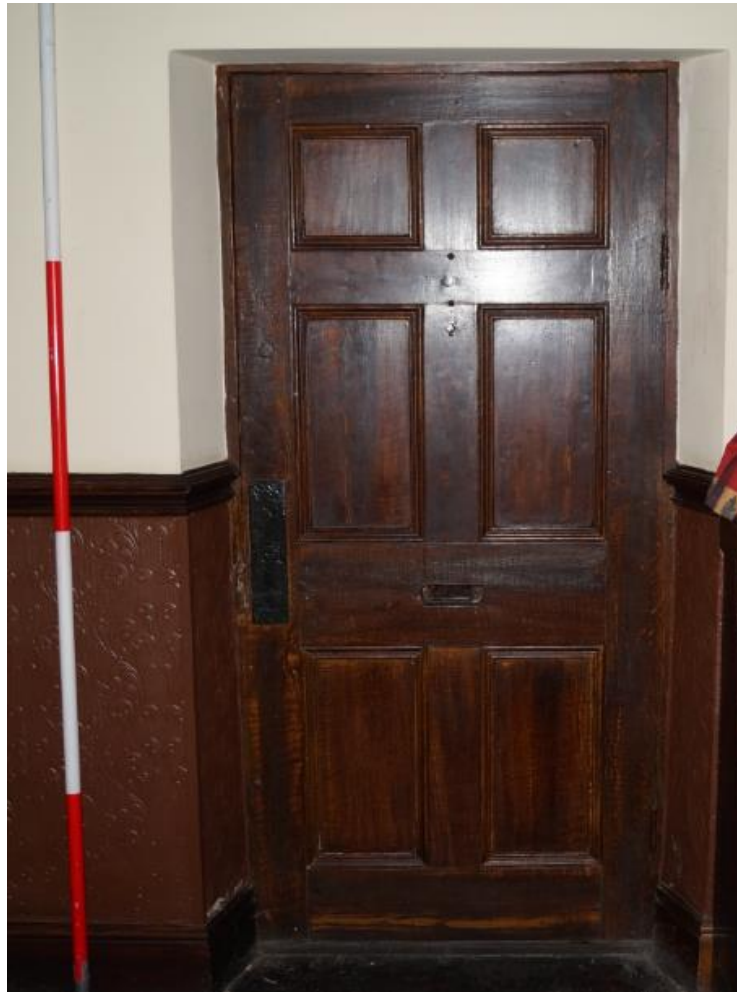
The doorway in the north elevation of room two is likely to be a later addition to form a new main entrance to the 17th century building. Given its location towards the centre of the front elevation of the 17th century building it is likely that it replaced the original main entrance made obsolete by the addition of the western porch (Plate 9).

Plate 9. Later 19th century entrance in north elevation of 17th century building

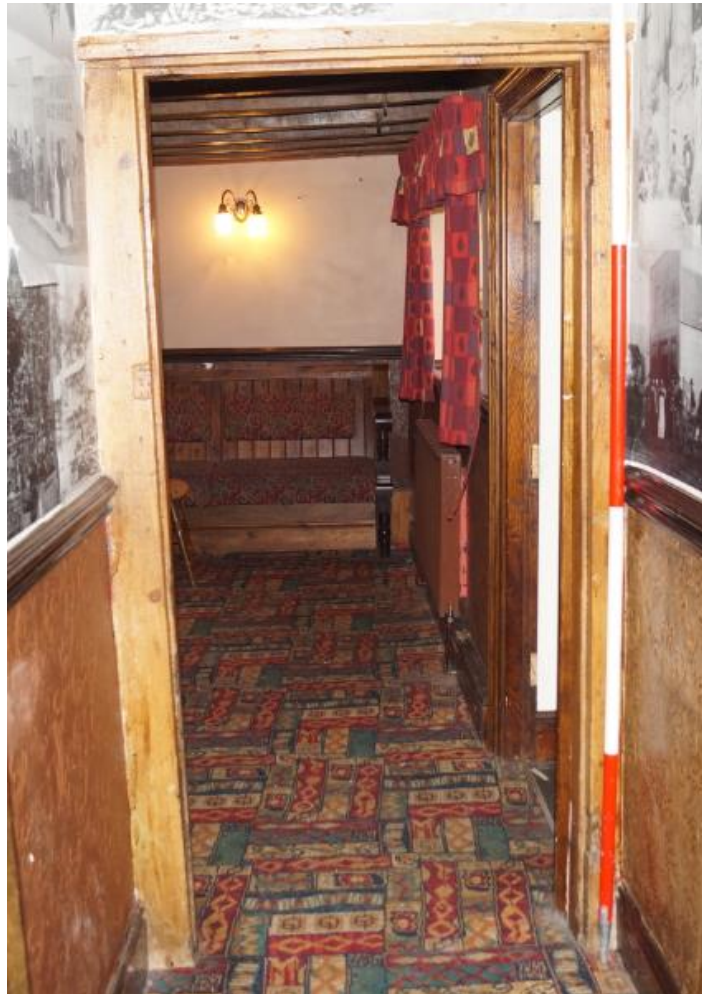
Plate 10. Doorway showing original timbers in passageway linking Room 2 to 3

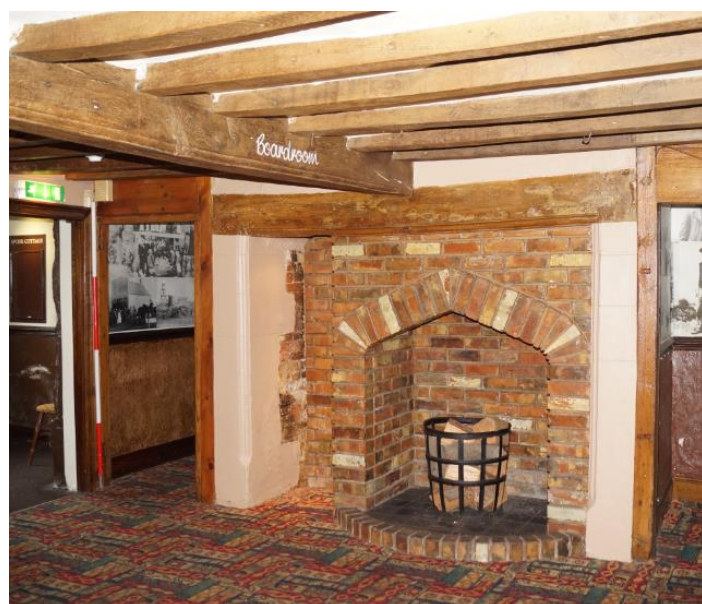
Room 3 is extensively covered by later additions; the fireplace appears to be original but has been painted and a brick façade inserted (Plate 11). The ovolo mouldings on the inner edge of the stone fire surround match that of the wooden beam over the fire opening and the main axial beam is visible and aligned west-east (Plate 13). The exposed timber framing forming the south partition of Room 3 had been re-used as evidenced by the presence of mortices and peg holes that did not align with the beams and studs (see Plate 14).

Plate 11. Room 3 fireplace and timbers showing modern brick insert

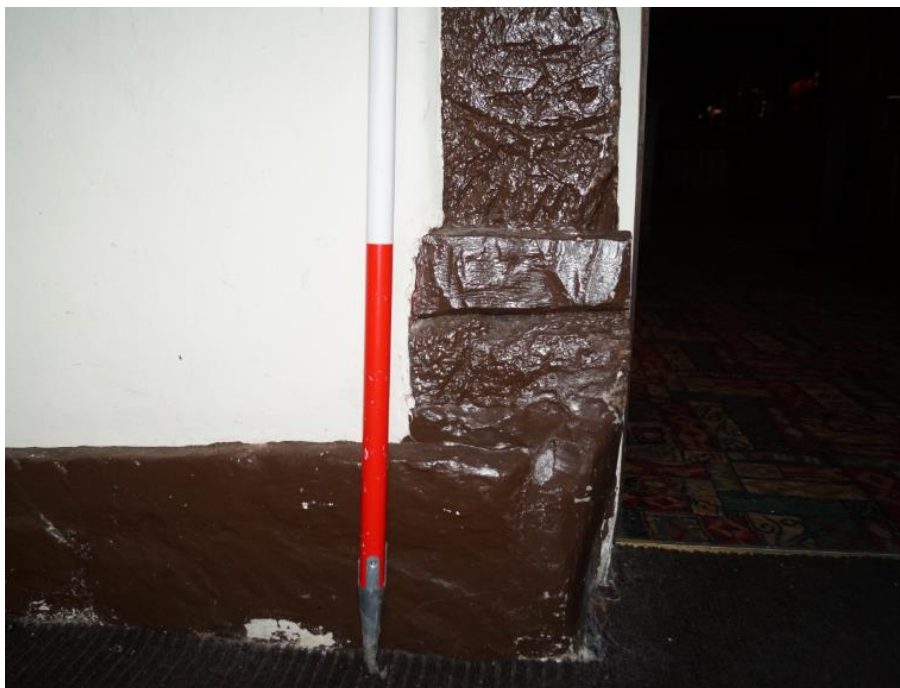
Ground Floor On the front elevation of the 17th century building there is an entrance via the western porch which gives access to the western side of the 17th century building. The doorway looks likely to be the original entrance to the building as the timbers look to be authentic (Plate 12). The doorway leads directly onto the significant, centrally located chimney stack and forms a “baffle” entry with the stairs located on the opposite side of the central stack.

Plate 12. Western porch - original timbers of original 17th century entrance visible

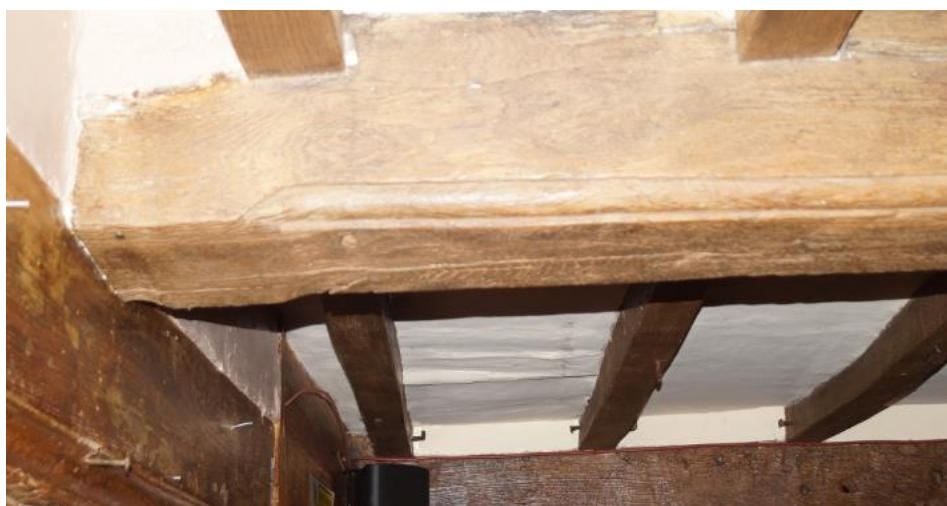
Plate 13. Room 3 axial beam visible, likely to be original.

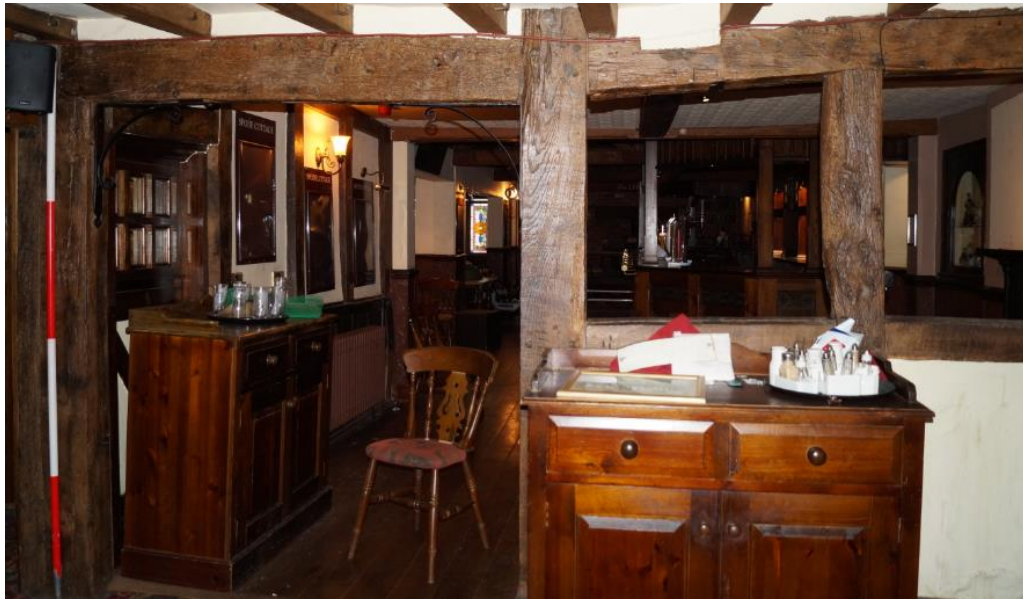
Plate 14. Re-used exposed timber partition in Room 3

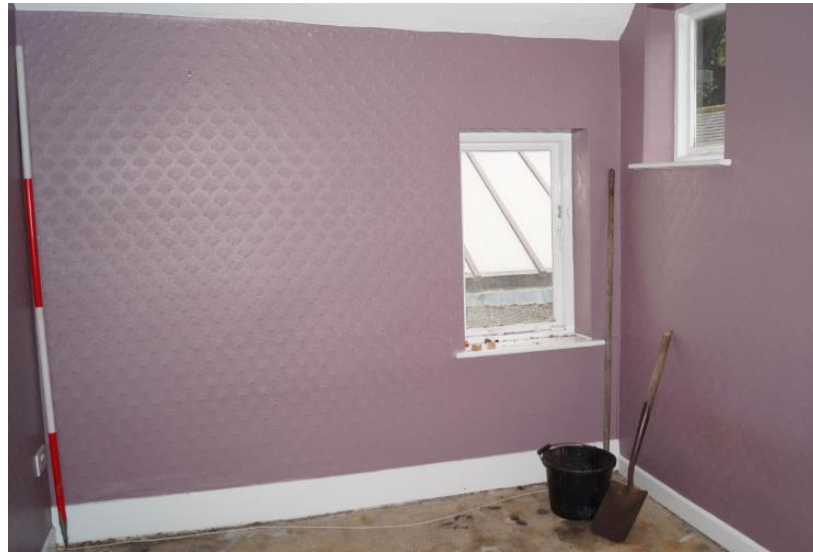
Room 5 – which is part of the 17th century building represents the first-floor room of the original 17th century south-wing (incorporated at ground level into the modern restaurant extension). There was no evidence of any historic fabric visible in room 5. (Plate 17). The remainder of rooms accessed via a hallway in the western bay, from the 20th century extension.

Plate 17. Room 5 – bedroom in south wing of western bay, no historic fabric is visible

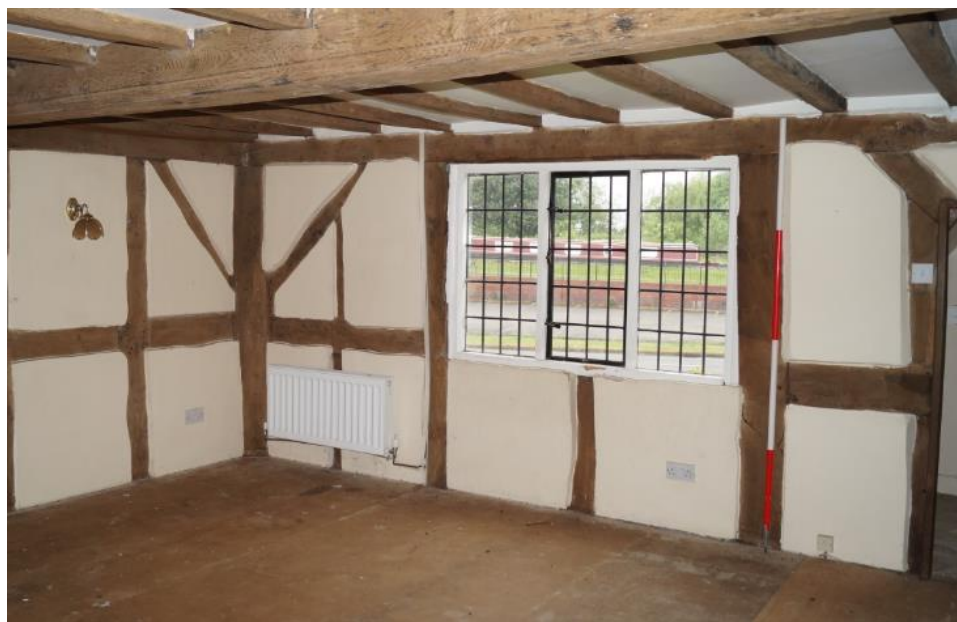
Room 6 had extensive timber framing in situ visible on the western wall. The stone fire surround may have been an original and has a modern gas fire inserted (Plate 19).

Plate 18. Room 6 showing original timbers

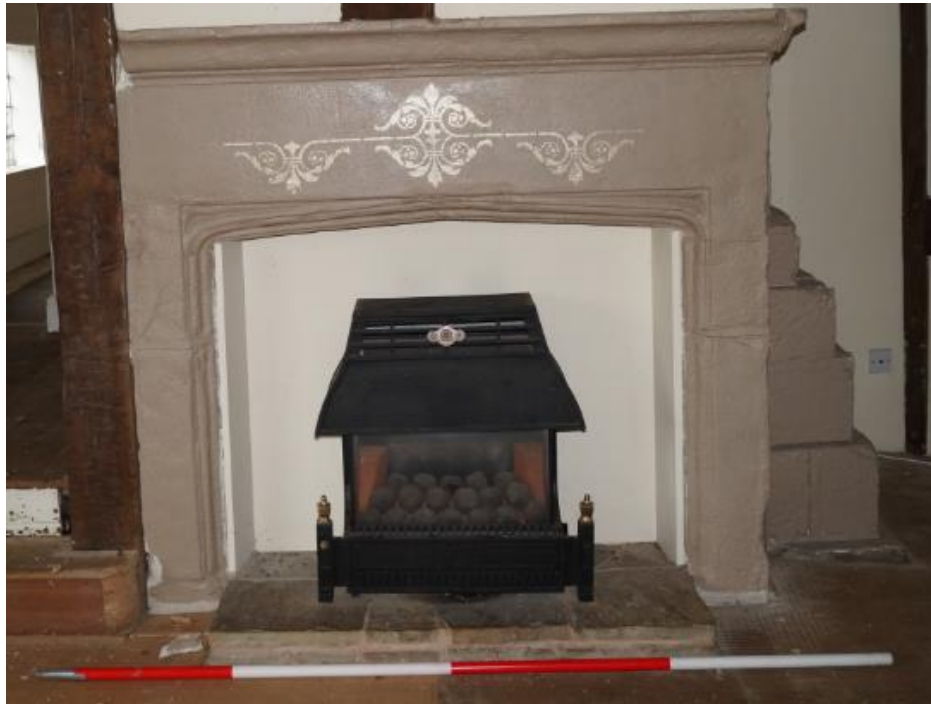
Plate 19. Room 6 fire surround, possible later addition with modern fire inserted

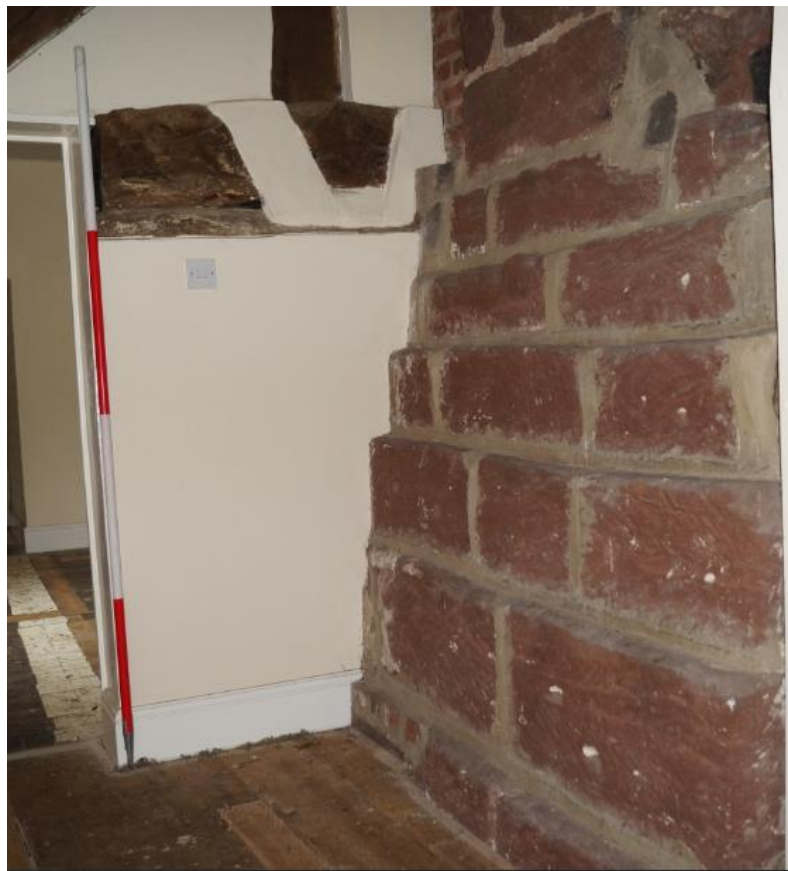
The large central chimney stack between Rooms 6 and 7 is constructed of large sandstone blocks surmounted by corbelled brickwork (Plate 20). The brickwork was most likely a 19th century addition to the 17th century stone stack. A narrow door located to the side of the upper part of the exposed chimney stack gives access to the roof void which contains the original roof beam (Plate 21).

Plate 20. North side of chimney stack in passageway between rooms 6 and 7

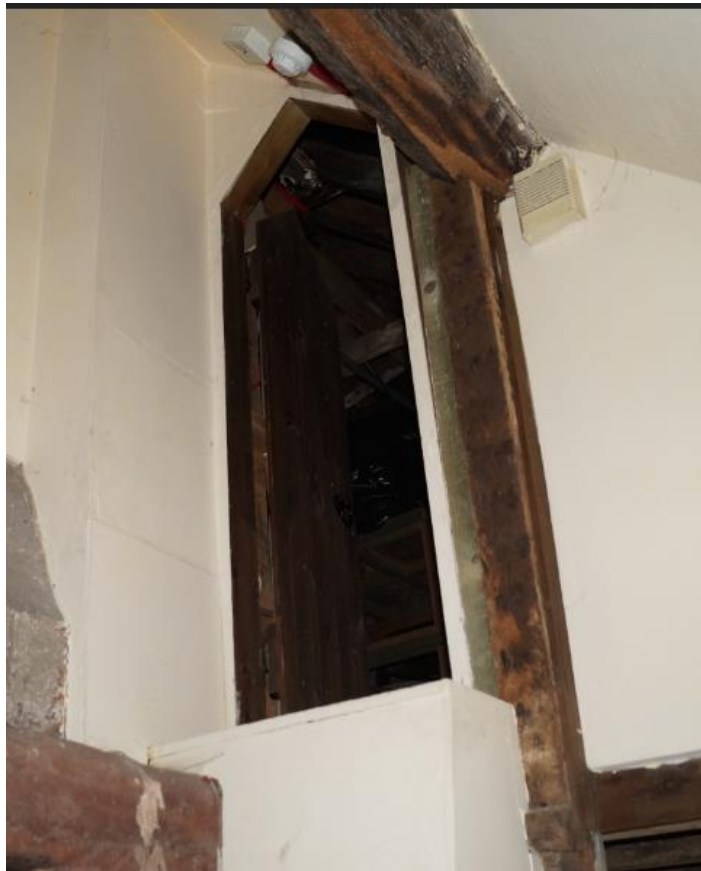
21. Doorway to roof void on northern side of chimney stack

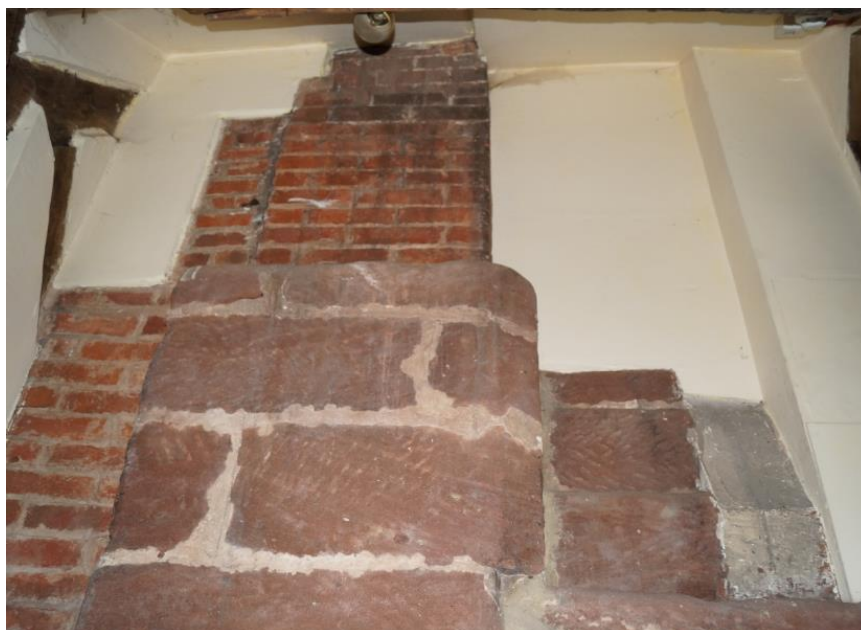
Plate 22. Northern side of chimney stack showing later brick corbelling

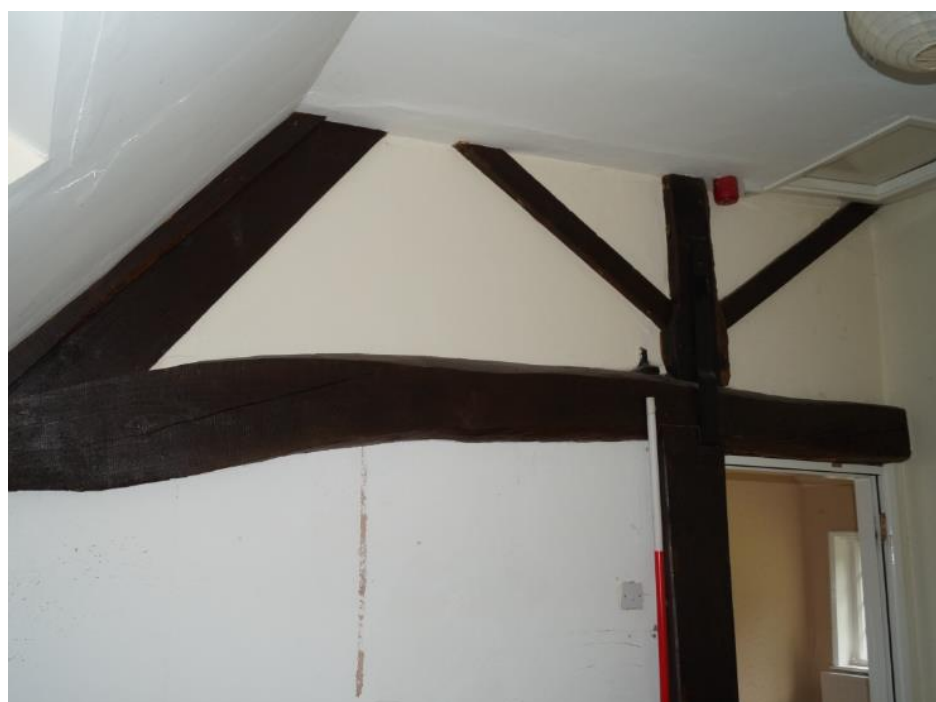
- Room 8** Room 8 is the first of the rooms which forms the eastern bay of Spode Cottage Public House and represents the later 19th century addition to the 17th century building. Partially visible in Room 8 is the base of a truss and tie beam which formed the original roof timbers. Although truncated by a modern false ceiling the original timbers show that the 17th century roof construction was of King post design. (see Plate 23) On all other walls of the room the original framing is obscured behind modern decoration .

Plate 23. Room 8, truss and tie beam truncated by modern ceiling

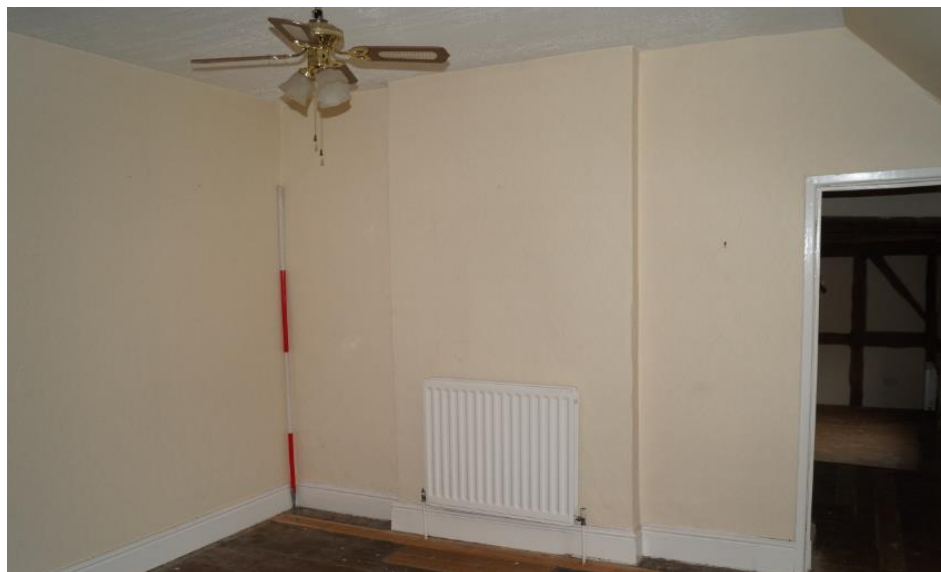
- Room 7** Room 7 which is located in the central bay of Spode Cottage Public House and forms the western side of the 17th century building, is accessed by passing the central chimney stack on its north side through an opening/hallway (Plate 20). The east wall of this room was the end wall of the 17th century building and any timber framing that still exists is completely obscured by modern decoration and repairs. (Plate 24).

Plate 24. Room 7 – 20th century additions obscuring any historic features

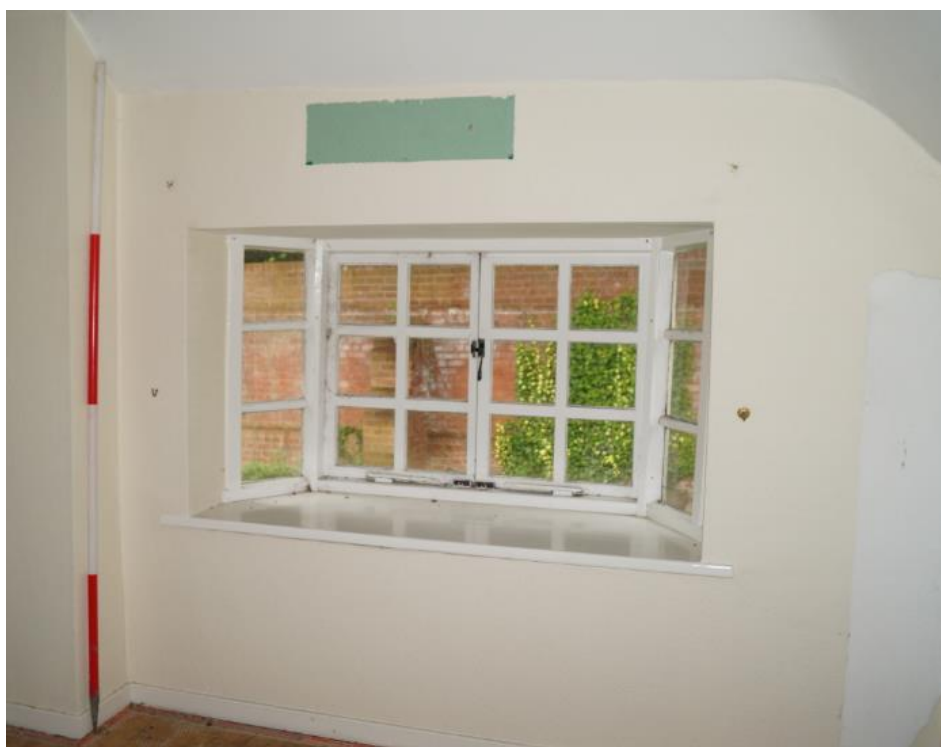
- Room 9** Room 9 is the second of the rooms which forms the eastern bay of Spode Cottage Public House. Of some interest, is a window in the eastern elevation of Room 9 with characteristic 19th century splay reveals, the window itself is probably a later replacement (Plate 25). An adjoining wing to the south elevation of Room 9 is part of the 20th century additions and comprises a dressing room with en-suite and is of no historical interest (Plate 2).

Plate 25 Room 9 - 19th century window with 19th century splay reveals

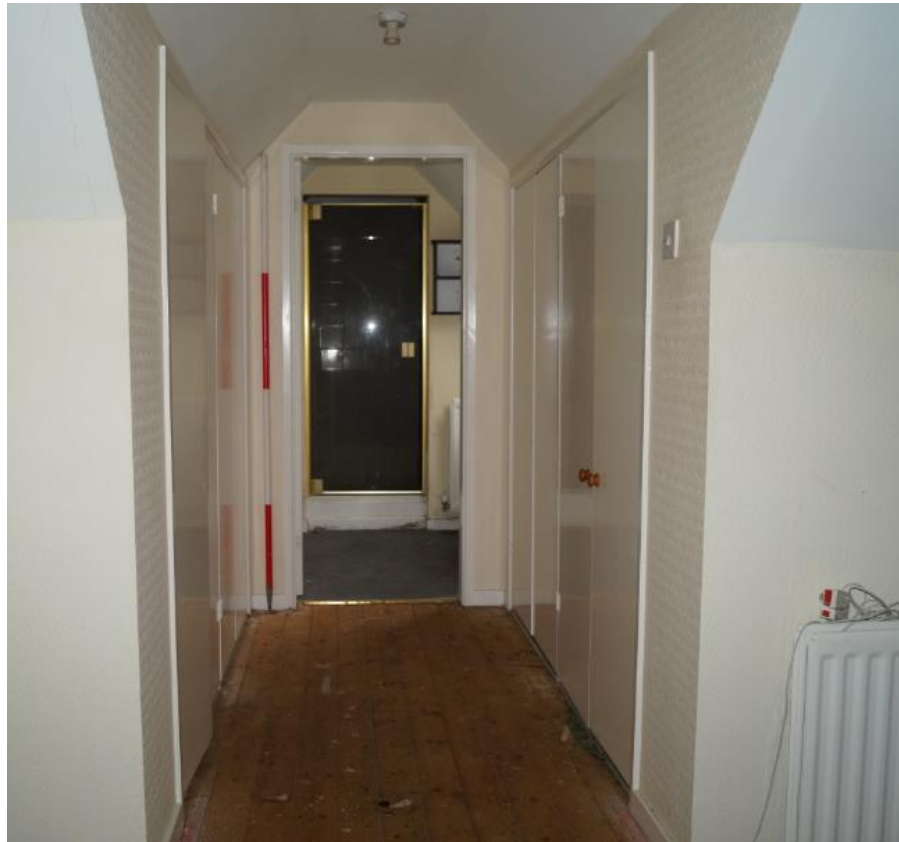
Plate 26. 20th Century additions comprising dressing room and ensuite
