OLD ORME BOYS' SCHOOL, ORME ROAD,  
NEWCASTLE UNDER LYME.

BUILDING RECORDING REPORT

PART 2

CATALOGUE OF PLATES.

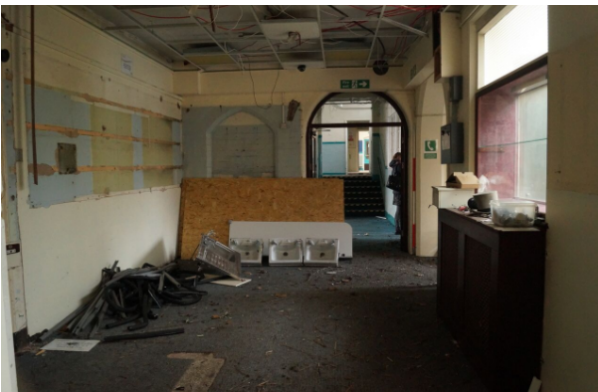
Plate 2. Mid to late 19<sup>th</sup> century entrance hall showing an existing arch and one blocked, pointed arch. Modern ceiling with wiring. Blocked arch possible entrance to the original mid-19<sup>th</sup> century school. New arch probably inserted during phase of later 19<sup>th</sup> century expansion. **8**

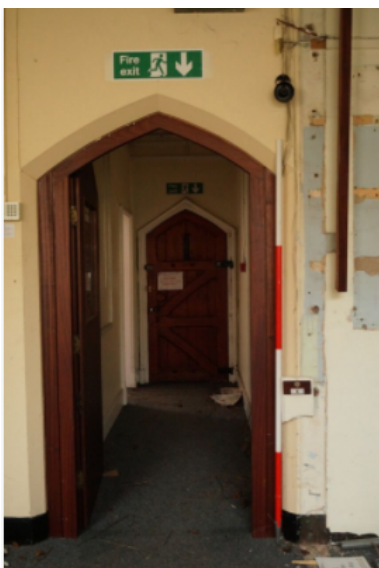
Plate 3. View towards entrance to master's house opening onto Higherland, part of the original mid-19<sup>th</sup> century school. **9**

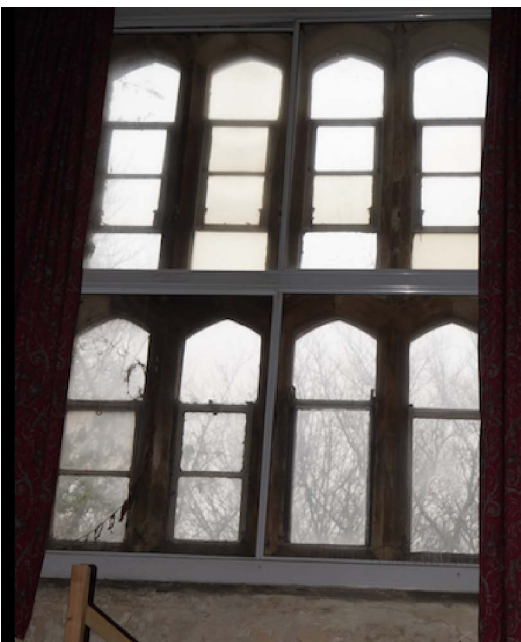
Plate 9. Example of lancet arched windows in the eastern elevation of the main hall with stone mullions and central transom. Hopper windows above and below transom, possibly original. Interior faced by modern UPVC secondary glazing. **26**

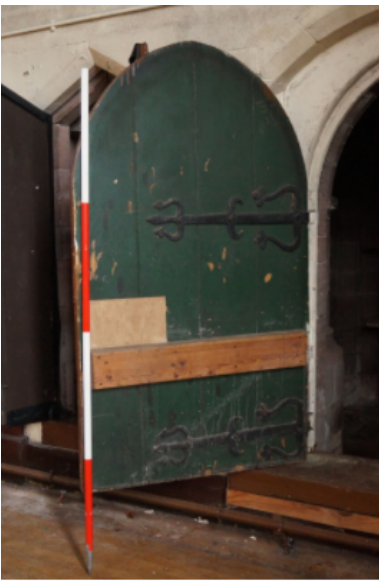
Plate 11. Detail of original doorway to porch showing original gothic revival style door with decorated strap hinges. **20**

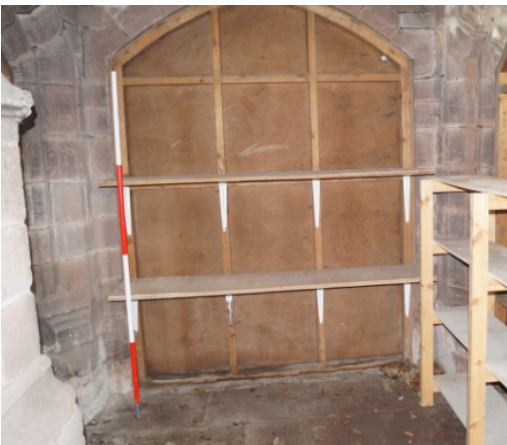
Plate 12. Detail of blocked archway in porch. The arches in the porch were originally open. **21, 22**

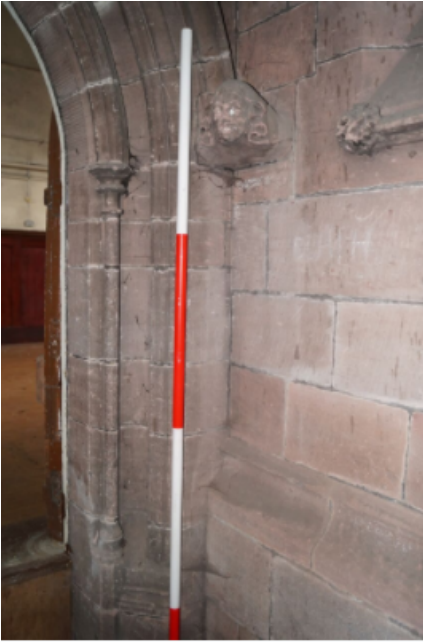
Plate 13. Detail of gargoyle decoration in the porch. 23

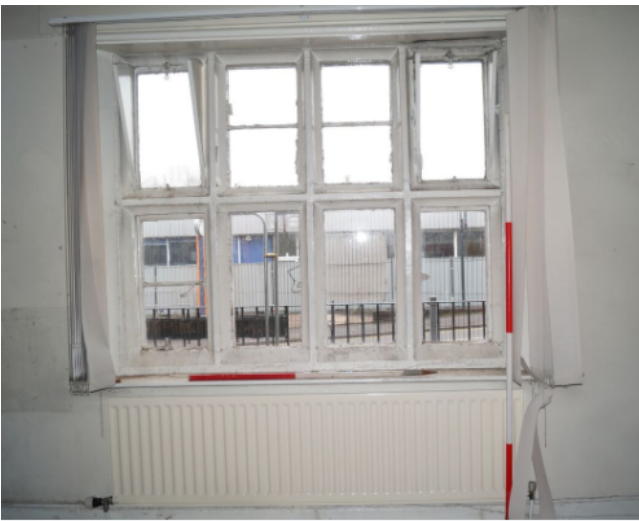
Plate 14. Shot of original stone mullioned window in Office 1 (the master's house). Window is divided by a central transom with four fixed lights below transom and two hopper windows either side of two fixed lights above transom. Stone probably painted white as part of later modernisation. 31

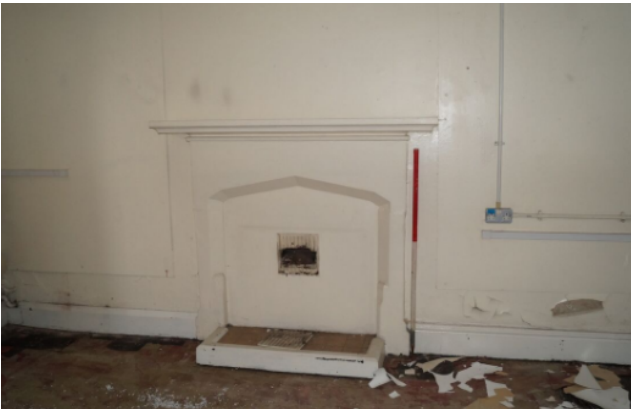
Plate 15. Office 2 (the master's house), original moulded stone fire surround with mantle. Fire place now blocked up with central vent remaining, probably as a result of modernisation. 32

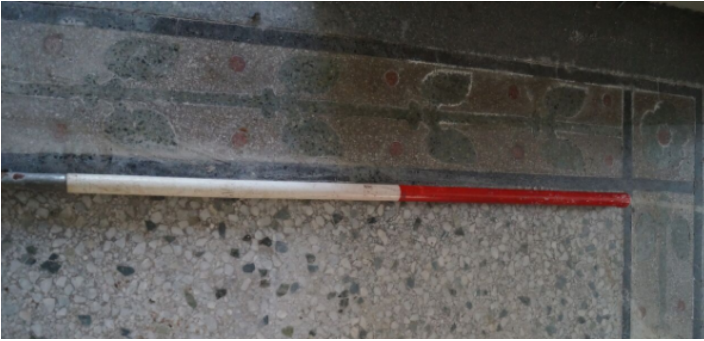
Plate 22. Detail of polished stone floor in upper corridor. 53

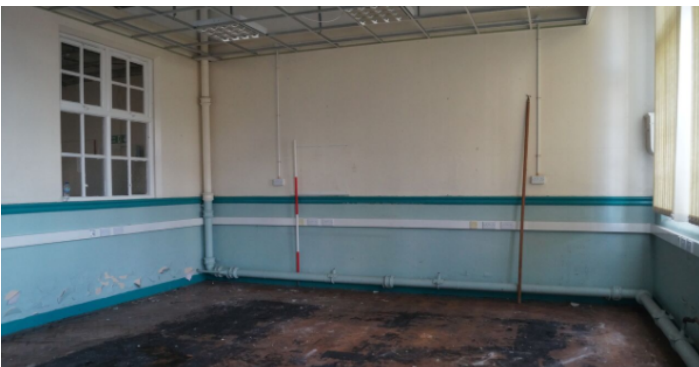
Plate 23. General view of Classroom 3 showing same decorative theme which characterises the Edwardian phase of the school. Window on left looks into upper corridor. Parquet flooring extant. 58

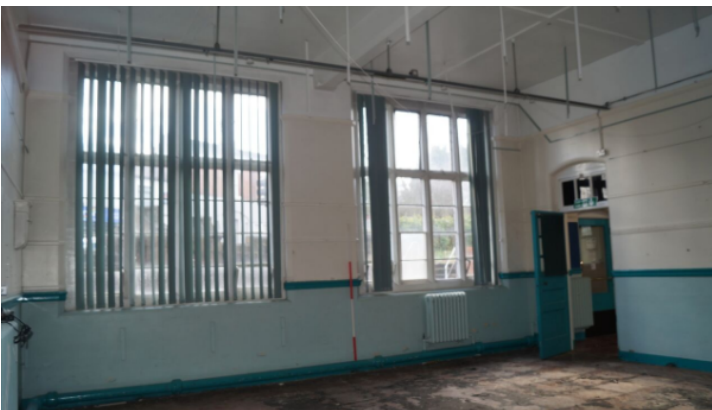
Plate 24 General view of Classroom 5, showing early Edwardian stone windows with fixed lights interspersed with hoppers. Parquet flooring extant. 61

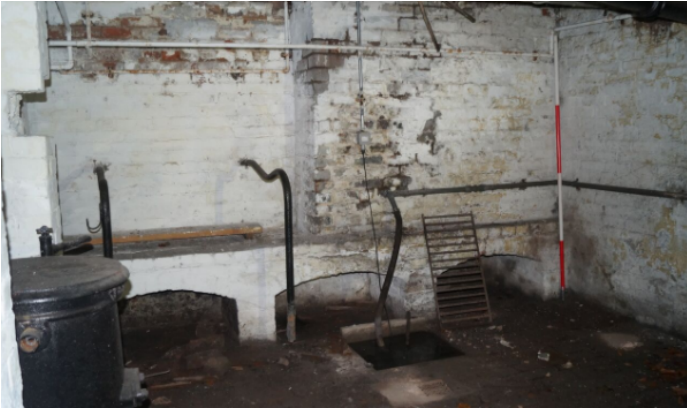
Plate 25. General view of basement showing arched brick flues/vents. 104,

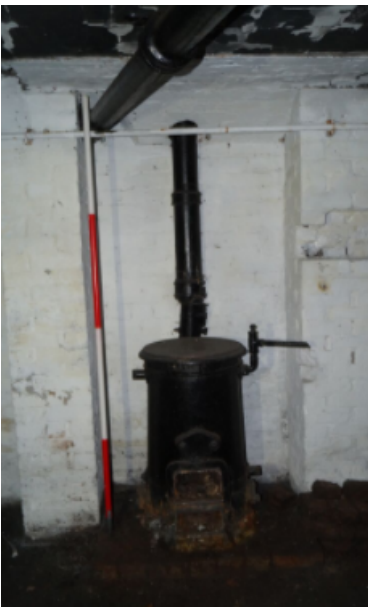
Plate 26. Cast iron stove in basement. 106

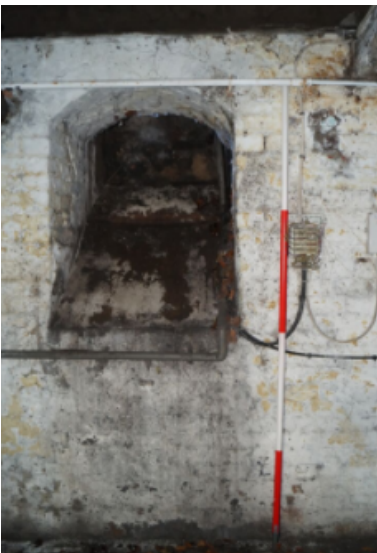
Plate 27. Coal chute in basement. 108

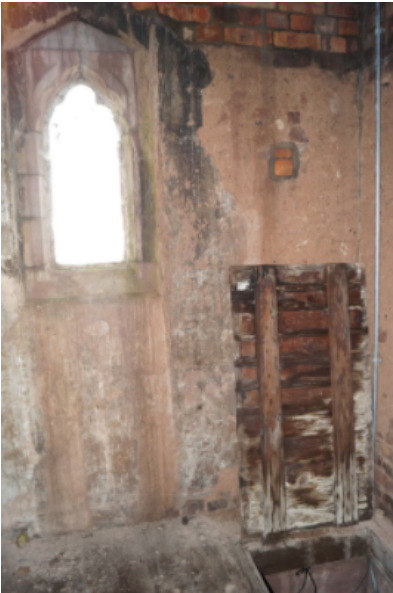
Plate 29 View into turret room showing wooden hatch in floor. **115**

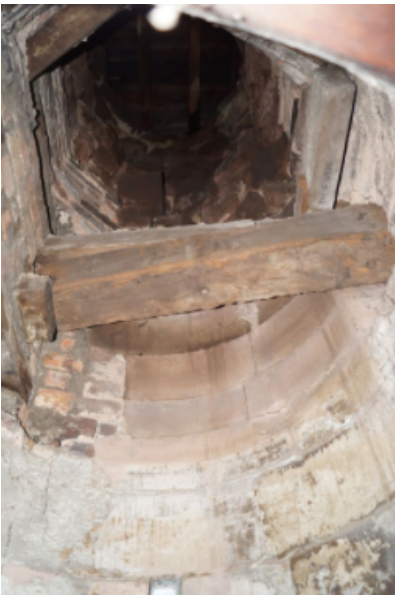
Plate 32. View up into turret roof. It could not be ascertained with certainty whether the tower contained a bell. If it did this might explain the function of the hatch through which bell ropes may have been dropped. [122](#)

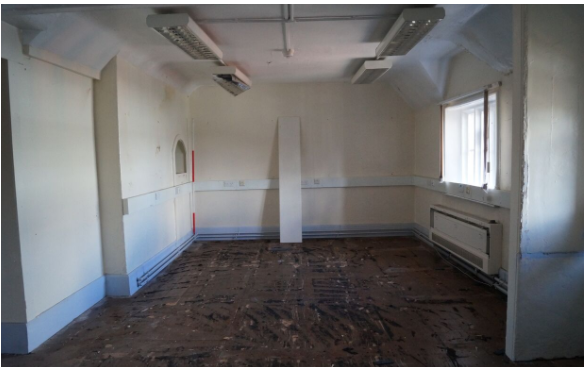
Plate 36. General view of Office 3 on first floor adjacent to the landing, original beam partly obscured by modern additions. 86

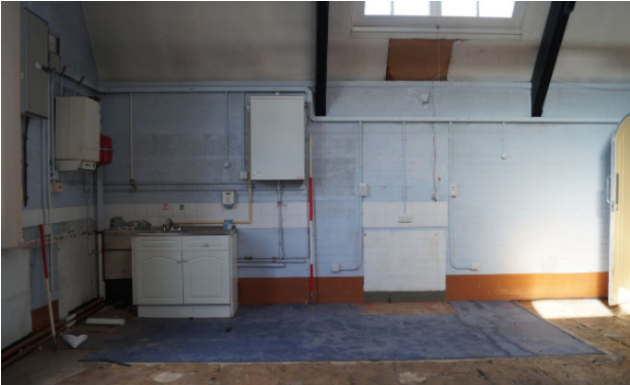
Plate 41. General shot looking from Classroom 8 into Classroom 1. Shows pointed arch doorway and ceiling beams obscured by modern additions. [94](#)

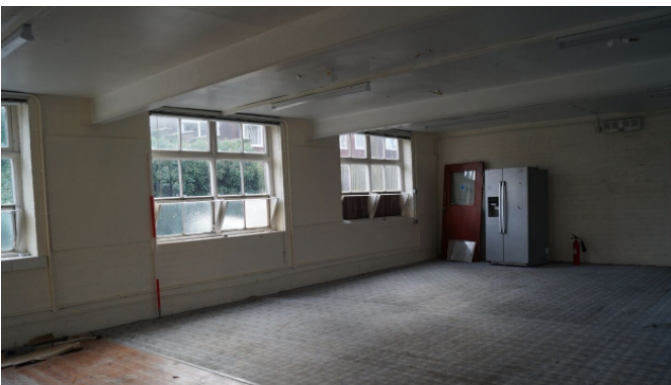
Plate 55. Office off main entrance. 127

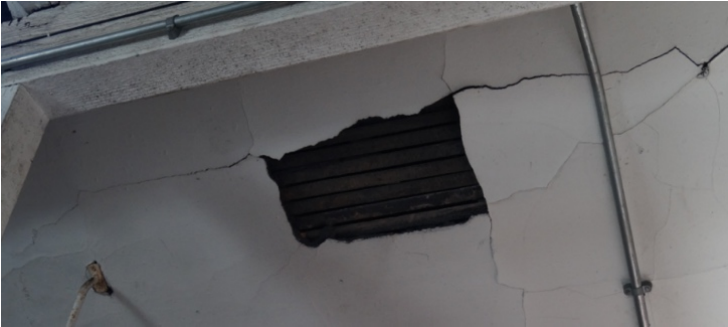
Plate 65 Storage room.  
150

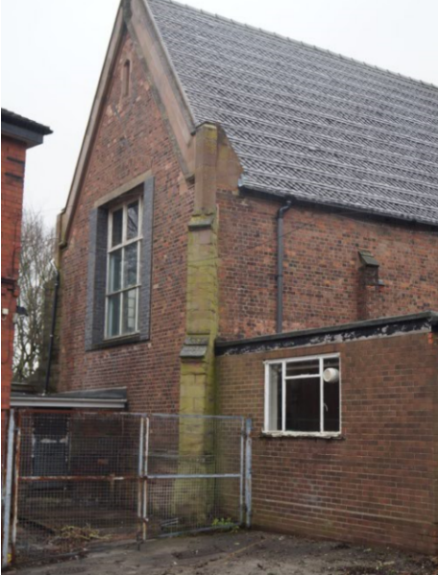
Plate 69. View of north west facing elevation of mid-19<sup>th</sup> century main hall showing detail of sandstone buttressing and blue brick window jambs..

To the fore is the 1970s kitchen block.

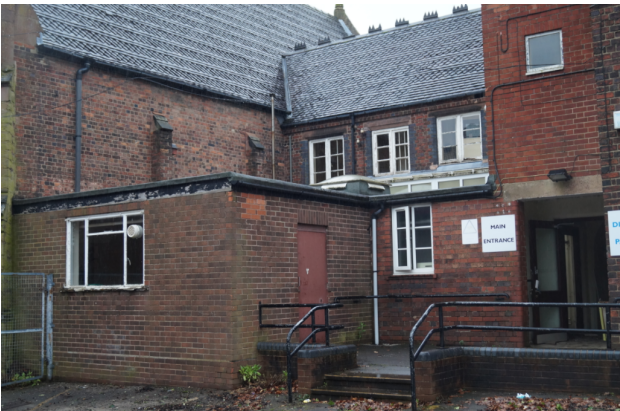
Plate 70. The rear of the mid-19<sup>th</sup> century building showing first floor of the master's house with later Edwardian additions in red-brick.

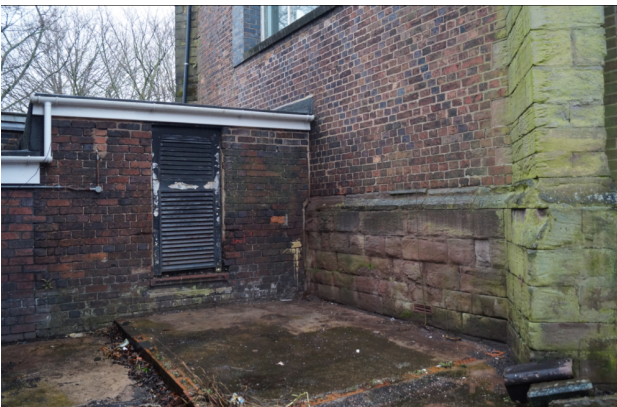
Plate 73. Boiler room which appears on the 1878 OS map (Figure 6).

Diapering on the main hall elevation is visible.

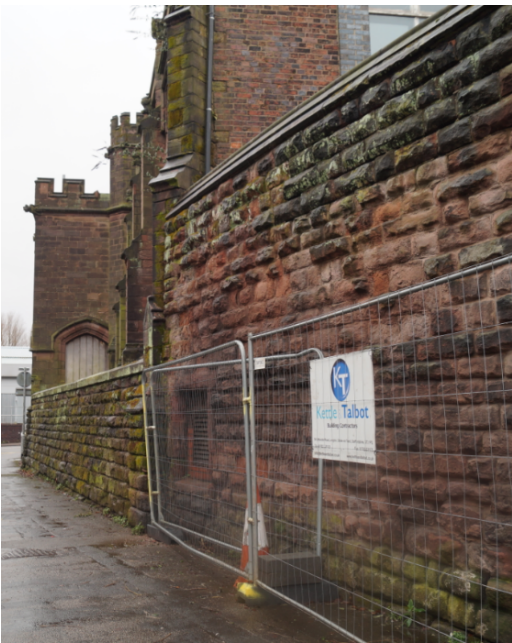
Plate 79. Rusticated sandstone wall on Orme Road, behind the wall is the basement boiler room. The window in the wall suggests the wall and boiler room once formed one building.

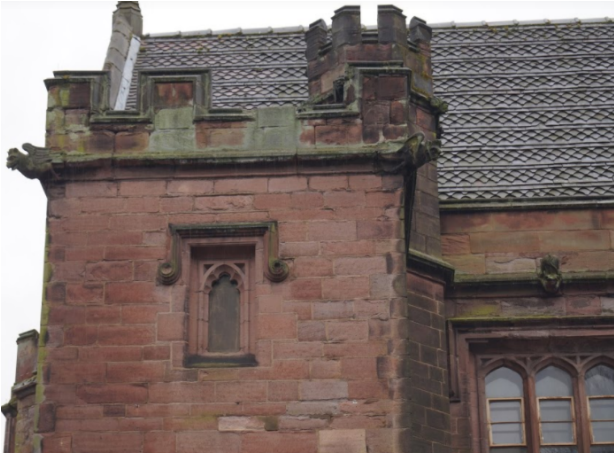
Plate 81. Detail of upper part of porch and turret showing lancet window with hood mould.

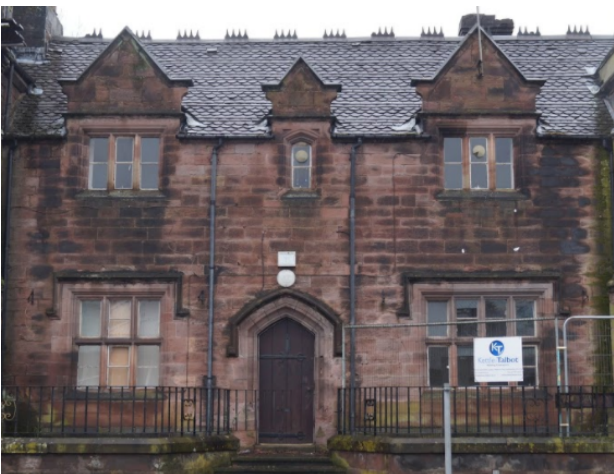
Plate 83 Front elevation of master's house showing detail of roof ridge cresting, dormer windows and pointed arch entrance with hood label.

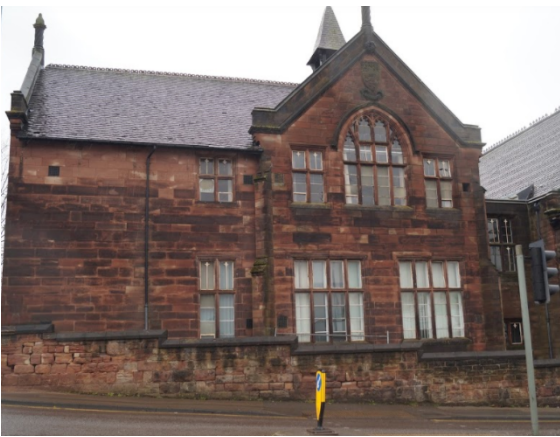
Plate 85. Detail of front elevation of Edwardian extension. The sandstone ashlars are markedly different in appearance to those of the earlier 18<sup>th</sup> century build.

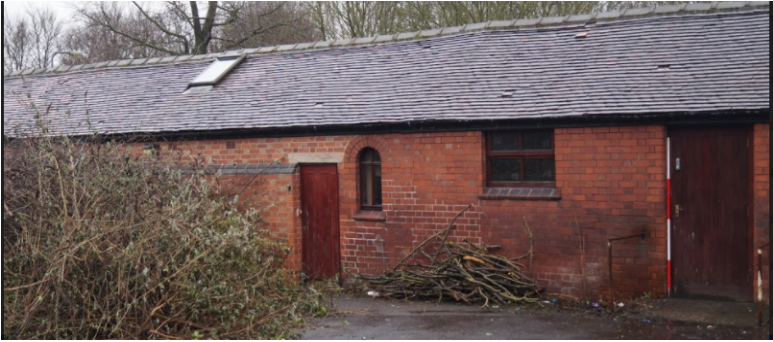
Plate 94. South west (front) elevation of the ancillary building showing detail of windows and doorways. To the left the Edwardian phase of the ancillary building adjoins the 1970s extension.
