OLD ORME BOY'S SCHOOL, ORME ROAD,
NEWCASTLE UNDER LYME

BUILDING RECORDING REPORT – LEVELS 1,
2 AND 3

CLIENT: KETTLE AND TALBOT

APRIL 2018

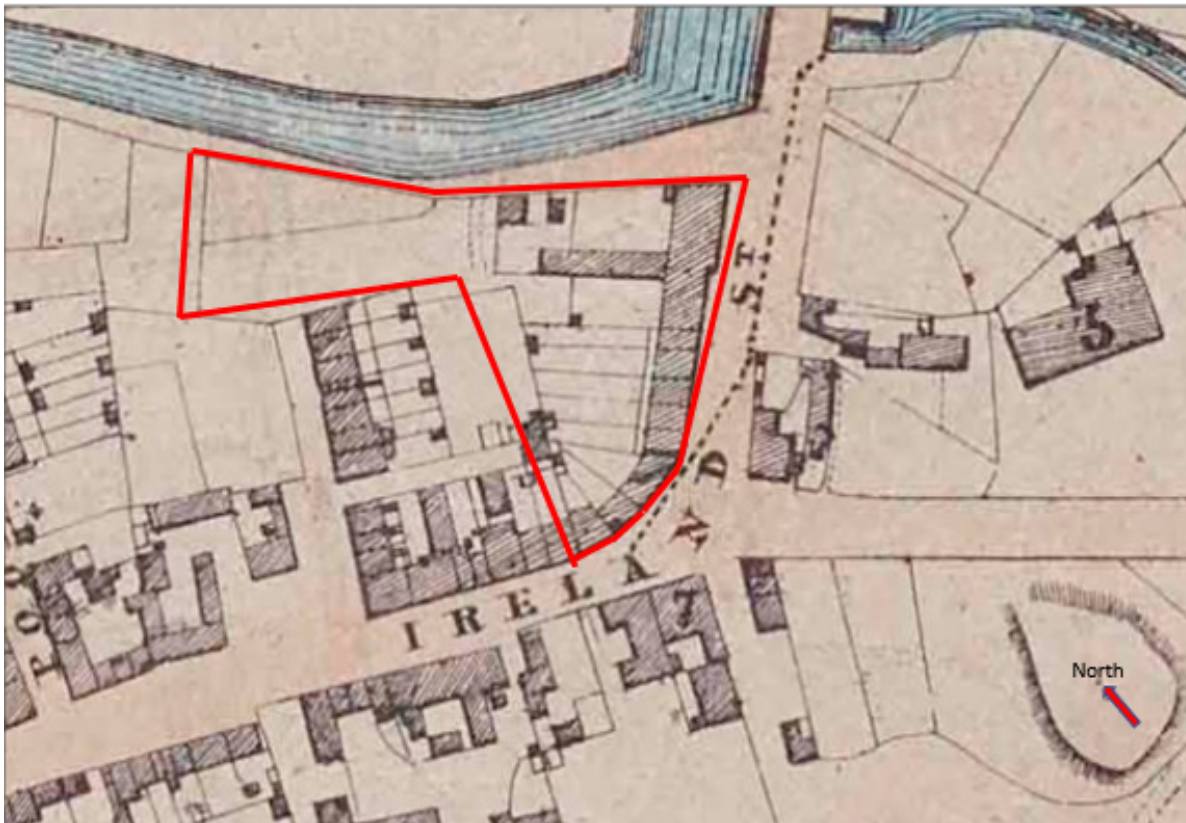
5.15 Figure 2 -1847 -Robert Malabar map of the Burgess lands

The map shows a T-shaped building occupying the north east part of the site. The building comprises one range aligned north east to south west fronting onto what is shown on the map as *Ireland St* (now *Higherland*) A second range extends in a roughly north west to south east alignment from the rear of the range fronting the street.

It shows Pool Dam running close to the north east boundary of the site. The map also shows, within the site boundary, a number of terraced dwellings fronting onto Ireland St with long linear back plots to their rear.

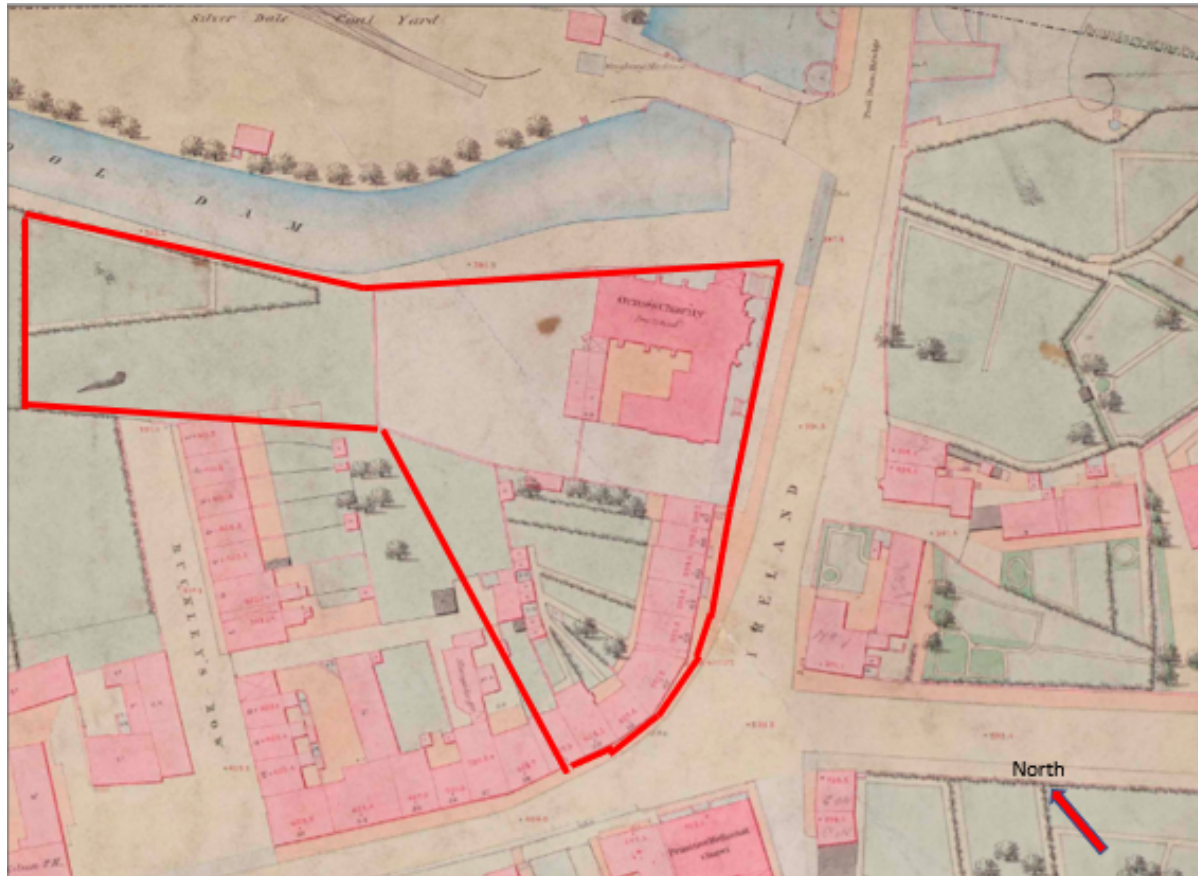
5.16 Figure 3 - Board of Health Cholera Map based on 1851 OS Map

By the time of the 1851 Cholera Map, based on the 1851 OS Map, the site had undergone some radical changes with the removal of the earlier T-shaped building and the appearance of the Orme Boys' School. The school building, which is depicted as a courtyard plan, is referred to as *Orme's Charity (free school)*. The building comprises four ranges with the north east range depicted with buttressing, porch and bay window.

Attached to the corner of the south west elevation is a structure depicted in a lighter pink colour which the accompanying map key denotes as a *covered walkway*. The courtyard area is denoted in a yellow colour which the key records as brick paving.

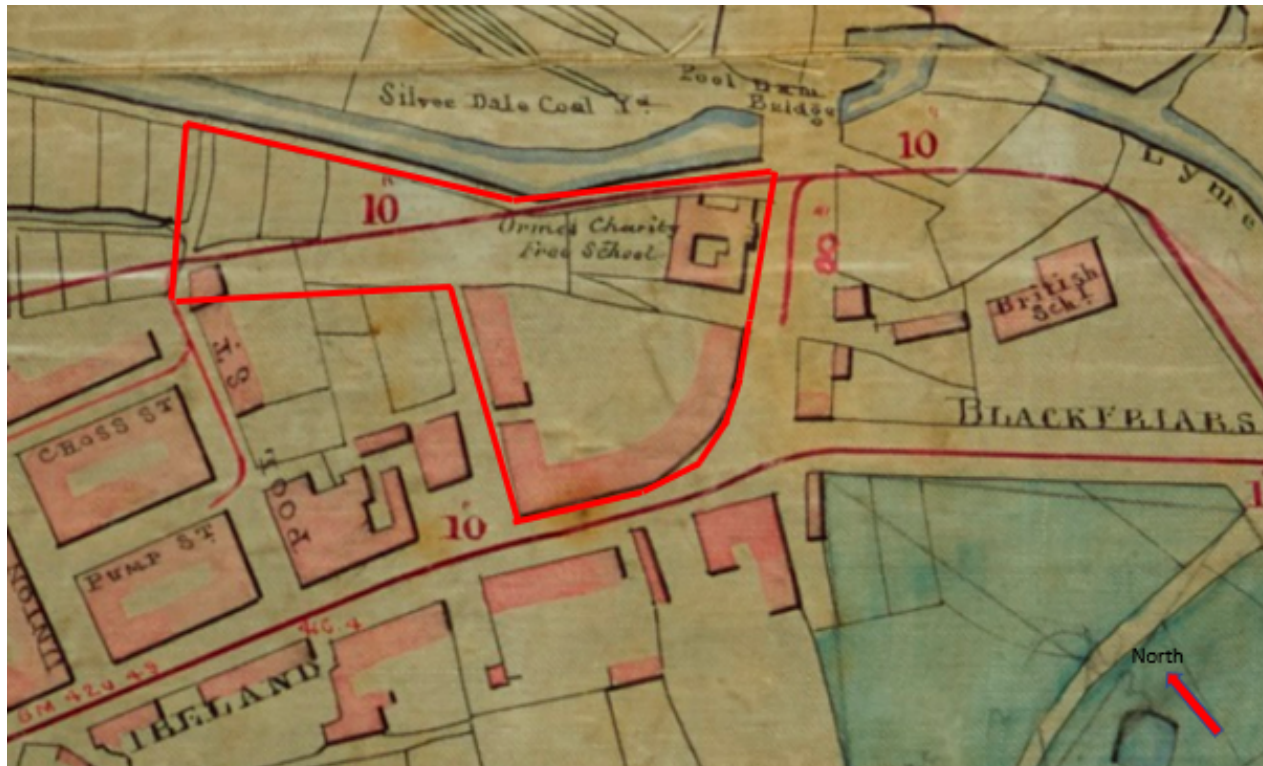
Figure 4 - Board of Health Draining Plan based on 1851 OS Map

This map, which is most likely contemporary with the Cholera Map is also based on the 1851 OS map. Interestingly the building is depicted here as a completely enclosed courtyard with no opening in the south west corner. The reason for this variation is uncertain but may have resulted from a less detailed recording of the building layout at the time perhaps because the map was specifically related to drainage rather than detail of buildings.

The school is still referred to as *Orme's Charity (free school)*.

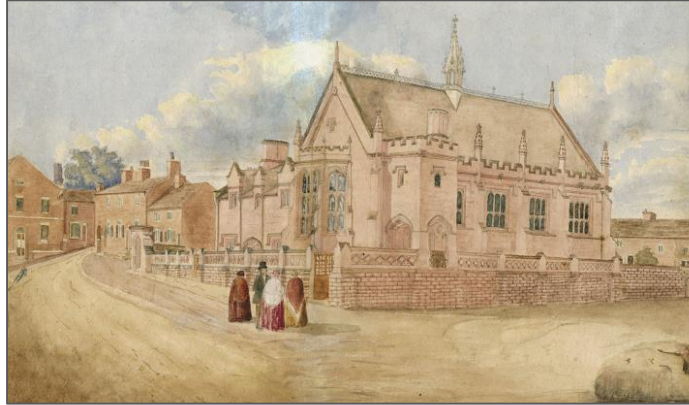
Figure 8. A watercolour by an unknown 19th century artist showing the extent of the Old Orme Boys' School prior to its extension to the south east in the latter half of the 19th century. Originally the school was of courtyard planform but the painting only shows the north eastern part of the building. The original entrance to the school is depicted in the form of the castellated porch, which adjoined the main hall, served by steps from the road. The fleche shown here on the roof of the main hall is not present on later photographs of the school. Note the domestic appearance of the building adjoining the main hall. This may have functioned as accommodation for a master.

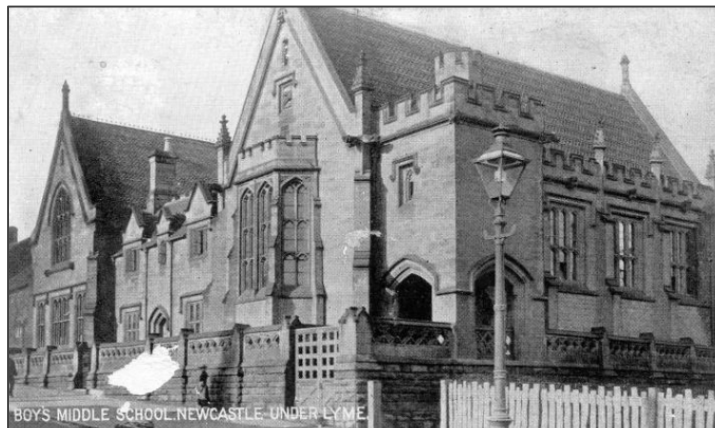
Figure 9. Late 1800s photograph showing a view of the Old Orme Boys' School, changed in the 1870s to become the Orme Boys' Middle School. The view is taken from Pool Dam looking south west. By this time an additional school building in keeping with the Gothic Revival architecture of the original school has been added to the south east elevation of the possible master's accommodation.

The terraced houses next to the school are still standing at this time. Note that by this date the fleche shown on the watercolour painting above has been removed.

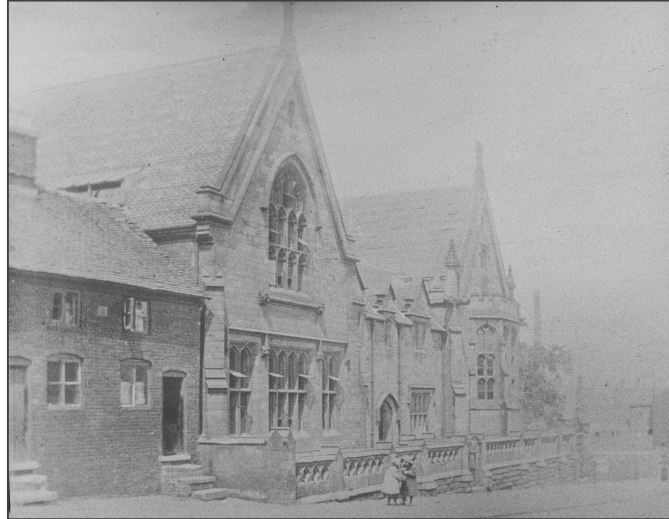
Figure 10. View of the school in the late 1800s showing detail of the terraced cottages adjoining the school building.

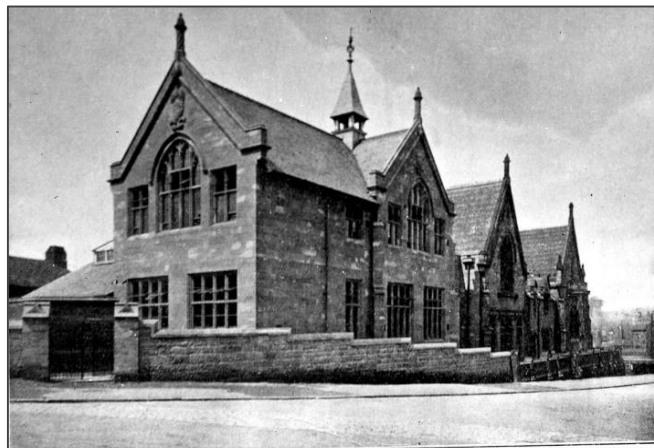
Figure 11. View across Higherland of Orme Boys' School circa 1915 showing the north east elevation and south east gable end of an Edwardian extension. Note that a fleche similar to the one depicted on the 19th century watercolour had been erected on the early 20th century Edwardian school building and that a stripped version of the Gothic Revival style was used for the outward facing elevations of the Edwardian build.

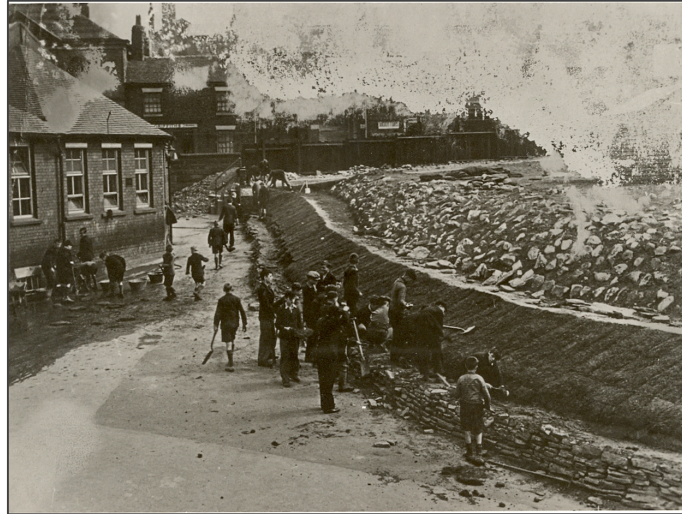
Figure 12. Photograph taken during 1930s showing boys carrying out works on the retained earth embankment in the north west part of the site. This embankment is now overgrown but it likely to contain evidence of the works being shown on the photograph. In addition, earlier map evidence shows that this area contained terraced buildings and back plots and evidence of these may also be present.

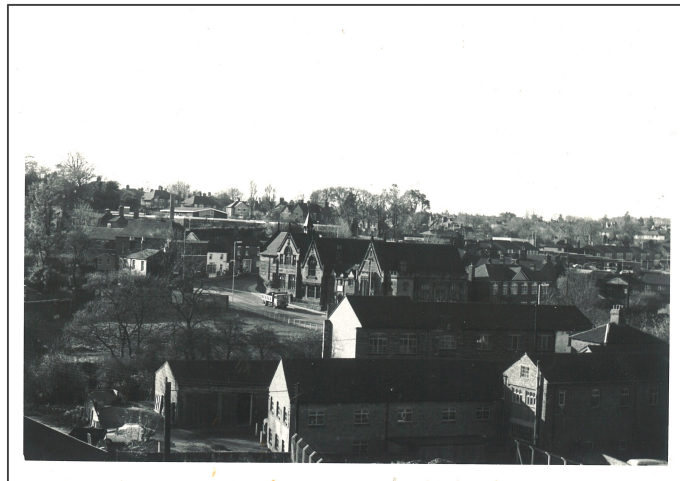
Figure 13. General view taken in 1972 looking south west towards the Orme Boys' School.

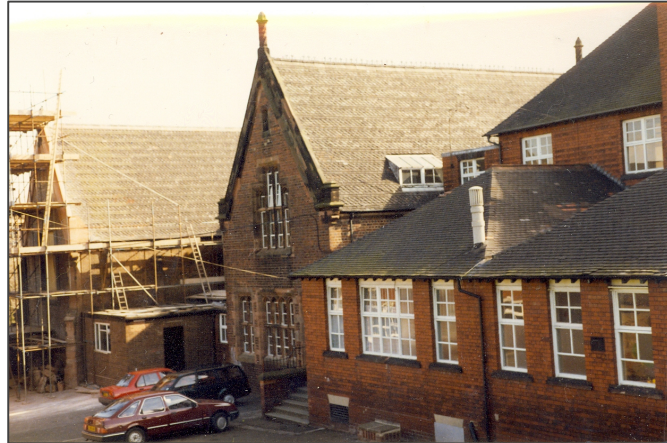
Figure 14. Photograph dating to the 1980s showing building works being undertaken on the original mid-19th century main hall. This may be when the main window in the north west elevation of the hall was blocked.

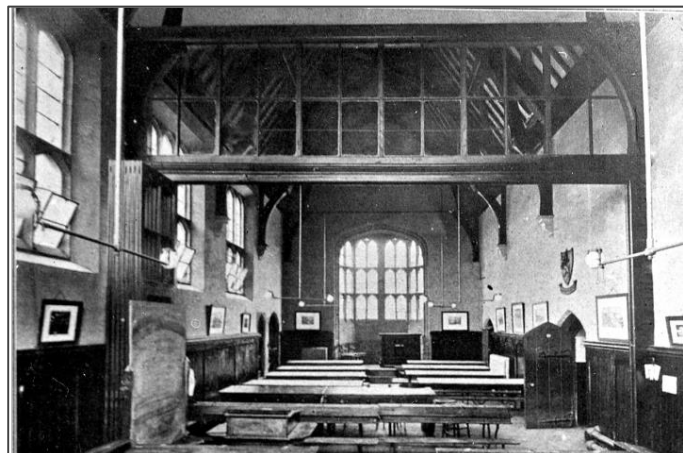
Figure 15. Photograph circa late 1800s/early 1900s of the main hall which represented the original Old Orme Boys' school building. Many elements of the hall interior, such as doors, dado rail and timber wainscoting remain in place today. The hall which functioned as a classroom is set out in Gothic Revival style deliberately evoking the appearance of a medieval great hall.

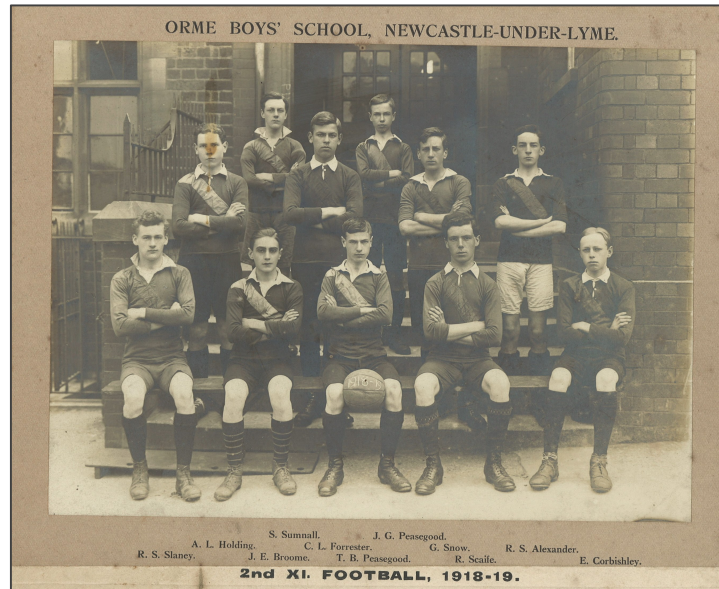
Figure 16. Photograph taken in 1918-1919 in front of the entrance to the red brick Edwardian extension to the south west elevation of the later 19th century school. The doors, railings and steps have survived up to the present day. At this time the school was still the Middle School educating boys between eight and sixteen.

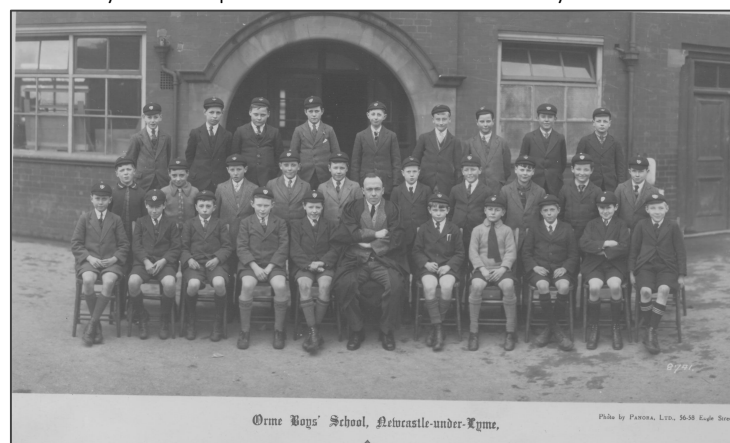
Figure 17. Boys with master in front of the Edwardian school building circa early 1900s. Elements of the architectural detailing and doors are still in existence.

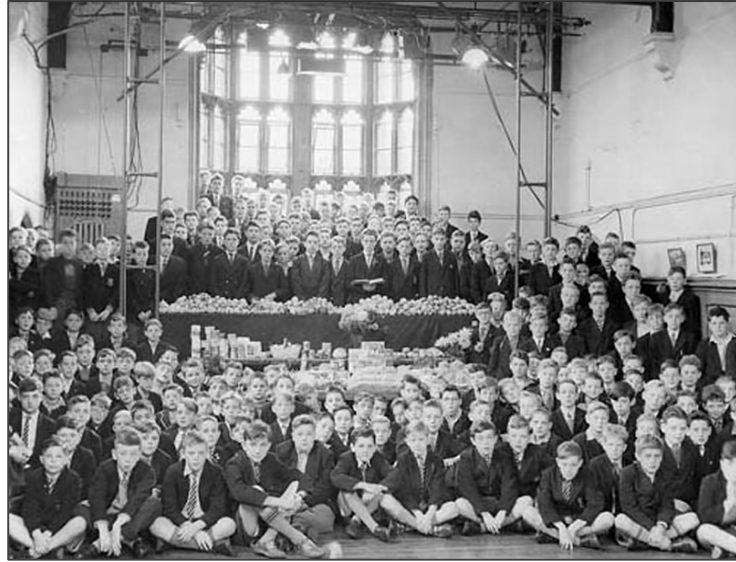
Figure 18. Boys at a Harvest Festival in the main hall in 1965. The main hall had changed by this time with whitewashed walls and the removal of the paraphernalia of a classroom suggesting it was being used as an assembly hall.

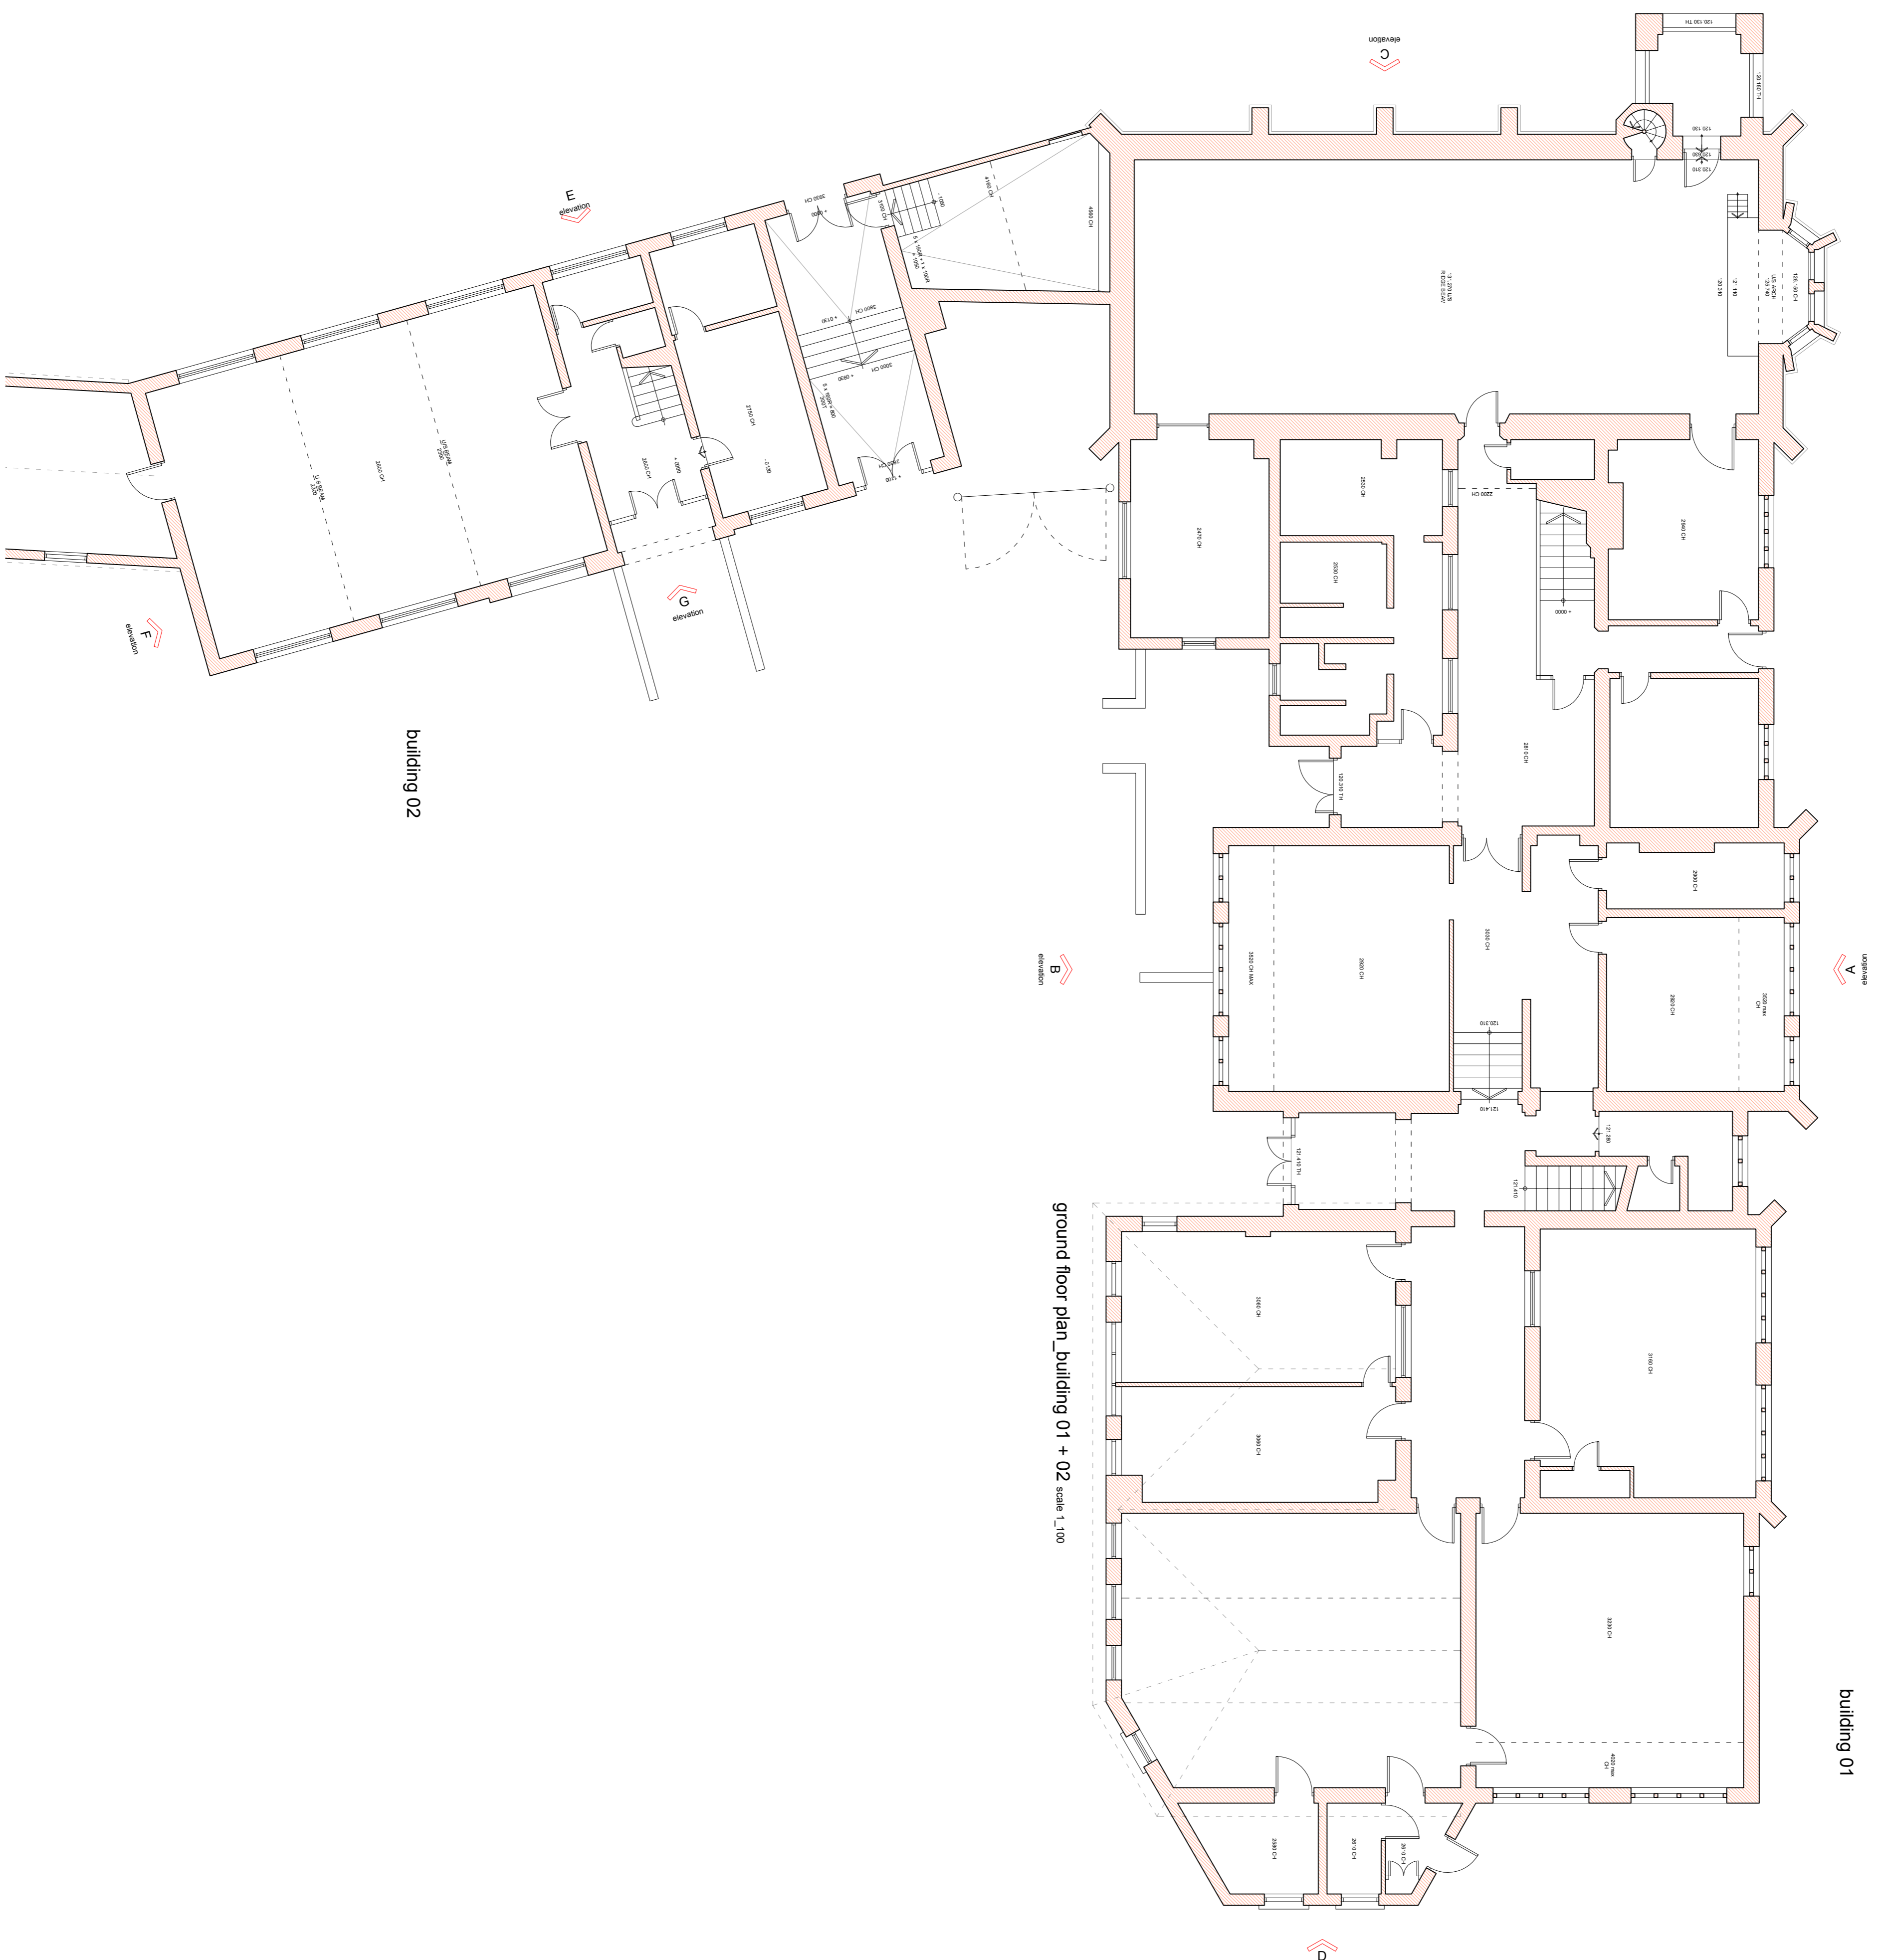
drawing revision
0880-104 -

revision	description	date
01	existing clay tile roof	
02	existing flat roof	
	existing walls
