**Exterior_007 -
South elevation**

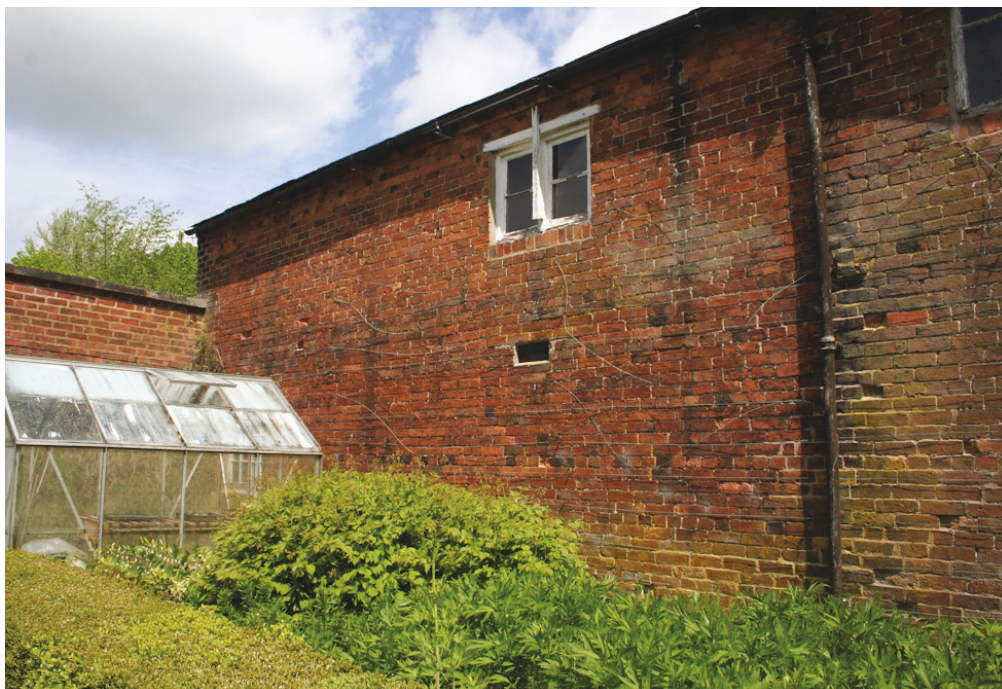
Western bay with plain ground floor, later pierced ventilator to stables and inserted first floor window, added when the building was converted to accommodate a laundry.

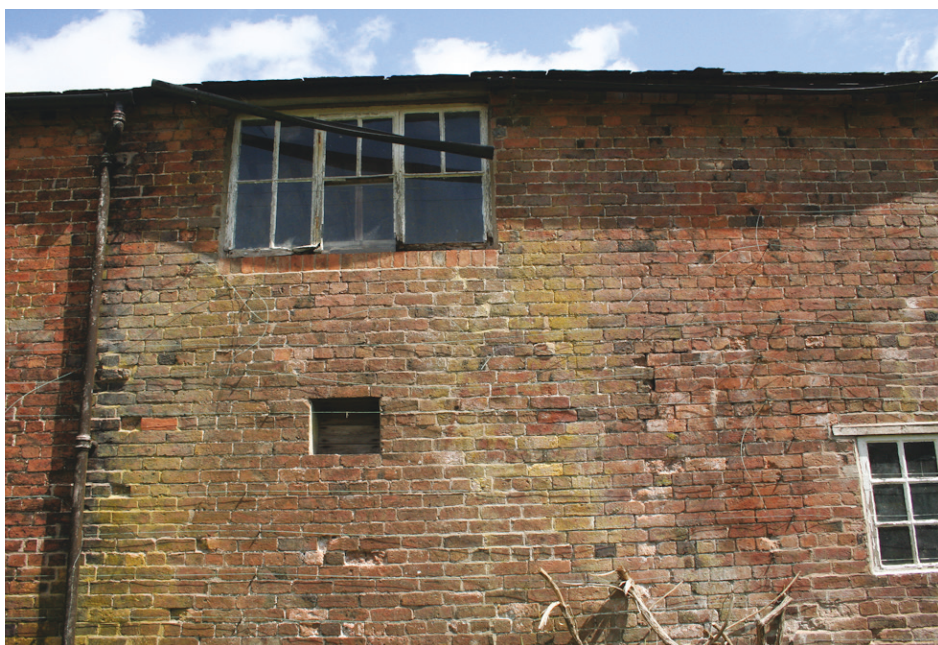
**Exterior_008
South elevation**

Inserted 20th century window to first floor, in poor condition, late 19th century ventilator (altered)

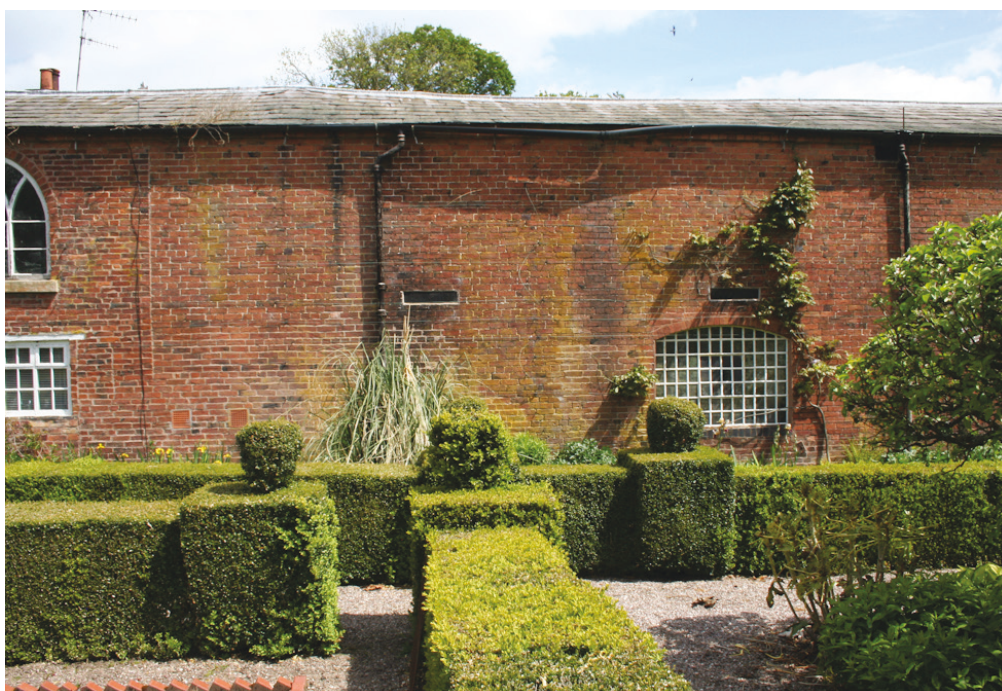
**Exterior_009
South elevation**

The rear elevation of the eastern stableblock, with relocated cast-iron window and late 19th century pierced metal ventilators

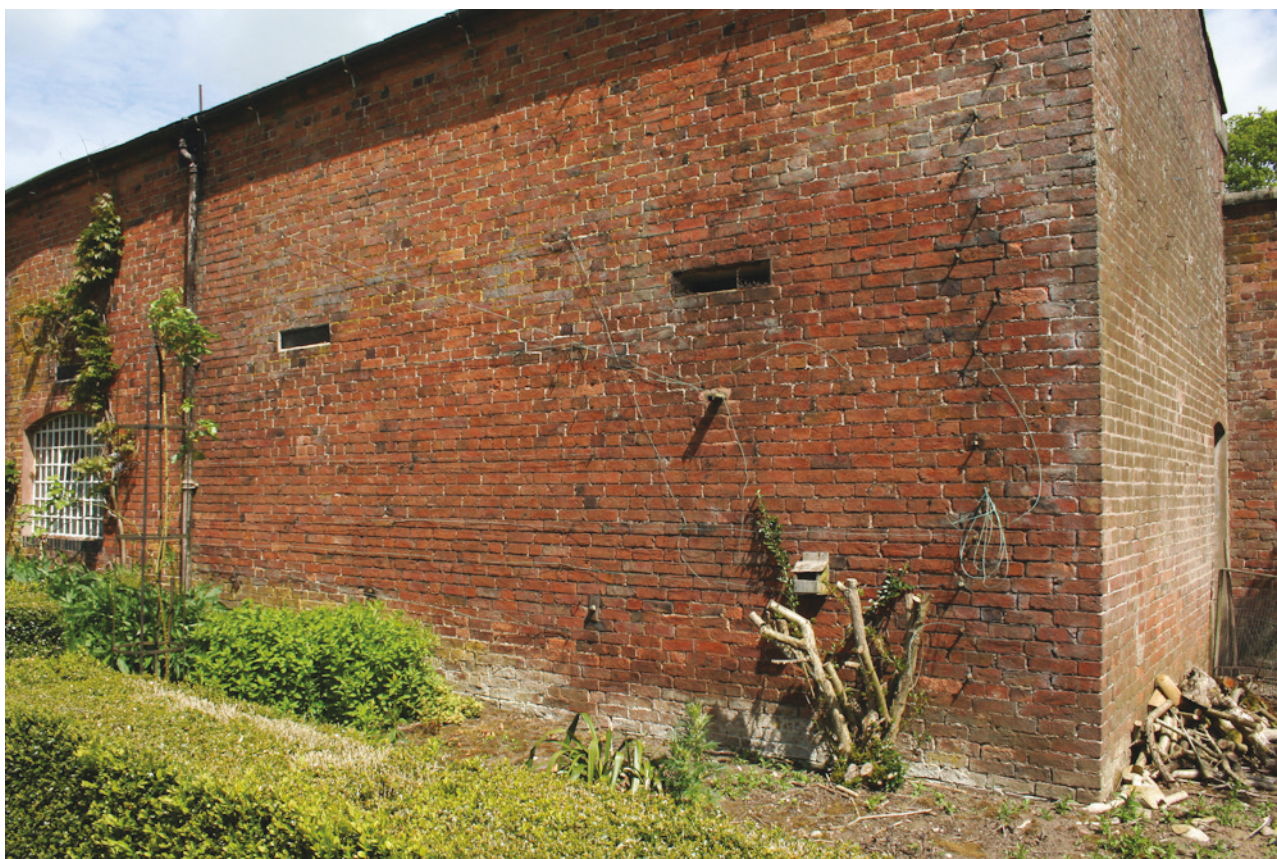
Exterior_010 - South elevation - eastern bay

The plain elevation reflects the original appearance of the stableblock on this elevation, which did not need rear access onto the garden. The doorway in the central bay and end wall may have been used to provide access for barrowing manure out into the garden. The pierced metal ventilators are later 19th century additions.

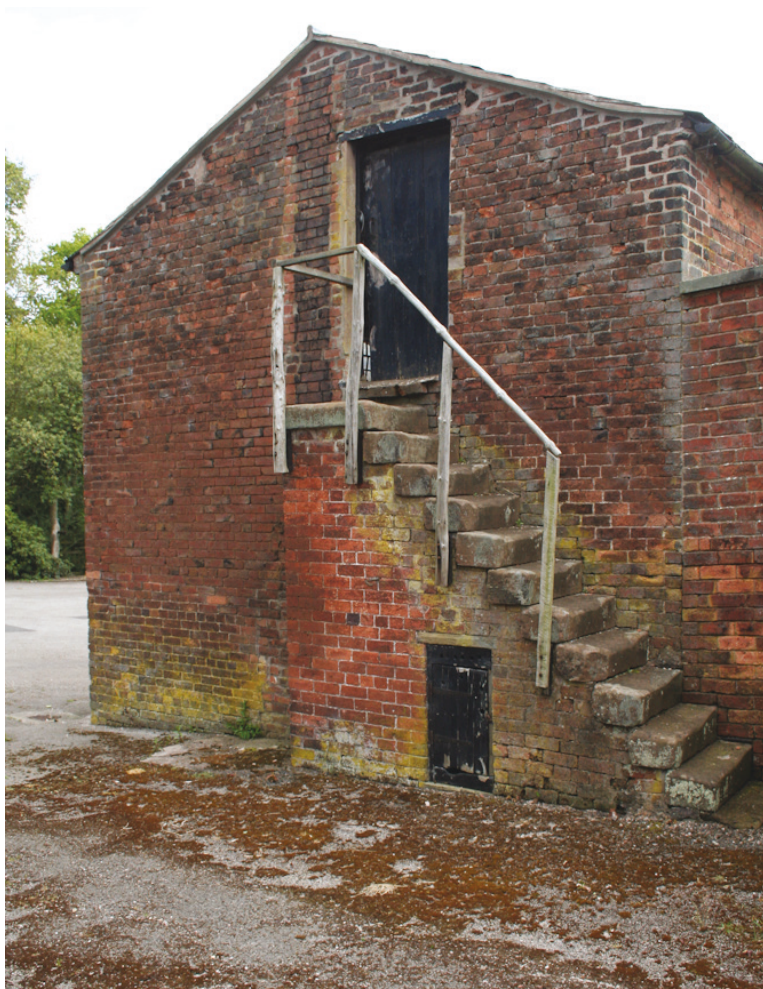
Exterior_012 - gable end of western stable block with external staircase access to hayloft and outline of former, added flue in darker bricks

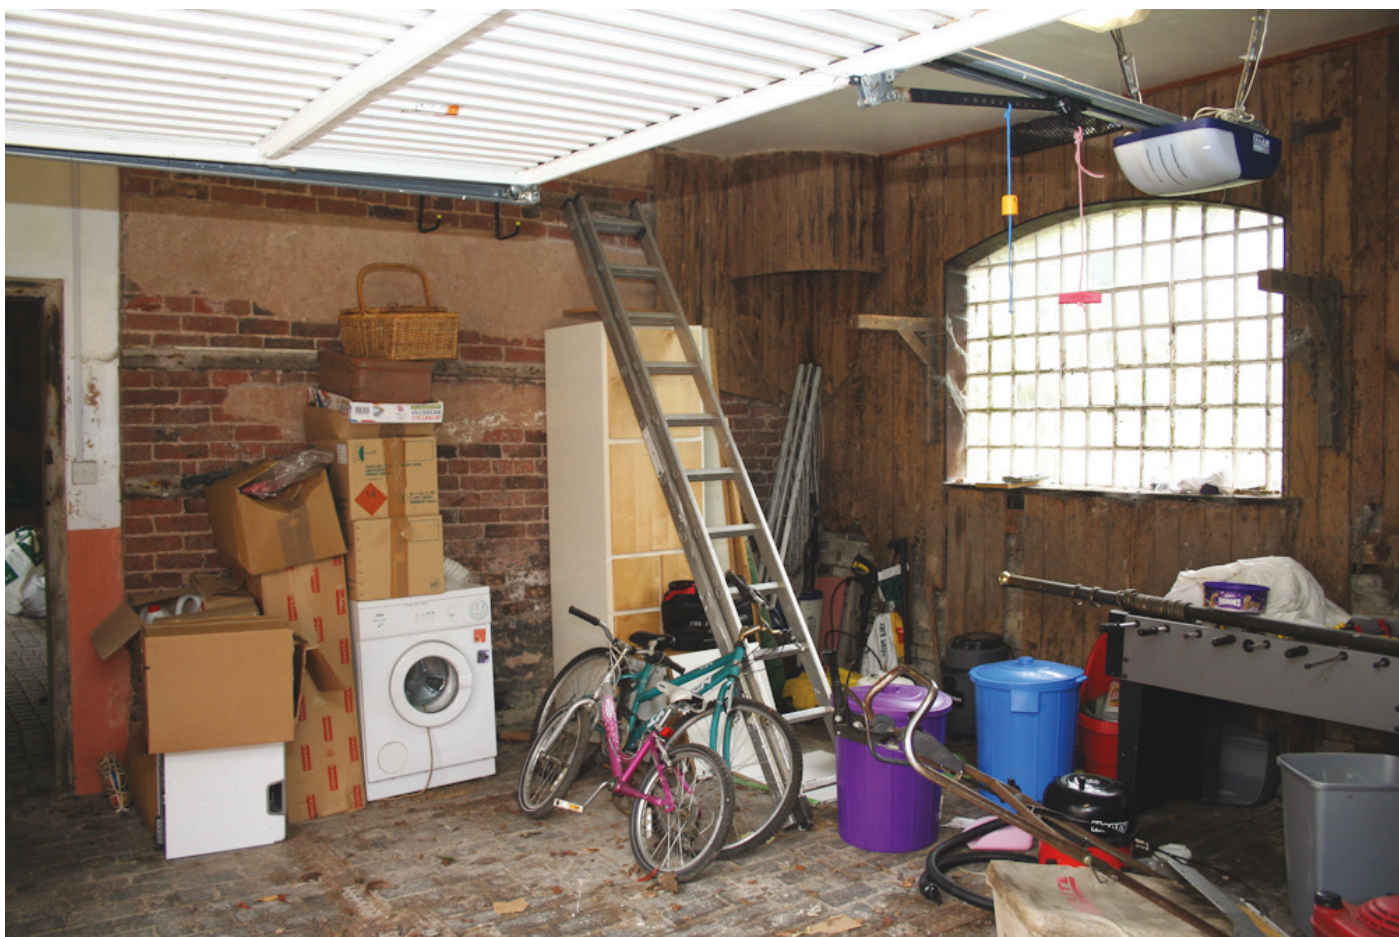
Ground_001 - Internal view of garage (former stables) with timber lining and clay paved block floor

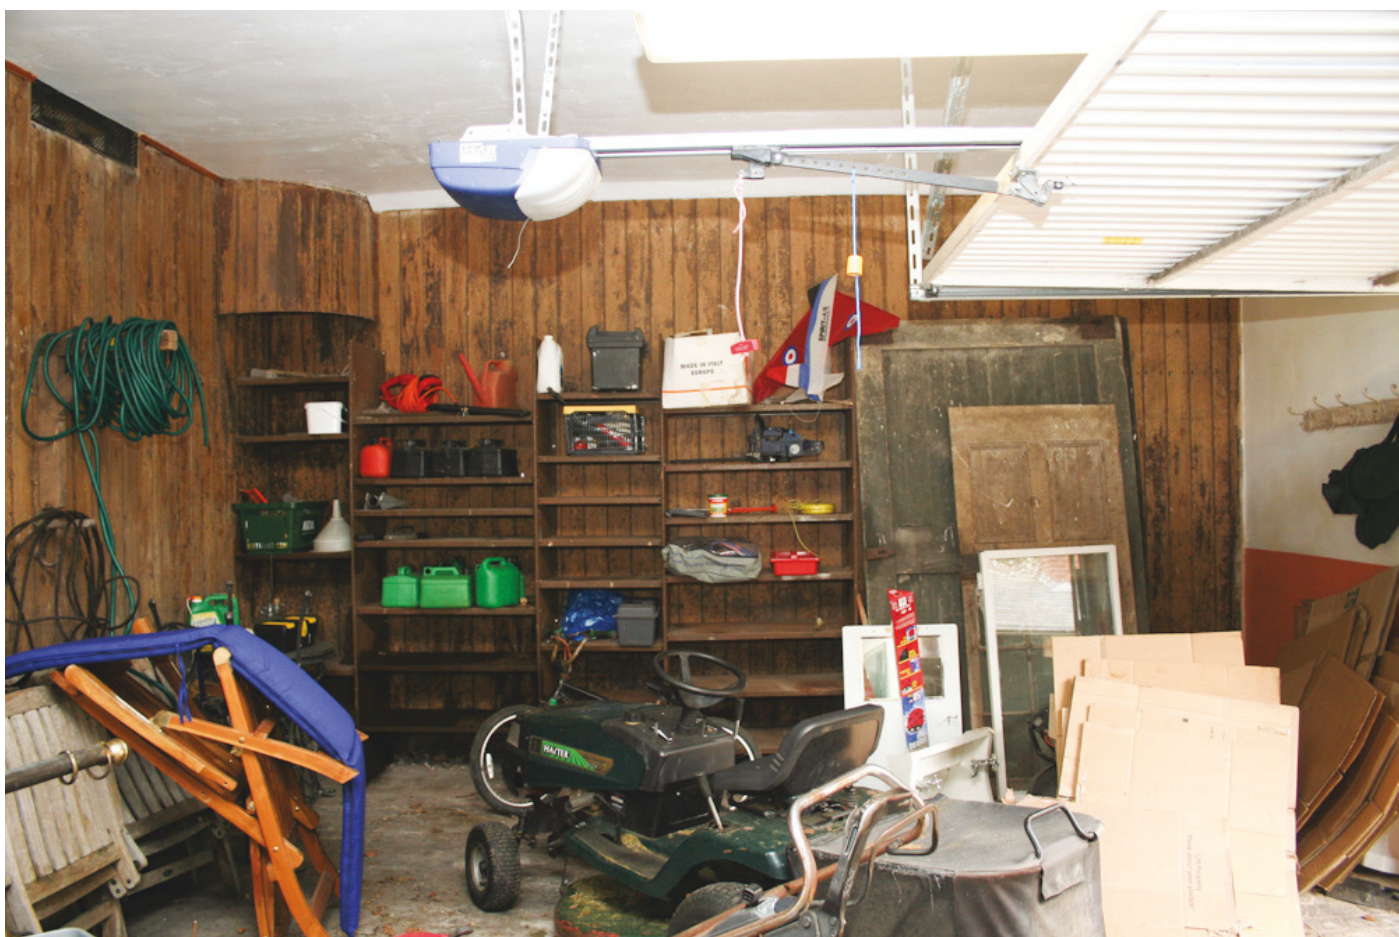
Ground_002 - internal view of garage looking north with panelled lining and hay drop baffle

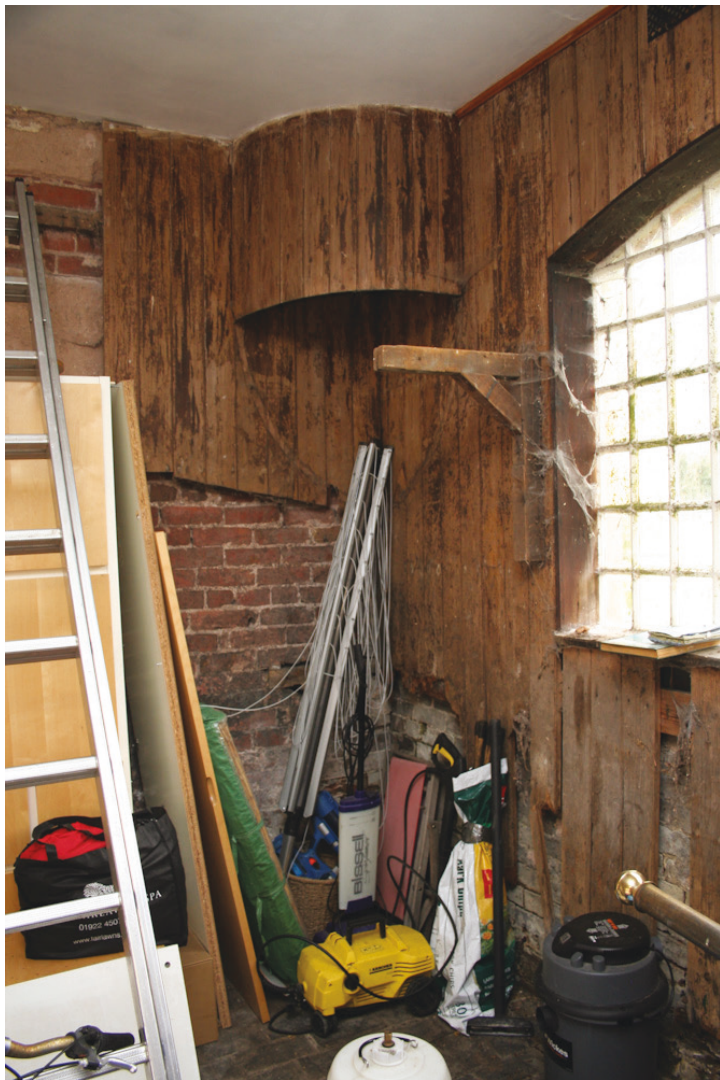
Ground_003 - lining to garage (former stables) with haydrop curved timber baffle, and re-located cast iron window

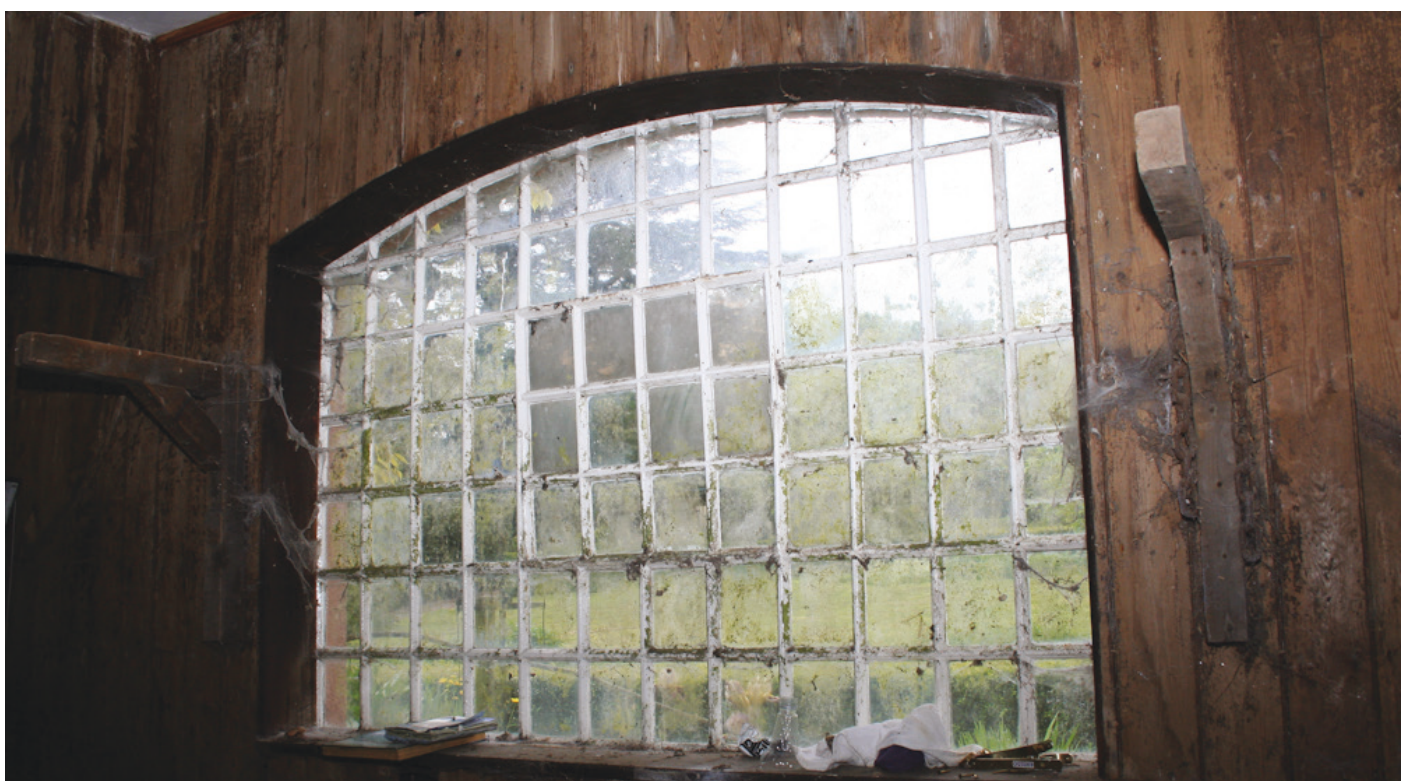
Ground_006 - Cast-iron window relocated into south elevation. This window is the original window from the north, courtyard elevation and was moved here after building was adapted as a garage / workshop. The timber panelling was carefully cut to accommodate the repositioned window. It would not have been used when the building was in use as a stables in the late 19th century.

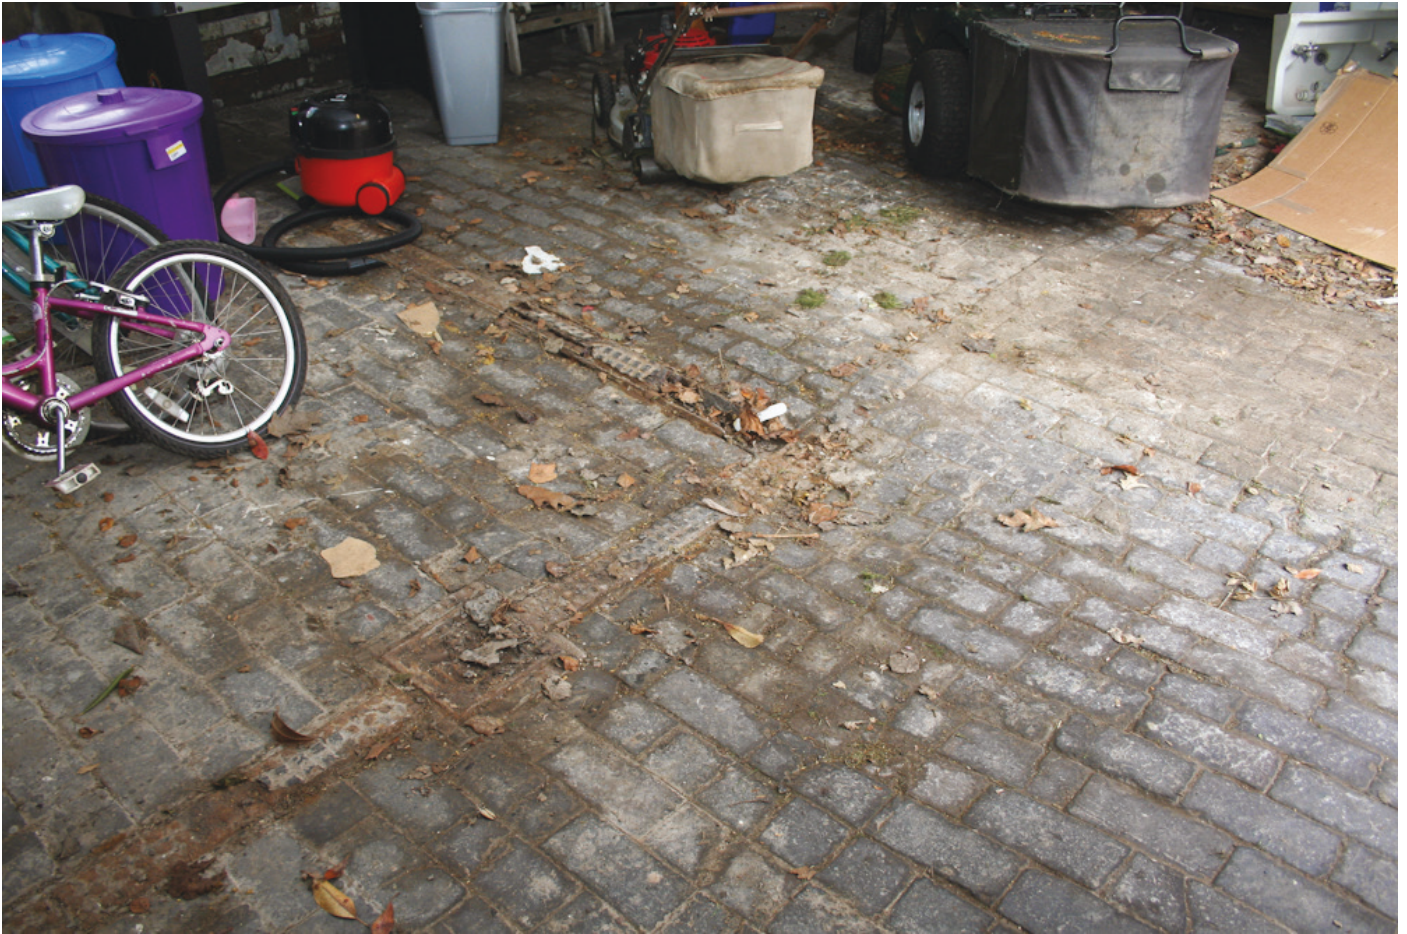
Ground_004 - Blue brick floor to Eastern Stableblock

The blue brick floor laid in brick bond is contemporary with the iron gratings, drainage channels, Stench Trap and the boarded fittings by Musgraves.

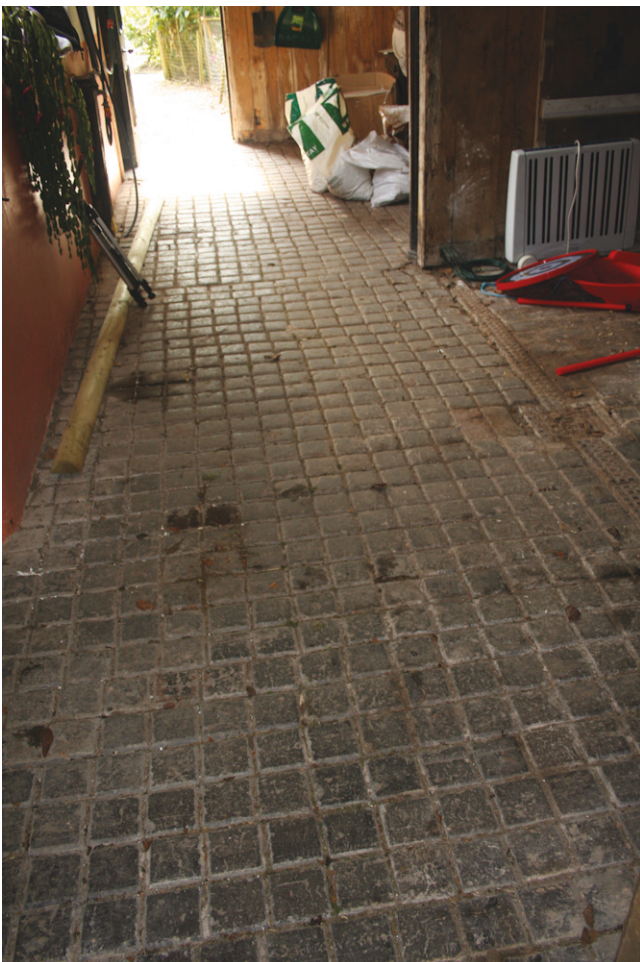
Ground_005 - Blue brick floor to Eastern Stableblock

Left - the earlier blue bricks were repaired and replaced in part with small blue clay tiles, with squared pattern, as seen left. Two phases of brick tiles are still evident.

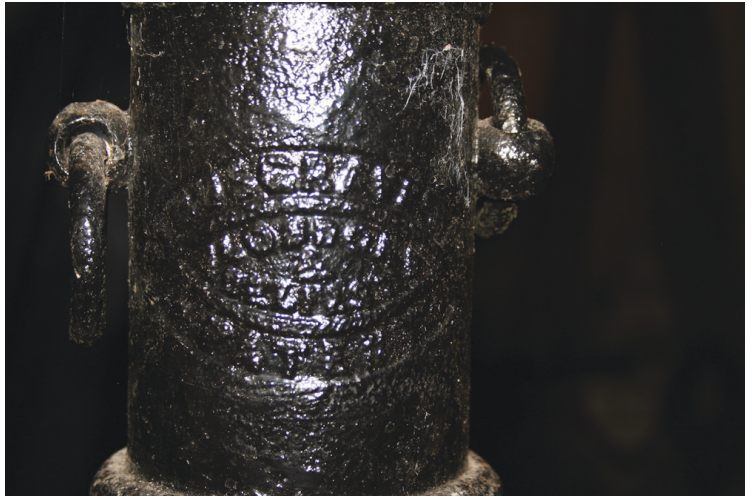
Ground_007 -

Right - "Musgrave's Patent London & Belfast"

detail of casting on the intermediate post to one of the stalls

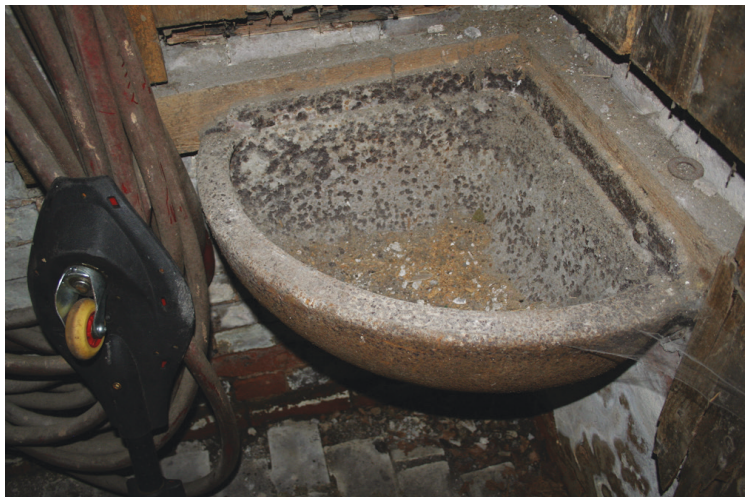
Ground_008 -

Right below - Musgrave's Patent

cast-iron water bowl or mash feeding trough

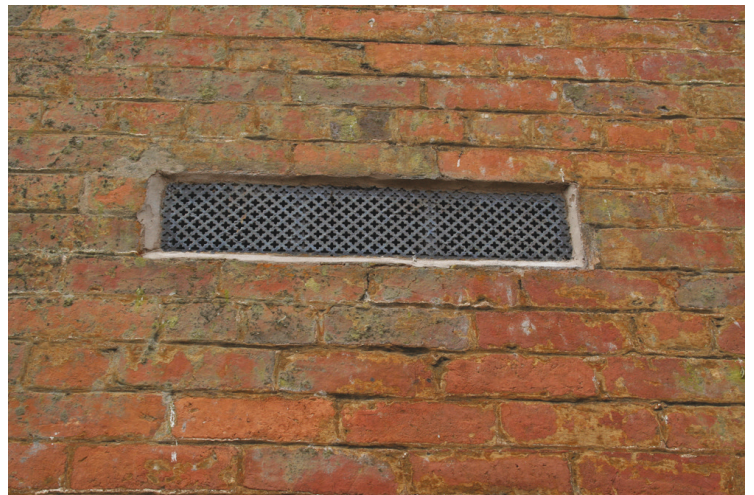
Exterior_011 - Pierced ventilator - right

The pierced, non-ferrous, quatrefoil pattern ventilators were inserted during the Musgrave's refurbishment of ca. 1890 and are one of their standard design details for stables.

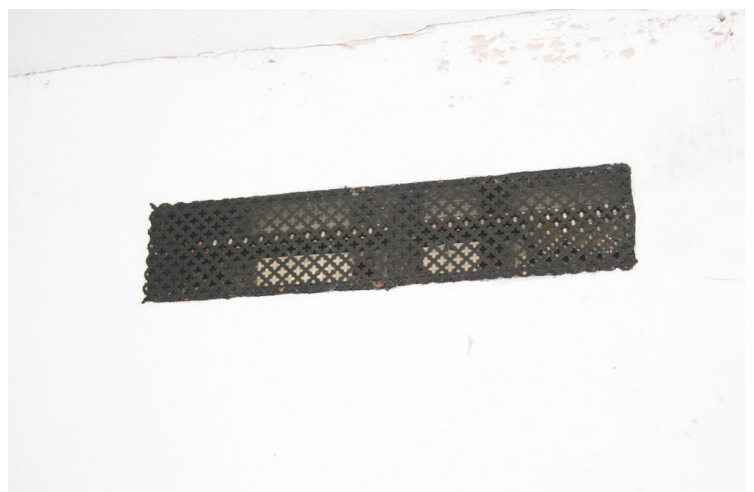
Ground_015 - Pierced Ventilator - right

Pierced quatrefoil pattern

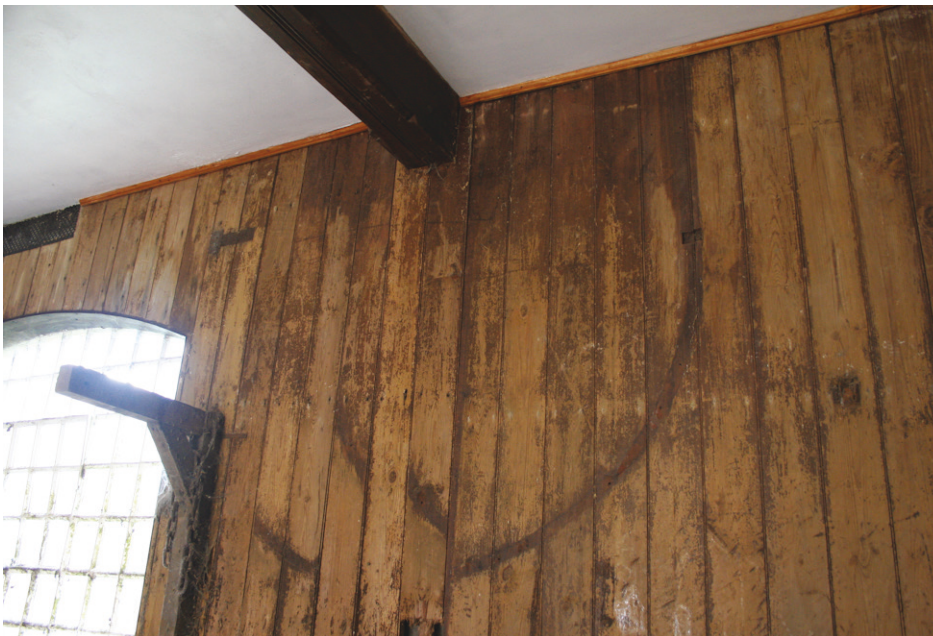
Ground_010 - Impression - left
 Ghosted impression of both former iron mangers and timber boarded baffles from the c1890 refurbishment within the timber boarded lining to the pair of central stalls - now within the garage

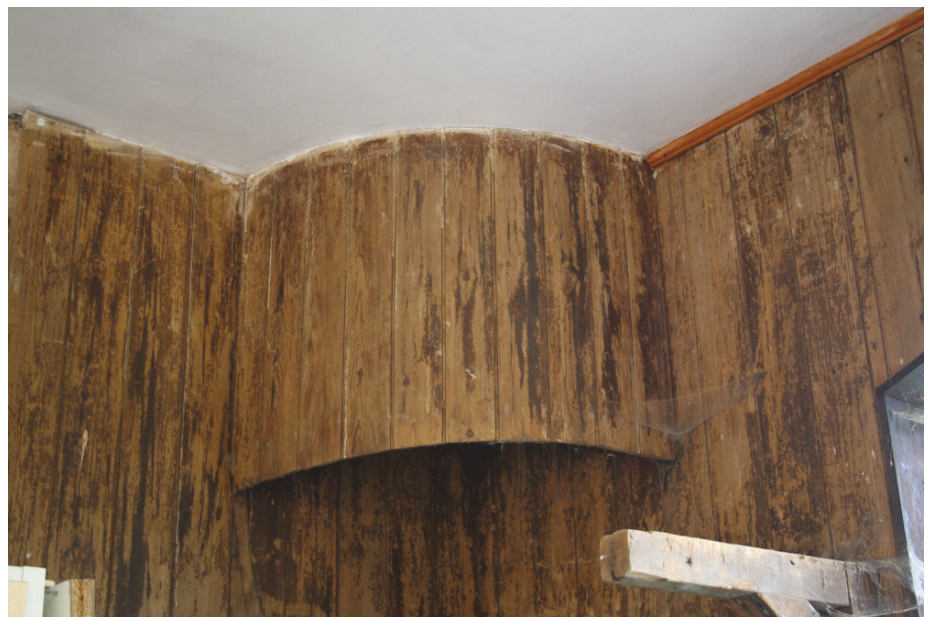
**Ground_009
 Boarded baffle - right**

One of two boarded curved baffles surviving from the c1890 refurbishment and now contained within the garage. Located below the chute / hatch in the hayloft floor, it prevented hay from dropping onto the stable floor

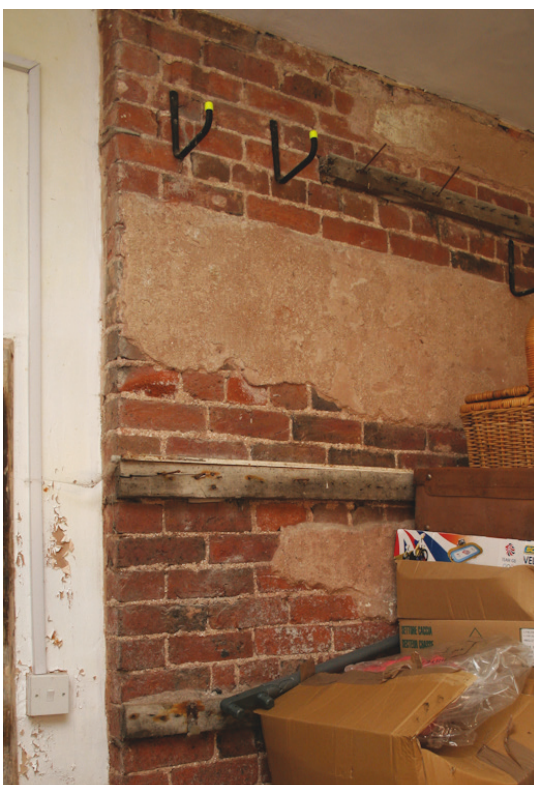
Ground_011

Eastern Stableblock - below

Brick party wall between the two stables. The brickwork may have been plastered originally, and later battened to take the boarded lining of c1890, which has been removed from this wall

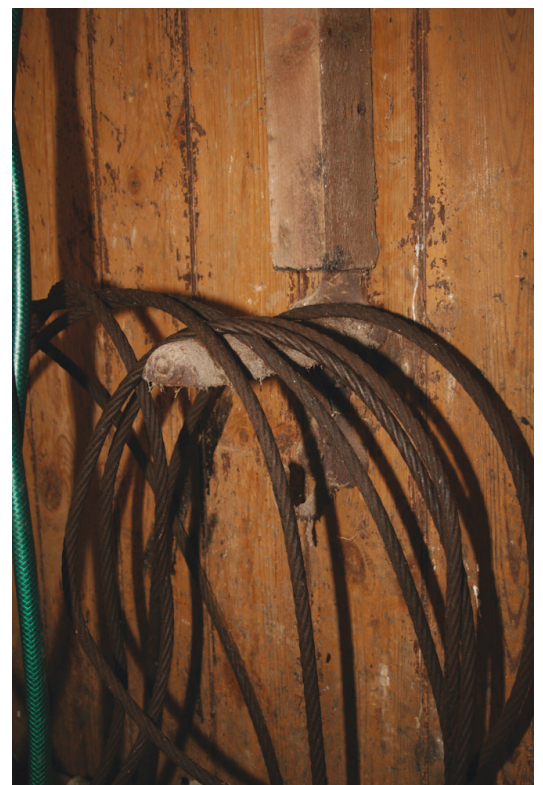
**Ground_012
 Right -**

iron bracket for a saddle, one of many Musgrave's fittings of c.1890.

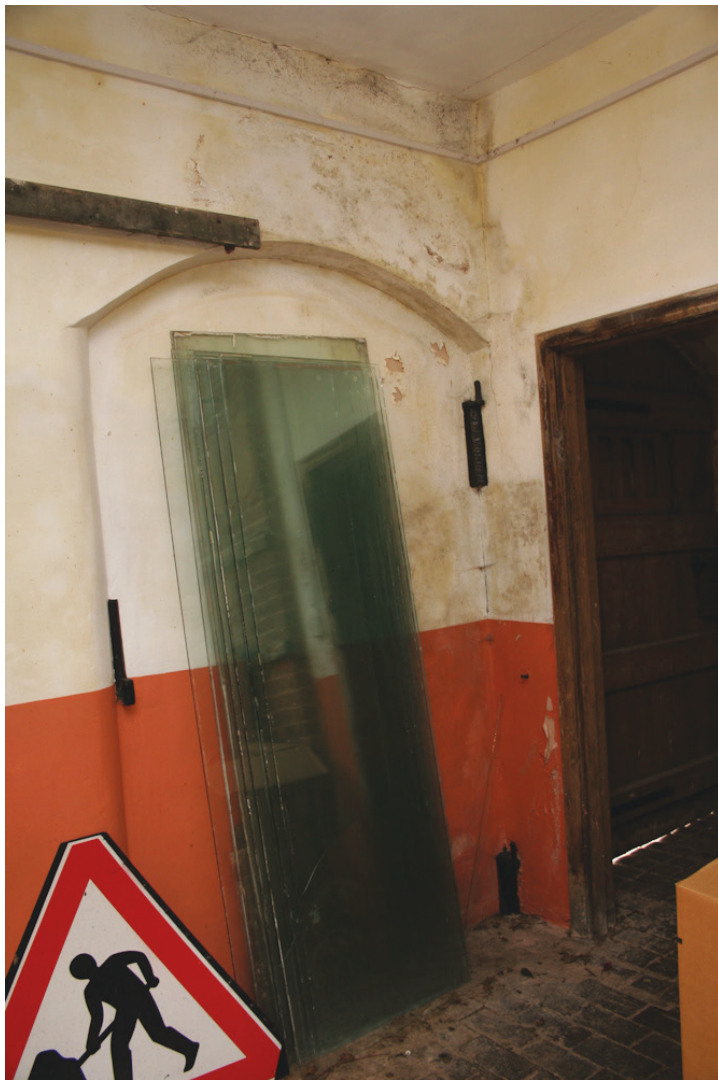
Ground_014

Blocked up former stable doorway, with hinge pins in-situ

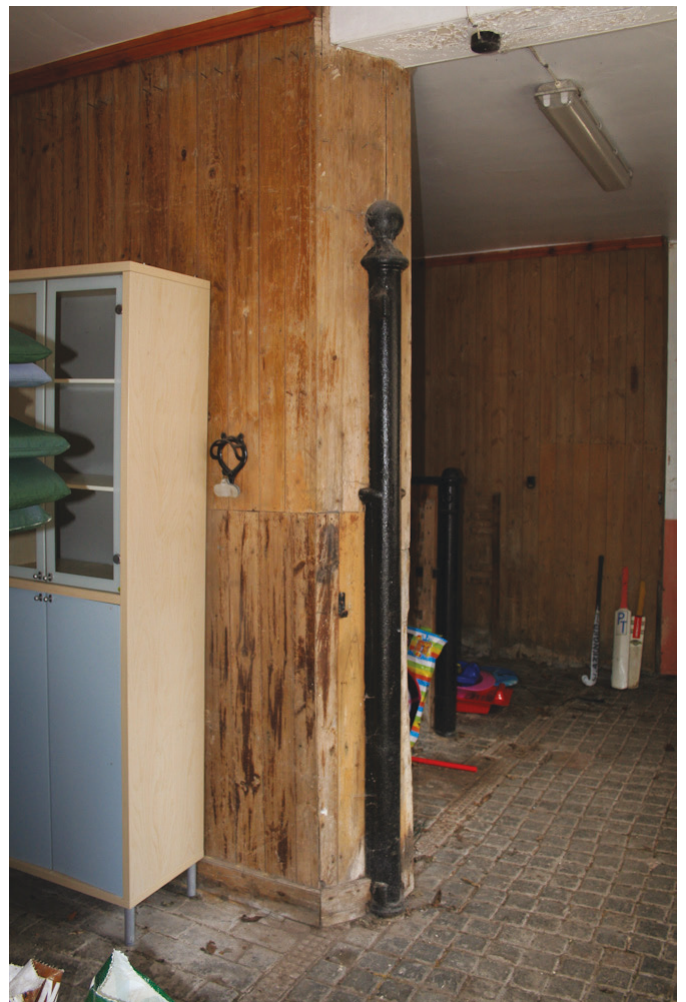
Ground_022

Cast-iron intermediate post with ball-finial, D-rings and fixing points (Musgrave's fittings) Belfast
