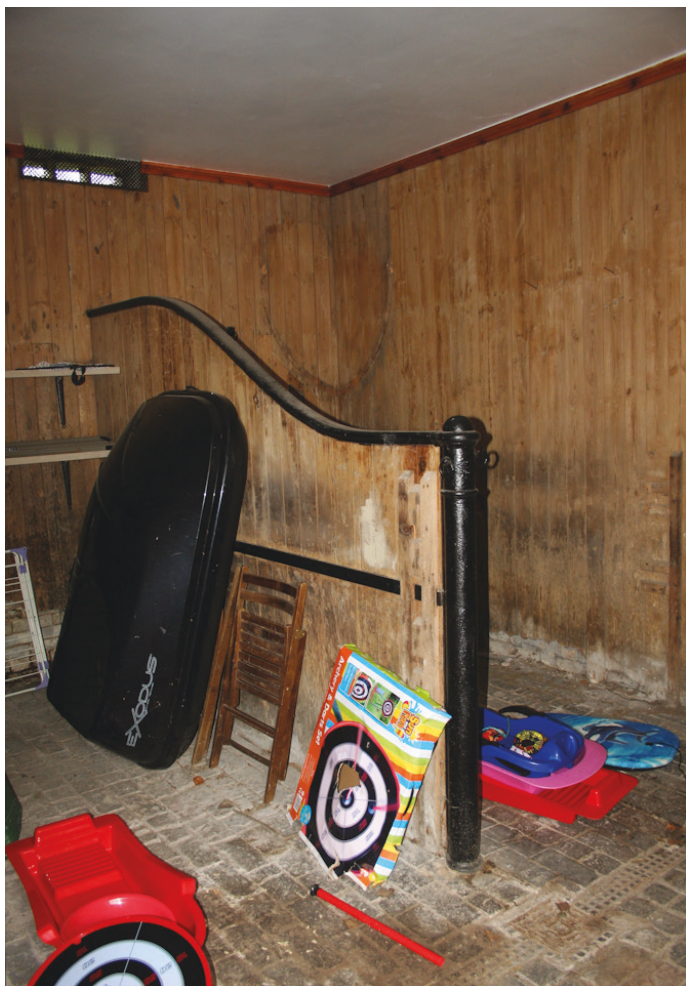
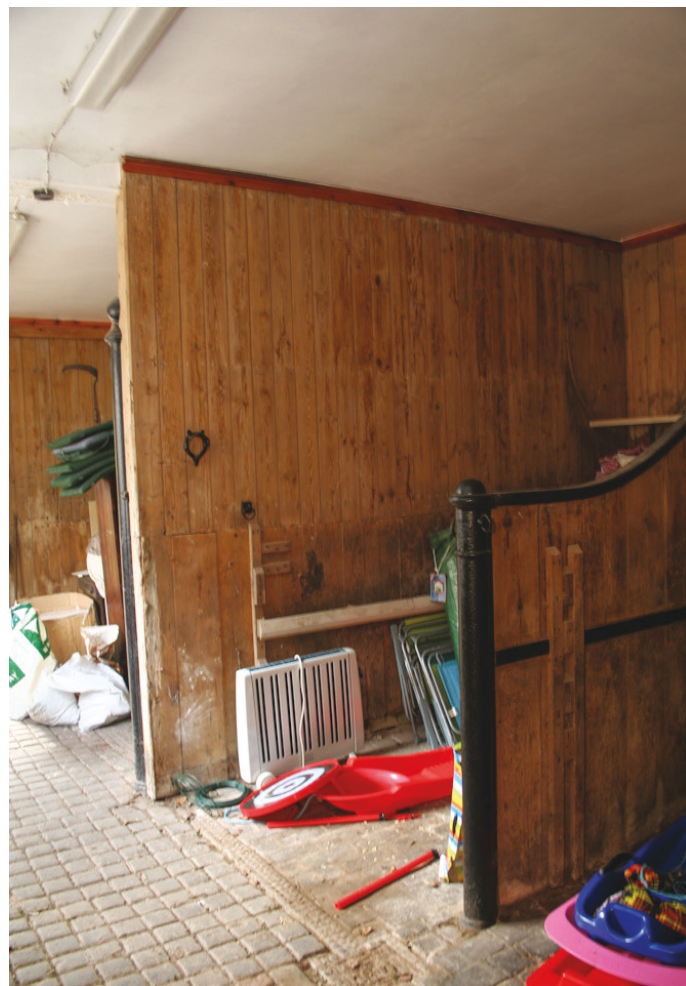
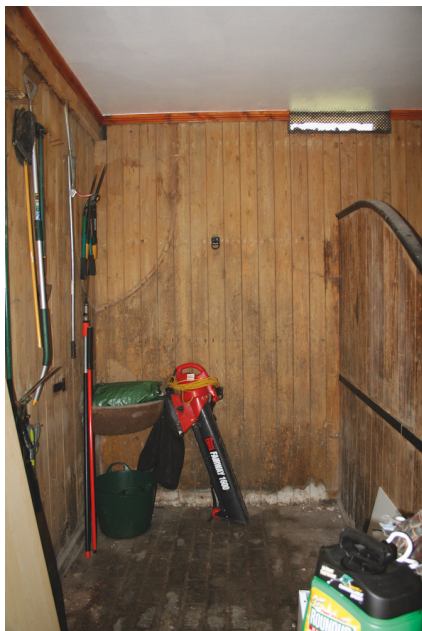
Ground_018 - (above left)

Stable fittings and stalls of c1890 by Musgrave's of Belfast. Musgrave's Patent horse stall fittings with iron 'ramp', iron 'barrier sheath' and cast-iron post with integral tether rings. Musgrave's cast-iron posts in-situ, of c.1890, cast-iron water bowl. The original mangers, probably also by Musgrave's, have all been removed.

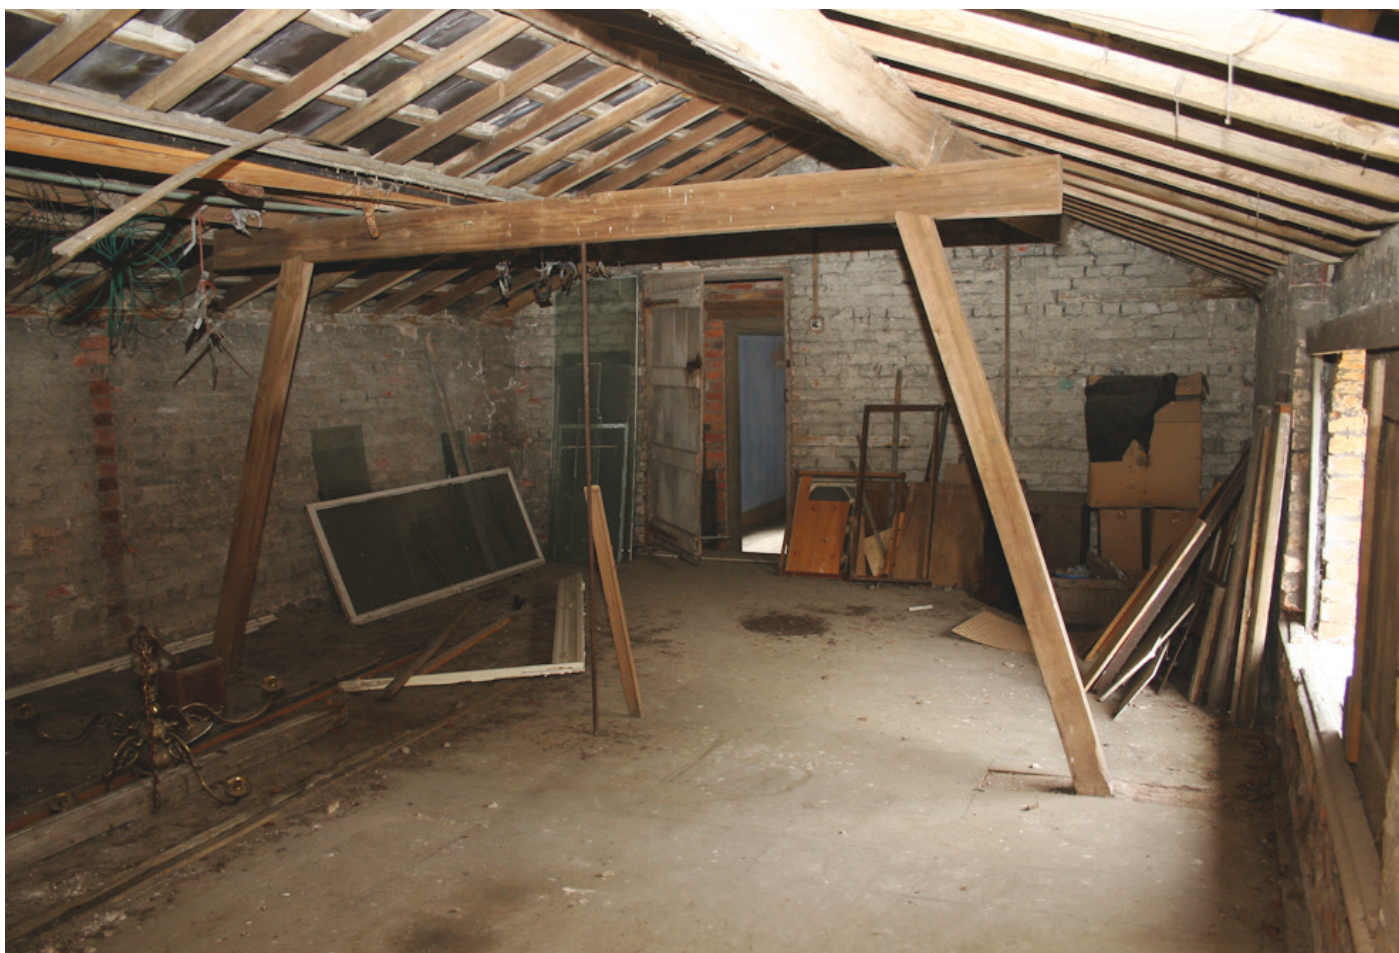
First_001 - Hayloft

The two bays over the garage were adapted, the original brick dividing wall removed and replaced with a pair of struts, collar and tie-rod to support the purlins in the 1890s.

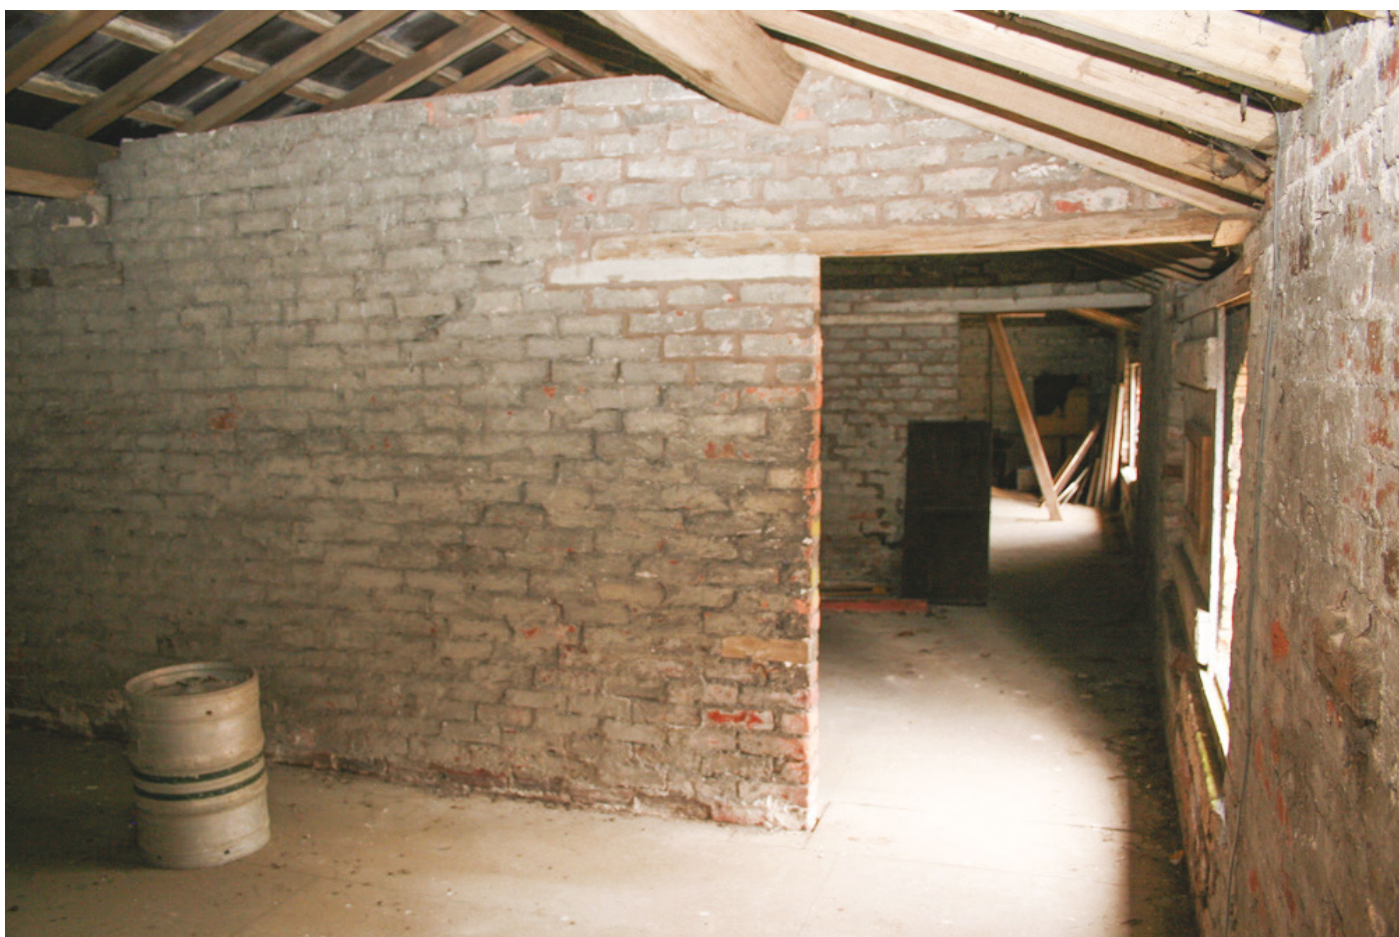
First_004 - Hayloft

Original brick dividing wall over the stalls to the eastern bay

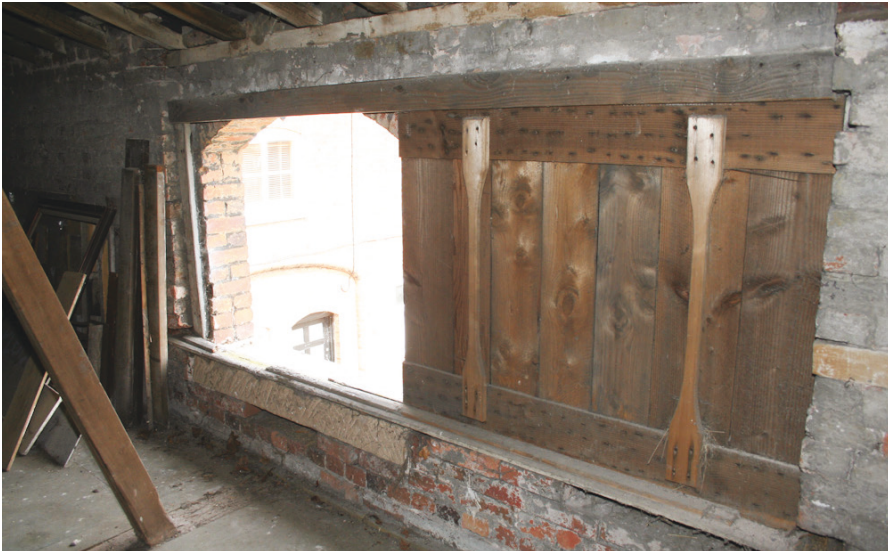
First_002
horizontal sliding shutter to hayloft
over garage (late C19 replacement)
in original opening

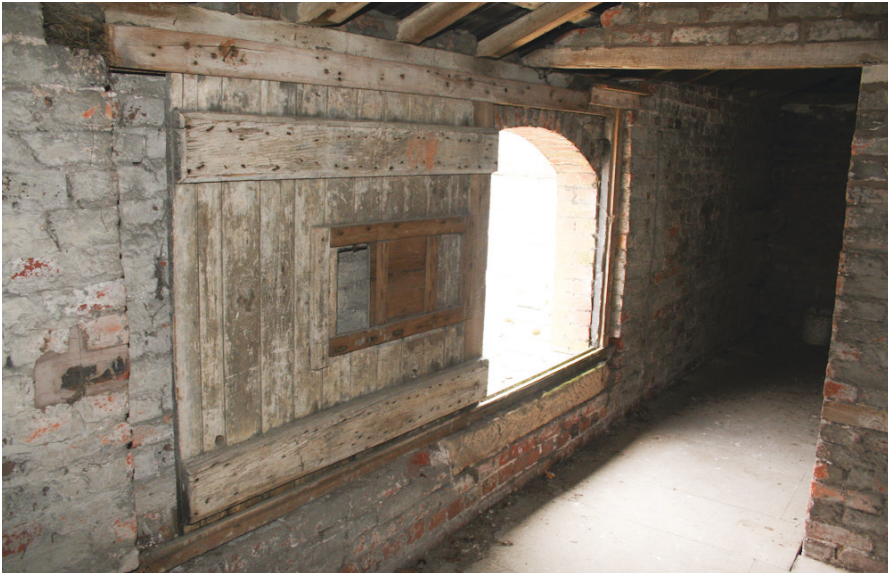
First_003
horizontal sliding shutter - original
boarded shutter with opening vent

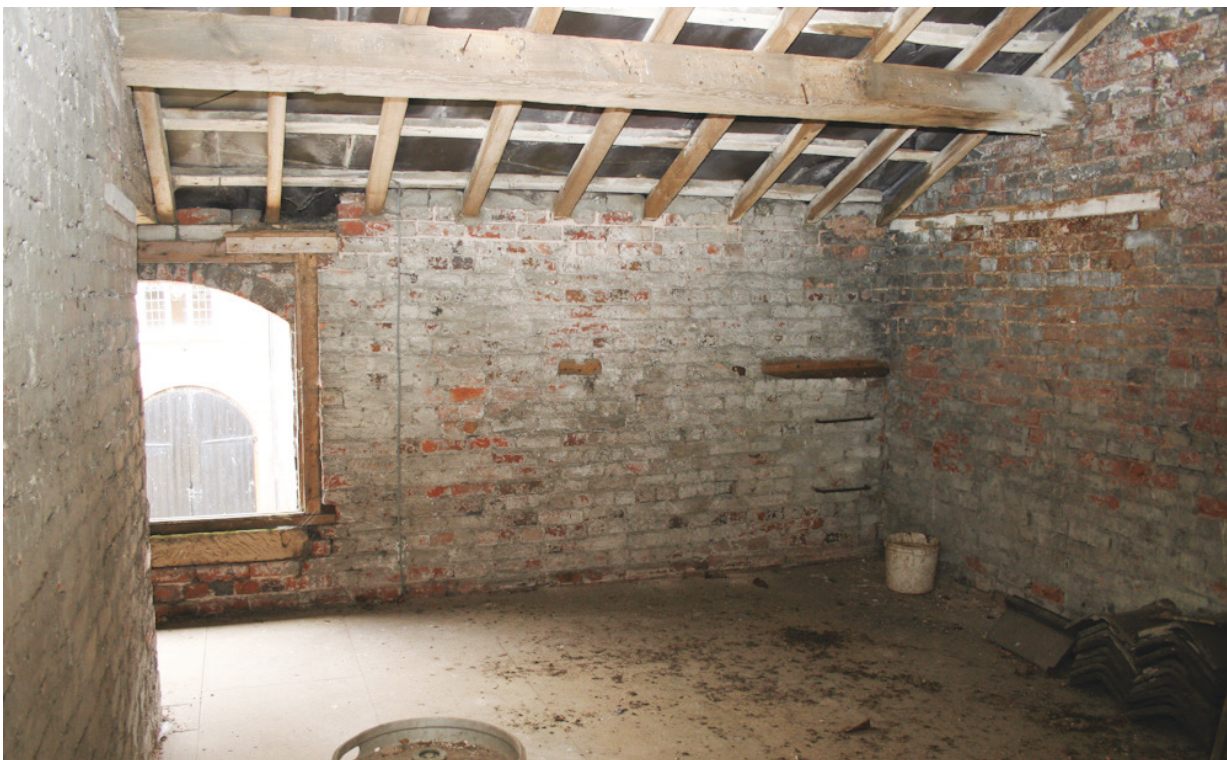
First_005

First bay of eastern hayloft, with brick cross wall, limewashed brickwork, shuttered opening and original roof structure in-situ. Modern chipboard floor

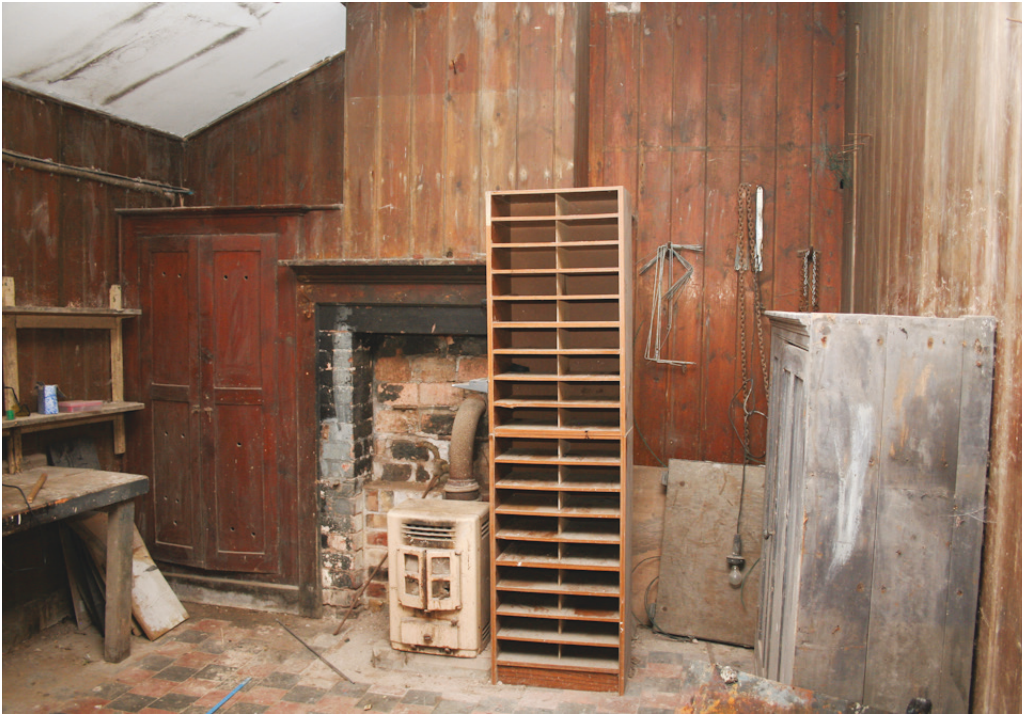
Ground_023 - Harness Room

The Harness Room dates from c1890 and contains a fireplace to provide heating for the groom and stable hands whilst they worked on maintaining the harnesses and tack. The original stove has been replaced.

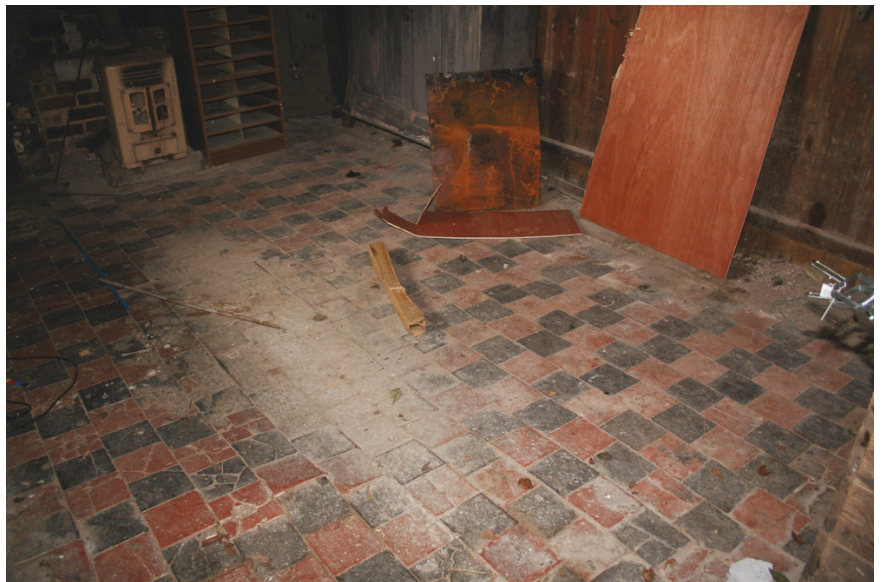
Ground_024 - Right - red and blue tiled floor of the Harness Room, c.1890

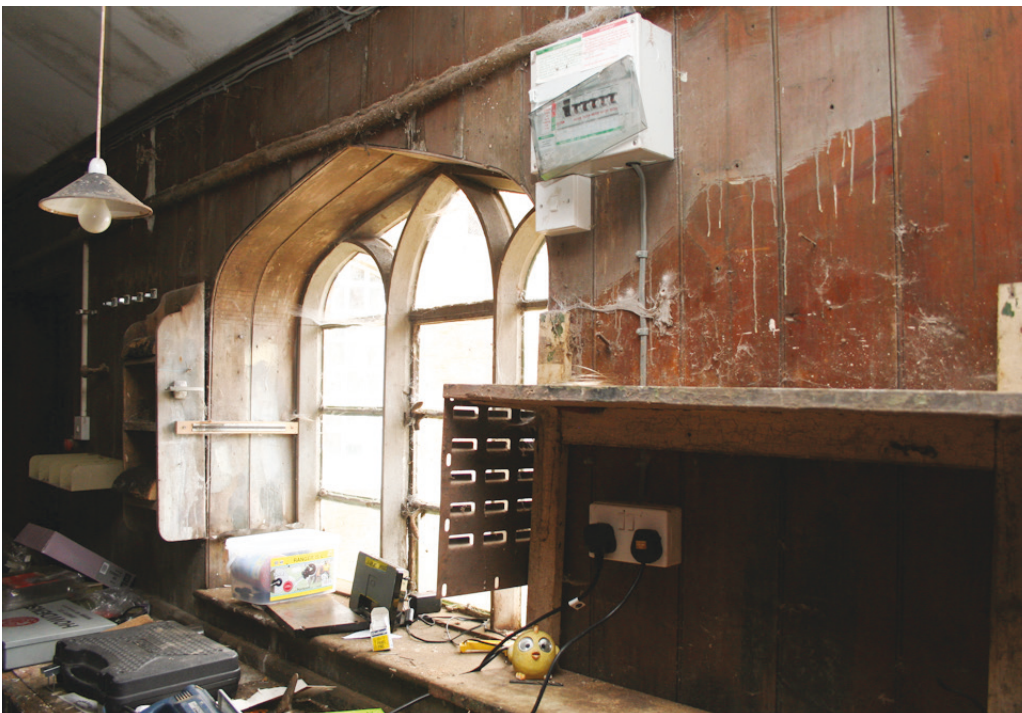
**Ground_025
Harness Room -
courtyard wall**

The Harness or Tack Room was also lined in boarding, with scratch mouldings. Late C19. The earlier window was re-used in this location. Fittings for the harness room were designed to create a dry environment for the tack: harnesses, saddles and bridles, although the fittings have been removed.

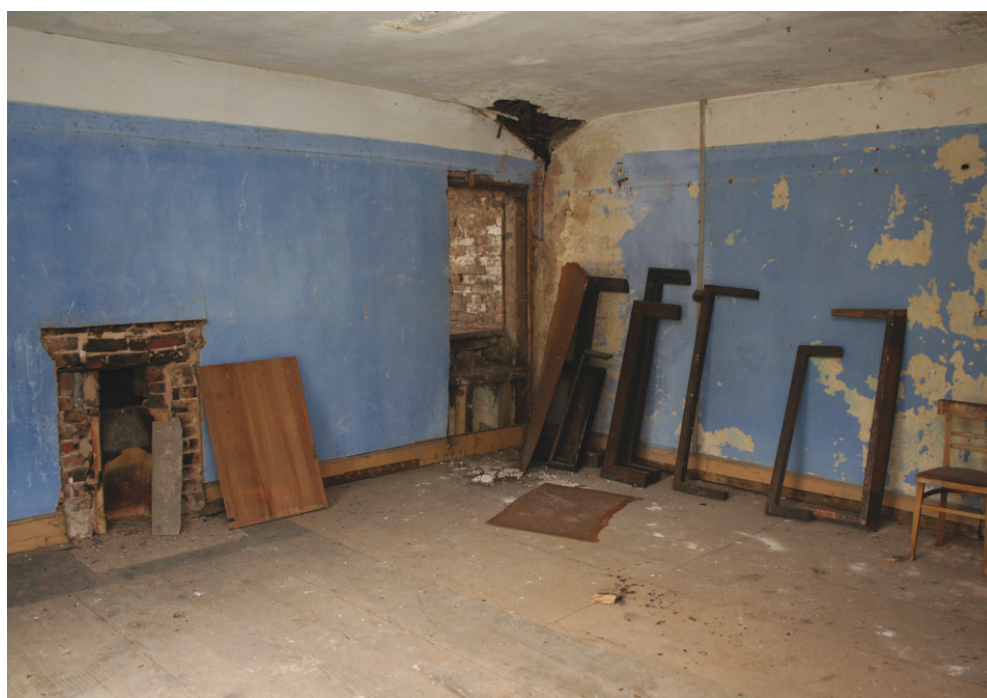
First_007

Right - fireplace hearth has been removed. This was a later addition when this part of the building was made into habitable accommodation

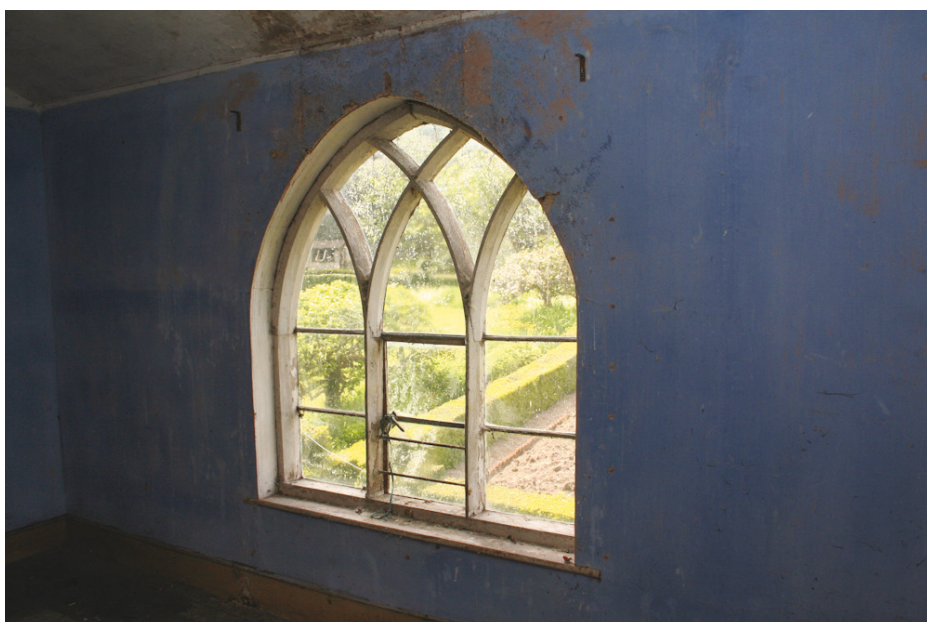
First_008

Left - Gothic tracery window, dating from circa 1823-27 relocated into the first floor accommodation. The original window incorporates round saddle bars, but has lost its original leaded-lights.

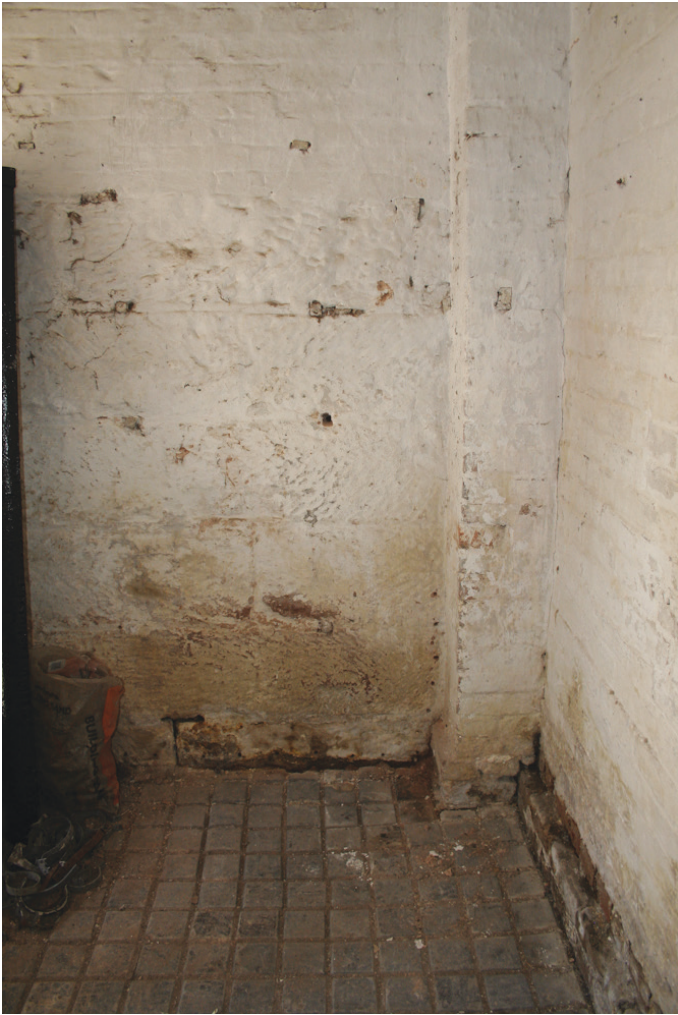
Ground_027 - Bothy Interior

Above left - stone masonry wall, at low level to the internal cross wall, with six courses and large blocks of regular tooled pink ashlar, probably the remnants of an earlier building, with later blue brick floor.

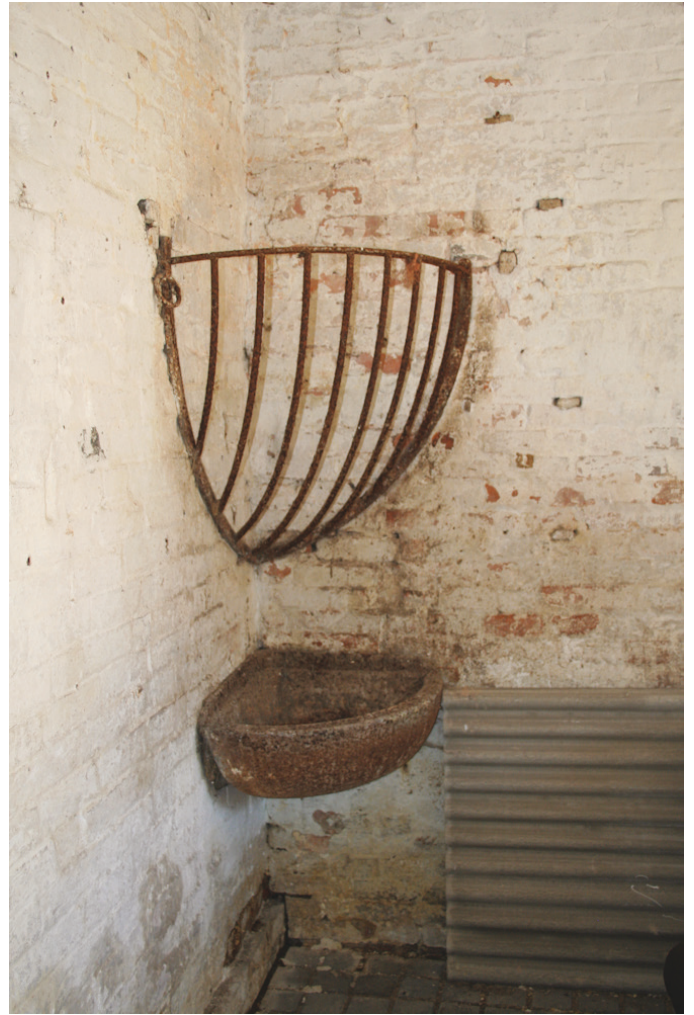
Ground_028 - Above right - the only original iron manger left within the complex is contained within the stable to the Bothy and a cast-iron water bowl or mash bowl, both by Musgrave's, ca. 1890

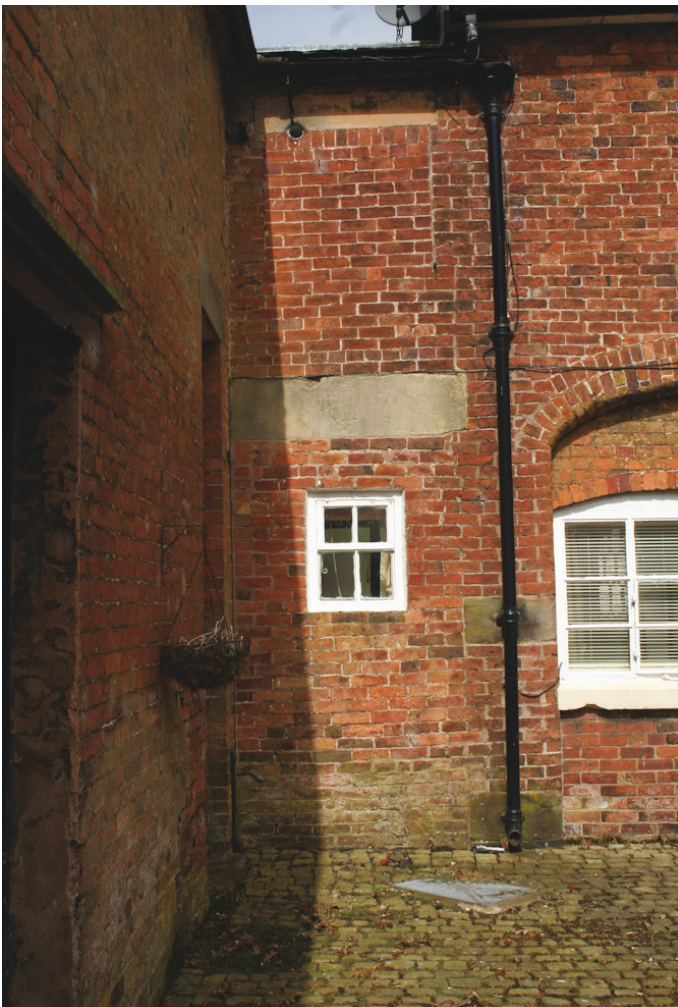
Exterior_013 - Left - junction of The Bothy and the Stables - the gap was infilled by 1874 and had a ground level doorway (later infilled), which would have provided a through-route to the outer stable yard and a first floor hay loft or window.

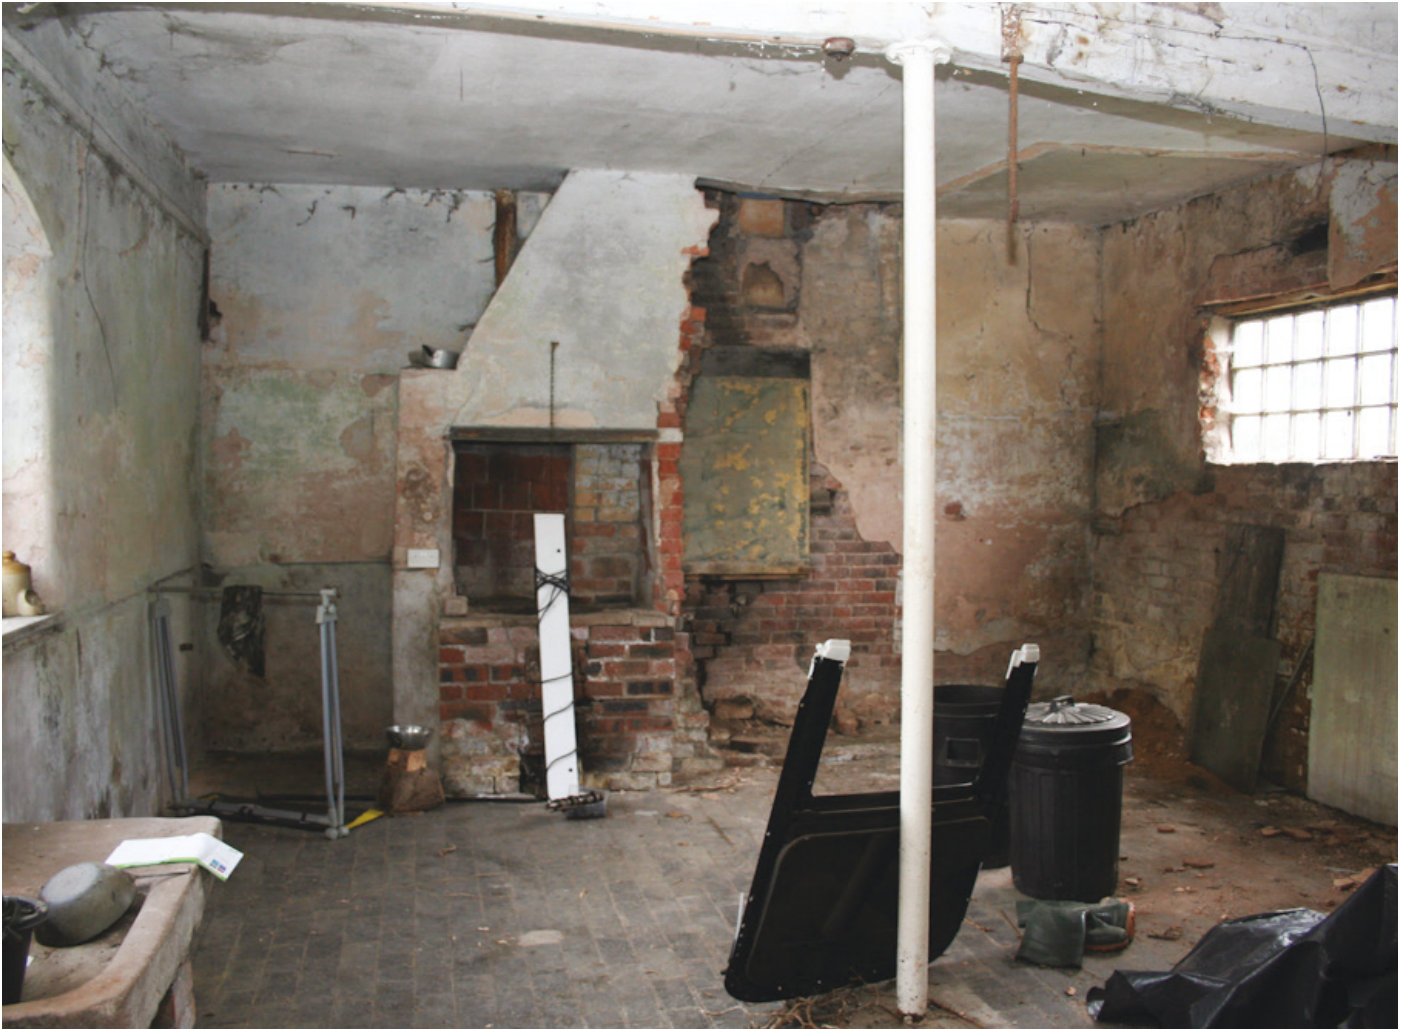
Ground_029 - Western Stableblock (Ground Floor)

Late 19th century Laundry Room, converted from a pair of stables (four stalls). The internal dividing brick wall was removed at ground floor level and replaced with an oak beam and cast-iron post, supporting the loadbearing brick wall above and the joists.

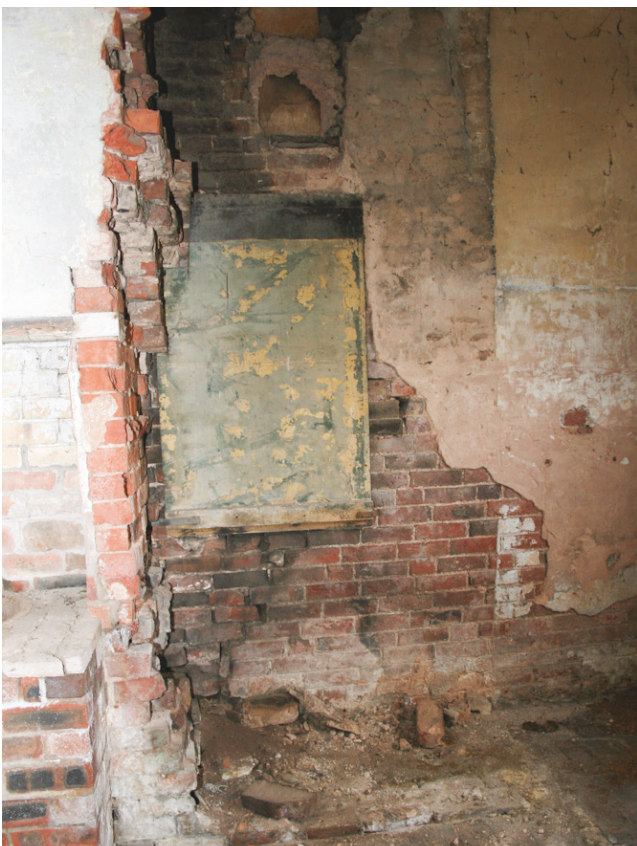
Ground_030 - The chimney breast and hearth was inserted, not keyed into the masonry, and has largely collapsed, leaving just the flue with the 'copper' and small heated chamber below.

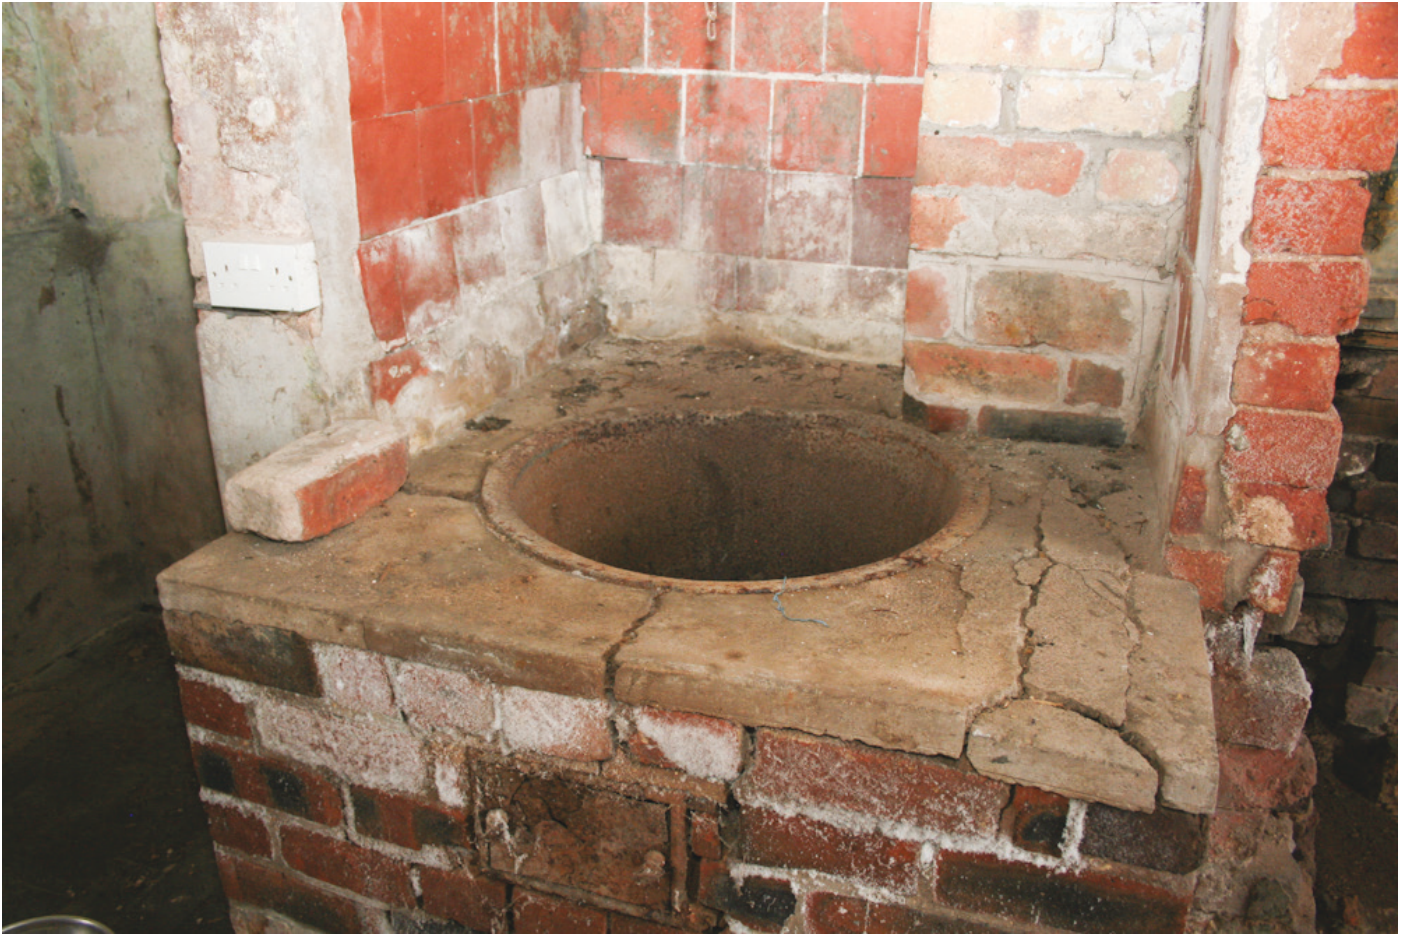
Ground_031 - Western Stableblock (Ground Floor)

Cast-iron copper, brick fire box with cast-iron door and stone thrall (damaged), clay tiles, inserted early C20

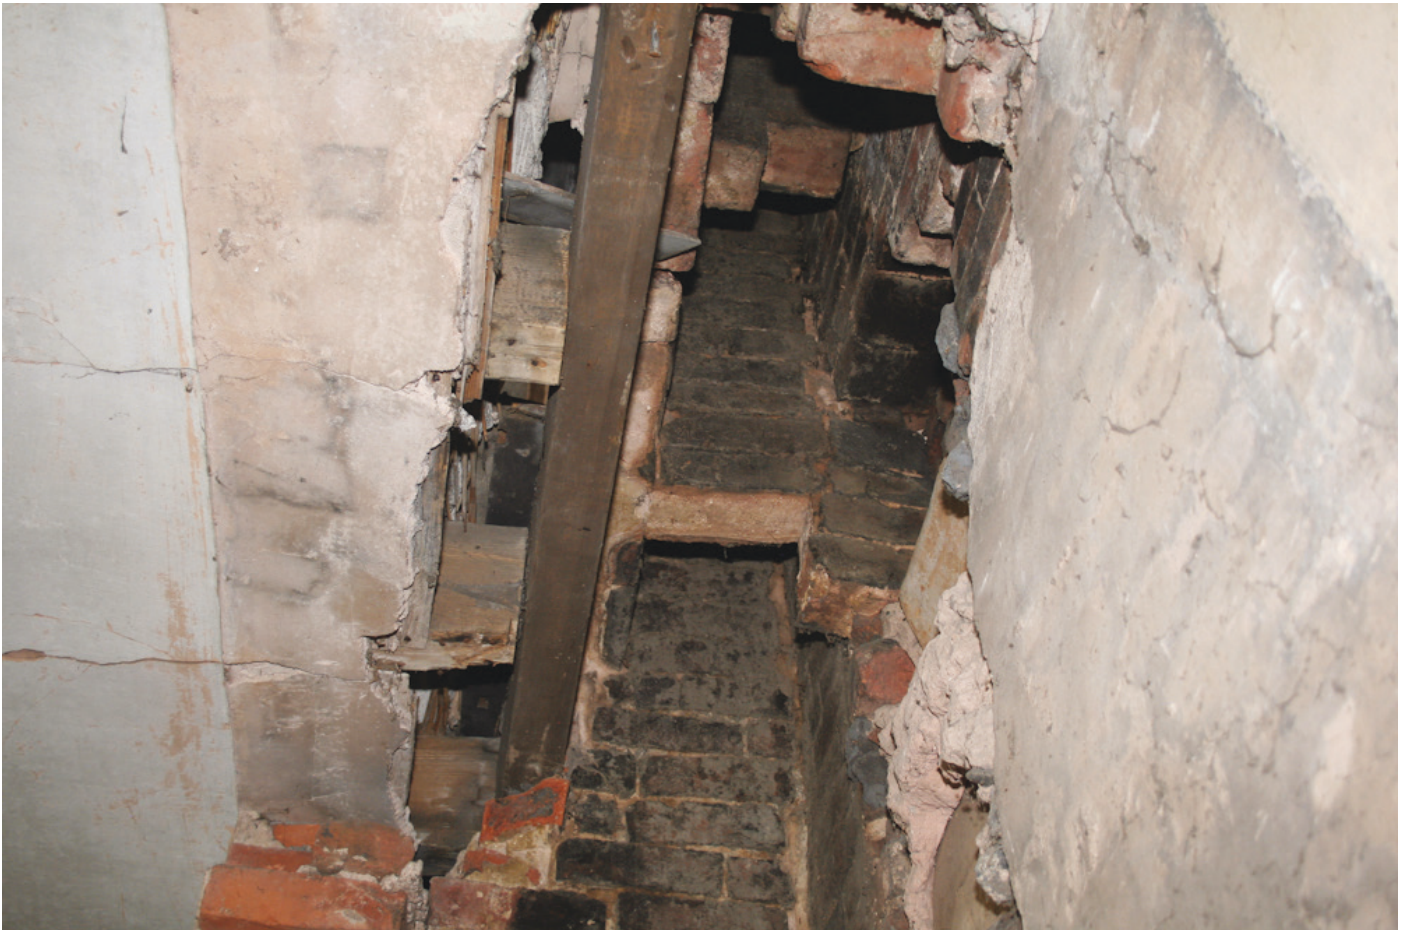
Ground_032 - internal view of collapsed flue and withies, and brickwork bearing onto inserted floor joist

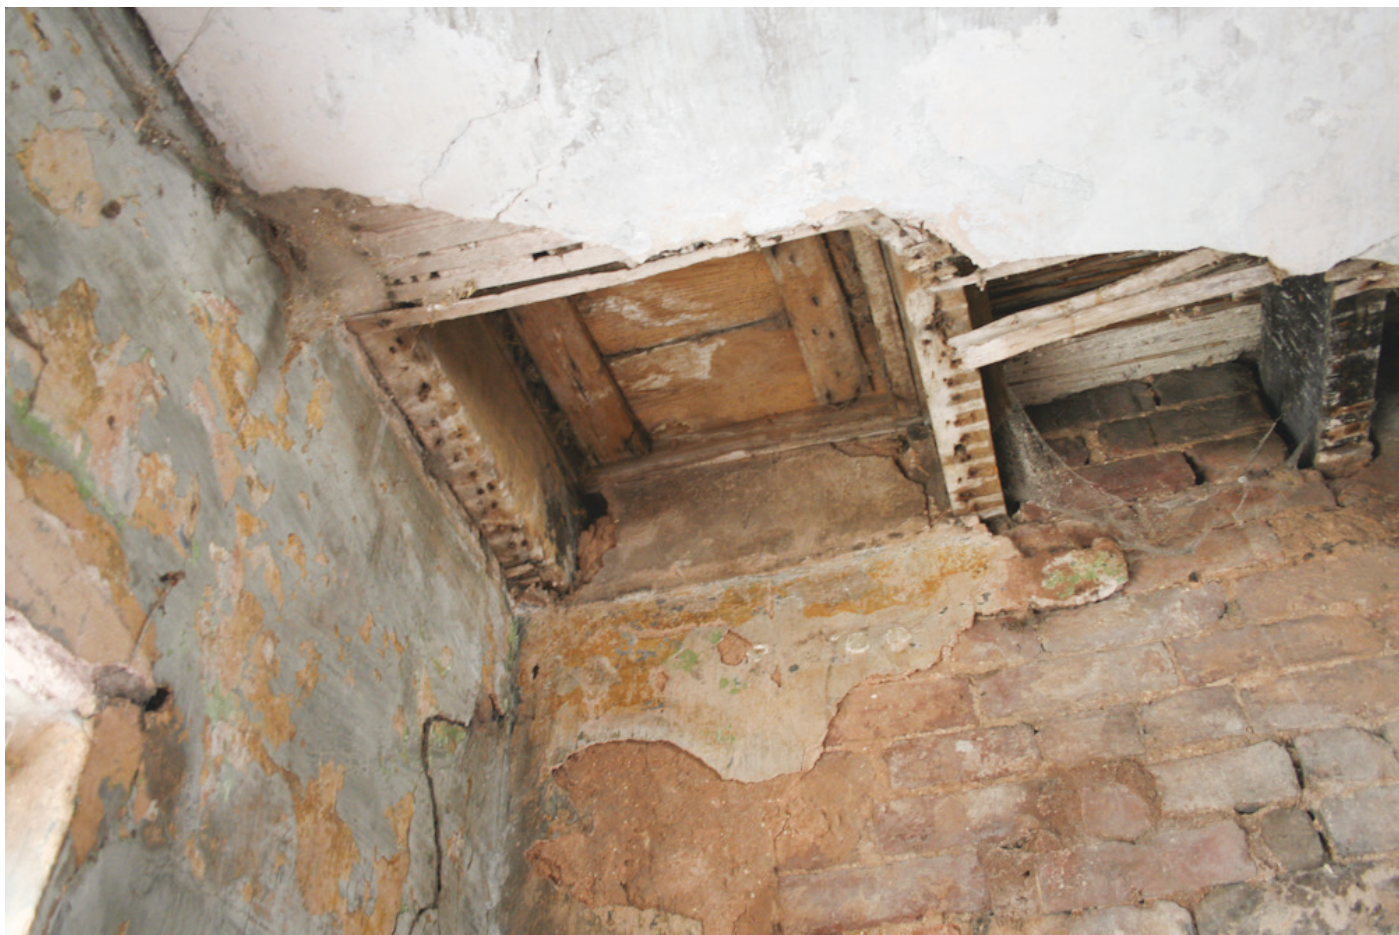
Ground_033 - Western Stableblock (Ground Floor)

hatch for dropping hay down to horses in former stables, lath and lime plaster ceiling. Original feed hatches and plastered ceilings for the stables were retained in-situ in each corner of this block

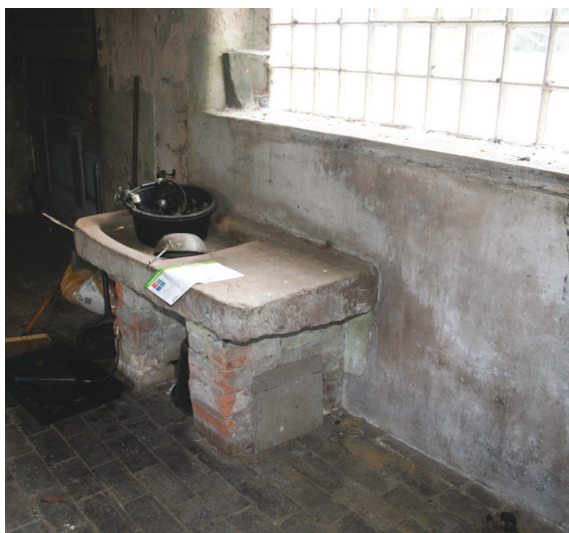
Ground_034

Stone sink from C19 laundry

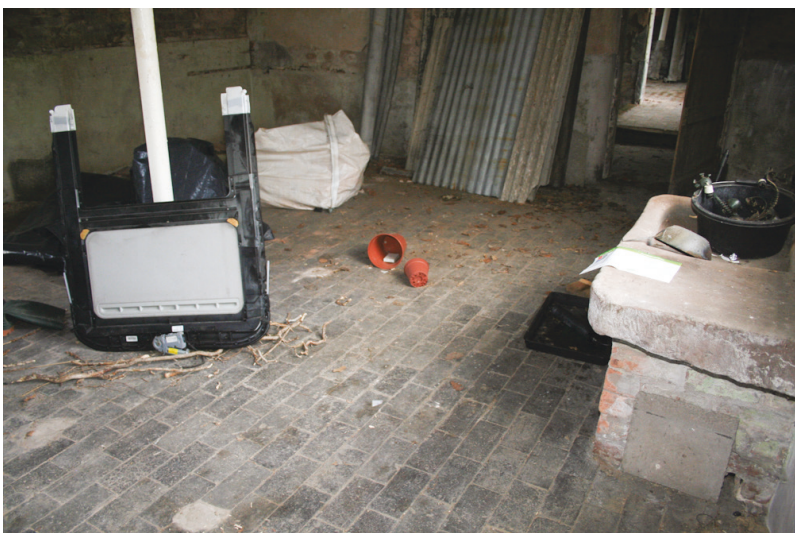
Ground_035

Blue-clay paved floor
