# Excavation of the Town Defences at Green Street, Northampton, 1995-6

ANDY CHAPMAN

## SUMMARY

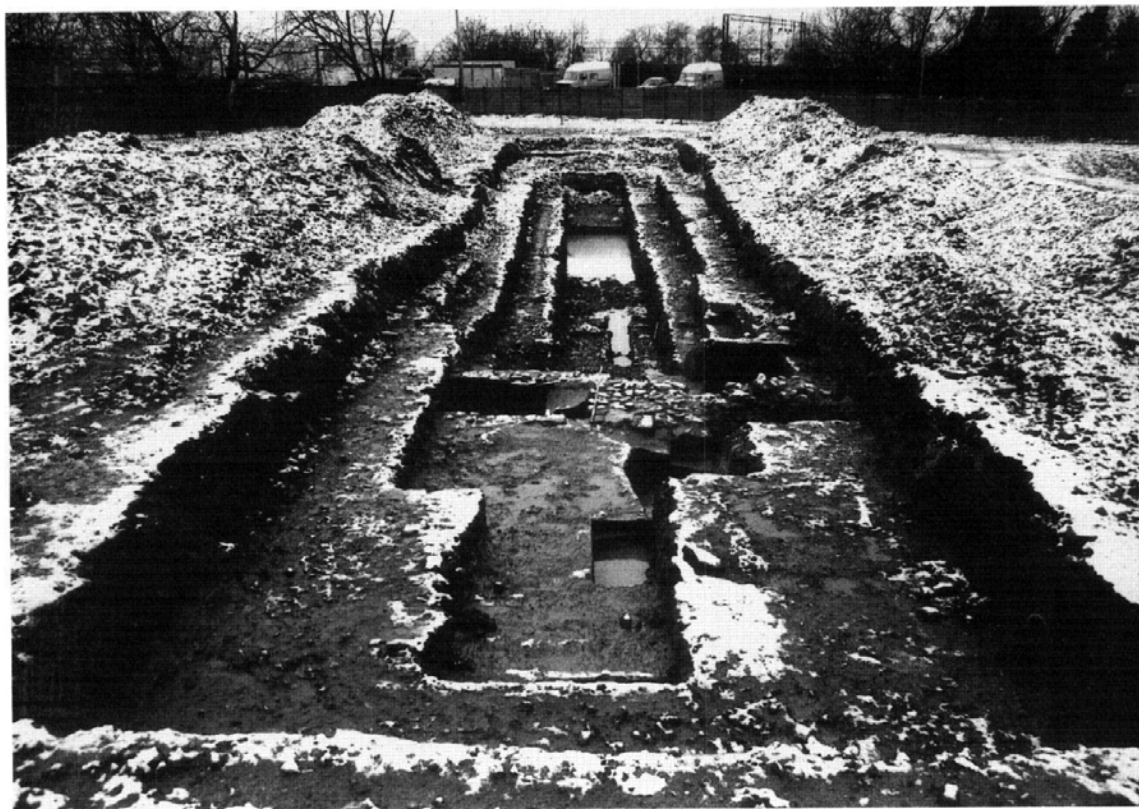
Plate 1 Trench 1, looking south-west and showing: the medieval wall (centre), the Saxon bank partially obscured by later deposits (foreground) and the medieval and Civil War ditches (background), as first exposed in December 1995.

The first stage of evaluation comprised the machine excavation of trench 1 to determine whether any remains of the former defences were present on the site. The trench was 43.0m long and 6.0-8.0m wide, descending in a series of *c.* 1.0m steps (Figs 2 and 7; Plate 1). Work commenced at the eastern end and the

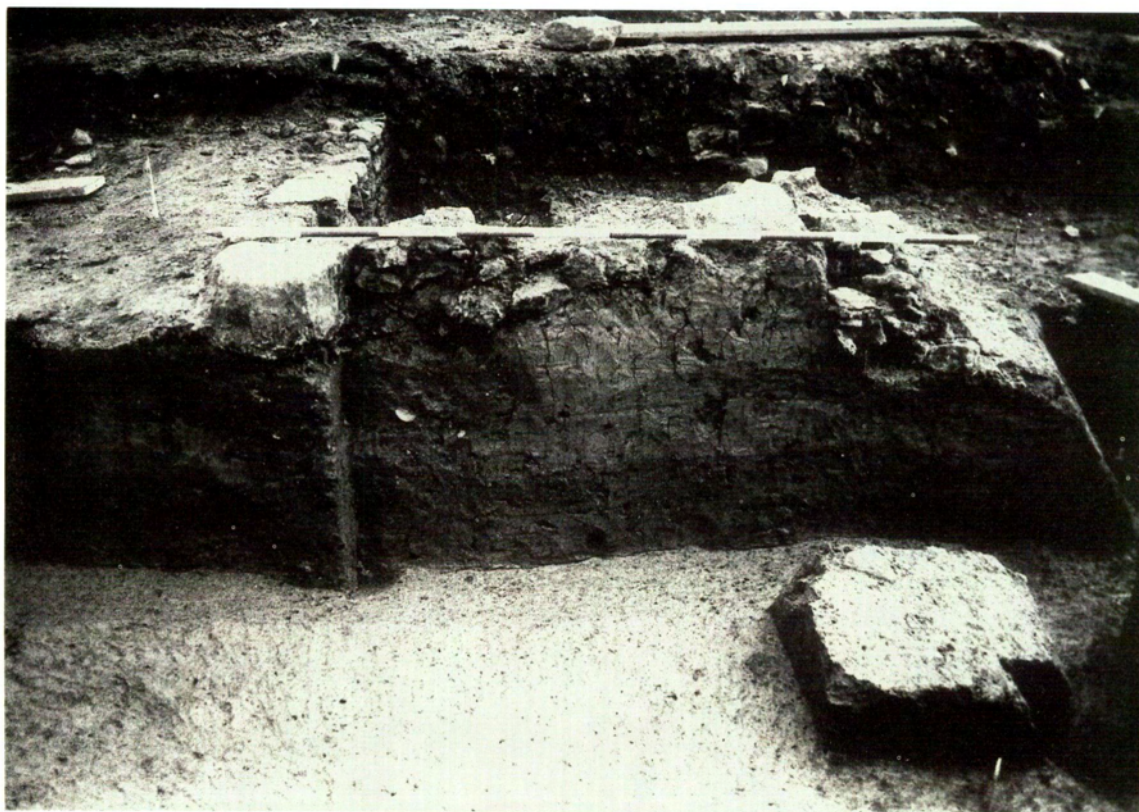
Plate 2 Trench 1, section across Saxon bank looking south-east (Fig. 10, S13); with remnants of the late Saxon stone revetment (right), and the medieval town wall (left).

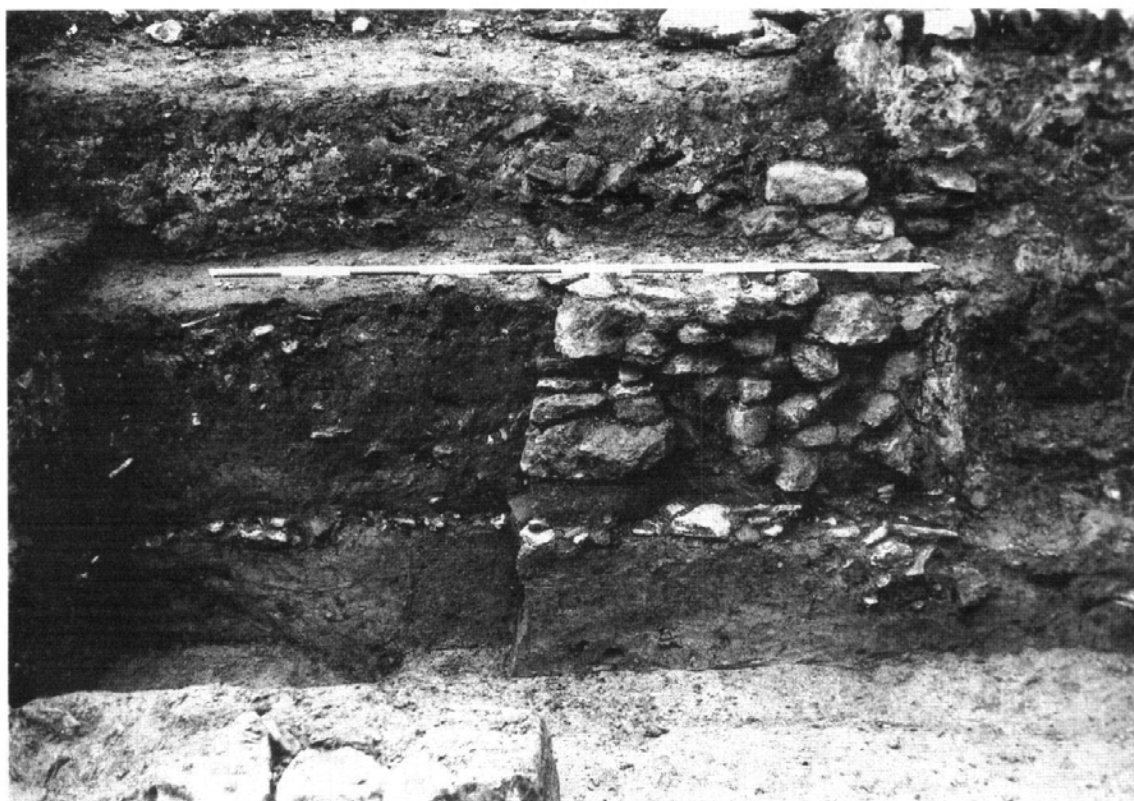
Plate 3 Trench 1, section looking north-west (Fig. 10, S12) and showing: the late Saxon revetment slot (bottom left); the late Saxon road metalling; and the overlying medieval town wall, cut by a post-medieval tanning pit (right).

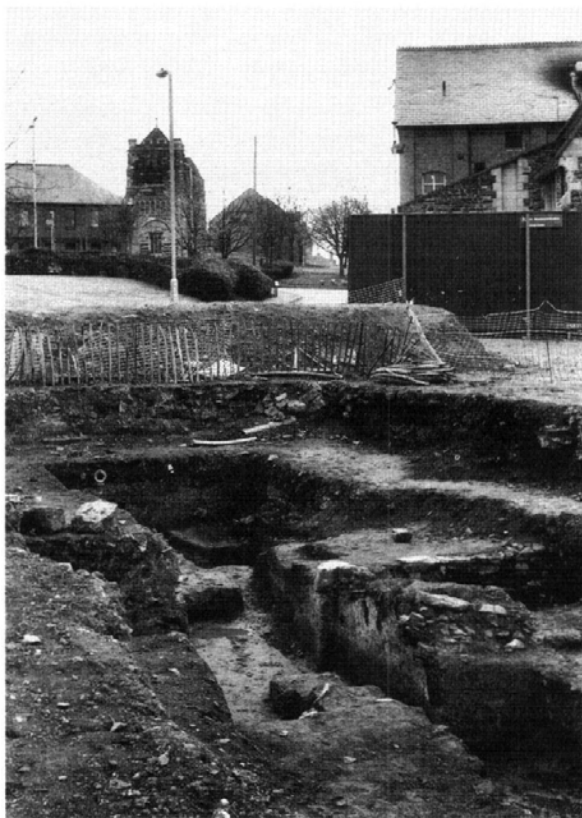
Plate 4 Trench 1, looking east: showing the Saxon bank in relation to Green Street and St. Peter's Church

A steep-sided, linear slot, with post-pits at intervals of 0.75m, ran along the outer face of the bank in trench 1 (Figs 10 and 12, context F97, and Plate 4). It would have held a timber revetment which probably comprised substantial upright posts supporting horizontal planking. There is no evidence for the use of any other substantial timbers in association with the bank. No similar slot was seen at the front of the bank in trench 2 but the appropriate levels were not fully investigated and it is possible

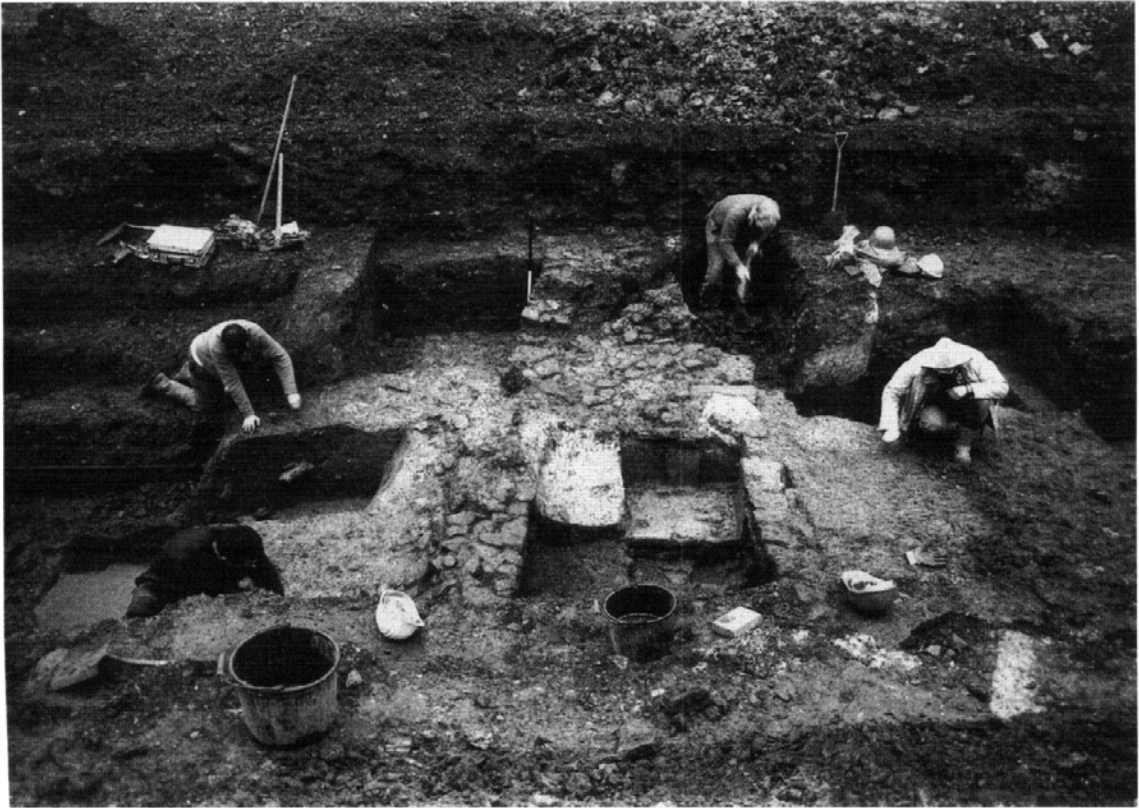
Plate 5 Trench 1, looking north and showing: the medieval town wall (top centre, with the Saxon bank to the right and the ditches to the left); disturbed by the post-medieval stone-lined pit (bottom centre).

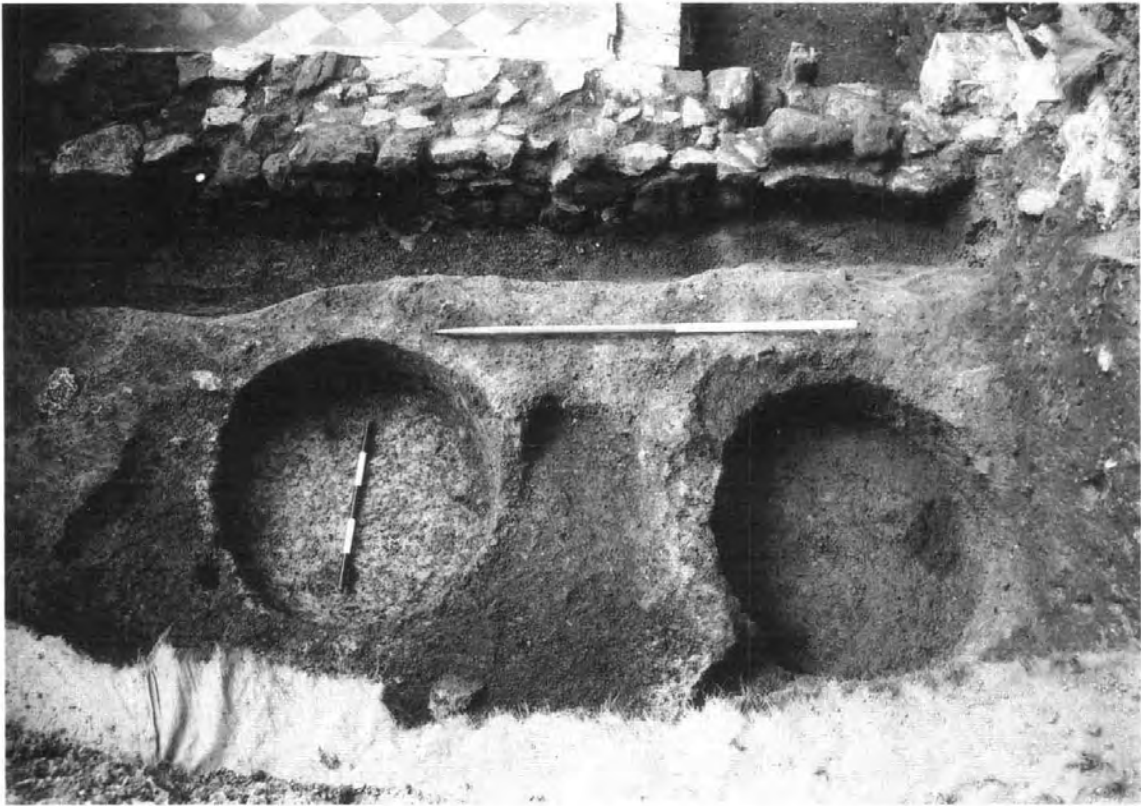
Plate 6 Trench 4, looking south-west, showing tanning pits cut into the top of the Saxon bank, and the post-medieval revetment wall.
